Your Ref: BMW X4  
(chassis number WBAUJ32020LK41874)  
Our Ref : CI/TP21003964/D

**INSPECTION REPORT OF AN UNREGISTERD BMW X4 MOTOR CAR WITH CHASSIS NUMBER WBAUJ32020LK41874**

1. I refer to your request on 25 March 2021 to conduct a physical inspection of an unregistered BMW X4 motor car bearing chassis number WBAUJ32020LK41874 (herein referred to as "**Motor Car**").
2. The purpose of this inspection is to primarily determine: -
  - a) the general road worthiness of the Motor Car, whether there is any possible mechanical problem(s) and/or operational issue(s) to the various operating systems of the Motor Car;
  - b) whether there was any work (repair) done to the chassis/structural body of the Motor Car, and if yes, whether all major components, welding and critical points of the Motor Car has been properly restored.

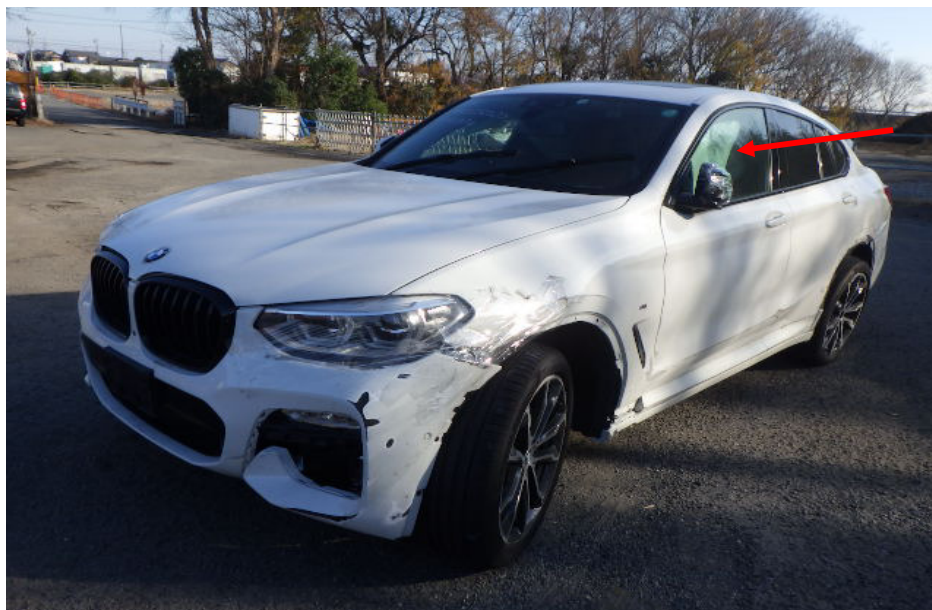
**Photo 1** shows the front left body of the Motor Car (photograph provided to me). The Motor Car was observed to have sustained damages along its entire left side portion. The front bumper, front bumper left lower grille, front bumper left day running light, front left headlamp and front left fender were amongst the parts that were observed to have been damaged. The left side curtain airbag (arrowed) was also deployed.

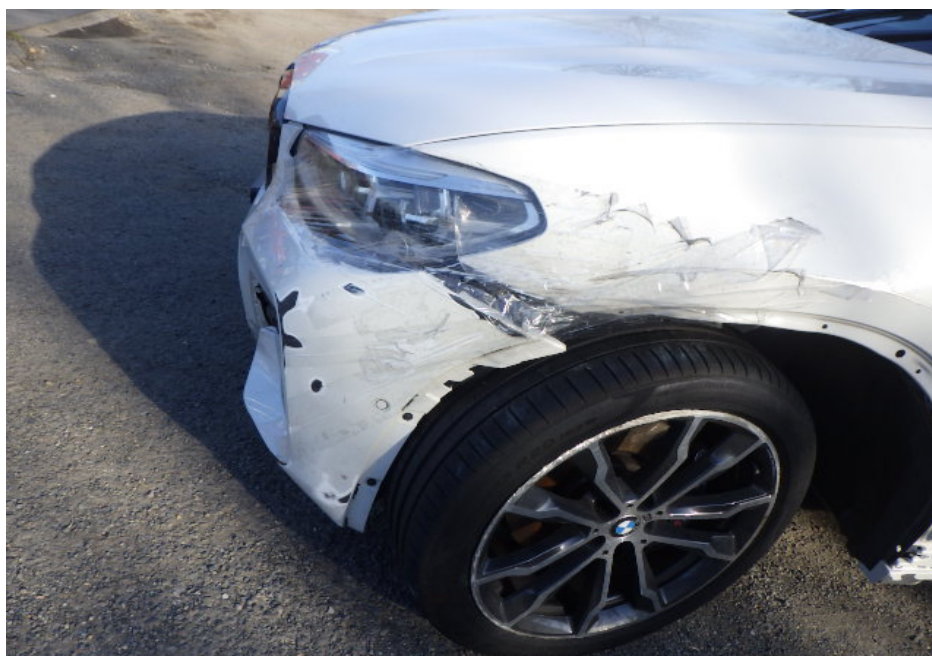
**Photo 2** shows a closer view of the damage at the front left portion of the Motor Car (photograph provided to me). The front bumper, front left fender, front left fender wheel arc garnish and front left wheel rim were amongst the parts that were observed to have been damaged. The orientation of the front left wheel and front right wheel (refer to photograph 5 below) indicate damage to the front left undercarriage parts of the Motor Car.

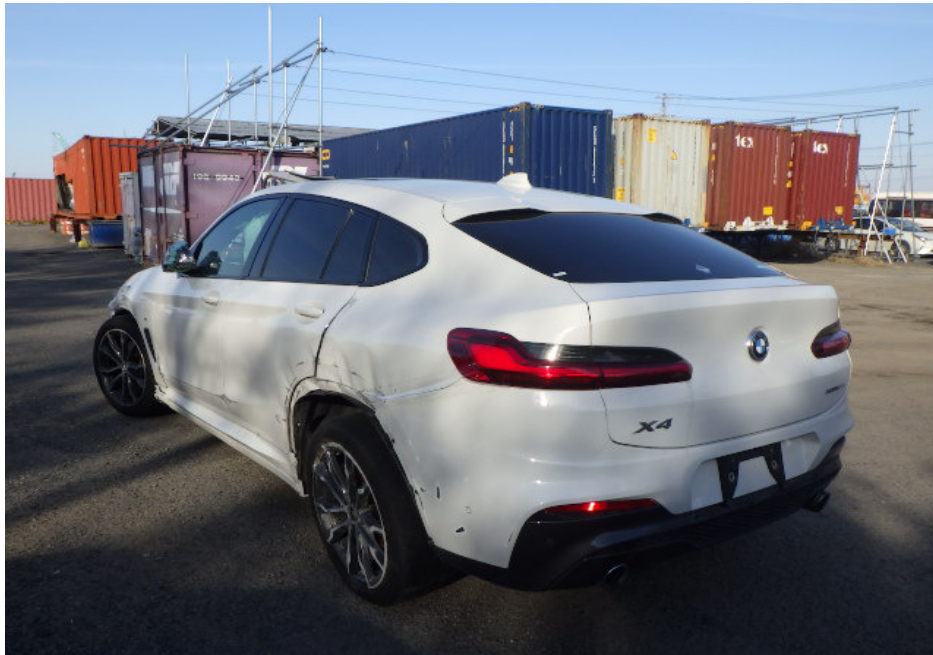
**Photo 3** shows the rear left body of the Motor Car (photograph provided to me). The Motor Car was observed to have sustained damages along its entire left side portion. The rear bumper, rear left fender, rear left fender wheel arc garnish, rear left wheel rim and rear left door were amongst the parts that were observed to have been damaged.

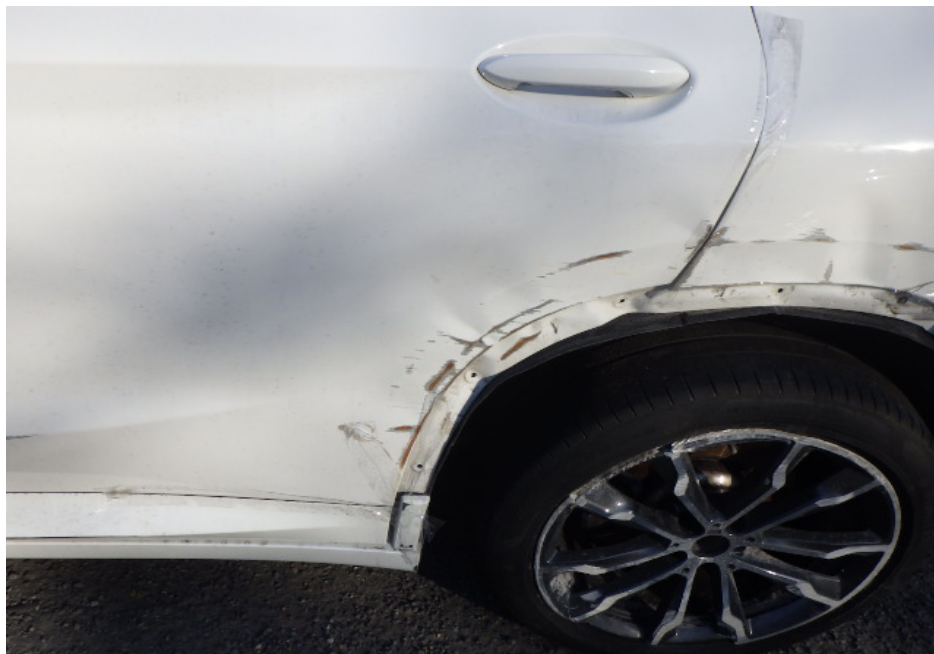
**Photo 4** shows a closer view of the damage at the rear left portion of the Motor Car (photograph provided to me). The rear left fender, rear left fender wheel arc garnish, rear left wheel rim, left rear door, left rear door lower moulding and left rocker panel garnish were amongst the parts that were observed to have been damaged.

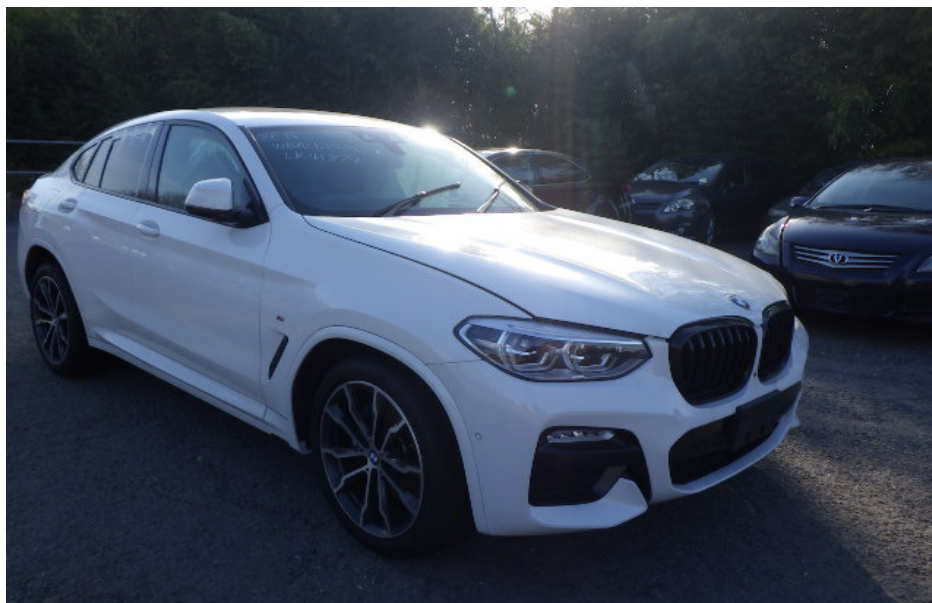
**Photo 5** shows the front right body of the Motor Car (photograph provided to me). The right side portion of the Motor Car was observed to be without any physical damage.

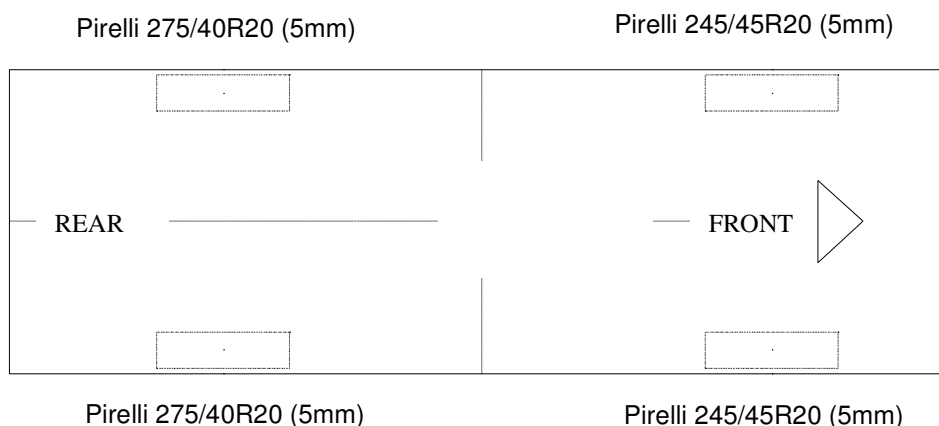
8. It was fitted with 20inch sport wheel rims that were wrapped with tyres that were observed to be of serviceable condition. The tyres were also sufficiently inflated for vehicular operation. The tyre brand, tyre size and approximate remaining tread depth of the 4 tyres of the Motor Car were recorded as follows: -

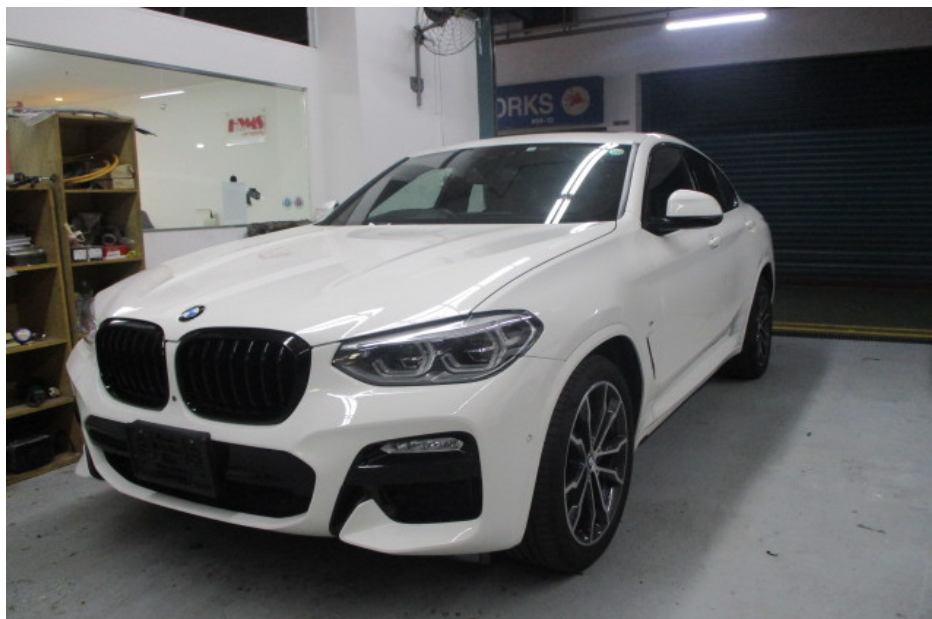
**Photo 6** shows a general view of the front left body of the Motor Car at the time of my inspection. The Motor Car was observed to be in a relatively good general condition with no loose exterior fittings observed. The body parts along the entire left side portion of the Motor Car were visually examined and it was observed that the repair/restoration works carried out to the damaged area of the Motor Car (refer to photograph 1 - 4 above) were reasonably adequate and in order.

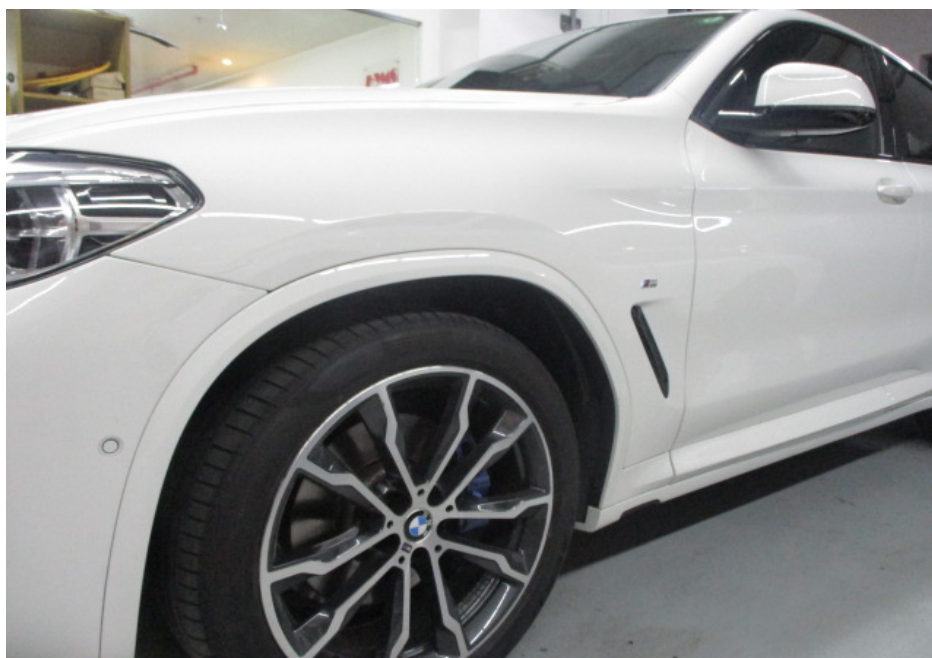
**Photo 7** shows a closer view of the front bumper, front left fender, front left wheel arc garnish, front left wheel rim, left wing mirror and left front door of the Motor Car. The body parts along the entire left side portion of the Motor Car were visually examined and it was observed that the repair/restoration works carried out to the damaged area of the Motor Car (refer to photograph 1 & 2 above) were reasonably adequate and in order.

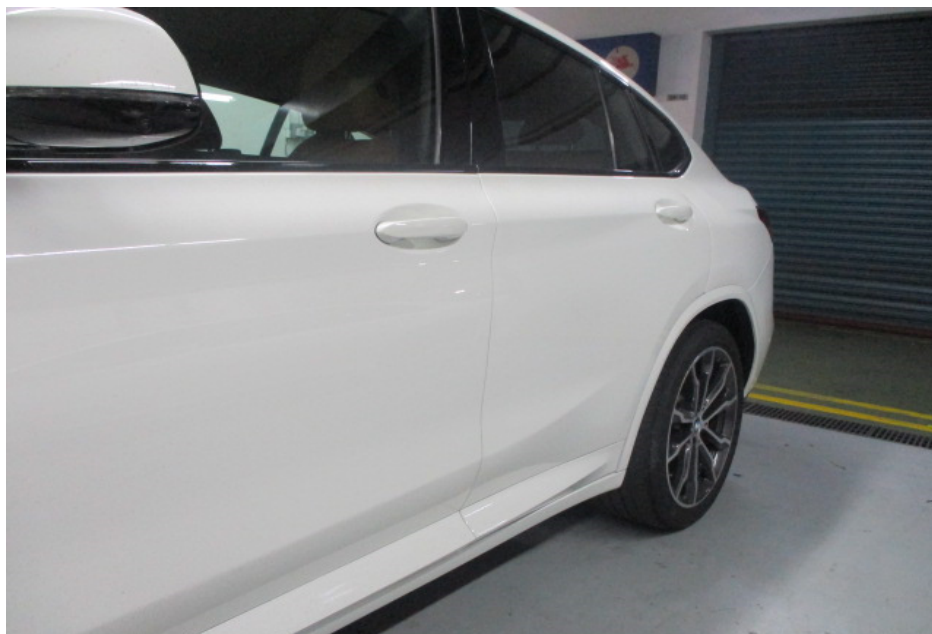
**Photo 8** shows a closer view of the left front door, left front door lower moulding, left rear door and left rear door lower moulding of the Motor Car. The body parts along the entire left side portion of the Motor Car were visually examined and it was observed that the repair/restoration works carried out to the damaged area of the Motor Car (refer to photograph 1 - 4 above) were reasonably adequate and in order.

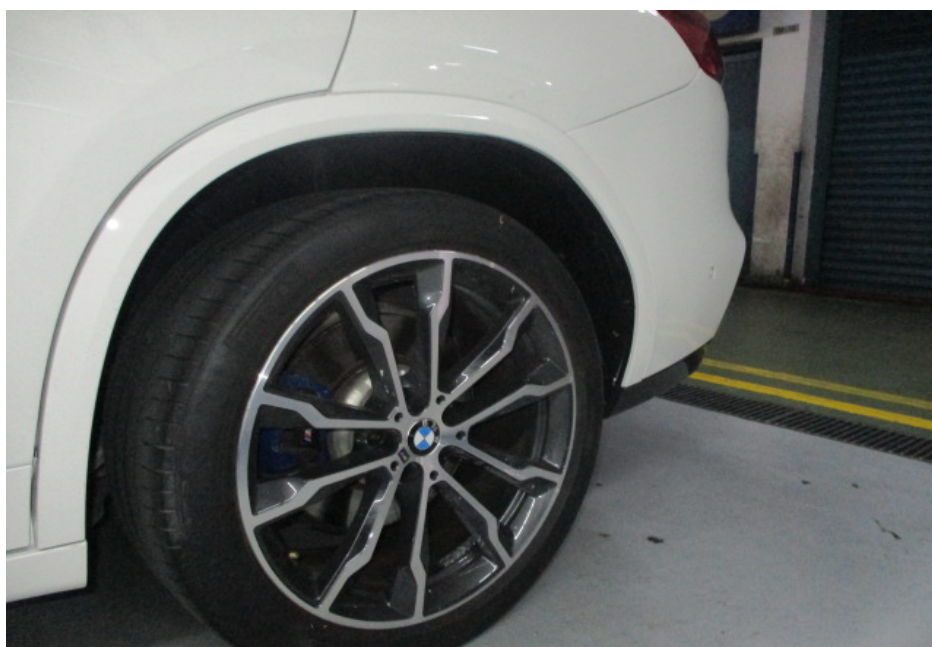
**Photo 9** shows a closer view of the rear left fender, rear left fender wheel arc garnish, rear left wheel rim and rear bumper of the Motor Car. The body parts along the entire left side portion of the Motor Car were visually examined and it was observed that the repair/restoration works carried out to the damaged area of the Motor Car (refer to photograph 3 & 4 above) were reasonably adequate and in order.

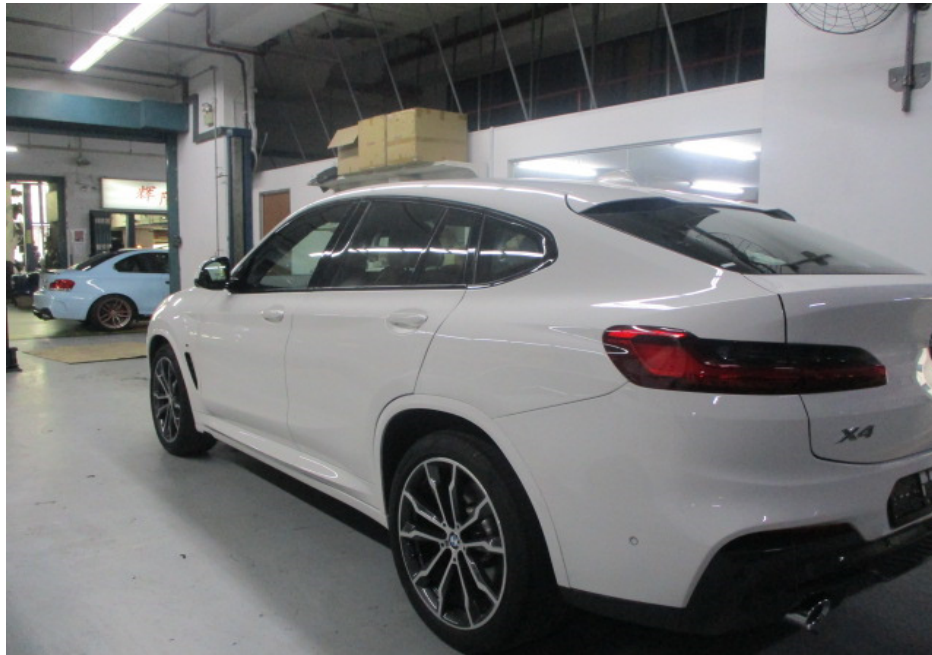
**Photo 10** shows a general view of the rear left body of the Motor Car at the time of my inspection. The Motor Car was observed to be in a relatively good general condition with no loose exterior fittings observed. The body parts along the entire left side portion of the Motor Car were visually examined and it was observed that the repair/restoration works carried out to the damaged area of the Motor Car (refer to photograph 1 - 4 above) were reasonably adequate and in order.

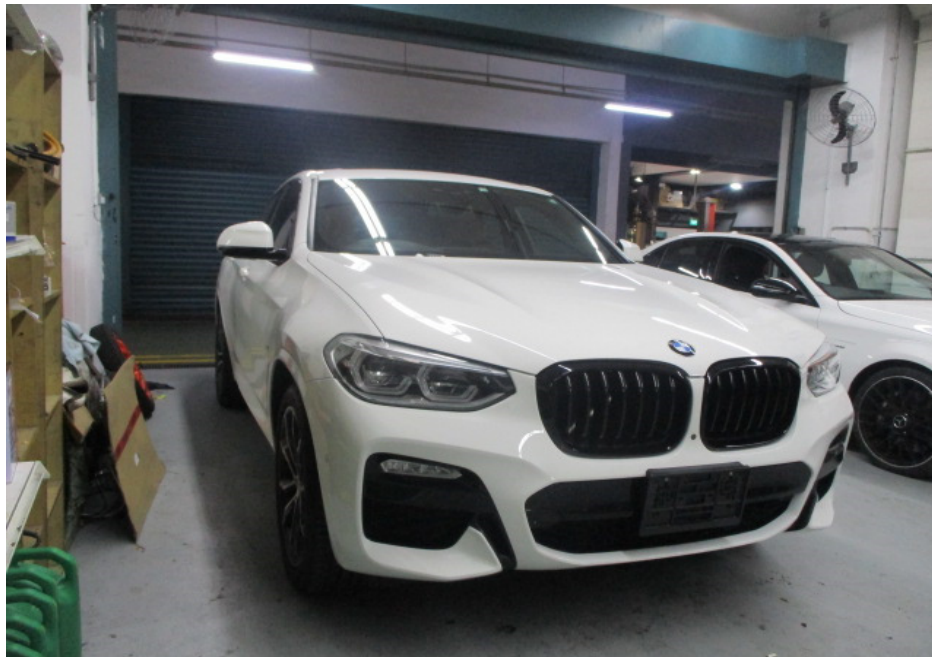
**Photo 11** shows a general view of the front right body of the Motor Car at the time of my inspection. The Motor Car was observed to be in a relatively good general condition with no loose exterior fittings observed. The mileage of the Motor Car recorded at the time of my inspection was 36,998km.

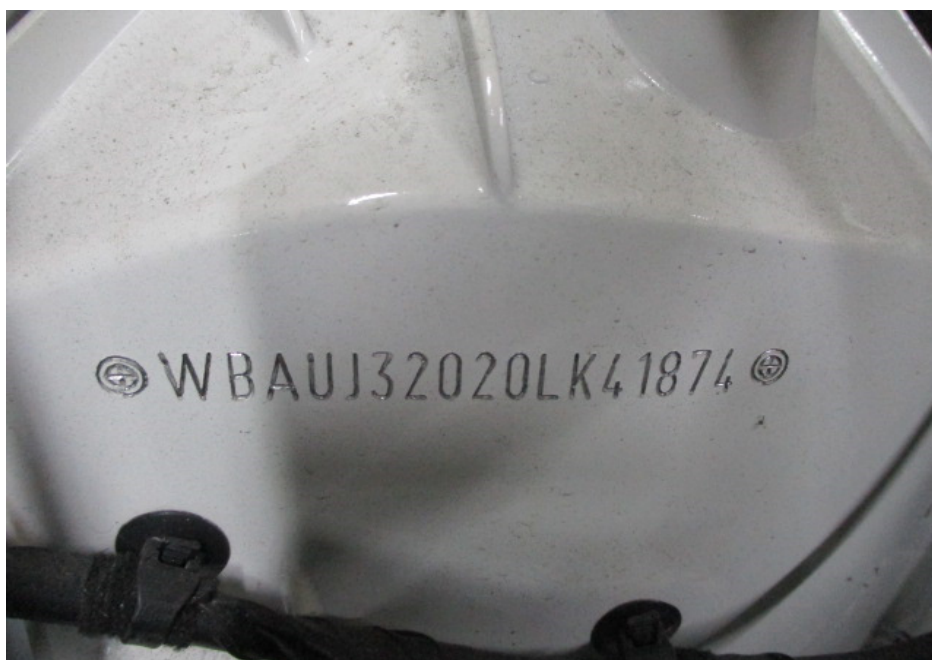
**Photo 12** shows the chassis number of the Motor Car. The chassis number recorded was WBAUJ32020LK41874.

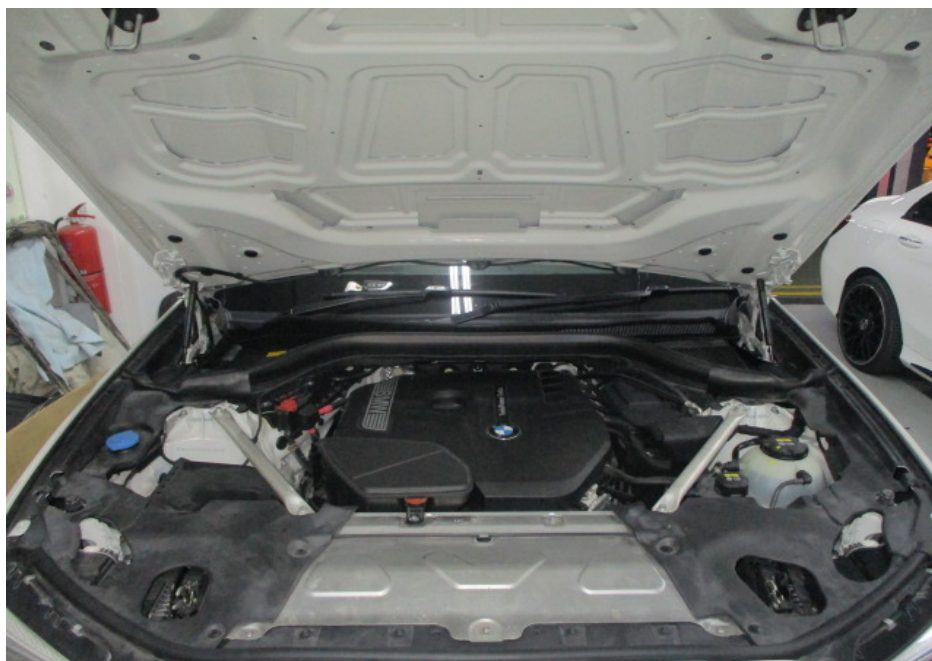
**Photo 13** shows a general view of the engine compartment of the Motor Car at the time of my inspection. The various parts and components inside the engine compartment were all observed to be intact and properly fitted. There was also no sign(s) or indication(s) of fluid leak and/or fluid stain found inside the engine compartment.

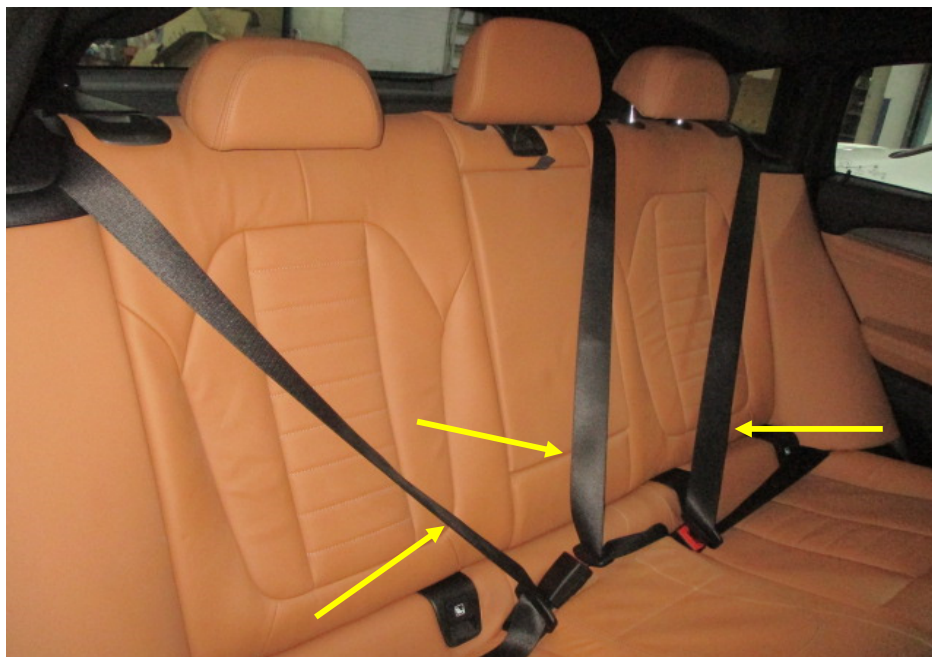
**Photo 14** shows the rear seats of the Motor Car. All the seats of the Motor Car were secured via seat rails to the floorboard. They were also fitted with a retractable seat belt reel and a pre-tensioner. The seat belts (arrowed) were tested and were able to be fastened into the respective pre-tensions that were fitted on the side of each individual seat.

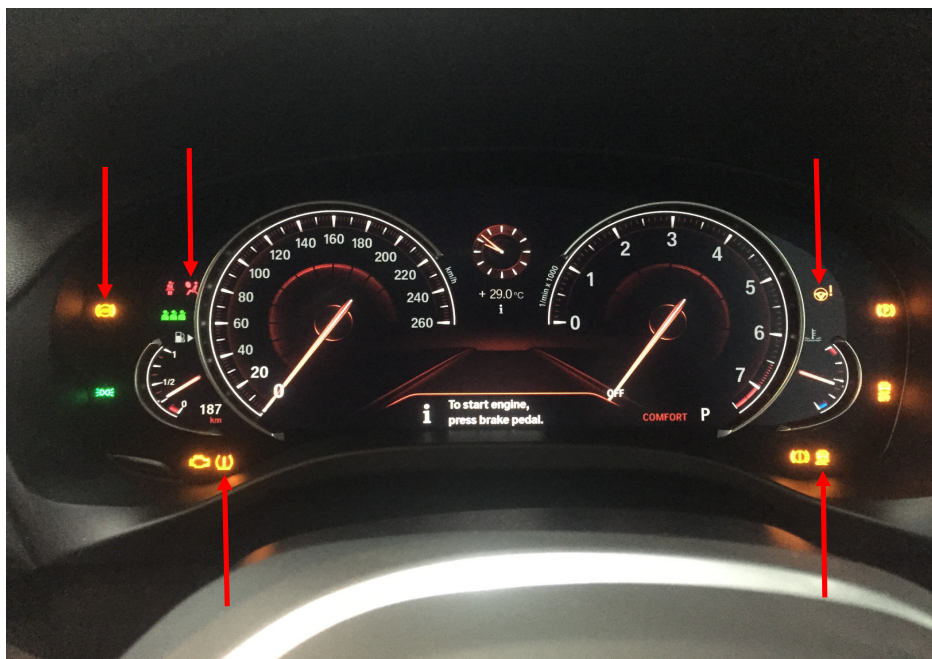
**Photo 15** shows the warning lights for the various electronic safety features appearing on the instrument panel of the Motor Car during its self-test when the engine is cranked, in particular the ABS, SRS, IAS, TPM and DSC lights (arrowed).

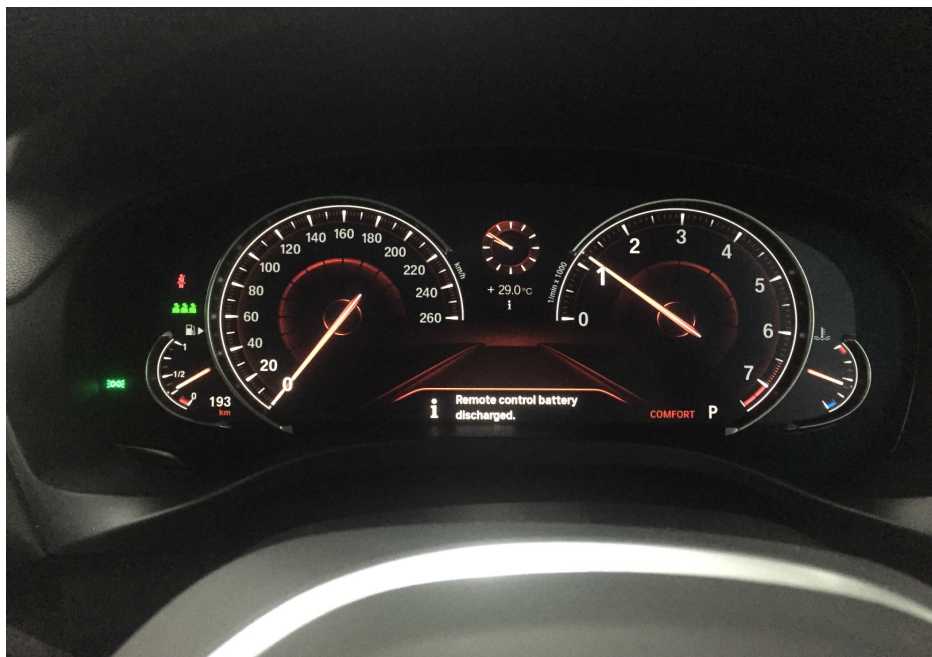
**Photo 16** shows the respective warning lights no longer illuminated, indicating that there is no fault detected to the ABS, SRS, IAS, TPM and DSC systems of the Motor Car during the self-test. These electronic systems were hence in working condition at the time of my inspection.

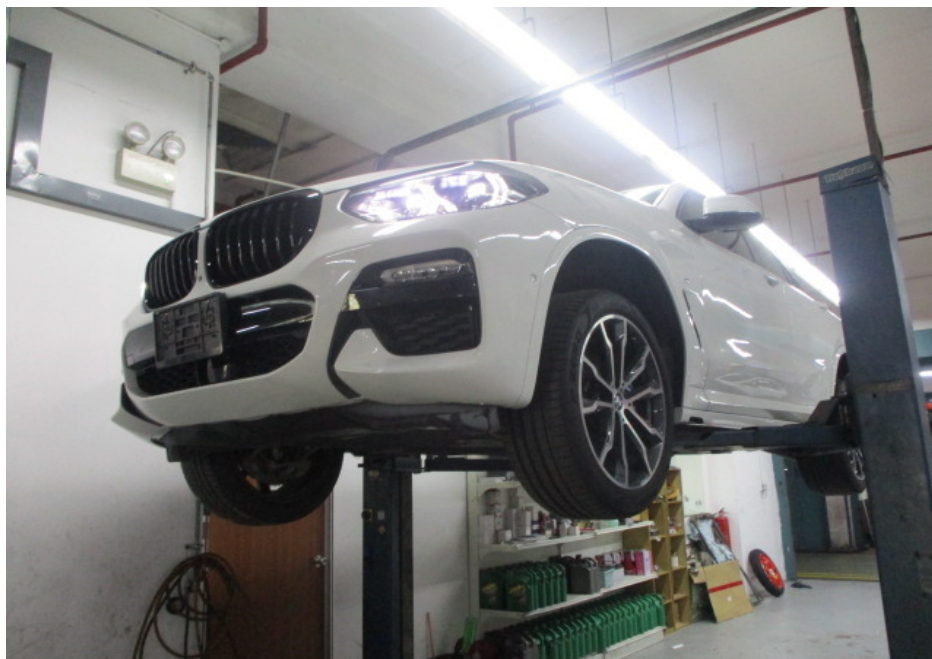
**Photo 17** shows the Motor Car hoisted up for checks on its undercarriage. There was no sign(s) or indication(s) of fluid leakage and/or fluid stain(s) on the underside of the Motor Car. The undercarriage components of the Motor Car were also all observed to be intact and secured in an appropriate manner.

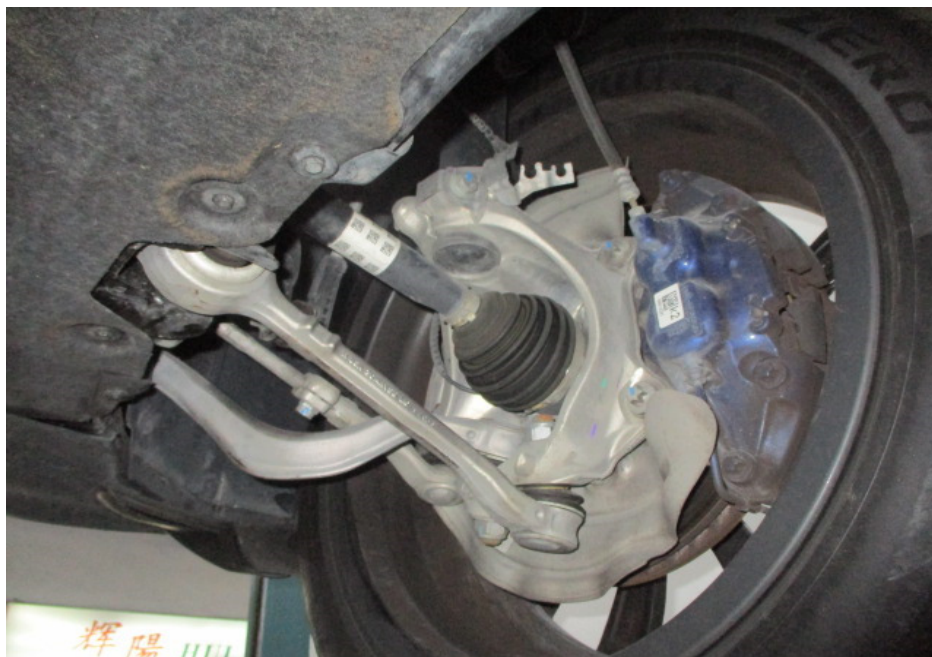
**Photo 18** shows the various undercarriage components at the front right wheel of the Motor Car. The mechanical components, control arms and linkages were all found to be intact and secured in an appropriate manner. I also did not observe any fluid leak and/or fluid stain on the underside of the Motor Car.

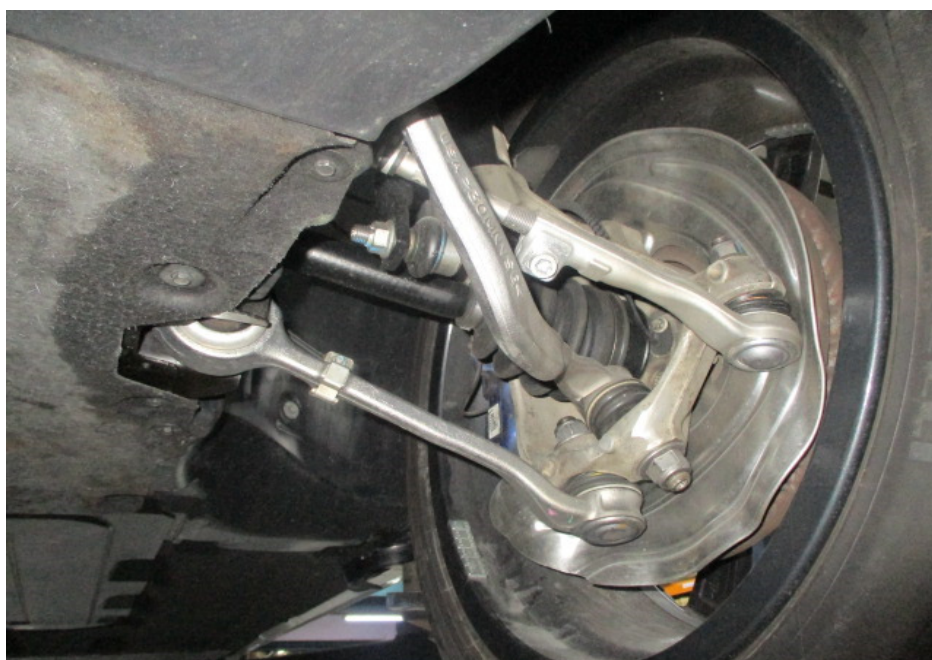
**Photo 19** shows the various undercarriage components at the front left wheel of the Motor Car. The mechanical components, control arms and linkages were all found to be intact and secured in an appropriate manner.

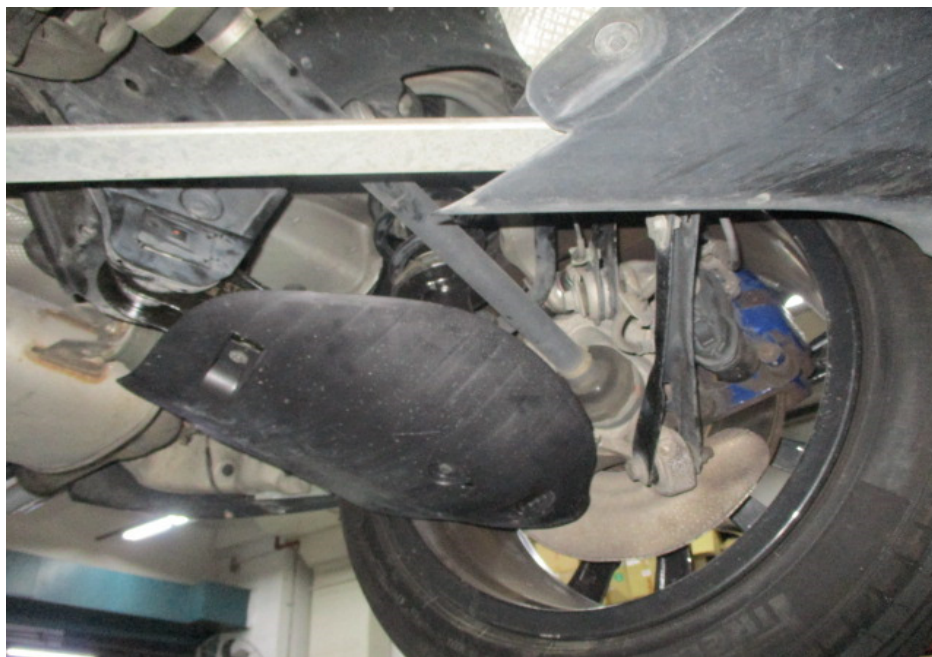
**Photo 20** shows a general view of the control arms and linkages at the rear left wheel of the Motor Car. I did not observe any fluid leak and/or fluid stain on the underside of the Motor Car. All of the Motor Car's undercarriage components were observed to be intact and secured in an appropriate manner.

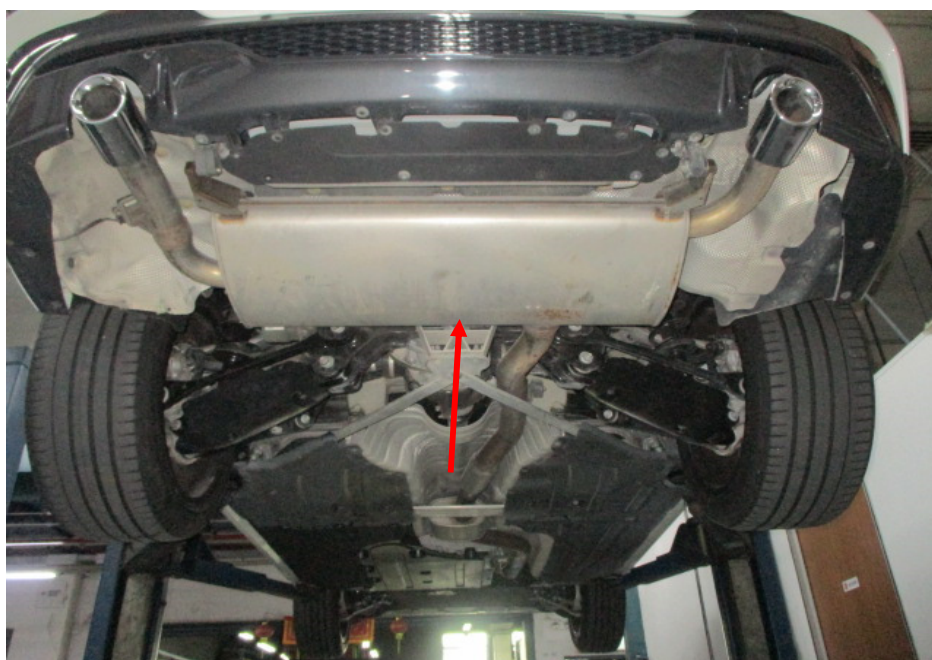
**Photo 21** shows the Motor Car's rear muffler (arrowed). My examination of the Motor Car's exhaust system revealed no sign(s) or indication(s) of any cut or weld marks along its exhaust pipes and on its catalytic converter.

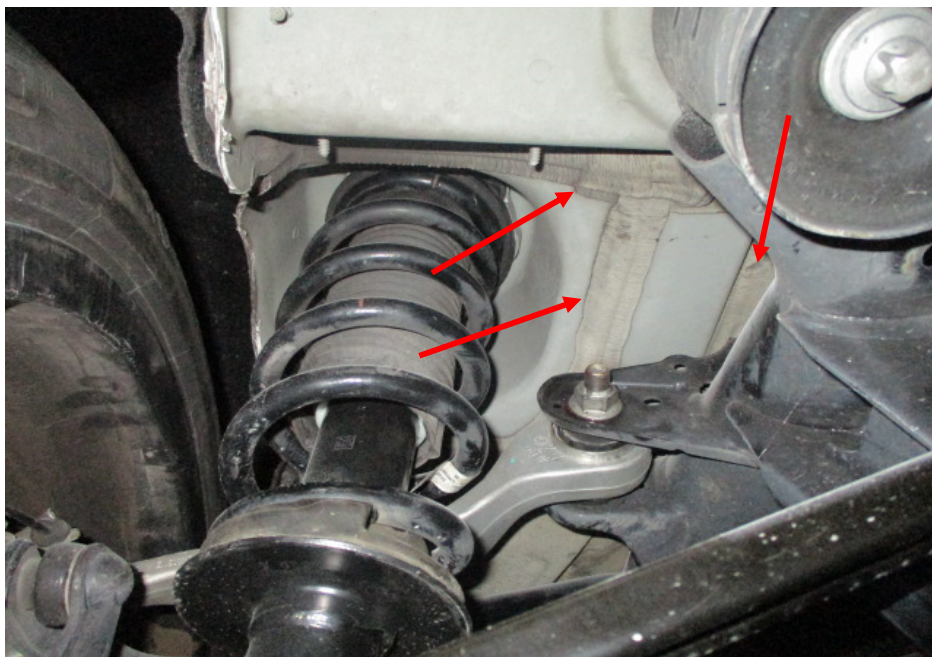
**Photo 22** shows the chassis/structural body at the underside rear left of the Motor Car. I did not find any weld marks other than original spot weld marks on the chassis/structural body of the Motor Car. The original factory sealant (arrowed) at the joints along the chassis/structural body was also untouched, indicating no work was done on the chassis/structural body of the Motor Car and that the chassis/structural body was originally fitted.

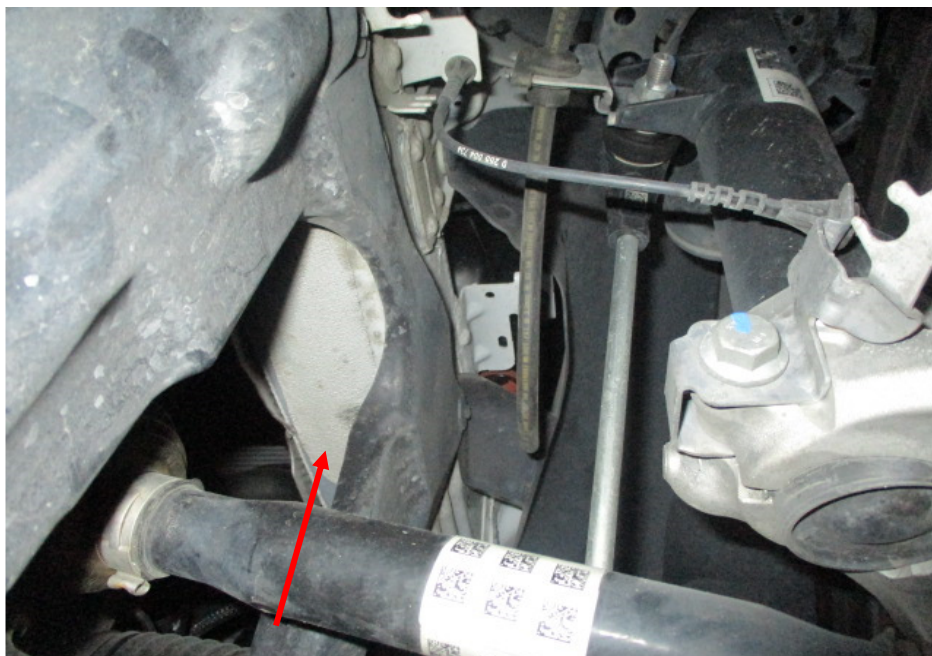
**Photo 23** shows the chassis/structural body at the underside front right of the Motor Car. The original factory sealant (arrowed) at the joints along the chassis/structural body was observed to be untouched. In general, I had found no work was carried out on the chassis/structural body of the Motor Car. The chassis/structural body of the Motor Car was originally fitted.

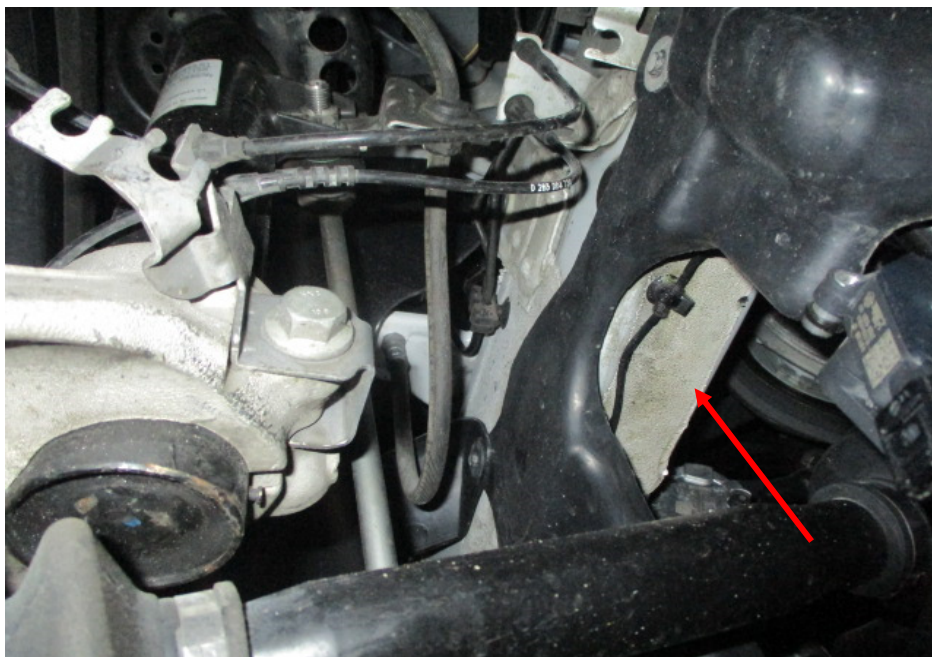
**Photo 24** shows the chassis/structural body at the underside front left of the Motor Car. I did not find any weld marks other than original spot weld marks on the chassis/structural body of the Motor Car. The original factory sealant (arrowed) at the joints along the chassis/structural body was also untouched, indicating no work was done on the chassis/structural body of the Motor Car and that the chassis/structural body was originally fitted.

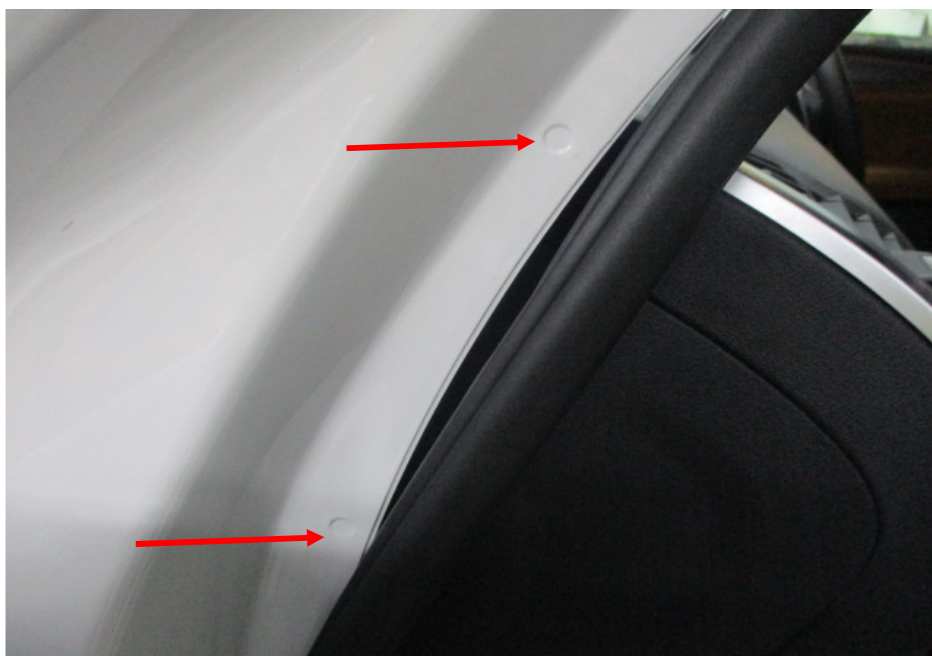
**Photo 25** shows the left side "A" pillar of the Motor Car. I did not find any weld marks other than original spot weld marks (arrowed) on the left side "A" pillar of the Motor Car which, indicates that there was no re-welding works carried out. In general, I had found all the non-detachable body panels of the Motor Car to be originally fitted at the time of my inspection.

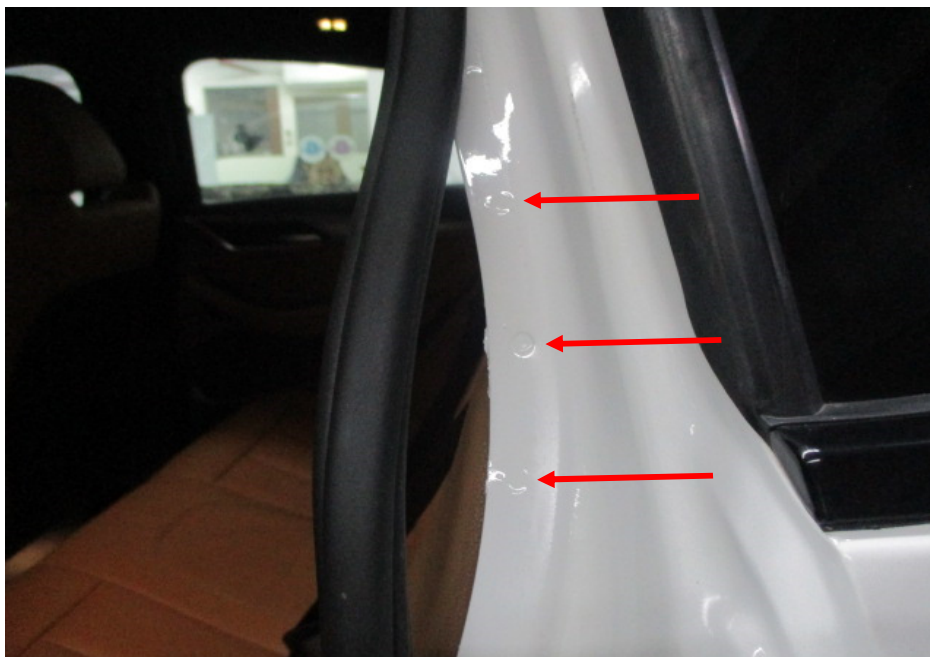
**Photo 26** shows the left side "C" pillar of the Motor Car. I did not find any weld marks other than original spot weld marks (arrowed) on the left side "C" pillar of the Motor Car which, indicates that there was no re-welding works carried out. In general, I had found all the non-detachable body panels of the Motor Car to be originally fitted at the time of my inspection.
