Your Ref: D21001017MFVS
Our Ref : CS4/FCI21004180/P

**TECHNICAL INVESTIGATION REPORT OF FIRE INCIDENT INVOLVING THE
INSURED VEHICLE YN 5689K ON 23rd March 2021**

Vehicle Registration No.	: YN 5689K
Make / Model	: DULEVO, 5000 VELOCE EU5 A/T 2WD ROAD SWEEPER
Chassis No	: ZA9S5020E5AC38183
Year of Registration	: 26 July 2014
Mileage	: N.A (wiring affected)

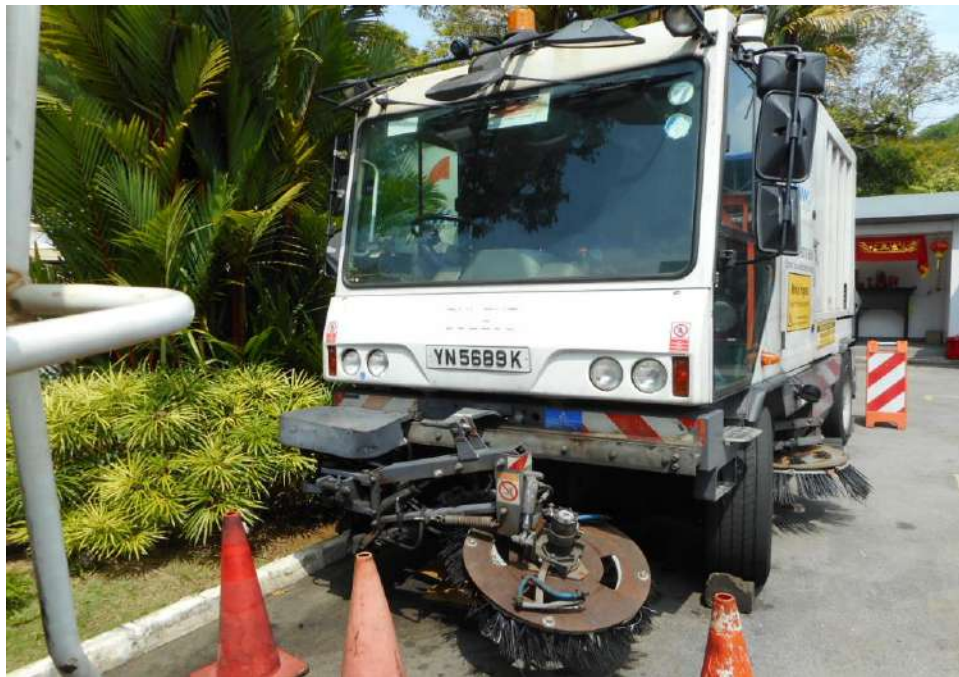
Photo 1 shows the front portion of the Insured Vehicle, which was observed to be unaffected by the fire.

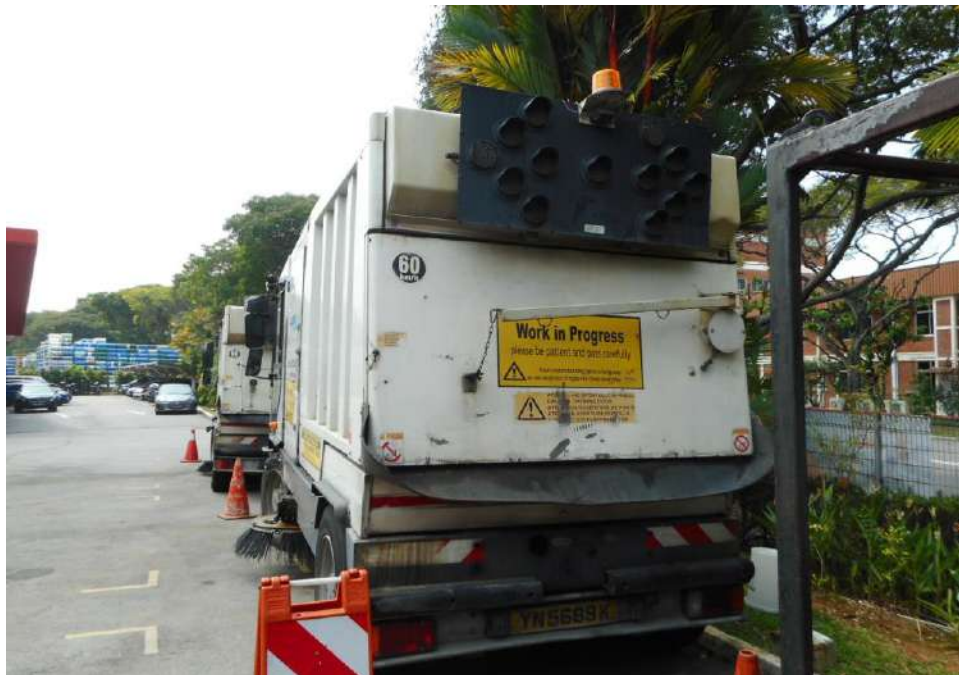
Photo 2 shows the rear portion of the Insured Vehicle, which was observed to be unaffected by the fire.

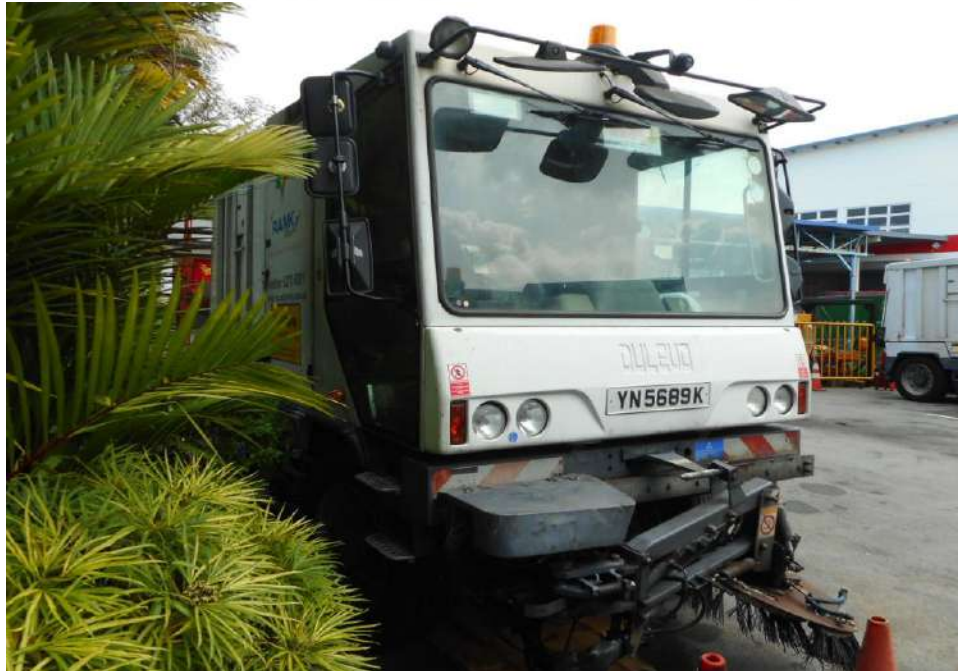
Photo 3 shows the right body of the Insured Vehicle, which was observed to be unaffected by the fire.

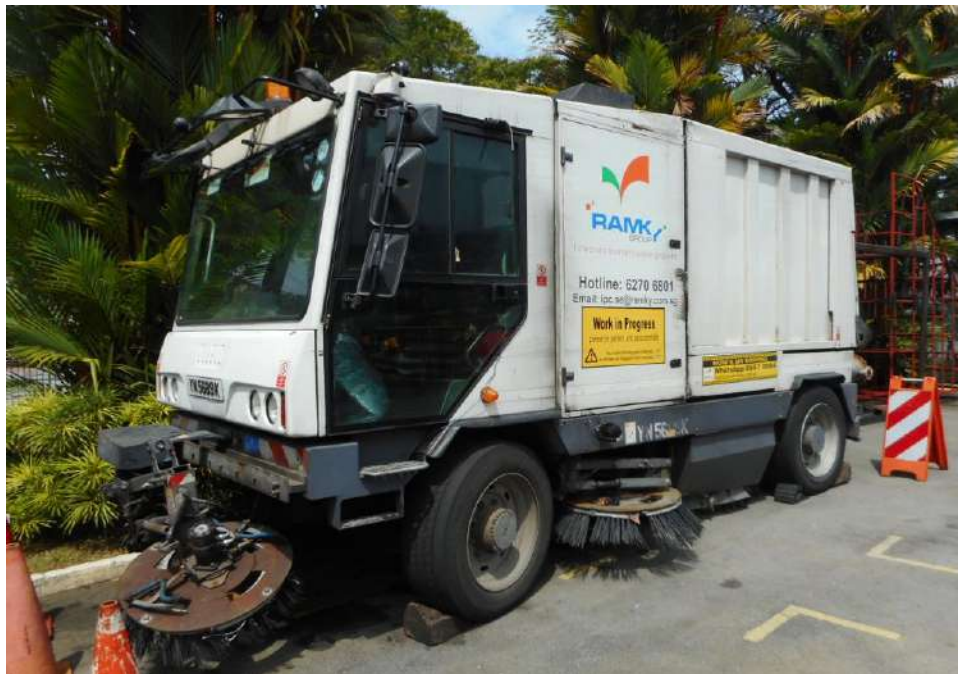
Photo 4 shows the left body of the Insured Vehicle, which was observed to be unaffected by the fire.

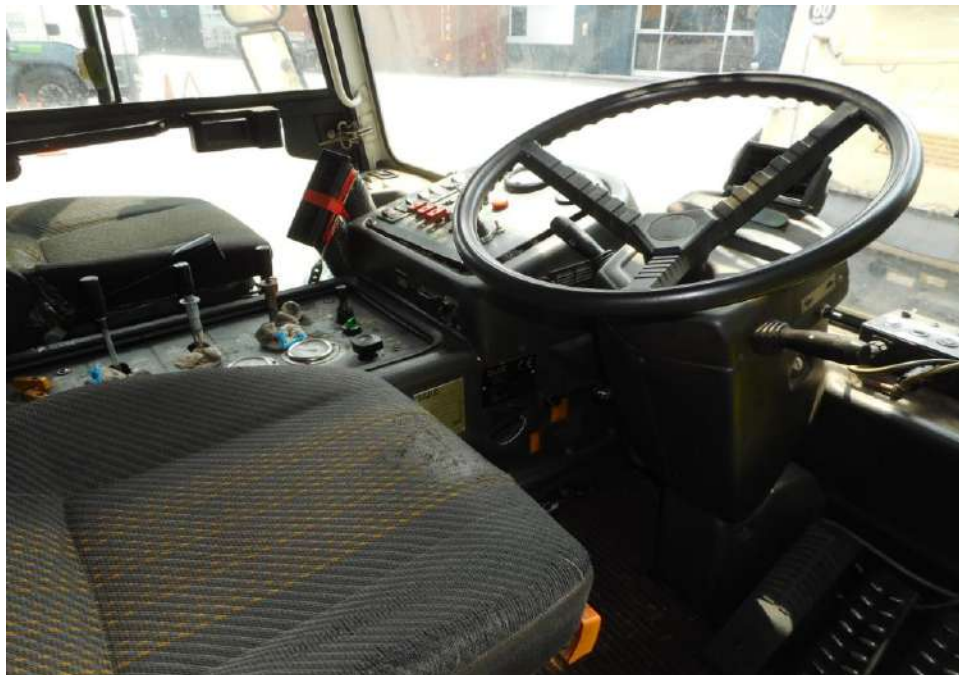
Photo 5 shows the general view of the interior compartment of the Insured Vehicle at the time of our inspection was observed to be unaffected by the fire.

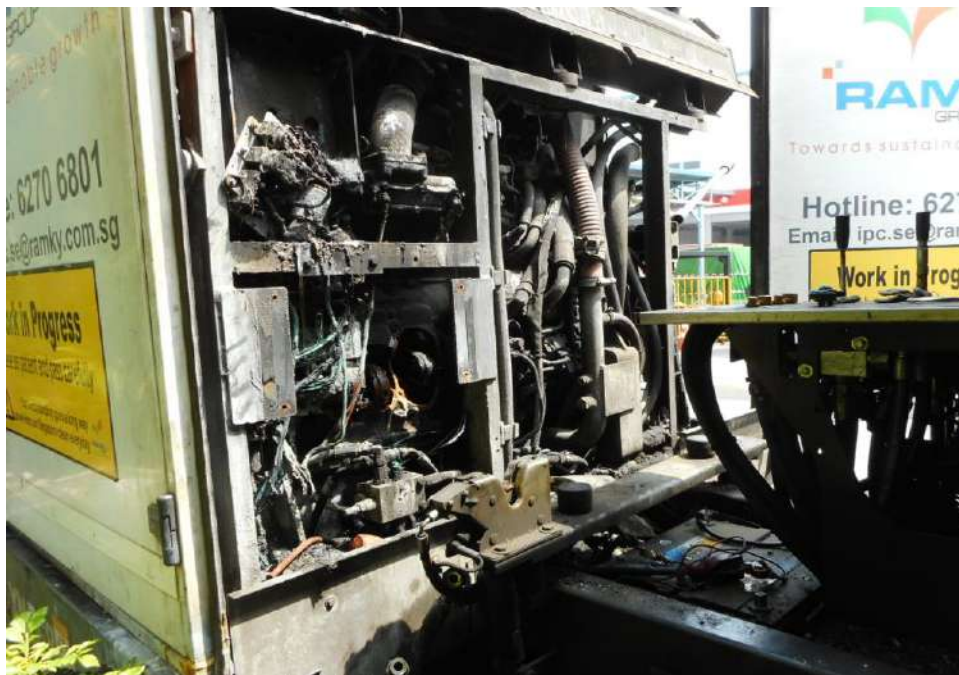
5. The Insured Vehicle was observed to have sustained minor fire damage confined only to its engine compartment in the middle, the electrical wirings, engine block and components around the engine area was damaged as a result of the fire. The other parts of the Insured Vehicle was not affected by the fire See photos 1 – 8 below.

Photo 6 shows the engine compartment in the middle of the Insured Vehicle at the time of our inspection. The engine compartment of the Insured Vehicle was observed to be burnt. The electrical wirings, engine block and components around the engine area was damaged as a result of the fire.

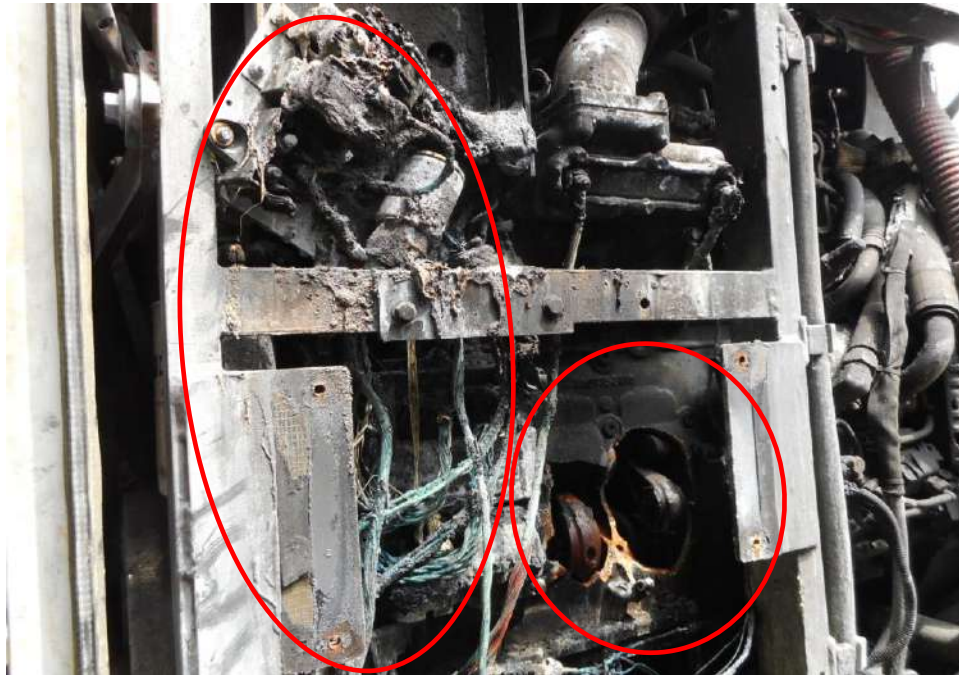
Photo 7 shows the engine compartment of the Insured Vehicle at the time of our inspection. The Insured Vehicle was observed to have sustained fire damage to its electrical wirings and components (red circled) and engine block (yellow circle) was damaged as a result of the fire.

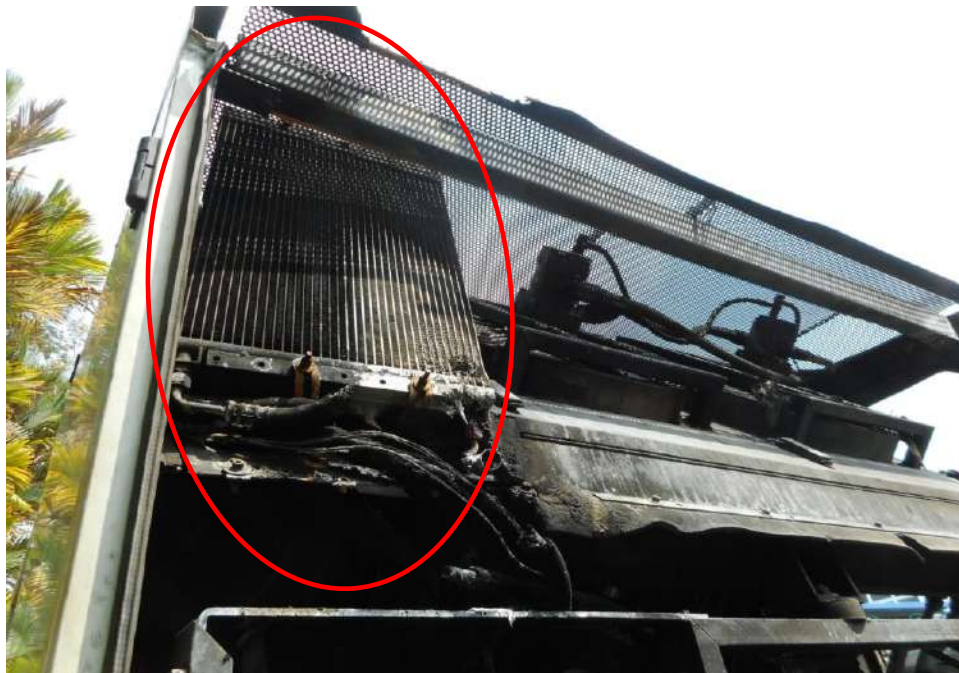
Photo 8 shows the engine compartment of the Insured Vehicle at the time of our inspection. The Insured Vehicle was observed to have sustained fire damage to its engine radiator component (circled) was damaged as a result of the fire.

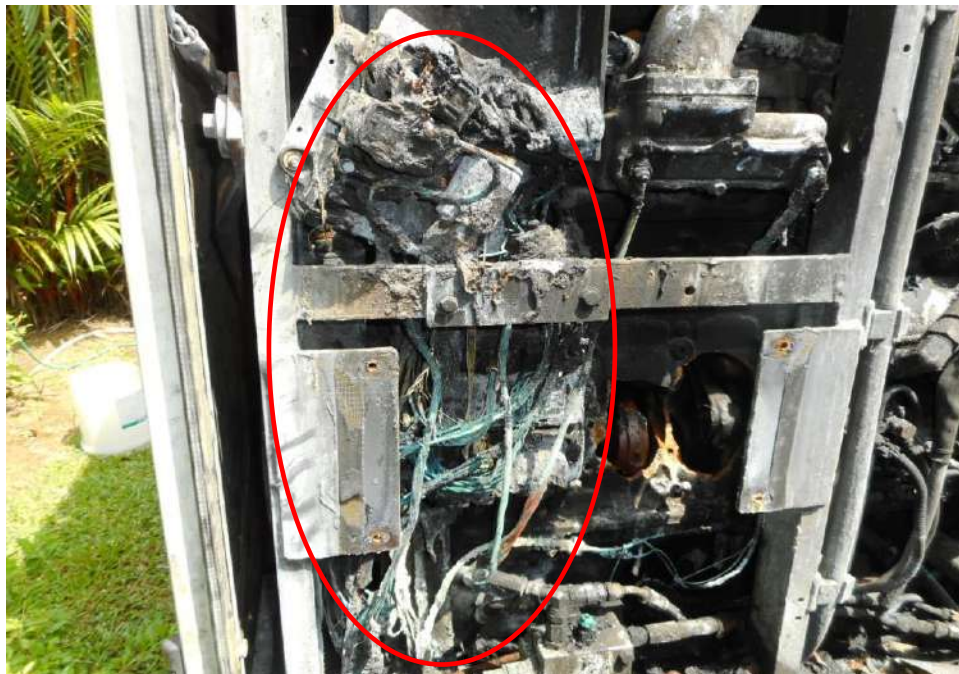
7. Based on the circumstances for this particular case, the fire appears to have originated from the engine area of the Insured Vehicle, somewhere around the middle portion. This can be determined basing on the area where the extent of fire damage was most severe, the circumstances of the fires' origin at the material time of incident and also the high heat intensity burn marks (whitish burn marks) that were found on the exterior surface close to the engine portion.

8. These whitish burn marks are a result of exposure to prolong heat intensity. Rust would normally start to develop around these areas soon after a fire as the prolonged exposure to high heat intensity usually causes the bare steel/metal material of the body parts to be exposed to natural environmental condition. The rust that had developed on the front bonnet and centre portion, in the immediate vicinity of where these whitish burn marks were found, would also support our findings of where the fire had affected the Insured Vehicle. See photo 9- 10 below.

Photo 9 shows the close up view of the engine of the Insured Vehicle at the time of our inspection. The burn pattern of the various components which were observed to be partly melted and burn from the high heat intensity and exposure of bare copper wirings (circled) indicates that the fire had originated from the wirings of the engine portion of the Insured Vehicle.

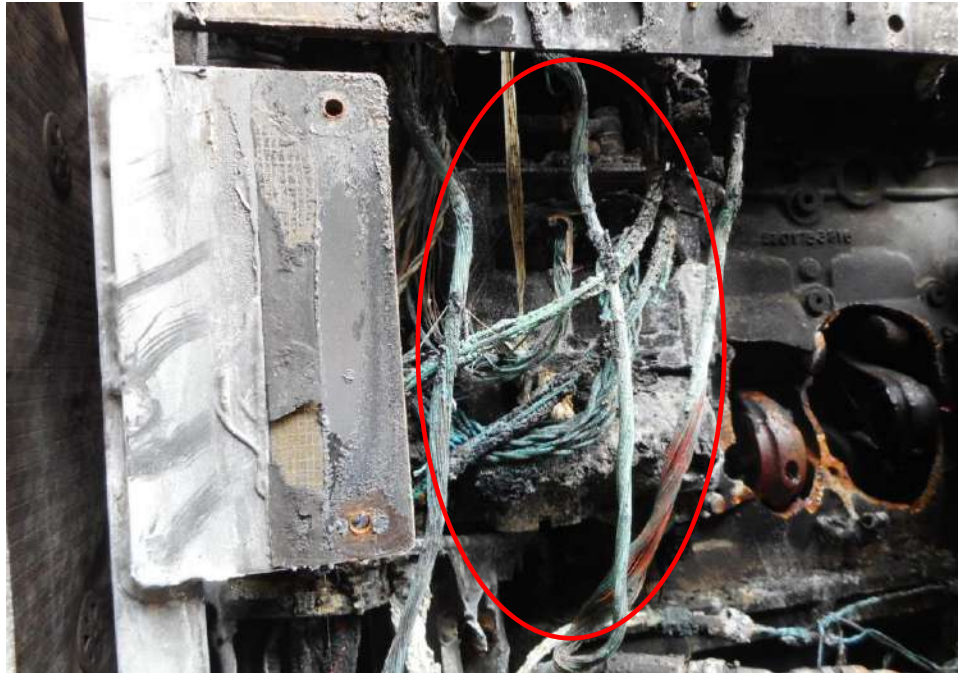
Photo 10 shows the close up view of the engine of the Insured Vehicle at the time of our inspection. The burn pattern of the various components which were observed to be partly melted and burn from the high heat intensity and exposure of bare copper wirings (circled) indicates that the fire had originated from the wirings of the engine portion of the Insured Vehicle.

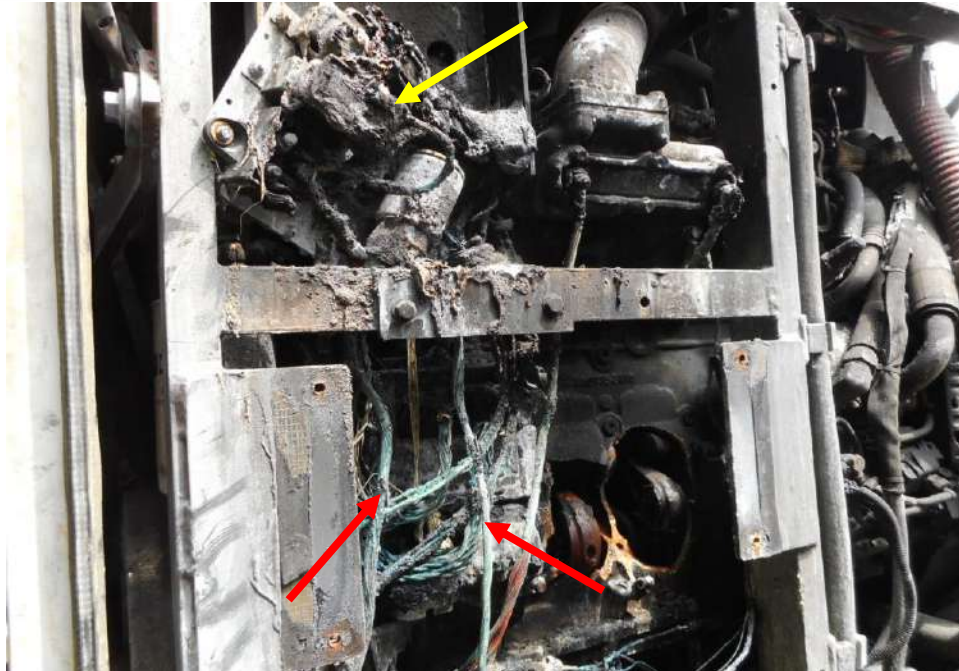
9. Upon closer examination of the engine compartment portion Insured Vehicle which was where the fire had likely started, we had found traces of greenish residue on the main wiring's harnesses leading from the batteries to the electrical components of the Insured Vehicle. The wirings were original wirings fitted from the manufacturer. The presence of greenish residue indicates internal heating of copper wires, a sign of an electrical short circuit occurring. The greenish residue is normally left behind from the oxidation as a result of chemical reaction involving the copper wires. This physical evidence would then appear to suggest that the cause of fire to the Insured Vehicle could have possibly been due to electrical in nature. See photos 11 and 13 below.

Photo 11 shows the general view of the engine compartment of the Insured Vehicle at the time of our inspection. The fire damage to the Insured Vehicle has affected its engine compartment. Its wirings from the batteries (red arrow), electrical components (yellow arrow) and various original wiring harnesses was amongst the parts in the compartment that were found to have been affected as a result of the fire.

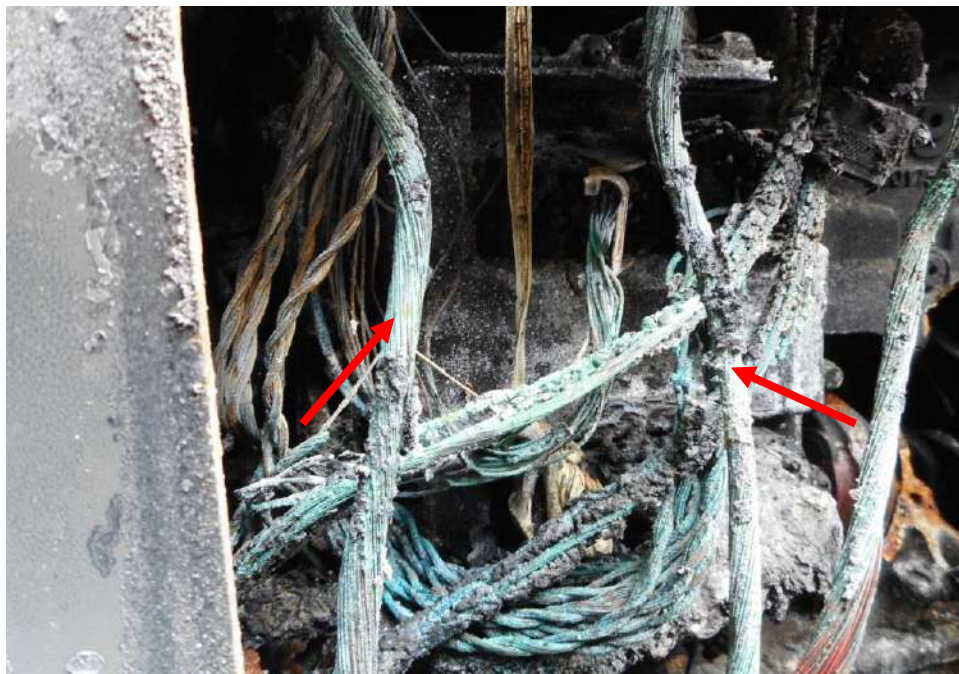
Photo 12 shows a close up view of the original wiring harness from the batteries (arrowed) was observed with greenish residue on the surface. The presence of greenish residue indicates internal heating of copper wires, a sign of an electrical short circuit occurring. The greenish residue is normally left behind from oxidation as a result of chemical reaction involving the copper wires.

24. The possibility of the fire being due to electrical in nature would then seem more likely given that engine overheating and external factors would both seem unlikely. The fire being due to electrical nature is also supported by the condition of the several stretches of original wirings from the batteries to its electrical components which was burnt internally to its bare copper state on the Insured Vehicle which was a sign of short circuit that which was earlier discussed in paragraph 9 above.

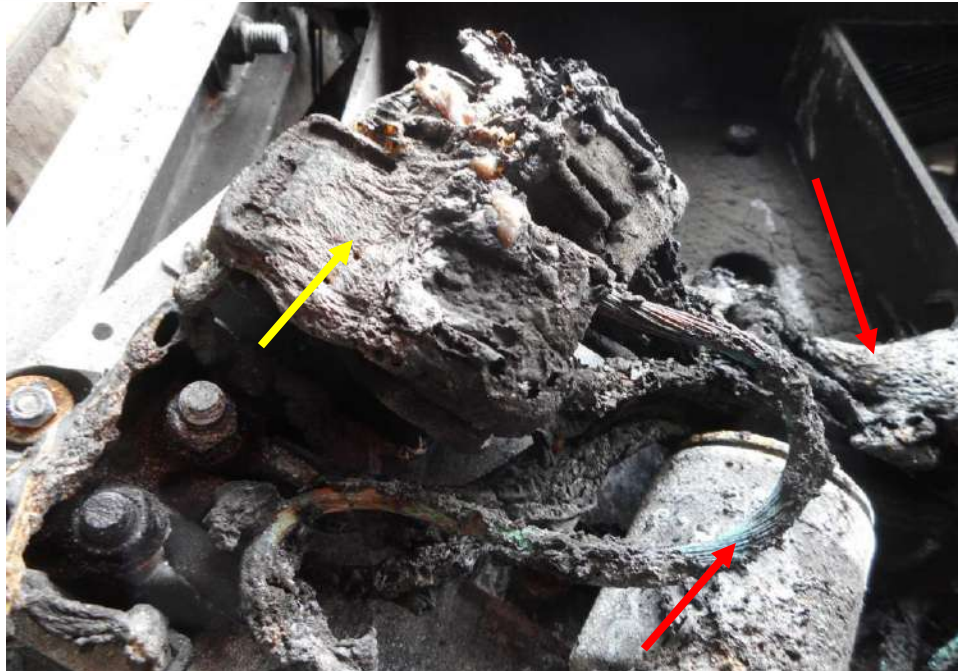
Photo 13 shows close up view of the original wiring harness from the batteries (red arrow) to the electrical components (yellow arrow) was observed with greenish residue on the surface. The presence of greenish residue indicates internal heating of copper wires, a sign of an electrical short circuit occurring. The greenish residue is normally left behind from oxidation as a result of chemical reaction involving the copper wires.

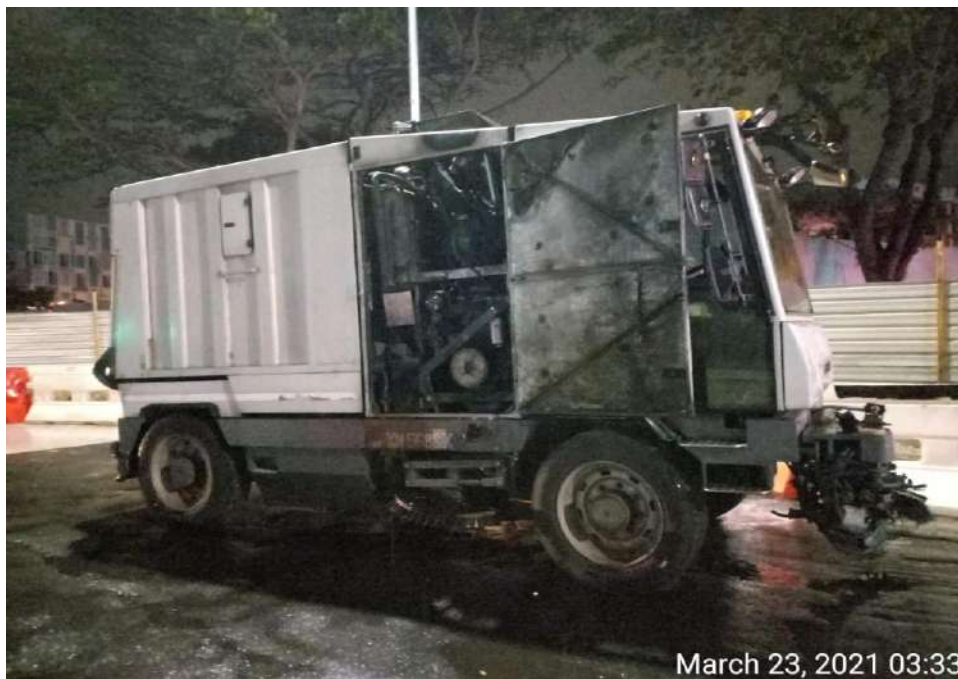
Photo 14 shows the burned Insured Vehicle at the road junction after the fire was put out. In general, the information that could be gathered from this photograph had corresponded to the events that were related to us by Mr Rosli, location when the fire broke out.

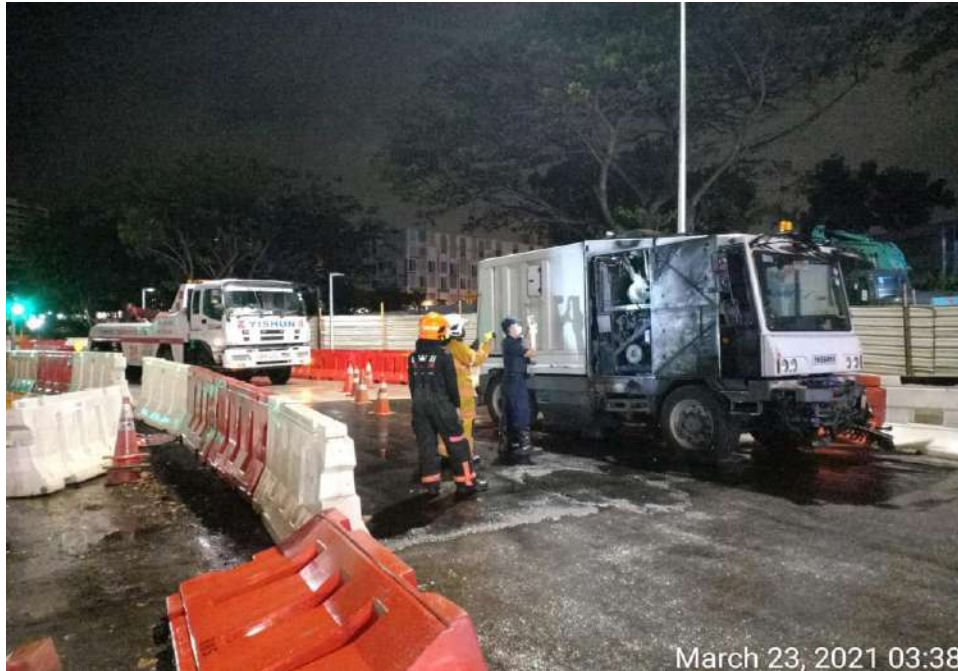
Photo 15 shows the SCDF officer on scene after the fire was put out on the Insured Vehicle. In general, the information that could be gathered from this photograph had corresponded to the events that were related to us by Mr Rosli, location when the fire broke out.

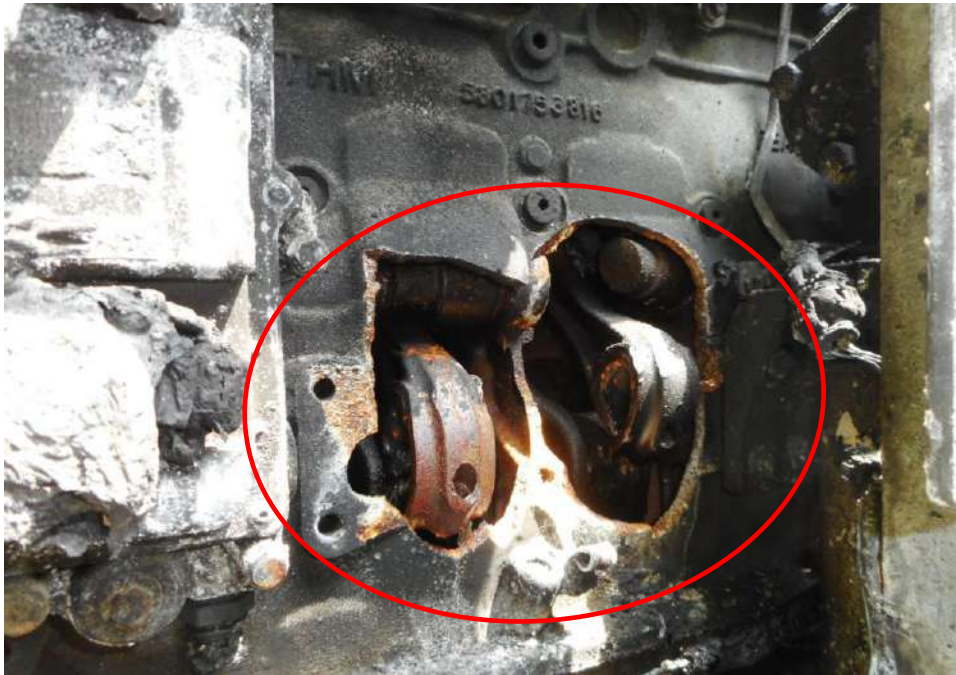
28. From our understanding, the components in the engine block like the pistons and the crankshaft to be damaged in this particular case was highly due to insufficient engine oil for lubrication and heat removal purposes in the engine. And in this case these components had seized up and were not able to be moved in any other way and that explains why the engine could not be started up when cranked.

29. As the components in engine was seized when the Insured Vehicle had stalled in the first place and the cranking motion conducted by the driver to get the engine starter to run the engine had overloaded the jumpstarting electrical systems of the Insured Vehicle and cause the electric wires to heat up and break off its insulation cover thus causing the wires to touch each other and therefore causing a short circuit that results in a this fire. See photos 16 and 17 below.

Photo 16 shows the close up view of the engine block on the Insured Vehicle at the time of our inspection. The Insured Vehicle was observed to have sustained damaged to its engine block and piston connecting rod (circled) due to insufficient engine oil for lubrication and heat removal purposes in the engine that resulted in the sudden seizure of the running components in the engine causing them to break.

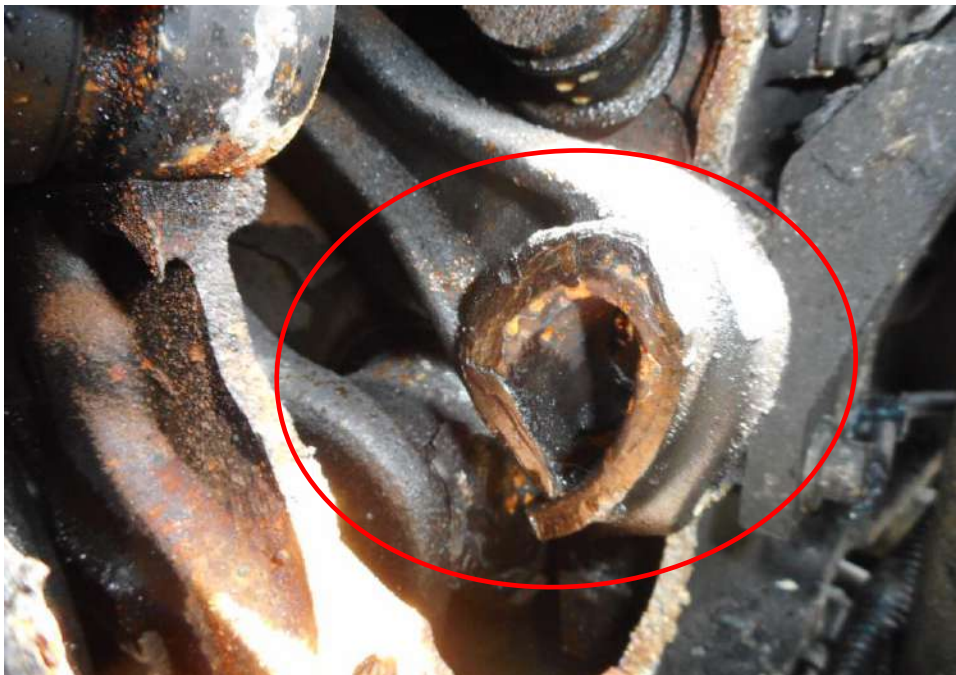
Photo 17 shows the close up view of the engine block on the Insured Vehicle at the time of our inspection. The Insured Vehicle was observed to have sustained damaged to piston connecting rod (red circled) due to insufficient engine oil for lubrication and heat removal purposes in the engine that resulted in the sudden seizure of the running components in the engine causing them to break.
