Your Ref: D21001017MFVS  
Our Ref : CS4/FCI21004180/P

**M/s FIRST CAPITAL INSURANCE LTD**

**TECHNICAL INVESTIGATION REPORT OF FIRE INCIDENT INVOLVING THE  
INSURED VEHICLE YN 5689K ON 23<sup>rd</sup> March 2021**

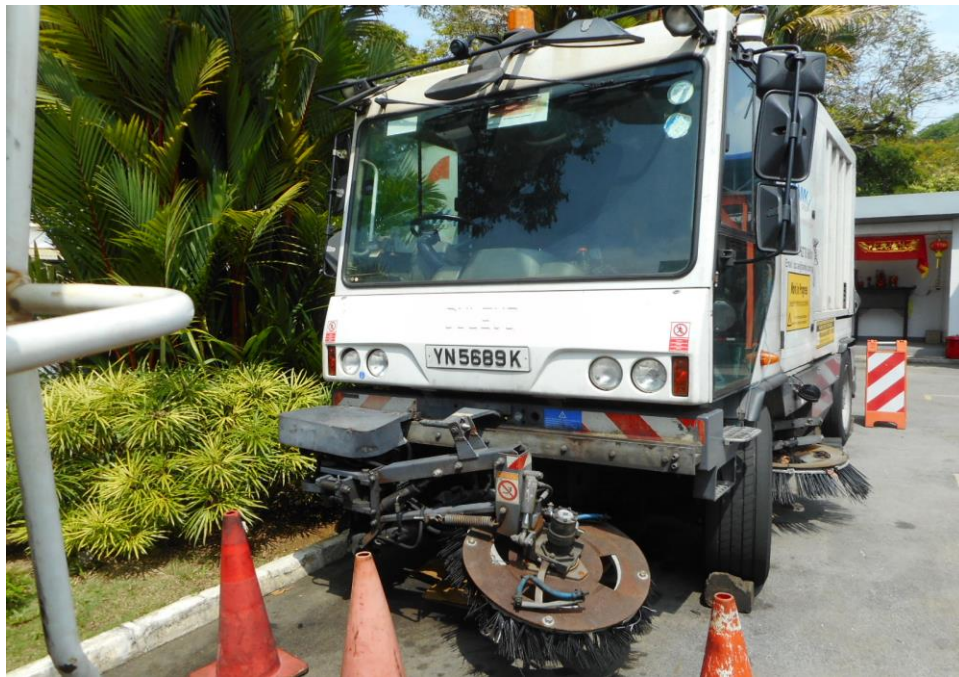
**Photo 1** shows the front portion of the Insured Vehicle, which was observed to be unaffected by the fire.

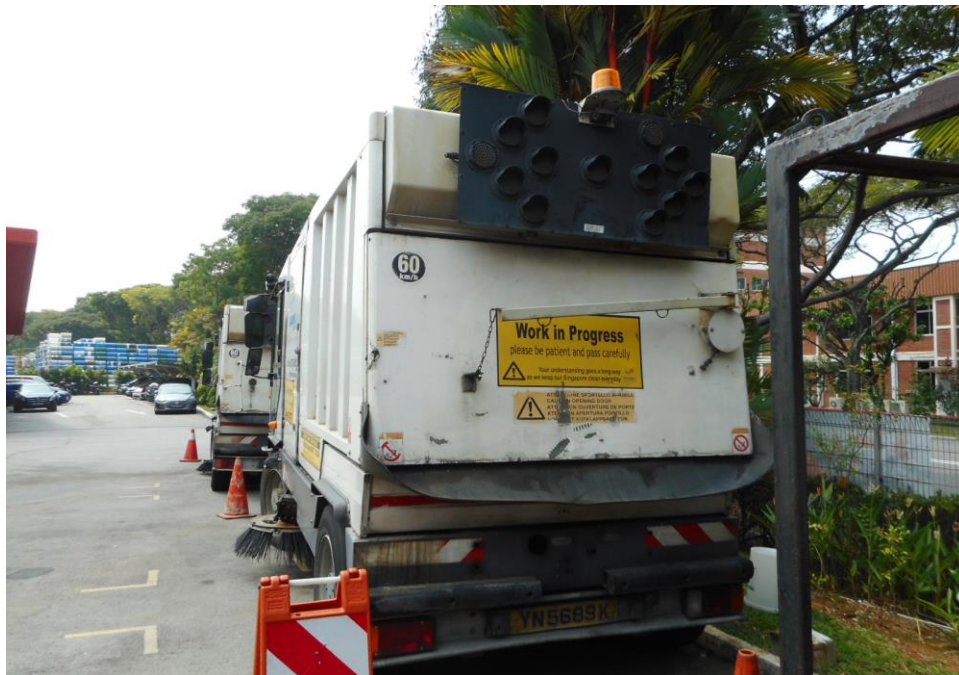
**Photo 2** shows the rear portion of the Insured Vehicle, which was observed to be unaffected by the fire.

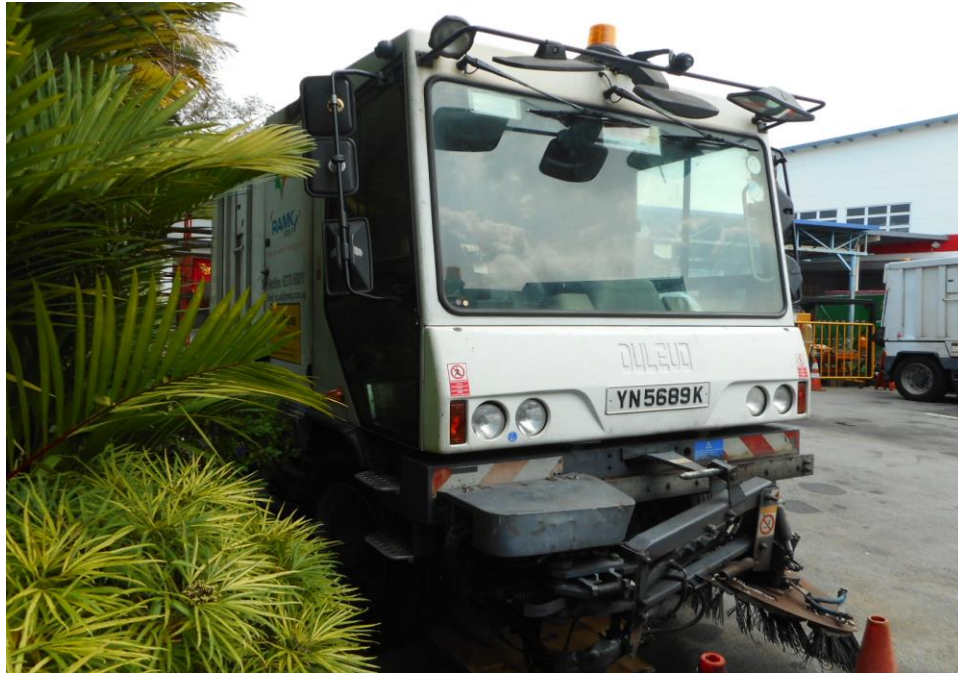
**Photo 3** shows the right body of the Insured Vehicle, which was observed to be unaffected by the fire.

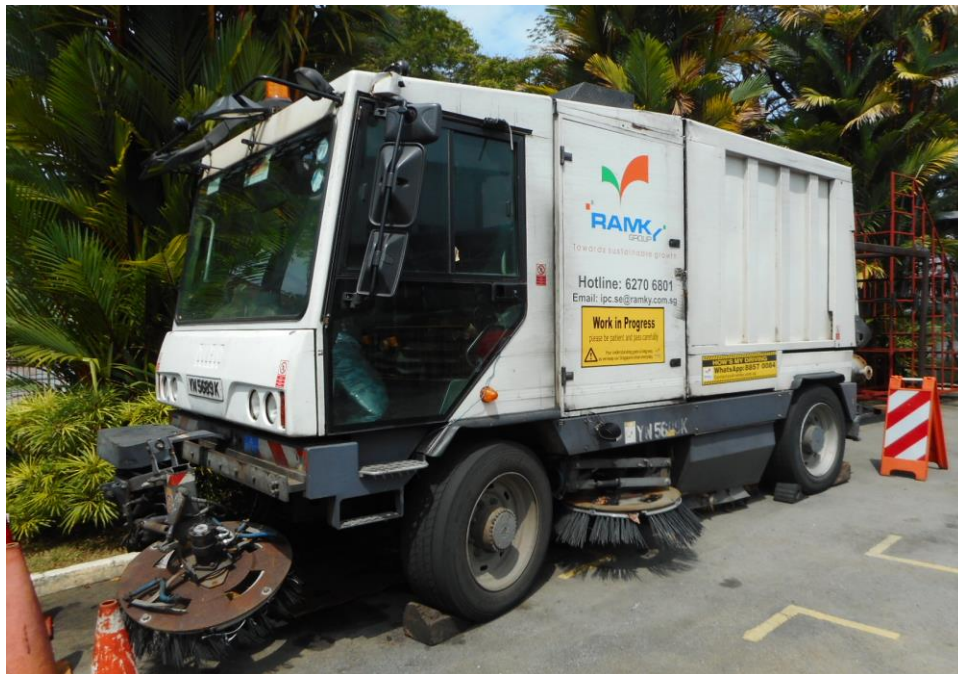
**Photo 4** shows the left body of the Insured Vehicle, which was observed to be unaffected by the fire.

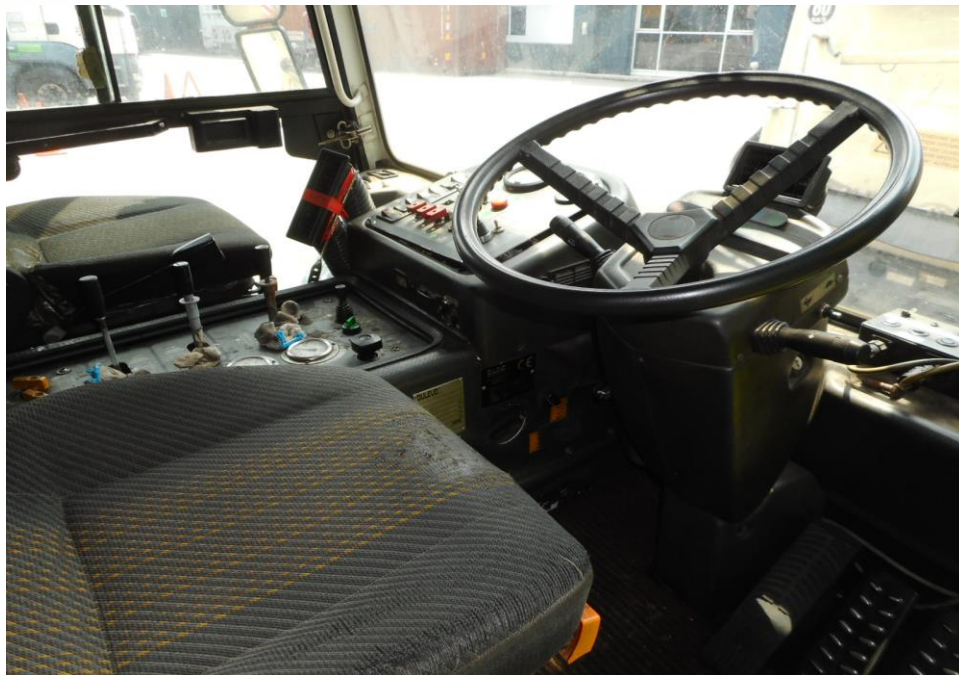
**Photo 5** shows the general view of the interior compartment of the Insured Vehicle at the time of our inspection was observed to be unaffected by the fire.

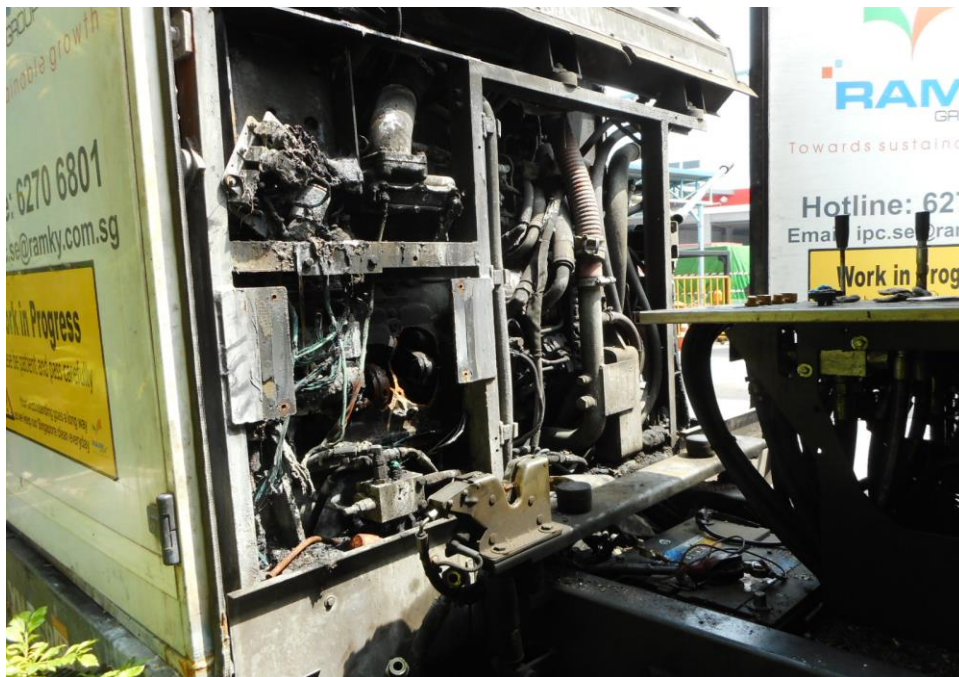
5. The Insured Vehicle was observed to have sustained minor fire damage confined only to its engine compartment in the middle, the electrical wirings, engine block and components around the engine area was damaged as a result of the fire. The other parts of the Insured Vehicle was not affected by the fire See photos 1 – 8 below.

**Photo 6** shows the engine compartment in the middle of the Insured Vehicle at the time of our inspection. The engine compartment of the Insured Vehicle was observed to be burnt. The electrical wirings, engine block and components around the engine area was damaged as a result of the fire.

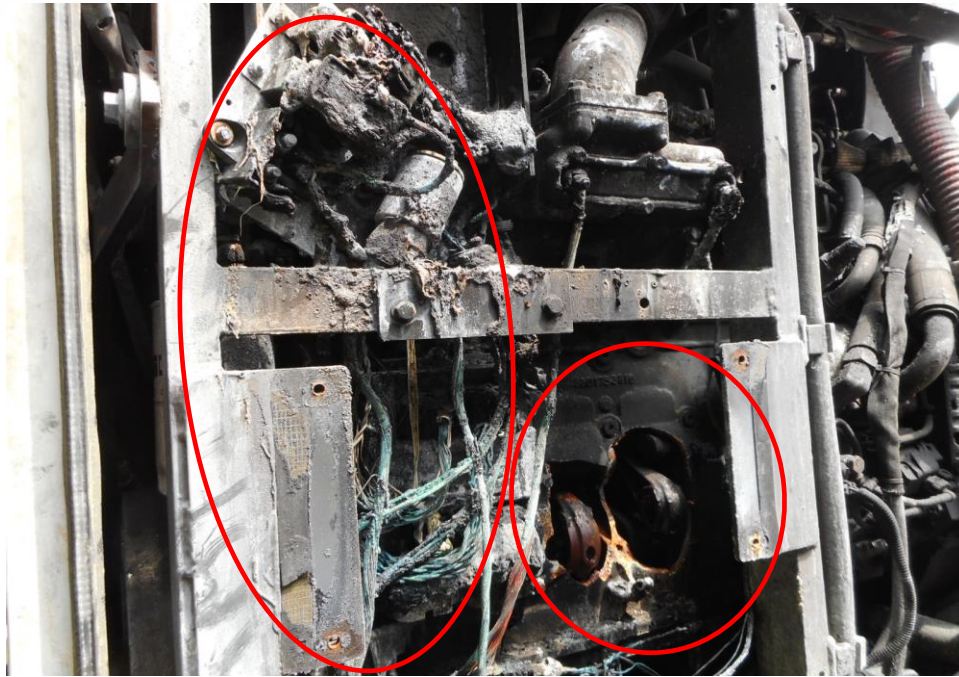
**Photo 7** shows the engine compartment of the Insured Vehicle at the time of our inspection. The Insured Vehicle was observed to have sustained fire damage to its electrical wirings and components (red circled) and engine block (yellow circle) was damaged as a result of the fire.

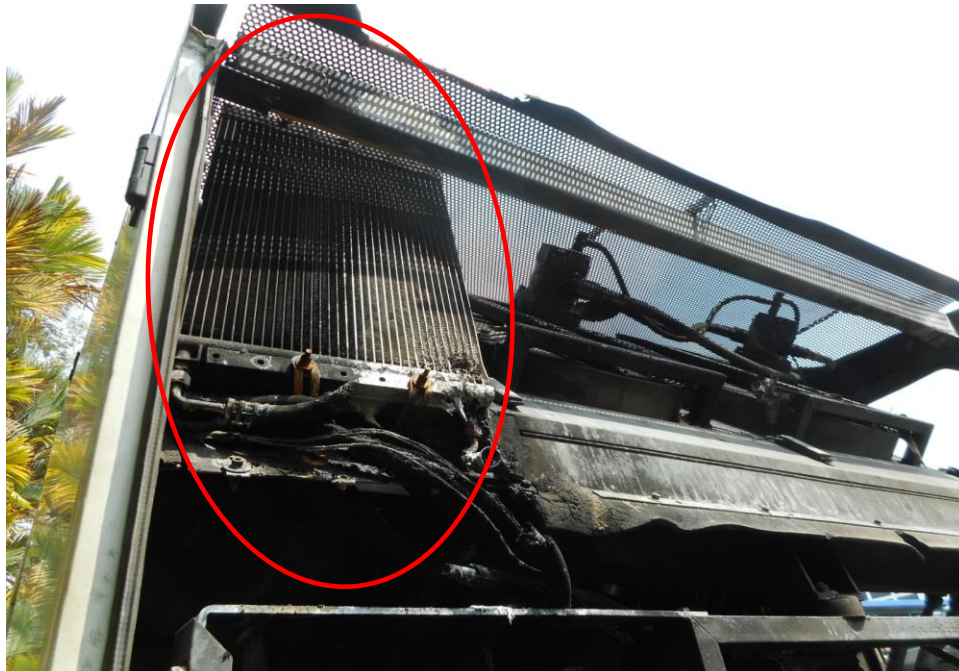
**Photo 8** shows the engine compartment of the Insured Vehicle at the time of our inspection. The Insured Vehicle was observed to have sustained fire damage to its engine radiator component (circled) was damaged as a result of the fire.

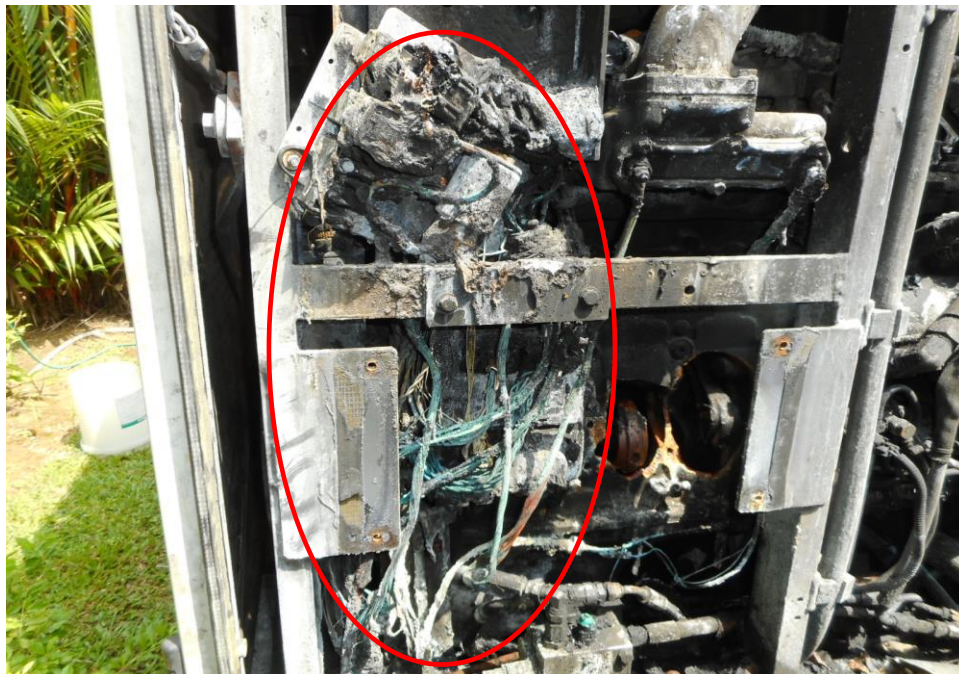
7. Based on the circumstances for this particular case, the fire appears to have originated from the engine area of the Insured Vehicle, somewhere around the middle portion. This can be determined basing on the area where the extent of fire damage was most severe, the circumstances of the fires' origin at the material time of incident and also the high heat intensity burn marks (whitish burn marks) that were found on the exterior surface close to the engine portion.

8. These whitish burn marks are a result of exposure to prolong heat intensity. Rust would normally start to develop around these areas soon after a fire as the prolonged exposure to high heat intensity usually causes the bare steel/metal material of the body parts to be exposed to natural environmental condition. The rust that had developed on the front bonnet and centre portion, in the immediate vicinity of where these whitish burn marks were found, would also support our findings of where the fire had affected the Insured Vehicle. See photo 9- 10 below.

**Photo 9** shows the close up view of the engine of the Insured Vehicle at the time of our inspection. The burn pattern of the various components which were observed to be partly melted and burn from the high heat intensity and exposure of bare copper wirings (circled) indicates that the fire had originated from the wirings of the engine portion of the Insured Vehicle.

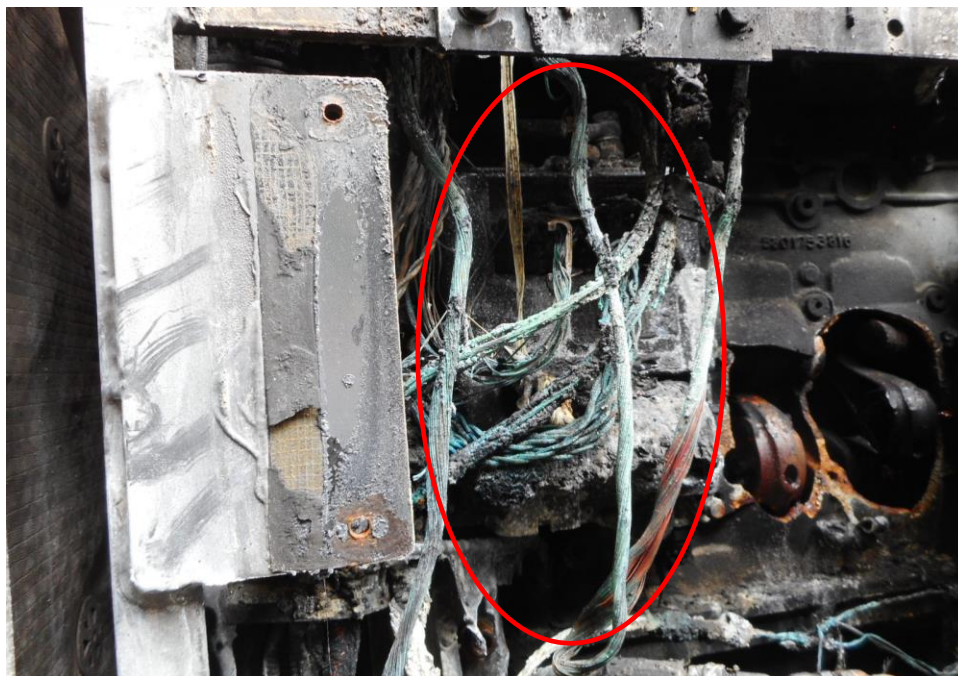
**Photo 10** shows the close up view of the engine of the Insured Vehicle at the time of our inspection. The burn pattern of the various components which were observed to be partly melted and burn from the high heat intensity and exposure of bare copper wirings (circled) indicates that the fire had originated from the wirings of the engine portion of the Insured Vehicle.

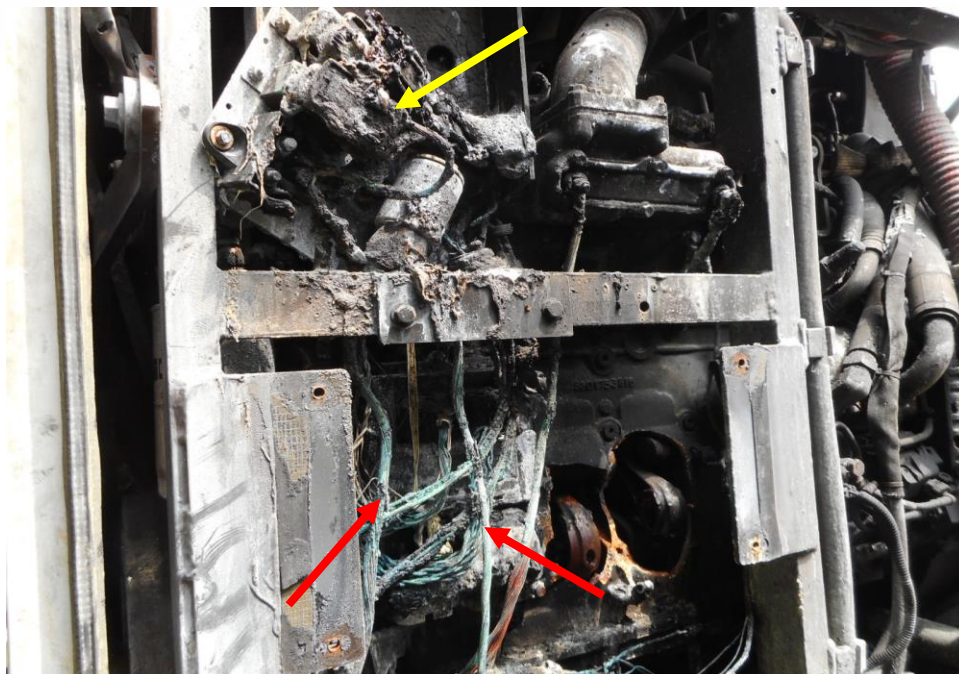
9. Upon closer examination of the engine compartment portion Insured Vehicle which was where the fire had likely started, we had found traces of greenish residue on the main wiring's harnesses leading from the batteries to the electrical components of the Insured Vehicle. The wirings were original wirings fitted from the manufacturer. The presence of greenish residue indicates internal heating of copper wires, a sign of an electrical short circuit occurring. The greenish residue is normally left behind from the oxidation as a result of chemical reaction involving the copper wires. This physical evidence would then appear to suggest that the cause of fire to the Insured Vehicle could have possibly been due to electrical in nature. See photos 11 and 13 below.

**Photo 11** shows the general view of the engine compartment of the Insured Vehicle at the time of our inspection. The fire damage to the Insured Vehicle has affected its engine compartment. Its wirings from the batteries (red arrow), electrical components (yellow arrow) and various original wiring harnesses was amongst the parts in the compartment that were found to have been affected as a result of the fire.

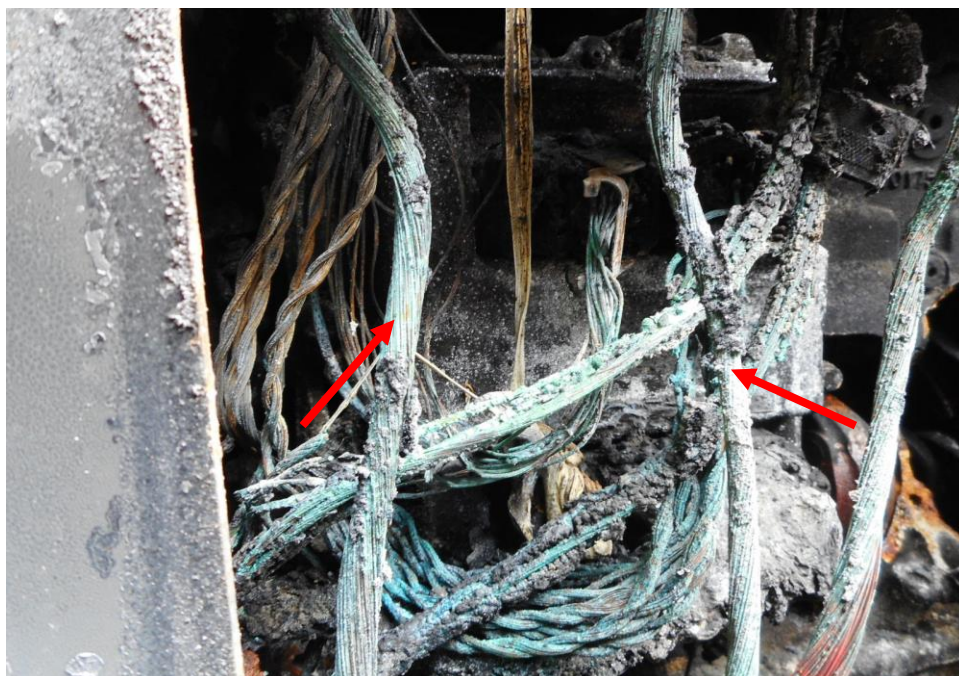
**Photo 12** shows a close up view of the original wiring harness from the batteries (arrowed) was observed with greenish residue on the surface. The presence of greenish residue indicates internal heating of copper wires, a sign of an electrical short circuit occurring. The greenish residue is normally left behind from oxidation as a result of chemical reaction involving the copper wires.

24. The possibility of the fire being due to electrical in nature would then seem more likely given that engine overheating and external factors would both seem unlikely. The fire being due to electrical nature is also supported by the condition of the several stretches of original wirings from the batteries to its electrical components which was burnt internally to its bare copper state on the Insured Vehicle which was a sign of short circuit that which was earlier discussed in paragraph 9 above.

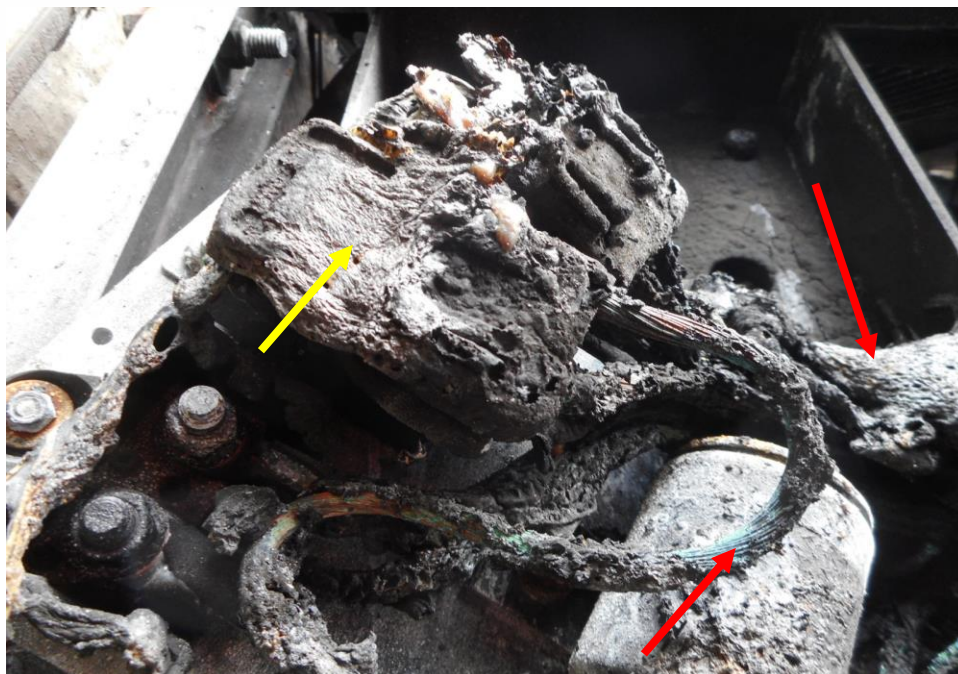
**Photo 13** shows close up view of the original wiring harness from the batteries (red arrow) to the electrical components (yellow arrow) was observed with greenish residue on the surface. The presence of greenish residue indicates internal heating of copper wires, a sign of an electrical short circuit occurring. The greenish residue is normally left behind from oxidation as a result of chemical reaction involving the copper wires.

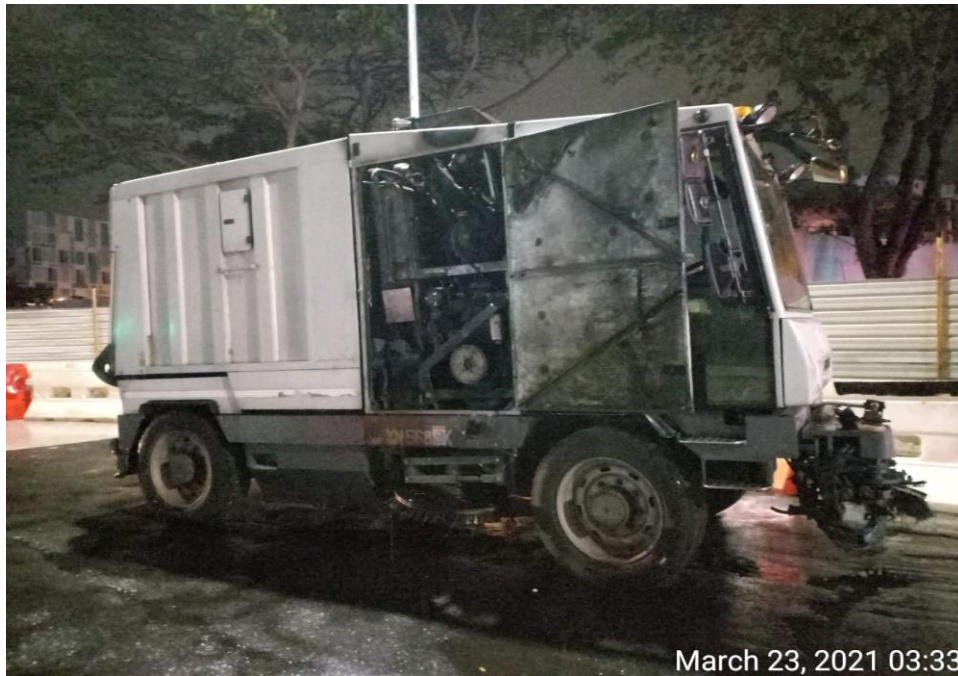
**Photo 14** shows the burned Insured Vehicle at the road junction after the fire was put out. In general, the information that could be gathered from this photograph had corresponded to the events that were related to us by Mr Rosli, location when the fire broke out.

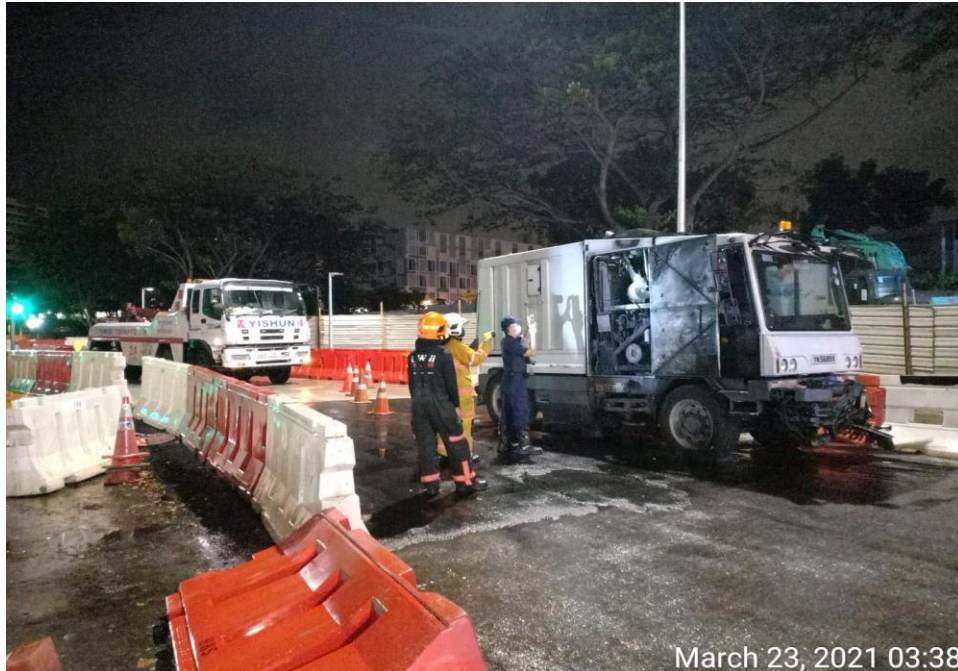
**Photo 15** shows the SCDF officer on scene after the fire was put out on the Insured Vehicle. In general, the information that could be gathered from this photograph had corresponded to the events that were related to us by Mr Rosli, location when the fire broke out.

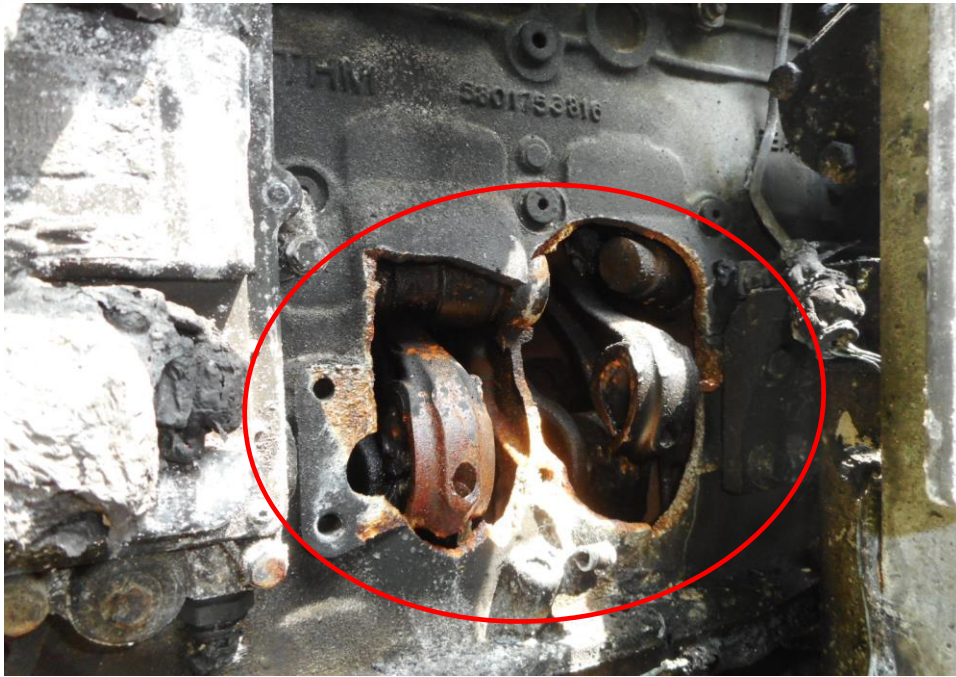
28. From our understanding, the components in the engine block like the pistons and the crankshaft to be damaged in this particular case was highly due to insufficient engine oil for lubrication and heat removal purposes in the engine. And in this case these components had seized up and were not able to be moved in any other way and that explains why the engine could not be started up when cranked.

29. As the components in engine was seized when the Insured Vehicle had stalled in the first place and the cranking motion conducted by the driver to get the engine starter to run the engine had overloaded the jumpstarting electrical systems of the Insured Vehicle and cause the electric wires to heat up and break off its insulation cover thus causing the wires to touch each other and therefore causing a short circuit that results in a this fire. See photos 16 and 17 below.

**Photo 16** shows the close up view of the engine block on the Insured Vehicle at the time of our inspection. The Insured Vehicle was observed to have sustained damaged to its engine block and piston connecting rod (circled) due to insufficient engine oil for lubrication and heat removal purposes in the engine that resulted in the sudden seizure of the running components in the engine causing them to break.

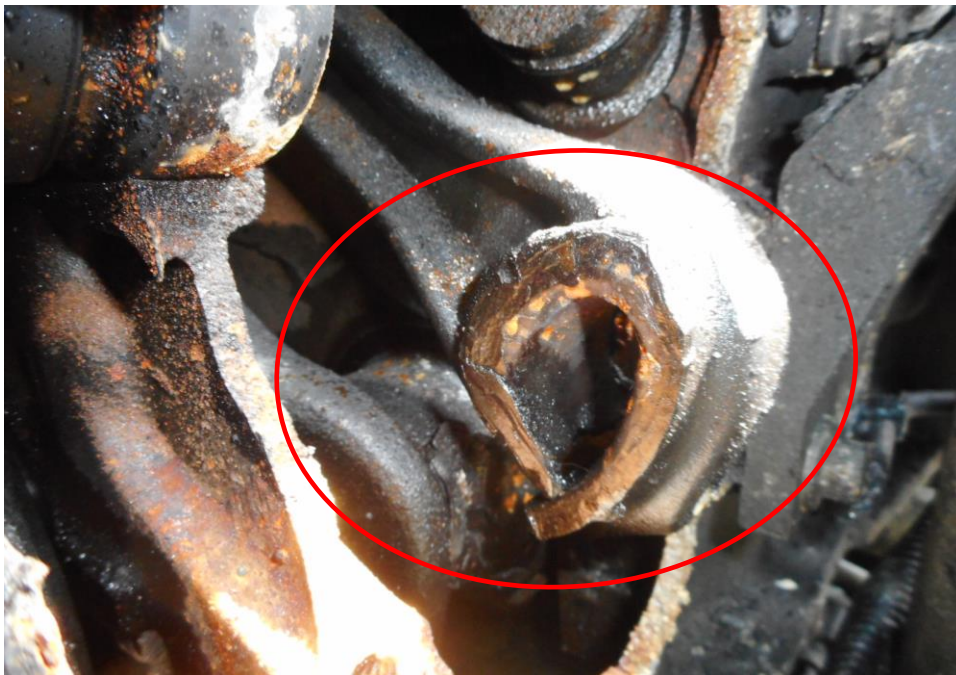
**Photo 17** shows the close up view of the engine block n the Insured Vehicle at the time of our inspection. The Insured Vehicle was observed to have sustained damaged to piston connecting rod (red circled) due to insufficient engine oil for lubrication and heat removal purposes in the engine that resulted in the sudden seizure of the running components in the engine causing them to break.
