Your Ref: C10009641/ST
Our Ref : CS4/AGI21004205/P

AUTOMOBILE INSPECTION REPORT OF INSURED VEHICLE SJV 1657P

Vehicle Registration No.	: SJV 1657P
Make / Model	: LANCER 1.5 MIVEC SPORTS AT ABS D/AB
Chassis No	: JMYSRCY2AAU000578
Year of Registration	: 2010 (January)
Mileage	: 159,123km

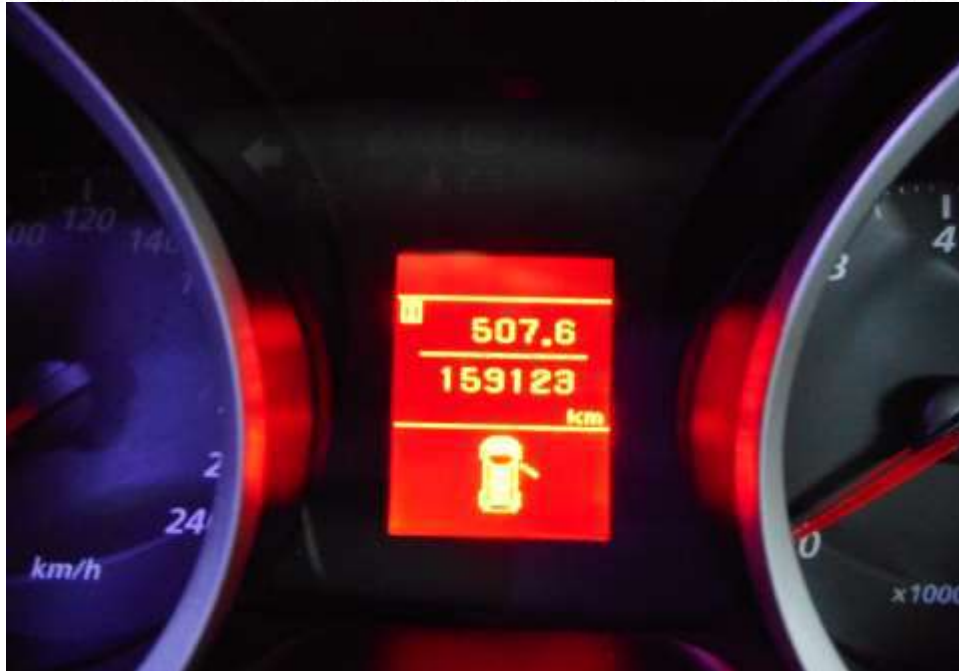
Photo 1 shows the mileage of the Motor Car at the time of my inspection. The mileage observed was 159,123km.

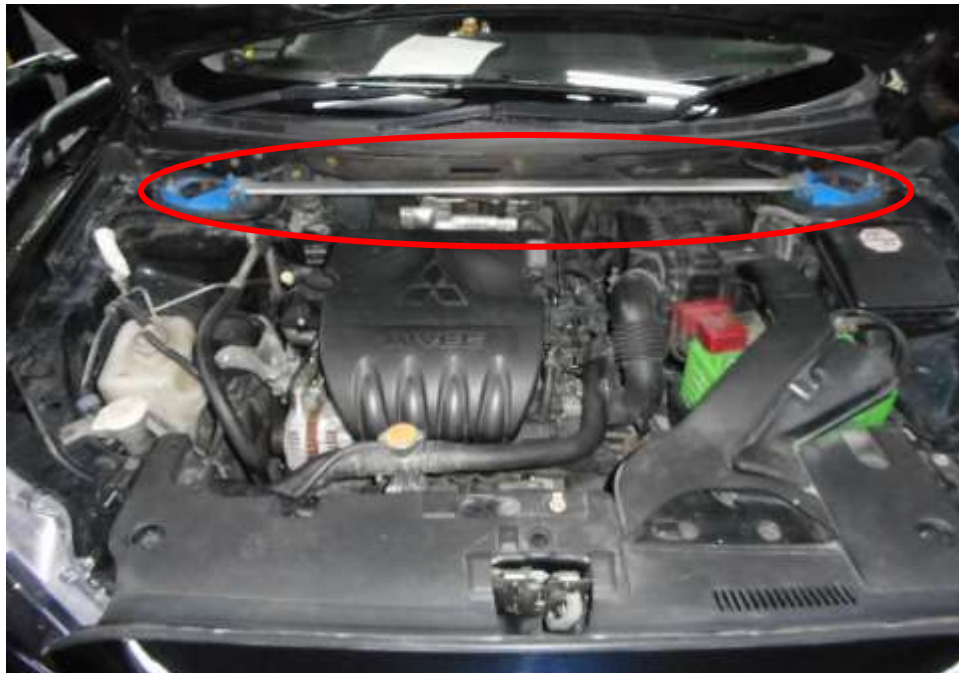
6. Upon checking the engine compartment of the insured vehicle, I had found additional non-standard parts fitted. This includes additionally fitted front anti-roll bar and electronic component. See photo 6 – 9 below.

Photo 6 shows a general view of the engine compartment of the insured vehicle. Additional non-standard parts were found fitted. This includes an additionally fitted front anti-roll bar and electronic component.

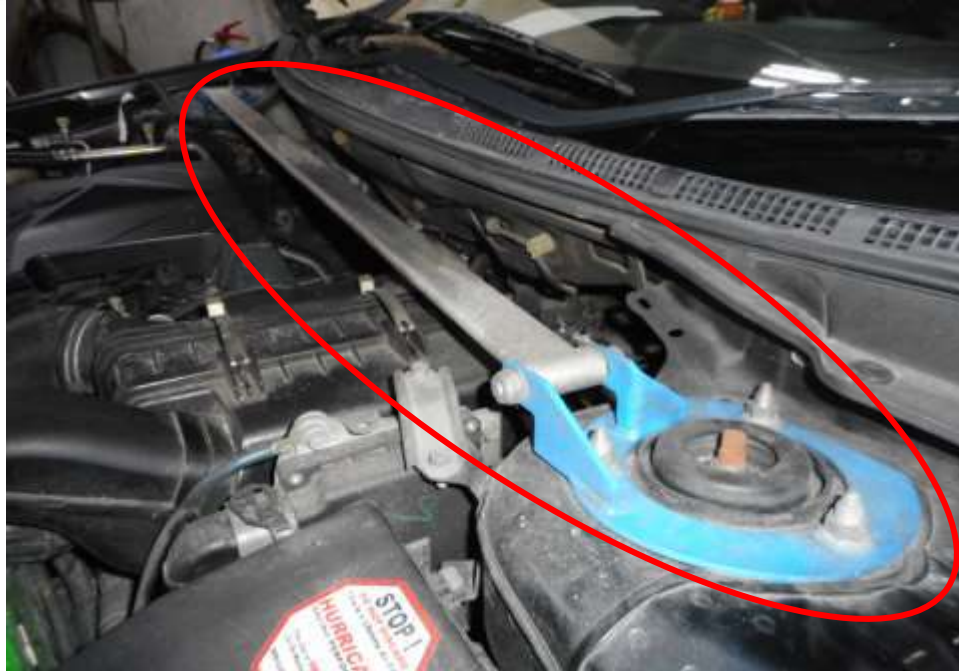
Photo 7 shows a general view of the engine compartment of the insured vehicle. Additional non-standard parts were found fitted. This includes an additionally fitted front anti-roll bar (circled) and electronic component.

Modification/additionally fitted non-standard part	LTA's guideline	Effect(s) on insured vehicle
Anti-roll bar	Compliant	Overall stability enhanced
Aftermarket exhaust system	Not compliant. Owner does not have any approval from LTA	Overall engine performance enhanced
Aftermarket voltage stabilizer	Compliant	Acceleration response and fuel efficiency enhanced

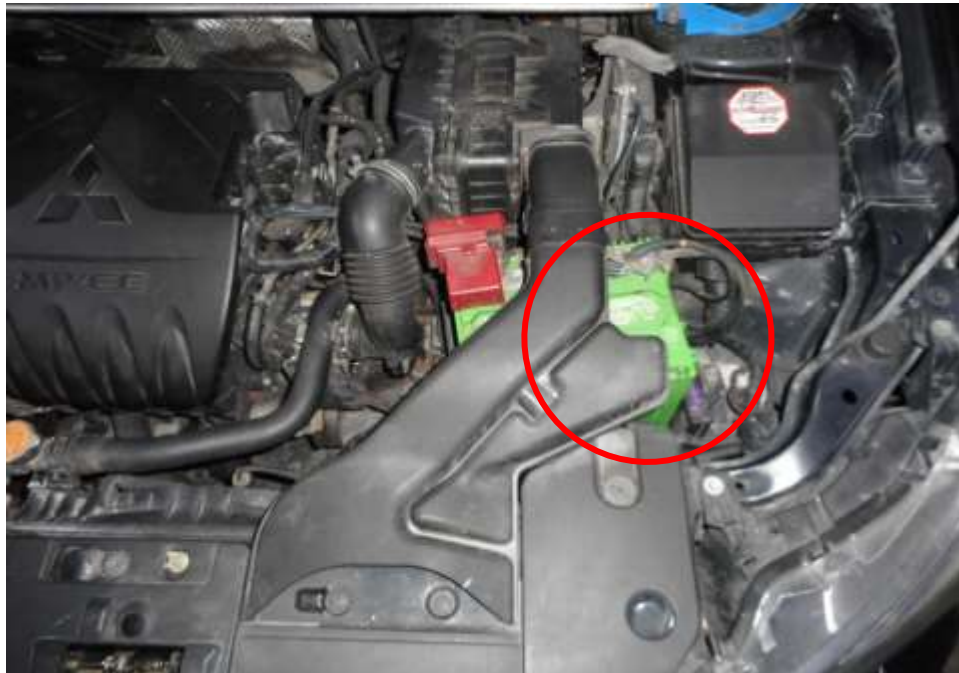
Photo 8 shows a general view of the additionally fitted electronic component that were found inside the engine compartment of the insured vehicle.

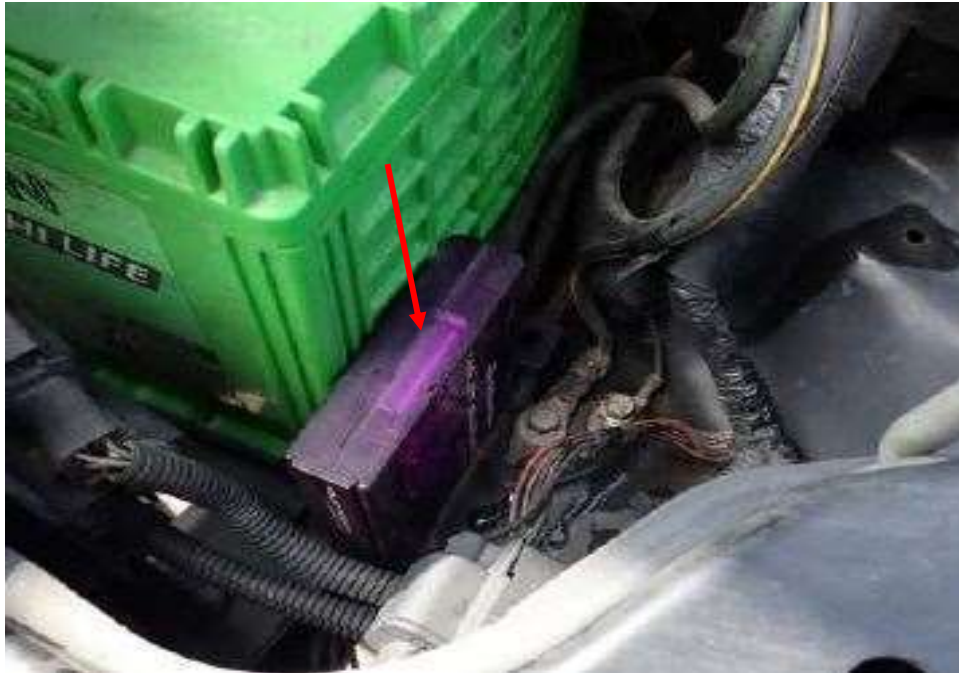
Photo 9 shows a closer view of the additionally fitted electronic component that was found inside the engine compartment of the insured vehicle. From my understanding and from my research this electronic component is collectively advertised to be able to improve acceleration response whilst improving fuel efficiency through stabilization of the electrical system of a motor car.

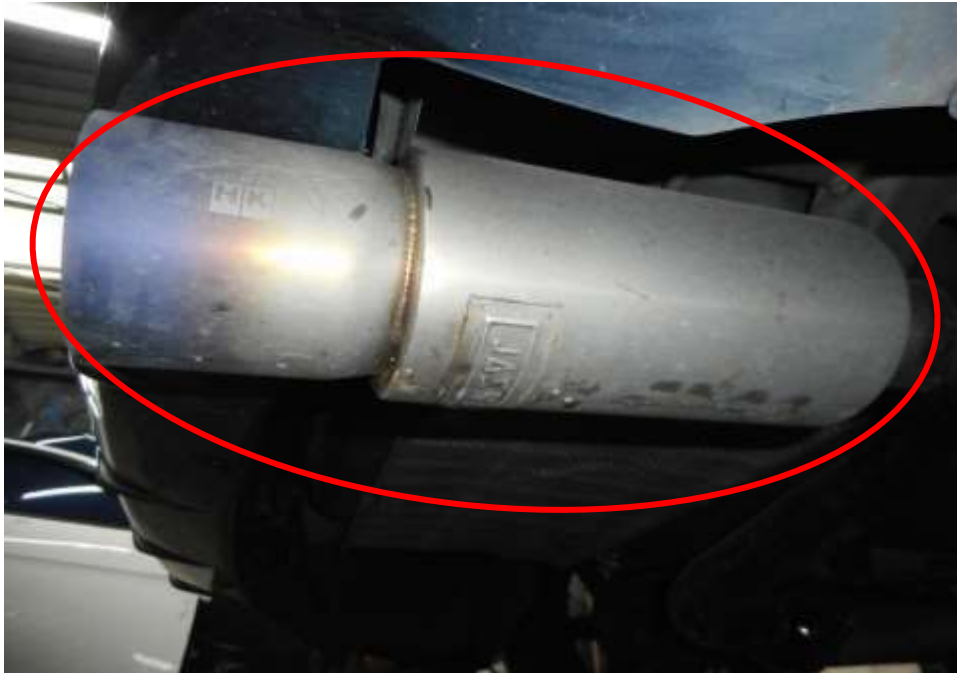
7. I had also found the insured vehicle to be fitted with a non-original exhaust system. This was at the rear, the exhaust muffler of the insured vehicle. There was additional piping and welding marks linking the exhaust muffler to the middle pipe of the Insured Vehicle's exhaust system. Such exhaust system is not LTA compliant. The exhaust system fitted on the insured vehicle will enhance the overall engine performance of the insured vehicle. See photo 10 and 11 below.

Photo 10 shows the exhaust muffler (arrowed) that was fitted on the insured vehicle at the time of my inspection. This was at the rear section where it was fitted. From my observations, the exhaust system fitted on the insured vehicle was not LTA compliant.

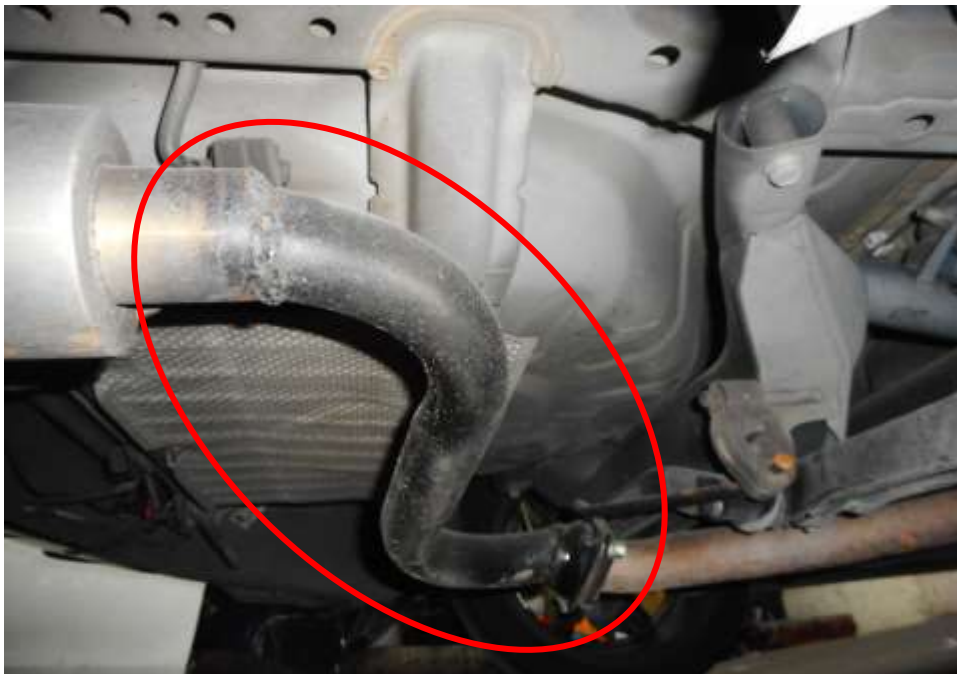
Photo 11 shows the additionally fitted exhaust pipe (arrowed) that was fitted on the insured vehicle at the time of my inspection. This was at the tailpipe section, at the rear of the insured vehicle. It was noted that there was additional piping and welding marks linking the exhaust muffler to the middle pipe of the Insured Vehicle's exhaust system. From my observations, the exhaust system fitted on the insured vehicle is not LTA compliant.

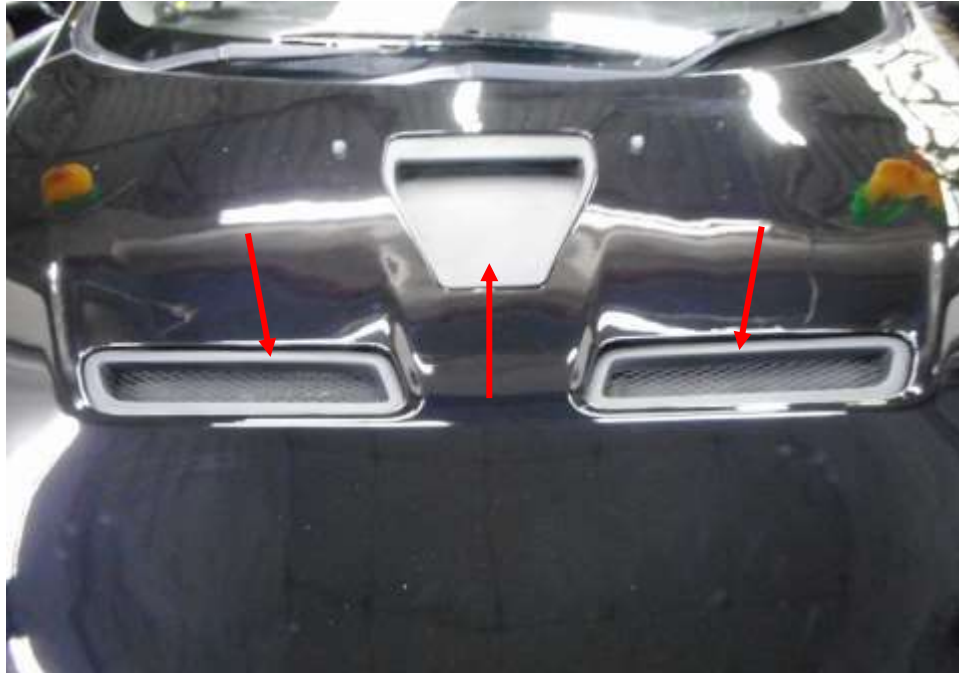
8. Exteriorly, the insured vehicle was fitted with an aftermarket front bonnet with scoops and was of carbon fiber material type, which is non-original. This is LTA complaint and generally referred as cosmetic type of modifications. See photo 12 & 13 below.

Photo 12 shows a general view of the front bonnet of the insured vehicle. An aftermarket front bonnet with scoops (arrowed) made of carbon fiber material type were found fitted.

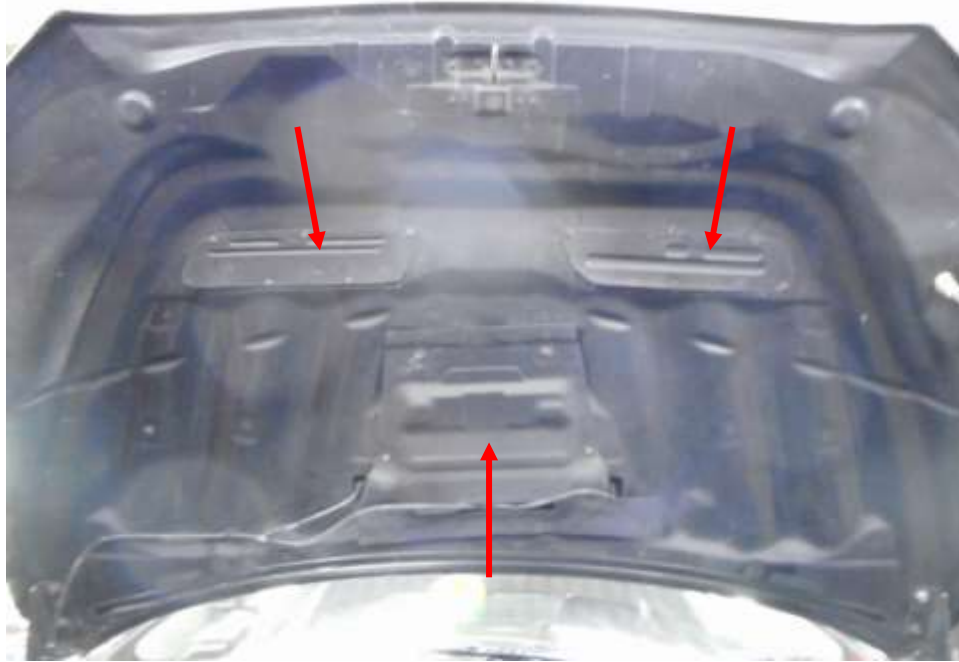
Photo 13 shows a general underside view of the front bonnet of the insured vehicle. An aftermarket front bonnet with scoops (arrowed) made of carbon fiber material type were found fitted.
