Your Ref : SNM21D201821/C02  
Our Ref : CS3/CTI21004225/P

**M/s CHINA TAIPING INSURANCE (S) PTE LTD.**

**AUTOMOBILE TECHNICAL INVESTIGATION REPORT OF ACCIDENT  
INVOLVING YQ 2540J AND YP 9159L ON 20 MARCH 2021**

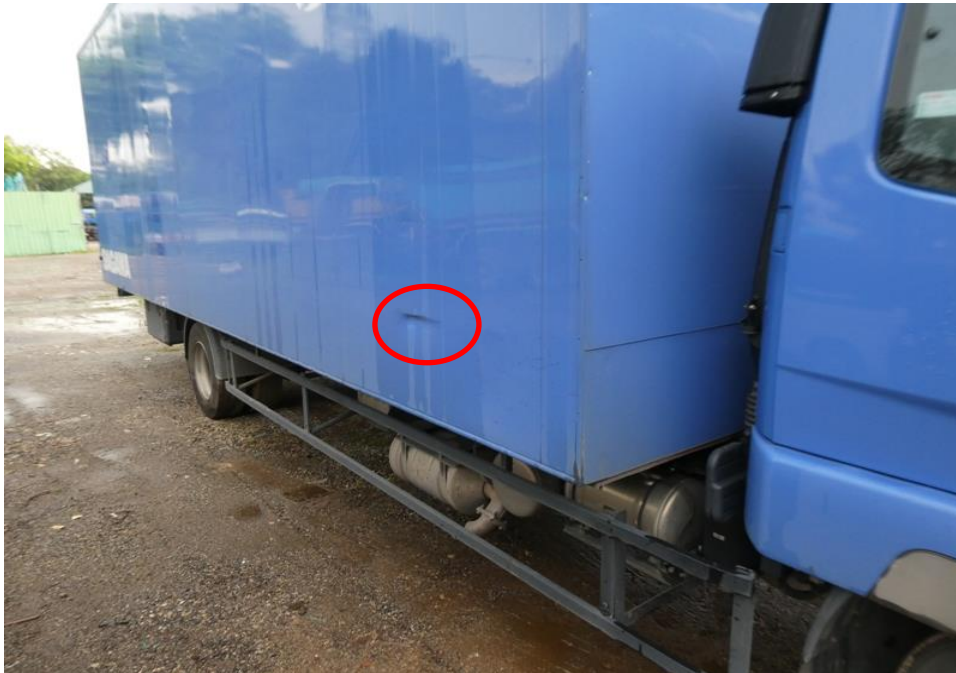
9. From the Vehicle Damage Inspection Report of Third Party by LKK Auto Consultants Pte. Ltd., we note that the Third Party had sustained damage onto its right body panel portion. The main body part(s) listed as damaged in the report was the right body panel and this was depicted in the photographs that were attached in the aforesaid report.
10. Examination of these photographs showed the right body panel had been damaged. It was also noted that these were paint crack marks, dents and black rubber marks on the right body panel of Third Party. See photos 1 and 2 below.

**Photo 1** shows the general view of the rear portion of Third Party at the time of inspection. The right body panel had been damaged. It was also noted that these were paint crack marks, dents and black rubber marks (circled).

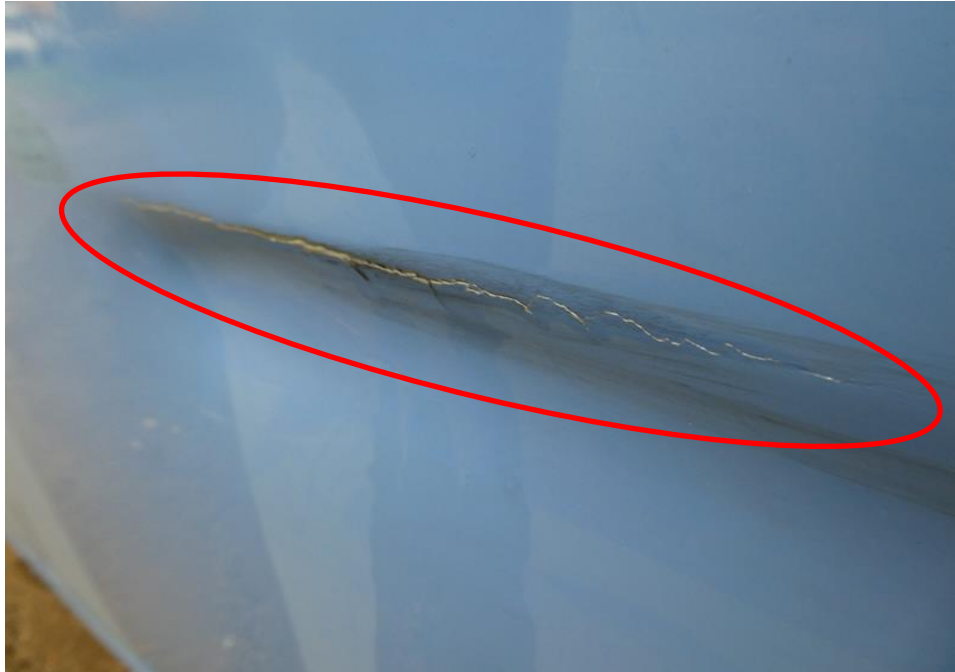
**Photo 2** shows the close up view of the rear portion of Third Party at the time of inspection. The right body panel had been damaged. It was also noted that these were paint crack marks, dents and black rubber marks (circled).

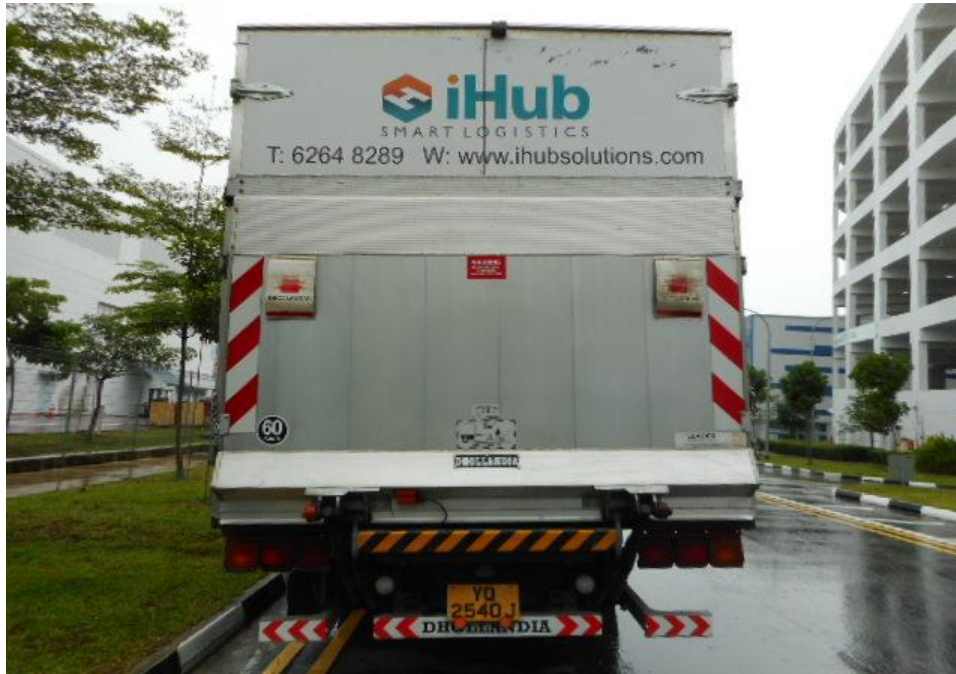
**Photo 3** shows the general view of the rear portion of Insured at the time of our inspection.

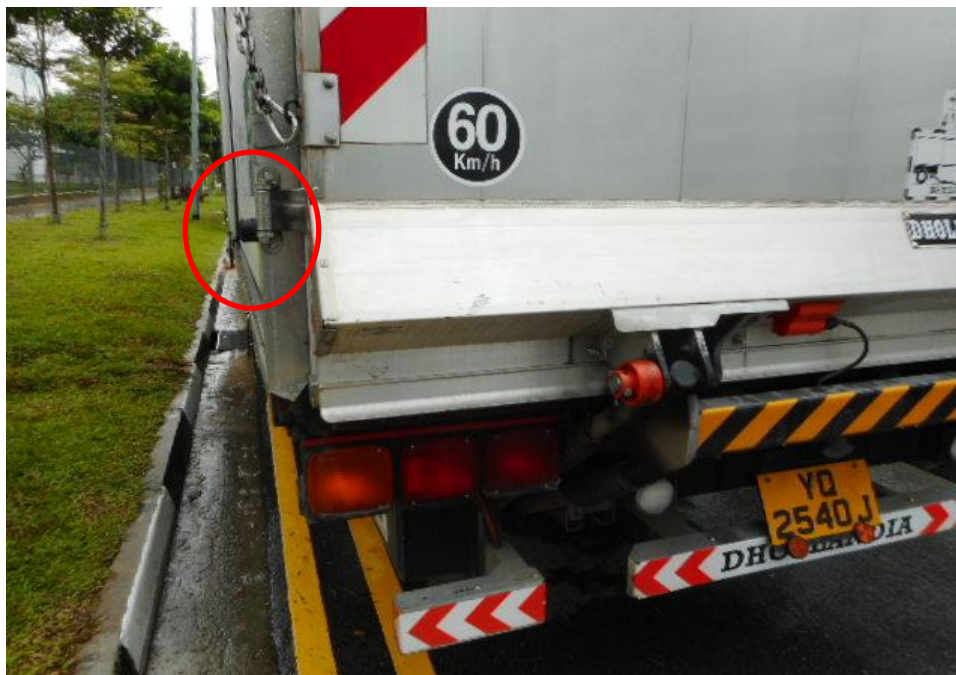
11. The Insured was physically inspected on 30 September 2021 at the premises 15 Pioneer Walks, 627753.
12. Based on the circumstances of the accident as iterated by Mr. Wang, we are of the opinion that the point of contact of Insured would be at its rear left portion since Insured was on the right side of the Third Party vehicle at the mentioned point of collision. At the time of our inspection, Insured was observed to have sustained scratch marks on the rear left side rubber stopper at its rear left portion.
13. Insured driver Mr. Yazid was not aware of the damage to rear left side rubber stopper of the Insured Vehicle. See photos 3 - 6 below.

**Photo 4** shows a close up view of the Insured rear portion. We observed scratches on the rear left rubber stopper (circled).

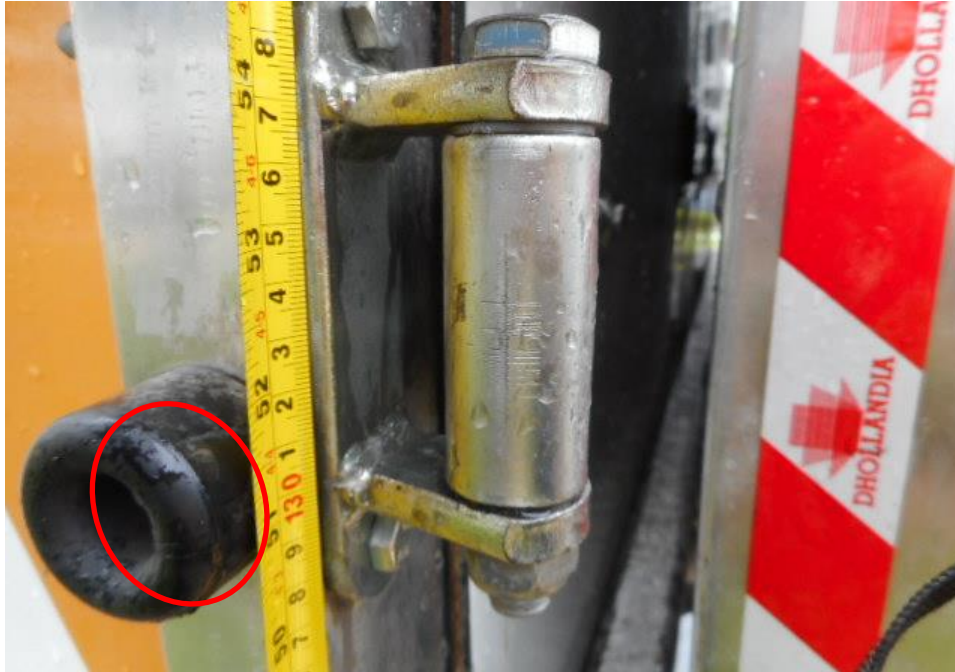
**Photo 5** shows a close up view of the Insured rear portion. We observed scratches on the rear left rubber stopper (circled).

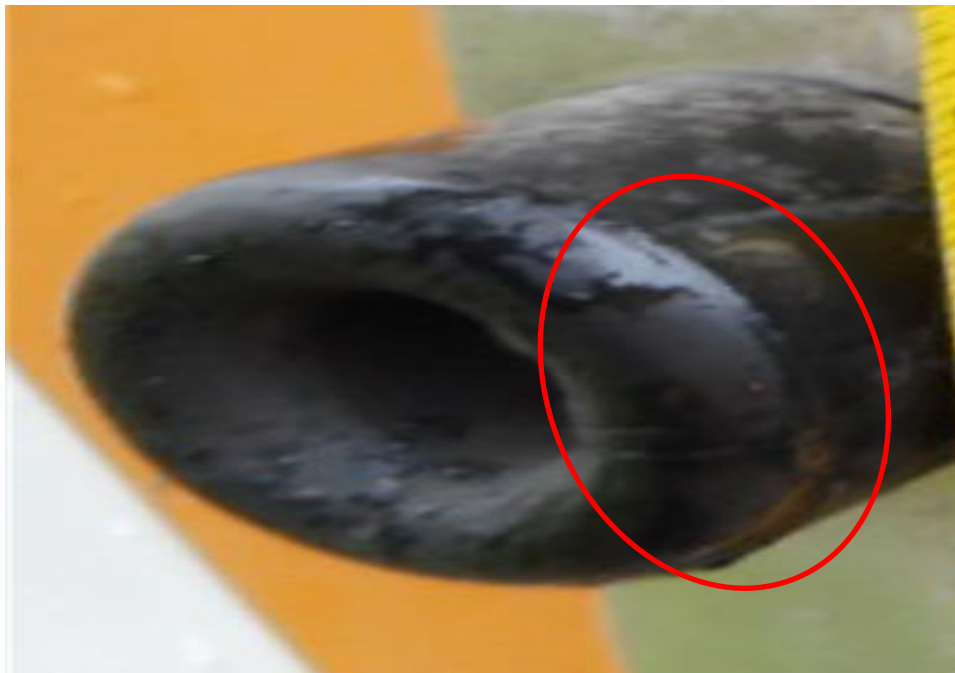
**Photo 6** shows a close up view of the Insured rear portion. We observed scratches on the rear left rubber stopper (circled).

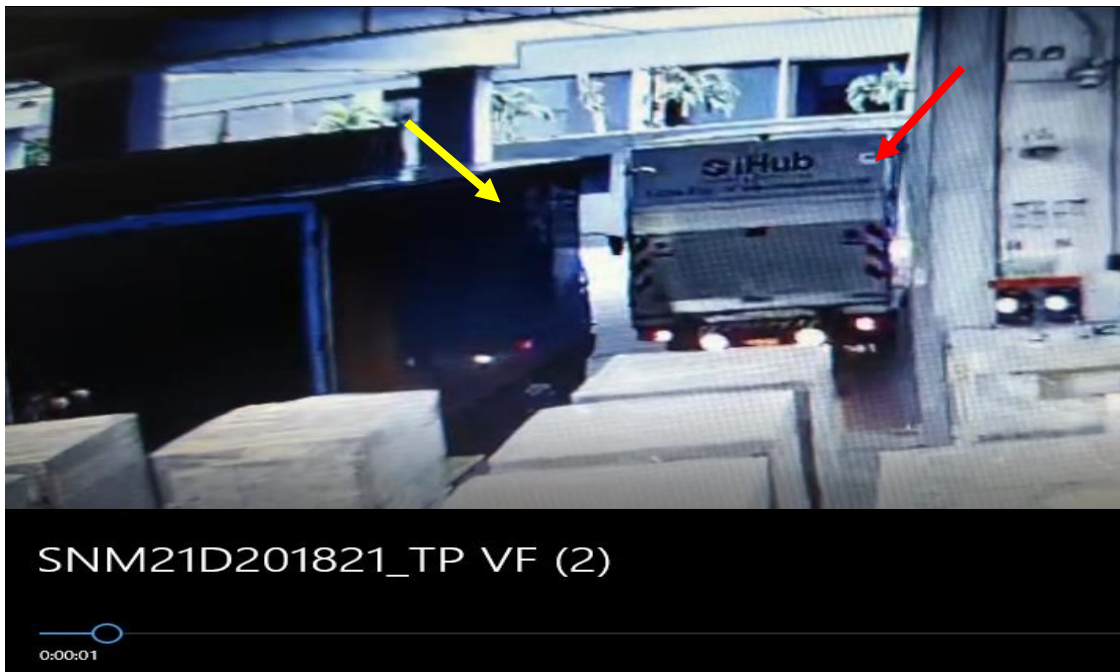
**Screenshot 1** shows at the 8 second mark of the video recording, we had noted that Insured (red arrow) was reversing into the parking lot beside the Third Party where the Third Party was stationary in the lot (yellow arrow).

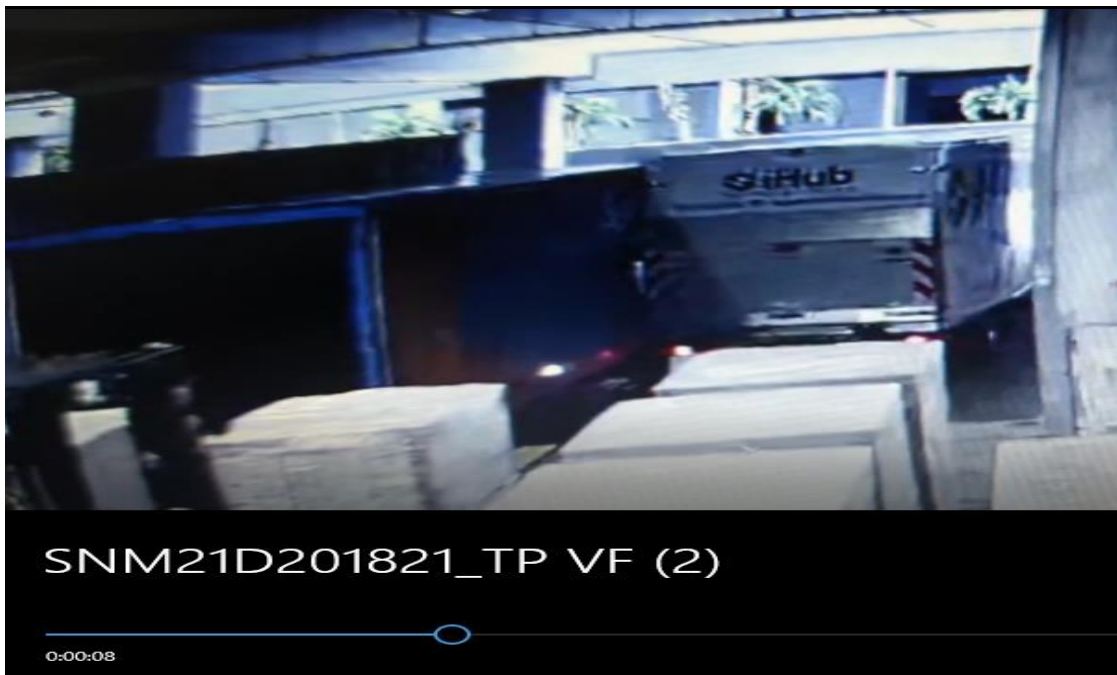
15. From the video recording, Insured could be seen reversing on into the unloading bay parking lot on the right side of the Third Party. From the rear view video showing the front footage, at 1 second mark of the video recording, we had noted that Insured was reversing into the parking lot beside the Third Party where the Third Party was stationary in the lot. At 8 second mark Insured's vehicle had come to a halt while reversing without applying any brake and this is where the said collision might have taken place.

**Screenshot 2** shows at 8 second mark Insured's vehicle had come to a halt while reversing without applying any brake and this is where the said collision might have taken place.

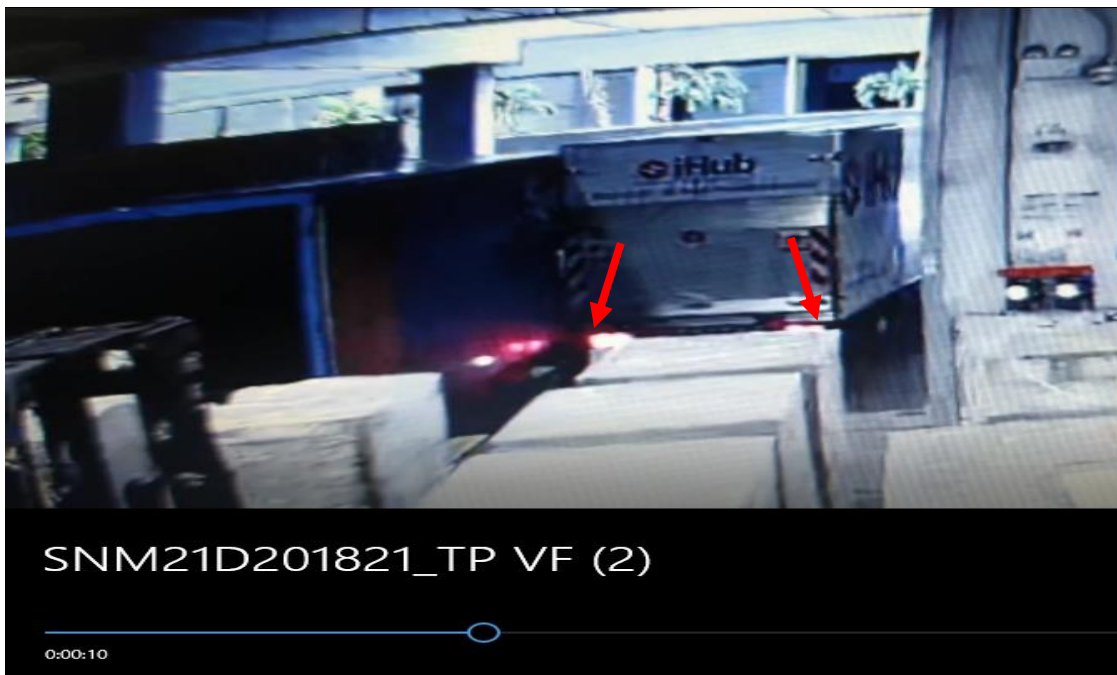
**Screenshot 3** shows at the 10 second mark Insured had applied the brakes (arrowed) as we can observe by the lighting up of the outer red lights (arrowed) which was the brake lights.

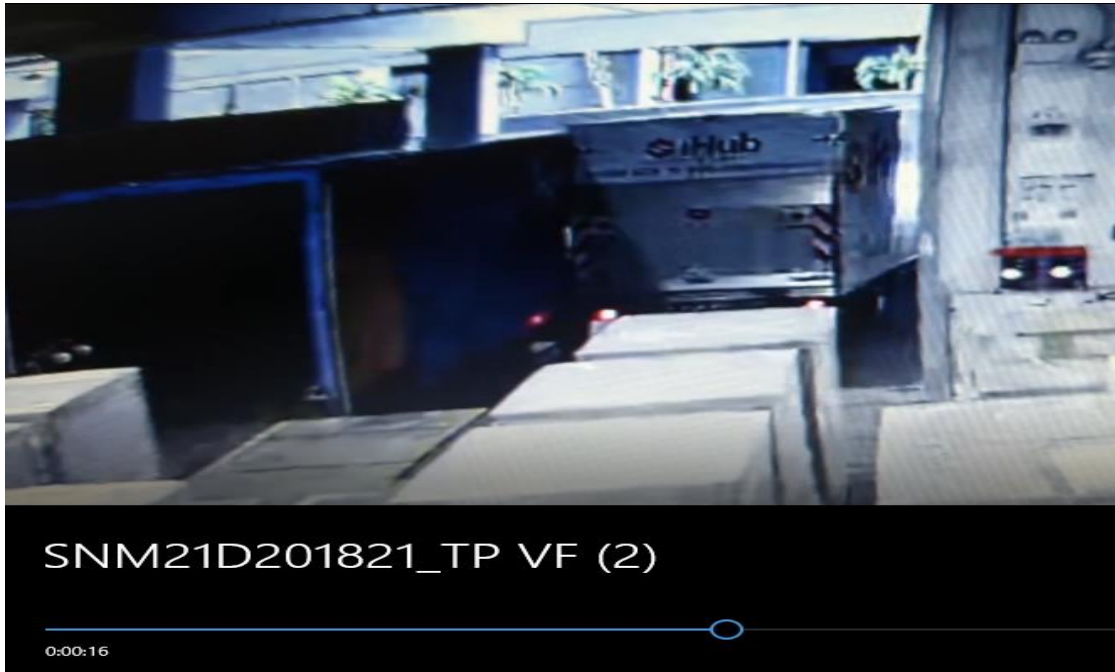
**Screenshot 4** shows At the 16 second mark started to move forward and realign the Insured Vehicle to park again.

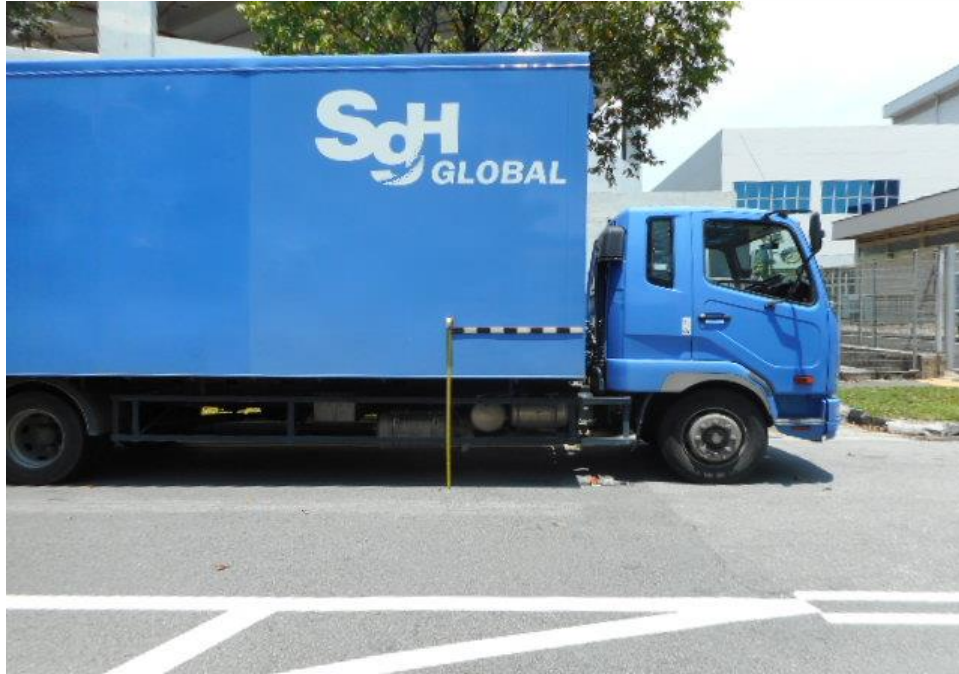
**Photo 7** shows the general view of the height measurement being conducted on the right portion of Third Party. The height above ground level of where the damages were found to the right body panel of the Third Party was between 130cm and 135cm.

- a) the height above ground level of the range of damages (which included the dents, crack marks and black rubber marks on the right body panel portion of Third Party) was measured to be approximately between 130cm to 135cm;
- b) the height above ground level of the scratched marks that we observed on the rear left portion rubber stopper of Insured was measured to be between 129cm to 132cm respectively;
- c) The height measurements appear to support the findings of possible contact between the right portion of Third Party and the rear left portion of Insured.

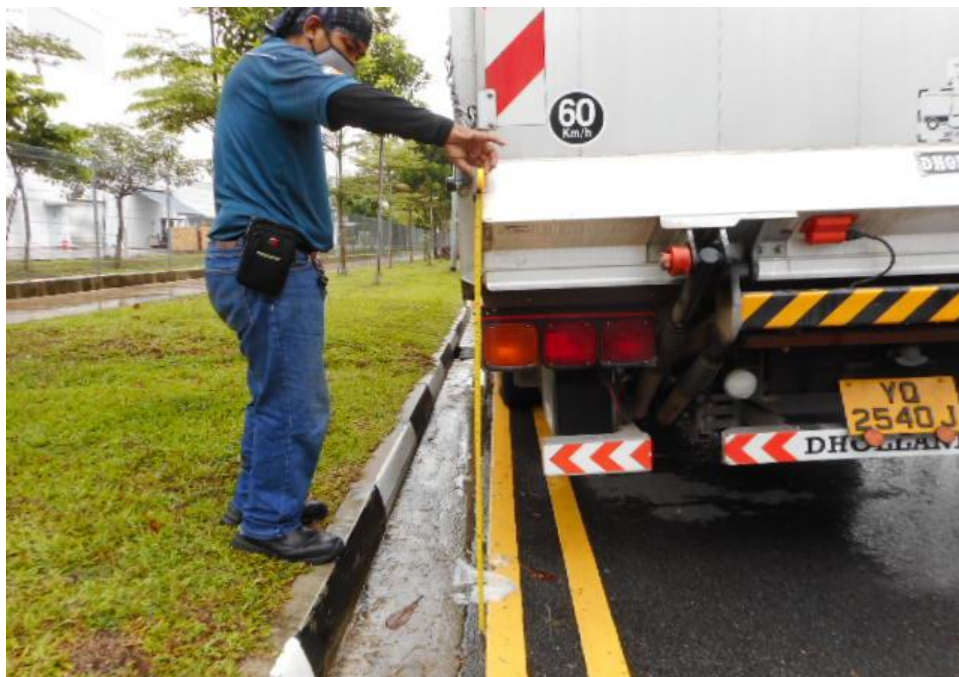
**Photo 8** shows a general view of the height measurement being conducted on the rear left portion of Insured. The scratch marks found on the rear left rubber stopper was measured to be between 129cm to 132cm above ground level.

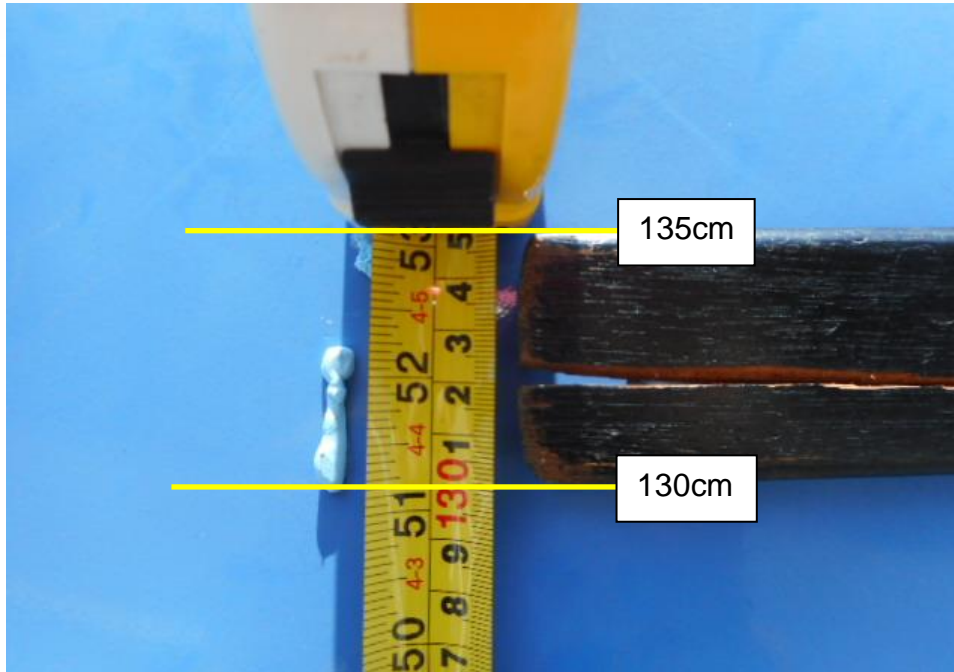
**Photo 9** shows the close up view of the height measurement being conducted on the right portion of Third Party. The height above ground level of where the damages were found to the right body panel was measured to be between 130cm and 135cm.

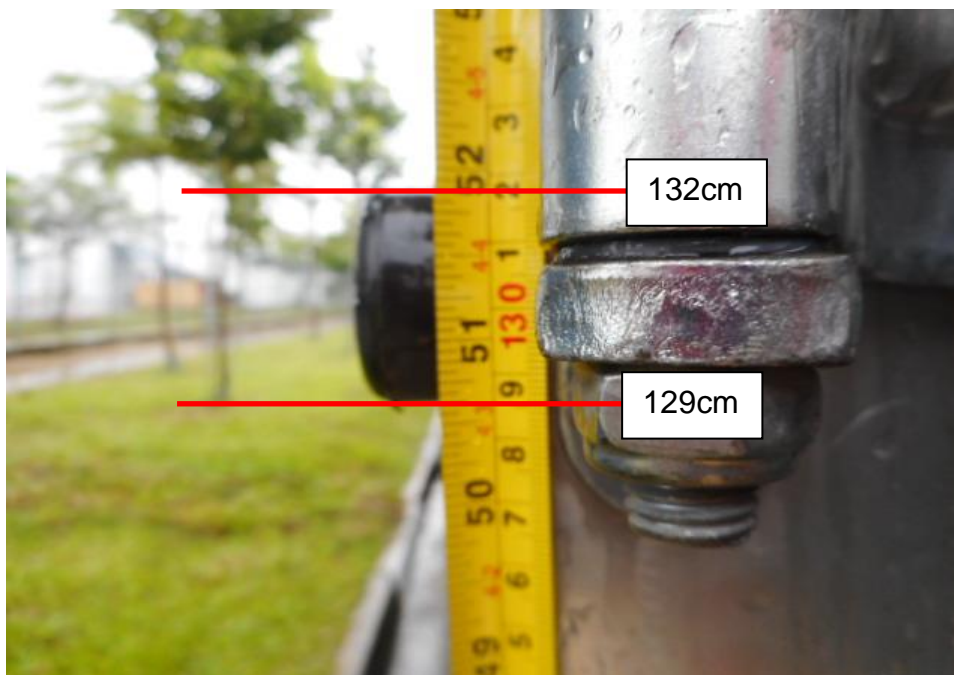
**Photo 10** shows the close up view of the height measurement being conducted on the rear left portion of Insured. The scratch marks found on the rear left rubber stopper was measured to be between 129cm to 132cm above ground level.
