Your Ref: Volkswagen Golf R  
(chassis number WVVZZZAUZKW157978)  
Our Ref : CI/TP21004425/D

10 April 2021

**INSPECTION REPORT OF AN UNREGISTERED VOLKSWAGEN GOLF R  
MOTOR CAR WITH CHASSIS NUMBER WVVZZZAUZKW157978**

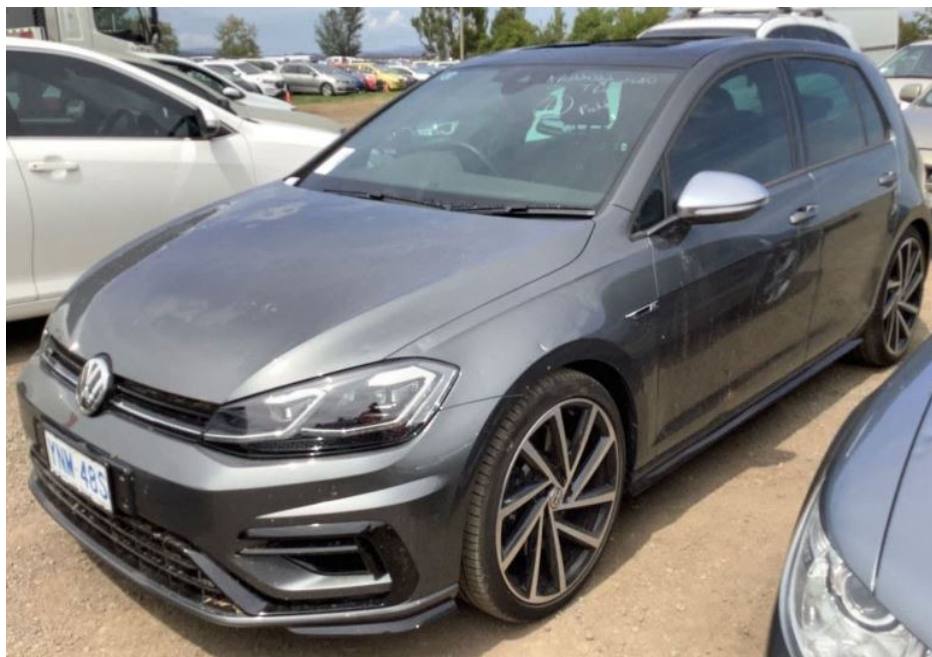
**Photo 1** shows the front left body of the Motor Car prior to any repairs being carried out (photograph provided to me). The Motor Car was observed to have sustained damages of indentation nature to exterior body parts like its front bonnet.

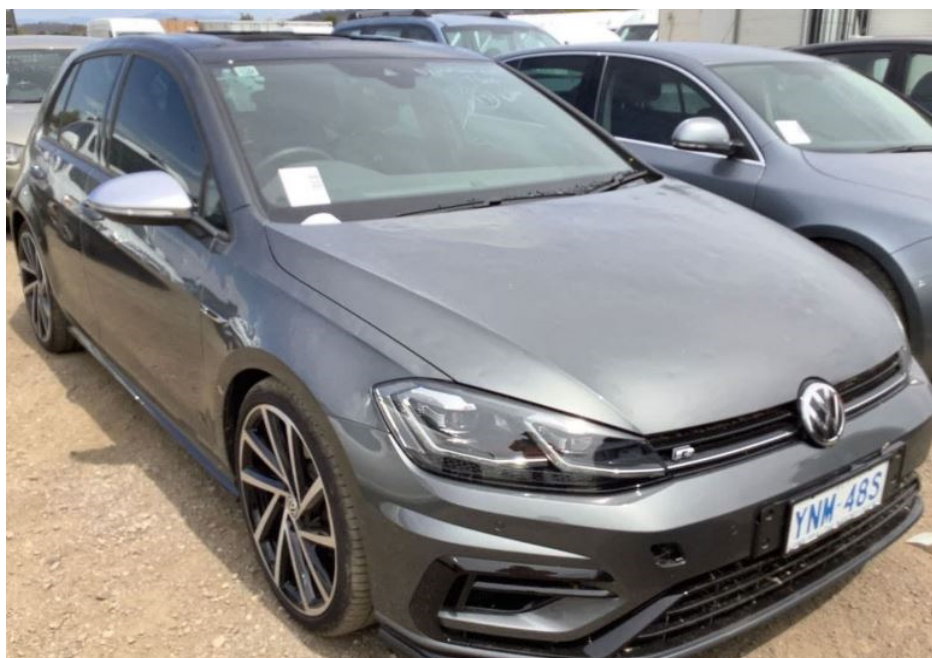
**Photo 2** shows the front right body of the Motor Car prior to any repairs being carried out (photograph provided to me). The Motor Car was observed to have sustained damages of indentation nature to exterior body parts like its front bonnet. As seen from the photograph, there were multiple relatively minor indentations on the front bonnet.

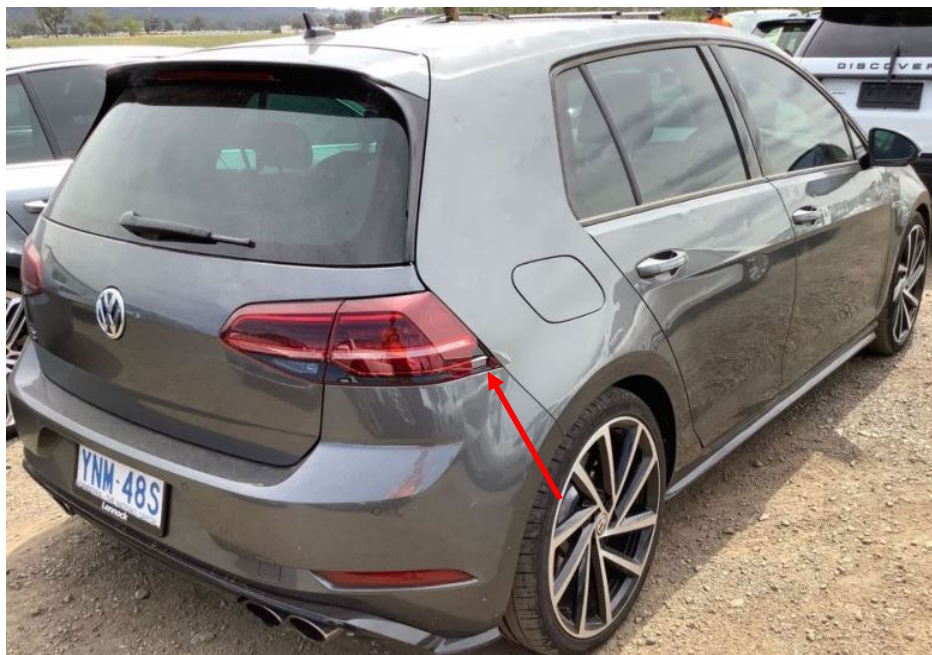
**Photo 3** shows the rear right body of the Motor Car prior to any repairs being carried out (photograph provided to me). The Motor Car was observed to have sustained damages of indentation nature to exterior body parts. The rear right taillamp (arrowed) was also observed to be broken.

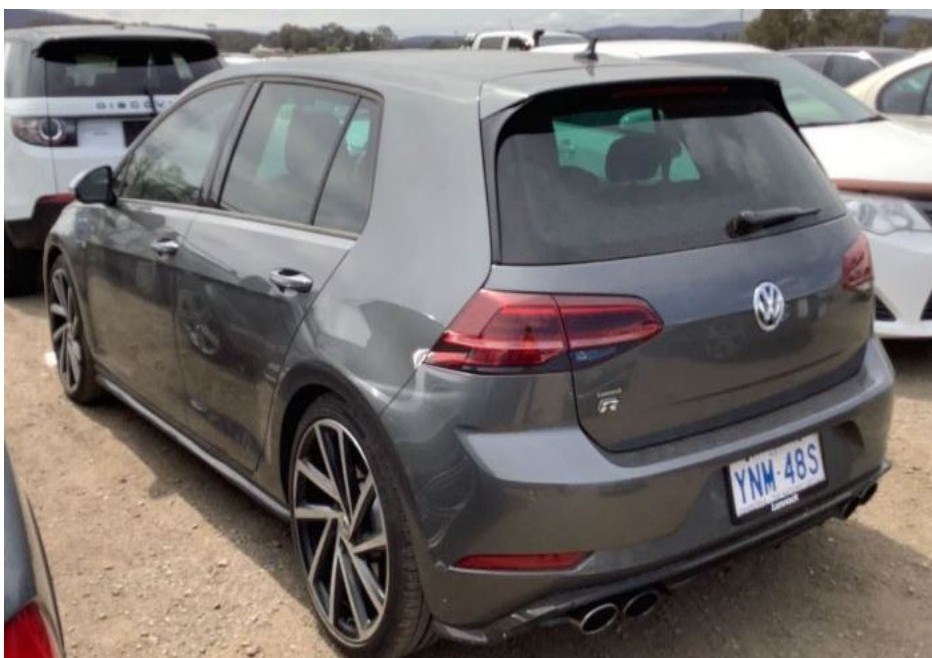
**Photo 4** shows the rear left body of the Motor Car prior to any repairs being carried out (photograph provided to me). The Motor Car was observed to have sustained damages of indentation nature to exterior body parts. As seen from the photographs provided, the indentations to the exterior body parts were relatively minor.

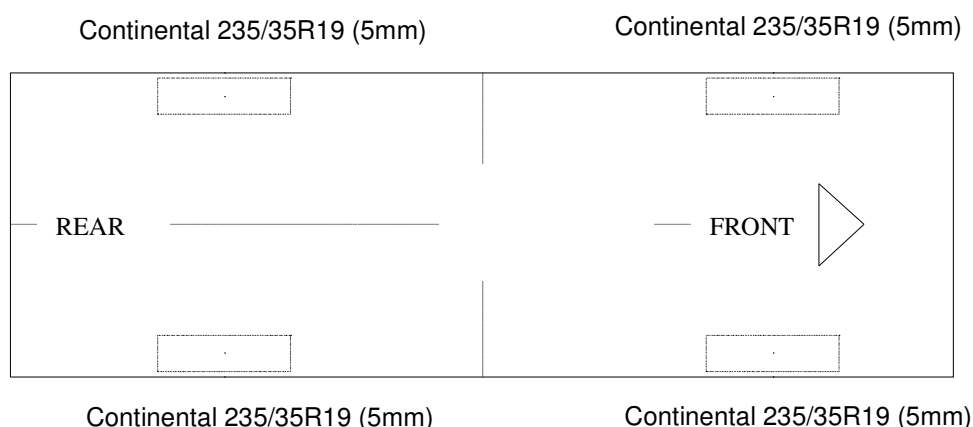
7. It was fitted with 19inch sport wheel rims that were wrapped with tyres that were observed to be of serviceable condition. The tyres were also sufficiently inflated for vehicular operation. The tyre brand, tyre size and approximate remaining tread depth of the 4 tyres of the Motor Car were recorded as follows: -

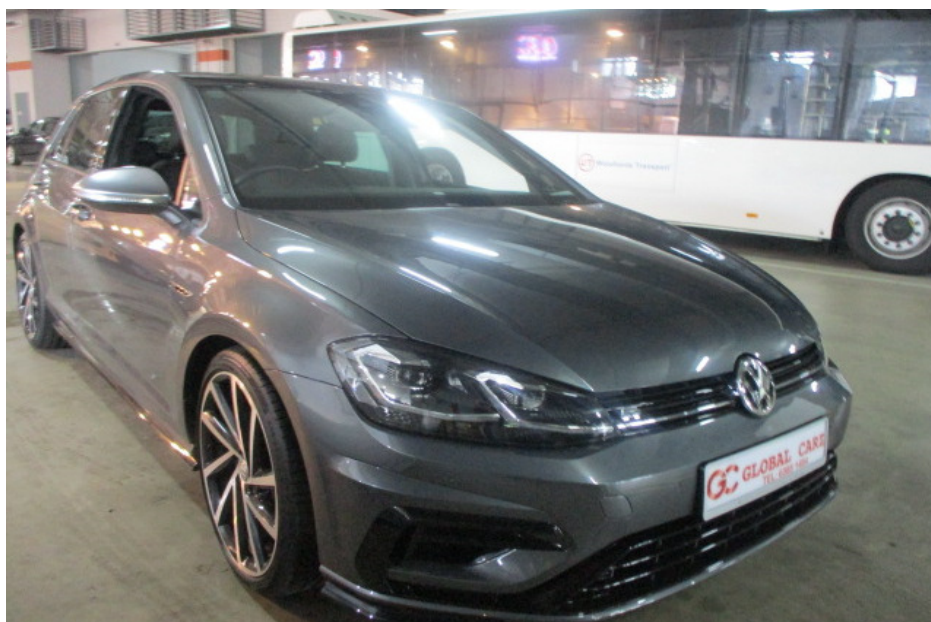
**Photo 5** shows a general view of the front right body of the Motor Car at the time of my inspection. The Motor Car was observed to be in a relatively good general condition with no loose exterior fittings observed. The exterior body parts at the frontal portion of the Motor Car, like the front bumper, front bonnet and front fenders, were visually examined and it was observed that the repair/restoration works carried out to the damaged area of the Motor Car (refer to photograph 1 & 2 above) were reasonably adequate and in order.

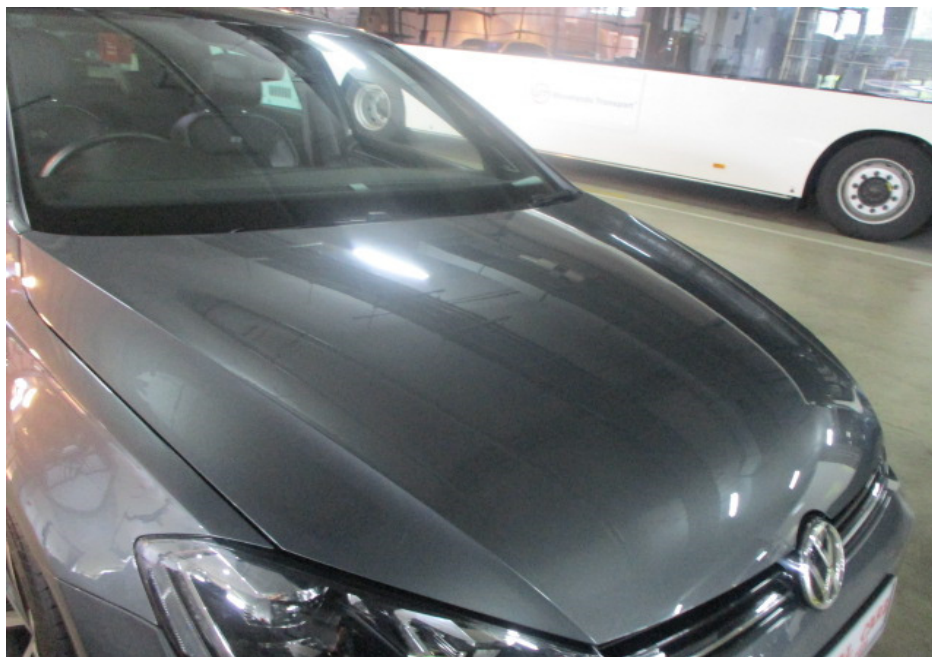
**Photo 6** shows a closer view of the Motor Car's front bonnet at the time of my inspection. In general, I had found that the repair/restoration works carried out to the damaged area of the Motor Car (refer to photograph 1 & 2 above) were reasonably adequate and in order.

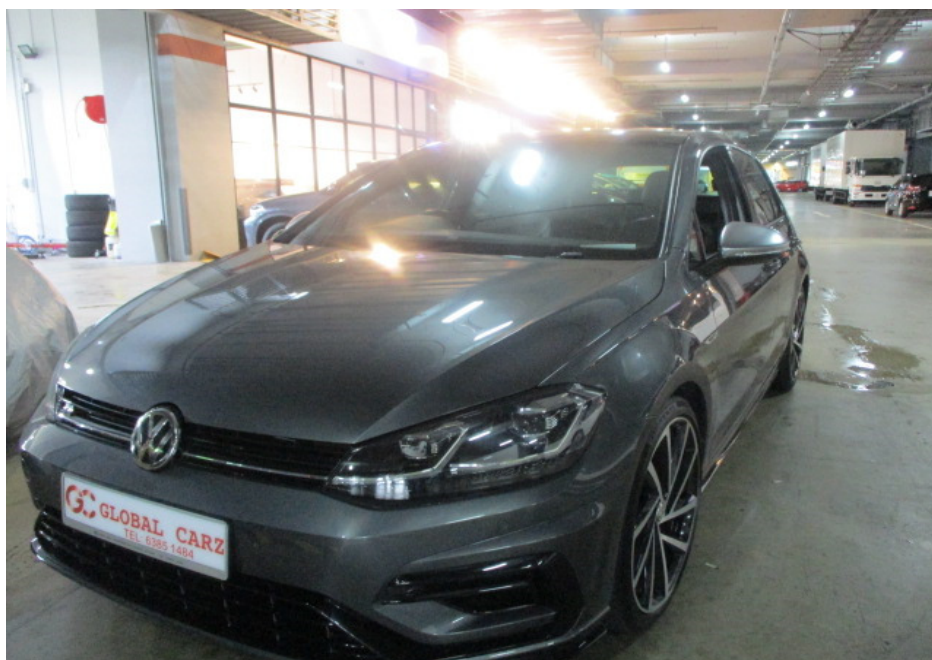
**Photo 7** shows a general view of the front left body of the Motor Car at the time of my inspection. The Motor Car was observed to be in a relatively good general condition with no loose exterior fittings observed. The exterior body parts at the frontal portion of the Motor Car were visually examined, and it was observed that the repair/restoration works carried out to the damaged area of the Motor Car (refer to photograph 1 & 2 above) were reasonably adequate and in order.

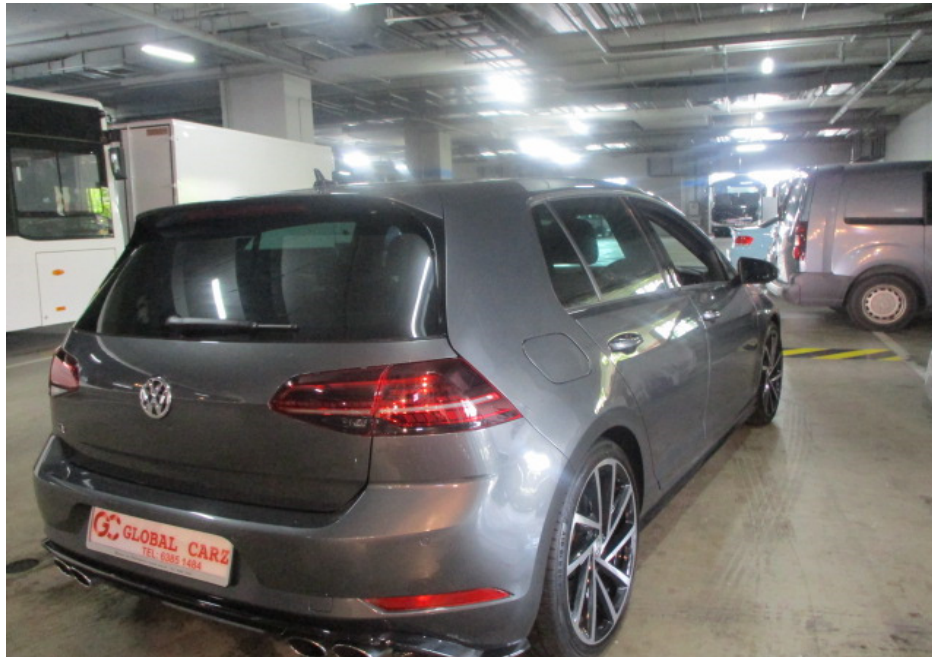
**Photo 8** shows a general view of the rear right body of the Motor Car at the time of my inspection. The Motor Car was observed to be in a relatively good general condition with no loose exterior fittings observed. The exterior body parts at the rear portion of the Motor Car, like the rear bumper, rear tailgate, rear taillamps and rear fenders, were visually examined and it was observed that the repair/restoration works carried out to the damaged area of the Motor Car (refer to photograph 3 & 4 above) were reasonably adequate and in order.

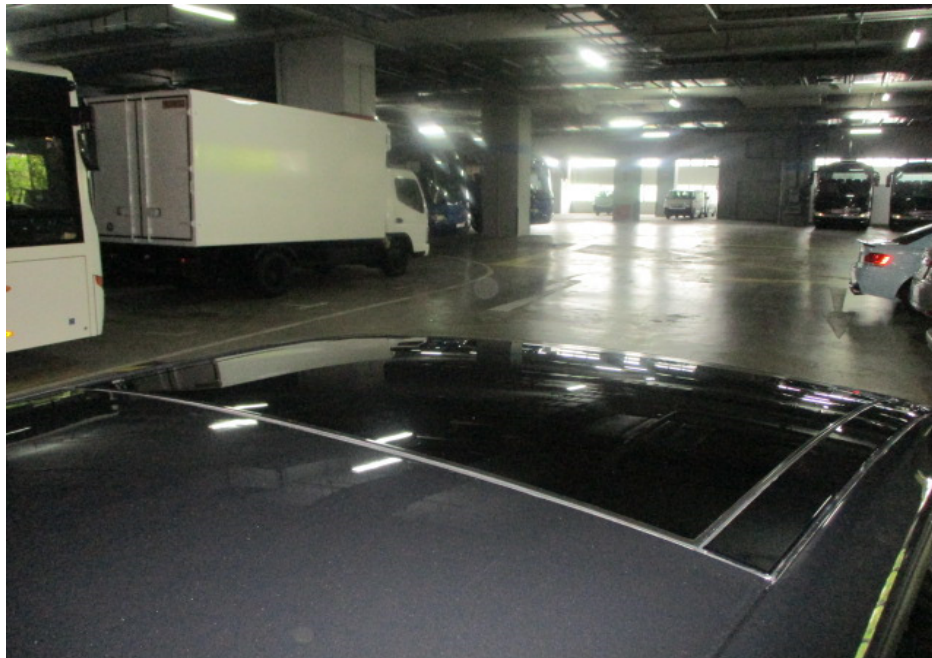
**Photo 9** shows the roof panel and panoramic sunroof of the Motor Car at the time of my inspection. In general, I had found that the repair/restoration works carried out to the damaged area of the Motor Car (refer to photograph 1 to 4 above) were reasonably adequate and in order.

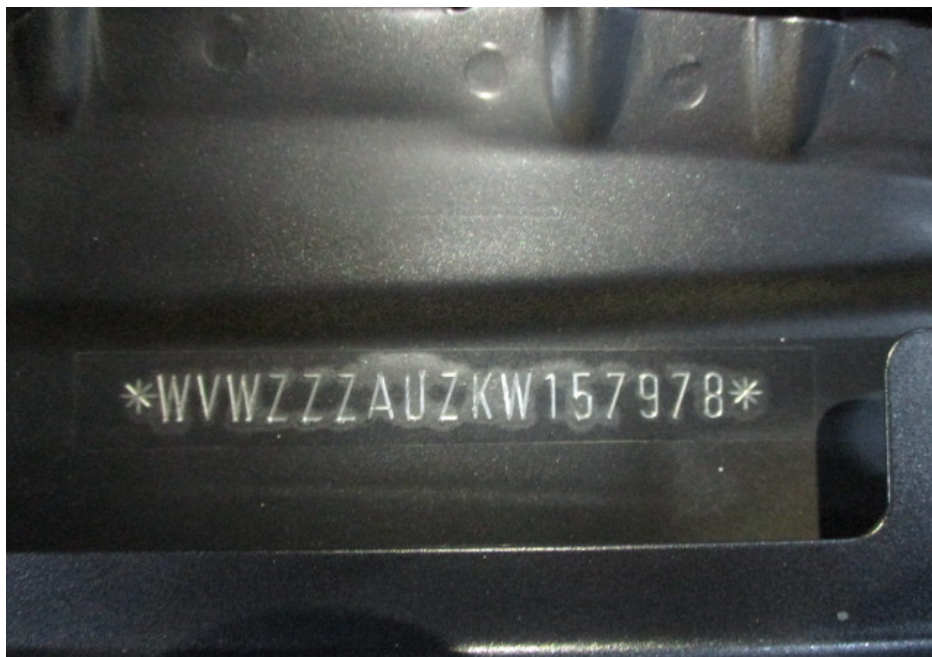
**Photo 10** shows the chassis number of the Motor Car. The chassis number recorded was WVWZZZAUZKW157978.

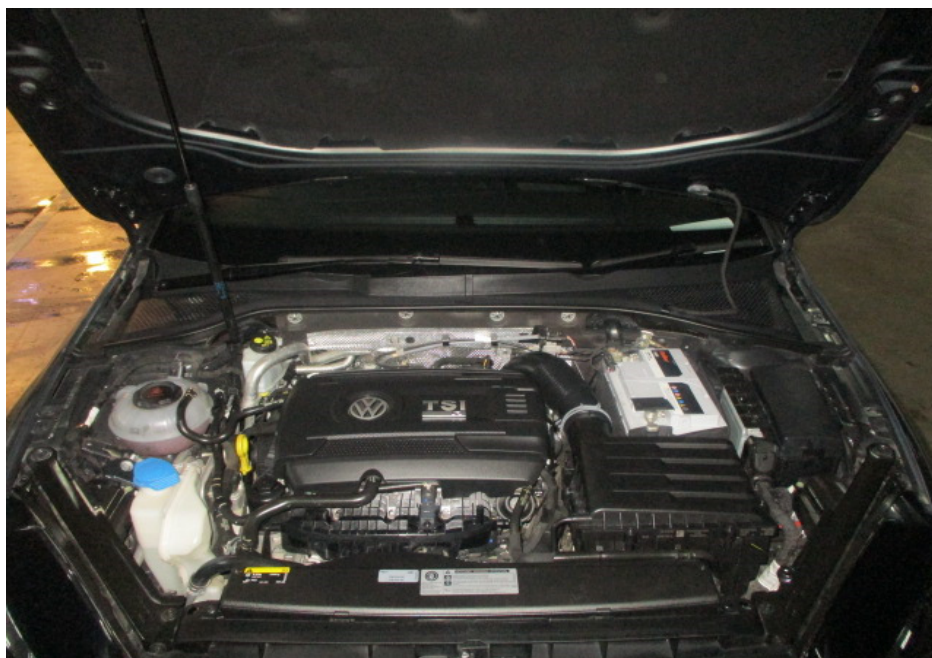
**Photo 11** shows a general view of the engine compartment of the Motor Car at the time of my inspection. The various parts and components inside the engine compartment were all observed to be intact and properly fitted. There was also no sign(s) or indication(s) of fluid leak and/or fluid stain found inside the engine compartment.

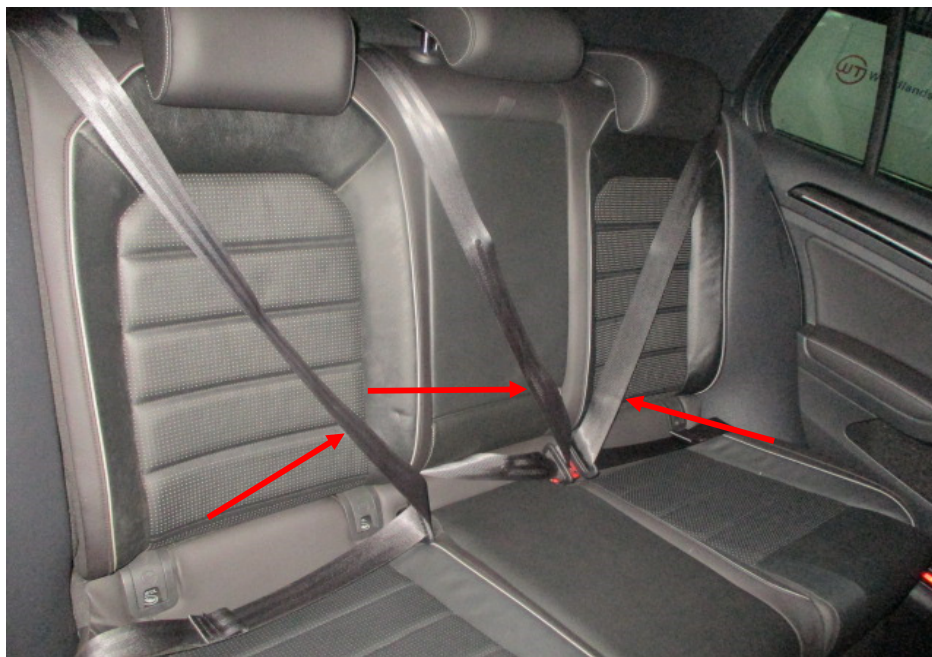
**Photo 12** shows the rear seats of the Motor Car. All the seats of the Motor Car were secured via seat rails to the floorboard. They were also fitted with a retractable seat belt reel and a pre-tensioner. The seat belts (arrowed) were tested and were able to be fastened into the respective pre-tensions that were fitted on the side of each individual seat.

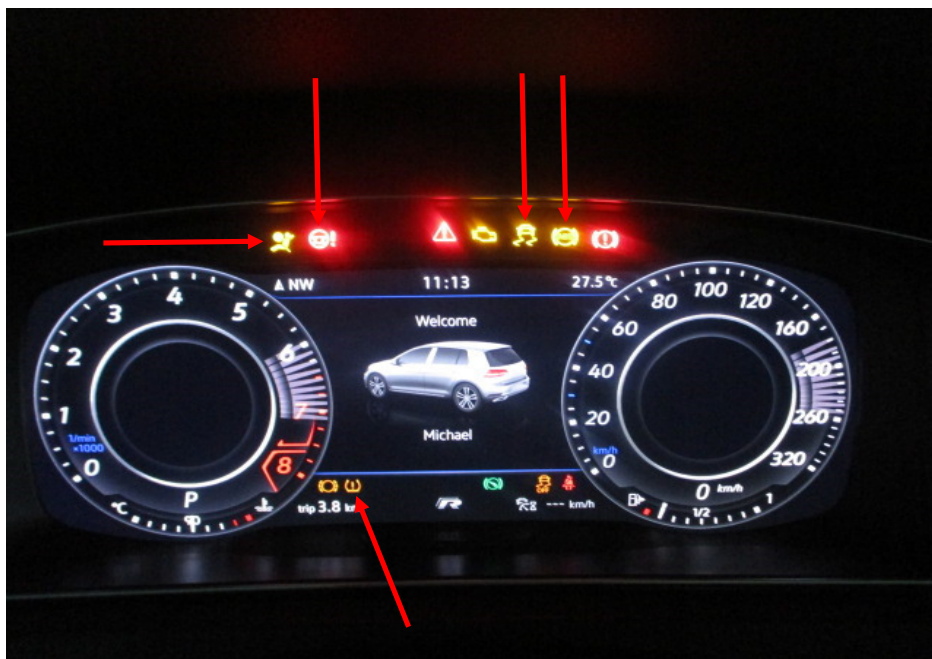
**Photo 13** shows the warning lights for the various electronic safety features appearing on the instrument panel of the Motor Car during its self-test when the engine is cranked, in particular the ABS, SRS, EPS and TCS lights (arrowed).

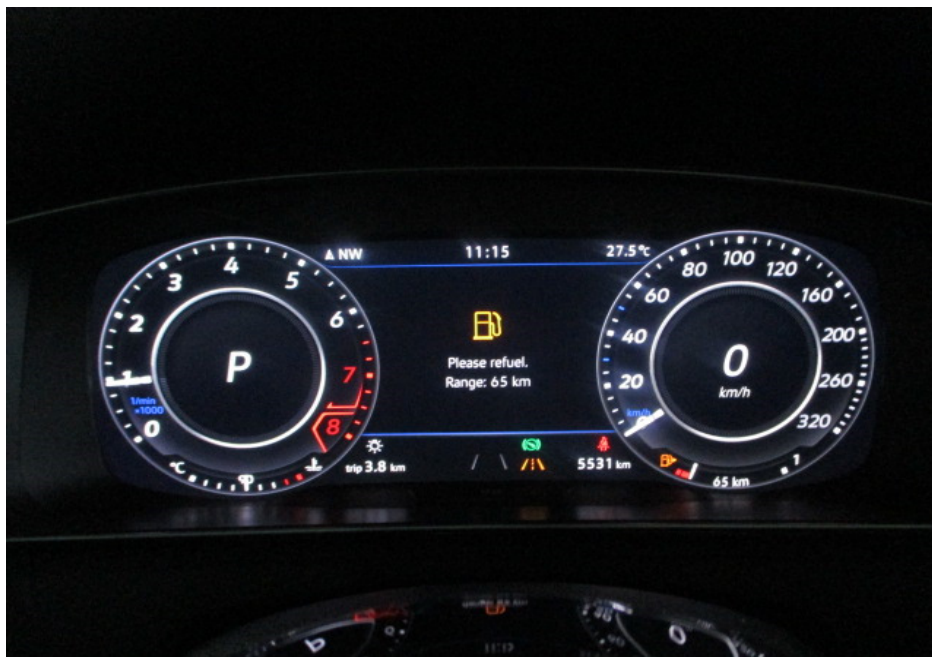
**Photo 14** shows the respective warning lights no longer illuminated, indicating that there is no fault detected to the ABS, SRS, EPS and TCS systems of the Motor Car during the self-test. These electronic systems were hence in working condition at the time of my inspection.

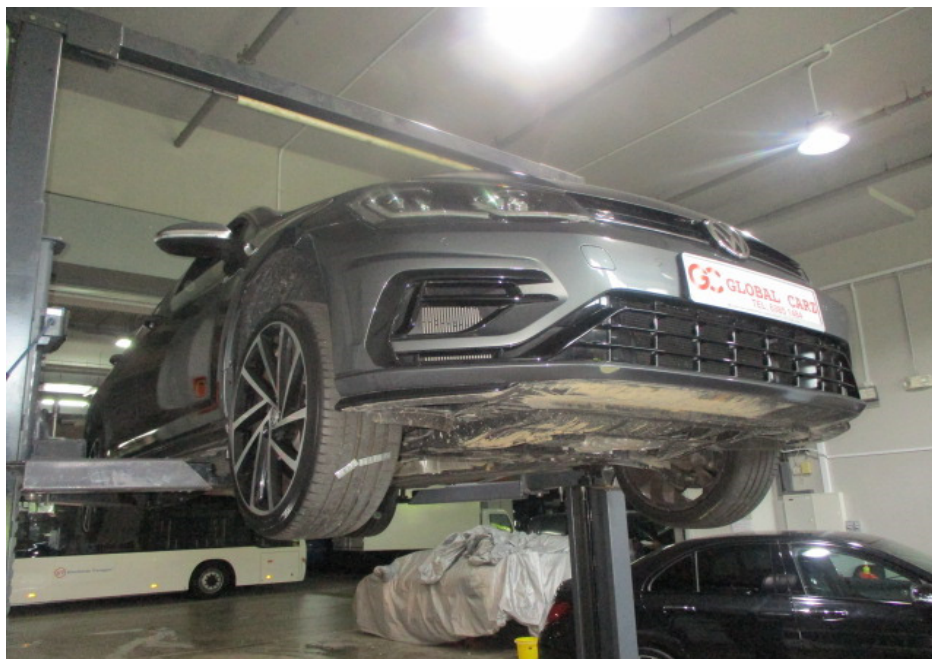
**Photo 15** shows the Motor Car hoisted up for checks on its undercarriage. There was no sign(s) or indication(s) of fluid leakage and/or fluid stain(s) on the underside of the Motor Car. The undercarriage components of the Motor Car were also all observed to be intact and secured in an appropriate manner.

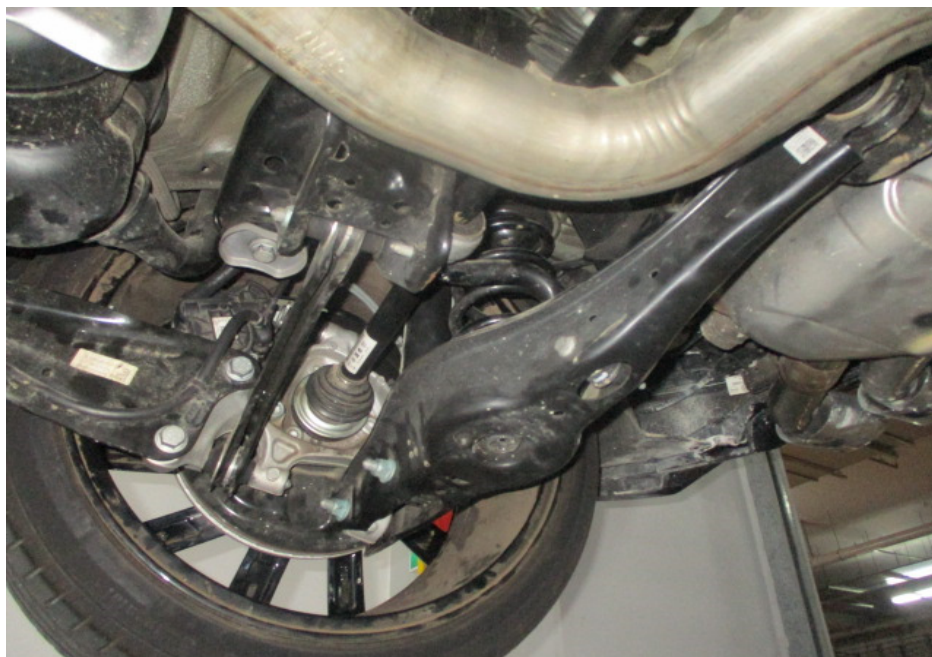
**Photo 16** shows a general view of the control arms and linkages at the rear right wheel of the Motor Car. I did not observe any fluid leak and/or fluid stain on the underside of the Motor Car. All the Motor Car's undercarriage components were observed to be intact and secured in an appropriate manner.

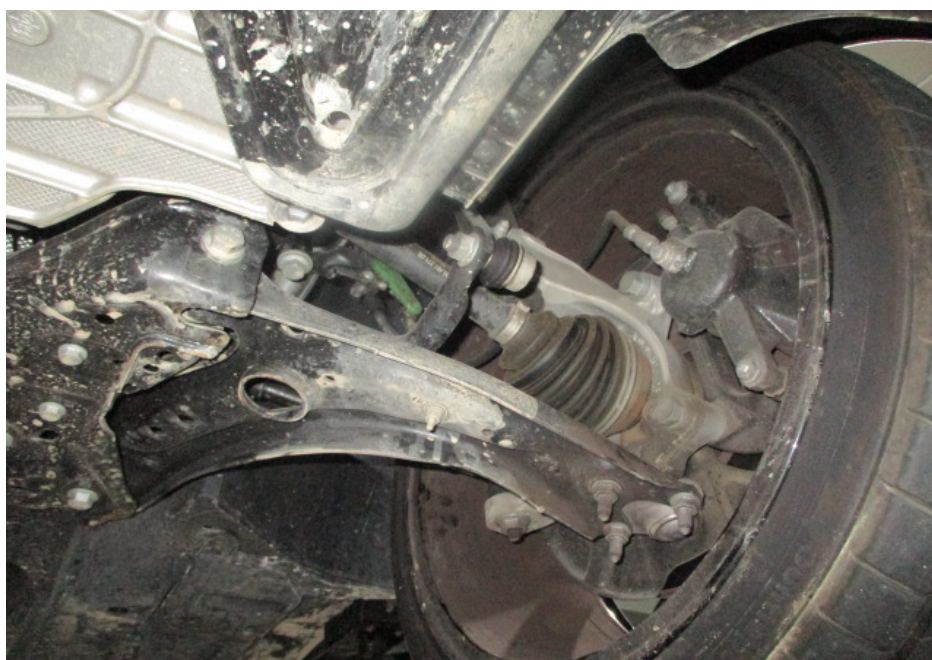
**Photo 17** shows the various undercarriage components at the front left wheel of the Motor Car. The mechanical components, control arms and linkages were all found to be intact and secured in an appropriate manner.

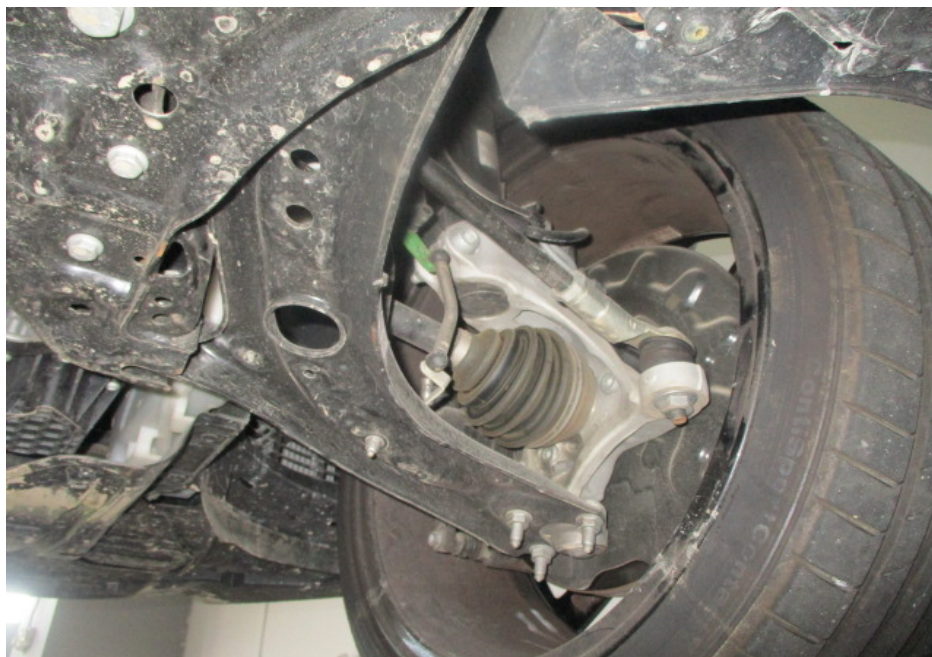
**Photo 18** shows the various undercarriage components at the front right wheel of the Motor Car. The mechanical components, control arms and linkages were all found to be intact and secured in an appropriate manner. I also did not observe any fluid leak and/or fluid stain on the underside of the Motor Car.

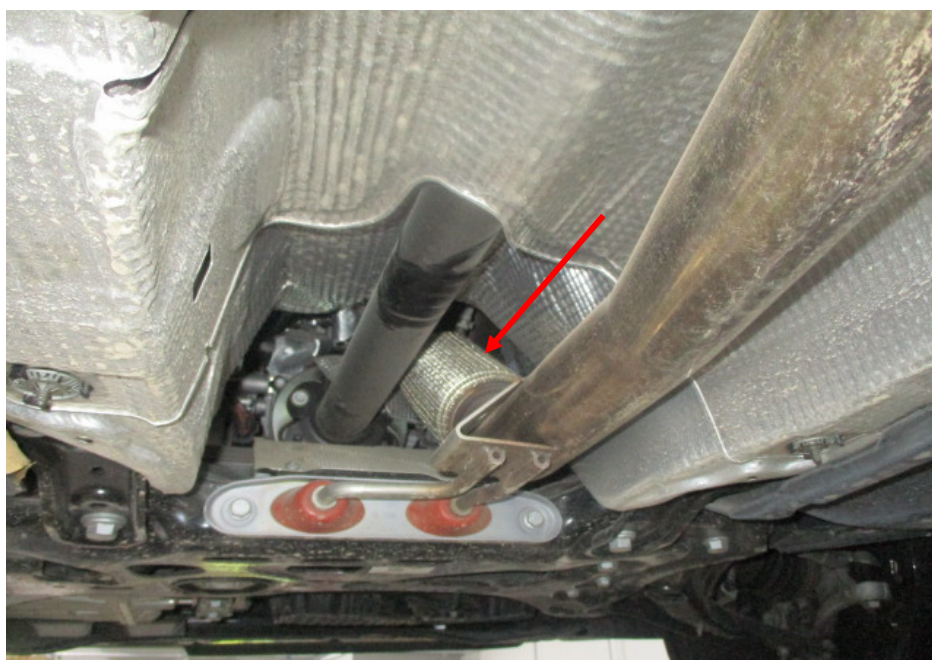
**Photo 19** shows the Motor Car's catalytic converter (arrowed). My examination of the Motor Car's exhaust system revealed no sign(s) or indication(s) of any cut or weld marks along its exhaust pipes and on its rear exhaust muffler.

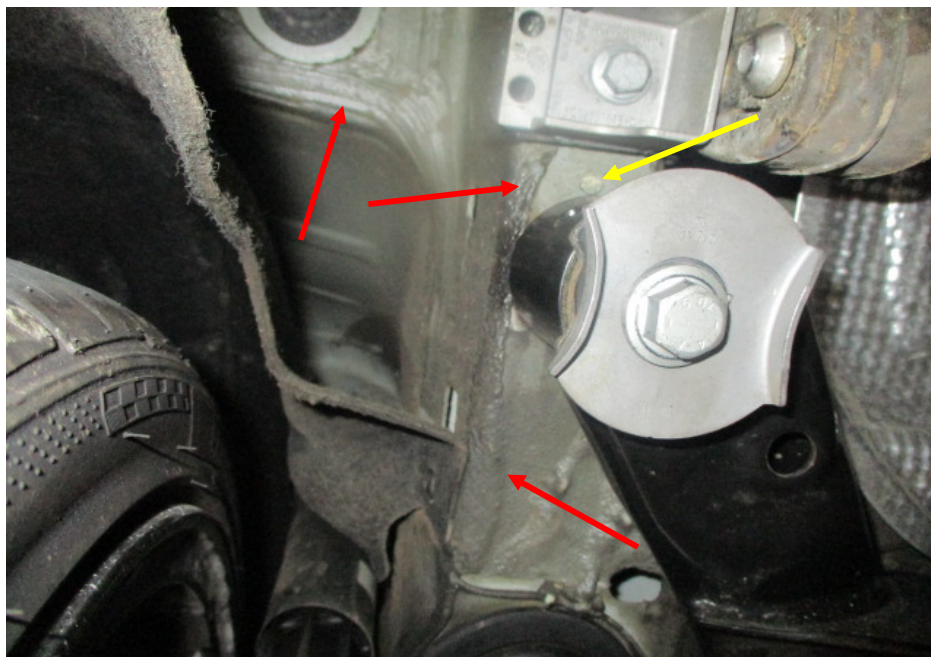
**Photo 20** shows the chassis/structural body at the underside rear left of the Motor Car. I did not find any weld marks other than original spot weld marks (yellow arrow) on the chassis/structural body of the Motor Car. The original factory sealant (red arrow) at the joints along the chassis/structural body was untouched, indicating no work was done on the chassis/structural body of the Motor Car and that the chassis/structural body was originally fitted.

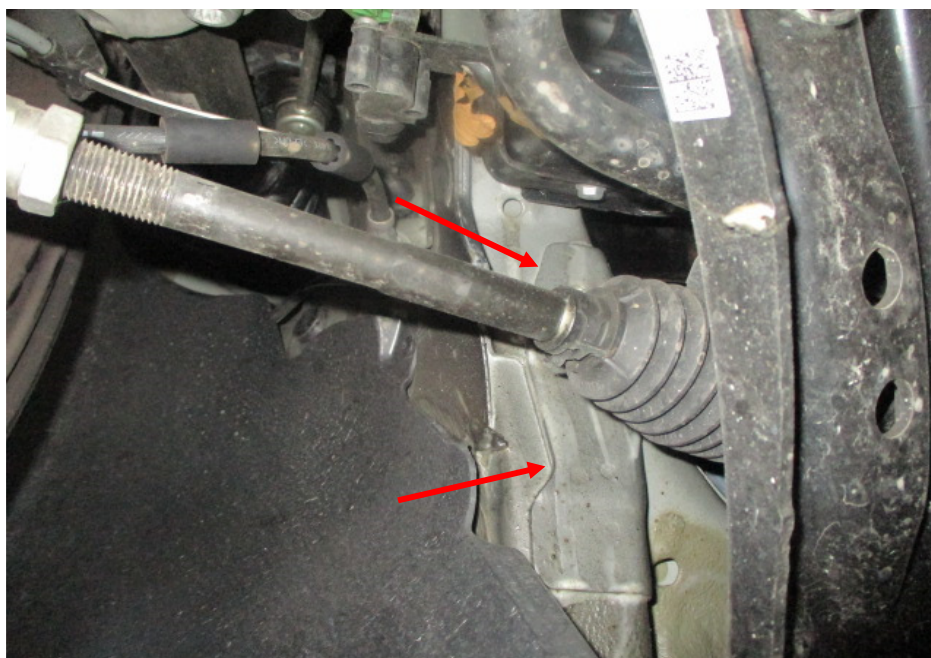
**Photo 21** shows the chassis/structural body at the underside front right of the Motor Car. The original factory sealant (arrowed) at the joints along the chassis/structural body was observed to be untouched. In general, I had found no work was carried out on the chassis/structural body of the Motor Car. The chassis/structural body of the Motor Car was originally fitted.

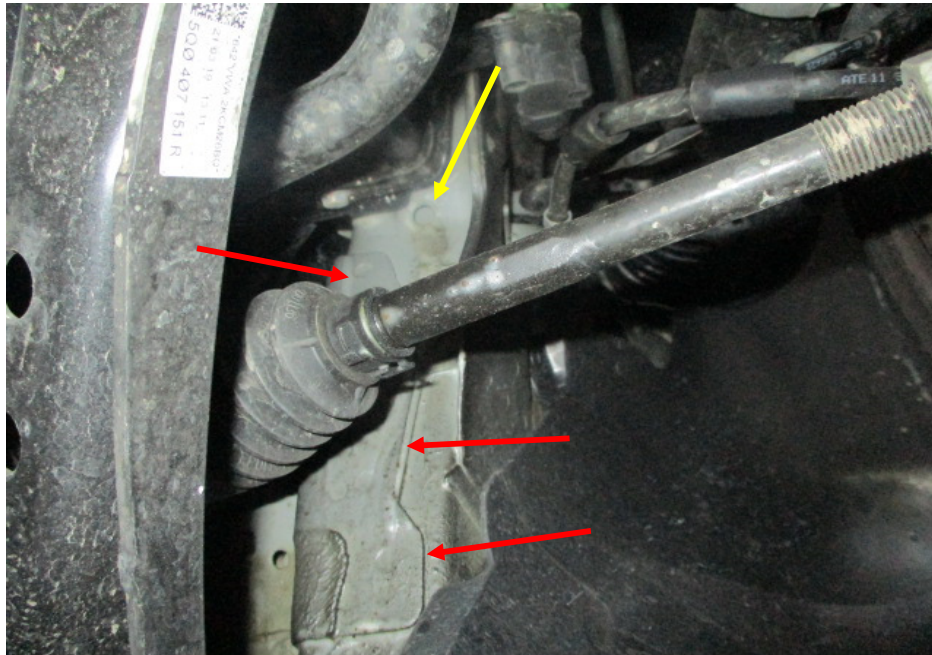
**Photo 22** shows the chassis/structural body at the underside front left of the Motor Car. I did not find any weld marks other than original spot weld marks (yellow arrow) on the chassis/structural body of the Motor Car. The original factory sealant (red arrow) at the joints along the chassis/structural body was untouched, indicating no work was done on the chassis/structural body of the Motor Car and that the chassis/structural body was originally fitted.
