Your Ref: Mercedes Benz C43
(chassis number WDD2050642R471223)
Our Ref : CI/TP21004426/D

10 April 2021

**INSPECTION REPORT OF AN UNREGISTERD MERCEDES BENZ C43
MOTOR CAR WITH CHASSIS NUMBER WDD2050642R471223**

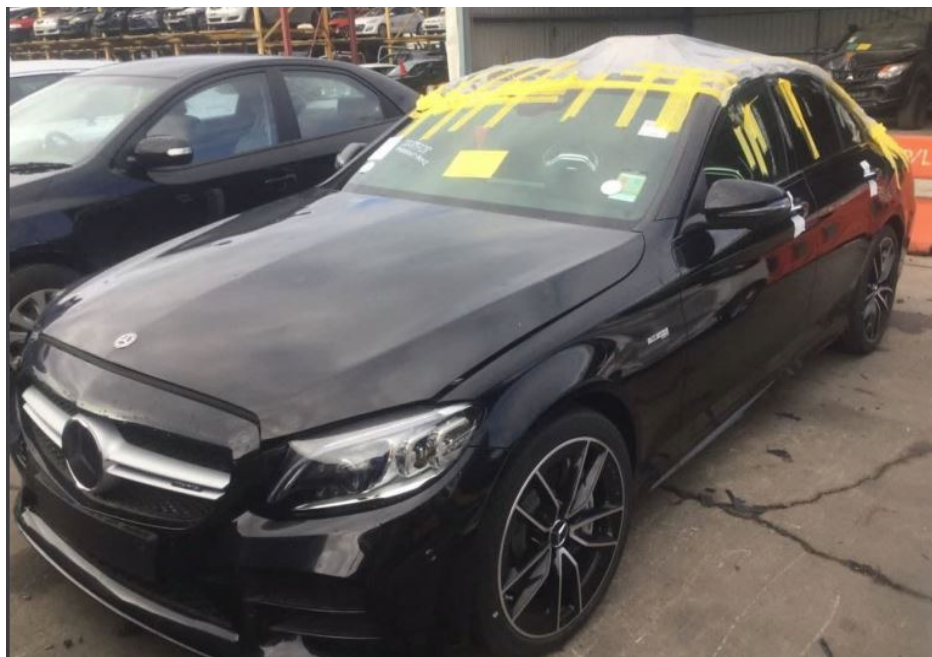
Photo 1 shows the front left body of the Motor Car prior to any repairs being carried out (photograph provided to me). The Motor Car was observed to have sustained damages of indentation nature to exterior body parts like its front bonnet.

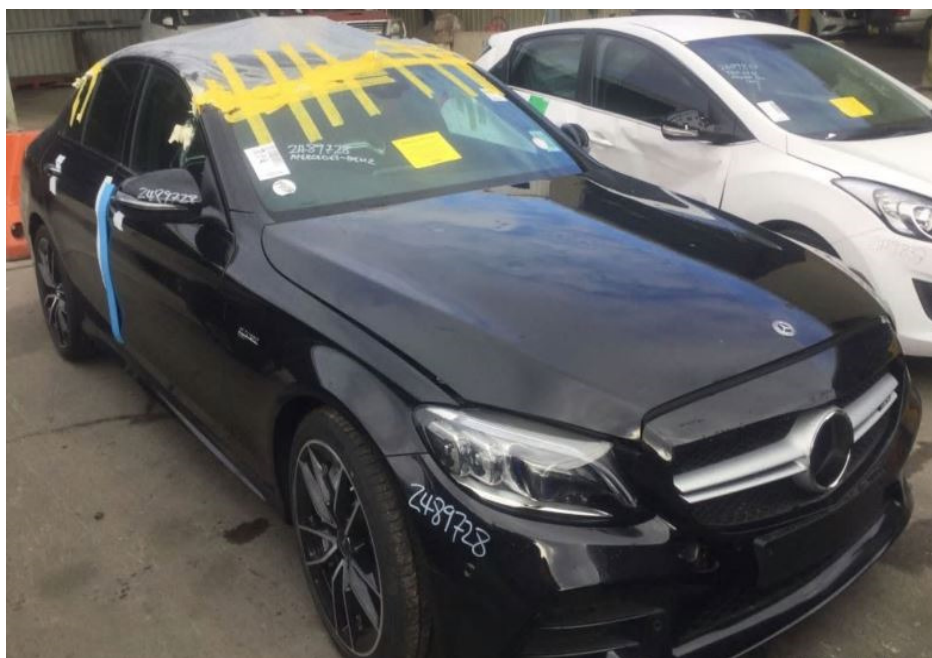
Photo 2 shows the front right body of the Motor Car prior to any repairs being carried out (photograph provided to me). The Motor Car was observed to have sustained damages of indentation nature to exterior body parts like its front bonnet. As seen from the photograph, there were multiple relatively minor indentations on the front bonnet.

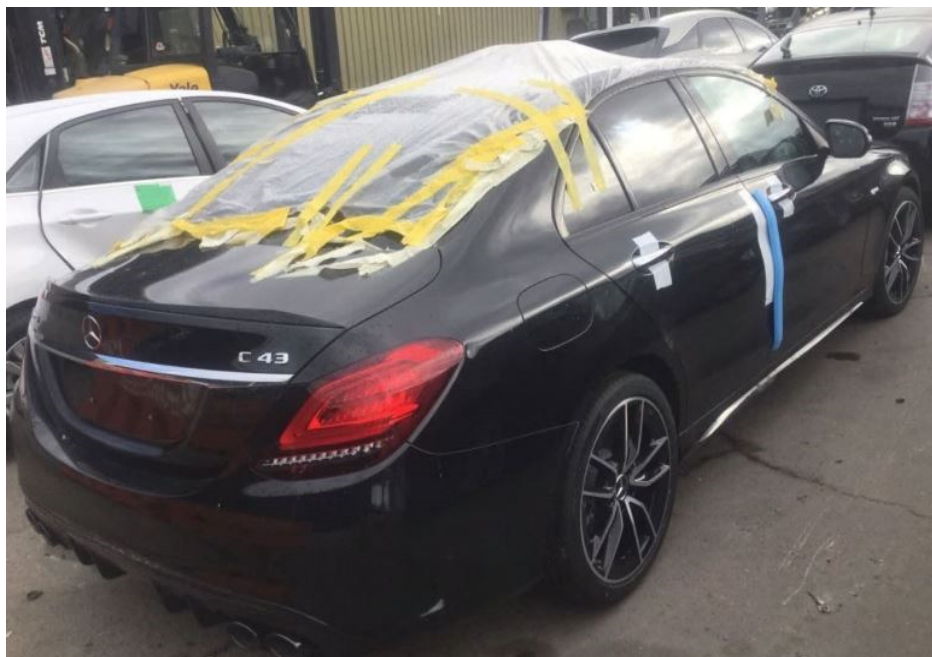
Photo 3 shows the rear right body of the Motor Car prior to any repairs being carried out (photograph provided to me). The Motor Car was observed to have sustained damages of indentation nature to exterior body parts. The roof panel and rear windscreen of the Motor Car were covered with plastic sheets, indicating possible damage to the rear windscreen and panoramic sunroof of the Motor Car.

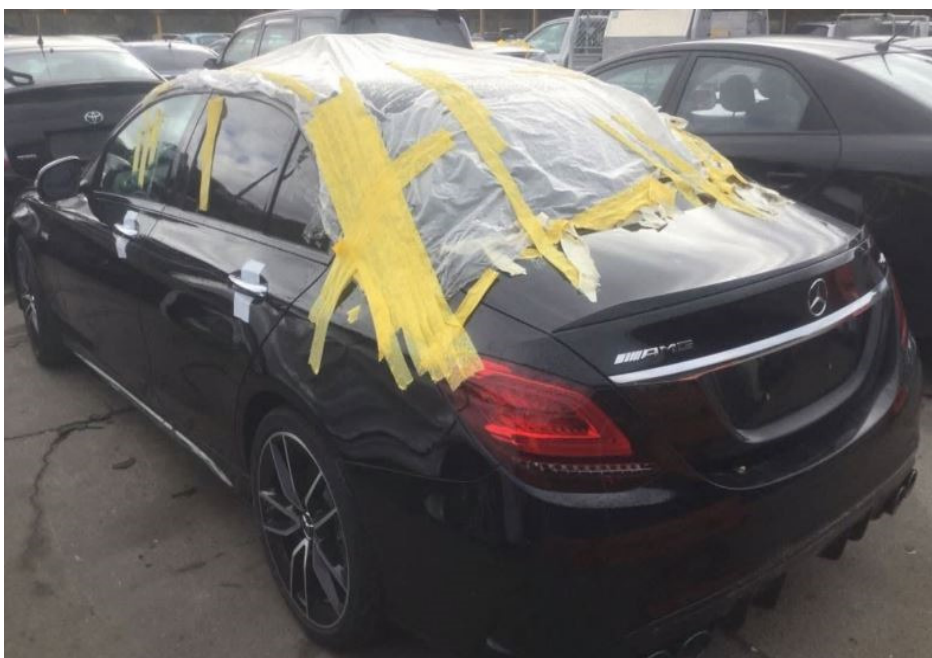
Photo 4 shows the rear left body of the Motor Car prior to any repairs being carried out (photograph provided to me). The Motor Car was observed to have sustained damages of indentation nature to exterior body parts. The roof panel and rear windscreen of the Motor Car were covered with plastic sheets, indicating possible damage to the rear windscreen and panoramic sunroof of the Motor Car.

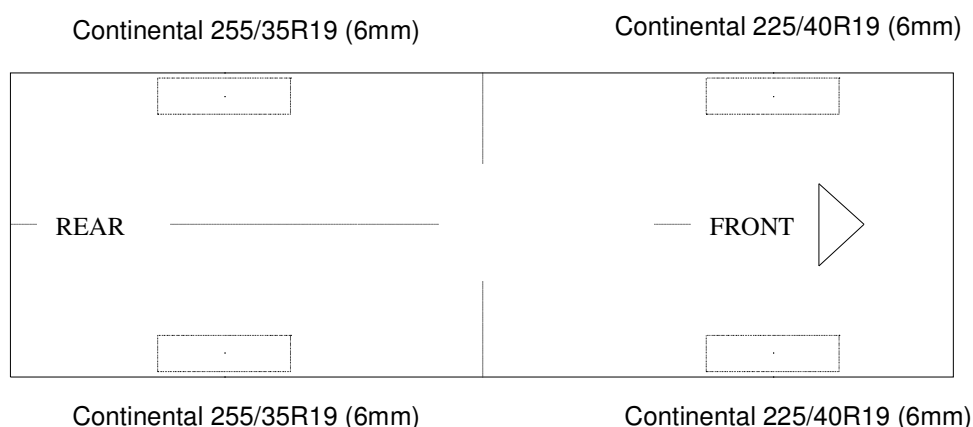
8. It was fitted with 19inch sport wheel rims that were wrapped with tyres that were observed to be of serviceable condition. The tyres were also sufficiently inflated for vehicular operation. The tyre brand, tyre size and approximate remaining tread depth of the 4 tyres of the Motor Car were recorded as follows: -

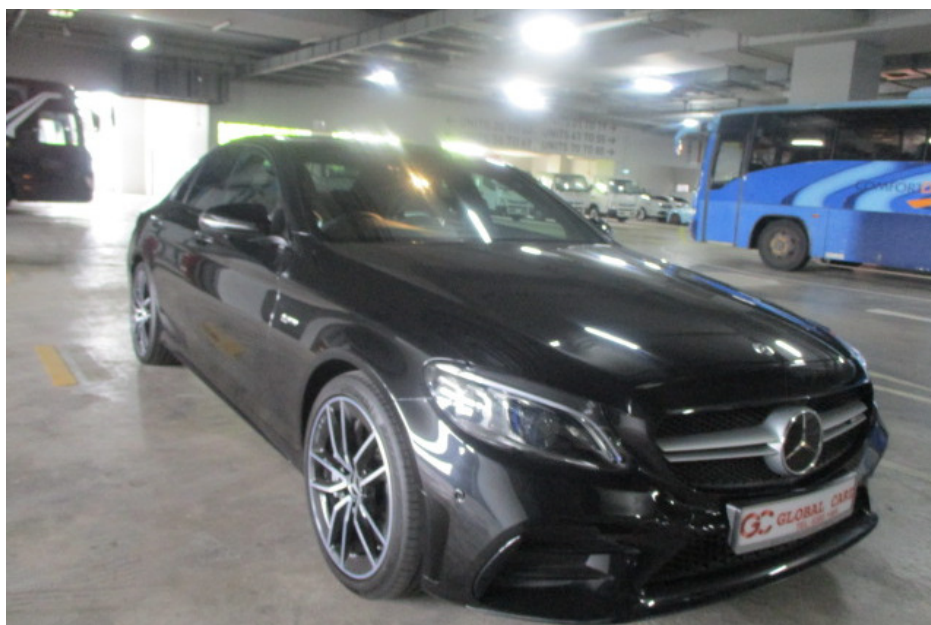
Photo 5 shows a general view of the front right body of the Motor Car at the time of my inspection. The Motor Car was observed to be in a relatively good general condition with no loose exterior fittings observed. The exterior body parts at the frontal portion of the Motor Car, like the front bumper, front bonnet and front fenders, were visually examined and it was observed that the repair/restoration works carried out to the damaged area of the Motor Car (refer to photograph 1 & 2 above) were reasonably adequate and in order.

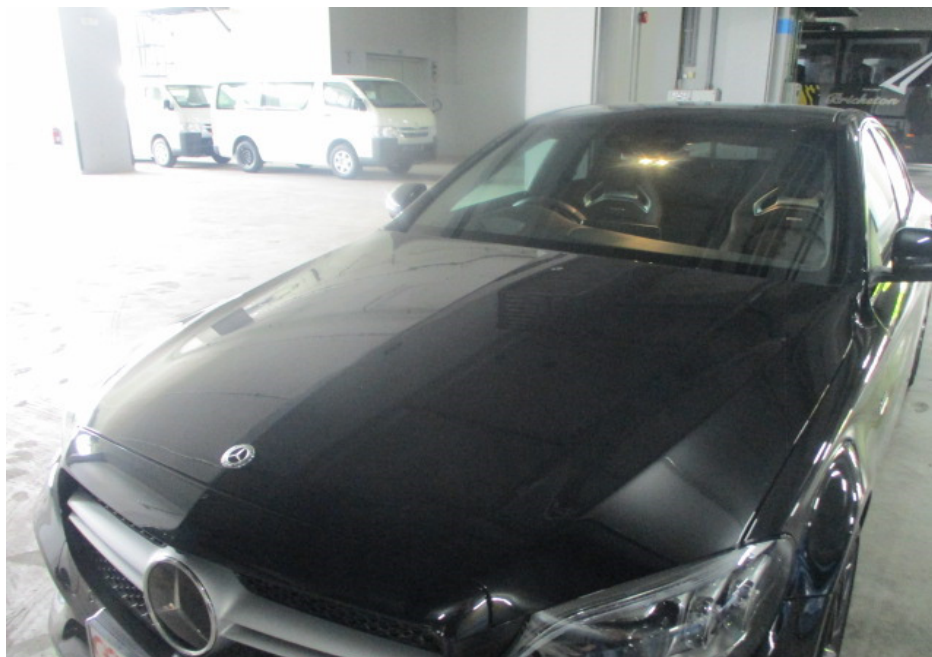
Photo 6 shows a closer view of the Motor Car's front bonnet at the time of my inspection. In general, I had found that the repair/restoration works carried out to the damaged area of the Motor Car (refer to photograph 1 & 2 above) were reasonably adequate and in order.

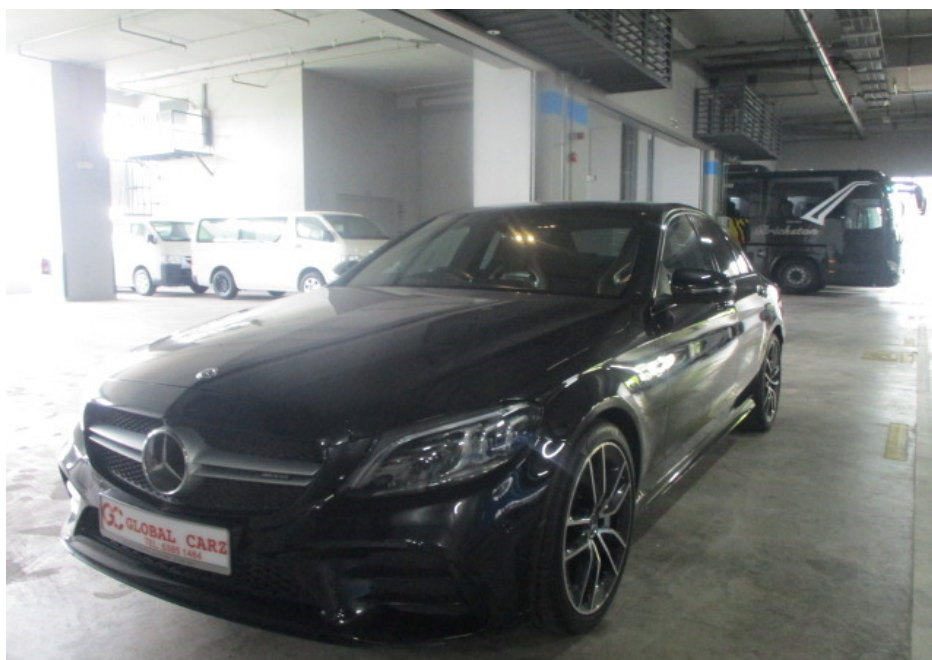
Photo 7 shows a general view of the front left body of the Motor Car at the time of my inspection. The Motor Car was observed to be in a relatively good general condition with no loose exterior fittings observed. The exterior body parts at the frontal portion of the Motor Car were visually examined, and it was observed that the repair/restoration works carried out to the damaged area of the Motor Car (refer to photograph 1 & 2 above) were reasonably adequate and in order.

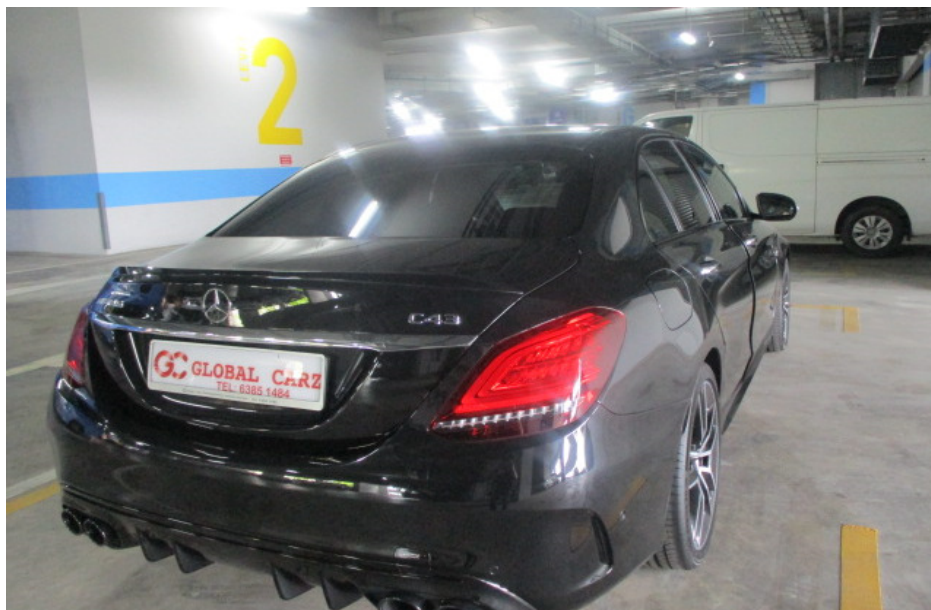
Photo 8 shows a general view of the rear right body of the Motor Car at the time of my inspection. The Motor Car was observed to be in a relatively good general condition with no loose exterior fittings observed. The exterior body parts at the rear portion of the Motor Car, like the rear bumper, rear bootlid, rear taillamps and rear fenders, were visually examined and it was observed that the repair/restoration works carried out to the damaged area of the Motor Car (refer to photograph 3 & 4 above) were reasonably adequate and in order.

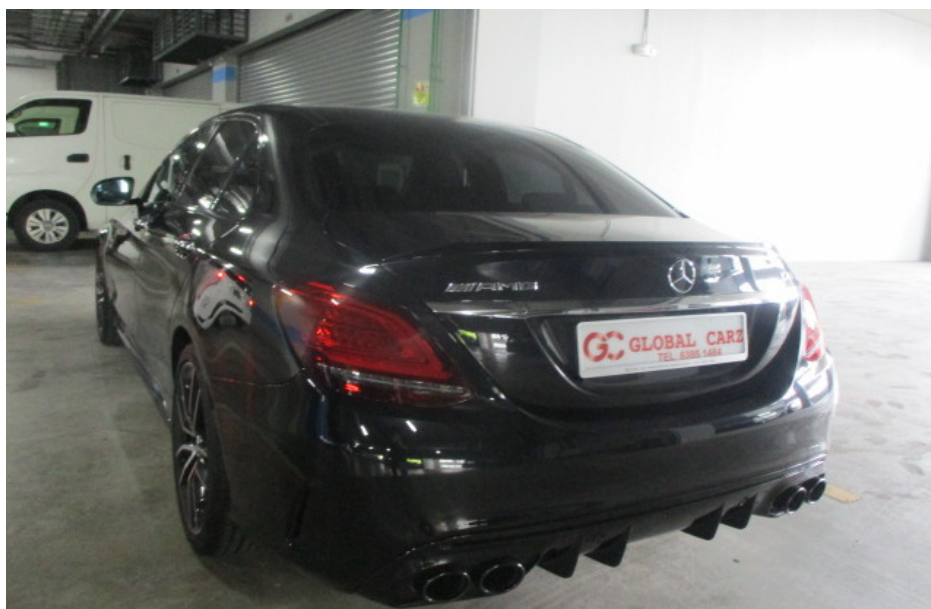
Photo 9 shows a general view of the rear left body of the Motor Car at the time of my inspection. The Motor Car was observed to be in a relatively good general condition with no loose exterior fittings observed. The exterior body parts at the rear portion of the Motor Car, like the rear bumper, rear bootlid, rear windscreen and rear fenders, were visually examined and it was observed that the repair/restoration works carried out to the damaged area of the Motor Car (refer to photograph 3 & 4 above) were reasonably adequate and in order.

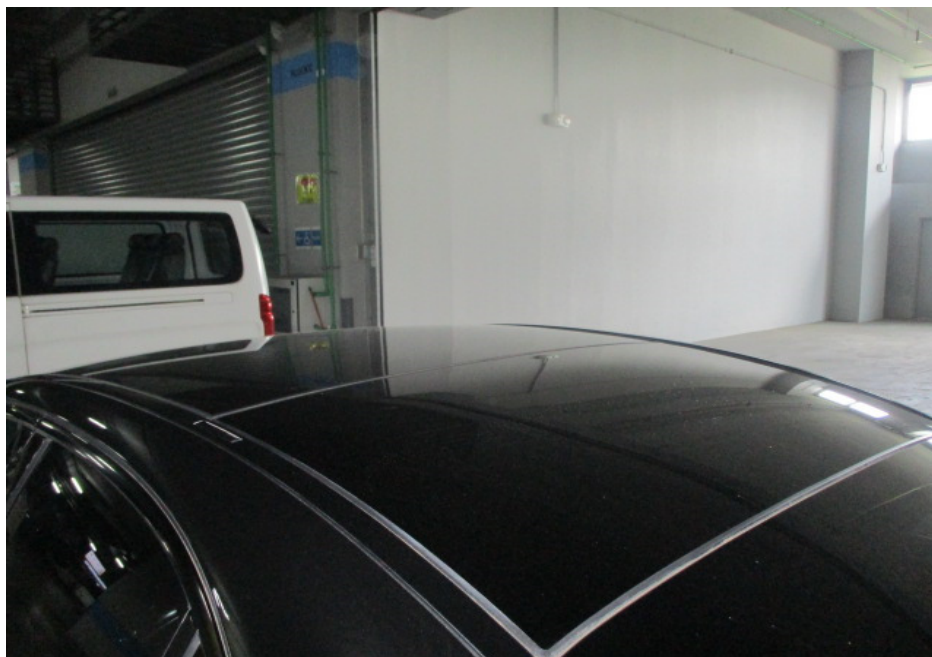
Photo 10 shows the roof panel and panoramic sunroof of the Motor Car at the time of my inspection. In general, I had found that the repair/restoration works carried out to the damaged area of the Motor Car (refer to photograph 3 & 4 above) were reasonably adequate and in order.

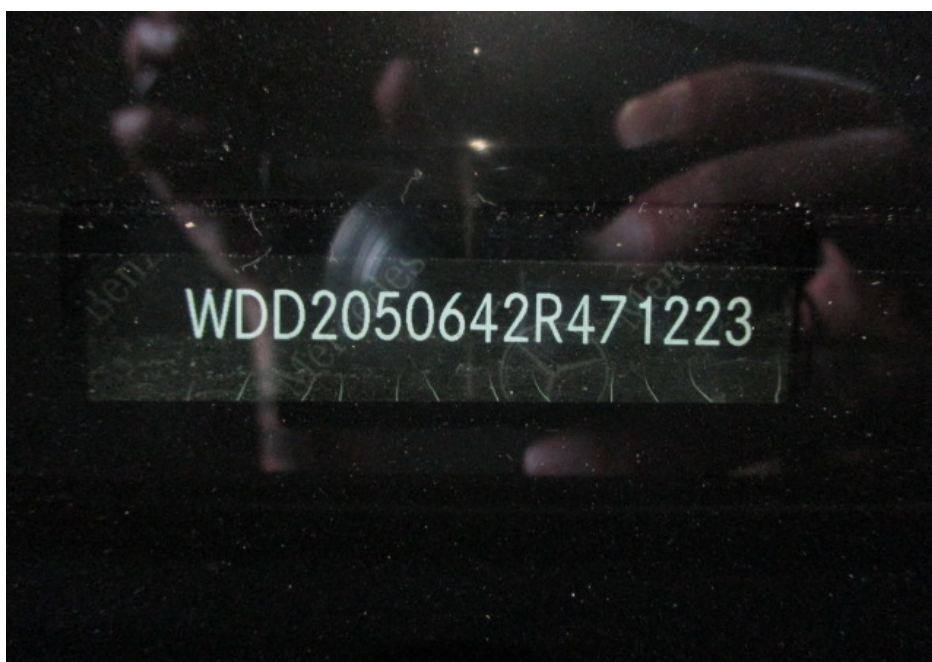
Photo 11 shows the chassis number of the Motor Car. The chassis number recorded was WDD2050642R471223.

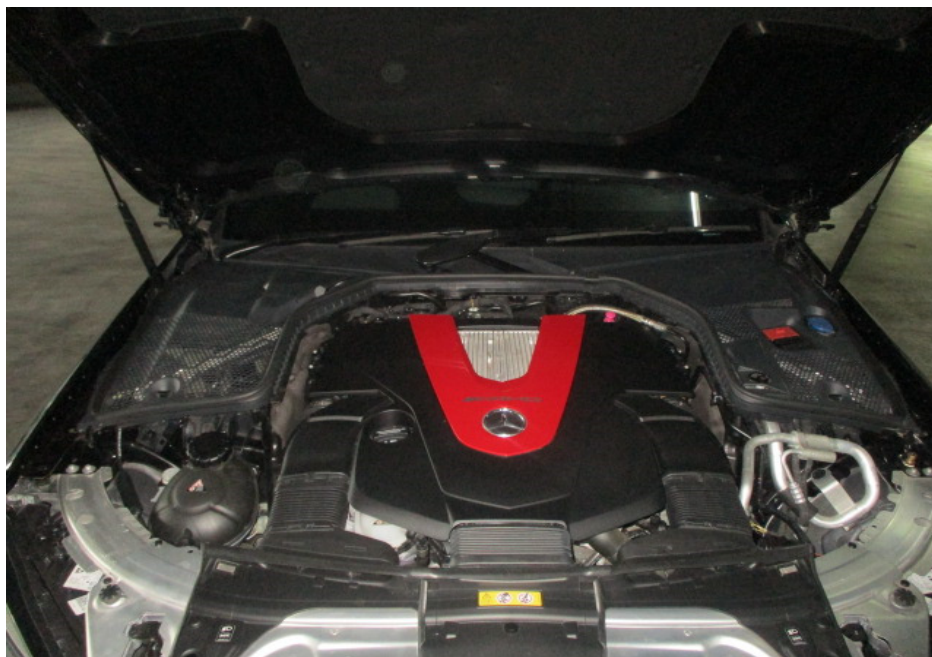
Photo 12 shows a general view of the engine compartment of the Motor Car at the time of my inspection. The various parts and components inside the engine compartment were all observed to be intact and properly fitted. There was also no sign(s) or indication(s) of fluid leak and/or fluid stain found inside the engine compartment.

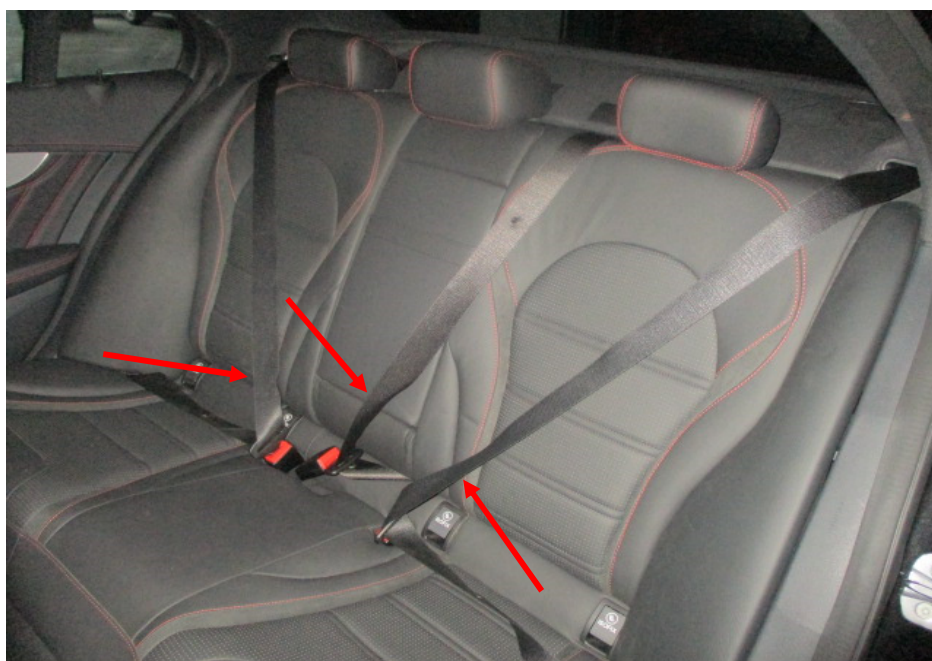
Photo 13 shows the rear seats of the Motor Car. All the seats of the Motor Car were secured via seat rails to the floorboard. They were also fitted with a retractable seat belt reel and a pre-tensioner. The seat belts (arrowed) were tested and were able to be fastened into the respective pre-tensions that were fitted on the side of each individual seat.

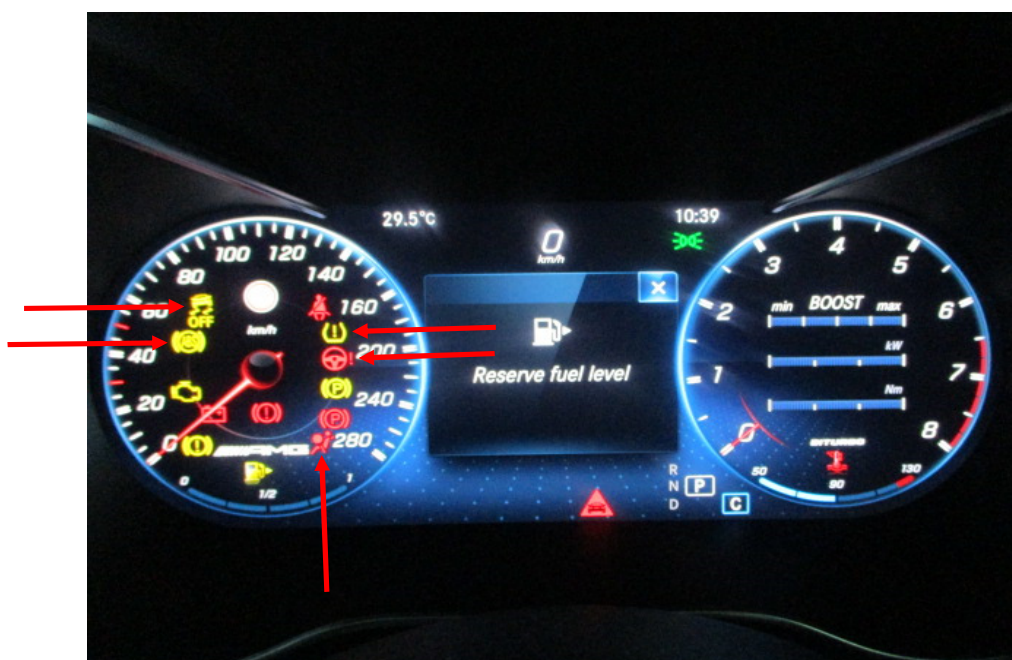
Photo 14 shows the warning lights for the various electronic safety features appearing on the instrument panel of the Motor Car during its self-test when the engine is cranked, in particular the ABS, SRS, EPS and TCS lights (arrowed).

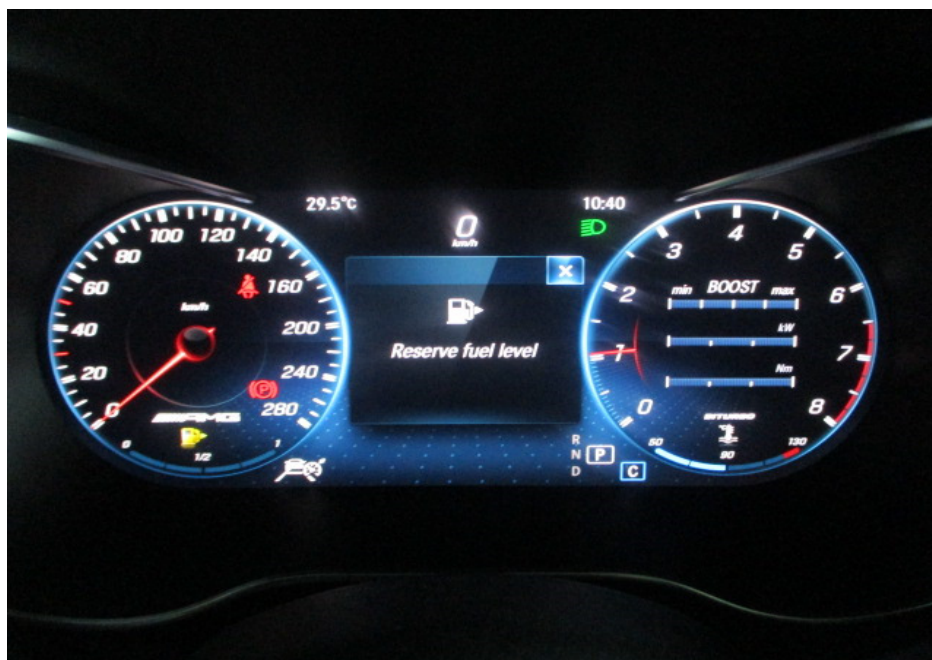
Photo 15 shows the respective warning lights no longer illuminated, indicating that there is no fault detected to the ABS, SRS, EPS and TCS systems of the Motor Car during the self-test. These electronic systems were hence in working condition at the time of my inspection.

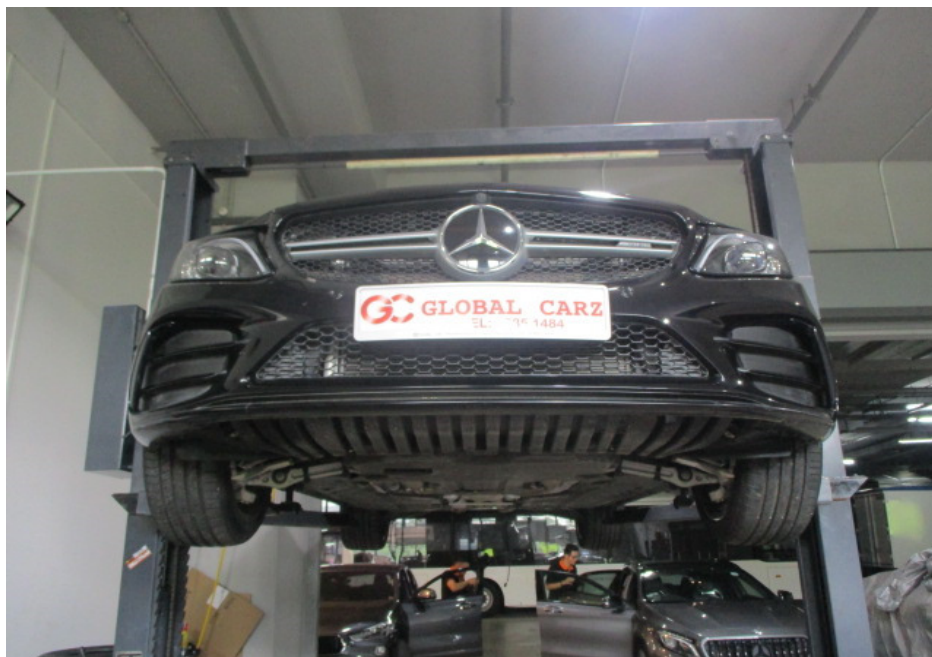
Photo 16 shows the Motor Car hoisted up for checks on its undercarriage. There was no sign(s) or indication(s) of fluid leakage and/or fluid stain(s) on the underside of the Motor Car. The undercarriage components of the Motor Car were also all observed to be intact and secured in an appropriate manner.

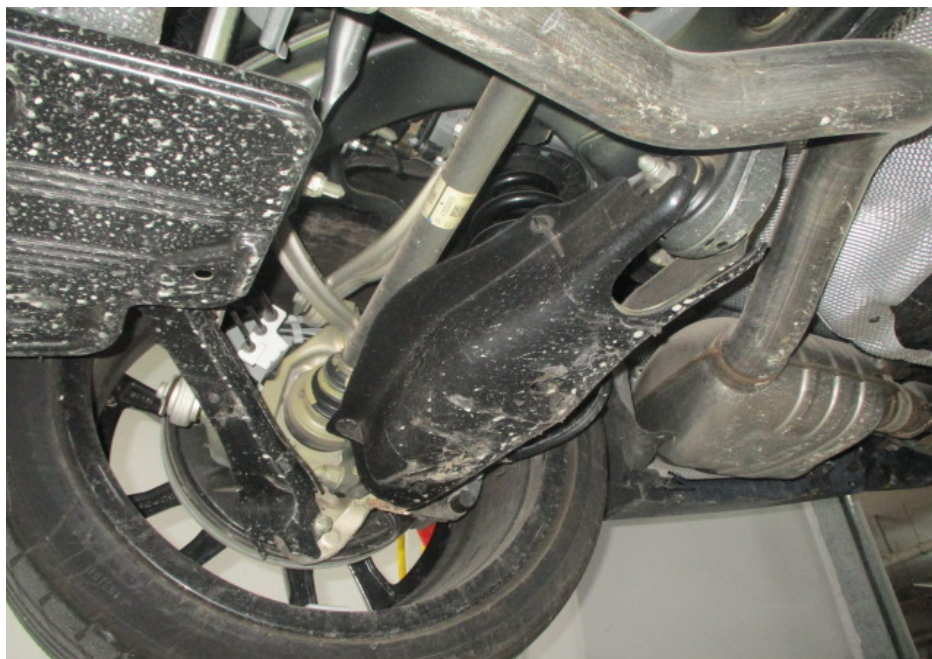
Photo 17 shows a general view of the control arms and linkages at the rear right wheel of the Motor Car. I did not observe any fluid leak and/or fluid stain on the underside of the Motor Car. All the Motor Car's undercarriage components were observed to be intact and secured in an appropriate manner.

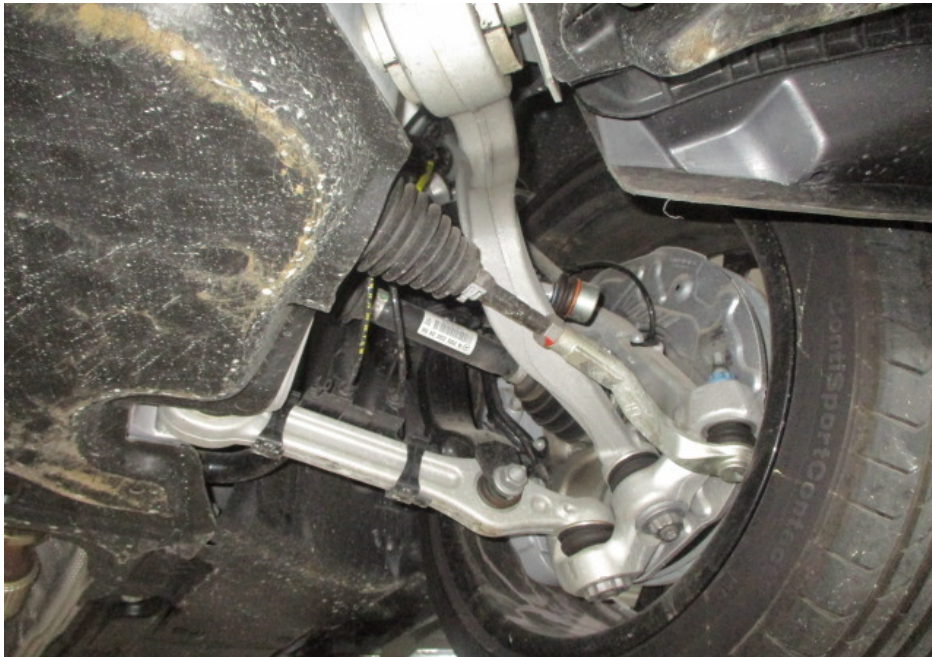
Photo 18 shows the various undercarriage components at the front left wheel of the Motor Car. The mechanical components, control arms and linkages were all found to be intact and secured in an appropriate manner.

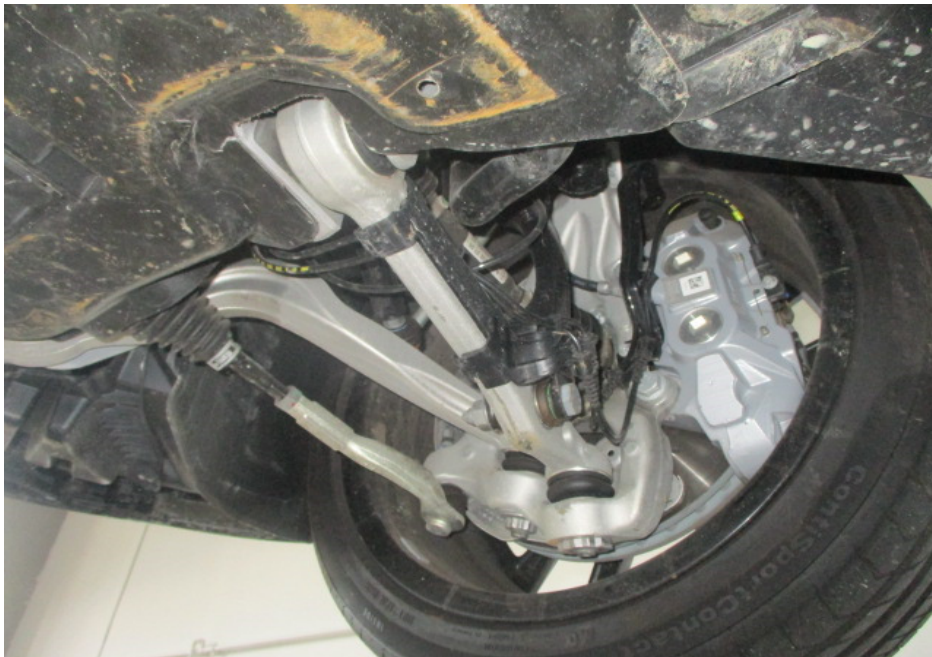
Photo 19 shows the various undercarriage components at the front right wheel of the Motor Car. The mechanical components, control arms and linkages were all found to be intact and secured in an appropriate manner. I also did not observe any fluid leak and/or fluid stain on the underside of the Motor Car.

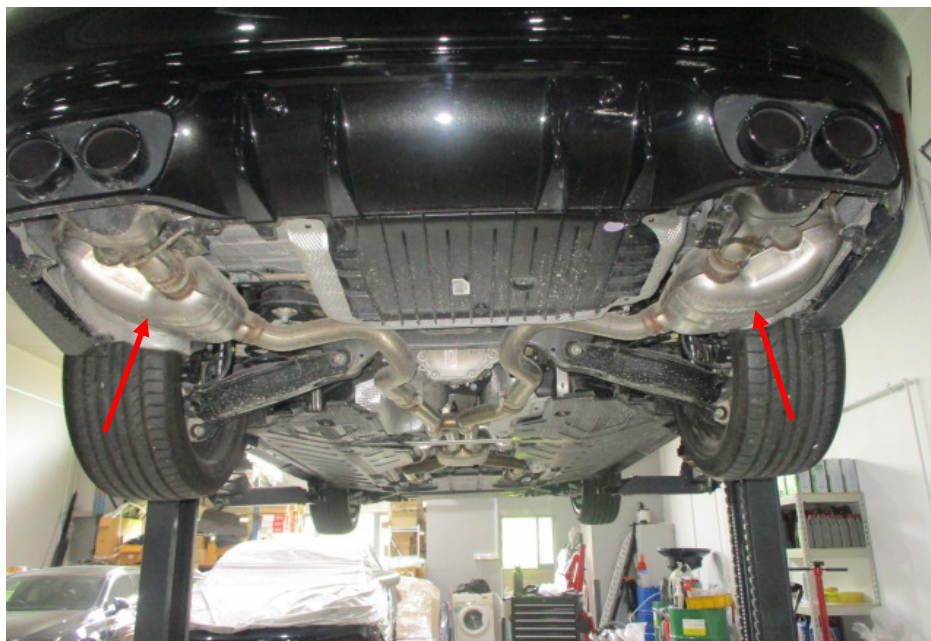
Photo 20 shows a general view of the Motor Car's exhaust system (arrowed). My examination of the Motor Car's exhaust system revealed no sign(s) or indication(s) of any cut or weld marks along its catalytic converters, exhaust pipes and on its rear mufflers (arrowed).

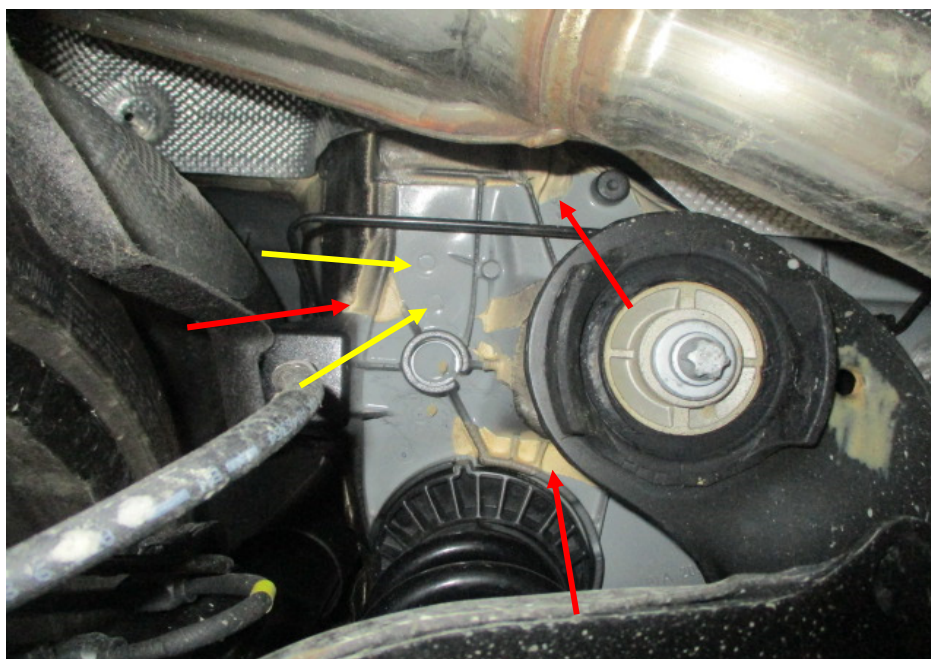
Photo 21 shows the chassis/structural body at the underside rear left of the Motor Car. I did not find any weld marks other than original spot weld marks (yellow arrow) on the chassis/structural body of the Motor Car. The original factory sealant (red arrow) at the joints along the chassis/structural body was also untouched. In general, I had found no work was carried out on the chassis/structural body of the Motor Car. The chassis/structural body of the Motor Car was originally fitted.

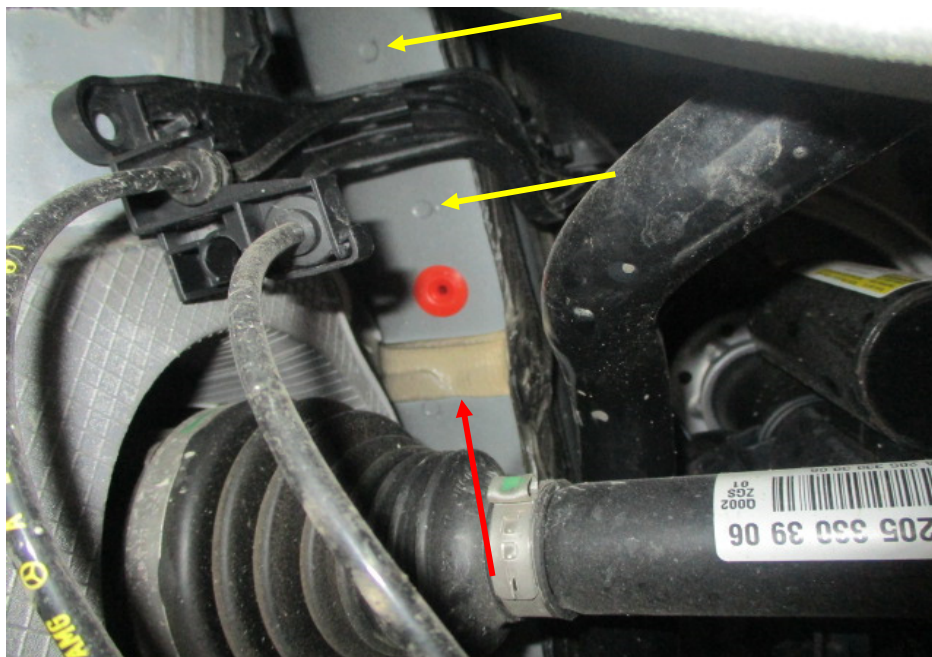
Photo 22 shows the chassis/structural body at the underside front left of the Motor Car. I did not find any weld marks other than original spot weld marks (yellow arrow) on the chassis/structural body of the Motor Car. The original factory sealant (red arrow) at the joints along the chassis/structural body was untouched, indicating no work was done on the chassis/structural body of the Motor Car and that the chassis/structural body was originally fitted.

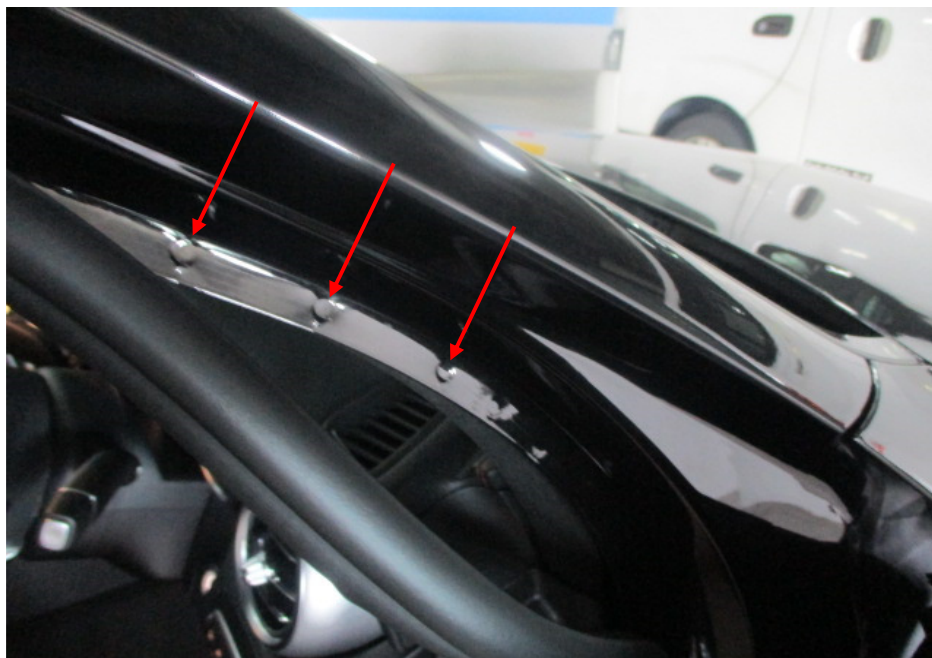
Photo 23 shows the right side "A" pillar of the Motor Car. I did not find any weld marks other than original spot weld marks (arrowed) on the right side "A" pillar of the Motor Car which, indicates that there was no re-welding works carried out. In general, I had found all the non-detachable body panels of the Motor Car to be originally fitted at the time of my inspection.

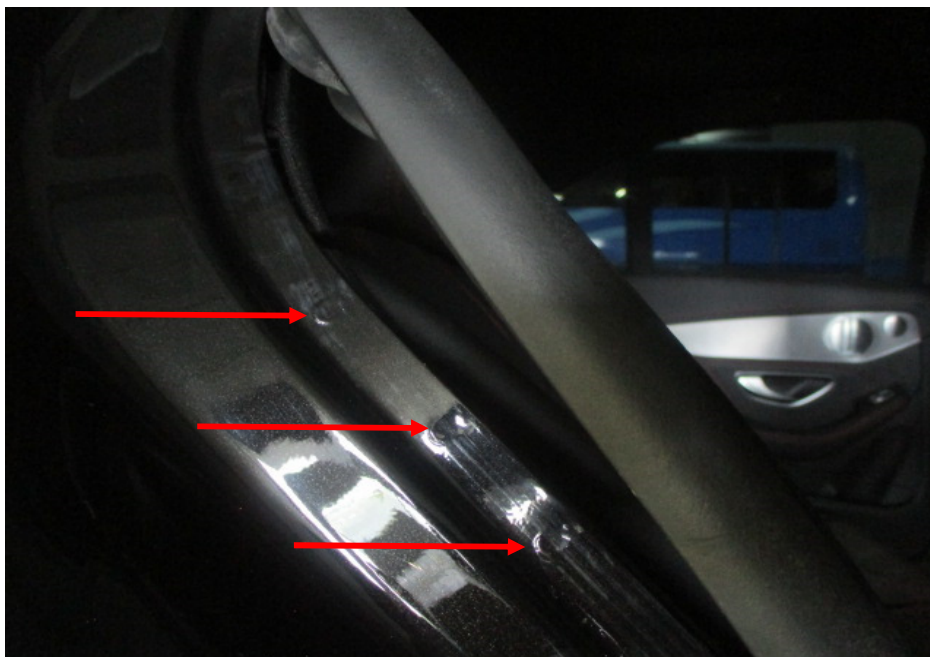
Photo 24 shows the right side "C" pillar of the Motor Car. I did not find any weld marks other than original spot weld marks (arrowed) on the right side "C" pillar of the Motor Car which, indicates that there was no re-welding works carried out. In general, I had found all the non-detachable body panels of the Motor Car to be originally fitted at the time of my inspection.
