Your Ref: D21001017MFVS  
Our Ref : CS4/FCI21004180/P

**M/s FIRST CAPITAL INSURANCE LTD**

**TECHNICAL INVESTIGATION REPORT OF FIRE INCIDENT INVOLVING THE  
INSURED VEHICLE YN 5689K ON 23<sup>rd</sup> March 2021**

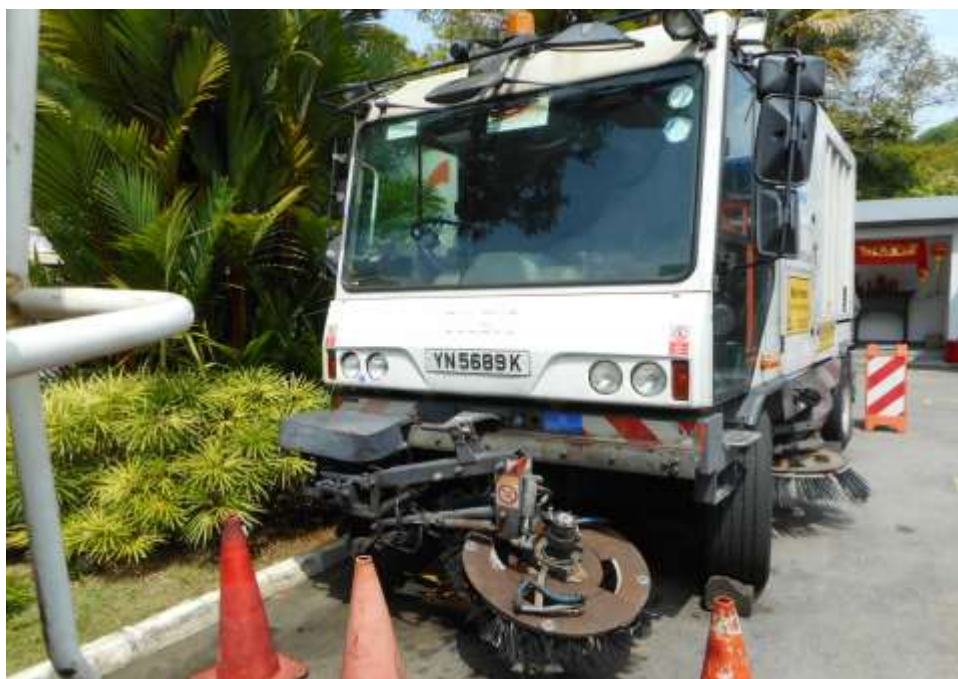
**Photo 1** shows the front portion of the Insured Vehicle, which was observed to be unaffected by the fire.

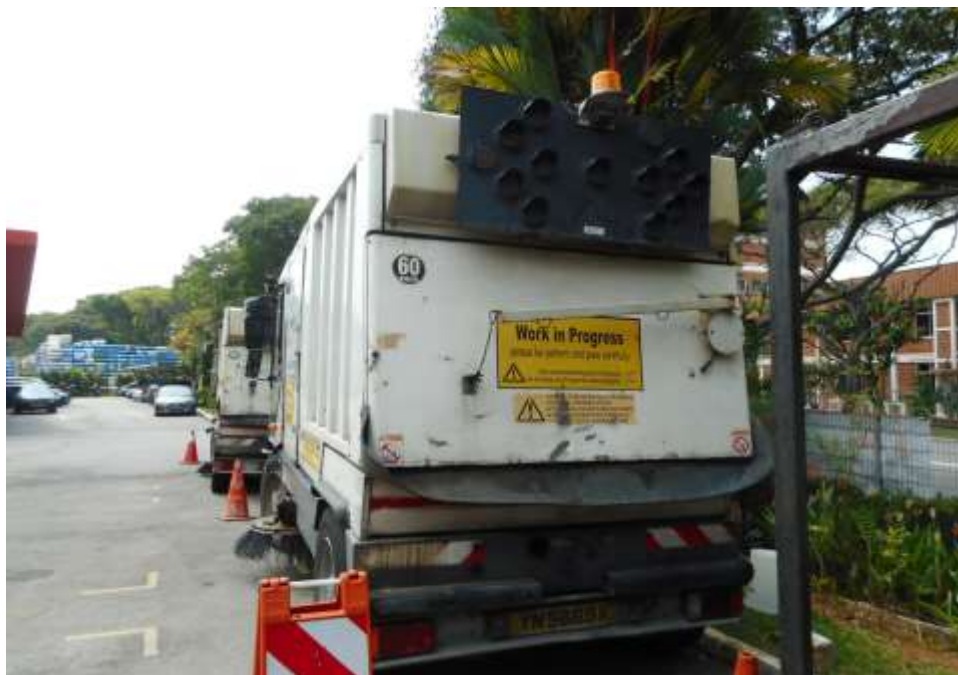
**Photo 2** shows the rear portion of the Insured Vehicle, which was observed to be unaffected by the fire.

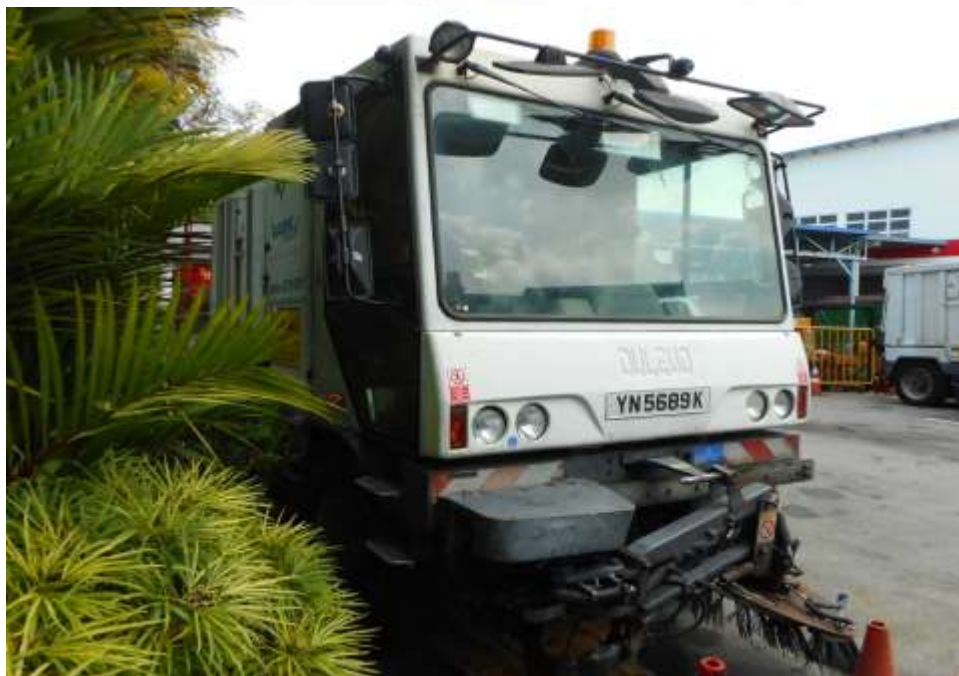
**Photo 3** shows the right body of the Insured Vehicle, which was observed to be unaffected by the fire.

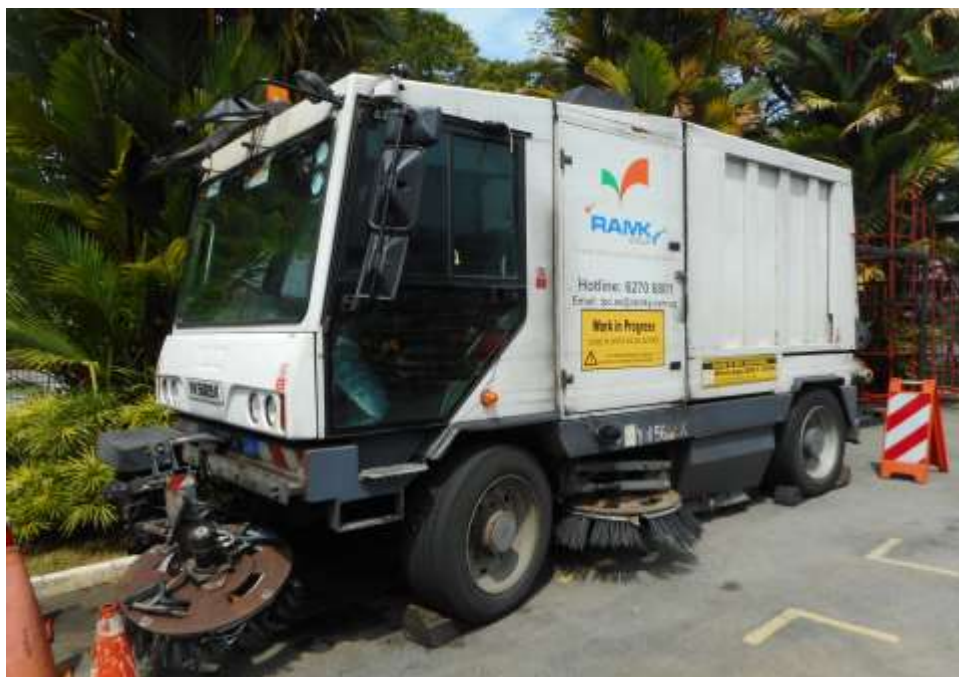
**Photo 4** shows the left body of the Insured Vehicle, which was observed to be unaffected by the fire.

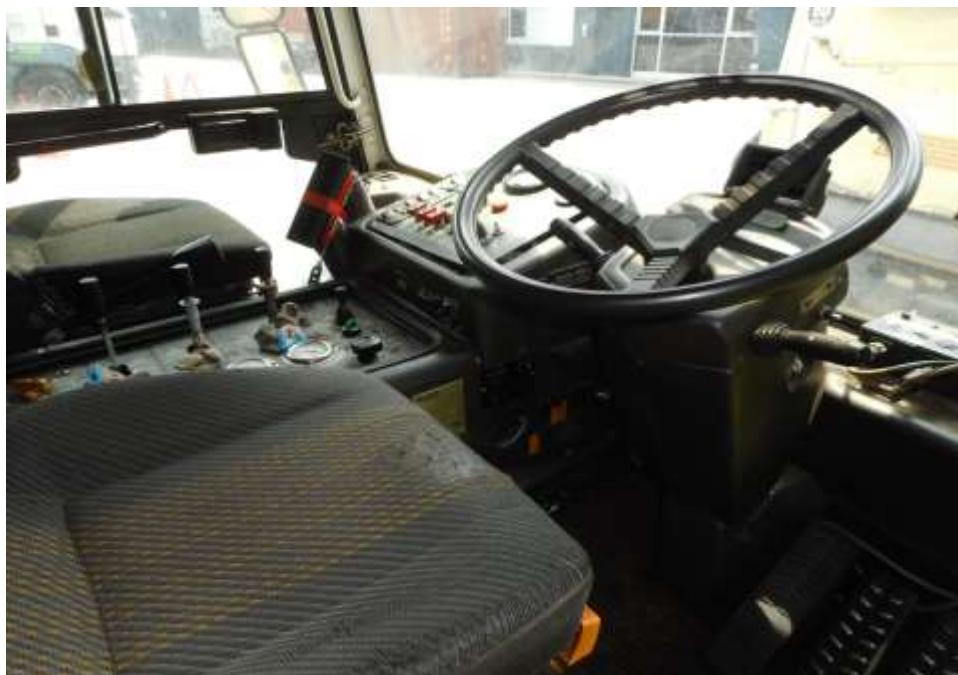
**Photo 5** shows the general view of the interior compartment of the Insured Vehicle at the time of our inspection was observed to be unaffected by the fire.

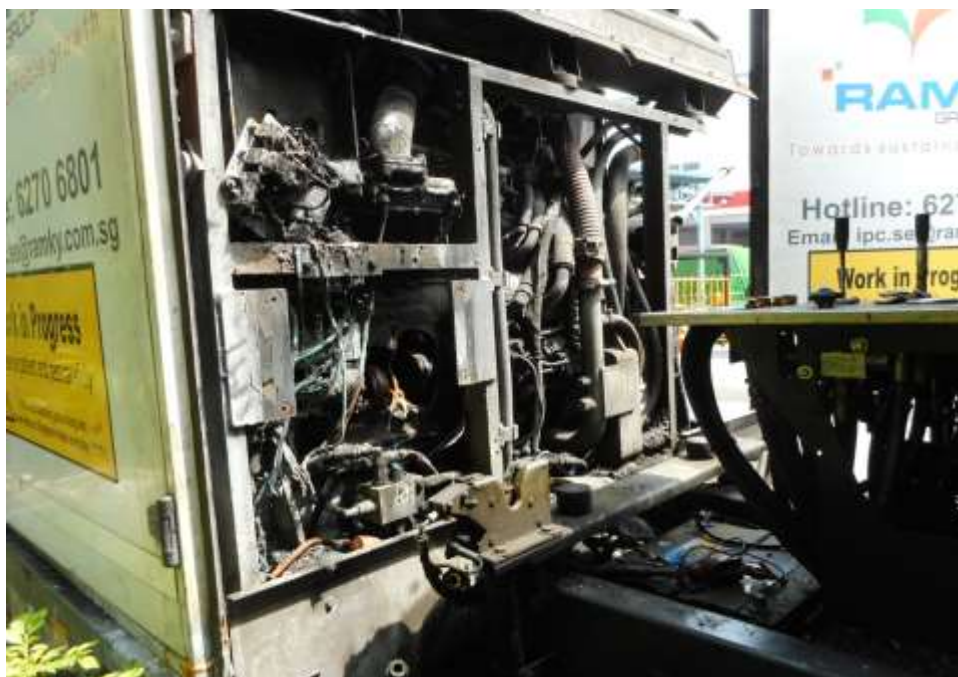
5. The Insured Vehicle was observed to have sustained minor fire damage confined only to its engine compartment in the middle, the electrical wirings, engine block and components around the engine area was damaged as a result of the fire. The other parts of the Insured Vehicle was not affected by the fire See photos 1 – 8 below.

**Photo 6** shows the engine compartment in the middle of the Insured Vehicle at the time of our inspection. The engine compartment of the Insured Vehicle was observed to be burnt. The electrical wirings, engine block and components around the engine area was damaged as a result of the fire.

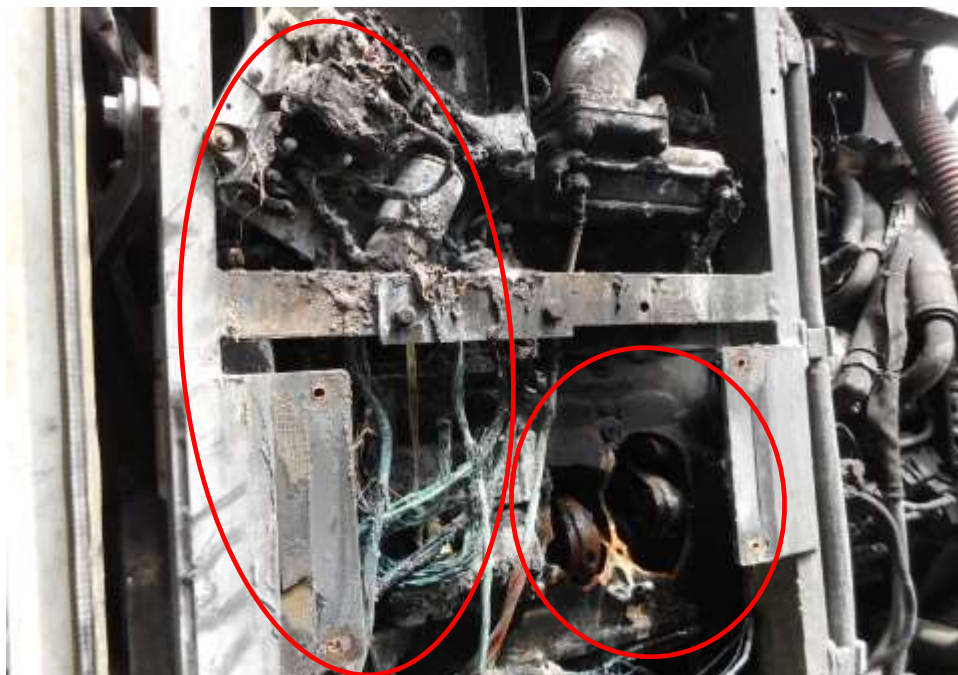
**Photo 7** shows the engine compartment of the Insured Vehicle at the time of our inspection. The Insured Vehicle was observed to have sustained fire damage to its electrical wirings and components (red circled) and engine block (yellow circle) was damaged as a result of the fire.

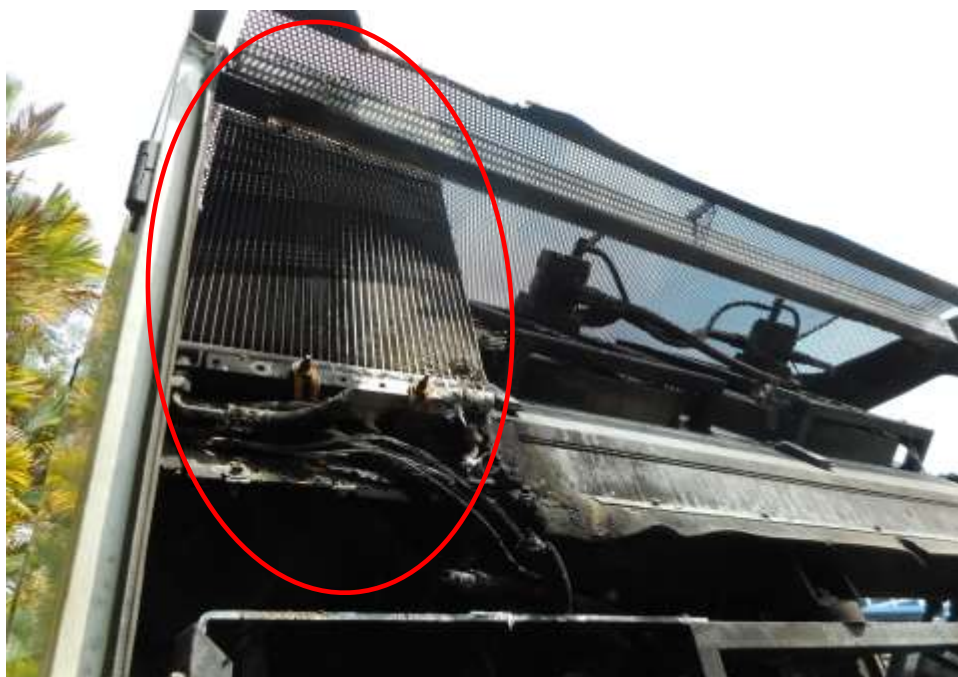
**Photo 8** shows the engine compartment of the Insured Vehicle at the time of our inspection. The Insured Vehicle was observed to have sustained fire damage to its engine radiator component (circled) was damaged as a result of the fire.

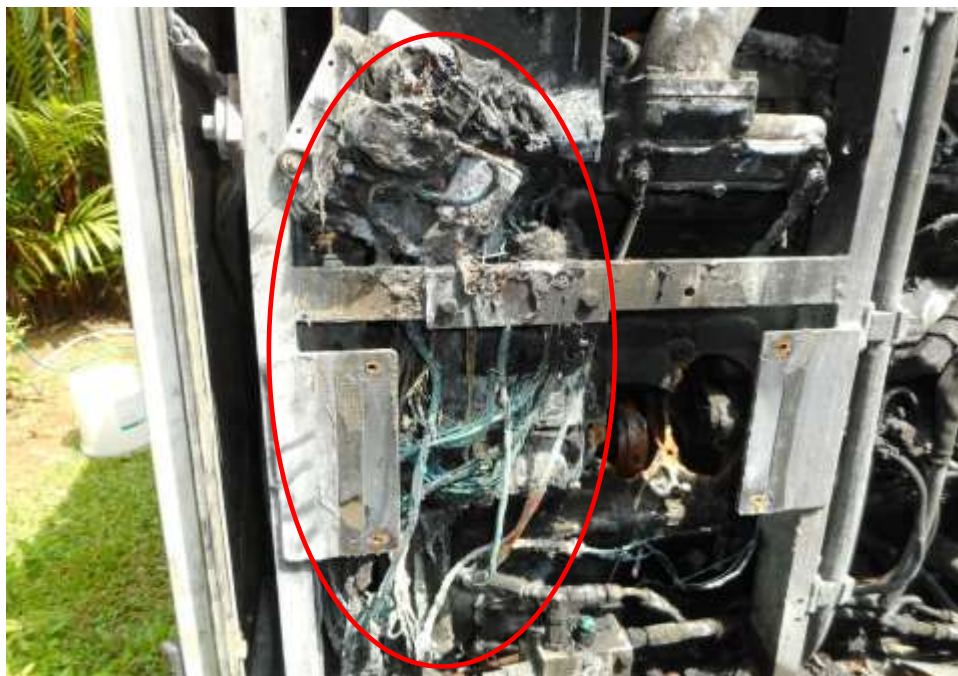
7. Based on the circumstances for this particular case, the fire appears to have originated from the engine area of the Insured Vehicle, somewhere around the middle portion. This can be determined basing on the area where the extent of fire damage was most severe, the circumstances of the fires' origin at the material time of incident and also the high heat intensity burn marks (whitish burn marks) that were found on the exterior surface close to the engine portion.

8. These whitish burn marks are a result of exposure to prolong heat intensity. Rust would normally start to develop around these areas soon after a fire as the prolonged exposure to high heat intensity usually causes the bare steel/metal material of the body parts to be exposed to natural environmental condition. The rust that had developed on the front bonnet and centre portion, in the immediate vicinity of where these whitish burn marks were found, would also support our findings of where the fire had affected the Insured Vehicle. See photo 9- 10 below.

**Photo 9** shows the close up view of the engine of the Insured Vehicle at the time of our inspection. The burn pattern of the various components which were observed to be partly melted and burn from the high heat intensity and exposure of bare copper wirings (circled) indicates that the fire had originated from the wirings of the engine portion of the Insured Vehicle.

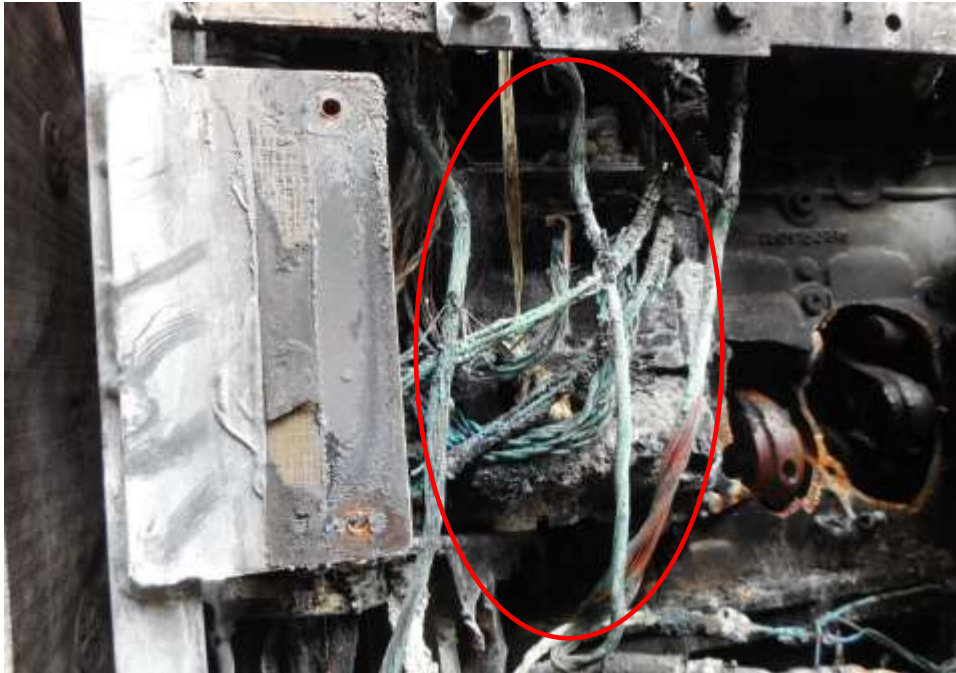
**Photo 10** shows the close up view of the engine of the Insured Vehicle at the time of our inspection. The burn pattern of the various components which were observed to be partly melted and burn from the high heat intensity and exposure of bare copper wirings (circled) indicates that the fire had originated from the wirings of the engine portion of the Insured Vehicle.

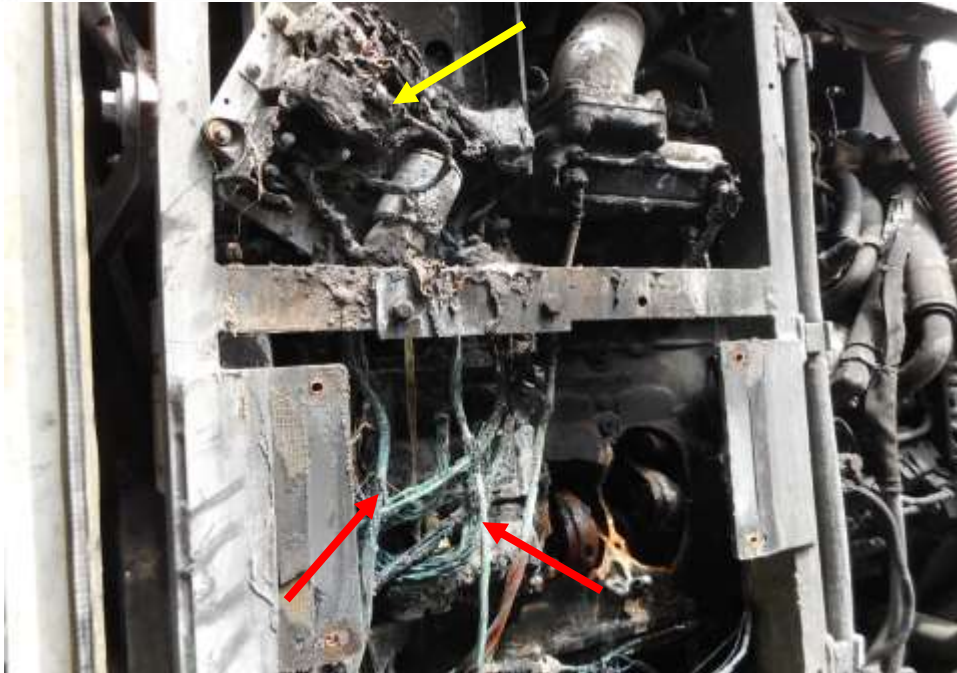
9. Upon closer examination of the engine compartment portion Insured Vehicle which was where the fire had likely started, we had found traces of greenish residue on the main wiring's harnesses leading from the batteries to the electrical components of the Insured Vehicle. The wirings were original wirings fitted from the manufacturer. The presence of greenish residue indicates internal heating of copper wires, a sign of an electrical short circuit occurring. The greenish residue is normally left behind from the oxidation as a result of chemical reaction involving the copper wires. This physical evidence would then appear to suggest that the cause of fire to the Insured Vehicle could have possibly been due to electrical in nature. See photos 11 and 12 below.

**Photo 11** shows the general view of the engine compartment of the Insured Vehicle at the time of our inspection. The fire damage to the Insured Vehicle has affected its engine compartment. Its wirings from the batteries (red arrow), electrical components (yellow arrow) and various original wiring harnesses was amongst the parts in the compartment that were found to have been affected as a result of the fire.

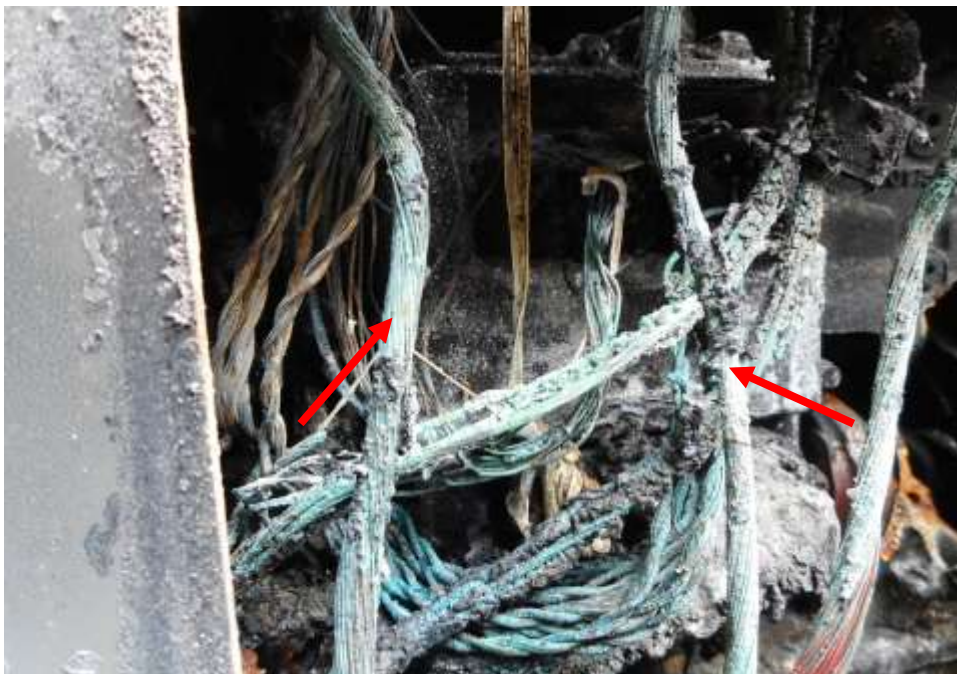
**Photo 12** shows a close up view of the original wiring harness from the batteries (arrowed) was observed with greenish residue on the surface. The presence of greenish residue indicates internal heating of copper wires, a sign of an electrical short circuit occurring. The greenish residue is normally left behind from oxidation as a result of chemical reaction involving the copper wires.

24. The possibility of the fire being due to electrical in nature would then seem more likely given that engine overheating and external factors would both seem unlikely. The fire being due to electrical nature is also supported by the condition of the several stretches of original wirings from the batteries to its electrical components which was burnt internally to its bare copper state on the Insured Vehicle which was a sign of short circuit that which was earlier discussed in paragraph 9 above.

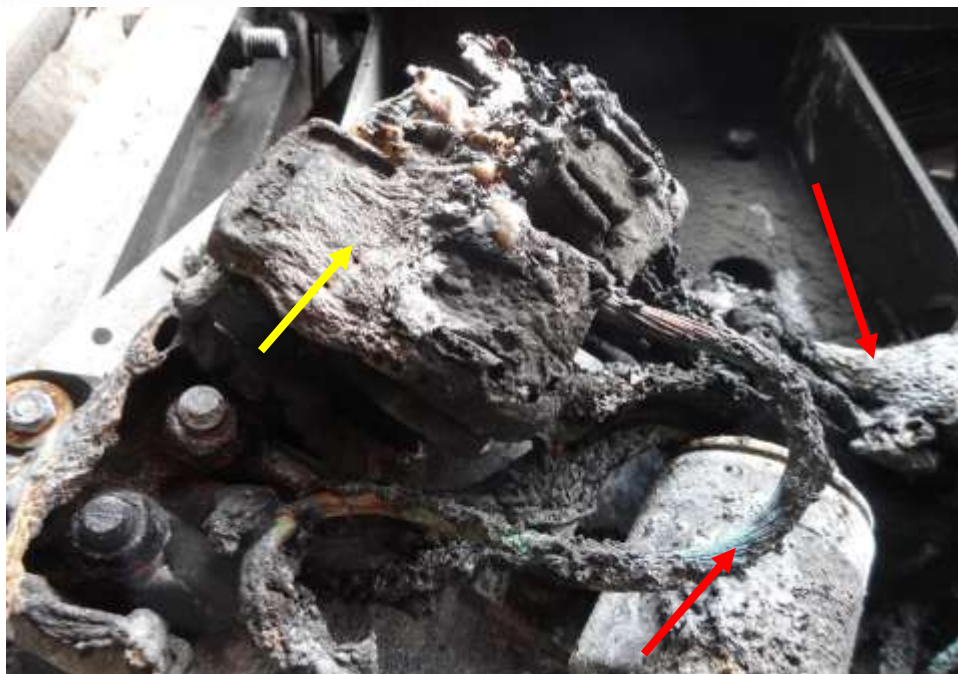
**Photo 12** shows close up view of the original wiring harness from the batteries (red arrow) to the electrical components (yellow arrow) was observed with greenish residue on the surface. The presence of greenish residue indicates internal heating of copper wires, a sign of an electrical short circuit occurring. The greenish residue is normally left behind from oxidation as a result of chemical reaction involving the copper wires.

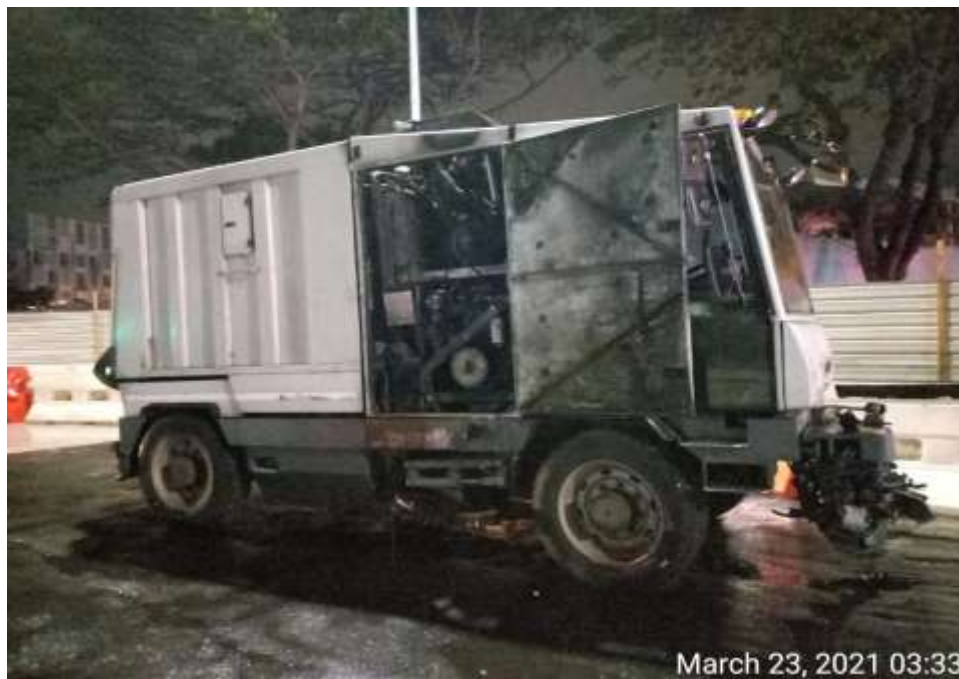
20. During the course of our investigations, we were able to obtain coloured photographs showing the Insured Vehicle at the incident after the fire was extinguished and SCDF personnel was on the scene. These were provided to us by Mr Rosli.
21. Our examination of these photographs revealed that the fire had started from the front of the Insured Vehicle. The photographs had also showed the Insured Vehicle on fire and similar extent of damage and burn pattern to the Insured Vehicle as per what we had observed during our physical inspection of the Insured Vehicle. Apart from the aforesaid; there was no further notable information that could be gathered from these photographs. See photos 13 and 14 below which were provided to us by Mr Rosli.

**Photo 13** shows the burned Insured Vehicle at the road junction after the fire was put out. In general, the information that could be gathered from this photograph had corresponded to the events that were related to us by Mr Rosli, location when the fire broke out.

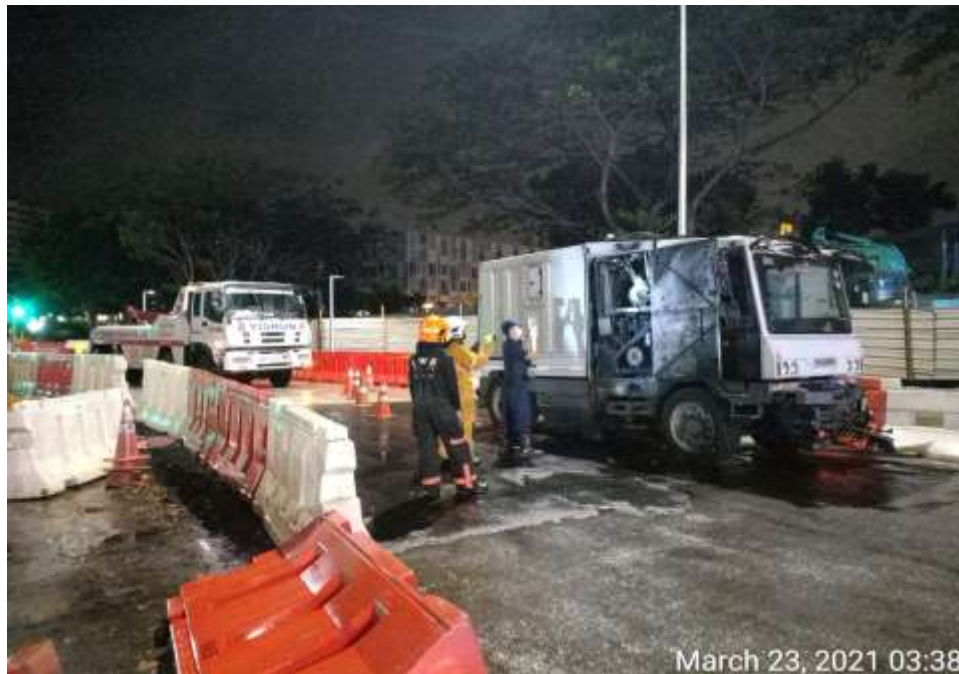
**Photo 14** shows the SCDF officer on scene after the fire was put out on the Insured Vehicle. In general, the information that could be gathered from this photograph had corresponded to the events that were related to us by Mr Rosli, location when the fire broke out.

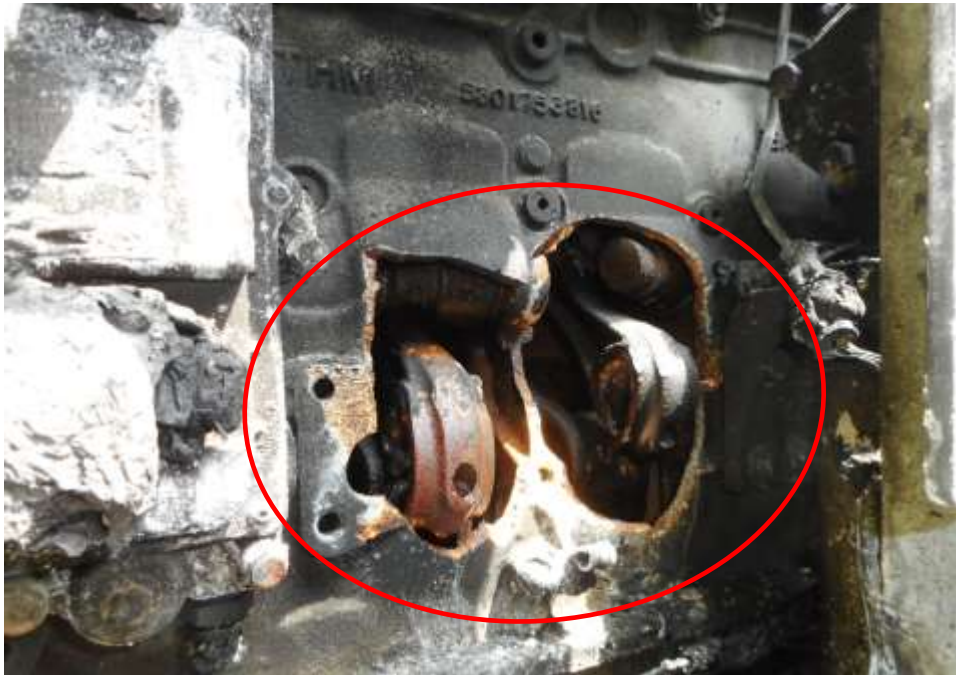
28. From our understanding, the components in the engine block like the pistons and the crankshaft to be damaged in this particular case was highly due to insufficient engine oil for lubrication and heat removal purposes in the engine. And in this case these components had seized up and were not able to be moved in any other way and that explains why the engine could not be started up when cranked.

29. As the components in engine was seized when the Insured Vehicle had stalled in the first place and the cranking motion conducted by the driver to get the engine starter to run the engine had overloaded the jumpstarting electrical systems of the Insured Vehicle and cause the electric wires to heat up and break off its insulation cover thus causing the wires to touch each other and therefore causing a short circuit that results in a this fire. See photos 15 and 16 below.

**Photo 15** shows the close up view of the engine block on the Insured Vehicle at the time of our inspection. The Insured Vehicle was observed to have sustained damaged to its engine block and piston connecting rod (circled) due to insufficient engine oil for lubrication and heat removal purposes in the engine that resulted in the sudden seizure of the running components in the engine causing them to break.

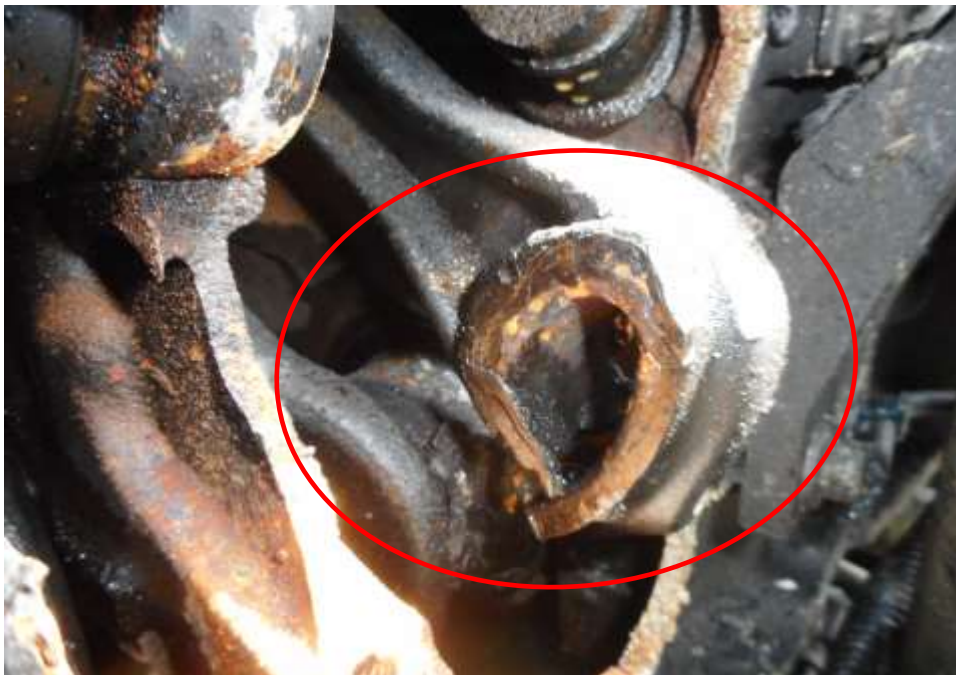
**Photo 16** shows the close up view of the engine block n the Insured Vehicle at the time of our inspection. The Insured Vehicle was observed to have sustained damaged to piston connecting rod (red circled) due to insufficient engine oil for lubrication and heat removal purposes in the engine that resulted in the sudden seizure of the running components in the engine causing them to break.
