Your Ref: 7140128801SG  
Our Ref : CS/AIG21004477/N

15 April 2021

**TECHNICAL INVESTIGATION REPORT OF FIRE INCIDENT INVOLVING THE INSURED VEHICLE SJJ 1001U ON 31 MARCH 2021**

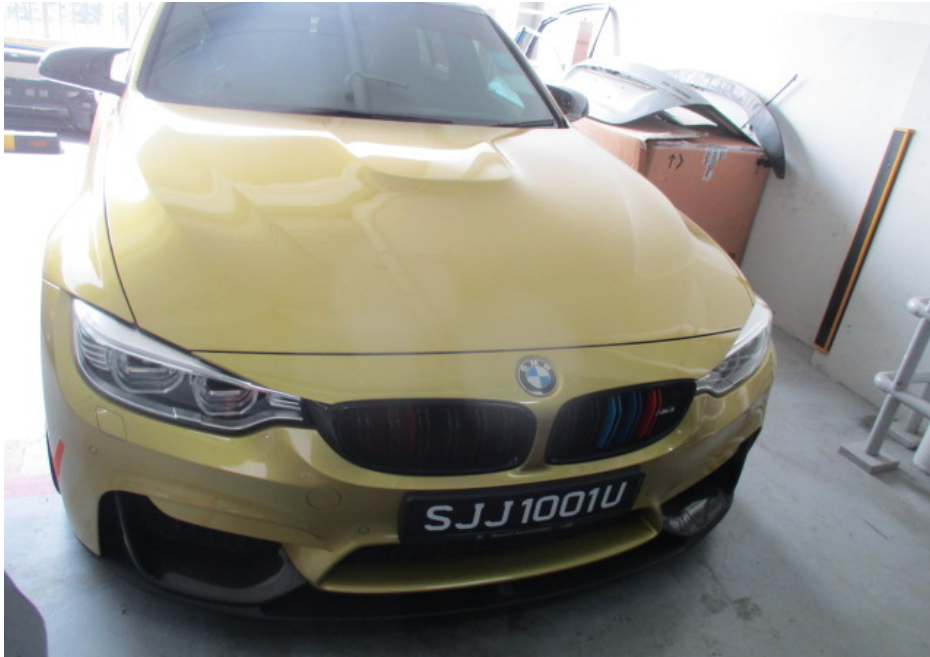
**Photo 1** shows the general view of the frontal portion of the Insured Vehicle at the time of our inspection. The fire damage was confined to its interior compartment. The exterior portion of the Insured Vehicle was observed to be relatively unaffected by the fire with the exception of the driver window glass.

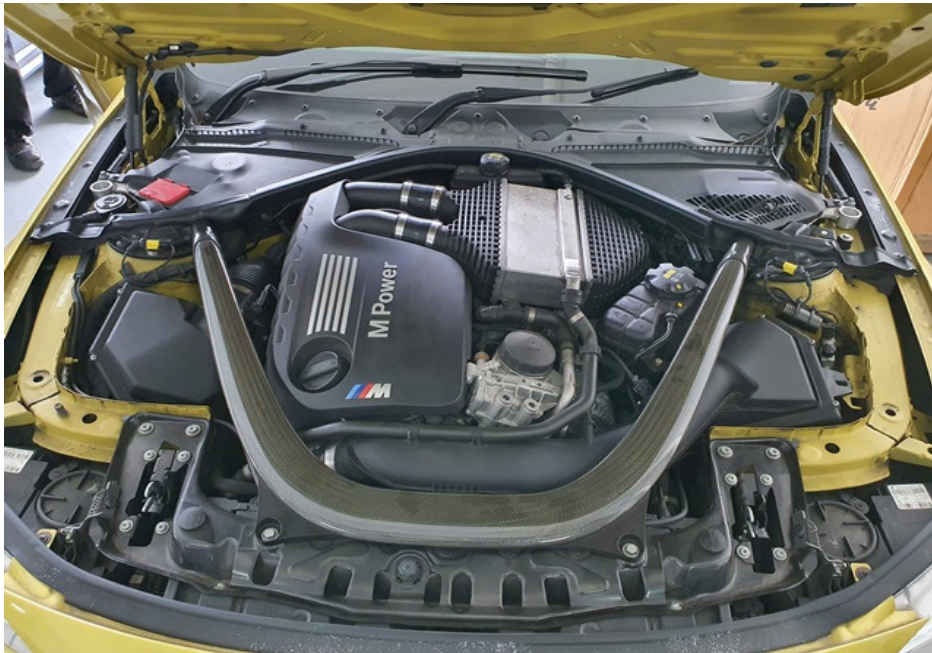
**Photo 2** shows the general view of the engine compartment of the Insured Vehicle at the time of our inspection. The fire damage was confined to its interior compartment. The engine compartment of the Insured Vehicle was observed to be relatively unaffected by the fire.

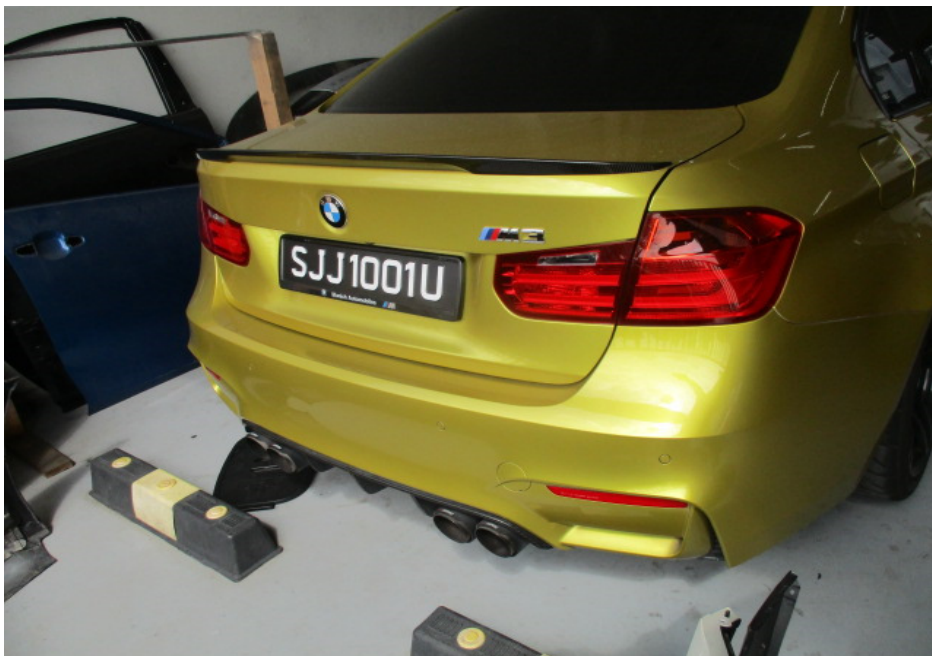
**Photo 3** shows the general view of the rear portion of the Insured Vehicle at the time of our inspection. The fire damage was confined to its interior compartment. The exterior portion of the Insured Vehicle was observed to be relatively unaffected by the fire with the exception of the driver window glass.

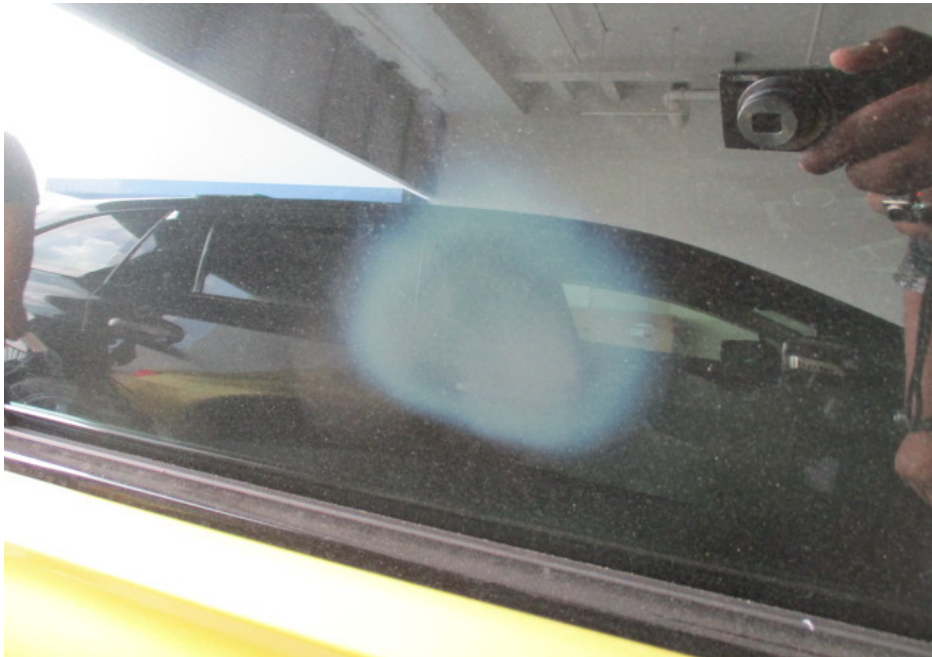
**Photo 4** shows the general view of the driver window glass of the Insured Vehicle at the time of our inspection. The driver window glass had sustained slight damage as a result of the fire.

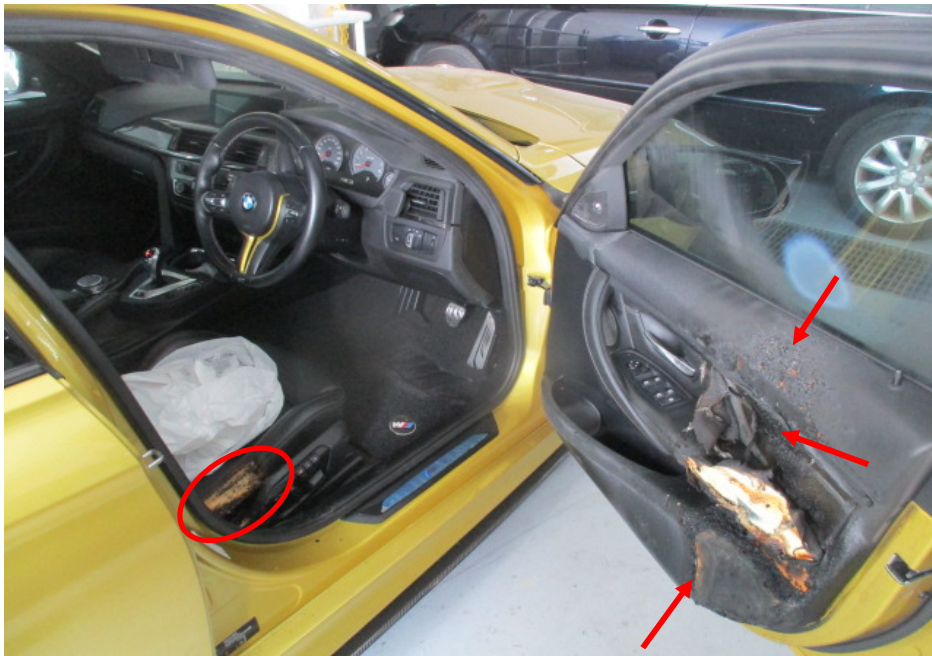
6. The fire had resulted in several components in the interior compartment to be slightly burnt and/or damaged. This had included its driver seat, floor carpet, insulating material covering the floor panel and driver door panel amongst others. See photos 1 – 7 below.

**Photo 5** shows the interior compartment of the Insured Vehicle at the time of our inspection. The fire had resulted in several components in the interior compartment to be slightly burnt and/or damaged. This had included its driver seat (circled), floor carpet, insulating material covering the floor panel and driver door panel (red arrows) amongst others.

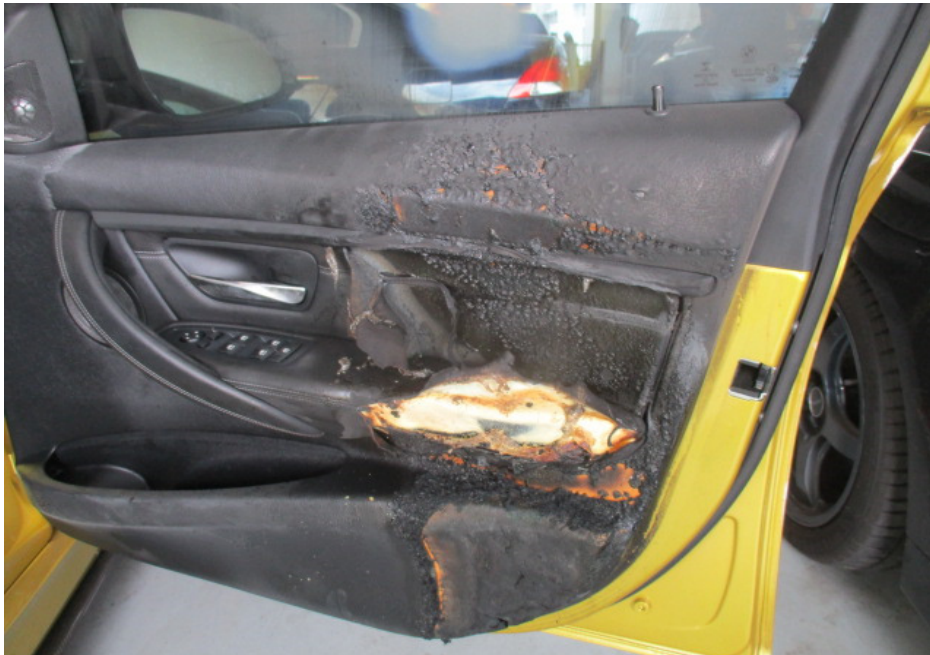
**Photo 6** shows the driver door panel of the Insured Vehicle at the time of our inspection. The fire damage was confined to its driver side. The driver door panel was observed to be partially burnt and/or melted.

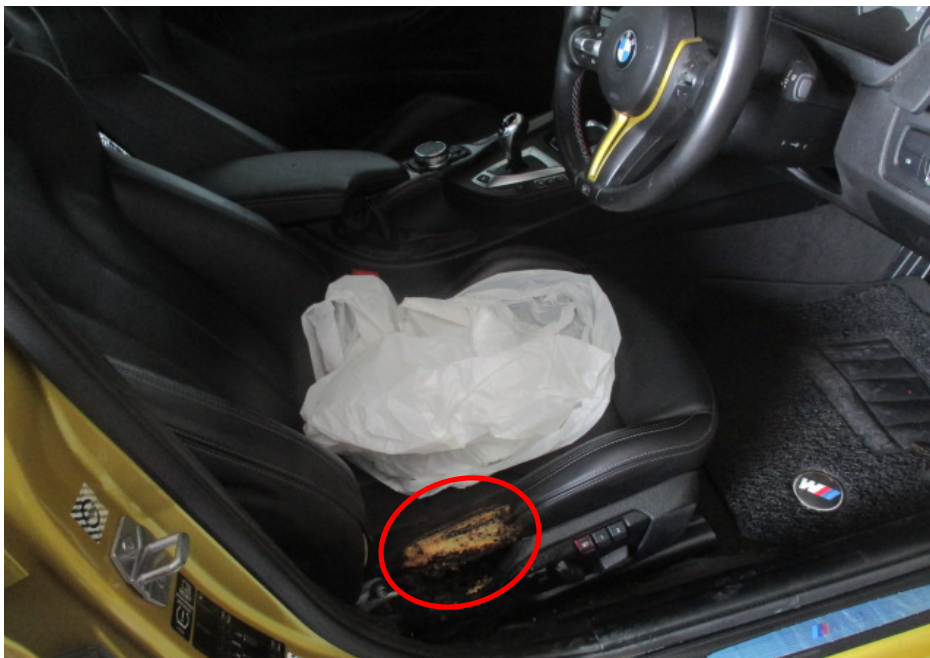
**Photo 7** shows the driver seat of the Insured Vehicle at the time of our inspection. The fire damage was confined to its driver side. The driver seat was observed to be partially burnt and/or melted (circled).

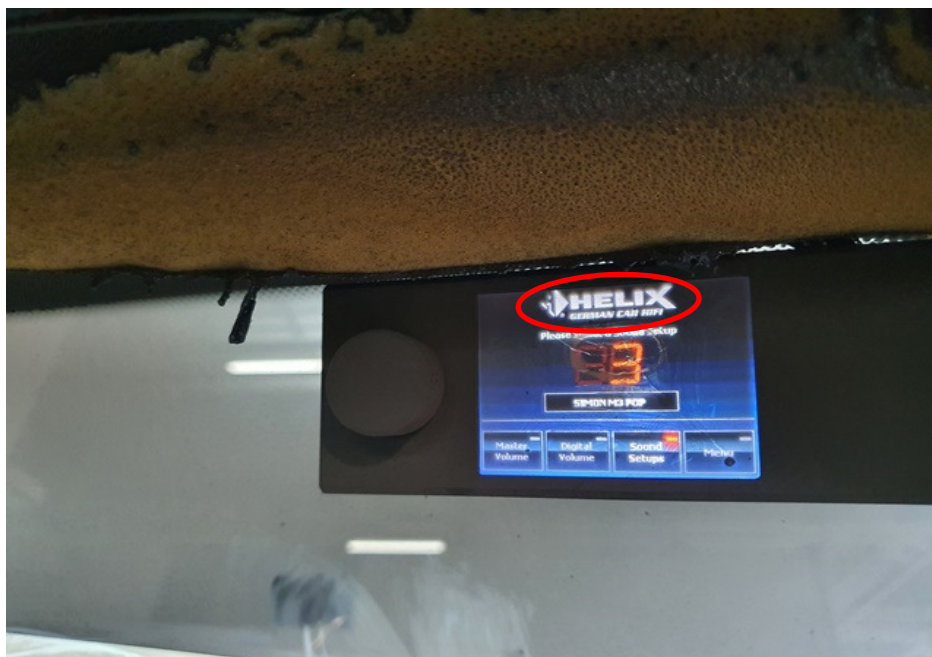
**Photo 8** shows the audio display remote control additionally fitted onto the Insured Vehicle upon our inspection which had sustained minor fire damage. The brand of the remote control was 'HELIX' (circled).

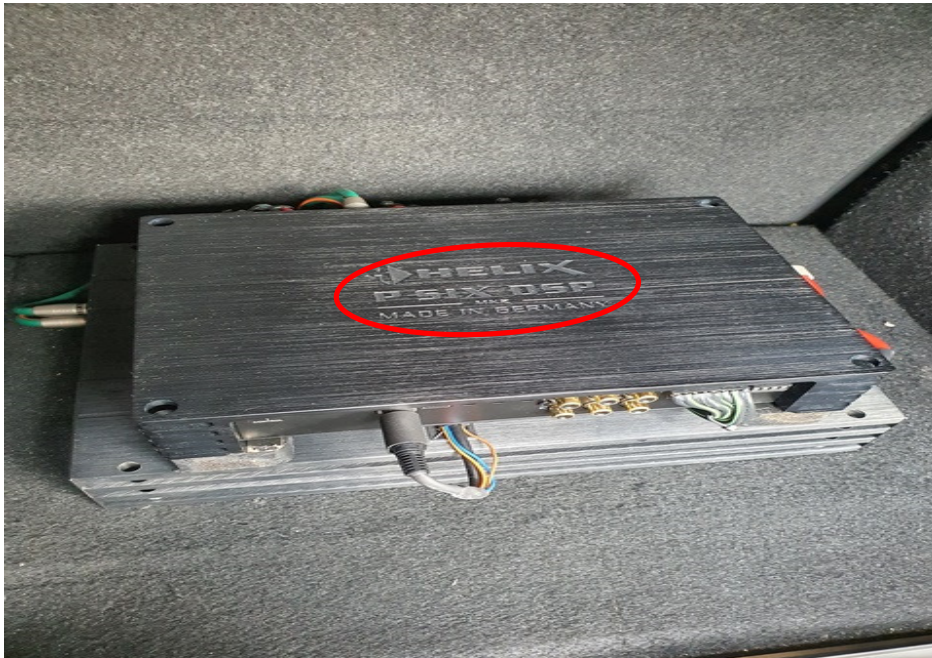
**Photo 9** shows the aftermarket amplifier fitted at the boot of the Insured Vehicle upon our inspection. The brand of the amplifier was 'HELIX' (circled).

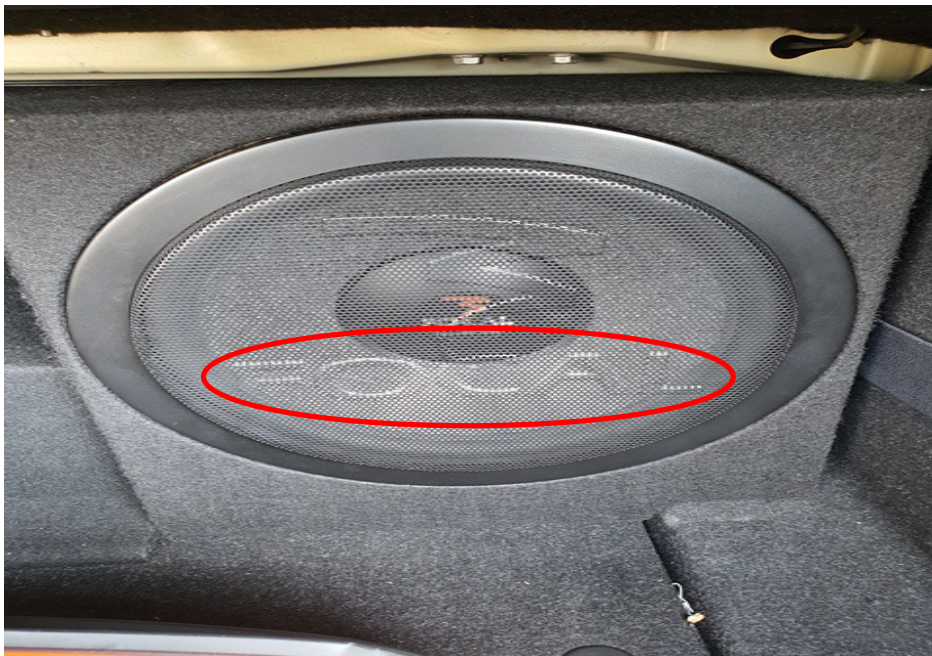
**Photo 10** shows a close up view of the aftermarket active subwoofer fitted at the boot of the Insured Vehicle upon our inspection. The brand of the subwoofer was 'FOCAL' (circled).

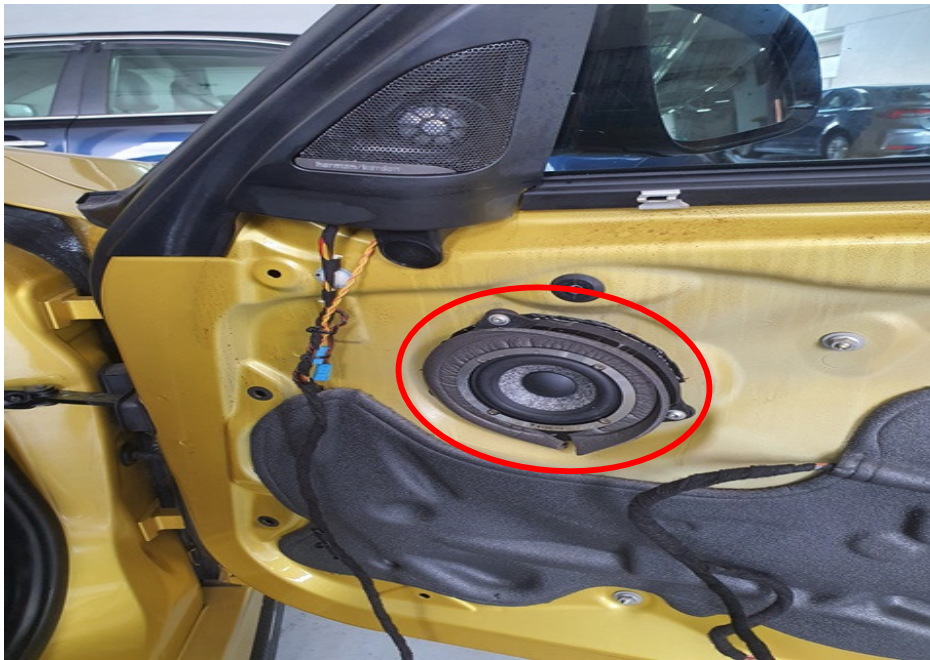
**Photo 11** shows the 1st aftermarket speaker fitted at the driver door panel (circled). The brand of the speaker was 'FOCAL'.

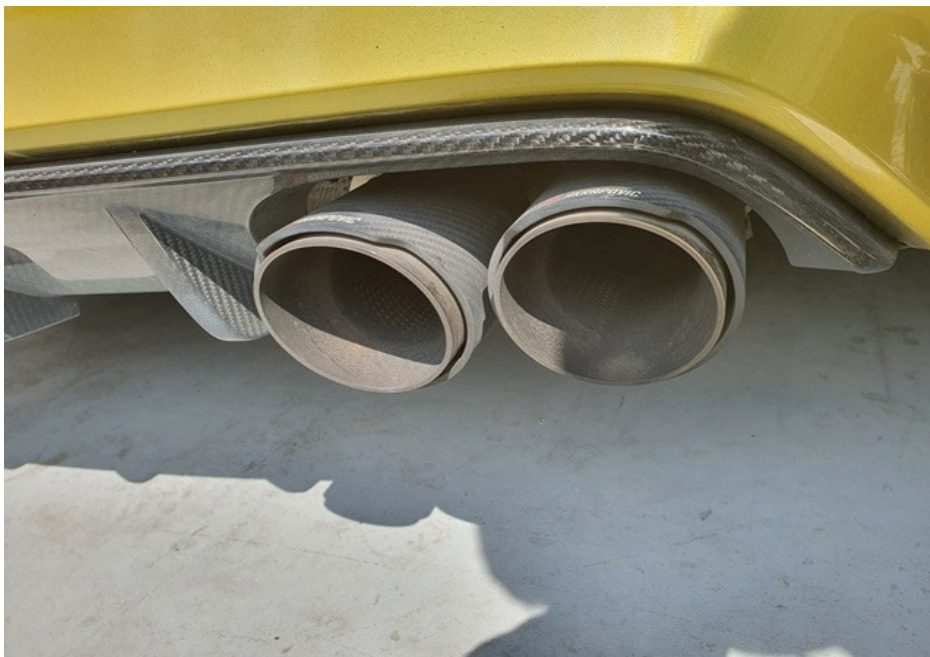
**Photo 12** shows a front view of the non-standard rear exhaust mufflers that were found to be fitted on the Insured Vehicle at the time of our inspection.

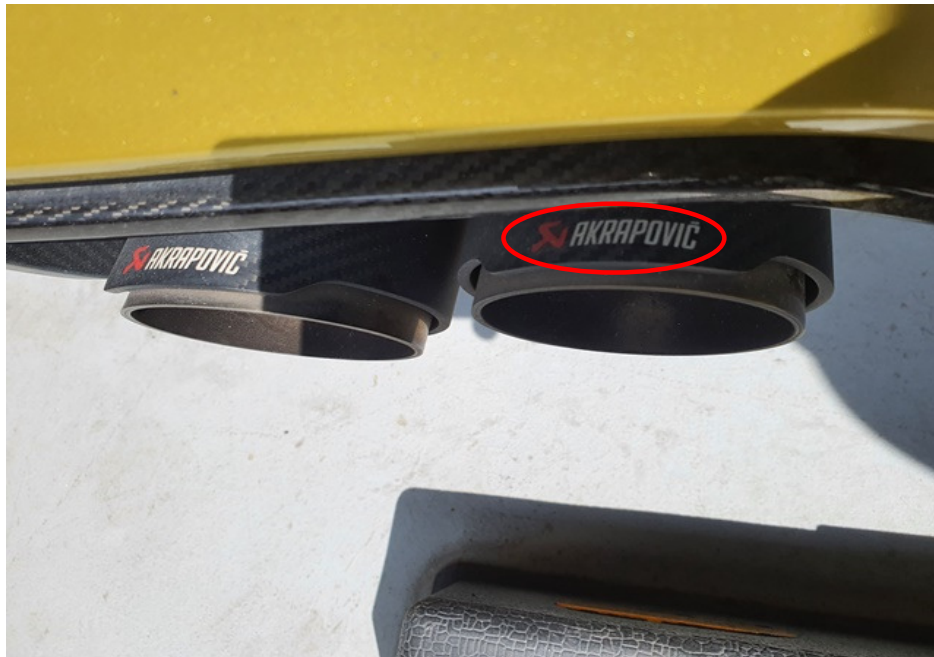
**Photo 13** shows a close up top view of the non-standard rear exhaust mufflers that were found to be fitted on the Insured Vehicle at the time of our inspection. The brand of the rear exhaust mufflers was 'AKRAPOVIC' (circled).

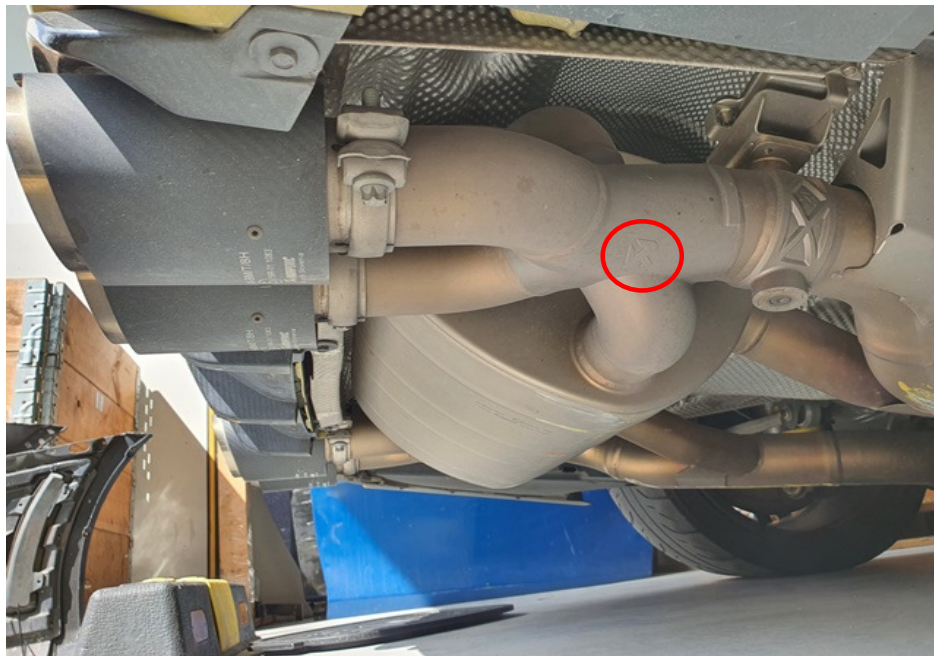
**Photo 14** shows a close up bottom view of the non-standard rear exhaust mufflers that were found to be fitted on the Insured Vehicle at the time of our inspection. The brand of the rear exhaust mufflers was 'AKRAPOVIC' (circled).

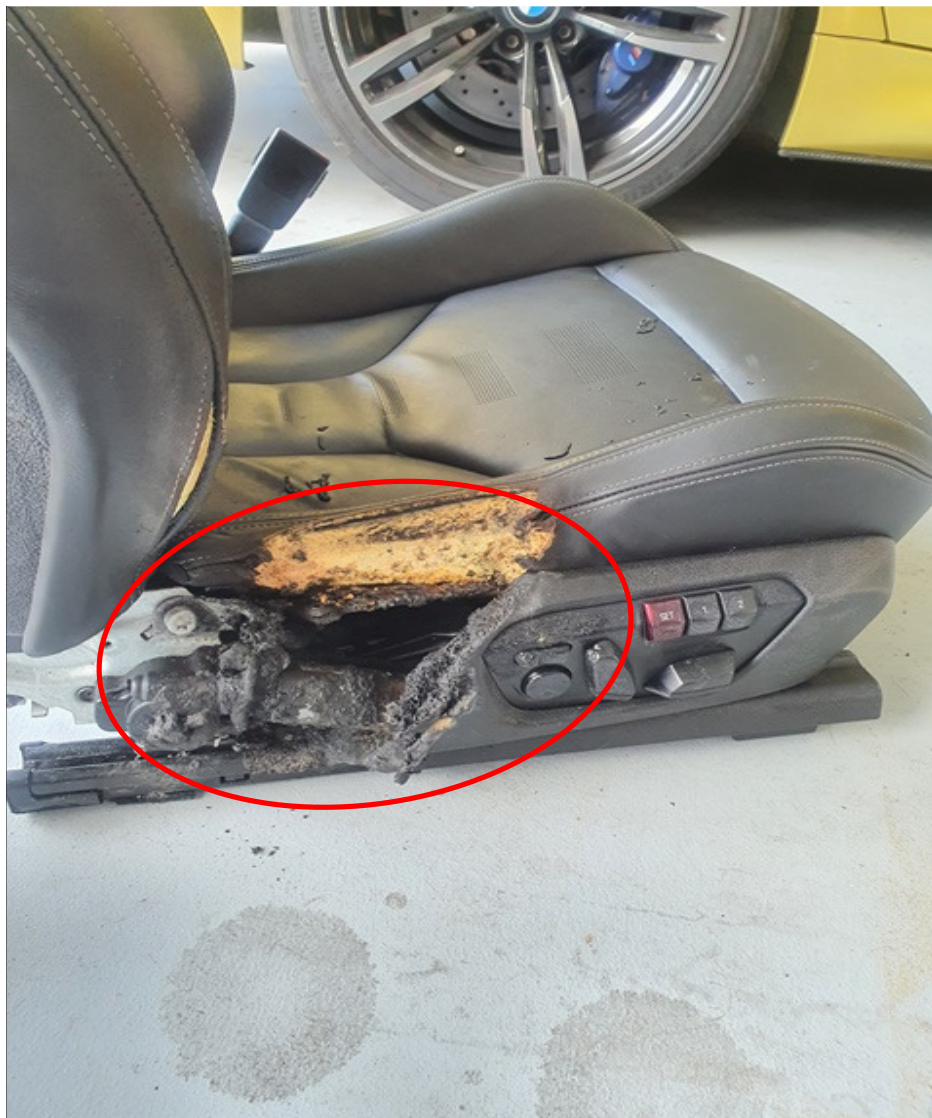
8. For this particular case, the fire appears to have originated from the right portion of the driver seat of the Insured Vehicle. This can be observed from the burnt components of the driver seat. See photos 15 & 16 below.

**Photo 15** shows the dismantled driver seat of the Insured Vehicle. The fire appears to have originated from the right portion of the driver seat of the Insured Vehicle. This can be observed from the burnt components of the driver seat (circled).

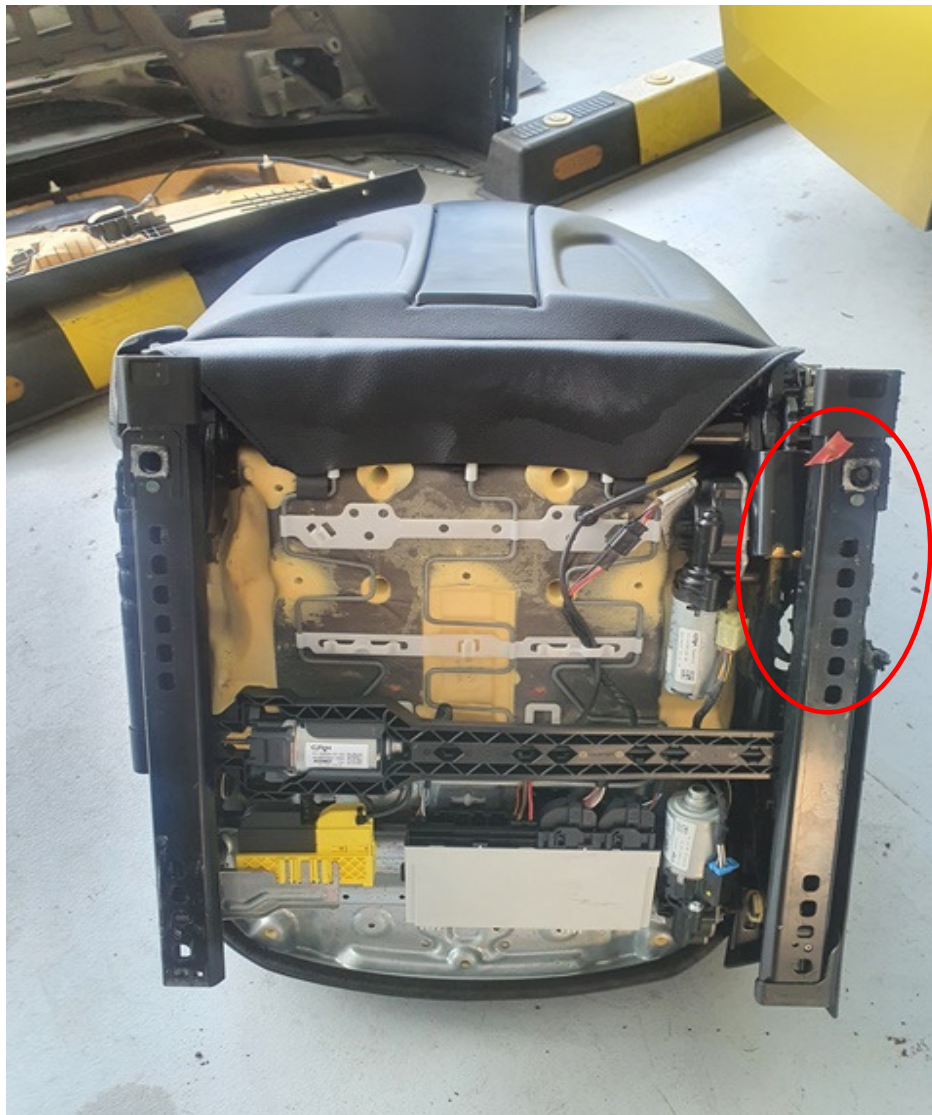
**Photo 16** shows the underside of the dismantled driver seat of the Insured Vehicle. The components on the underside of the driver seat were relatively unaffected by the fire. Hence the fire appears to have originated from the right portion of the driver seat of the Insured Vehicle (circled).

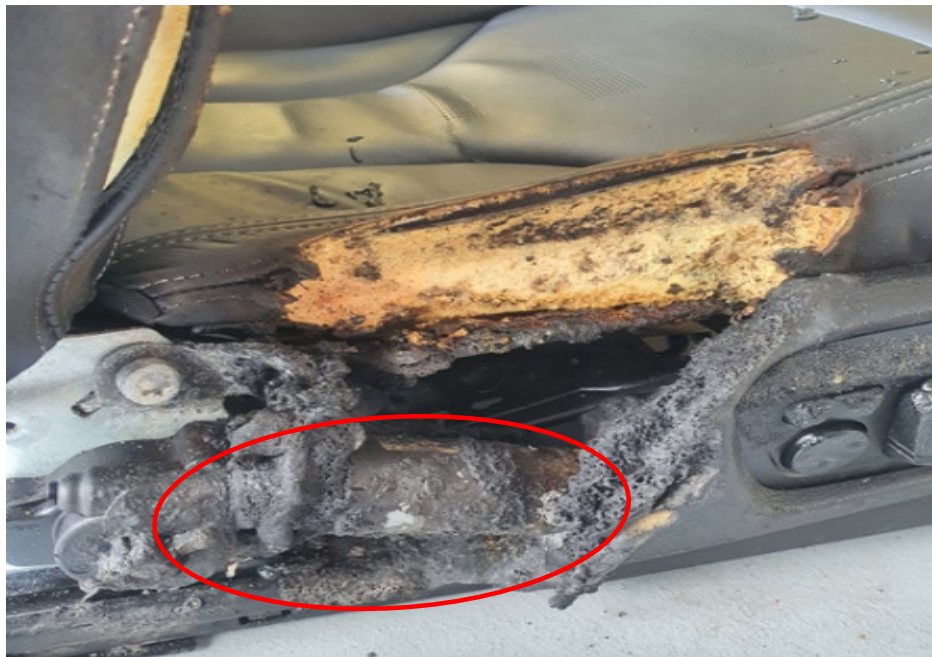
9. Upon closer examination of the area where the fire to the Insured Vehicle had likely started, we found greenish residue on some of the wirings leading from one of the motors of the driver seat. The presence of greenish residue further indicates internal heating of copper wires, another sign of an electrical short circuit occurring. The greenish residue is normally left behind from oxidation as a result of chemical reaction involving the copper wires. This physical evidence would then appear to suggest that the cause of fire to the Insured Vehicle could have possibly been due to electrical in nature. See photos 17 - 20 below.

**Photo 17** shows upon closer examination, the fire appears to have started from one of the motors located at the right portion of the driver seat (circled).

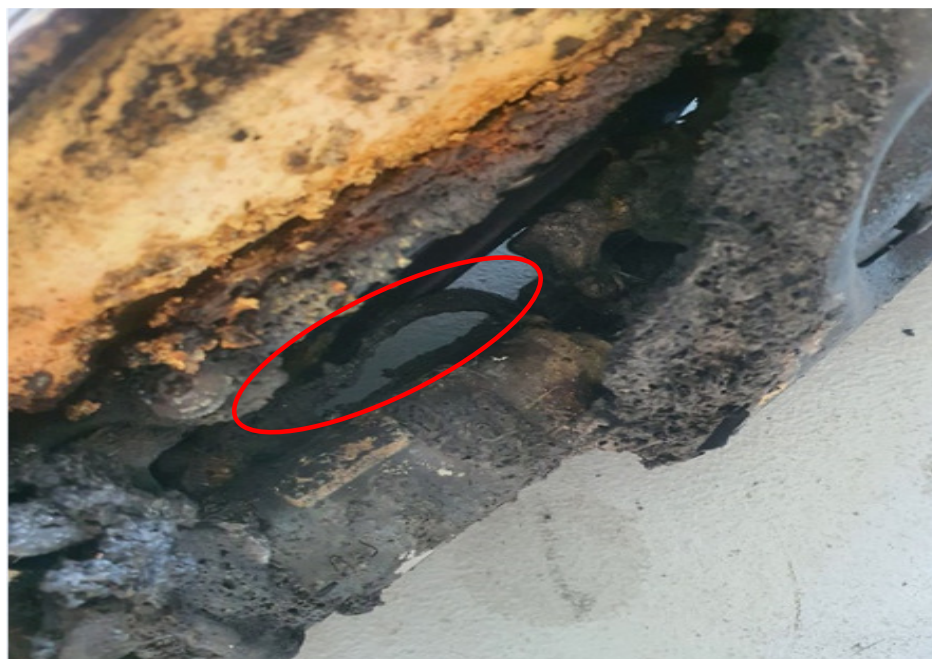
**Photo 18** shows a closer look at the wirings leading from the motor located at the right portion of the driver seat of the Insured Vehicle. We found greenish residue on some of the wirings (circled). The presence of such greenish residue suggest occurrence of an electrical short circuit. The greenish residue is normally left behind from oxidation as a result of chemical reaction involving the copper wires.

25. Having investigated and technically analysed the damages of burnt nature to the Insured Vehicle, we are of the view that the cause of fire to the Insured Vehicle was of electrical in nature. For this particular case, the fire had originated along the wirings leading from one of the motors somewhere around the right portion of the driver seat. The wirings were original factory wirings of the Insured Vehicle.

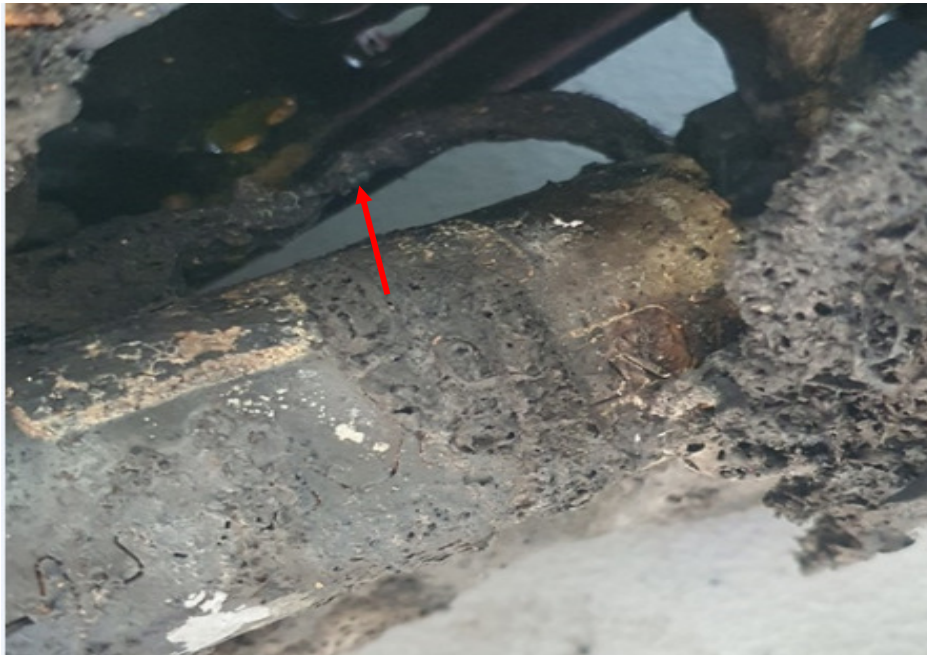
**Photo 19** shows a closer view of some of the wirings with greenish residue (arrowed). The presence of such greenish residue suggest occurrence of an electrical short circuit.

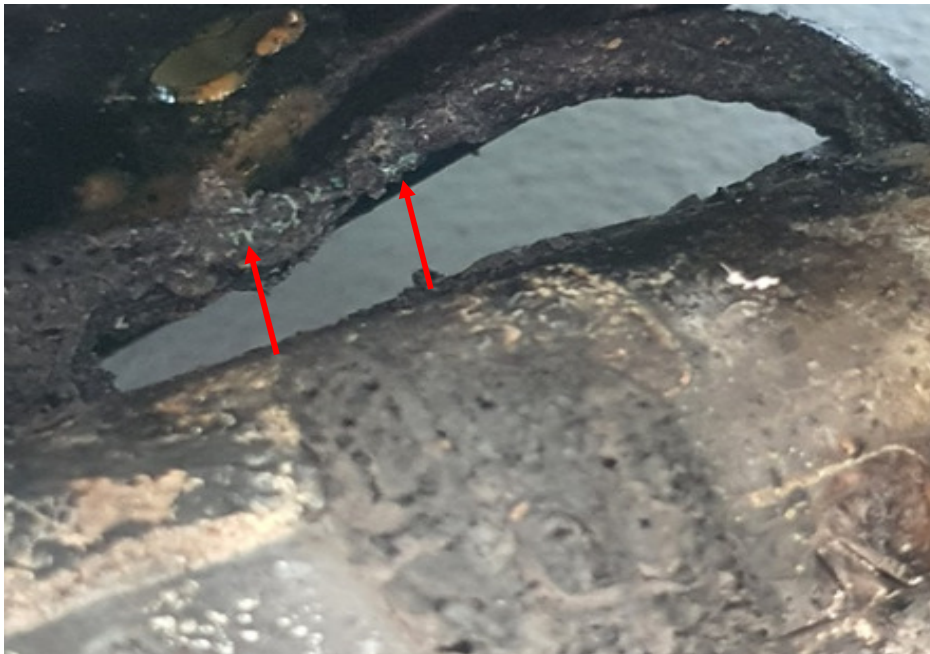
**Photo 20** shows a close up view of some of the wirings with greenish residue (arrowed). The presence of such greenish residue suggest occurrence of an electrical short circuit.

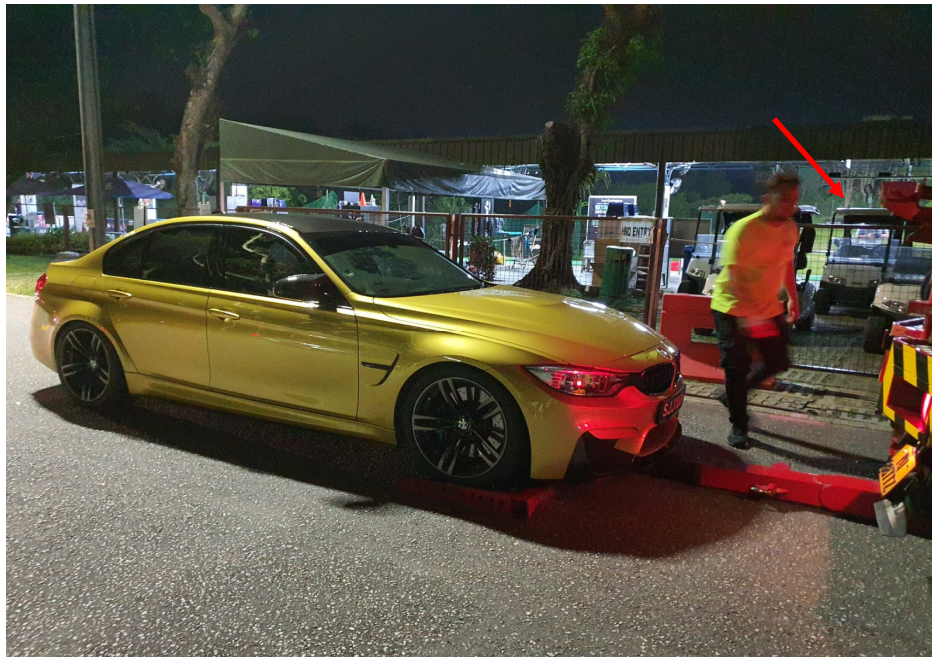
**Photo 23** shows the Insured Vehicle being prepped to be towed to MBM post-incident. In general, the information that could be gathered from this photograph had corresponded to the events that were related to us by Mr Simon, which is the fire had occurred while the Insured Vehicle was parked at the open carpark of the golf driving range (arrowed).

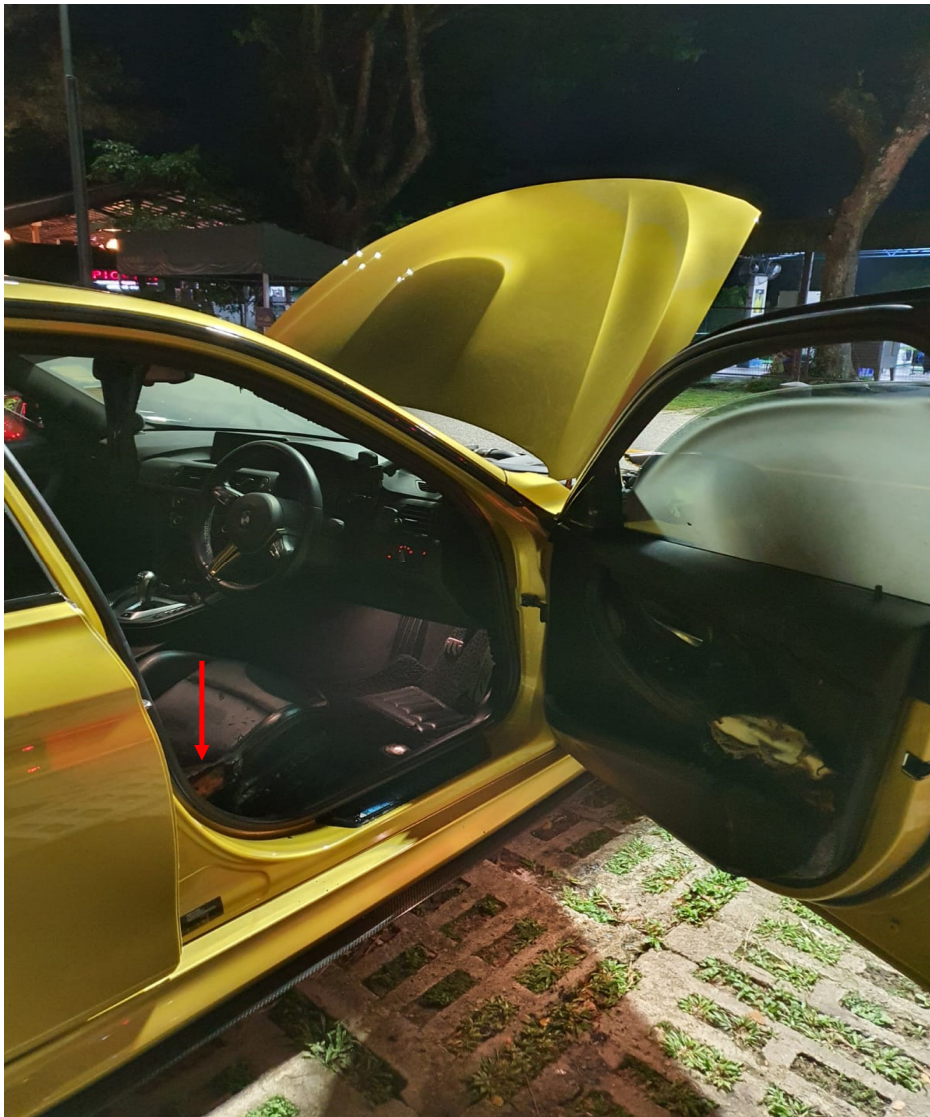
**Photo 24** shows the interior compartment of the Insured Vehicle post- incident. In general, the information that could be gathered from this photograph had corresponded to the events that were related to us by Mr Simon, which is the fire had started from the driver seat of the Insured Vehicle (arrowed).

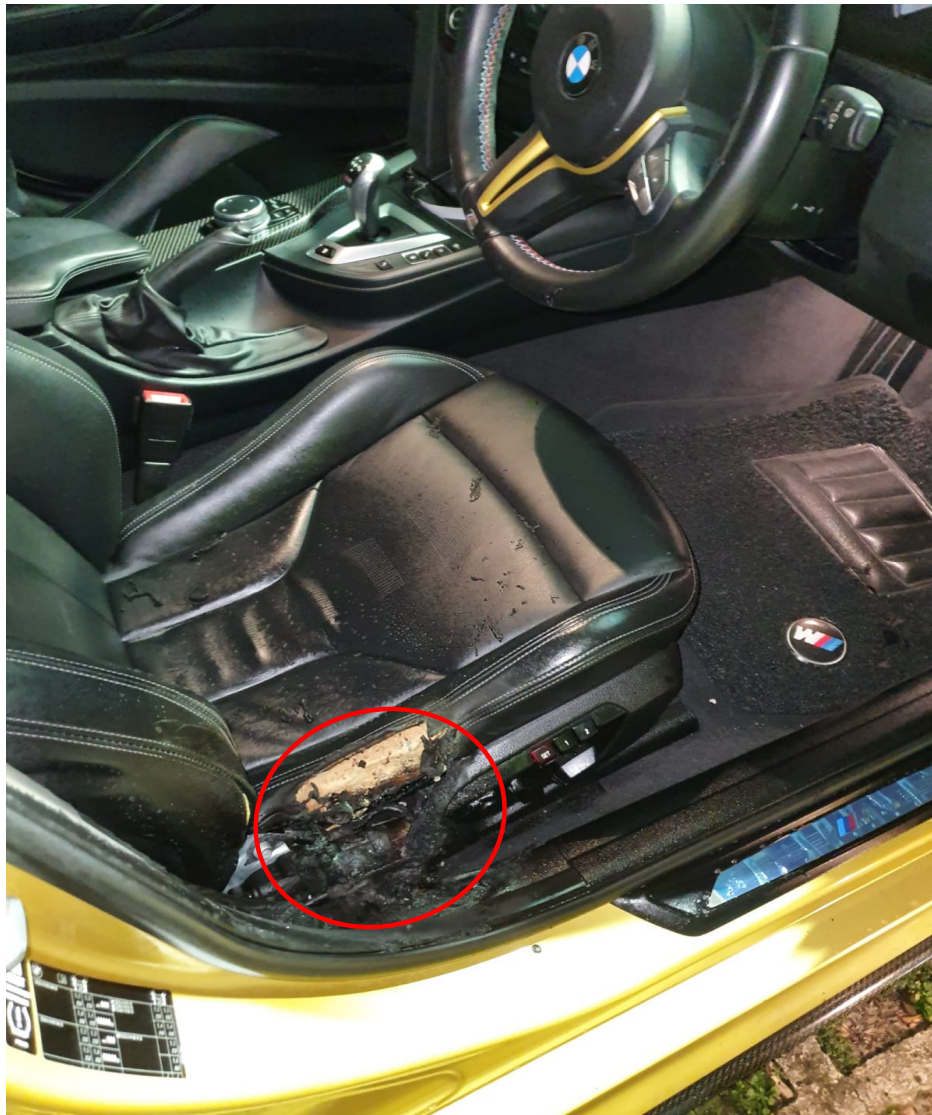
**Photo 25** shows a close up view of the driver seat of the Insured Vehicle post-incident. In general, the information that could be gathered from this photograph had corresponded to the events that were related to us by Mr Simon, which is the fire had started from the driver seat of the Insured Vehicle (circled).
