Re : Third Party Claim For Vehicle Registration No. VBK5018

VEHICLE INSPECTION REPORT

Registration no.	: VBK5018	Odometer	: 37073 km
Make / Model	: Volkswagen Passat TSI Trendline (Cf	Chassis no.	: PPVZZZ3CZHL000372
Regn. date	: 2018	Engine no.	: T.B.A
Body colour	: Black	Engine cap.	: 1798 cc

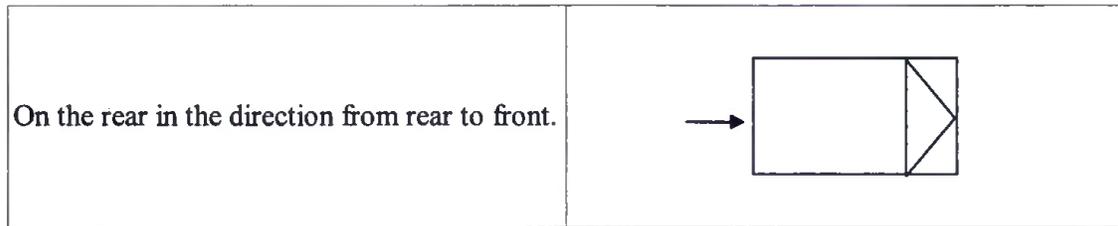
POINT OF IMPACT

The impact of the collision has damaged / affected the bootlid, taillamps, rear bumper, rear end panel and etc...
