**Re : Third Party Claim For Vehicle Registration No. VBK5018**

## VEHICLE INSPECTION REPORT

Our ref. : UAM21.01.04-PT-STP-CSM-VBK5018

Date : 08 Jan 2021

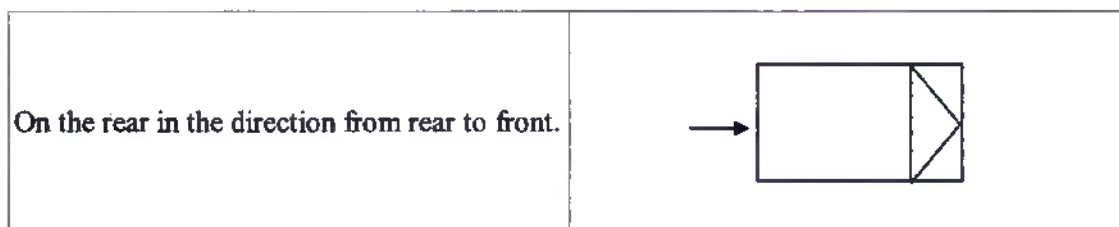
**POINT OF IMPACT**

The impact of the collision has damaged / affected the bootlid, taillamps, rear bumper, rear end panel and etc...
