UNITED Appraisal And Management Pte Ltd

Re : Third Party Claim For Vehicle Registration No. VBK5018

VEHICLE INSPECTION REPORT

Registration no.	: VBK5018	Odometer	: 37073 km
Make / Model	: Volkswagen Passat TSI Trendline (Cf	Chassis no.	: PPVZZZ3CZHL000372
Regn. date	: 2018	Engine no.	: T.B.A
Body colour	: Black	Engine cap.	: 1798 cc

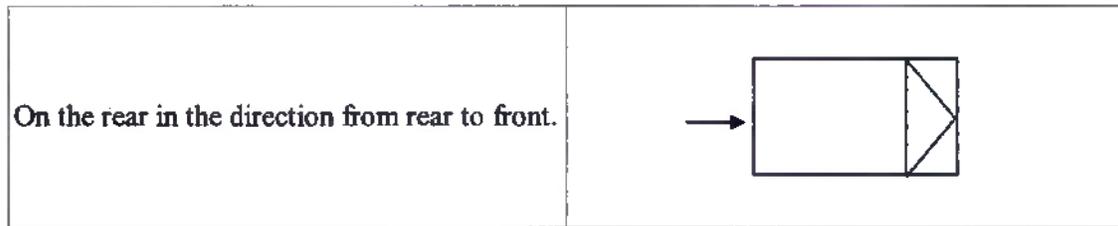
POINT OF IMPACT

The impact of the collision has damaged / affected the bootlid, taillamps, rear bumper, rear end panel and etc...
