Your Ref: TP/IP/47421/2020  
Our Ref : CI/TPD21004823/P

16<sup>th</sup> April 2021

**MECHANICAL INSPECTION REPORT OF MINI BUS PC 1879U**

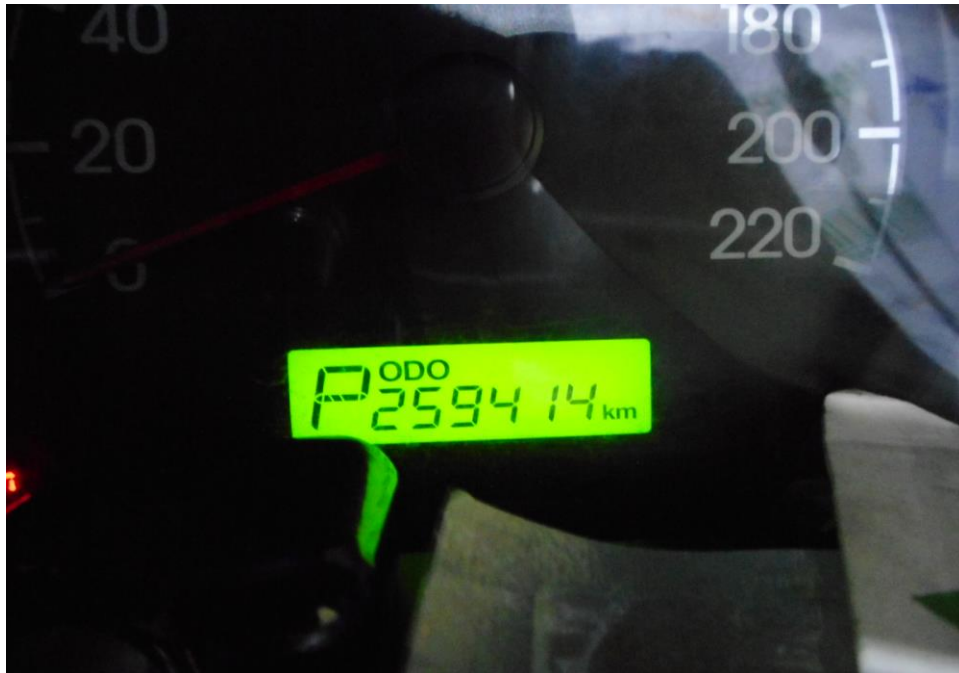
**Photo 1** shows a general view of the instrument cluster of the Mini Bus at the time of my inspection. The mileage of the Mini Bus was 259,414 km

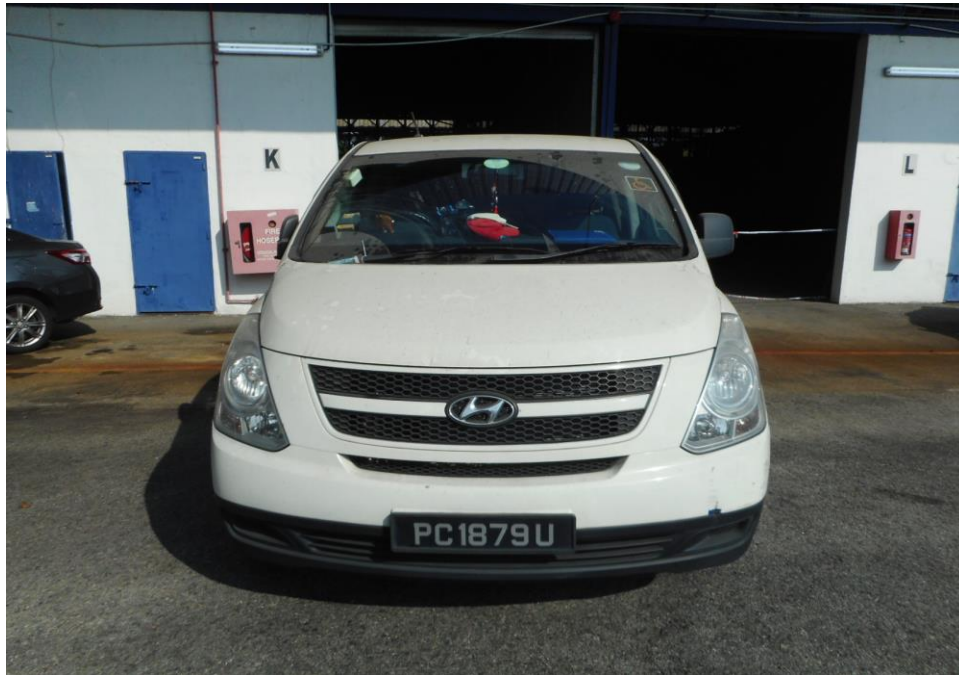
**Photo 2** shows a general view of the Mini Bus's frontal portion at the time of my inspection. The Mini Bus was observed to be intact and unaffected by the accident.

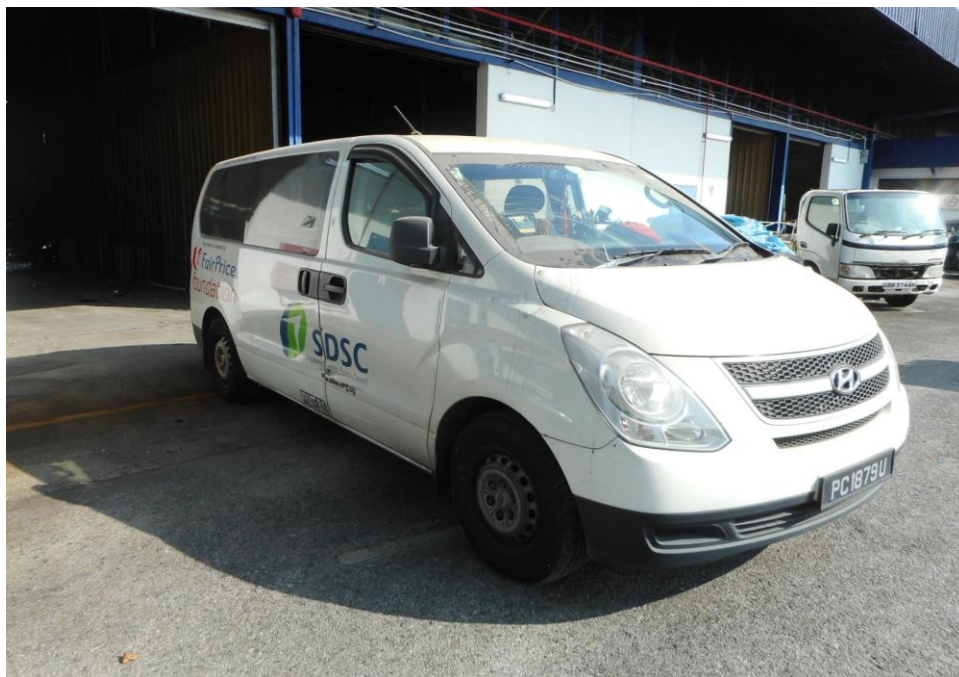
4. The mileage of the Mini Bus at the time of my inspection was 259,414km.
5. The Mini Bus was observed to sustained damage at its right portion. Its front right door were damage at the time of my inspection.

**Photo 3** shows a general view of the right body of the Mini Bus at the time of my inspection. It appeared to have sustained damage at its right portion. Its front right door were damage at the time of my inspection.

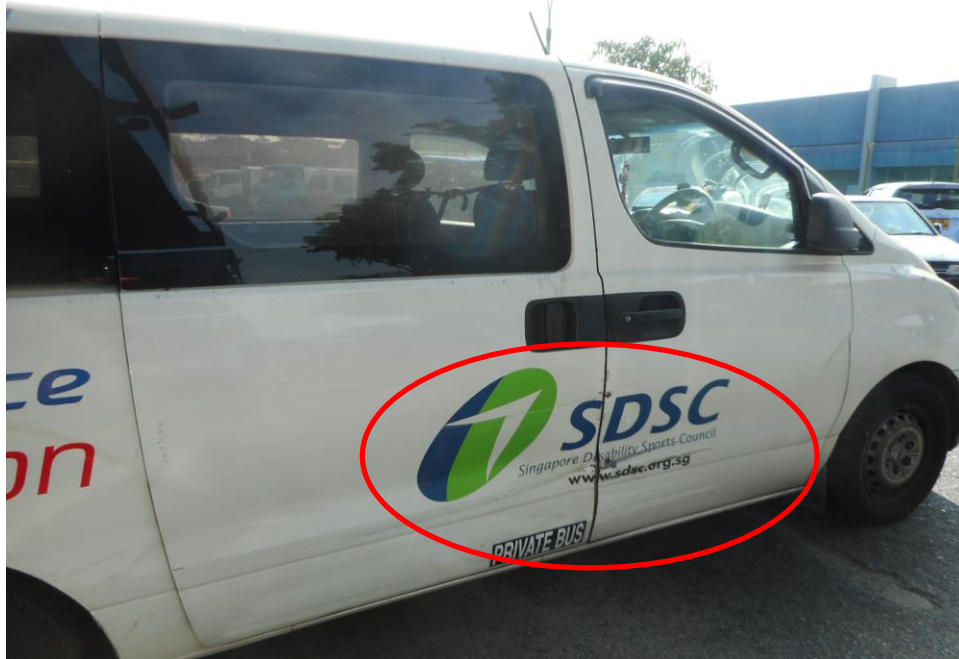
**Photo 4** shows a close up view of the Mini Bus's right portion of the Mini Bus at the time of my inspection. It appeared to have sustained damage at its right portion. Its front right door (circled) were damage at the time of my inspection.

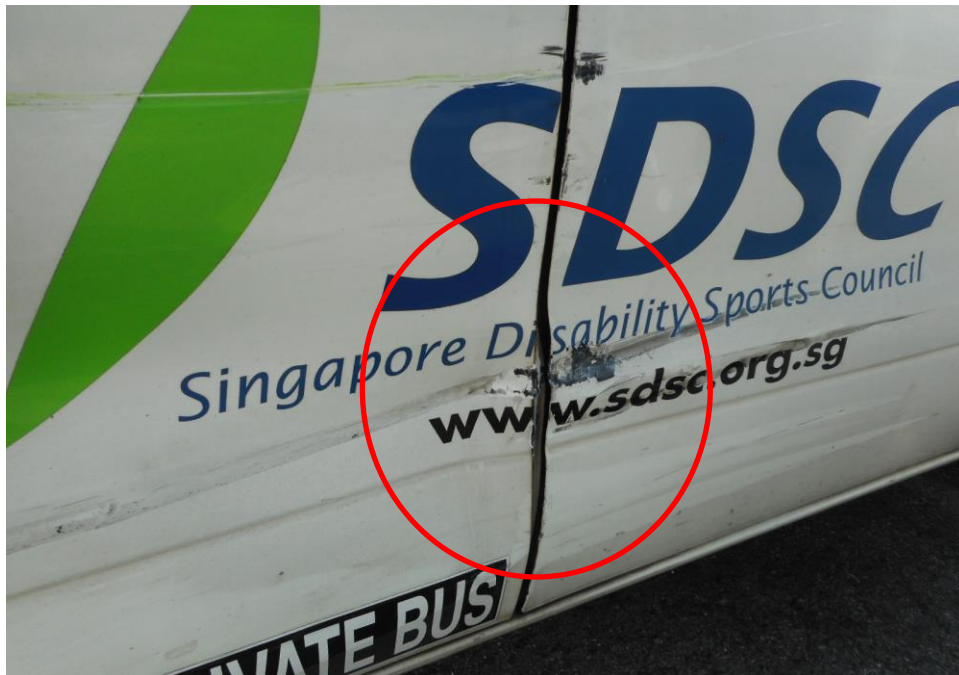
**Photo 5** shows a close up view of the Mini Bus's right portion at the time of my inspection. Its right door (circled) was damage at the time of my inspection as a result of the accident.

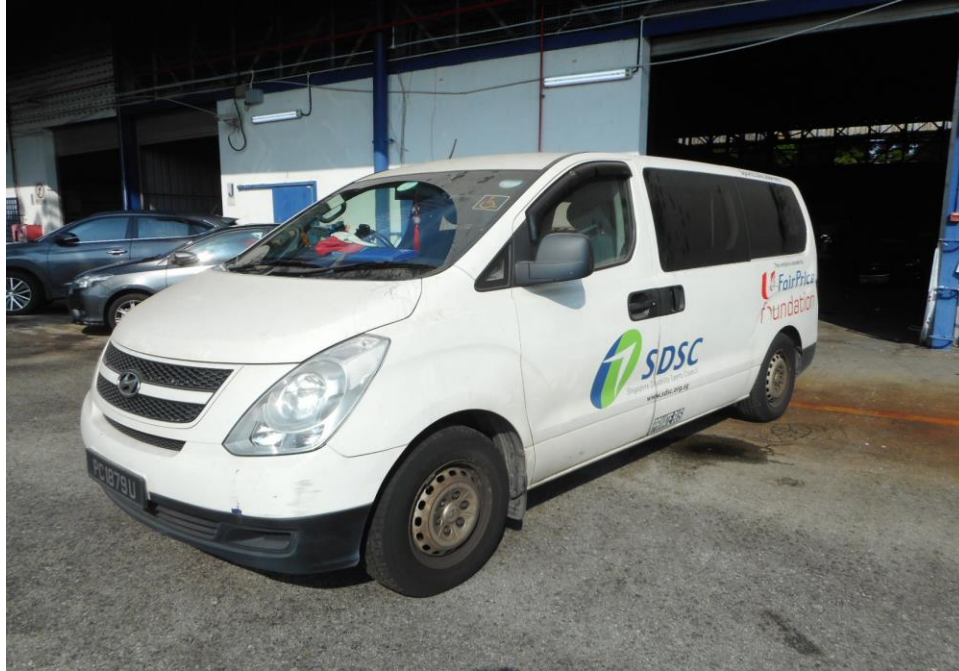
**Photo 6** shows a general view of the left body of the Mini Bus at the time of my inspection. The Mini Bus was observed to be intact and unaffected by the accident.

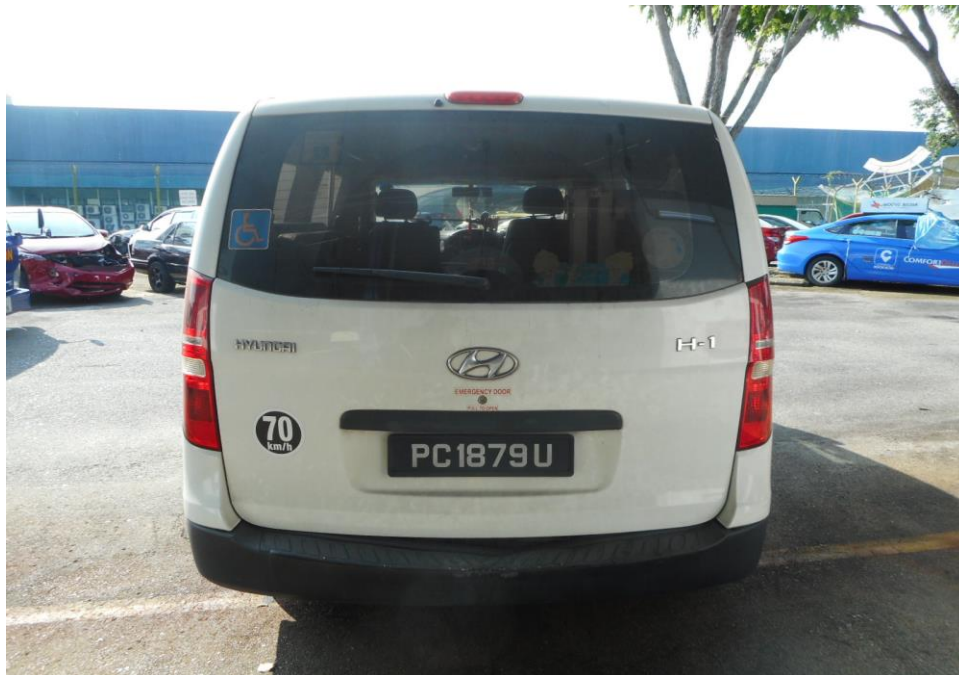
**Photo 7** shows a general view of the rear body of the Mini Bus at the time of my inspection. The Mini Bus was observed to be intact and unaffected by the accident.

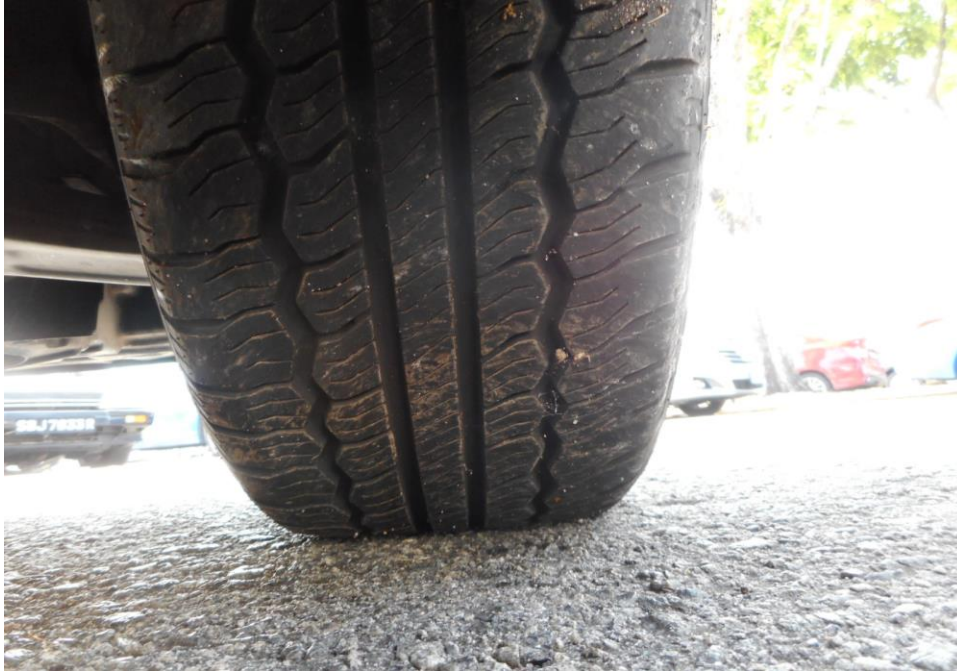
**Photo 8** shows the condition of the front right tyre of the Mini Bus, which was observed to be in serviceable condition with remaining tread depth of approximately 6.1mm. The tyre, which was wrapped around standard steel wheel rim, was also observed to be sufficiently inflated for vehicular operation. There was no tear, cut or burst mark(s) on the outer and the inner sidewalls as well as across the tread of the 4 tyres that were fitted on the Mini Bus.

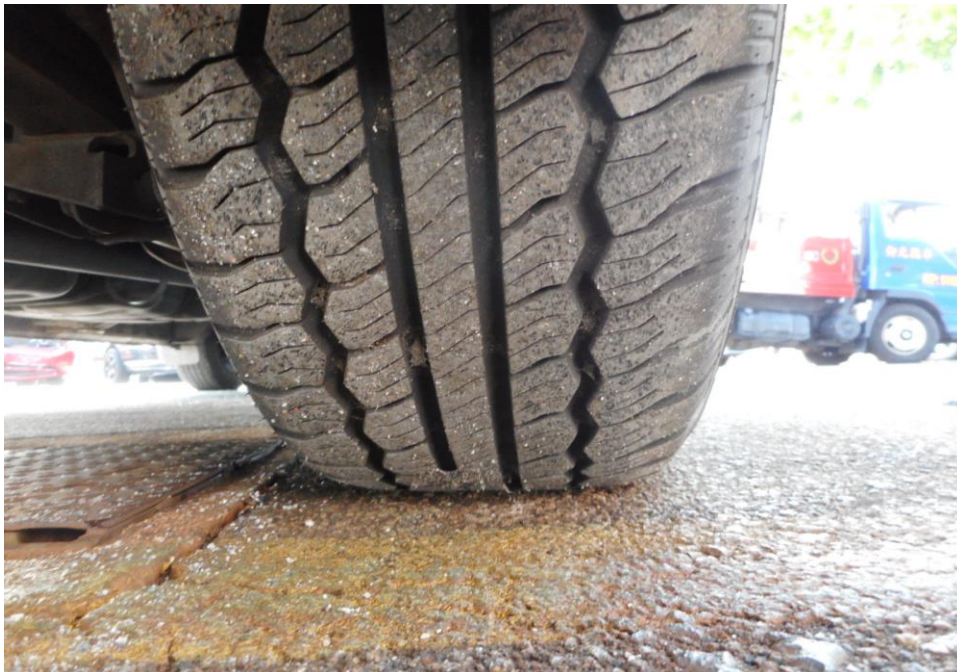
**Photo 9** shows the condition of the rear right tyre of the Mini Bus, which was observed to be in serviceable condition with remaining tread depth of approximately 5.7mm. The tyre, which was wrapped around standard steel wheel rim, it was observed to be sufficiently inflated for vehicular operation.

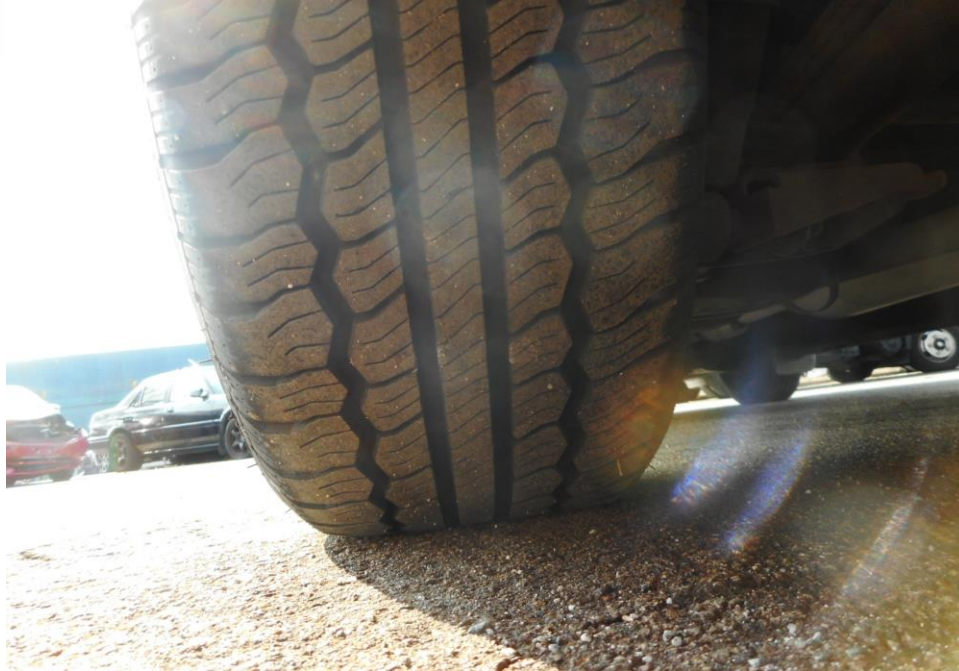
**Photo 10** shows the condition of the rear left tyres of the Mini Bus, which was observed to be in serviceable condition with remaining tread depth of approximately 5.9mm. The tyres, which were wrapped around standard steel wheel rim, were also observed to be sufficiently inflated for vehicular operation. There was also no damage found on all 4 steel wheel rims of the Mini Bus.

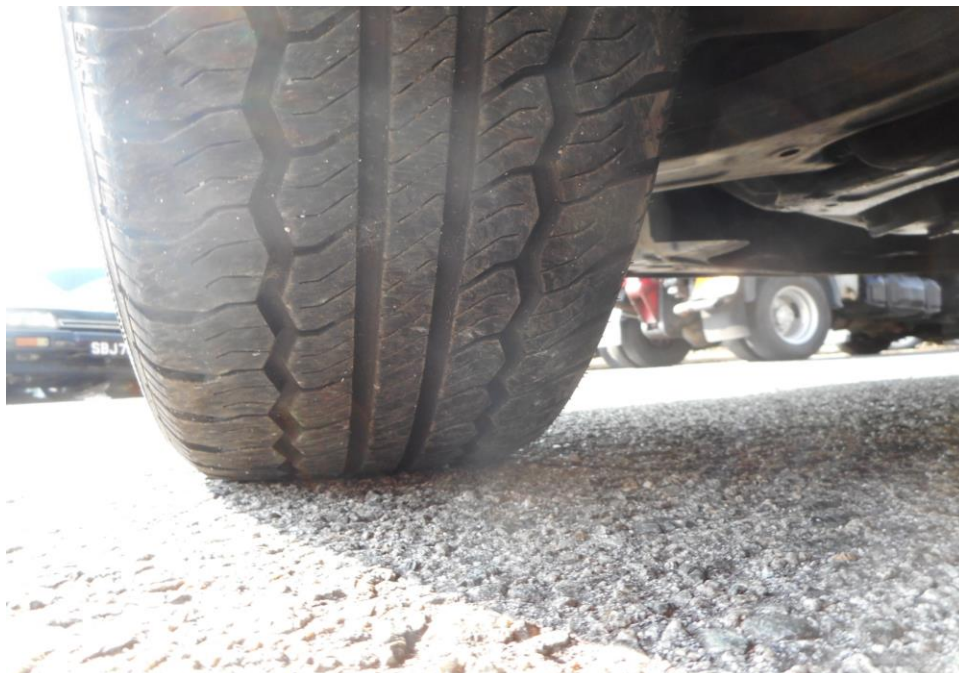
**Photo 11** shows the condition of the rear right tyres of the Mini Bus, which were observed to be in serviceable condition with remaining, tread depth of approximately 5.5mm. There was also no tear, cut or burst mark(s) on the outer and the inner sidewalls as well as across the tread of the 4 tyres that were fitted on the Mini Bus.

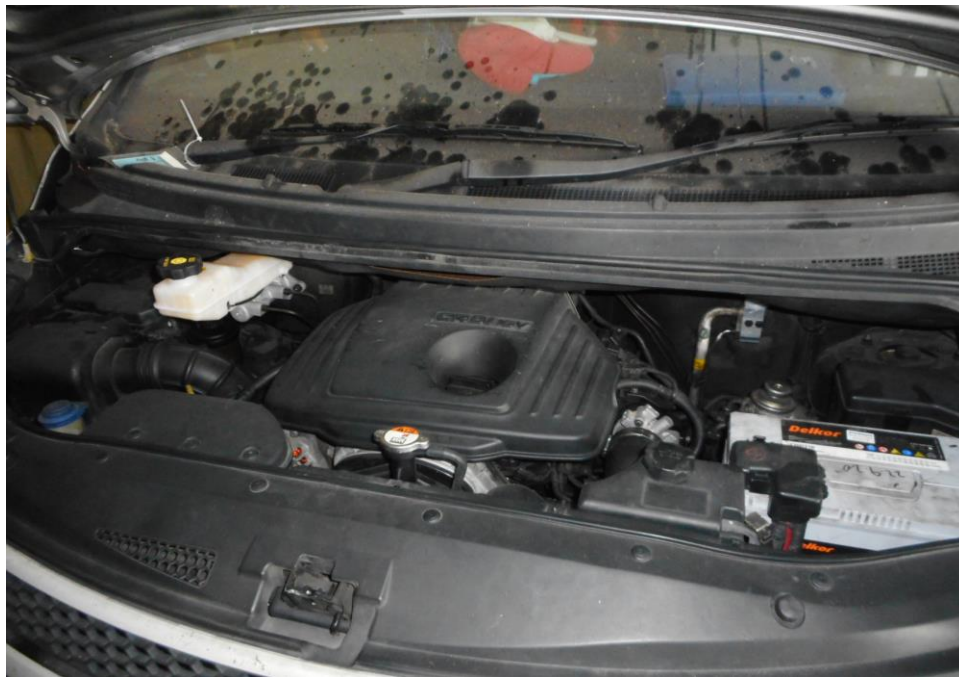
**Photo 12** shows a general view of the Mini Bus's engine compartment, which was accessed by lifting the front cabin of the Mini Bus. The various parts and components inside the engine compartment were unaffected by the accident. There was also no sign(s) or indication(s) of fresh fluid leakage and/or fluid stain within the engine compartment

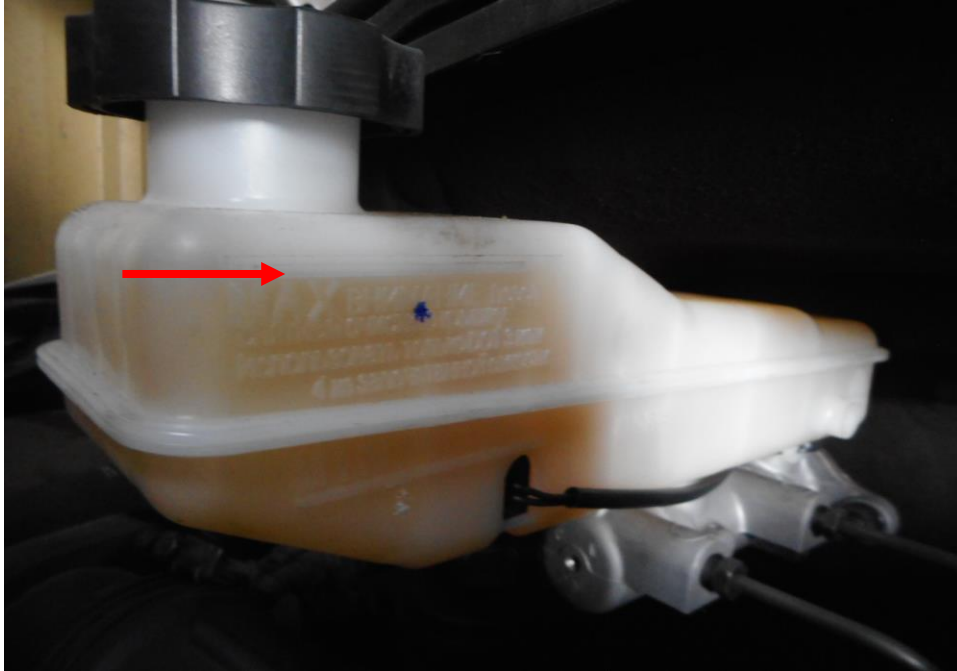
**Photo 13** shows the brake fluid reservoir of the Mini Bus at the time of my inspection. The brake fluid was observed to be of sufficient level (arrowed) and without any visible contamination.

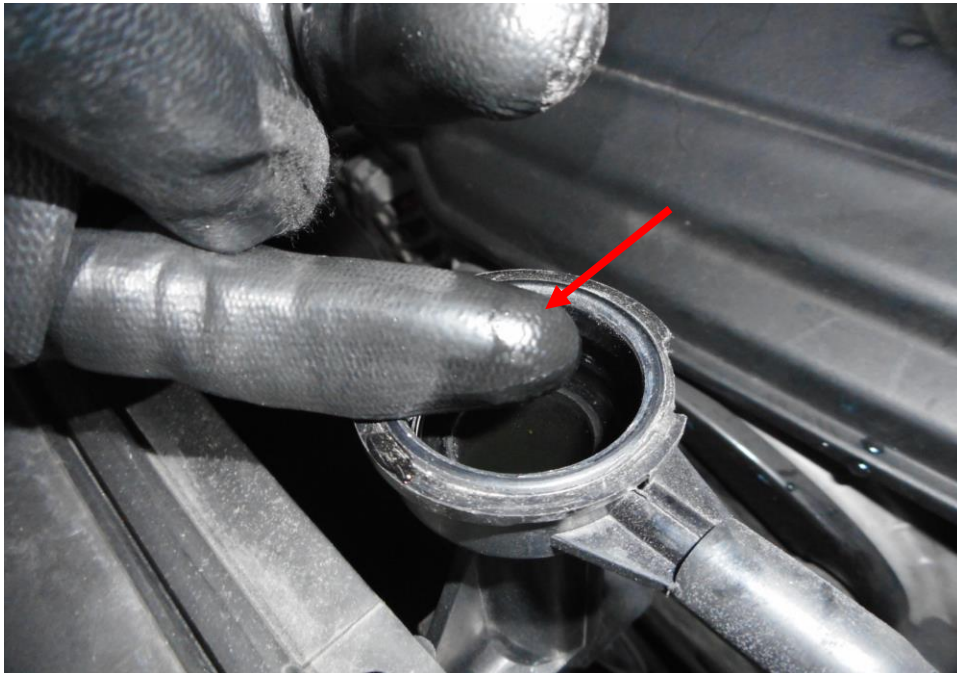
**Photo 14** shows the engine coolant reservoir of the Mini Bus at the time of my inspection. The engine coolant was observed to be of sufficient level (arrowed) and without any visible contamination.

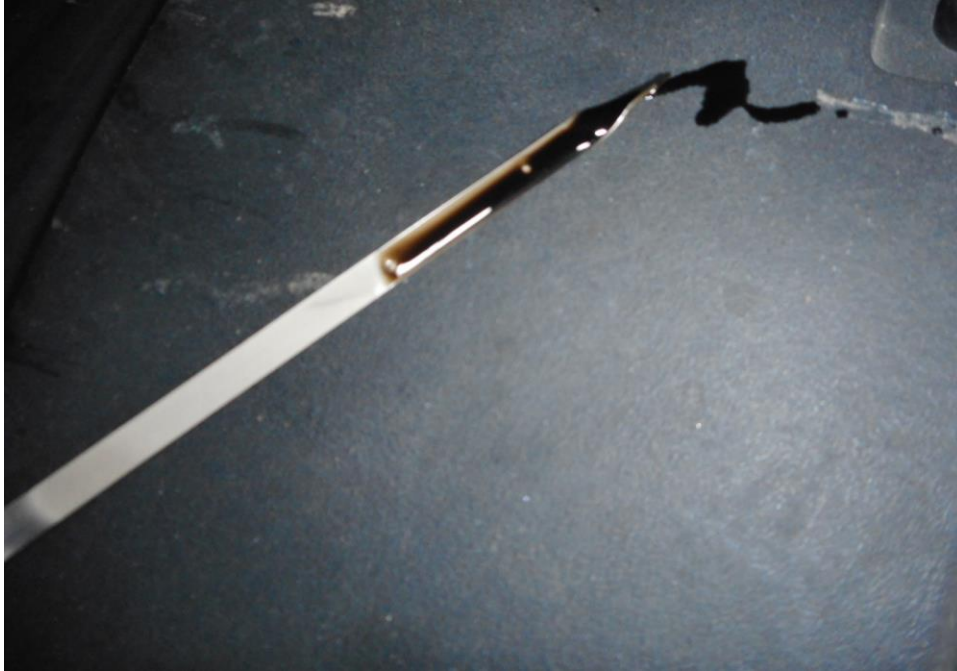
**Photo 15** shows the engine oil dip stick of the Mini Bus at the time of my inspection. The engine oil was observed to be of sufficient level and without any visible contamination.

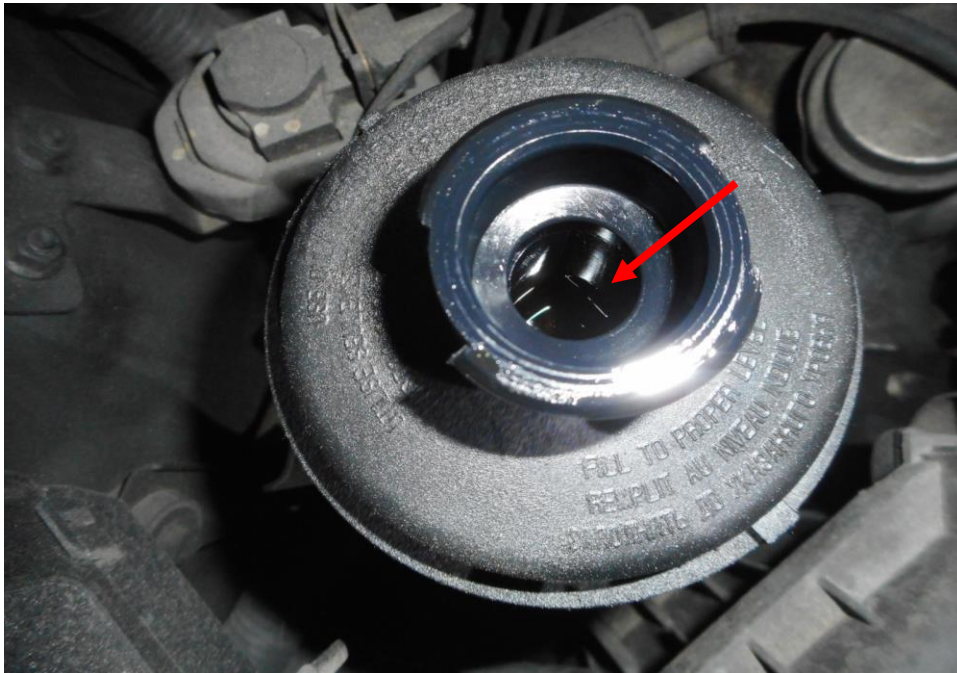
**Photo 16** shows the power steering fluid reservoir of the Mini Bus at the time of my inspection. The power steering fluid was observed to be of sufficient level (arrowed) and without any visible contamination.

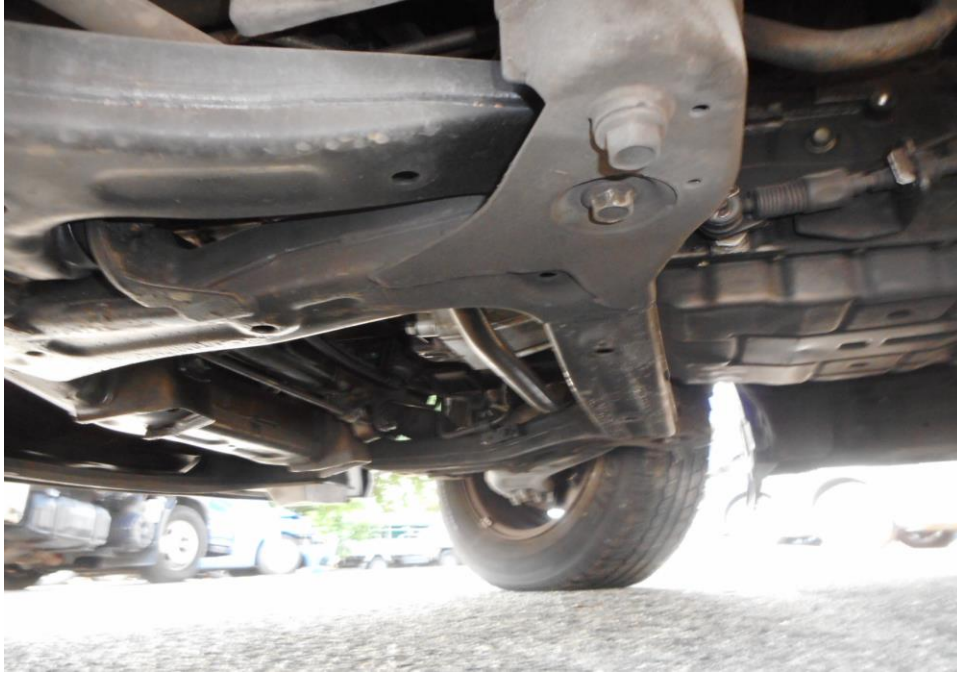
**Photo 17** shows the undercarriage of the Mini Bus, at the area where the engine housing and transmission housing are located. I did not find any sign(s) or indication(s) of fluid leak and/or fluid stain(s) on the underside of the Mini Bus.

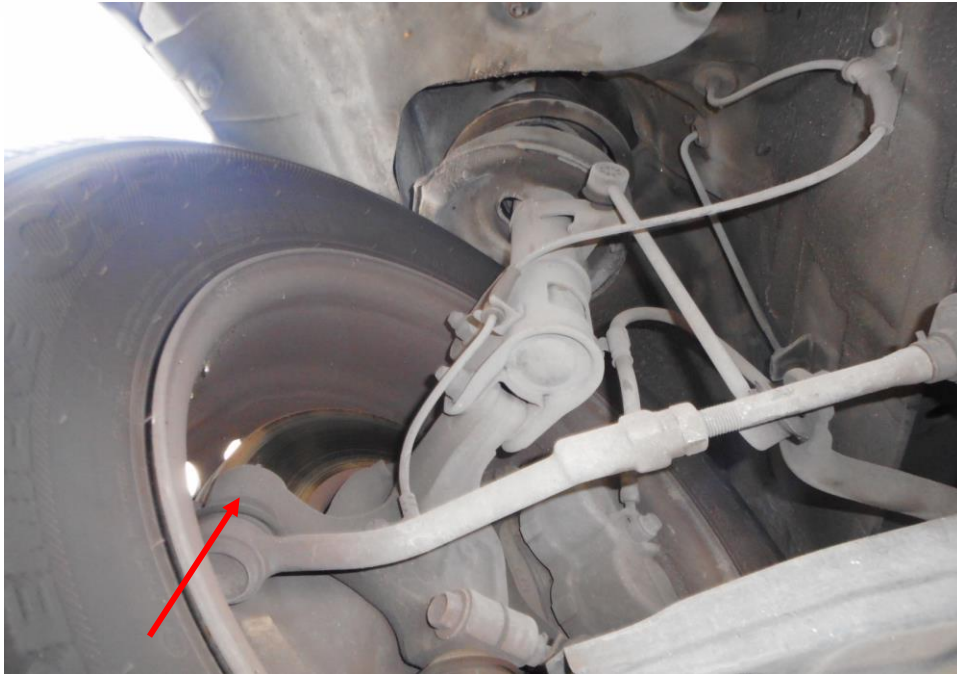
**Photo 18** shows the various undercarriage components at the front right wheel of the Mini Bus, in particular the steering tie rod end (arrowed). The various steering components were all found to be intact, suggesting that the steering system of the Mini Bus was likely to be in serviceable condition at the material time of accident. There was also no sign of fluid stain(s) observed on the various undercarriage components.

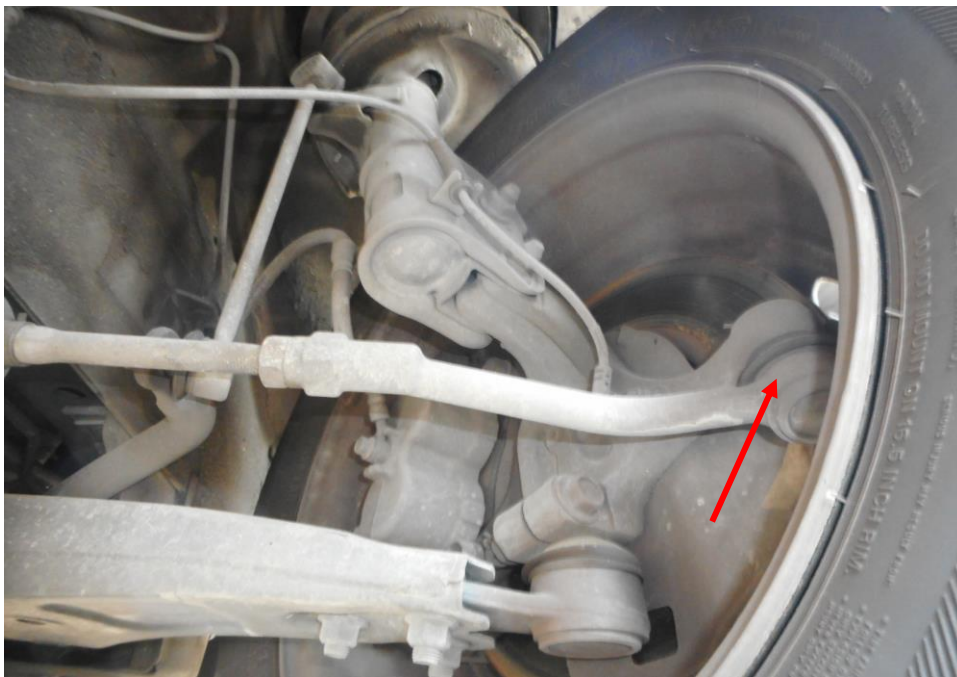
**Photo 19** shows the various undercarriage components at the front left wheel of the Mini Bus, in particular the steering tie rod end (arrowed). The various undercarriage components of the Mini Bus were all found to be intact without any visible damage. There was also no sign of fluid stain(s) observed on the various undercarriage components.

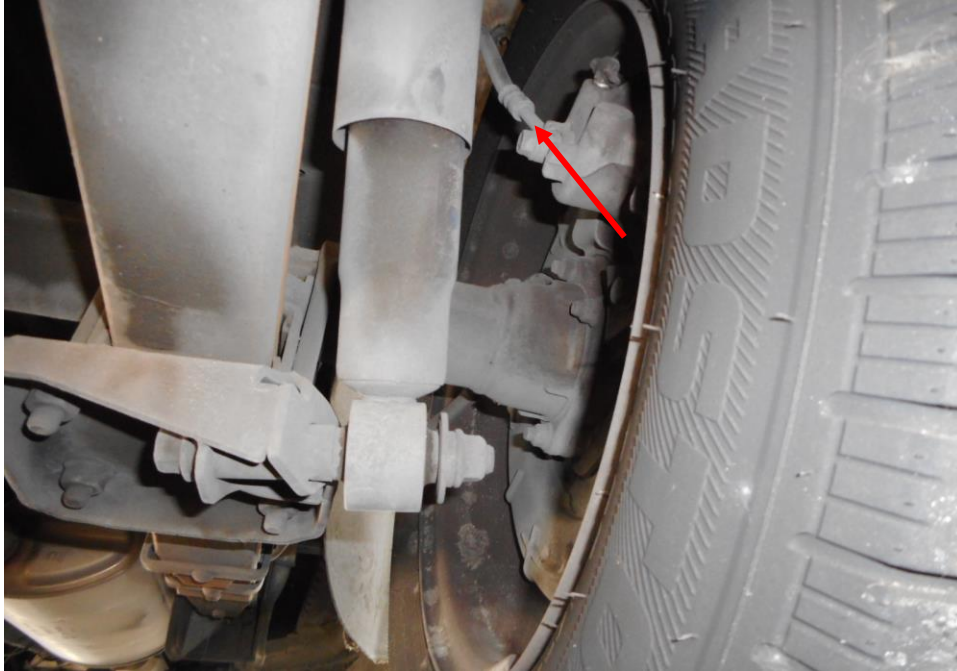
**Photo 20** shows the brake pipe (arrowed) at the rear right wheel of the Mini Bus. I did not observe any leakage of brake fluid at the time of my inspection of the Mini Bus. My static tests of the Mini Bus's braking system, along with my visual examination of the various mechanical components in the braking system, had indicated that there was no internal leakage of pressure/vacuum. Hence the braking system of the Mini Bus was likely to be in serviceable condition at the material time of accident.

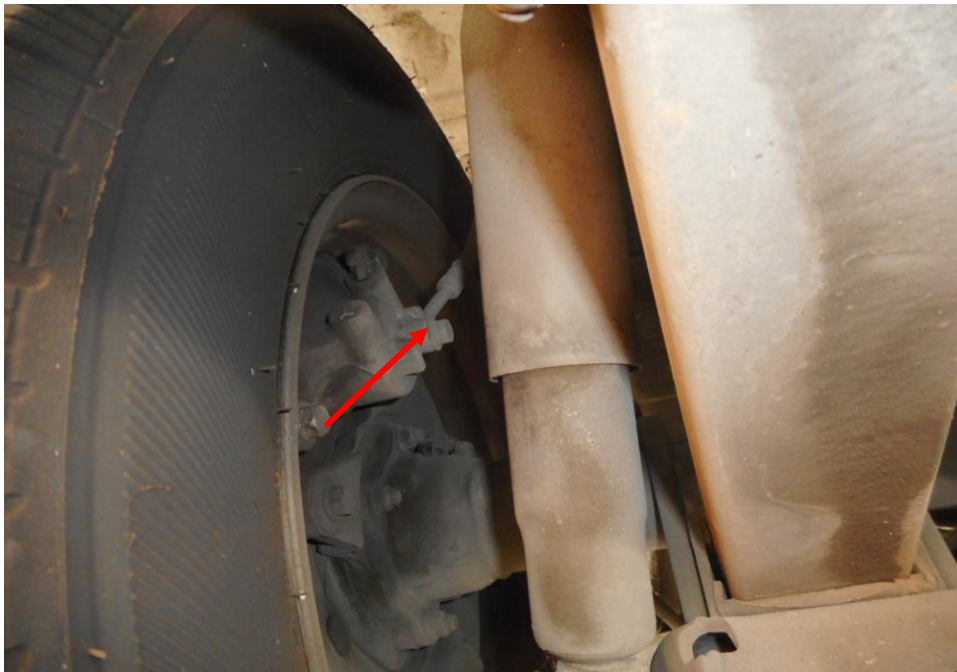
**Photo 21** shows the brake pipe (arrowed) at the rear left wheel of the Mini Bus. I did not observe any leakage of brake fluid at the time of my inspection of the Mini Bus. My static tests of the Mini Bus's braking system, along with my visual examination of the various mechanical components in the braking system had indicated that there was no internal leakage of pressure/vacuum. Hence the braking system of the Mini Bus was likely to be in serviceable condition at the material time of accident.

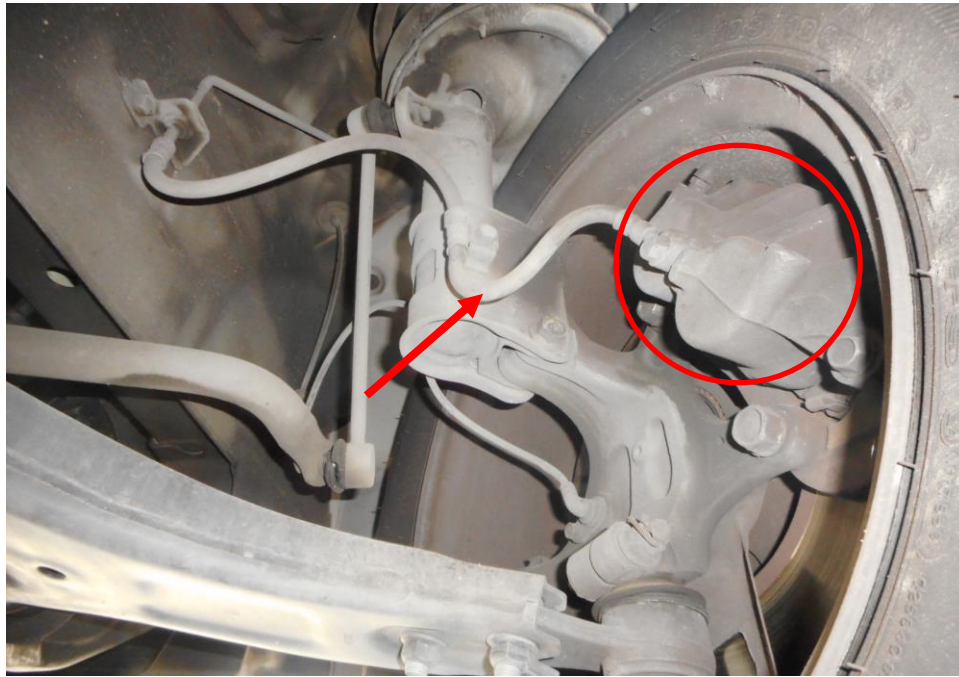
**Photo 22** shows the brake hose/pipe (arrowed) at the front right wheel of the Mini Bus. No leakage of brake fluid was observed. Visual examination of the various components of the braking system like the brake caliper (circled), brake booster, brake pedal etc had revealed all to be intact and without visible damage at the time of accident. There was also no sign of fluid stain(s) observed on the various undercarriage components.

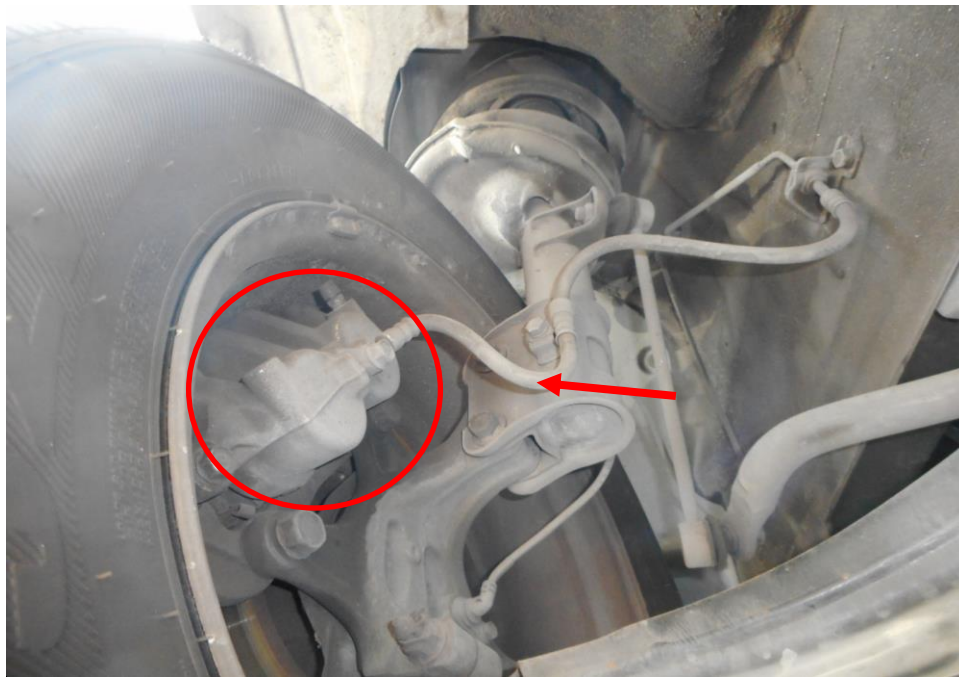
**Photo 23** shows the brake hose/pipe (arrowed) at the front left wheel of the Mini Bus. No leakage of brake fluid was observed. Visual examination of the various components of the braking system like the brake caliper (circled), brake booster, brake pedal etc had revealed all to be intact and without visible damage at the time of accident. There was also no sign of fluid stain(s) observed on the various undercarriage components.

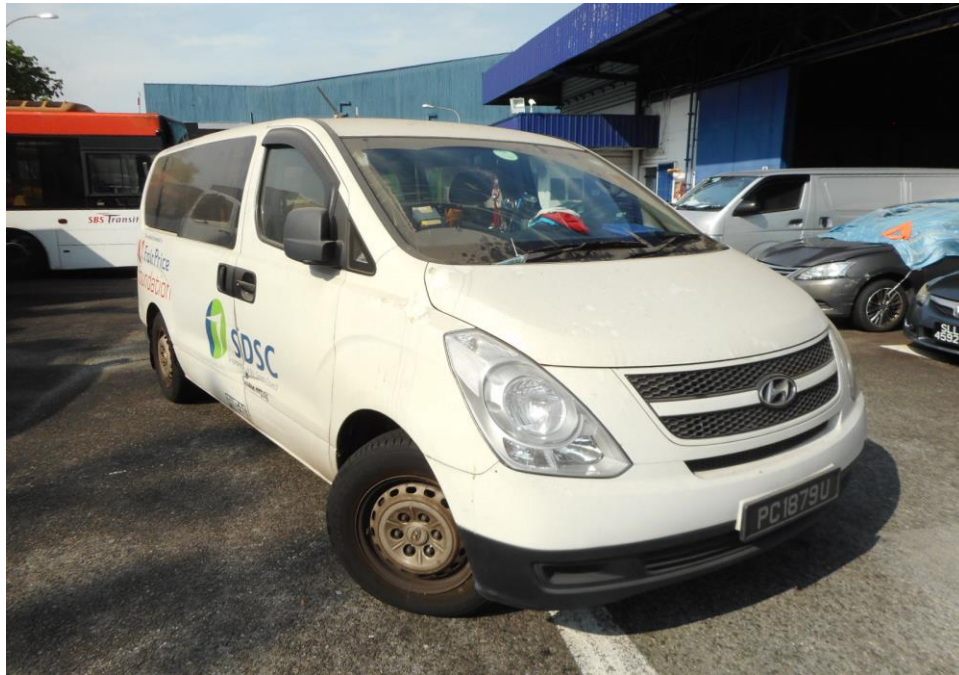
**Photo 24** shows the front right wheel of the Mini Bus turned to its full left. During my steering system test, I did not experience any abnormal free play and/or resistance when I had turned the steering wheel towards full left and full right. This would suggest that the steering system of the Mini Bus was likely to be in serviceable condition at the material time of accident.

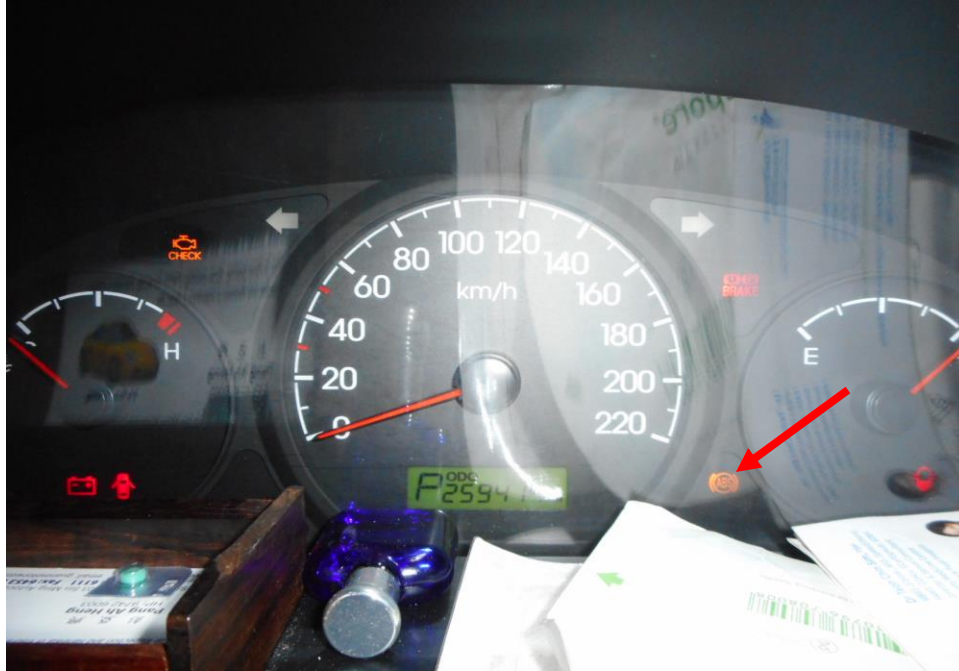
**Photo 25** shows the warning light for Anti-Lock Brake System (ABS) (arrowed) appearing on the instrument panel of the Mini Bus during the self-test of its various electronic operating systems when its engine was cranked.

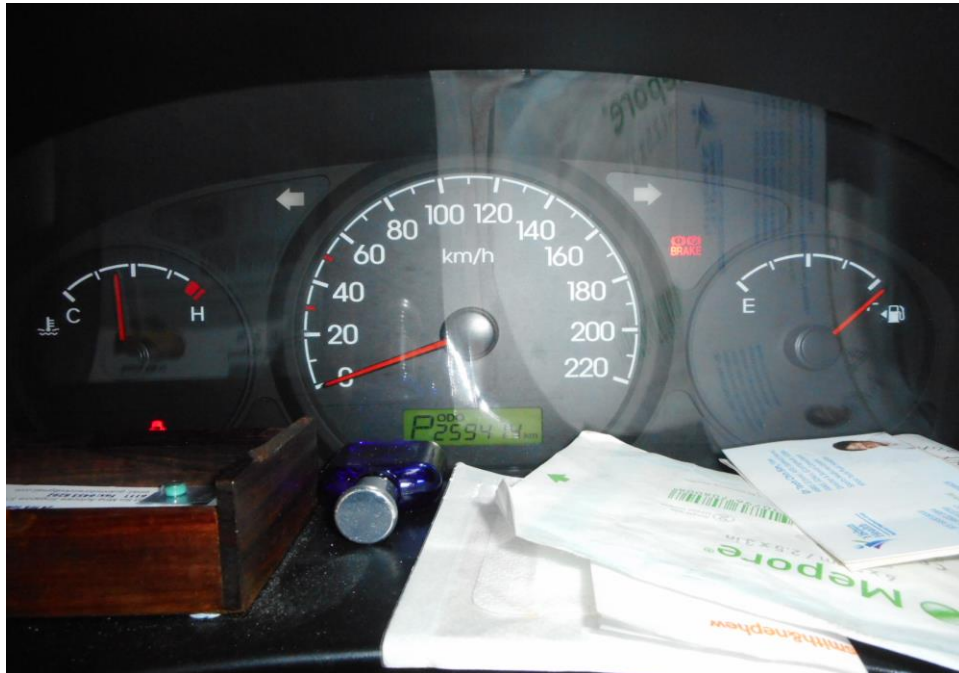
**Photo 26** shows no warning lights illuminated on the instrument panel of the Mini Bus after the engine was cranked. This would suggest that there was no abnormality to the electronic operating system of the Mini Bus, like the ABS and etc.
