Your Ref: BMW 530e
(chassis number WBAJA92070BN75832)
Our Ref : CI/TP21004827/D

23 April 2021

**INSPECTION REPORT OF AN UNREGISTERD BMW 530e MOTOR CAR
WITH CHASSIS NUMBER WBAJA92070BN75832**

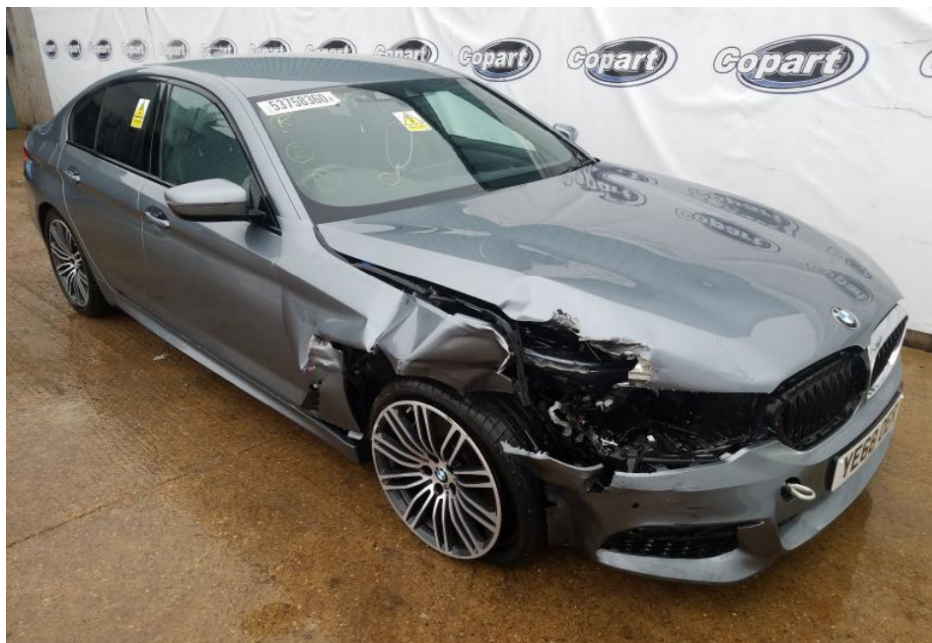
Photo 1 shows the front right body of the Motor Car (photograph provided to me). The Motor Car was observed to have sustained damages at its front right portion. The front bumper, front bumper right lower grille, front right radiator grille, front right headlamp, front right fender, front right fender inner shield, front right wheel rim, front right tyre, right side rocker panel garnish and front bonnet were amongst the parts that were observed to have been damaged.

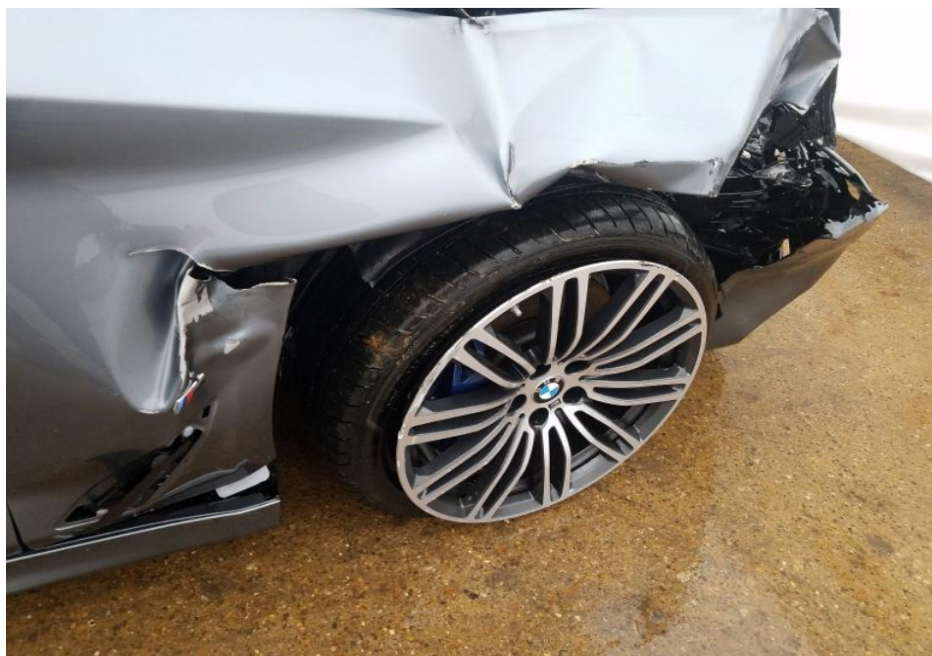
Photo 2 shows a closer view of the damage at the front right portion of the Motor Car (photograph provided to me). The front bumper, front right fender, front right wheel rim and right side rocker panel garnish were amongst the parts that were observed to have been damaged. The front right tyre was observed to have slipped out from the front right wheel rim.

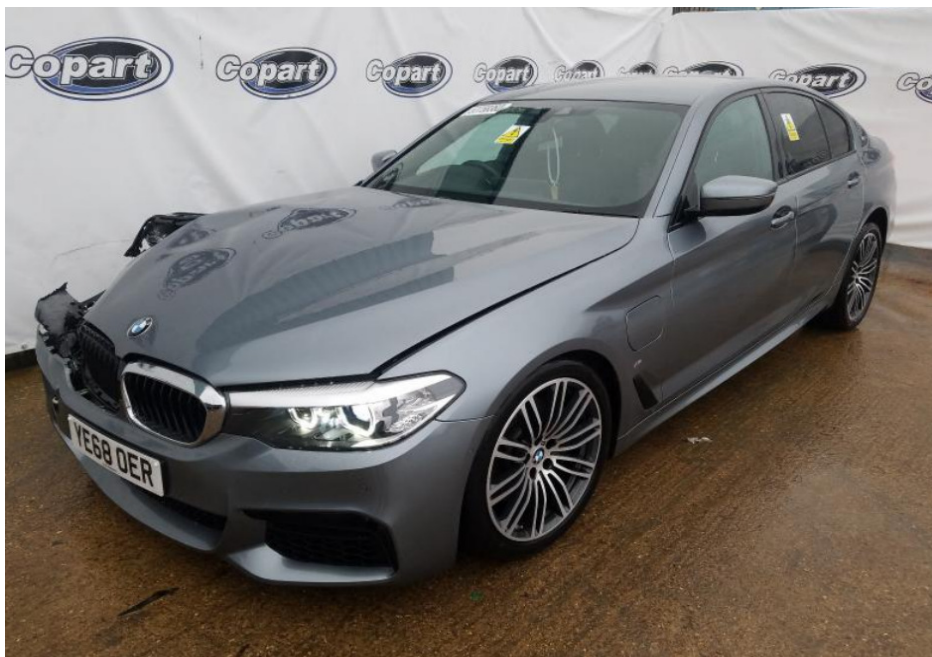
Photo 3 shows the front left body of the Motor Car (photograph provided to me). Apart for the front right portion, there was no physical damage seen to other areas of the Motor Car. The airbags were also not deployed.

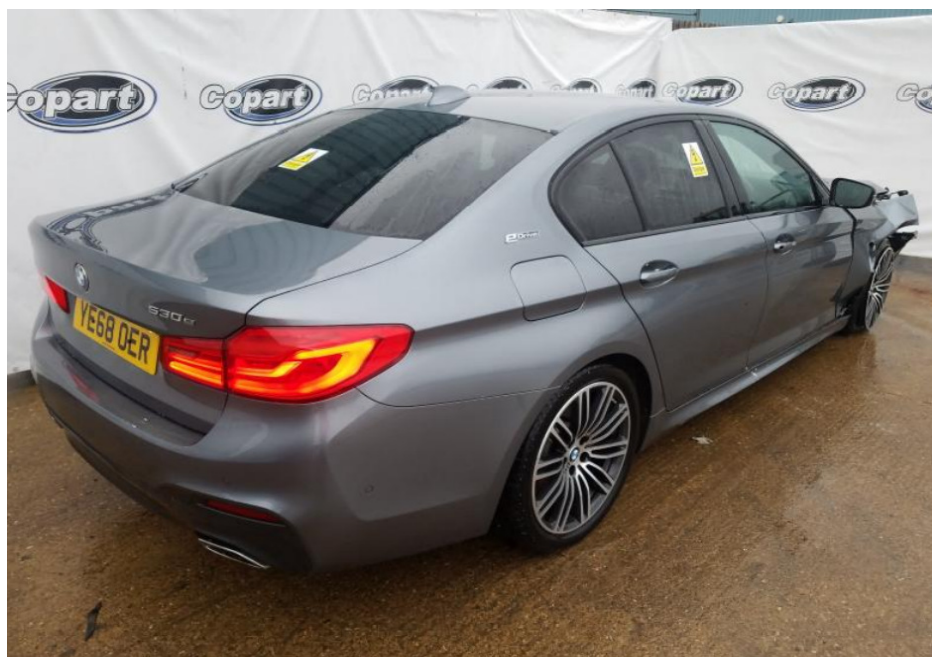
Photo 4 shows the rear right body of the Motor Car (photograph provided to me). Apart for the front right portion, there was no physical damage seen to other areas of the Motor Car.

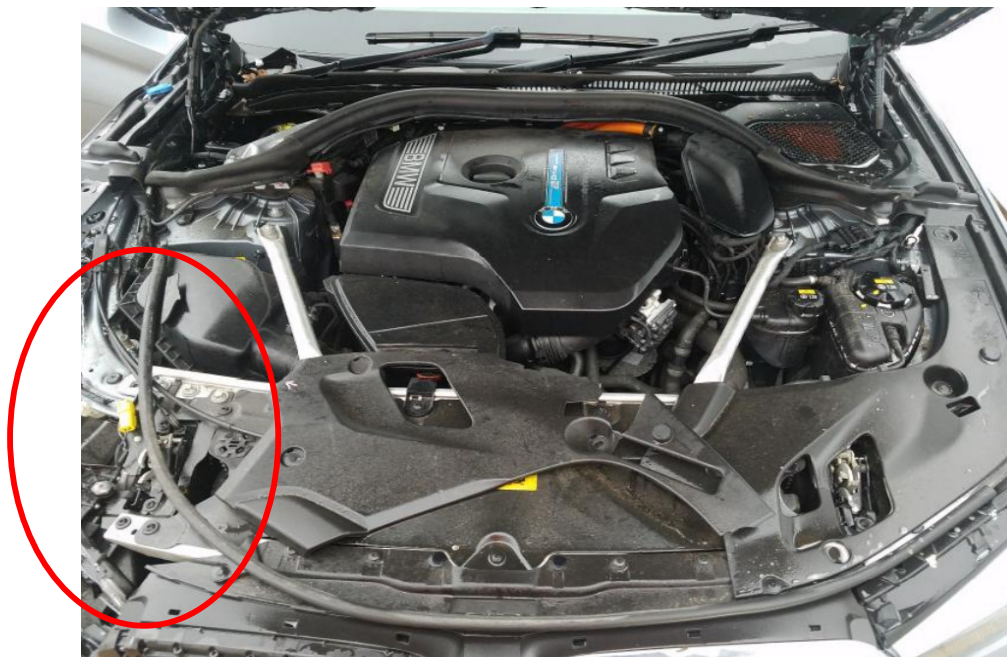
Photo 5 shows a general view of the Motor Car's engine compartment (photograph provided to me). Parts and components within the engine compartment were observed to be largely intact and unaffected. I had however observed damage to the front right headlamp top panel, front right top panel garnish and front support panel at the circled area.

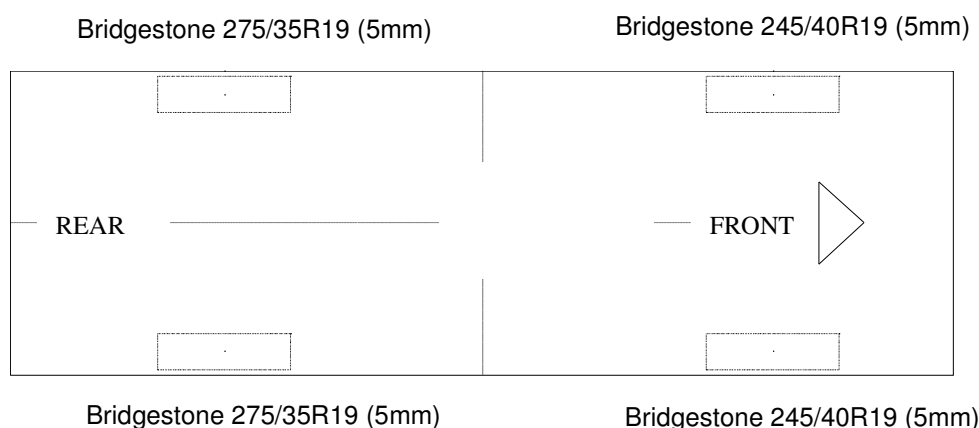
8. It was fitted with 19inch sport wheel rims that were wrapped with tyres that were observed to be of serviceable condition. The tyres were also sufficiently inflated for vehicular operation. The tyre brand, tyre size and approximate remaining tread depth of the 4 tyres of the Motor Car were recorded as follows: -

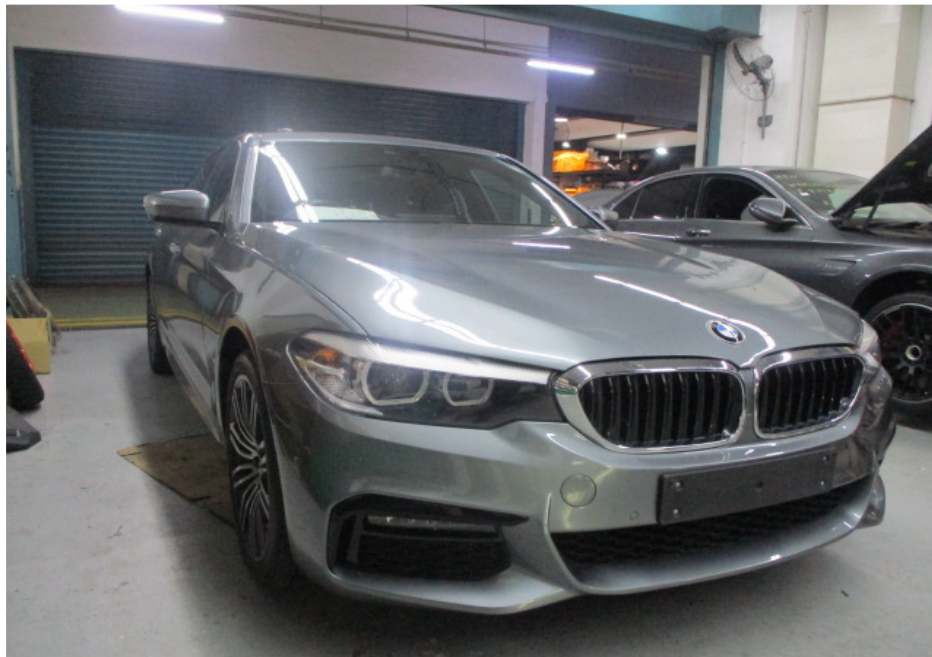
Photo 6 shows a general view of the front right body of the Motor Car at the time of my inspection. The Motor Car was observed to be in a relatively good general condition with no loose exterior fittings observed. The body parts at the front right portion of the Motor Car were visually examined and it was observed that the repair/restoration works carried out to the damaged area of the Motor Car (refer to photograph 1 & 2 above) were reasonably adequate and in order.

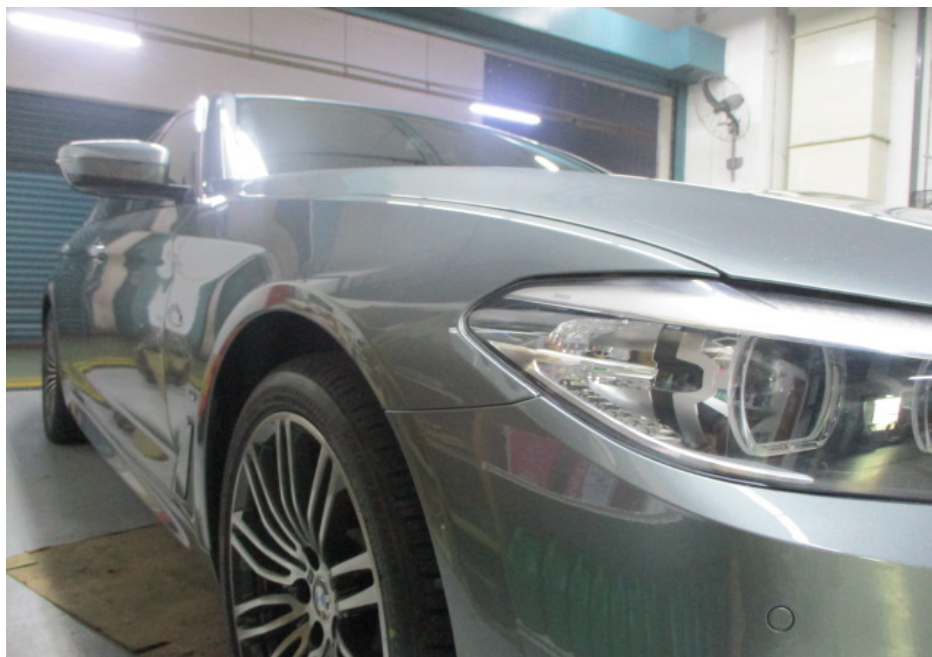
Photo 7 shows a closer view of the front bumper, front right fender and front right headlamp of the Motor Car. The body parts at the front right portion of the Motor Car were visually examined and it was observed that the repair/restoration works carried out to the damaged area of the Motor Car (refer to photograph 1 & 2 above) were reasonably adequate and in order.

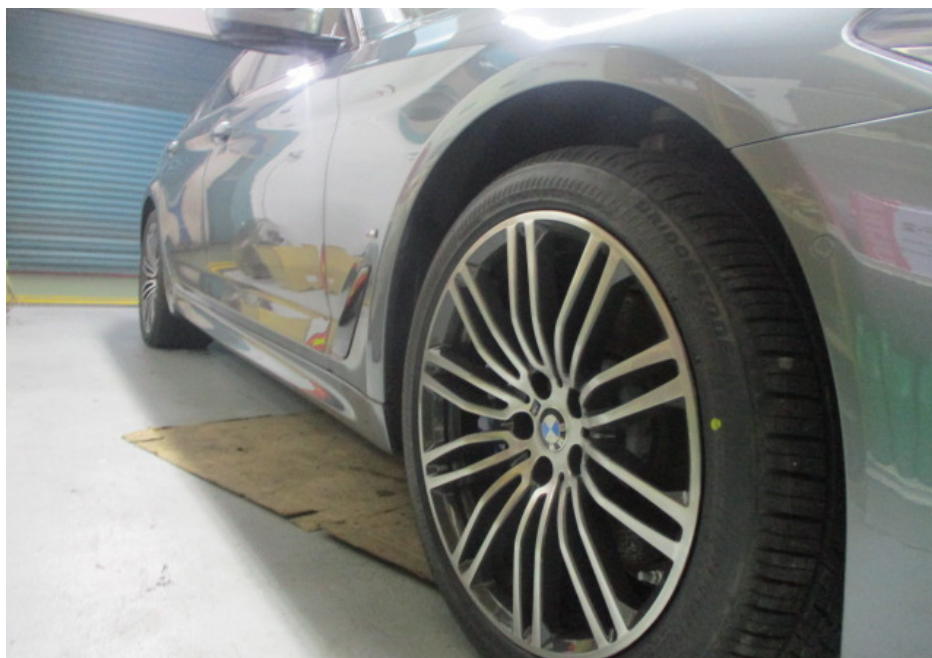
Photo 8 shows a closer view of the front right fender, front right wheel rim, front right tyre and right side rocker panel garnish of the Motor Car. The body parts at the front right portion of the Motor Car were visually examined and it was observed that the repair/restoration works carried out to the damaged area of the Motor Car (refer to photograph 1 & 2 above) were reasonably adequate and in order.

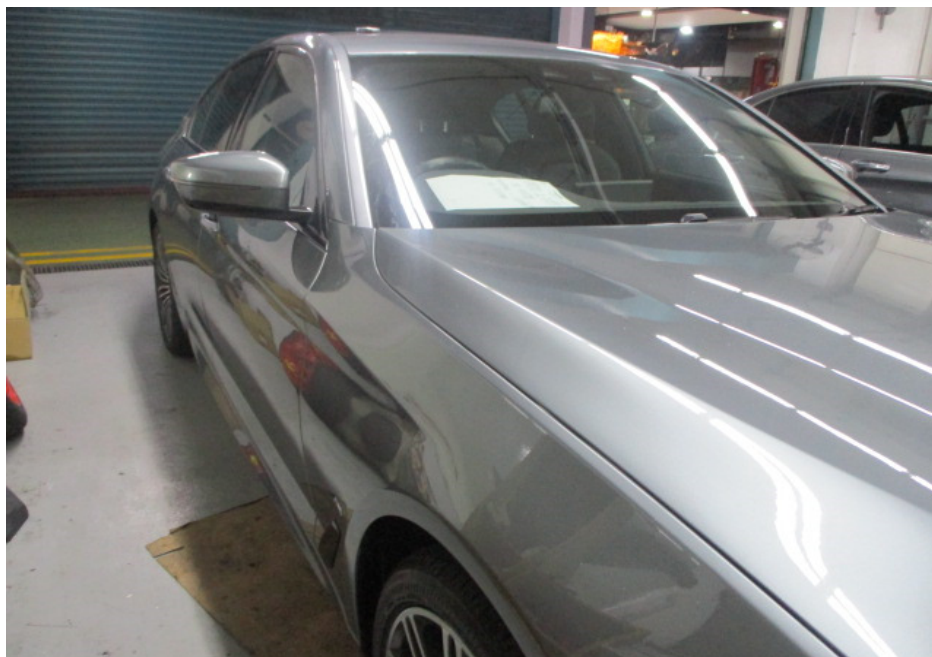
Photo 9 shows a closer view of the front bonnet and front right fender of the Motor Car. The body parts at the front right portion of the Motor Car were visually examined and it was observed that the repair/restoration works carried out to the damaged area of the Motor Car (refer to photograph 1 & 2 above) were reasonably adequate and in order.

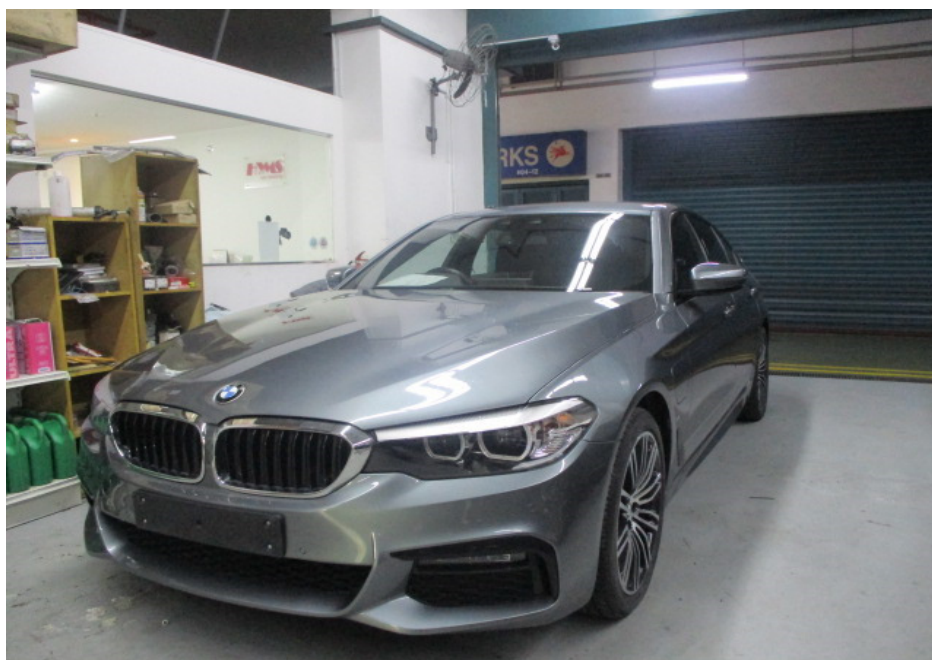
Photo 10 shows a general view of the front left body of the Motor Car at the time of my inspection. The Motor Car was observed to be in a relatively good general condition with no loose exterior fittings observed. The mileage of the Motor Car recorded at the time of my inspection was 15,674km.

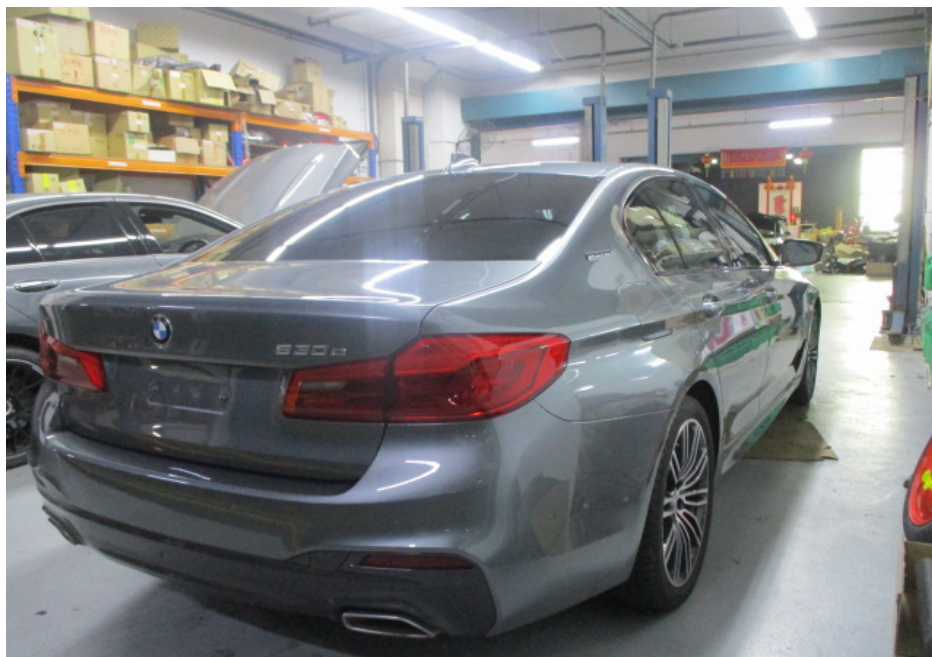
Photo 11 shows a general view of the rear right body of the Motor Car at the time of my inspection. The Motor Car was observed to be in a relatively good general condition with no loose exterior fittings observed. The mileage of the Motor Car recorded at the time of my inspection was 15,674km.

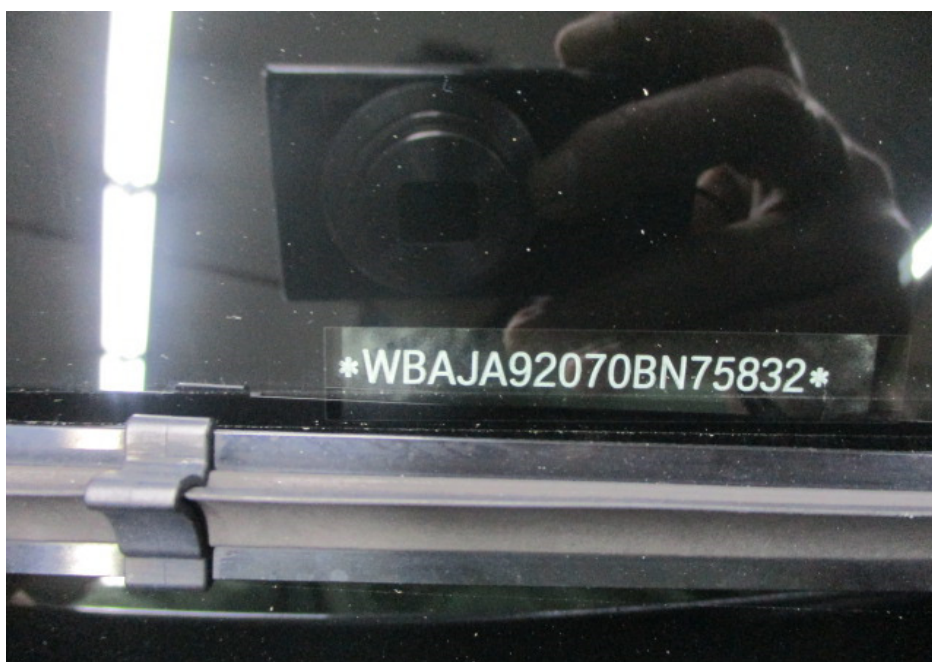
Photo 12 shows the chassis number of the Motor Car. The chassis number recorded was WBAJA92070BN75832.

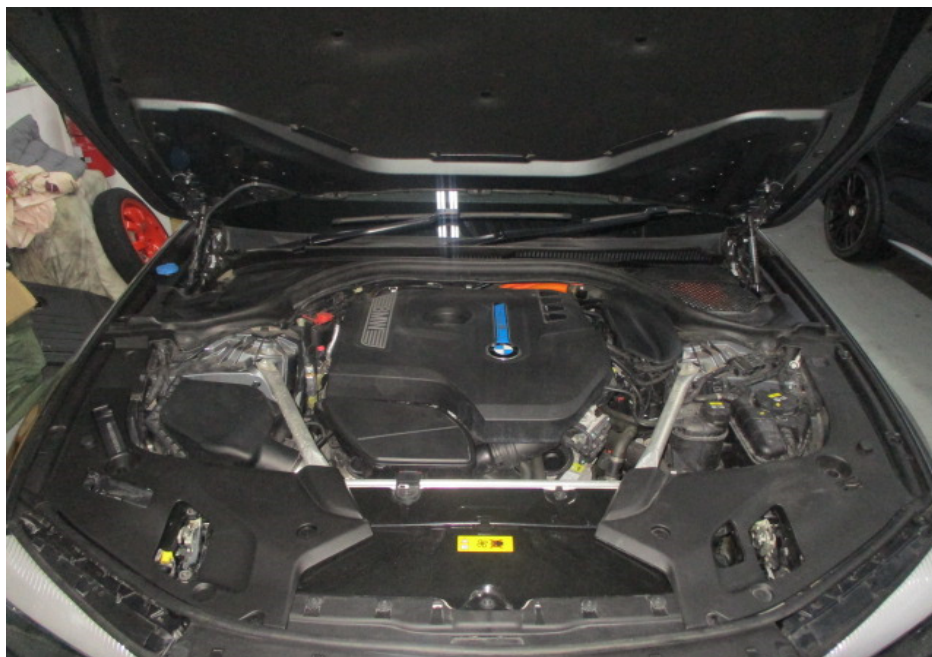
Photo 13 shows a general view of the engine compartment of the Motor Car at the time of my inspection. The various parts and components inside the engine compartment were all observed to be intact and properly fitted. There was also no sign(s) or indication(s) of fluid leak and/or fluid stain found inside the engine compartment.

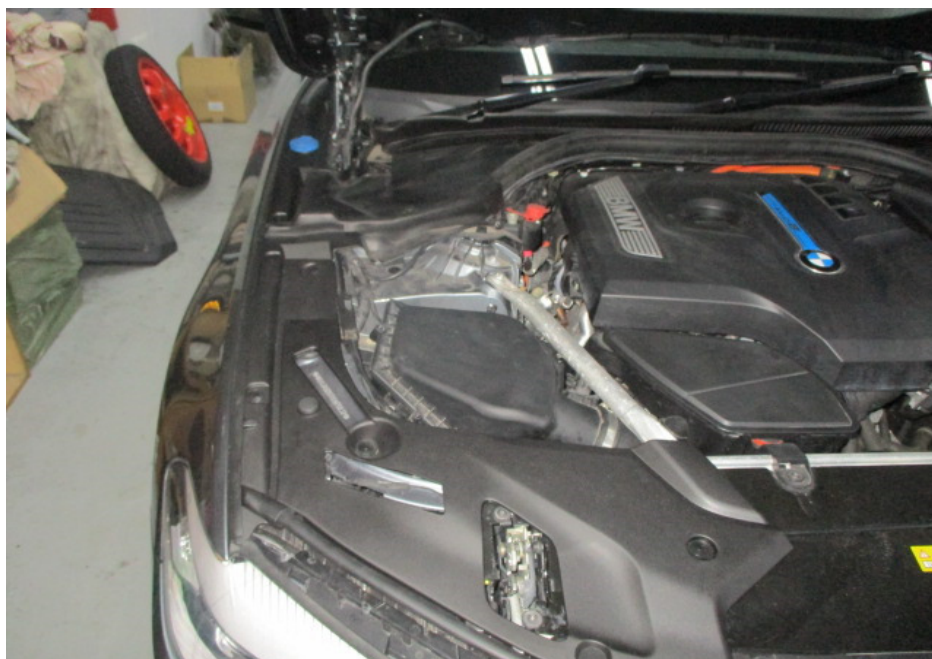
Photo 14 shows a closer view of the right side of the Motor Car's engine compartment. The panel and garnishes at the right side were visually examined and it was observed that the repair/restoration works carried out to the damaged area of the Motor Car (refer to photograph 5 above) were reasonably adequate and in order.

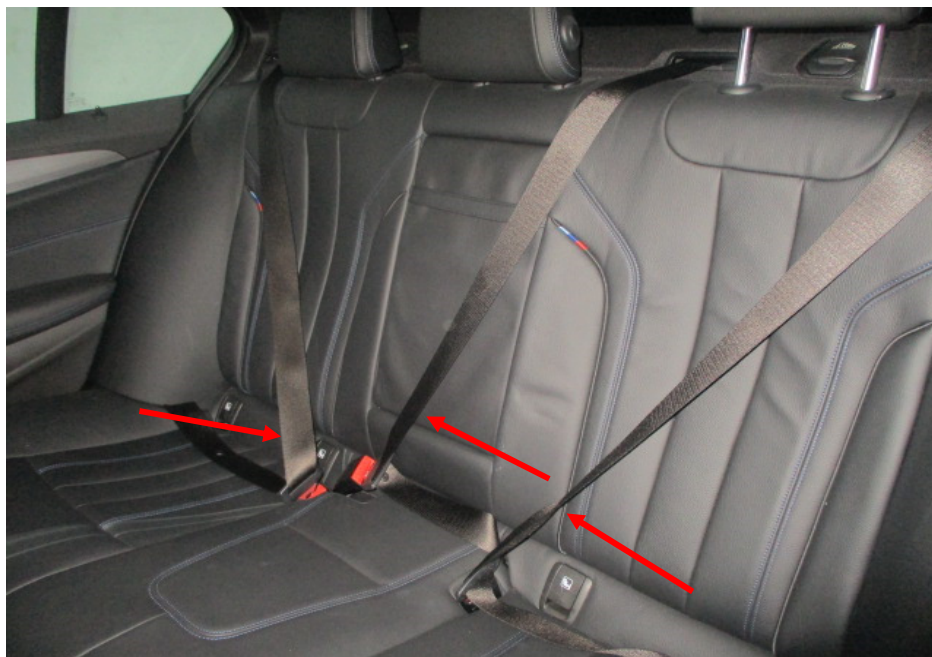
Photo 15 shows the rear seats of the Motor Car. All the seats of the Motor Car were secured via seat rails to the floorboard. They were also fitted with a retractable seat belt reel and a pre-tensioner. The seat belts (arrowed) were tested and were able to be fastened into the respective pre-tensions that were fitted on the side of each individual seat.

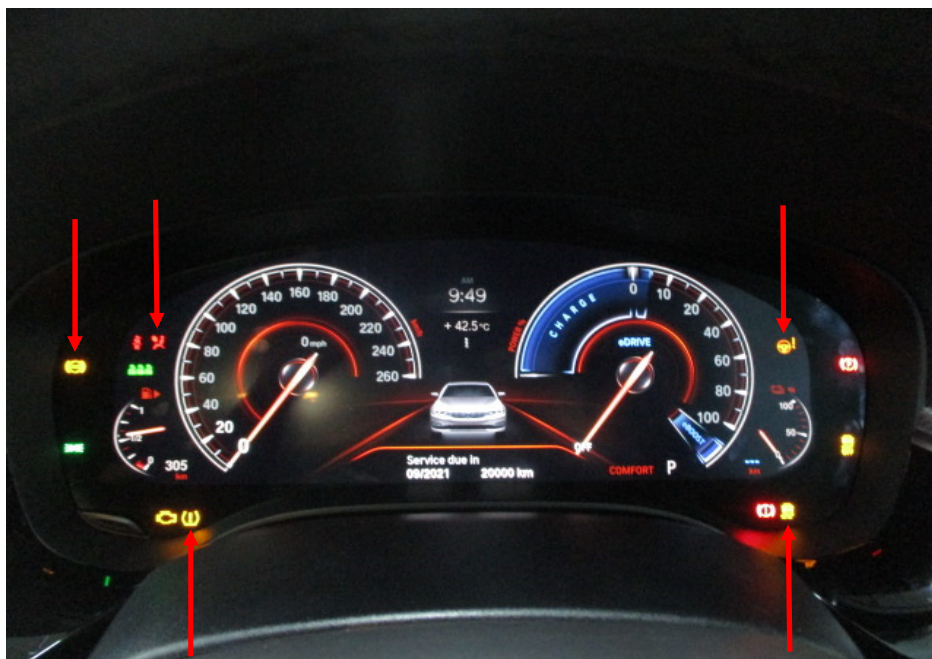
Photo 16 shows the warning lights for the various electronic safety features appearing on the instrument panel of the Motor Car during its self-test when the engine is cranked, in particular the ABS, SRS, IAS, TPM and DSC lights (arrowed).

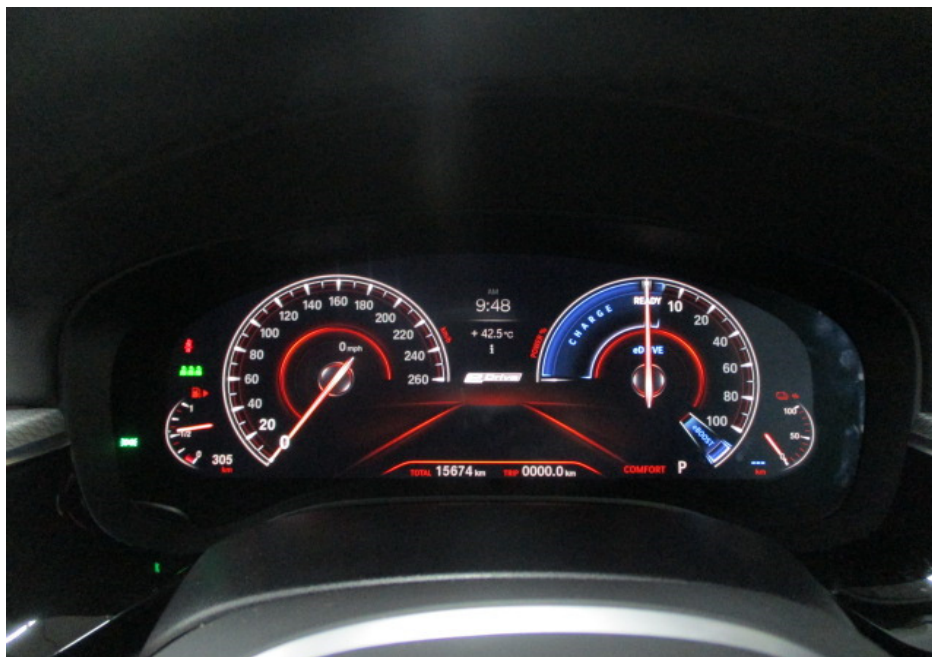
Photo 17 shows the respective warning lights no longer illuminated, indicating that there is no fault detected to the ABS, SRS, IAS, TPM and DSC systems of the Motor Car during the self-test. These electronic systems were hence in working condition at the time of my inspection.

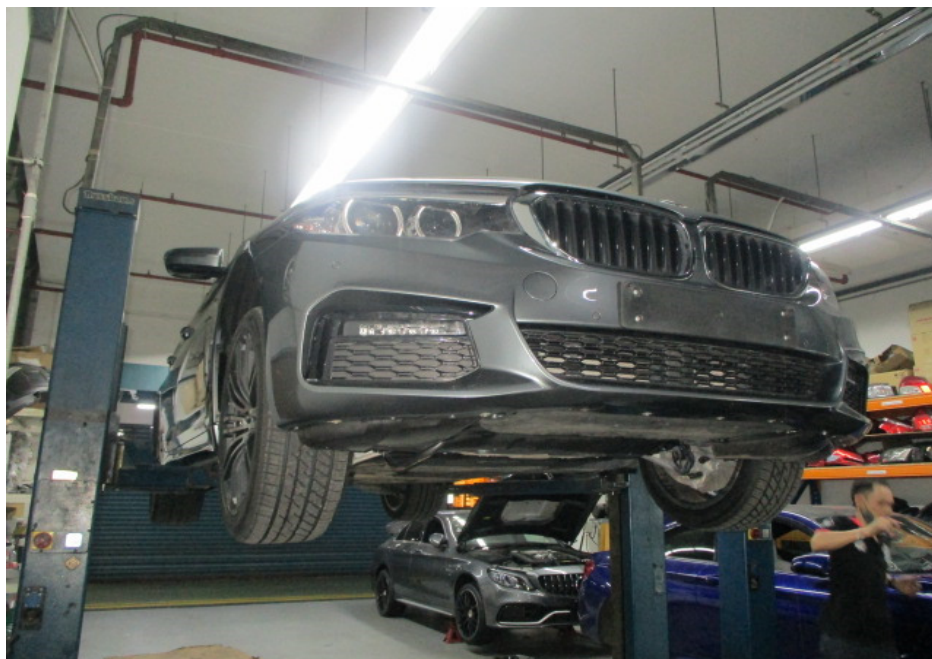
Photo 18 shows the Motor Car hoisted up for checks on its undercarriage. There was no sign(s) or indication(s) of fluid leakage and/or fluid stain(s) on the underside of the Motor Car. The undercarriage components of the Motor Car were also all observed to be intact and secured in an appropriate manner.

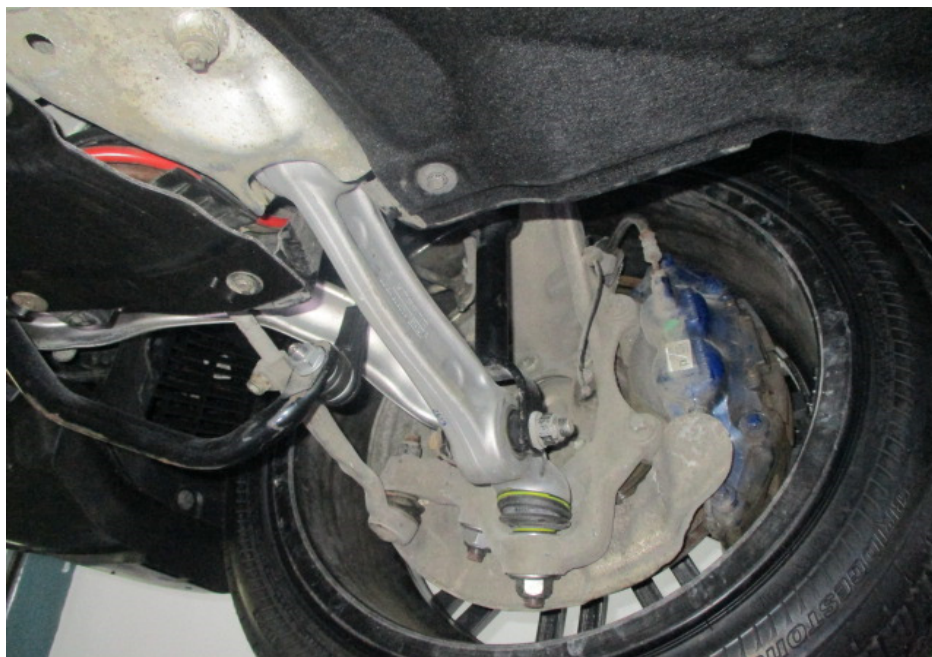
Photo 19 shows the various undercarriage components at the front right wheel of the Motor Car. The mechanical components, control arms and linkages were all found to be intact and secured in an appropriate manner. I also did not observe any fluid leak and/or fluid stain on the underside of the Motor Car.

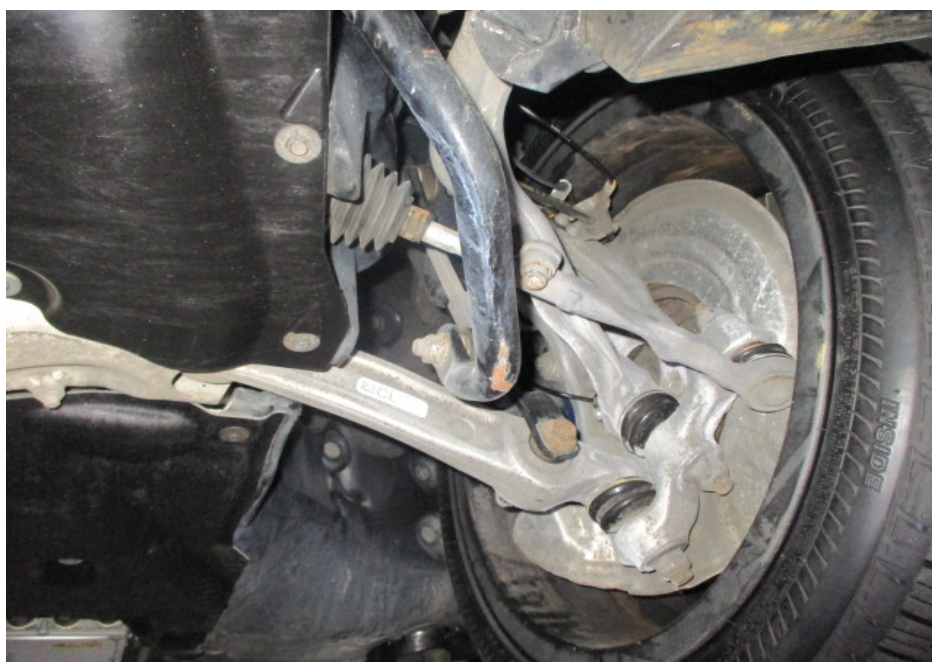
Photo 20 shows the various undercarriage components at the front left wheel of the Motor Car. The mechanical components, control arms and linkages were all found to be intact and secured in an appropriate manner.

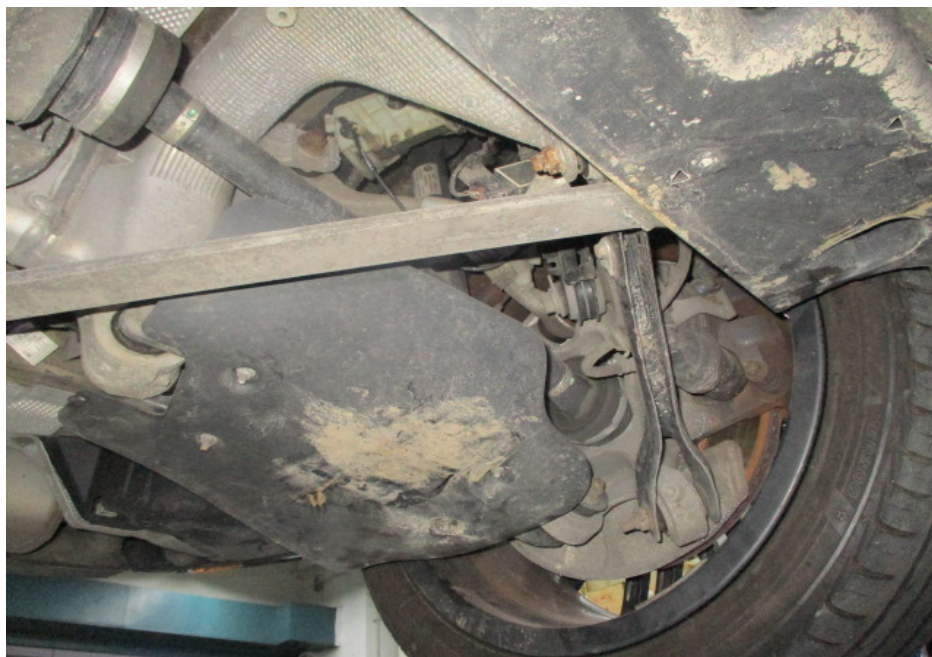
Photo 21 shows a general view of the control arms and linkages at the rear left wheel of the Motor Car. I did not observe any fluid leak and/or fluid stain on the underside of the Motor Car. All of the Motor Car's undercarriage components were observed to be intact and secured in an appropriate manner.

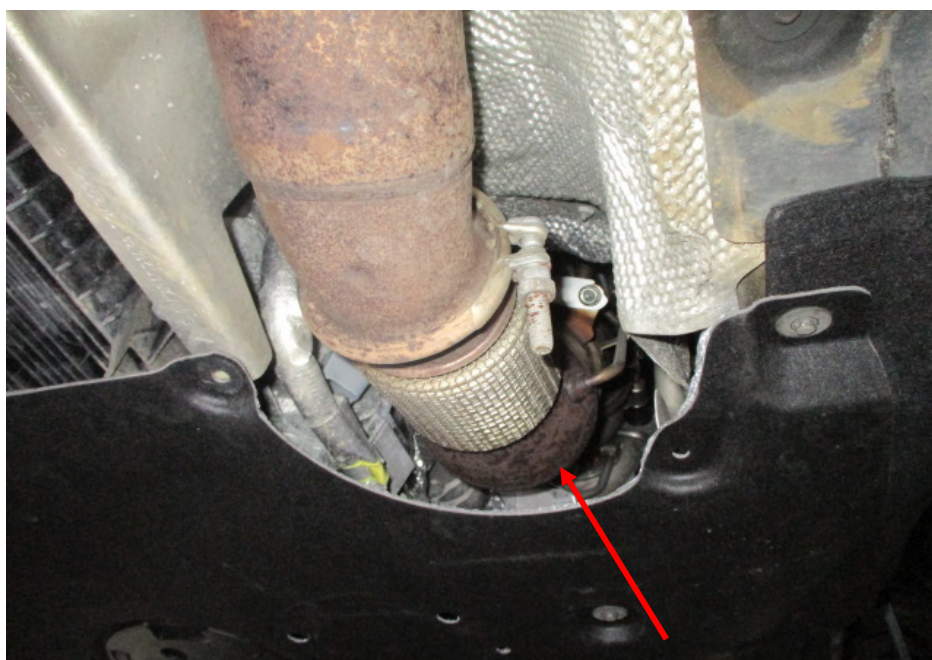
Photo 22 shows the Motor Car's catalytic converter (arrowed). My examination of the Motor Car's exhaust system revealed no sign(s) or indication(s) of any cut or weld marks along its exhaust pipes and on its rear muffler.

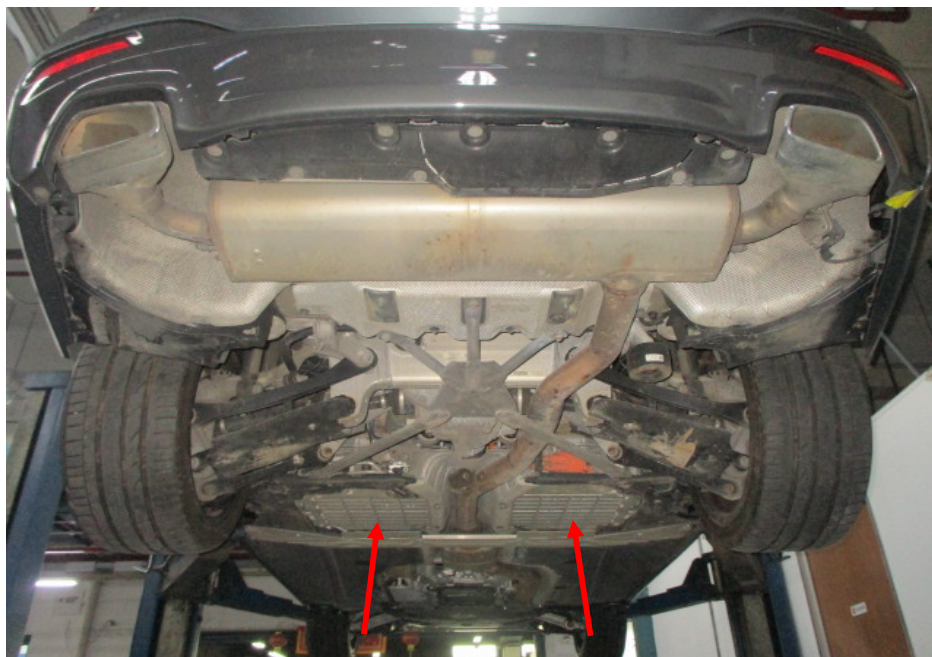
Photo 23 shows a general view of the Motor Car's electric battery (arrowed) that was fitted at the underside centre of the Motor Car. The cable connections were checked and found to be securely fitted into the respective connectors.

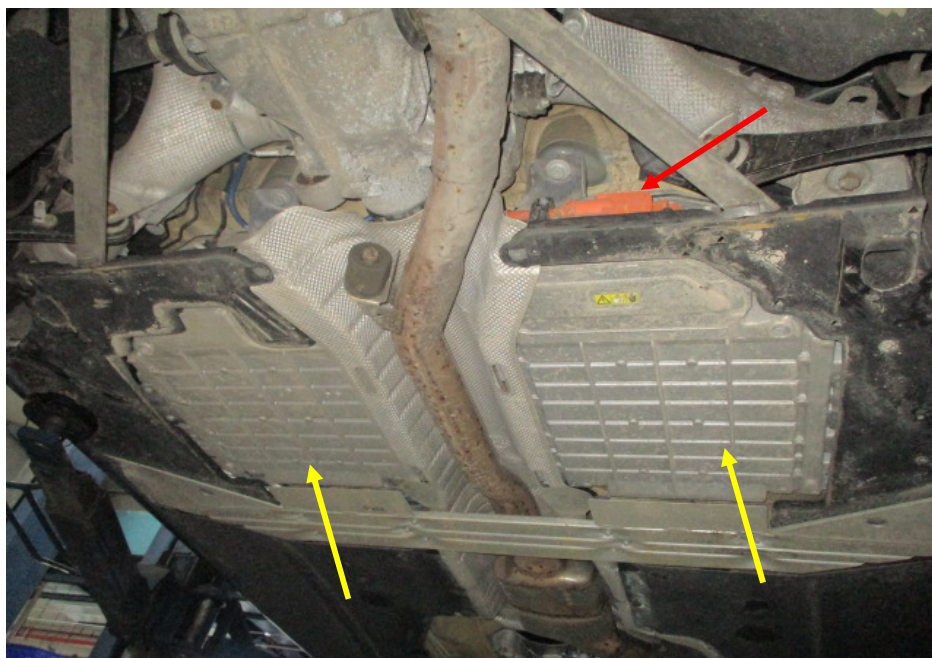
Photo 24 shows the Motor Car's electric battery (yellow arrow) that was fitted at the underside centre of the Motor Car. The cable connections (red arrow) were checked and found to be securely fitted into the respective connectors. The electric battery was also observed to be fitted securely. The electric cables connecting the electric motor within the engine compartment to the electric battery were securely fitted into the respective connectors and protected by dust covers.

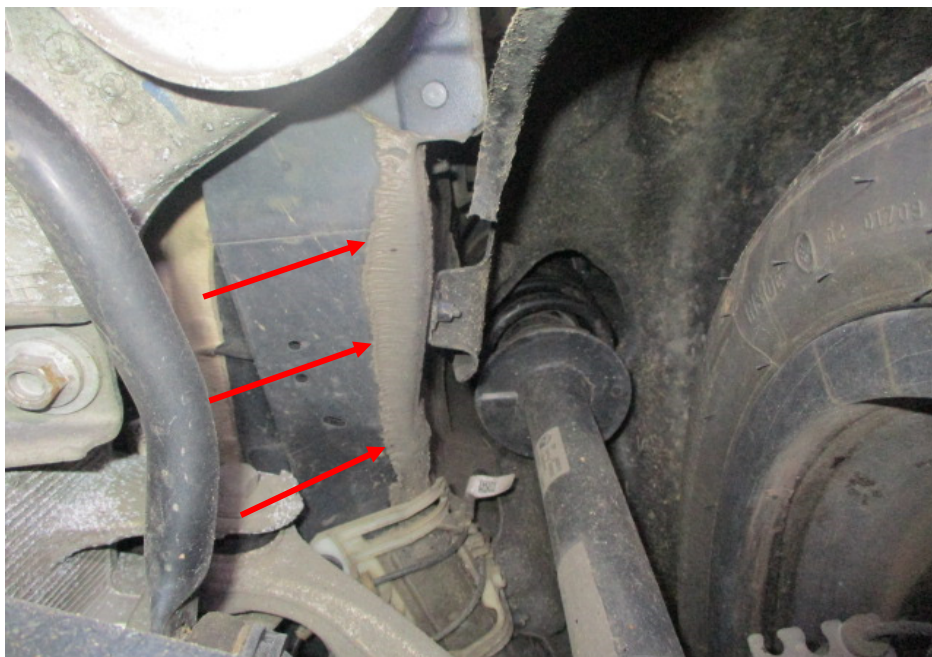
Photo 25 shows the chassis/structural body at the underside rear right of the Motor Car. I did not find any weld marks other than original spot weld marks on the chassis/structural body of the Motor Car. The original factory sealant (arrowed) at the joints along the chassis/structural body was also untouched, indicating no work was done on the chassis/structural body of the Motor Car and that the chassis/structural body was originally fitted.

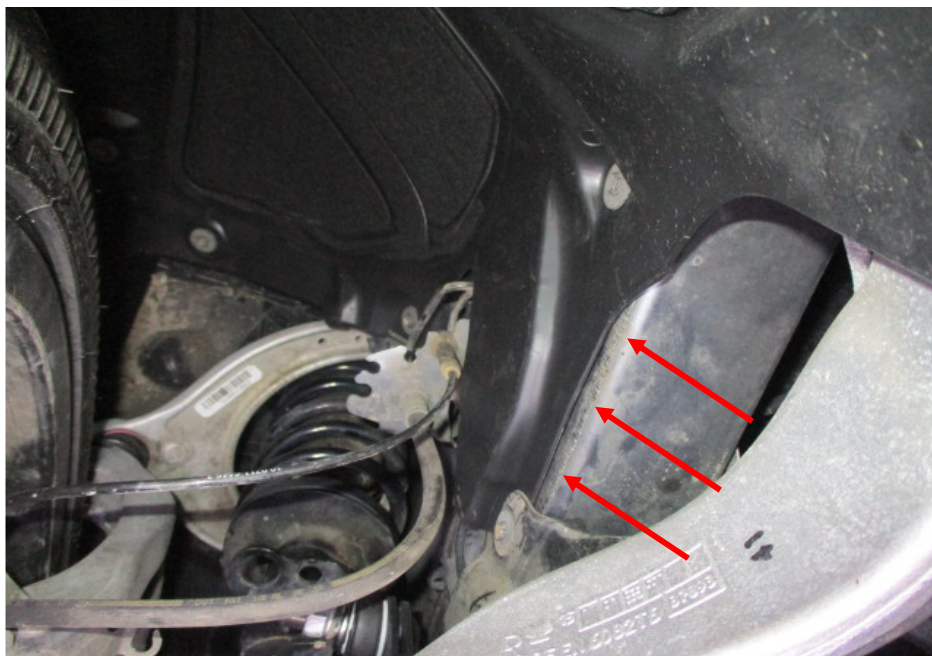
Photo 26 shows the chassis/structural body at the underside front right of the Motor Car. The original factory sealant (arrowed) at the joints along the chassis/structural body was observed to be untouched. In general, I had found no work was carried out on the chassis/structural body of the Motor Car. The chassis/structural body of the Motor Car was originally fitted.

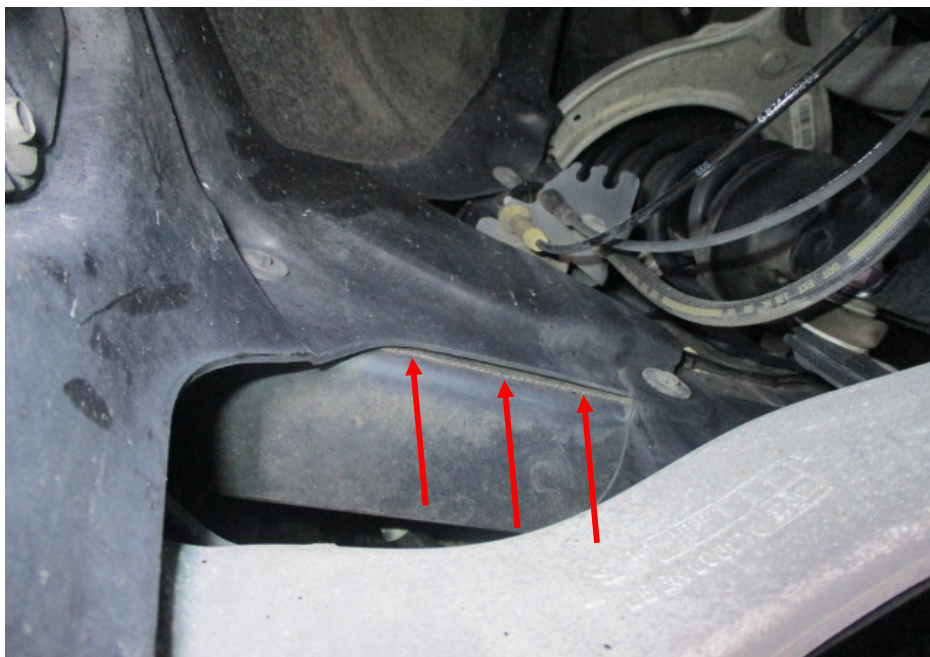
Photo 27 shows the chassis/structural body at the underside front left of the Motor Car. I did not find any weld marks other than original spot weld marks on the chassis/structural body of the Motor Car. The original factory sealant (arrowed) at the joints along the chassis/structural body was also untouched, indicating no work was done on the chassis/structural body of the Motor Car and that the chassis/structural body was originally fitted.

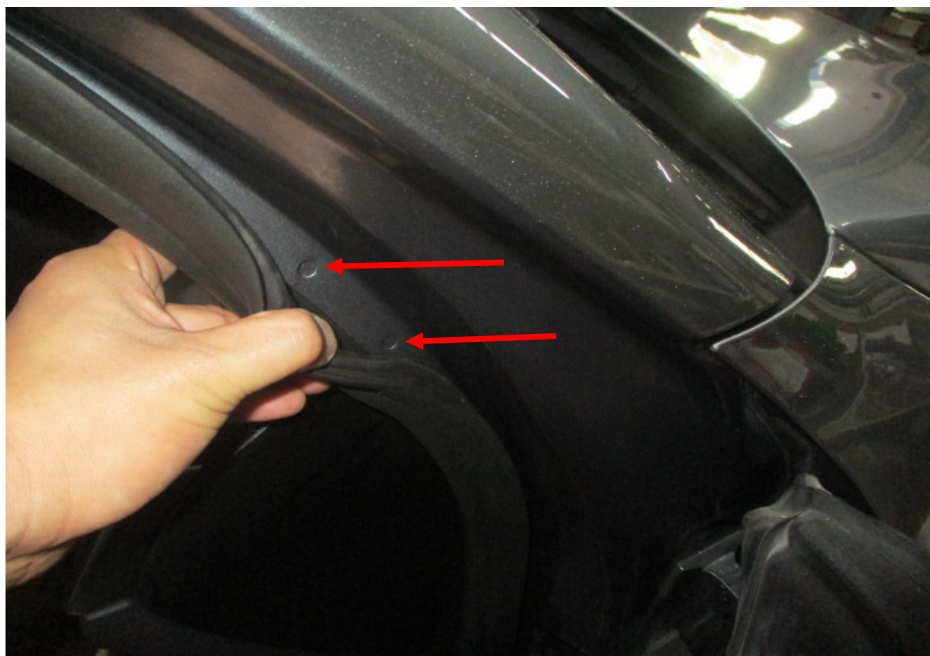
Photo 28 shows the right side "A" pillar of the Motor Car. I did not find any weld marks other than original spot weld marks (arrowed) on the right side "A" pillar of the Motor Car which, indicates that there was no re-welding works carried out. In general, I had found all the non-detachable body panels of the Motor Car to be originally fitted at the time of my inspection.

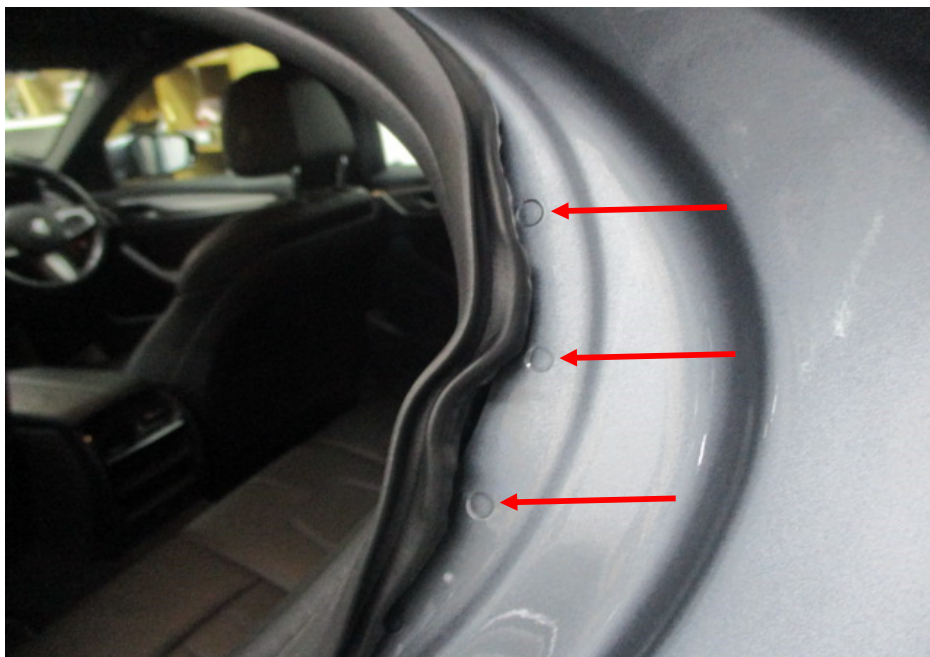
Photo 29 shows the left side "C" pillar of the Motor Car. I did not find any weld marks other than original spot weld marks (arrowed) on the left side "C" pillar of the Motor Car which, indicates that there was no re-welding works carried out. In general, I had found all the non-detachable body panels of the Motor Car to be originally fitted at the time of my inspection.
