Your Ref: TP/IP/47421/2020
Our Ref : CI/TPD21004869/N

15 April 2021

MECHANICAL INSPECTION REPORT OF MOTORCYCLE FBK 4046K

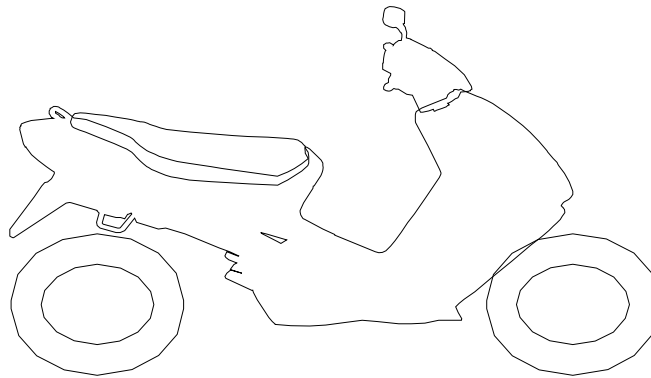
Pirelli 190/55 R17 (3mm)

Pirelli 120/70 R17 (4mm)
(Deflated)

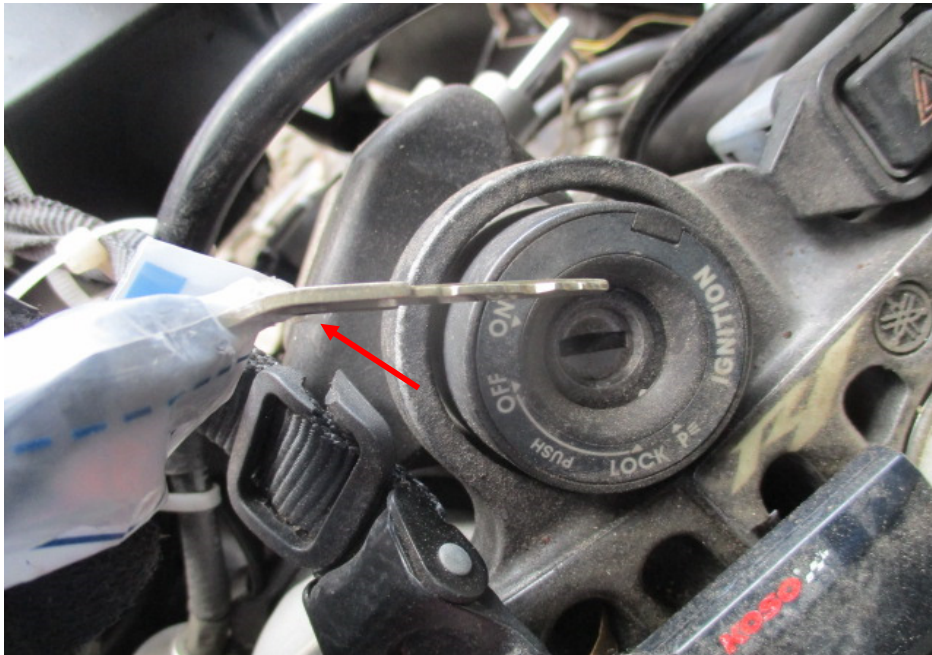
4. The mileage of the Motorcycle at the time of our inspection was not recorded due to a bent ignition key as a result of the accident.
5. The Motorcycle had sustained damages all around. Body parts that were found to have been damaged include its headlight assembly, front mudguard, front fork assembly, front wheel rim, front brake lever, front brake lever guard, clutch lever, clutch lever guard, petrol tank, side cowlings, right rear frame slider, rear brake pedal, right front footrest, right swingarm spool, rear side covers, tail light cover, rear seat cowl, pillion foot peg brackets and pillion foot pegs, amongst others.

Photo 1 shows a closer view of the ignition key of the Motorcycle. The mileage of the Motorcycle was not recorded at the time of our inspection due to the bent ignition key as a result of the accident (arrowed).

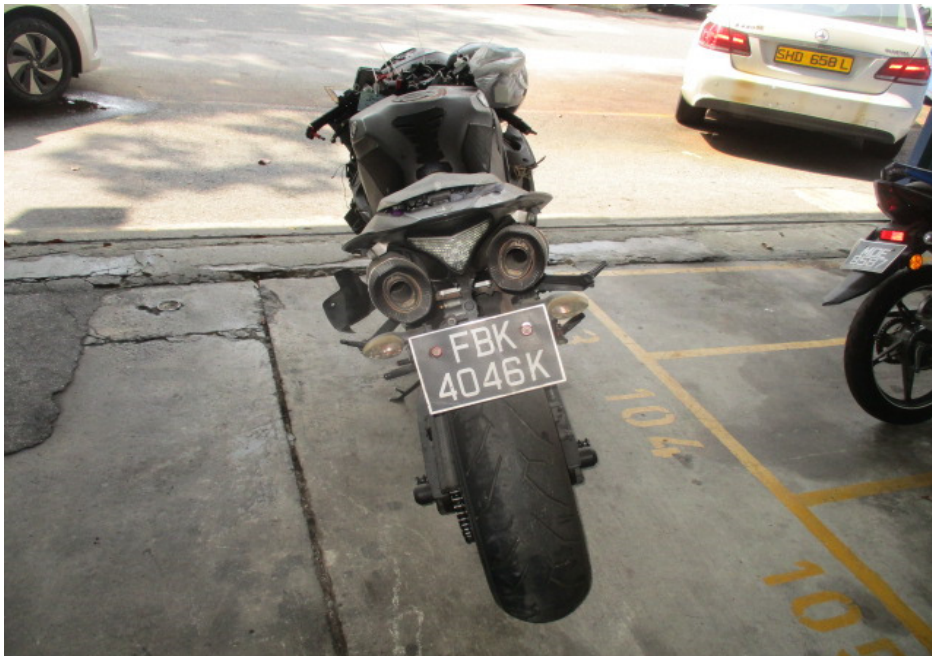
Photo 2 shows a general view of the rear portion of the Motorcycle at the time of our inspection. The Motorcycle had sustained damages all around.

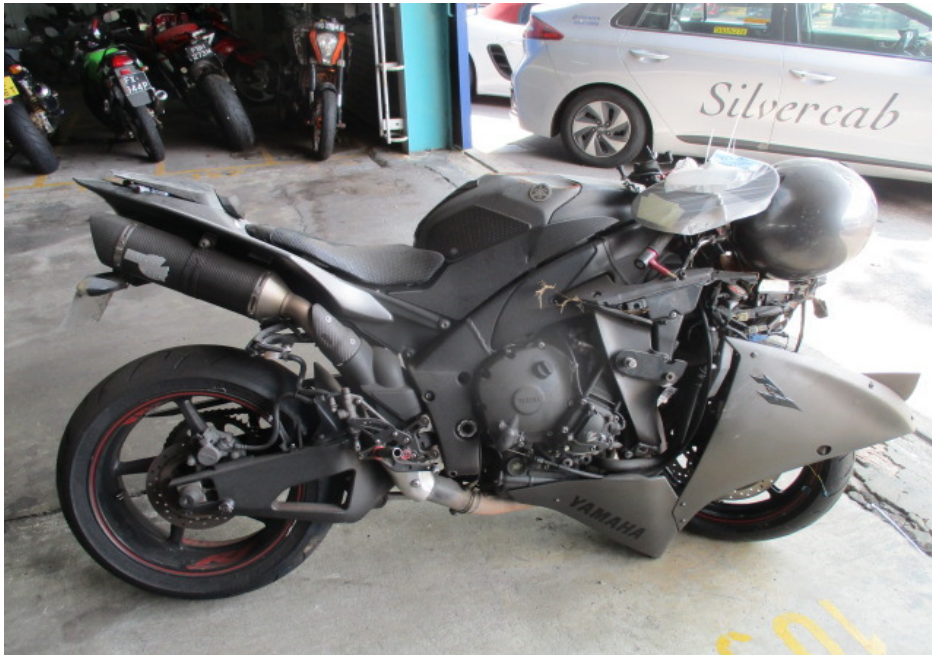
Photo 3 shows a general view of the right body of the Motorcycle at the time of our inspection. The Motorcycle had sustained damages all around.

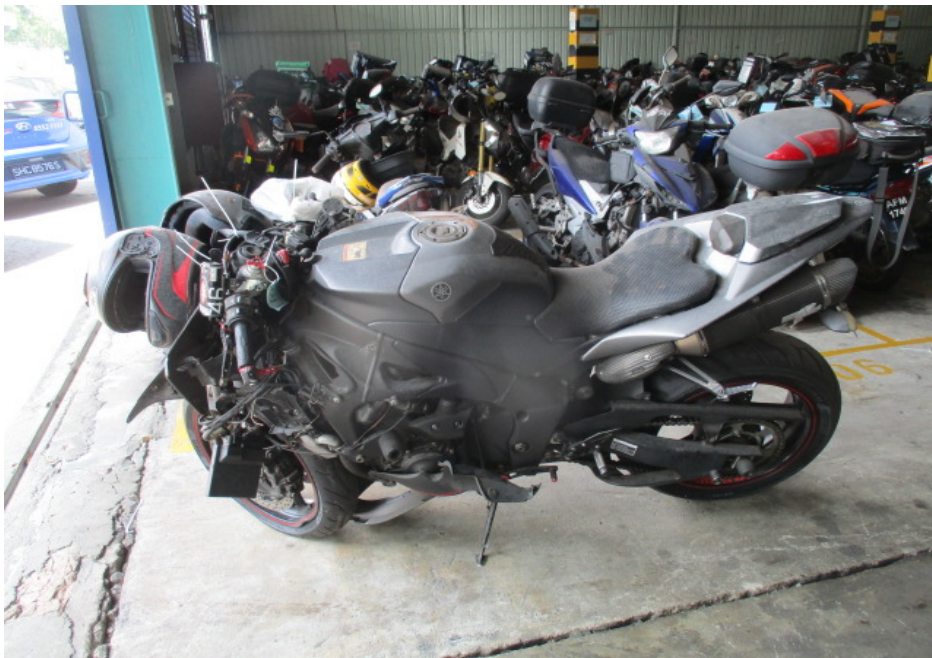
Photo 4 shows a general view of the left body of the Motorcycle at the time of our inspection. The Motorcycle had sustained damages all around.

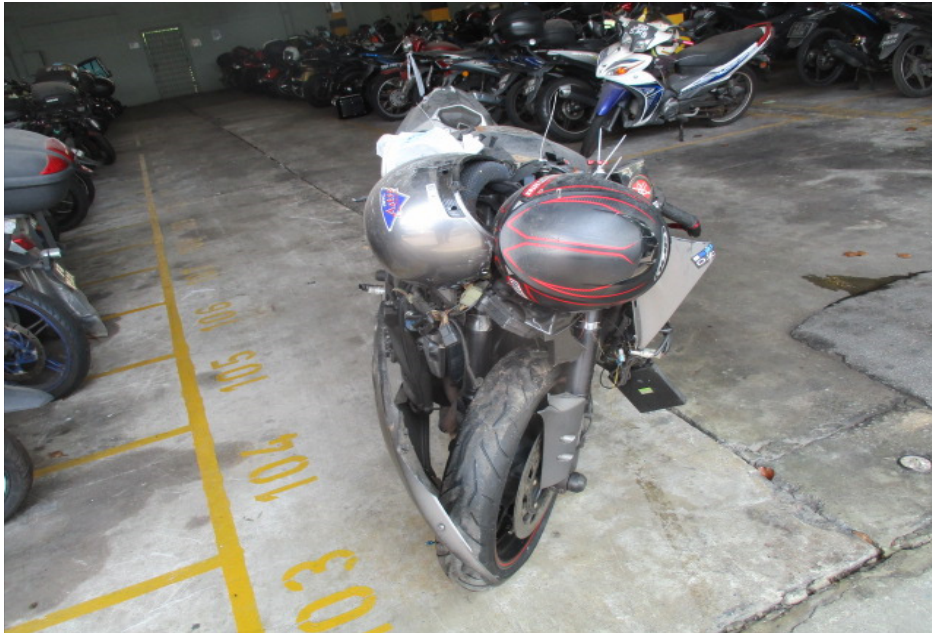
Photo 5 shows a general view of the frontal portion of the Motorcycle at the time of our inspection. The Motorcycle had sustained damages all around. Body parts that were found to have been damaged include its headlight assembly, front mudguard, front fork assembly, front wheel rim, front brake lever, front brake lever guard, clutch lever, clutch lever guard, petrol tank, side cowlings, right rear frame slider, rear brake pedal, right front footrest, right swingarm spool, rear side covers, tail light cover, rear seat cowl, pillion foot peg brackets and pillion foot pegs, amongst others.

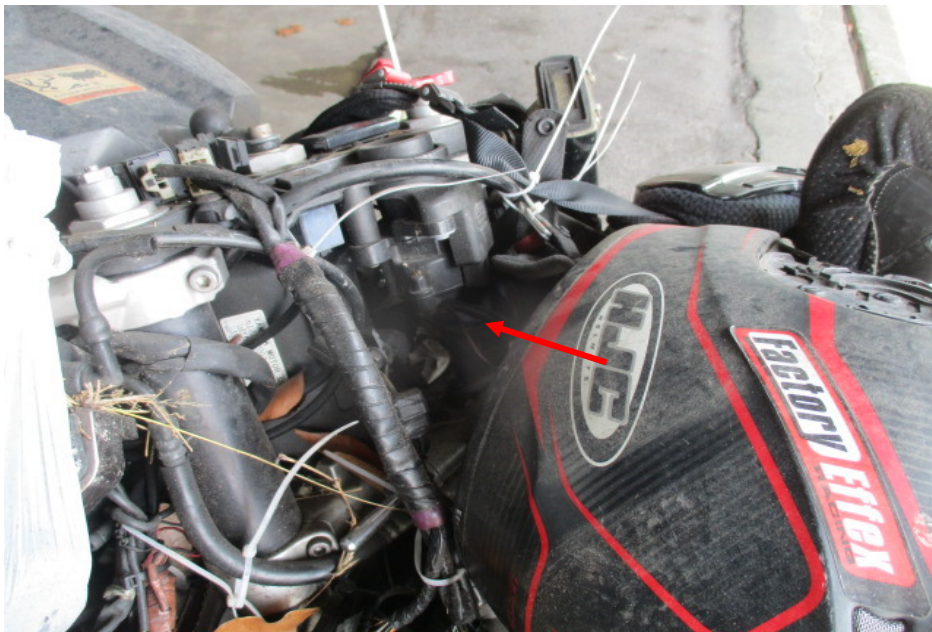
Photo 6 shows a closer view of the missing headlight assembly which was amongst the body parts at the front body of the Motorcycle that had sustained damage as a result of the accident (arrowed).

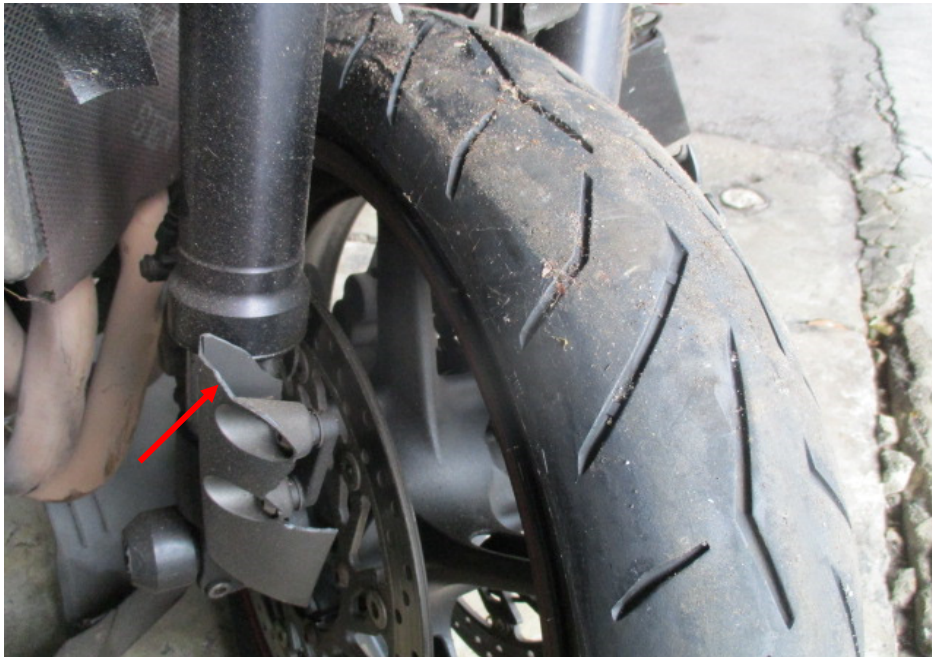
Photo 7 shows a closer view of the cracked front mudguard (arrowed) which was amongst the body parts at the front body of the Motorcycle that had sustained damage as a result of the accident.

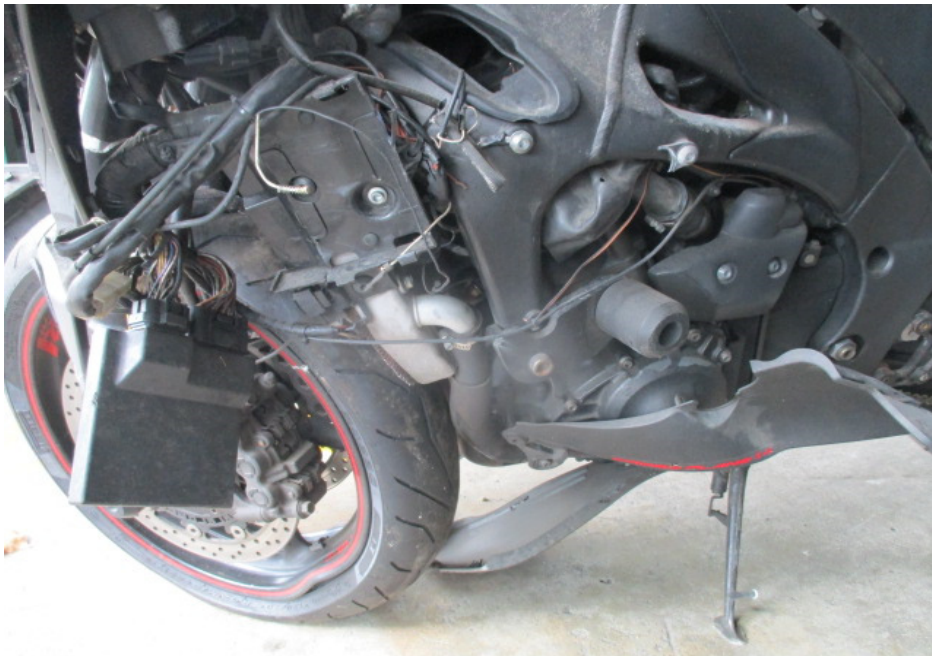
Photo 8 shows a closer view of the missing left cowling of the Motorcycle as a result of the accident.

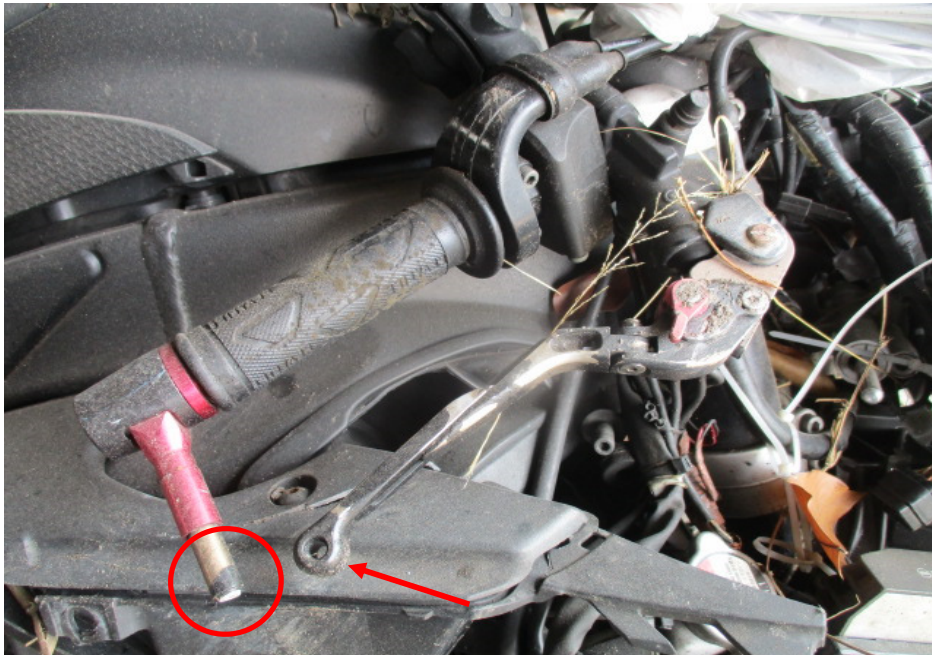
Photo 9 shows a closer view of the front brake lever (arrowed) and front brake lever guard (circled) which were amongst the body parts at the front body of the Motorcycle that had sustained damage as a result of the accident.

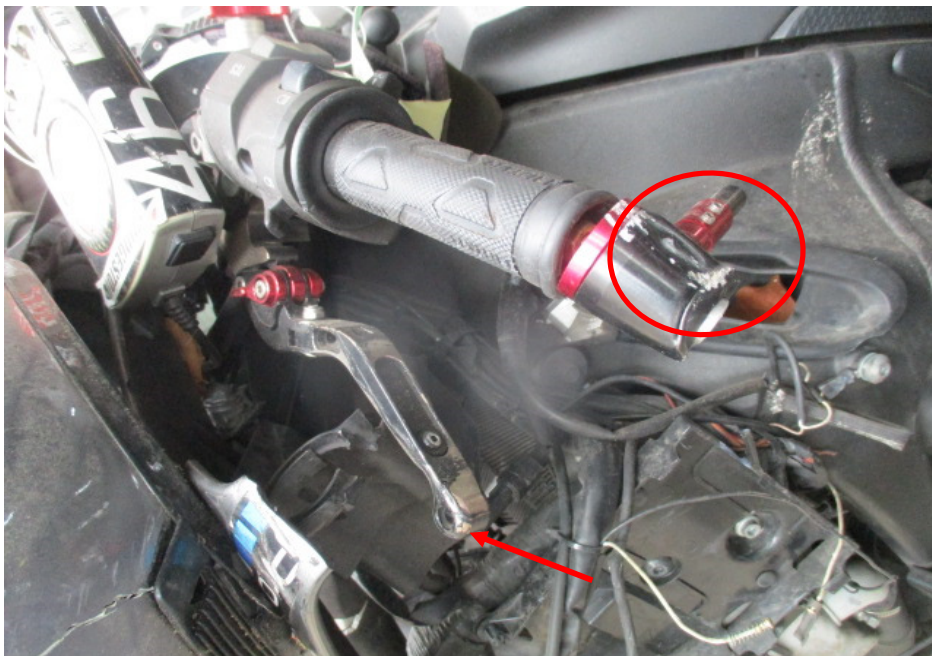
Photo 10 shows a closer view of the clutch lever (arrowed) and clutch lever guard (circled) which were amongst the body parts at the front body of the Motorcycle that had sustained damage as a result of the accident.

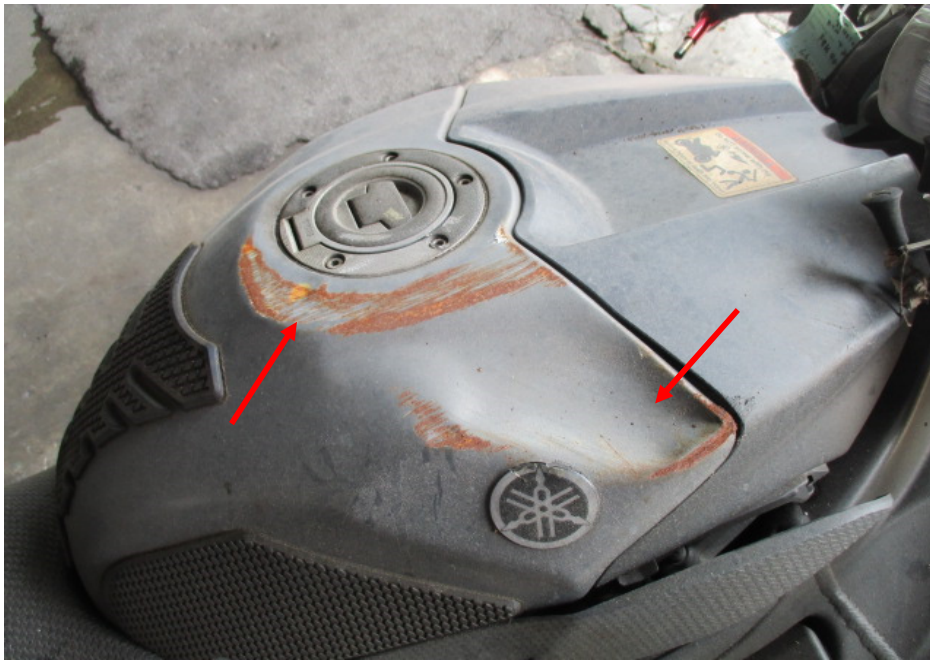
Photo 11 shows a closer view of the dented petrol tank (arrowed) of the Motorcycle as a result of the accident.

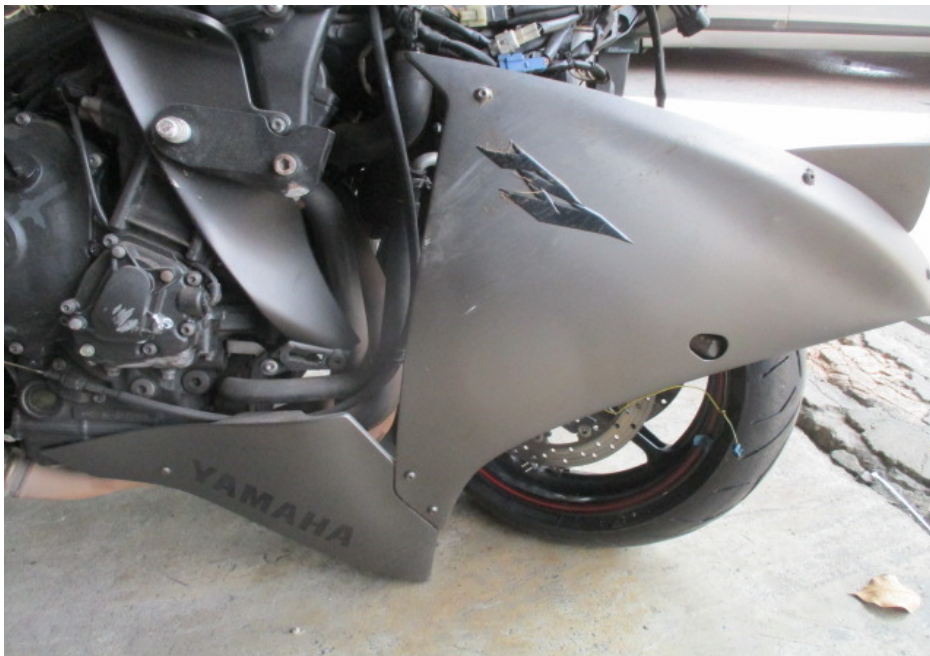
Photo 12 shows a closer view of the broken right cowling of the Motorcycle as a result of the accident.

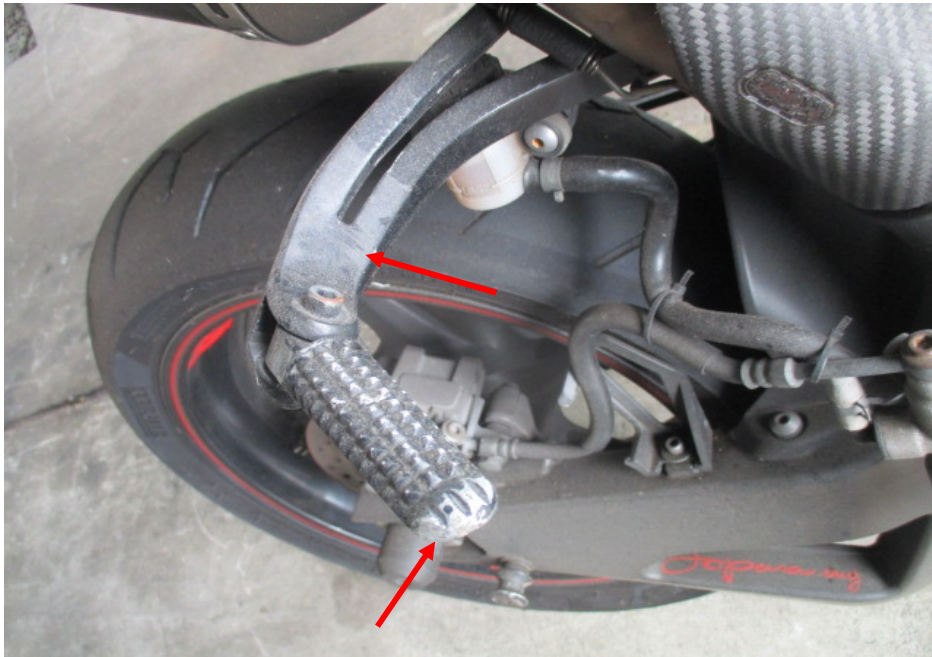
Photo 13 shows the bent right pillion foot peg and bracket (arrowed) of the Motorcycle as a result of the accident.

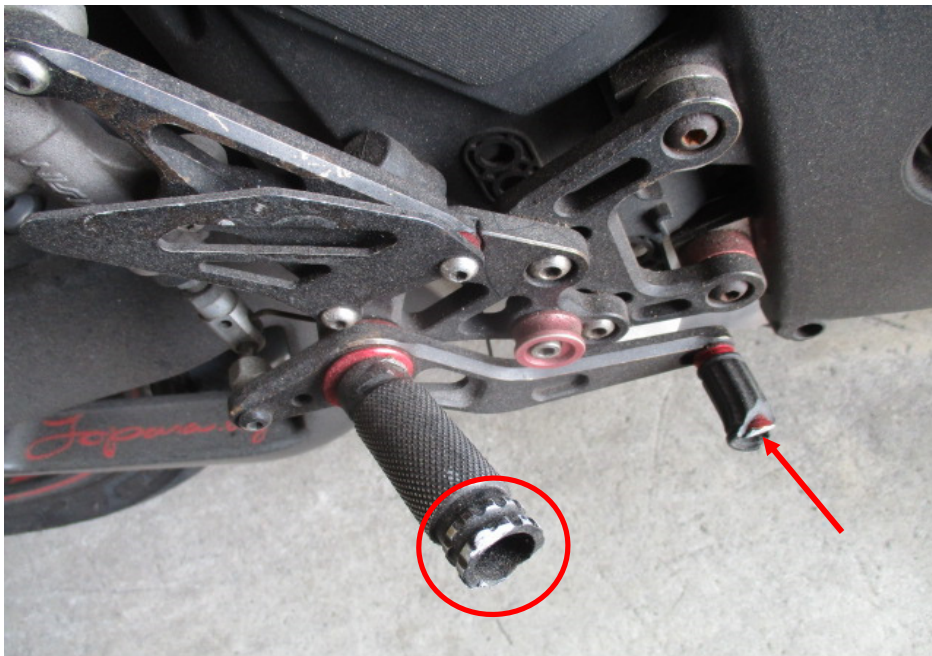
Photo 14 shows a closer view of the right front footrest (circled) and rear brake pedal (arrowed) which were amongst the body parts of the Motorcycle that had sustained damage as a result of the accident.

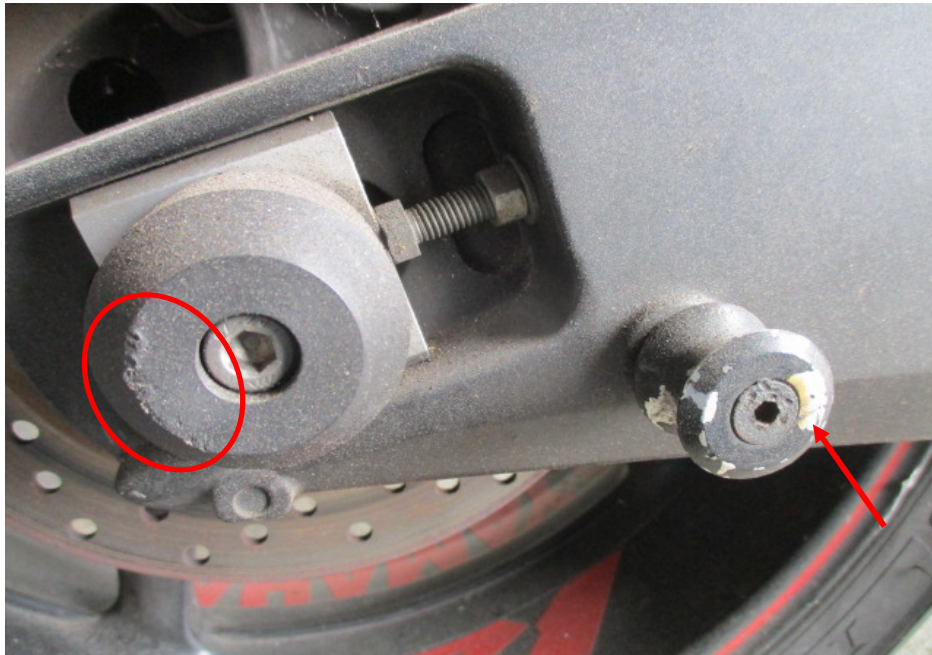
Photo 15 shows a closer view of the right rear slider (circled) and swingarm spool (arrowed) which were amongst the body parts of the Motorcycle that had sustained damages of grazing nature as a result of the accident.

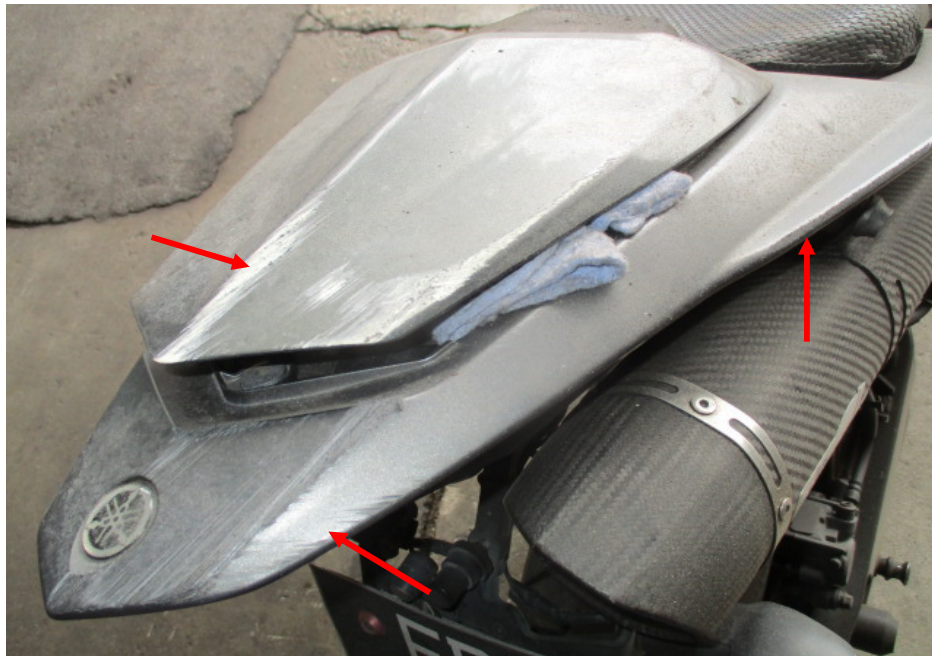
Photo 16 shows the grazed tail light cowl, right rear side cover and rear seat cowl (arrowed) of the Motorcycle as a result of the accident.

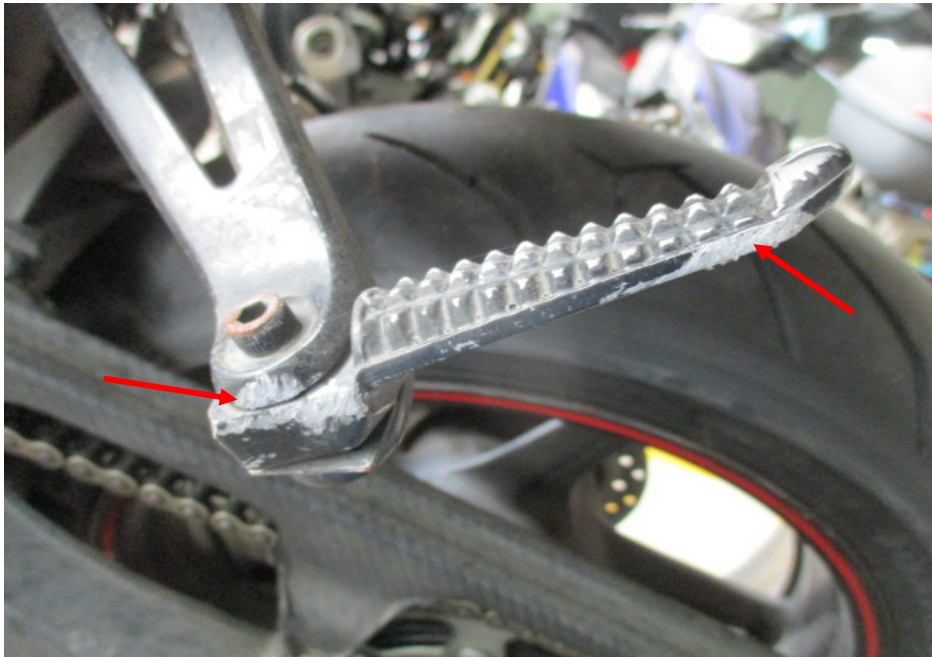
Photo 17 shows the grazed left pillion foot peg and bracket (arrowed) of the Motorcycle as a result of the accident.

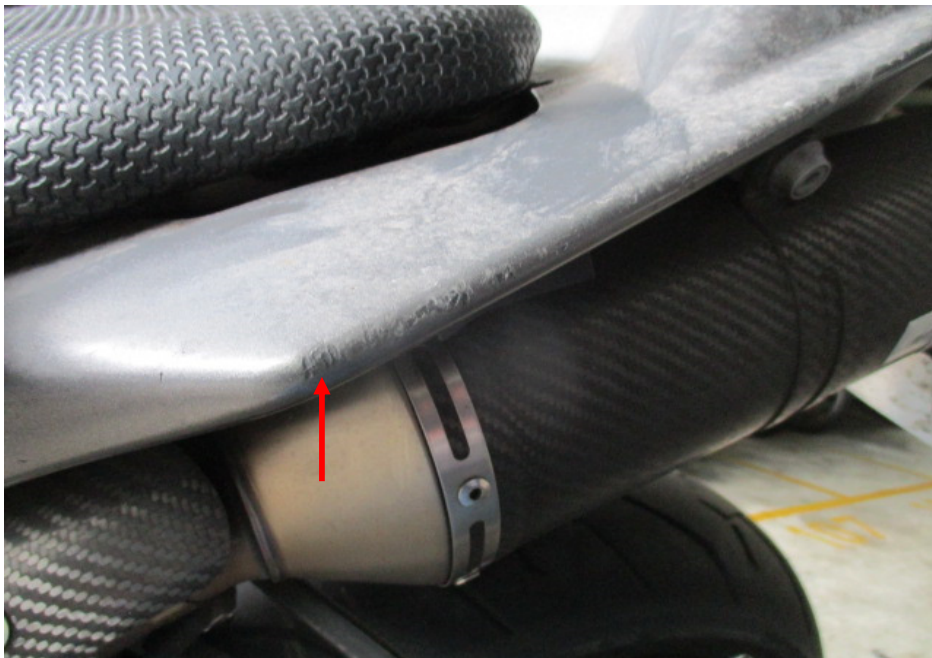
Photo 18 shows the grazed left rear side cover (arrowed) of the Motorcycle as a result of the accident.

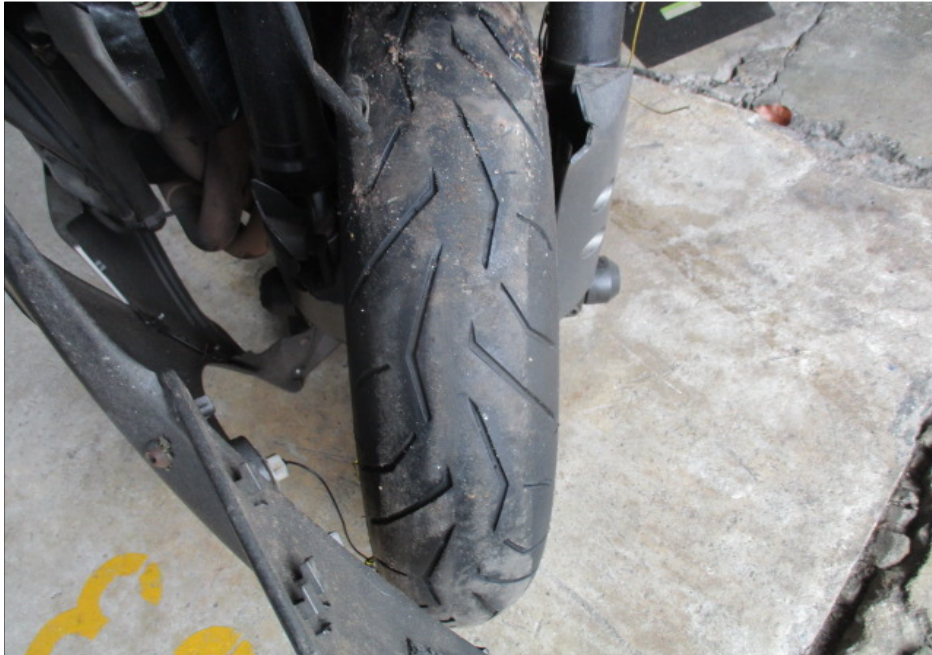
Photo 19 shows the condition of the Motorcycle's front tyre. The front tyre was observed to be in serviceable condition with remaining tread depth of approximately 4mm. We did not observe any tear, burst mark(s) and/or punctured hole(s) on the sidewalls as well as across the tread of the front tyre. However the front tyre was observed to be deflated.

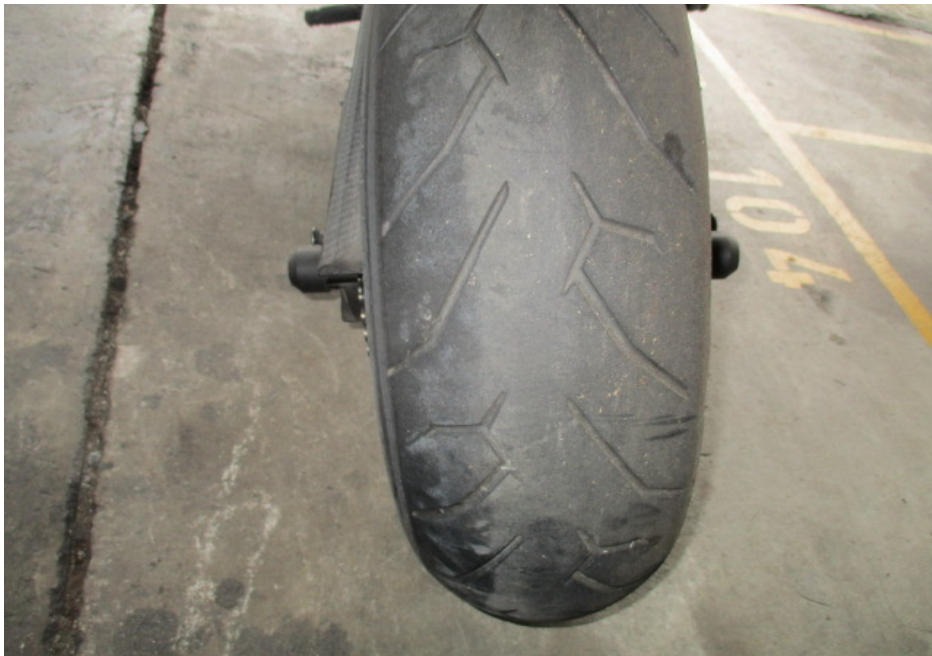
Photo 20 shows the condition of the Motorcycle's rear tyre. The rear tyre was observed to be in serviceable condition with remaining tread depth of approximately 3mm. The tyre was also observed to be sufficiently inflated for vehicular operation. We did not observe any tear, burst mark(s) and/or punctured hole(s) on the sidewalls as well as across the tread of the rear tyre.

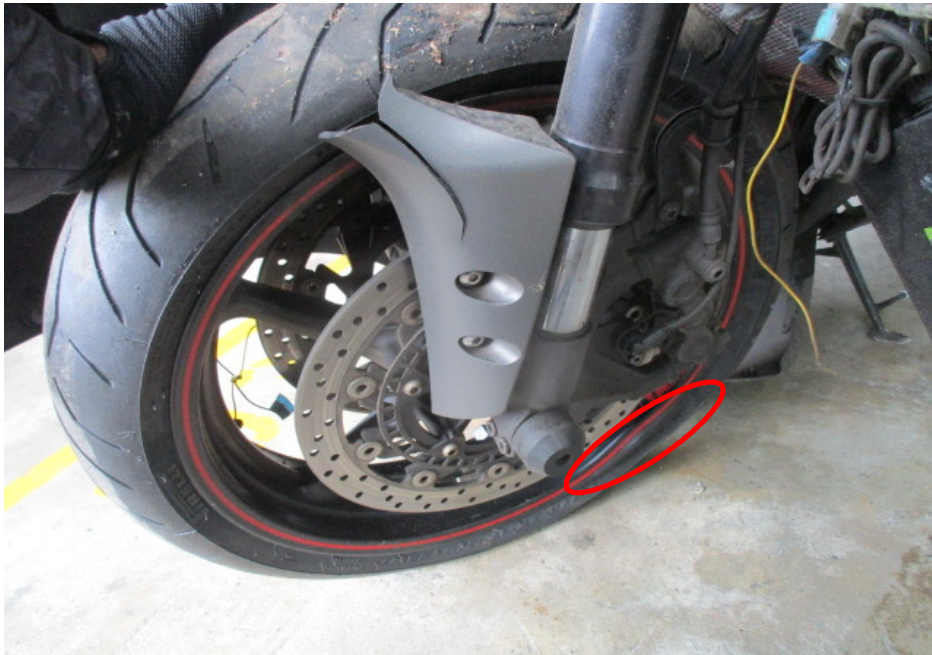
8. The 2 tyres were wrapped around alloy wheel rims. At the time of our inspection, we did not observe any visible damage on the rear wheel rim of the Motorcycle. However we observed that the front wheel rim of the Motorcycle was bent. See photos 1 – 22 below.

Photo 21 shows the bent front wheel rim of the Motorcycle at the time of our inspection (circled).

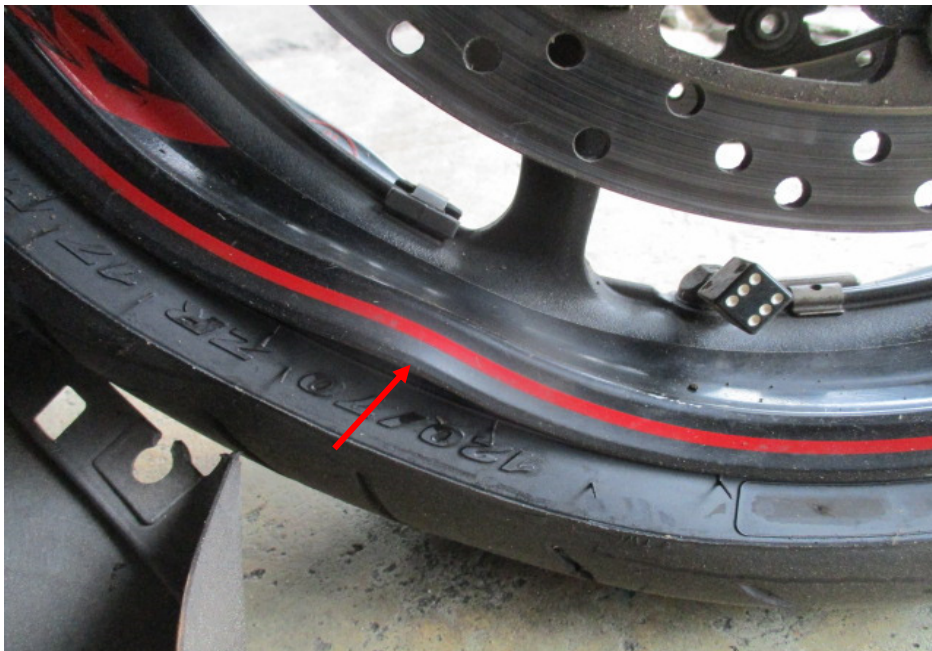
Photo 22 shows a close up view of the bent front wheel rim of the Motorcycle at the time of our inspection (arrowed).

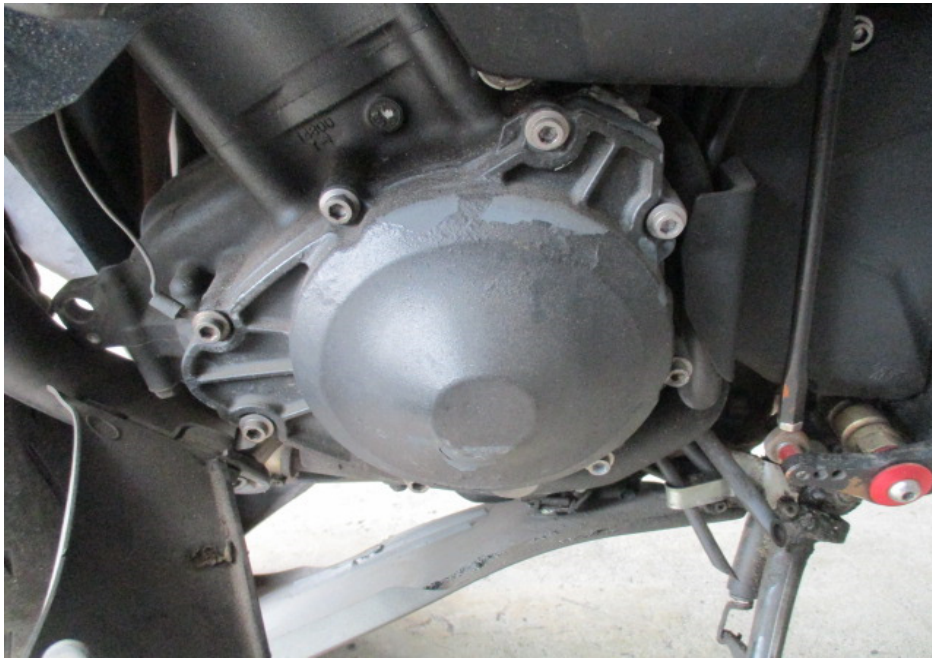
Photo 23 shows the left side of the engine of the Motorcycle at the time of our inspection. The various engine related parts and components were found to be intact with no visible damage. There was also no sign(s) or indication(s) of fluid leak observed around the left engine area of the Motorcycle.

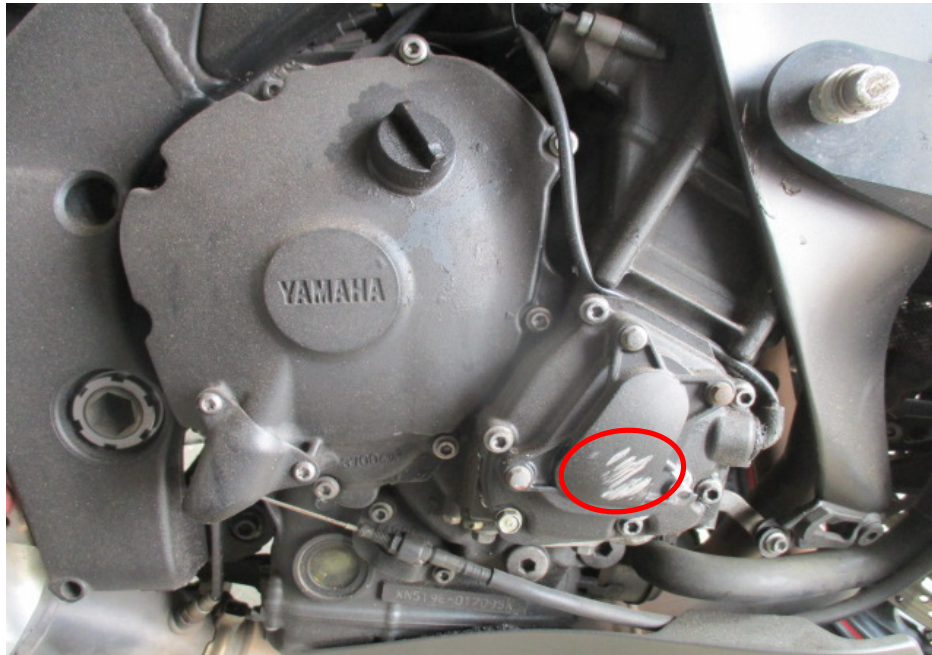
Photo 24 shows the right side of the engine of the Motorcycle at the time of our inspection. The various right engine components had sustained damage of grazing nature as a result of the accident (circled) however the engine components were still intact. There was also no fluid leak and/or fluid stain found around the right engine area of the Motorcycle.

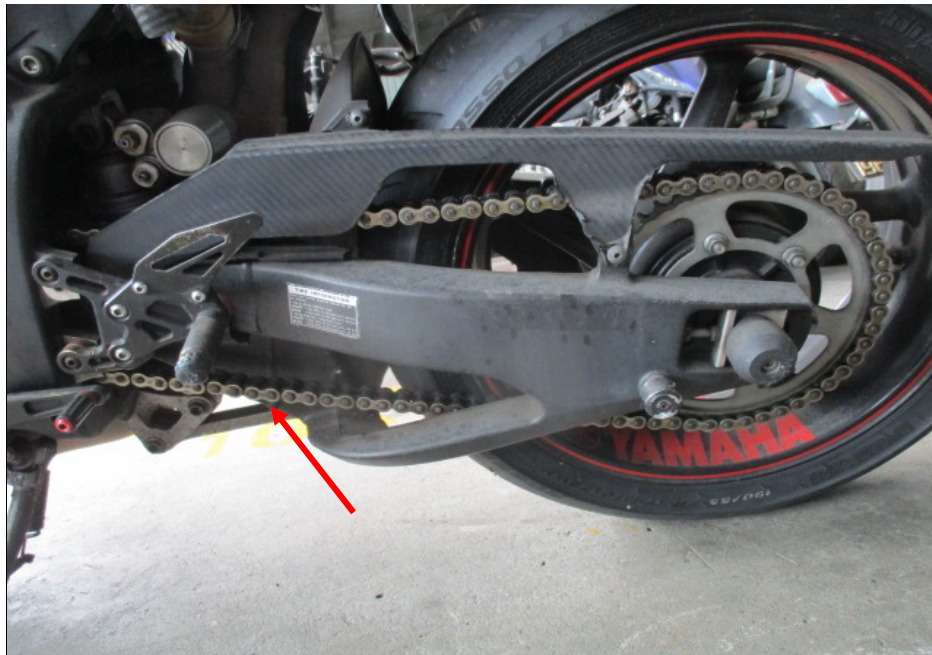
Photo 25 shows the gear chain (arrowed) of the Motorcycle, which was observed to be intact with no misalignment. It was also adequately lubricated for operating purposes. The gear chain rotates the rear wheel of the Motorcycle.

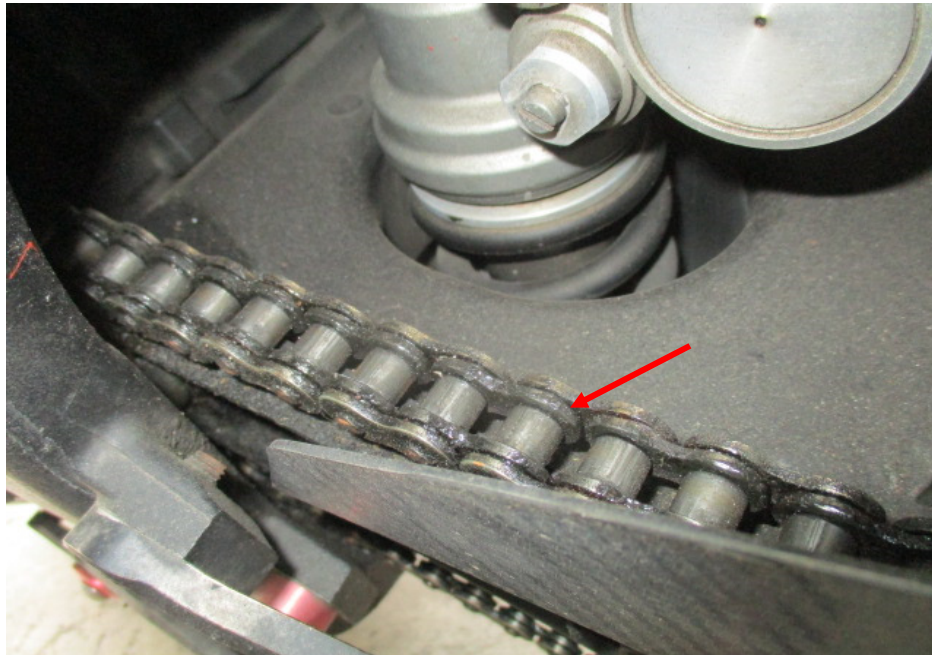
Photo 26 shows the closer view of the gear chain (arrowed) of the Motorcycle, which was observed to be intact with no misalignment. It was also adequately lubricated for operating purposes.

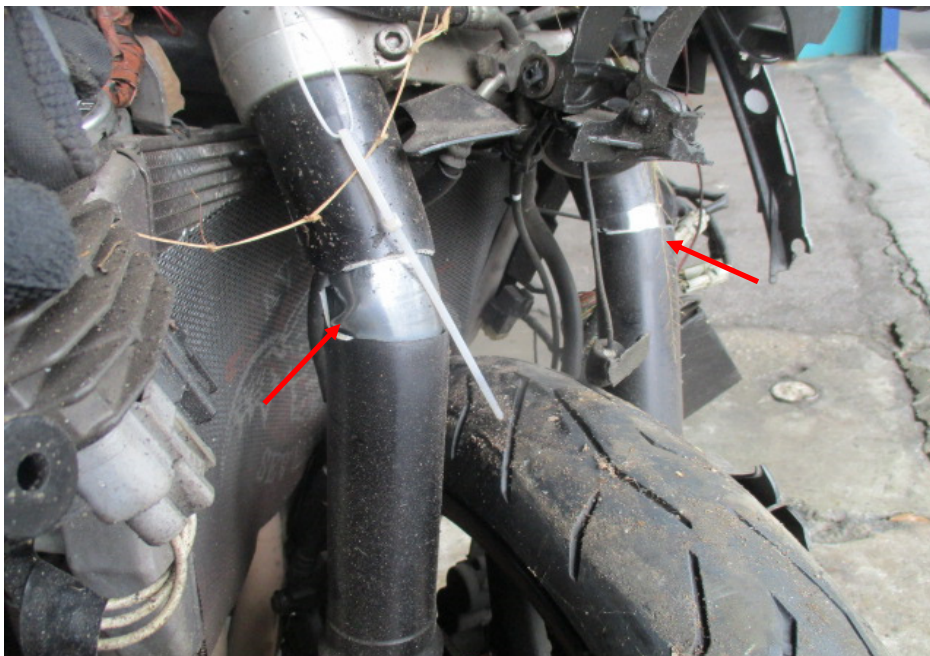
11. For this case, we were not able to conduct any test(s) on the steering system of the Motorcycle due to the damage of its front fork assembly. The front forks were found to be bent inwards as a result of the accident.

Photo 27 shows the front forks of the Motorcycle. The front forks (arrowed) were observed to be bent inwards as a result of the accident. We were hence not able to conduct any tests on the steering system of the Motorcycle.

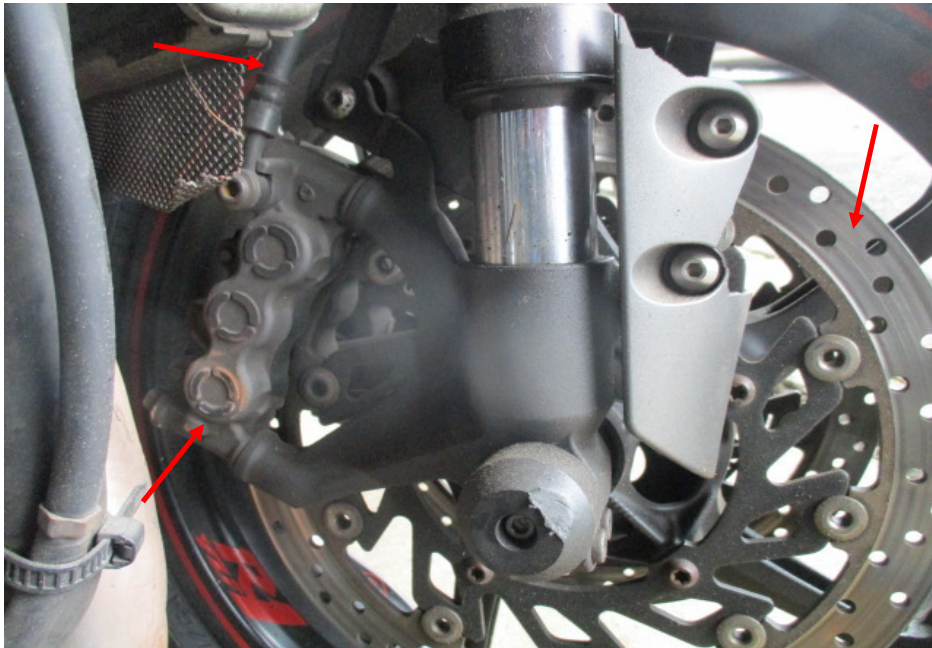
Photo 28 shows a close up view of the front brake caliper, front brake disc and front brake hose (arrowed) at the right side of the Motorcycle's front wheel, which are all part of the components in the hydraulic front brake system of the Motorcycle. Our visual checks of these various components had revealed all to be intact with no visible damage. No leakage of brake fluid was also observed.

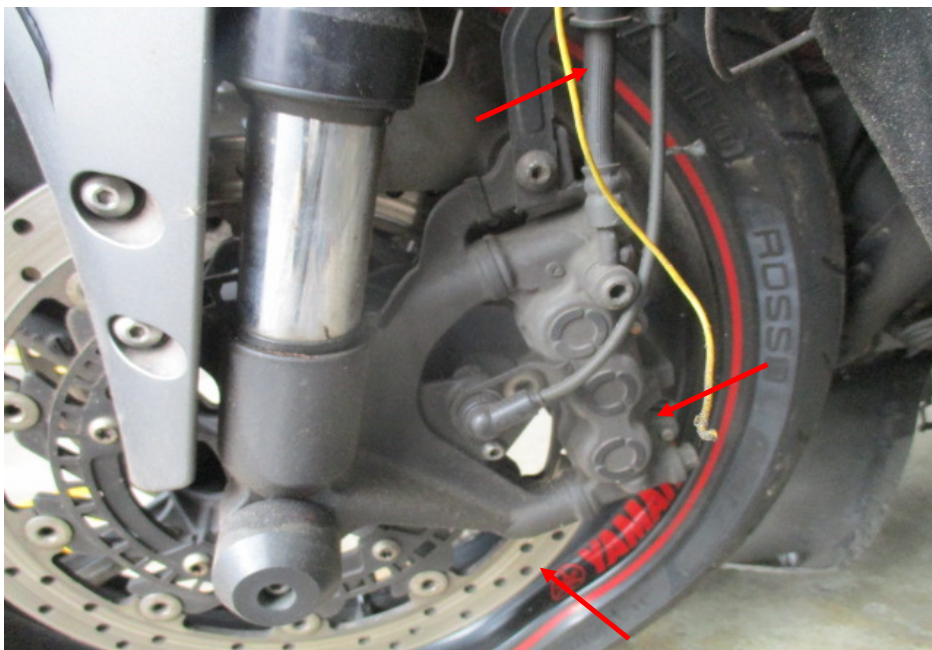
Photo 29 shows a close up view of the front brake caliper, front brake disc and front brake hose (arrowed) at the left side of the Motorcycle's front wheel, which are all part of the components in the hydraulic front brake system of the Motorcycle. Our visual checks of these various components had revealed all to be intact with no visible damage. No leakage of brake fluid was also observed.

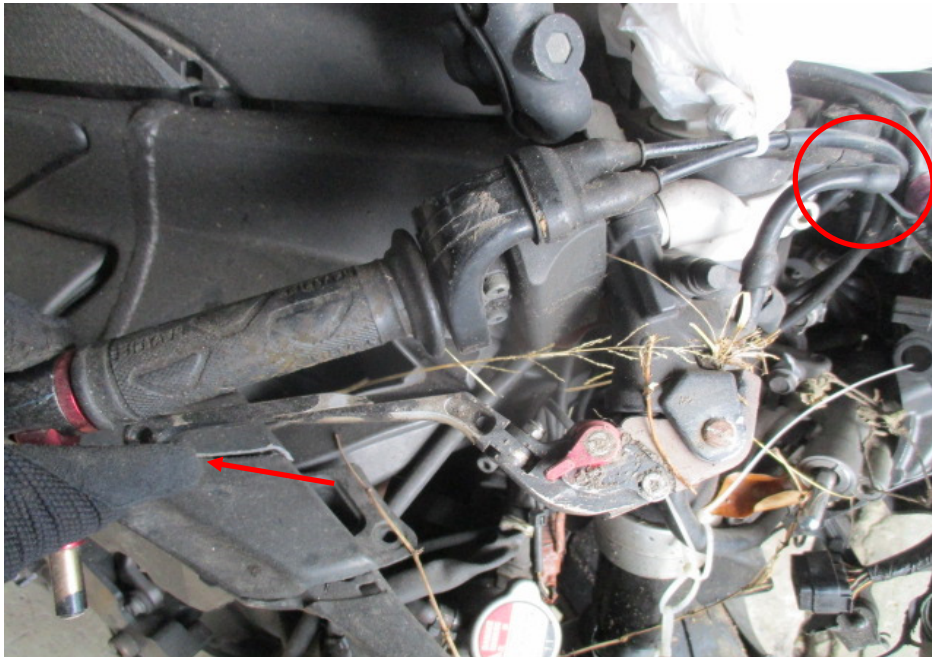
15. Static brake tests conducted on the Motorcycle had appear to indicate that the front braking system of the Motorcycle was not in serviceable condition. There was no resistance felt (spongy like feel) upon pressing the front brake lever. This would indicate that there was a leakage of pressure/vacuum in the brake system due to the missing front brake reservoir.

Photo 30 shows the front brake lever being depressed. There was no resistance felt (spongy like feel) upon pressing the front brake lever (arrowed). This would indicate that there is a leakage of pressure/vacuum in the front brake system due to the missing front brake reservoir as a result of the accident (circled).

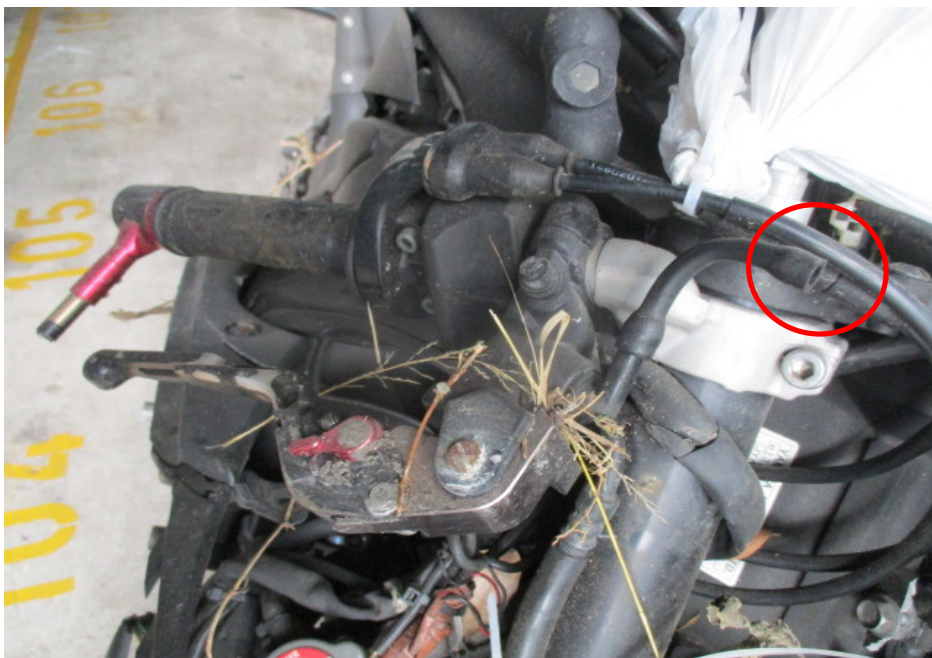
13. Our visual examination of the various components in the Motorcycle's braking system like the brake discs, brake calipers, brake lever, brake foot pedal and brake hoses revealed all to be intact and without damage. The brake fluid for rear brake was found to be of sufficiently level and without any contamination. However the front brake reservoir was observed to be missing as a result of the accident.

Photo 31 shows a closer view of the missing front brake reservoir of the Motorcycle as a result of the accident (circled).

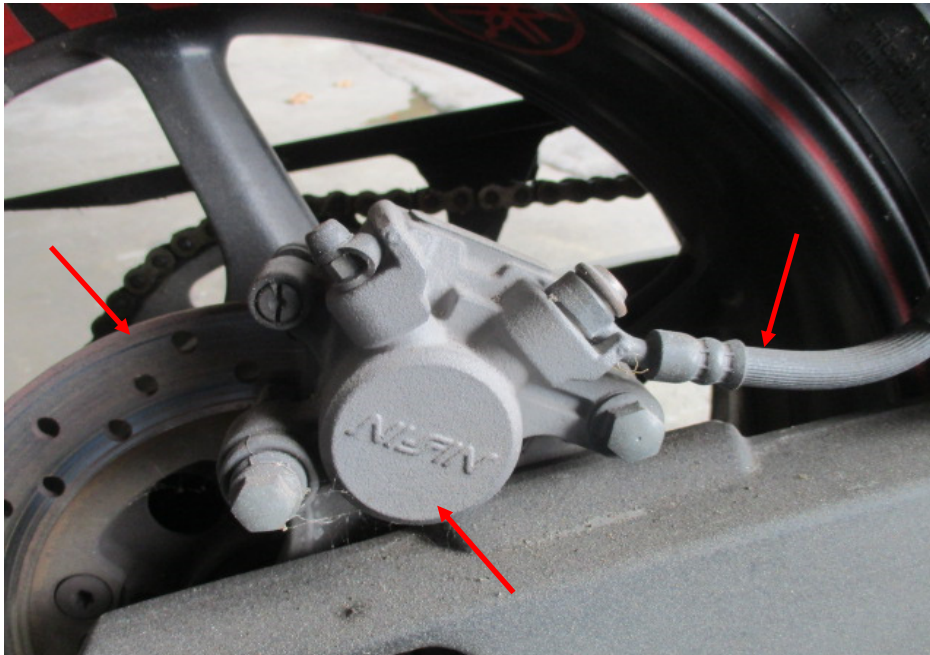
Photo 32 shows a close up view of the rear brake caliper, rear brake disc and rear brake hose (arrowed) of the Motorcycle, which are all part of the components in the hydraulic rear brake system of the Motorcycle. Our visual checks of these various components had revealed all to be intact with no visible damage. No leakage of brake fluid was also observed.

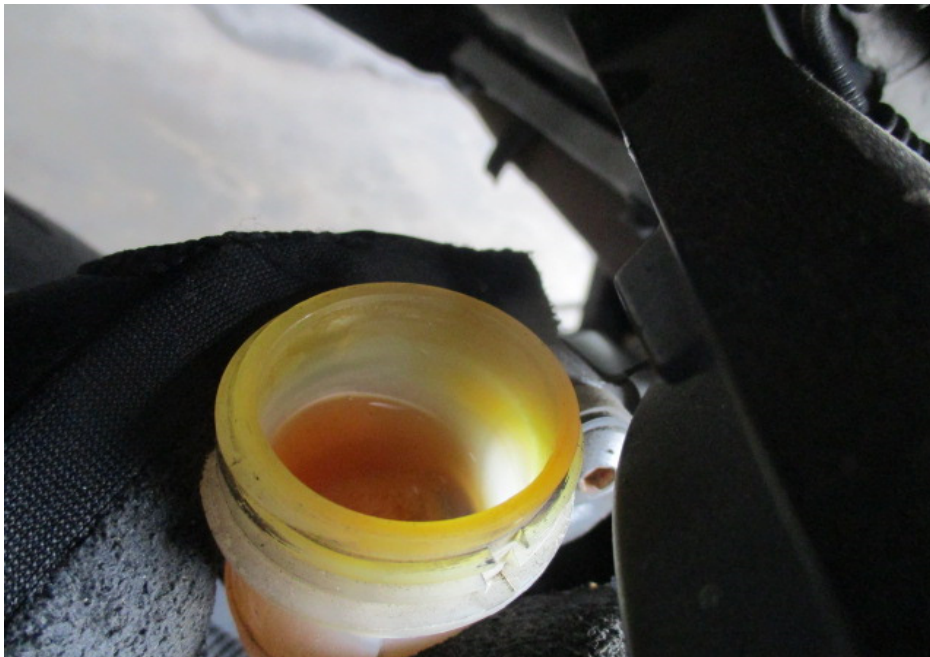
Photo 33 shows the brake fluid reservoir for the rear brake of the Motorcycle. The brake fluid was observed to be of sufficient level and without contamination for operational purposes.
