You're Ref: TP/IP/13069/2021  
Our Ref: CI/TPD21004894/P

**Fatal Accident Investigation Team**

**MECHANICAL INSPECTION REPORT OF MOTOR CAR SMJ 2391B**

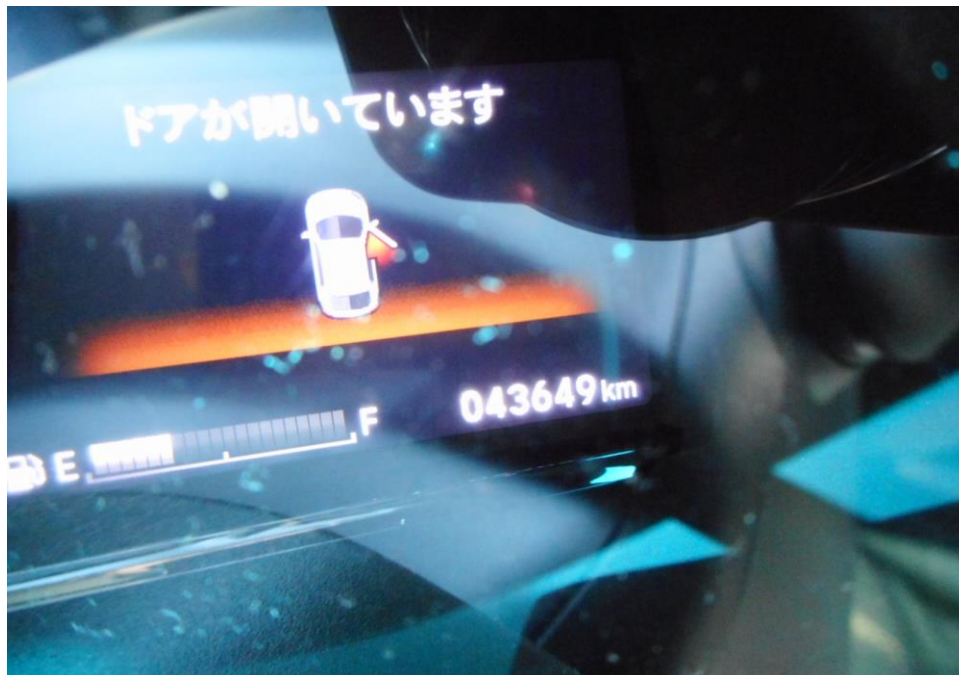
**Photo 1** shows the mileage of the Motor Car at the time of my inspection. The mileage observed was 43,649km.

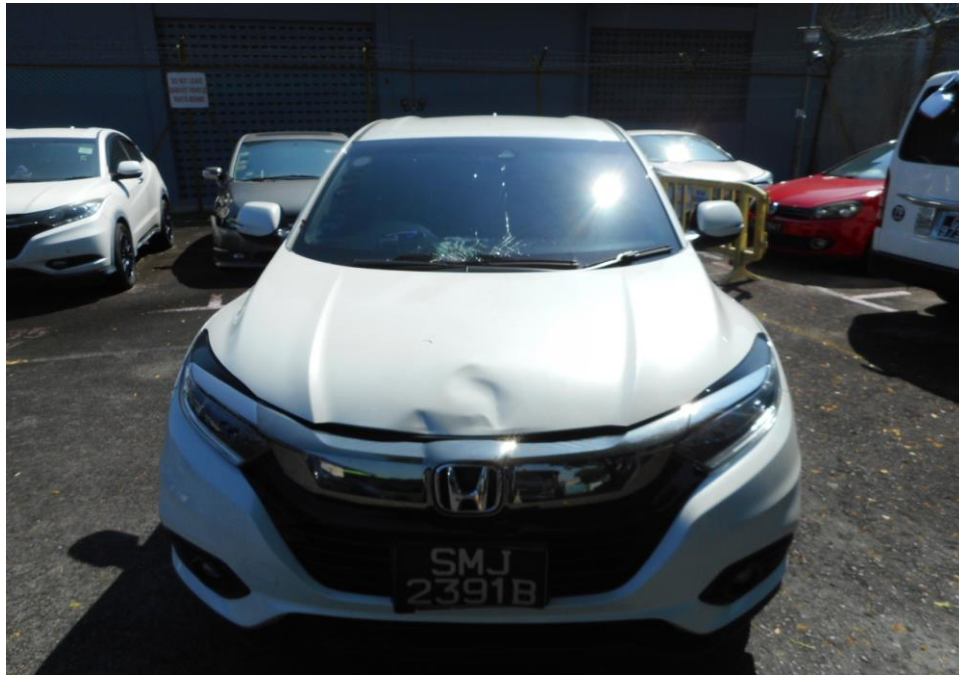
4. The mileage of the Motor Car at the time of my inspection was 43,649km.
5. The Motor Car was observed to have sustained damage at its front portion. Its front windscreen and front bonnet was the body parts that were damaged as a result of the accident.

**Photo 2** shows a general view of the Motor Car's front body at the time of my inspection. The front portion of the Motor Car was observed to have sustained damage. Its front windscreen and front bonnet was the body parts that were damaged as a result of the accident.

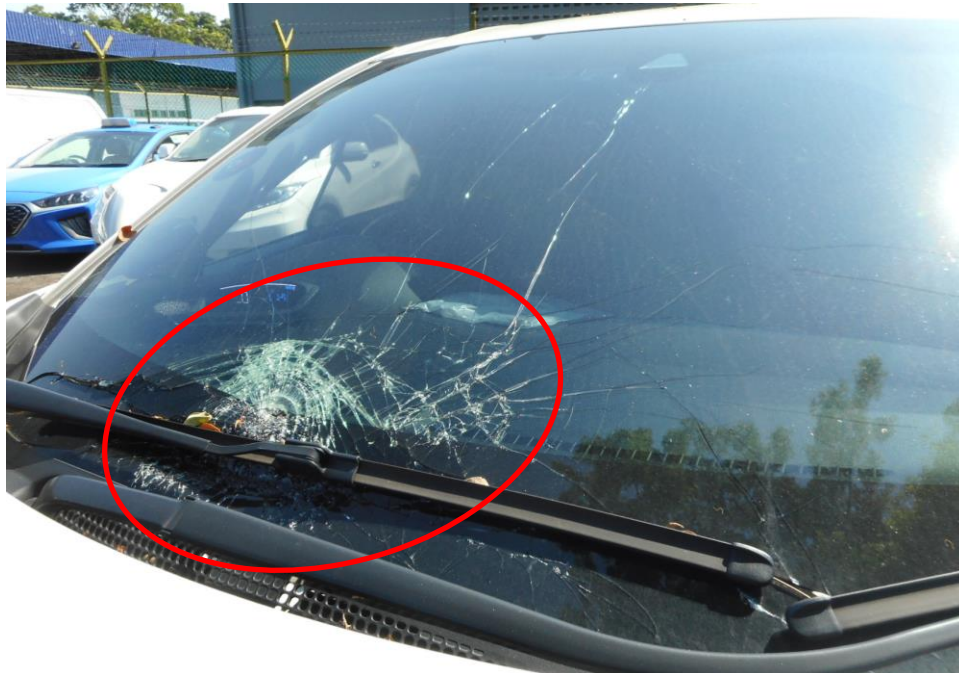
**Photo 3** shows the close up view of the Motor Car's front body at the time of my inspection. The Motor Car was observed to have sustained damage at its front windscreen (circled) as a result of the accident.

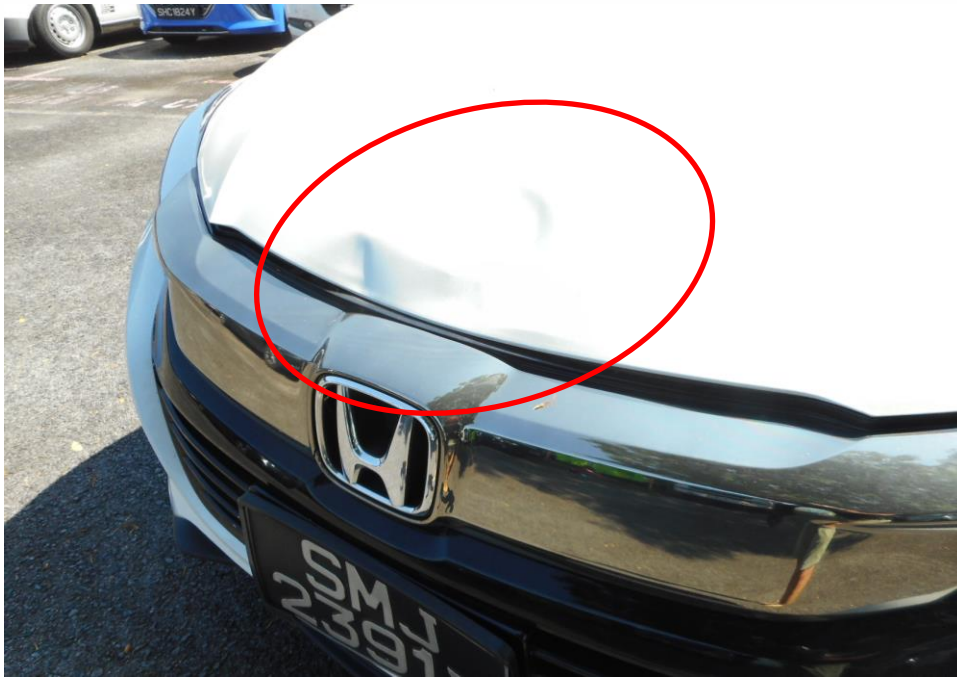
**Photo 4** shows the close up view of the Motor Car's front body at the time of my inspection. The Motor Car was observed to have sustained damage at its front bonnet (circled) as a result of the accident.

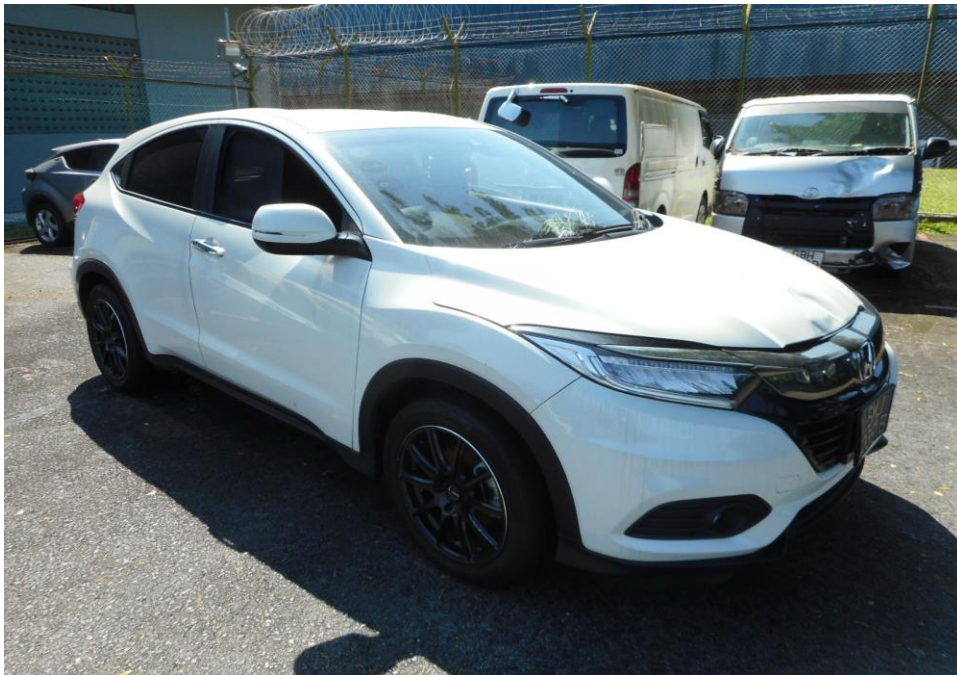
**Photo 5** shows a general view of the Motor Car's right body at the time of my inspection. The right portion of the Motor Car was observed to have been unaffected by the accident.

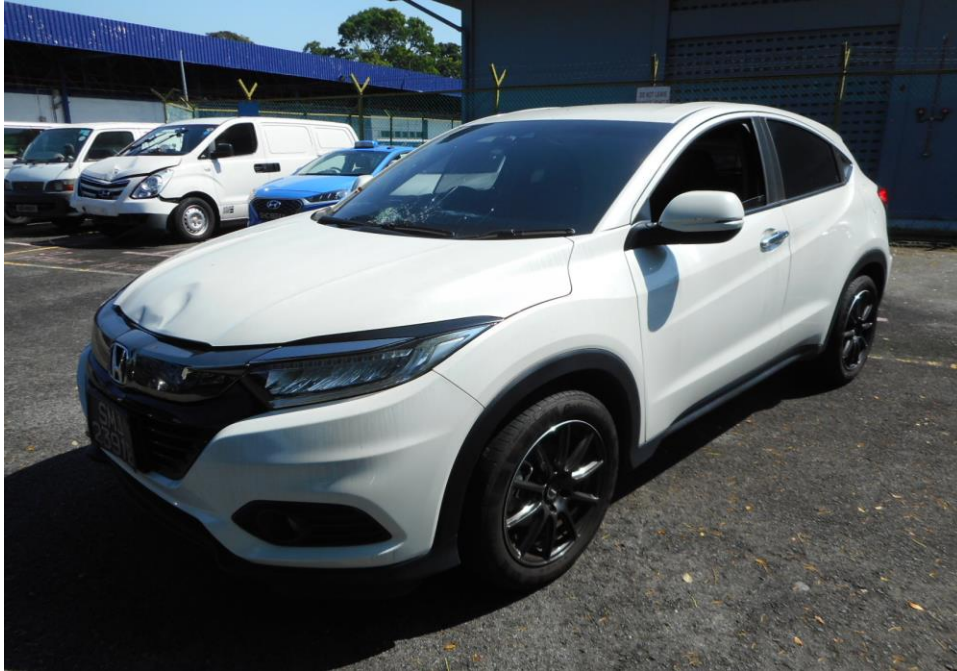
**Photo 6** shows a general view of the Motor Car's left body at the time of my inspection. The left portion of the Motor Car was observed to have been unaffected by the accident.

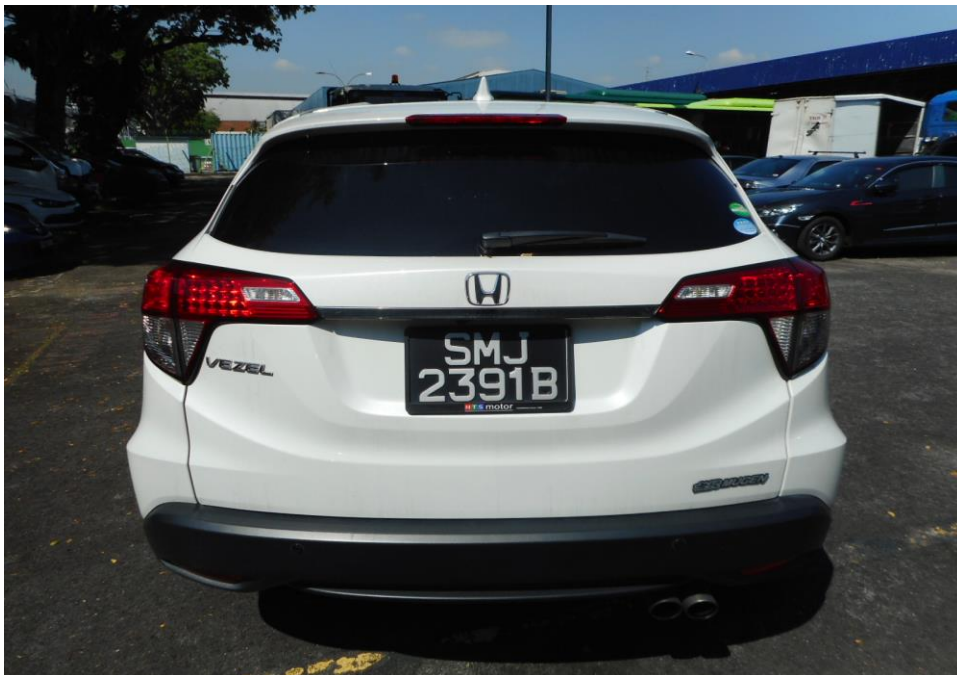
**Photo 7** shows the general view of the Motor Car's rear body at the time of my inspection. The Motor Car rear was observed to be unaffected by the accident.

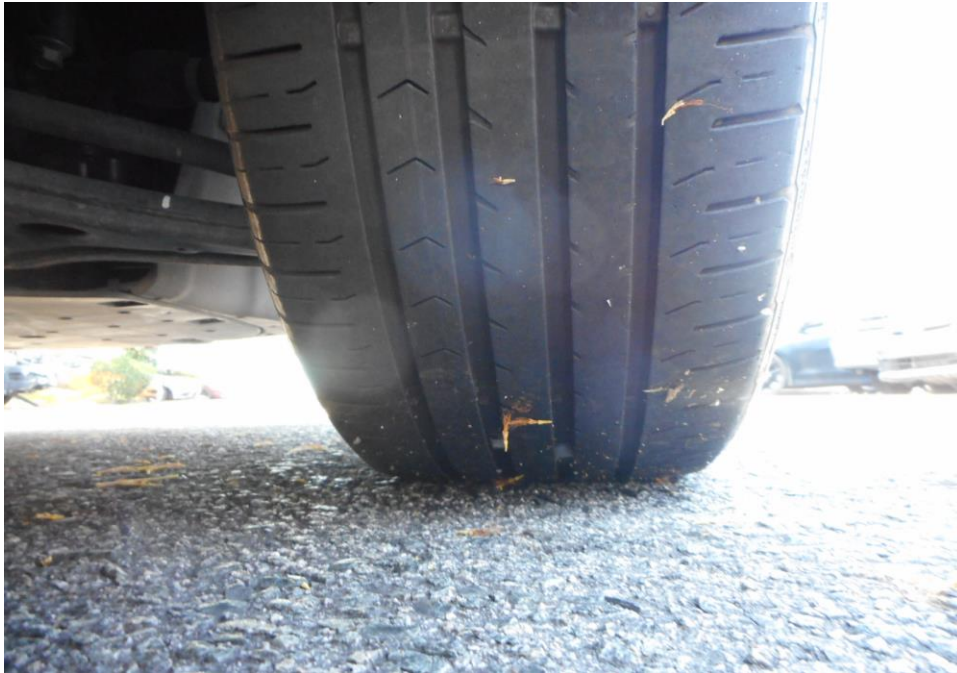
**Photo 8** shows the condition of the front right tyre of the Motor Car, which was observed to be in serviceable condition with remaining tread depth of approximately 4.1mm. The tyre was sufficiently inflated for vehicular operation with no tear, cut or burst mark(s) on the outer and the inner sidewalls as well as across the tread. The 4 tyres of the Motor Car were wrapped around standard steel wheel rims without any damage.

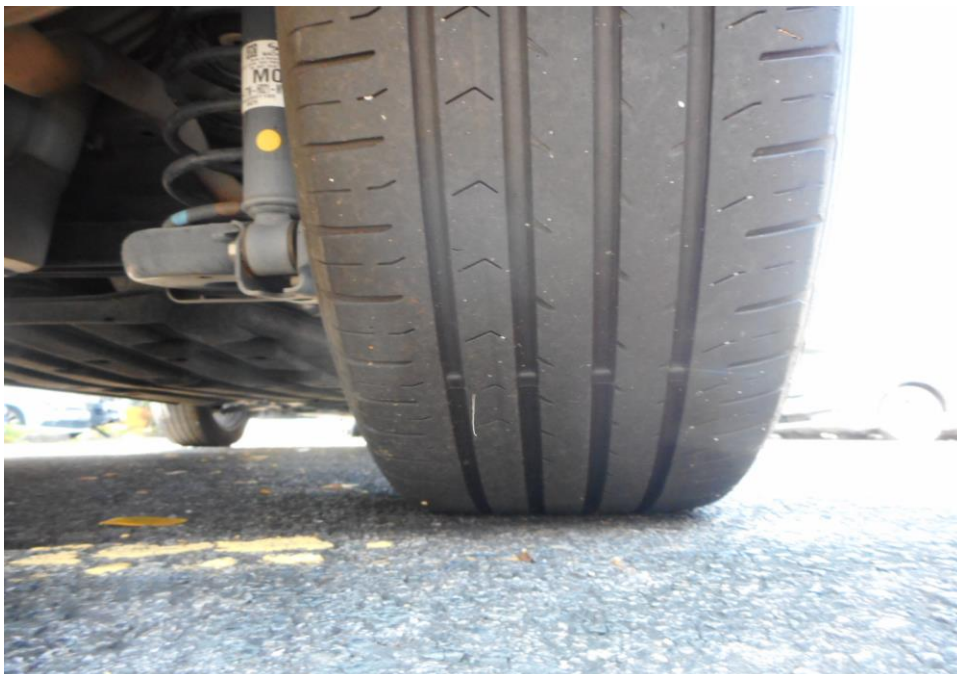
**Photo 9** shows the condition of the rear right tyre of the Motor Car, which was observed to be in serviceable condition with remaining tread depth of approximately 4mm. The tyre was also observed to be sufficiently inflated for vehicular operation with no tear, cut or burst mark(s).

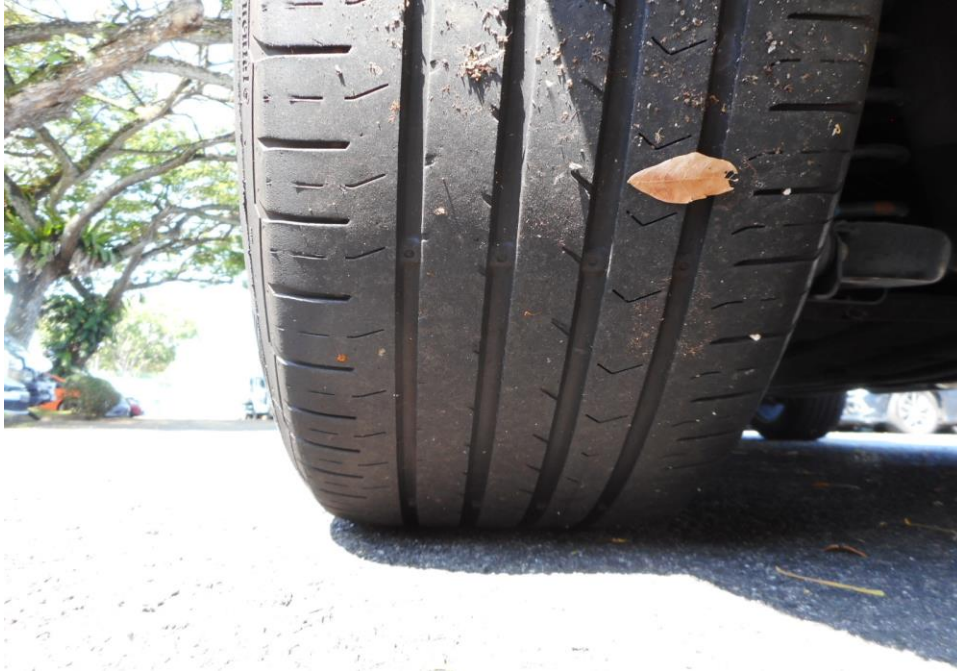
**Photo 10** shows the condition of the rear left tyre of the Motor Car, which was observed to be in serviceable condition with remaining tread depth of approximately 3.7mm. The tyre, which was wrapped around steel wheel rim, was also observed to be sufficiently inflated for vehicular operation. The 4 tyres of the Motor Car were wrapped around standard steel wheel rims.

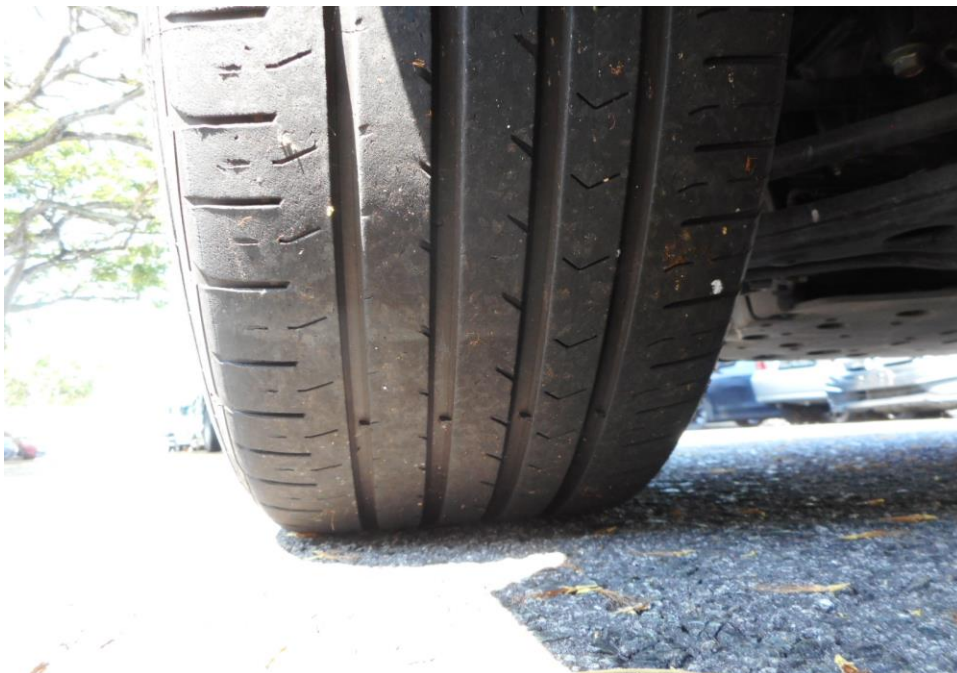
**Photo 11** shows the condition of the front left tyre of the Motor Car, which was observed to be in serviceable condition with remaining tread depth of approximately 3.5mm. There was also no tear, cut or burst mark(s) on the outer and the inner sidewalls as well as across the tread of the Motor Car's 4 tyres.

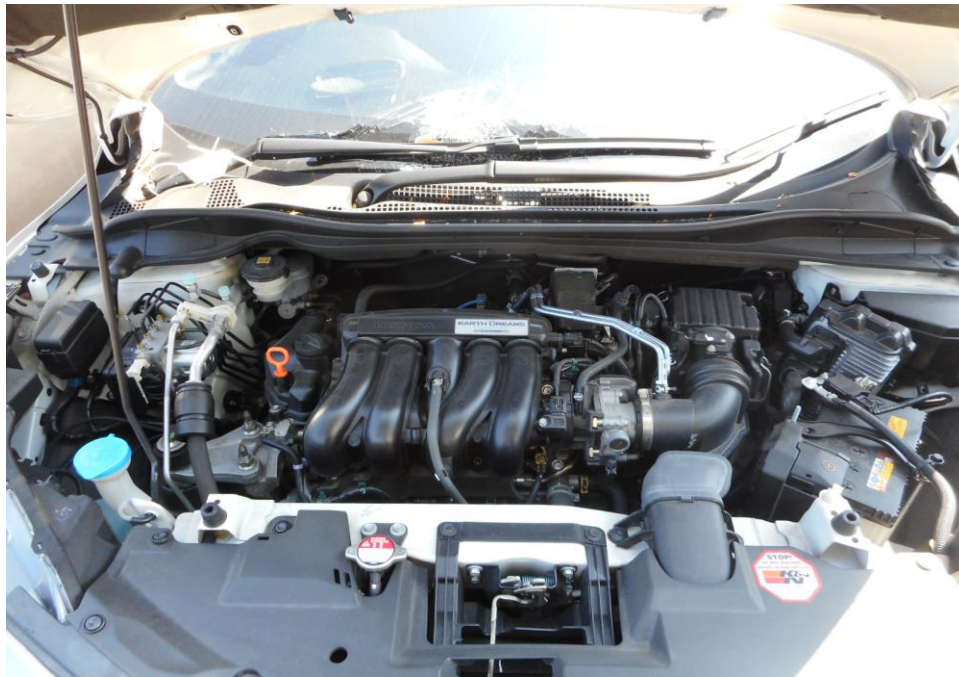
**Photo 12** shows a general view of the Motor Car's engine compartment. The various parts and components inside the engine compartment were unaffected by the accident. There was also no sign(s) or indication(s) of fluid leakage and/or fluid stain within the engine compartment.

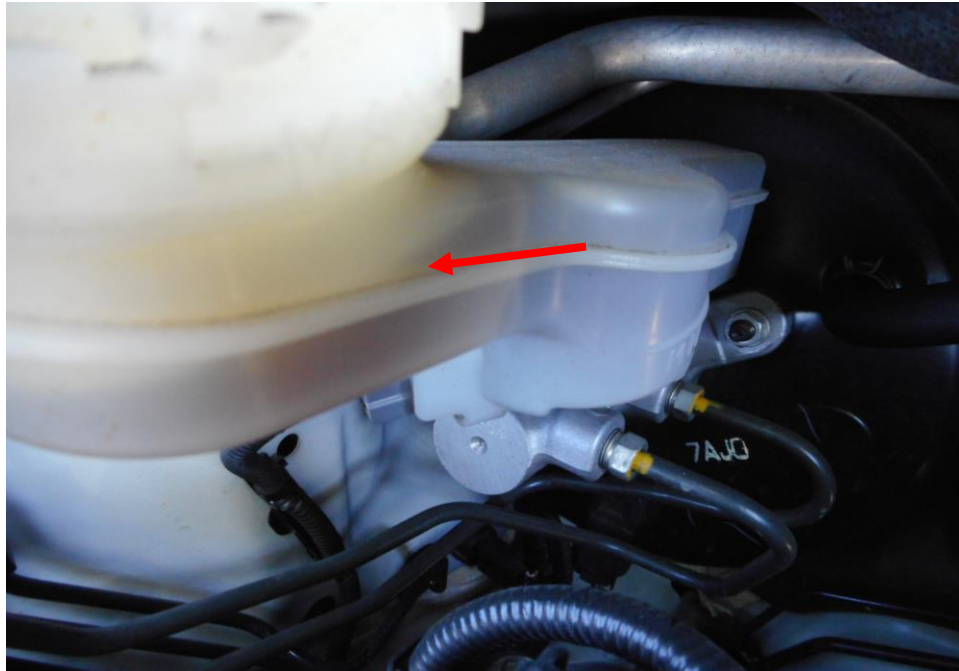
**Photo 13** shows the brake fluid reservoir of the Motor Car at the time of my inspection. The brake fluid was observed to be of sufficient level (arrowed) and without any visible contamination.

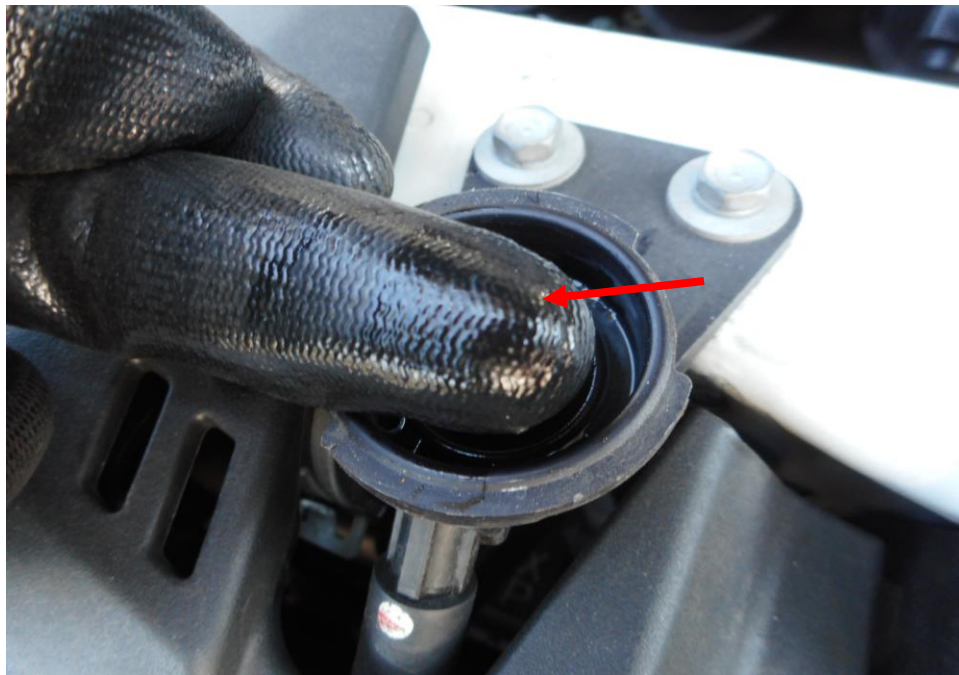
**Photo 14** shows checks being carried out to the engine coolant of the Motor Car at the time of my inspection. The engine coolant was observed to be of sufficient level (arrowed) and without any visible contamination.

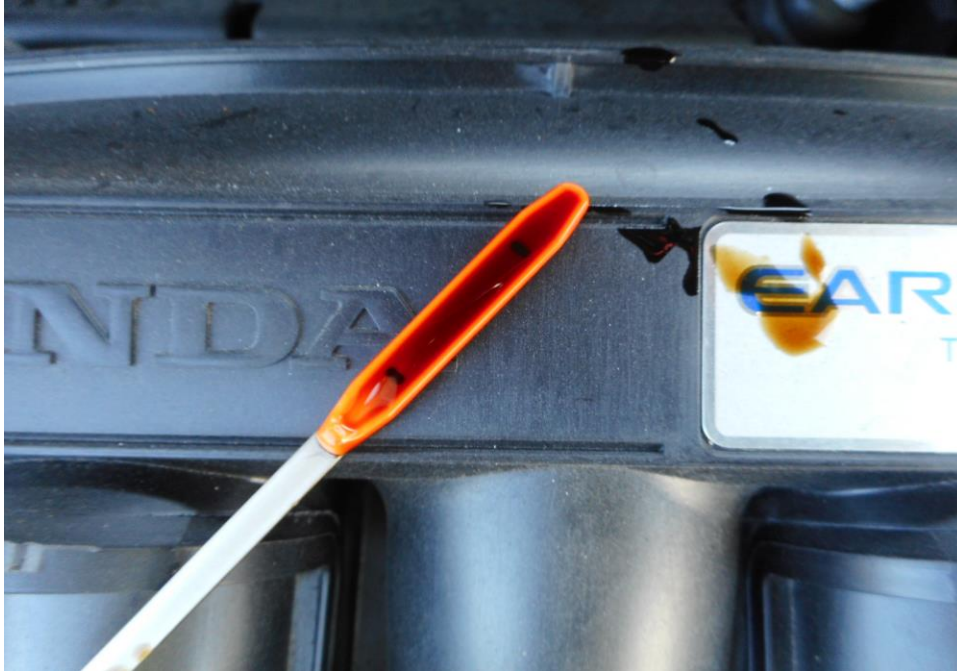
**Photo 15** shows the engine oil dip stick of the Motor Car at the time of my inspection. The engine oil was observed to be of sufficient level and without any visible contamination.

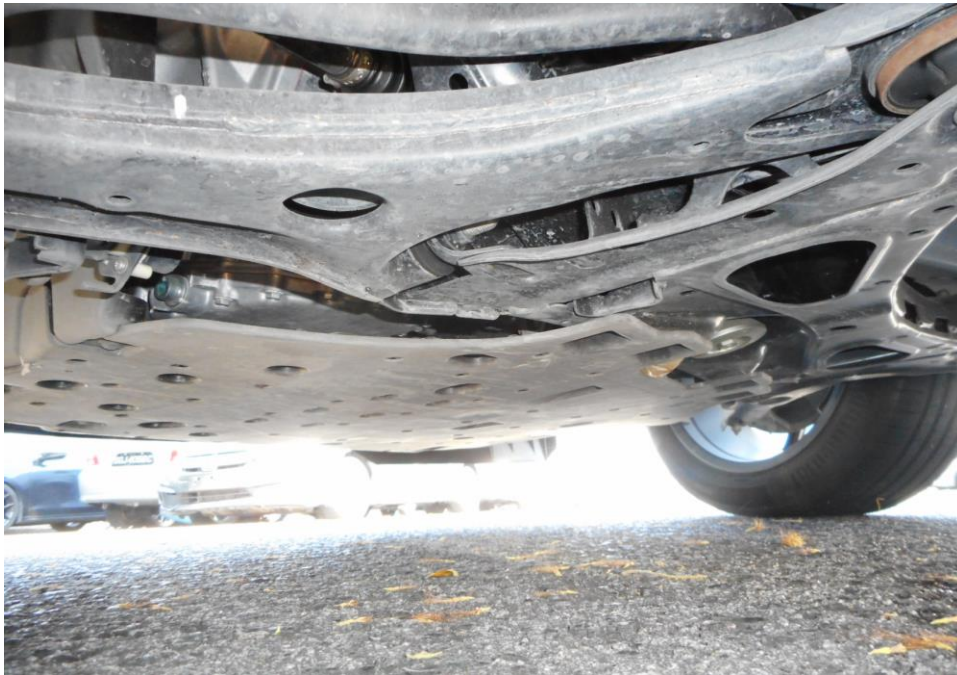
**Photo 16** shows the undercarriage of the Motor Car, at the area where the engine housing and transmission housing are located. I did not find any sign(s) or indication(s) of fluid leak and/or fluid stain(s) on the underside of the Motor Car.

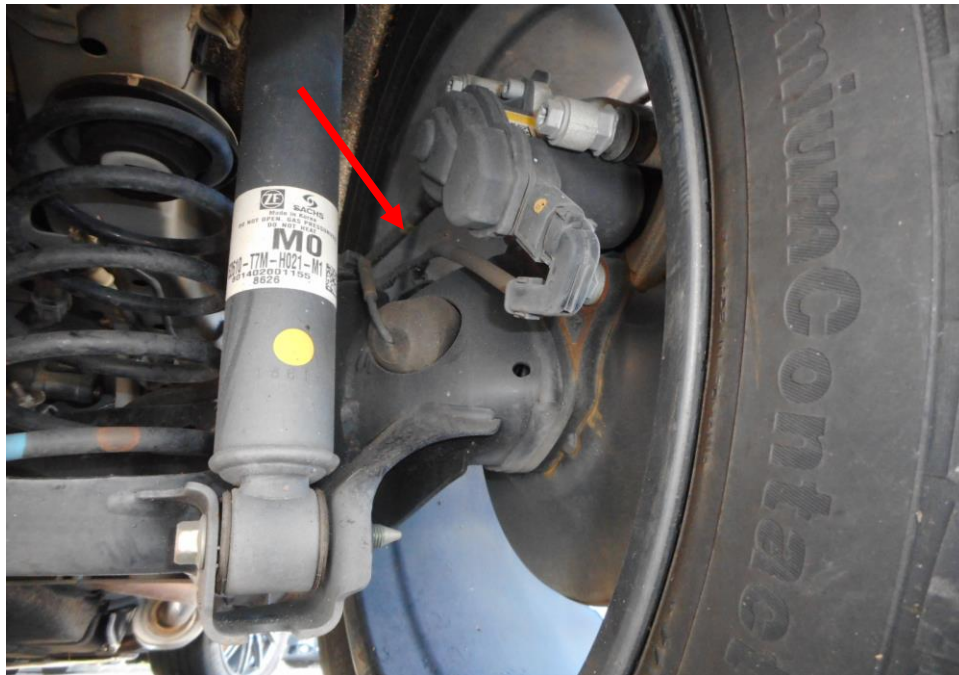
**Photo 17** shows the brake hose/pipe (arrowed) at the rear right wheel of the Motor Car. No leakage of brake fluid was observed. Visual examination of the various components of the braking system like the drum brake, brake booster, brake pedal etc. had revealed all to be intact and without visible damage.

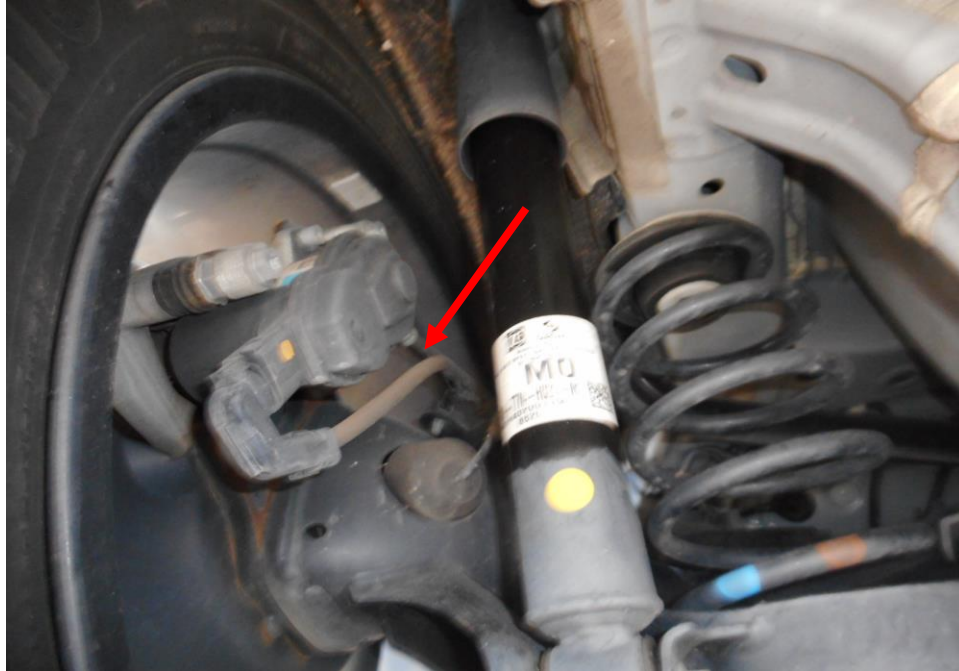
**Photo 18** shows the brake hose/pipe (arrowed) at the rear left wheel of the Motor Car. I did not observe any leakage of brake fluid at the time of my inspection of the Motor Car. Static tests of the Motor Car's braking system had indicated that there was no internal leakage of pressure/vacuum. The undercarriage components of the Motor Car were also all found to be intact and without any visible damage.

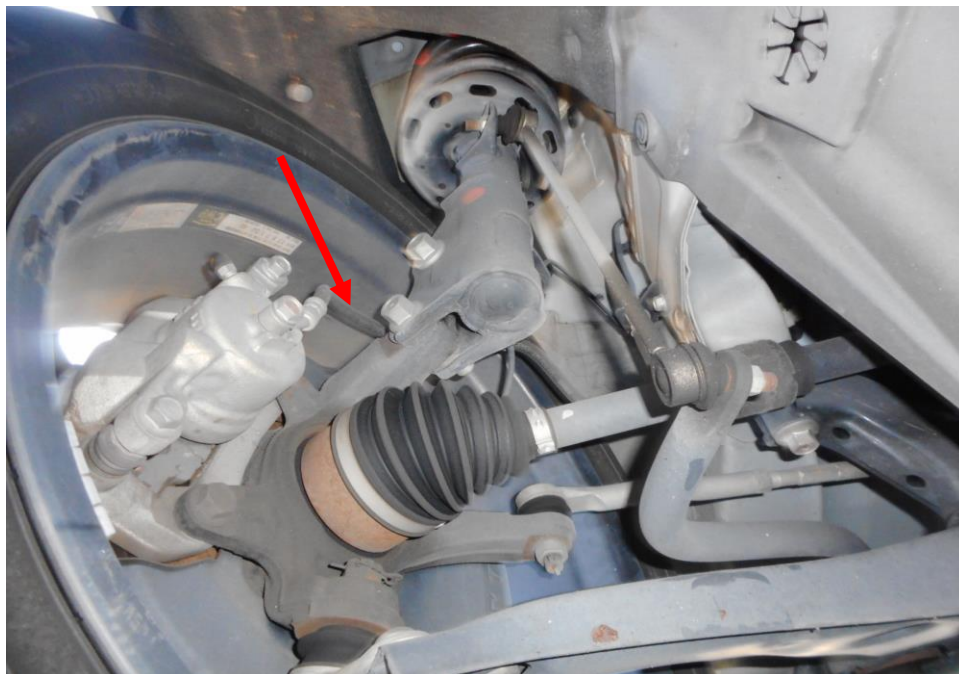
**Photo 19** shows the brake hose/pipe (arrowed) at the front right wheel of the Motor Car. I did not observe any leakage of brake fluid at the time of my inspection of the Motor Car. Static tests of the Motor Car's braking system had indicated that there was no internal leakage of pressure/vacuum. The undercarriage components of the Motor Car were also all found to be intact and without any visible damage.

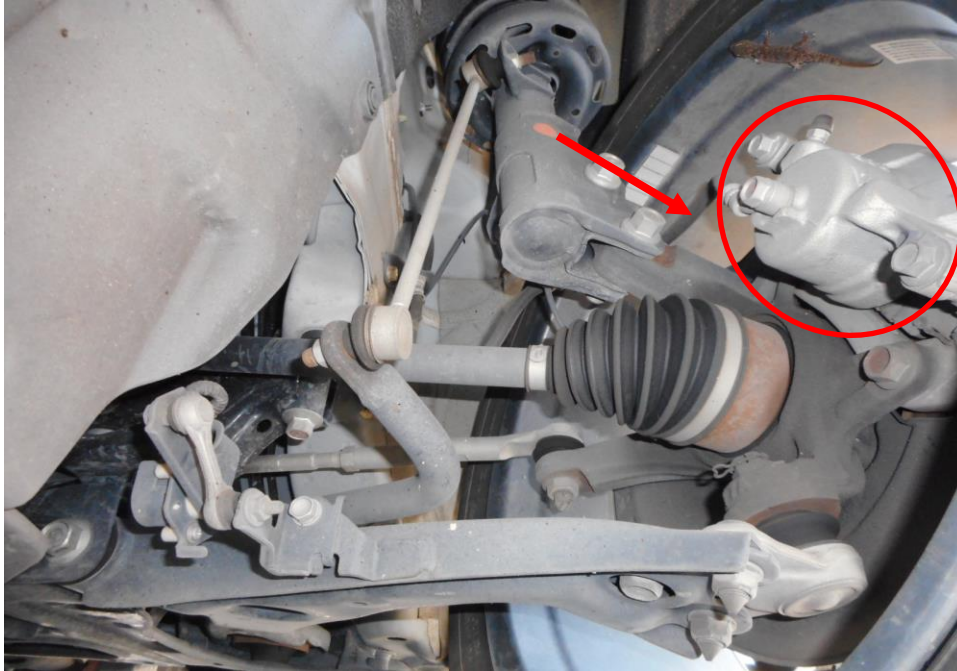
**Photo 20** shows the brake hose/pipe (arrowed) at the front left wheel of the Motor Car. No leakage of brake fluid was observed. Visual examination of the various components of the braking system like the brake caliper (circled), brake booster, brake pedal etc had revealed all to be intact and without visible damage.

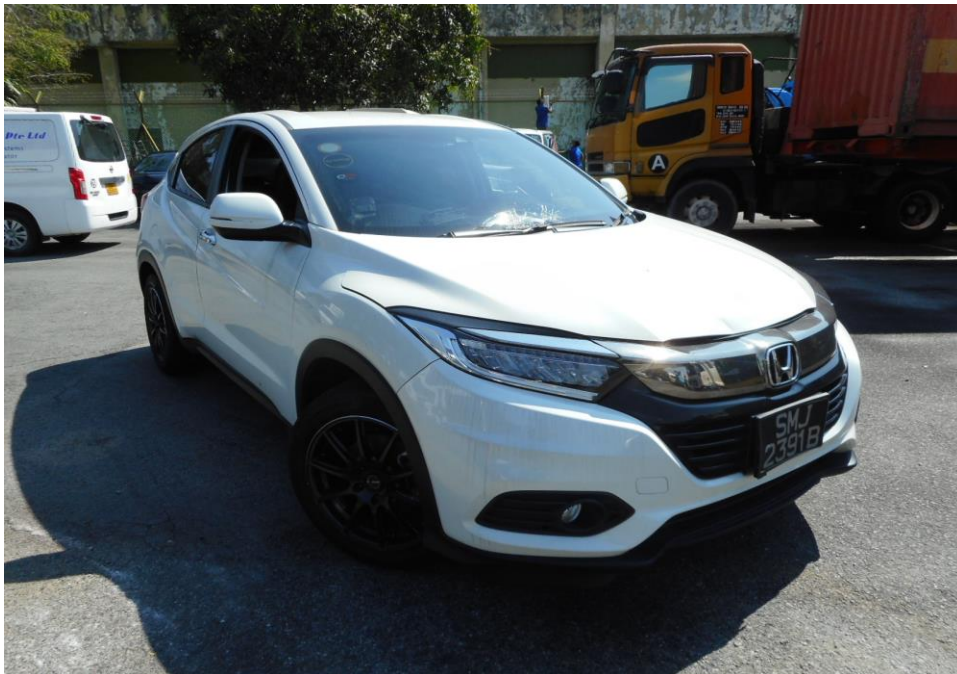
**Photo 21** shows the front right wheel of the Motor Car turned to its full left. During my steering system test, I did not experience any abnormal free play and/or resistance when I had turned the steering wheel towards the left and right. This would suggest that the steering system of the Motor Car was likely to be in serviceable condition at the material time of accident.

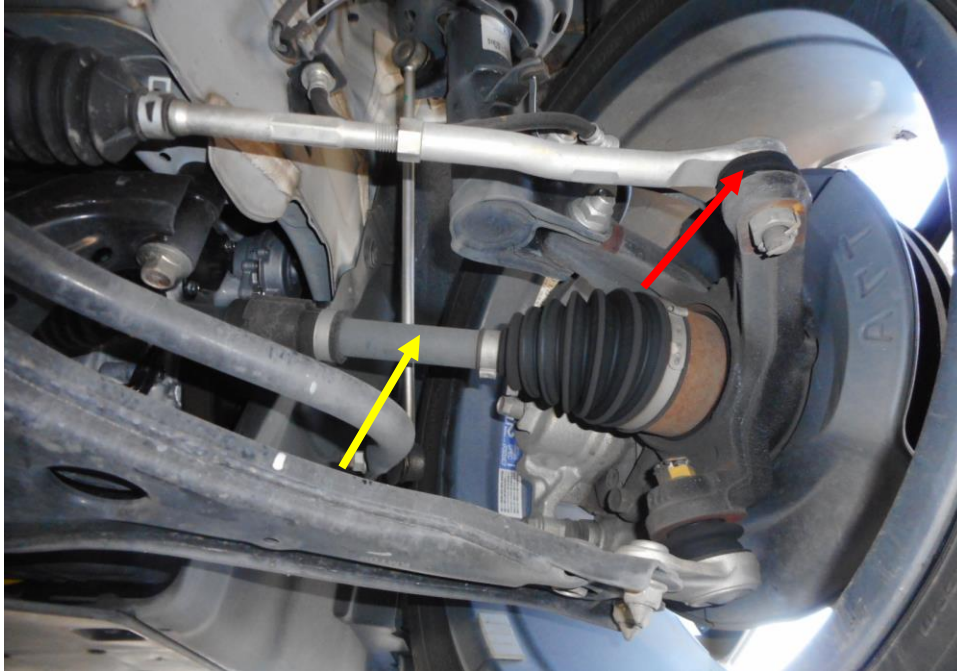
**Photo 22** shows the various undercarriage components at the front right wheel of the Motor Car, in particular the steering tie rod (red arrow) and drive shaft (yellow arrow). The various steering components were all found to be intact, suggesting that the steering system of the Motor Car was likely to be in serviceable condition at the material time of accident. There was also no sign of fluid stain observed on the various undercarriage components at the front right wheel of the Motor Car.

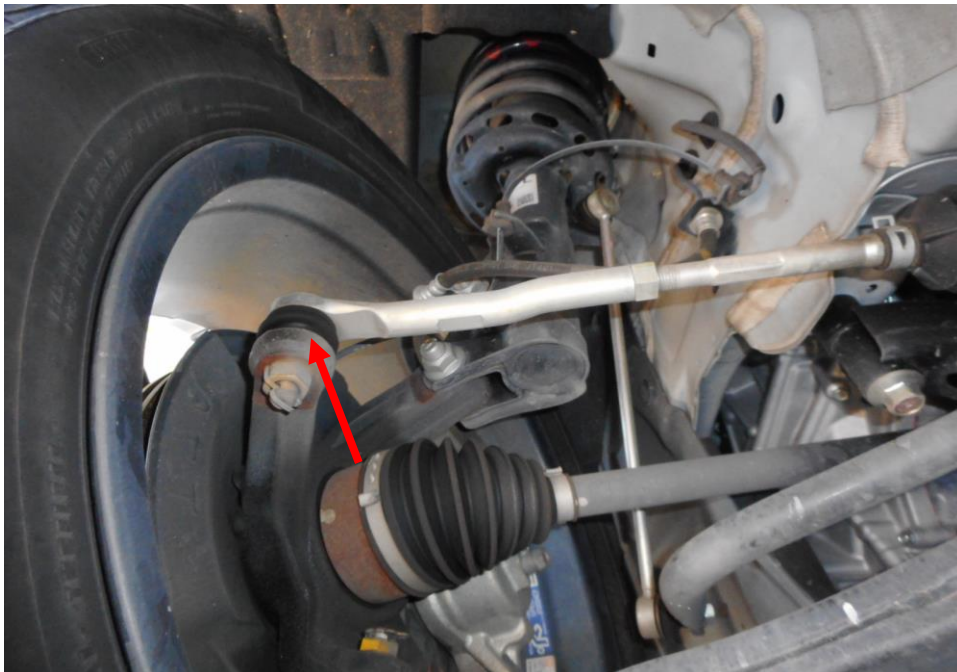
**Photo 23** shows the various undercarriage components at the front left wheel of the Motor Car, which had included the steering tie rod (red arrow). The various undercarriage components of the Motor Car were all found to be intact without any visible damage.

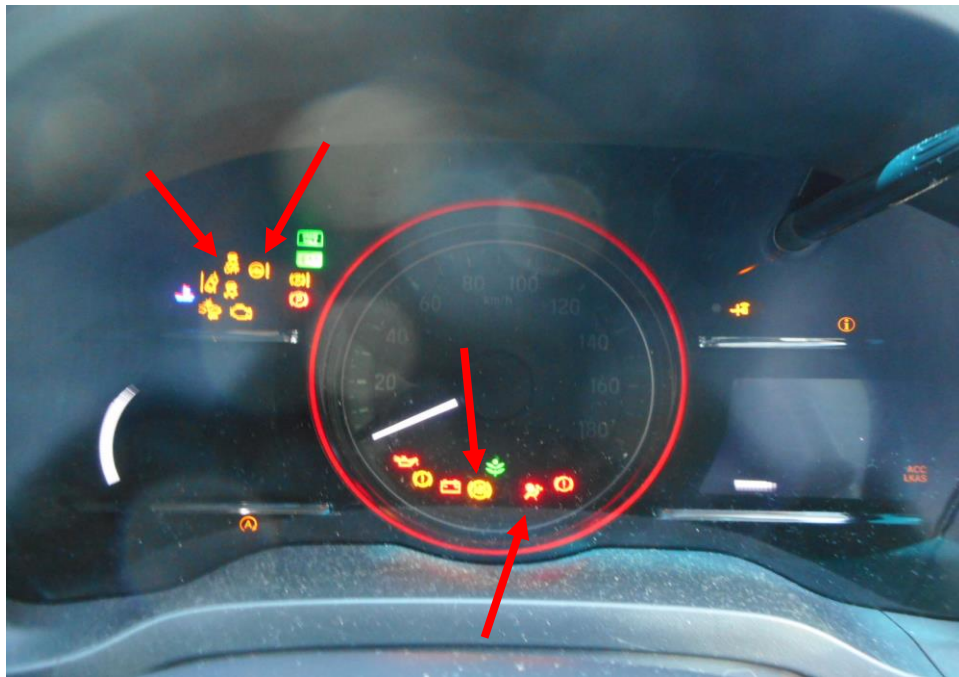
**Photo 24** shows the warning light for Anti-Lock Brake System (ABS) and Power Steering System (EPS), Supplemental Restraint System (SRS) and Traction Control (TC) (arrowed) appearing on the instrument panel of the Motor Car during the self-test of its various electronic operating systems when its engine was cranked.

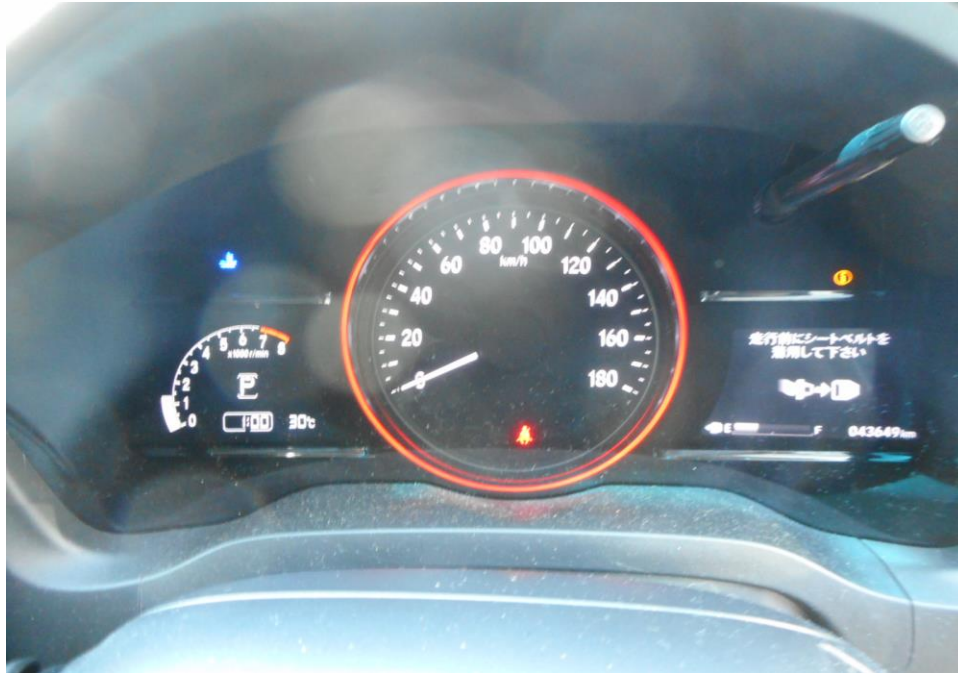
**Photo 25** shows no warning lights illuminated on the instrument panel of the Motor Car after the engine was cranked. This would suggest that there was no abnormality to the electronic operating system of the Motor Car, like the ABS, EPS, SRS, and TC etc.
