Your Ref: TP/IP/02429/2021
Our Ref : CI/TPD21004895/P

Fatal Accident Investigation Team

MECHANICAL INSPECTION REPORT OF MOTOR VAN GBJ 998U

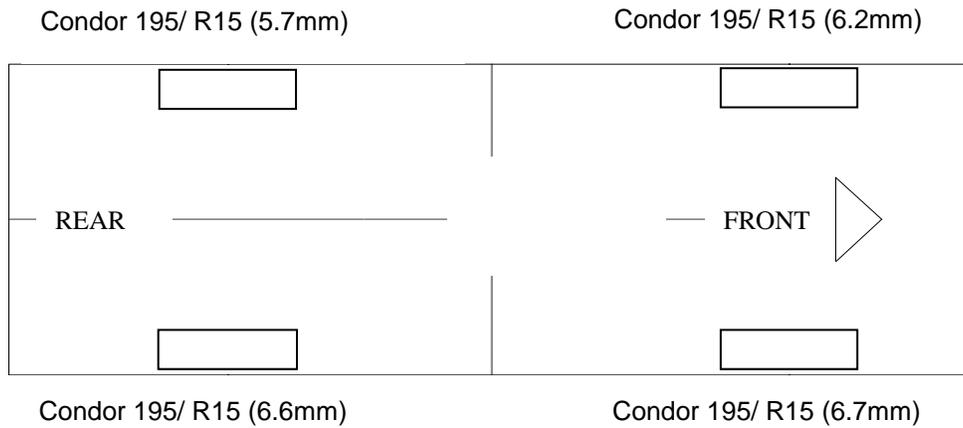
6. The 4 tyres of the Motor Van were observed to be in serviceable condition and sufficiently inflated for vehicular operation. I did not find any tear, cut or burst mark(s) on the outer and the inner sidewalls as well as across the tread of the 4 tyres. The tyre brand, tyre size and remaining tread depth of the 4 tyres of the Motor Van were recorded as follows:-

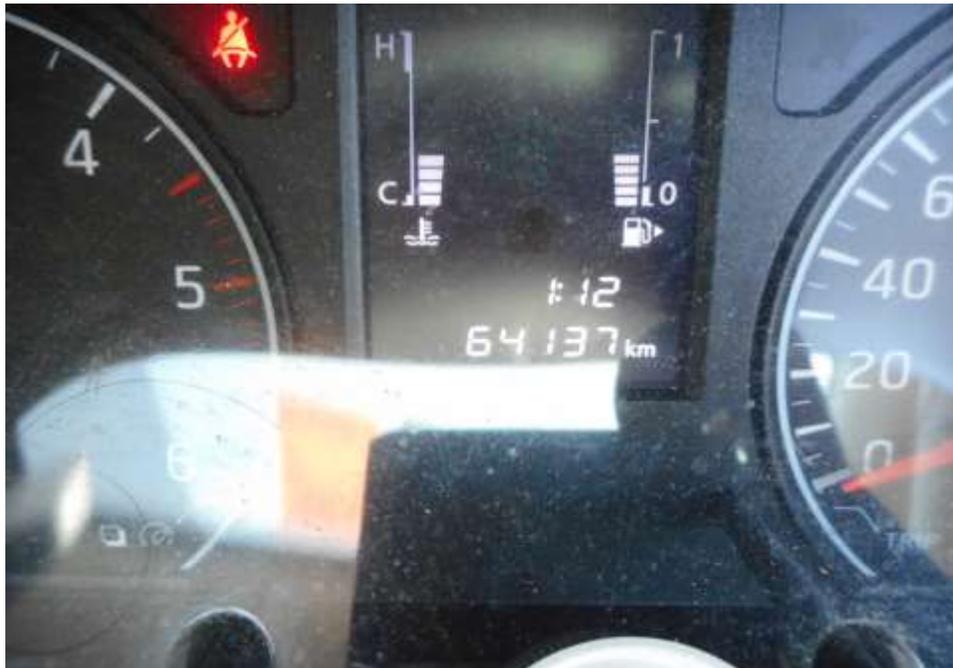
4. The mileage of the Motor Van at the time of my inspection was 64,137km.
5. The Motor Van was observed to sustained damage at its rear portion. Its rear windscreen, rear left headlamp, rear bumper and rear body panel were damage at the time of my inspection.

Photo 1 shows a general view of the instrument cluster of the Motor Van at the time of my inspection. The mileage of the Motor Van was 64,137 km

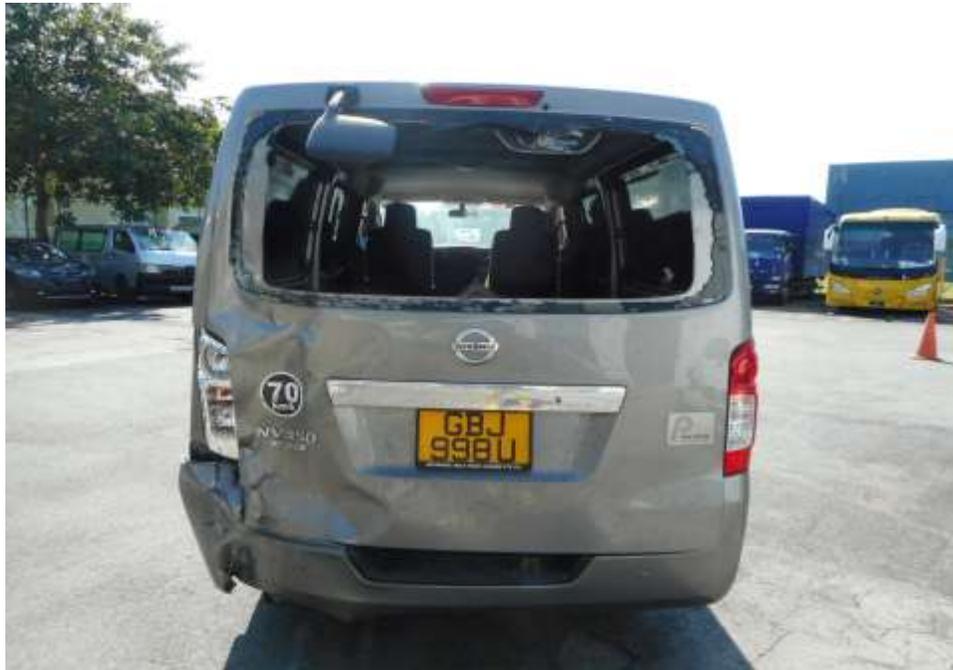
Photo 2 shows a general view of the rear portion of the Motor Van at the time of my inspection. Its rear portion. Its rear windscreen, rear left headlamp, rear bumper and rear body panel were damage at the time of my inspection.

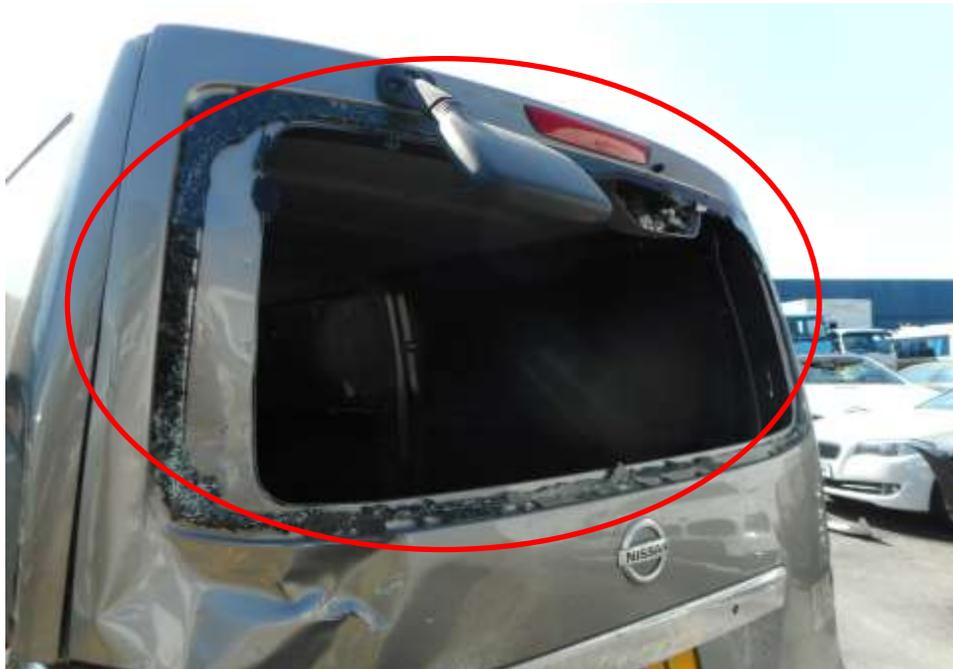
Photo 3 shows a close up view of the Motor Van's rear portion at the time of my inspection. Its rear windscreen (circled) was damage at the time of my inspection as a result of the accident.

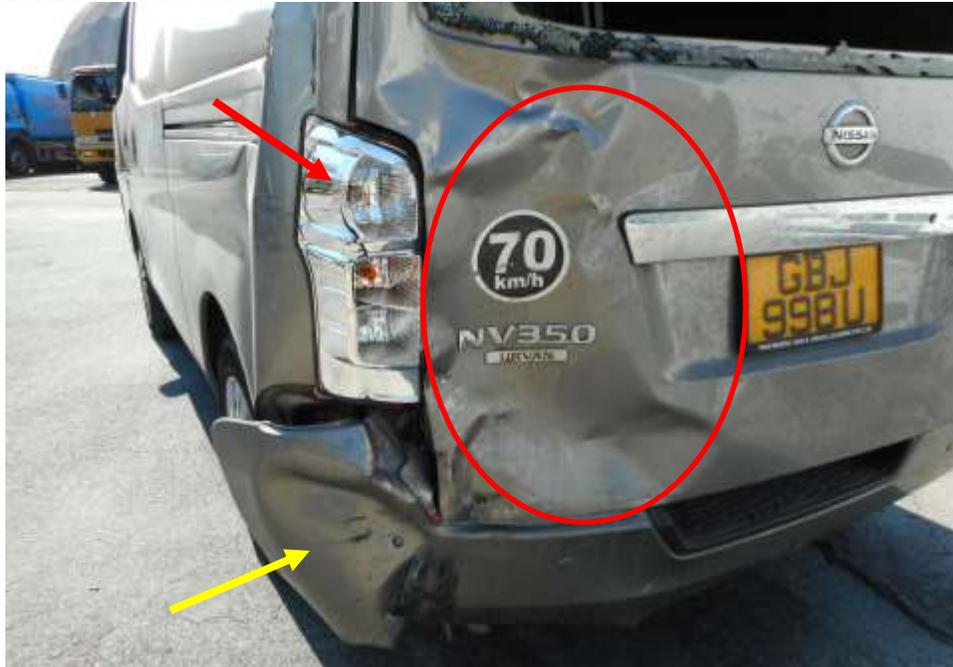
Photo 4 shows a close up view of the Motor Van's rear portion at the time of my inspection. Its rear left headlamp (red arrow), rear body panel (red circle) and rear bumper (yellow arrow) was damage at the time of my inspection as a result of the accident.

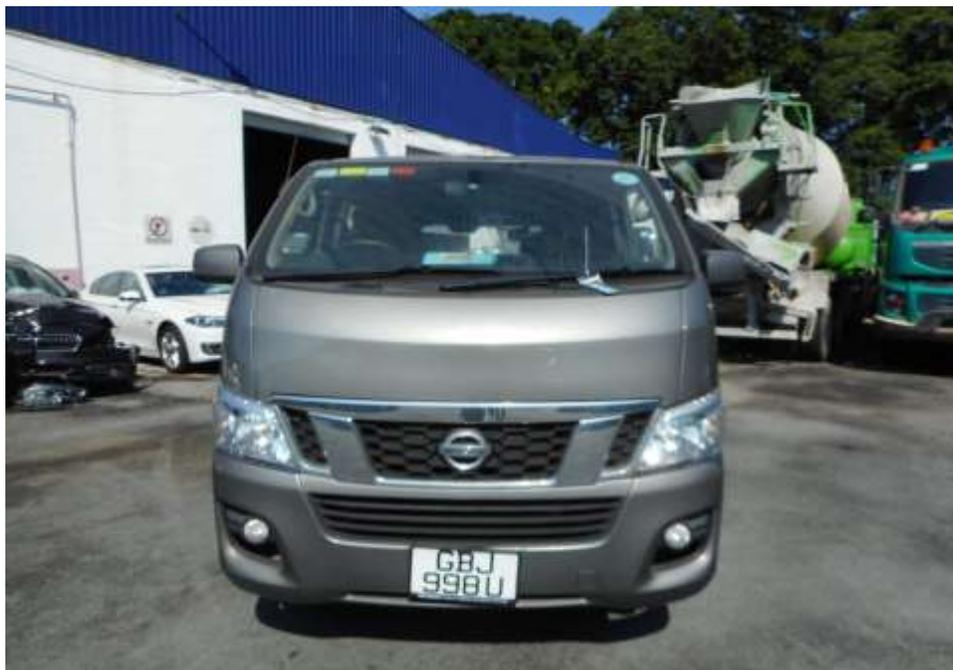
Photo 5 shows a general view of the Motor Van's frontal portion at the time of my inspection. The Motor Van was observed to be intact and unaffected by the accident.

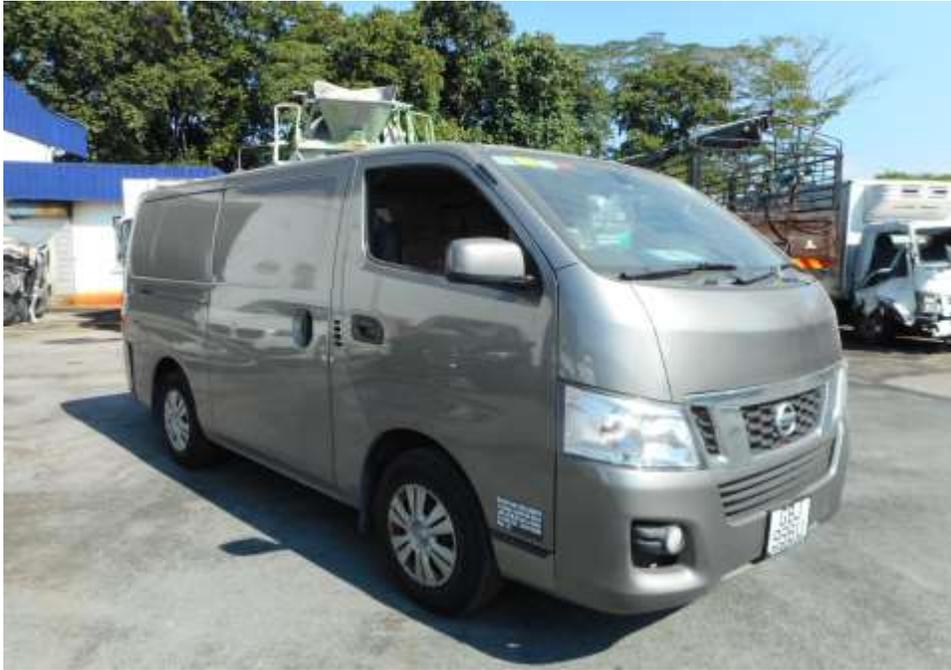
Photo 6 shows a general view of the right body of the Motor Van at the time of my inspection. The Motor Van was observed to be intact and unaffected by the accident.

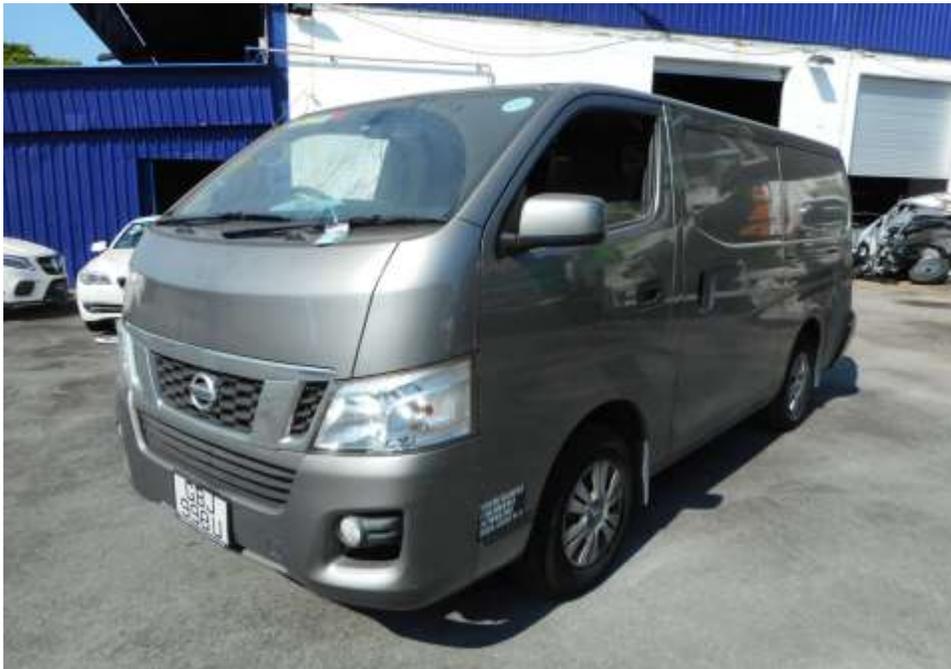
Photo 7 shows a general view of the left body of the Motor Van at the time of my inspection. The Motor Van was observed to be intact and unaffected by the accident.

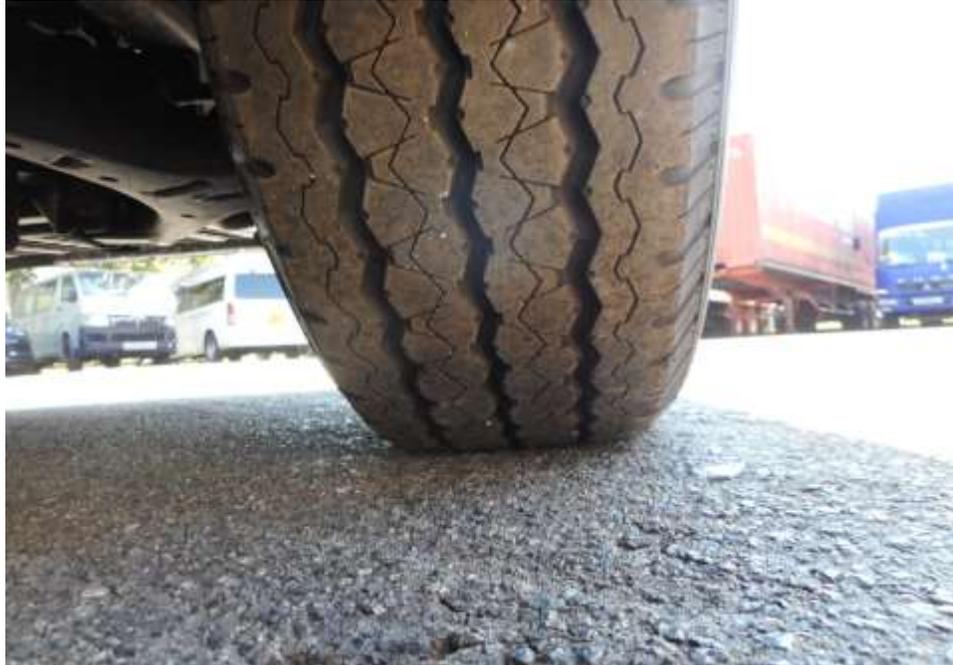
Photo 8 shows the condition of the front right tyre of the Motor Van, which was observed to be in serviceable condition with remaining tread depth of approximately 6.7mm. The tyre, which was wrapped around standard steel wheel rim, was also observed to be sufficiently inflated for vehicular operation. There was no tear, cut or burst mark(s) on the outer and the inner sidewalls as well as across the tread of the 4 tyres that were fitted on the Motor Van.

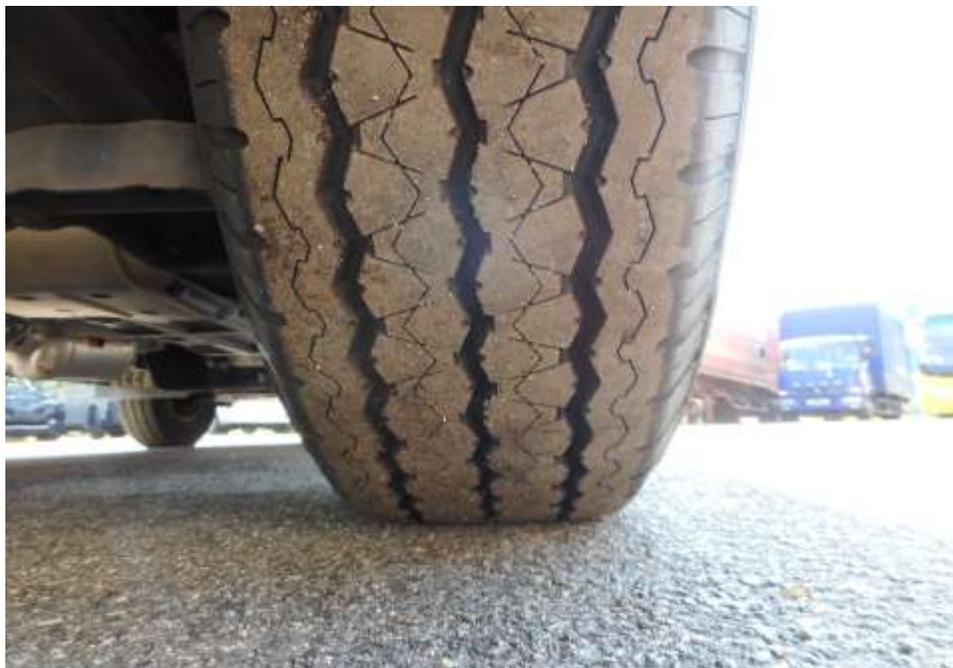
Photo 9 shows the condition of the rear right tyre of the Motor Van, which was observed to be in serviceable condition with remaining tread depth of approximately 6.6mm. The tyre, which was wrapped around standard steel wheel rim, it was observed to be sufficiently inflated for vehicular operation.

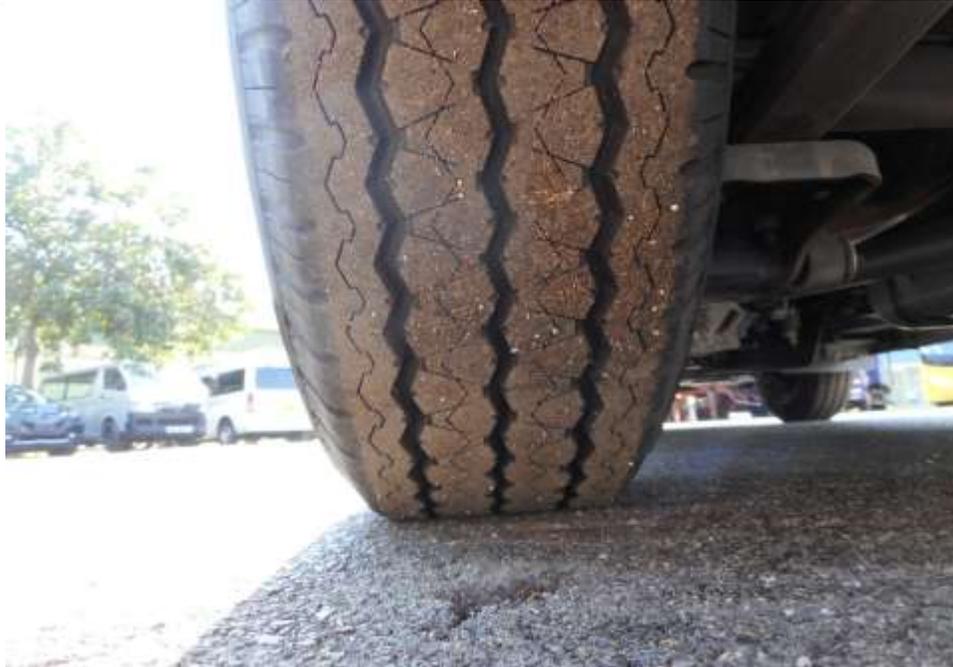
Photo 10 shows the condition of the rear left tyres of the Motor Van, which was observed to be in serviceable condition with remaining tread depth of approximately 5.7mm. The tyres, which were wrapped around standard steel wheel rim, were also observed to be sufficiently inflated for vehicular operation. There was also no damage found on all 4 steel wheel rims of the Motor Van.

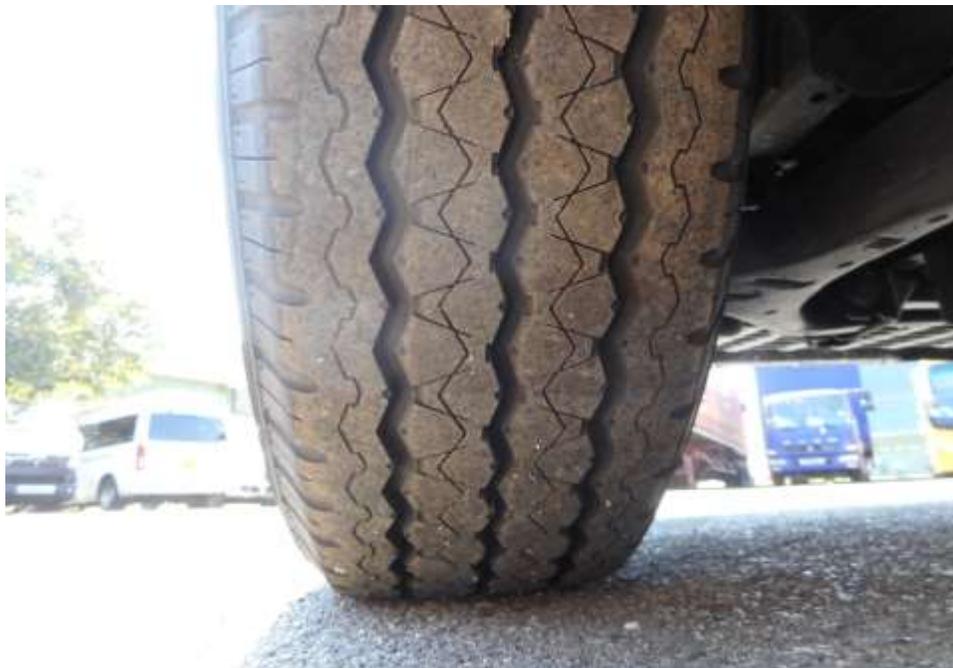
Photo 11 shows the condition of the rear right tyres of the Motor Van, which were observed to be in serviceable condition with remaining, tread depth of approximately 6.2mm. There was also no tear, cut or burst mark(s) on the outer and the inner sidewalls as well as across the tread of the 4 tyres that were fitted on the Motor Van.

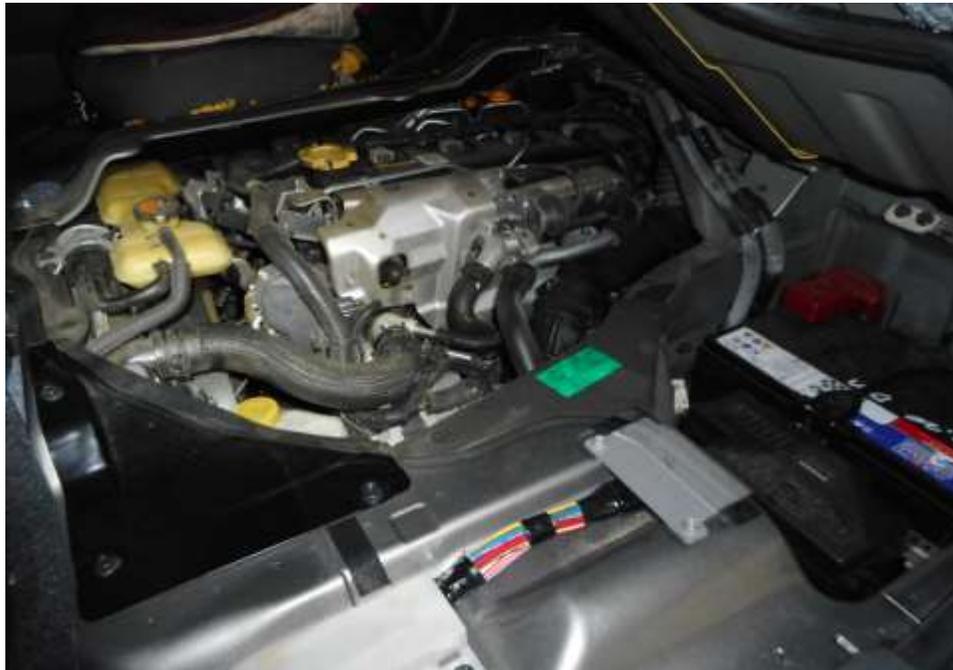
Photo 12 shows a general view of the Motor Van's engine compartment, which was accessed by lifting the front cabin of the Motor Van. The various parts and components inside the engine compartment were unaffected by the accident. There was also no sign(s) or indication(s) of fresh fluid leakage and/or fluid stain within the engine compartment

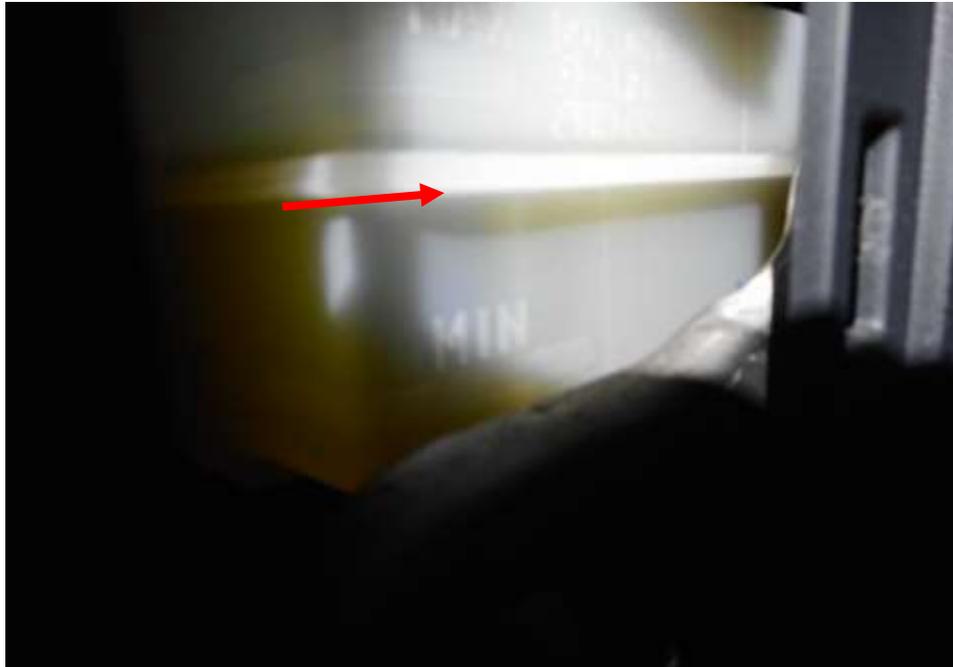
Photo 13 shows the brake fluid reservoir of the Motor Van at the time of my inspection. The brake fluid was observed to be of sufficient level (arrowed) and without any visible contamination.

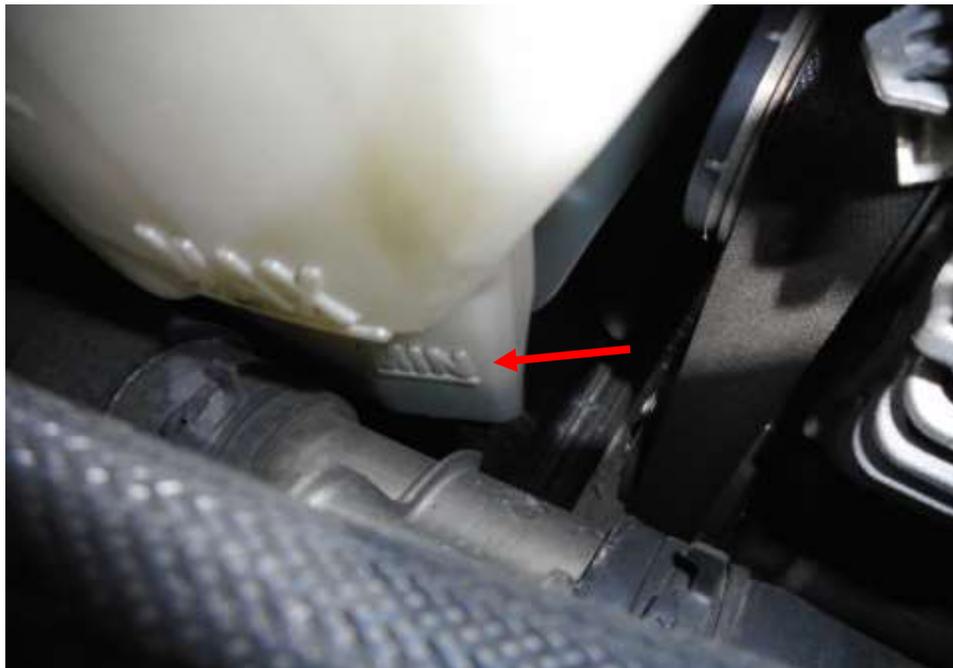
Photo 14 shows the engine coolant reservoir of the Motor Van at the time of my inspection. The engine coolant was observed to be of sufficient level (arrowed) and without any visible contamination.

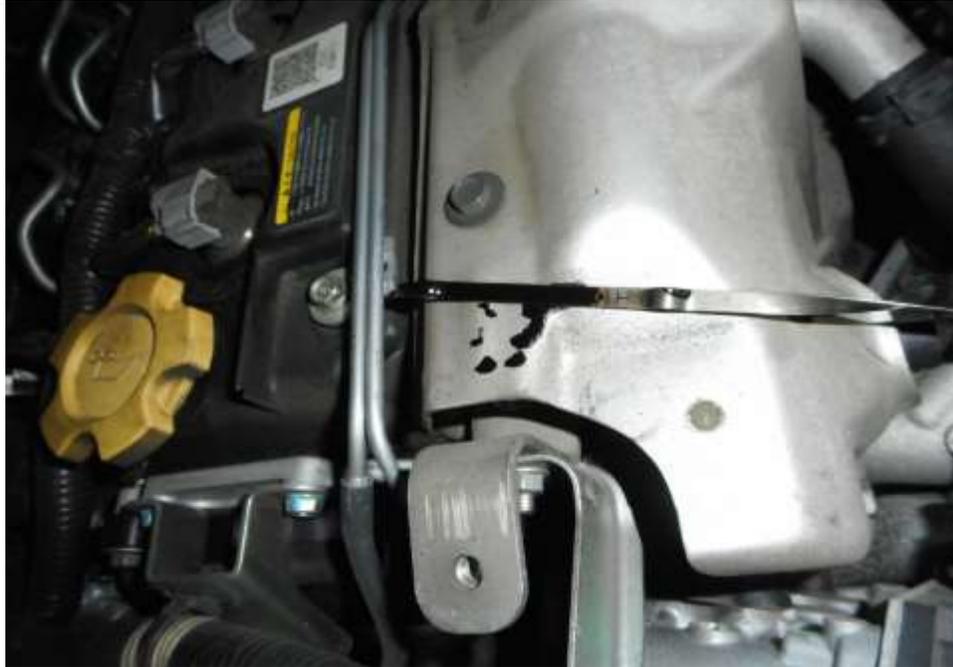
Photo 15 shows the engine oil dip stick of the Motor Van at the time of my inspection. The engine oil was observed to be of sufficient level and without any visible contamination.

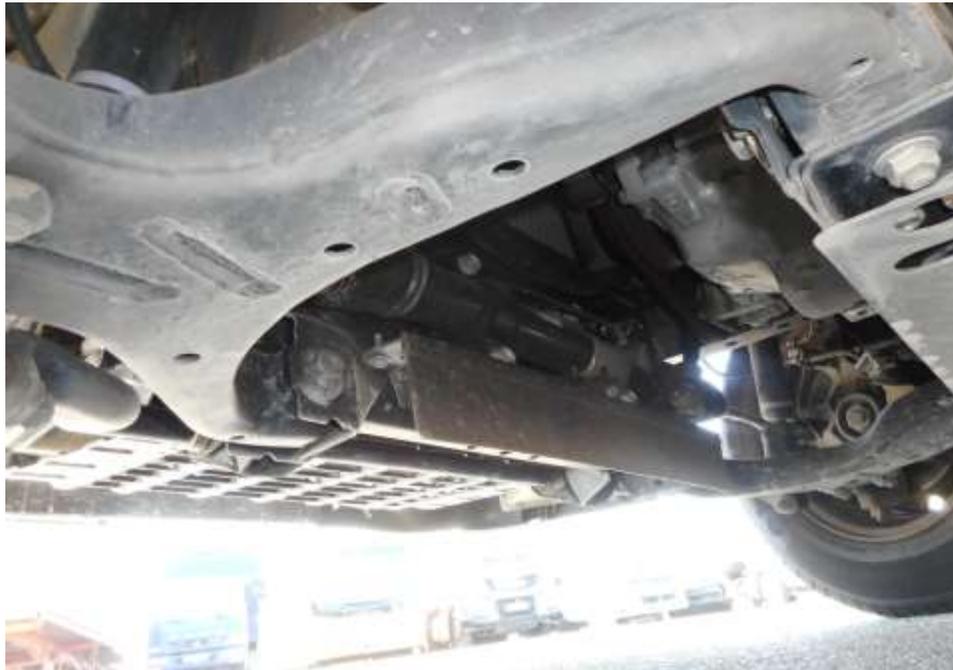
Photo 16 shows the undercarriage of the Motor Van, at the area where the engine housing and transmission housing are located. I did not find any sign(s) or indication(s) of fluid leak and/or fluid stain(s) on the underside of the Motor Van.

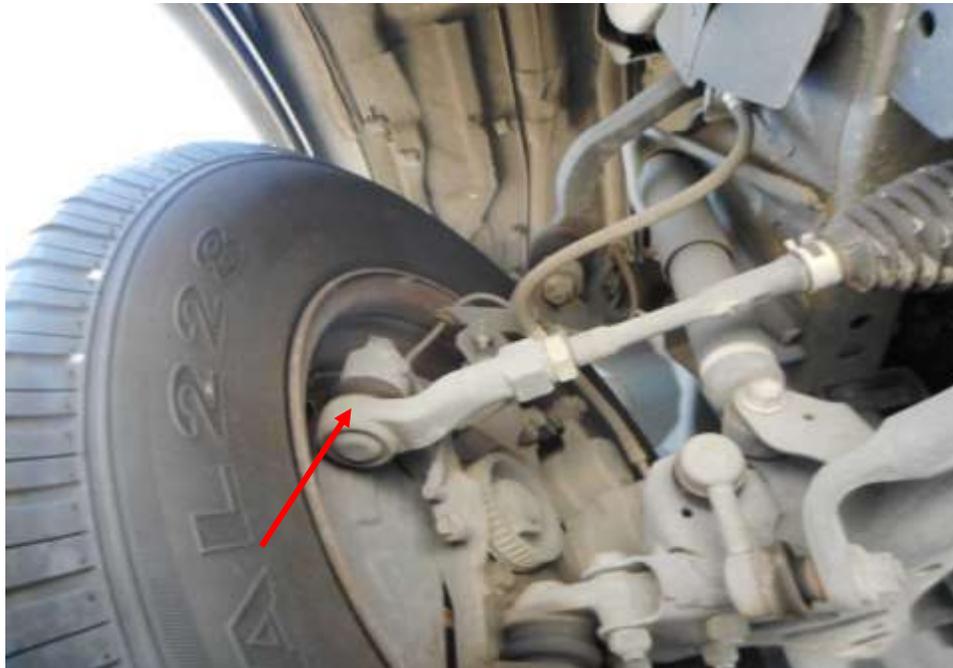
Photo 17 shows the various undercarriage components at the front right wheel of the Motor Van, in particular the steering tie rod end (arrowed). The various steering components were all found to be intact, suggesting that the steering system of the Motor Van was likely to be in serviceable condition at the material time of accident. There was also no sign of fluid stain(s) observed on the various undercarriage components.

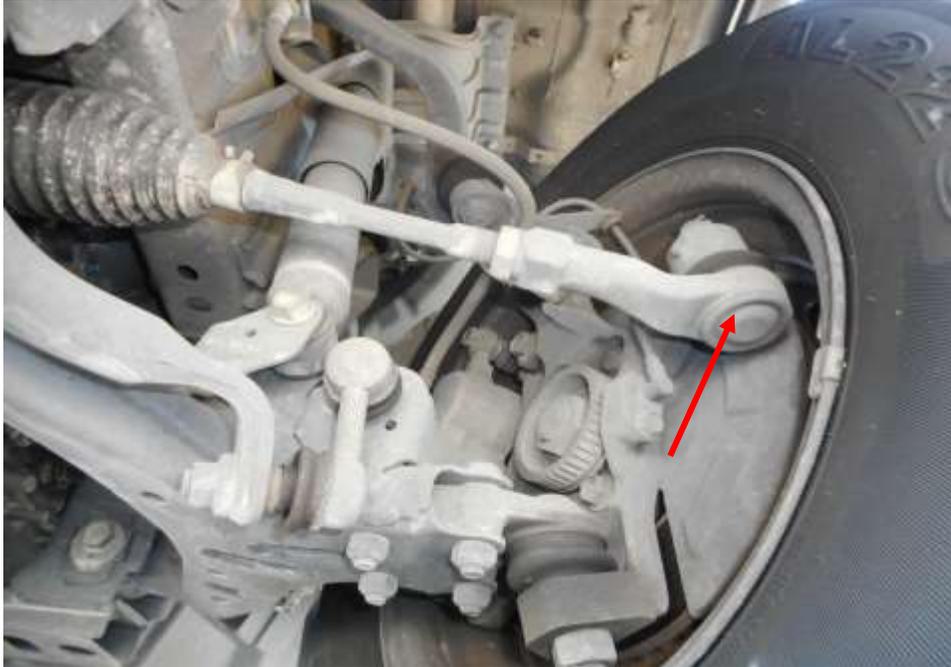
Photo 18 shows the various undercarriage components at the front left wheel of the Motor Van, in particular the steering tie rod end (arrowed). The various undercarriage components of the Motor Van were all found to be intact without any visible damage. There was also no sign of fluid stain(s) observed on the various undercarriage components.

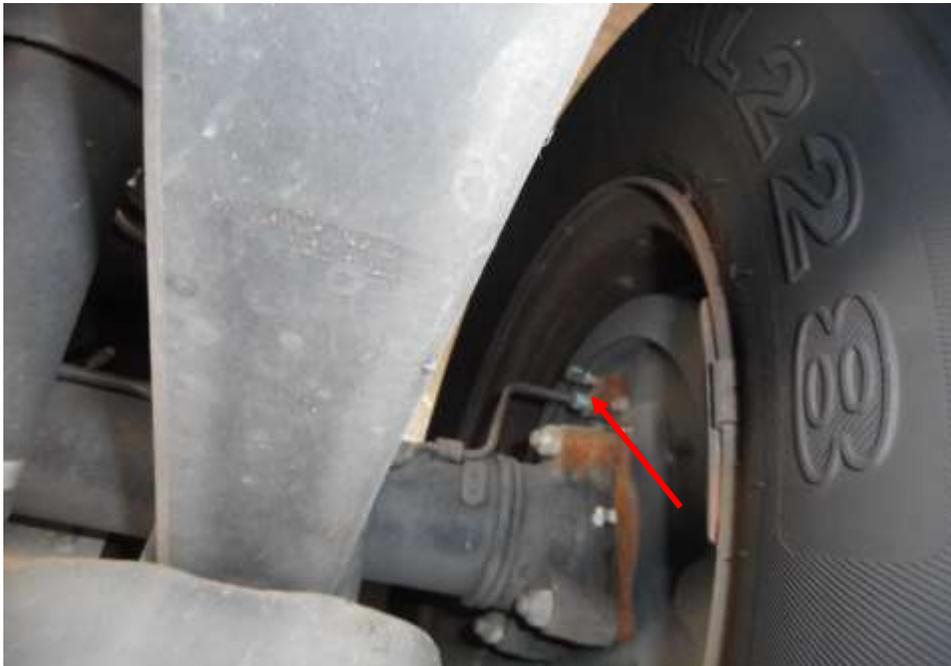
Photo 19 shows the brake pipe (arrowed) at the rear right wheel of the Motor Van. I did not observe any leakage of brake fluid at the time of my inspection of the Motor Van. My static tests of the Motor Van's braking system, along with my visual examination of the various mechanical components in the braking system, had indicated that there was no internal leakage of pressure/vacuum. Hence the braking system of the Motor Van was likely to be in serviceable condition at the material time of accident.

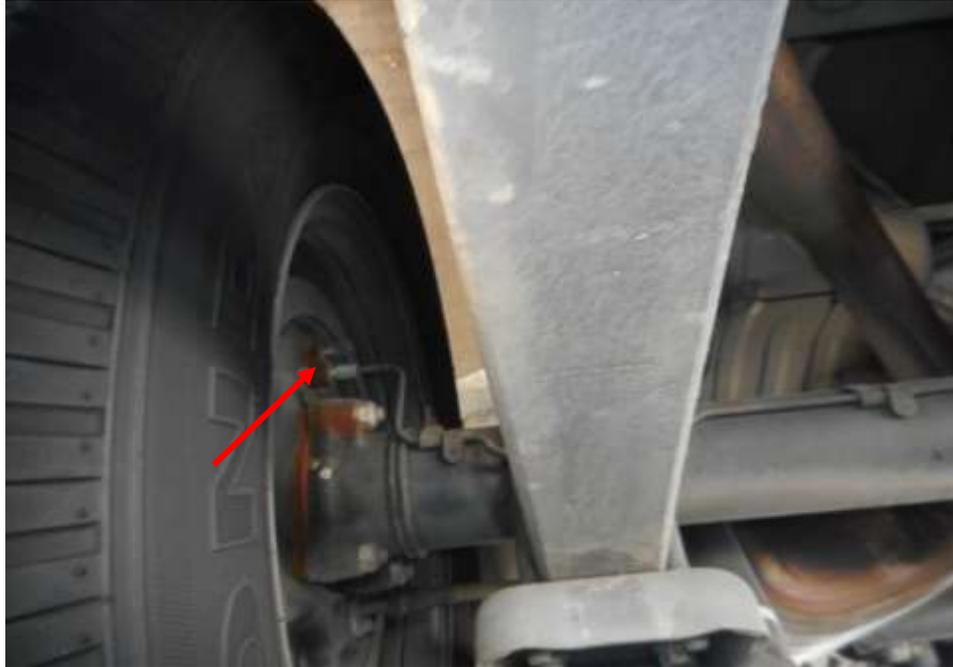
Photo 20 shows the brake pipe (arrowed) at the rear left wheel of the Motor Van. I did not observe any leakage of brake fluid at the time of my inspection of the Motor Van. My static tests of the Motor Van's braking system, along with my visual examination of the various mechanical components in the braking system had indicated that there was no internal leakage of pressure/vacuum. Hence the braking system of the Motor Van was likely to be in serviceable condition at the material time of accident.

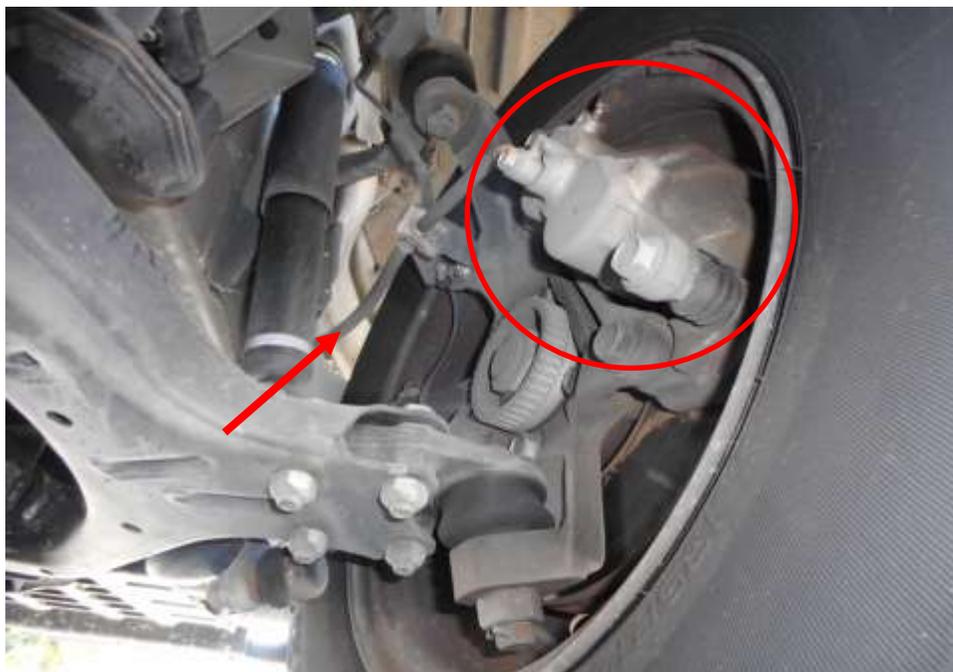
Photo 21 shows the brake hose/pipe (arrowed) at the front right wheel of the Motor Van. No leakage of brake fluid was observed. Visual examination of the various components of the braking system like the brake caliper (circled), brake booster, brake pedal etc had revealed all to be intact and without visible damage at the time of accident. There was also no sign of fluid stain(s) observed on the various undercarriage components.

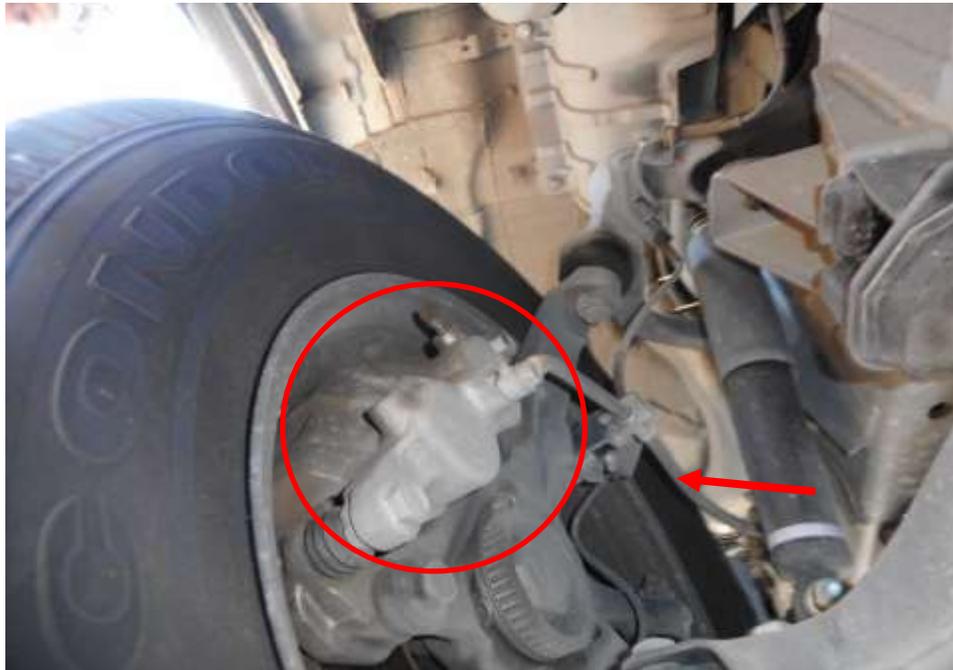
Photo 22 shows the brake hose/pipe (arrowed) at the front left wheel of the Motor Van. No leakage of brake fluid was observed. Visual examination of the various components of the braking system like the brake caliper (circled), brake booster, brake pedal etc had revealed all to be intact and without visible damage at the time of accident. There was also no sign of fluid stain(s) observed on the various undercarriage components.

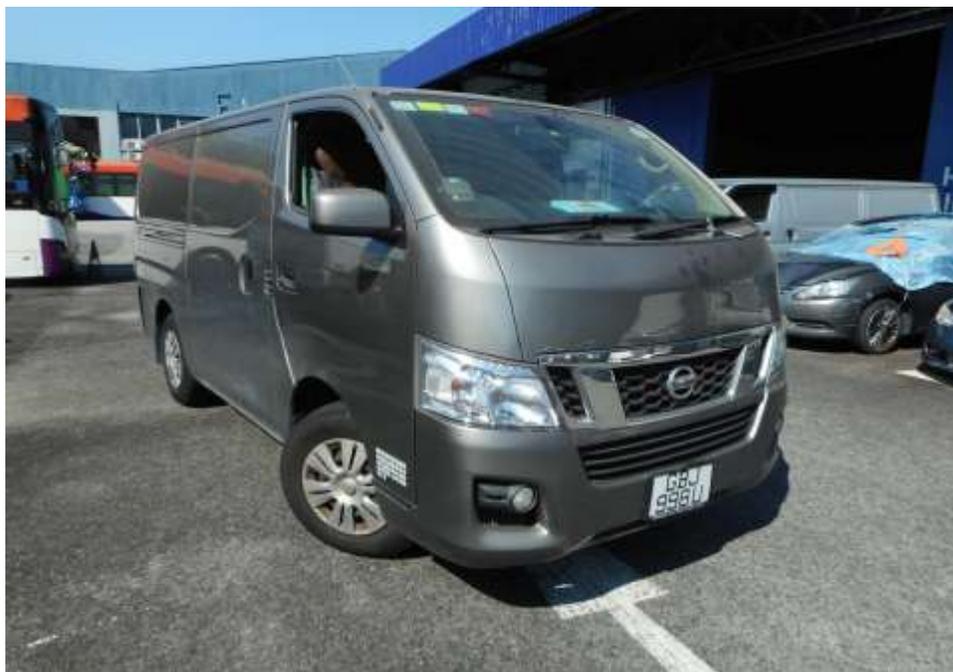
Photo 23 shows the front right wheel of the Motor Van turned to its full left. During my steering system test, I did not experience any abnormal free play and/or resistance when I had turned the steering wheel towards full left and full right. This would suggest that the steering system of the Motor Van was likely to be in serviceable condition at the material time of accident.

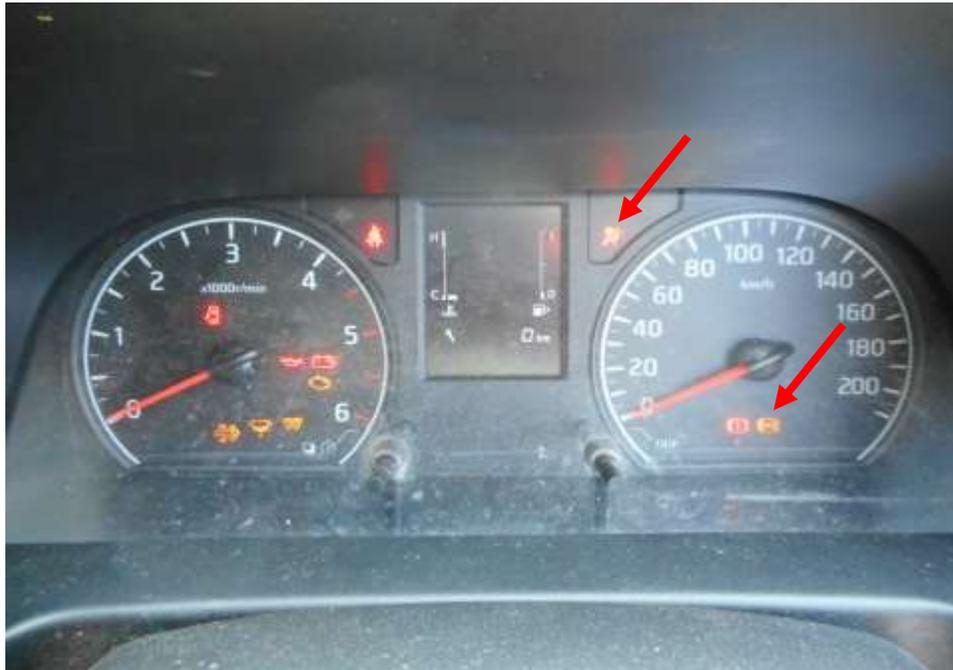
13. The Motor Van's automatic self-test of the functionality of its electronic operating systems like the Anti-Lock Brake System (ABS) and Supplemental Restraint System (SRS) during cranking of the engine had indicated that the system were in working condition and without abnormality. This can be established from the warning lights disappearing from the instrument panel after the self-test. See photo 24 & 25 below.

Photo 24 shows the warning light for Anti-Lock Brake System (ABS) and Supplemental Restraint System (SRS) (arrowed) appearing on the instrument panel of the Motor Van during the self-test of its various electronic operating systems when its engine was cranked.

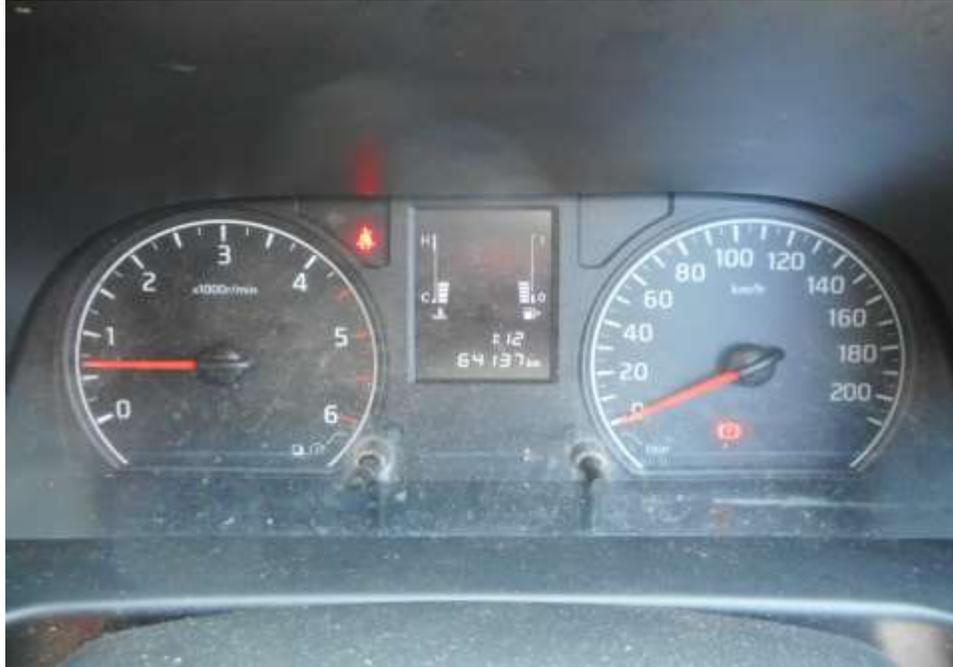
Photo 25 shows no warning lights illuminated on the instrument panel of the Motor Van after the engine was cranked. This would suggest that there was no abnormality to the electronic operating system of the Motor Van, like the ABS, and SRS etc.
