Your Ref: TP/IP/02429/2021
Our Ref : CI/TPD21004896/P

Fatal Accident Investigation Team

MECHANICAL INSPECTION REPORT OF MOTOR CAR SGG 349A

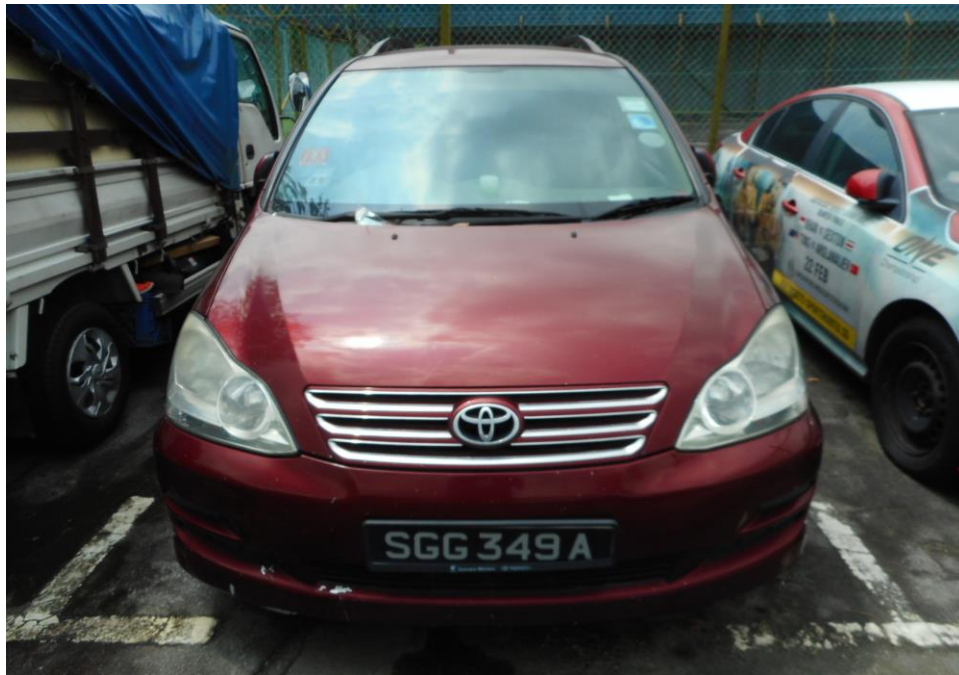
4. The mileage of the Motor Car at the time of my inspection was not recorded as the engine of the Motor Car was unable to be started up despite multiple attempts in jumpstarting it.
5. The Motor car was observed to have sustained damage at its front portion. Its front bumper was the body part that were damaged as a result of the accident.

Photo 1 shows a general view of the Motor Car at the time of my inspection. The Motor Car was observed to have sustained damage at its front portion. Its front bumper was the body part that were damaged as a result of the accident.

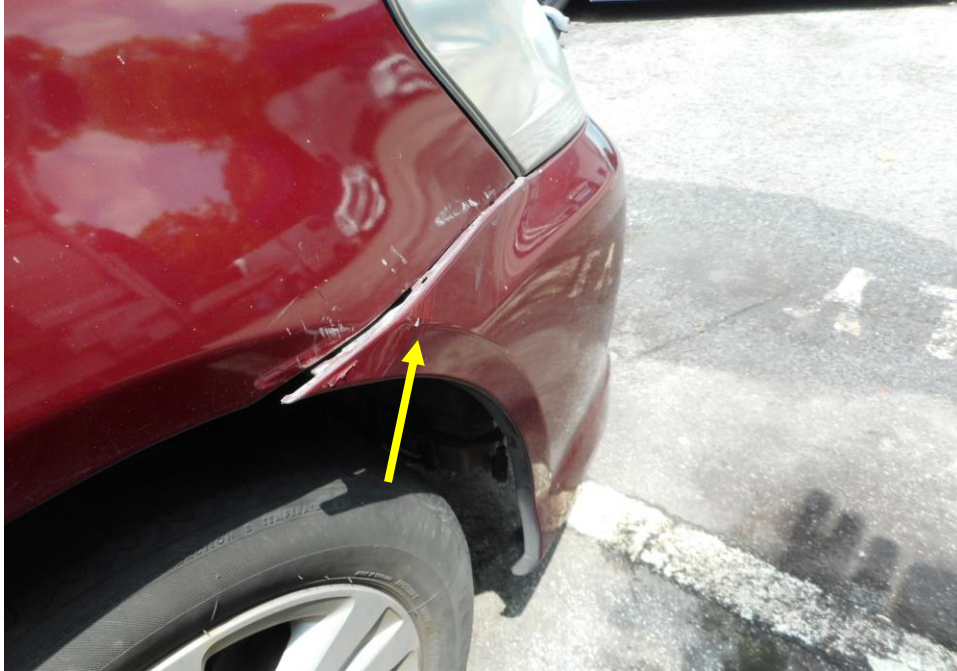
Photo 2 shows a close up view of the Motor Car at the time of my inspection. The Motor Car was observed to have sustained damage at its front portion. Its front bumper (yellow arrow) was the body part that were damaged as a result of the accident.

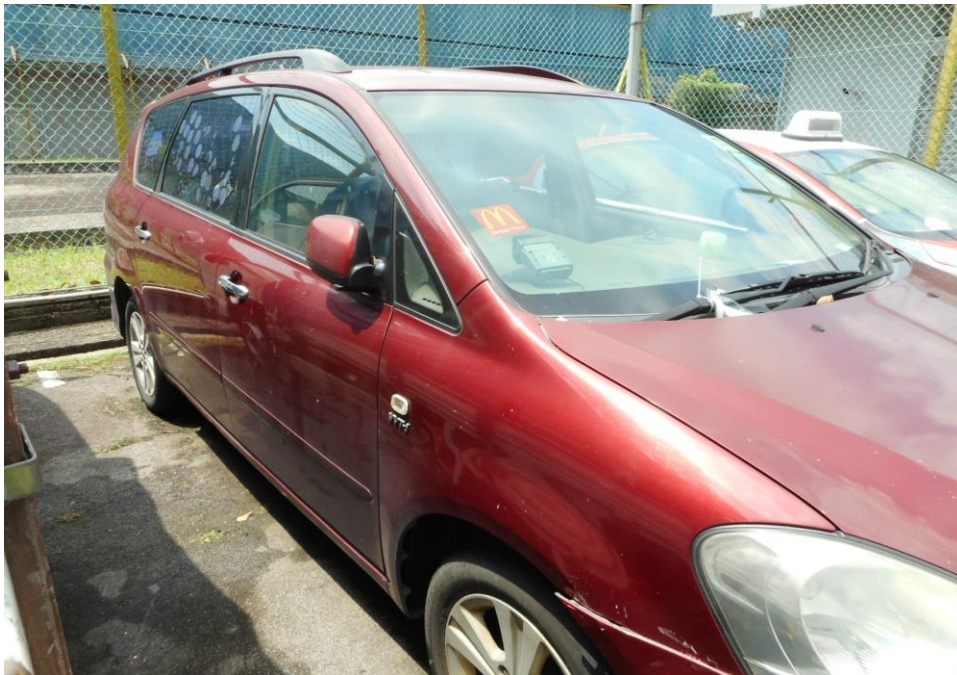
Photo 3 shows a general view of the right body of the Motor Car at the time of my inspection. The Motor Car was observed to be intact and unaffected by the accident.

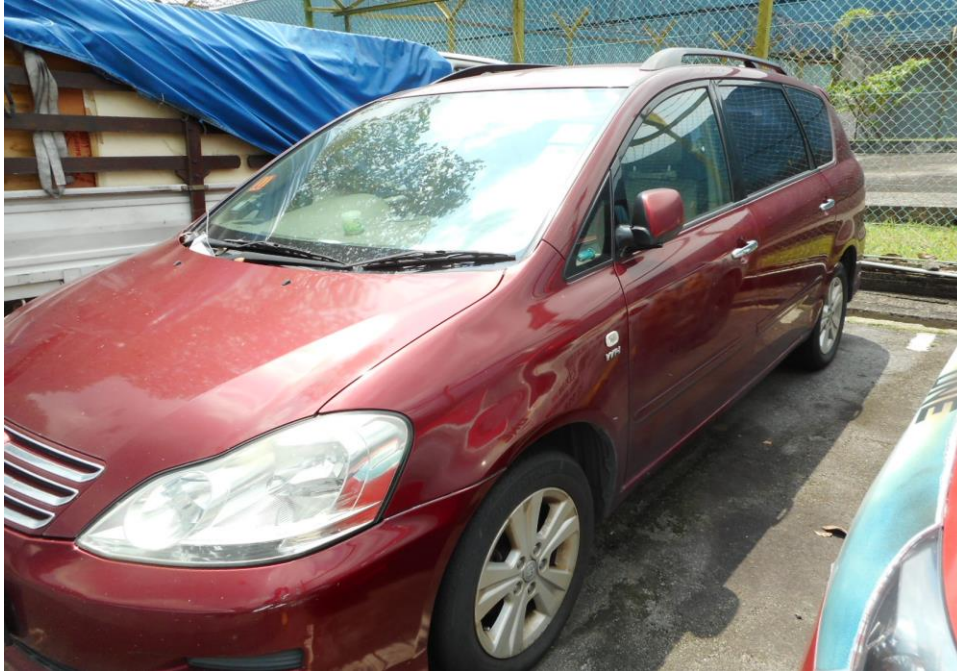
Photo 4 shows a general view of the left body of the Motor Car at the time of my inspection. The Motor Car was observed to be intact and unaffected by the accident.

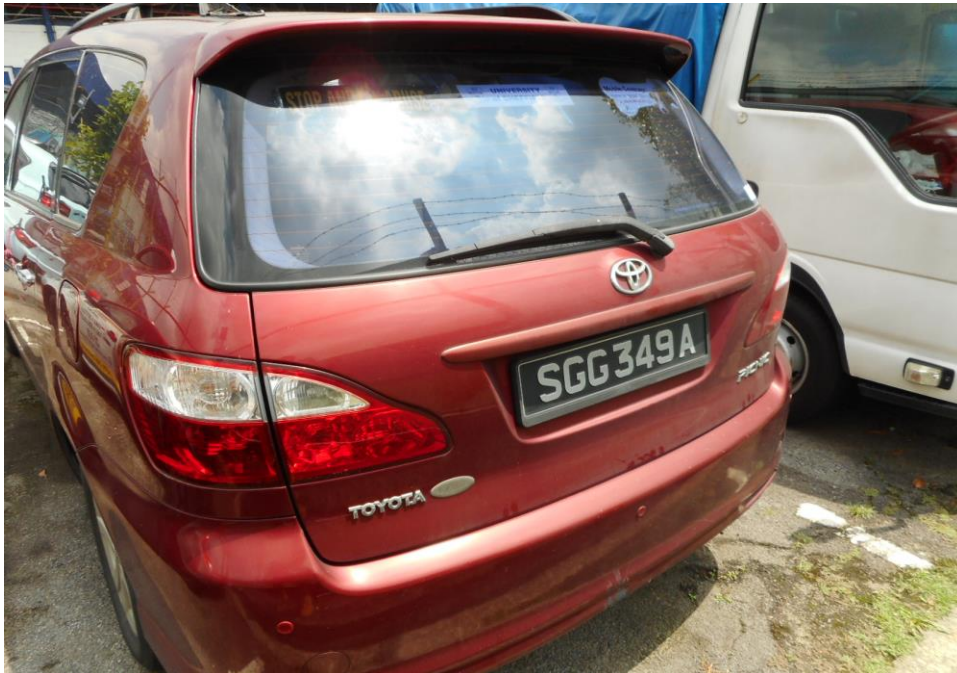
Photo 5 shows a general view of the rear body of the Motor Car at the time of my inspection. The Motor Car was observed to be intact and unaffected by the accident.

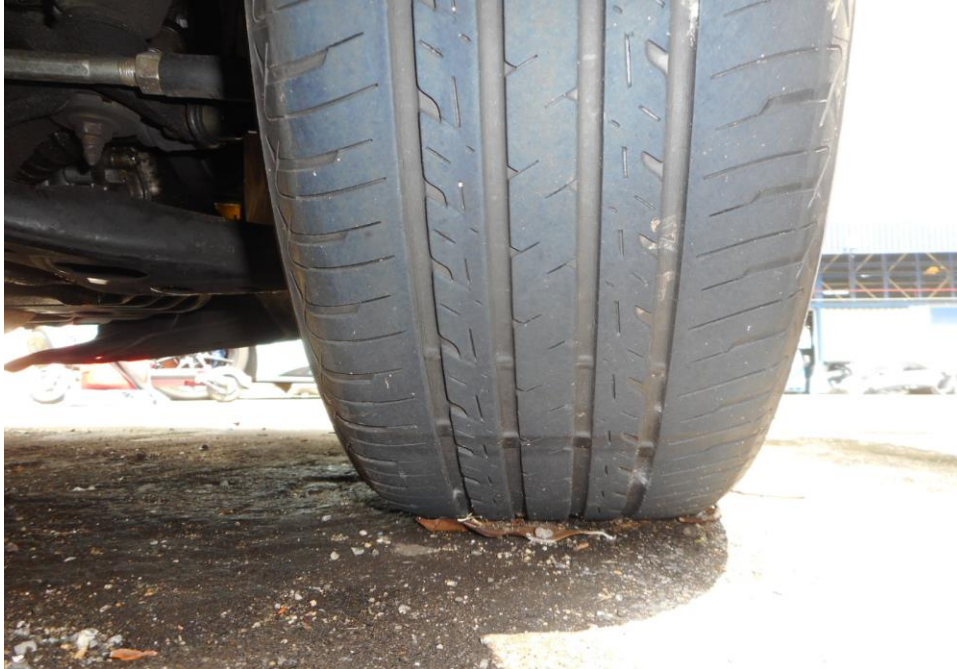
Photo 6 shows the condition of the front right tyre of the Motor Car, which was observed to be in serviceable condition with remaining tread depth of approximately 3.1mm. The tyre, which was wrapped around standard alloy wheel rim, was also observed to be sufficiently inflated for vehicular operation. There was no tear, cut or burst mark(s) on the outer and the inner sidewalls as well as across the tread of the 4 tyres that were fitted on the Motor Car.

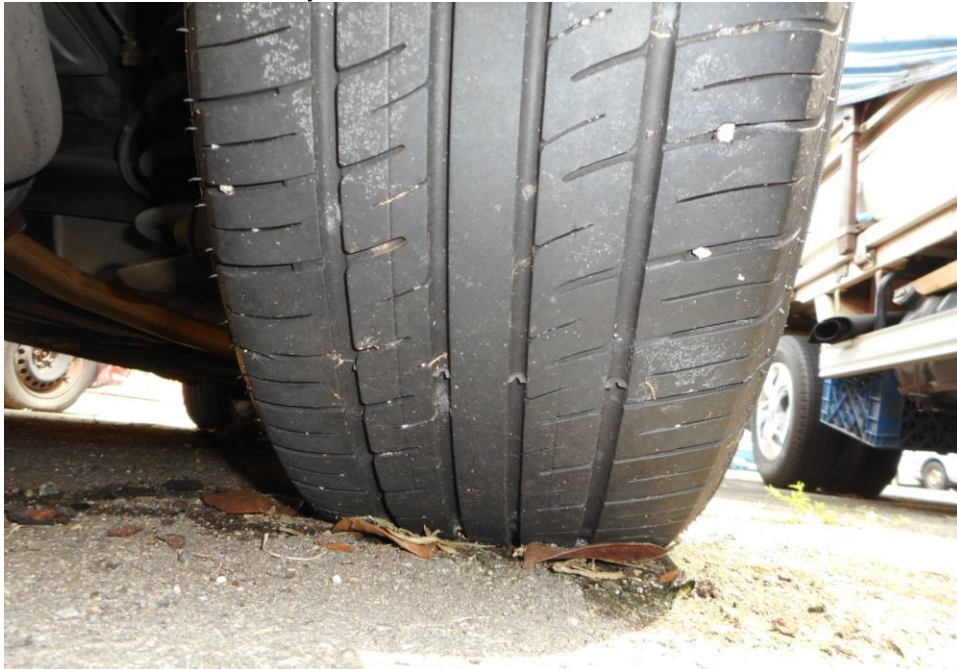
Photo 7 shows the condition of the rear tyre of the Motor Car, which was observed to be in serviceable condition with remaining tread depth of approximately 4.6mm. The tyre, which was wrapped around standard alloy wheel rim, was also observed to be sufficiently inflated for vehicular operation. There was no tear, cut or burst mark(s) on the outer and the inner sidewalls as well as across the tread of the 4 tyres that were fitted on the Motor Car.

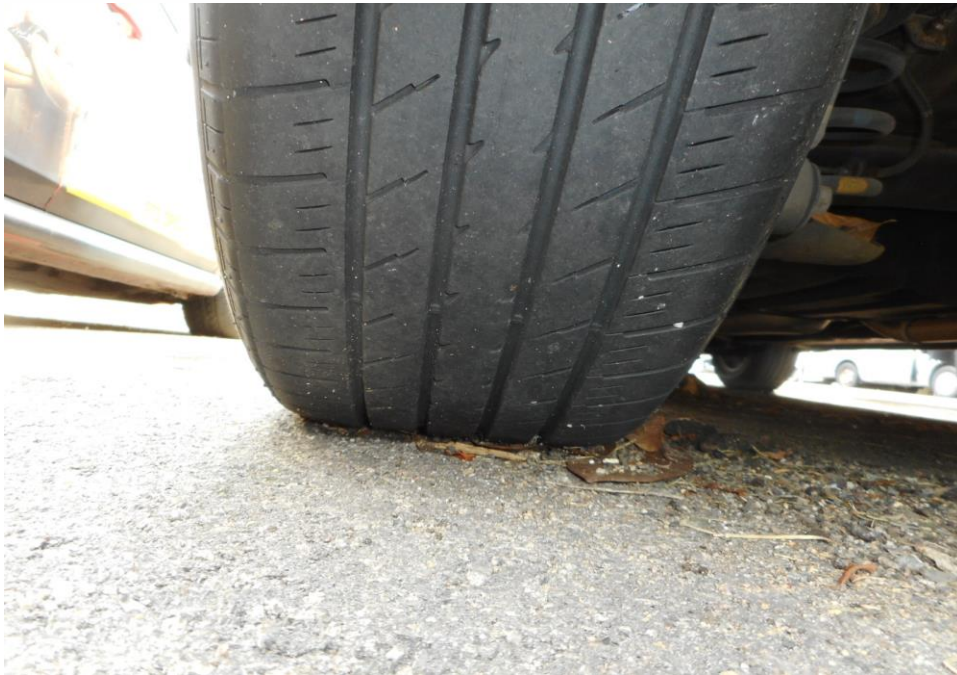
Photo 8 shows the condition of the rear left tyres of the Motor Car, which was observed to be in serviceable condition with remaining tread depth of approximately 4mm. The tyres, which were wrapped around standard alloy wheel rim, were also observed to be sufficiently inflated for vehicular operation. There was also no damage found on all 4 alloy wheel rims of the Motor Car.

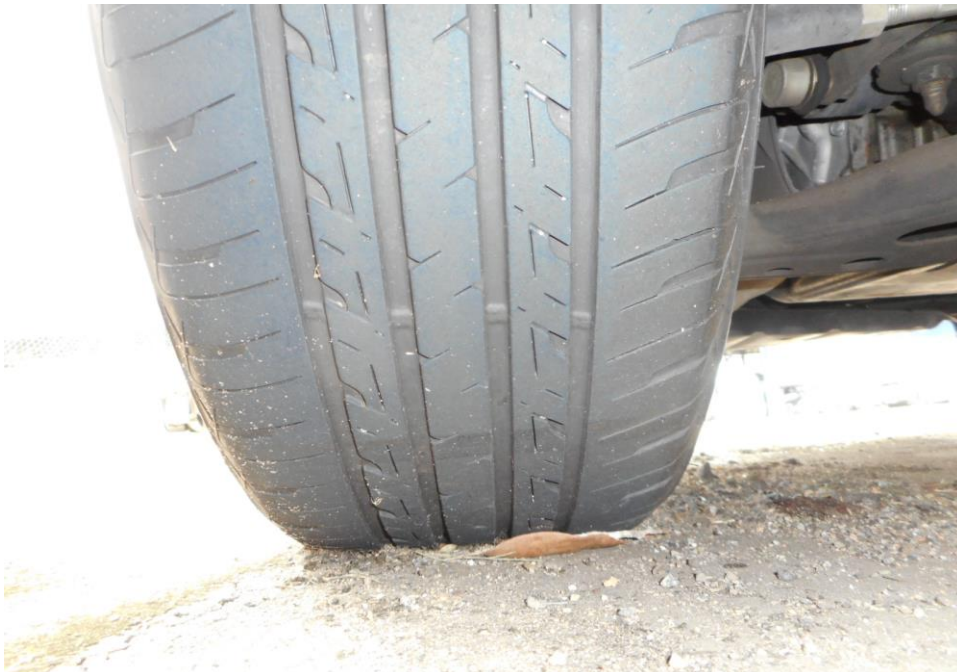
Photo 9 shows the condition of the rear right tyres of the Motor Car, which were observed to be in serviceable condition with remaining, tread depth of approximately 3.7mm. There was also no tear, cut or burst mark(s) on the outer and the inner sidewalls as well as across the tread of the 4 tyres that were fitted on the Motor Car.

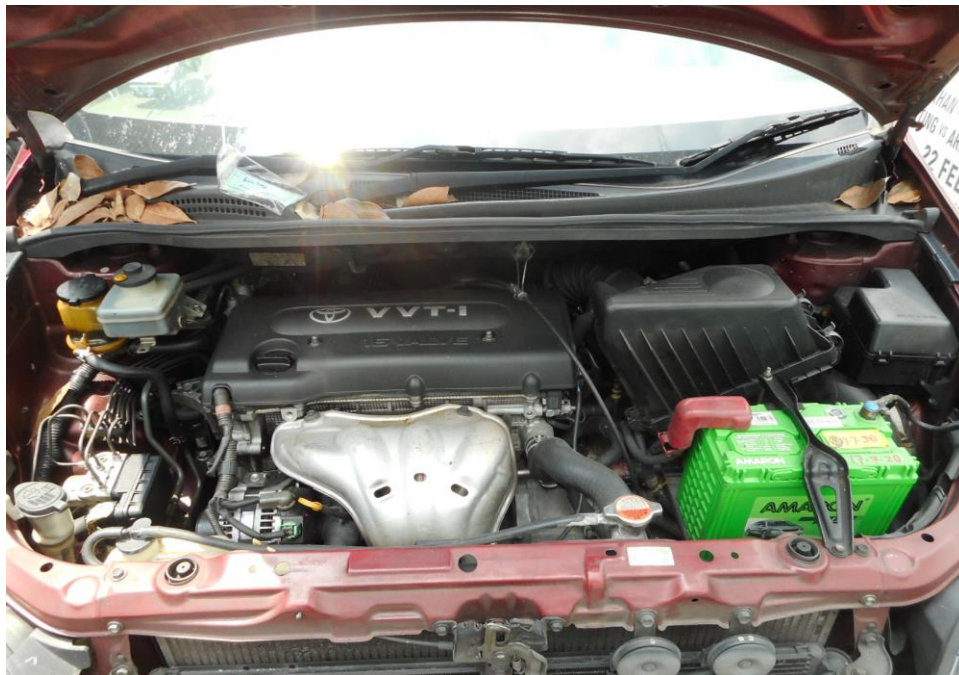
Photo 10 shows a general view of the Motor Car's engine compartment, which was accessed by lifting the front cabin of the Motor Car. The various parts and components inside the engine compartment were unaffected by the accident. There was also no sign(s) or indication(s) of fresh fluid leakage and/or fluid stain within the engine compartment

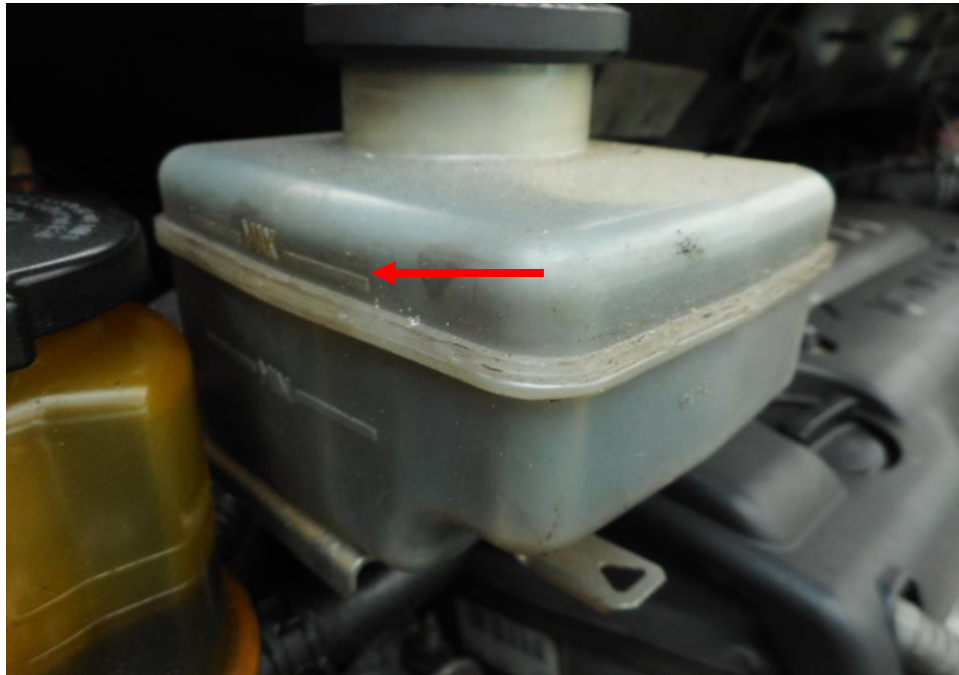
Photo 11 shows the brake fluid reservoir of the Motor Car at the time of my inspection. The brake fluid was observed to be of sufficient level (arrowed) and without any visible contamination.

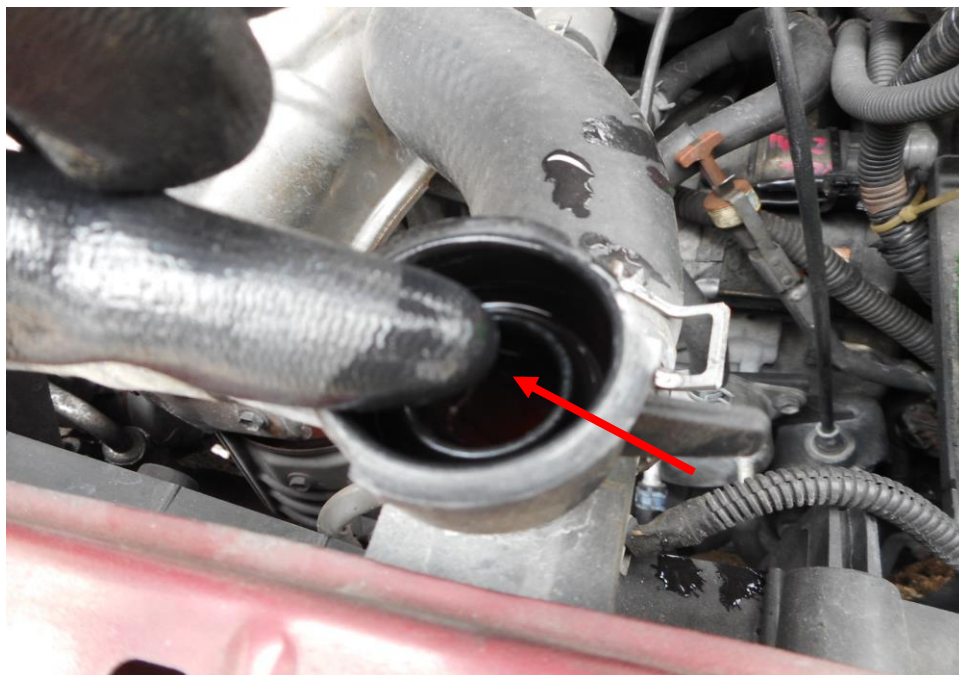
Photo 12 shows the engine coolant reservoir of the Motor Car at the time of my inspection. The engine coolant was observed to be of sufficient level (arrowed) and without any visible contamination.

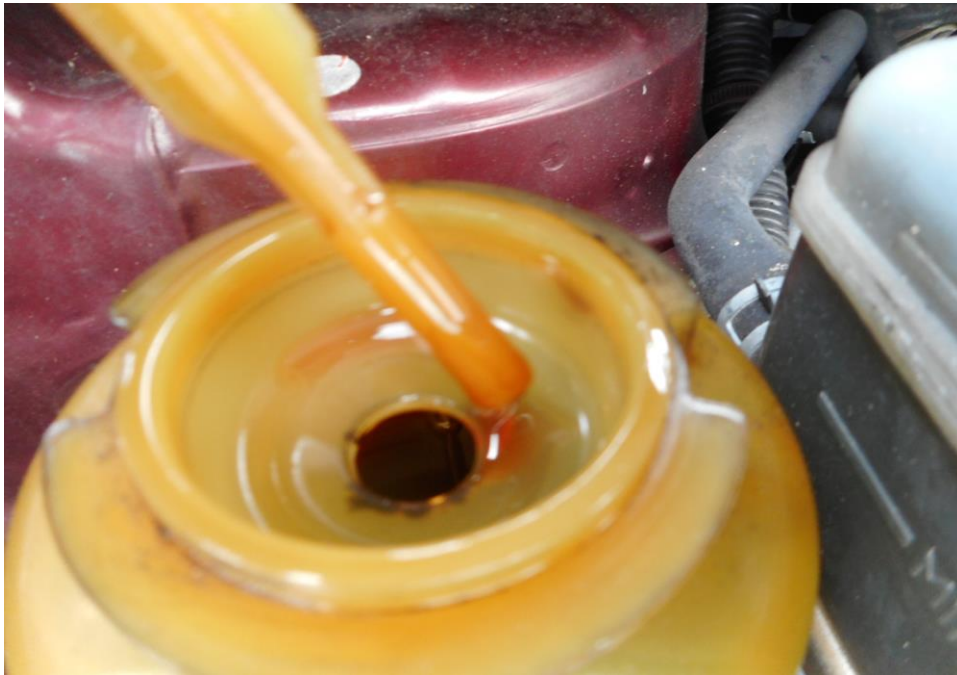
Photo 13 shows the power steering fluid dip stick of the Motor Car at the time of my inspection. The steering fluid was observed to be of sufficient level and without any visible contamination.

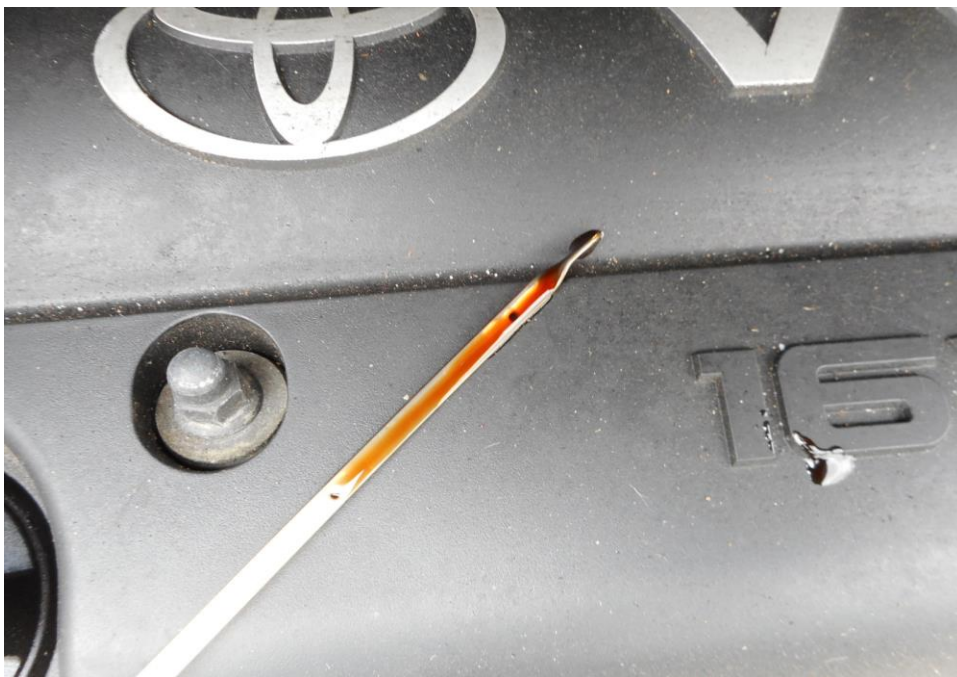
Photo 14 shows the engine oil dip stick of the Motor Car at the time of my inspection. The engine oil was observed to be of sufficient level and without any visible contamination.

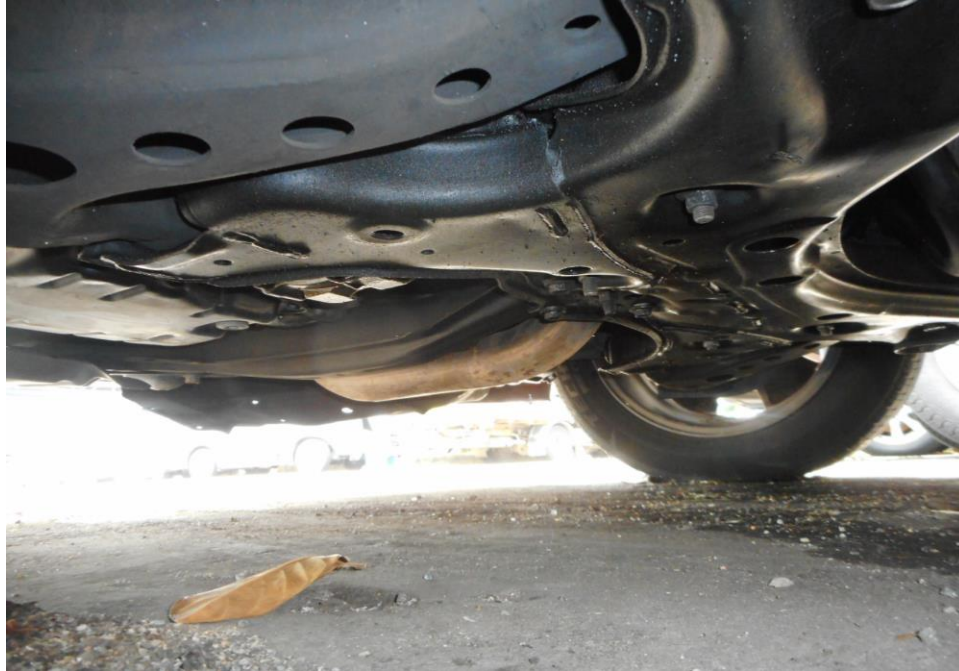
Photo 15 shows the undercarriage of the Motor Car, at the area where the engine housing and transmission housing are located. . I did not find any sign(s) or indication(s) of fluid leak and/or fluid stain(s) on the underside of the Motor Car.

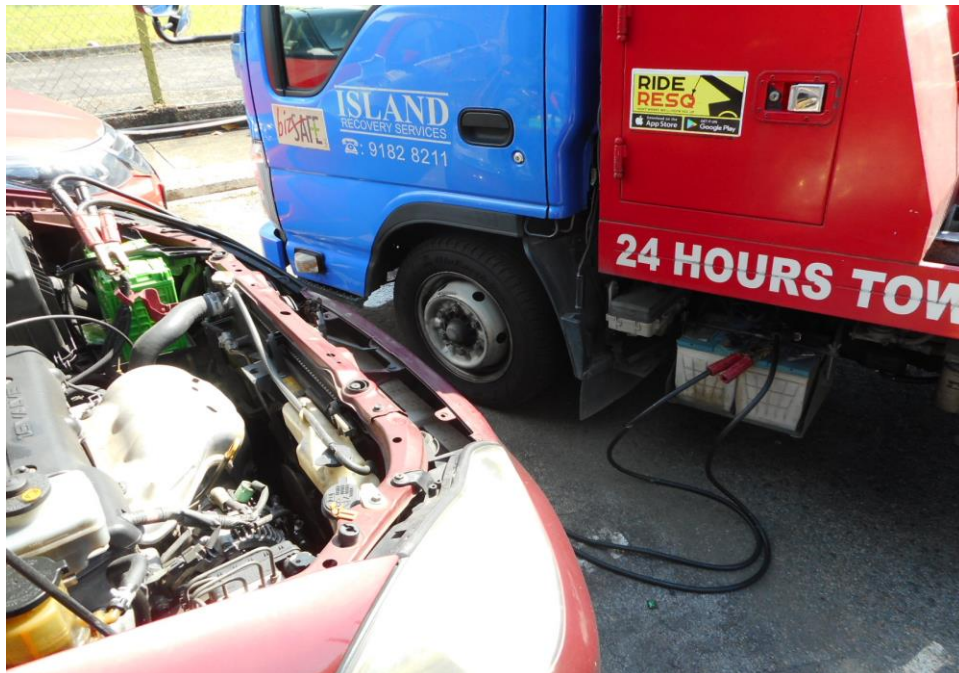
11. However the Motor car's engine was not able to be started up despite multiple attempts of jumpstarting it. See photo 16 below.

Photo 16 shows the jumpstarting of the Motor Car's engine, it was not able to be started up despite multiple attempts in jump starting the engine.

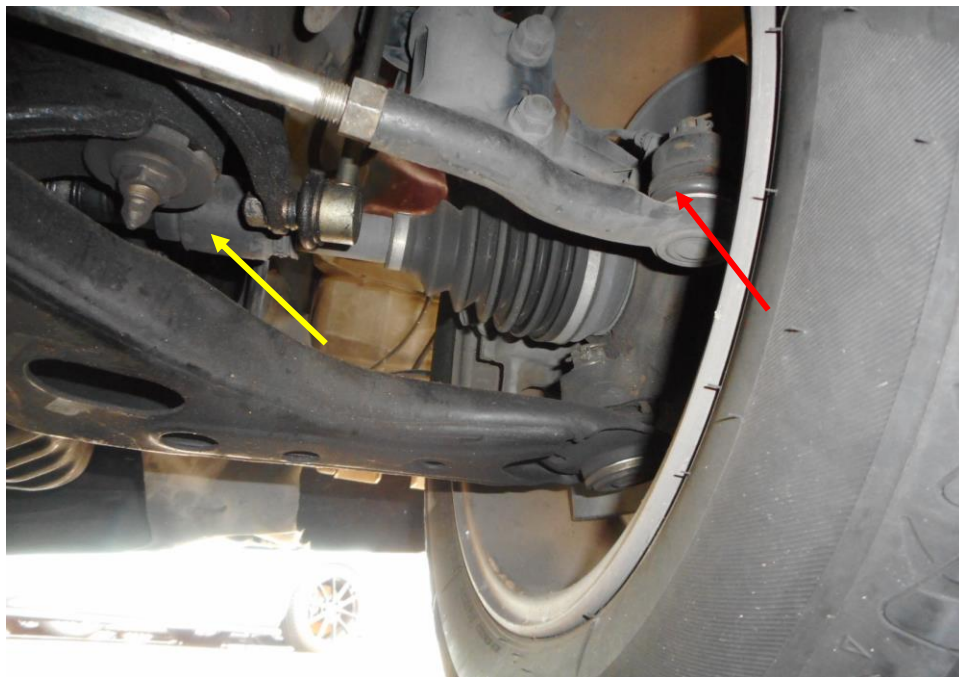
Photo 17 shows the various undercarriage components at the front right wheel of the Motor Car, in particular the steering tie rod end (red arrow) and drive shaft (yellow arrow). The various steering components were all found to be intact, suggesting that the steering system of the Motor Car was likely to be in serviceable condition at the material time of accident. There was also no sign of fluid stain(s) observed on the various undercarriage components.

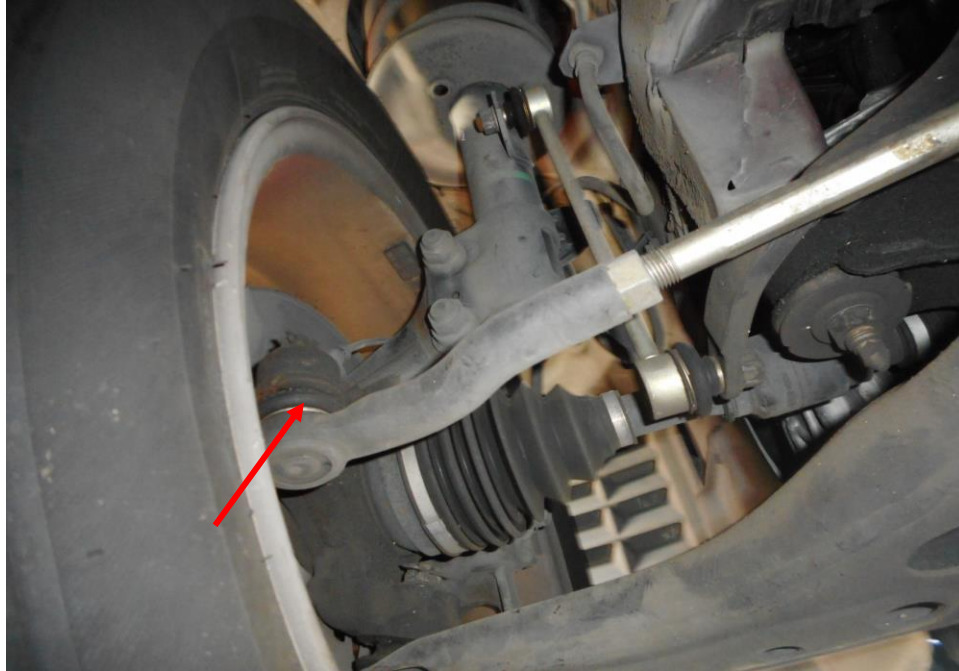
Photo 18 shows the various undercarriage components at the front left wheel of the Motor Car, in particular the steering tie rod end (arrowed). The various Undercarriage components of the Motor Car were all found to be intact without any visible damage. There was also no sign of fluid stain(s) observed on the various undercarriage components.

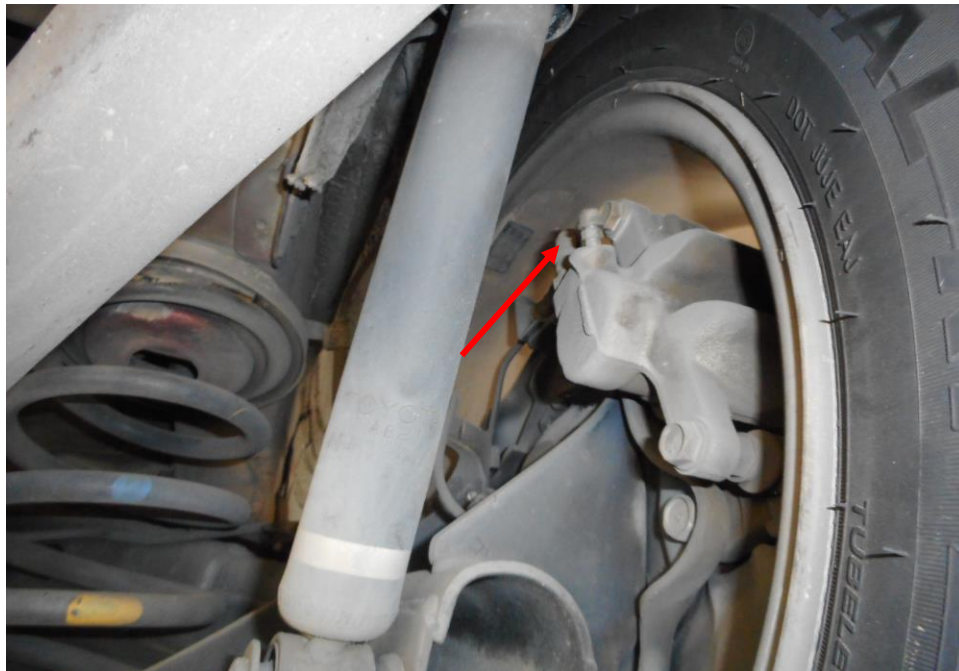
Photo 19 shows the brake pipe (arrowed) at the rear right wheel of the Motor Car. I did not observe any leakage of brake fluid at the time of my inspection of the Motor Car. My static tests of the Motor Car's braking system, along with my visual examination of the various mechanical components in the braking system, had indicated that there was no internal leakage of pressure/vacuum. Hence the braking system of the Motor Car was likely to be in serviceable condition at the material time of accident.

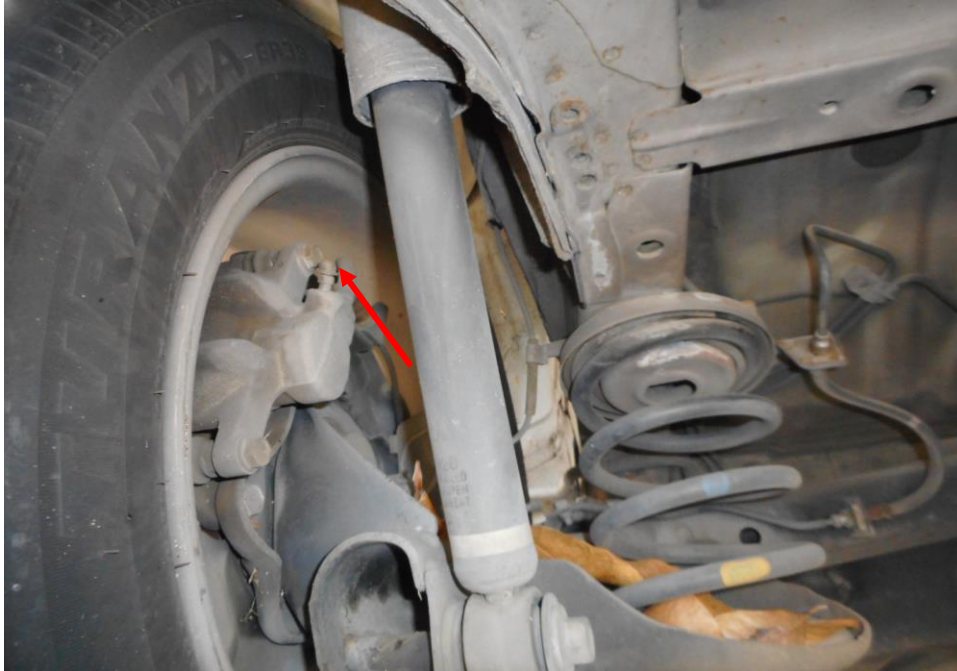
Photo 20 shows the brake pipe (arrowed) at the rear left wheel of the Motor Car. I did not observe any leakage of brake fluid at the time of my inspection of the Motor Car. My static tests of the Motor Car's braking system, along with my visual examination of the various mechanical components in the braking system had indicated that there was no internal leakage of pressure/vacuum. Hence the braking system of the Motor Car was likely to be in serviceable condition at the material time of accident.

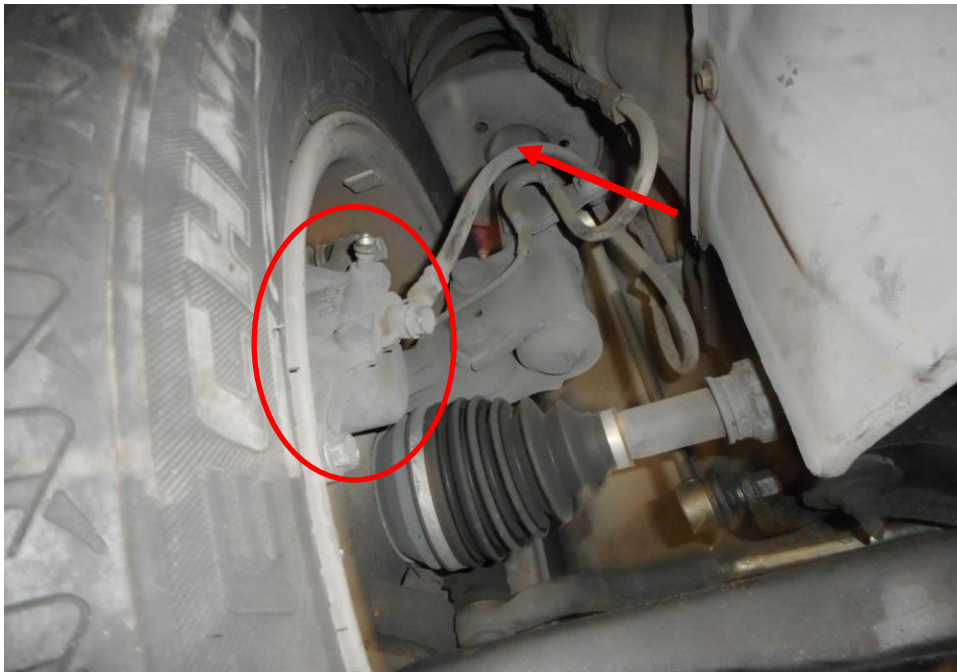
Photo 21 shows the brake hose/pipe (arrowed) at the front right wheel of the Motor Car. No leakage of brake fluid was observed. Visual examination of the various components of the braking system like the brake caliper (circled), brake booster, brake pedal etc had revealed all to be intact and without visible damage at the time of accident. There was also no sign of fluid stain(s) observed on the various undercarriage components.

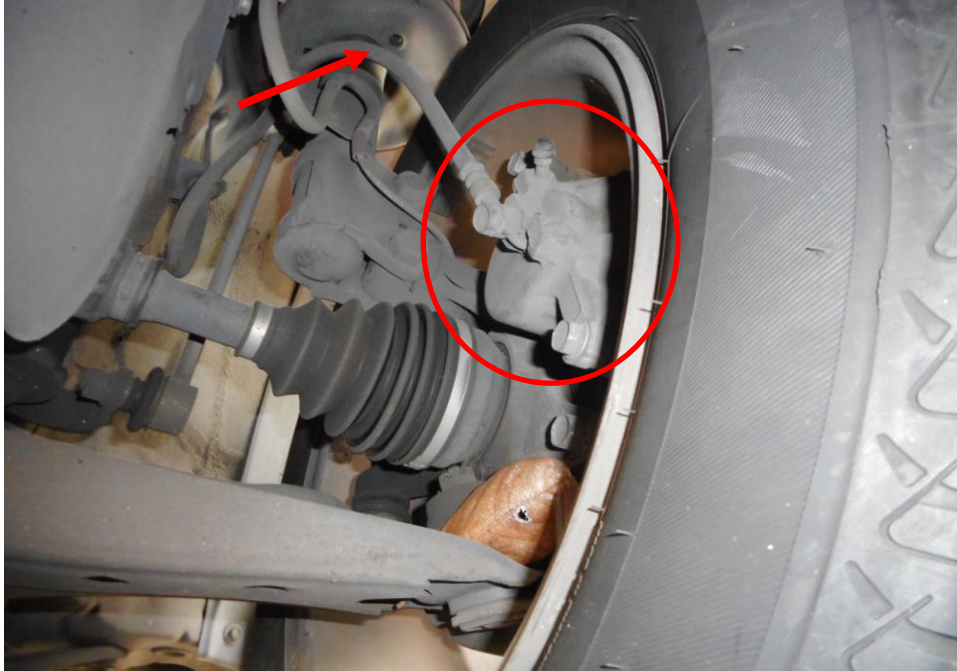
Photo 22 shows the brake hose/pipe (arrowed) at the front left wheel of the Motor Car. No leakage of brake fluid was observed. Visual examination of the various components of the braking system like the brake caliper (circled), brake booster, brake pedal etc had revealed all to be intact and without visible damage at the time of accident. There was also no sign of fluid stain(s) observed on the various undercarriage components.
