Your Ref: TP/IP/15465/2021
Our Ref : CI/TPD21004897/P

24th June 2021

Fatal Accident Investigation Team

MECHANICAL INSPECTION REPORT OF MOTOR CAR SLS 5842L

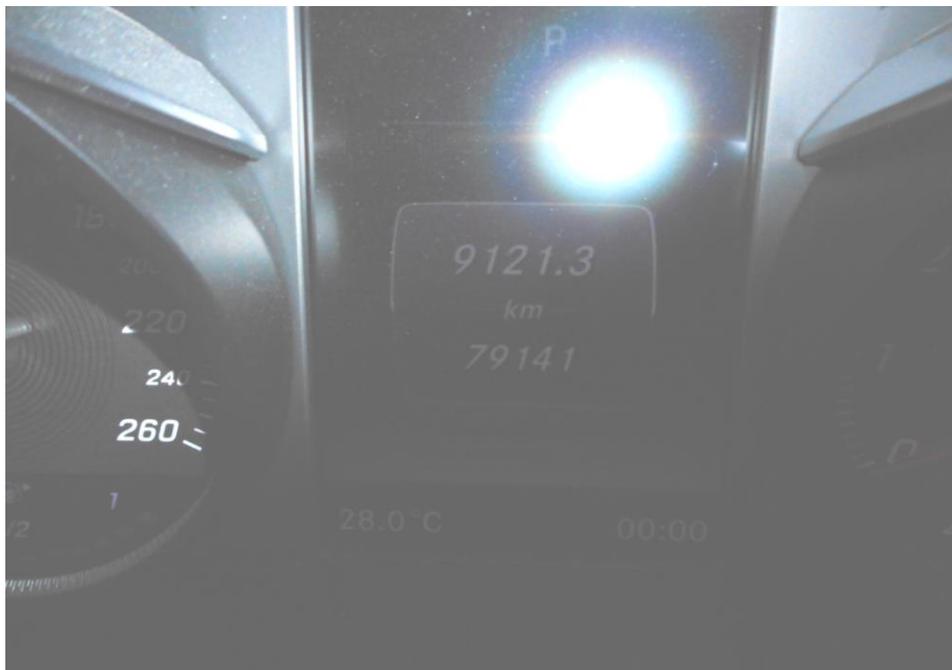
Photo 1 shows the mileage of the Motor Car at the time of my inspection. The mileage observed was 79,141km.

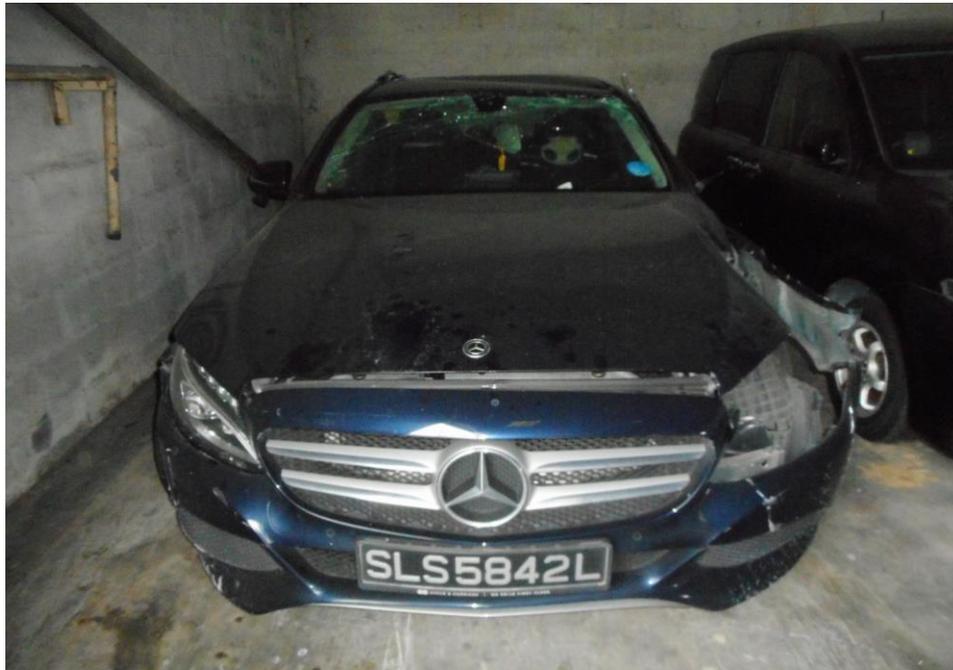
Photo 2 shows a general view of the Motor Car at the time of my inspection. The Motor Car was observed to have sustained damage around the whole vehicle. Its front portion; front windscreen, front bonnet, front left fender, front bumper and front left headlamp. Its right portion; right door. Its rear portion; rear windscreen, rear left brake lamp, rear boot and rear bumper. Its left portion; body panels and windscreens. Its roof portion; roof panel. These are the body parts that were damaged as a result of the accident.

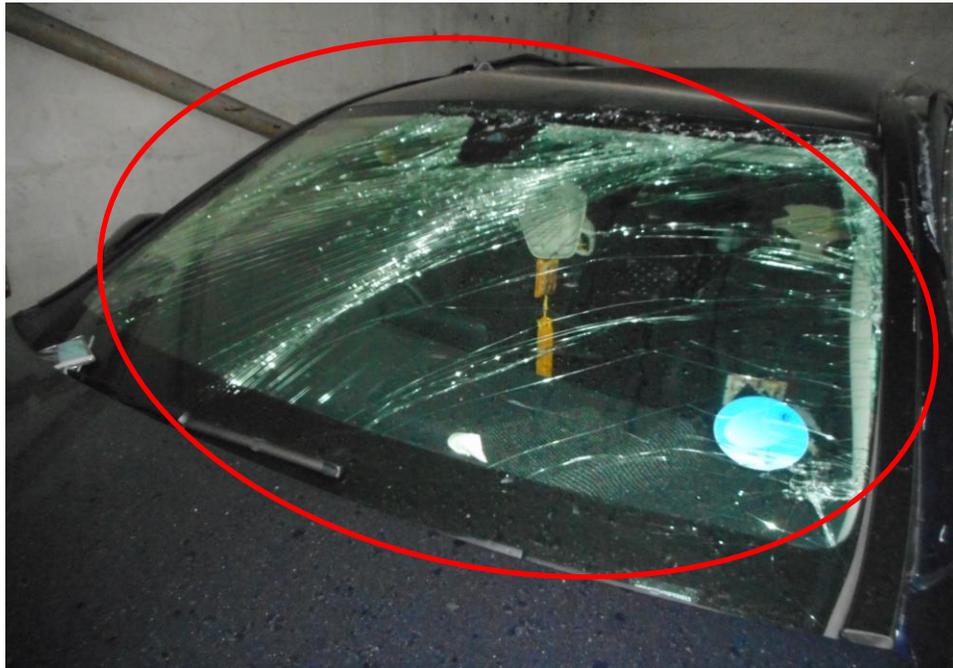
Photo 3 shows a close up view of the Motor Car at the time of my inspection. The Motor Car was observed to have sustained damage at its front portion. Its front windscreen (circled) was the body part that were damaged as a result of the accident.

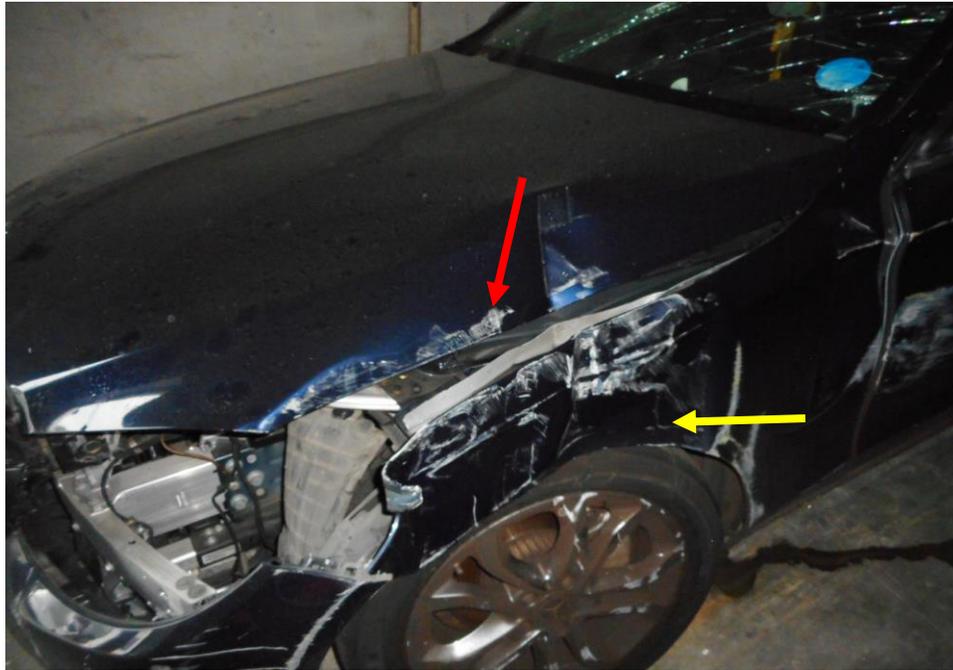
Photo 4 shows a close up view of the Motor Car at the time of my inspection. The Motor Car was observed to have sustained damage at its front portion. Its front bonnet (red arrow) and front left fender (yellow arrow) was damaged as a result of the accident.

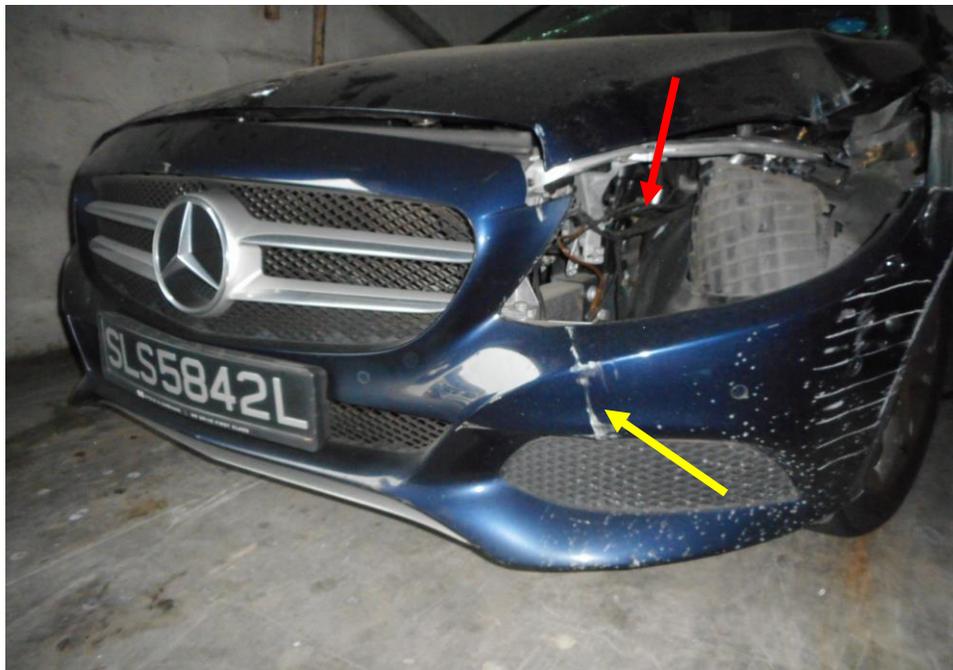
Photo 5 shows a close up view of the Motor Car at the time of my inspection. The Motor Car was observed to have sustained damage at its front portion. Its front bumper (yellow arrow) and front left headlamp (red arrow) was the body part that were damaged as a result of the accident.

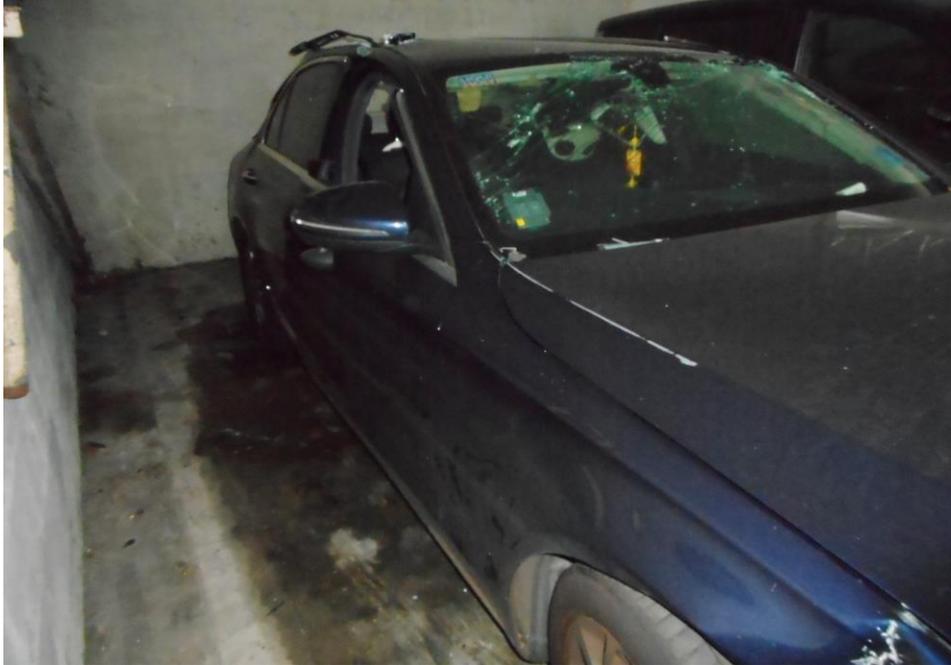
Photo 6 shows a general view of the Motor Car at the time of my inspection. The Motor Car was observed to have sustained damage at its right portion. Its right door was damaged as a result of the accident.

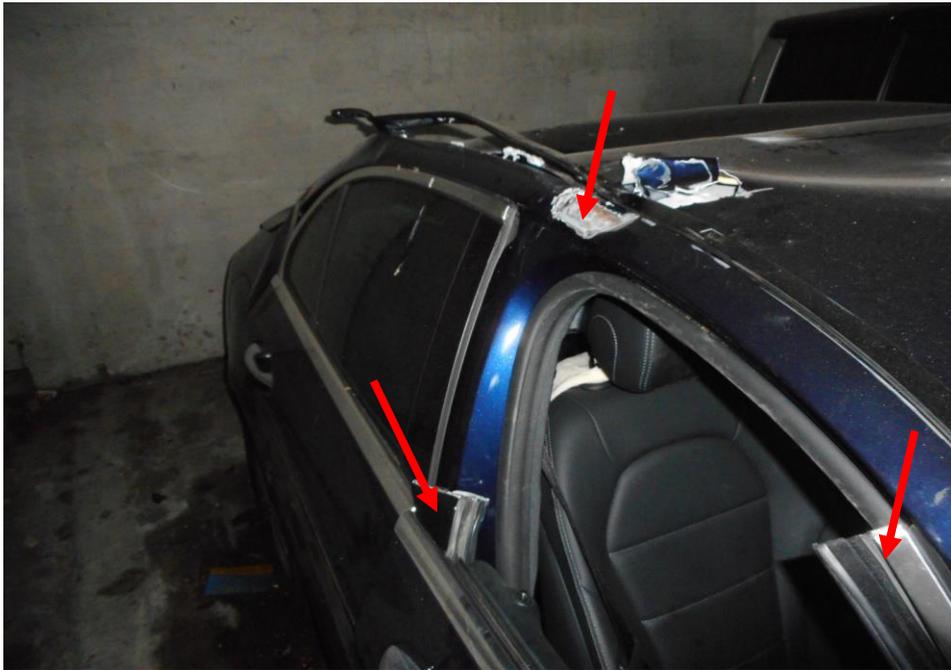
Photo 7 shows the close up view of the Motor Car at the time of my inspection. The Motor Car was observed to have sustained damage at its right portion. Its right door (arrowed) was damaged as a result of the accident.

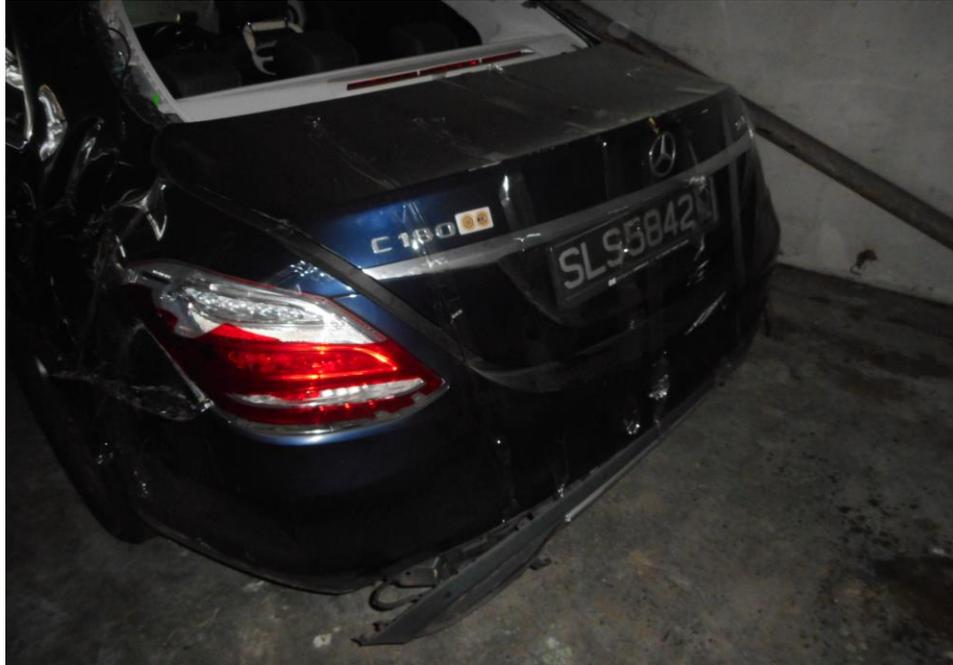
Photo 8 shows a general view of the Motor Car at the time of my inspection. The Motor Car was observed to have sustained damage at its rear portion. Its rear windscreen, rear left brake lamp, rear boot and rear bumper was damaged as a result of the accident.

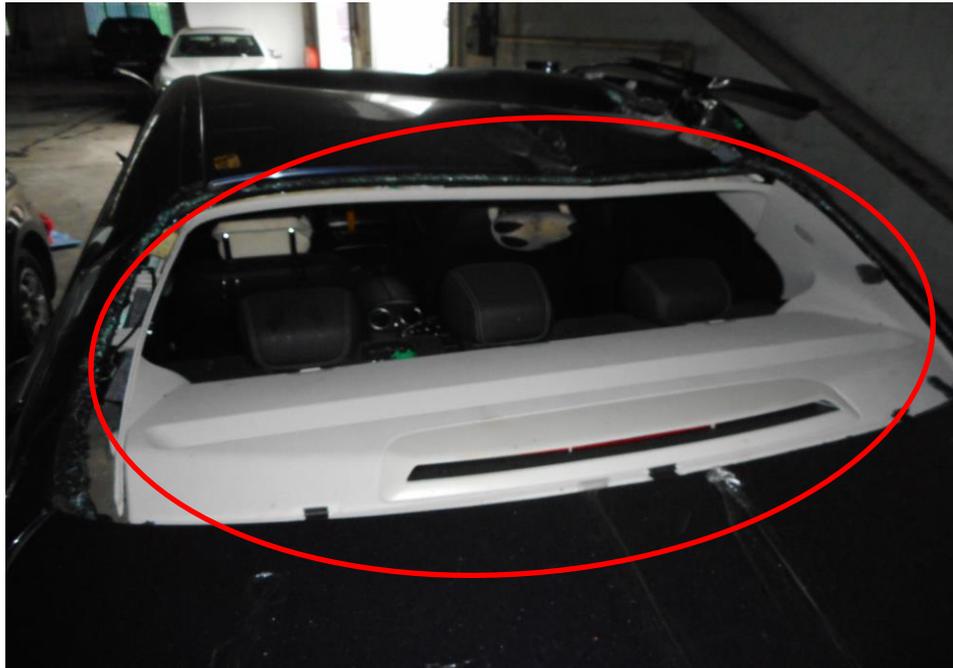
Photo 9 shows a close up view of the Motor Car at the time of my inspection. The Motor Car was observed to have sustained damage at its rear portion. Its rear windscreen (circled) was damaged as a result of the accident.

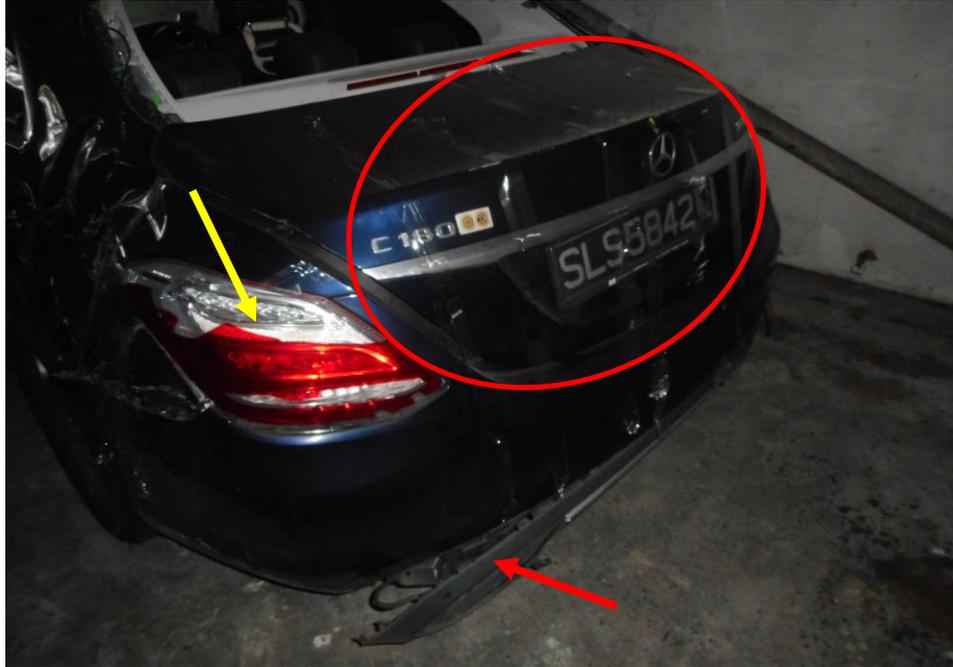
Photo 10 shows a close up view of the Motor Car at the time of my inspection. The Motor Car was observed to have sustained damage at its rear portion. Its rear left brake lamp (yellow arrow), rear boot (circled) and rear bumper (red arrow) was the body part that were damaged as a result of the accident.

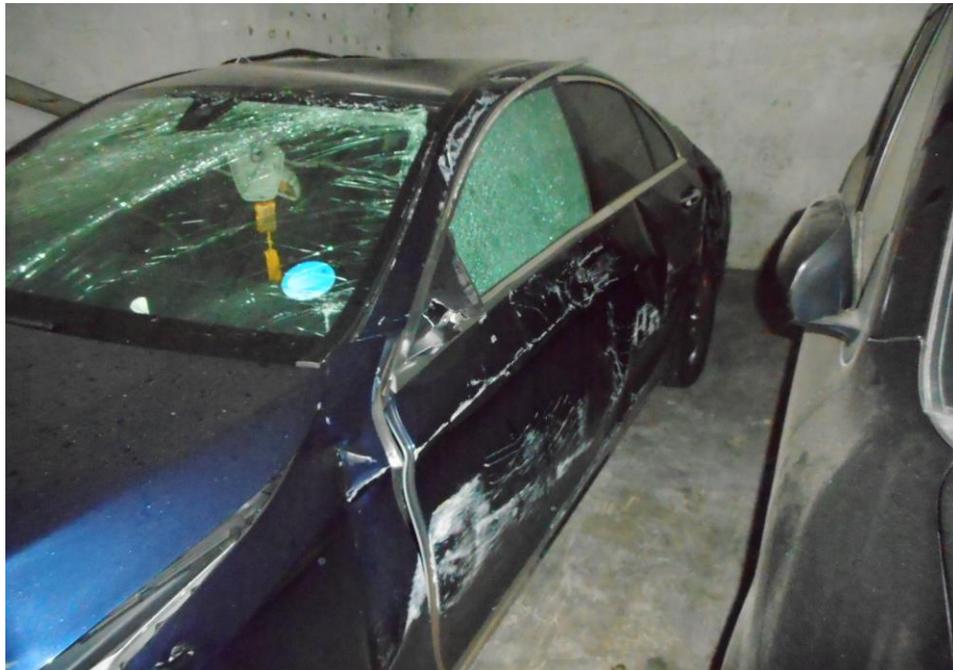
Photo 11 shows a general view of the Motor Car at the time of my inspection. The Motor Car was observed to have sustained damage at its left portion. Its left door panels and windscreen was damaged as a result of the accident.

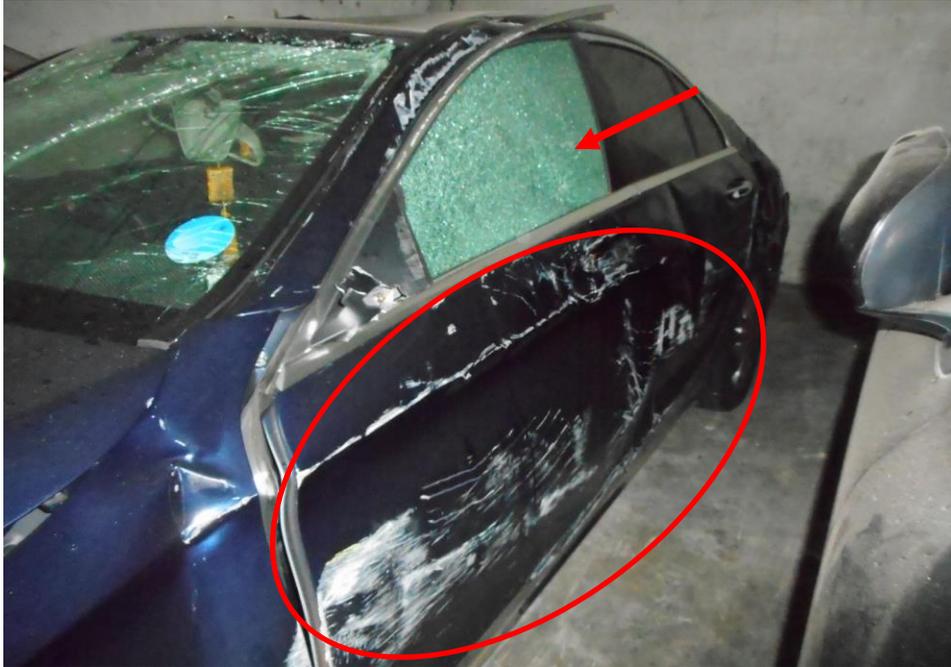
Photo 12 shows a close up view of the Motor Car at the time of my inspection. The Motor Car was observed to have sustained damage at its left portion. Its left door panels (circled) and windscreen (arrowed) was the body part that were damaged as a result of the accident.

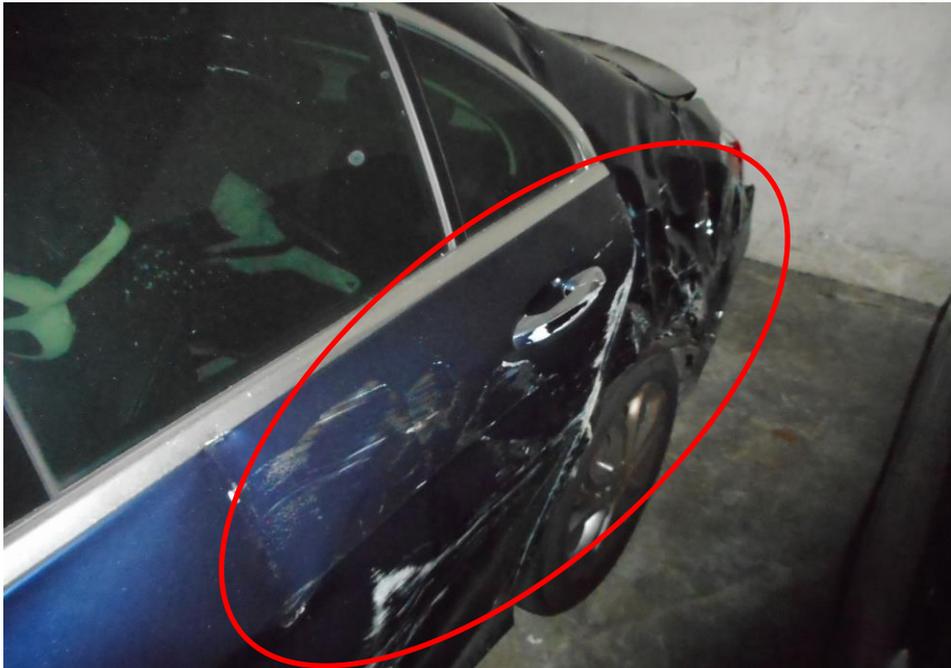
Photo 13 shows a close up view of the Motor Car at the time of my inspection. The Motor Car was observed to have sustained damage at its left portion. Its left door panels (circled) was damaged as a result of the accident.

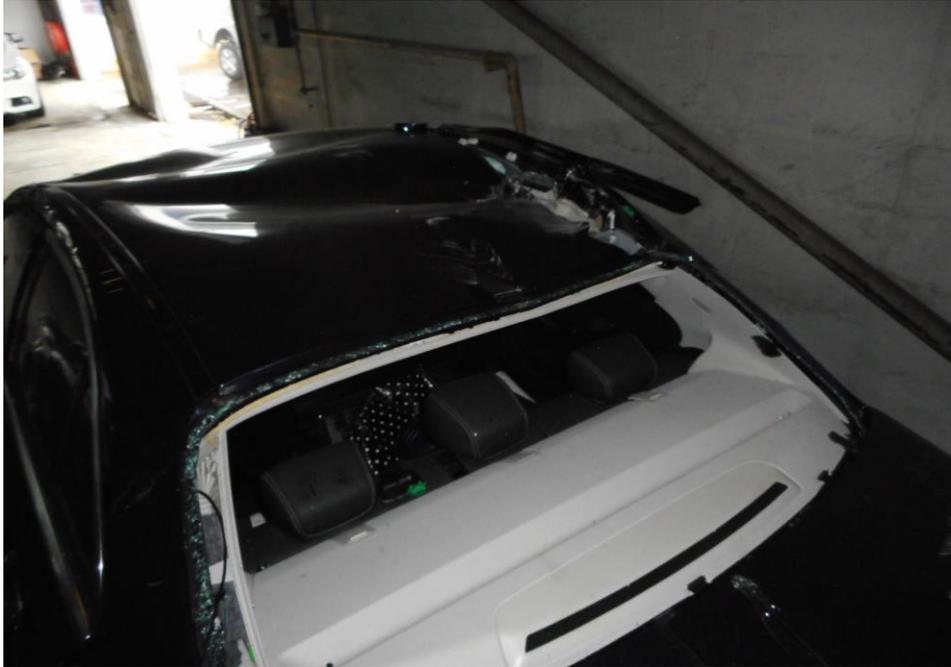
Photo 14 shows a general view of the Motor Car at the time of my inspection. The Motor Car was observed to have sustained damage at its roof portion. Its roof panel was damaged as a result of the accident.

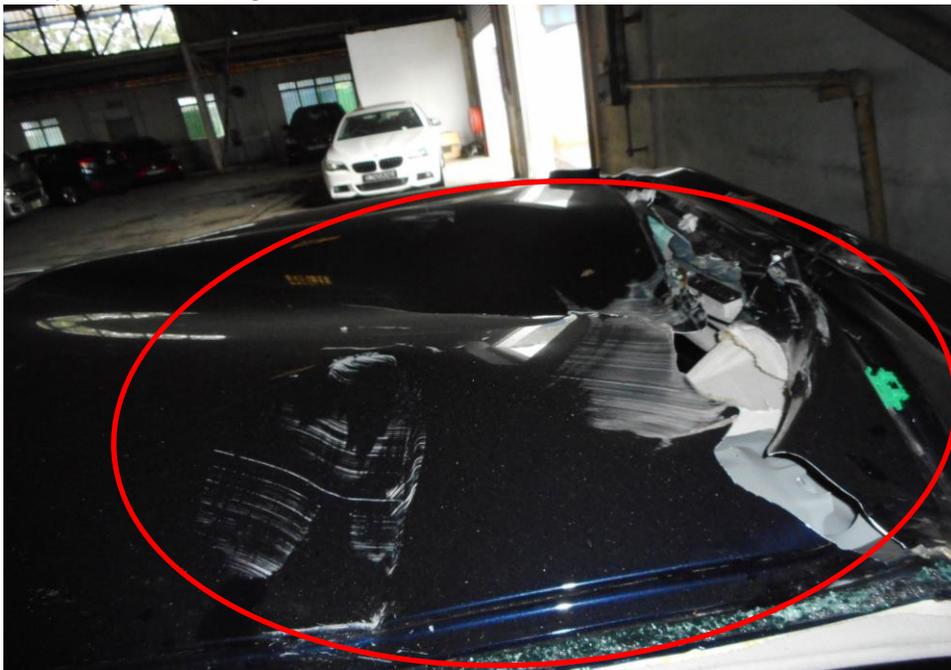
Photo 15 shows a close up view of the Motor Car at the time of my inspection. The Motor Car was observed to have sustained damage at its roof portion. Its roof panel (circled) was damaged as a result of the accident.

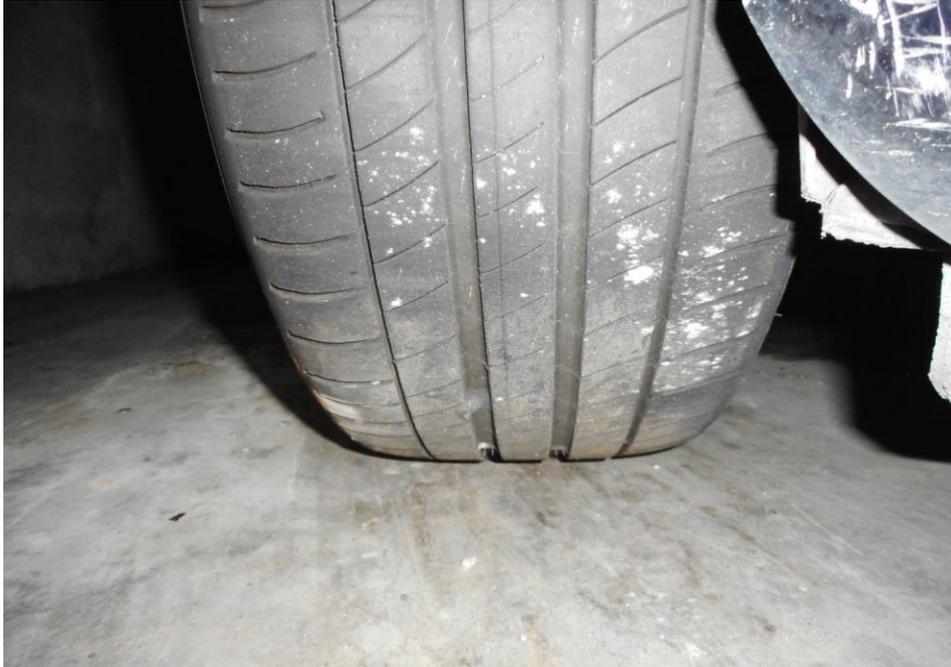
Photo 16 shows the condition of the front right tyre of the Motor Car, which was observed to be in serviceable condition with remaining tread depth of approximately 4.5mm. The tyre, which was wrapped around standard alloy wheel rim, was also observed to be sufficiently inflated for vehicular operation. There was no tear, cut or burst mark(s) on the outer and the inner sidewalls as well as across the tread of the 4 tyres that were fitted on the Motor Car.

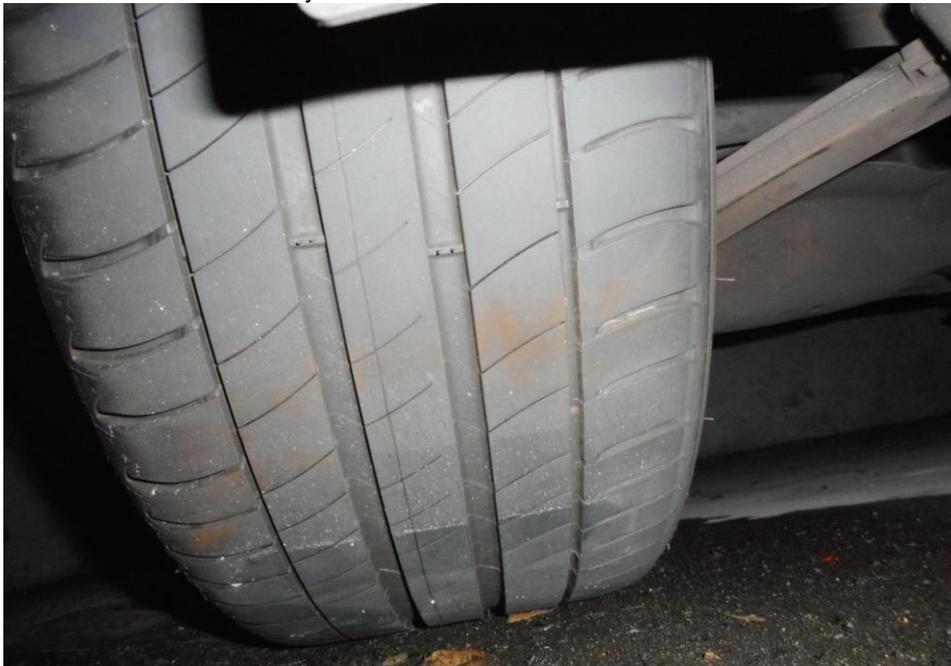
Photo 17 shows the condition of the rear tyre of the Motor Car, which was observed to be in serviceable condition with remaining tread depth of approximately 4.2mm. The tyre, which was wrapped around standard alloy wheel rim, was also observed to be sufficiently inflated for vehicular operation. There was no tear, cut or burst mark(s) on the outer and the inner sidewalls as well as across the tread of the 4 tyres that were fitted on the Motor Car.

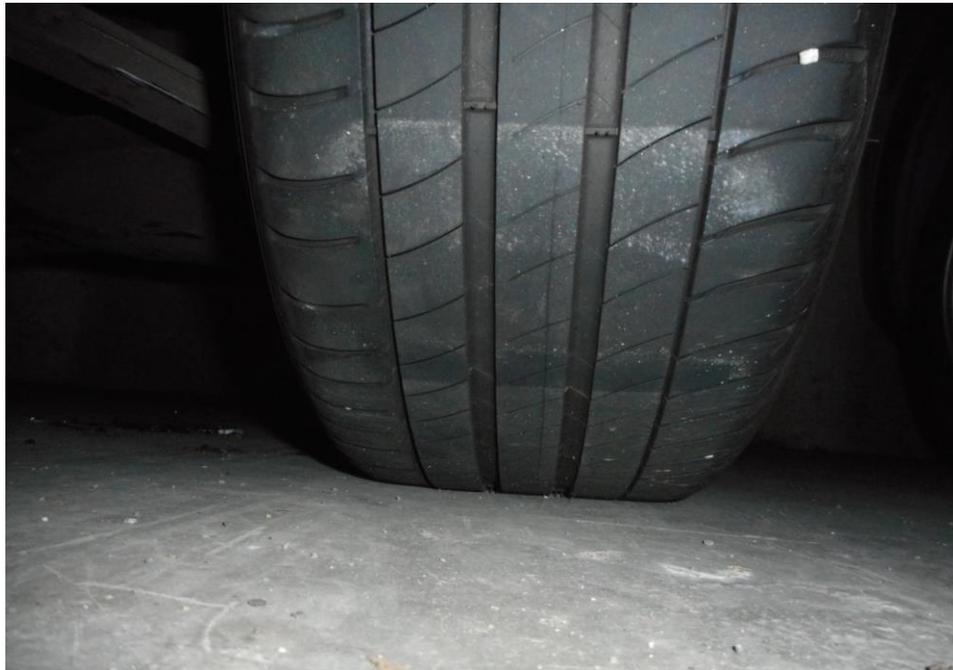
Photo 18 shows the condition of the rear left tyres of the Motor Car, which was observed to be in serviceable condition with remaining tread depth of approximately 4.3mm. The tyres, which were wrapped around standard alloy wheel rim, were also observed to be sufficiently inflated for vehicular operation. There was also no damage found on all 4 alloy wheel rims of the Motor Car.

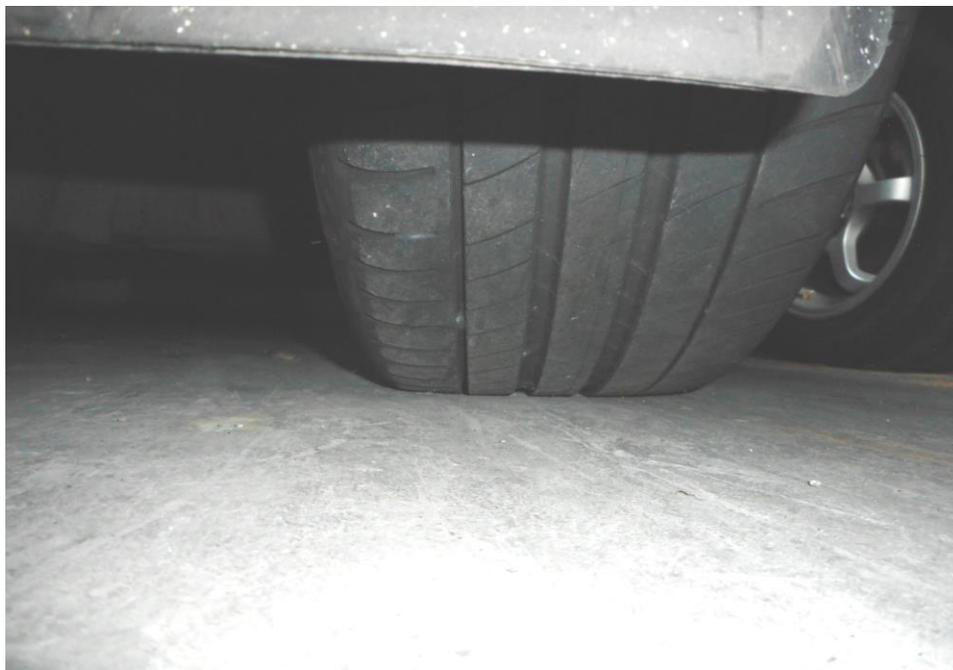
Photo 19 shows the condition of the rear right tyres of the Motor Car, which were observed to be in serviceable condition with remaining, tread depth of approximately 4.4mm. There was also no tear, cut or burst mark(s) on the outer and the inner sidewalls as well as across the tread of the 4 tyres that were fitted on the Motor Car.

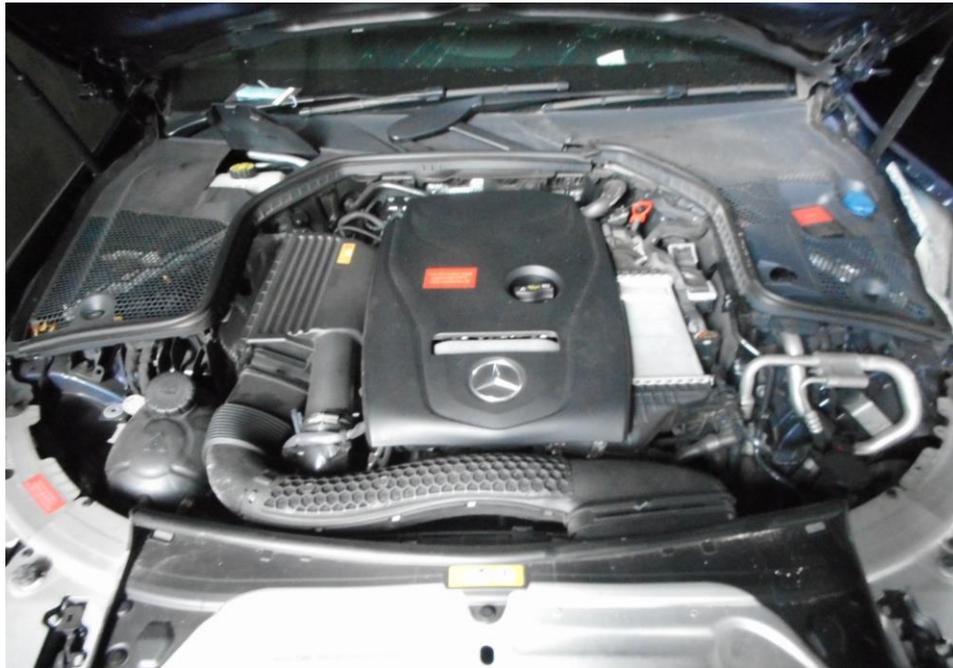
Photo 20 shows a general view of the Motor Car's engine compartment, which was accessed by lifting the front cabin of the Motor Car. The various parts and components inside the engine compartment were unaffected by the accident. There was also no sign(s) or indication(s) of fresh fluid leakage and/or fluid stain within the engine compartment

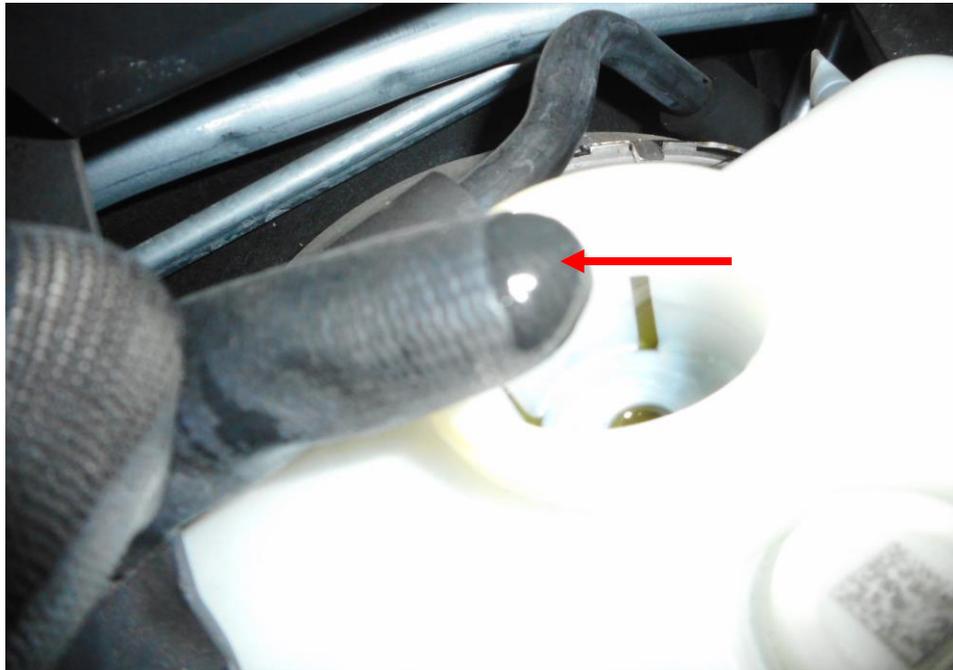
Photo 21 shows the brake fluid reservoir of the Motor Car at the time of my inspection. The brake fluid was observed to be of sufficient level (arrowed) and without any visible contamination.

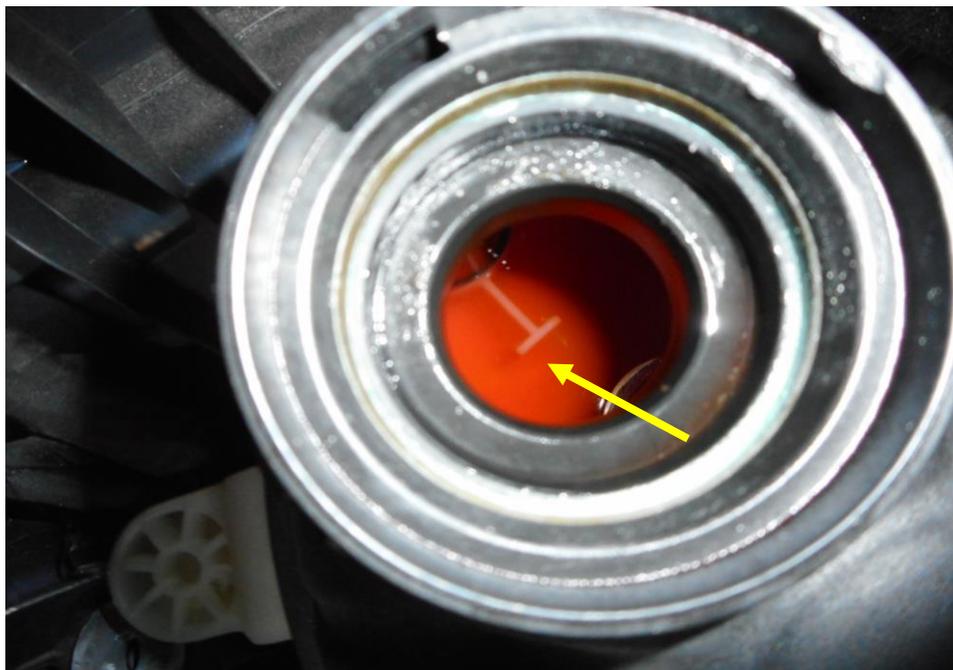
Photo 22 shows the engine coolant reservoir of the Motor Car at the time of my inspection. The engine coolant was observed to be of sufficient level (arrowed) and without any visible contamination.

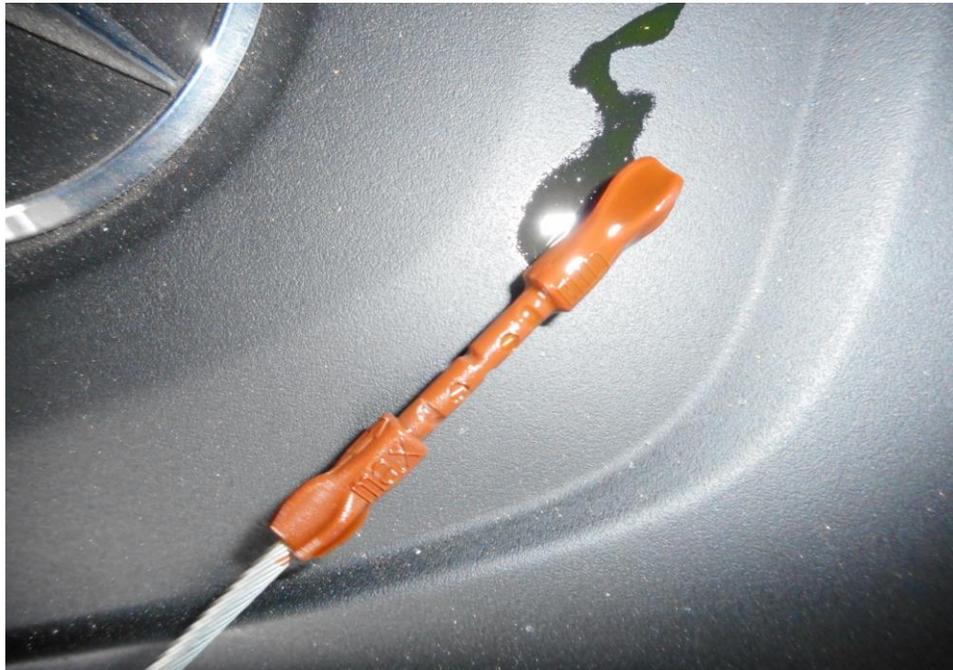
Photo 23 shows the engine oil dip stick of the Motor Car at the time of my inspection. The engine oil was observed to be of sufficient level and without any visible contamination.

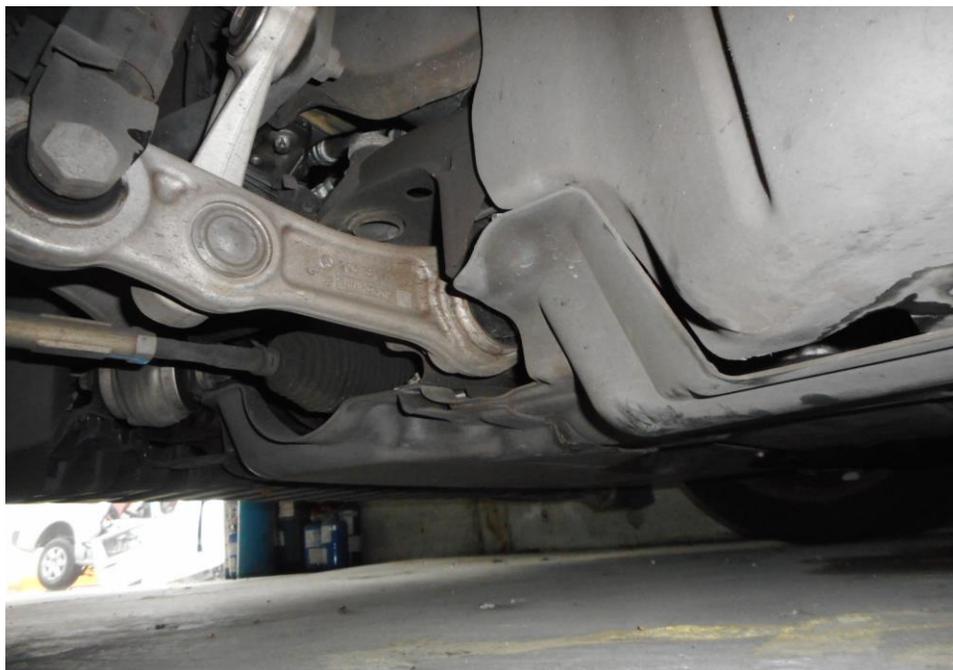
Photo 24 shows the undercarriage of the Motor Car, at the area where the engine housing and transmission housing are located. . I did not find any sign(s) or indication(s) of fluid leak and/or fluid stain(s) on the underside of the Motor Car.

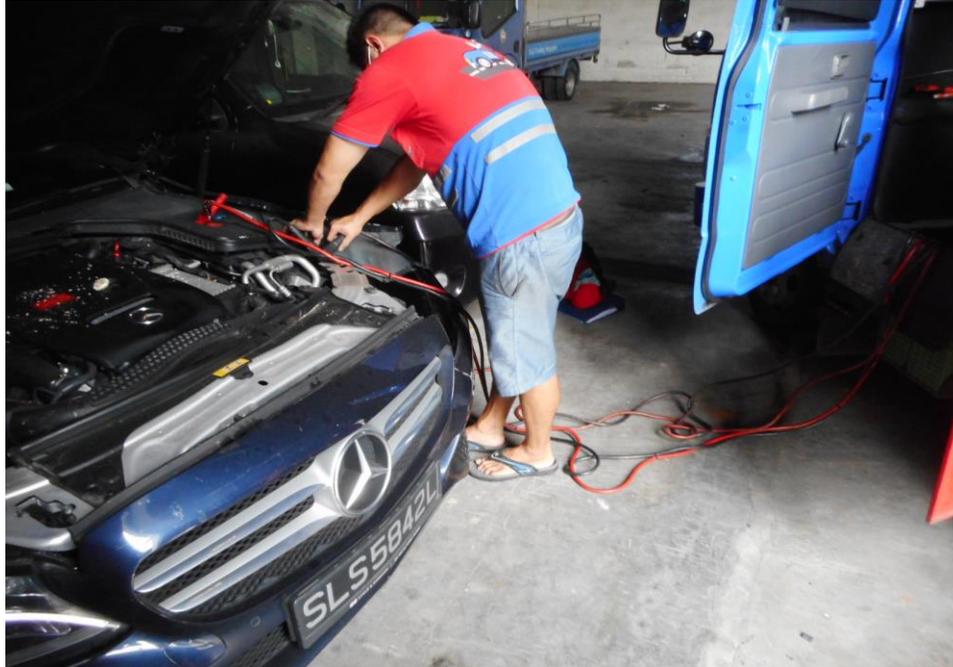
11. The Motor car's engine was not able to be started up despite multiple attempts of jumpstarting it. See photo 25 below.

Photo 25 shows the jumpstarting of the Motor Car's engine, it was not able to be started up despite multiple attempts in jump starting the engine.

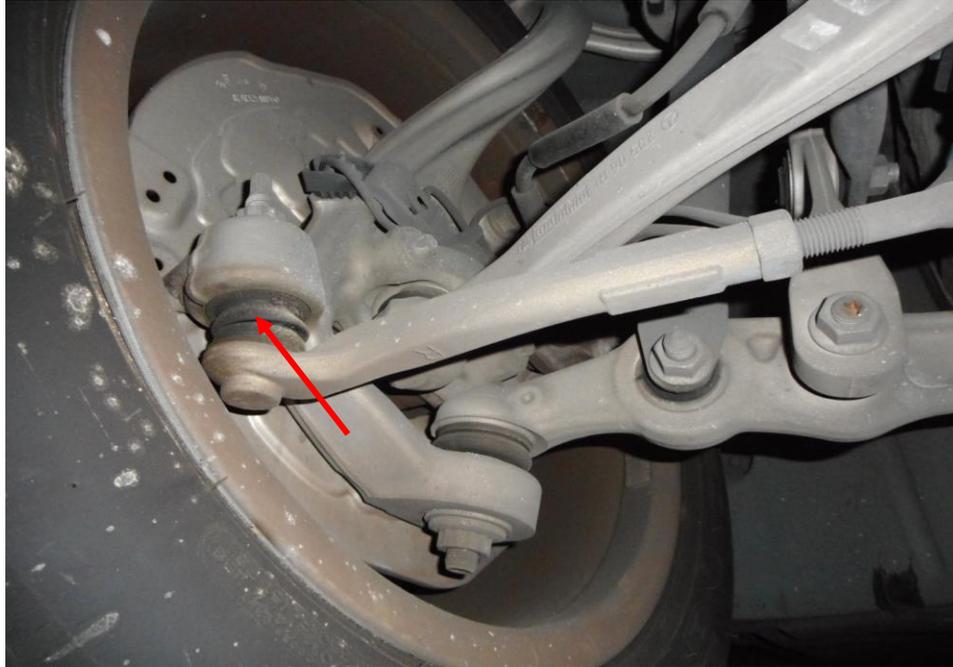
Photo 26 shows the various undercarriage components at the front right wheel of the Motor Car, in particular the steering tie rod end (red arrow). The various steering components were all found to be intact, suggesting that the steering system of the Motor Car was likely to be in serviceable condition at the material time of accident. There was also no sign of fluid stain(s) observed on the various undercarriage components.

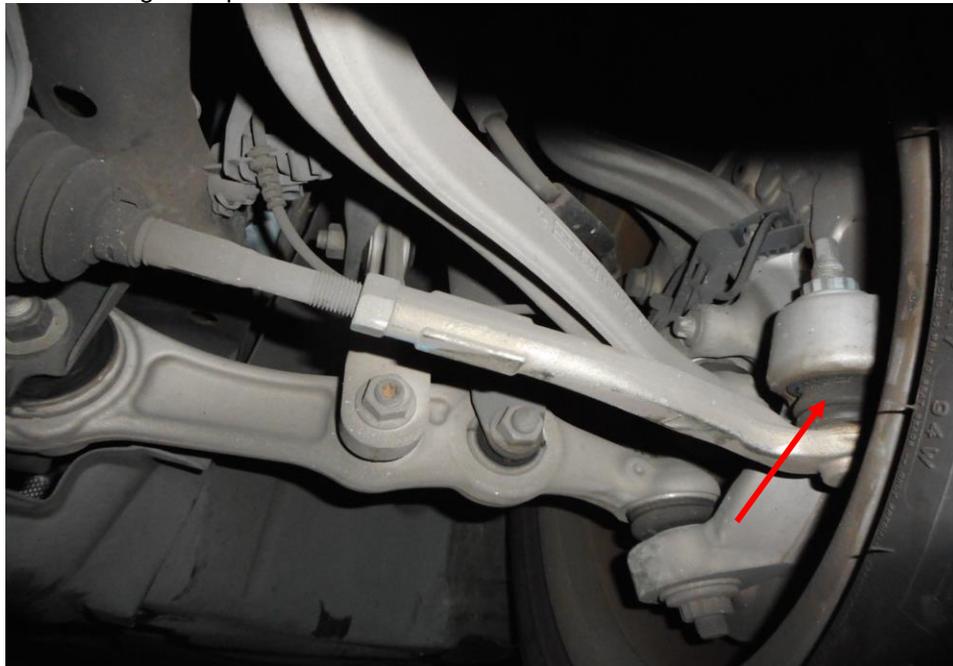
Photo 27 shows the various undercarriage components at the front left wheel of the Motor Car, in particular the steering tie rod end (arrowed). The various undercarriage components of the Motor Car were all found to be intact without any visible damage. There was also no sign of fluid stain(s) observed on the various undercarriage components.

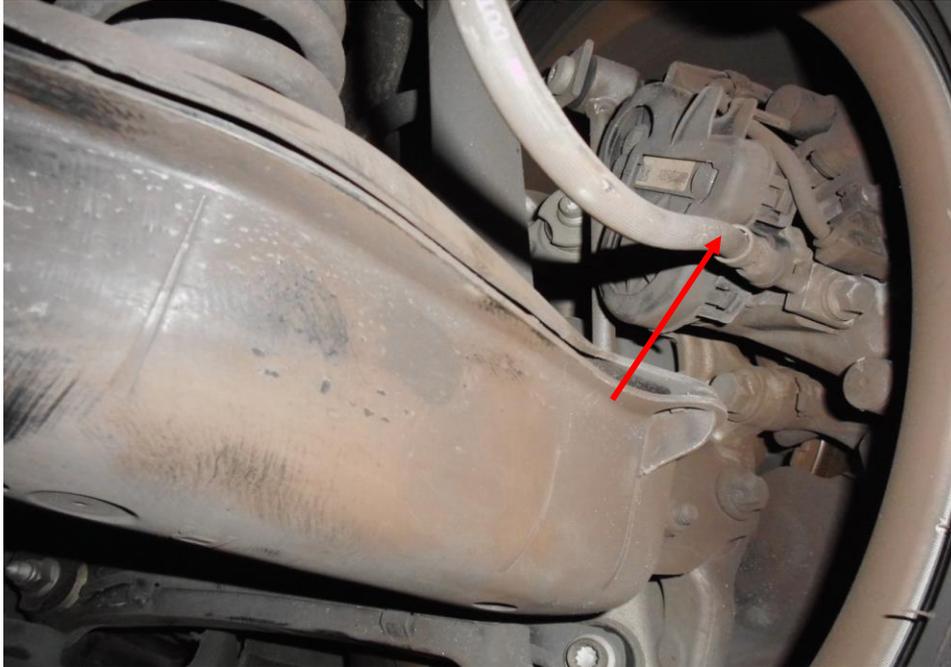
Photo 28 shows the brake pipe (arrowed) at the rear right wheel of the Motor Car. I did not observe any leakage of brake fluid at the time of my inspection of the Motor Car. My static tests of the Motor Car's braking system, along with my visual examination of the various mechanical components in the braking system, had indicated that there was no internal leakage of pressure/vacuum. Hence the braking system of the Motor Car was likely to be in serviceable condition at the material time of accident.

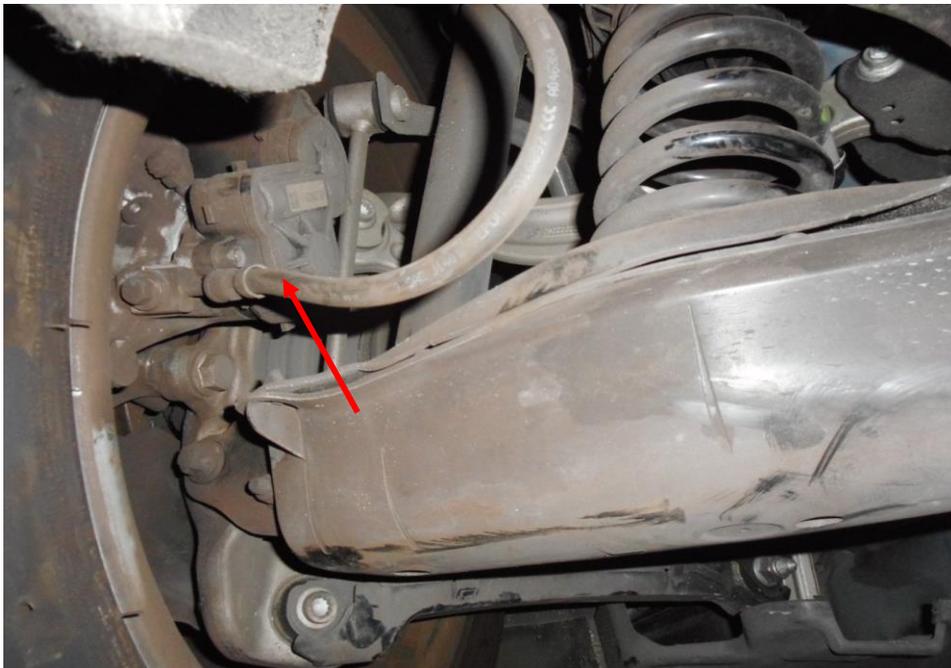
Photo 29 shows the brake pipe (arrowed) at the rear left wheel of the Motor Car. I did not observe any leakage of brake fluid at the time of my inspection of the Motor Car. My static tests of the Motor Car's braking system, along with my visual examination of the various mechanical components in the braking system had indicated that there was no internal leakage of pressure/vacuum. Hence the braking system of the Motor Car was likely to be in serviceable condition at the material time of accident.

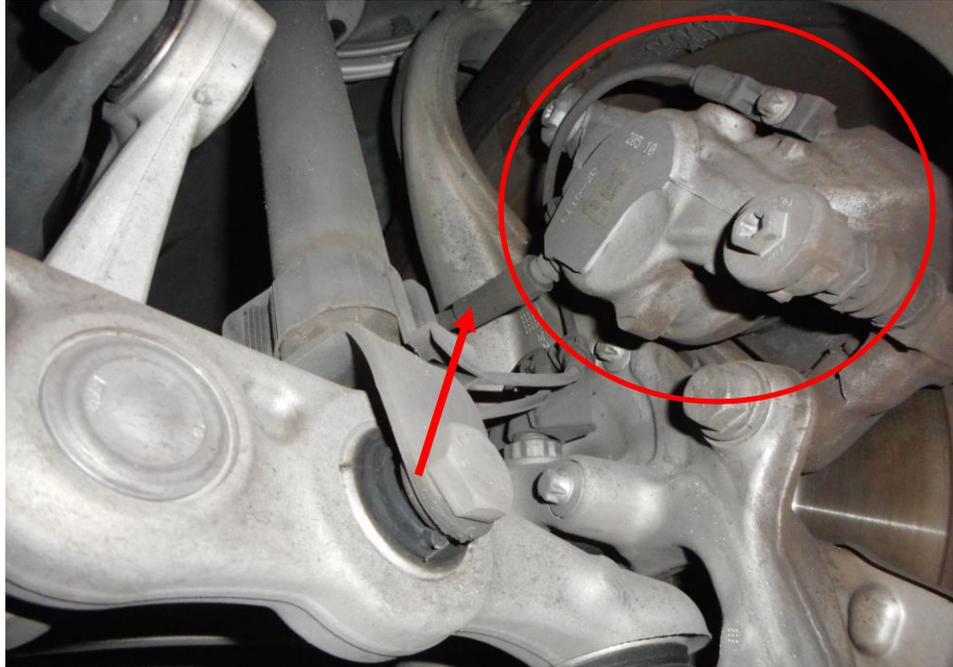
Photo 30 shows the brake hose/pipe (arrowed) at the front right wheel of the Motor Car. No leakage of brake fluid was observed. Visual examination of the various components of the braking system like the brake caliper (circled), brake booster, brake pedal etc had revealed all to be intact and without visible damage at the time of accident. There was also no sign of fluid stain(s) observed on the various undercarriage components.

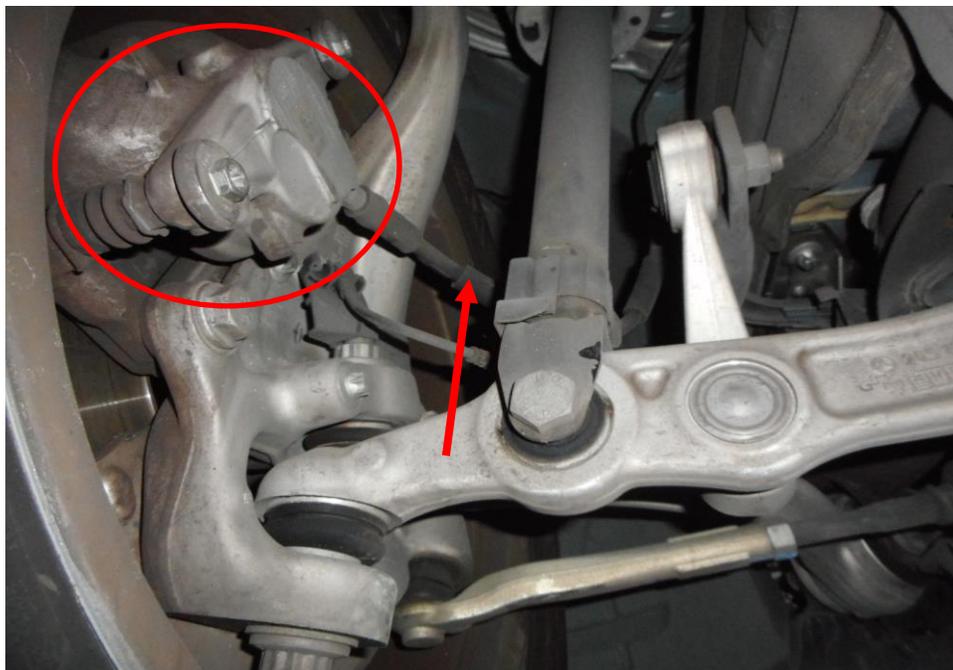
Photo 31 shows the brake hose/pipe (arrowed) at the front left wheel of the Motor Car. No leakage of brake fluid was observed. Visual examination of the various components of the braking system like the brake caliper (circled), brake booster, brake pedal etc had revealed all to be intact and without visible damage at the time of accident. There was also no sign of fluid stain(s) observed on the various undercarriage components.
