Your Ref: TP/IP/15465/2021
Our Ref : CI/TPD21004897/P

24th June 2021

Fatal Accident Investigation Team

MECHANICAL INSPECTION REPORT OF MOTOR CAR SLS 5842L

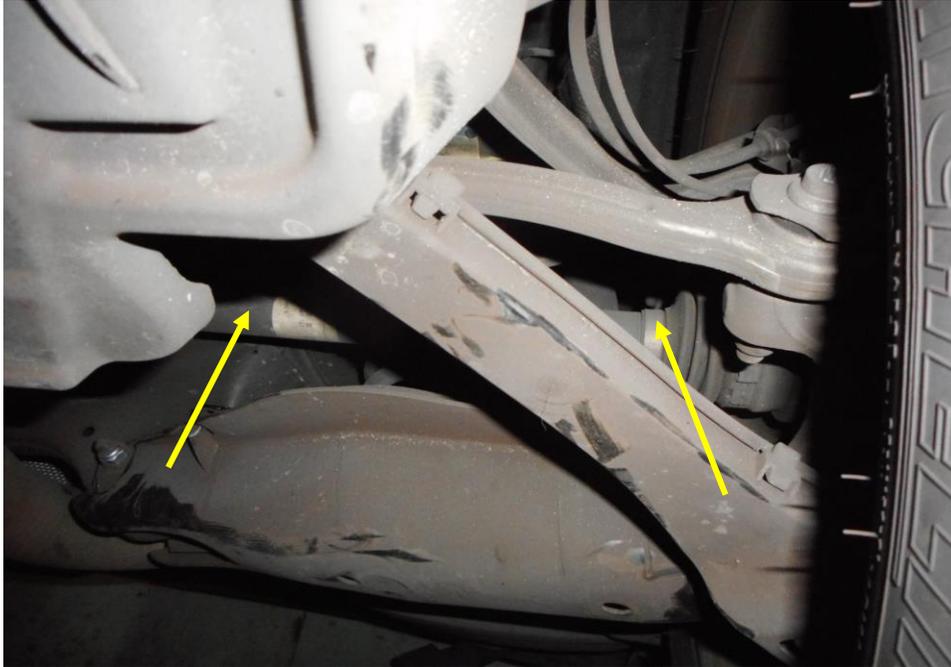
Photo 32 shows the various undercarriage components at the front right wheel of the Motor Car, in particular the drive shaft (arrowed) were all found to be intact, suggesting that the drive shaft of the Motor Car was likely to be in serviceable condition at the material time of accident. There was also no sign of fluid stain(s) observed on the various undercarriage components.
