Your Ref: TP/IP/15481/2021
Our Ref : CI/TPD21004898/P

18th May 2021

MECHANICAL INSPECTION REPORT OF MOTOR VAN GBD 5545S

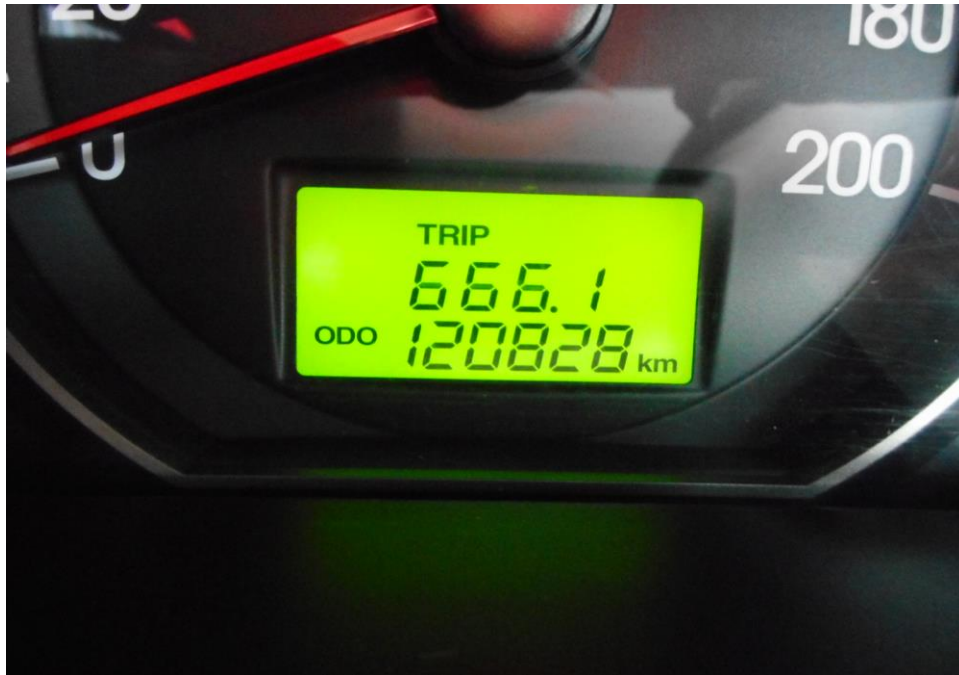
4. The mileage of the Motor Van at the time of my inspection was 120,828km.
5. The Motor Van was observed to sustained damage at its front portion. Its front bonnet, front right headlamp, front bumper and its various engine components were damage at the time of my inspection.

Photo 1 shows a general view of the instrument cluster of the Motor Van at the time of my inspection. The mileage of the Motor Van was 120,828 km

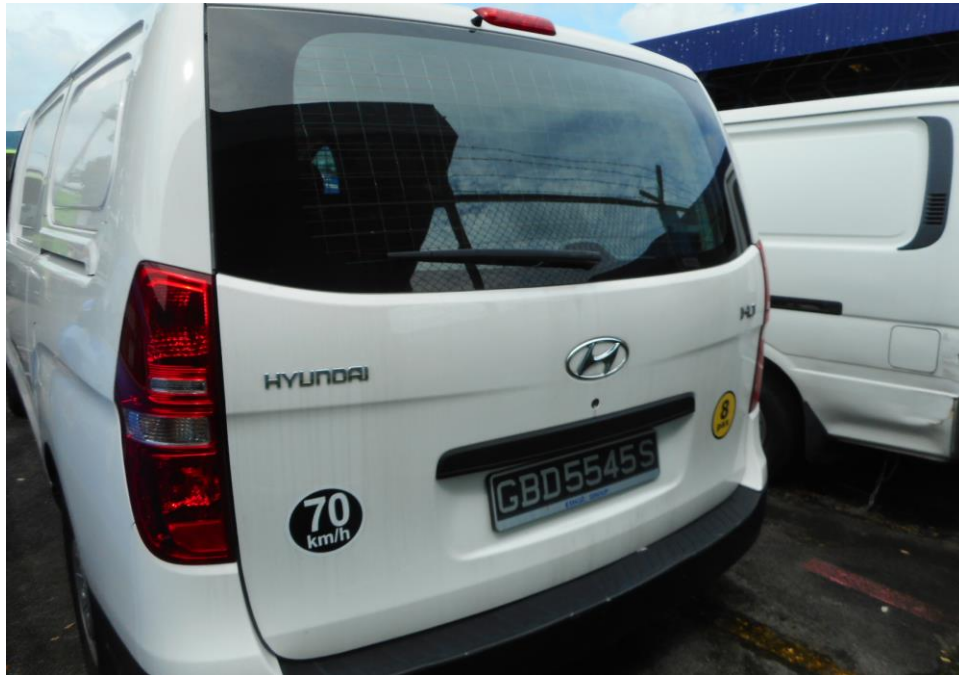
Photo 2 shows a general view of the rear body of the Motor Van at the time of my inspection. The Motor Van was observed to be intact and unaffected by the accident.

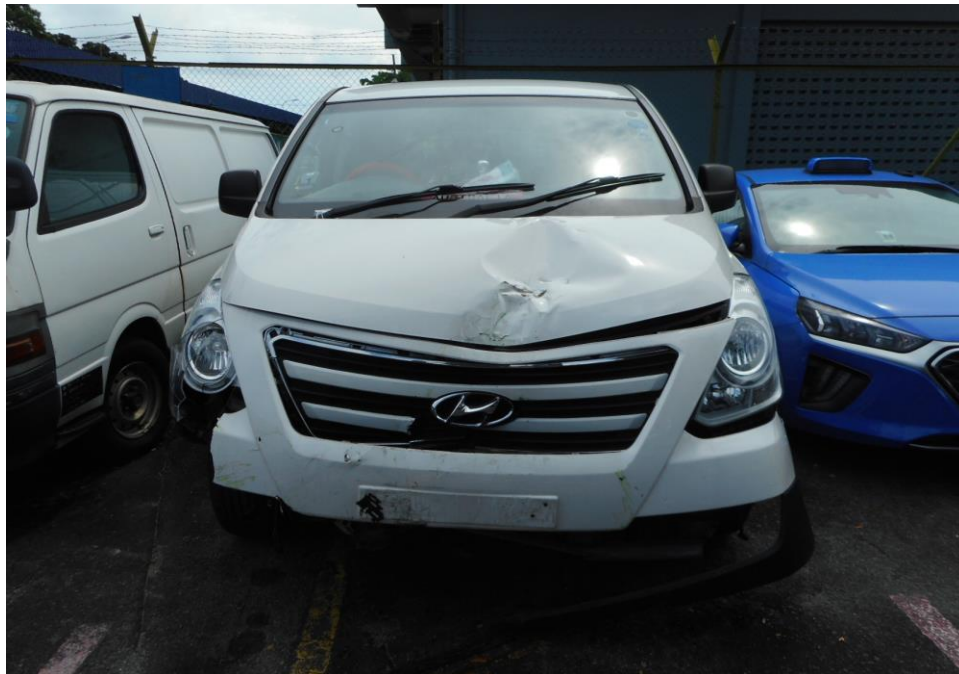
Photo 3 shows a general view of the Motor Van's frontal portion at the time of my inspection. It appeared to have sustained damage at its front portion. Its front bonnet, front right headlamp, front bumper and its various engine components were damage at the time of my inspection.

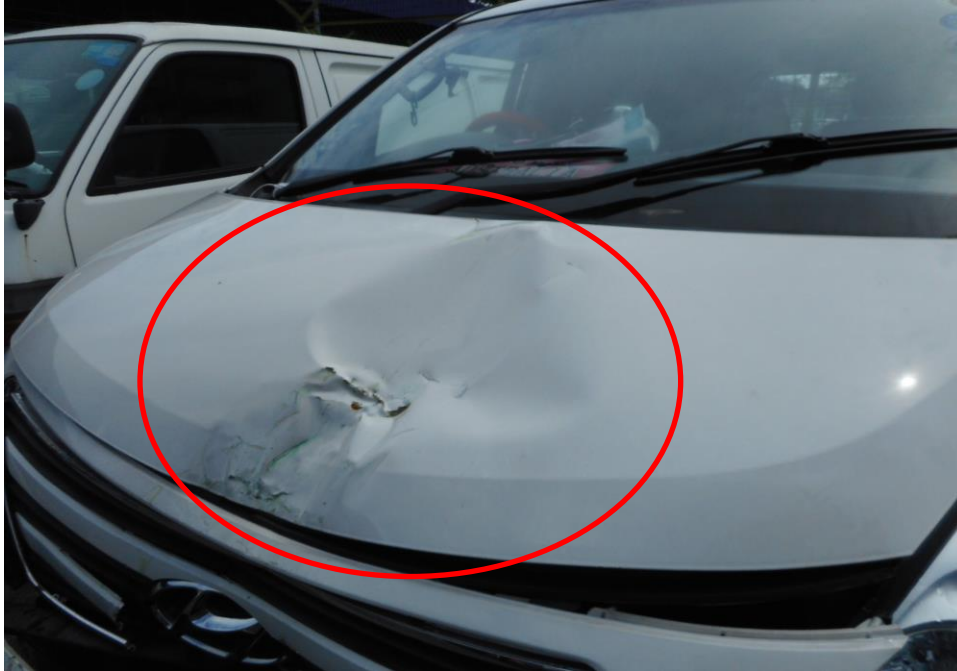
Photo 4 shows a close up view of the Motor Van's front portion at the time of my inspection. Its front bonnet (red circle) was damage at the time of my inspection as a result of the accident.

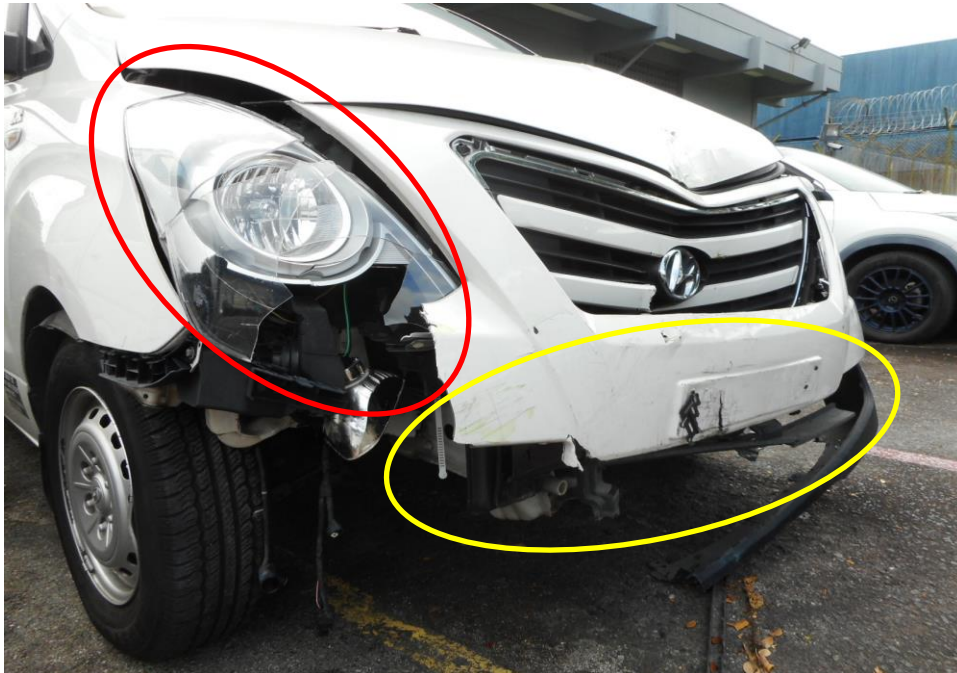
Photo 5 shows a close up view of the Motor Van's front portion at the time of my inspection. Its front right headlamp (red circle) and front bumper (yellow circle) was damage at the time of my inspection as a result of the accident.

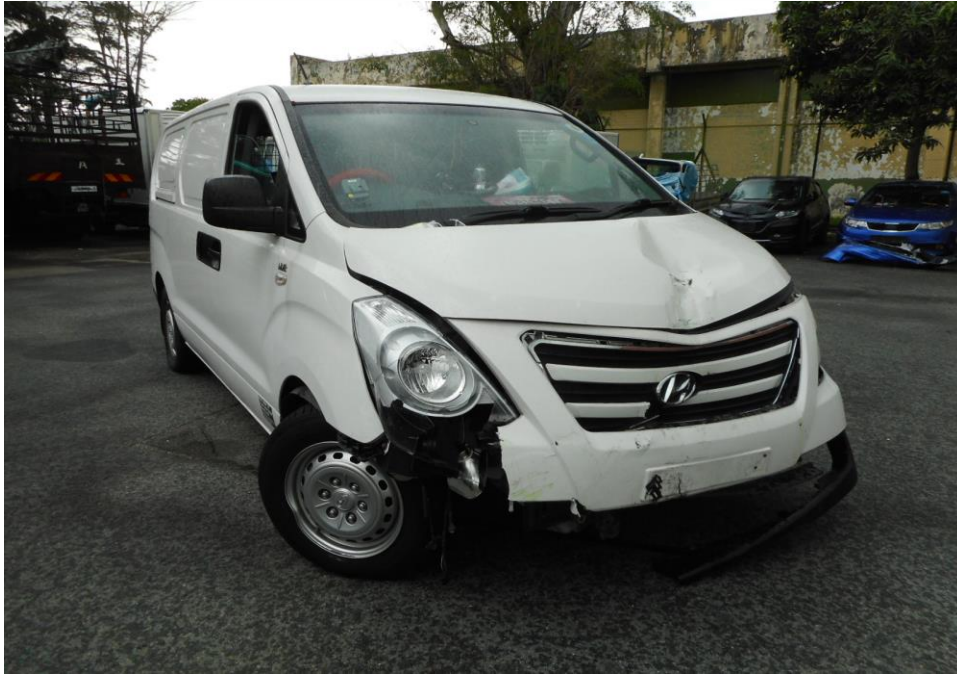
Photo 6 shows a general view of the right body of the Motor Van at the time of my inspection. The Motor Van was observed to be intact and unaffected by the accident.

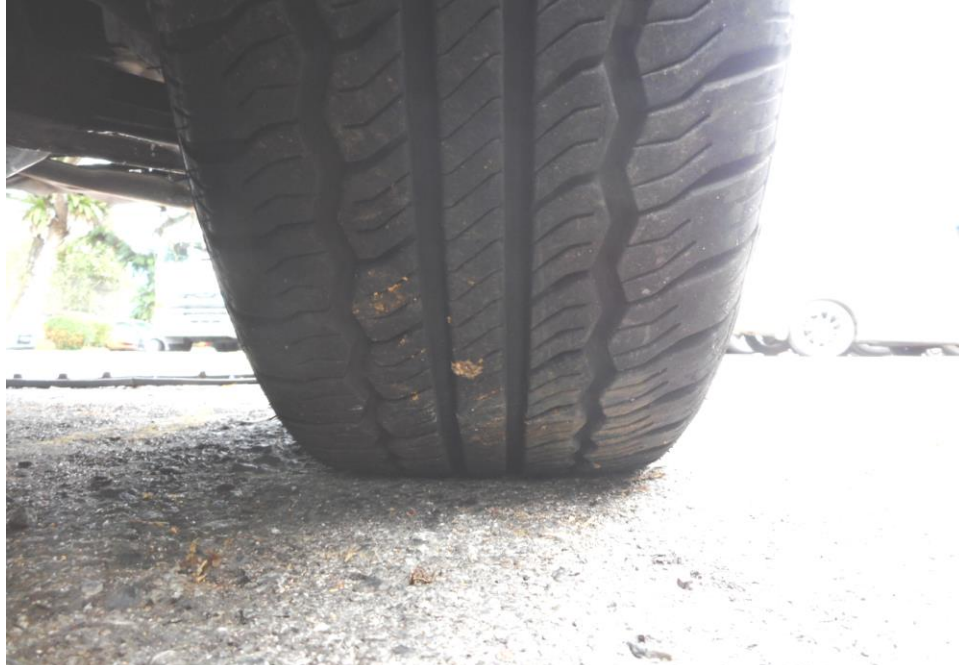
Photo 8 shows the condition of the front right tyre of the Motor Van, which was observed to be in serviceable condition with remaining tread depth of approximately 5.9mm. The tyre, which was wrapped around standard steel wheel rim, was also observed to be sufficiently inflated for vehicular operation. There was no tear, cut or burst mark(s) on the outer and the inner sidewalls as well as across the tread of the 4 tyres that were fitted on the Motor Van.

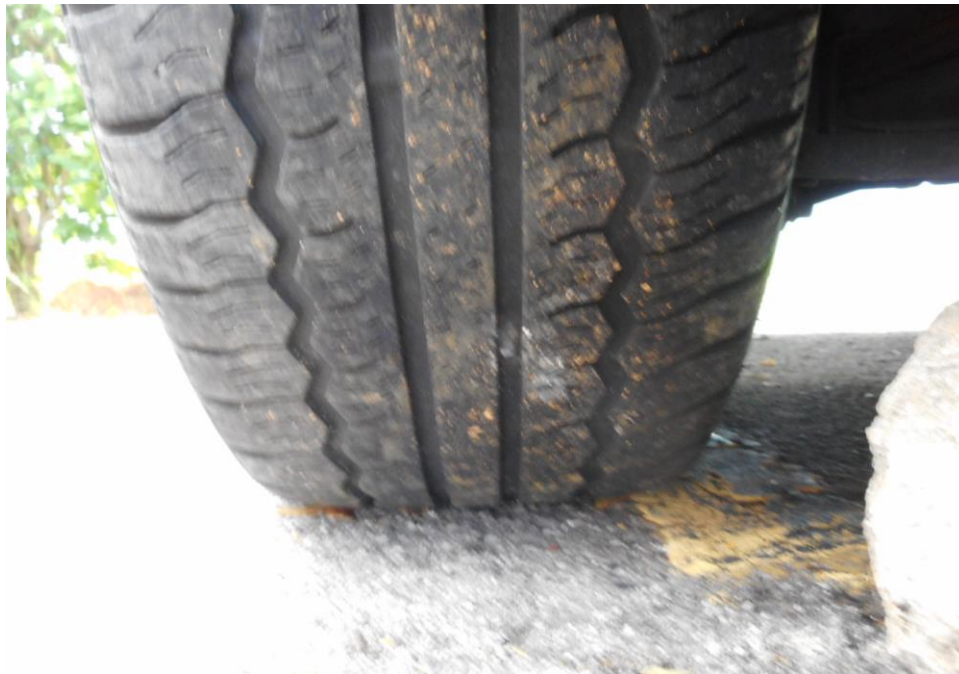
Photo 9 shows the condition of the rear right tyre of the Motor Van, which was observed to be in serviceable condition with remaining tread depth of approximately 3.4mm. The tyre, which was wrapped around standard steel wheel rim, it was observed to be sufficiently inflated for vehicular operation.

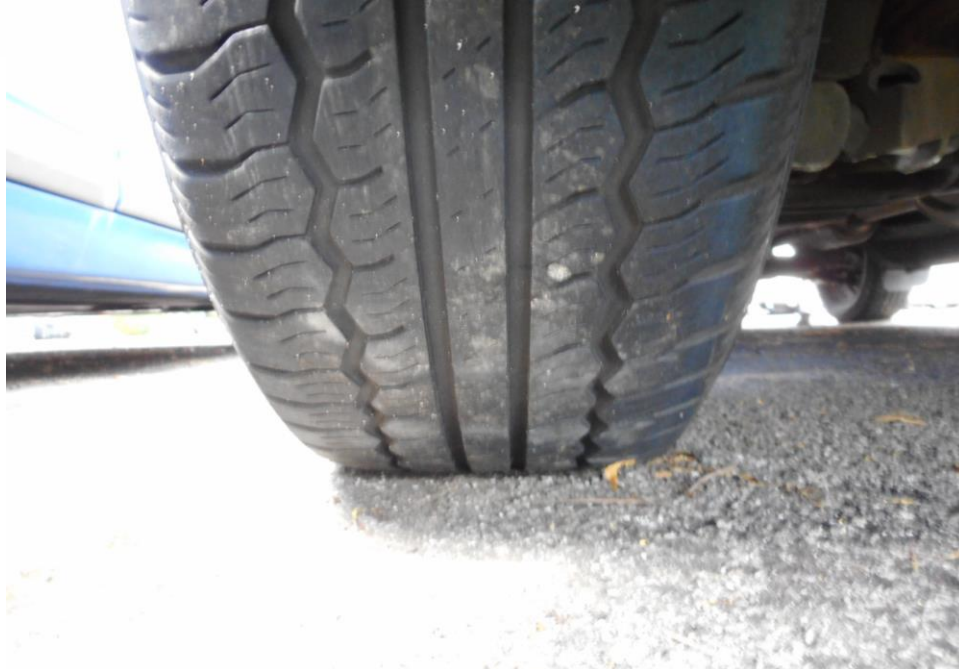
Photo 10 shows the condition of the rear left tyres of the Motor Van, which was observed to be in serviceable condition with remaining tread depth of approximately 4.4mm. The tyres, which were wrapped around standard steel wheel rim, were also observed to be sufficiently inflated for vehicular operation. There was also no damage found on all 4 steel wheel rims of the Motor Van.

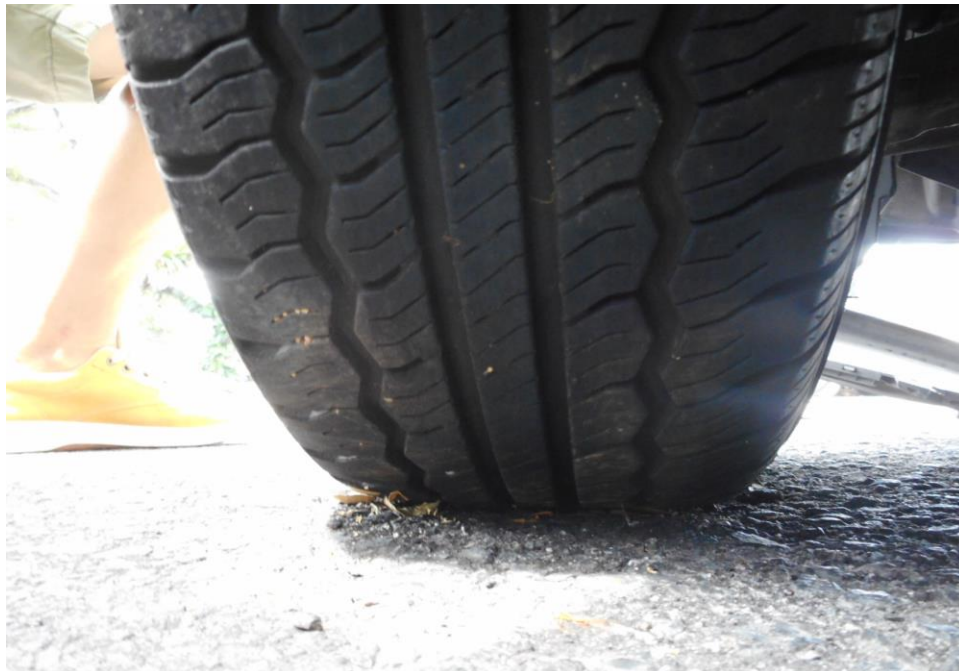
Photo 11 shows the condition of the rear right tyres of the Motor Van, which were observed to be in serviceable condition with remaining tread depth of approximately 6mm. There was also no tear, cut or burst mark(s) on the outer and the inner sidewalls as well as across the tread of the 4 tyres that were fitted on the Motor Van.

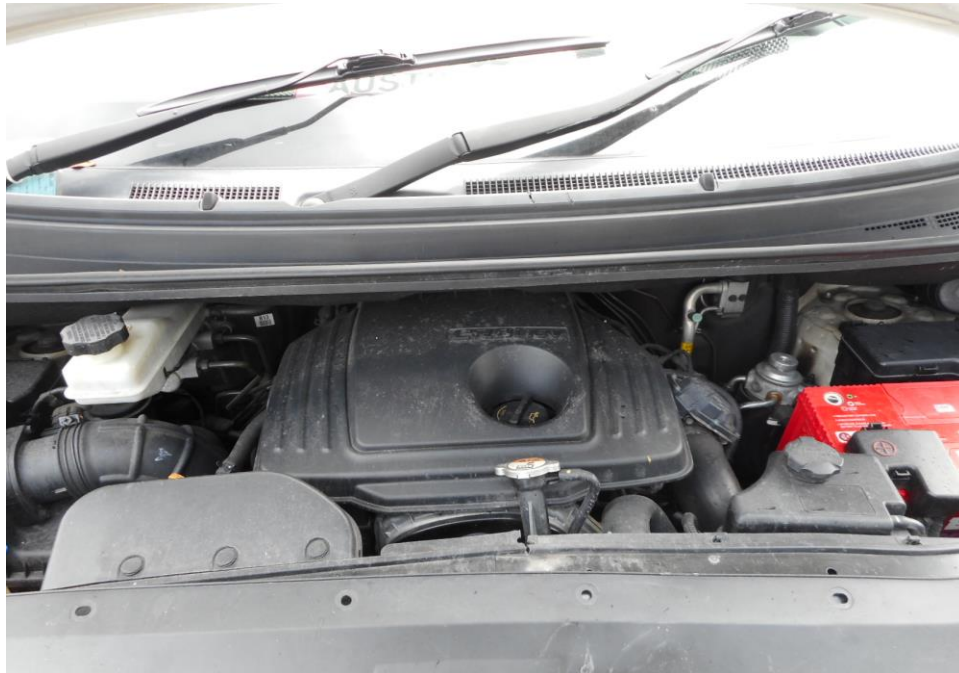
Photo 12 shows a general view of the Motor Van's engine compartment, which was accessed by lifting the front cabin of the Motor Van. The various parts and components inside the engine compartment were unaffected by the accident. There was also no sign(s) or indication(s) of fresh fluid leakage and/or fluid stain within the engine compartment

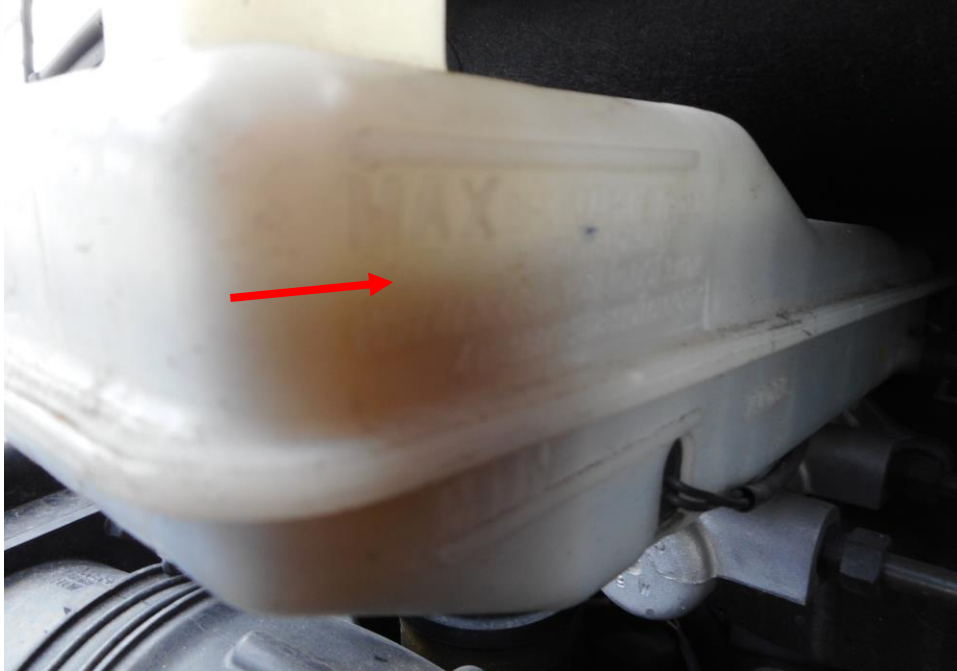
Photo 13 shows the brake fluid reservoir of the Motor Van at the time of my inspection. The brake fluid was observed to be of sufficient level (arrowed) and without any visible contamination.

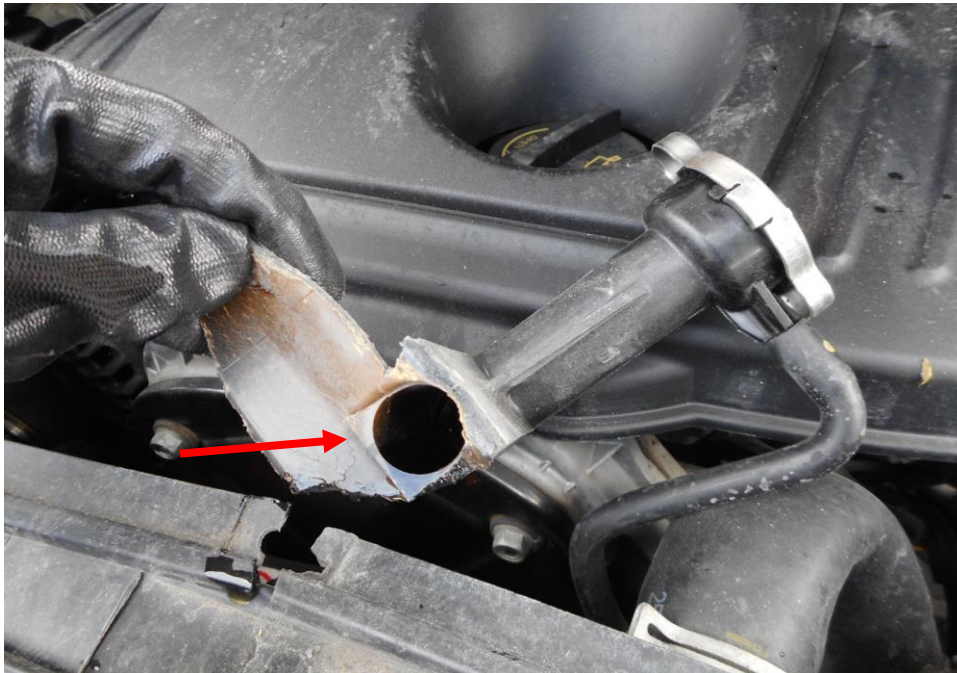
8. Upon examination of the Motor Van's engine compartment, I had observed all the parts and components inside the engine compartment to be intact and unaffected by the accident. The brake fluid, power steering fluid and engine oil were all found to be of sufficient level for operating purposes. Visually, there was also no contamination found to these fluids. However, the engine coolant found observed to be insufficient as the engine coolant radiator was damaged as a result of the accident and had caused the coolant to leak out.

Photo 14 shows the engine coolant reservoir of the Motor Van at the time of my inspection. The engine coolant was observed to be of insufficient level due to the damage sustained to the engine coolant radiator (arrowed) as a result of the accident.

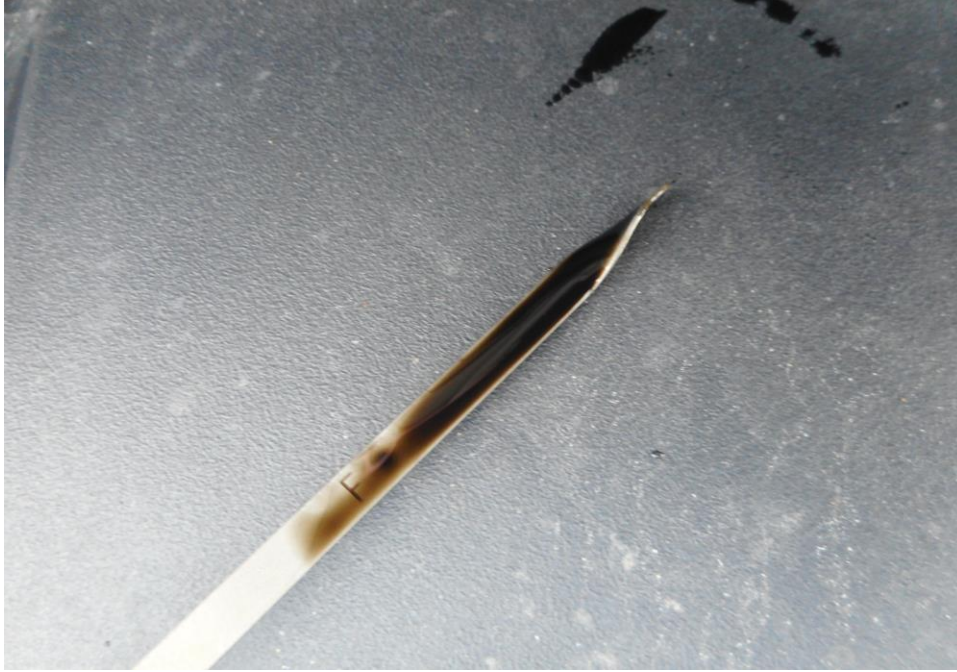
Photo 15 shows the engine oil dip stick of the Motor Van at the time of my inspection. The engine oil was observed to be of sufficient level and without any visible contamination.

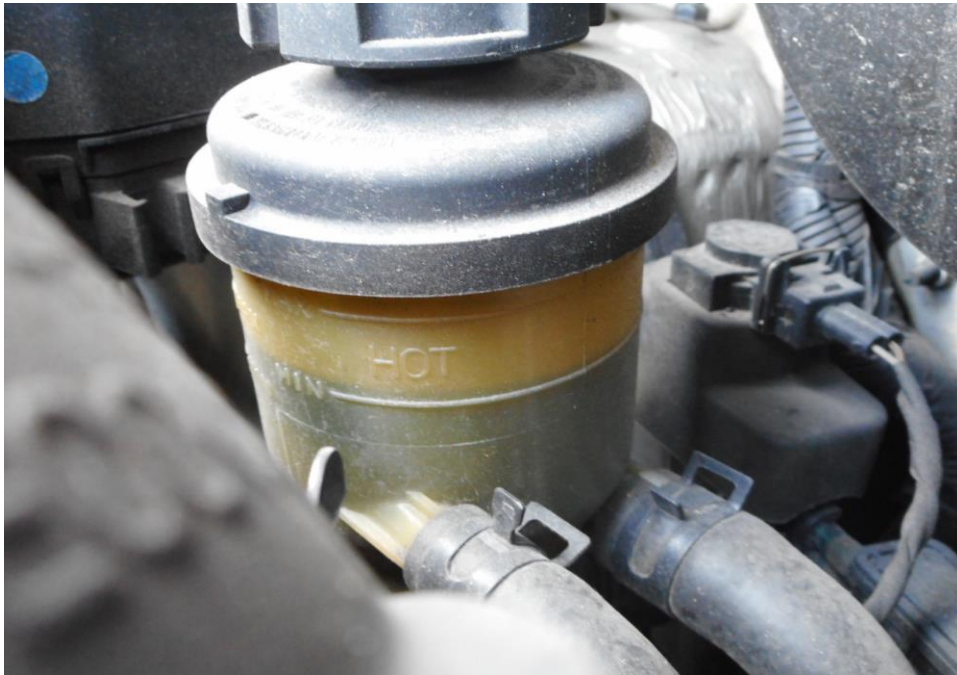
Photo 16 shows the power steering fluid reservoir of the Motor Van at the time of my inspection. The power steering fluid was observed to be of sufficient level (arrowed) and without any visible contamination.

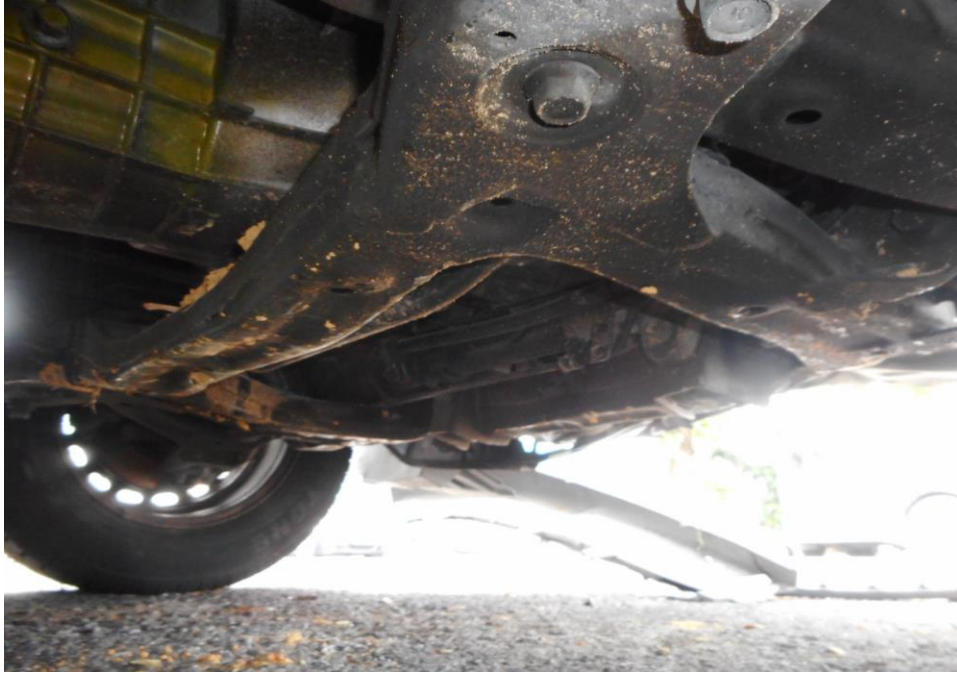
Photo 17 shows the undercarriage of the Motor Van, at the area where the engine housing and transmission housing are located. I did not find any sign(s) or indication(s) of fluid leak and/or fluid stain(s) on the underside of the Motor Van.

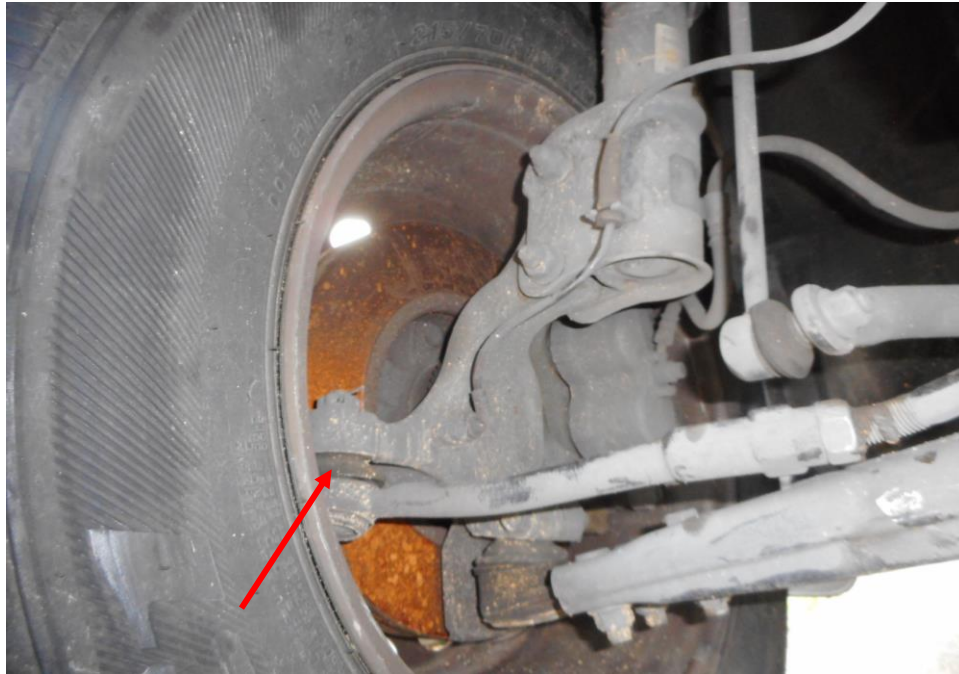
Photo 18 shows the various undercarriage components at the front right wheel of the Motor Van, in particular the steering tie rod end (arrowed). The various steering components were all found to be intact, suggesting that the steering system of the Motor Van was likely to be in serviceable condition at the material time of accident. There was also no sign of fluid stain(s) observed on the various undercarriage components.

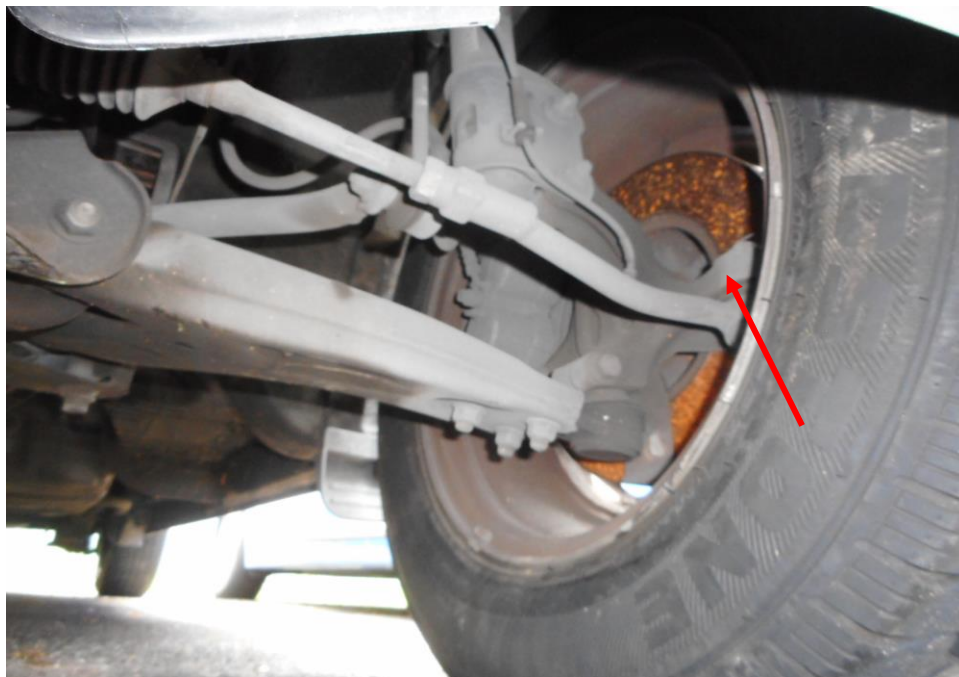
Photo 19 shows the various undercarriage components at the front left wheel of the Motor Van, in particular the steering tie rod end (arrowed). The various undercarriage components of the Motor Van were all found to be intact without any visible damage. There was also no sign of fluid stain(s) observed on the various undercarriage components.

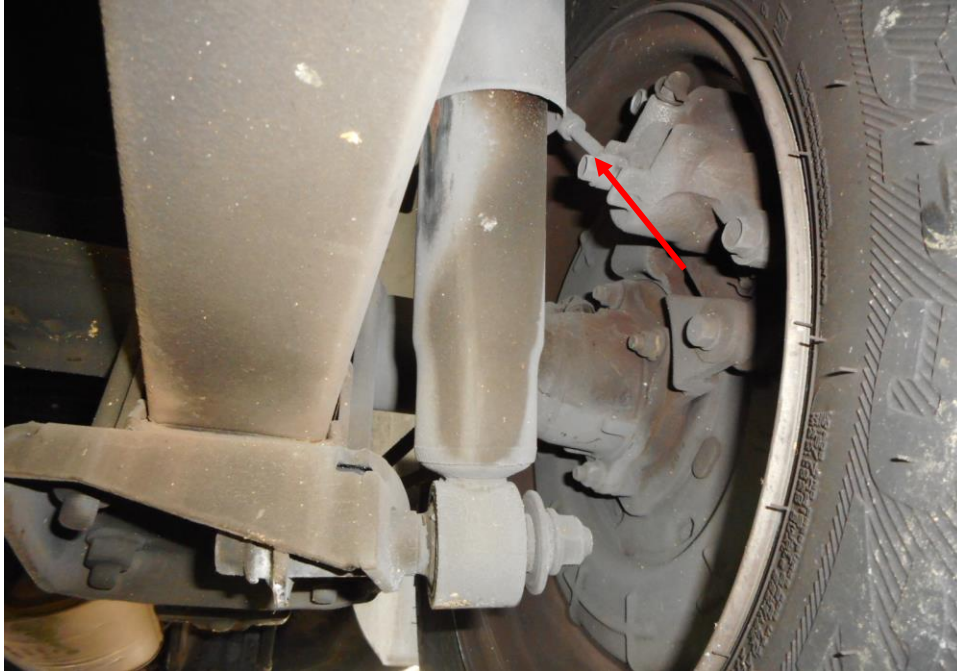
Photo 20 shows the brake pipe (arrowed) at the rear right wheel of the Motor Van. I did not observe any leakage of brake fluid at the time of my inspection of the Motor Van. My static tests of the Motor Van's braking system, along with my visual examination of the various mechanical components in the braking system, had indicated that there was no internal leakage of pressure/vacuum. Hence the braking system of the Motor Van was likely to be in serviceable condition at the material time of accident.

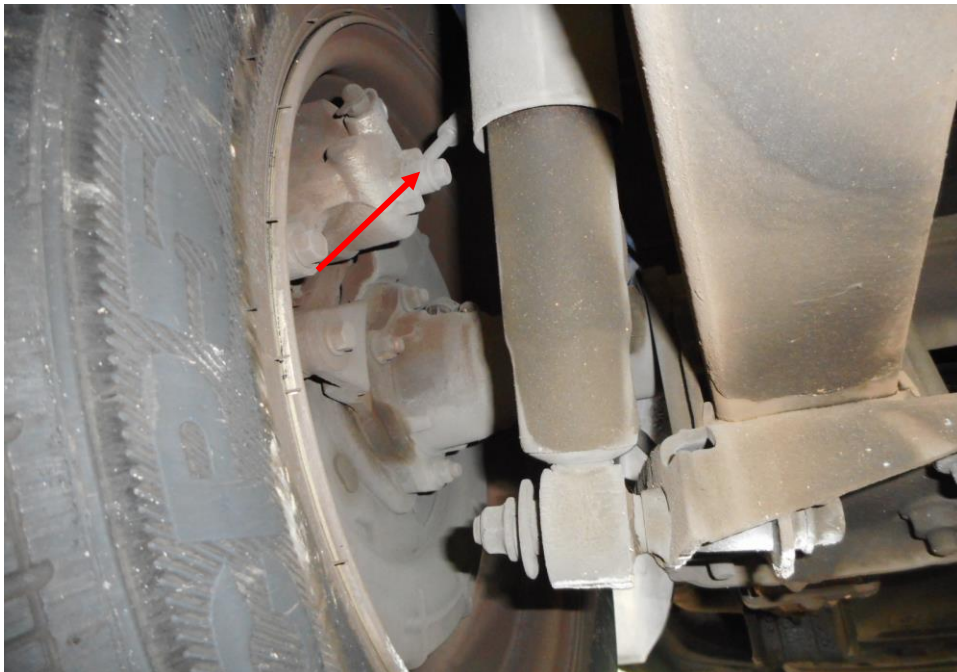
Photo 21 shows the brake pipe (arrowed) at the rear left wheel of the Motor Van. I did not observe any leakage of brake fluid at the time of my inspection of the Motor Van. My static tests of the Motor Van's braking system, along with my visual examination of the various mechanical components in the braking system had indicated that there was no internal leakage of pressure/vacuum. Hence the braking system of the Motor Van was likely to be in serviceable condition at the material time of accident.

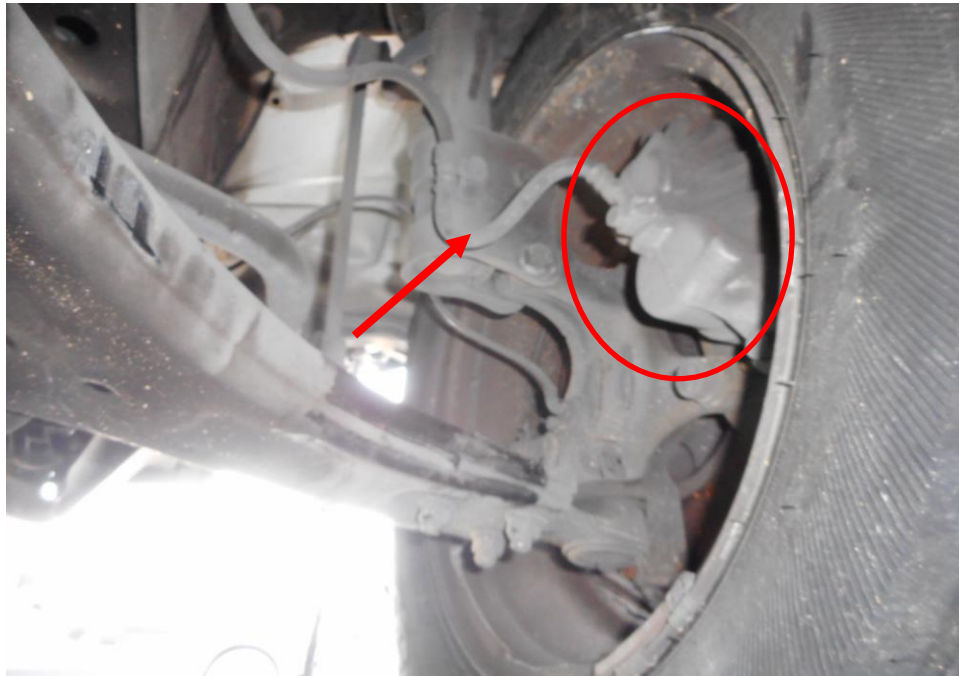
Photo 22 shows the brake hose/pipe (arrowed) at the front right wheel of the Motor Van. No leakage of brake fluid was observed. Visual examination of the various components of the braking system like the brake caliper (circled), brake booster, brake pedal etc had revealed all to be intact and without visible damage at the time of accident. There was also no sign of fluid stain(s) observed on the various undercarriage components.

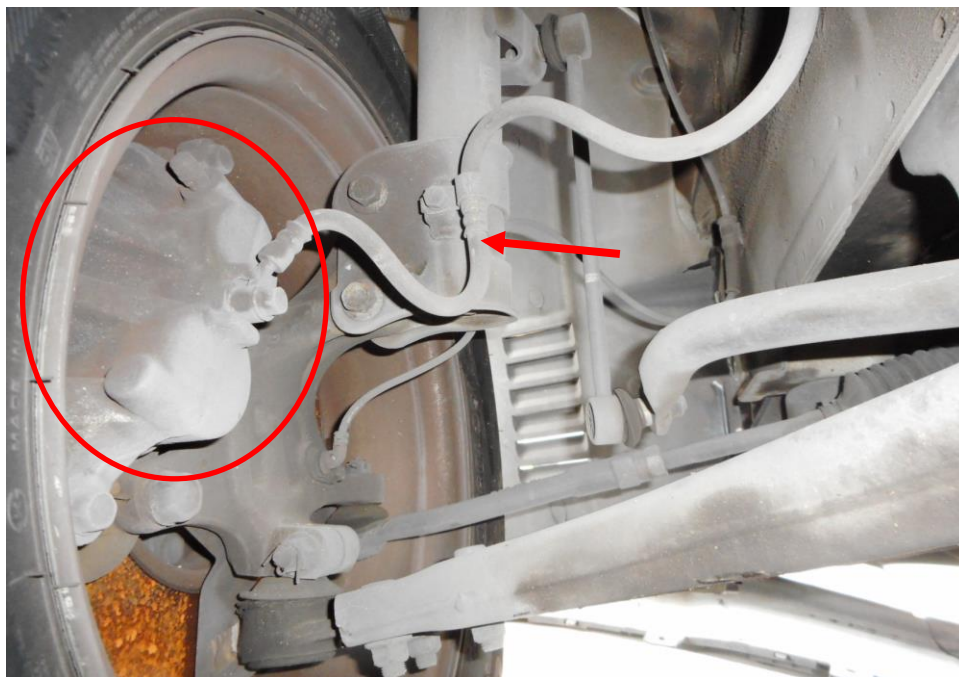
Photo 23 shows the brake hose/pipe (arrowed) at the front left wheel of the Motor Van. No leakage of brake fluid was observed. Visual examination of the various components of the braking system like the brake caliper (circled), brake booster, brake pedal etc had revealed all to be intact and without visible damage at the time of accident. There was also no sign of fluid stain(s) observed on the various undercarriage components.

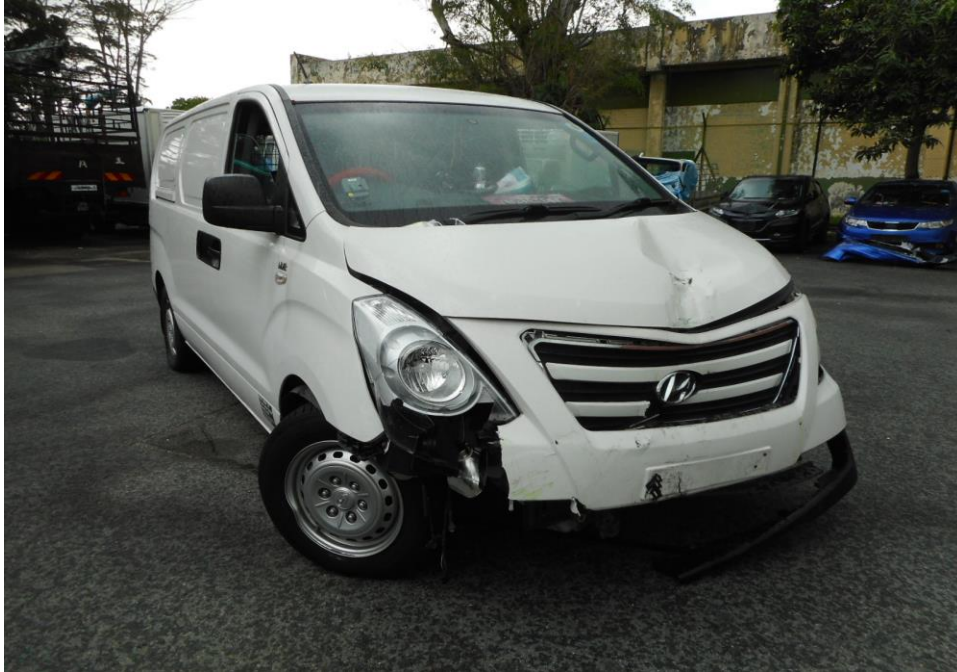
Photo 24 shows the front right wheel of the Motor Van turned to its full left. During my steering system test, I did not experience any abnormal free play and/or resistance when I had turned the steering wheel towards full left and full right. This would suggest that the steering system of the Motor Van was likely to be in serviceable condition at the material time of accident.

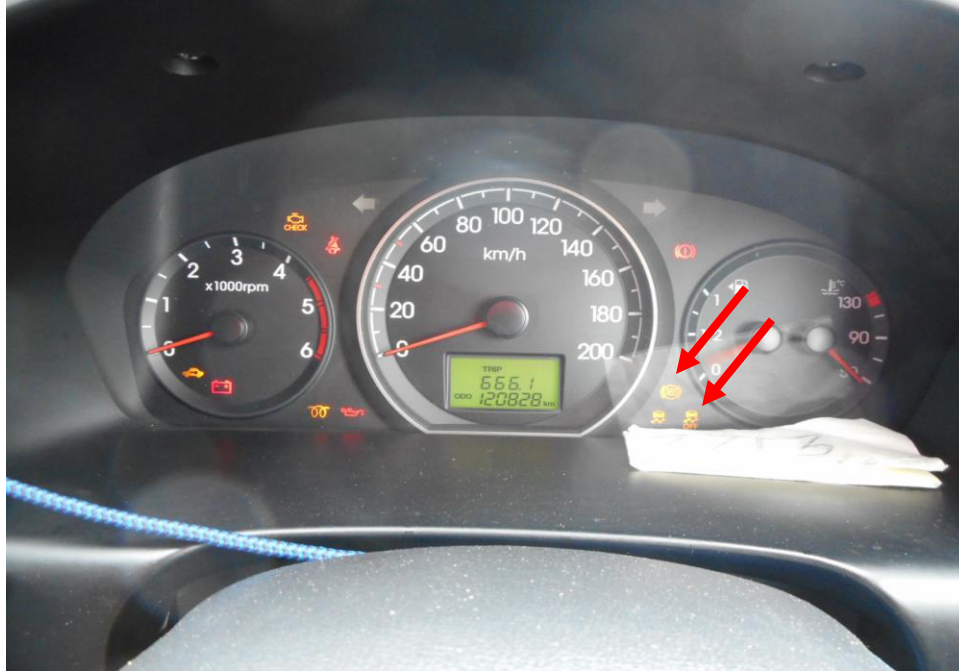
Photo 25 shows the warning light for Anti-Lock Brake System (ABS) and Traction Control System (TCS) (arrowed) appearing on the instrument panel of the Motor Van during the self-test of its various electronic operating systems when its engine was cranked.

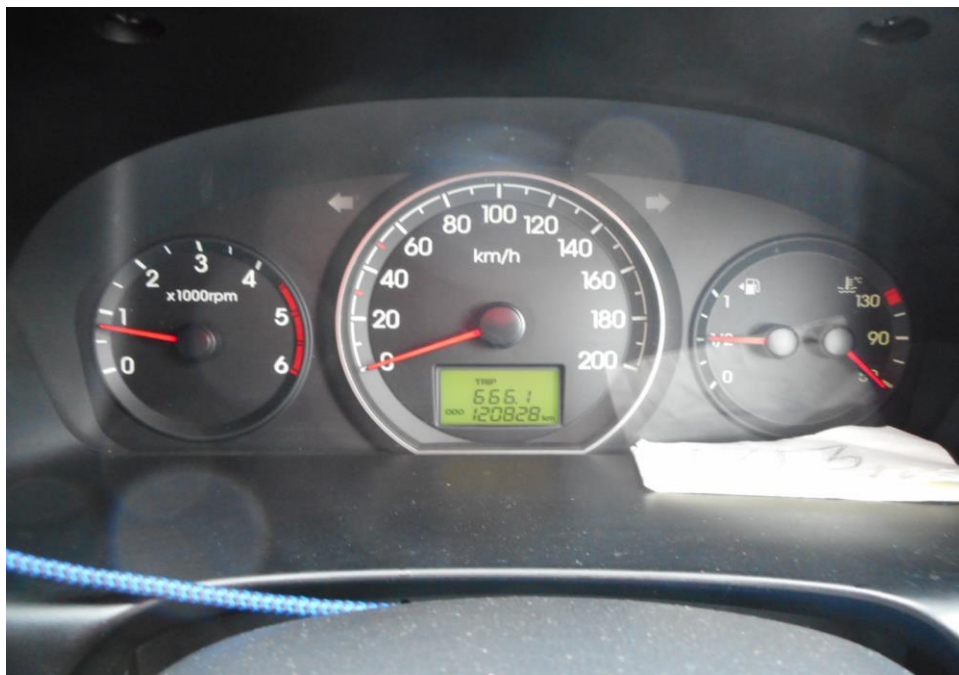
Photo 26 shows no warning lights illuminated on the instrument panel of the Motor Van after the engine was cranked. This would suggest that there was no abnormality to the electronic operating system of the Motor Van, like the ABS, and TCS etc.
