You're Ref: TP/IP/13053/2021  
Our Ref: CI/TPD21004899/P

21<sup>st</sup> April 2021

**MECHANICAL INSPECTION REPORT OF MOTOR CAR SMK 6091K**

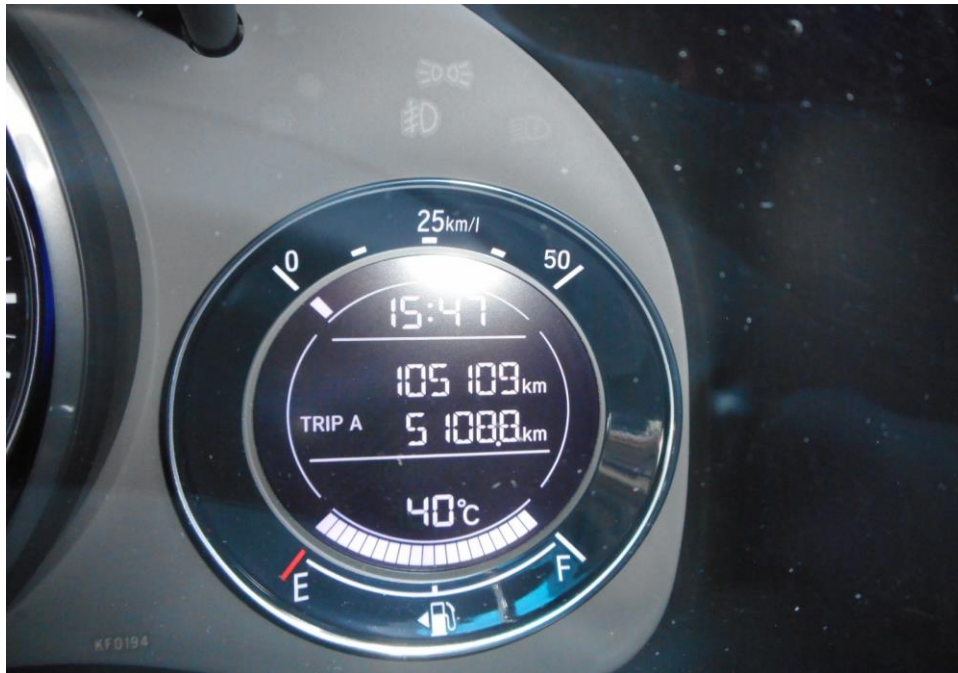
**Photo 1** shows the mileage of the Motor Car at the time of my inspection. The mileage observed was 105,109km.

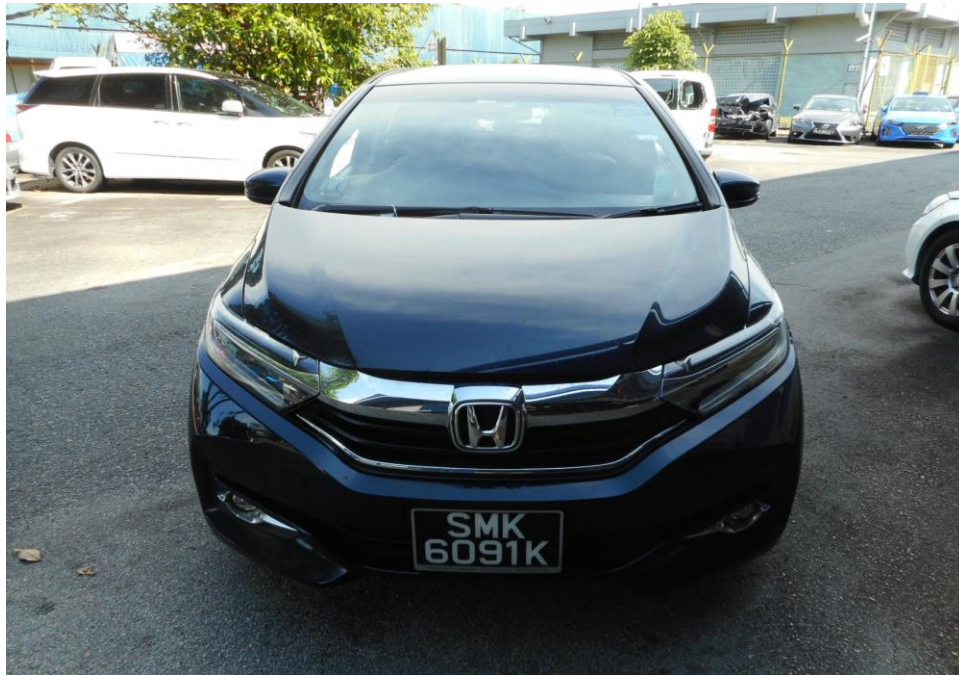
**Photo 2** shows a general view of the Motor Car's front body at the time of my inspection. The left portion of the Motor Car was observed to have sustained damage. Its left rear door was the body parts that were damaged as a result of the accident.

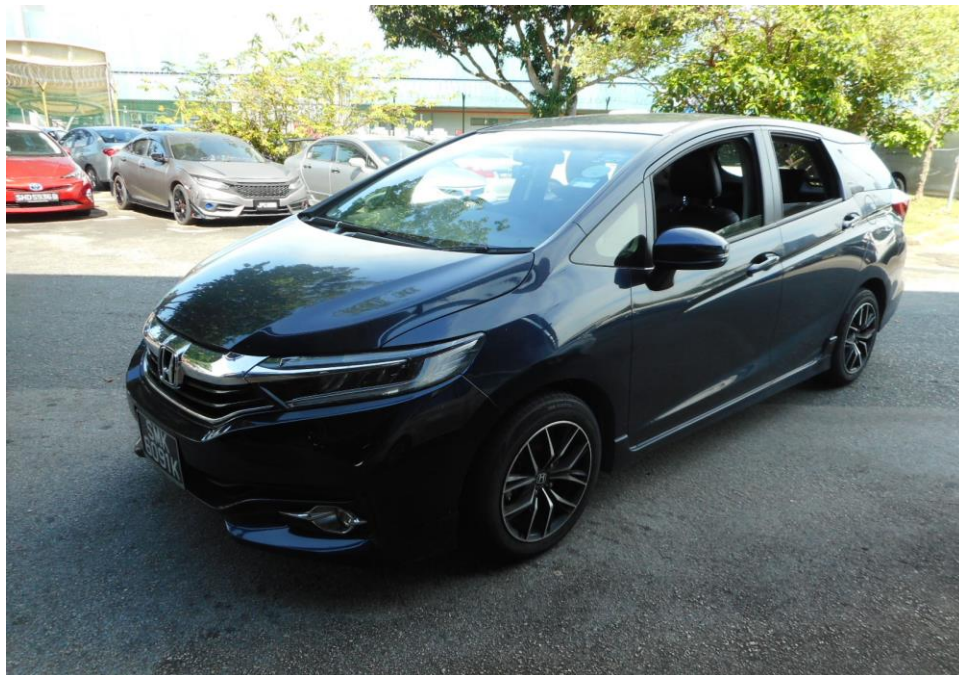
4. The mileage of the Motor Car at the time of my inspection was 105,109km.
5. The Motor Car was observed to have sustained damage at its left portion. Its left rear door was the body parts that were damaged as a result of the accident.

**Photo 3** shows a general view of the Motor Car's left body at the time of my inspection. The Motor Car was observed to have sustained damage at its left rear door as a result of the accident.

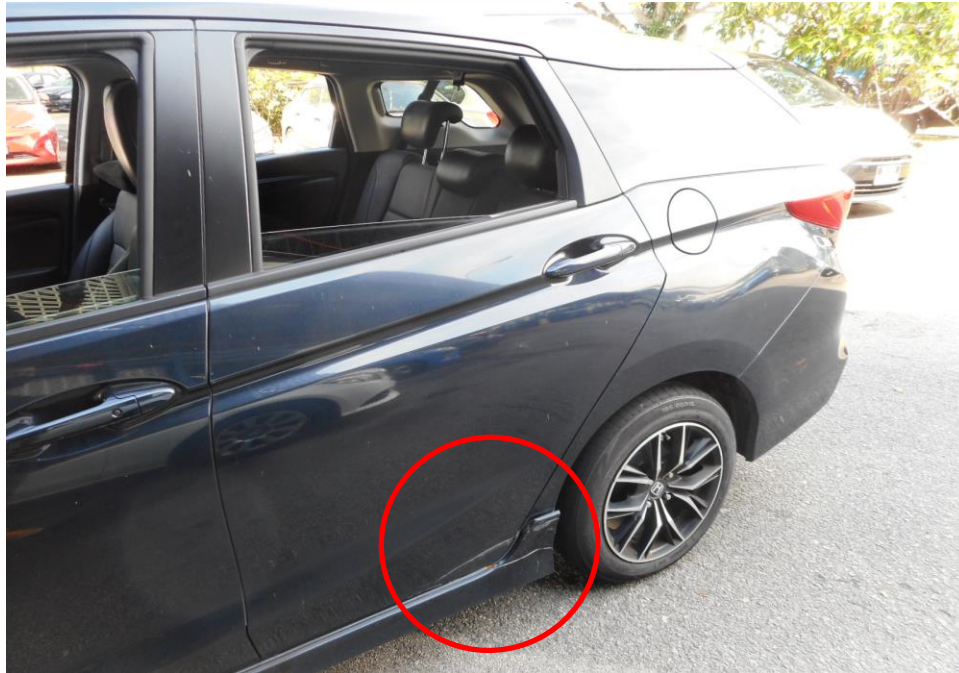
**Photo 4** shows the close up view of the Motor Car's left body at the time of my inspection. The Motor Car was observed to have sustained damage at its left rear door (circled) as a result of the accident.

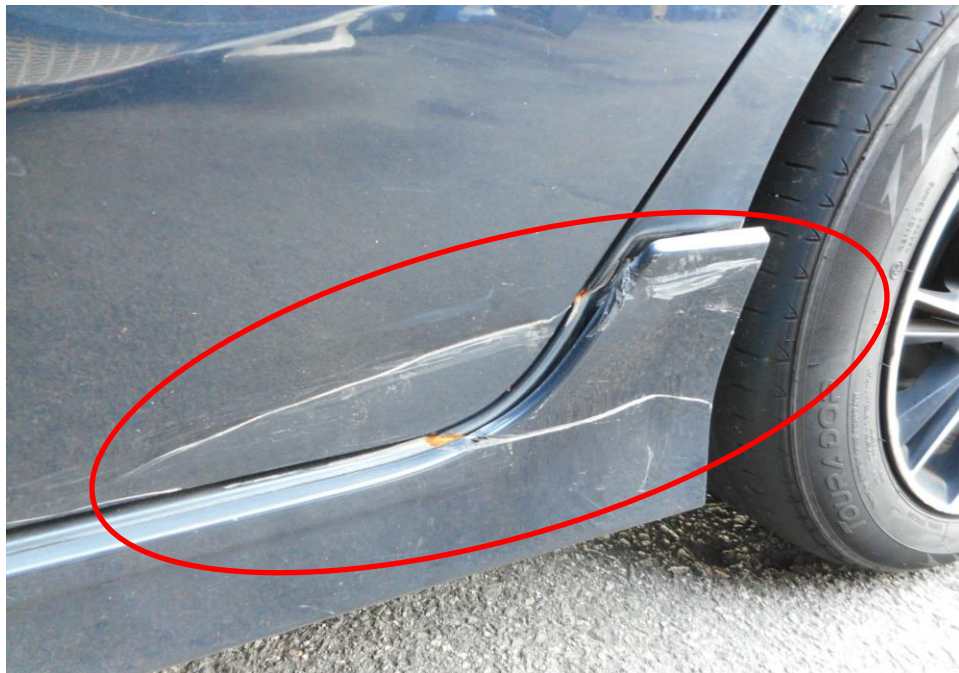
**Photo 5** shows the close up view of the Motor Car's left body at the time of my inspection. The Motor Car was observed to have sustained damage at its left rear door (circled) as a result of the accident.

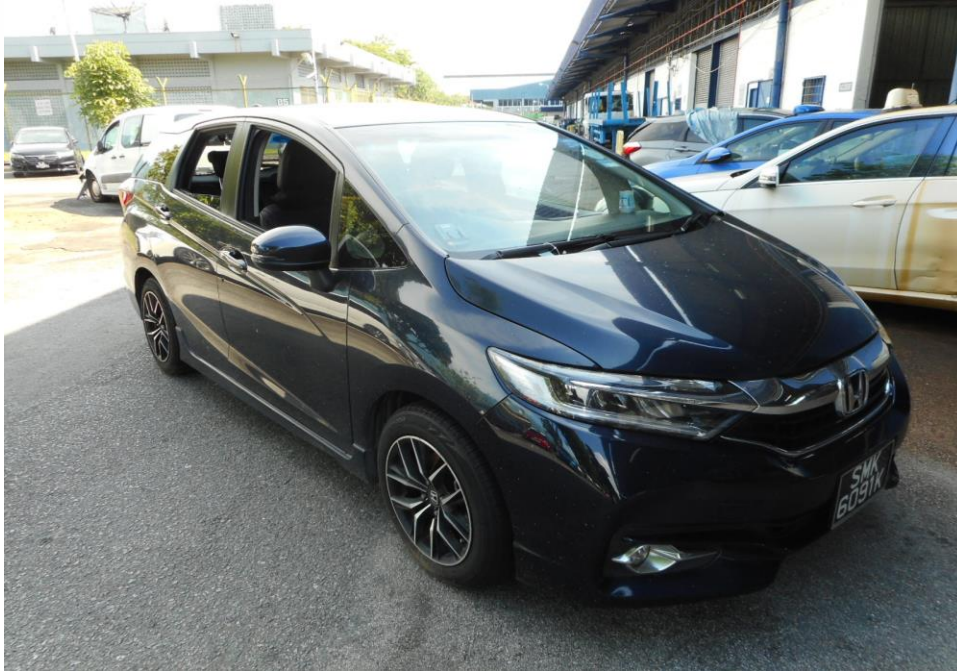
**Photo 6** shows a general view of the Motor Car's right body at the time of my inspection. The right portion of the Motor Car was observed to have been unaffected by the accident.

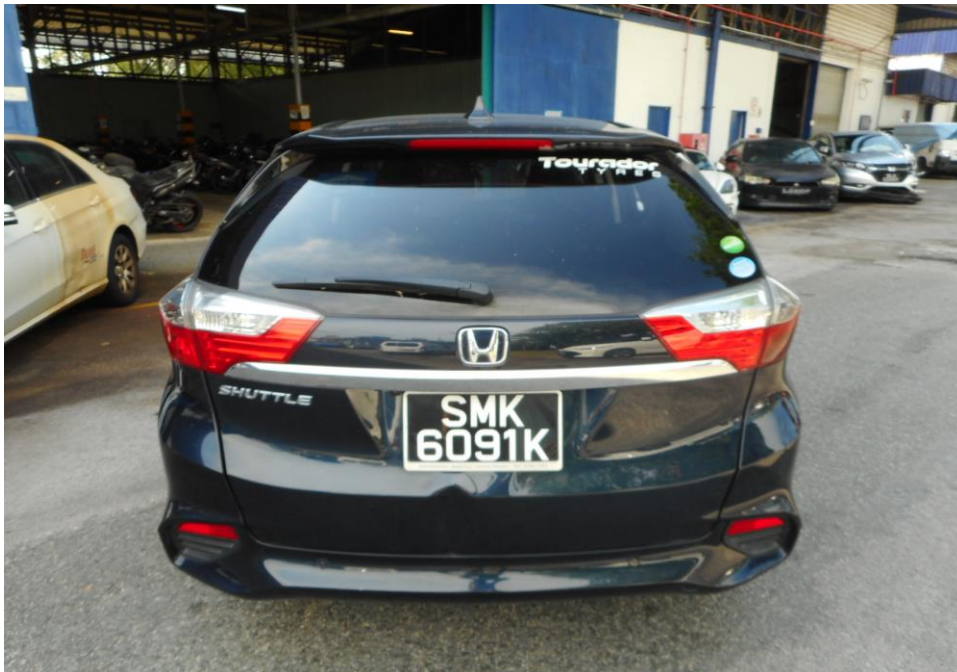
**Photo 7** shows the general view of the Motor Car's rear body at the time of my inspection. The Motor Car rear was observed to be unaffected by the accident.

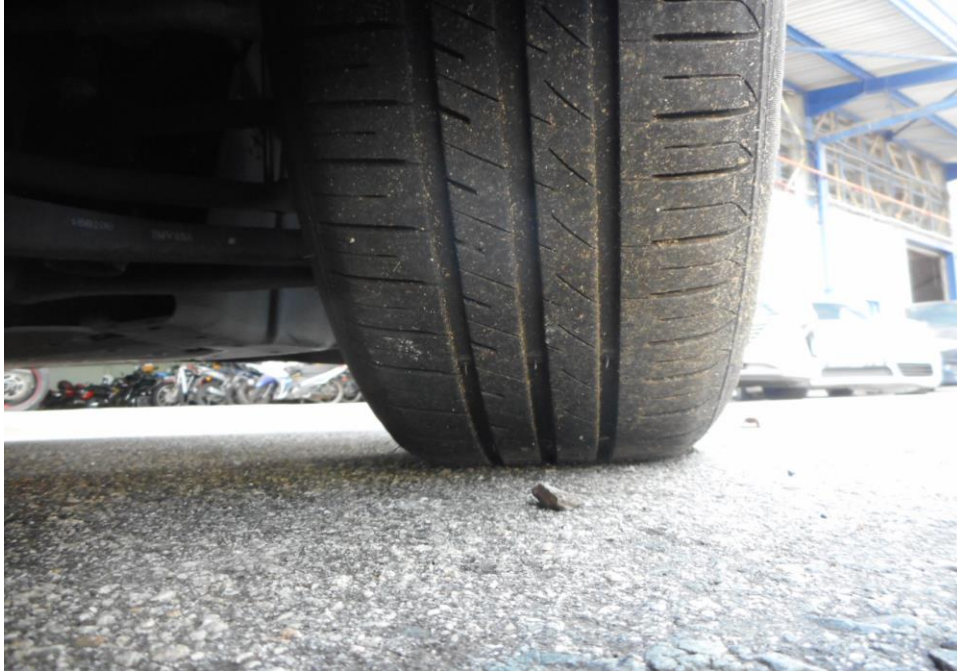
**Photo 8** shows the condition of the front right tyre of the Motor Car, which was observed to be in serviceable condition with remaining tread depth of approximately 5.3mm. The tyre was sufficiently inflated for vehicular operation with no tear, cut or burst mark(s) on the outer and the inner sidewalls as well as across the tread. The 4 tyres of the Motor Car were wrapped around standard steel wheel rims without any damage.

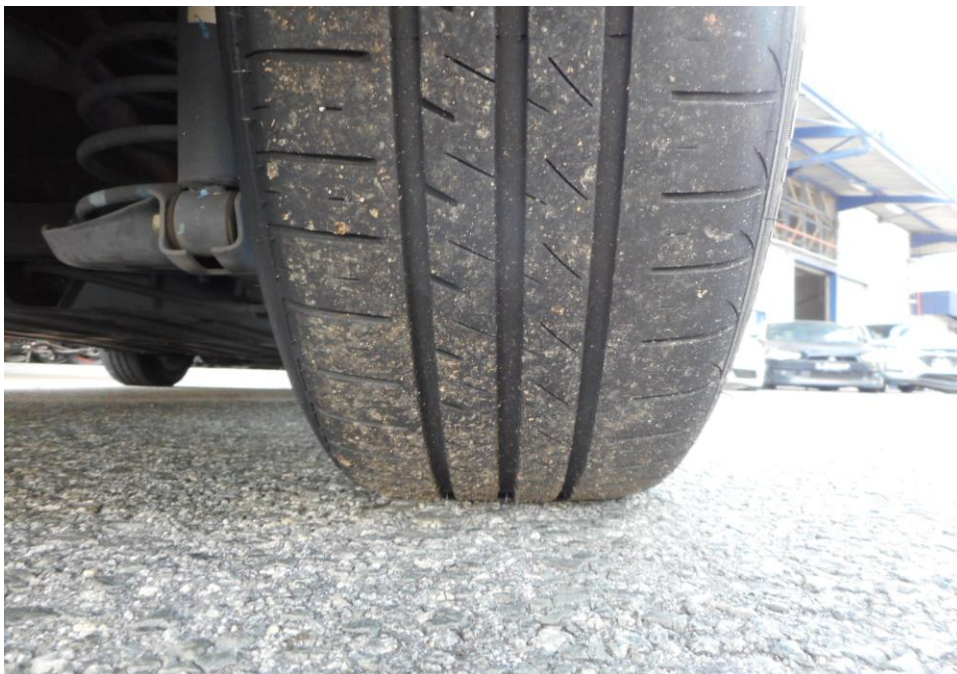
**Photo 9** shows the condition of the rear right tyre of the Motor Car, which was observed to be in serviceable condition with remaining tread depth of approximately 4.2mm. The tyre was also observed to be sufficiently inflated for vehicular operation with no tear, cut or burst mark(s).

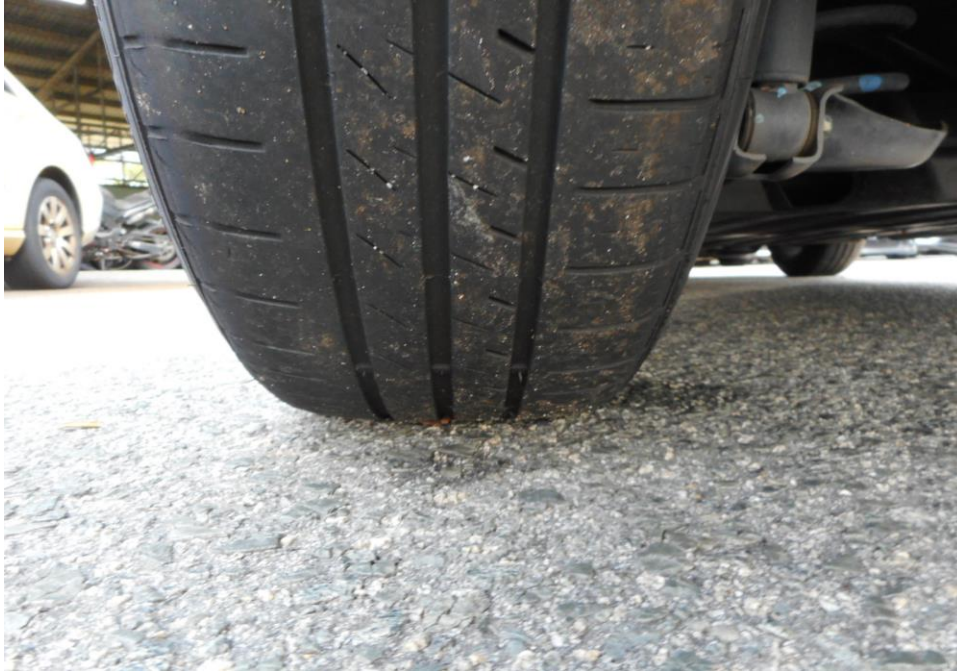
**Photo 10** shows the condition of the rear left tyre of the Motor Car, which was observed to be in serviceable condition with remaining tread depth of approximately 3.7mm. The tyre, which was wrapped around steel wheel rim, was also observed to be sufficiently inflated for vehicular operation. The 4 tyres of the Motor Car were wrapped around standard steel wheel rims.

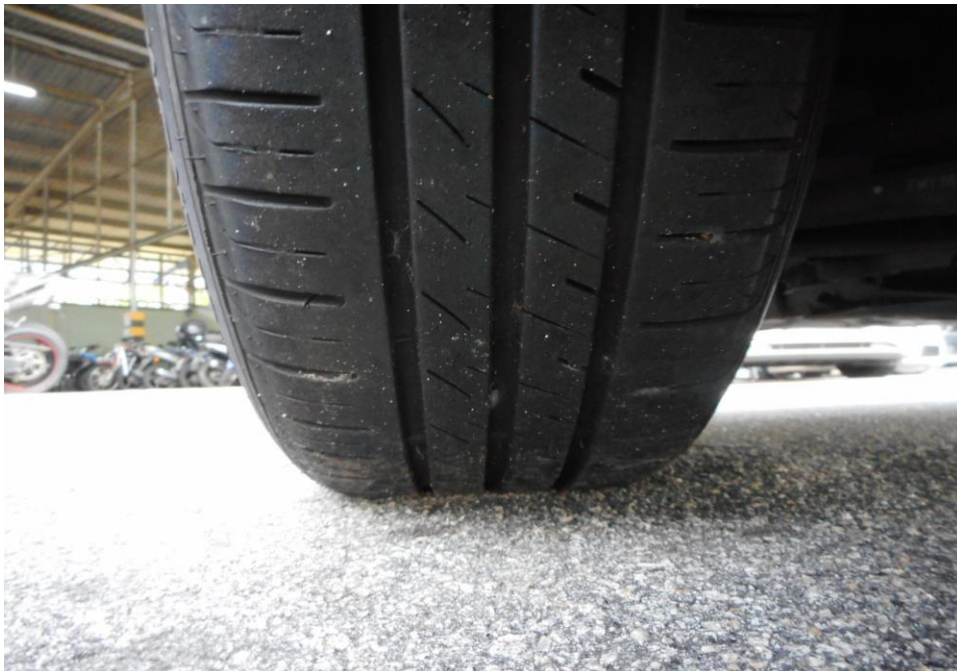
**Photo 11** shows the condition of the front left tyre of the Motor Car, which was observed to be in serviceable condition with remaining tread depth of approximately 4.2mm. There was also no tear, cut or burst mark(s) on the outer and the inner sidewalls as well as across the tread of the Motor Car's 4 tyres.

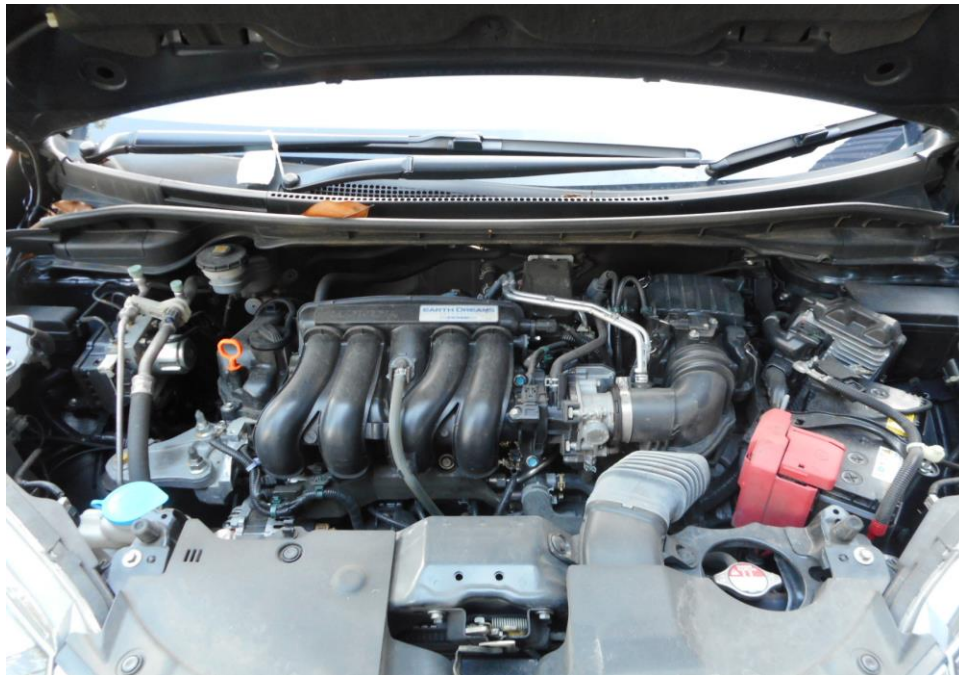
**Photo 12** shows a general view of the Motor Car's engine compartment. The various parts and components inside the engine compartment were unaffected by the accident. There was also no sign(s) or indication(s) of fluid leakage and/or fluid stain within the engine compartment.

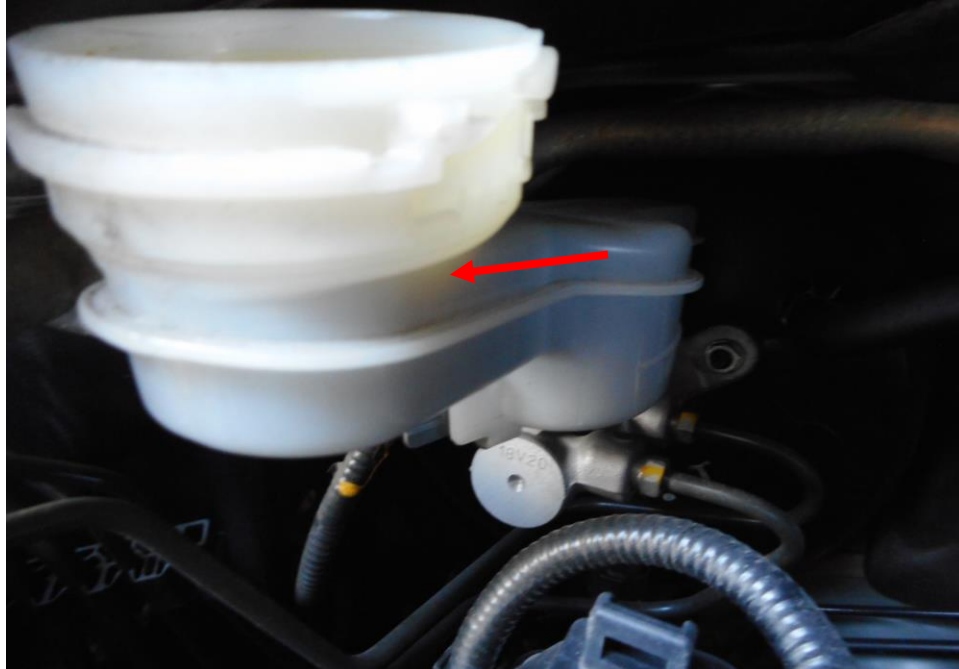
**Photo 13** shows the brake fluid reservoir of the Motor Car at the time of my inspection. The brake fluid was observed to be of sufficient level (arrowed) and without any visible contamination.

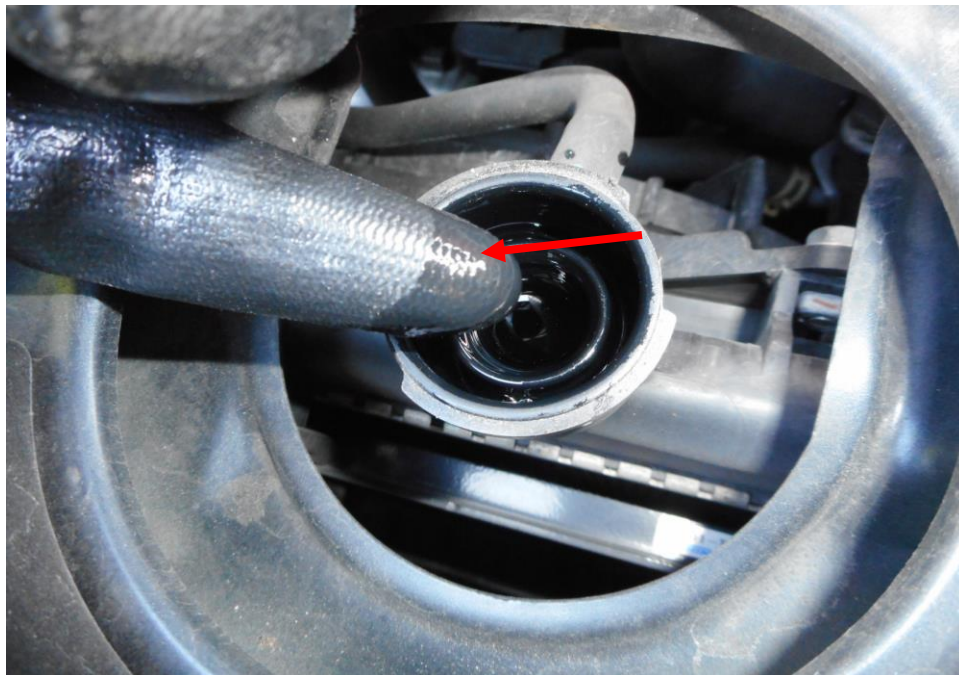
**Photo 14** shows checks being carried out to the engine coolant of the Motor Car at the time of my inspection. The engine coolant was observed to be of sufficient level (arrowed) and without any visible contamination.

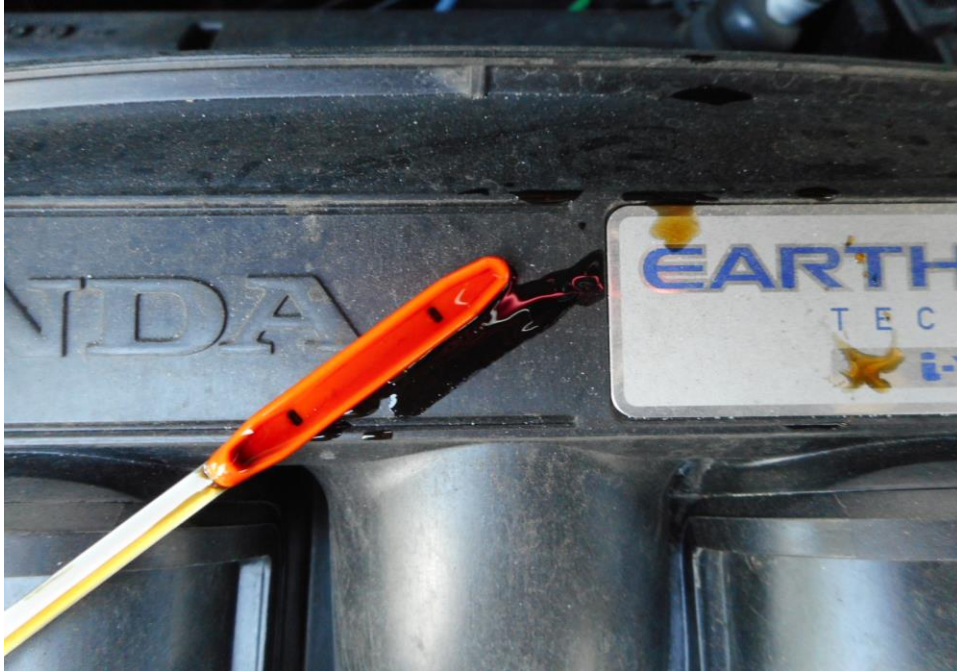
**Photo 15** shows the engine oil dip stick of the Motor Car at the time of my inspection. The engine oil was observed to be of sufficient level and without any visible contamination.

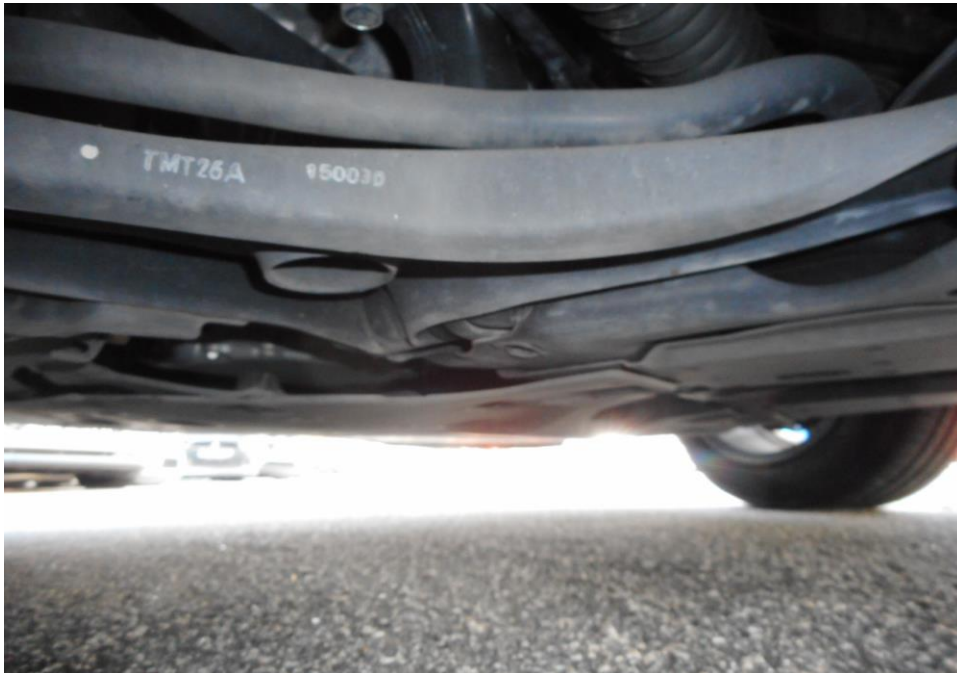
**Photo 16** shows the undercarriage of the Motor Car, at the area where the engine housing and transmission housing are located. I did not find any sign(s) or indication(s) of fluid leak and/or fluid stain(s) on the underside of the Motor Car.

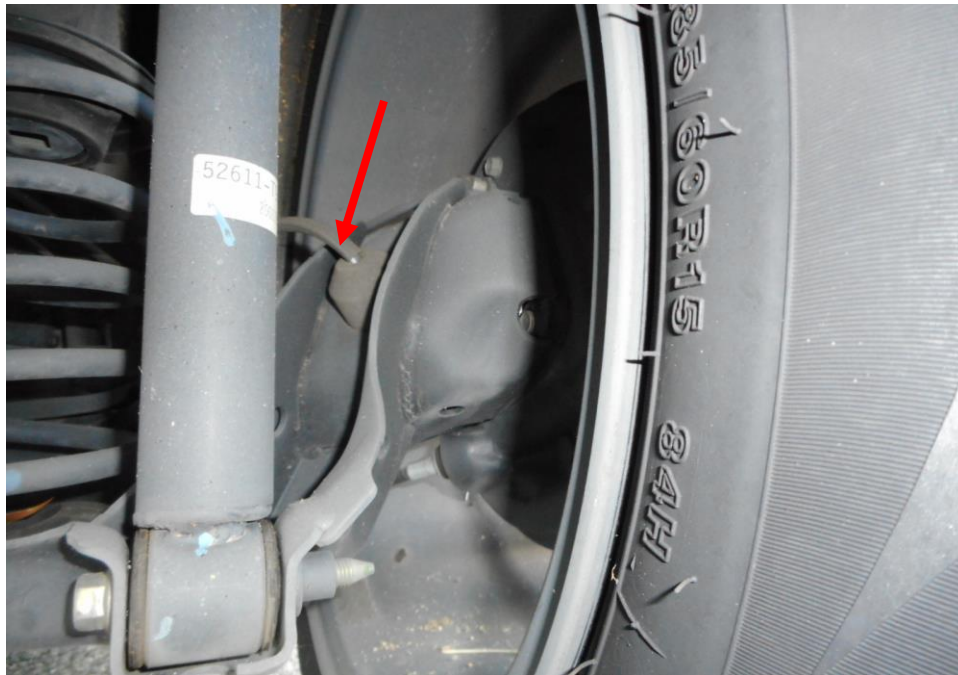
**Photo 17** shows the brake hose/pipe (arrowed) at the rear right wheel of the Motor Car. No leakage of brake fluid was observed. Visual examination of the various components of the braking system like the drum brake, brake booster, brake pedal etc. had revealed all to be intact and without visible damage.

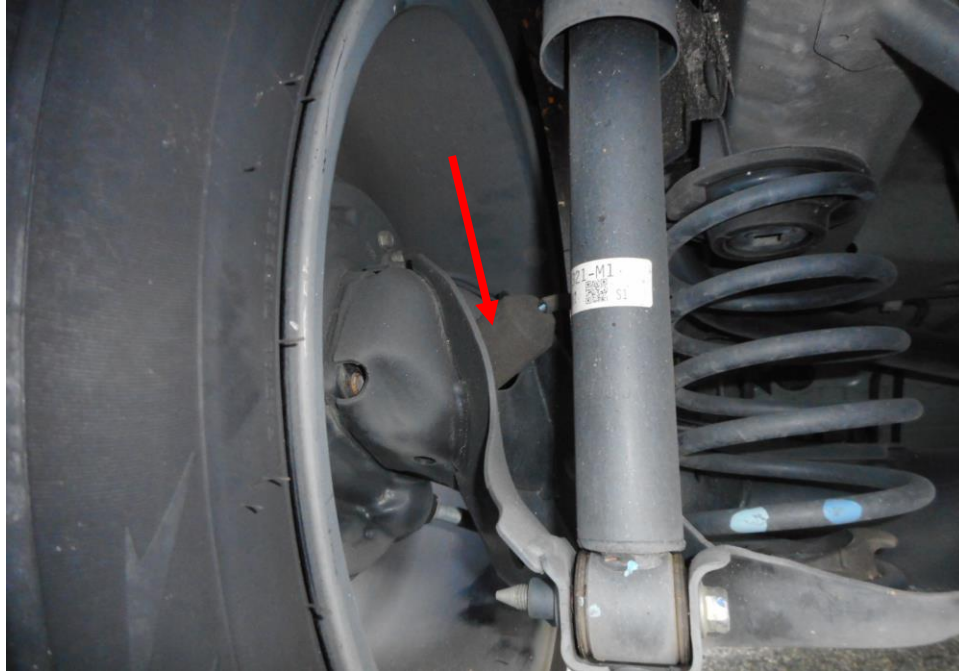
**Photo 18** shows the brake hose/pipe (arrowed) at the rear left wheel of the Motor Car. I did not observe any leakage of brake fluid at the time of my inspection of the Motor Car. Static tests of the Motor Car's braking system had indicated that there was no internal leakage of pressure/vacuum. The undercarriage components of the Motor Car were also all found to be intact and without any visible damage.

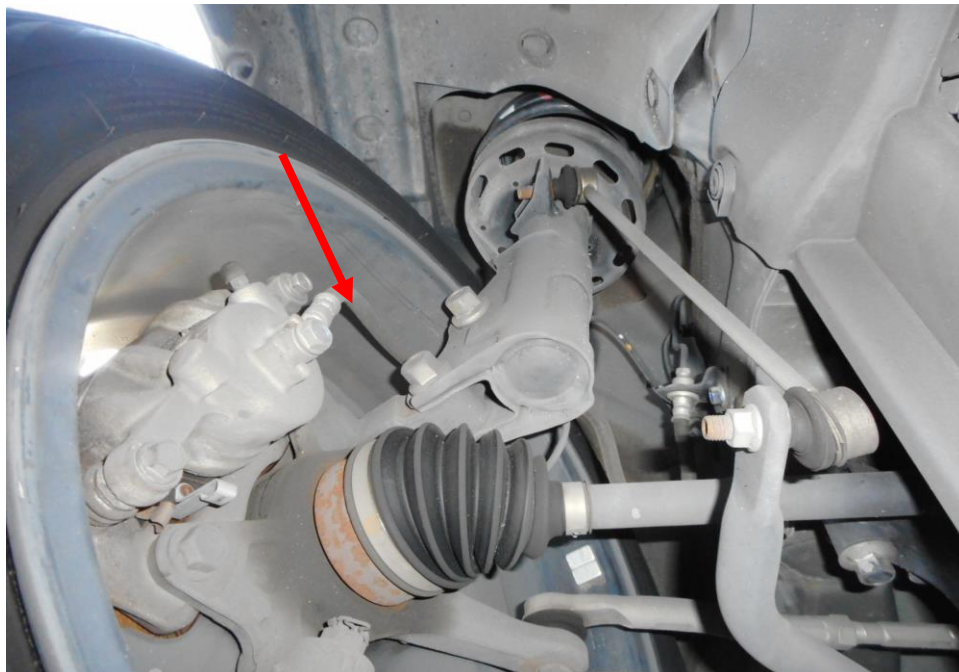
**Photo 19** shows the brake hose/pipe (arrowed) at the front right wheel of the Motor Car. I did not observe any leakage of brake fluid at the time of my inspection of the Motor Car. Static tests of the Motor Car's braking system had indicated that there was no internal leakage of pressure/vacuum. The undercarriage components of the Motor Car were also all found to be intact and without any visible damage.

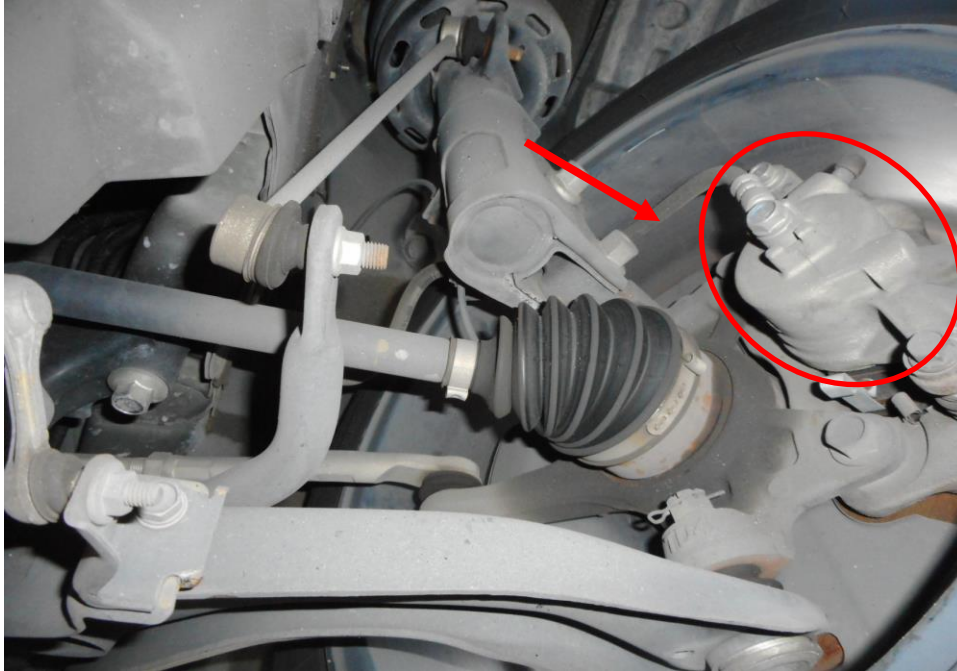
**Photo 20** shows the brake hose/pipe (arrowed) at the front left wheel of the Motor Car. No leakage of brake fluid was observed. Visual examination of the various components of the braking system like the brake caliper (circled), brake booster, brake pedal etc had revealed all to be intact and without visible damage.

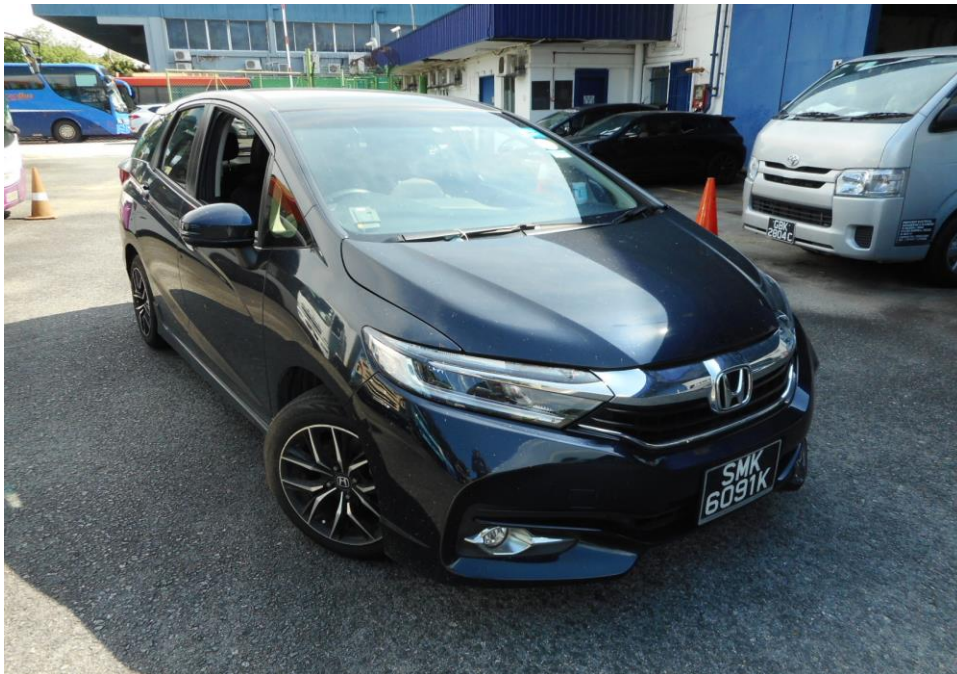
**Photo 21** shows the front right wheel of the Motor Car turned to its full left. During my steering system test, I did not experience any abnormal free play and/or resistance when I had turned the steering wheel towards the left and right. This would suggest that the steering system of the Motor Car was likely to be in serviceable condition at the material time of accident.

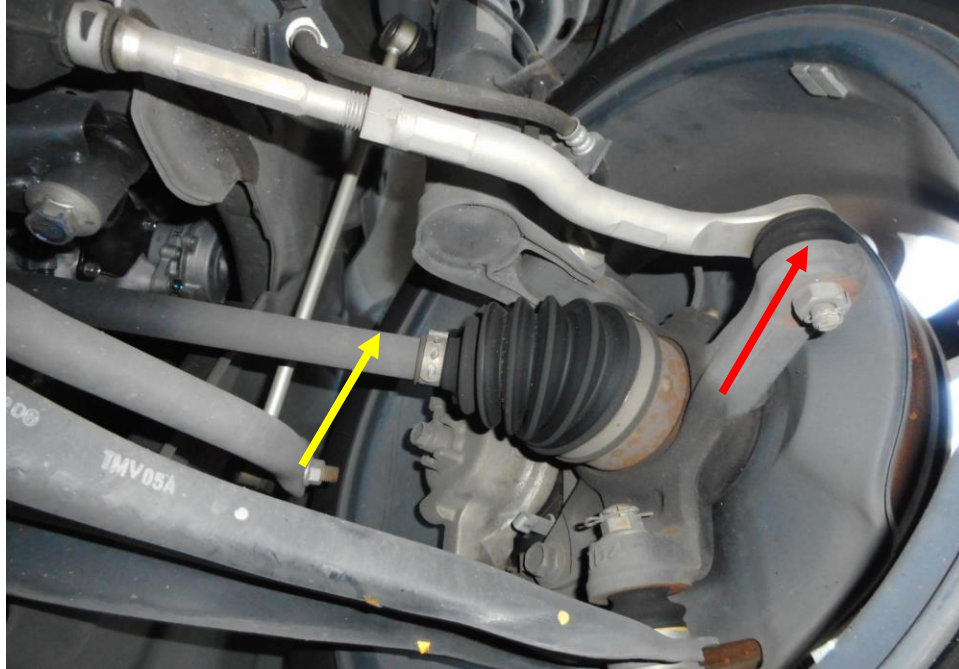
**Photo 22** shows the various undercarriage components at the front right wheel of the Motor Car, in particular the steering tie rod (red arrow) and drive shaft (yellow arrow). The various steering components were all found to be intact, suggesting that the steering system of the Motor Car was likely to be in serviceable condition at the material time of accident. There was also no sign of fluid stain observed on the various undercarriage components at the front right wheel of the Motor Car.

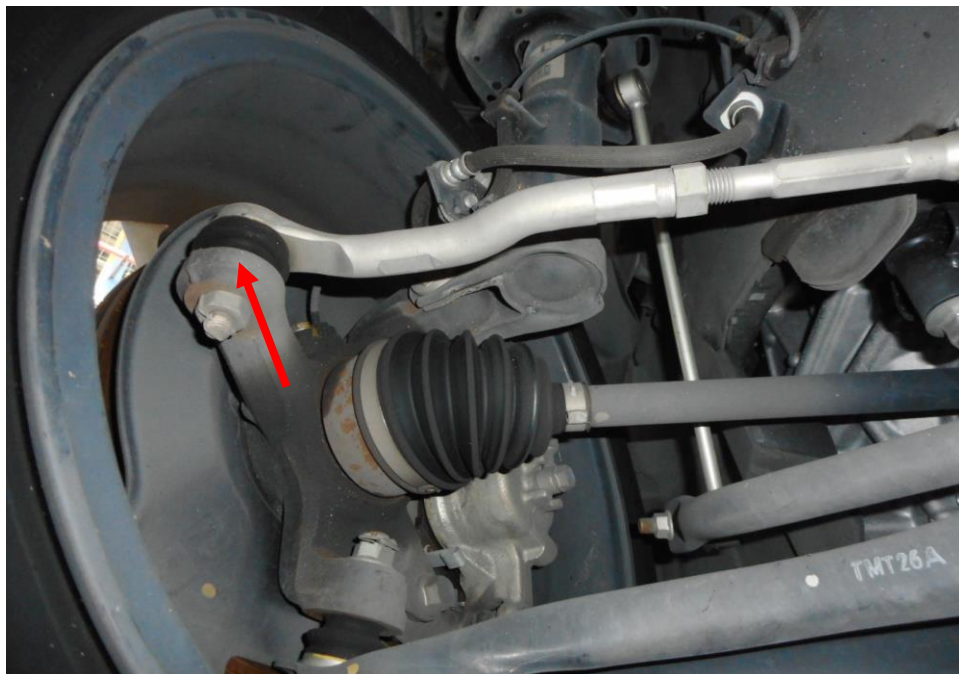
**Photo 23** shows the various undercarriage components at the front left wheel of the Motor Car, which had included the steering tie rod (red arrow). The various undercarriage components of the Motor Car were all found to be intact without any visible damage.

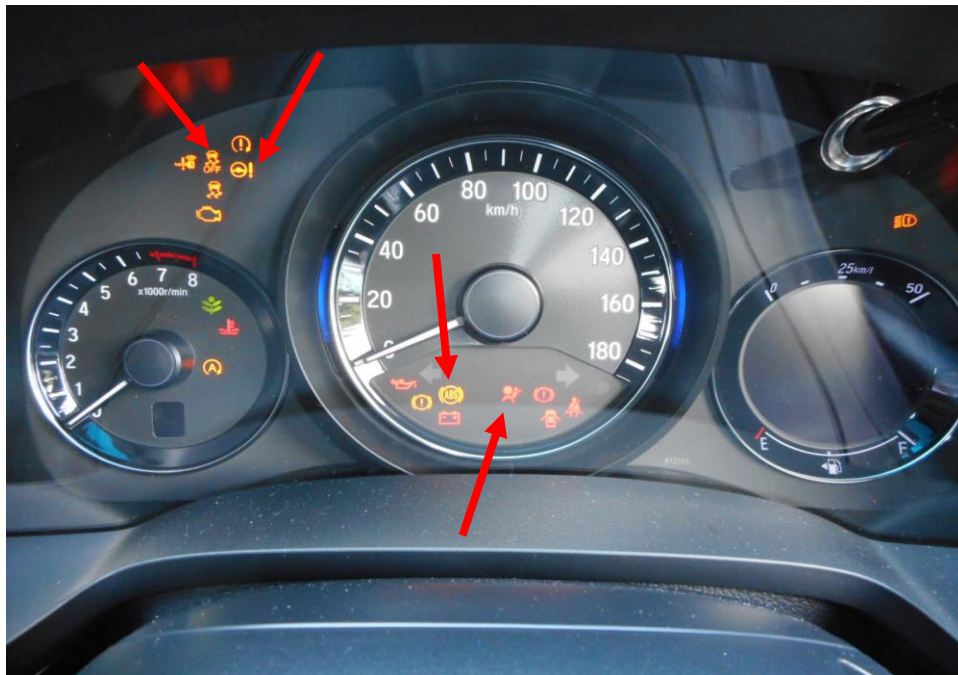
**Photo 24** shows the warning light for Anti-Lock Brake System (ABS) and Power Steering System (EPS), Supplemental Restraint System (SRS) and Traction Control (TC) (arrowed) appearing on the instrument panel of the Motor Car during the self-test of its various electronic operating systems when its engine was cranked.

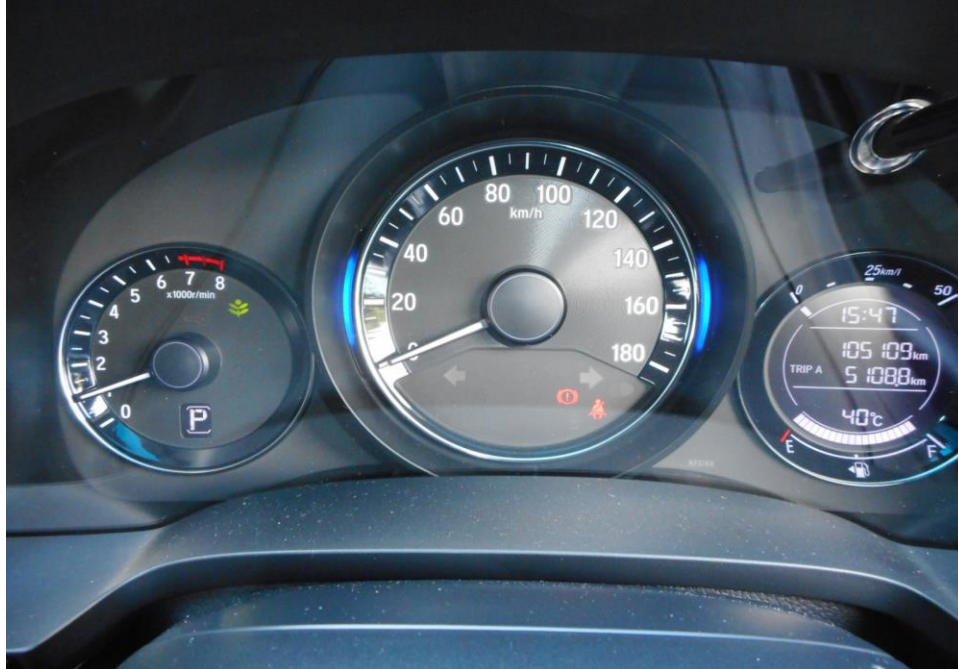
**Photo 25** shows no warning lights illuminated on the instrument panel of the Motor Car after the engine was cranked. This would suggest that there was no abnormality to the electronic operating system of the Motor Car, like the ABS, EPS, SRS, and TC etc.
