Your Ref: TP/IP/17125/2021
Our Ref : CI/TPD21004901/P

Fatal Accident Investigation Team

MECHANICAL INSPECTION REPORT OF MOTOR LORRY GY 3259L

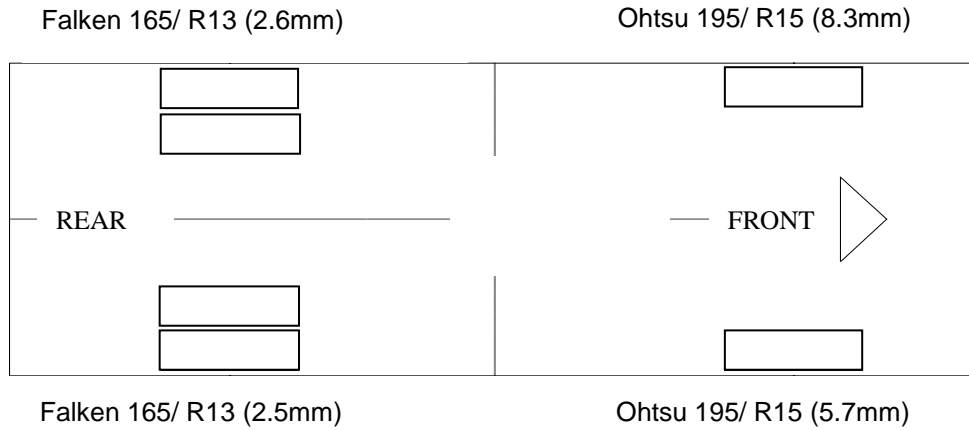
6. The 6 tyres of the Motor Lorry were observed to be in serviceable condition and sufficiently inflated for vehicular operation. I did not find any tear, cut or burst mark(s) on the outer and the inner sidewalls as well as across the tread of the 6 tyres. The tyre brand, tyre size and remaining tread depth of the 6 tyres of the Motor Lorry were recorded as follows:-

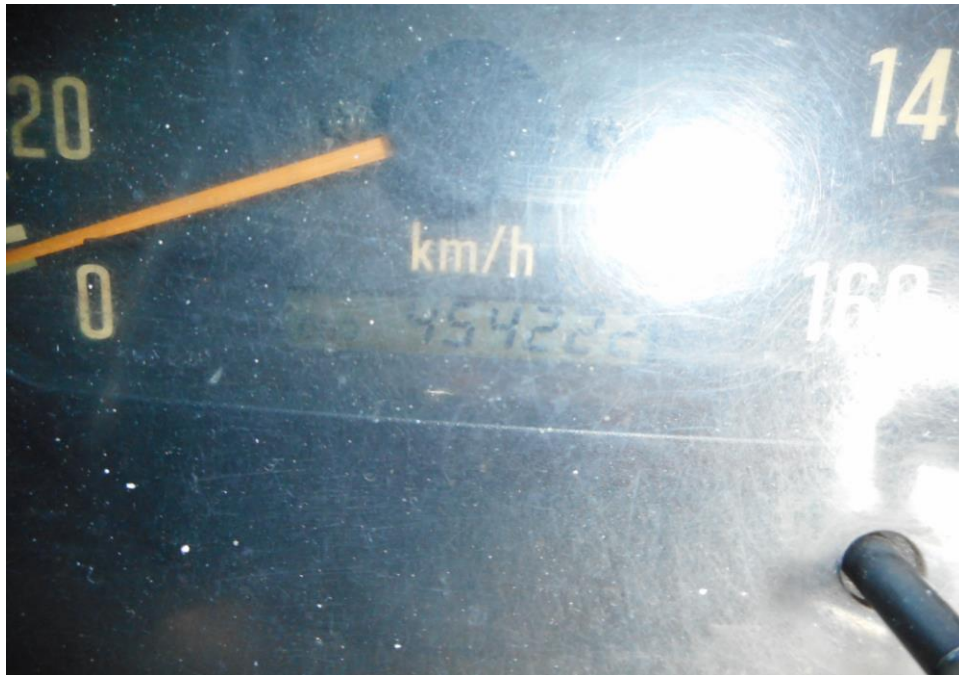
Photo 1 shows a general view of the instrument cluster of the Motor Lorry at the time of my inspection. The mileage of the Motor Lorry was 454,222 km

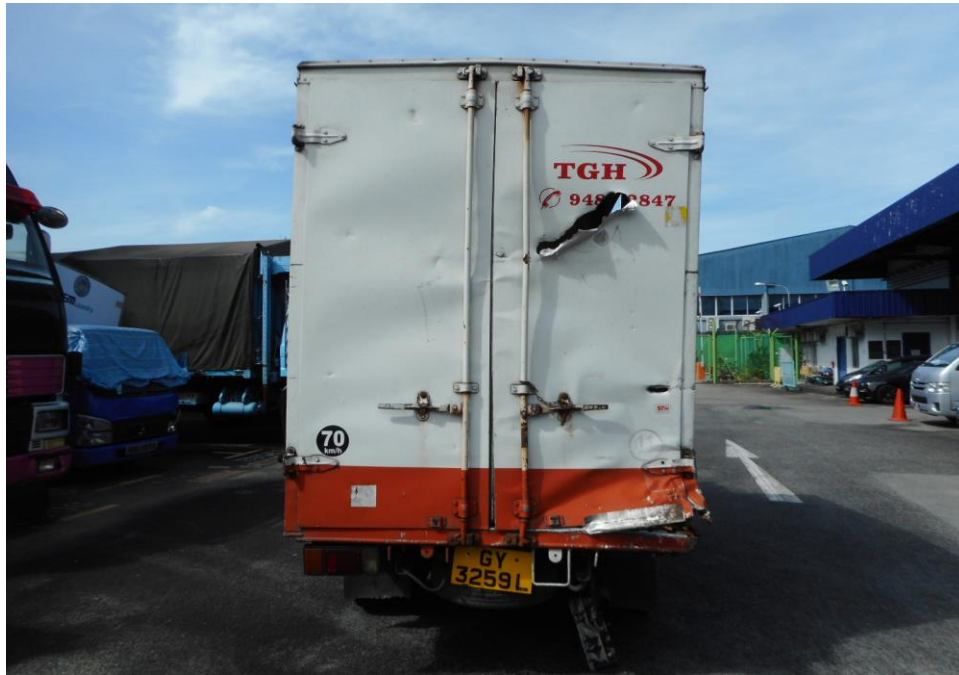
Photo 2 shows a general view of the rear body of the Motor Lorry at the time of my inspection. The Motor Lorry was observed to sustained damage at its front, right and rear portion. Its front windscreen, front body panel, front bumper, front right headlamp, right body panel, rear body panel and brake lamp were damage at the time of my inspection.

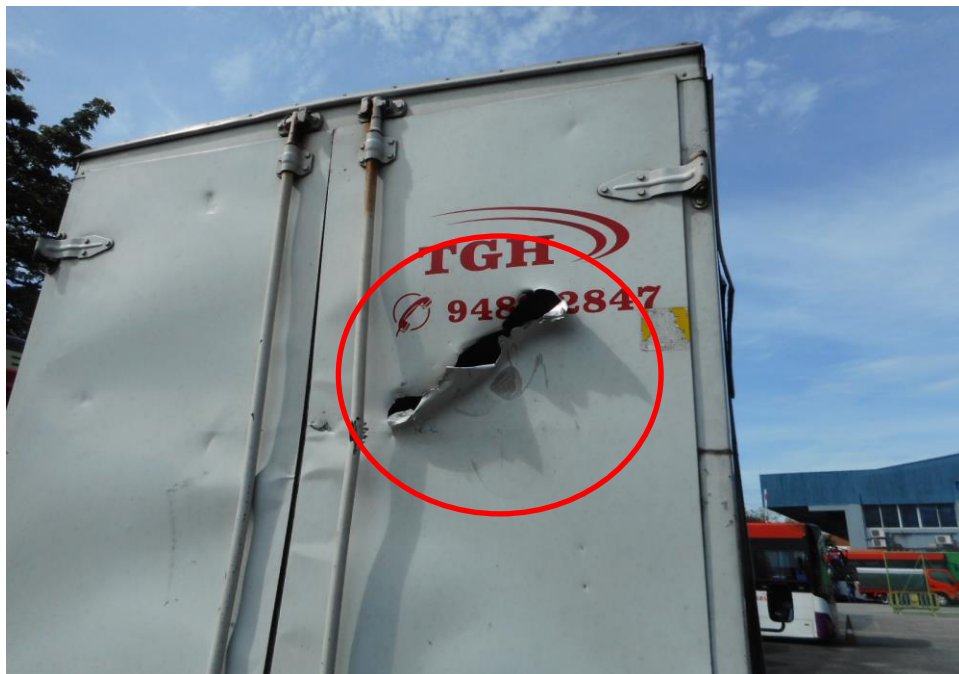
Photo 3 shows a close up view of the rear body of the Motor Lorry at the time of my inspection. Its rear body panel (circled) were damage at the time of my inspection.

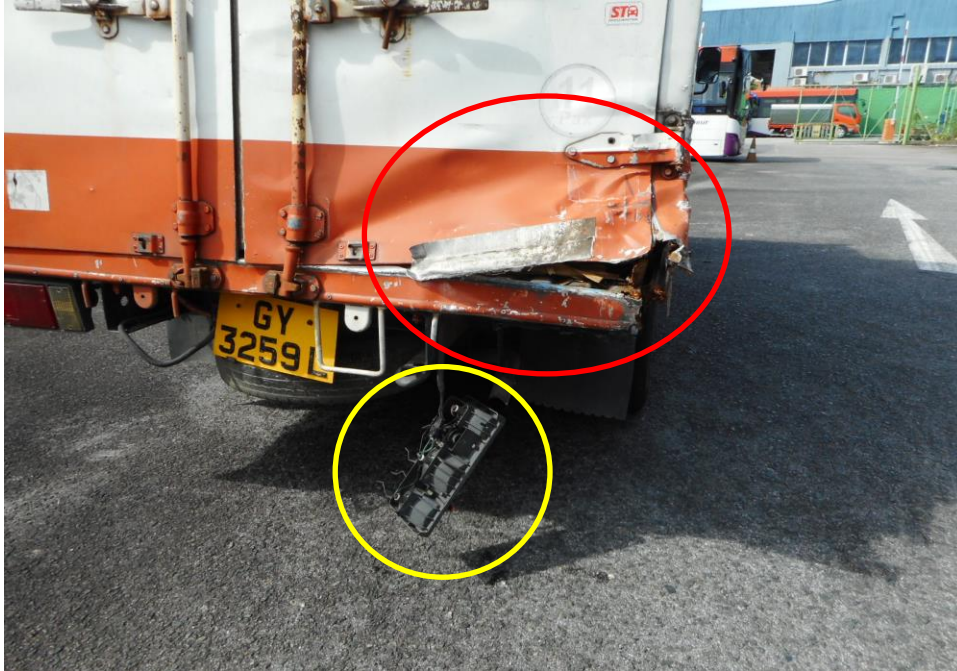
Photo 4 shows a close up view of the rear body of the Motor Lorry at the time of my inspection. Its rear body panel (red circle) and brake lamp (yellow circle) were damage at the time of my inspection.

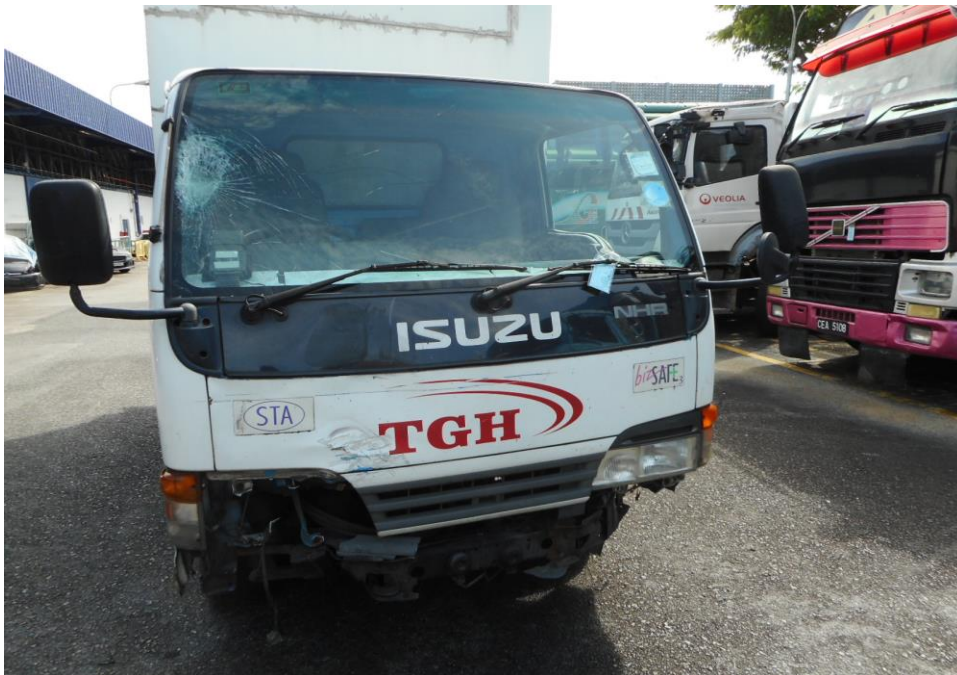
Photo 5 shows a general view of the front body of the Motor Lorry at the time of my inspection. Its front windscreen, front body panel, front bumper and front right headlamp were damage at the time of my inspection.

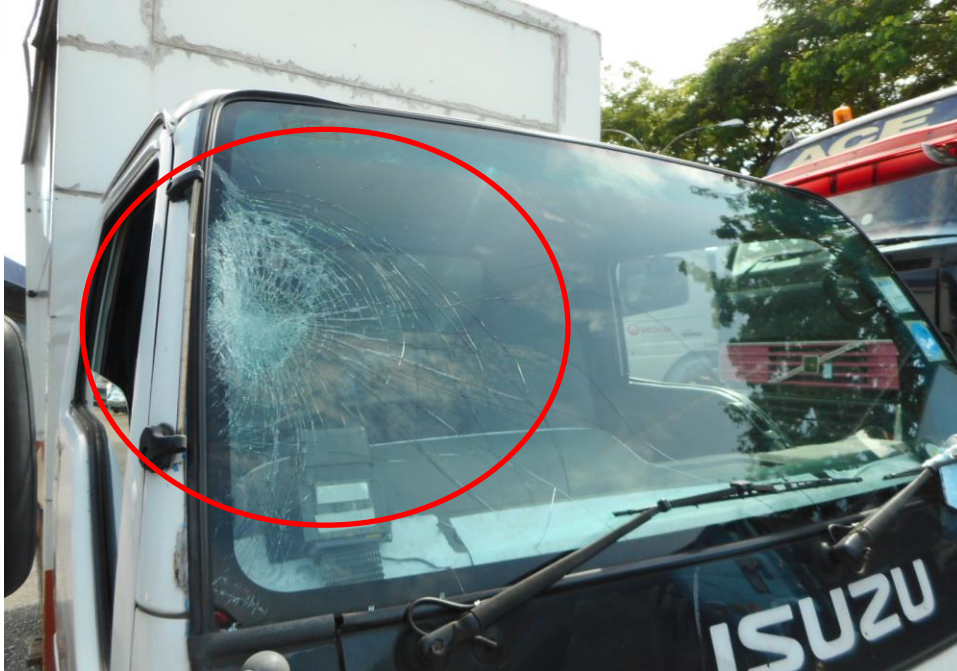
Photo 6 shows a close up view of the Motor Lorry's frontal portion at the time of my inspection. Its front windscreen (circled) were damage at the time of my inspection as the result of the accident.

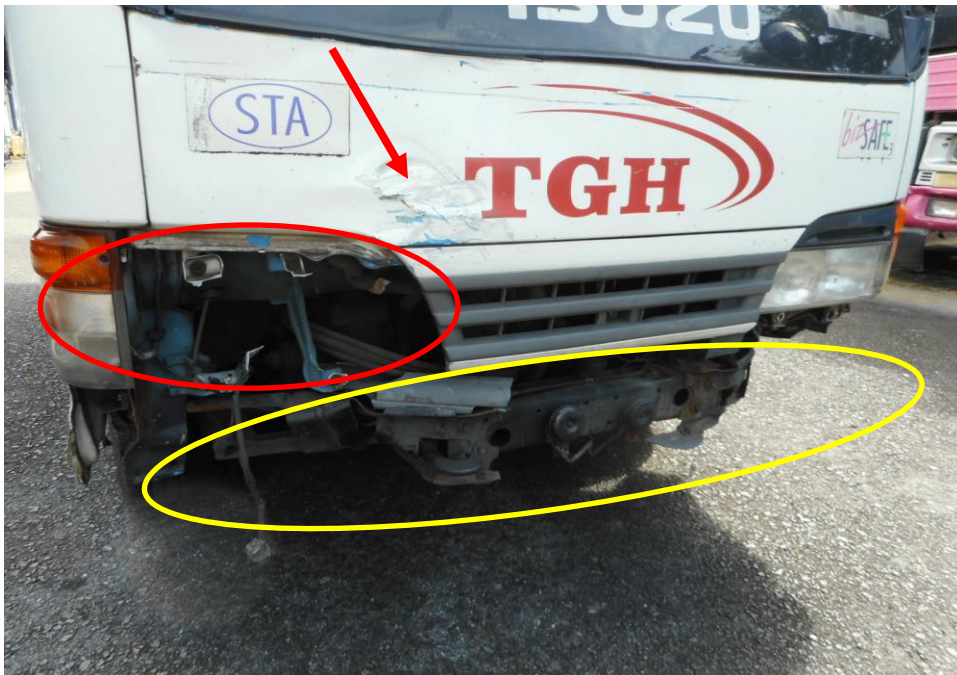
Photo 7 shows a close up view of the Motor Lorry's frontal portion at the time of my inspection. Its front body panel (arrowed) front bumper (yellow circled) and front right headlamp (red circled) were damage at the time of my inspection as the result of the accident.

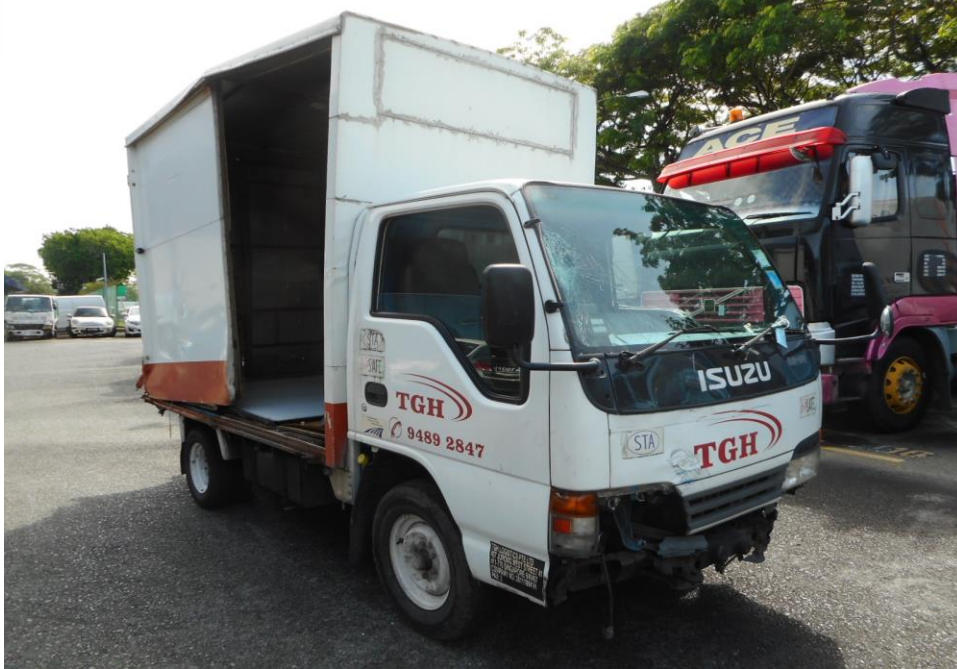
Photo 8 shows a general view of the right body of the Motor Lorry at the time of my inspection. Its right body panel were damage at the time of my inspection.

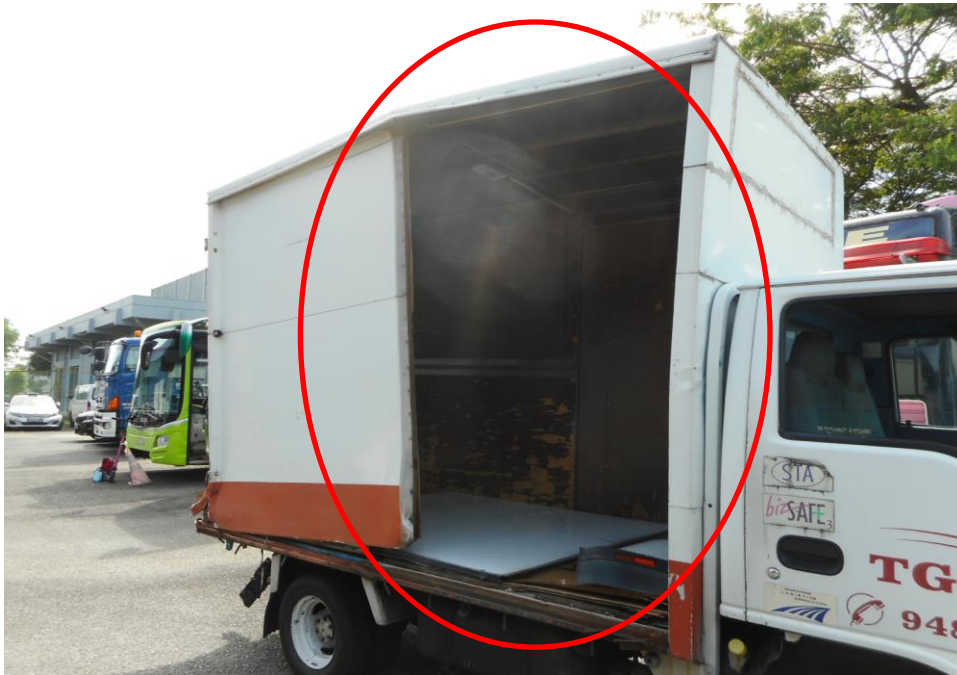
Photo 9 shows a close up view of the right body of the Motor Lorry at the time of my inspection. Its right body panel (circled) were damage at the time of my inspection.

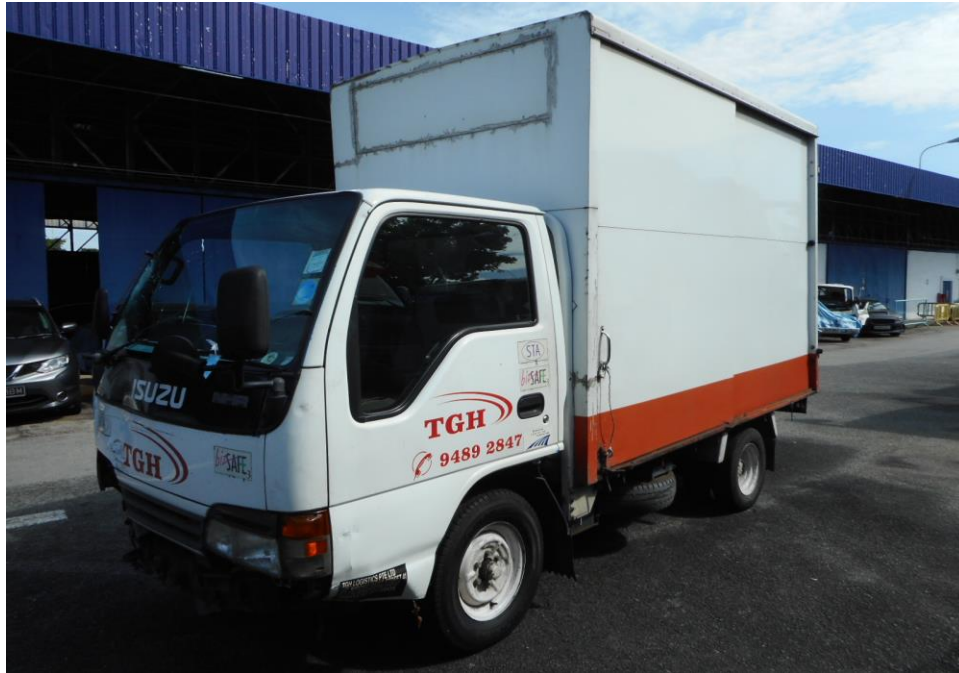
Photo 10 shows a general view of the left body of the Motor Lorry at the time of my inspection. The Motor Lorry was observed to be intact and unaffected by the accident.

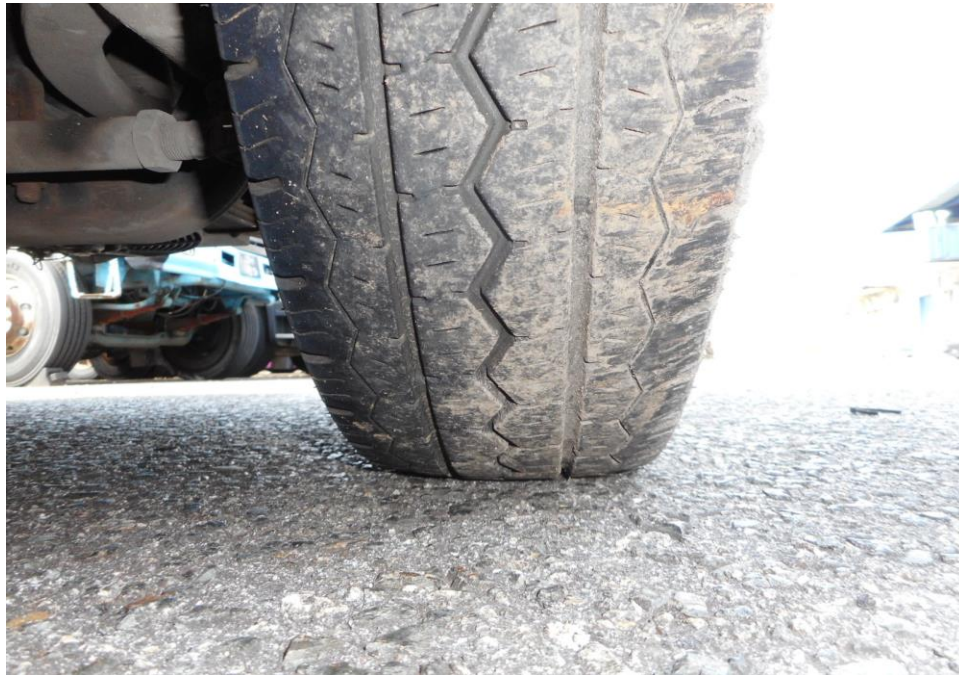
Photo 11 shows the condition of the front right tyre of the Motor Lorry, which was observed to be in serviceable condition with remaining tread depth of approximately 5.7mm. The tyre, which was wrapped around standard steel wheel rim, was also observed to be sufficiently inflated for vehicular operation. There was no tear, cut or burst mark(s) on the outer and the inner sidewalls as well as across the tread of the 6 tyres that were fitted on the Motor Lorry.

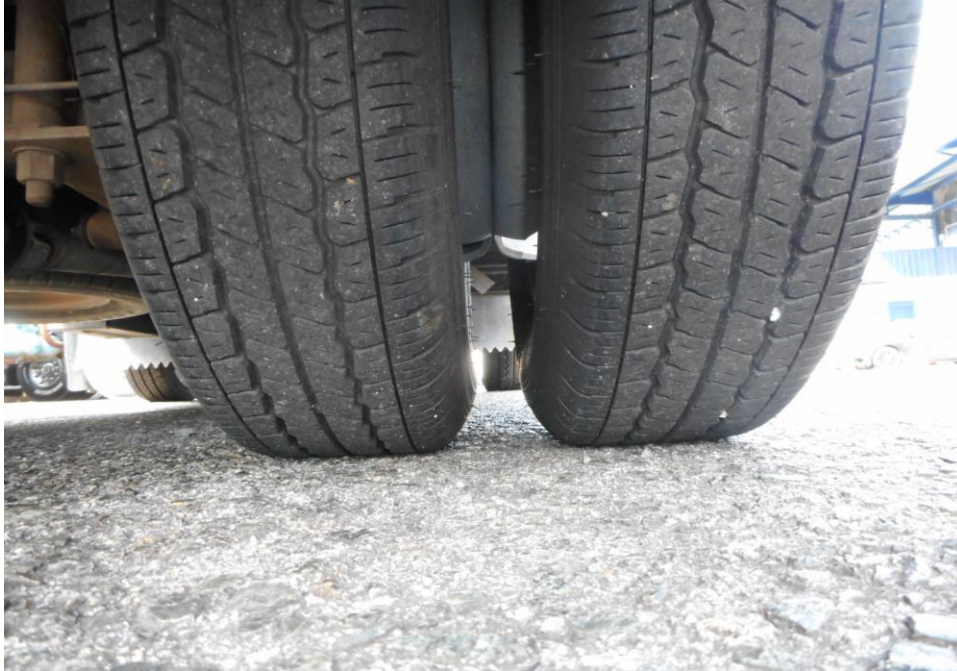
Photo 12 shows the condition of the rear right tyre of the Motor Lorry, which was observed to be in serviceable condition with remaining tread depth of approximately 2.5mm. The tyre, which was wrapped around standard steel wheel rim, it was observed to be sufficiently inflated for vehicular operation.

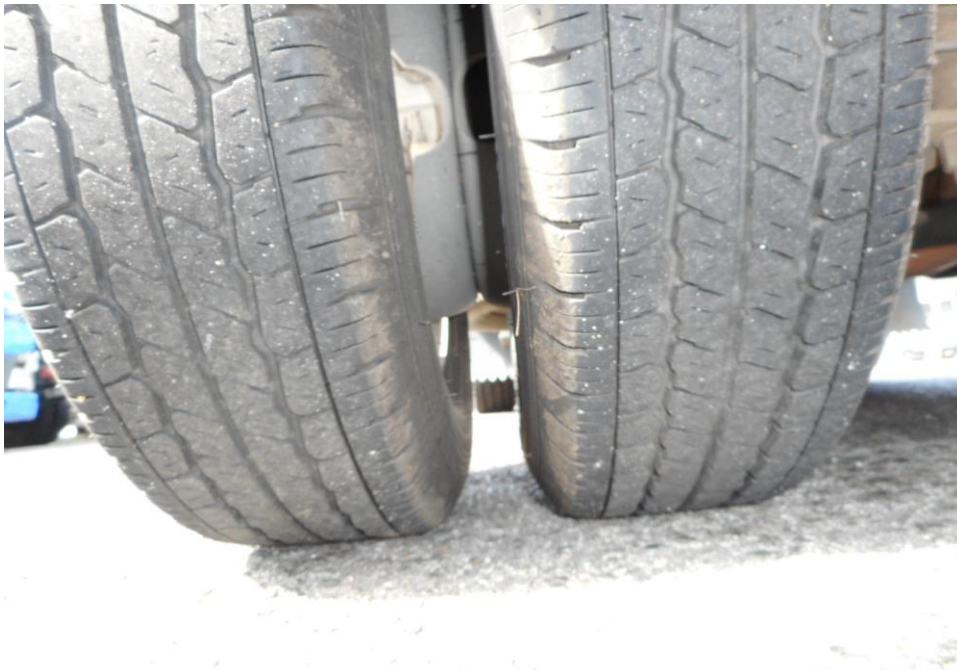
Photo 13 shows the condition of the rear left tyres of the Motor Lorry, which was observed to be in serviceable condition with remaining tread depth of approximately 2.6mm. The tyres, which were wrapped around standard steel wheel rim, were also observed to be sufficiently inflated for vehicular operation. There was also no damage found on all 6 steel wheel rims of the Motor Lorry.

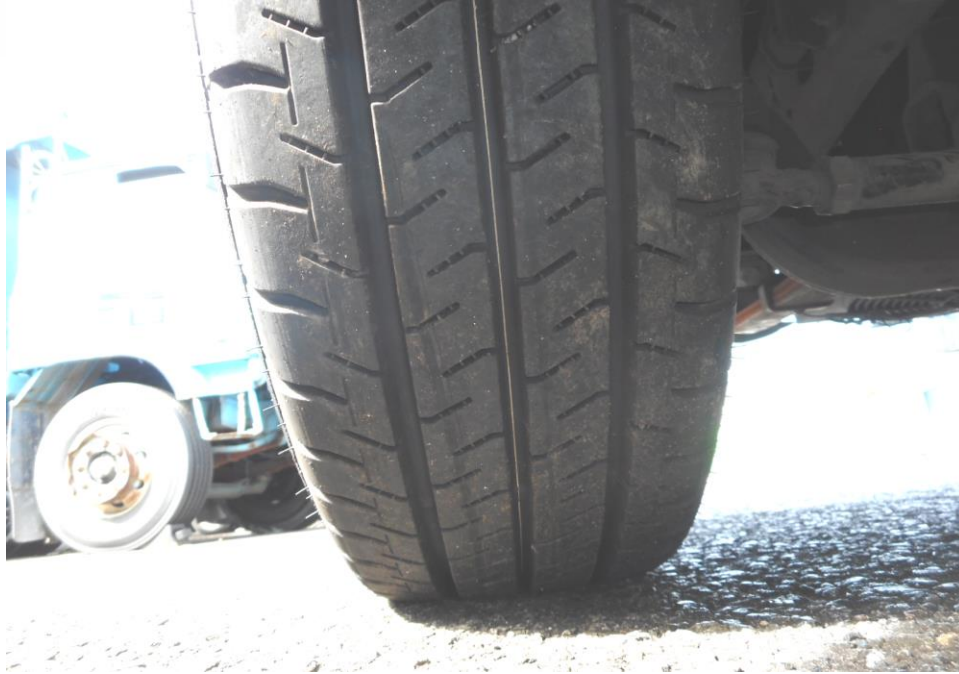
Photo 14 shows the condition of the rear right tyres of the Motor Lorry, which were observed to be in serviceable condition with remaining, tread depth of approximately 8.3mm. There was also no tear, cut or burst mark(s) on the outer and the inner sidewalls as well as across the tread of the 6 tyres that were fitted on the Motor Lorry.

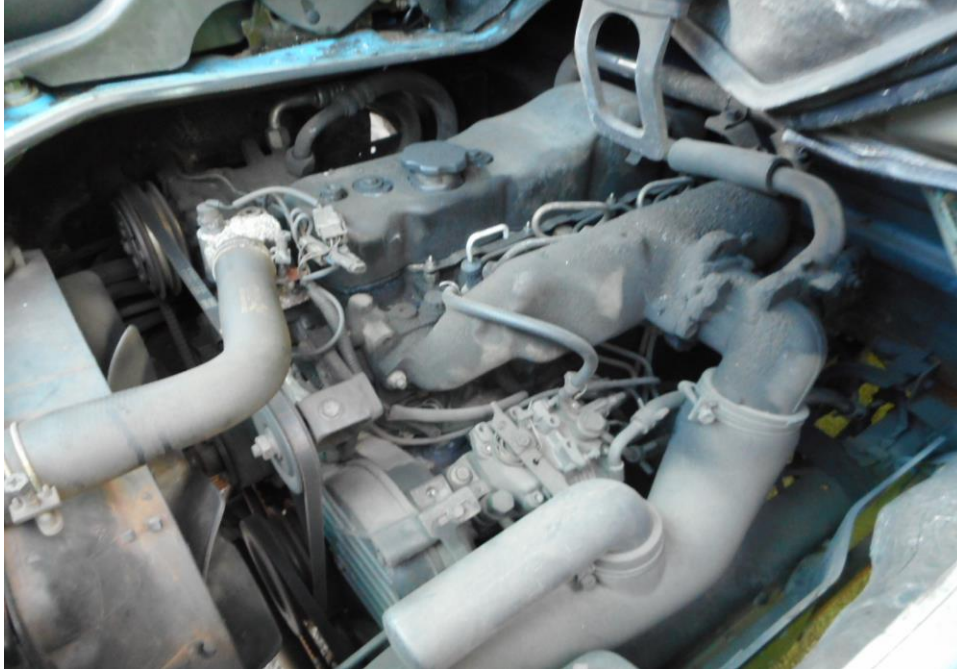
Photo 15 shows a general view of the Motor Lorry's engine compartment, which was accessed by lifting the front cabin of the Motor Lorry. The various parts and components inside the engine compartment were unaffected by the accident. There was also no sign(s) or indication(s) of fresh fluid leakage and/or fluid stain within the engine compartment

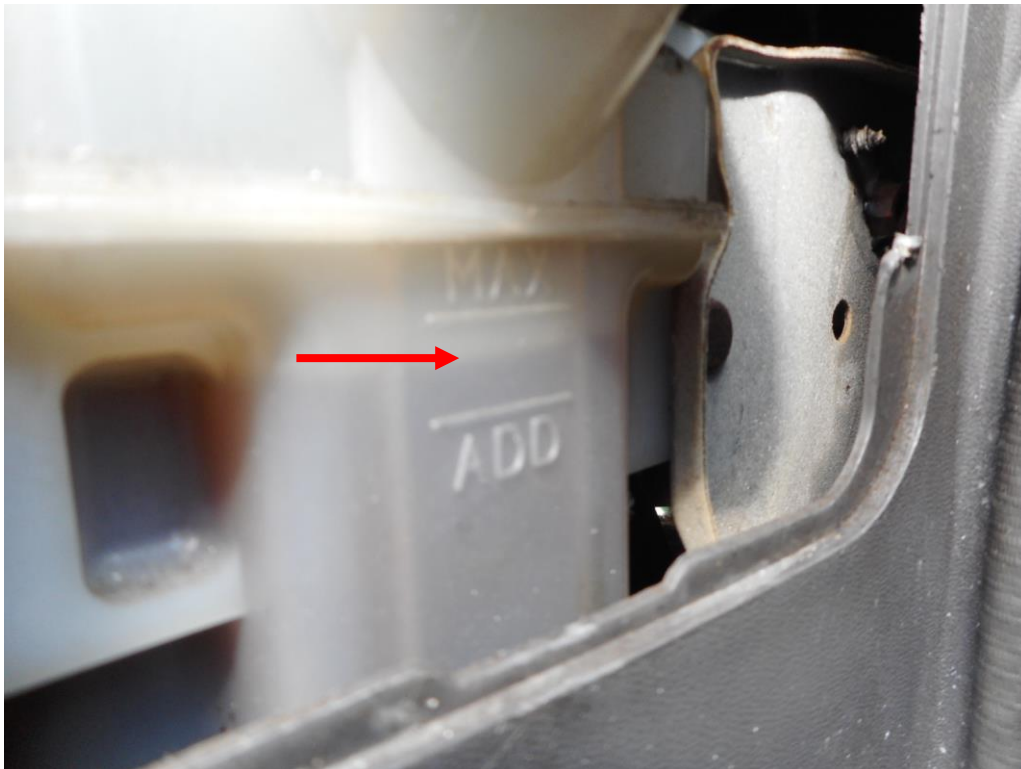
Photo 16 shows the brake fluid reservoir of the Motor Lorry at the time of my inspection. The brake fluid was observed to be of sufficient level (arrowed) and without any visible contamination.

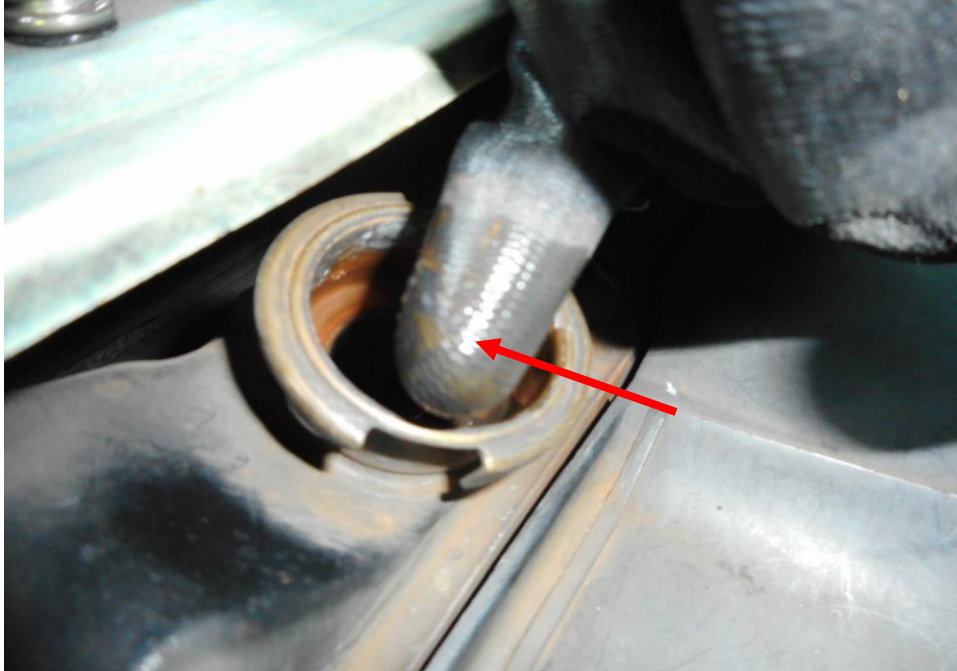
Photo 17 shows the engine coolant reservoir of the Motor Lorry at the time of my inspection. The engine coolant was observed to be of sufficient level (arrowed) and without any visible contamination.

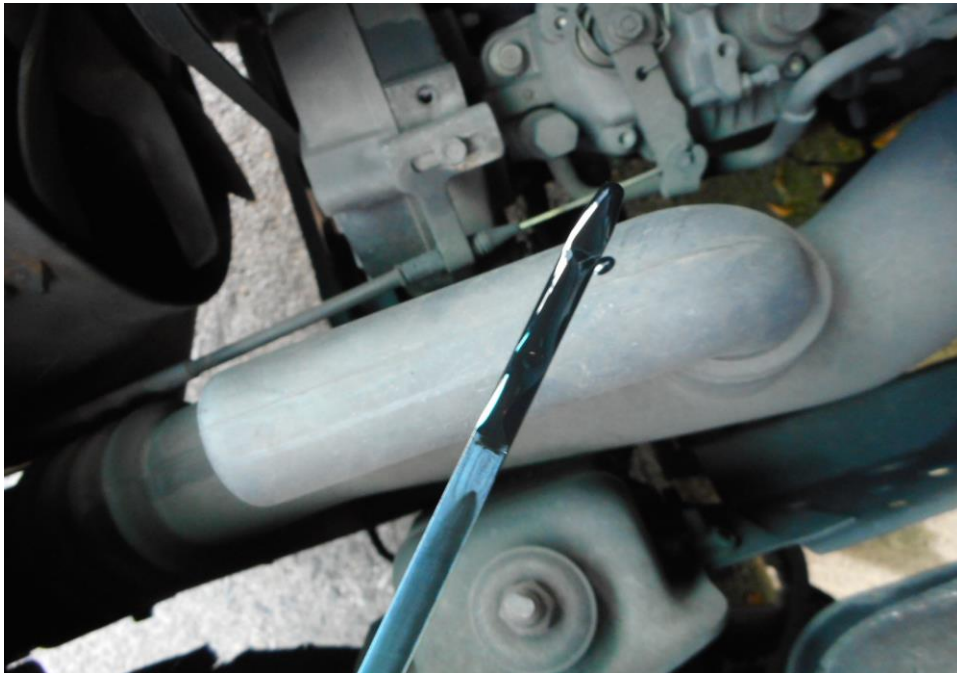
Photo 18 shows the engine oil dip stick of the Motor Lorry at the time of my inspection. The engine oil was observed to be of sufficient level and without any visible contamination.

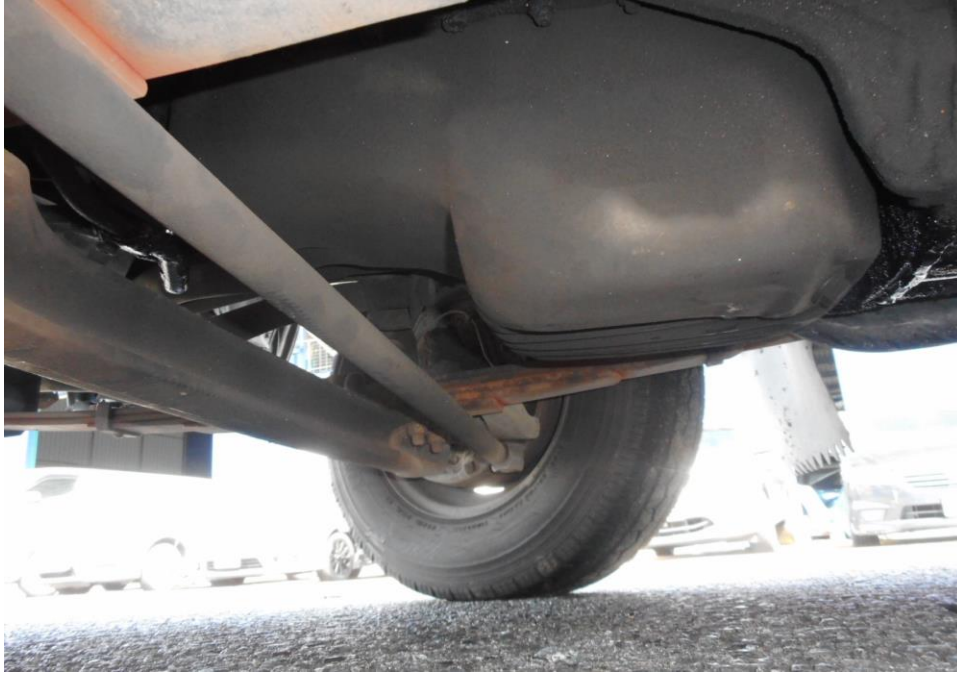
Photo 19 shows the undercarriage of the Motor Lorry, at the area where the engine housing and transmission housing are located. I did not find any sign(s) or indication(s) of fluid leak and/or fluid stain(s) on the underside of the Motor Lorry.

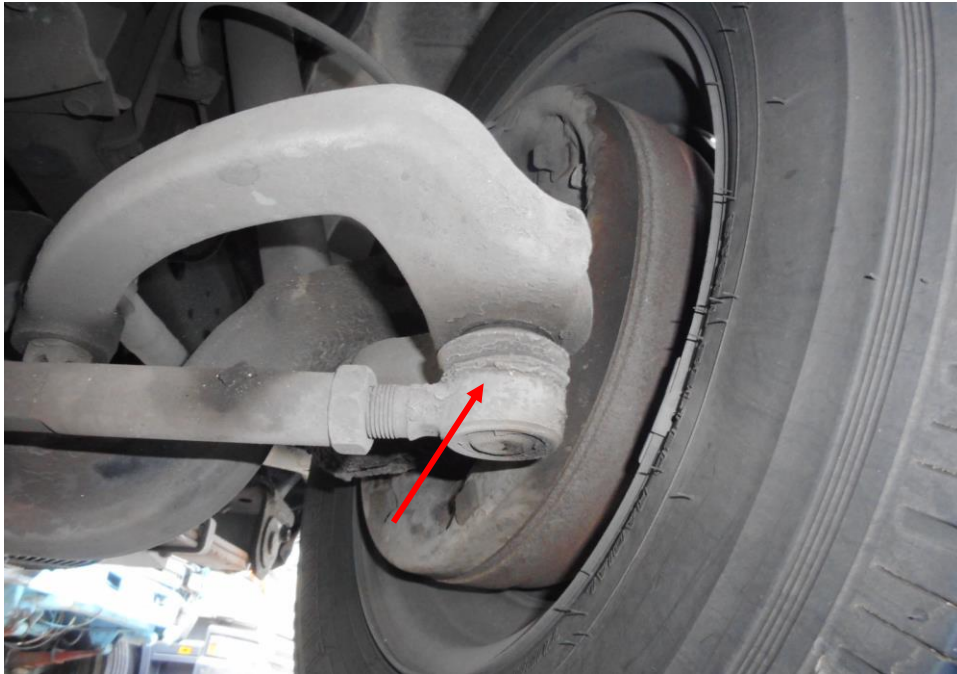
Photo 20 shows the various undercarriage components at the front right wheel of the Motor Lorry, in particular the steering tie rod end (arrowed). The various steering components were all found to be intact, suggesting that the steering system of the Motor Lorry was likely to be in serviceable condition at the material time of accident. There was also no sign of fluid stain(s) observed on the various undercarriage components.

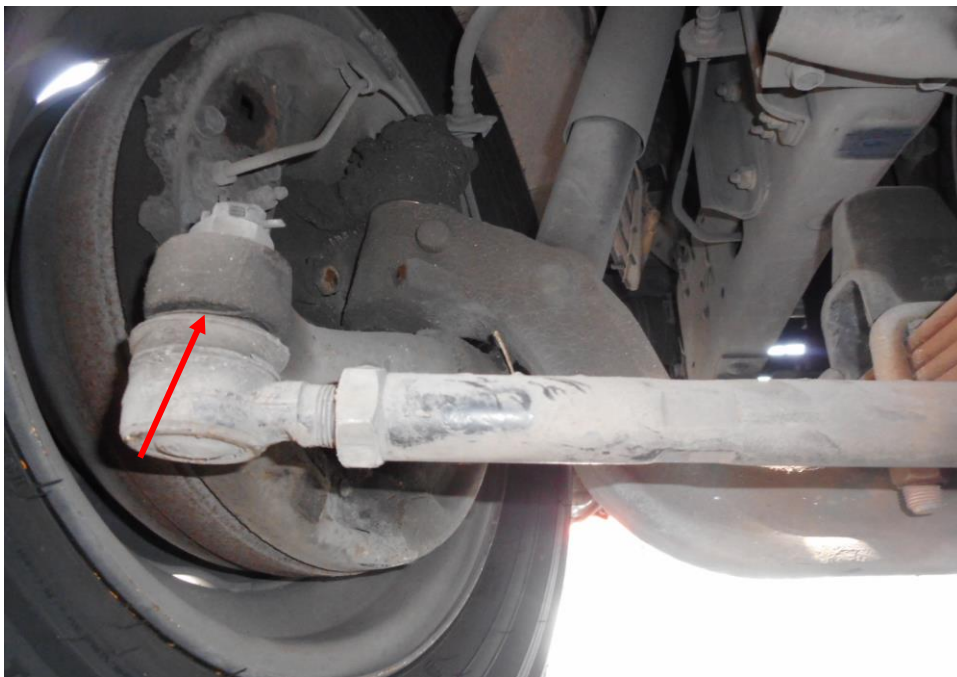
Photo 21 shows the various undercarriage components at the front left wheel of the Motor Lorry, in particular the steering tie rod end (arrowed). The various undercarriage components of the Motor Lorry were all found to be intact without any visible damage. There was also no sign of fluid stain(s) observed on the various undercarriage components.

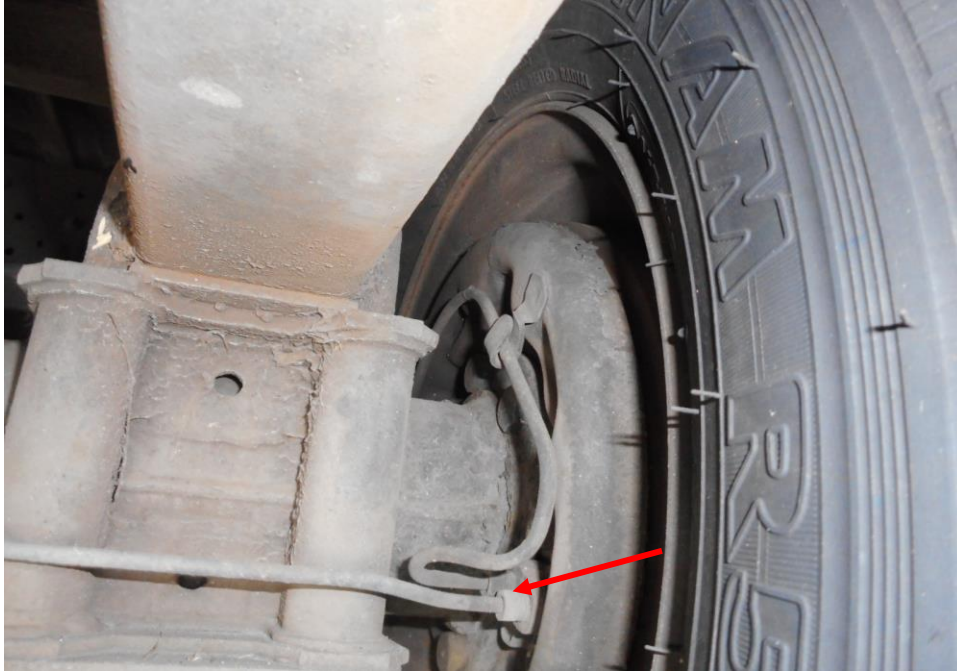
Photo 22 shows the brake pipe (arrowed) at the rear right wheel of the Motor Lorry. I did not observe any leakage of brake fluid at the time of my inspection of the Motor Lorry. My static tests of the Motor Lorry's braking system, along with my visual examination of the various mechanical components in the braking system, had indicated that there was no internal leakage of pressure/vacuum. Hence the braking system of the Motor Lorry was likely to be in serviceable condition at the material time of accident.

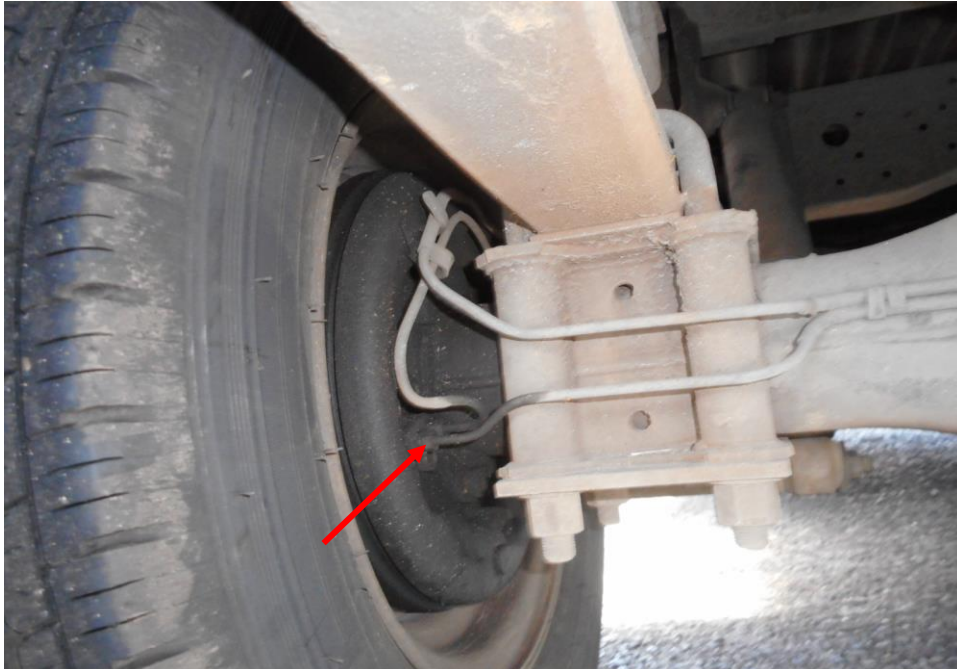
Photo 23 shows the brake pipe (arrowed) at the rear left wheel of the Motor Lorry. I did not observe any leakage of brake fluid at the time of my inspection of the Motor Lorry. My static tests of the Motor Lorry's braking system, along with my visual examination of the various mechanical components in the braking system had indicated that there was no internal leakage of pressure/vacuum. Hence the braking system of the Motor Lorry was likely to be in serviceable condition at the material time of accident.

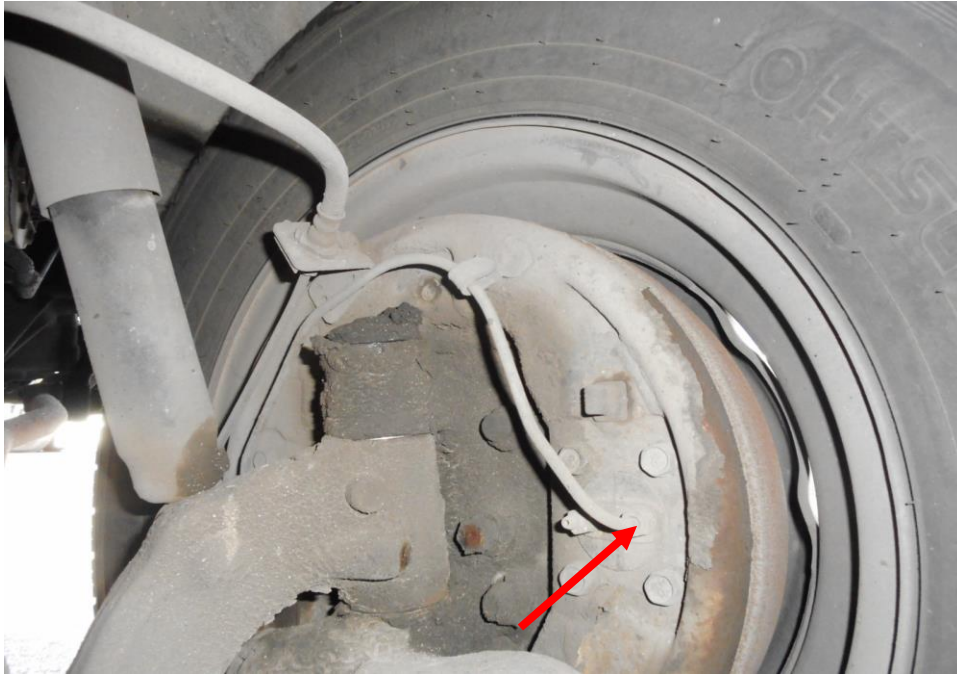
Photo 24 shows the brake hose/pipe (arrowed) at the front right wheel of the Motor Lorry. No leakage of brake fluid was observed. Visual examination of the various components of the braking system like the brake drum, brake booster, brake pedal etc had revealed all to be intact and without visible damage at the time of accident. There was also no sign of fluid stain(s) observed on the various undercarriage components.

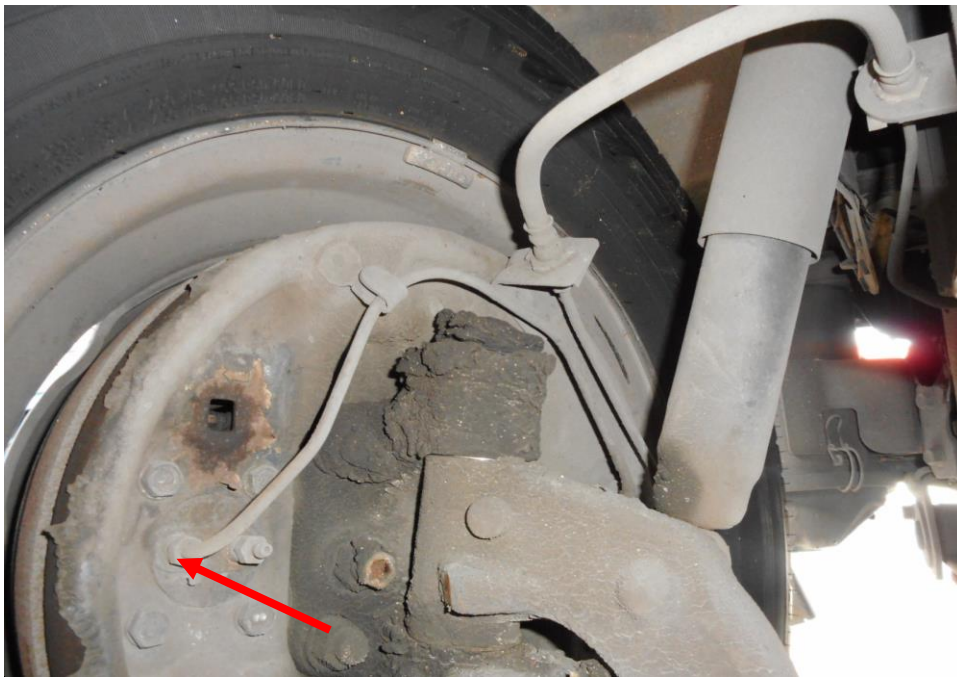
Photo 25 shows the brake hose/pipe (arrowed) at the front left wheel of the Motor Lorry. No leakage of brake fluid was observed. Visual examination of the various components of the braking system like the brake drum, brake booster, brake pedal etc had revealed all to be intact and without visible damage at the time of accident. There was also no sign of fluid stain(s) observed on the various undercarriage components.

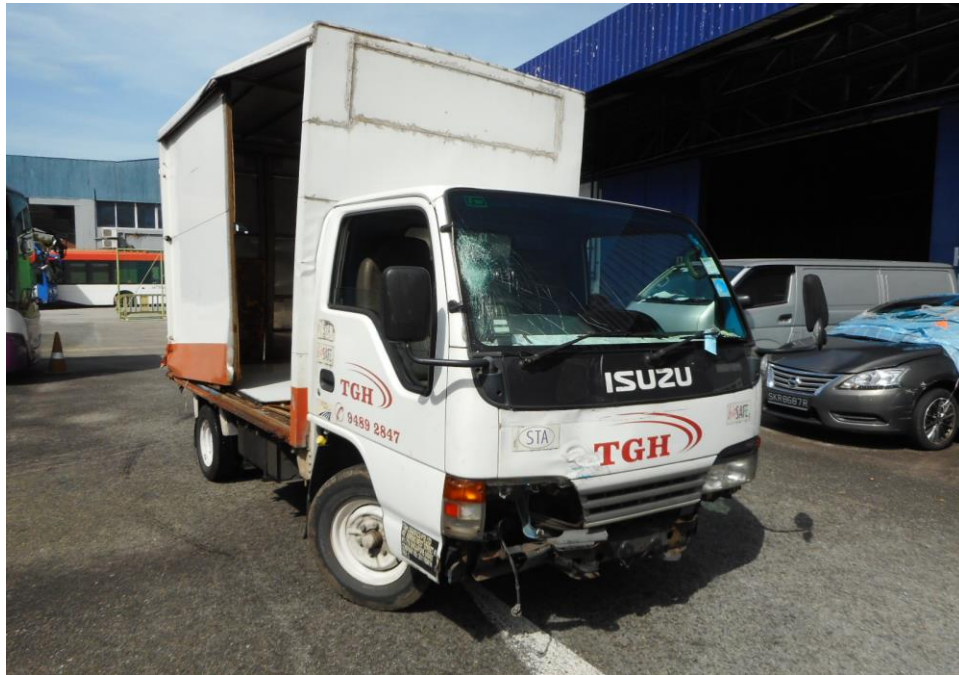
Photo 26 shows the front right wheel of the Motor Lorry turned to its full left. During my steering system test, I did not experience any abnormal free play and/or resistance when I had turned the steering wheel towards full left and full right. This would suggest that the steering system of the Motor Lorry was likely to be in serviceable condition at the material time of accident.
