Your Ref: TP/IP/17125/2021  
Our Ref : CI/TPD21004902/P

27<sup>th</sup> April 2021

**Fatal Accident Investigation Team**

**MECHANICAL INSPECTION REPORT OF MOTOR LORRY YP 3073P**

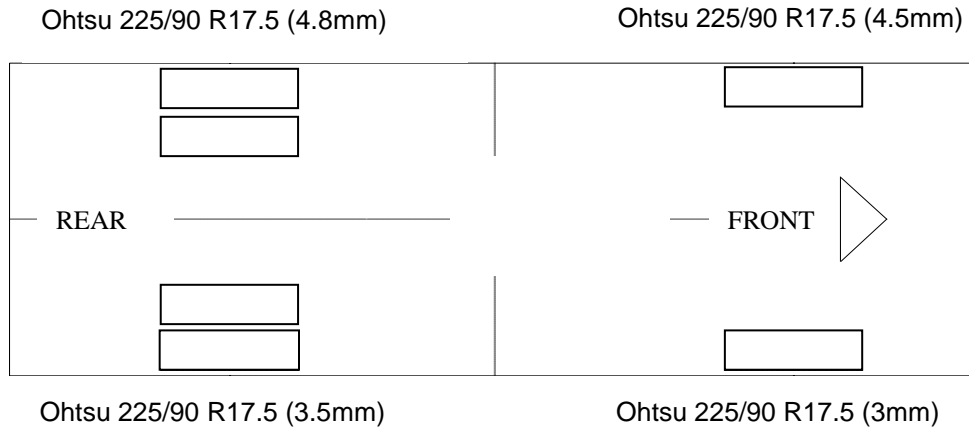
6. The 6 tyres of the Motor Lorry were observed to be in serviceable condition and sufficiently inflated for vehicular operation. I did not find any tear, cut or burst mark(s) on the outer and the inner sidewalls as well as across the tread of the 6 tyres. The tyre brand, tyre size and remaining tread depth of the 6 tyres of the Motor Lorry were recorded as follows:-

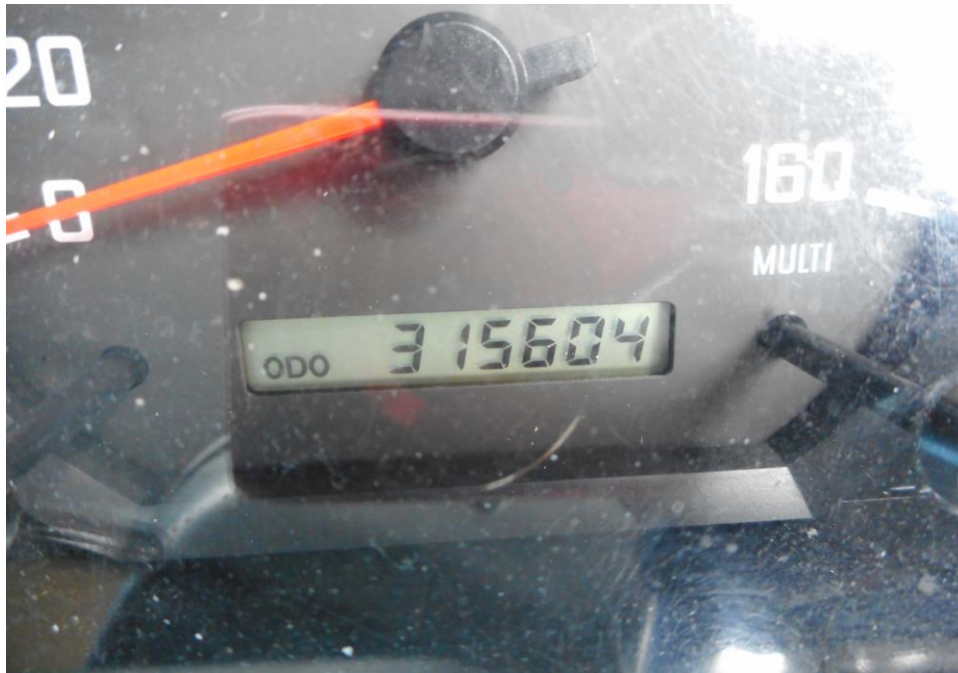
**Photo 1** shows a general view of the instrument cluster of the Motor Lorry at the time of my inspection. The mileage of the Motor Lorry was 315,604 km

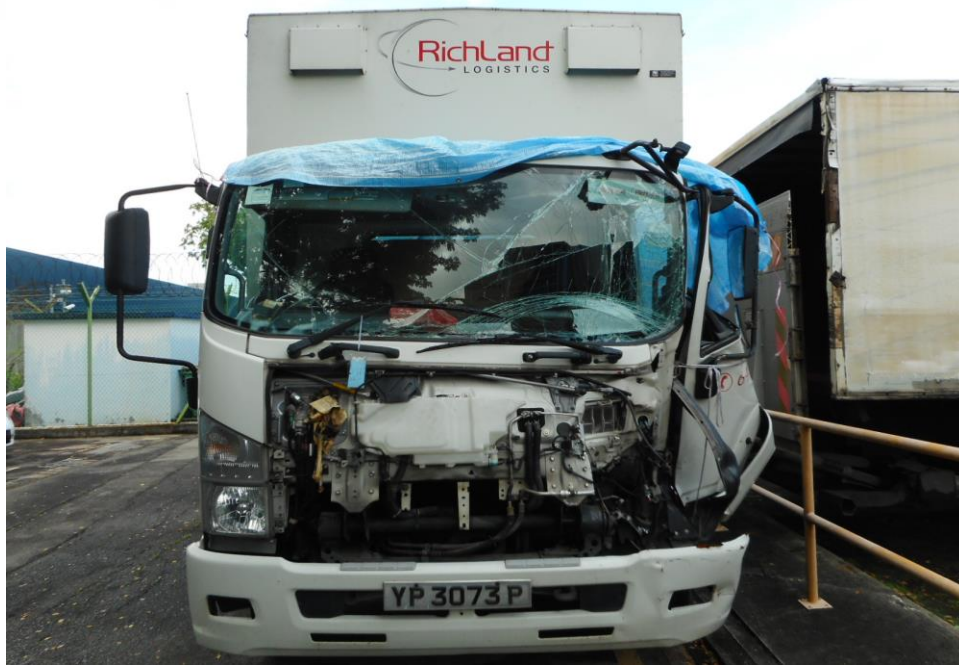
4. The mileage of the Motor Lorry at the time of my inspection was 315,604km.
5. The Motor Lorry appeared to have sustained damage at its front portion. Its front windscreen, front cabin panel and front left door were damaged at the time of my inspection.

**Photo 2** shows a general view of the Motor Lorry's frontal portion at the time of my inspection. The Motor Lorry was observed to have sustained damage at its front portion. Its front windscreen, front cabin panel and front left door were damage at the time of my inspection.

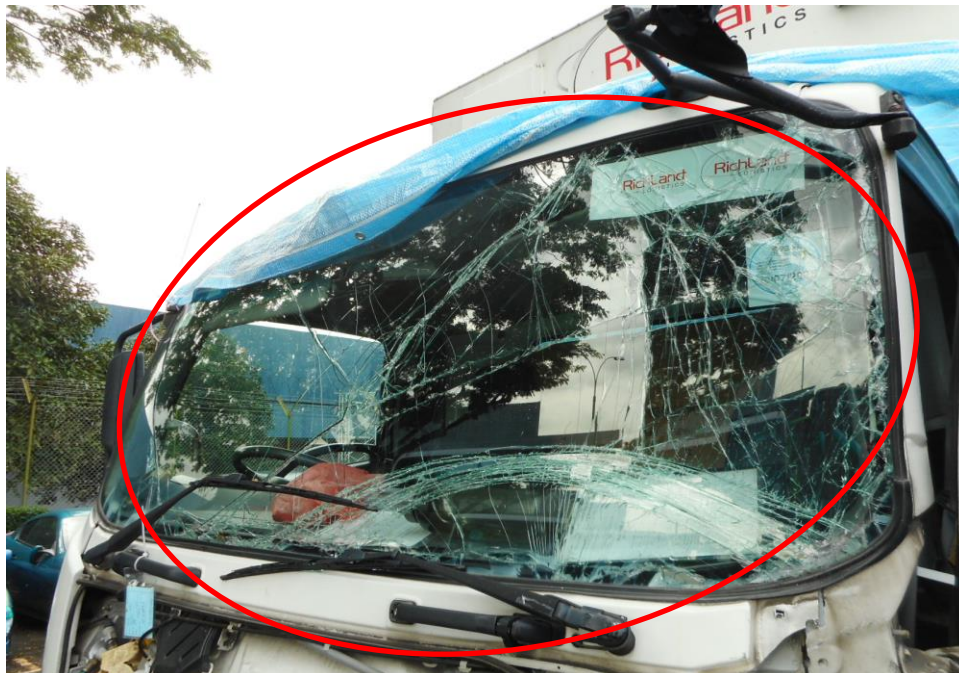
**Photo 3** shows a close up view of the Motor Lorry's front portion at the time of my inspection. It appeared to have sustained damage at its front portion. Its front windscreen (circled) was damage at the time of my inspection as a result of the accident.

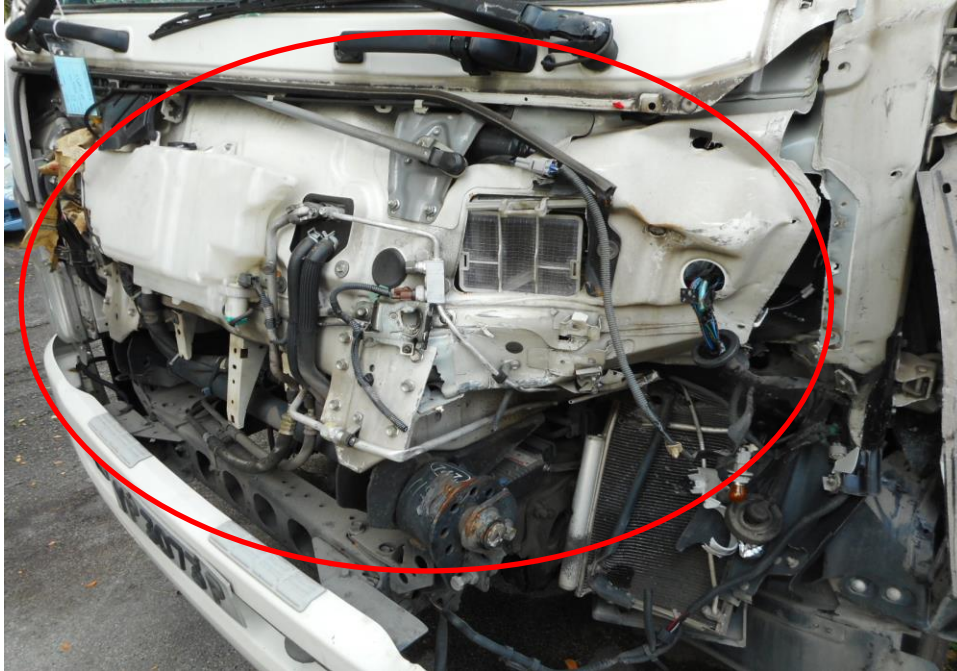
**Photo 4** shows a close up view of the Motor Lorry's front portion at the time of my inspection. It appeared to have sustained damage at its front portion. Its front cabin panel (circled) were damage at the time of my inspection.

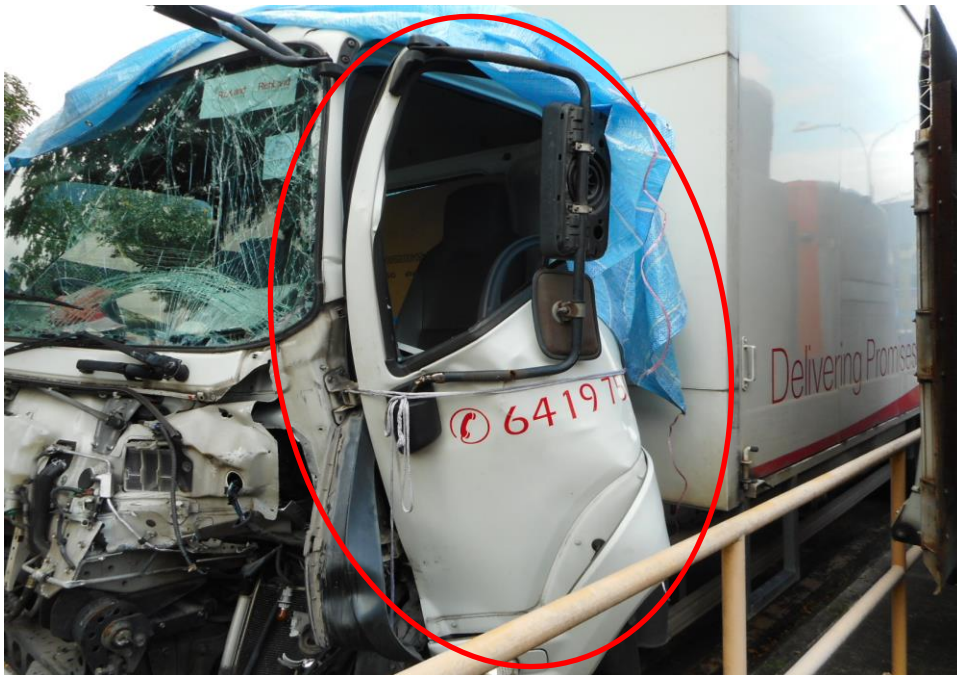
**Photo 5** shows a close up view of the Motor Lorry's front portion at the time of my inspection. It appeared to have sustained damage at its front portion. Its front left door (circled) were damage at the time of my inspection.

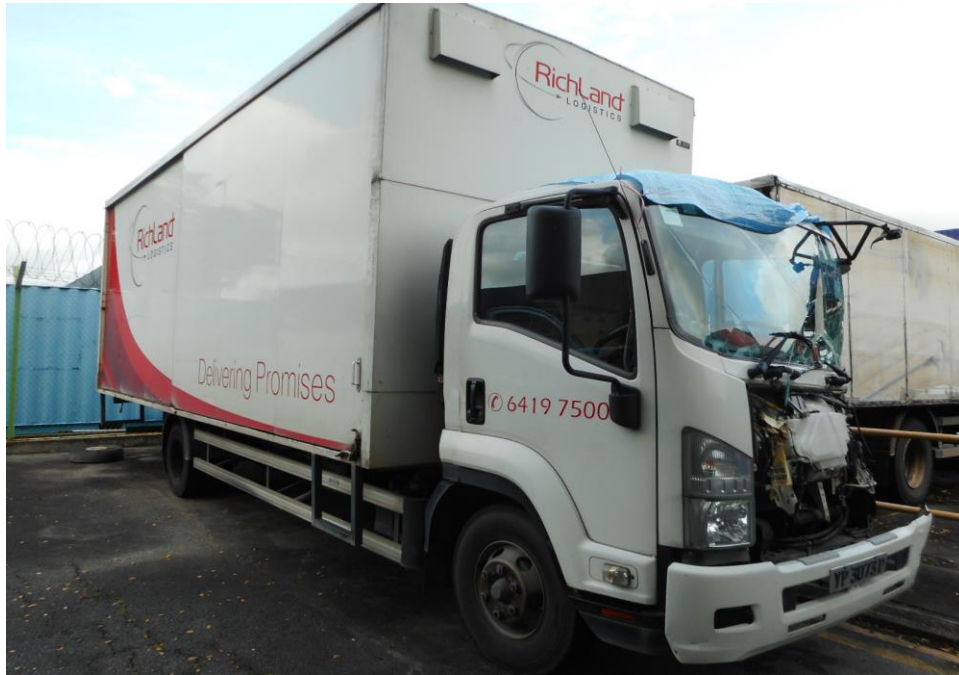
**Photo 6** shows a general view of the right body of the Motor Lorry at the time of my inspection. The Motor Lorry was observed to be intact and unaffected by the accident.

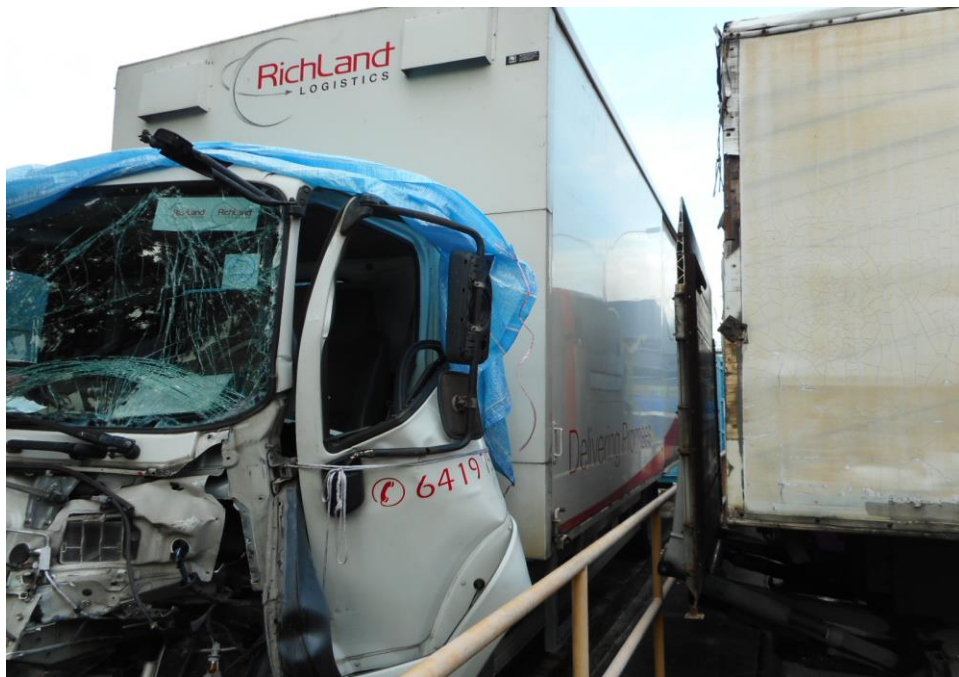
**Photo 7** shows a general view of the left body of the Motor Lorry at the time of my inspection. The Motor Lorry was observed to be intact and unaffected by the accident.

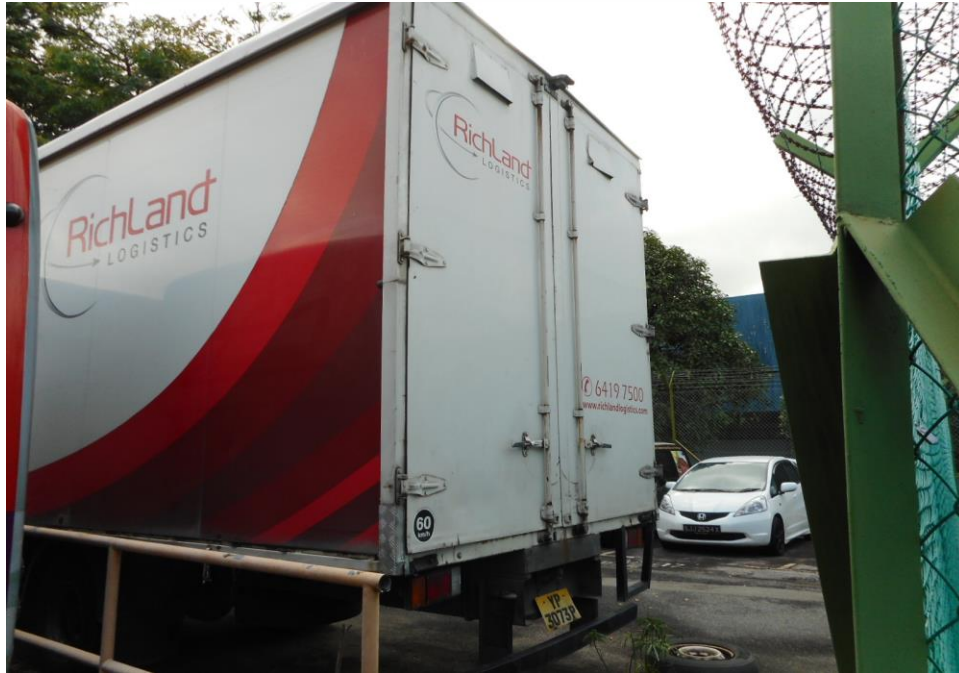
**Photo 8** shows a general view of the rear body of the Motor Lorry at the time of my inspection. The Motor Lorry was observed to be intact and unaffected by the accident.

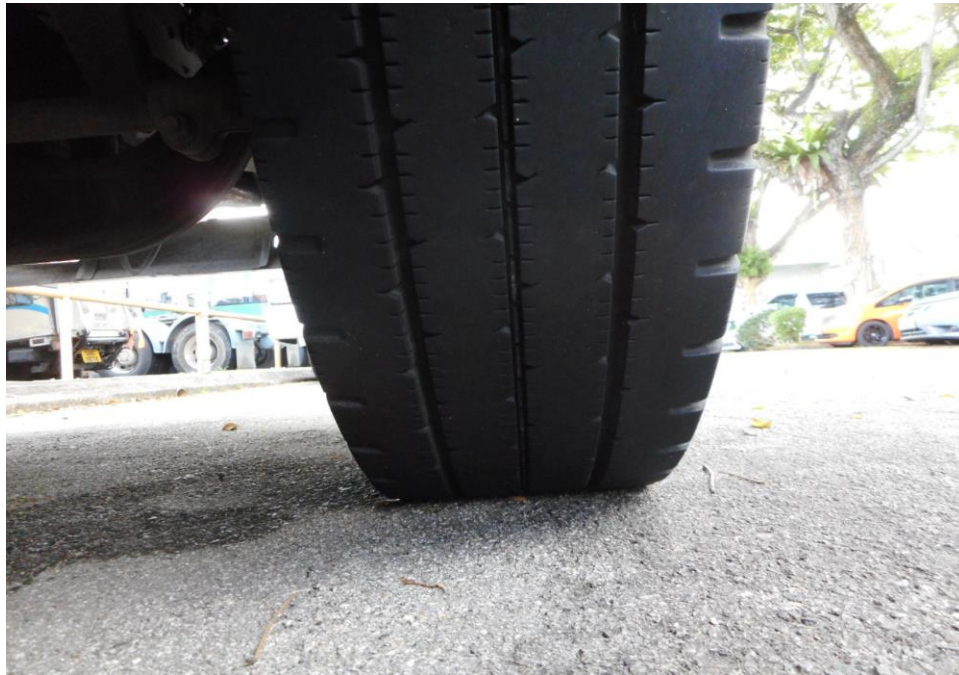
**Photo 9** shows the condition of the front right tyre of the Motor Lorry, which was observed to be in serviceable condition with remaining tread depth of approximately 3mm. The tyre, which was wrapped around standard steel wheel rim, was also observed to be sufficiently inflated for vehicular operation. There was no tear, cut or burst mark(s) on the outer and the inner sidewalls as well as across the tread of the 6 tyres that were fitted on the Motor Lorry.

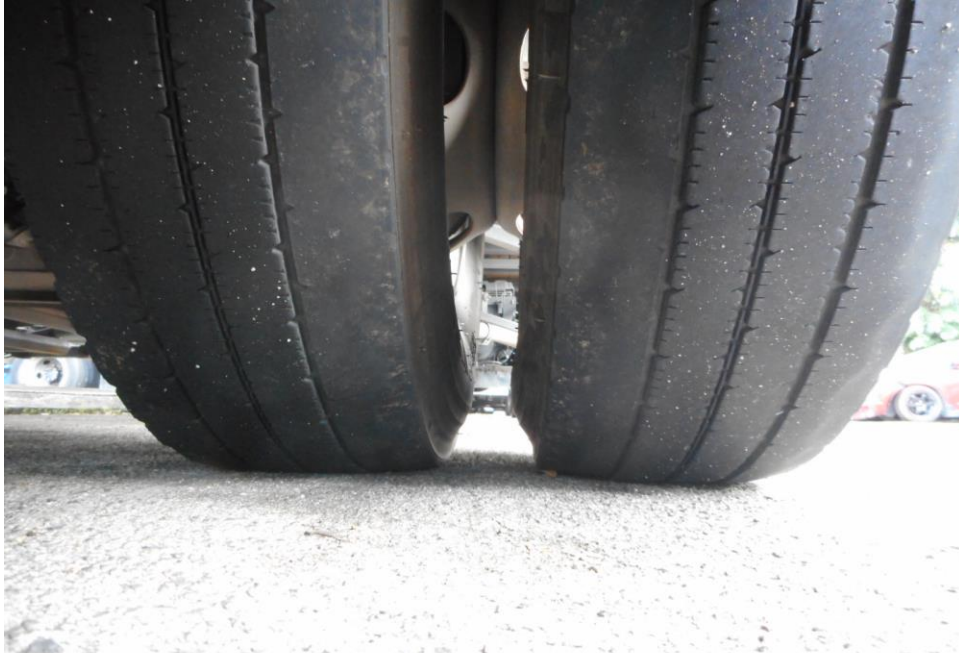
**Photo 10** shows the condition of the rear right tyre of the Motor Lorry, which was observed to be in serviceable condition with remaining tread depth of approximately 3.5mm. The tyre, which was wrapped around standard steel wheel rim, it was observed to be sufficiently inflated for vehicular operation.

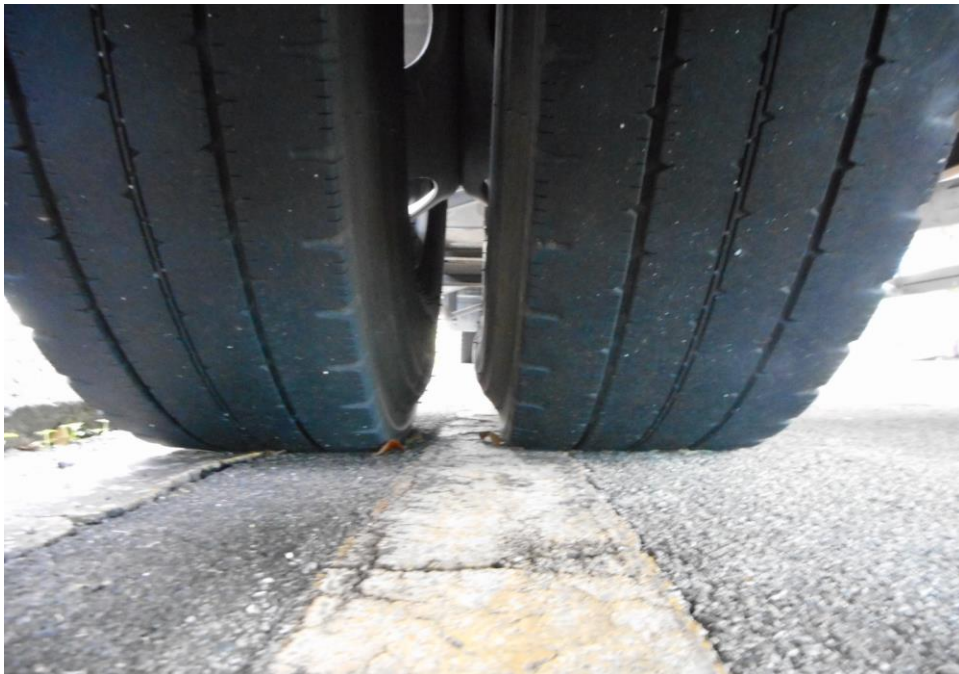
**Photo 11** shows the condition of the rear left tyres of the Motor Lorry, which was observed to be in serviceable condition with remaining tread depth of approximately 4.8mm. The tyres, which were wrapped around standard steel wheel rim, were also observed to be sufficiently inflated for vehicular operation. There was also no damage found on all 6 steel wheel rims of the Motor Lorry.

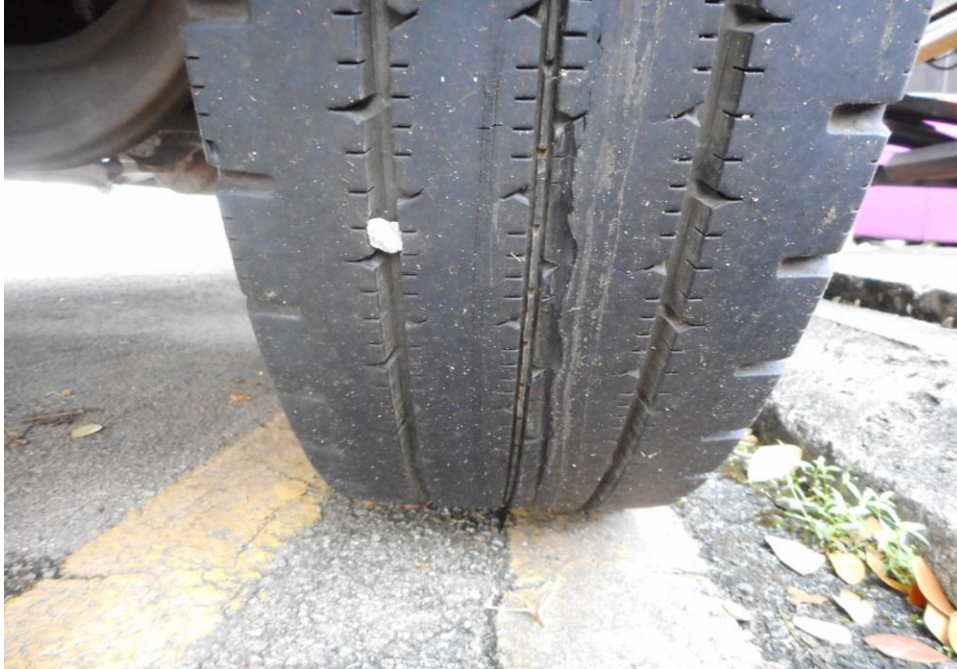
**Photo 12** shows the condition of the rear right tyres of the Motor Lorry, which were observed to be in serviceable condition with remaining, tread depth of approximately 4.5mm. There was also no tear, cut or burst mark(s) on the outer and the inner sidewalls as well as across the tread of the 6 tyres that were fitted on the Motor Lorry.

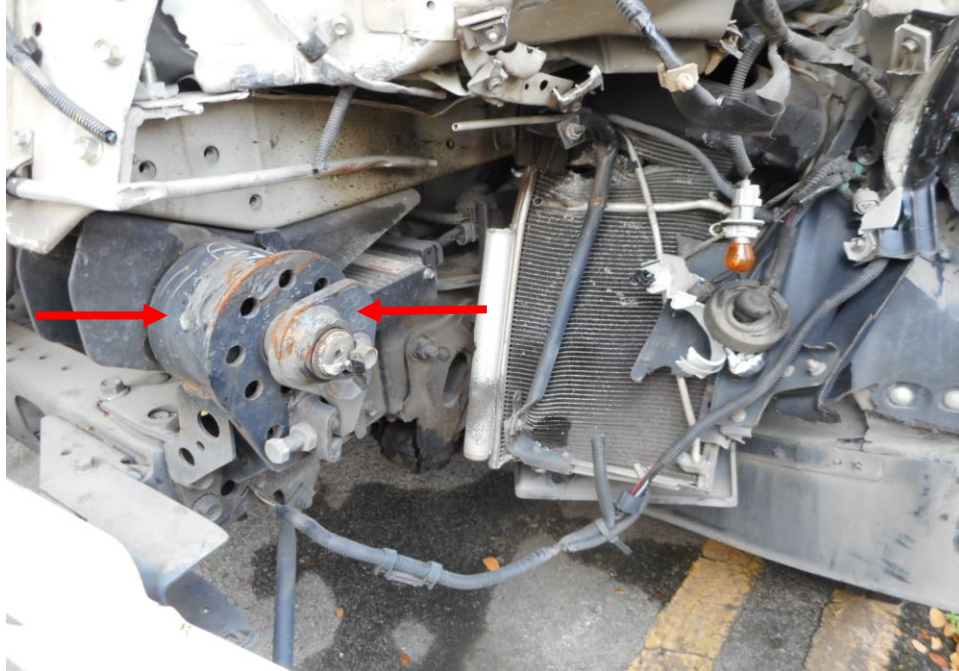
**Photo 13** shows the induced damage that had jam the cabin of the Motor Lorry's and immobilised the opening and viewing (arrowed) of the various parts and components inside the engine compartment, a result of the accident.

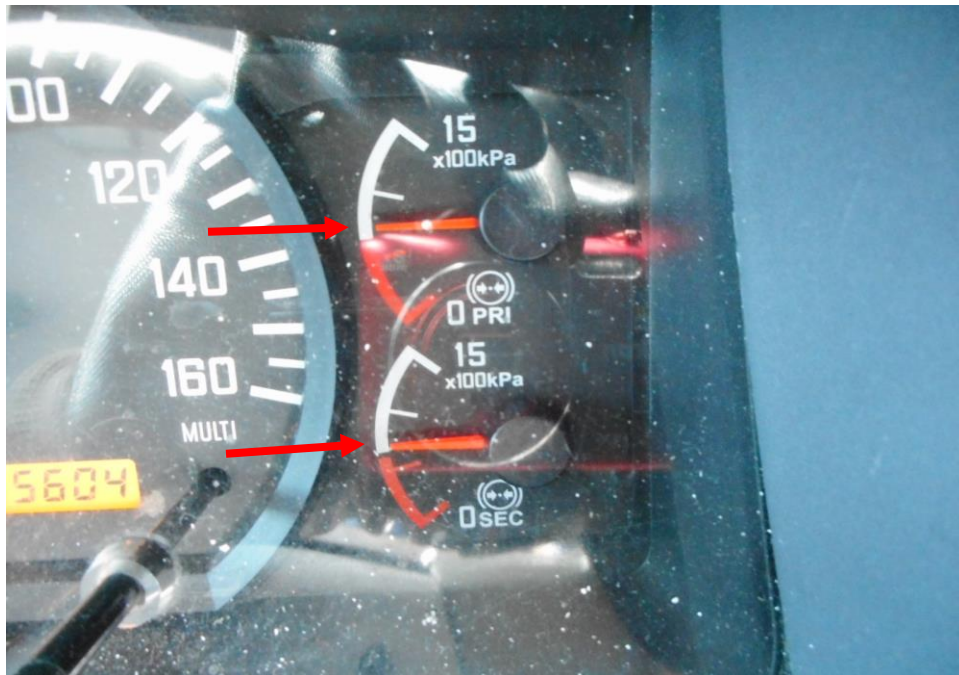
**Photo 14** shows the air in the air brake cylinder of the Motor Lorry at the time of my inspection. The air in the cylinder was observed to be of sufficient level & serviceable at the time of the accident.

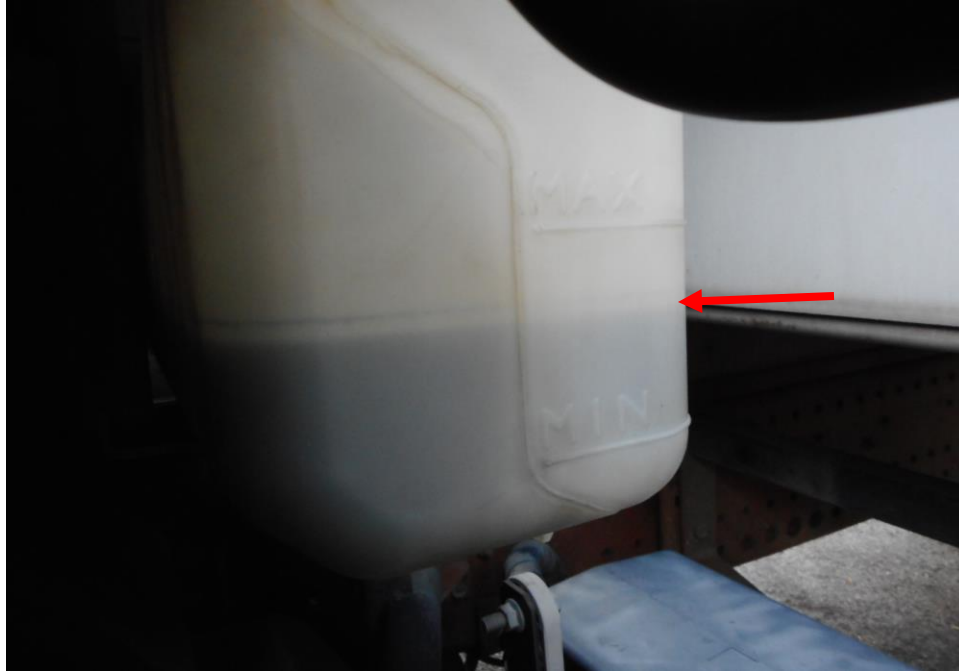
**Photo 15** shows the engine coolant reservoir of the Motor Lorry at the time of my inspection. The engine coolant was observed to be of sufficient level (arrowed) and without any visible contamination.

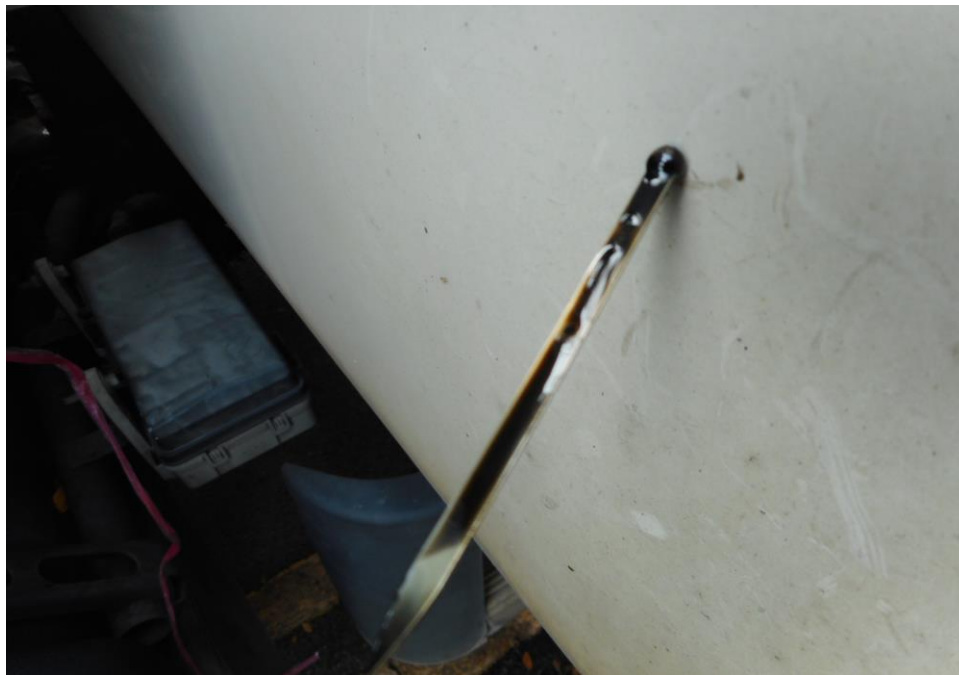
**Photo 16** shows the engine oil dip stick of the Motor Lorry at the time of my inspection. The engine oil was observed to be of sufficient level and without any visible contamination.

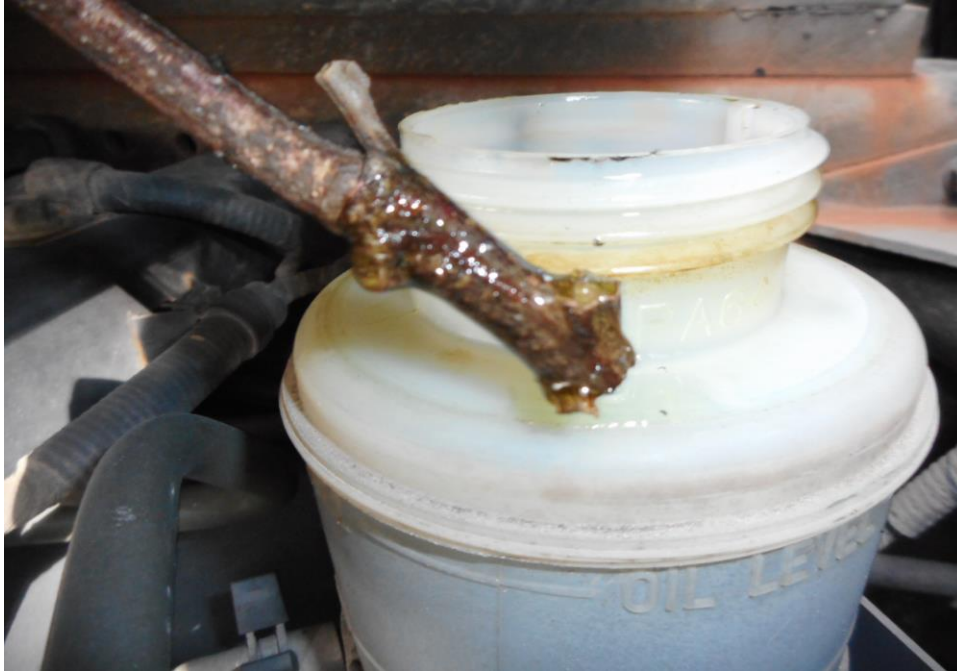
**Photo 17** shows the power steering fluid reservoir of the Motor Lorry at the time of my inspection. The power steering fluid was observed to be of sufficient level (arrowed) and without any visible contamination.

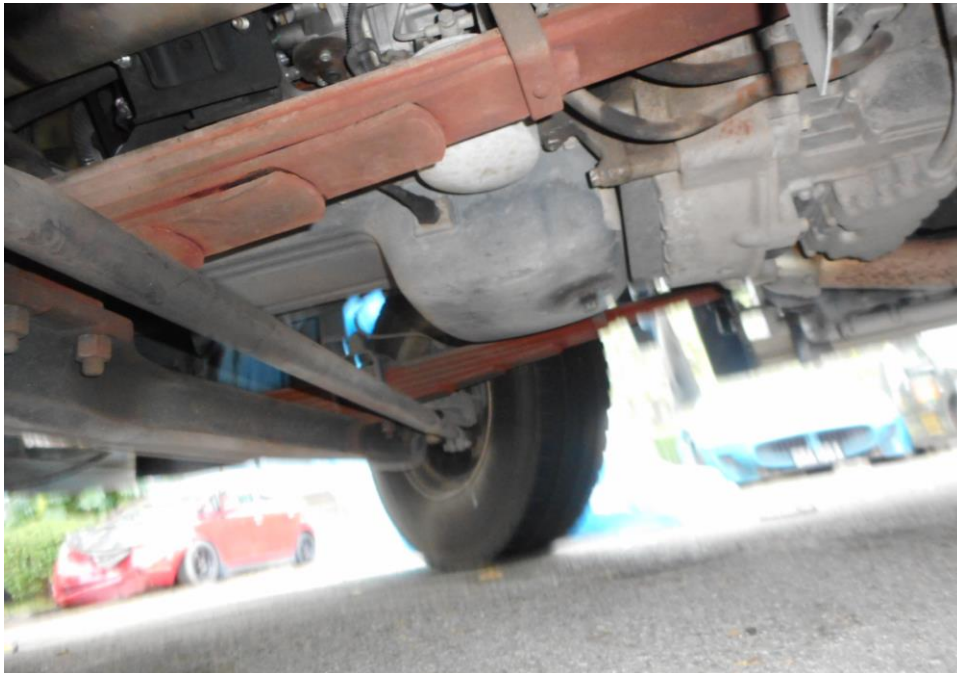
**Photo 18** shows the undercarriage of the Motor Lorry, at the area where the engine housing and transmission housing are located. I did not find any sign(s) or indication(s) of fluid leak and/or fluid stain(s) on the underside of the Motor Lorry.

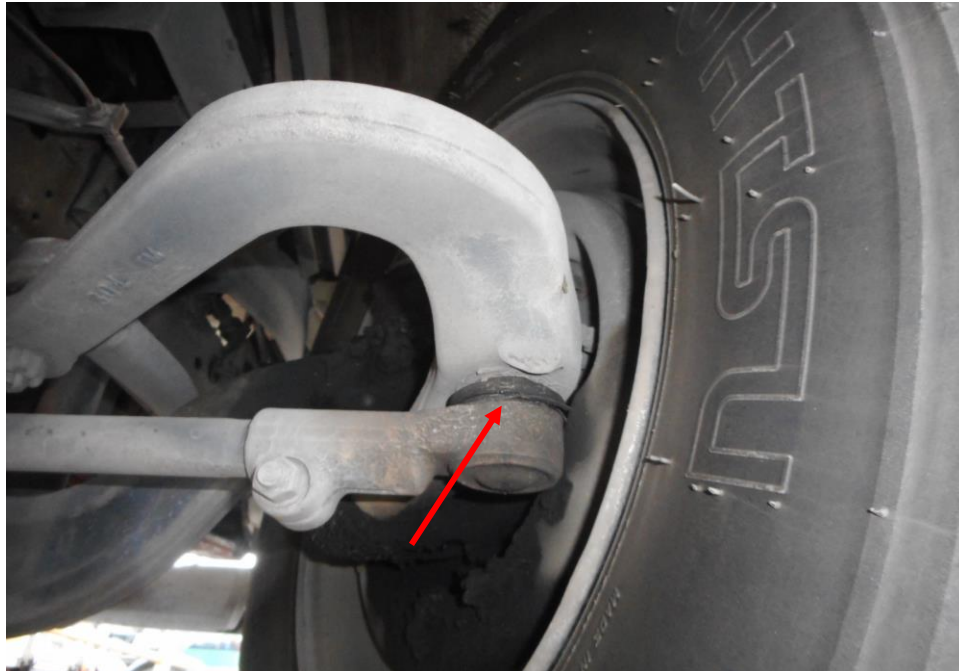
**Photo 19** shows the various undercarriage components at the front right wheel of the Motor Lorry, in particular the steering tie rod end (arrowed). The various steering components were all found to be intact, suggesting that the steering system of the Motor Lorry was likely to be in serviceable condition at the material time of accident. There was also no sign of fluid stain(s) observed on the various undercarriage components.

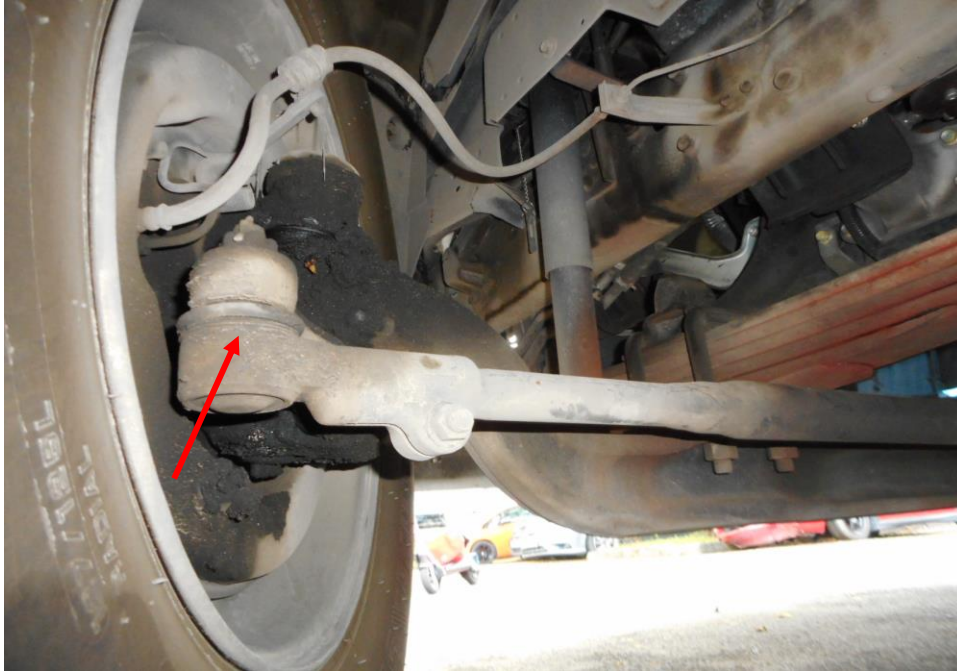
**Photo 20** shows the various undercarriage components at the front left wheel of the Motor Lorry, in particular the steering tie rod end (arrowed). The various undercarriage components of the Motor Lorry were all found to be intact without any visible damage. There was also no sign of fluid stain(s) observed on the various undercarriage components.

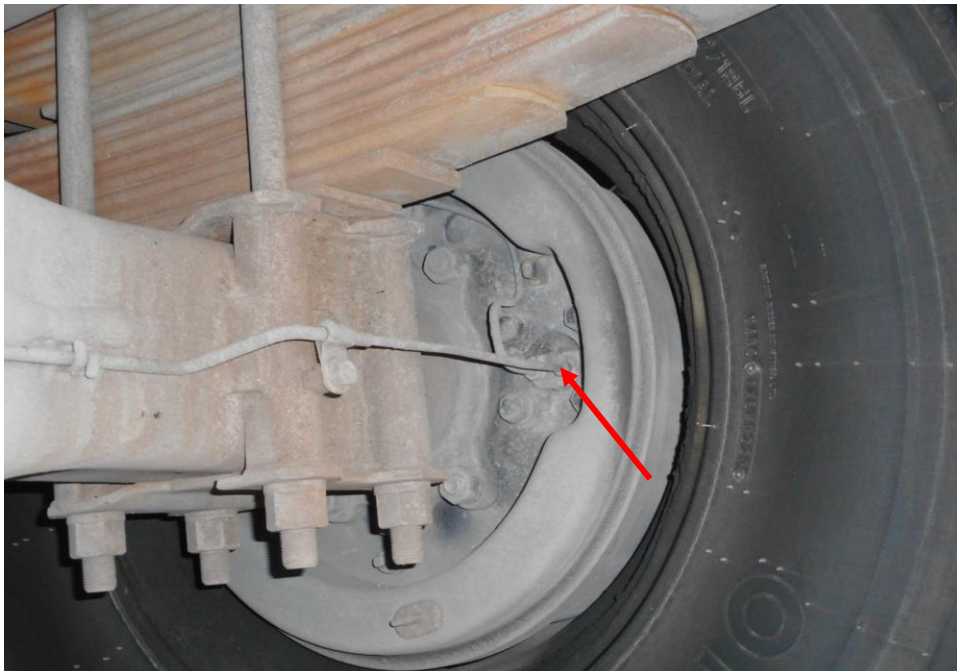
**Photo 21** shows the brake pipe (arrowed) at the rear right wheel of the Motor Lorry. I did not observe any leakage of brake fluid at the time of my inspection of the Motor Lorry. My static tests of the Motor Lorry's braking system, along with my visual examination of the various mechanical components in the braking system, had indicated that there was no internal leakage of pressure/vacuum. Hence the braking system of the Motor Lorry was likely to be in serviceable condition at the material time of accident.

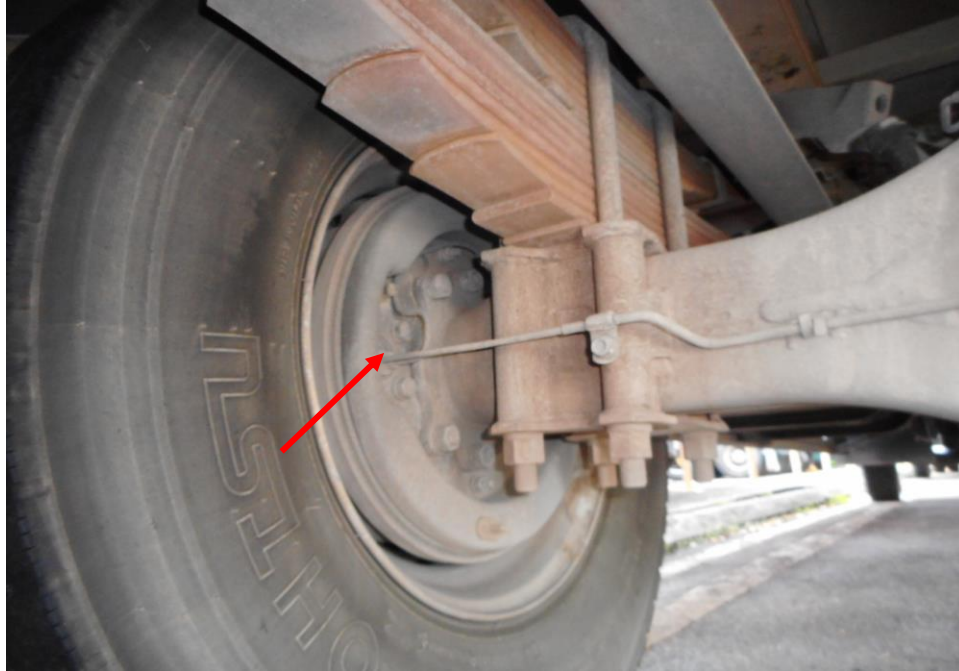
**Photo 22** shows the brake pipe (arrowed) at the rear left wheel of the Motor Lorry. I did not observe any leakage of brake fluid at the time of my inspection of the Motor Lorry. My static tests of the Motor Lorry's braking system, along with my visual examination of the various mechanical components in the braking system had indicated that there was no internal leakage of pressure/vacuum. Hence the braking system of the Motor Lorry was likely to be in serviceable condition at the material time of accident.

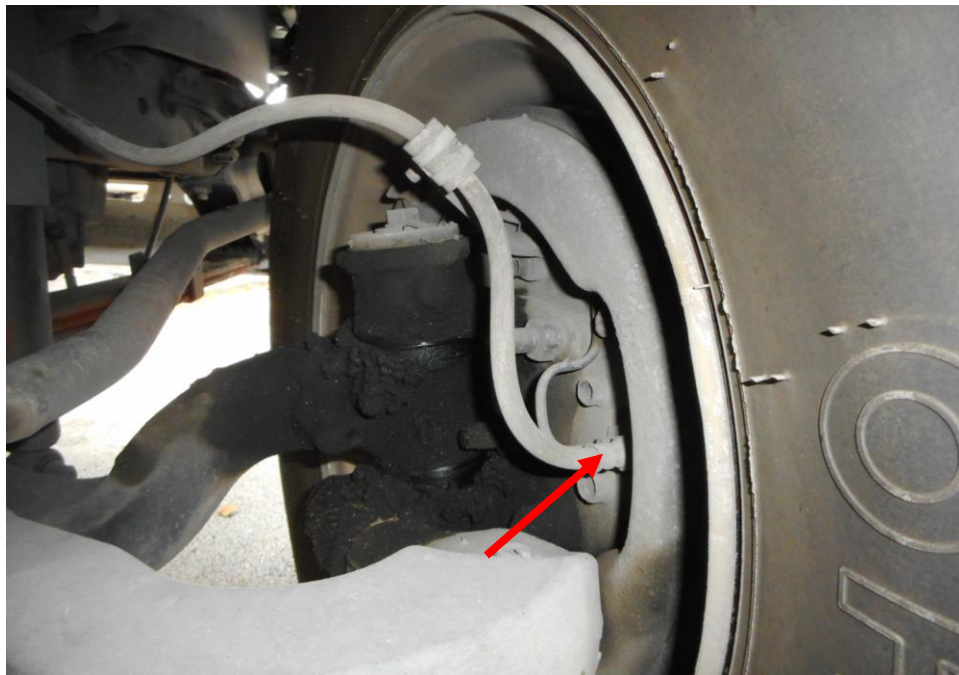
**Photo 23** shows the brake hose/pipe (arrowed) at the front right wheel of the Motor Lorry. My static tests of the Motor Bus's braking system, along with my visual examination of the various mechanical components in the braking system had indicated that there was no internal leakage of pressure/vacuum. Hence the braking system of the Motor Bus was likely to be in serviceable condition at the material time of accident.

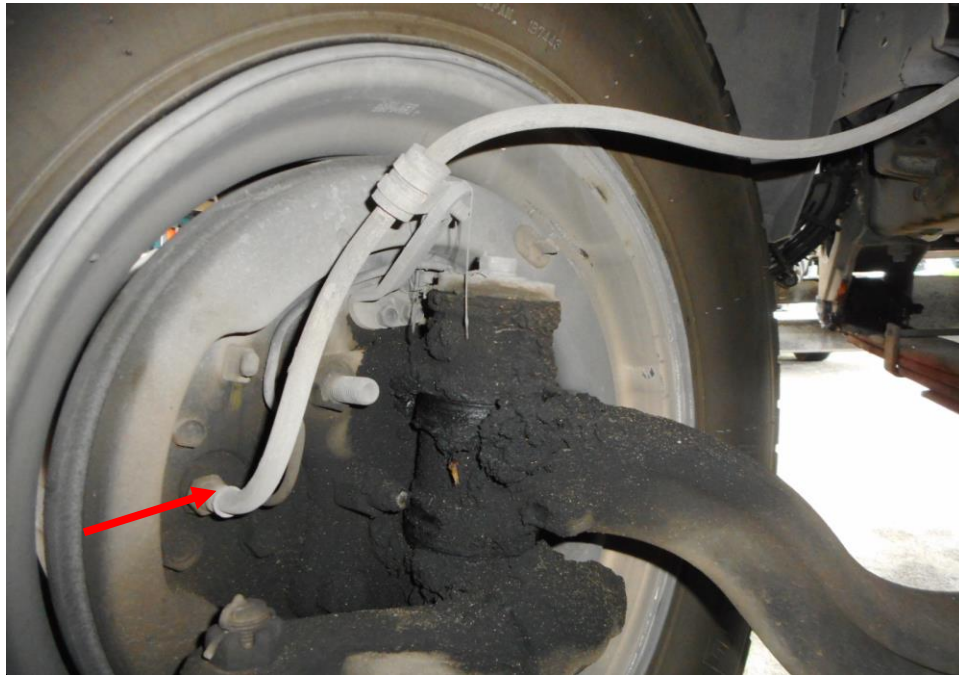
**Photo 24** shows the brake hose/pipe (arrowed) at the front left wheel of the Motor Lorry. My static tests of the Motor Bus's braking system, along with my visual examination of the various mechanical components in the braking system had indicated that there was no internal leakage of pressure/vacuum. Hence the braking system of the Motor Bus was likely to be in serviceable condition at the material time of accident.

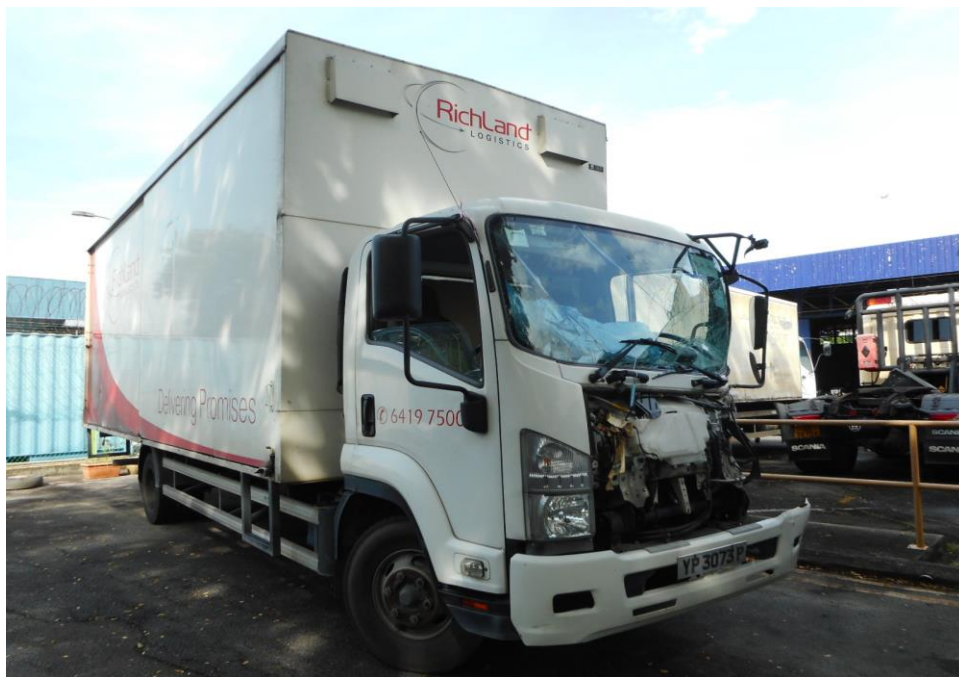
**Photo 25** shows the front right wheel of the Motor Lorry turned to its full left. During my steering system test, I did not experience any abnormal free play and/or resistance when I had turned the steering wheel towards full left and full right. This would suggest that the steering system of the Motor Lorry was likely to be in serviceable condition at the material time of accident.
