Your Ref : CDMPG21000693
Our Ref : CS/EGI21004954/N

2 August 2021

**AUTOMOBILE TECHNICAL INVESTIGATION REPORT OF ACCIDENT
INVOLVING SLM 2910A AND SMX 6822A ON 9 APRIL 2021**

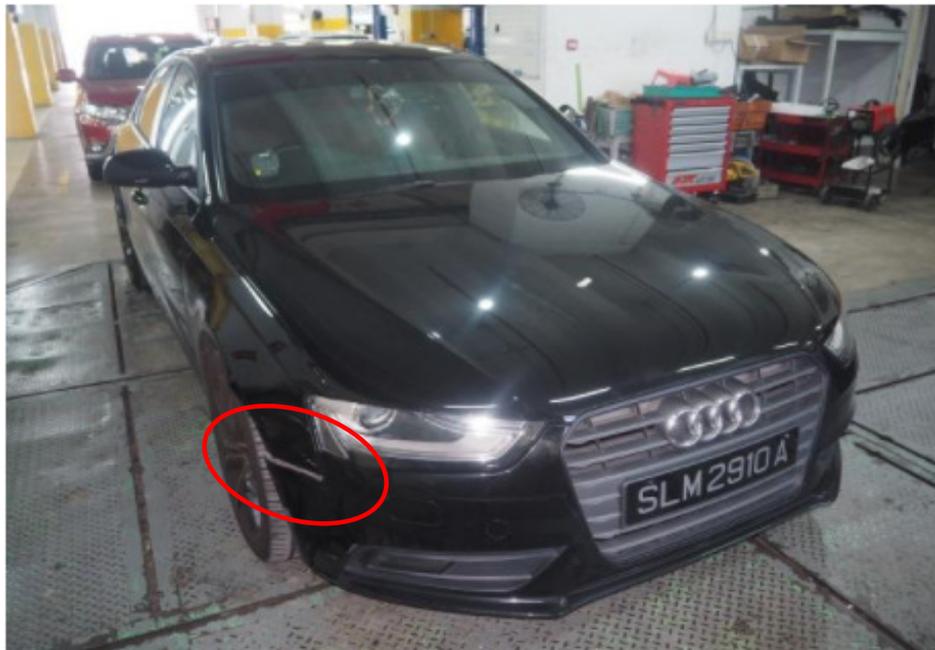
Photo 1 shows the general view of the frontal portion of the Audi at the time of the Pre- Repair Survey conducted by LKK Auto Consultants Pte. Ltd. which was taken about 3 weeks after the accident. The damage to the Audi was observed to be confined to the front bumper and right front fender (circled).

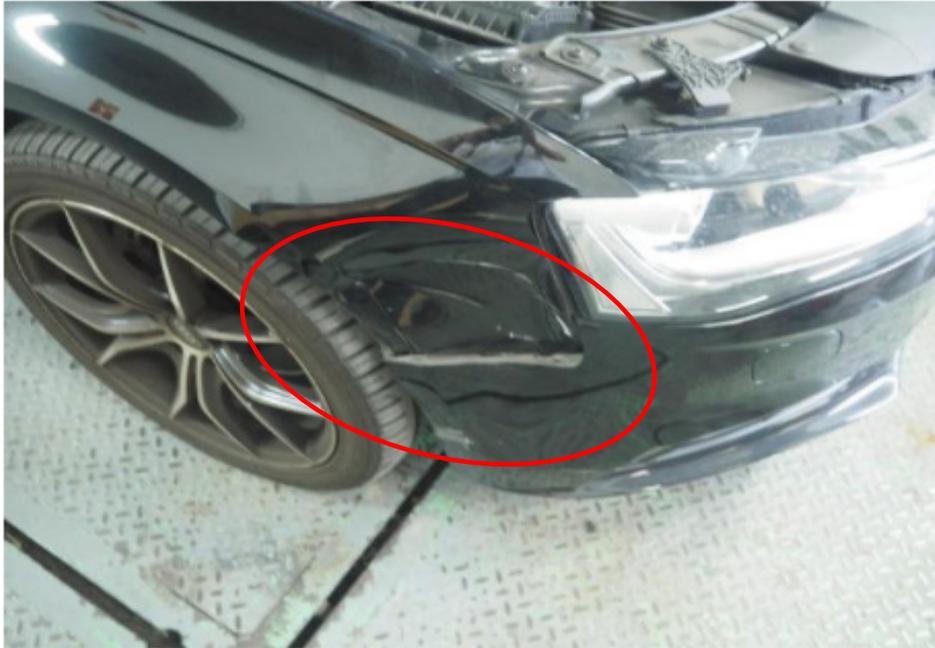
Photo 2 shows the damage observed on the front bumper and right front fender of the Audi (circled).

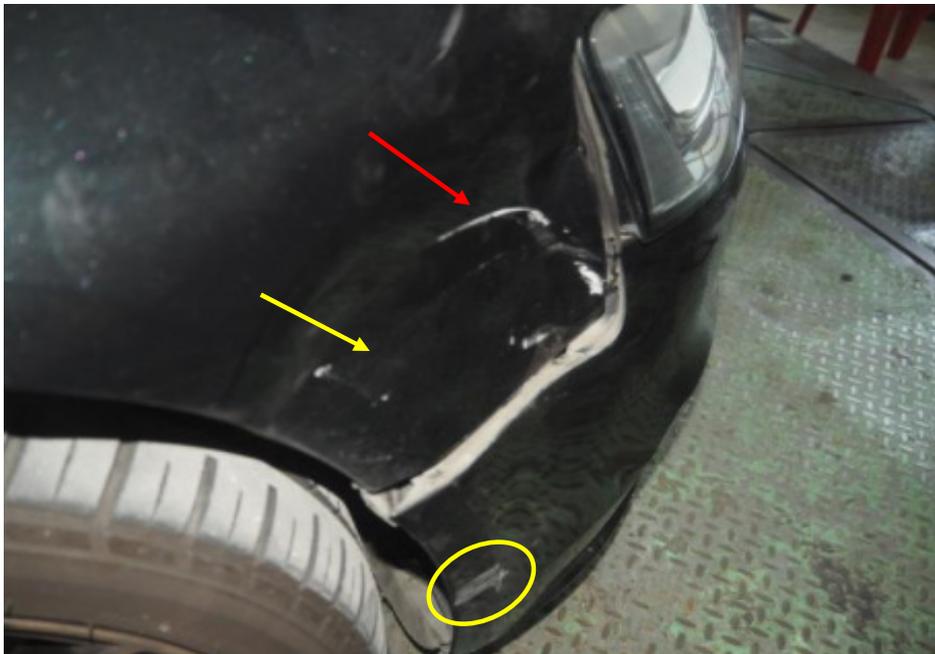
Photo 3 shows a closer view of the dent (yellow arrow) and whitish marks (red arrow) found on the right front fender as well as paint graze marks found on the lower right portion of the front bumper of the Audi (circled).

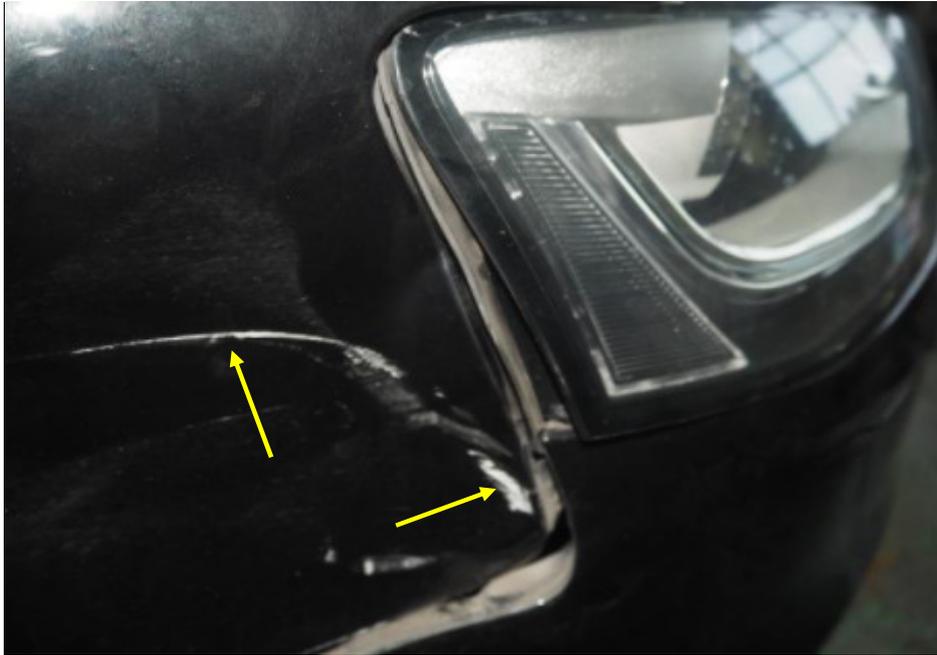
Photo 4 shows a close up view of the whitish marks found on the right front fender of the Audi (arrowed).

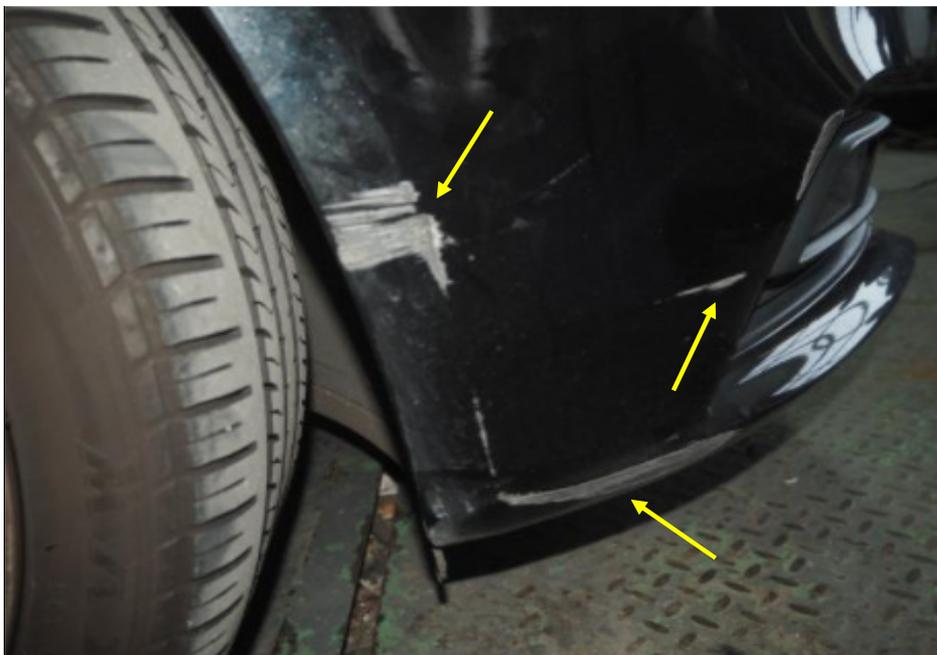
Photo 5 shows a close up view of the paint graze marks found on the lower right portion of the front bumper of the Audi (arrowed).

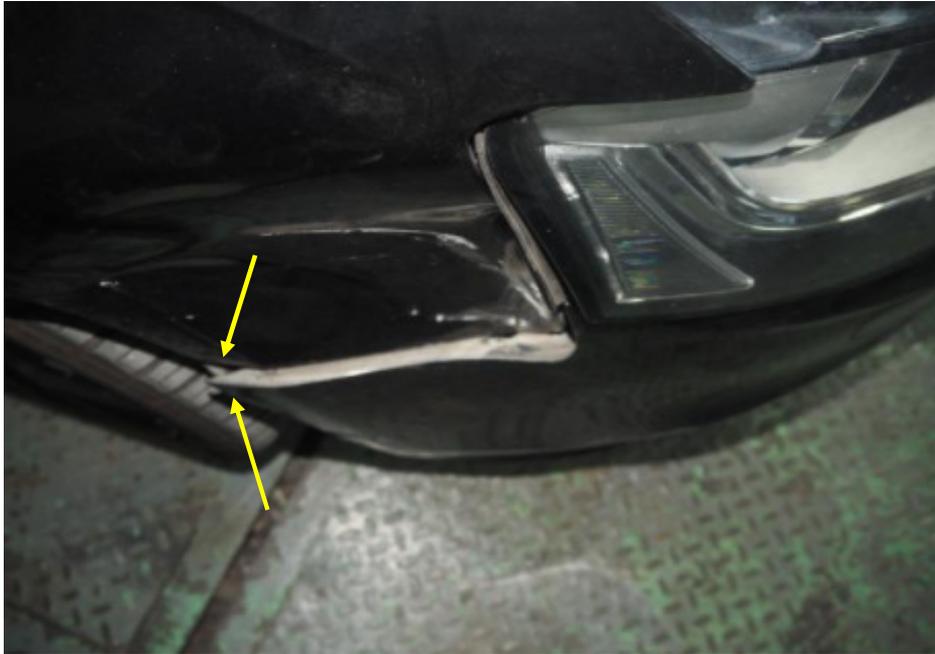
Photo 6 shows the right corner edge of the front bumper of the Audi. We observed that the front bumper was dislodged at the right corner edge (arrowed).

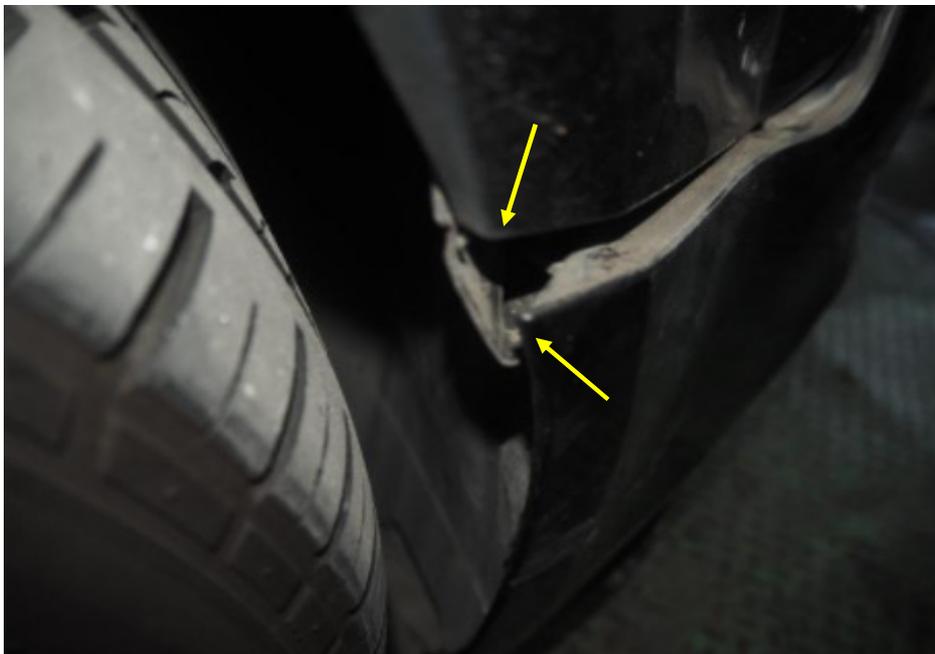
Photo 7 shows a close up view of the right corner edge of the front bumper of the Audi. We observed that the front bumper was dislodged at the right corner edge (arrowed).

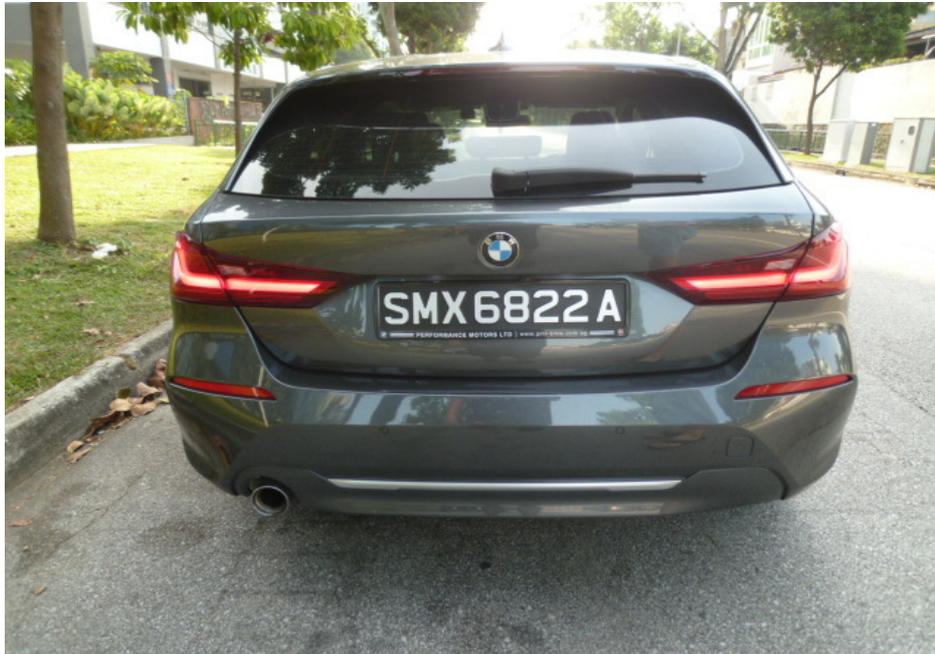
Photo 8 shows the general view of the rear portion of the BMW at the time of our inspection. The physical inspection carried out had primarily focused on the rear portion of the BMW, in particular its rear bumper as the accident was reported to be of a rear to head nature where the BMW was in front of the Audi at the material time. The mileage recorded was 7, 324km.

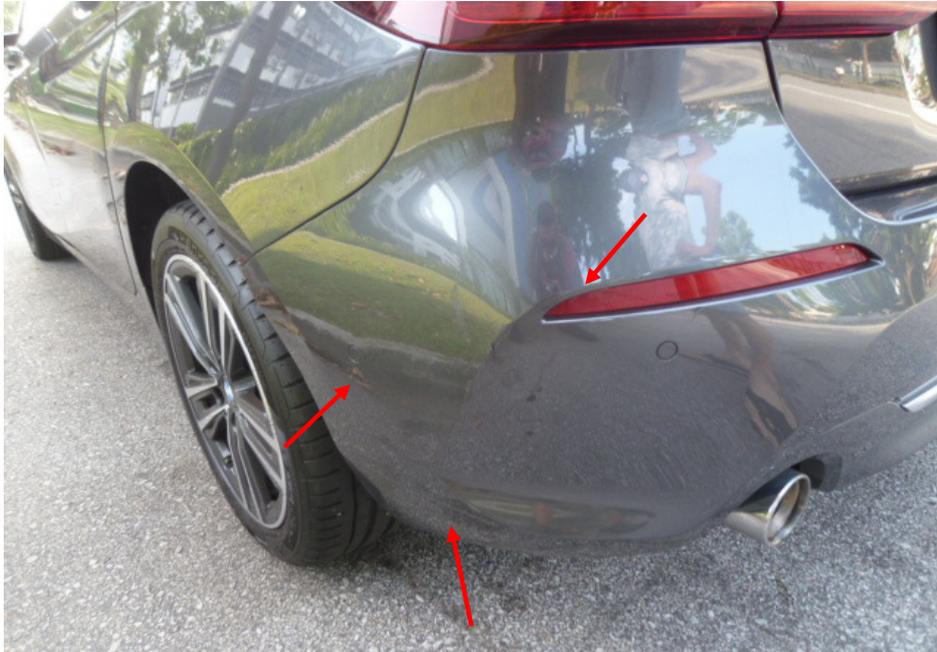
Photo 9 shows upon closer visual examination, we observed paint graze marks on the left portion of the BMW's rear bumper (arrowed).

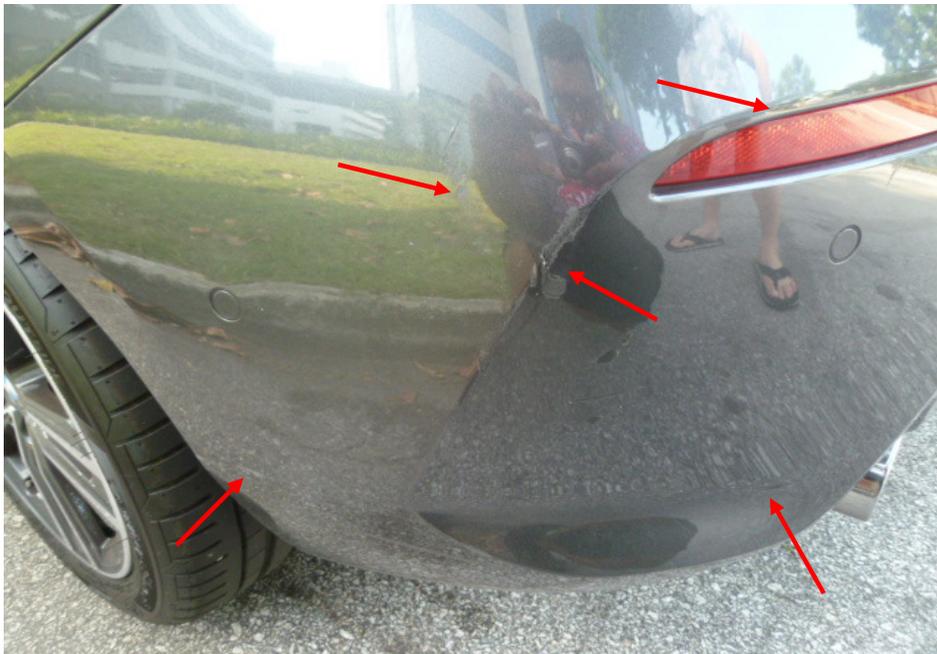
Photo 10 shows a closer view of the paint graze marks on the left portion of the BMW's rear bumper (arrowed).

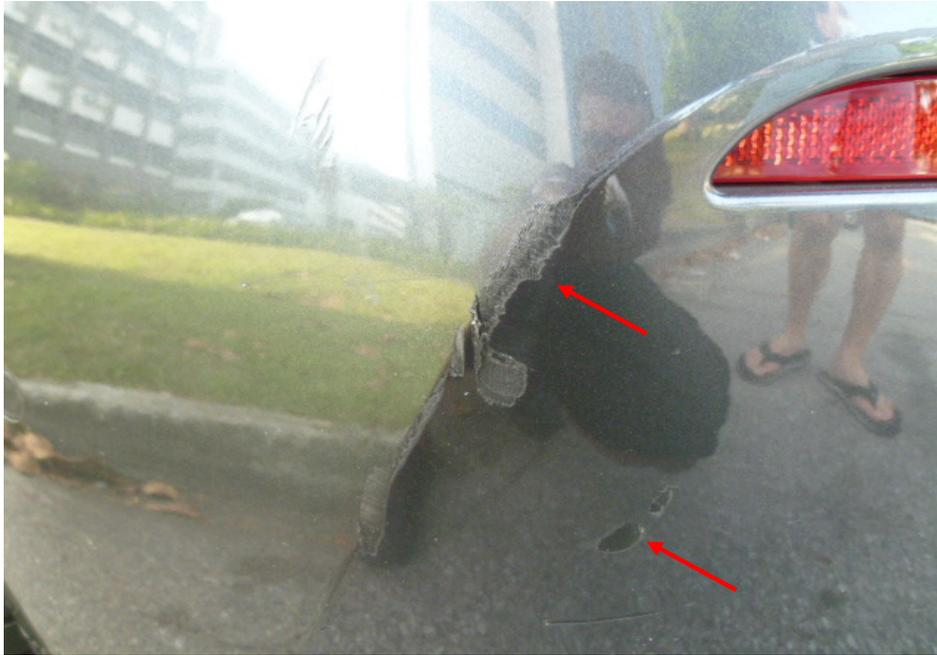
Photo 11 shows a close up view of the paint graze marks on the left portion of the BMW's rear bumper (arrowed).

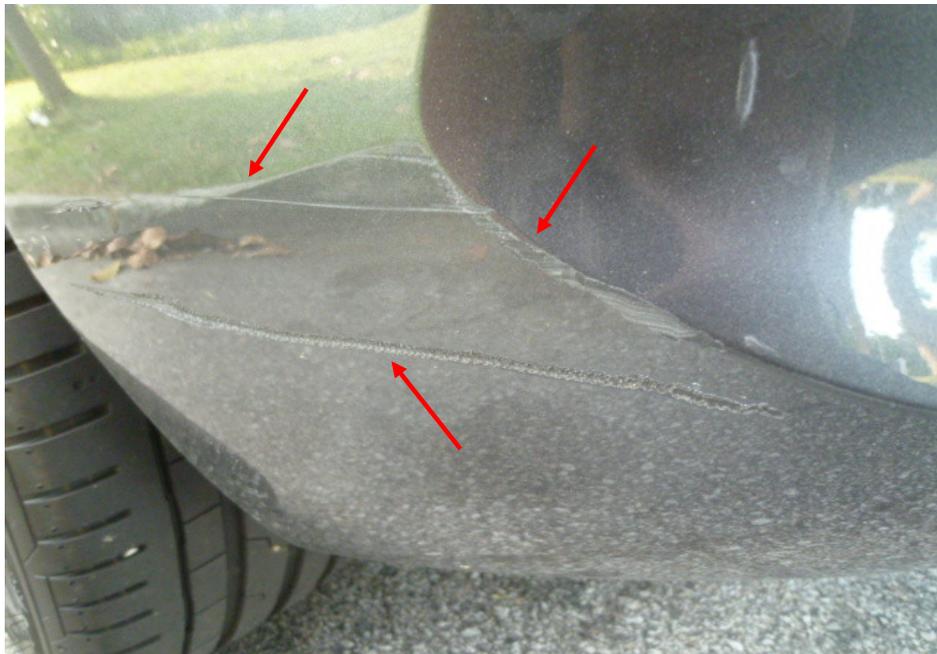
Photo 12 shows a close up view of the paint graze marks on the lower left portion of the BMW's rear bumper (arrowed).

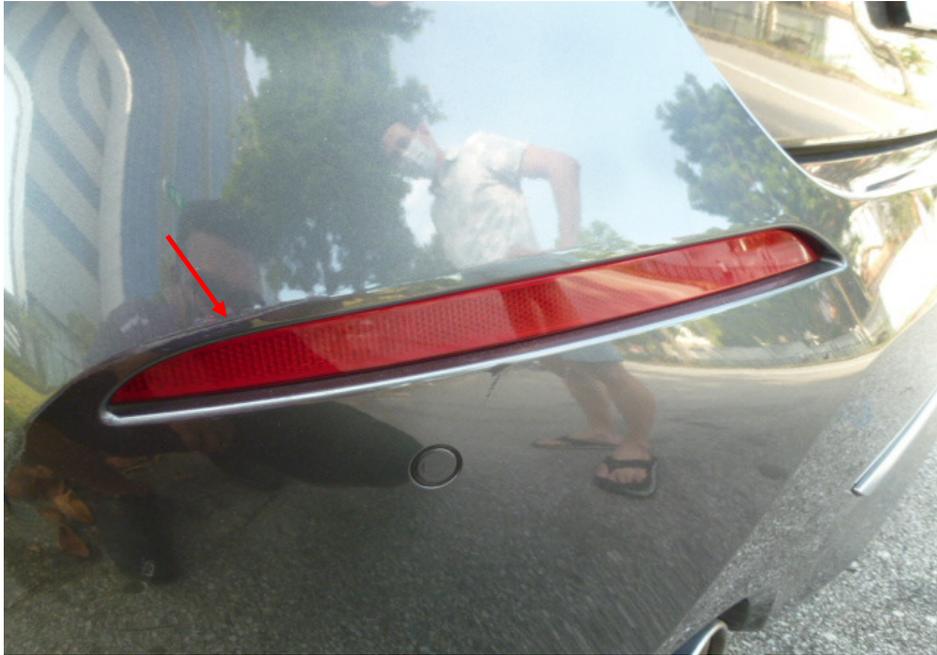
Photo 13 shows a closer view of the paint graze marks observed around the left reflector of the BMW's rear bumper (arrowed).

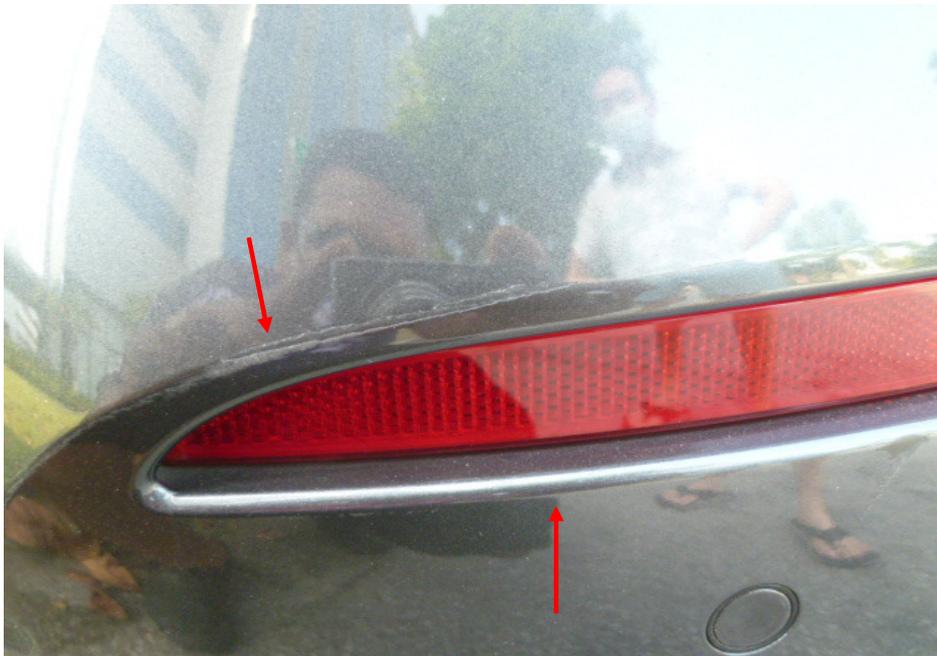
Photo 14 shows a close up view of the paint graze marks observed around the left reflector of the BMW's rear bumper (arrowed).

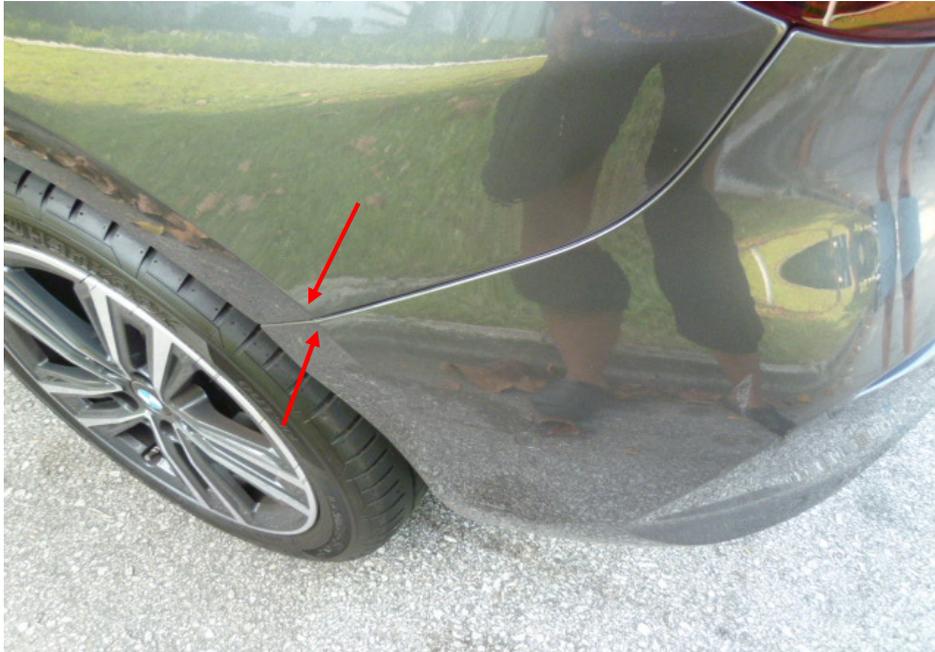
Photo 15 shows a closer view of the left corner edge of the front bumper of the BMW. We observed that there was a slight misalignment at the corner edges (red arrows).

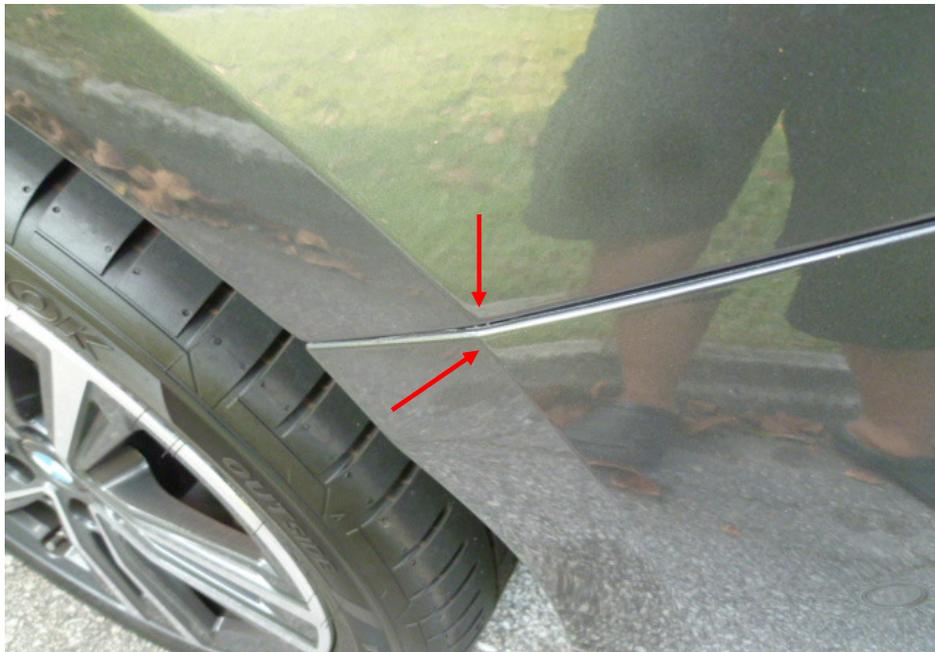
Photo 16 shows a close up view of the slight misalignment at the left corner edges of the BMW's rear bumper (red arrows).

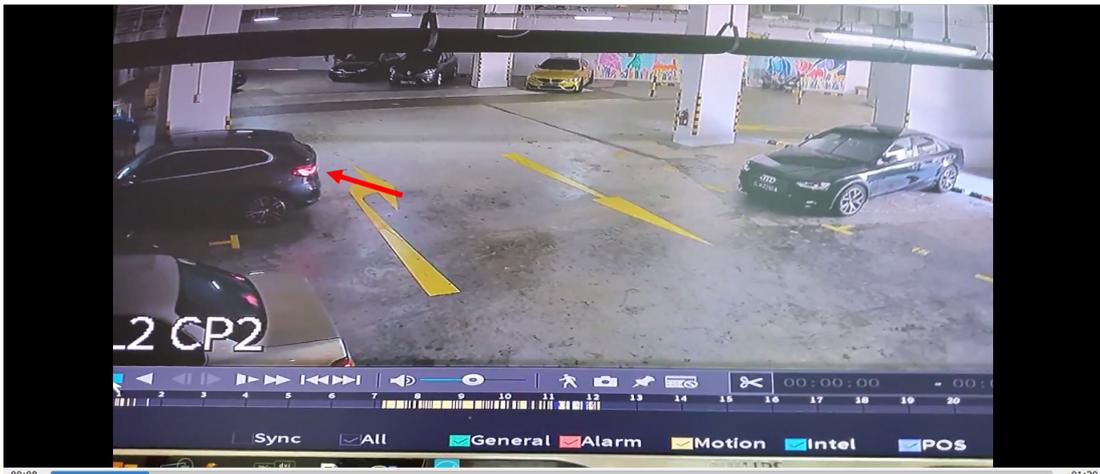
Screenshot 1 shows the 8 second mark of the video recording. The BMW could be seen reversing out of the parking lot of the carpark located at the Mapex building (arrowed).

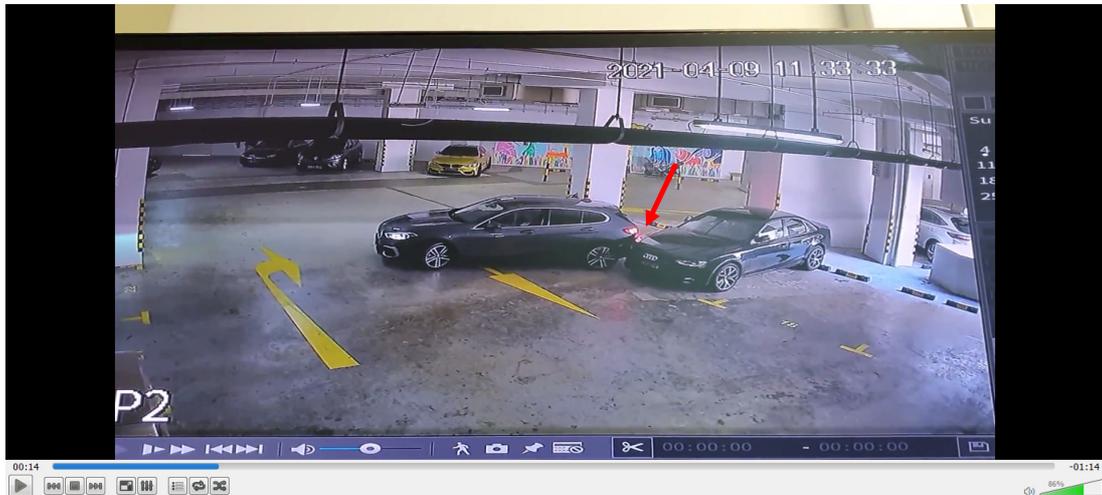
Screenshot 2 shows the 14 second mark of the video recording. Between the 14th and 15th second mark of the video recording, the BMW had reversed into the right front portion of the parked Audi. We had noted a slight movement of the parked Audi, indicating that there was contact between the rear portion of the BMW and the front portion of the Audi (arrowed).

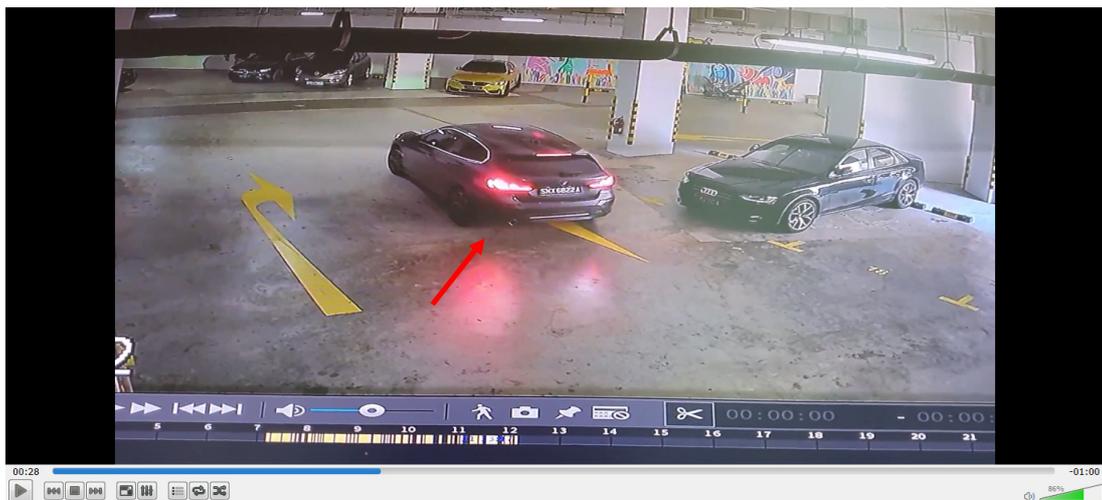
Screenshot 3 shows the 28 second mark of the video recording. The BMW could be seen reversing into a spot post- accident before the driver of the BMW alighted to examine the damage to the BMW (arrowed).

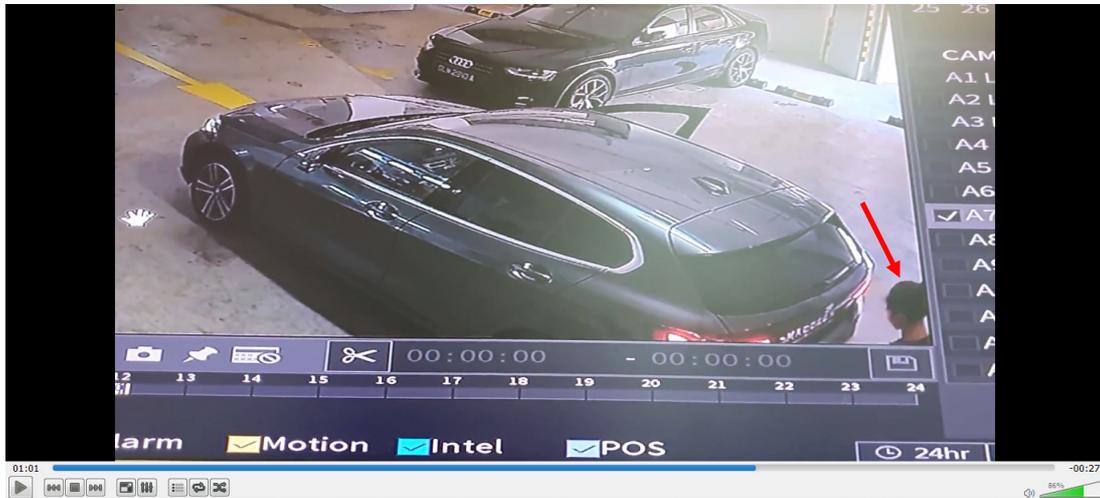
Screenshot 4 shows the 1 minute 01 second mark of the video recording. The driver of the BMW could be seen examining the damage to the BMW (arrowed).

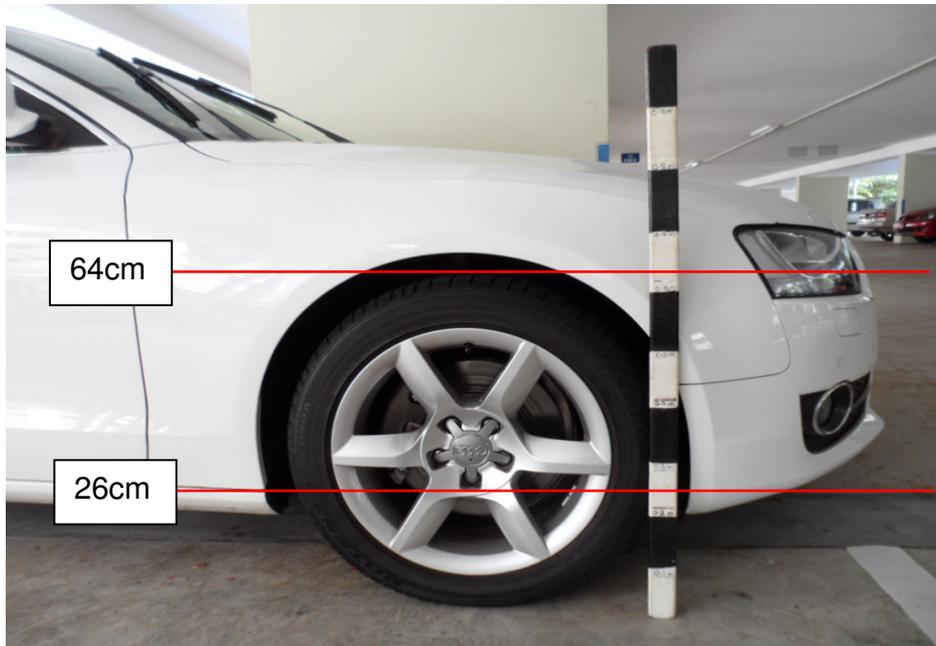
Photo 17 shows the height measurement being conducted on the right frontal portion of the Audi (using a similar make and model). The height range above ground level of the front bumper of the Audi, at the area where the damages were found, was measured to be approximately between 26cm to 64cm.

- a) the height range above ground level of the front bumper of the Audi, at the area where the damages were found, was measured to be approximately between 26cm to 64cm;
- b) the body part at the height range of between 26cm to 64cm above ground level was the rear bumper of the BMW where the paint graze marks were observed;
- c) the height measurements appear to support the findings of possible contact between the rear portion of the BMW and the portion of the Mitsubishi. The damage observed on the rear bumper of the BMW was a result of this contact and corresponds to the damage observed on the front bumper of the Audi. In other words, the damage observed on the frontal portion of the Audi is consistent to the damage observed on the rear portion of the BMW.

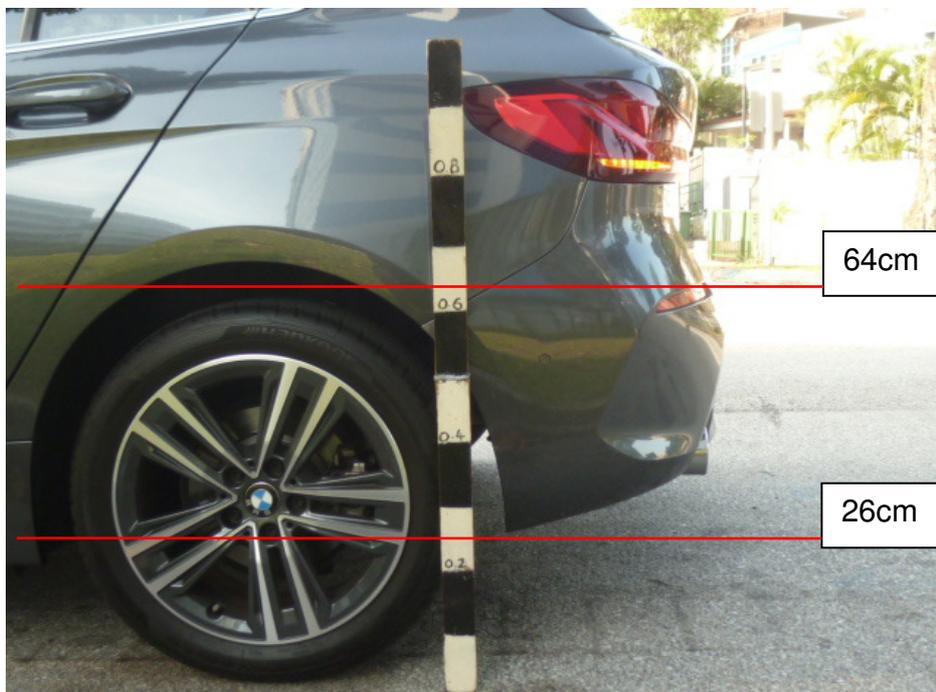
Photo 18 shows the height measurement being conducted on the rear left portion of the BMW. The body part at the height range of between 26cm to 64cm above ground level was the rear bumper of the BMW where the paint graze marks were observed.
