Your Ref: Mercedes Benz C43  
(chassis number WDD2050642R475302)  
Our Ref : CI/TP21004962/D

**INSPECTION REPORT OF AN UNREGISTERD MERCEDES BENZ C43  
MOTOR CAR WITH CHASSIS NUMBER WDD2050642R475302**

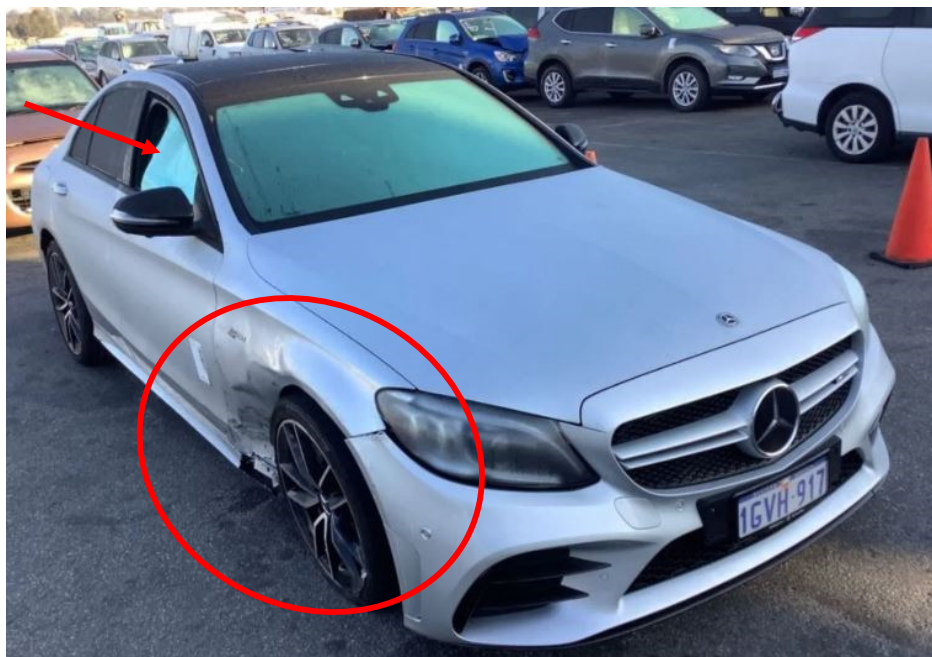
**Photo 1** shows the front right body of the Motor Car prior to any repairs being carried out (photograph provided to me). The Motor Car was observed to have sustained damages at its right front portion (circled). The front bumper, front right fender, front right wheel, front right door and right side rocker panel garnish were amongst the body parts that were observed to have been damaged. The right side curtain airbag (arrowed) was observed to have been deployed.

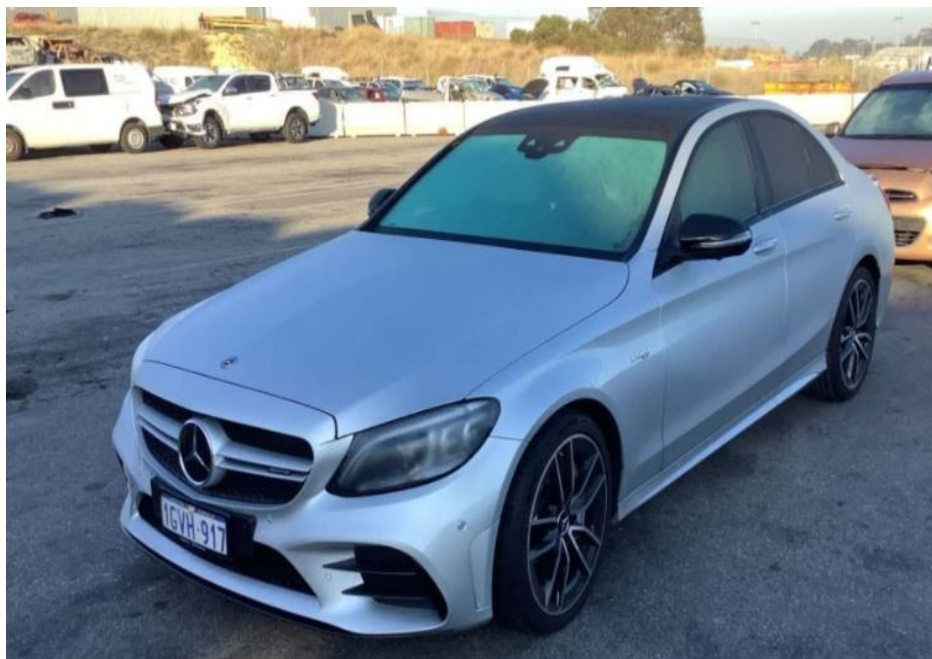
**Photo 2** shows the front left body of the Motor Car (photograph provided to me). Apart for the right front portion, there was no physical damage seen to other areas of the Motor Car.

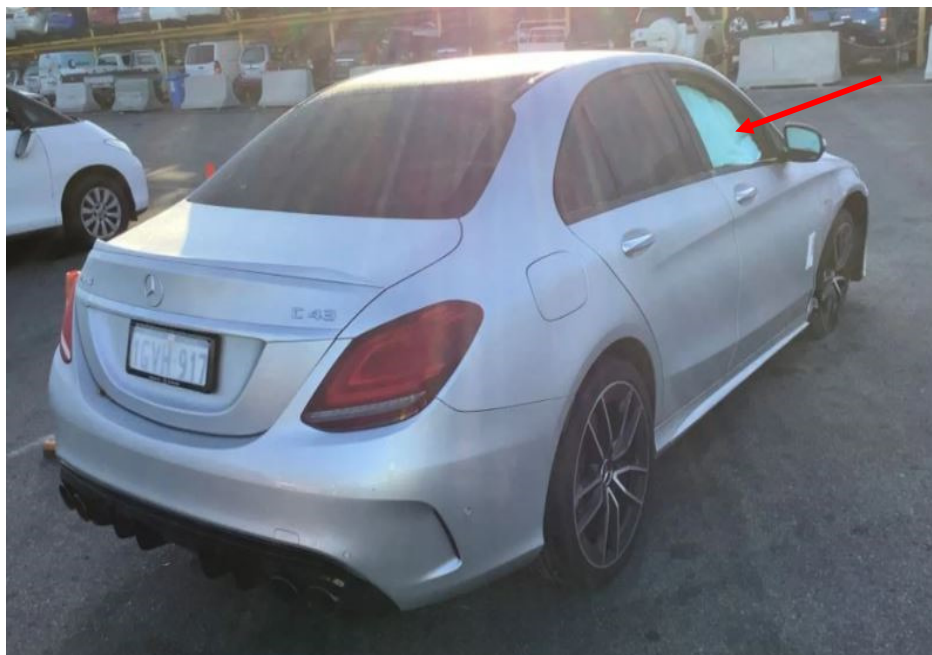
**Photo 3** shows the rear right body of the Motor Car (photograph provided to me). Apart for the right front portion, there was no physical damage seen to other areas of the Motor Car. However, the right side curtain airbag (arrowed) was observed to have been deployed.

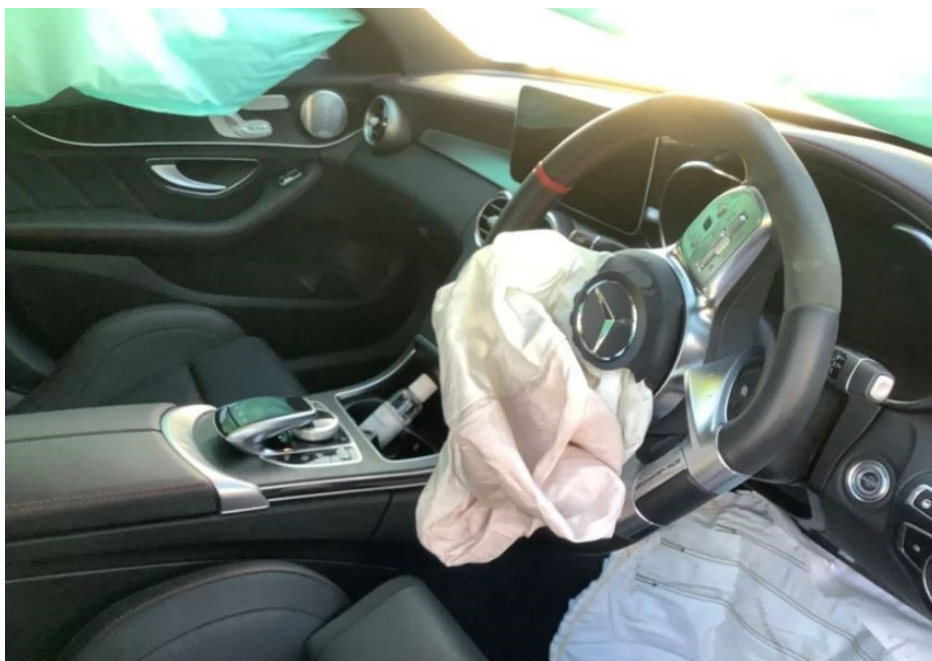
**Photo 4** shows the interior compartment of the Motor Car prior to any repairs being carried out (photograph provided to me). The driver's airbag, driver's knee airbag, right side curtain airbag and left side curtain airbags were deployed as seen from the photographs that were provided to me.

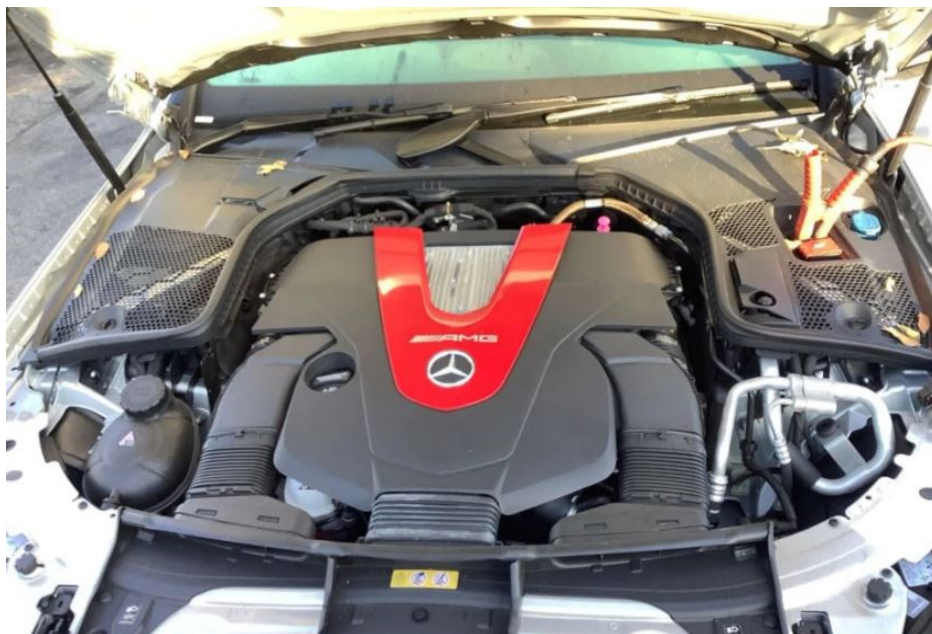
**Photo 5** shows the engine compartment of the Motor Car prior to any repairs being carried out (photograph provided to me). Parts and components within the engine compartment were intact and unaffected.

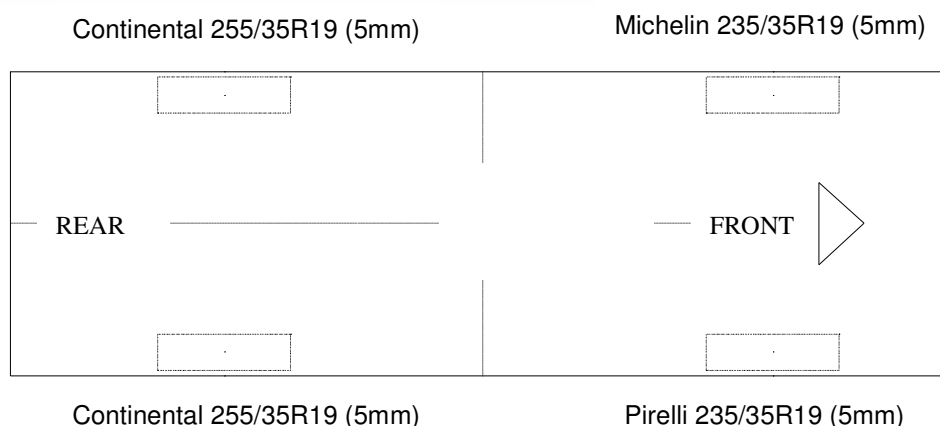
8. It was fitted with 19inch sport wheel rims that were wrapped with tyres that were observed to be of serviceable condition. The tyres were also sufficiently inflated for vehicular operation. The tyre brand, tyre size and approximate remaining tread depth of the 4 tyres of the Motor Car were recorded as follows: -

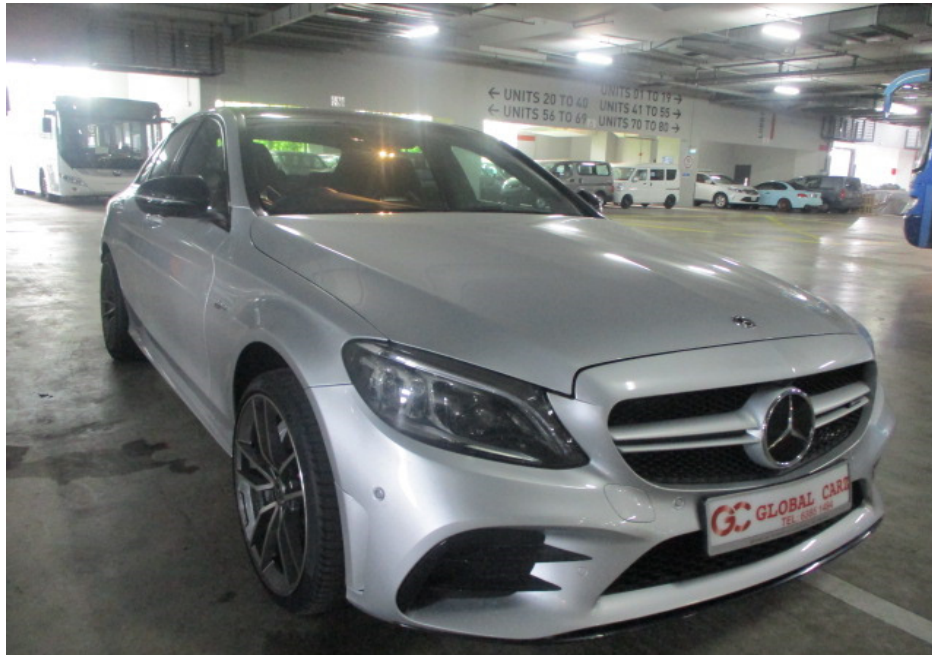
**Photo 6** shows a general view of the front right body of the Motor Car at the time of my inspection. The Motor Car was observed to be in a relatively good general condition with no loose exterior fittings observed. The exterior body parts at the right front portion of the Motor Car were visually examined and it was observed that the repair/restoration works carried out to the damaged area of the Motor Car (refer to photograph 1 above) were reasonably adequate and in order.

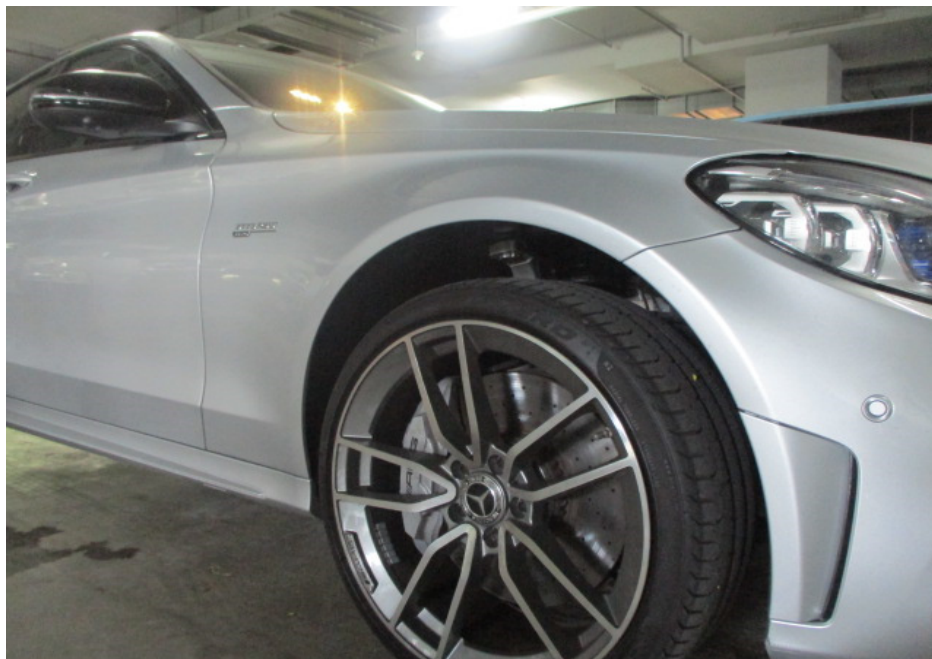
**Photo 7** shows a closer view of the Motor Car's front bumper, front right fender, front right wheel rim, front right door and right side rocker panel. In general, I had found that the repair/restoration works carried out to the damaged area of the Motor Car (refer to photograph 1 above) were reasonably adequate and in order.

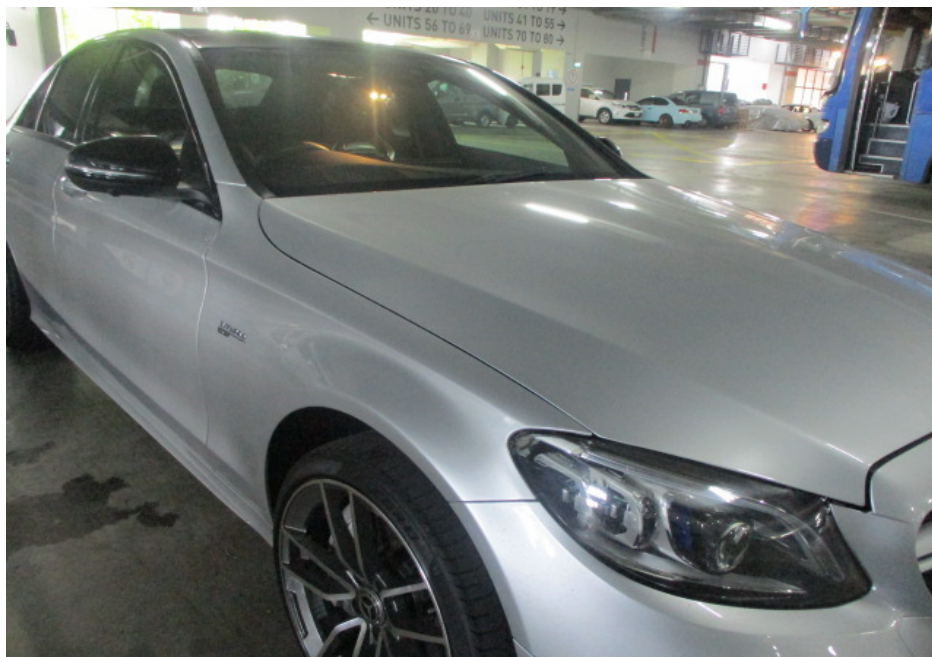
**Photo 8** shows the Motor Car's front bumper, front right fender, front right wheel rim, front right door and right side rocker panel at the time of my inspection. In general, I had found that the repair/restoration works carried out to the damaged area of the Motor Car (refer to photograph 1 above) were reasonably adequate and in order.

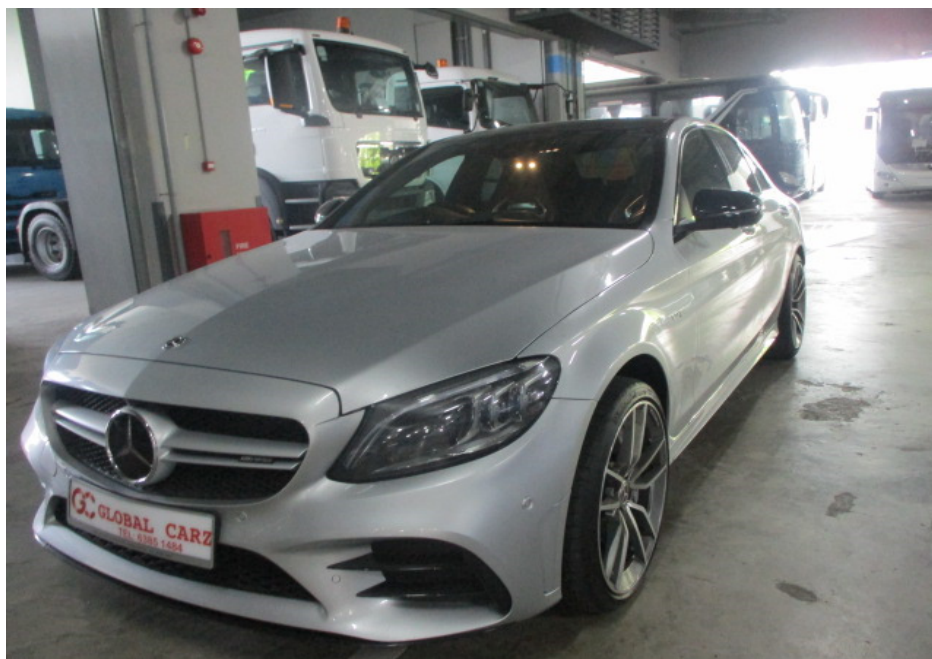
**Photo 9** shows a general view of the front left body of the Motor Car at the time of my inspection. The Motor Car was observed to be in a relatively good general condition with no loose exterior fittings observed. The mileage of the Motor Car recorded at the time of my inspection was 13,267km.

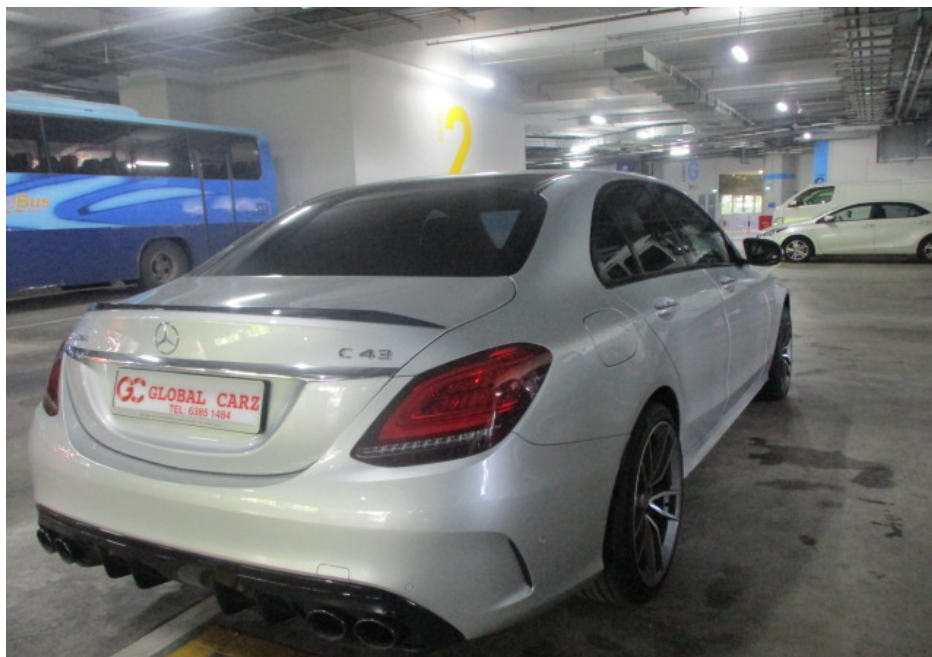
**Photo 10** shows a general view of the rear right body of the Motor Car at the time of my inspection. The Motor Car was observed to be in a relatively good general condition with no loose exterior fittings observed. The mileage of the Motor Car recorded at the time of my inspection was 13,267km.

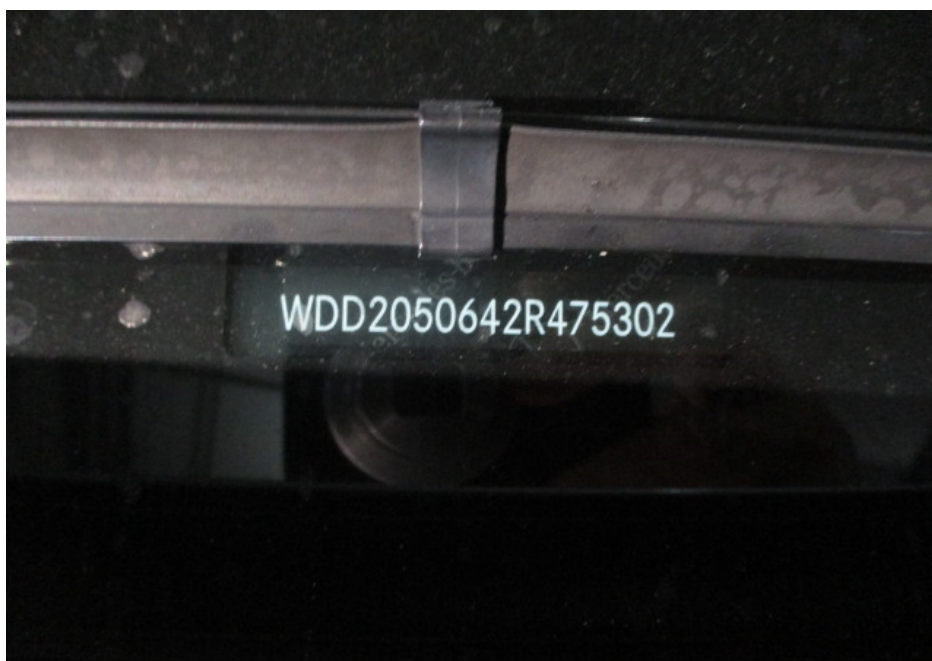
**Photo 11** shows the chassis number of the Motor Car. The chassis number recorded was WDD2050642R475302.

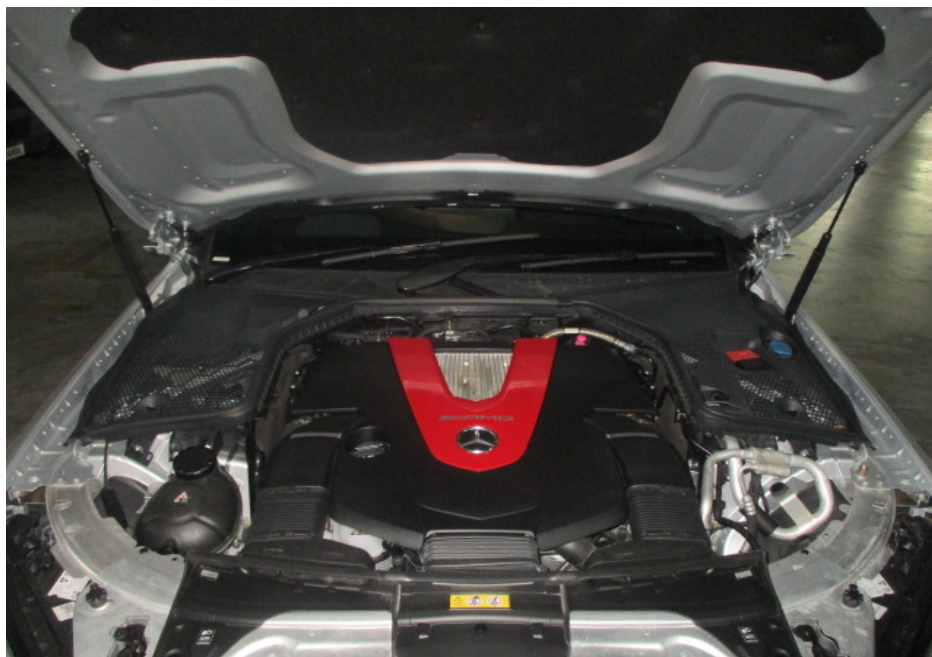
**Photo 12** shows a general view of the engine compartment of the Motor Car at the time of my inspection. The various parts and components inside the engine compartment were all observed to be intact and properly fitted. There was also no sign(s) or indication(s) of fluid leak and/or fluid stain found inside the engine compartment.

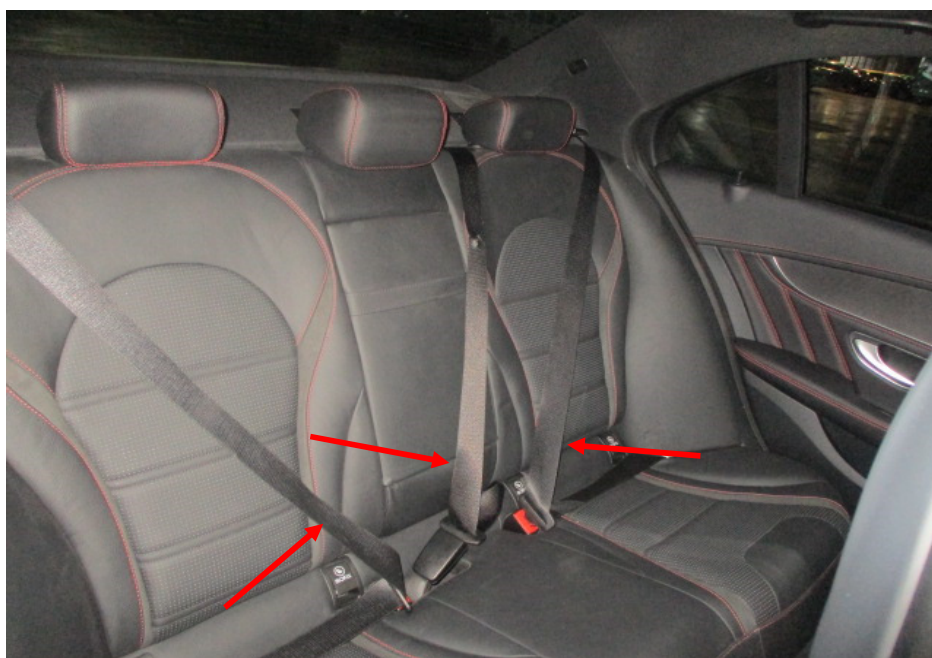
**Photo 13** shows the rear seats of the Motor Car. All the seats of the Motor Car were secured via seat rails to the floorboard. They were also fitted with a retractable seat belt reel and a pre-tensioner. The seat belts (arrowed) were tested and were able to be fastened into the respective pre-tensions that were fitted on the side of each individual seat.

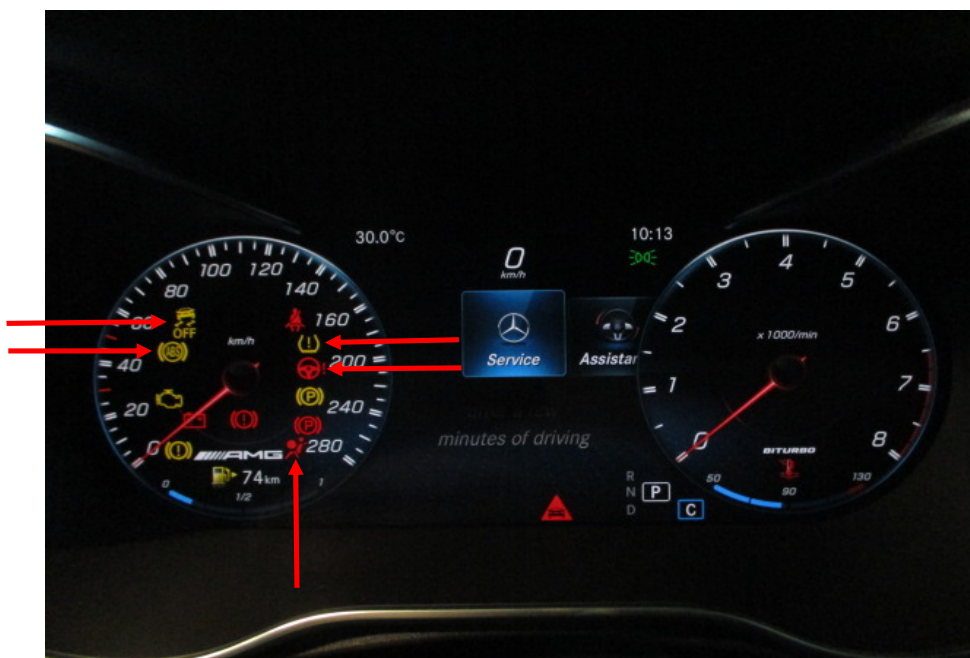
**Photo 14** shows the warning lights for the various electronic safety features appearing on the instrument panel of the Motor Car during its self-test when the engine is cranked, in particular the ABS, SRS, EPS, TPM and TCS lights (arrowed).

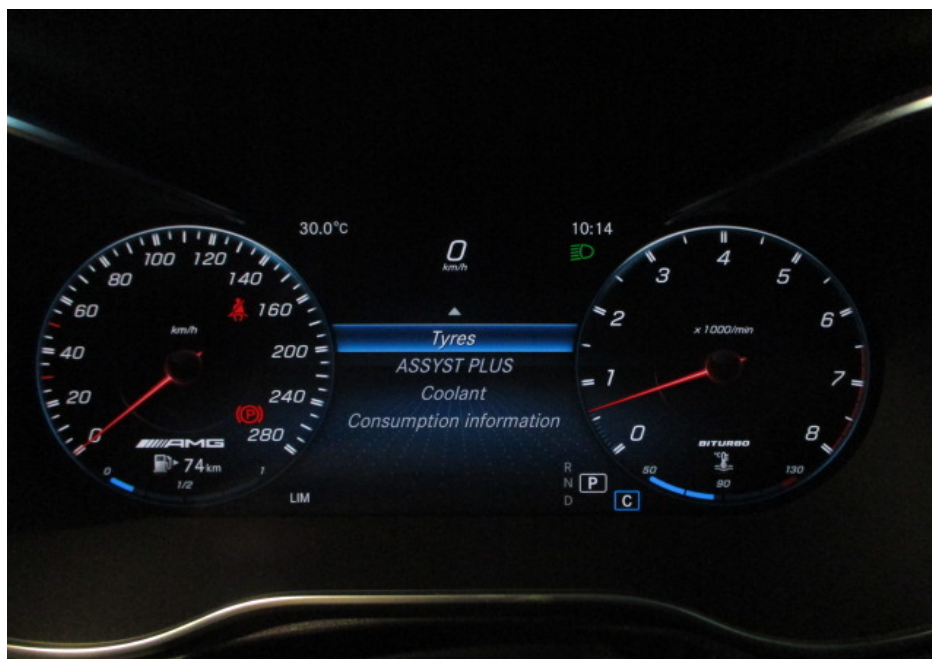
**Photo 15** shows the respective warning lights no longer illuminated, indicating that there is no fault detected to the ABS, SRS, EPS, TPM and TCS systems of the Motor Car during the self-test. These electronic systems were hence in working condition at the time of my inspection.

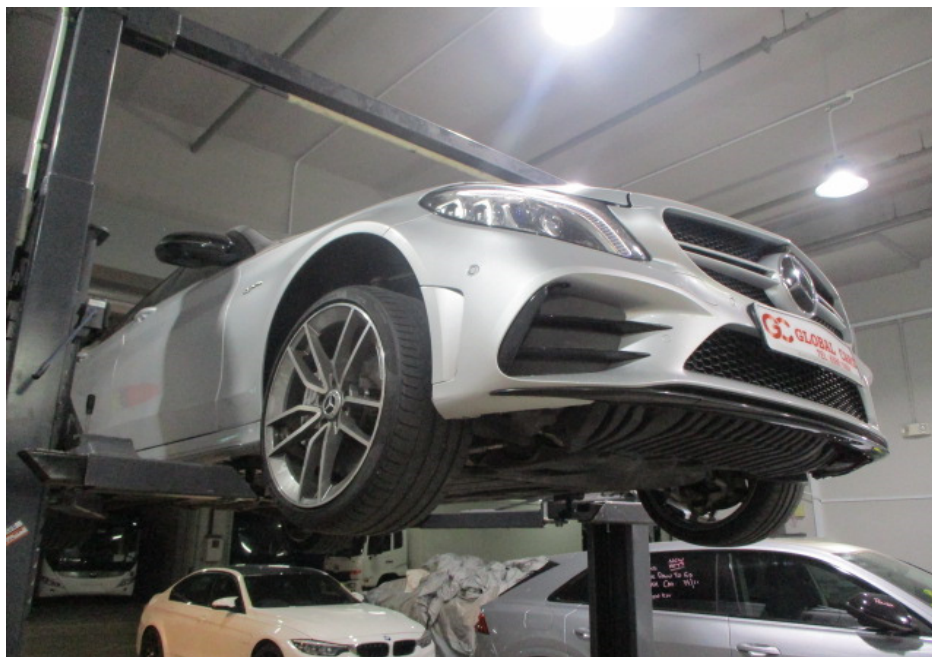
**Photo 16** shows the Motor Car hoisted up for checks on its undercarriage. There was no sign(s) or indication(s) of fluid leakage and/or fluid stain(s) on the underside of the Motor Car. The undercarriage components of the Motor Car were also all observed to be intact and secured in an appropriate manner.

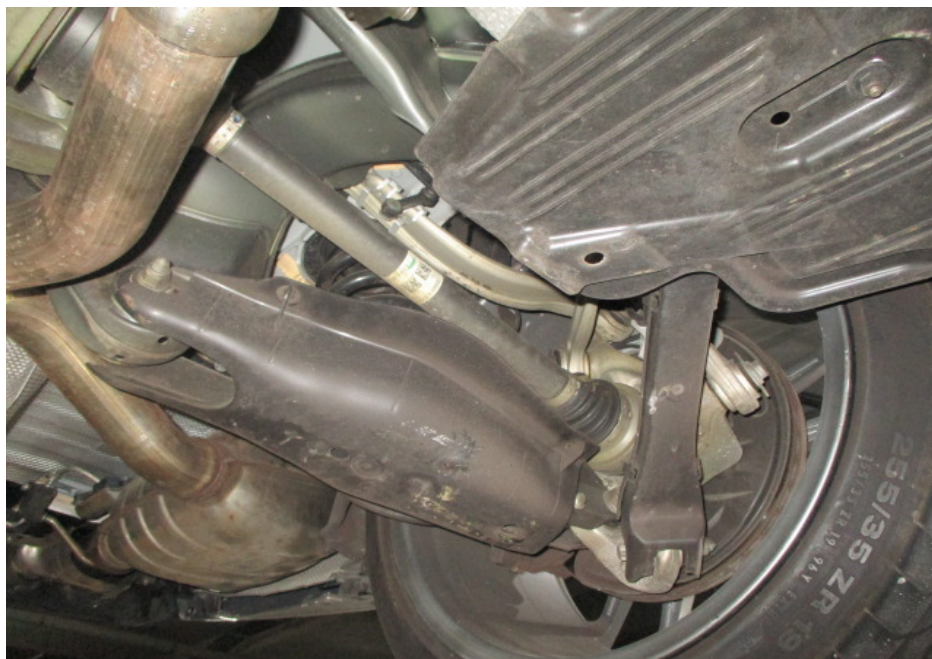
**Photo 17** shows a general view of the control arms and linkages at the rear left wheel of the Motor Car. I did not observe any fluid leak and/or fluid stain on the underside of the Motor Car. All the Motor Car's undercarriage components were observed to be intact and secured in an appropriate manner.

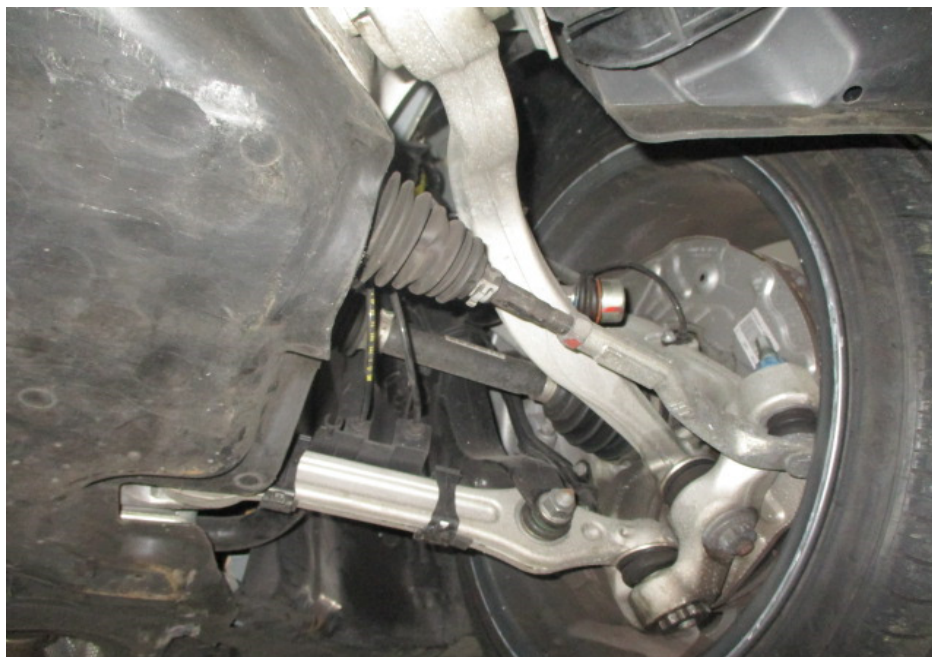
**Photo 18** shows the various undercarriage components at the front left wheel of the Motor Car. The mechanical components, control arms and linkages were all found to be intact and secured in an appropriate manner.

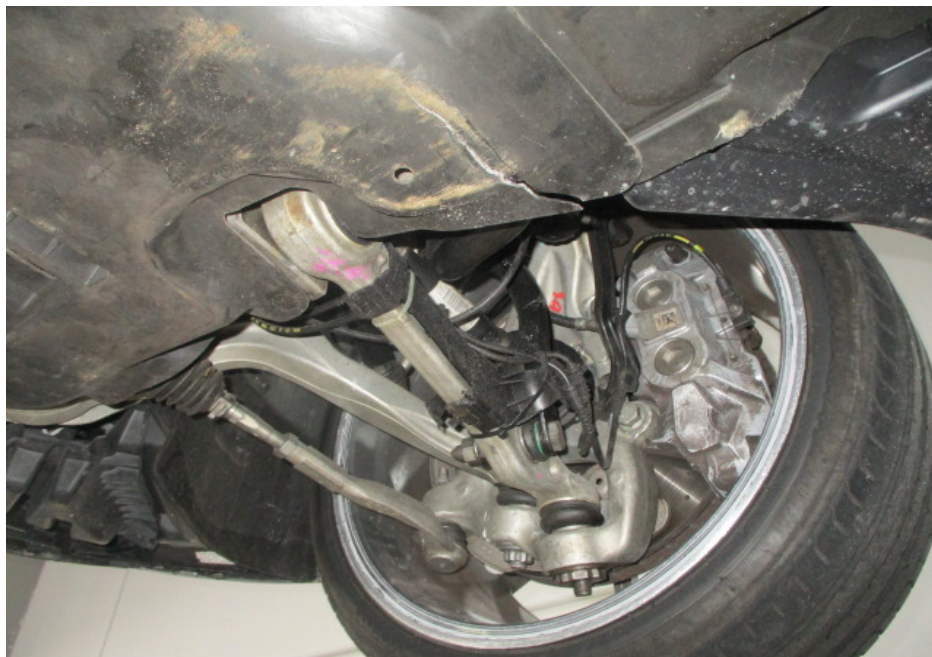
**Photo 19** shows the various undercarriage components at the front right wheel of the Motor Car. The mechanical components, control arms and linkages were all found to be intact and secured in an appropriate manner. I also did not observe any fluid leak and/or fluid stain on the underside of the Motor Car.

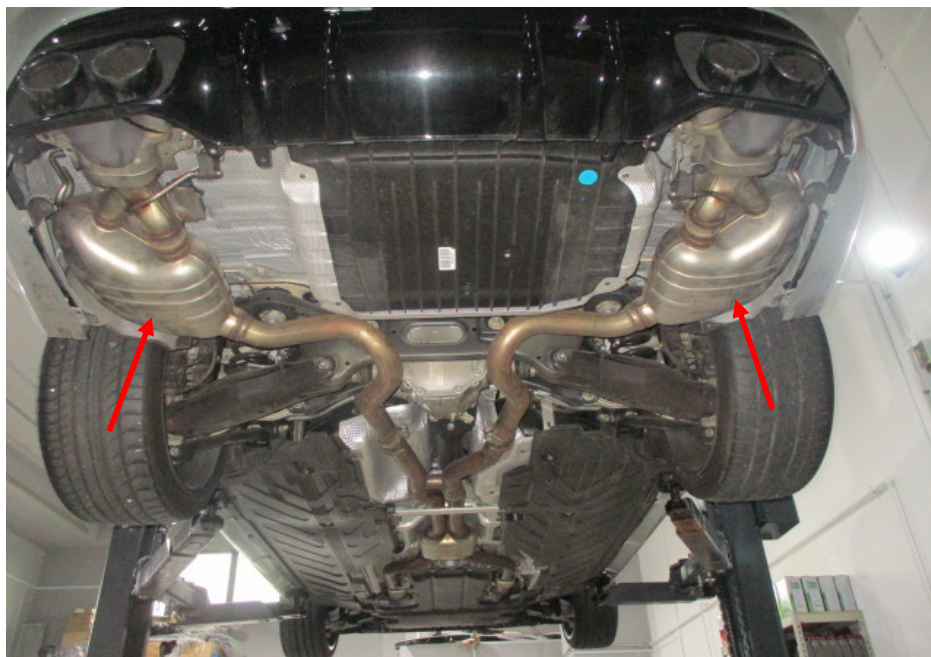
**Photo 20** shows a general view of the Motor Car's exhaust system (arrowed). My examination of the Motor Car's exhaust system revealed no sign(s) or indication(s) of any cut or weld marks along its catalytic converters, exhaust pipes and on its rear mufflers (arrowed).

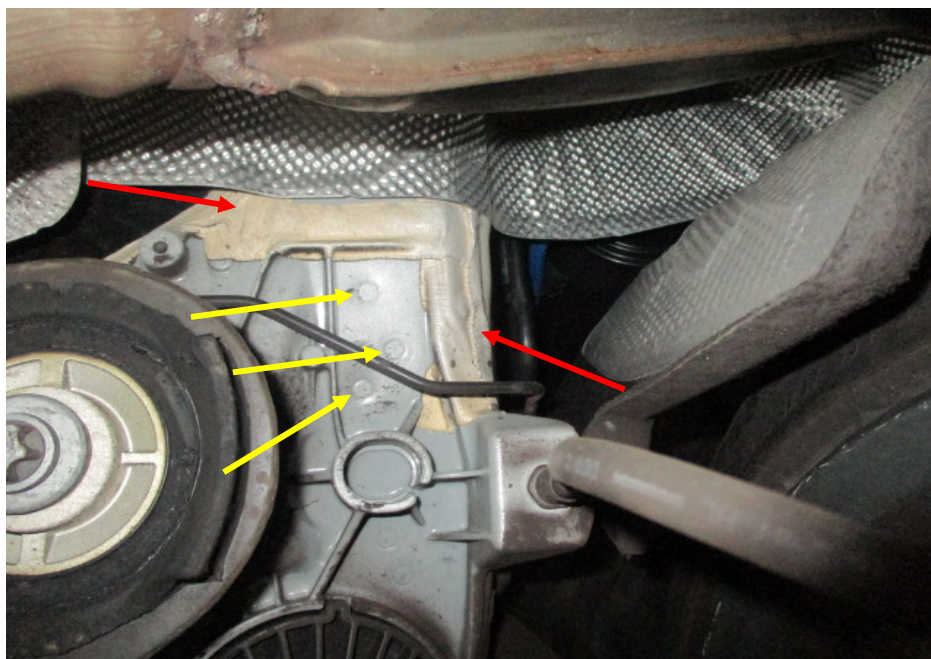
**Photo 21** shows the chassis/structural body at the underside rear right of the Motor Car. I did not find any weld marks other than original spot weld marks (yellow arrow) on the chassis/structural body of the Motor Car. The original factory sealant (red arrow) at the joints along the chassis/structural body was also untouched. In general, I had found no work was carried out on the chassis/structural body of the Motor Car. The chassis/structural body of the Motor Car was originally fitted.

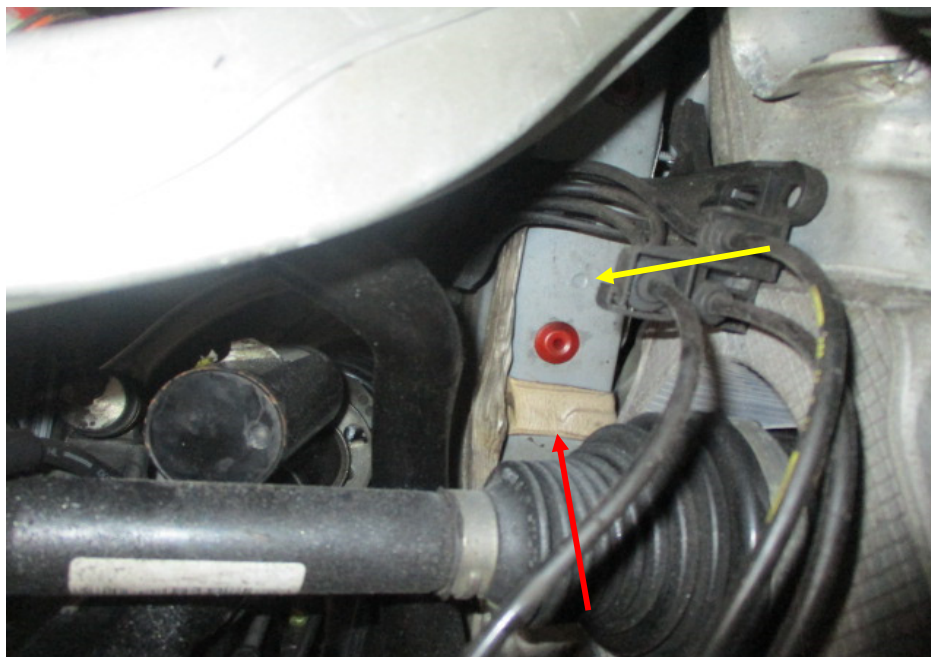
**Photo 22** shows the chassis/structural body at the underside front right of the Motor Car. I did not find any weld marks other than original spot weld marks (yellow arrow) on the chassis/structural body of the Motor Car. The original factory sealant (red arrow) at the joints along the chassis/structural body was untouched, indicating no work was done on the chassis/structural body of the Motor Car and that the chassis/structural body was originally fitted.

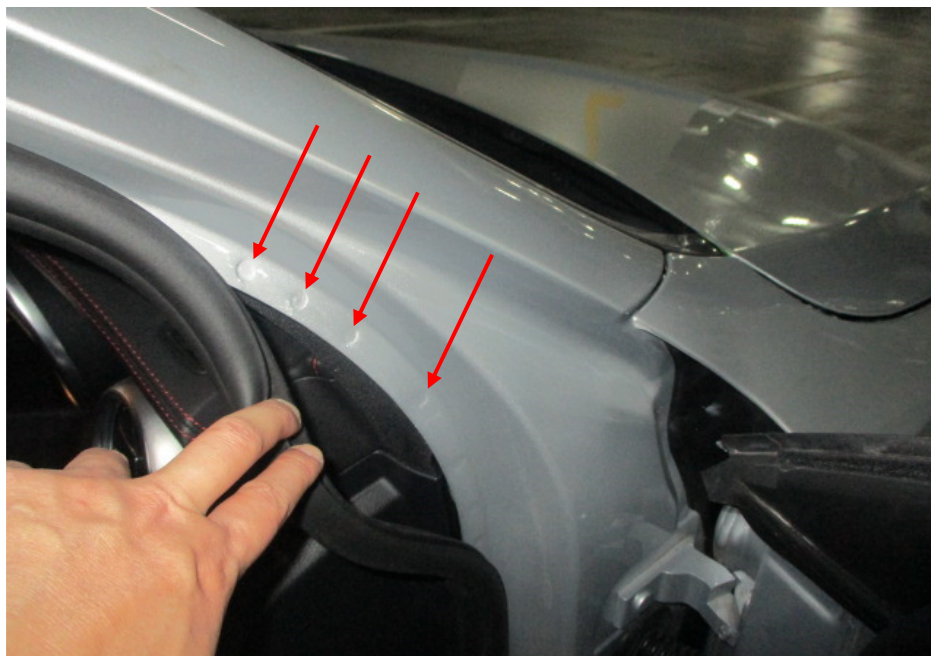
**Photo 23** shows the right side "A" pillar of the Motor Car. I did not find any weld marks other than original spot weld marks (arrowed) on the right side "A" pillar of the Motor Car which, indicates that there was no re-welding works carried out. In general, I had found all the non-detachable body panels of the Motor Car to be originally fitted at the time of my inspection.

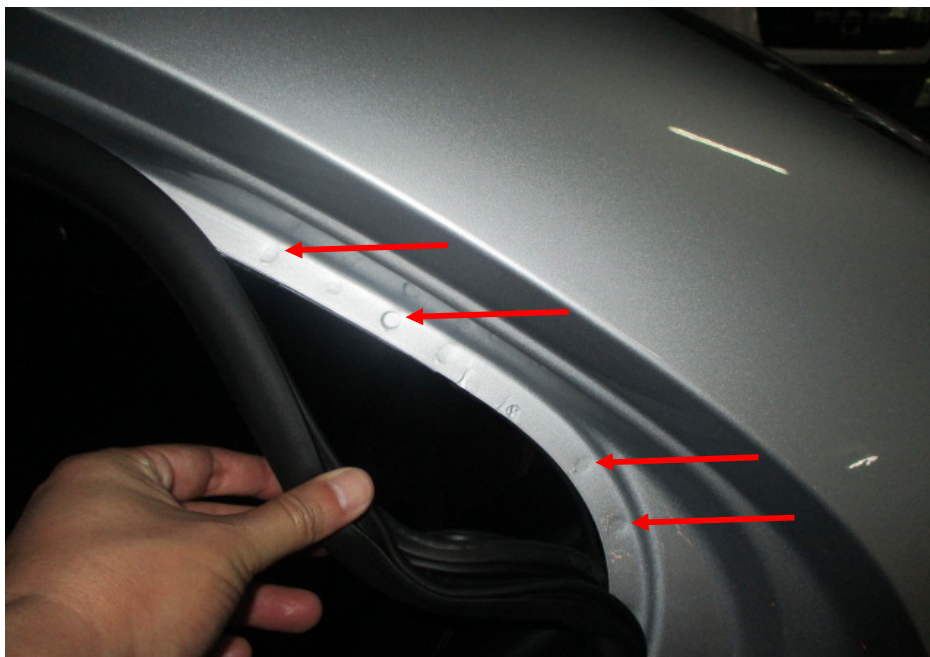
**Photo 24** shows the left side "C" pillar of the Motor Car. I did not find any weld marks other than original spot weld marks (arrowed) on the left side "C" pillar of the Motor Car which, indicates that there was no re-welding works carried out. In general, I had found all the non-detachable body panels of the Motor Car to be originally fitted at the time of my inspection.
