Your Ref: BMW X2  
(chassis number WBAYH32000EH38278)  
Our Ref : CI/TP21004963/D

20 April 2021

**INSPECTION REPORT OF AN UNREGISTERD BMW X2 MOTOR CAR WITH CHASSIS NUMBER WBAYH32000EH38278**

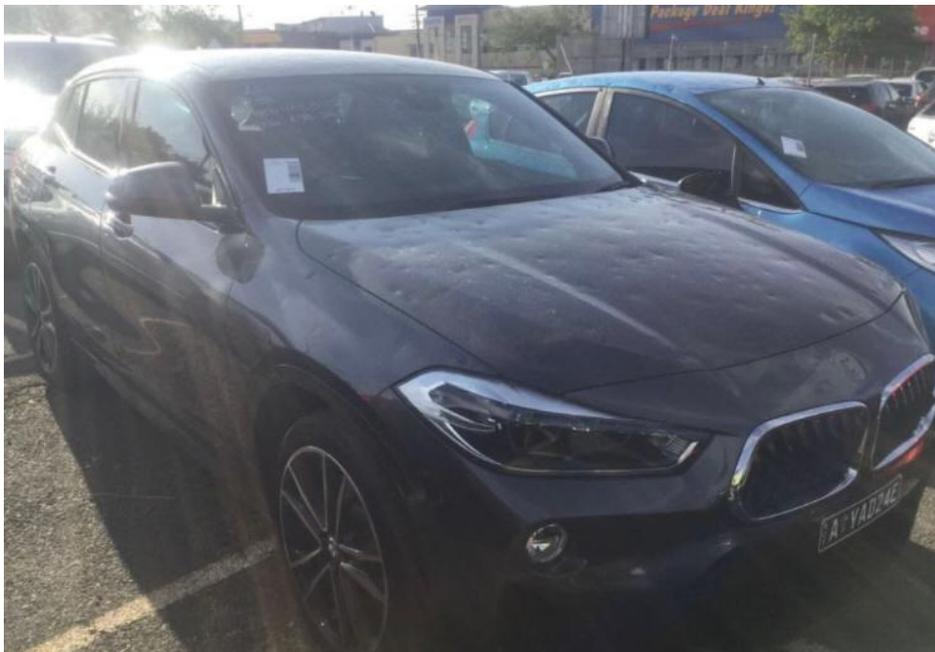
**Photo 2** shows the front right body of the Motor Car prior to any repairs being carried out (photograph provided to me). The Motor Car was observed to have sustained damages of indentation nature to exterior body parts like its front bonnet and front right fender. As seen from the photograph, there were multiple relatively minor indentations on the front bonnet and front right fender.

22. The damaged exterior body parts of the Motor Car were visually examined, and it was noted that the repair/restoration works carried out to the damaged areas of the Motor Car (refer to photograph 1 – 3 above) were reasonably adequate and in order.

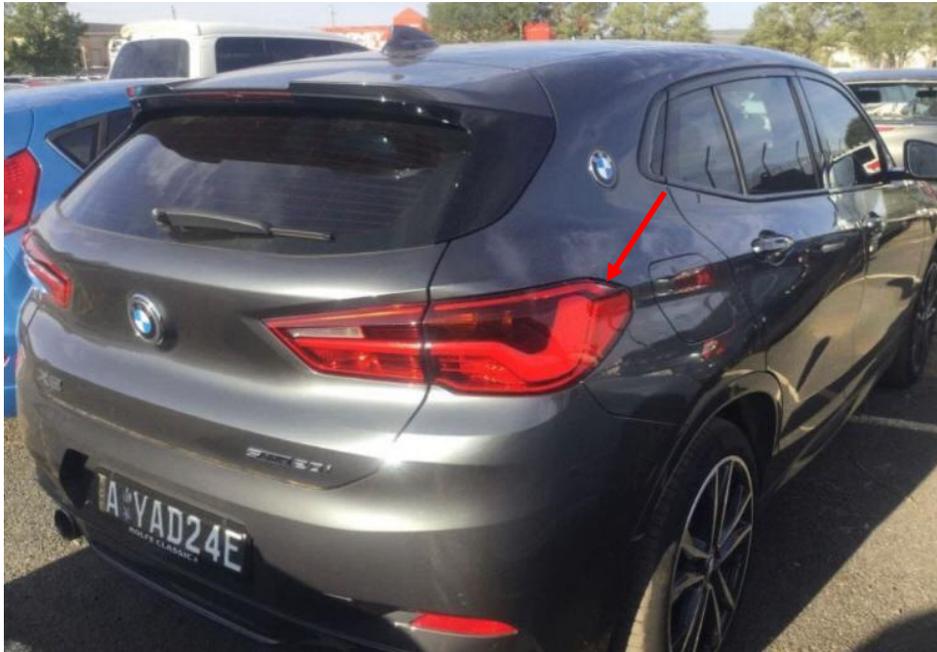
**Photo 3** shows the rear right body of the Motor Car prior to any repairs being carried out (photograph provided to me). The Motor Car was observed to have sustained damages of indentation nature to exterior body parts like its roof panel and rear right fender. The rear right taillamp (arrowed) was also observed to be broken.

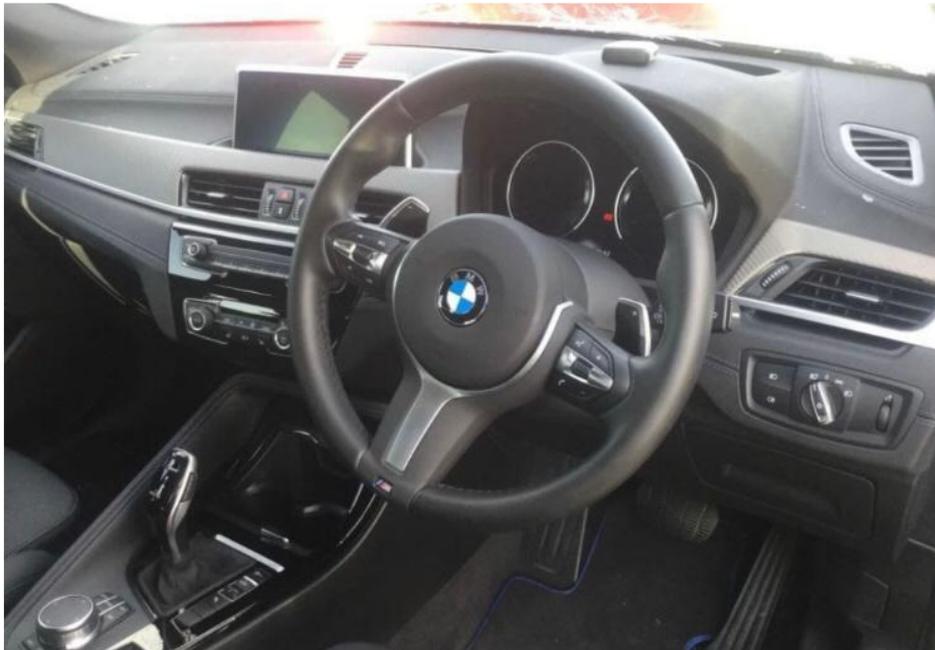
**Photo 4** shows the front dashboard of the Motor Car (photograph provided to me). The interior compartment of the Motor Car was observed to be intact and unaffected. The airbags of the Motor Car were also not deployed.

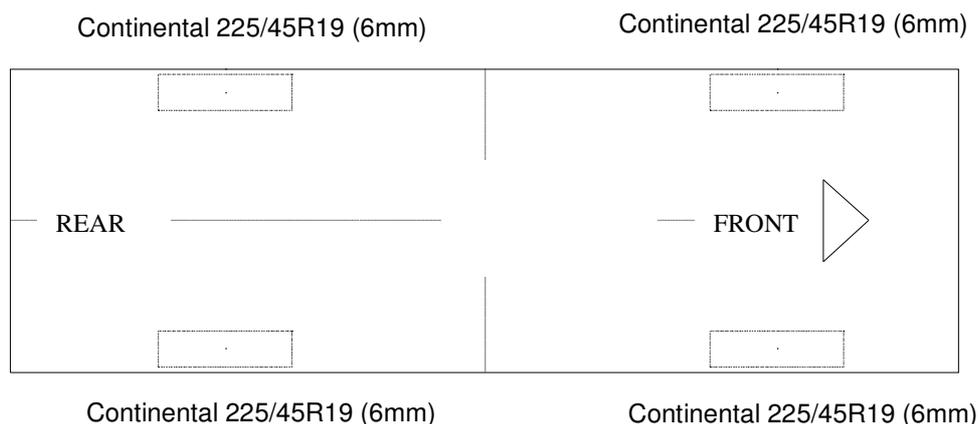
- It was fitted with 19inch sport wheel rims that were wrapped with tyres that were observed to be of serviceable condition. The tyres were also sufficiently inflated for vehicular operation. The tyre brand, tyre size and approximate remaining tread depth of the 4 tyres of the Motor Car were recorded as follows: -

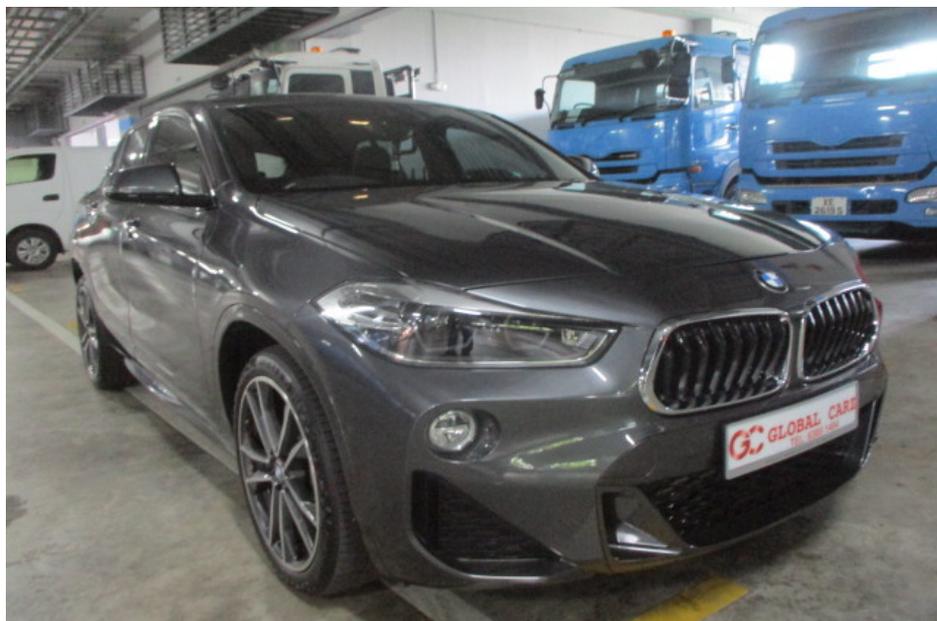
**Photo 5** shows a general view of the front right body of the Motor Car at the time of my inspection. The Motor Car was observed to be in a relatively good general condition with no loose exterior fittings observed. The exterior body parts at the frontal portion of the Motor Car, like the front bumper, front bonnet and front fenders, were visually examined and it was observed that the repair/restoration works carried out to the damaged area of the Motor Car (refer to photograph 1 & 2 above) were reasonably adequate and in order.

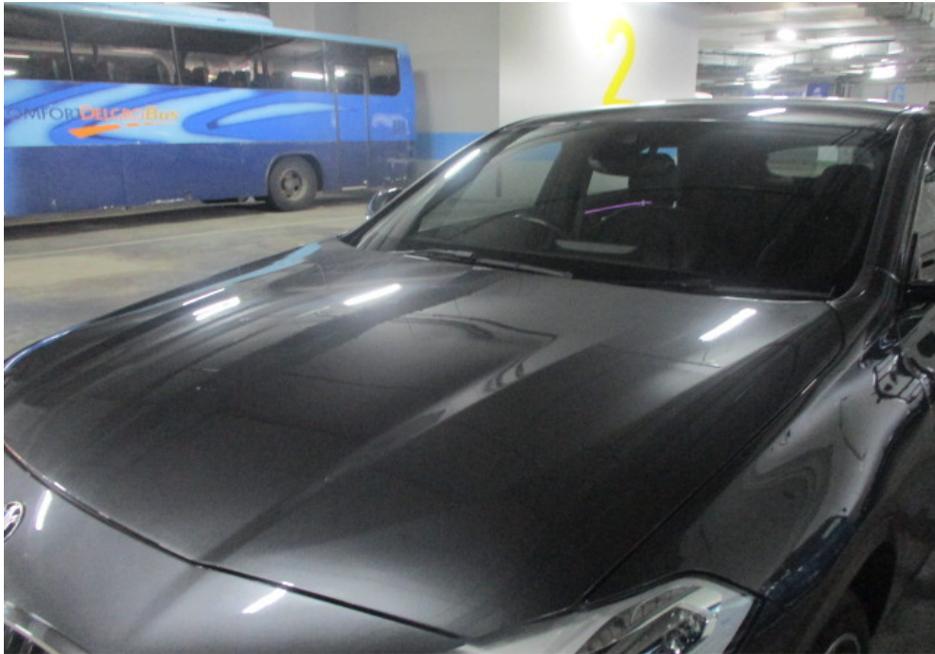
**Photo 6** shows a closer view of the Motor Car's front bonnet at the time of my inspection. In general, I had found that the repair/restoration works carried out to the damaged area of the Motor Car (refer to photograph 1 & 2 above) were reasonably adequate and in order.

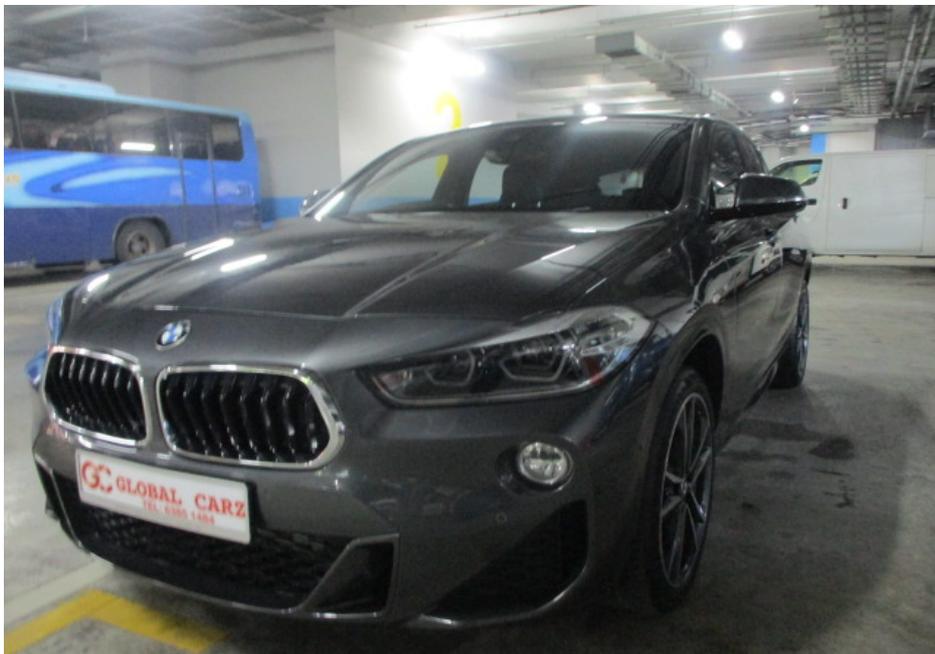
**Photo 7** shows a general view of the front left body of the Motor Car at the time of my inspection. The Motor Car was observed to be in a relatively good general condition with no loose exterior fittings observed. The exterior body parts at the frontal portion of the Motor Car were visually examined, and it was observed that the repair/restoration works carried out to the damaged area of the Motor Car (refer to photograph 1 & 2 above) were reasonably adequate and in order.

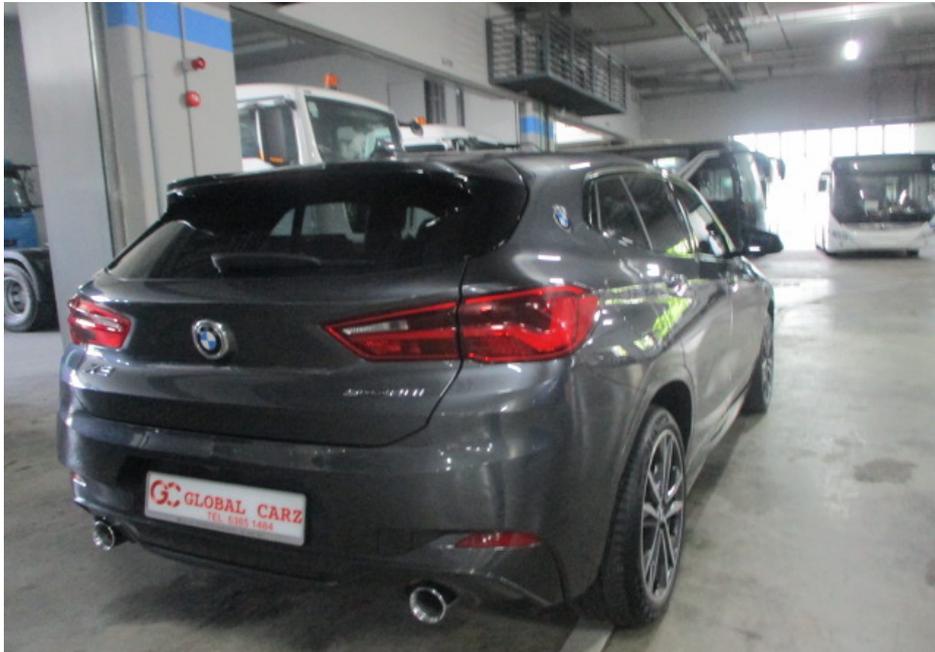
**Photo 8** shows a general view of the rear right body of the Motor Car at the time of my inspection. The Motor Car was observed to be in a relatively good general condition with no loose exterior fittings observed. The exterior body parts at the rear portion of the Motor Car, like the rear bumper, rear tailgate, rear taillamps and rear fenders, were visually examined and it was observed that the repair/restoration works carried out to the damaged area of the Motor Car (refer to photograph 3 above) were reasonably adequate and in order.

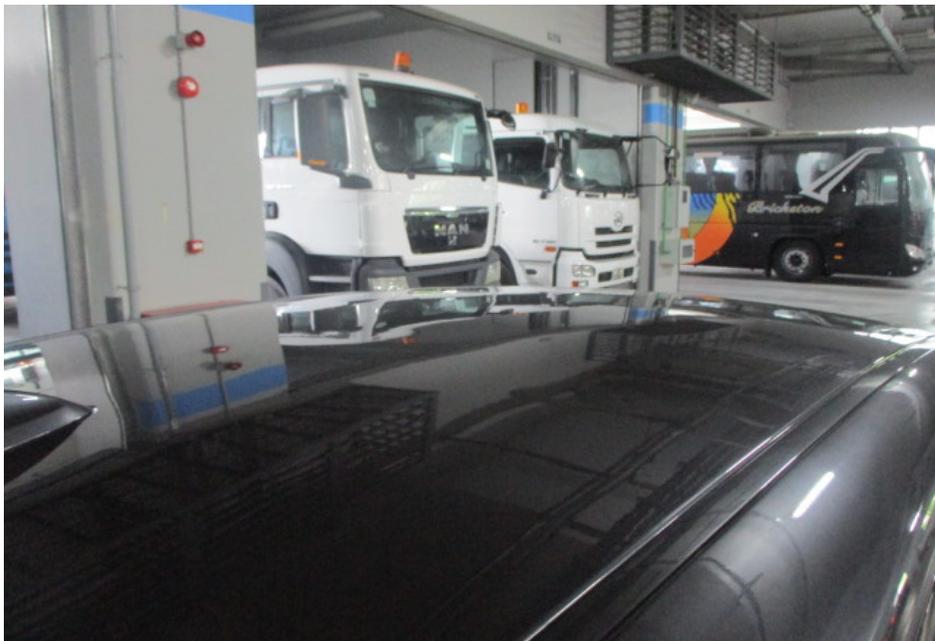
**Photo 9** shows the roof panel of the Motor Car at the time of my inspection. In general, I had found that the repair/restoration works carried out to the damaged area of the Motor Car (refer to photograph 3 above) were reasonably adequate and in order.

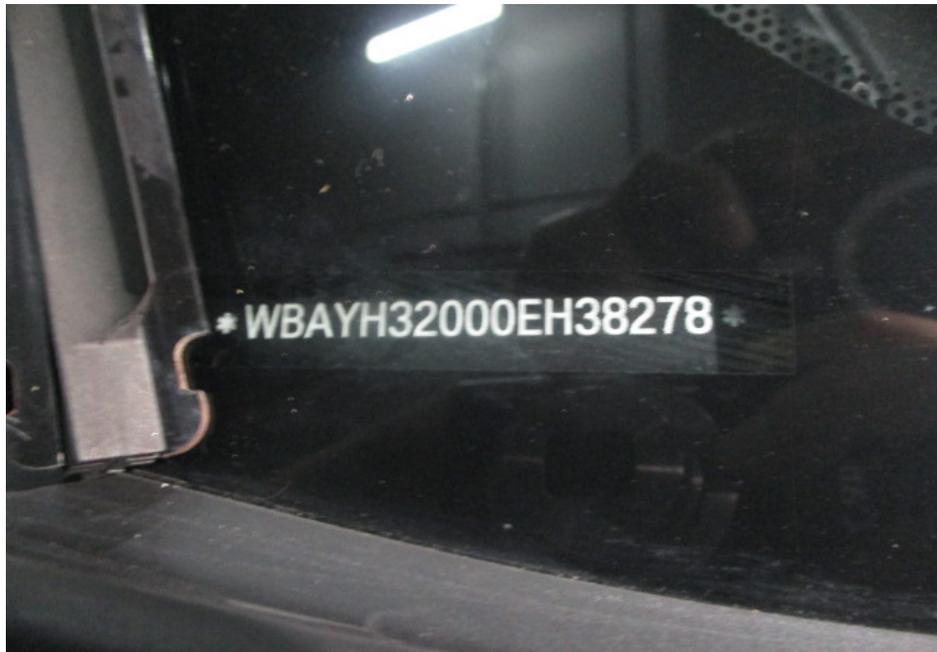
**Photo 10** shows the chassis number of the Motor Car. The chassis number recorded was WBAYH32000EH38278.

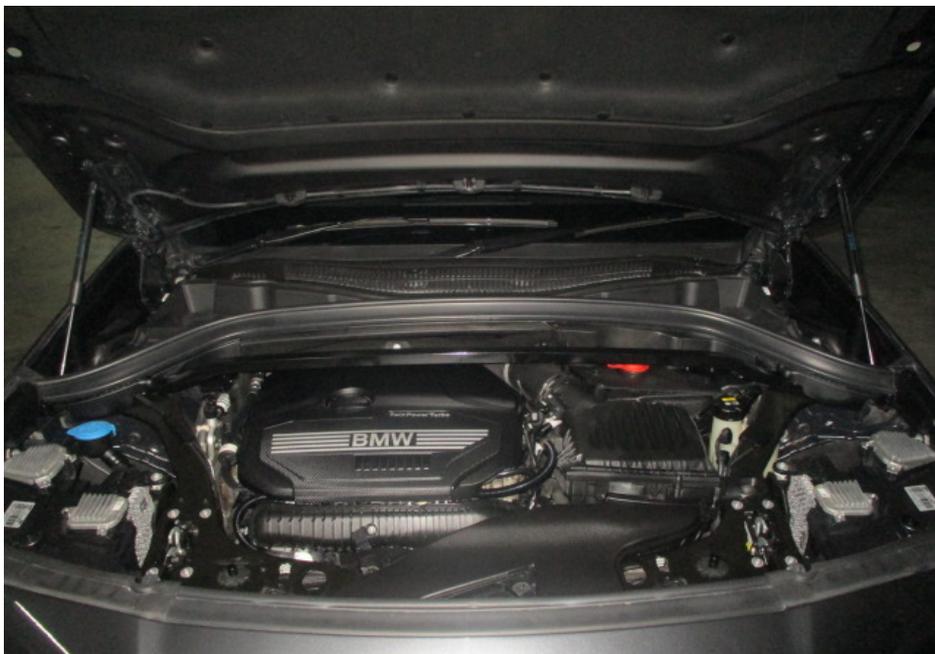
**Photo 11** shows a general view of the engine compartment of the Motor Car at the time of my inspection. The various parts and components inside the engine compartment were all observed to be intact and properly fitted. There was also no sign(s) or indication(s) of fluid leak and/or fluid stain found inside the engine compartment.

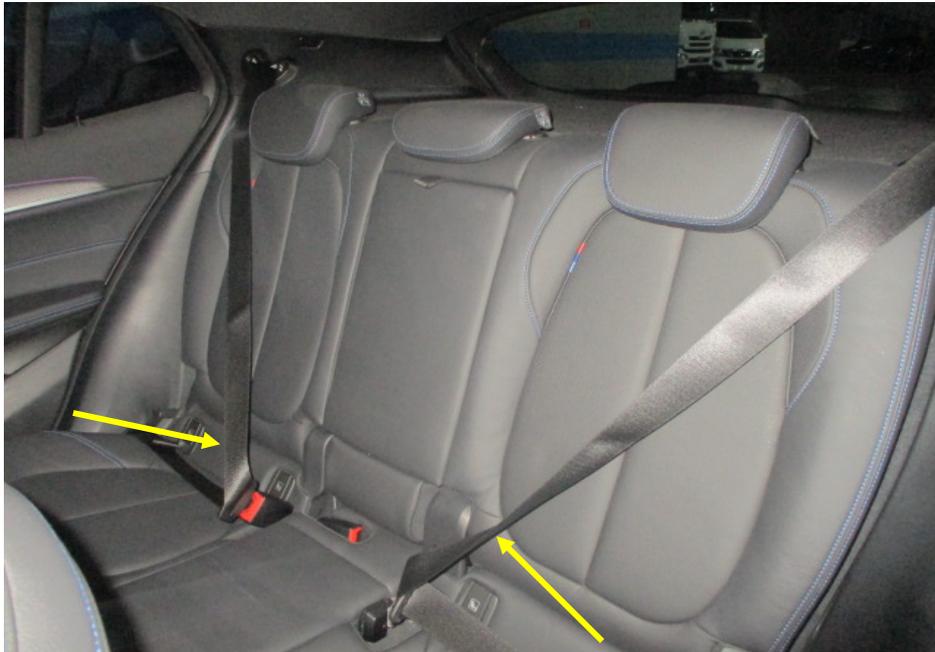
**Photo 12** shows the rear seats of the Motor Car. All the seats of the Motor Car were secured via seat rails to the floorboard. They were also fitted with a retractable seat belt reel and a pre-tensioner. The seat belts (arrowed) were tested and were able to be fastened into the respective pre-tensions that were fitted on the side of each individual seat.

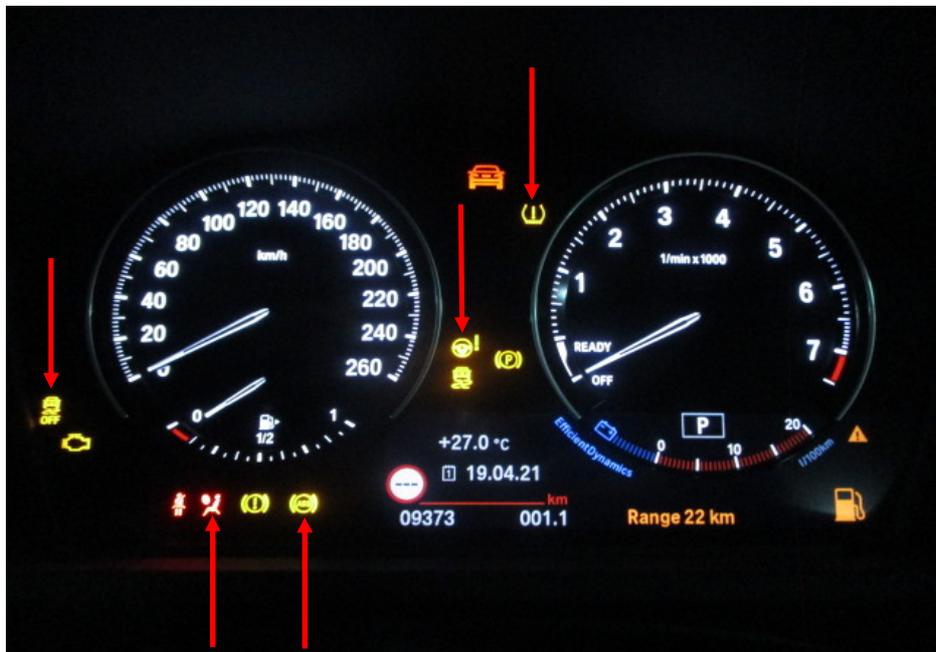
**Photo 13** shows the warning lights for the various electronic safety features appearing on the instrument panel of the Motor Car during its self-test when the engine is cranked, in particular the ABS, SRS, IAS, TPM and DSC lights (arrowed).

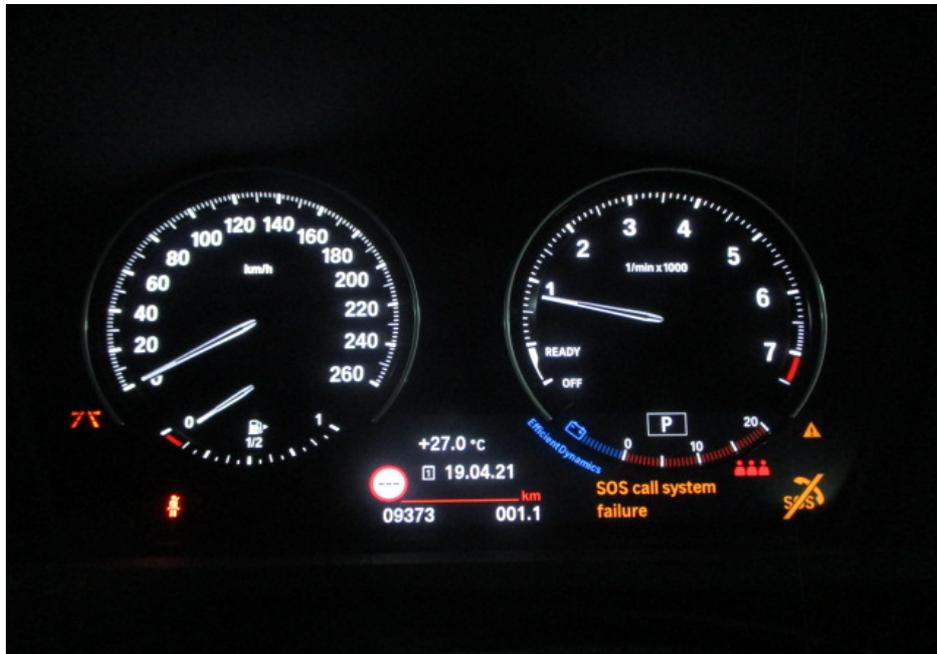
**Photo 14** shows the respective warning lights no longer illuminated, indicating that there is no fault detected to the ABS, SRS, IAS, TPM and DSC systems of the Motor Car during the self-test. These electronic systems were hence in working condition at the time of my inspection.

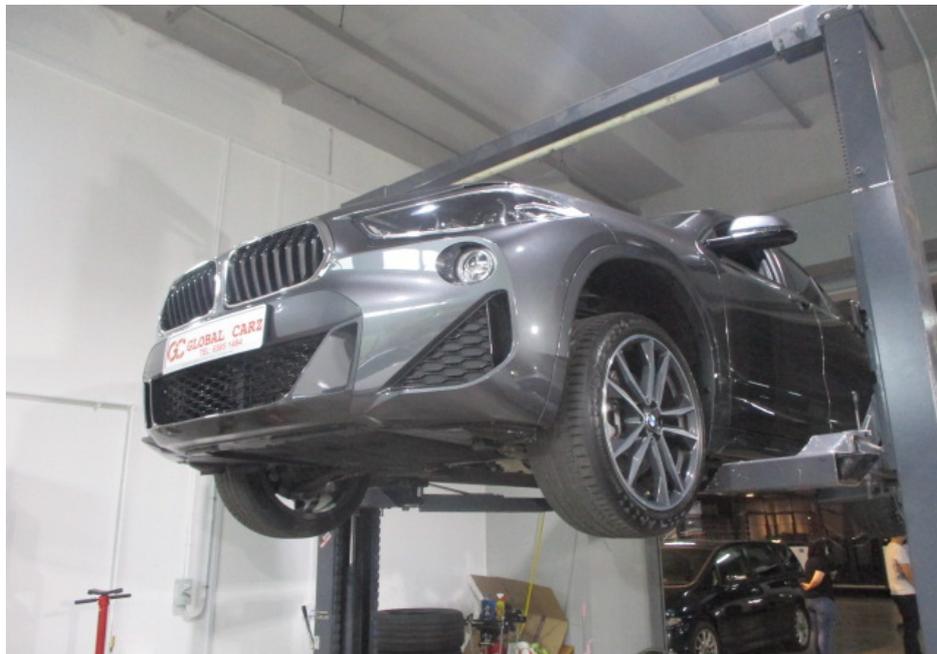
**Photo 15** shows the Motor Car hoisted up for checks on its undercarriage. There was no sign(s) or indication(s) of fluid leakage and/or fluid stain(s) on the underside of the Motor Car. The undercarriage components of the Motor Car were also all observed to be intact and secured in an appropriate manner.

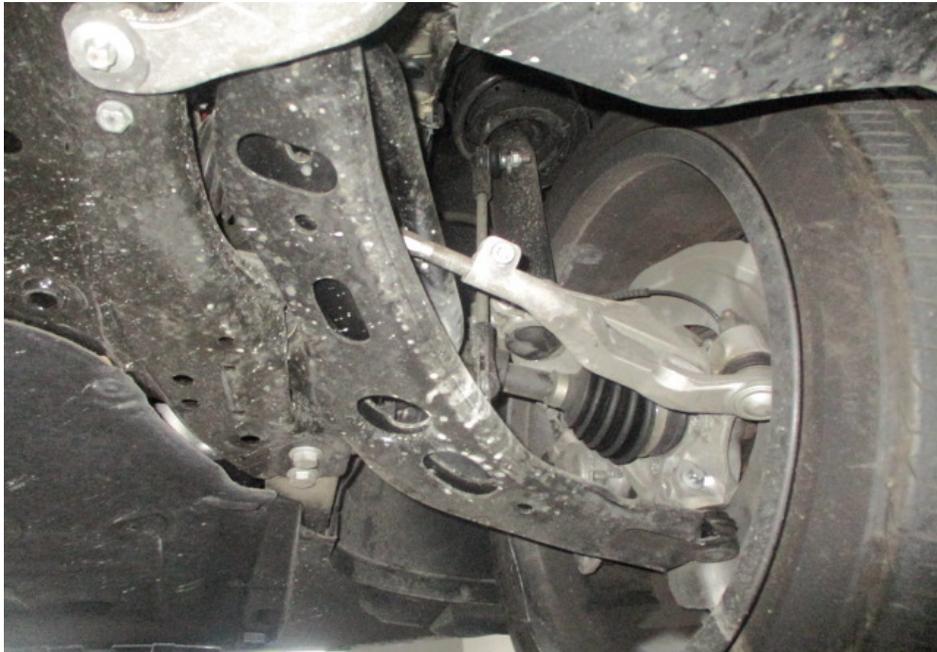
**Photo 16** shows the various undercarriage components at the front right wheel of the Motor Car. The mechanical components, control arms and linkages were all found to be intact and secured in an appropriate manner. I also did not observe any fluid leak and/or fluid stain on the underside of the Motor Car.

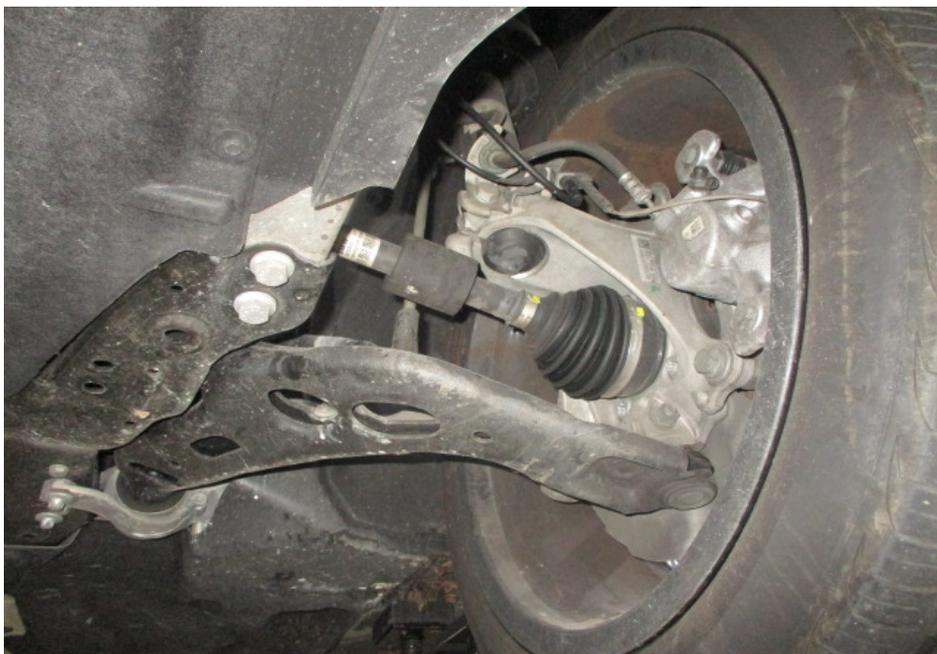
**Photo 17** shows the various undercarriage components at the front left wheel of the Motor Car. The mechanical components, control arms and linkages were all found to be intact and secured in an appropriate manner.

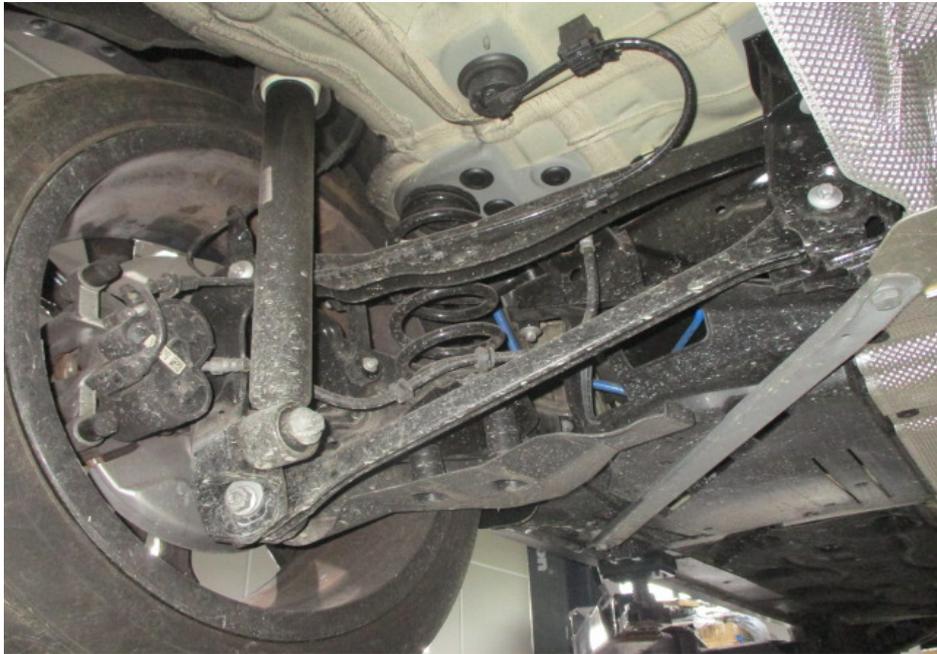
**Photo 18** shows a general view of the control arms and linkages at the rear left wheel of the Motor Car. I did not observe any fluid leak and/or fluid stain on the underside of the Motor Car. All of the Motor Car's undercarriage components were observed to be intact and secured in an appropriate manner.

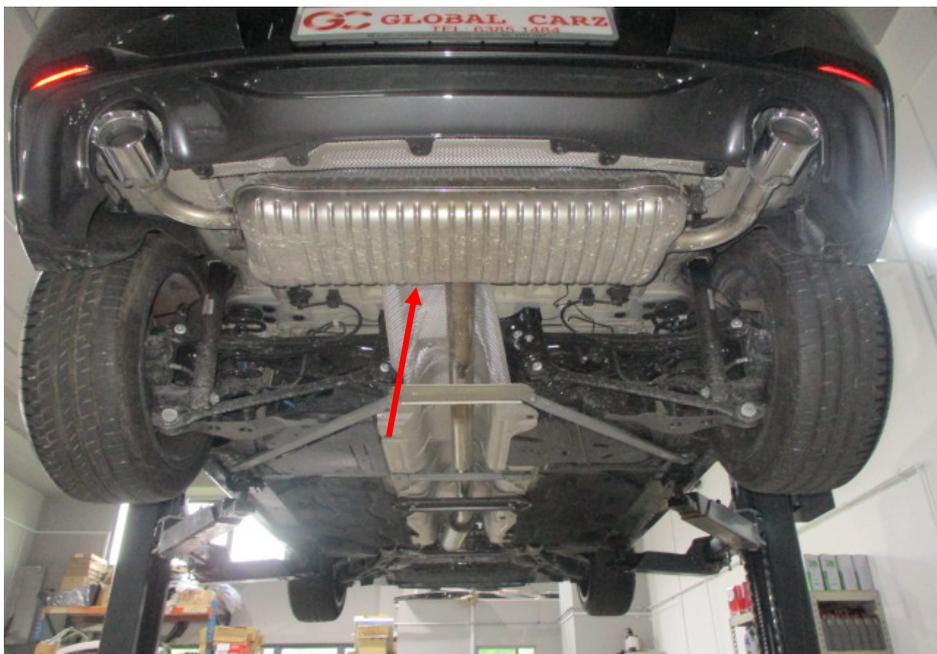
**Photo 19** shows the Motor Car's rear muffler (arrowed). My examination of the Motor Car's exhaust system revealed no sign(s) or indication(s) of any cut or weld marks along its exhaust pipes and on its catalytic converter.

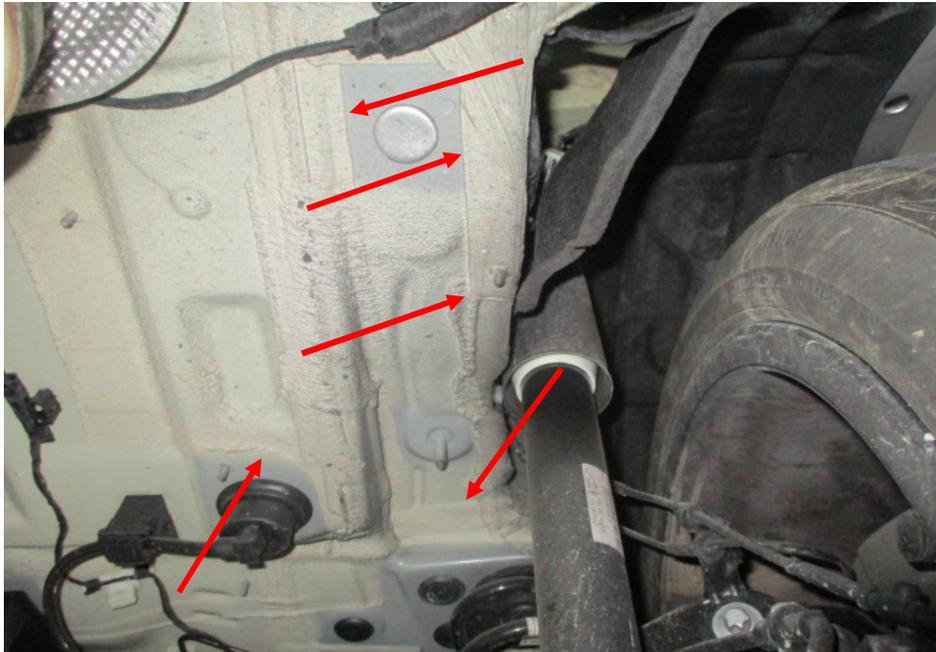
**Photo 20** shows the chassis/structural body at the underside rear right of the Motor Car. I did not find any weld marks other than original spot weld marks on the chassis/structural body of the Motor Car. The original factory sealant (arrowed) at the joints along the chassis/structural body was also untouched, indicating no work was done on the chassis/structural body of the Motor Car and that the chassis/structural body was originally fitted.

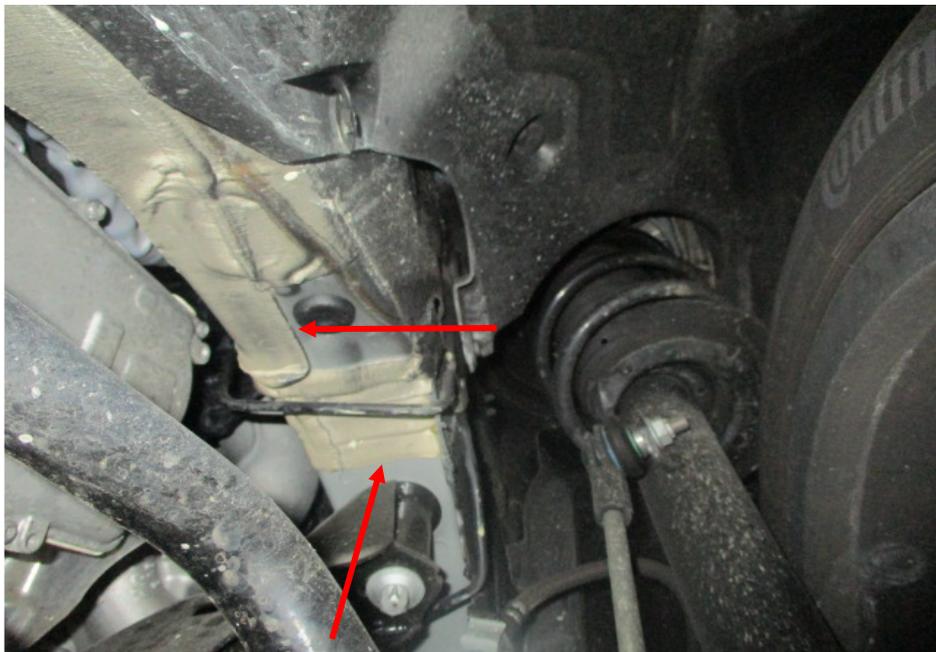
**Photo 21** shows the chassis/structural body at the underside front right of the Motor Car. The original factory sealant (arrowed) at the joints along the chassis/structural body was observed to be untouched. In general, I had found no work was carried out on the chassis/structural body of the Motor Car. The chassis/structural body of the Motor Ca was originally fitted.

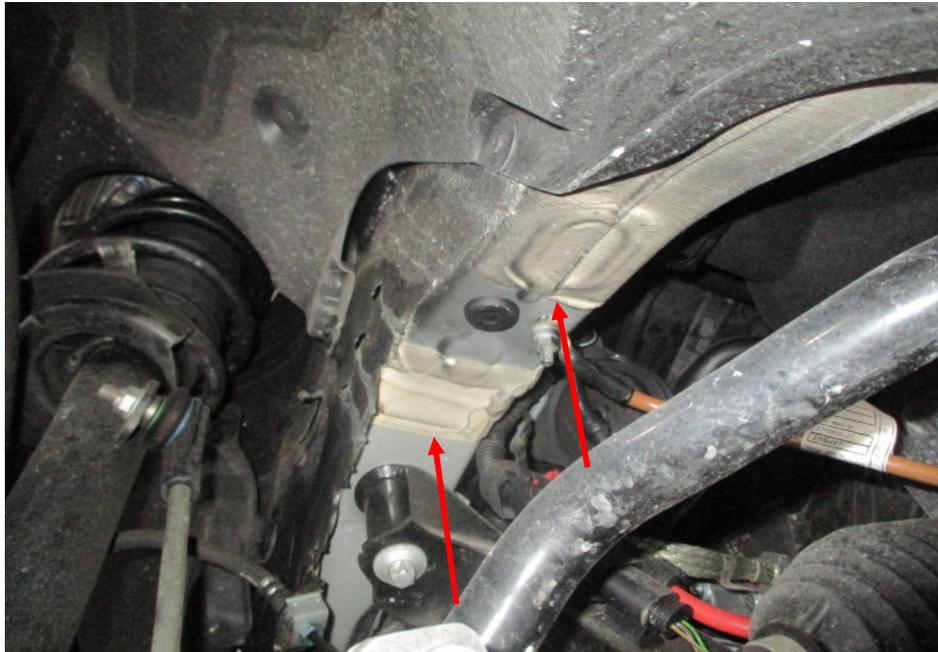
**Photo 22** shows the chassis/structural body at the underside front left of the Motor Car. I did not find any weld marks other than original spot weld marks on the chassis/structural body of the Motor Car. The original factory sealant (arrowed) at the joints along the chassis/structural body was also untouched, indicating no work was done on the chassis/structural body of the Motor Car and that the chassis/structural body was originally fitted.

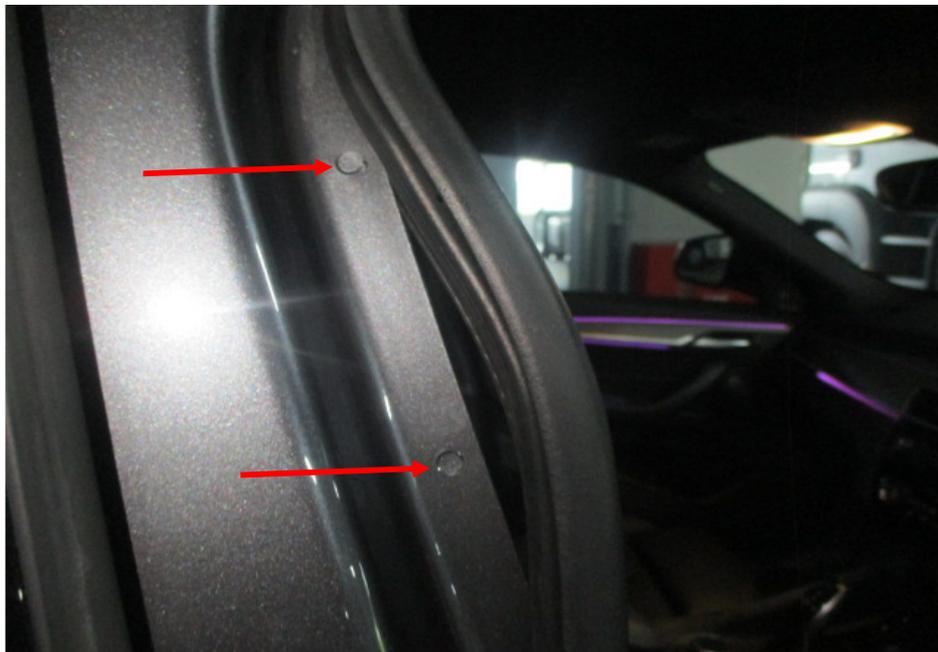
**Photo 23** shows the right side "B" pillar of the Motor Car. I did not find any weld marks other than original spot weld marks (arrowed) on the right side "B" pillar of the Motor Car which, indicates that there was no re-welding works carried out. In general, I had found all the non-detachable body panels of the Motor Car to be originally fitted at the time of my inspection.

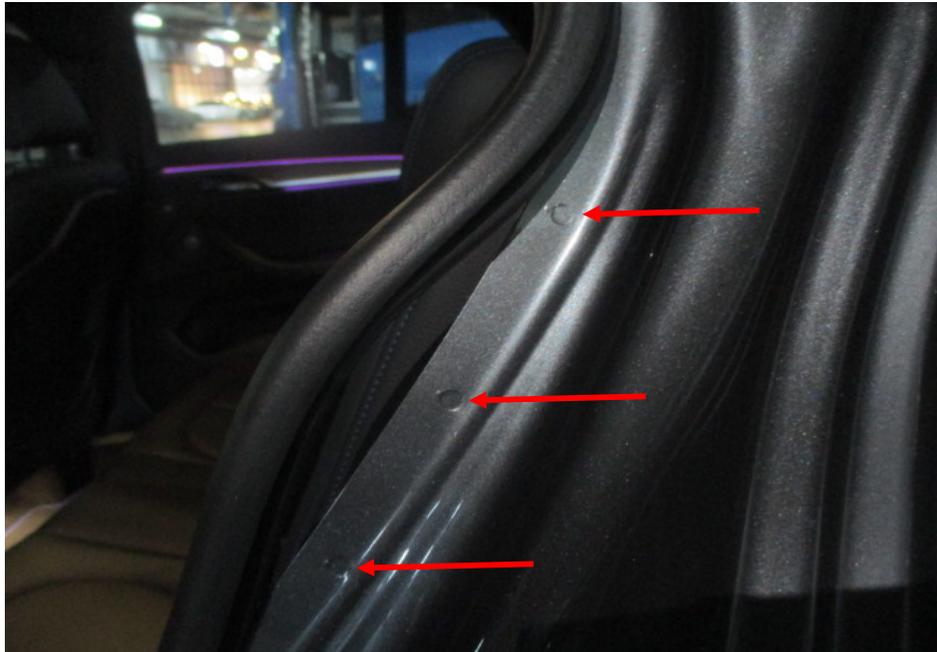
**Photo 24** shows the left side "C" pillar of the Motor Car. I did not find any weld marks other than original spot weld marks (arrowed) on the left side "C" pillar of the Motor Car which, indicates that there was no re-welding works carried out. In general, I had found all the non-detachable body panels of the Motor Car to be originally fitted at the time of my inspection.
