Your Ref: Mercedes Benz A200  
(chassis number WDD1771872W018967)  
Our Ref : CI/TP21004964/D

20 April 2021

**INSPECTION REPORT OF AN UNREGISTERD MERCEDES BENZ A200  
MOTOR CAR WITH CHASSIS NUMBER WDD1771872W018967**

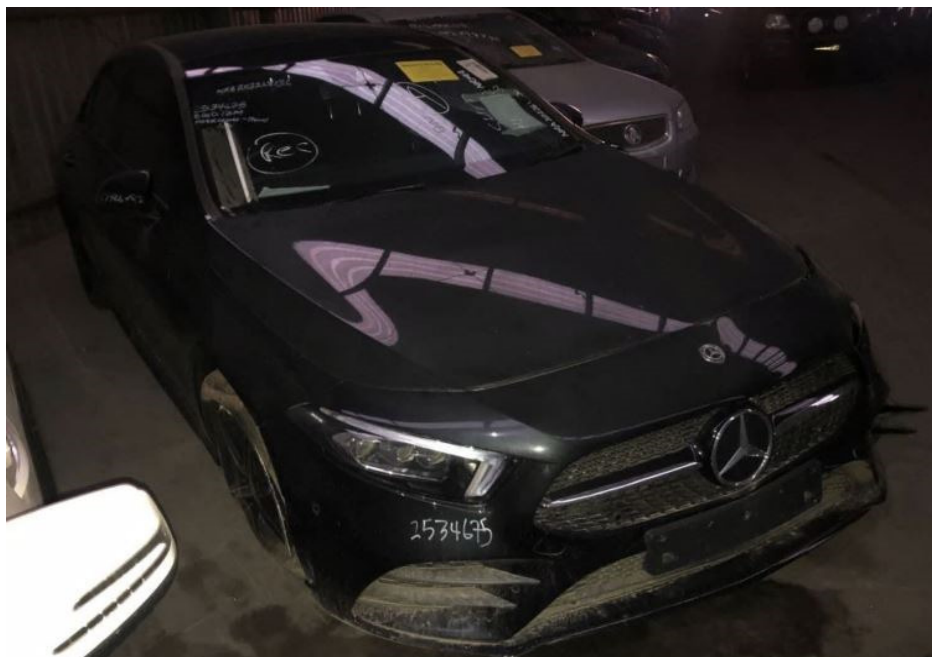
**Photo 1** shows the front right body of the Motor Car (photograph provided to me). The front right wheel and front right tyre were observed to be damaged. The nature of this damage suggests that the front right undercarriage parts of the Motor Car were also affected.

22. The damaged body parts at the front left portion and front right portion of the Motor Car were visually examined, and it was noted that the repair/restoration works carried out to the damaged areas of the Motor Car (refer to photograph 1 & 2 above) were reasonably adequate and in order.

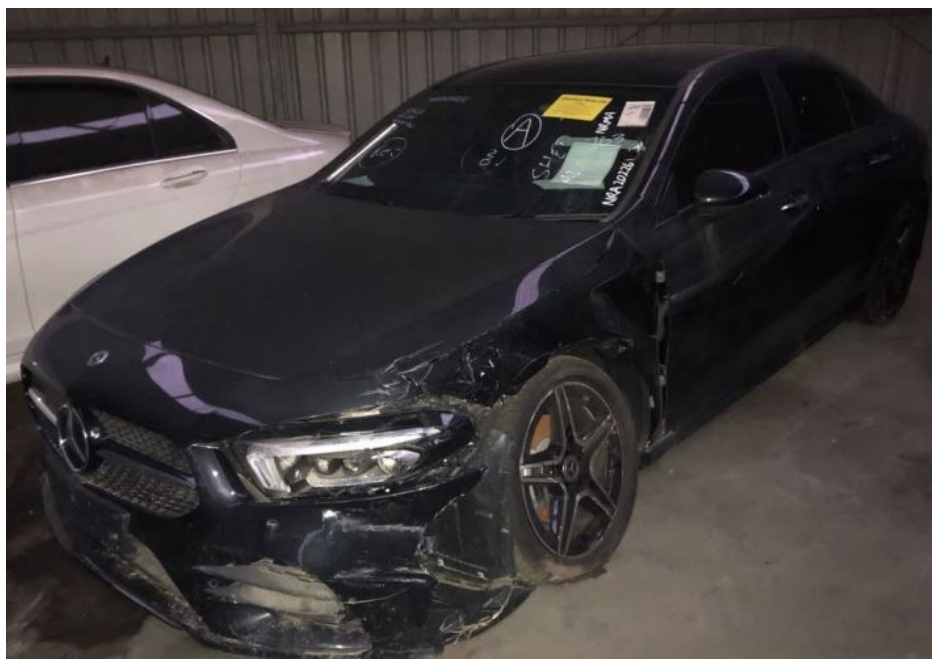
**Photo 2** shows the front left body of the Motor Car (photograph provided to me). Apart from the front right portion, the Motor Car had also sustained damage to the front left portion. The front bumper, front bumper left lower grille, front left headlamp, front bonnet, front left fender, front left door, front left wheel rim and front left tyre were amongst the parts that were observed to have been damaged. The nature of damage to the front left wheel suggests that the front left undercarriage parts of the Motor Car were also affected.

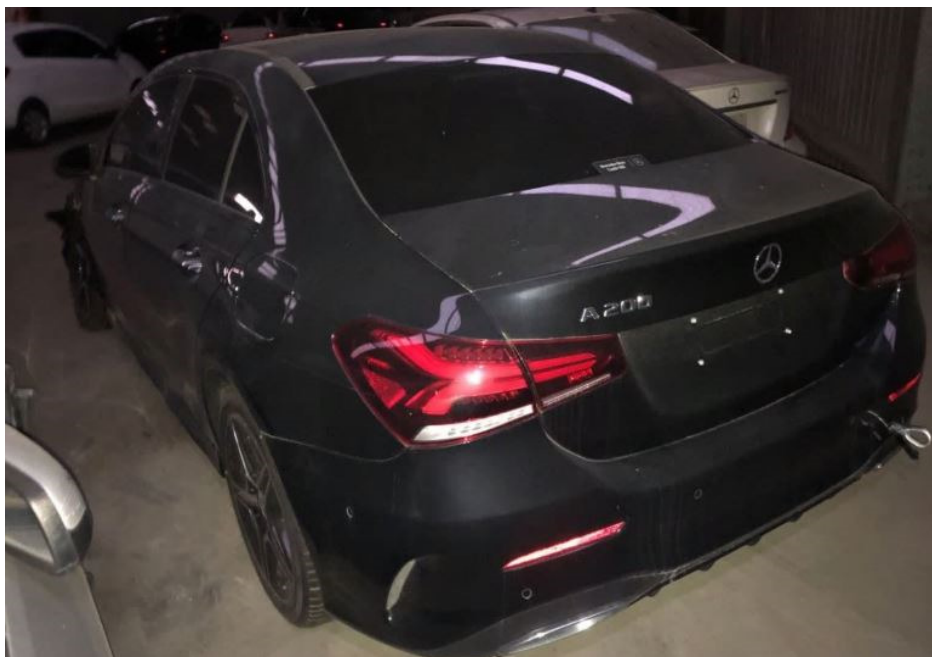
**Photo 3** shows the rear left body of the Motor Car (photograph provided to me). There appears to be no visible damage to the rear body of the Motor Car, as seen from the photographs that were provided to me.

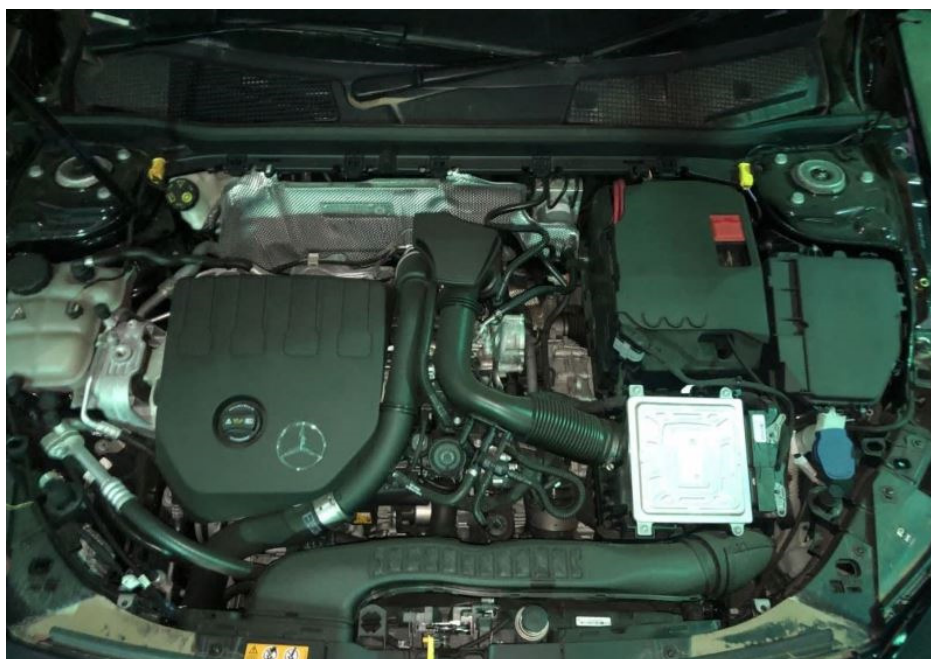
**Photo 4** shows the engine compartment of the Motor Car (photograph provided to me). Parts within the engine compartment were intact and unaffected.

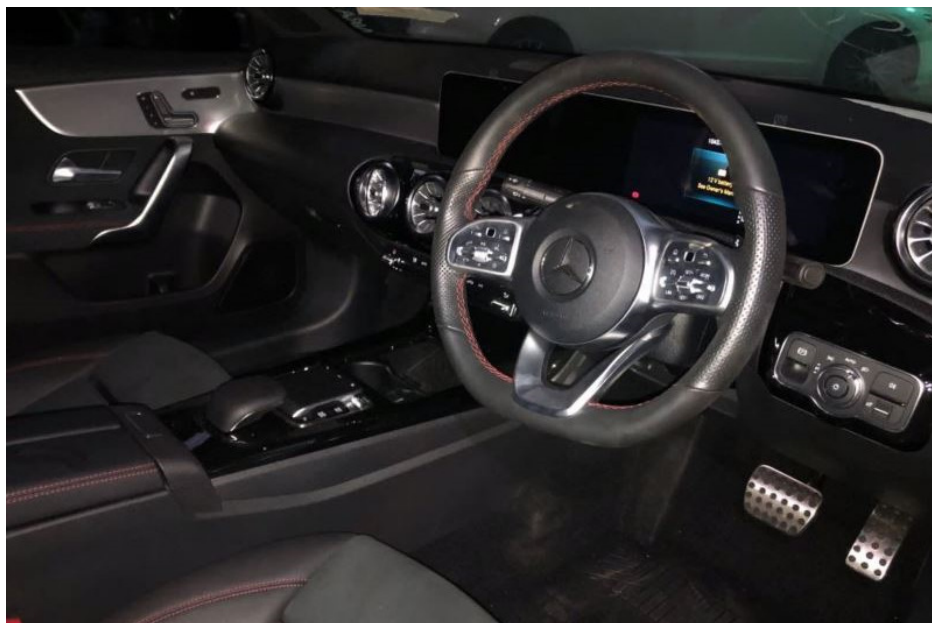
**Photo 5** shows the front dashboard of the Motor Car (photograph provided to me). The interior compartment of the Motor Car was observed to be intact and unaffected. The airbags of the Motor Car were also not deployed.

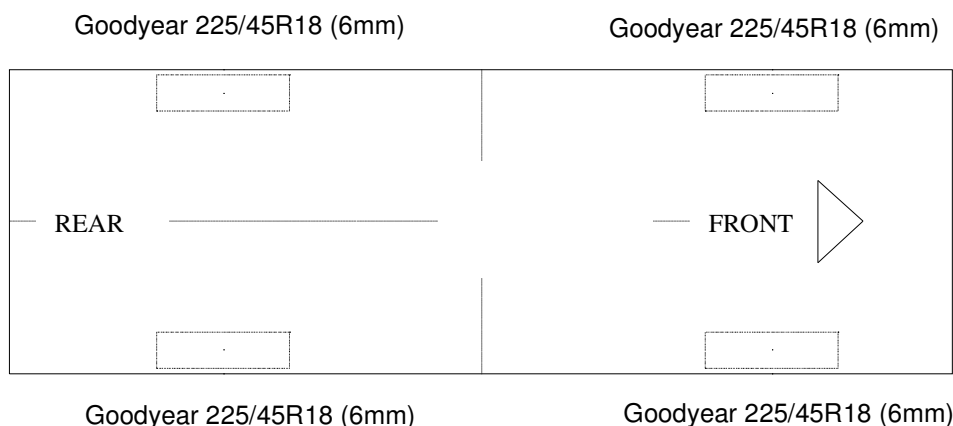
8. It was fitted with 18inch sport wheel rims that were wrapped with tyres that were observed to be of serviceable condition. The tyres were also sufficiently inflated for vehicular operation. The tyre brand, tyre size and approximate remaining tread depth of the 4 tyres of the Motor Car were recorded as follows: -

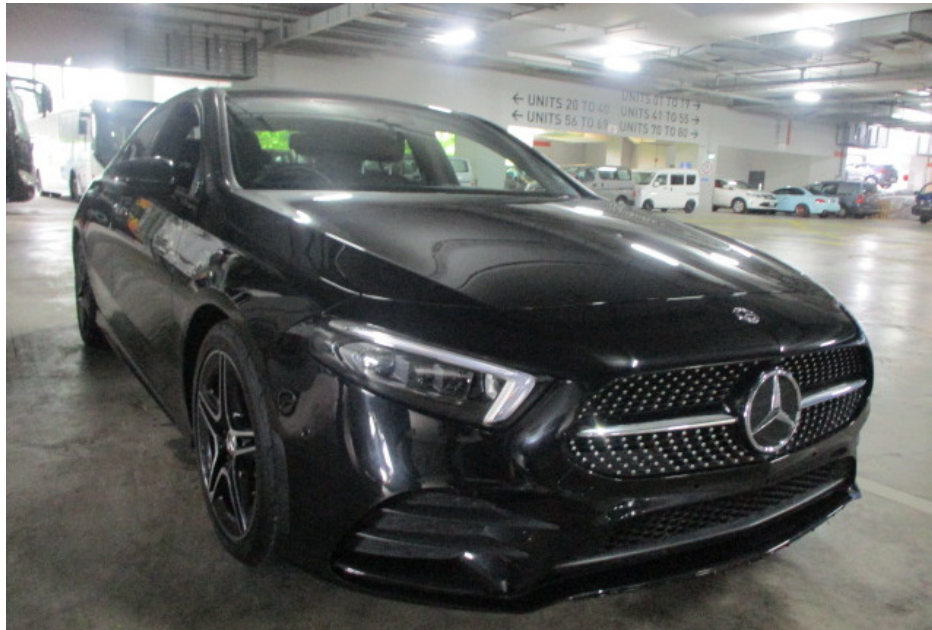
**Photo 6** shows a general view of the front right body of the Motor Car at the time of my inspection. The Motor Car was observed to be in a relatively good general condition with no loose exterior fittings observed. The body parts at the front right portion of the Motor Car were visually examined and it was observed that the repair/restoration works carried out to the damaged area of the Motor Car (refer to photograph 1 above) were reasonably adequate and in order.

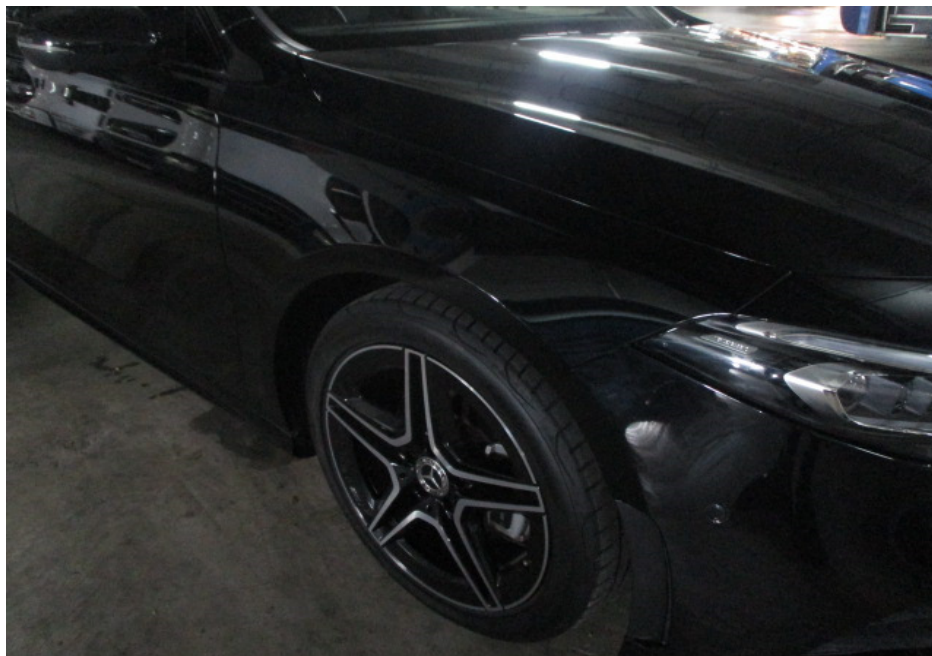
**Photo 7** shows a closer view of the front right wheel rim and front right tyre of the Motor Car. The body parts at the front right portion of the Motor Car were visually examined and it was observed that the repair/restoration works carried out to the damaged area of the Motor Car (refer to photograph 1 above) were reasonably adequate and in order.

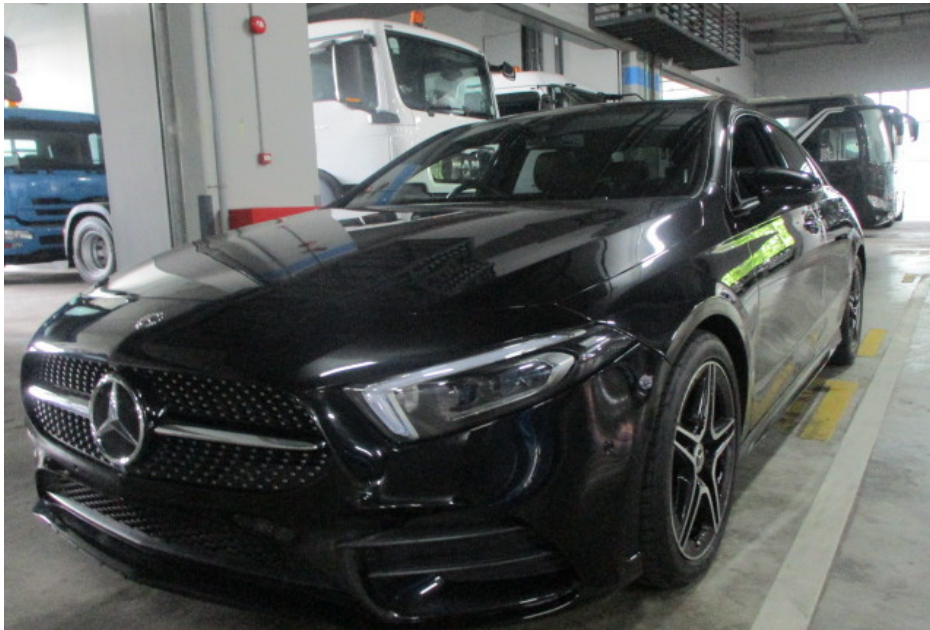
**Photo 8** shows a general view of the front left body of the Motor Car at the time of my inspection. The Motor Car was observed to be in a relatively good general condition with no loose exterior fittings observed. The body parts at the front left portion of the Motor Car were visually examined and it was observed that the repair/restoration works carried out to the damaged area of the Motor Car (refer to photograph 2 above) were reasonably adequate and in order.

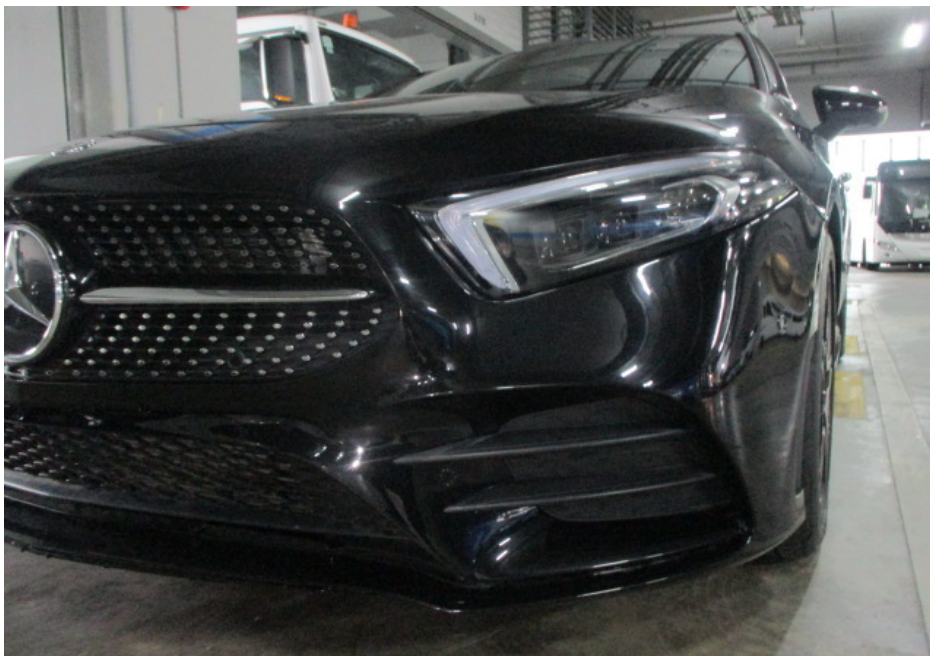
**Photo 9** shows a closer view of the front bumper, front bumper left lower grille and front left headlamp of the Motor Car. The body parts at the front left portion of the Motor Car were visually examined and it was observed that the repair/restoration works carried out to the damaged area of the Motor Car (refer to photograph 2 above) were reasonably adequate and in order.

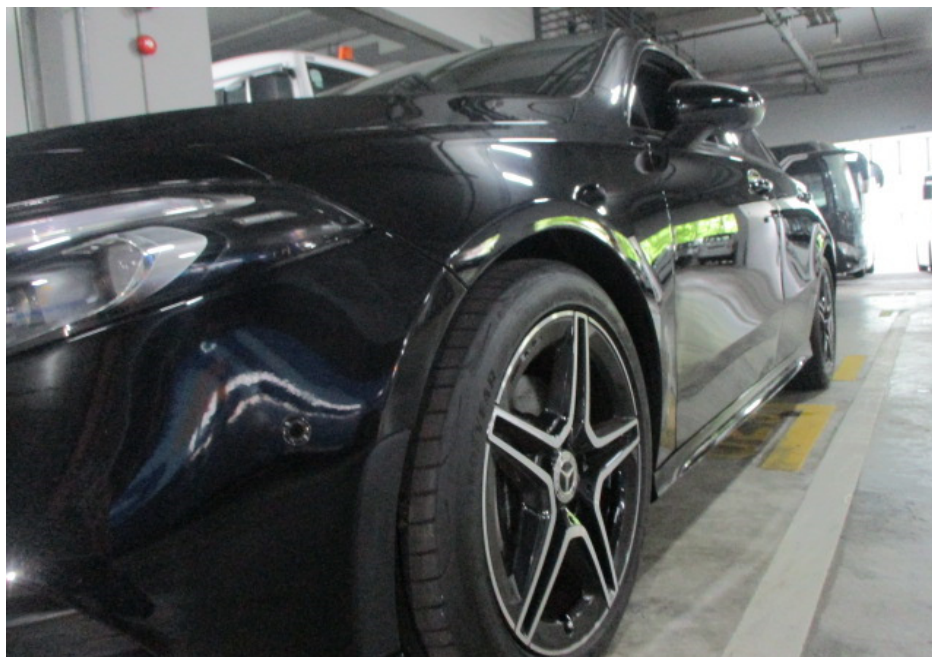
**Photo 10** shows a closer view of the front bumper, front left headlamp, front left fender, front bonnet, front left wheel rim and front left tyre of the Motor Car. The body parts at the front left portion of the Motor Car were visually examined and it was observed that the repair/restoration works carried out to the damaged area of the Motor Car (refer to photograph 2 above) were reasonably adequate and in order.

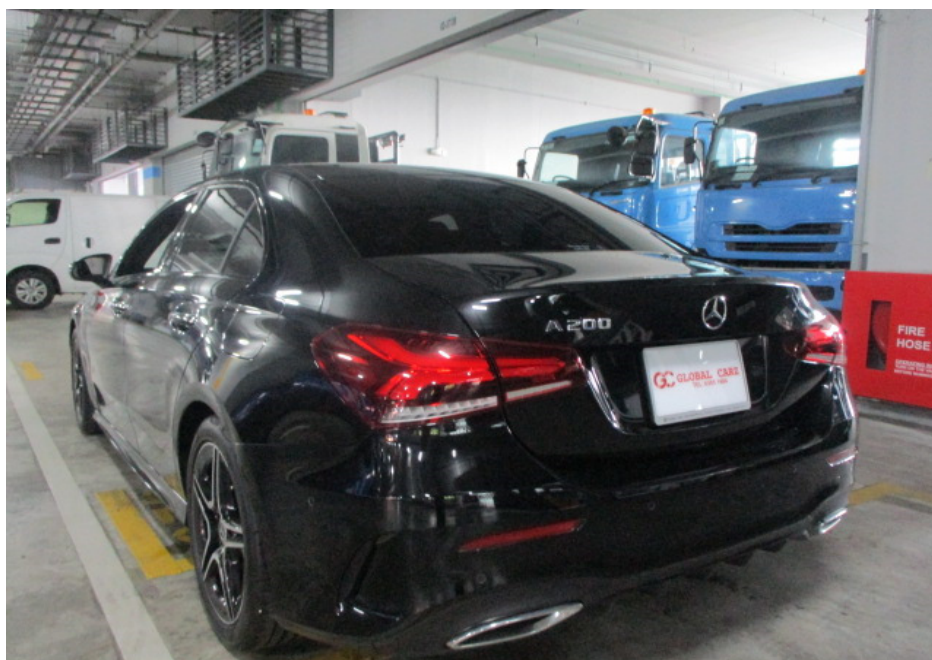
**Photo 11** shows a general view of the rear left body of the Motor Car at the time of my inspection. The Motor Car was observed to be in a relatively good general condition with no loose exterior fittings observed. The mileage of the Motor Car recorded at the time of my inspection was 1,222km.

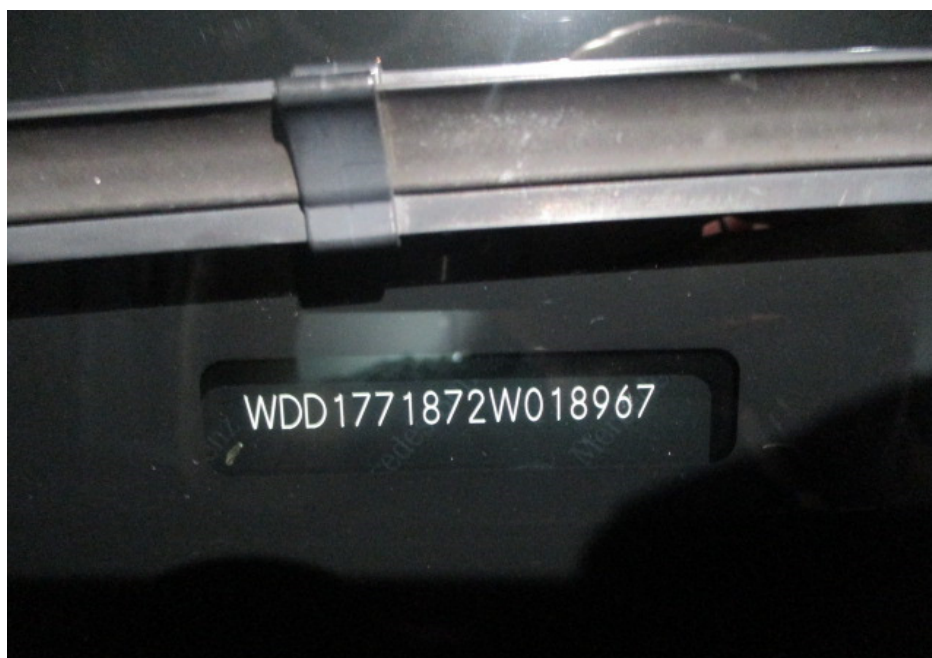
**Photo 12** shows the chassis number of the Motor Car. The chassis number recorded was WDD1771872W018967.

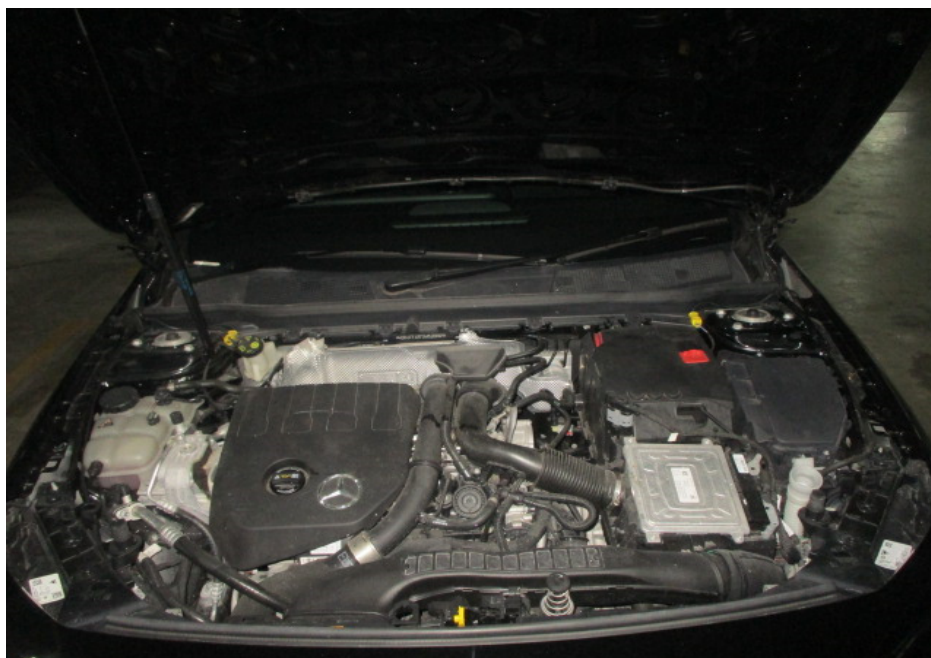
**Photo 13** shows a general view of the engine compartment of the Motor Car at the time of my inspection. The various parts and components inside the engine compartment were all observed to be intact and properly fitted. There was also no sign(s) or indication(s) of fluid leak and/or fluid stain found inside the engine compartment.

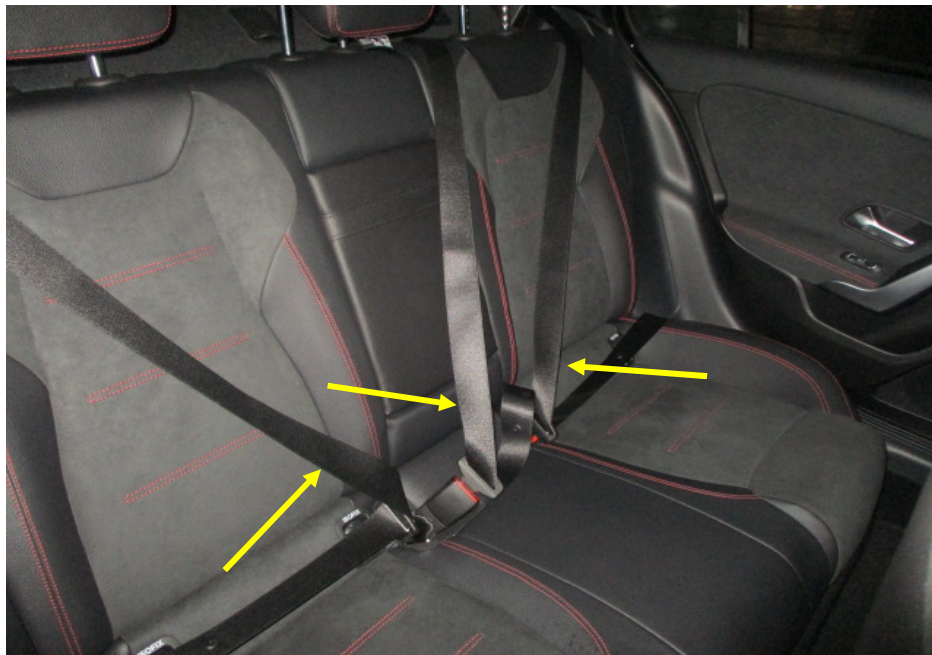
**Photo 14** shows the rear seats of the Motor Car. All the seats of the Motor Car were secured via seat rails to the floorboard. They were also fitted with a retractable seat belt reel and a pre-tensioner. The seat belts (arrowed) were tested and were able to be fastened into the respective pre-tensions that were fitted on the side of each individual seat.

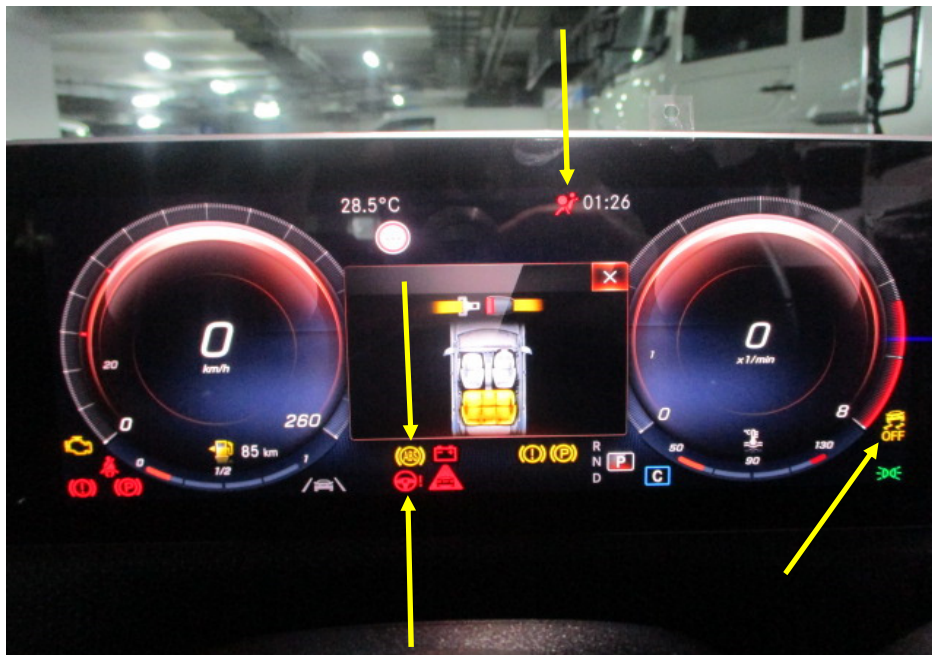
**Photo 15** shows the warning lights for the various electronic safety features appearing on the instrument panel of the Motor Car during its self-test when the engine is cranked, in particular the ABS, SRS, EPS and TCS lights (arrowed).

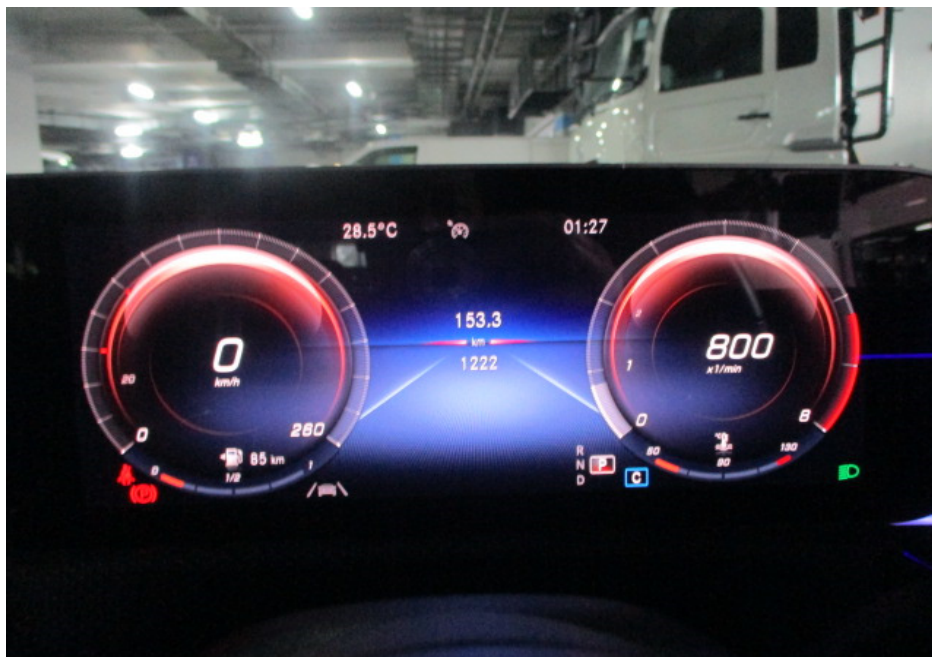
**Photo 16** shows the respective warning lights no longer illuminated, indicating that there is no fault detected to the ABS, SRS, EPS and TCS systems of the Motor Car during the self-test. These electronic systems were hence in working condition at the time of my inspection.

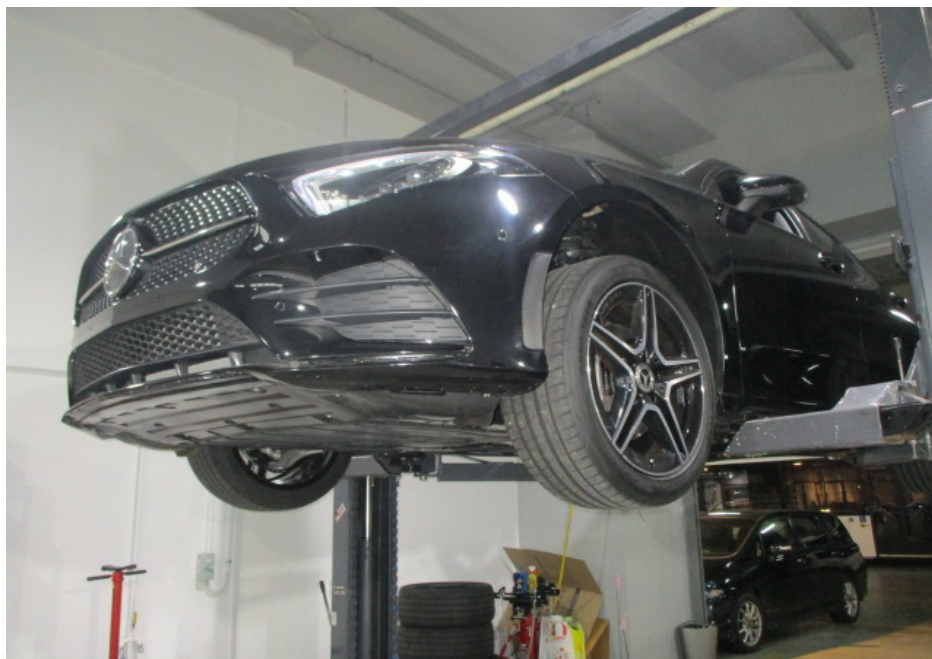
**Photo 17** shows the Motor Car hoisted up for checks on its undercarriage. There was no sign(s) or indication(s) of fluid leakage and/or fluid stain(s) on the underside of the Motor Car. The undercarriage components of the Motor Car were also all observed to be intact and secured in an appropriate manner.

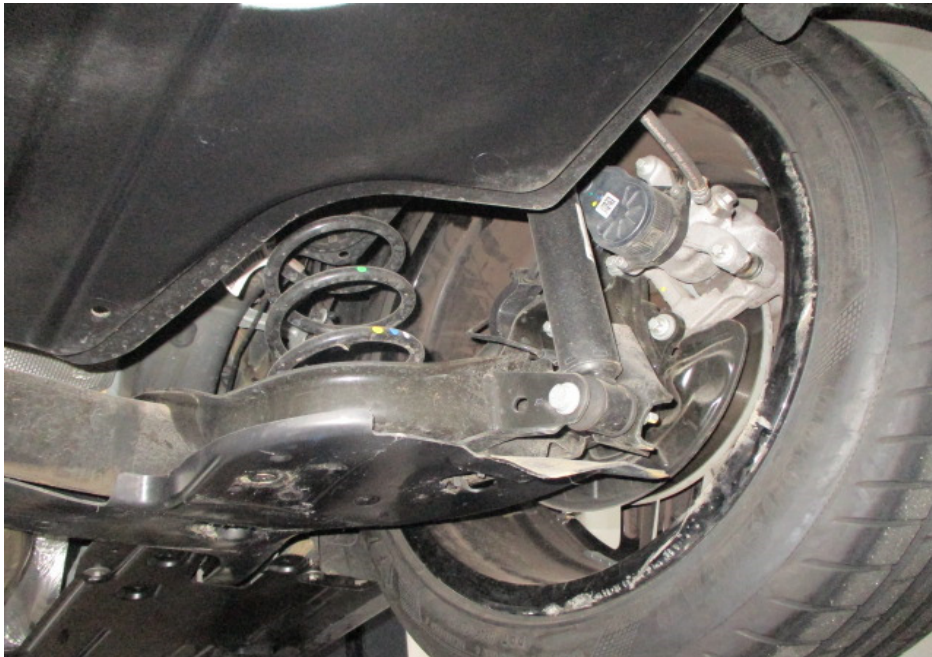
**Photo 18** shows a general view of the control arms and linkages at the rear right wheel of the Motor Car. I did not observe any fluid leak and/or fluid stain on the underside of the Motor Car. All of the Motor Car's undercarriage components were observed to be intact and secured in an appropriate manner.

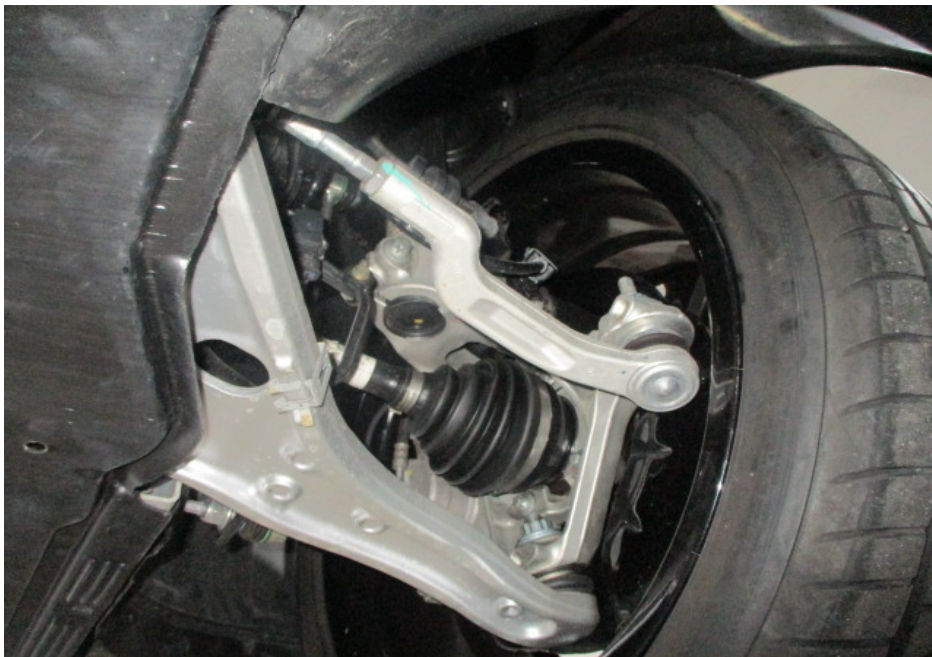
**Photo 19** shows the various undercarriage components at the front left wheel of the Motor Car. The mechanical components, control arms and linkages were all found to be intact and secured in an appropriate manner.

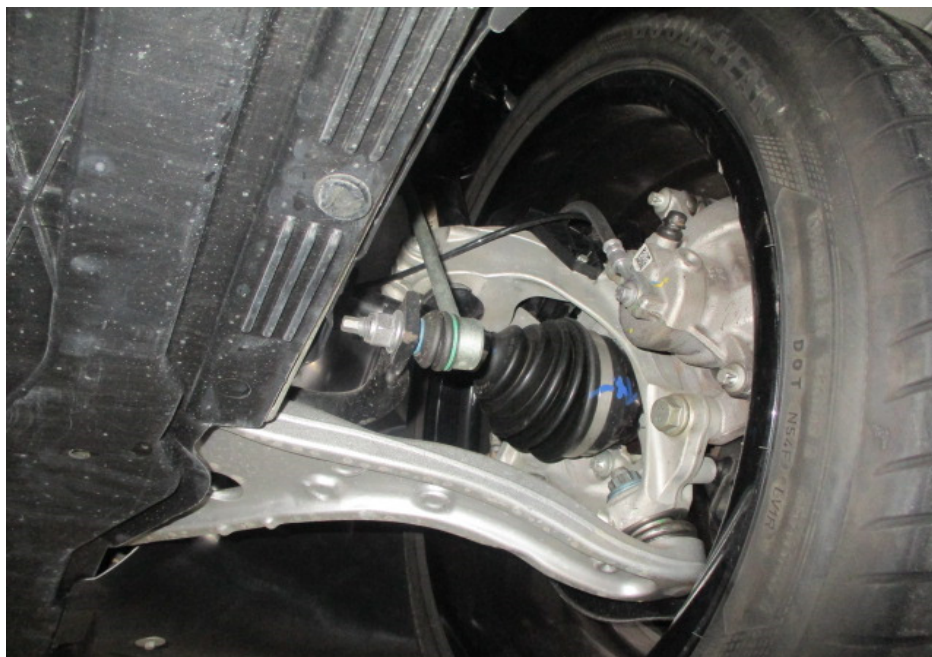
**Photo 20** shows the various undercarriage components at the front right wheel of the Motor Car. The mechanical components, control arms and linkages were all found to be intact and secured in an appropriate manner. I also did not observe any fluid leak and/or fluid stain on the underside of the Motor Car.

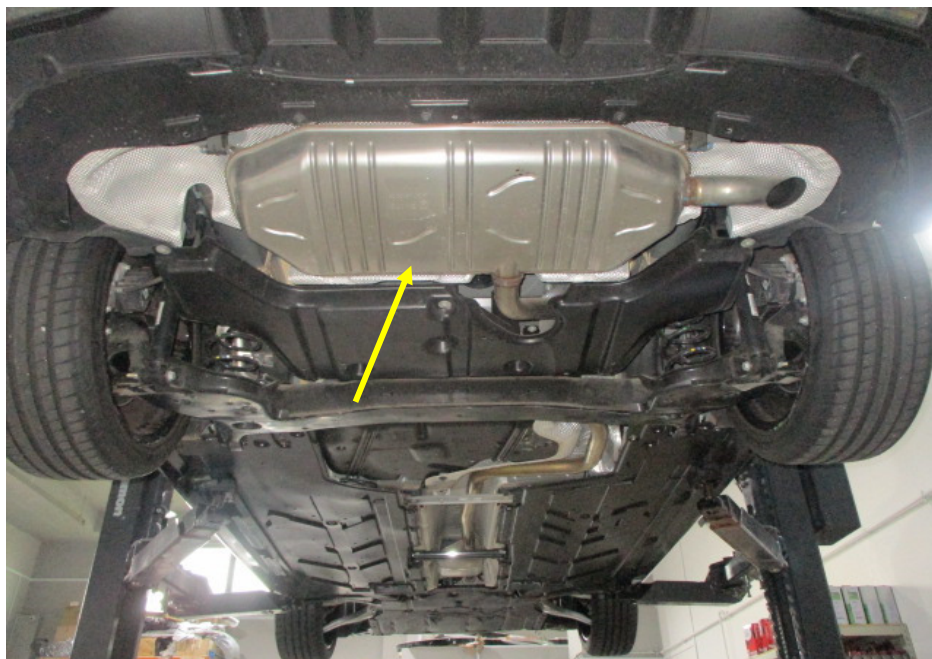
**Photo 21** shows a general view of the Motor Car's exhaust system. My examination of the Motor Car's exhaust system revealed no sign(s) or indication(s) of any cut or weld marks along its exhaust pipes, catalytic converter and on its rear muffler (arrowed).

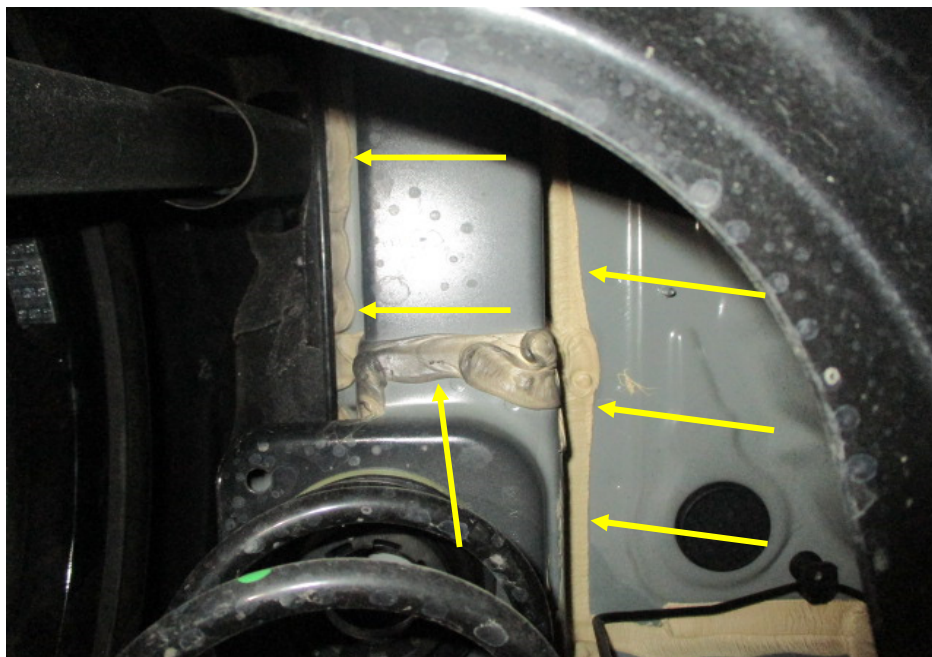
**Photo 22** shows the chassis/structural body at the underside rear left of the Motor Car. I did not find any weld marks other than original spot weld marks on the chassis/structural body of the Motor Car. The original factory sealant (arrowed) at the joints along the chassis/structural body was untouched, indicating no work was done on the chassis/structural body of the Motor Car and that the chassis/structural body was originally fitted.

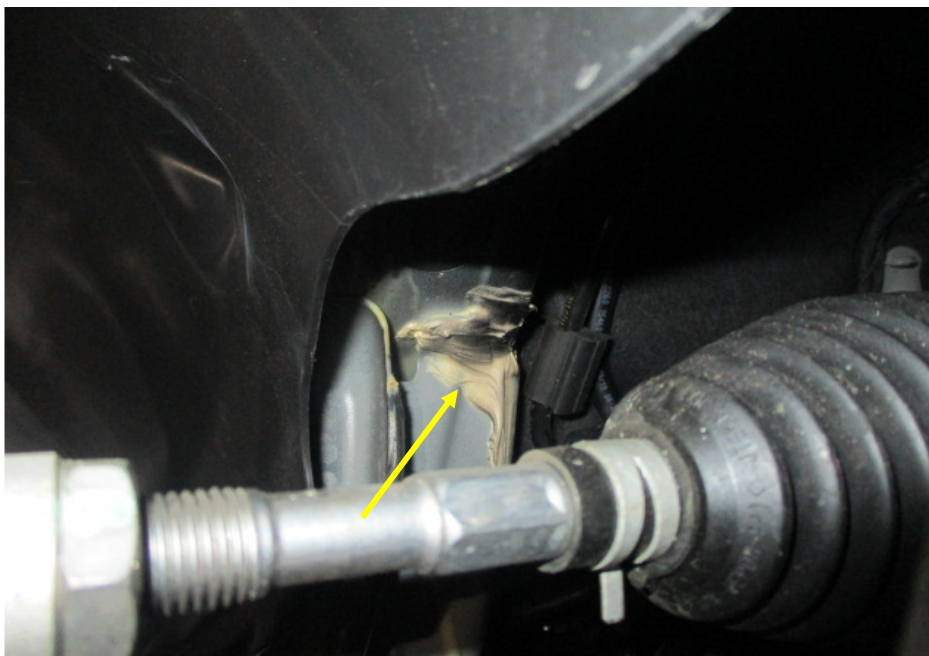
**Photo 23** shows the chassis/structural body at the underside front left of the Motor Car. The original factory sealant (arrowed) at the joints along the chassis/structural body was observed to be untouched. In general, I had found no work was carried out on the chassis/structural body of the Motor Car. The chassis/structural body of the Motor Car was originally fitted.

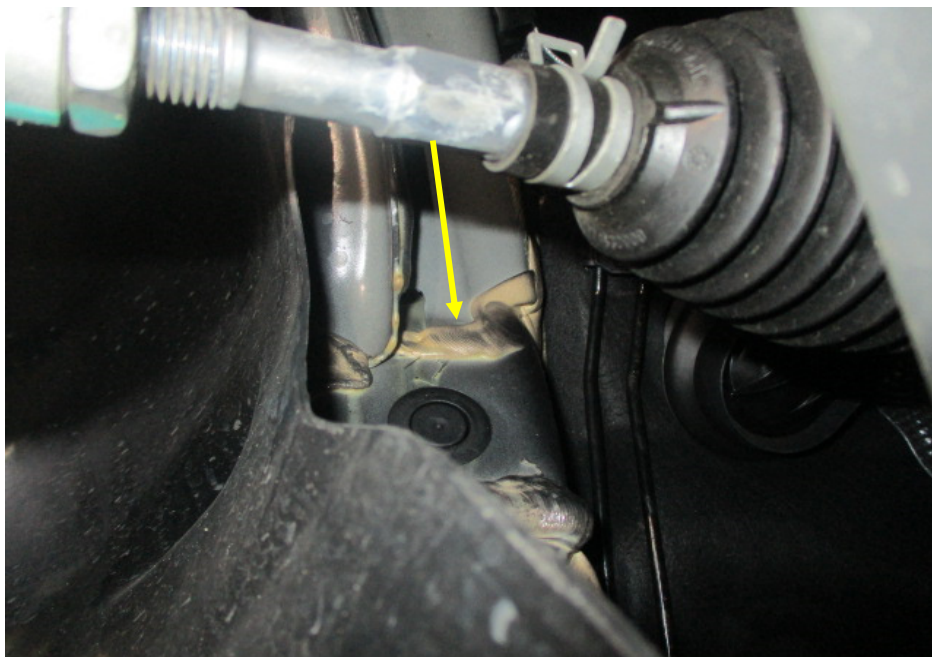
**Photo 24** shows the chassis/structural body at the underside front right of the Motor Car. I did not find any weld marks other than original spot weld marks on the chassis/structural body of the Motor Car. The original factory sealant (arrowed) at the joints along the chassis/structural body was untouched, indicating no work was done on the chassis/structural body of the Motor Car and that the chassis/structural body was originally fitted.

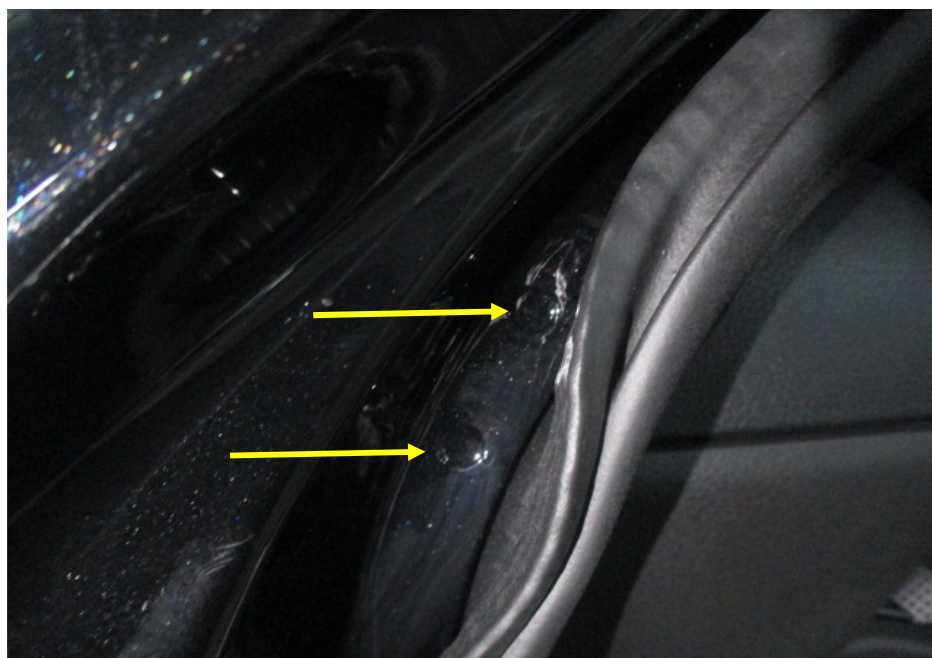
**Photo 25** shows the left side "A" pillar of the Motor Car. I did not find any weld marks other than original spot weld marks (arrowed) on the left side "A" pillar of the Motor Car which, indicates that there was no re-welding works carried out. In general, I had found all the non-detachable body panels of the Motor Car to be originally fitted at the time of my inspection.

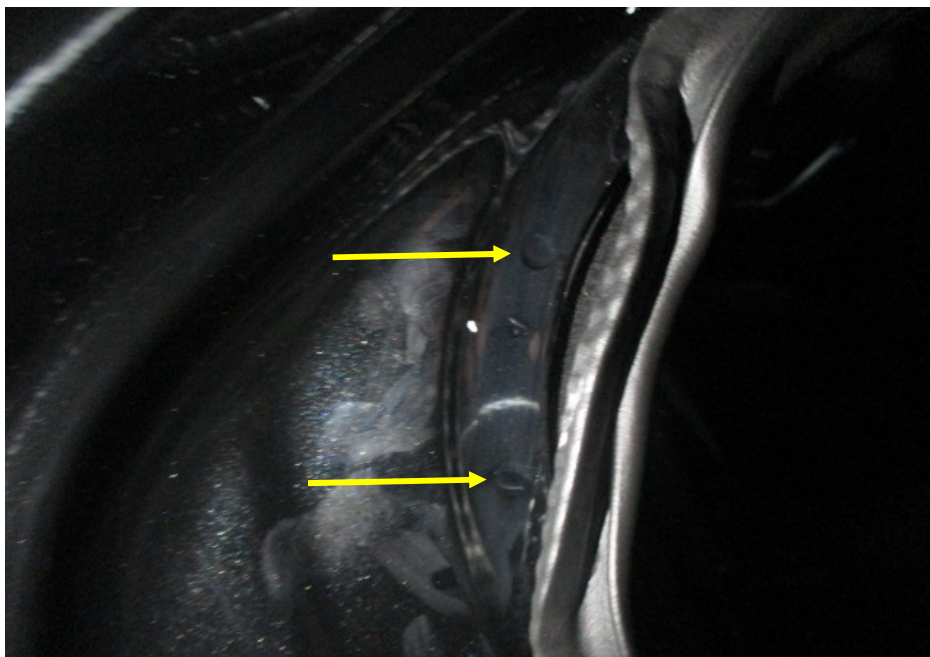
**Photo 26** shows the right side "C" pillar of the Motor Car. I did not find any weld marks other than original spot weld marks (arrowed) on the right side "C" pillar of the Motor Car which, indicates that there was no re-welding works carried out. In general, I had found all the non-detachable body panels of the Motor Car to be originally fitted at the time of my inspection.
