Your Ref: Mercedes Benz E200
(chassis number WDD2130422A315457)
Our Ref : CI/TP21005039/D

22 April 2021

**INSPECTION REPORT OF AN UNREGISTERD MERCEDES BENZ E200
MOTOR CAR WITH CHASSIS NUMBER WDD2130422A315457**

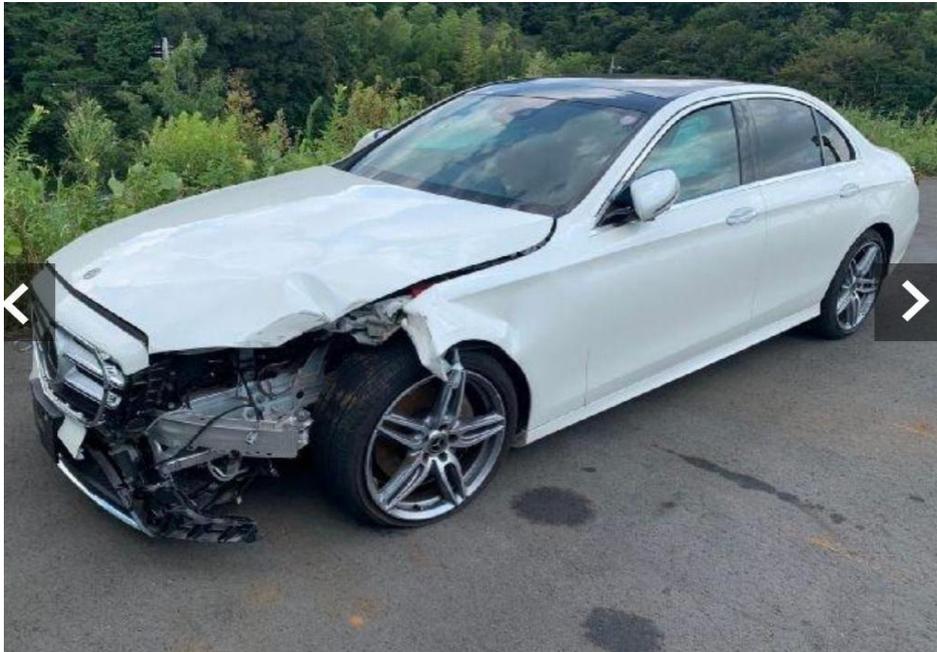
3. From the photographs provided to me, it was observed that the Motor Car had sustained damages at its front left portion. Body parts damaged include the front bumper, front bumper reinforcement, front bumper centre lower grille, front bumper left lower grille, front bumper centre lower chrome moulding, front grille, front bonnet, front bonnet hinges, front bonnet left lock, front left headlamp, front left headlamp top panel, front left fender, front left fender inner panel and front left fender inner shield amongst others.
4. No physical damage was seen to other areas of the Motor Car. The airbags of the Motor Car do not appear to have been deployed, as seen from the photographs provided. See photo 1 – 4 below.

Photo 1 shows the front left body of the Motor Car (photograph provided to me). The Motor Car was observed to have sustained damage at its front left portion. Body parts damaged include the front bumper, front bumper reinforcement, front bumper centre lower grille, front bumper left lower grille, front bumper centre lower chrome moulding, front grille, front bonnet, front left headlamp, front left headlamp top panel, front left fender, front left fender inner panel and front left fender inner shield amongst others.

22. The body parts at the front left portion of the Motor Car were visually examined and it was noted that the repair/restoration works carried out to the damaged area of the Motor Car (refer to photograph 1 above) were reasonably adequate and in order.

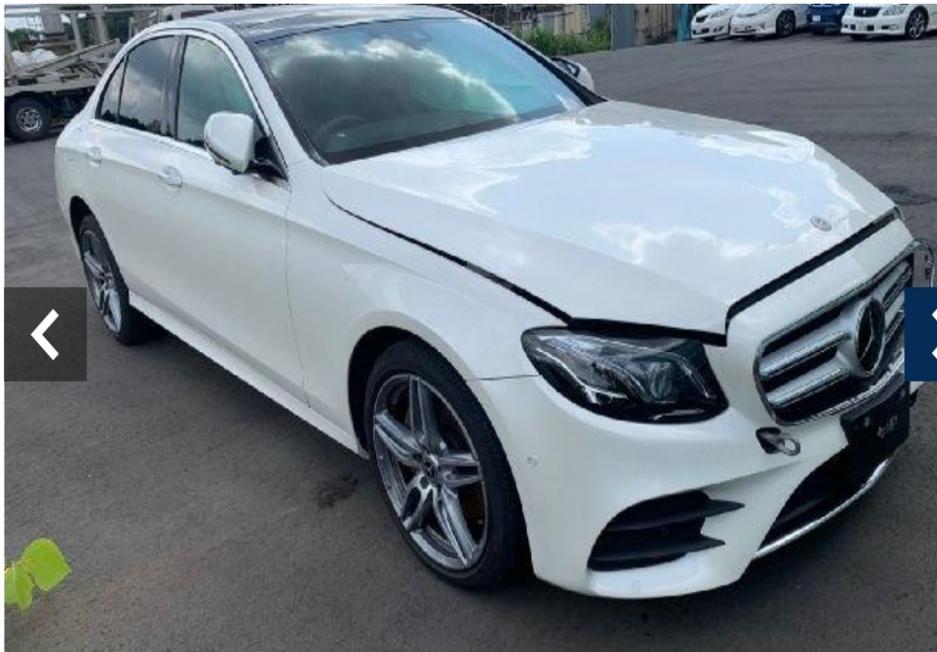
Photo 2 shows the front right body of the Motor Car (photograph provided to me). Apart for the front left portion, there was no physical damage seen to other areas of the Motor Car.

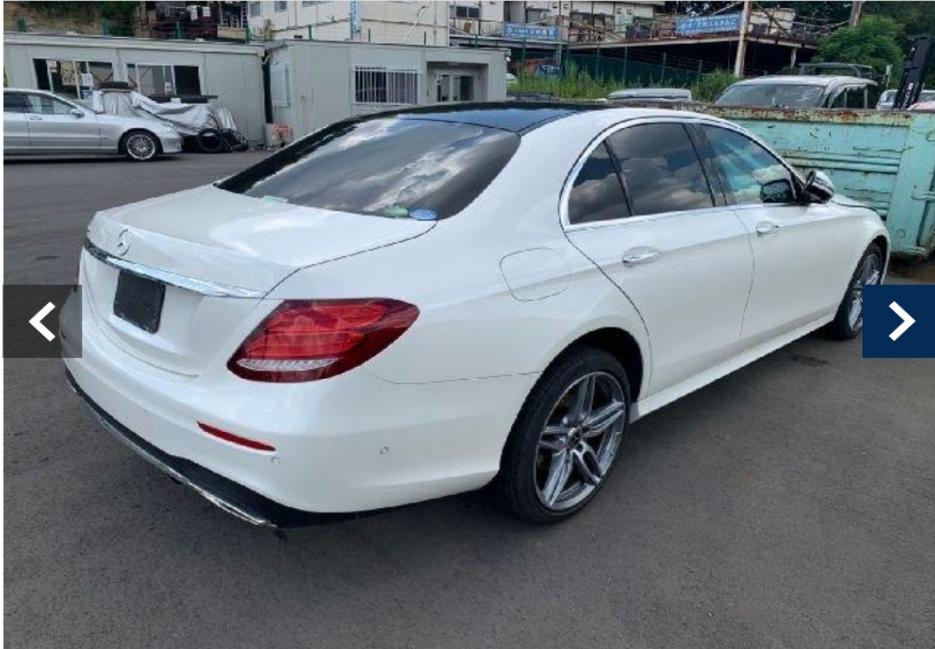
Photo 3 shows the rear right body of the Motor Car (photograph provided to me). Apart for the front left portion, there was no physical damage seen to other areas of the Motor Car.

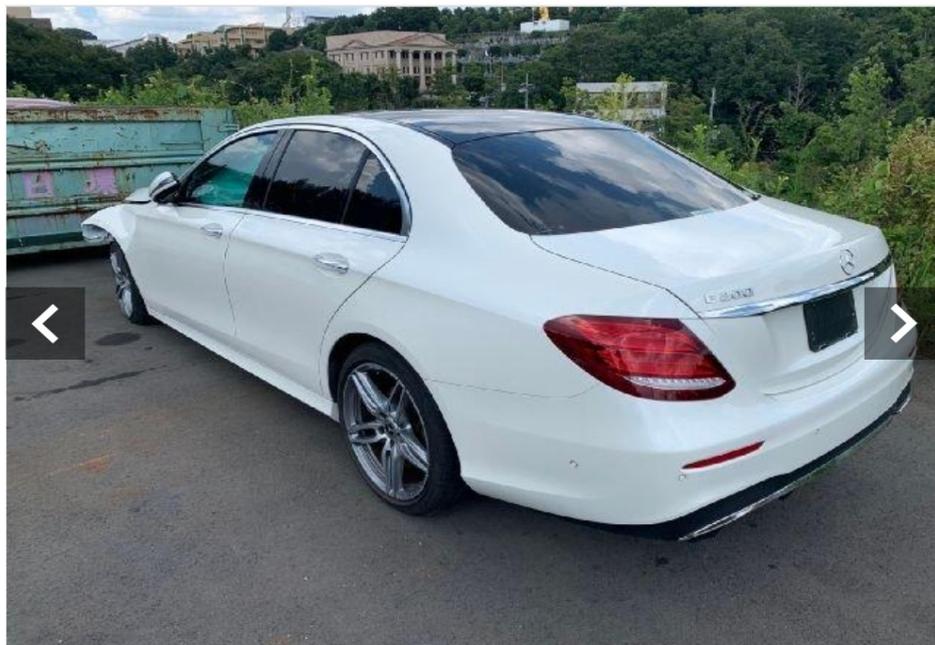
Photo 4 shows the rear left body of the Motor Car (photograph provided to me). Apart for the front left portion, there was no physical damage seen to other areas of the Motor Car.

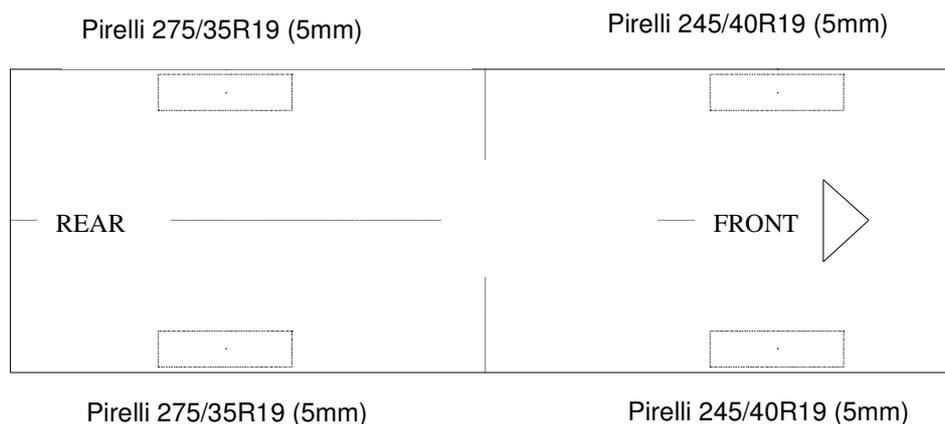
8. It was fitted with 19inch sport wheel rims that were wrapped with tyres that were observed to be of serviceable condition. The tyres were also sufficiently inflated for vehicular operation. The tyre brand, tyre size and approximate remaining tread depth of the 4 tyres of the Motor Car were recorded as follows: -

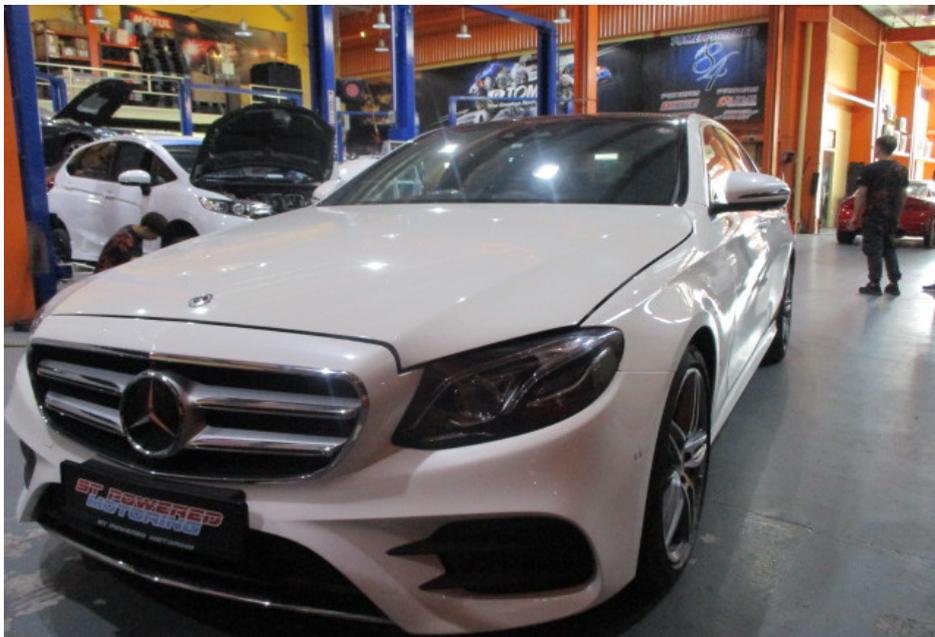
Photo 5 shows a general view of the front left body of the Motor Car at the time of my inspection. The Motor Car was observed to be in a relatively good general condition with no loose exterior fittings observed. The body parts at the front left portion of the Motor Car were visually examined and it was observed that the repair/restoration works carried out to the damaged area of the Motor Car (refer to photograph 1 above) were reasonably adequate and in order.

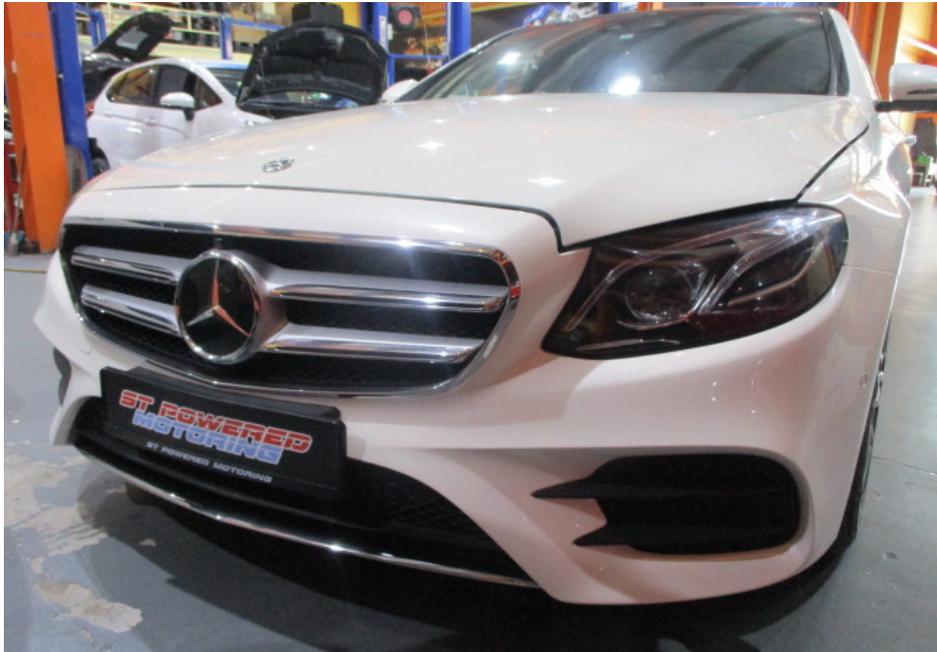
Photo 6 shows a closer view of the front bumper, front bumper lower grilles, front left headlamp, front bonnet and front grille of the Motor Car at the time of my inspection. The body parts at the front left portion of the Motor Car were visually examined and it was observed that the repair/restoration works carried out to the damaged area of the Motor Car (refer to photograph 1 above) were reasonably adequate and in order.

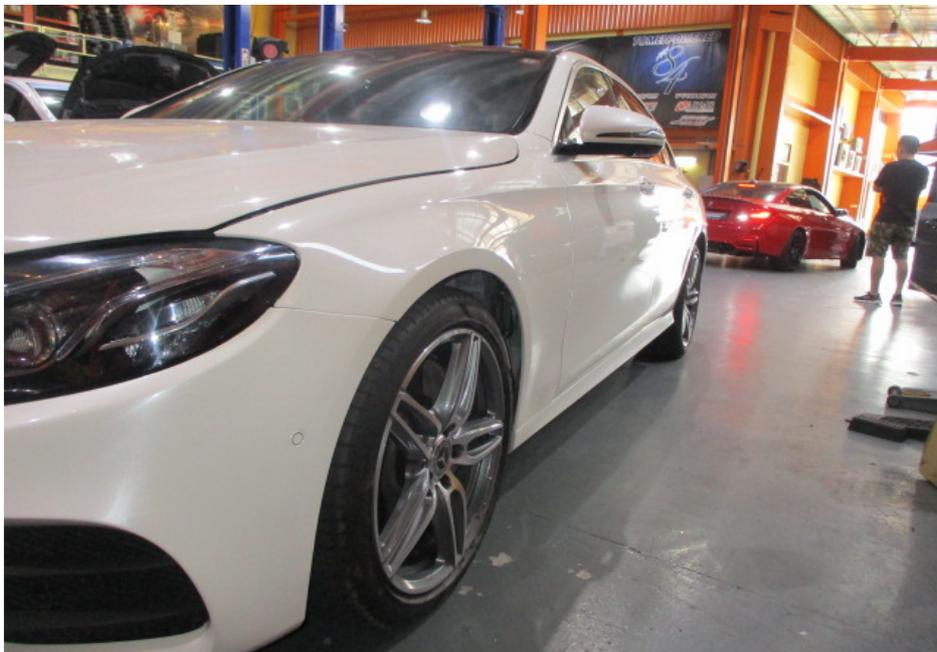
Photo 7 shows a closer view of the front bumper, front left headlamp, front bonnet and front left fender of the Motor Car. The body parts at the front left portion of the Motor Car were visually examined and it was observed that the repair/restoration works carried out to the damaged area of the Motor Car (refer to photograph 1 above) were reasonably adequate and in order.

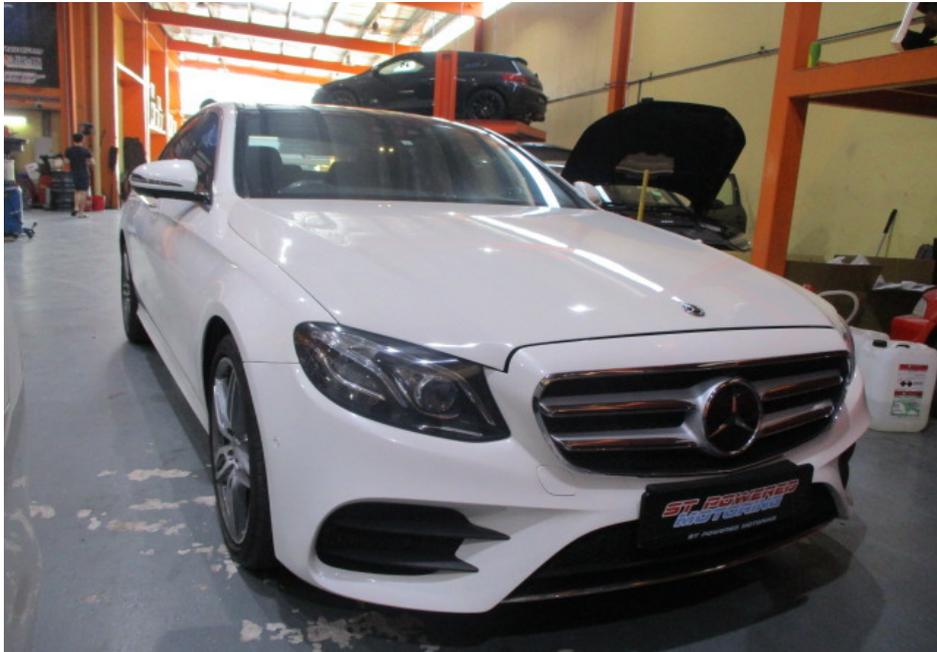
Photo 8 shows a general view of the front right body of the Motor Car at the time of my inspection. The Motor Car was observed to be in a relatively good general condition with no loose exterior fittings observed. The mileage of the Motor Car recorded at the time of my inspection was 16,432km.

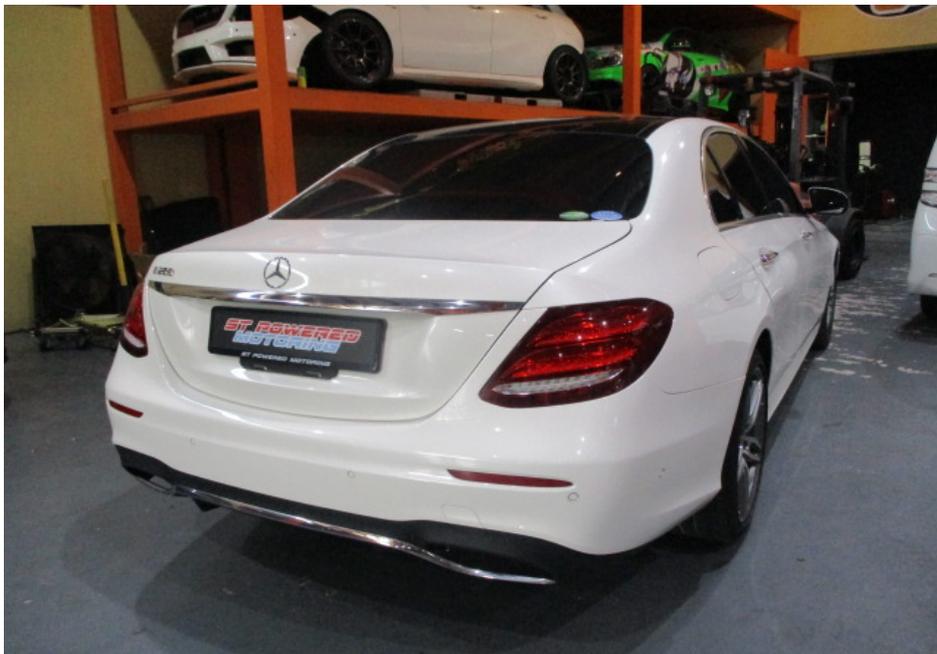
Photo 9 shows a general view of the rear right body of the Motor Car at the time of my inspection. The Motor Car was observed to be in a relatively good general condition with no loose exterior fittings observed. The mileage of the Motor Car recorded at the time of my inspection was 16,432km.

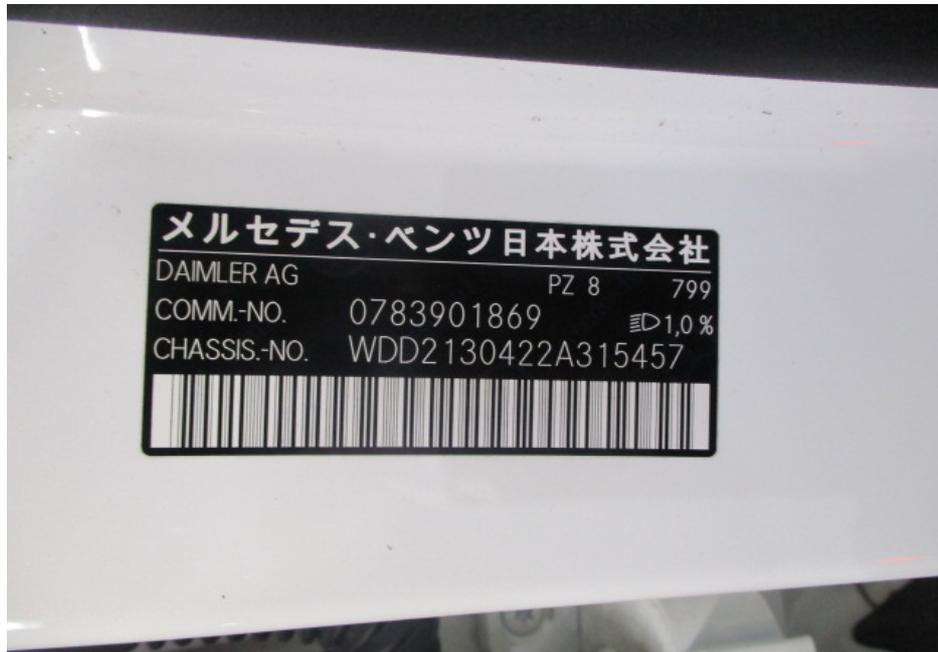
Photo 10 shows the chassis number of the Motor Car. The chassis number recorded was WDD2130422A315457.

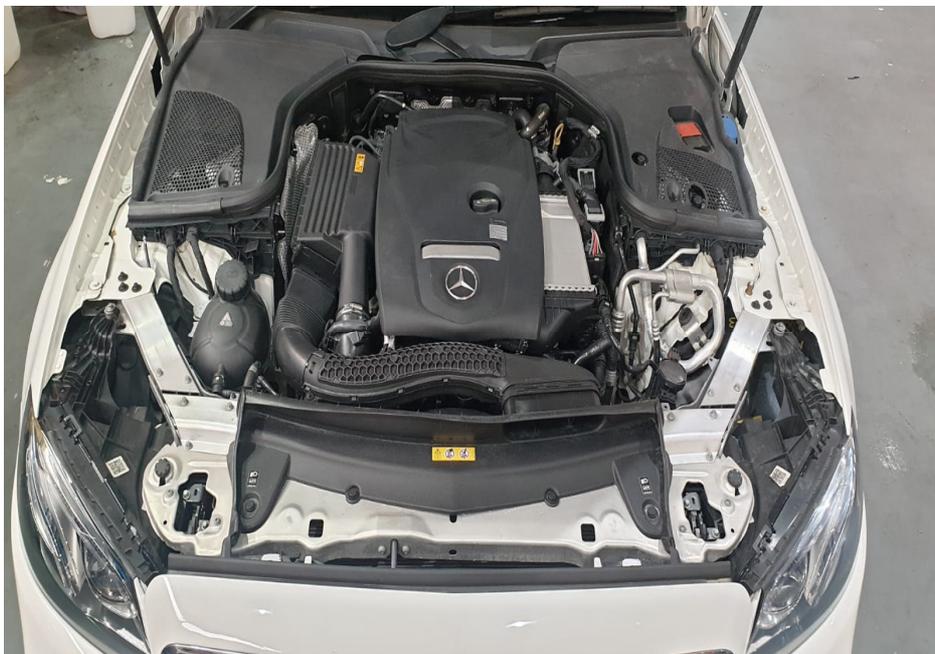
Photo 11 shows a general view of the engine compartment of the Motor Car at the time of my inspection. The various parts and components inside the engine compartment were all observed to be intact and properly fitted. There was also no sign(s) or indication(s) of fluid leak and/or fluid stain found inside the engine compartment.

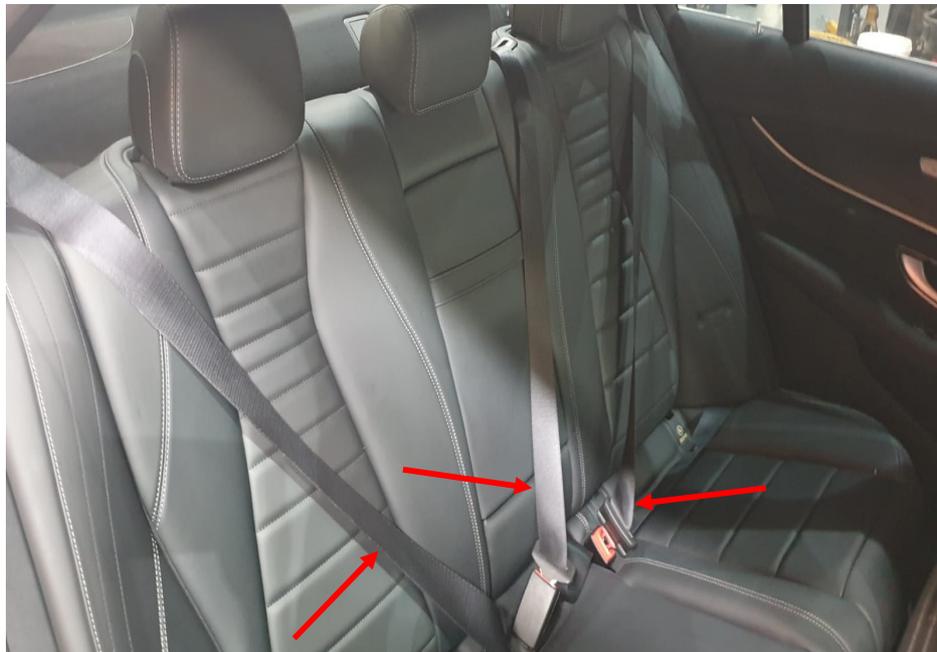
Photo 12 shows the rear seats of the Motor Car. All the seats of the Motor Car were secured via seat rails to the floorboard. They were also fitted with a retractable seat belt reel and a pre-tensioner. The seat belts (arrowed) were tested and were able to be fastened into the respective pre-tensions that were fitted on the side of each individual seat.

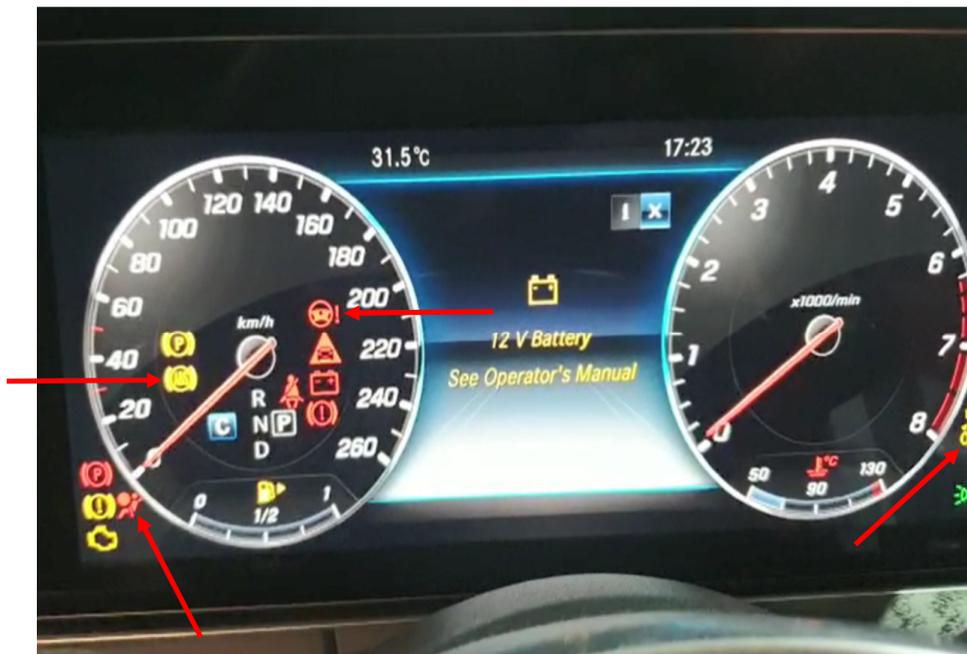
Photo 13 shows the warning lights for the various electronic safety features appearing on the instrument panel of the Motor Car during its self-test when the engine is cranked, in particular the ABS, SRS, EPS and TCS lights (arrowed).

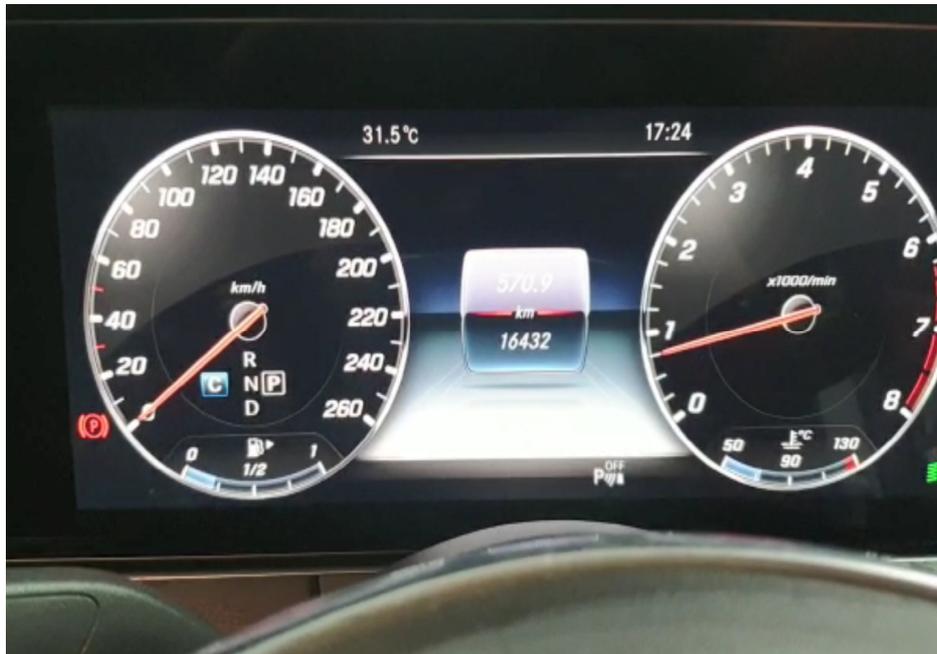
Photo 14 shows the respective warning lights no longer illuminated, indicating that there is no fault detected to the ABS, SRS, EPS and TCS systems of the Motor Car during the self-test. These electronic systems were hence in working condition at the time of my inspection.

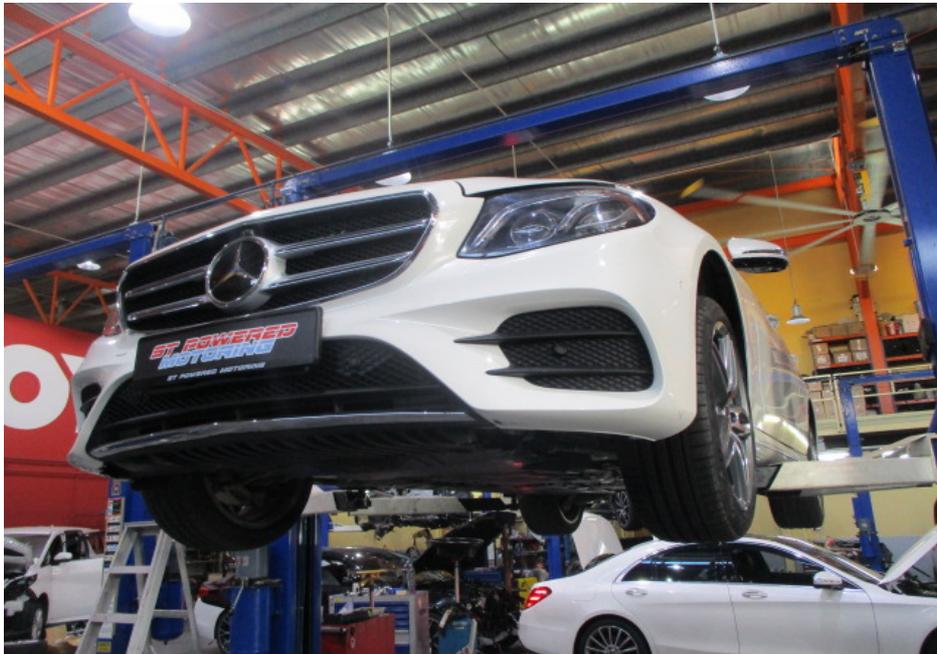
Photo 15 shows the Motor Car hoisted up for checks on its undercarriage. There was no sign(s) or indication(s) of fluid leakage and/or fluid stain(s) on the underside of the Motor Car. The undercarriage components of the Motor Car were also all observed to be intact and secured in an appropriate manner.

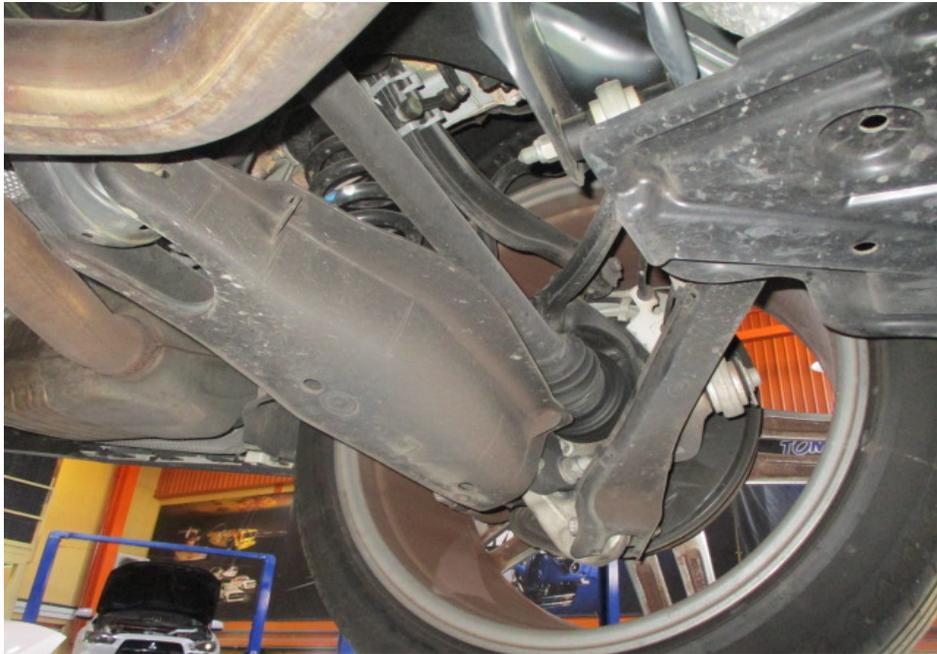
Photo 16 shows a general view of the control arms and linkages at the rear left wheel of the Motor Car. I did not observe any fluid leak and/or fluid stain on the underside of the Motor Car. All of the Motor Car's undercarriage components were observed to be intact and secured in an appropriate manner.

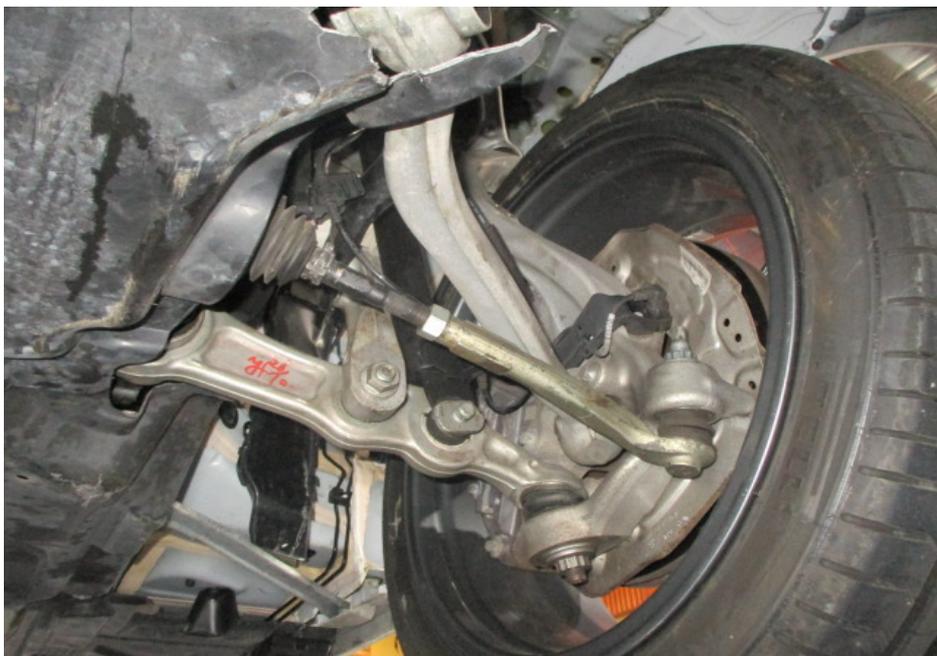
Photo 17 shows the various undercarriage components at the front left wheel of the Motor Car. The mechanical components, control arms and linkages were all found to be intact and secured in an appropriate manner.

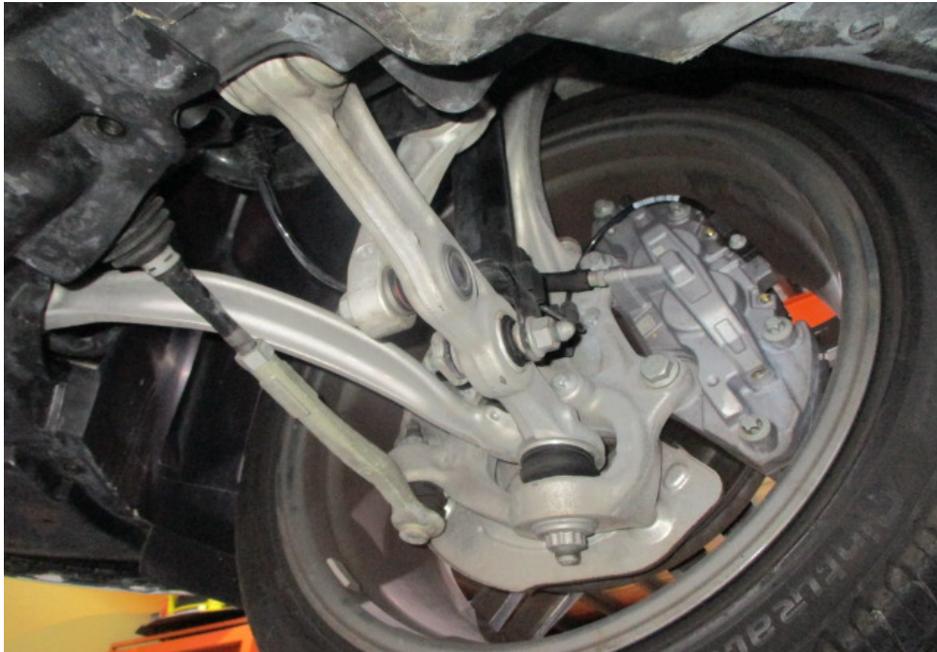
Photo 18 shows the various undercarriage components at the front right wheel of the Motor Car. The mechanical components, control arms and linkages were all found to be intact and secured in an appropriate manner. I also did not observe any fluid leak and/or fluid stain on the underside of the Motor Car.

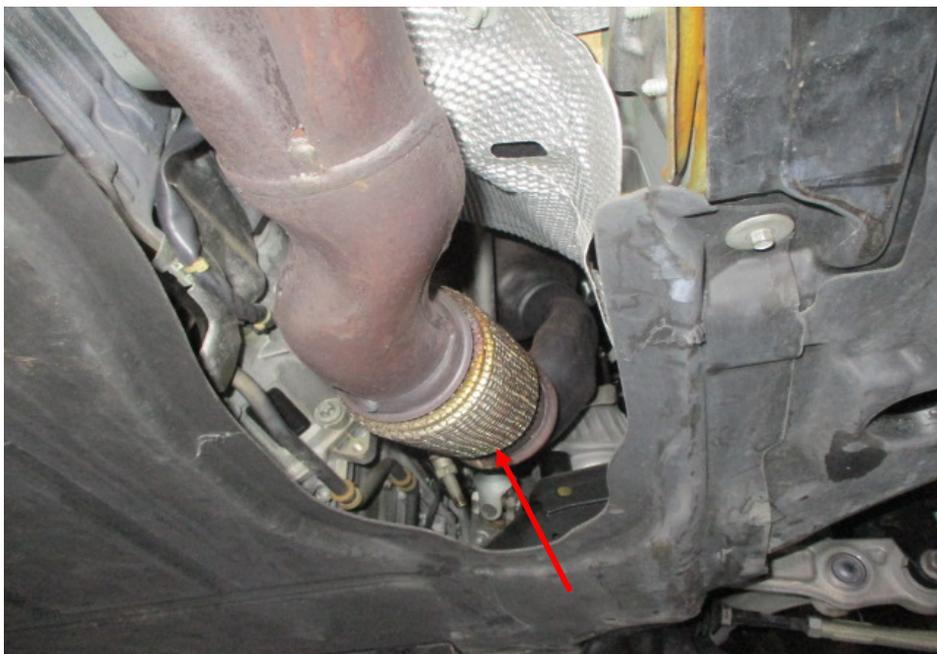
Photo 19 shows the Motor Car's catalytic converter (arrowed). My examination of the Motor Car's exhaust system revealed no sign(s) or indication(s) of any cut or weld marks along its exhaust pipes and on its rear mufflers.

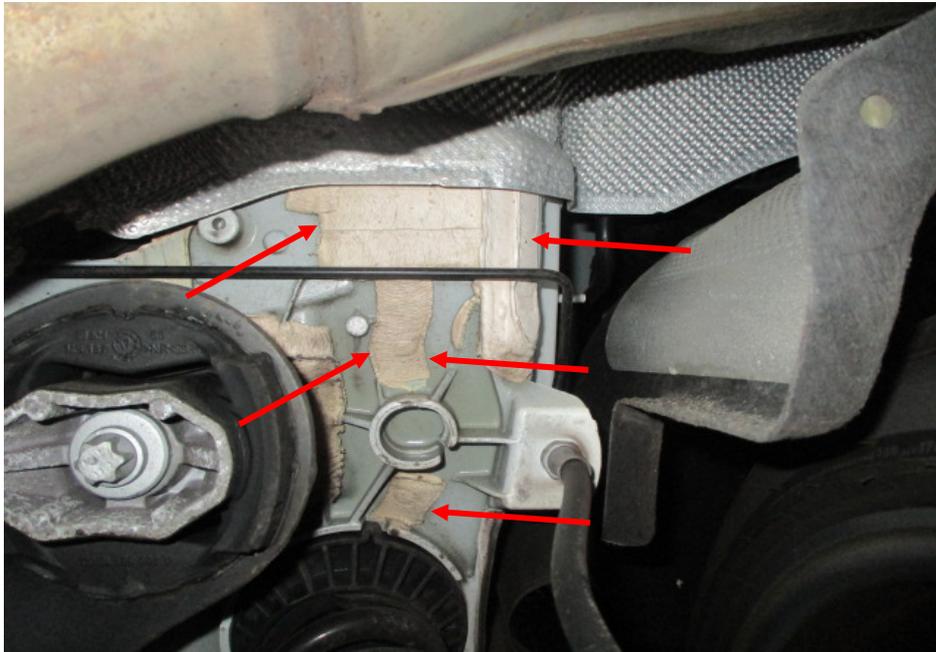
Photo 20 shows the chassis/structural body at the underside rear right of the Motor Car. I did not find any weld marks other than original spot weld marks on the chassis/structural body of the Motor Car. The original factory sealant (arrowed) at the joints along the chassis/structural body was untouched, indicating no work was done on the chassis/structural body of the Motor Car and that the chassis/structural body was originally fitted.

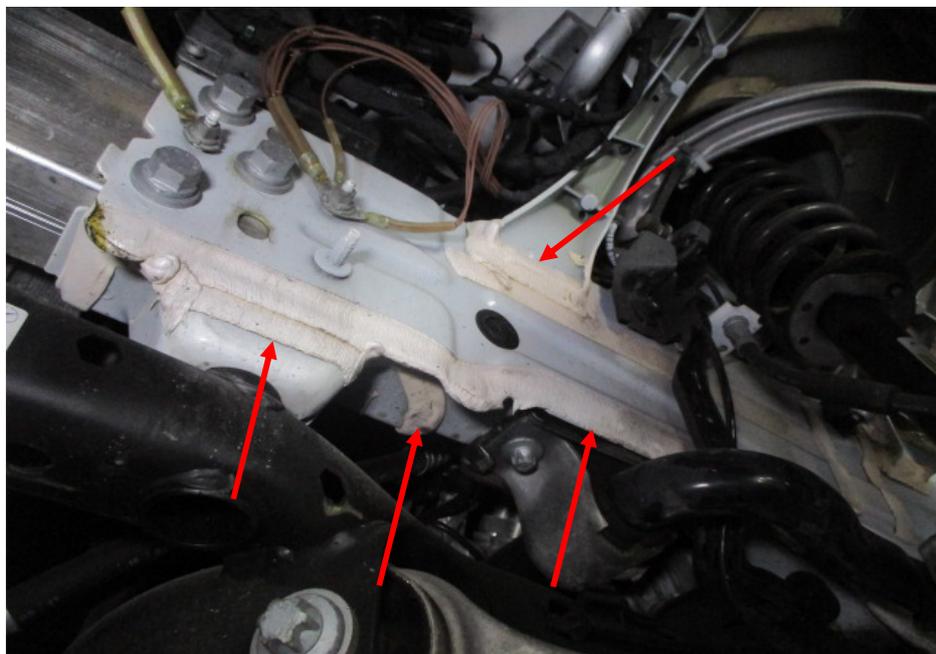
Photo 21 shows the chassis/structural body at the underside front left of the Motor Car. The original factory sealant (arrowed) at the joints along the chassis/structural body was observed to be untouched. In general, I had found no work was carried out on the chassis/structural body of the Motor Car. The chassis/structural body of the Motor Car was originally fitted.

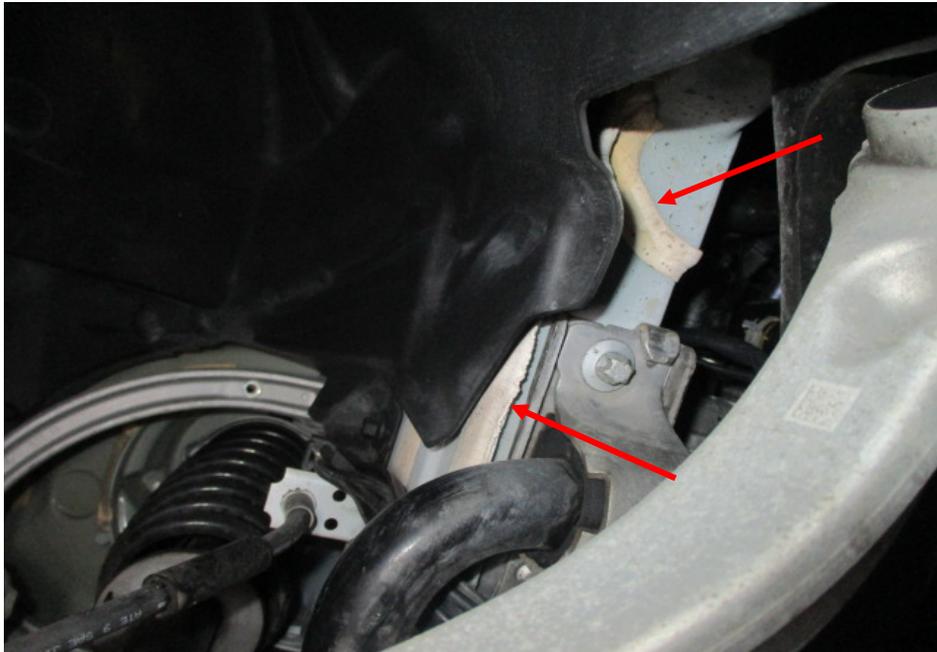
Photo 22 shows the chassis/structural body at the underside front right of the Motor Car. The original factory sealant (arrowed) at the joints along the chassis/structural body was observed to be untouched. In general, I had found no work was carried out on the chassis/structural body of the Motor Car. The chassis/structural body of the Motor Car was originally fitted.

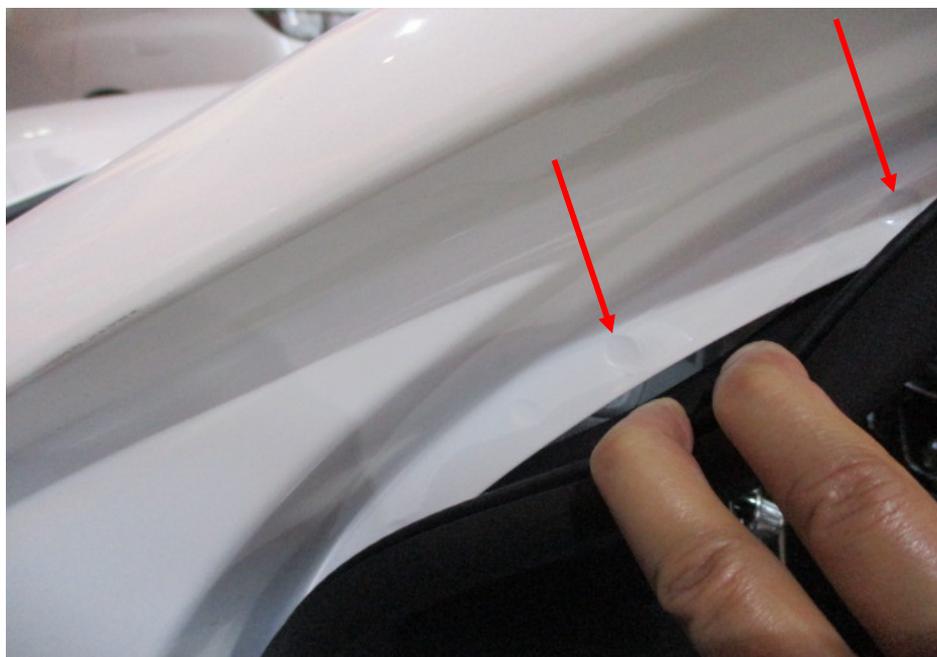
Photo 23 shows the left side "A" pillar of the Motor Car. I did not find any weld marks other than original spot weld marks (arrowed) on the left side "A" pillar of the Motor Car which, indicates that there was no re-welding works carried out. In general, I had found all the non-detachable body panels of the Motor Car to be originally fitted at the time of my inspection.

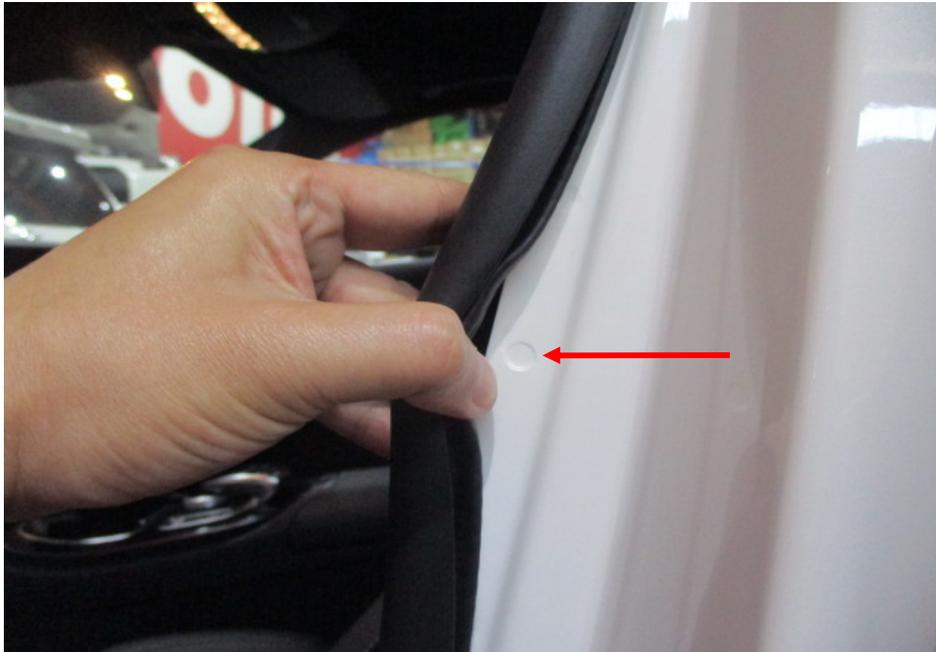
Photo 24 shows the left side “B” pillar of the Motor Car. I did not find any weld marks other than original spot weld marks (arrowed) on the left side “B” pillar panel of the Motor Car which, indicates that there was no re-welding works carried out. In general, I had found all the non-detachable body panels of the Motor Car to be originally fitted at the time of my inspection.
