Your Ref: BMW M4  
(chassis number WBS4Z920X0EE18492)  
Our Ref : CI/TP21005077/D

23 April 2021

**INSPECTION REPORT OF AN UNREGISTERD BMW M4 MOTOR CAR WITH CHASSIS NUMBER WBS4Z920X0EE18492**

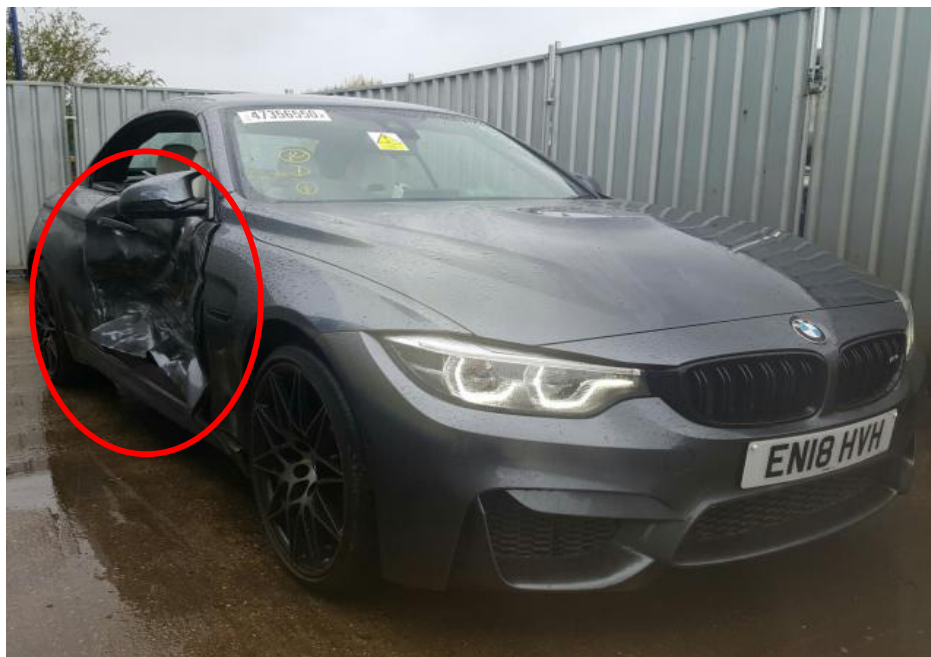
**Photo 1** shows the front right body of the Motor Car (photograph provided to me). The Motor Car was observed to have sustained damages at its right centre portion (circled). The front right door, rear right body panel, right side rocker panel garnish and right side wing mirror were amongst the body parts that were observed to have been damaged. The extent of damage to the front right door suggests that there was also damage to the front right door trim board and front right door window regulator.

23. The body parts at the right centre portion of the Motor Car were visually examined and it was noted that the repair/restoration works carried out to the damaged area of the Motor Car (refer to photograph 1 & 2 above) were reasonably adequate and in order.

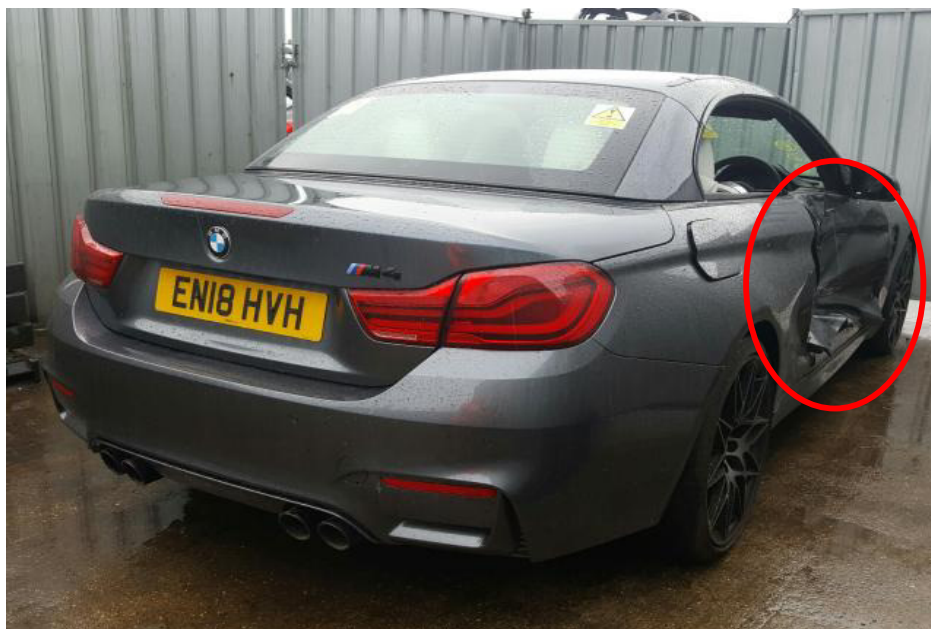
**Photo 2** shows the rear right body of the Motor Car (photograph provided to me). The Motor Car was observed to have sustained damages at its right centre portion (circled). The front right door, rear right body panel, right side rocker panel and right side wing mirror were amongst the body parts that were observed to have been damaged.

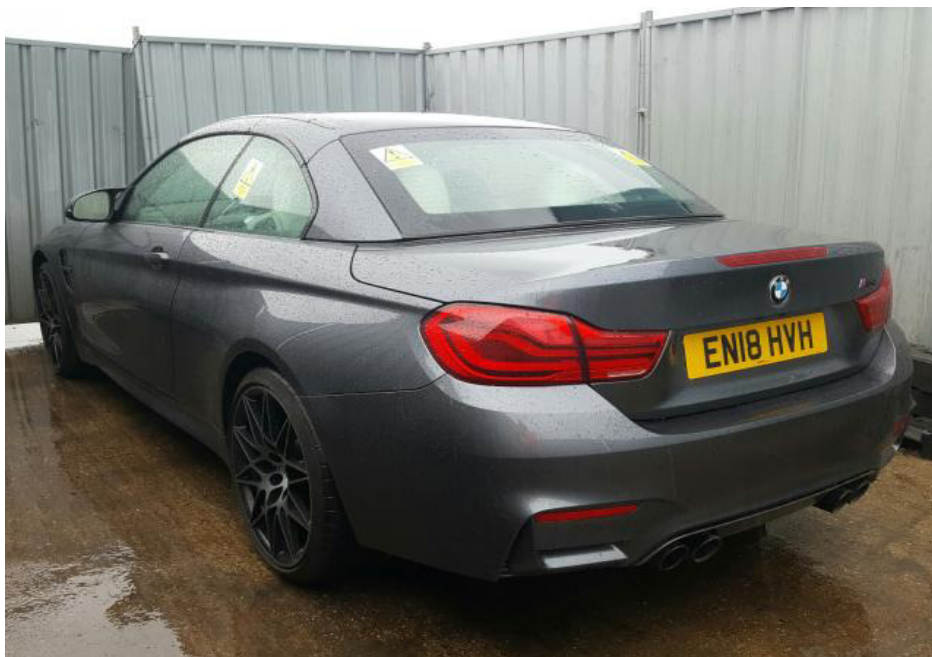
**Photo 3** shows the rear left body of the Motor Car (photograph provided to me). Apart for the right centre portion, there was no physical damage observed to other areas of the Motor Car.

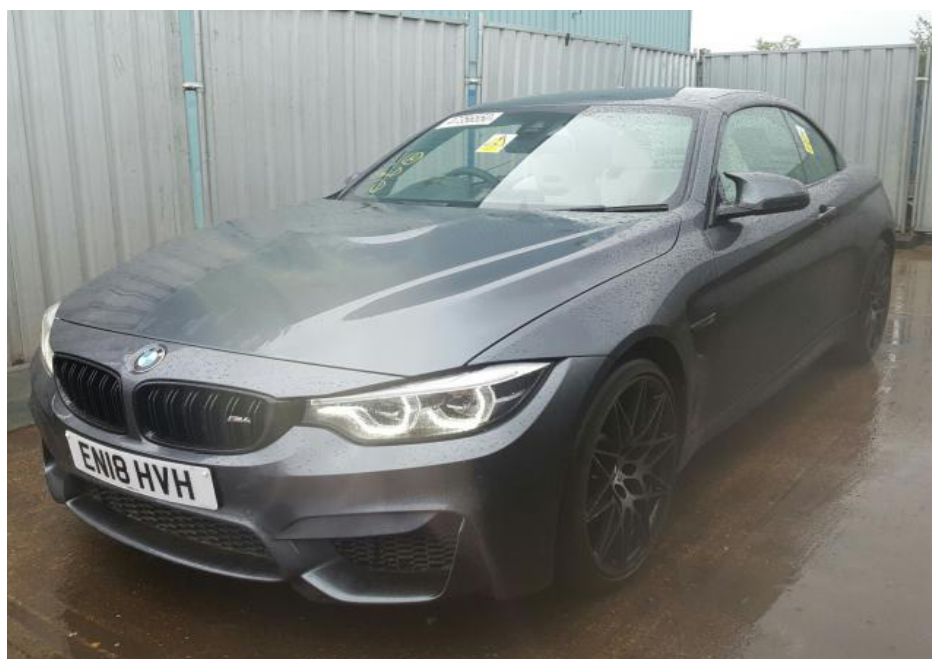
**Photo 4** shows the front left body of the Motor Car (photograph provided to me). Apart for the right centre portion, there was no physical damage observed to other areas of the Motor Car.

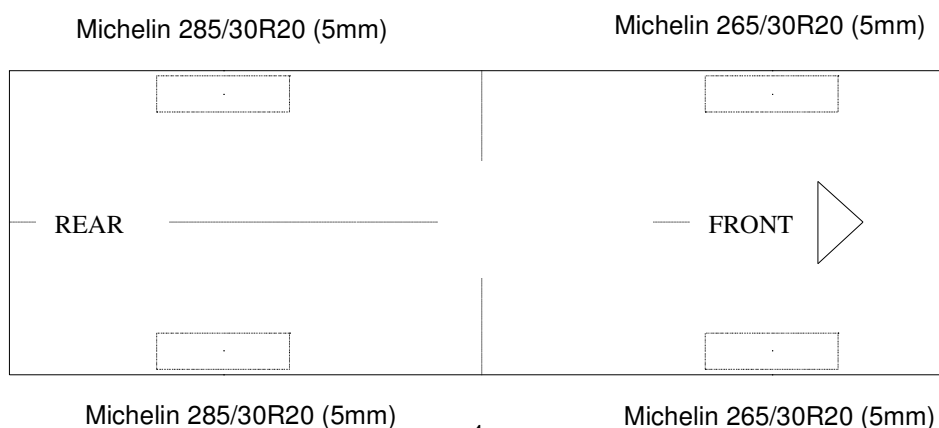
9. It was fitted with 20inch sport wheel rims that were wrapped with tyres that were observed to be of serviceable condition. The tyres were also sufficiently inflated for vehicular operation. The tyre brand, tyre size and approximate remaining tread depth of the 4 tyres of the Motor Car were recorded as follows: -

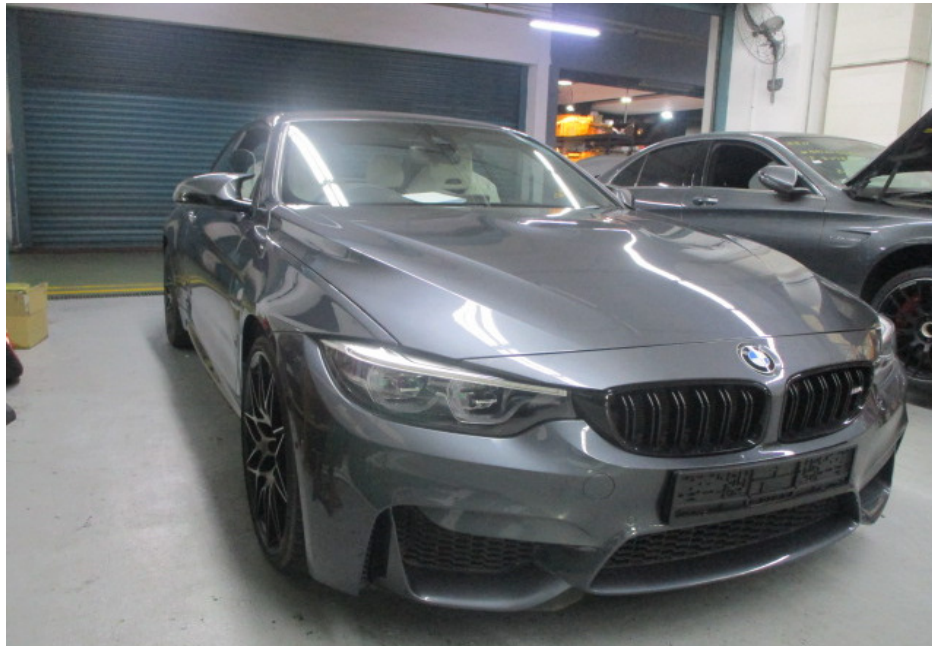
**Photo 5** shows a general view of the front right body of the Motor Car at the time of my inspection. The Motor Car was observed to be in a relatively good general condition with no loose exterior fittings observed. The body parts at the right centre portion of the Motor Car were visually examined and it was observed that the repair/restoration works carried out to the damaged area of the Motor Car (refer to photograph 1 & 2 above) were reasonably adequate and in order.

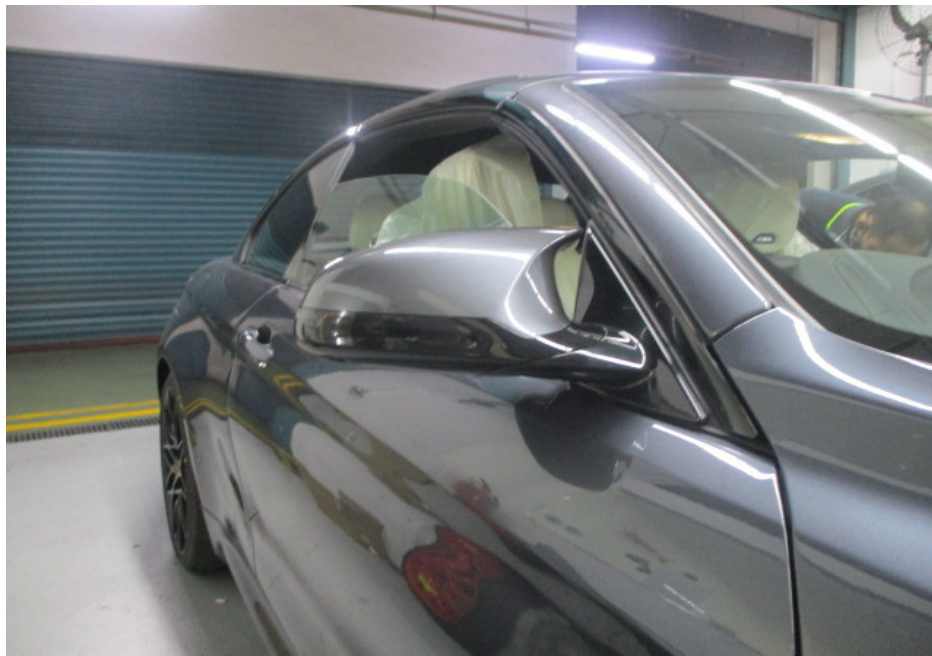
**Photo 6** shows a closer view of the right wing mirror and front right door of the Motor Car. The body parts at the right centre portion of the Motor Car were visually examined and it was observed that the repair/restoration works carried out to the damaged area of the Motor Car (refer to photograph 1 & 2 above) were reasonably adequate and in order.

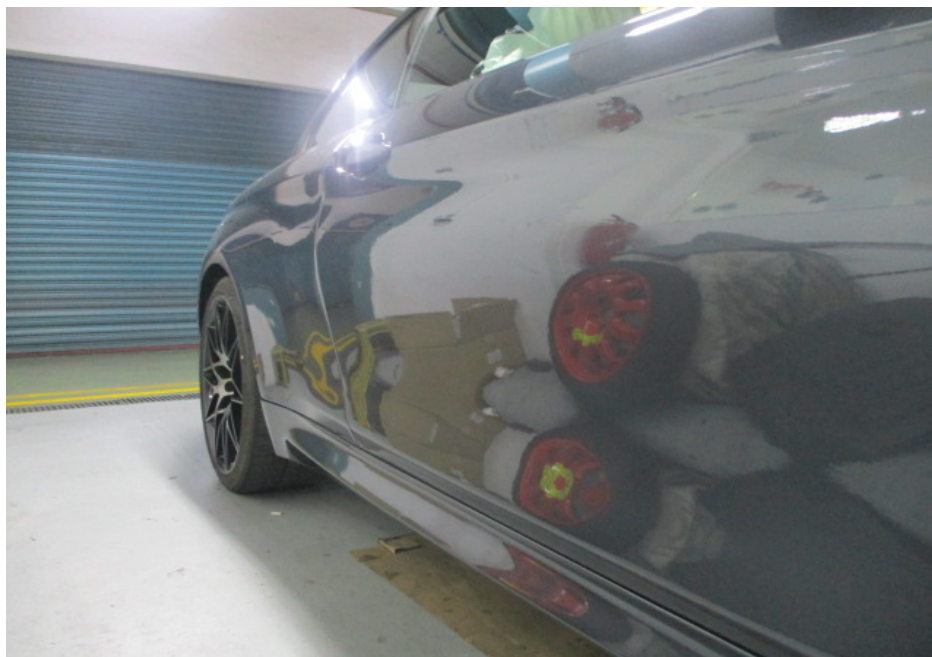
**Photo 7** shows a closer view of the front right door and right side rocker panel garnish of the Motor Car. The body parts at the right centre portion of the Motor Car were visually examined and it was observed that the repair/restoration works carried out to the damaged area of the Motor Car (refer to photograph 1 & 2 above) were reasonably adequate and in order.

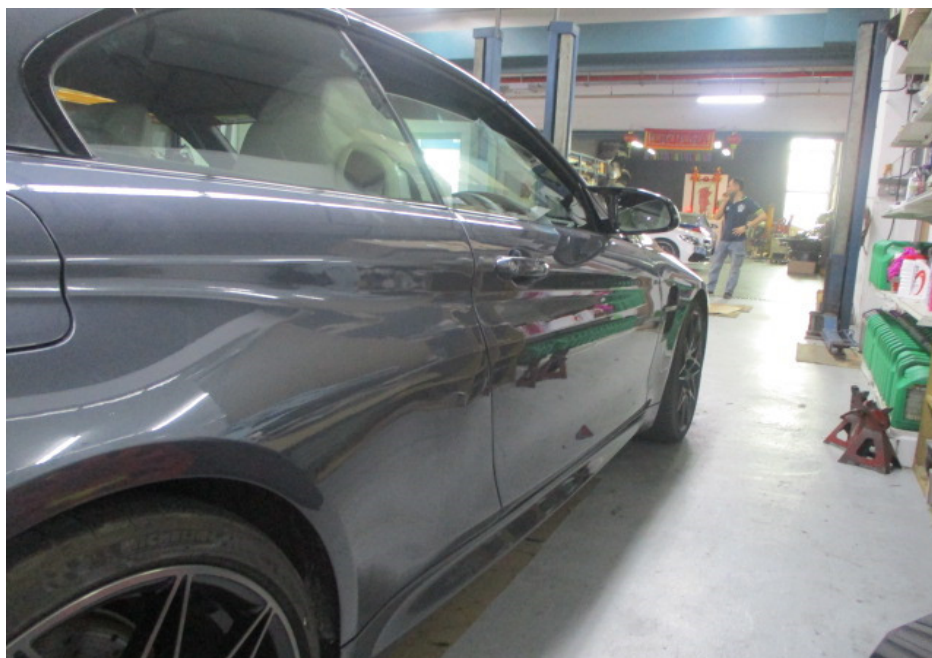
**Photo 8** shows a closer view of the rear right body panel, front right door and right side rocker panel garnish of the Motor Car. The body parts at the right centre portion of the Motor Car were visually examined and it was observed that the repair/restoration works carried out to the damaged area of the Motor Car (refer to photograph 1 & 2 above) were reasonably adequate and in order.

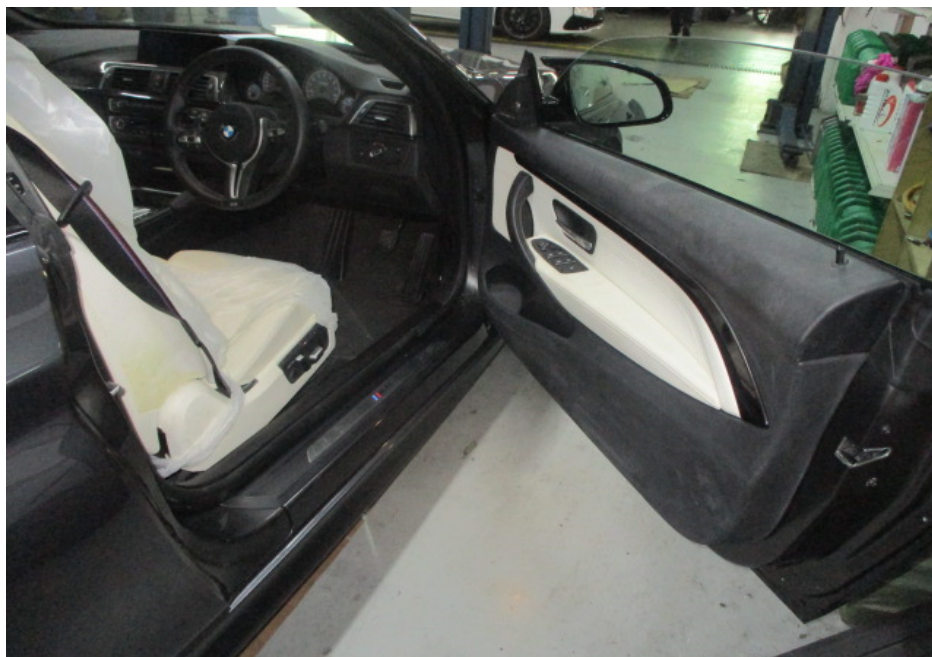
**Photo 9** shows the front right door trim board of the Motor Car at the time of my inspection. The Motor Car was observed to be in a relatively good general condition with no loose exterior fittings observed. The mileage of the Motor Car recorded at the time of my inspection was 16,744km.

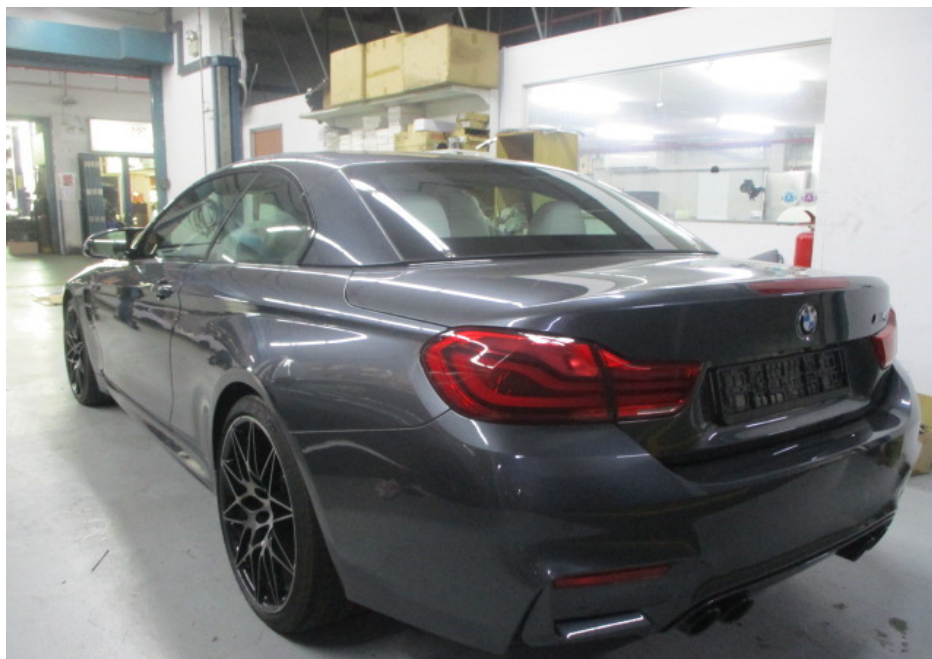
**Photo 10** shows a general view of the rear left body of the Motor Car at the time of my inspection. The Motor Car was observed to be in a relatively good general condition with no loose exterior fittings observed. The mileage of the Motor Car recorded at the time of my inspection was 16,744km.

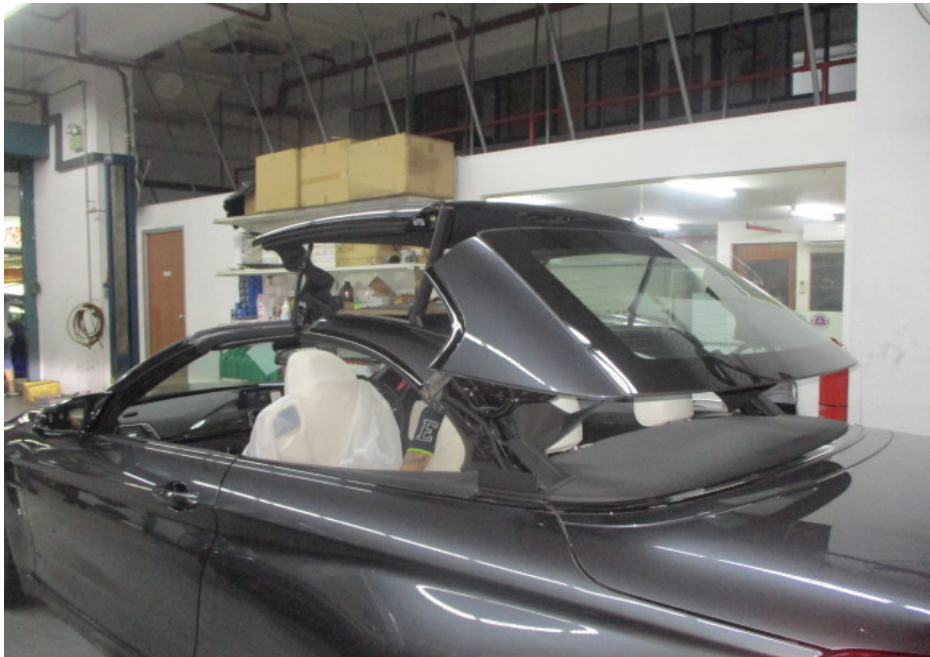
**Photo 11** shows the Motor Car's hard top roof (convertible) being tested. It was observed that as a safety feature, the hard top roof could only open and close when the Motor Car was in a stationary position. When opened, the hard top roof is completely folded into the rear boot compartment with no parts protruding out of the Motor Car's body. It was also observed that during the folding and unfolding process, the hard top roof did not extend laterally beyond the Motor Car's body.

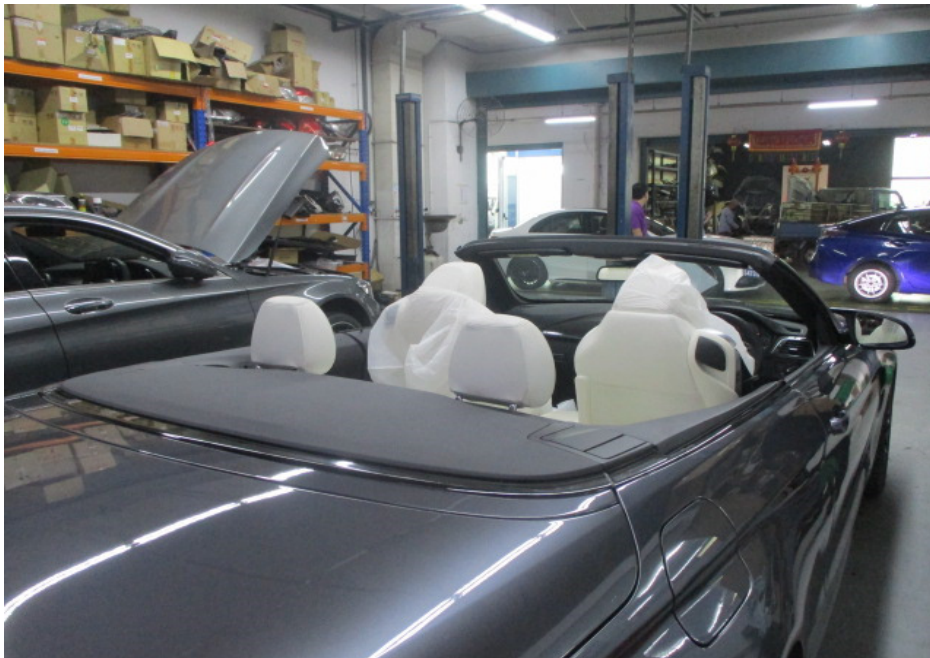
**Photo 12** shows the Motor Car with its hard top roof completely folded. When opened, the hard top roof is completely folded into the rear boot compartment with no parts protruding out of the Motor Car's body. The hard top roof was also found adequately secured to the "A" pillar after closing.

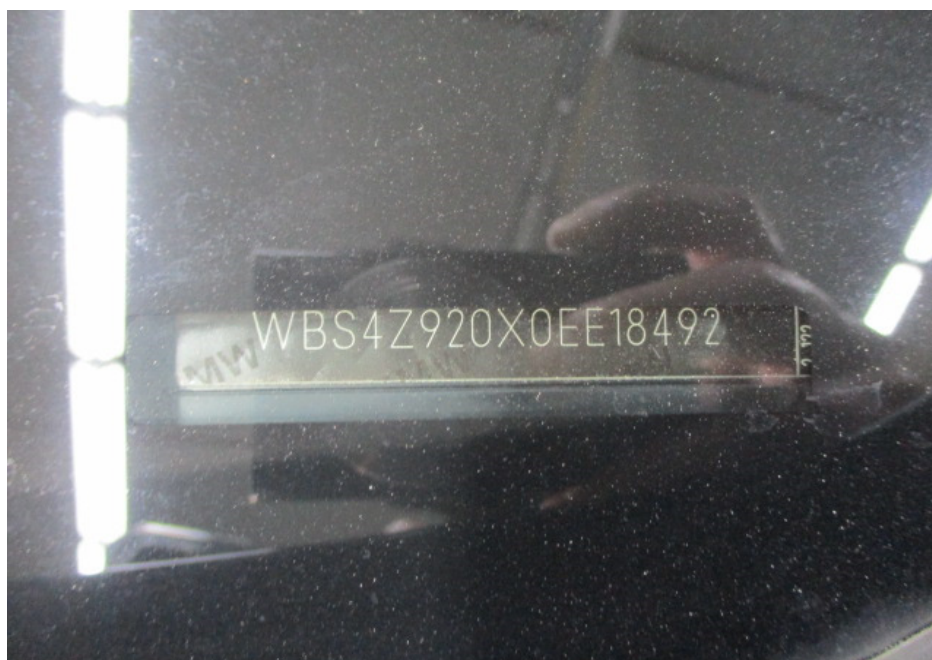
**Photo 13** shows the chassis number of the Motor Car. The chassis number recorded was WBS4Z920X0EE18492.

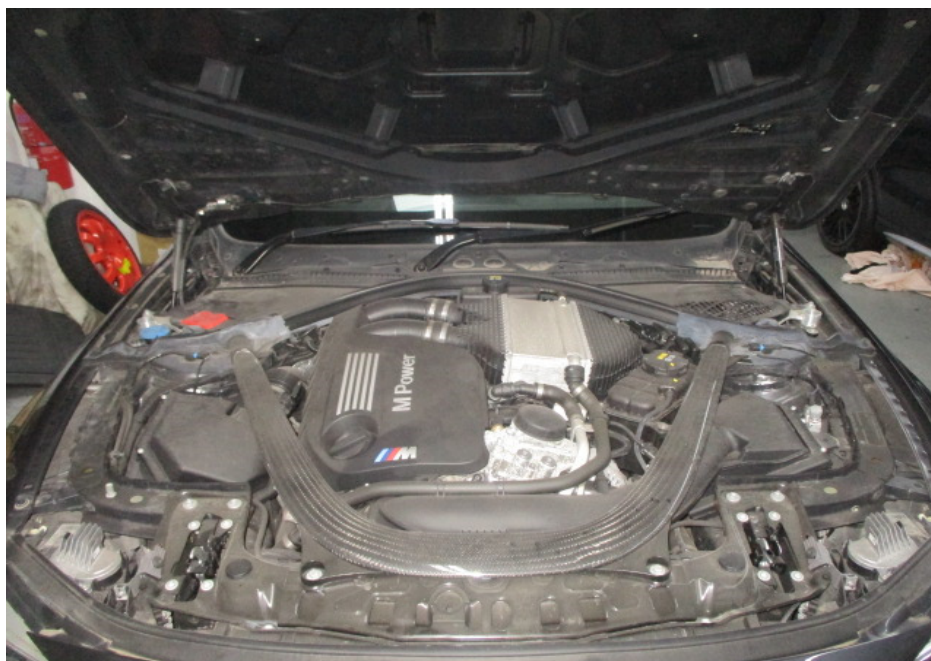
**Photo 14** shows a general view of the engine compartment of the Motor Car at the time of my inspection. The various parts and components inside the engine compartment were all observed to be intact and properly fitted. There was also no sign(s) or indication(s) of fluid leak and/or fluid stain found inside the engine compartment.

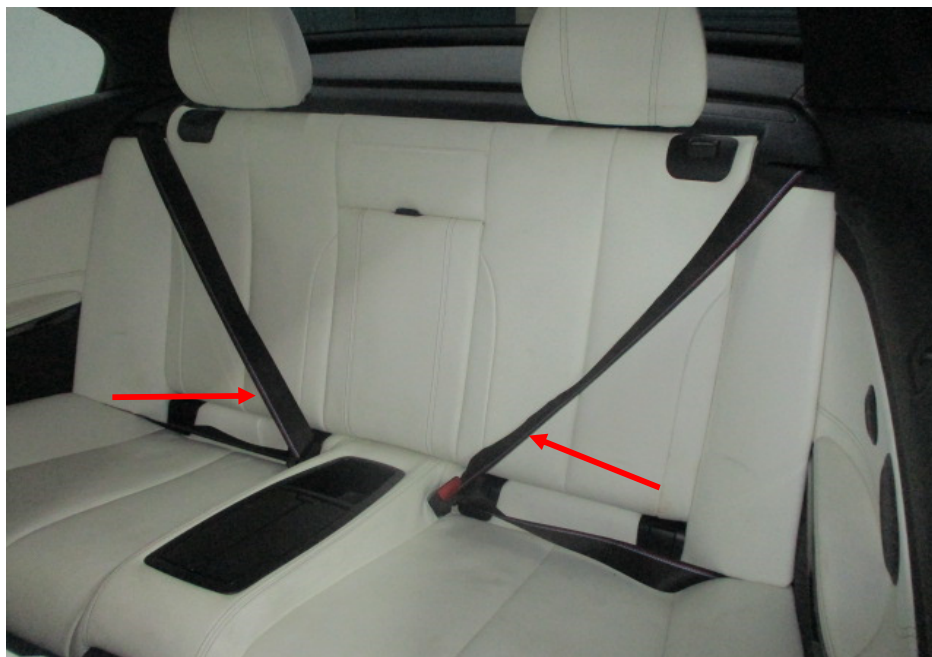
**Photo 15** shows the rear seats of the Motor Car. All the seats of the Motor Car were secured via seat rails to the floorboard. They were also fitted with a retractable seat belt reel and a pre-tensioner. The seat belts (arrowed) were tested and were able to be fastened into the respective pre-tensions that were fitted on the side of each individual seat.

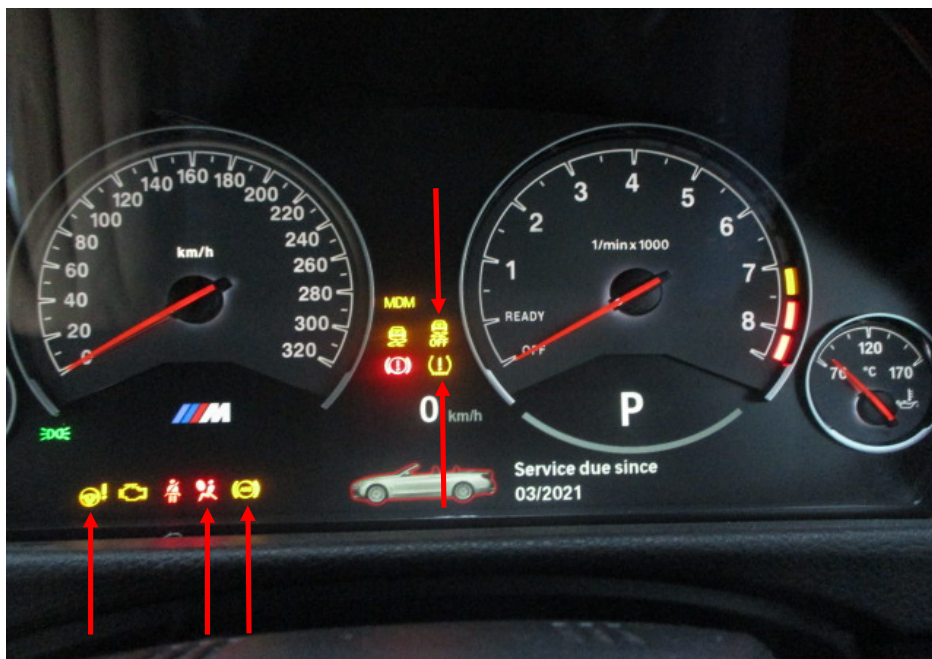
**Photo 16** shows the warning lights for the various electronic safety features appearing on the instrument panel of the Motor Car during its self-test when the engine is cranked, in particular the ABS, SRS, IAS, TPM and DSC lights (arrowed).

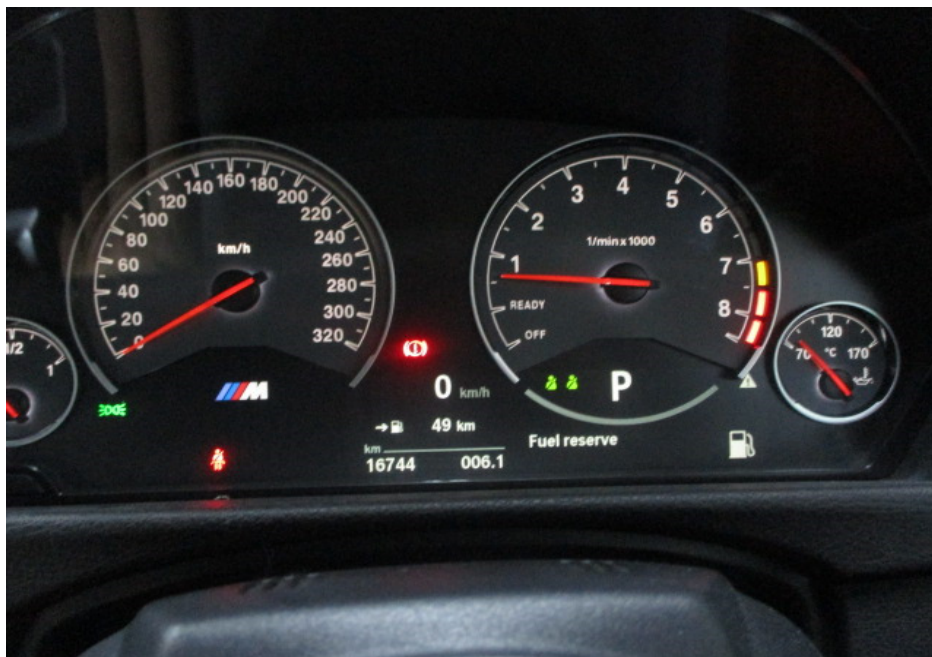
**Photo 17** shows the respective warning lights no longer illuminated, indicating that there is no fault detected to the ABS, SRS, IAS, TPM and DSC systems of the Motor Car during the self-test. These electronic systems were hence in working condition at the time of my inspection.

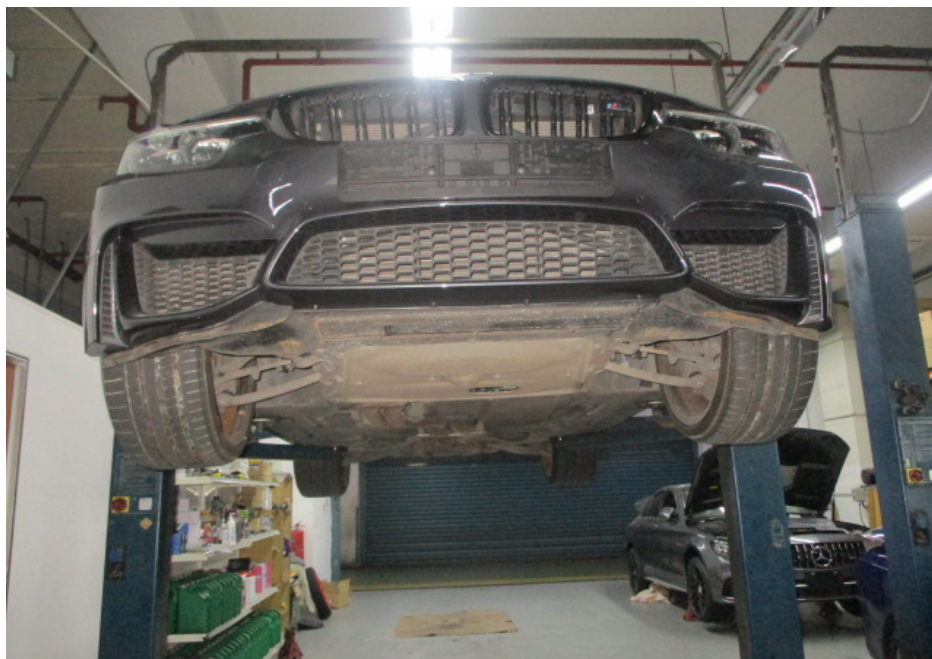
**Photo 18** shows the Motor Car hoisted up for checks on its undercarriage. There was no sign(s) or indication(s) of fluid leakage and/or fluid stain(s) on the underside of the Motor Car. The undercarriage components of the Motor Car were also all observed to be intact and secured in an appropriate manner.

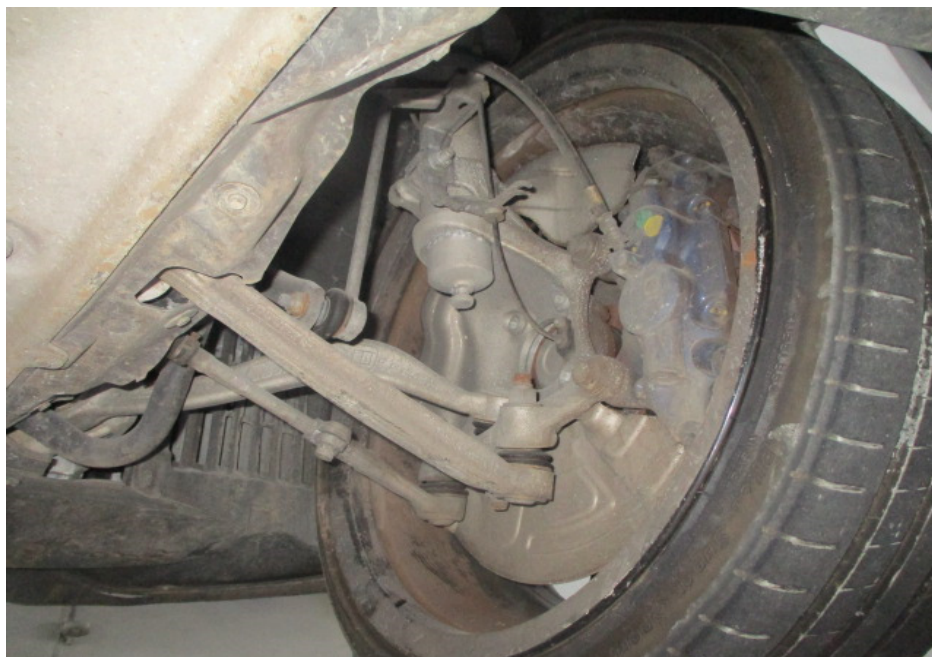
**Photo 19** shows the various undercarriage components at the front right wheel of the Motor Car. The mechanical components, control arms and linkages were all found to be intact and secured in an appropriate manner. I also did not observe any fluid leak and/or fluid stain on the underside of the Motor Car.

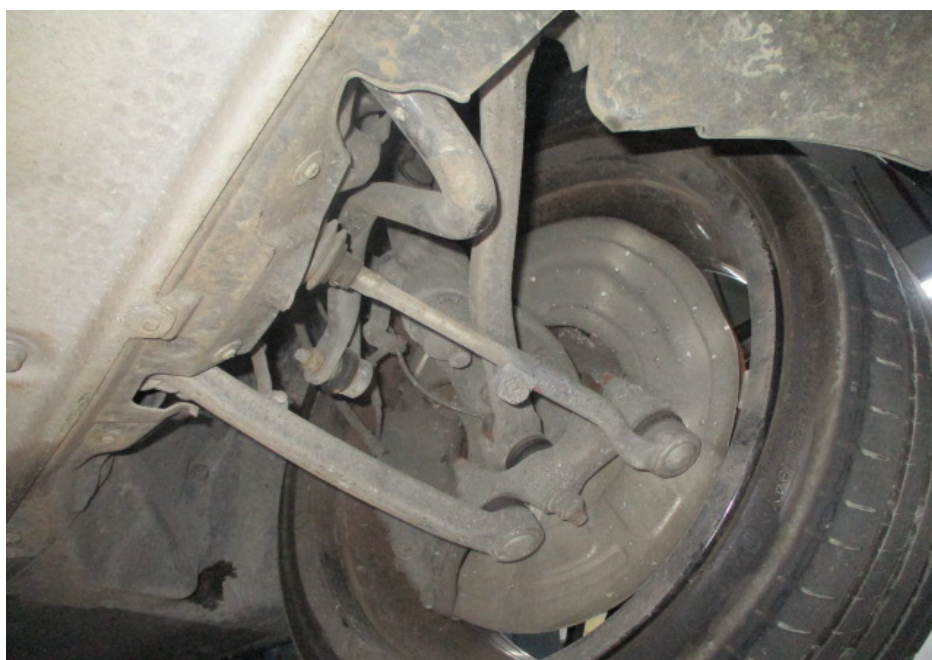
**Photo 20** shows the various undercarriage components at the front left wheel of the Motor Car. The mechanical components, control arms and linkages were all found to be intact and secured in an appropriate manner.

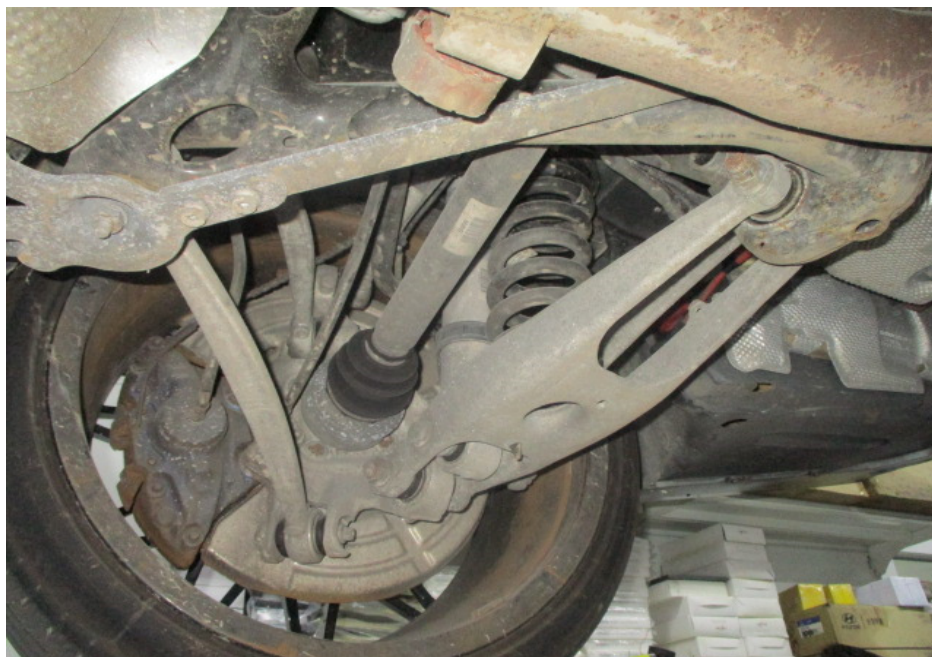
**Photo 21** shows a general view of the control arms and linkages at the rear right wheel of the Motor Car. I did not observe any fluid leak and/or fluid stain on the underside of the Motor Car. All of the Motor Car's undercarriage components were observed to be intact and secured in an appropriate manner.

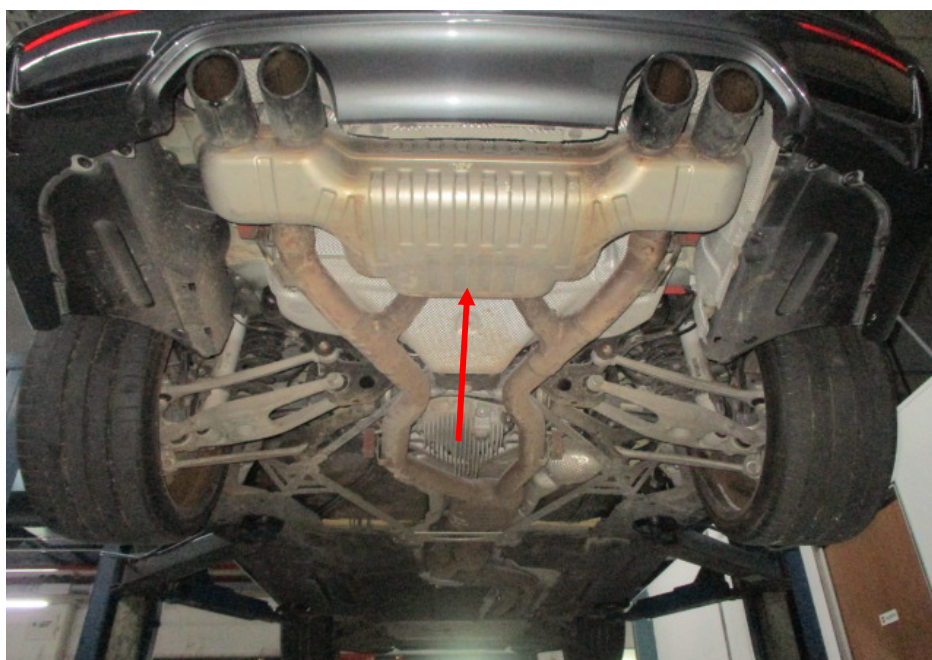
**Photo 22** shows the Motor Car's rear muffler (arrowed). My examination of the Motor Car's exhaust system revealed no sign(s) or indication(s) of any cut or weld marks along its exhaust pipes and on its catalytic converters.

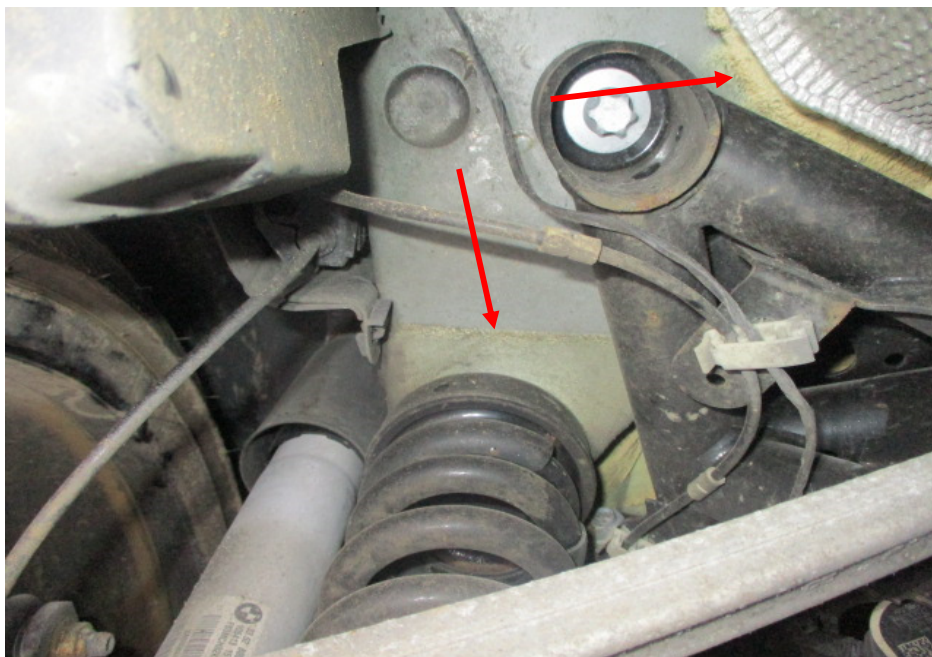
**Photo 23** shows the chassis/structural body at the underside rear left of the Motor Car. I did not find any weld marks other than original spot weld marks on the chassis/structural body of the Motor Car. The original factory sealant (arrowed) at the joints along the chassis/structural body was also untouched, indicating no work was done on the chassis/structural body of the Motor Car and that the chassis/structural body was originally fitted.

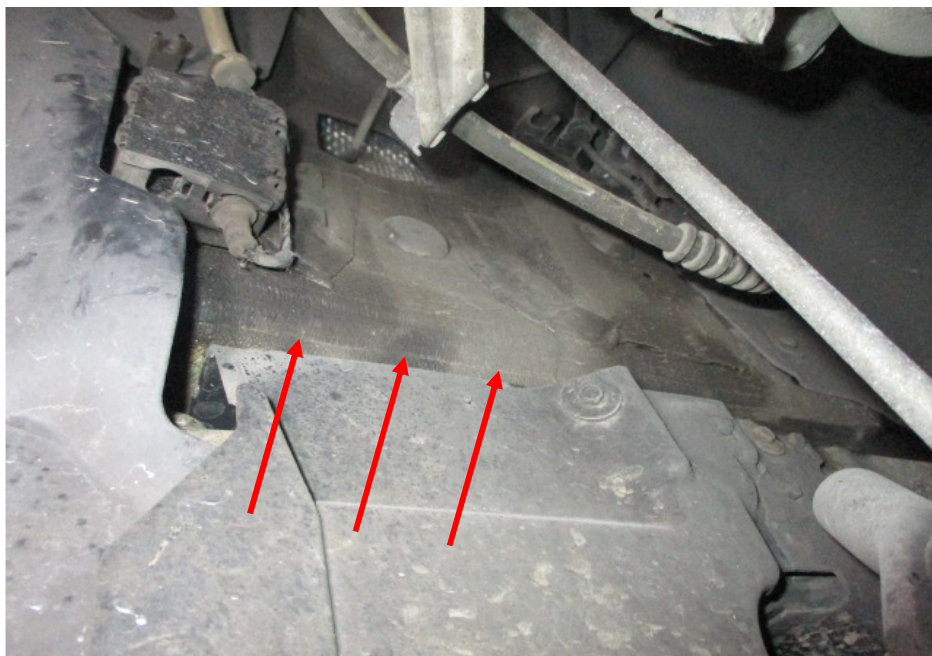
**Photo 24** shows the chassis/structural body at the underside front right of the Motor Car. The original factory sealant (arrowed) at the joints along the chassis/structural body was observed to be untouched. In general, I had found no work was carried out on the chassis/structural body of the Motor Car. The chassis/structural body of the Motor Ca was originally fitted.

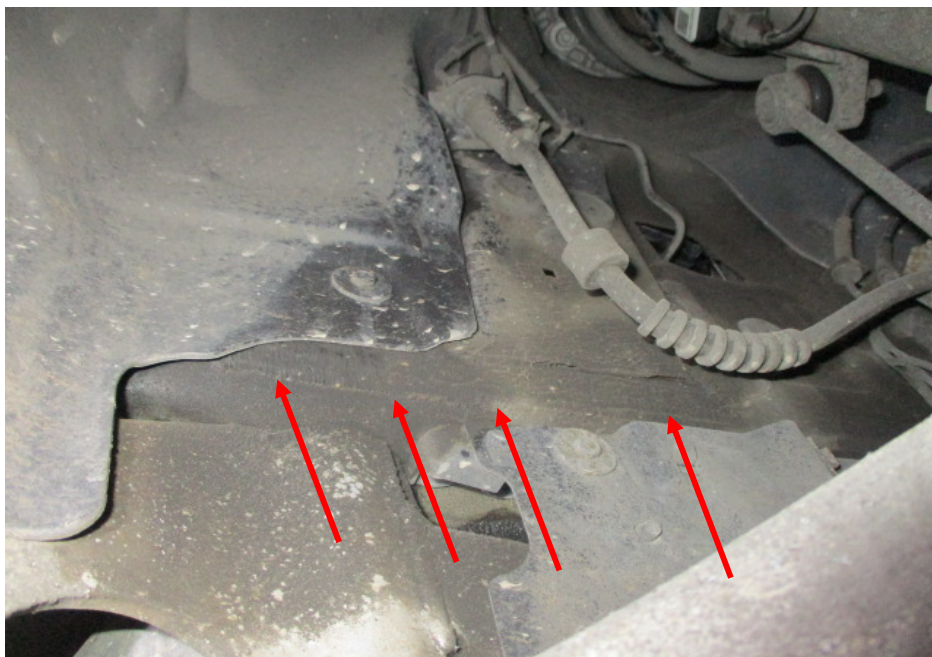
**Photo 25** shows the chassis/structural body at the underside front left of the Motor Car. I did not find any weld marks other than original spot weld marks on the chassis/structural body of the Motor Car. The original factory sealant (arrowed) at the joints along the chassis/structural body was also untouched, indicating no work was done on the chassis/structural body of the Motor Car and that the chassis/structural body was originally fitted.

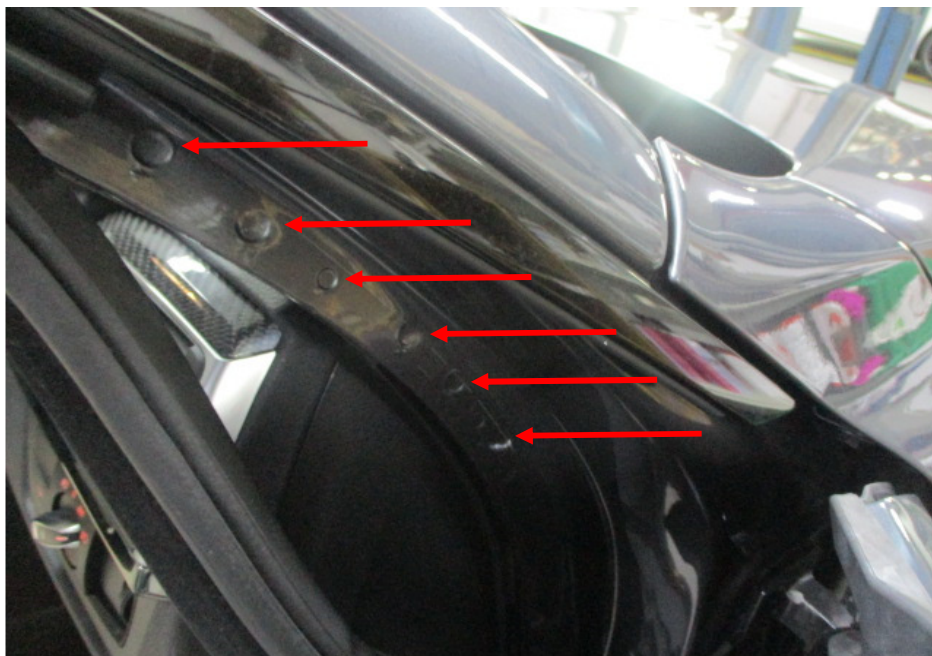
**Photo 26** shows the right side "A" pillar of the Motor Car. I did not find any weld marks other than original spot weld marks (arrowed) on the right side "A" pillar of the Motor Car which, indicates that there was no re-welding works carried out. In general, I had found all the non-detachable body panels of the Motor Car to be originally fitted at the time of my inspection.

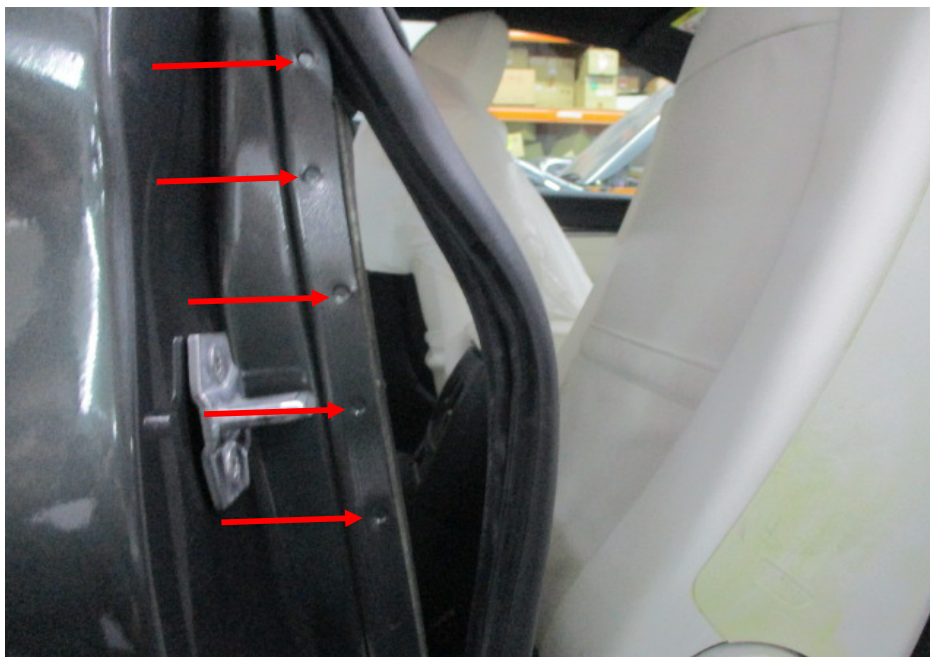
**Photo 27** shows the right side rear body panel of the Motor Car. I did not find any weld marks other than original spot weld marks (arrowed) on the right side rear body panel of the Motor Car which, indicates that there was no re-welding works carried out. In general, I had found all the non-detachable body panels of the Motor Car to be originally fitted at the time of my inspection.
