Your Ref : S1M038QS
Our Ref : CS4/ASM21005094/N

27 April 2021

TECHNICAL INVESTIGATION REPORT OF FIRE INCIDENT INVOLVING THE INSURED VEHICLE SHD 3272X ON 22 APRIL 2021

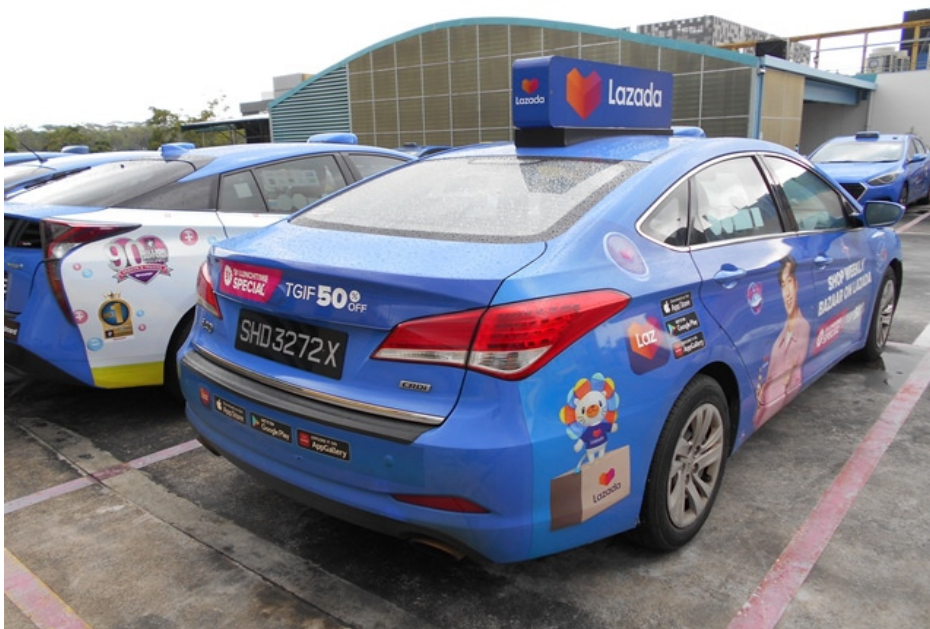
Photo 1 shows the general view of the right rear portion of the Insured Vehicle at the time of our inspection. The rear portion of the Insured Vehicle was relatively unaffected by the fire.

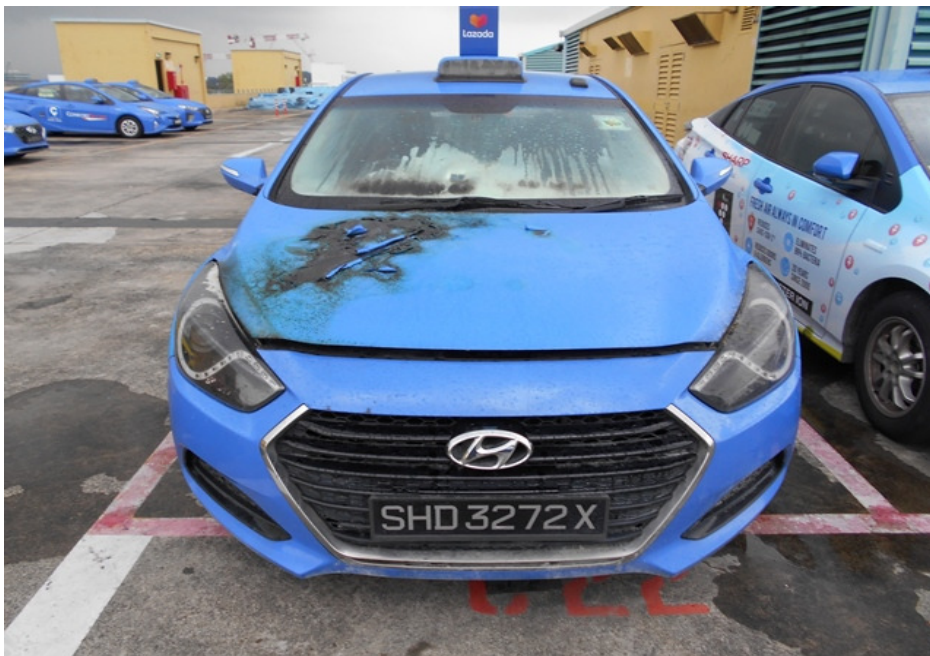
Photo 2 shows the general view of the frontal portion of the Insured Vehicle at the time of our inspection. The fire damage to the Insured Vehicle was confined to its frontal portion. The entire engine compartment of the Insured Vehicle was observed to be severely burnt while the interior compartment was observed to be severely affected by the fire.

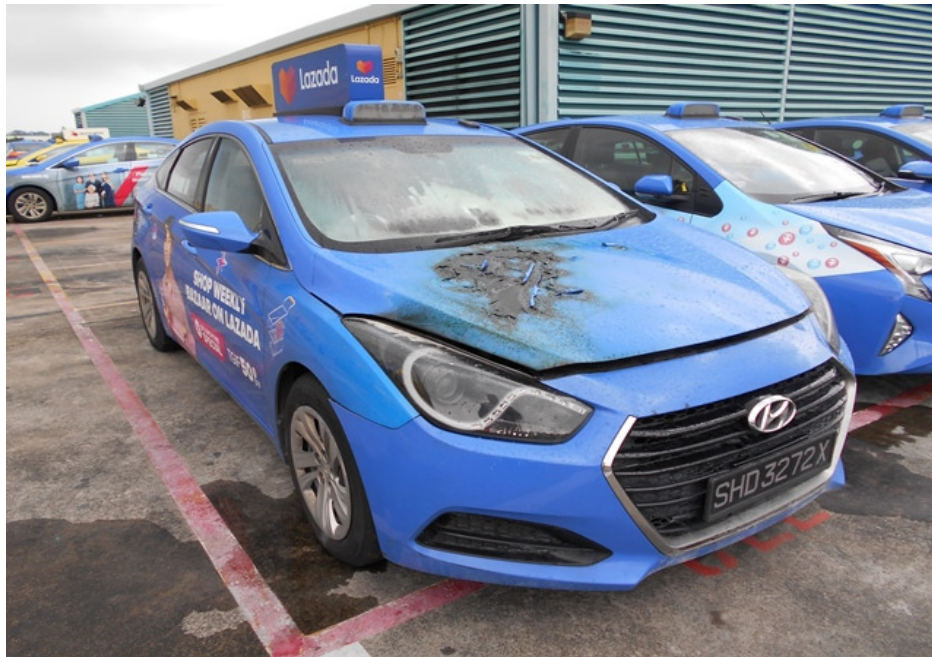
Photo 3 shows the closer view of the right front body of the Insured Vehicle at the time of our inspection. The fire damage to the Insured Vehicle was confined to its frontal portion. Its front bumper, front bonnet, front grille, front headlamps, front windscreen and front windscreen wipers were amongst the body parts that were found to have been affected by the fire.

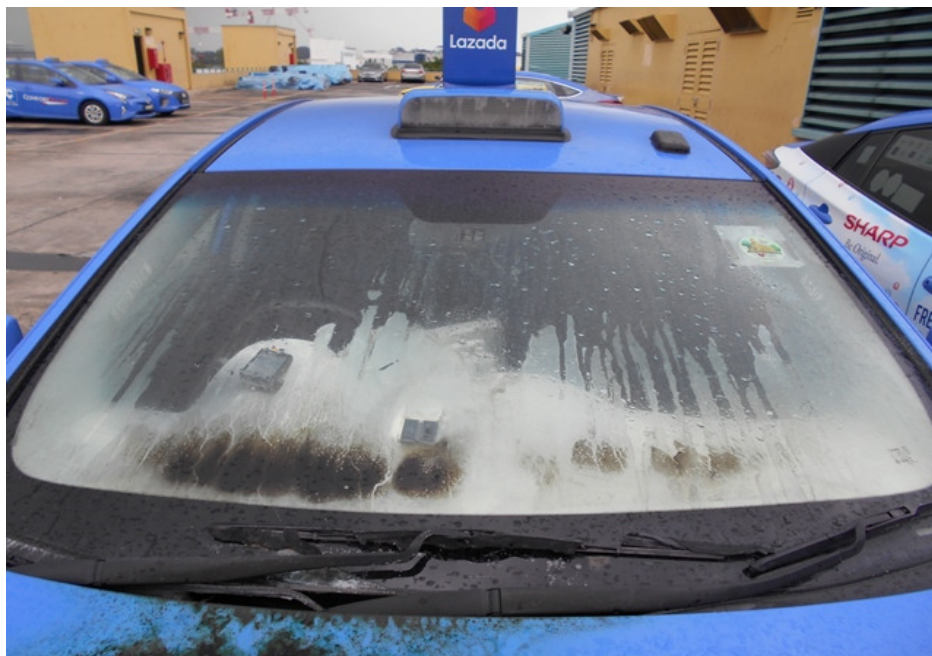
Photo 4 shows the general view of the front windscreen of the Insured Vehicle at the time of our inspection. The fire damage to the front windscreen was severe.

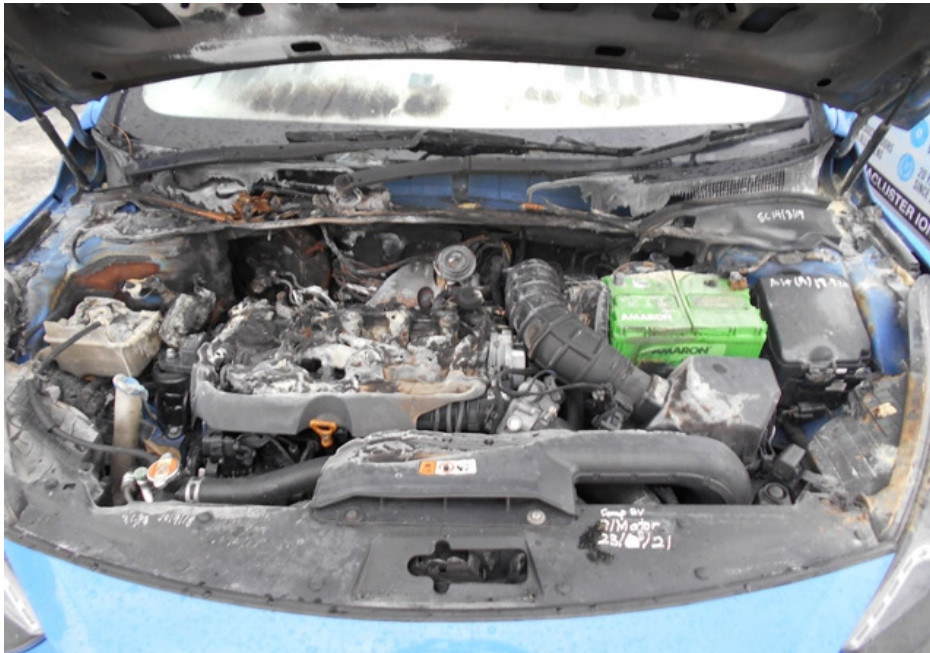
Photo 5 shows the engine compartment of the Insured Vehicle at the time of our inspection. The entire engine compartment of the Insured Vehicle was observed to be severely burnt. Most of the parts inside the engine compartment were found to be burnt and/or melted as a result of the fire.

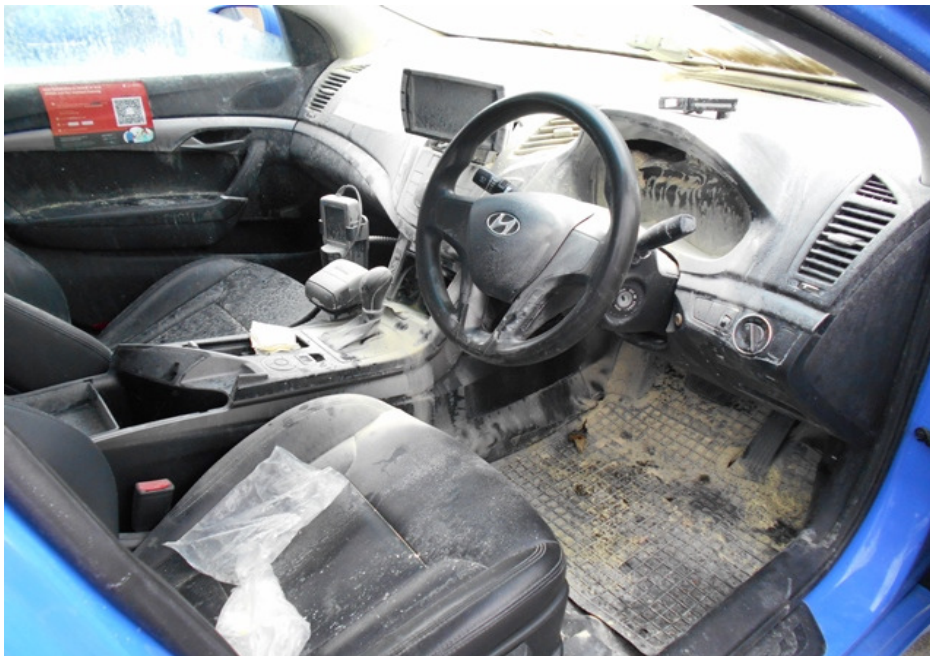
Photo 6 shows the interior compartment of the Insured Vehicle, which was seriously affected by the fire.

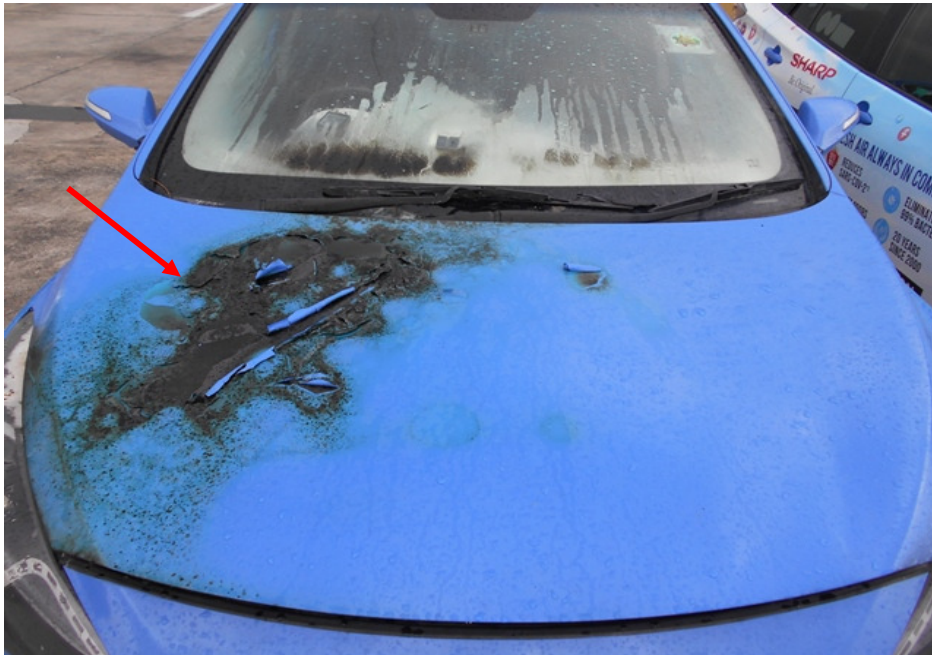
7. For this particular case, the fire appears to have originated within the engine compartment of the Insured Vehicle, somewhere around the right portion of the engine compartment. This can be determined due to the nature of the fire damage which was more extensive at the right portion, the burn pattern found on the right portion of the front bonnet of the Insured Vehicle and also the high heat intensity burn marks (whitish burn marks) as well as rust that had developed on the underside of the front bonnet, at the right portion.

8. The whitish burn marks are a result of exposure to prolonged heat intensity. Rust would normally start to develop around these areas soon after a fire as prolonged exposure to high heat intensity usually causes steel/metal material body parts to be exposed to natural environmental condition. The rust that had developed on the underside of the front bonnet, around the right portion, is an indication that the right portion of the engine compartment had sustained exposure to prolonged high heat intensity. See photos 7 - 9 below.

Photo 7 shows the burn pattern that was found on the right portion of the front bonnet of the Insured Vehicle (arrowed). Such whitish burn marks are a result of exposure to prolonged heat intensity, which may indicate where the fire had started. Rust would also begin to develop on these areas soon after the fire.

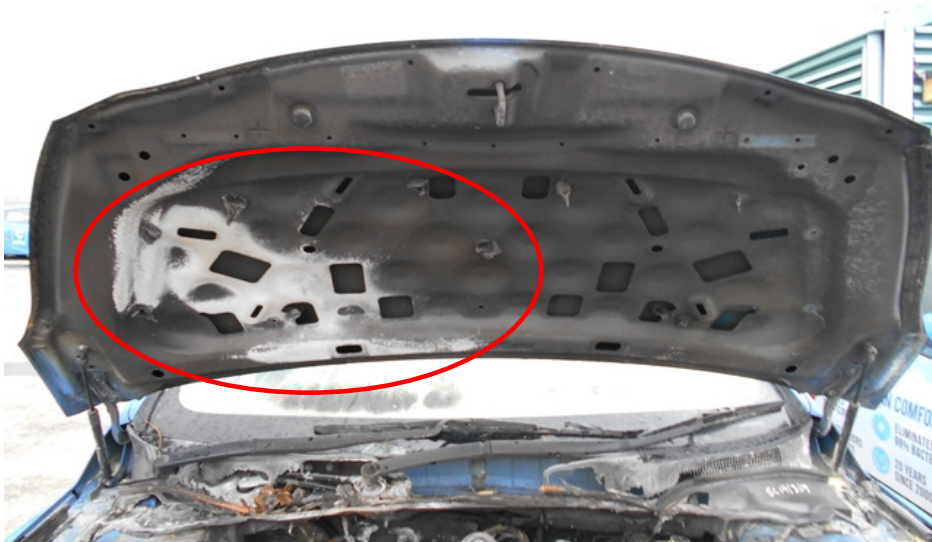
Photo 8 shows the whitish marks that were found on the underside of the front bonnet of the Insured Vehicle, at the right portion (circled). Such whitish burn marks are a result of exposure to prolonged heat intensity, which may indicate where the fire had started. Rust would also begin to develop on these areas soon after the fire.

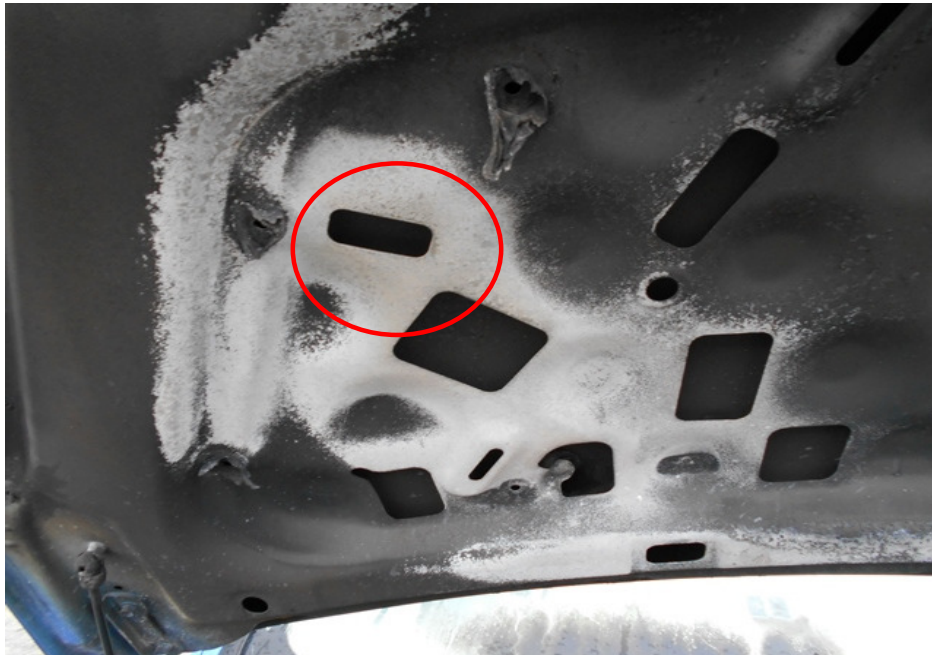
Photo 9 shows the rust that had developed on the underside of the front bonnet, around the right portion (circled). The development of rust is an indication that this area was subjected to prolonged exposure to high heat intensity, which had caused the steel/metal material of the front bonnet to be exposed to natural environmental condition. Hence the fire to the Insured Vehicle can be determined to have originated towards the right portion of the engine compartment.

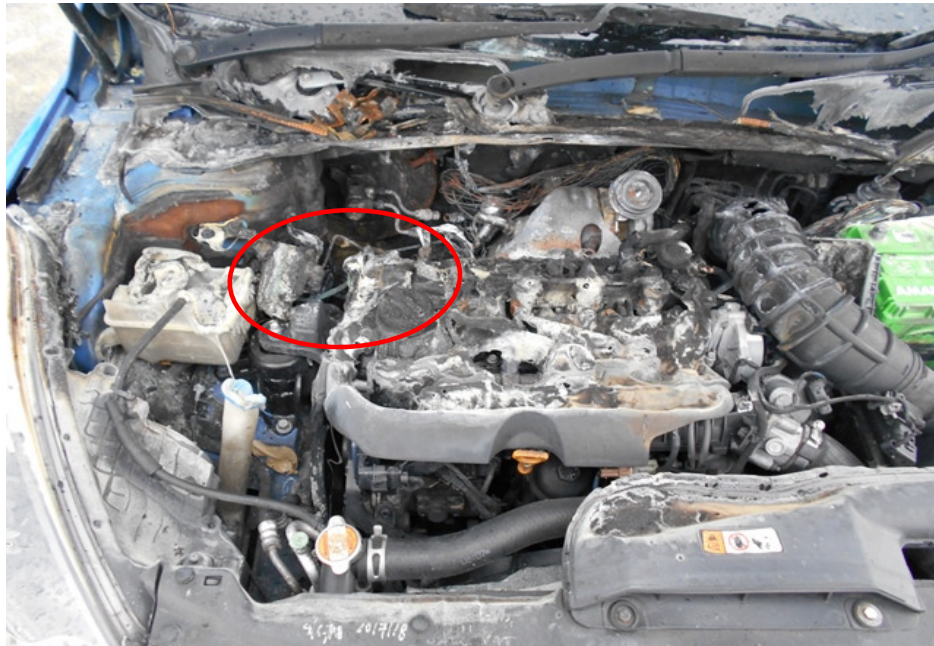
9. Upon closer examination of the right portion of the engine compartment, which was where the fire to the Insured Vehicle had likely started, we had found greenish residue on several burnt stretches of original factory fitted wirings around the right portion of the engine compartment. The presence of such greenish residue indicates internal heating of copper wires, a sign of an electrical short circuit occurring. The greenish residue is normally left behind from oxidation as a result of chemical reaction involving the copper wires. This physical evidence would then appear to suggest that the cause of fire to the Insured Vehicle could have possibly been due to electrical in nature. See photos 10 - 13 below.

Photo 10 shows the original factory fitted wirings around the right portion of the engine compartment, which is in the immediate vicinity where the fire to the Insured Vehicle had likely started. We had found greenish residue on several burnt stretches of these wirings (circled). The presence of such greenish residue indicates internal heating of copper wires, a sign of an electrical short circuit occurring. The greenish residue is normally left behind from oxidation as a result of chemical reaction involving the copper wires.

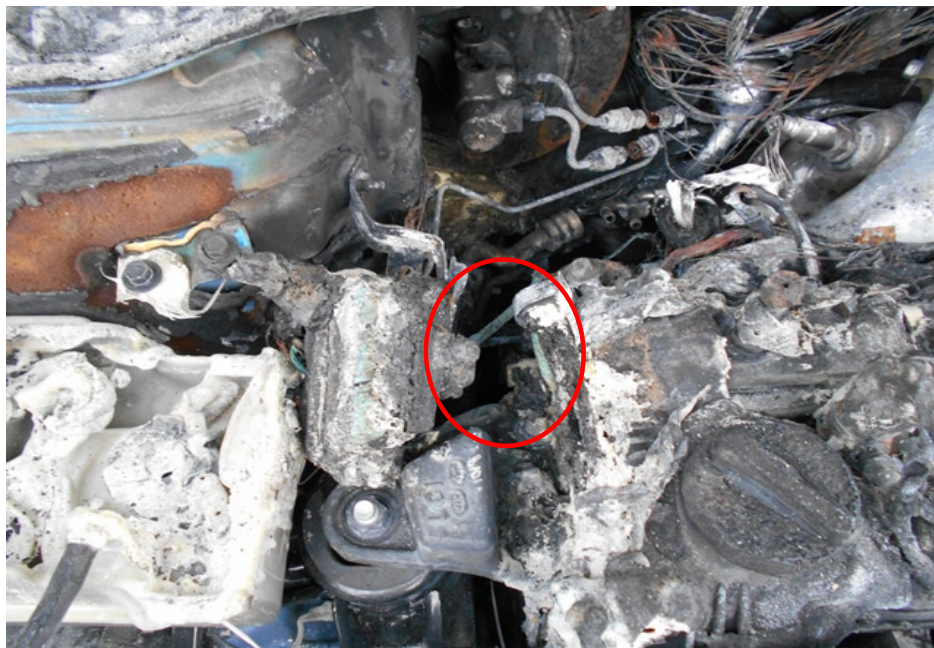
Photo 11 shows a closer view of the greenish residue found on some of the burnt stretches of original factory fitted wirings (arrowed). The presence of such greenish residue suggests occurrence of an electrical short circuit.

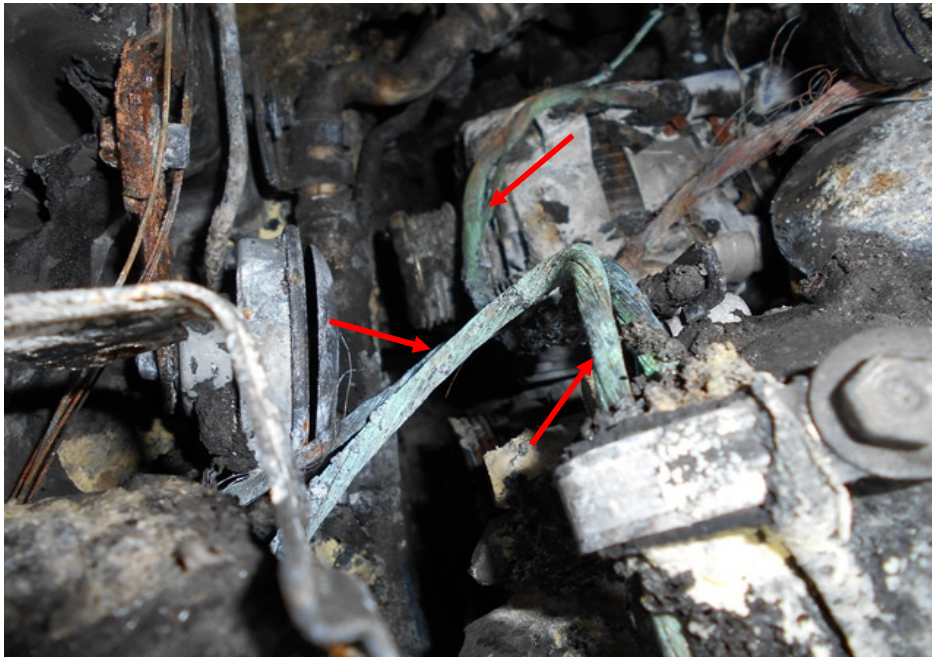
Photo 12 shows a close up view of the greenish residue found on some of the burnt stretches of original factory fitted wirings (arrowed). The presence of such greenish residue suggests occurrence of an electrical short circuit.

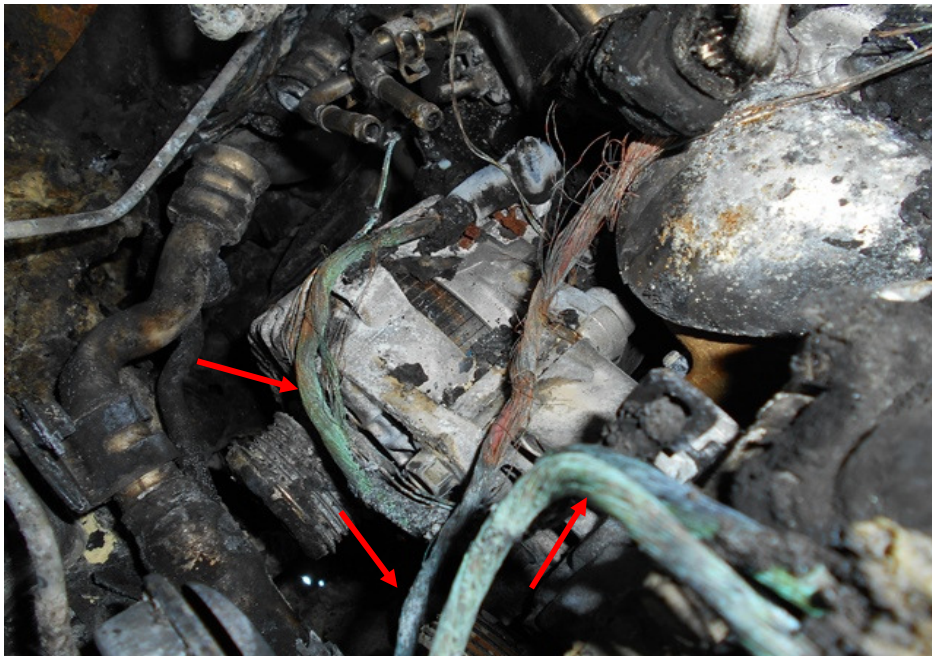
Photo 13 shows a close up view of the greenish residue found on some of the burnt stretches of original factory fitted wirings (arrowed). The presence of such greenish residue suggests occurrence of an electrical short circuit.

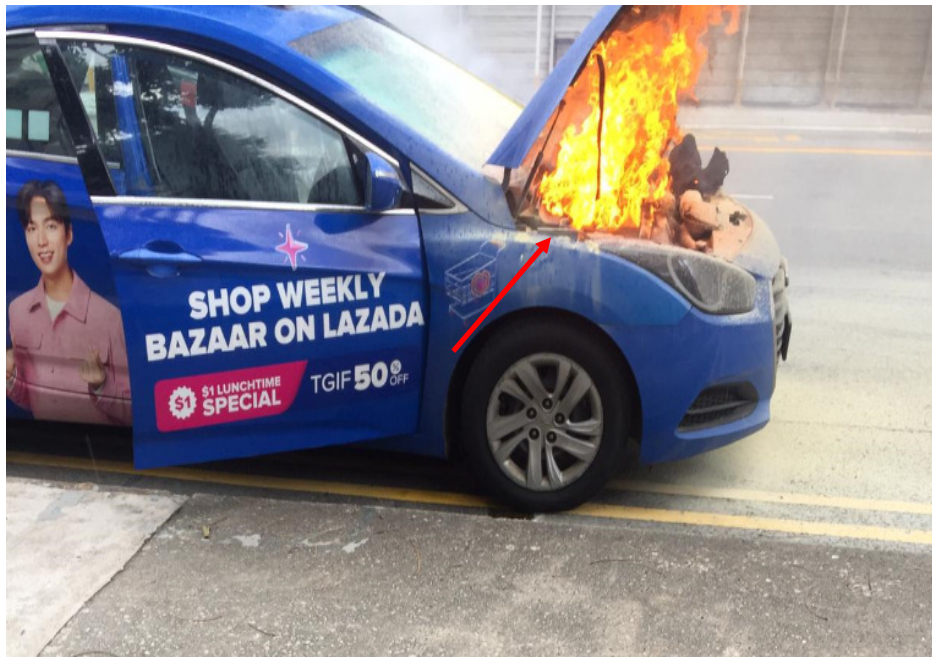
Photo 14 shows the Insured Vehicle on fire before the arrival of the SCDF. In general, the information that could be gathered from this photograph had corresponded to the events that were related to us by Mr Lim, which is the fire had started from the right portion of the engine compartment of the Insured Vehicle (arrowed).

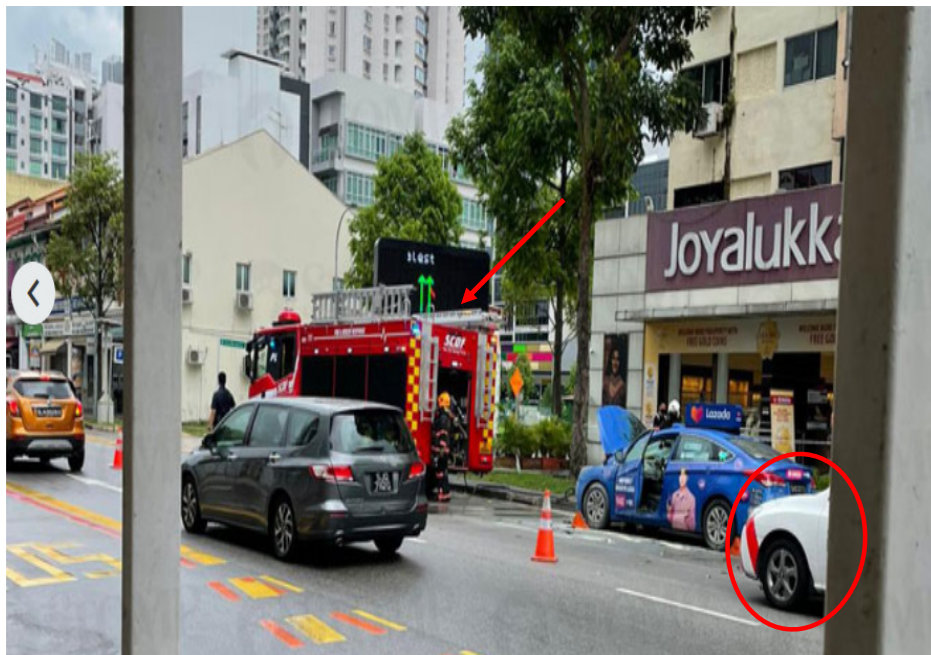
Photo 15 shows Insured Vehicle after the fire was extinguished by the SCDF. In general, the information that could be gathered from this photograph had corresponded to the events that were related to us by Mr Lim, which is the police (circled) and SCDF (arrowed) were present at the incident location.

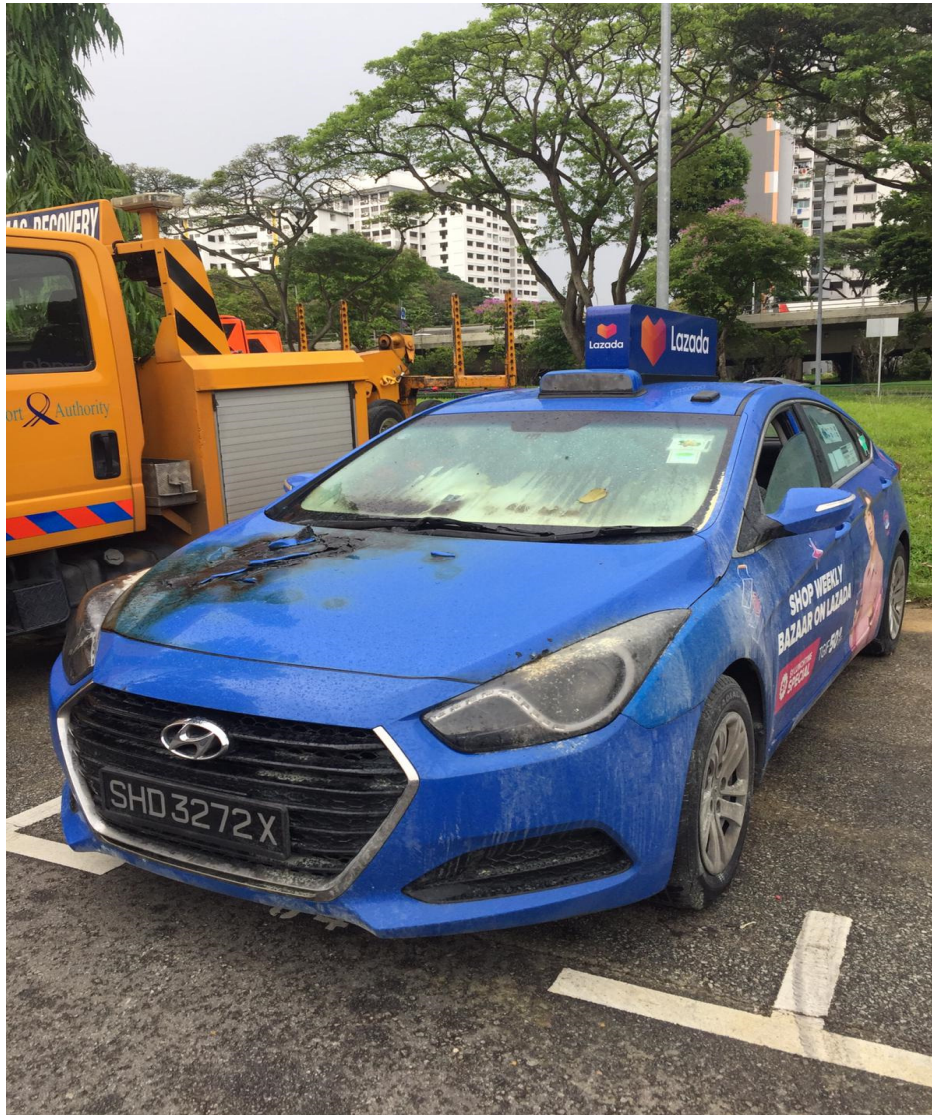
Photo 16 shows the Insured Vehicle after being towed to an open carpark near Paya Lebar Road by EMAS towing personnel post- incident.

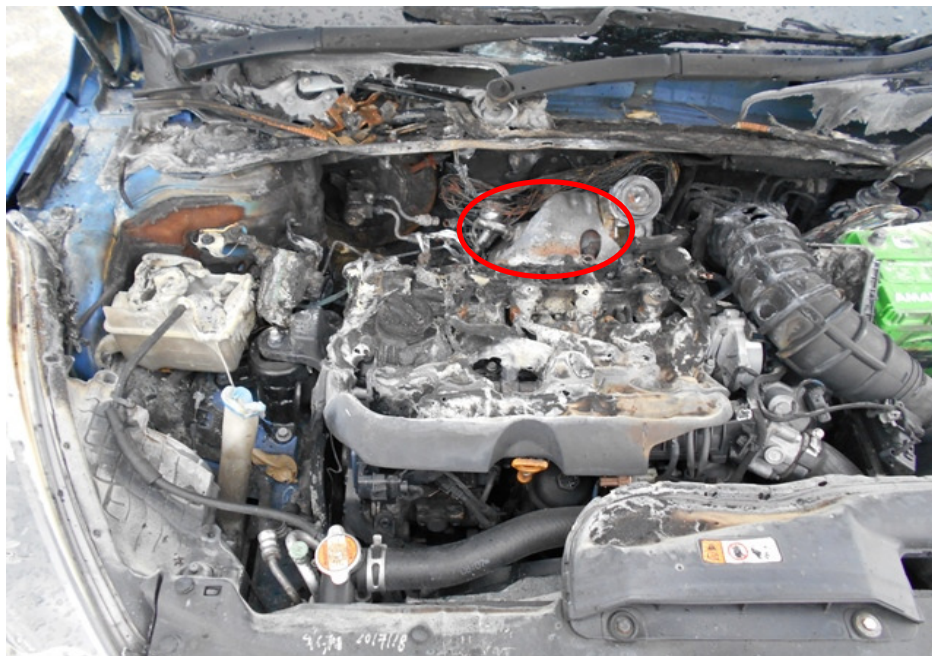
27. For this case, the driver had seen white smoke emitting from the exhaust muffler. This is likely to be overheating of the turbocharger or malfunction of the turbocharger. During our physical inspection of the Insured Vehicle, we observed that the turbocharger was fitted at the rear right portion of the engine compartment and this is in the immediate vicinity to where the fire had likely started. See photo 17 below.

Photo 17 shows during our physical inspection of the Insured Vehicle, we observed that the turbocharger was fitted at the rear right portion of the engine compartment (circled) and this is in the immediate vicinity to where the fire had likely started.

28. From the statement of Mr Lim, he had continued to drive the Insured Vehicle after seeing the white smoke emitting from the exhaust muffler. In our opinion, this continued driving had accelerated the heat intensity from the turbocharger which could have then deteriorated the wirings, leading to the electrical short circuit and subsequent fire. In other words, the fire would not have started if the Insured Vehicle was not driven / operated after the white smoke was seen. The fire is a consequence of the continued usage of the Insured Vehicle.
