### INTERIM REPORT

<b>YOUR REF.</b>	S0M02VJ5
<b>OUR REF.</b>	AAS2020-30133/WWK
<b>POLICY NO.</b>	GA508649
<b>PERIOD OF INSURANCE</b>	27/10/2019 –26/10/2020
<b>NAME OF INSURED</b>	Direct Builders Pte Ltd 7030 Ang Mo Kio Avenue 5 #08-81 Northstar@AMK Singapore 569880
<b>EMAIL ADDRESS &amp; CONTACT NO:</b>	Email: kk@directbuilders.com.sg Mobile: 9026 7848 (Insured's director: Mr Jayaraman)
<b>NAME OF AUTHORISED DRIVER &amp; ADDRESS</b>	Mr Perathaban Parry, 37 years old, Indian national (Insured's direct employee) Block 180 Bukit Batok West Ave 8 #03-191Singapore 650180
<b>EMAIL ADDRESS &amp; CONTACT NO:</b>	No Email Mobile: 8574 2141
<b>TIME , DAY &amp; DATE OF ACCIDENT:</b>	At about 2110 hours on Tuesday 13 October 2020
<b>LOCATION OF ACCIDENT</b>	Along Jurong West Avenue 2 towards Jurong West Avenue 4 before signalized junction of Bulim Avenue
<b>INSURED VEHICLE</b>	An Isuzu CYZ52K Tipper Truck, bearing registration number <b>XE2353H</b>

<b>THIRD PARTIES</b>	1) Mr Neo Sin Gee, 59 years old, Singapore citizen, driving a Toyota Altis vehicle <b>SKZ3582A (NTUC)</b>  2) Mr Chang Yang Sek, 61 years old, Singapore citizen, driving a Toyota Axio vehicle <b>SLE9272D (TMIS)</b>
<b>TYPE OF

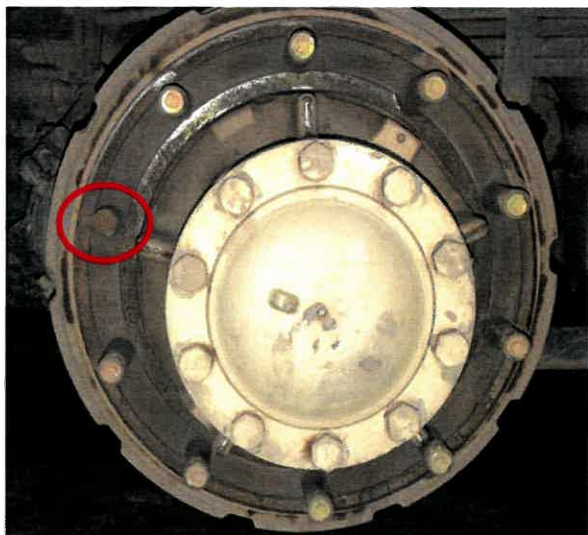
5.20 He inspected the dislodged wheel at the accident scene and noted that one of the wheel bolts was broken.

One of the wheel bolts mounted to the wheel drum was broken ('red' circle)

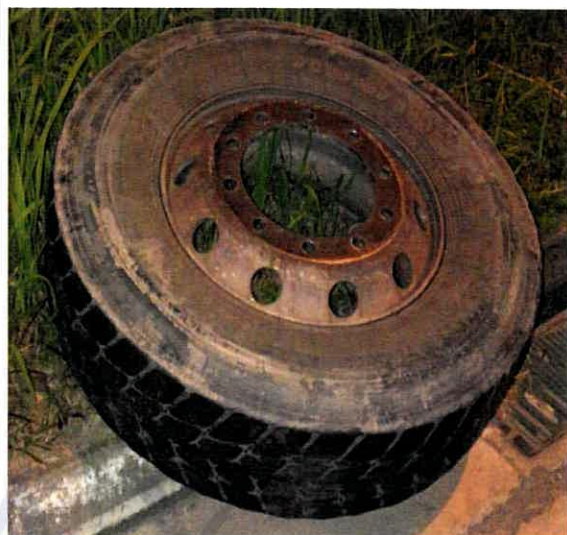
The dislodged tyre

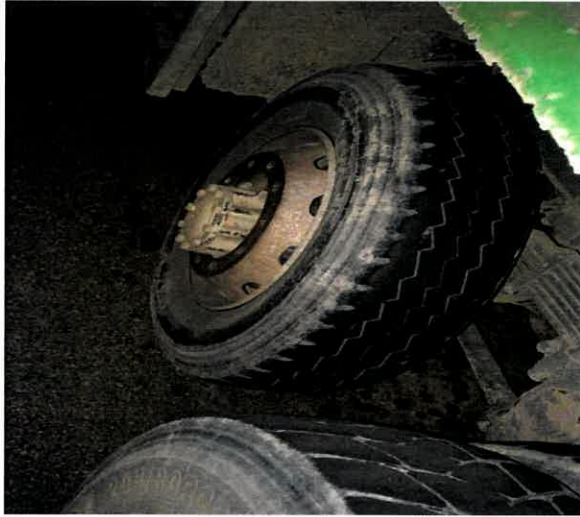
The dislodged tyre from left center outer tyre

6.2 The left center outer tyre of the Insured Vehicle was dislodged.

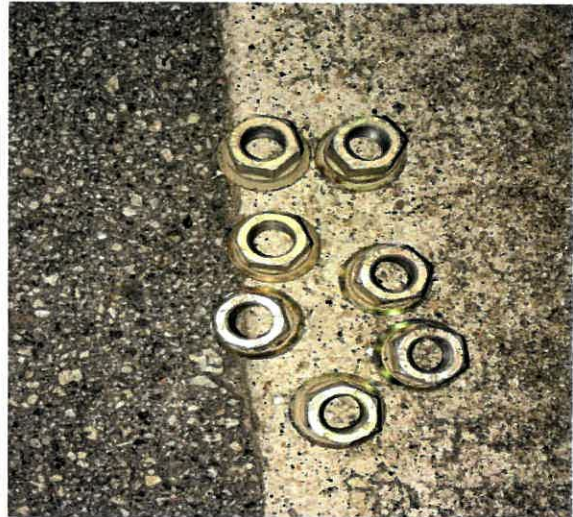
5.21 He also managed to retrieved 7 bolts which were supposed to secured the dislodged tyre with the remaining scattering off on the road.

7 nuts retrieved after the accident with remaining scattered off

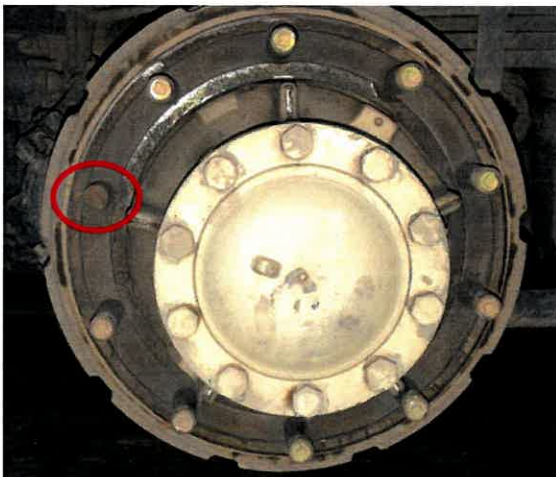
5.23 Based on the following photograph taken at the scene by the Authorised Driver, the 'Red' circle shows the broken bolt.

One of the wheel bolts mounted to the wheel drum was broken

5.25 The dislodged wheel is held by 10 bolts where one of it broke. However, we opined it may not be the probable cause since there are still 9 other bolts holding it and in addition, the wheel is still being secured by 10 nuts around it.

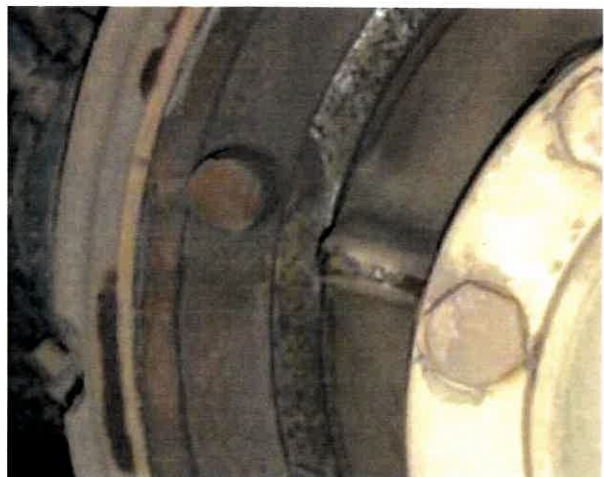
Evidence of rust on broken section

5.24 We noted that the broken section of the bolt is already rusted which suggest the broken bolt could have already existed prior to the accident.

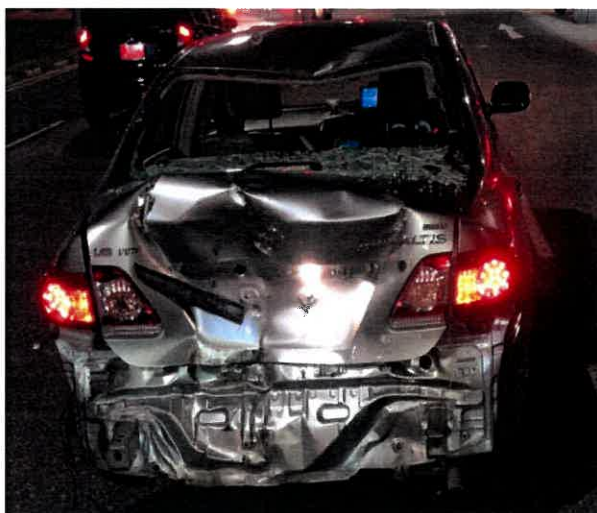
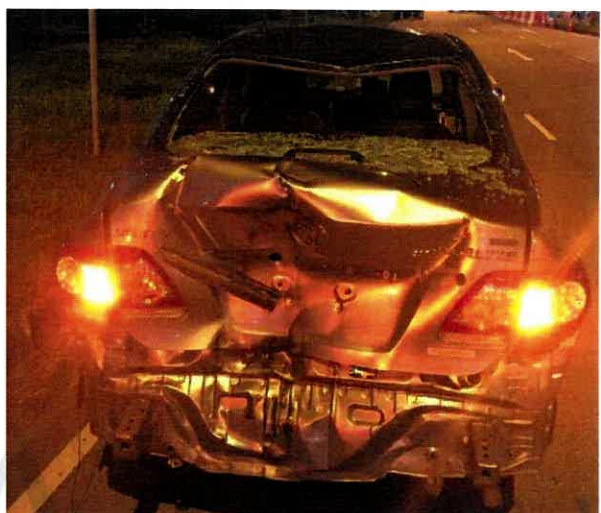
### THIRD PARTY VEHICLE - SKZ3582A (NTUC)

- xv. When he approached vehicle **SKZ3582A**, he noticed the rear portion of it was badly damaged, its rear windscreen was shattered and the roof top dented.

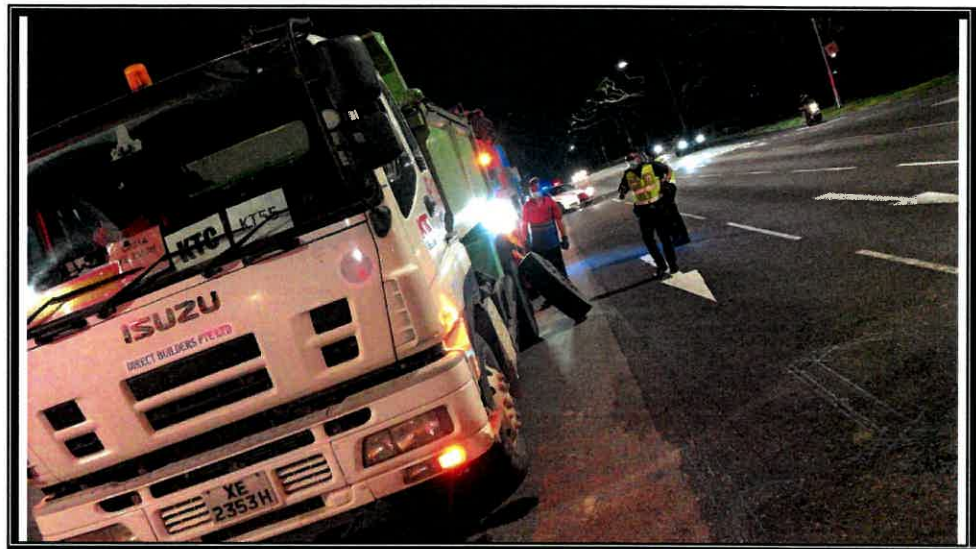
***Photo  
No 1***

**View of Insured Vehicle**

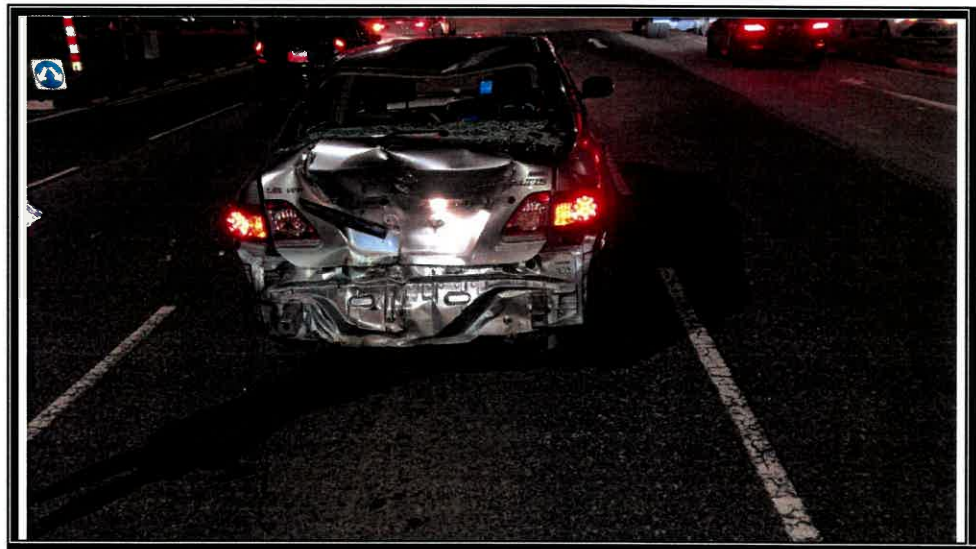
***Photo  
No 2***

**View of vehicle SKZ3582A**

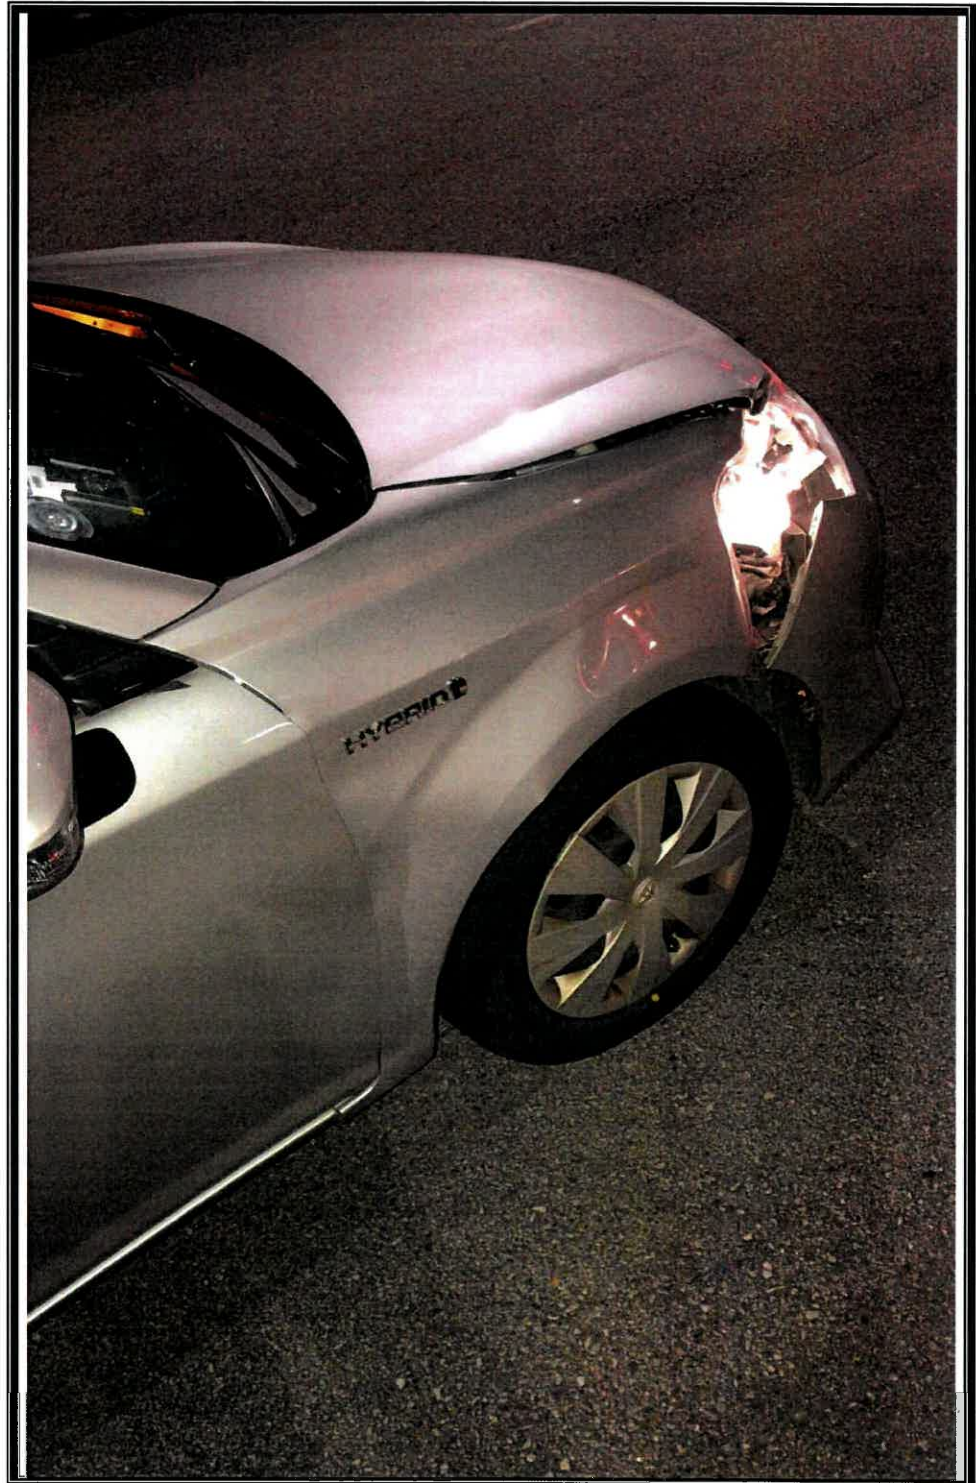
*Photo  
No 3*

**View of vehicle SLE9272D**

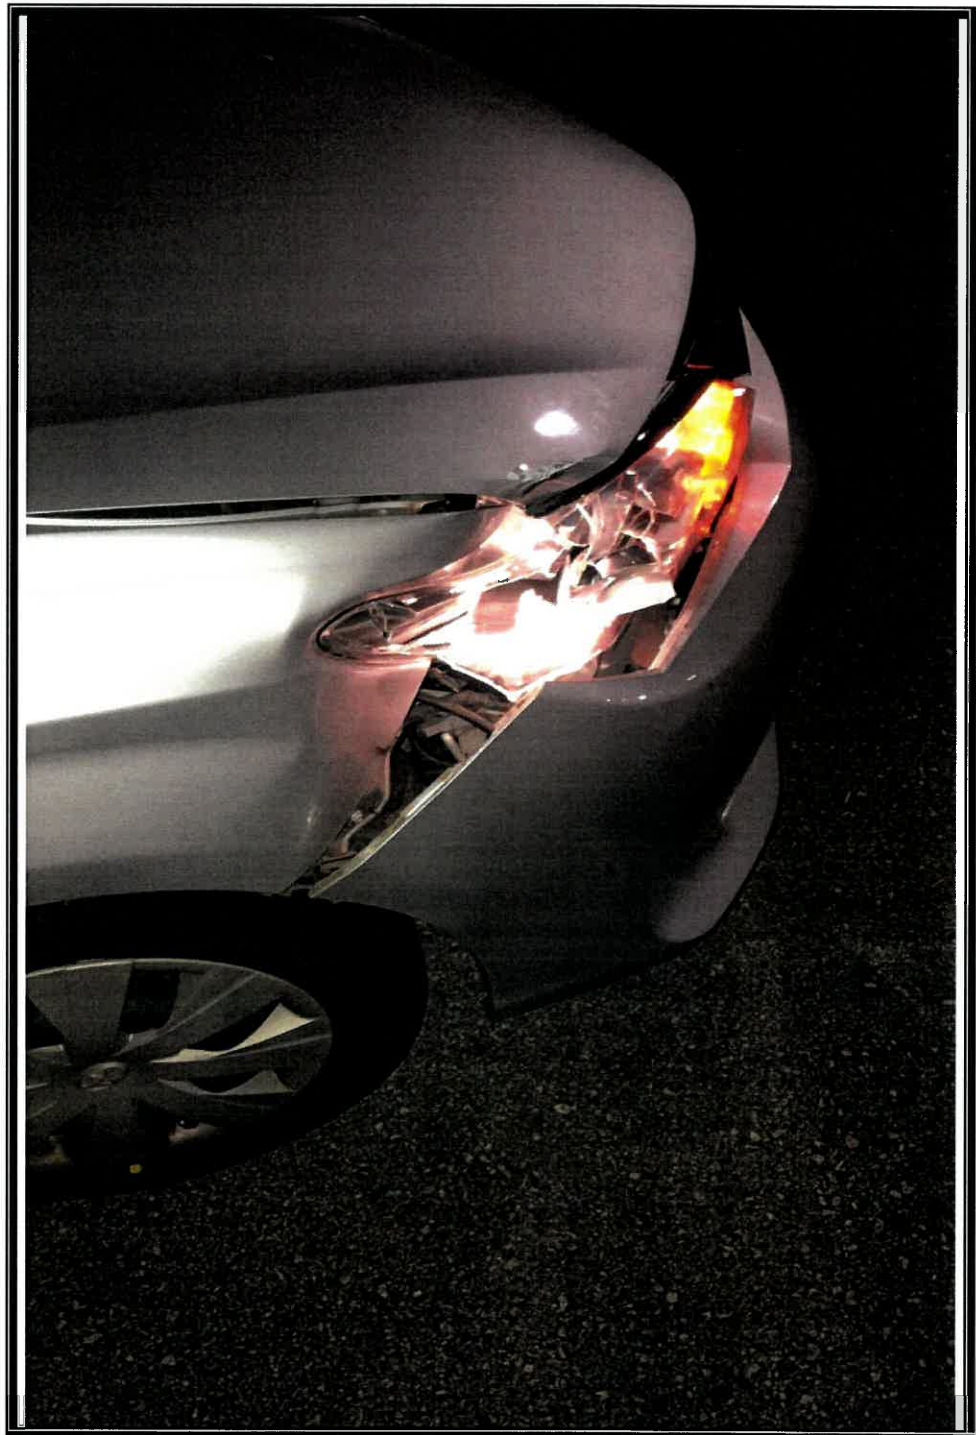
*Photo  
No 4*

**View of vehicle SLE9272D**

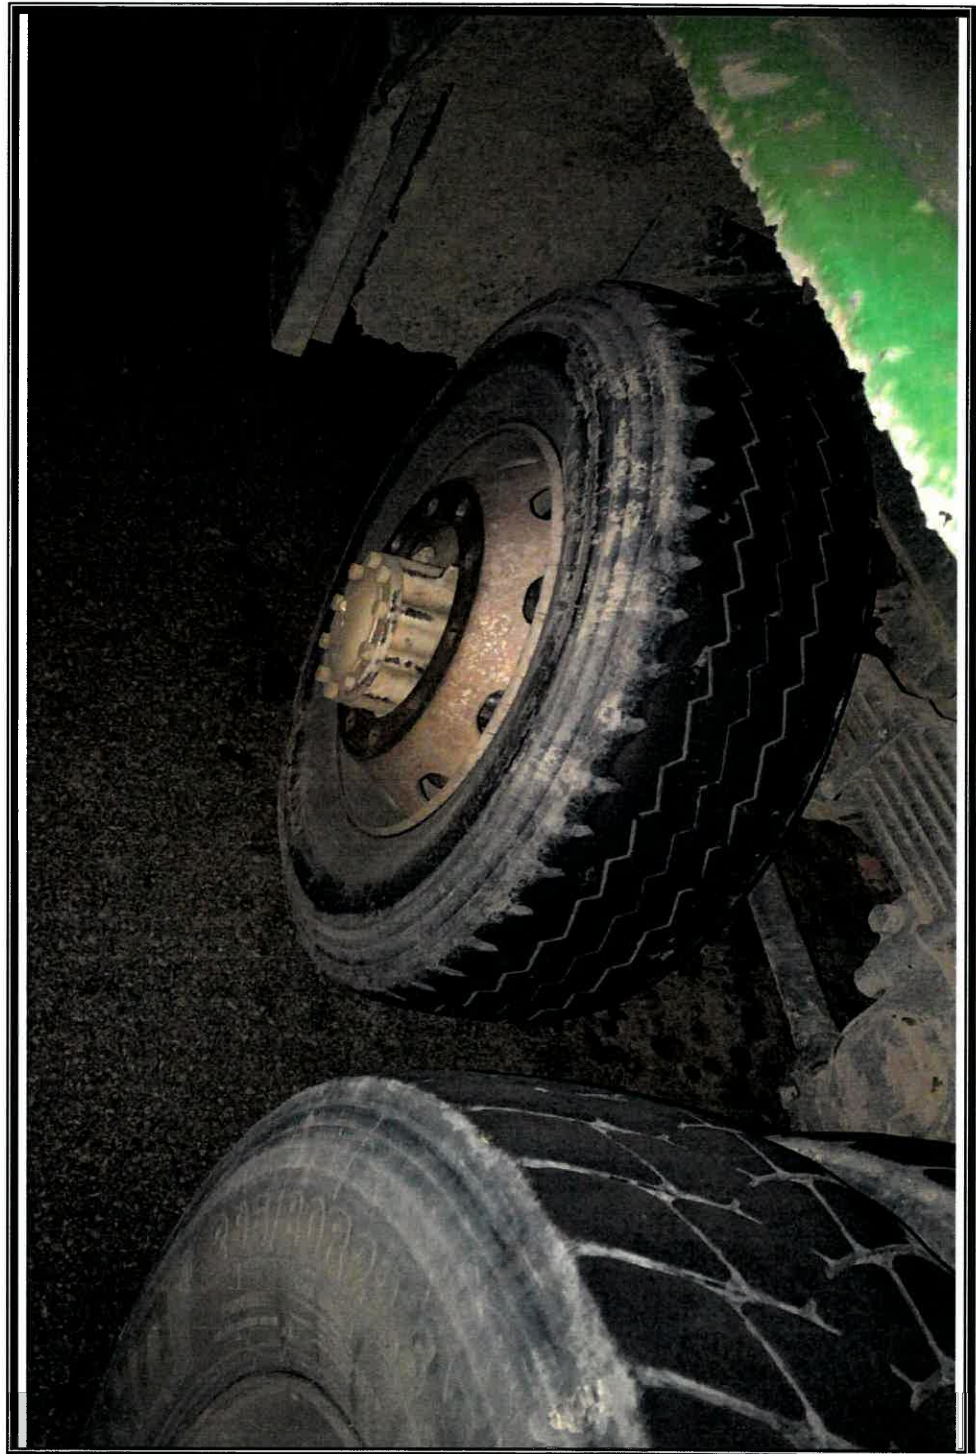
*Photo  
No 5*

**The dislodged tyre from left center outer tyre of Insured Vehicle**

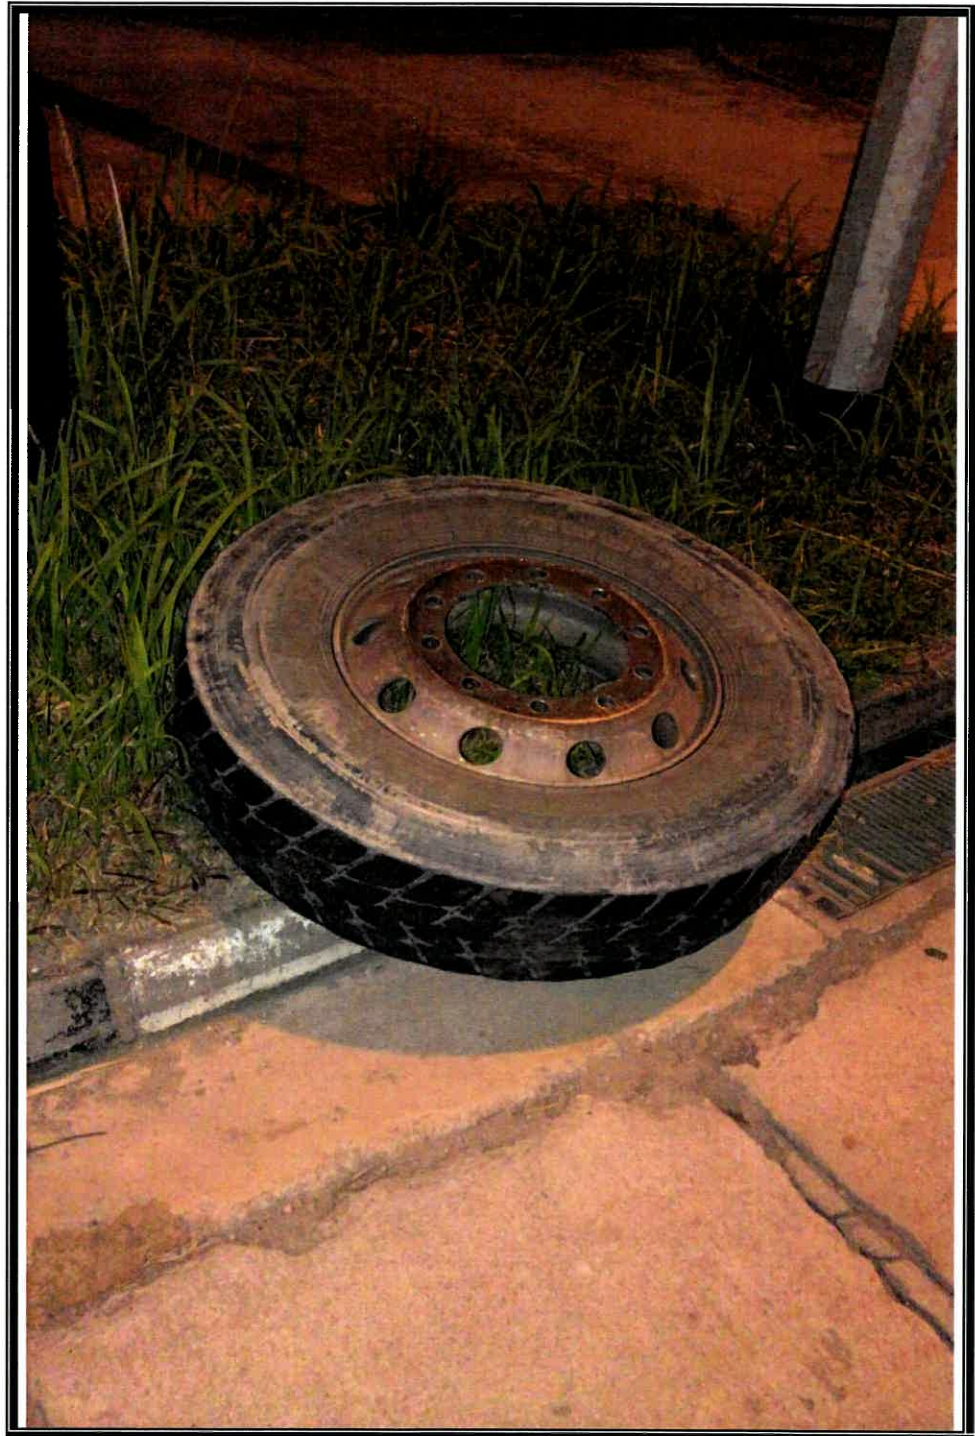
***Photo  
No 6***

**The dislodged tyre from left center outer tyre of Insured Vehicle**

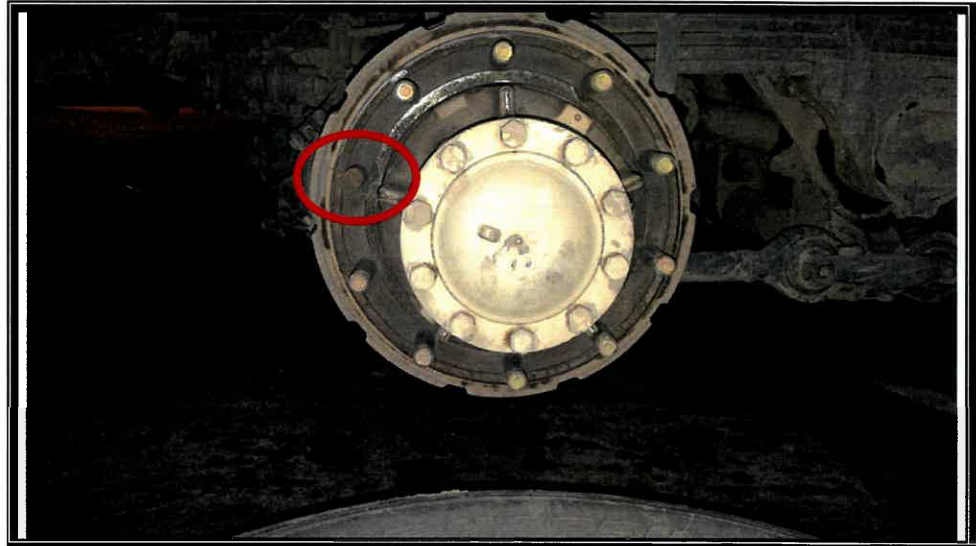
***Photo  
No 7***

**One of the wheel bolts mounted to the wheel drum was broken ('red' circle)**

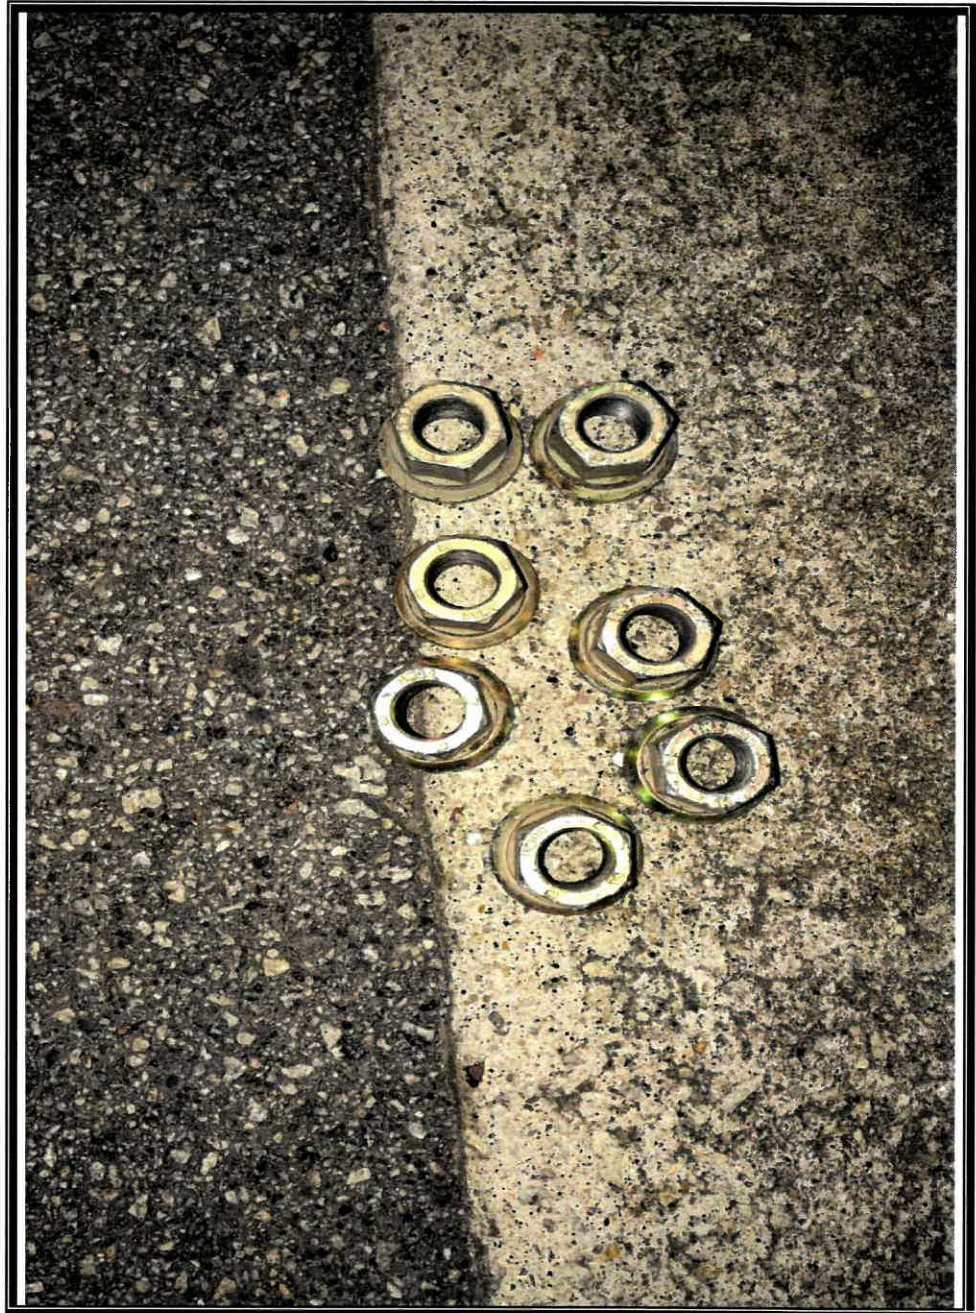
***Photo  
No 8***

**7 nuts retrieved after the accident with remaining scattered off**
