Your Ref: S0M02VJ5
Our Ref : CI/ASM21005184/D

14 May 2021

**TECHNICAL INVESTIGATION REPORT OF INCIDENT INVOLVING THE
INSURED VEHICLE XE 2353H ON 13 OCTOBER 2020**

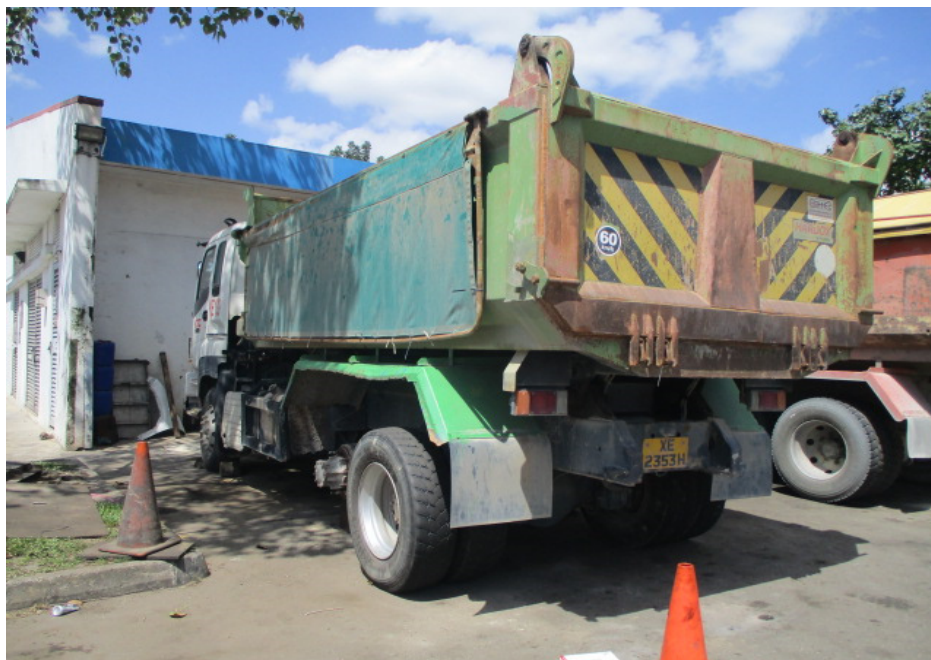
5. The Insured Vehicle, under normal circumstance, is fitted with 10 tyres on 3 axles however at the time of my inspection, both the left inner and outer tyres at the 2nd axle were not fitted on the Insured Vehicle. See photo 1 - 4 below.

Photo 1 shows a general view of the rear left body of the Insured Vehicle. The Insured Vehicle, under normal circumstance, is fitted with 10 tyres on 3 axles however at the time of my inspection, both the left inner and outer tyres at the 2nd axle were not fitted on the Insured Vehicle.

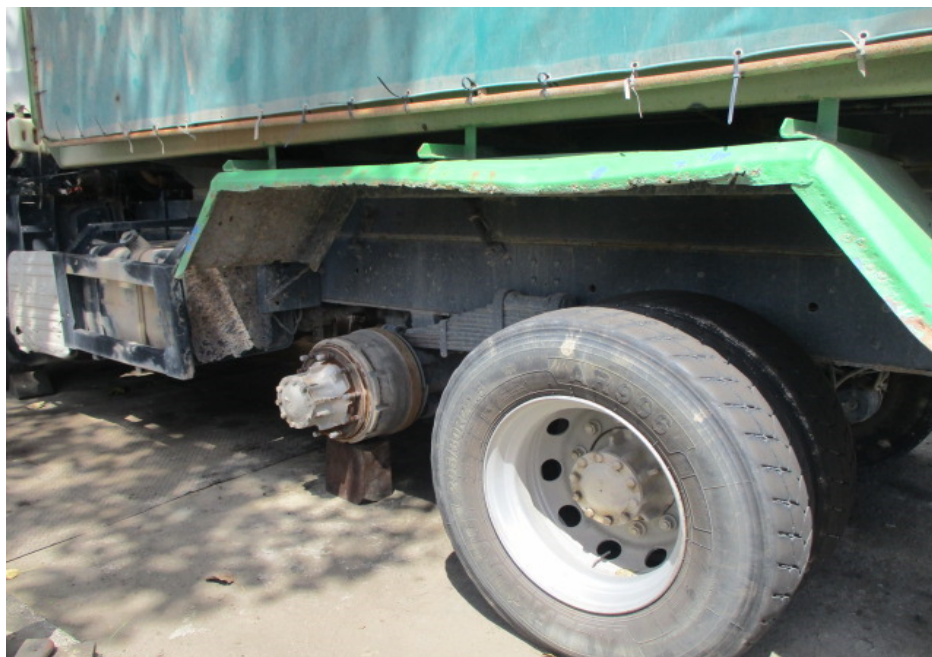
Photo 2 shows a closer view of the 2nd axle and 3rd axle at the left side of the Insured Vehicle. At the time of my inspection, the left inner and outer tyres at the 2nd axle were not fitted on the Insured Vehicle.

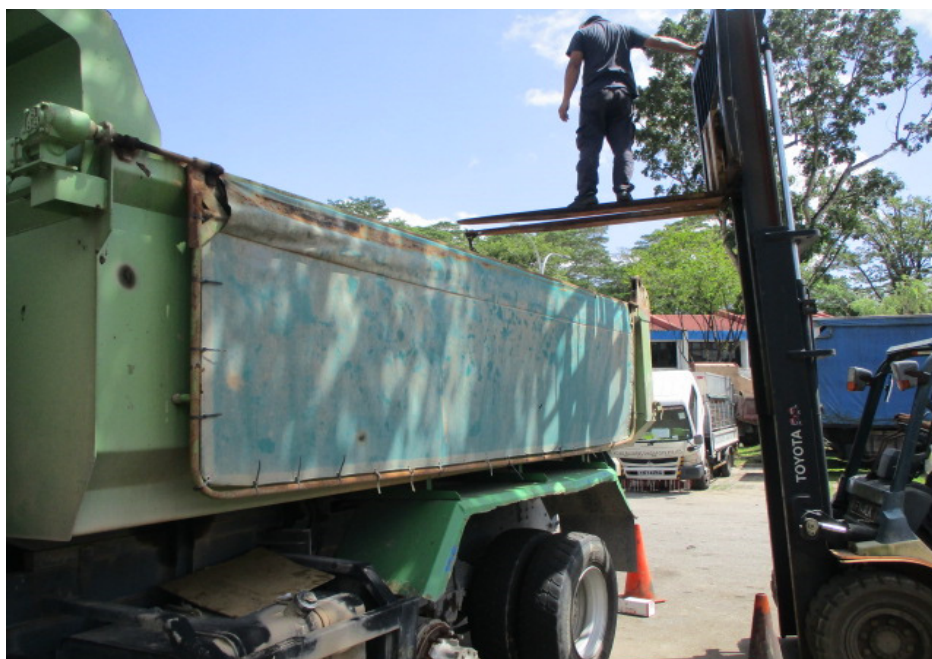
Photo 3 shows workers retrieving the left inner and outer tyres from the container bin of the Insured Vehicle.

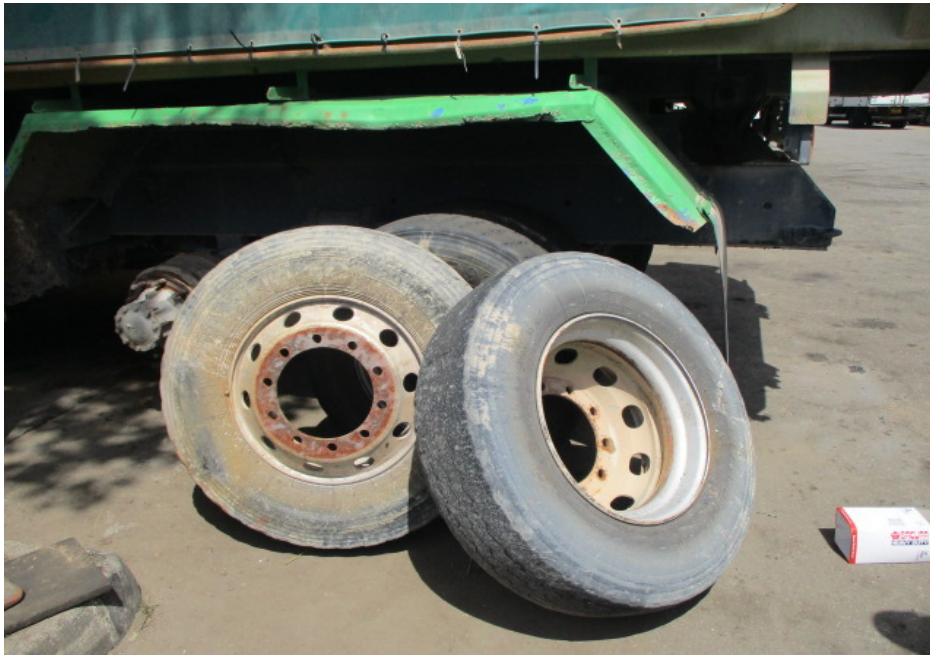
Photo 4 shows a general view of the left inner and outer tyres at the 2nd axle of the Insured Vehicle that were retrieved from the container bin of the Insured Vehicle.

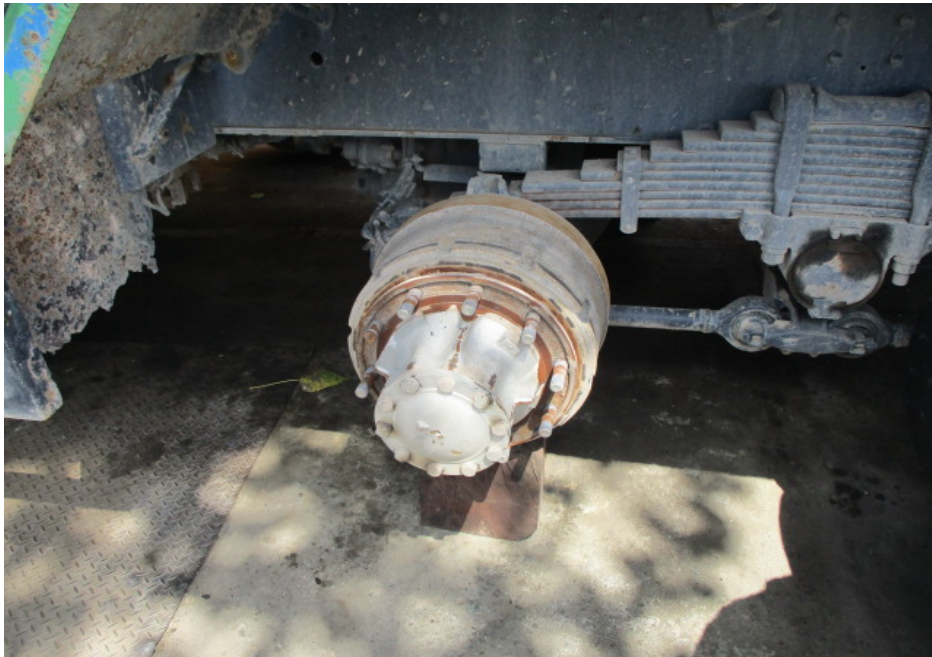
7. Upon examination of the wheel drum at the left side of the 2nd axle, I had observed that one of the bolts that fits the tyres onto the wheel drum was broken. Rust was also seen on the tread area, and on the broken surface area of the broken bolt. The remaining 9 unbroken bolts had rust on their tread area. Note: Under normal circumstance, 10 bolts and 10 nuts are used to fit and secure the tyres to the wheel drum. All the bolts were not loosely fitted into their respective bolt holes.

Photo 5 shows a general view of the wheel drum at the left side of the 2nd axle of the Insured Vehicle at the time of my inspection. 10 bolts are used to fit the tyres to the wheel drum. Out of the 10 bolts, one bolt was broken. All 10 bolts were also observed to be not loosely fitted into their respective bolt holes.

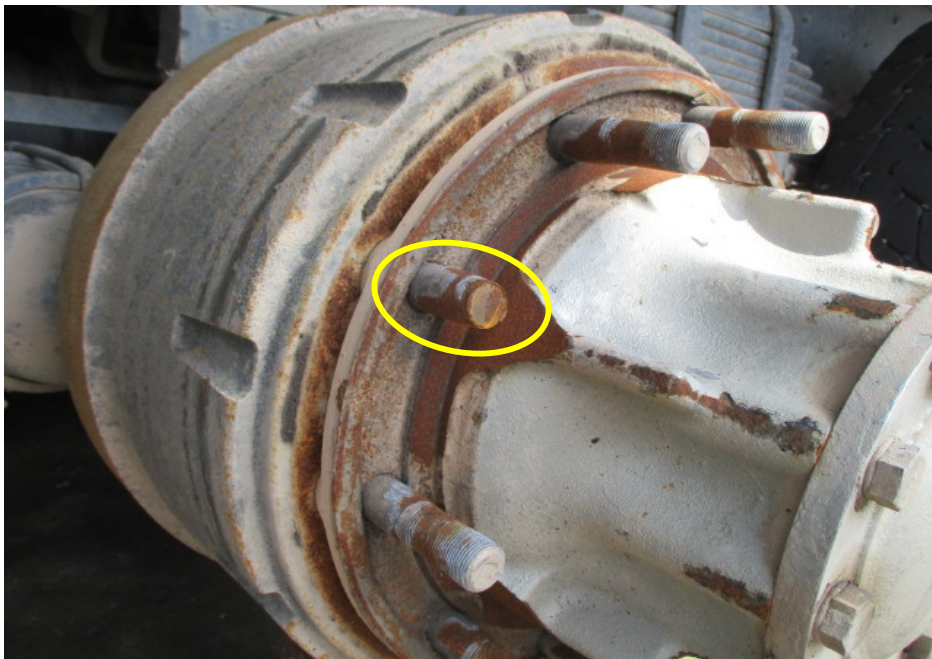
8. The Insured Vehicle was impounded at Traffic Police pound for more than 3 months after the incident. The rust that was seen on the 10 wheel bolts could have developed during this period due to the bolts being exposed to natural environmental condition. However, upon review of the incident scene photographs (refer to photograph 11 below), the broken surface area of the broken wheel bolt appears to be already rusted. Hence, it would be reasonable to say that the rust observed, at least on the broken surface area of the broken wheel bolt, had existed before the Insured Vehicle was impounded by Traffic Police. See photo 5 – 10 below.

Photo 6 shows a general view of the broken wheel bolt (circled). Rust was seen on the tread area of the broken wheel bolt and similarly seen on the tread area of the remaining 9 unbroken wheel bolts. The broken surface area of the broken wheel bolt was also rusted.

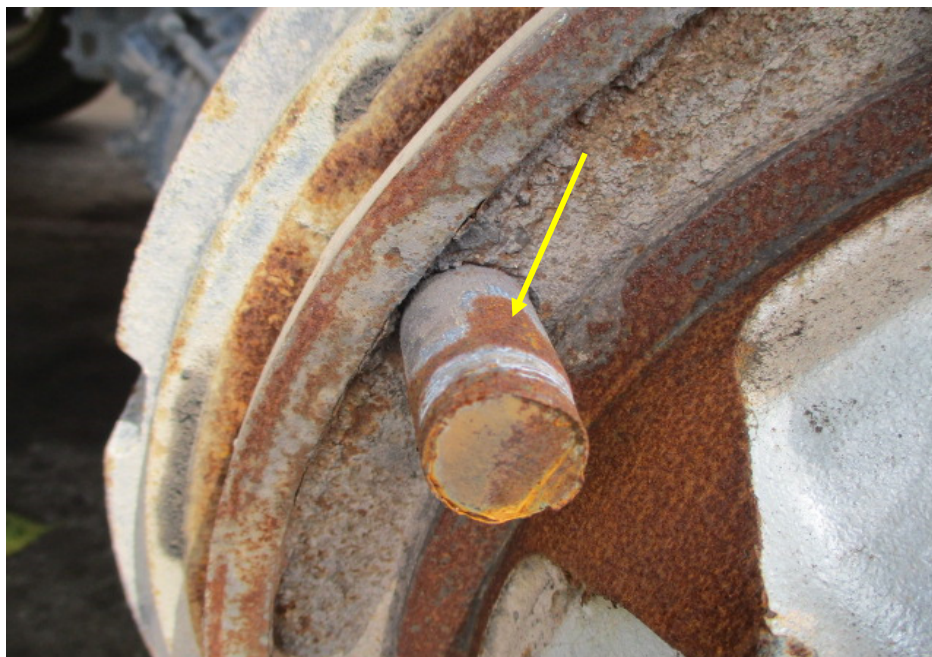
Photo 7 shows a closer view of the broken wheel bolt. Rust was seen on the tread area (arrowed) and broken surface area of the broken wheel bolt.

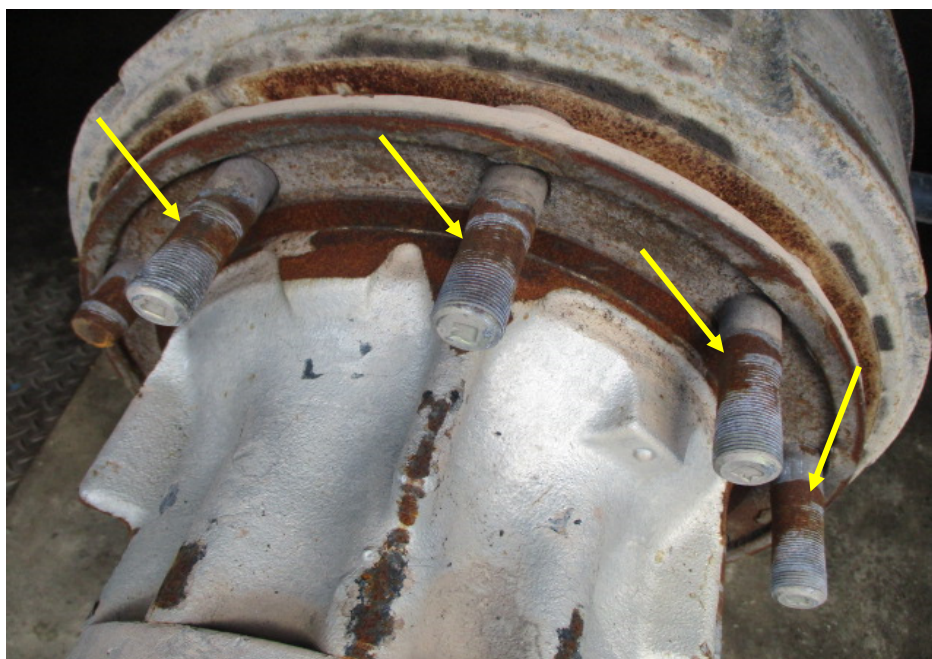
Photo 8 shows a general view of the other remaining unbroken wheel bolts. Similar to the broken wheel bolt, rust (arrowed) was also seen on the tread area of the remaining 9 unbroken wheel bolts. The rust seen on all 10 wheel bolts could have developed due to the bolts being exposed to natural environmental condition during the 3 months plus period when the Insured Vehicle was impounded by Traffic Police. However, upon review of the incident scene photographs, the broken surface area of the broken wheel bolt appears to be already rusted before the Insured Vehicle was impounded (refer to photograph 11 below).

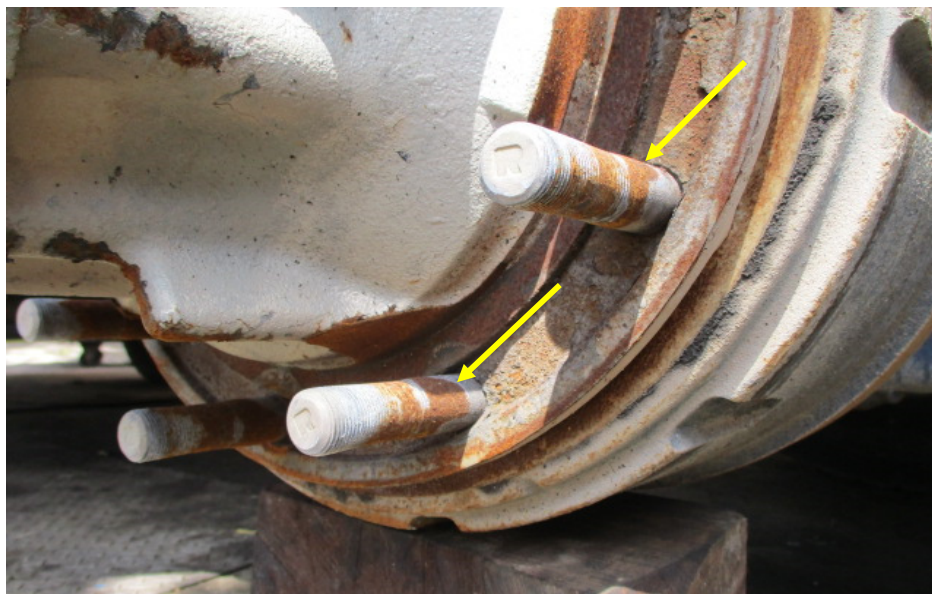
Photo 9 shows a general view of the other remaining unbroken wheel bolts. Similar to the broken wheel bolt, rust (arrowed) was also seen on the tread area of the remaining 9 unbroken wheel bolts. The rust seen on all 10 wheel bolts could have developed due to the bolts being exposed to natural environmental condition during the 3 months plus period when the Insured Vehicle was impounded by Traffic Police. However, upon review of the incident scene photographs, the broken surface area of the broken wheel bolt appears to be already rusted before the Insured Vehicle was impounded (refer to photograph 11 below).

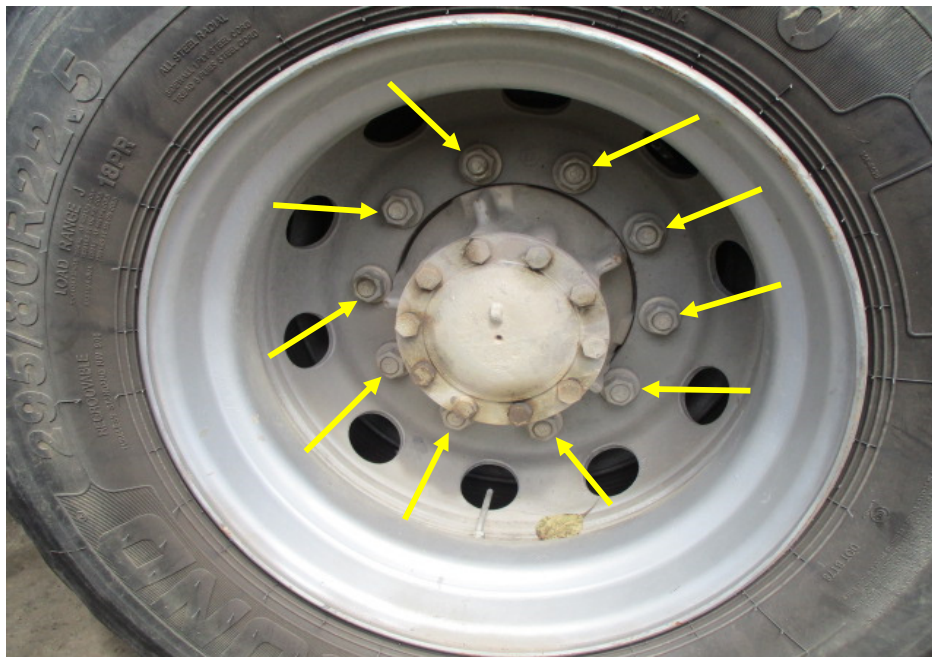
Photo 10 shows a general view of the 3rd axle at the left side of the Insured Vehicle. Under normal circumstance, the tyres of the Insured Vehicle are fitted and secured onto the wheel drum via 10 bolts and 10 nuts as indicated by the yellow arrows.

9. The 10 nuts used to secure the 10 wheel bolts that fit the tyres to the left side of the 2nd axle were missing/not seen at the time of my inspection of the Insured Vehicle.
10. Apart from paragraph 5 to 9 above, no other information, relevant to the purpose of report, could be gathered from my inspection of the Insured Vehicle.

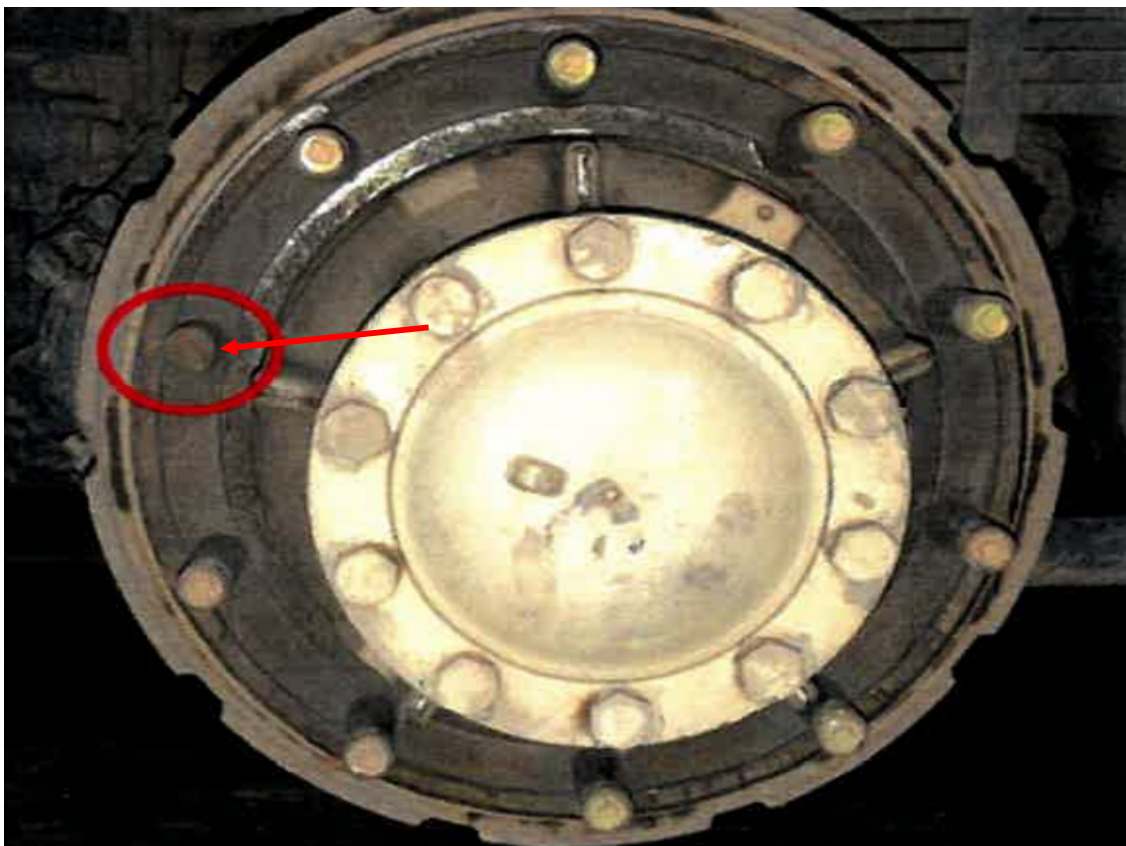
11. Earlier in paragraph 8, I had commented that the rust that was seen on the broken surface area of the broken wheel bolt had existed before the Insured Vehicle was impounded by Traffic Police. This was determined based on my review of the photographs taken at the incident scene (attached in the investigation report of M/s AJAX Adjustors and Surveyors Pte Ltd, and also attached in the Singapore Accident Statement of the driver of the Insured Vehicle). See photograph 11 below.

Photo 11 shows the wheel drum at the left side of the 2nd axle (photograph taken at the incident scene) before the Insured Vehicle was impounded by Traffic Police. The broken wheel bolt is highlighted by the red circle. As seen from the photograph, the broken surface area (arrowed) of the broken wheel bolt appears to be covered with dark coloured rusted immediately after the bolt was broken. The condition of all 10 wheel bolts also does not appear to be of new condition.

13. For this case, exposure to impact forces can be ruled out as there was no sign(s) of physical damage to the wheel drum of the Insured Vehicle.
14. Material fatigue because of corrosion weakening the strength of the wheel bolt may be possible, given that rust was seen on the broken surface area of the broken wheel bolt immediately after the bolt was broken. However, it is likely that the rust on the broken wheel bolt had existed for a prolong period of time as the colour of the rust was not of bright orange colour that is normally associated with "fresh" rust.
