Your Ref: S1M038J6
Our Ref : CS4/ASM21005245/P

**TECHNICAL INVESTIGATION REPORT OF FIRE INCIDENT INVOLVING THE
INSURED VEHICLE SMG 5366X ON 2nd February 2021**

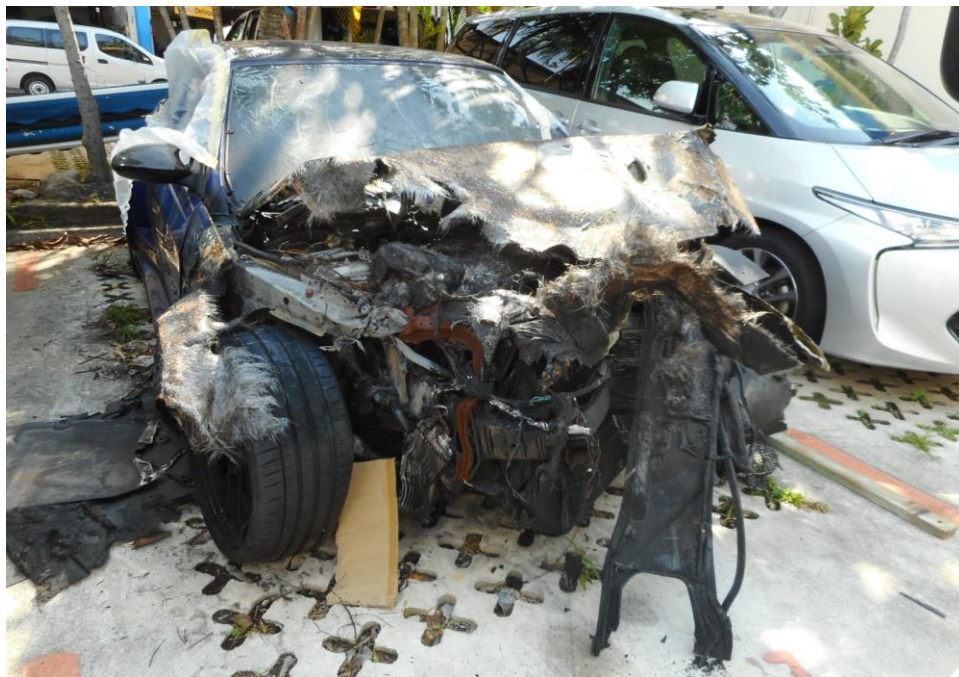
Photo 1 shows the general view of the front portion of the Insured Vehicle at the time of our inspection. The fire damage to the Insured Vehicle was confined to its front portion. This had included its front windscreen, right headlamp, bonnet, bumper and several parts inside the engine compartment were also observed to sustain heat damage. This includes the coolant fluid reservoir, brake fluid reservoir, ABS pump and its factory wiring harness are amongst the body parts that were found to have been affected as a result of the fire.

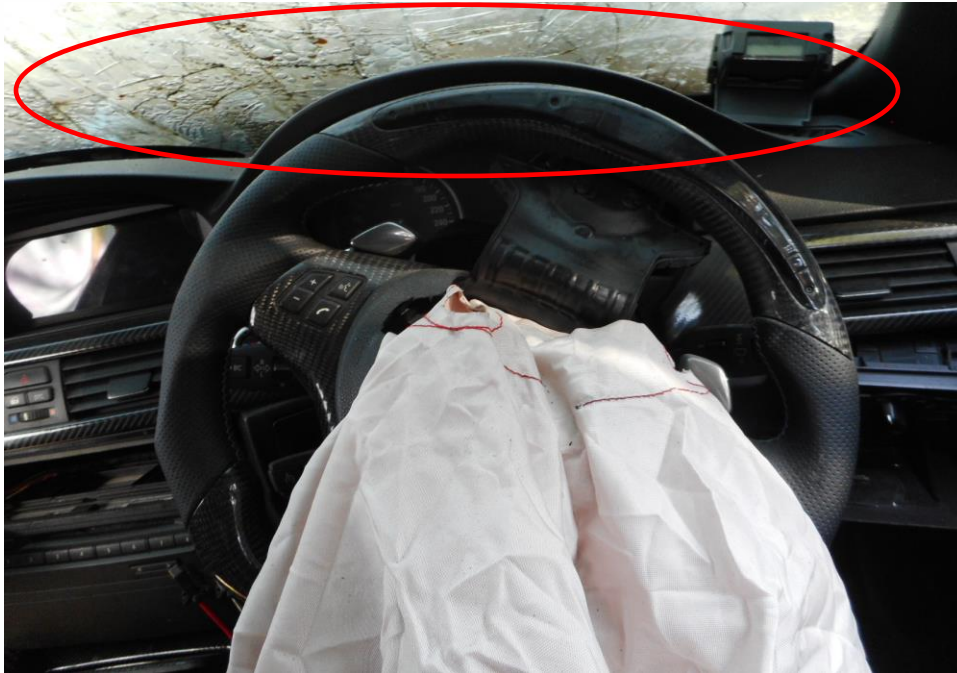
Photo 2 shows the close-up interior view of the front portion of the Insured Vehicle at the time of our inspection. The fire damage to the Insured Vehicle was confined to its front portion. As observed its front windscreen (circled) had suffered heat and smoke damage as a result of the fire.

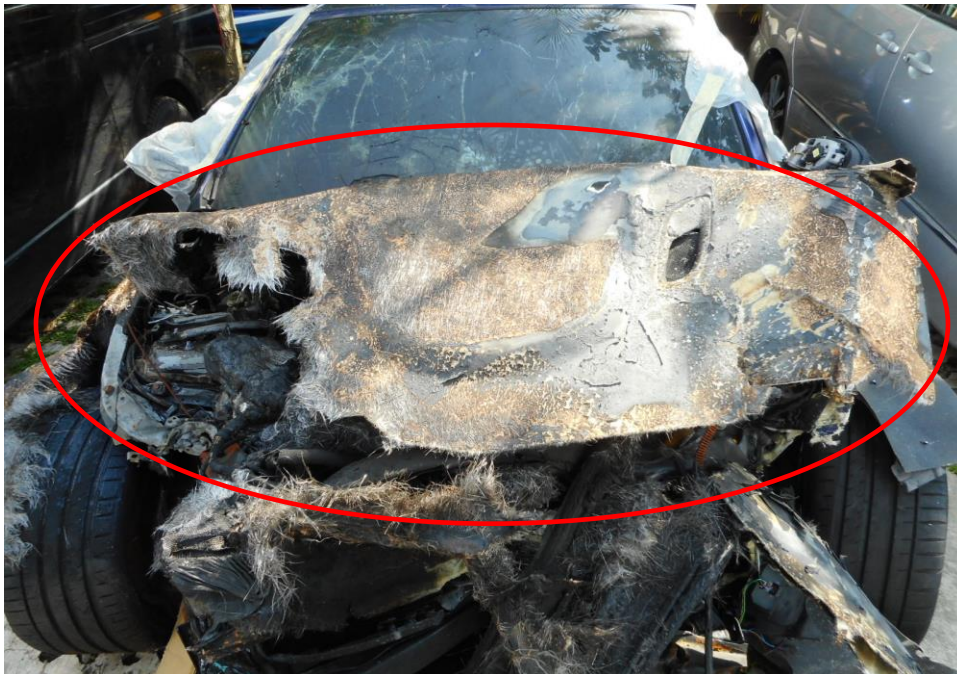
Photo 3 shows the close-up view of the front portion of the Insured Vehicle at the time of our inspection. The fire damage to the Insured Vehicle was confined to its front portion. As observed whitish burn marks (circled) on the surface are a result of exposure to prolonged heat intensity as a result of the fire.

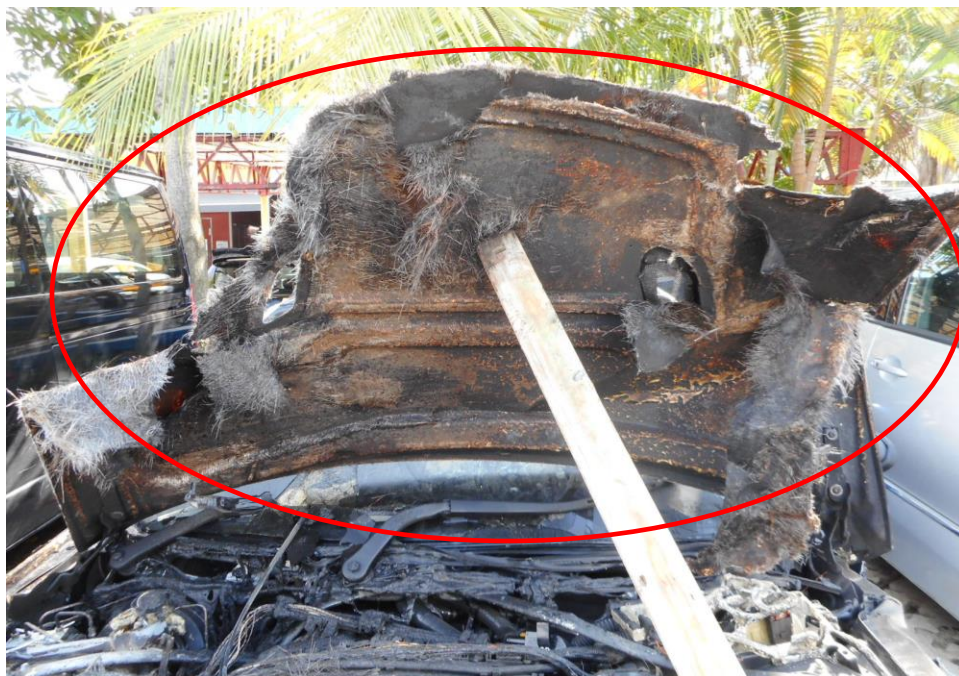
Photo 3 shows the close-up view of the front portion of the Insured Vehicle at the time of our inspection. The fire damage to the Insured Vehicle was confined to its front portion. As observed whitish burn marks (circled) on the surface are a result of exposure to prolonged heat intensity as a result of the fire.

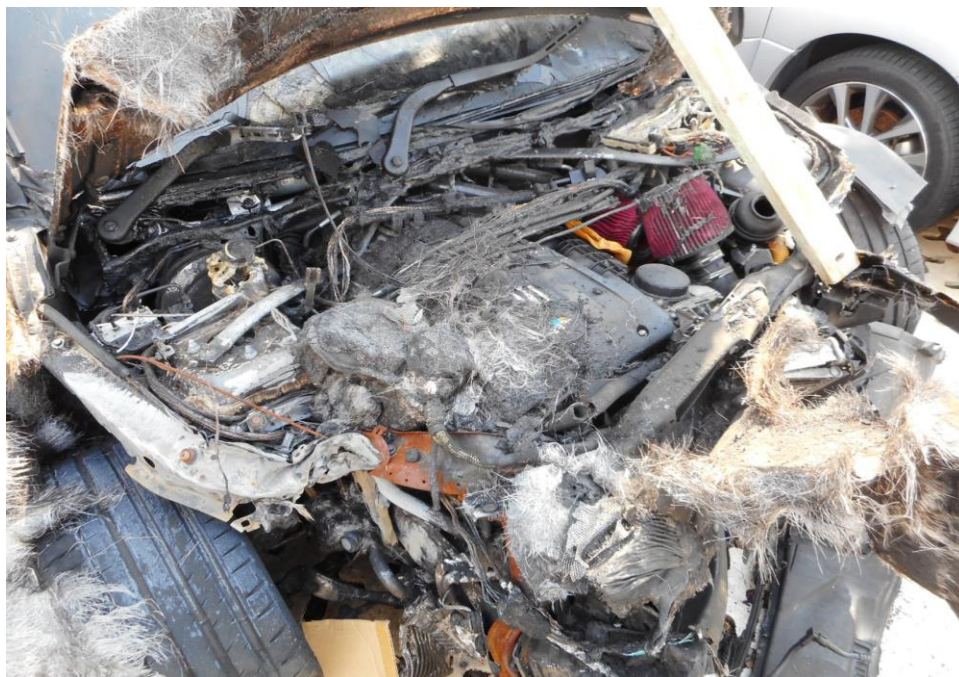
Photo 4 shows the general view of the engine compartment of the Insured Vehicle at the time of our inspection. The fire damage to the Insured Vehicle was confined to its front portion. This had included its right headlamp, bonnet, bumper and several parts inside the engine compartment were also observed to sustain heat damage. This includes the coolant fluid reservoir, brake fluid reservoir, ABS pump and its factory wiring harness are amongst the body parts that were found to have been affected as a result of the fire.

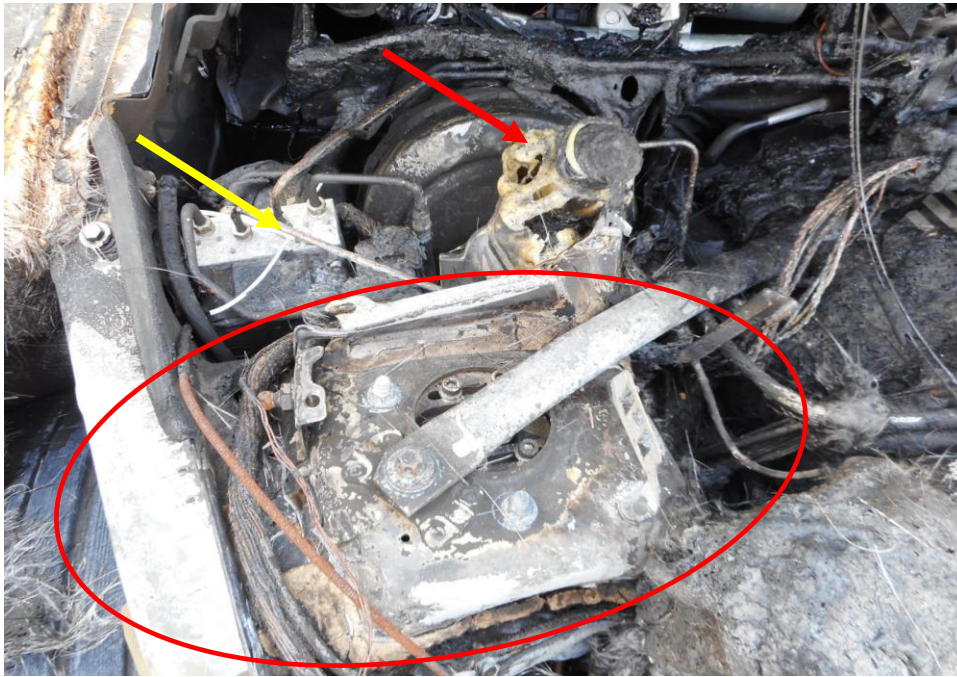
Photo 5 shows the close-up view of the front engine compartment portion of the Insured Vehicle at the time of our inspection. Its brake fluid reservoir (arrowed) and ABS pump unit was damaged as a result of the fire. As observed whitish burn marks (circled) on the surface are a result of exposure to prolonged heat intensity as a result of the fire.

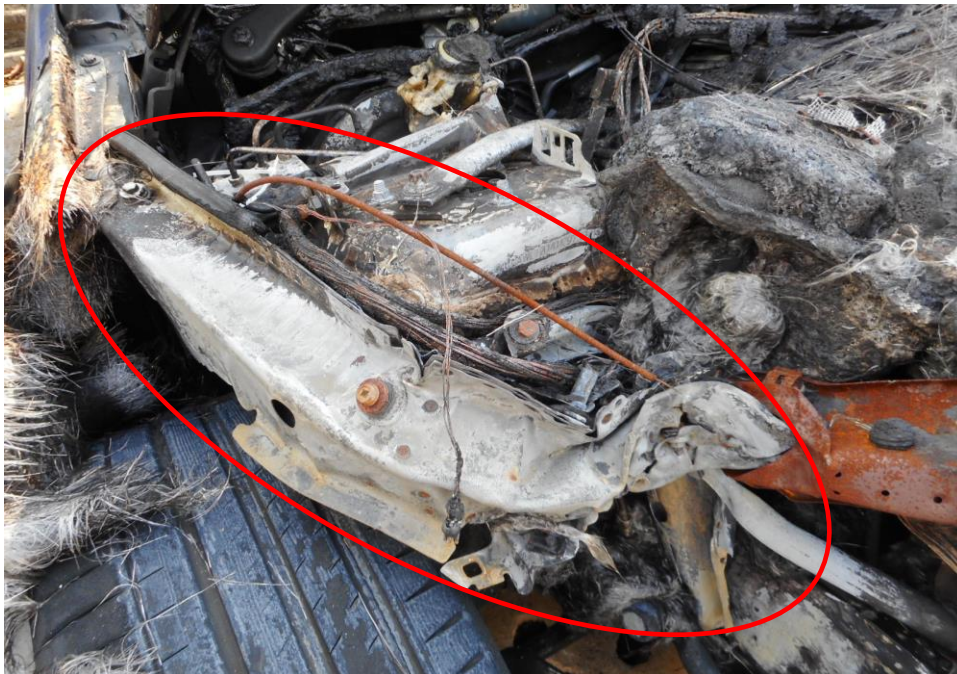
Photo 6 shows the close-up view of the front engine compartment portion of the Insured Vehicle at the time of our inspection. As observed whitish burn marks (circled) on the surface are a result of exposure to prolonged heat intensity as a result of the fire.

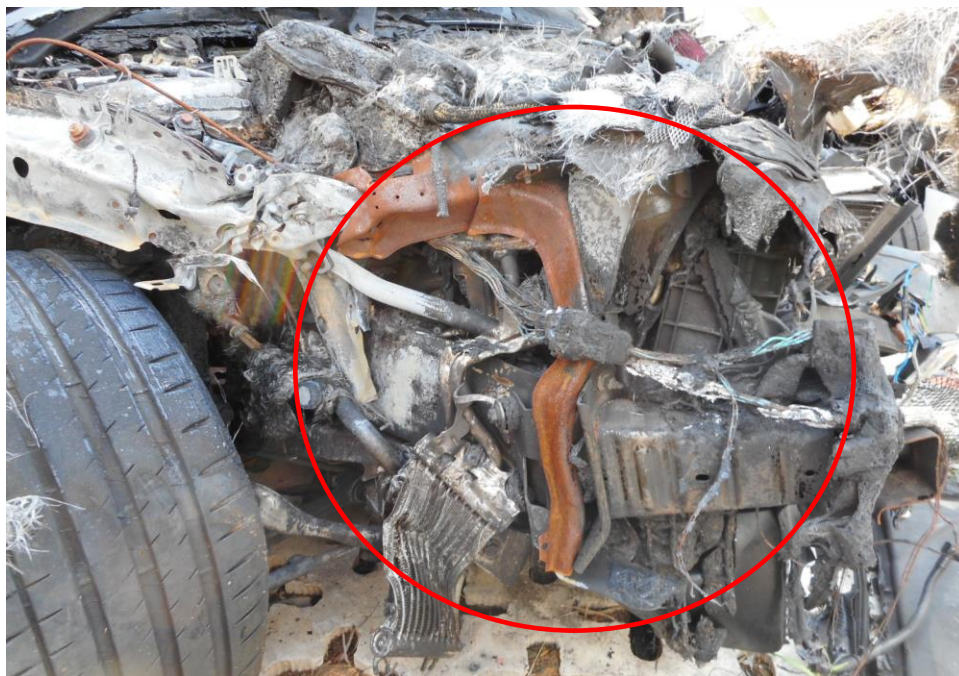
Photo 7 shows the close-up view of the front right head lamp portion of the Insured Vehicle at the time of our inspection. The whole of the head lamp including its housing and its factory wiring harness (circled) were damaged and melted down as a result of the fire.

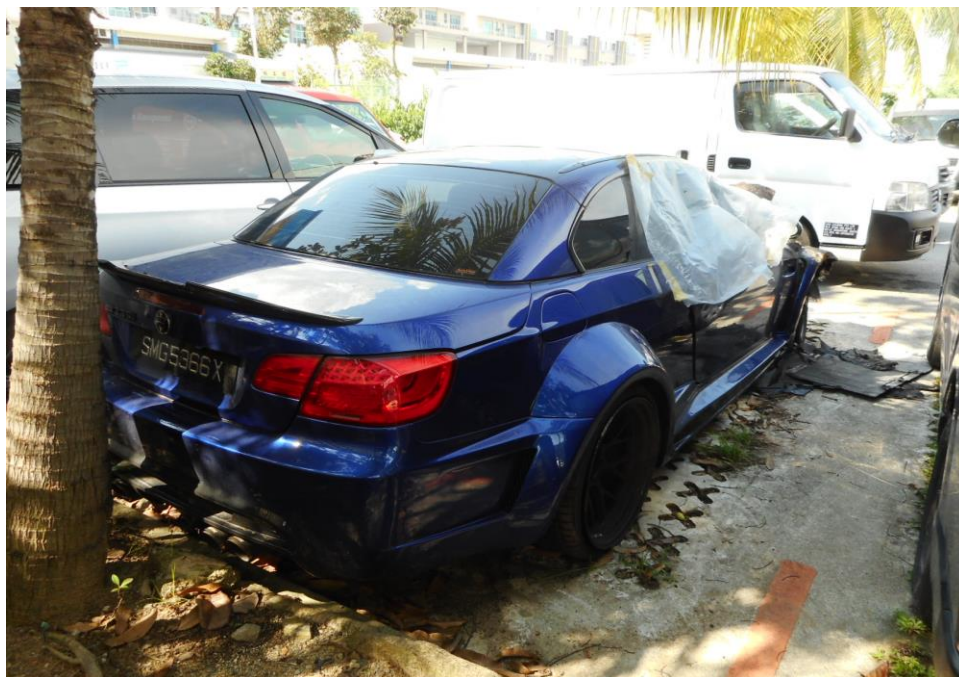
Photo 8 shows the right portion of the Insured Vehicle, which was observed to be unaffected by the fire.

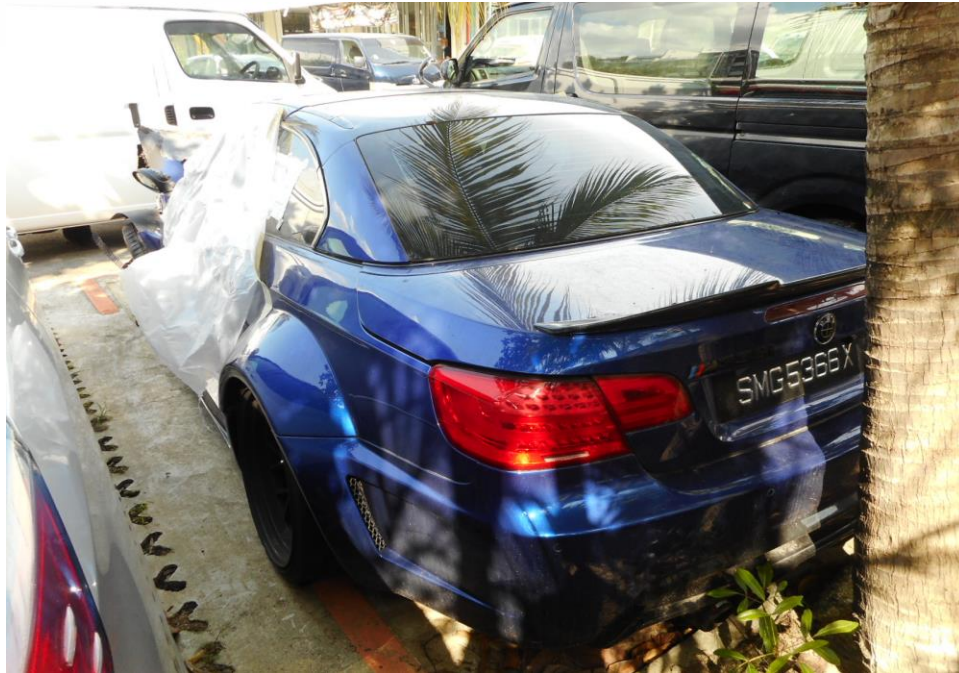
Photo 9 shows the left portion of the Insured Vehicle, which was observed to be unaffected by the fire.

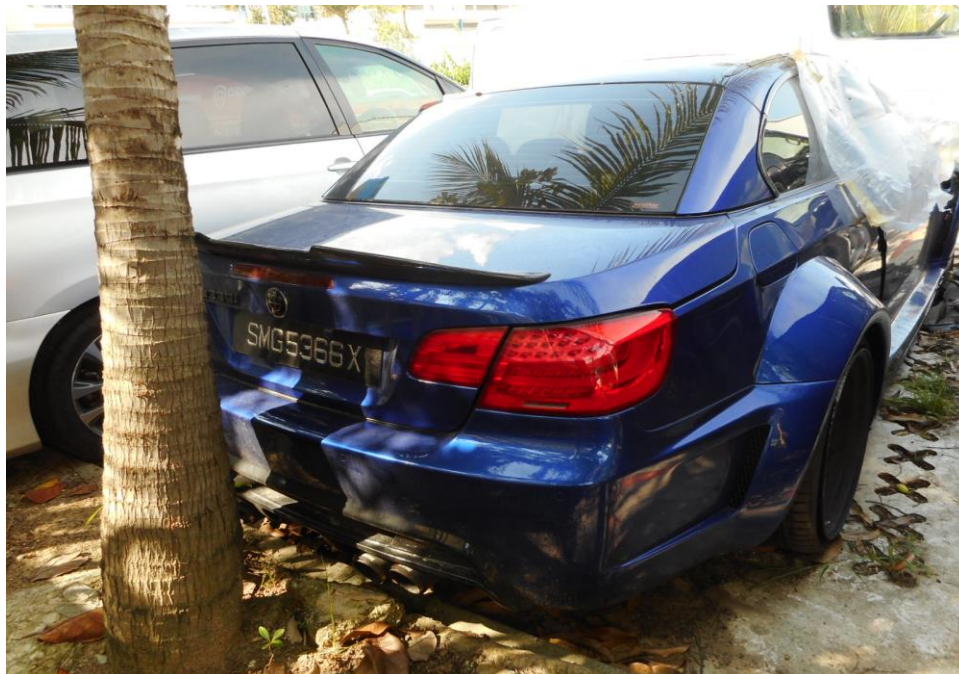
Photo 10 shows the rear portion of the Insured Vehicle, which was observed to be unaffected by the fire.

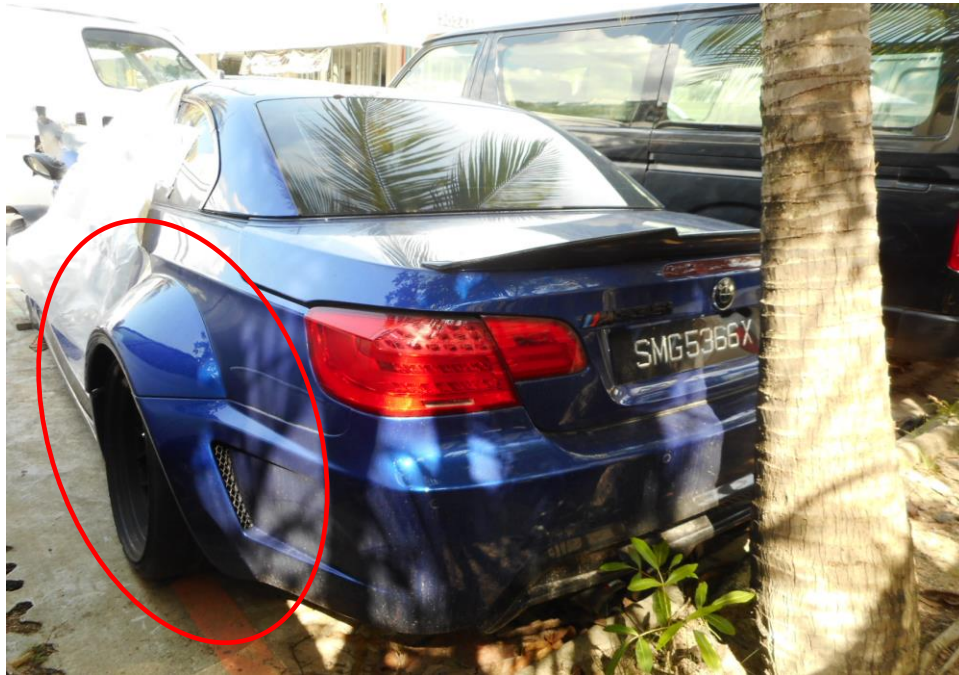
Photo 11 shows the aftermarket wide body kit (circled) of the Insured Vehicle, which was observed to be unaffected by the fire.

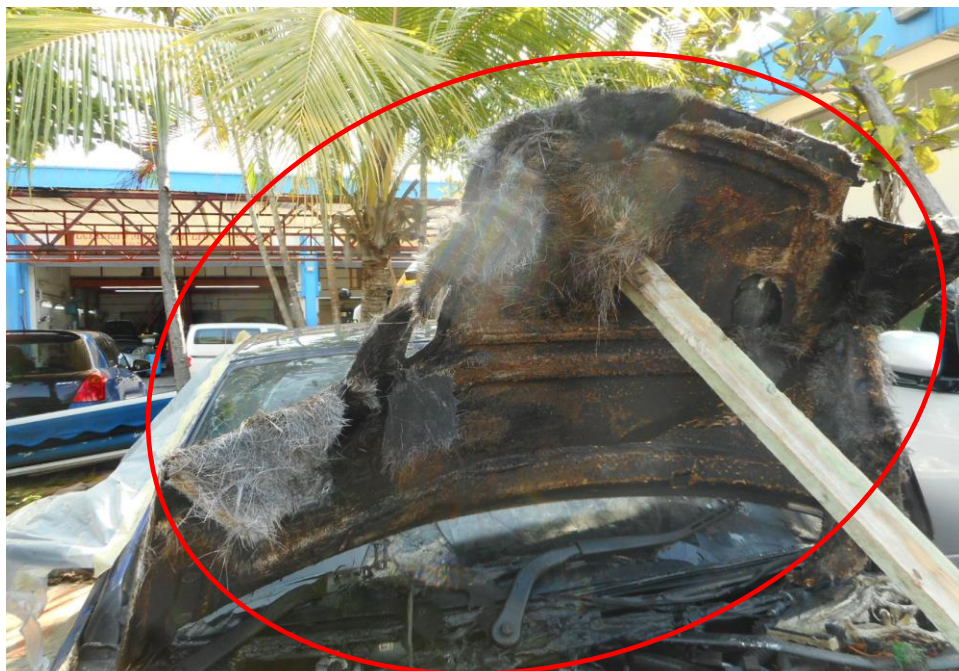
Photo 12 shows the aftermarket carbon fibre bonnet (circled) of the Insured Vehicle, which was observed to be damaged by the fire.

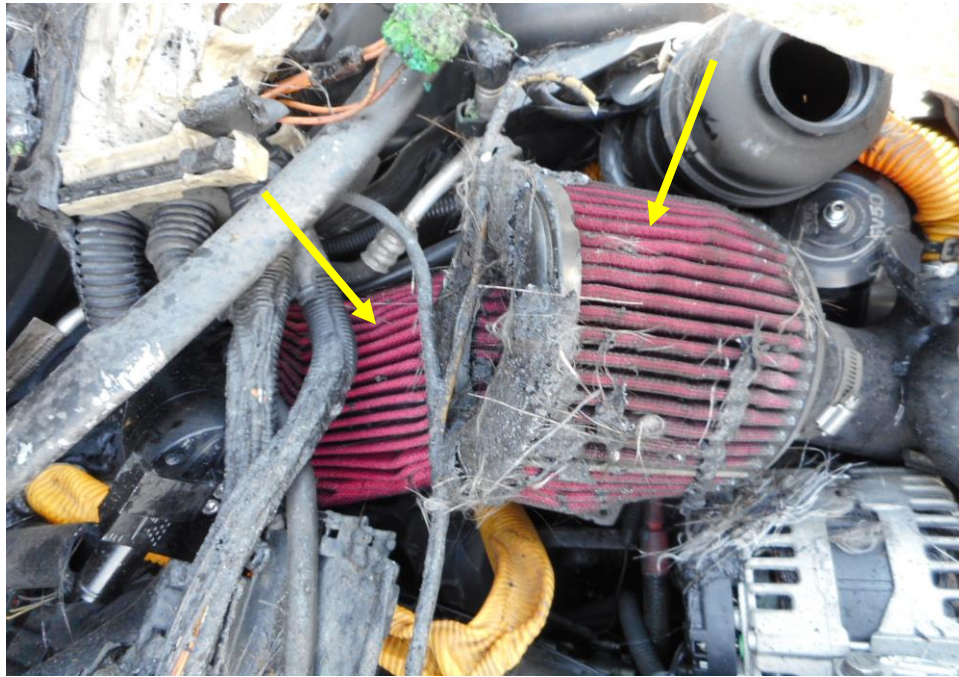
Photo 13 shows the aftermarket air filters (arrowed) of the Insured Vehicle, which was observed to be damaged by the fire.

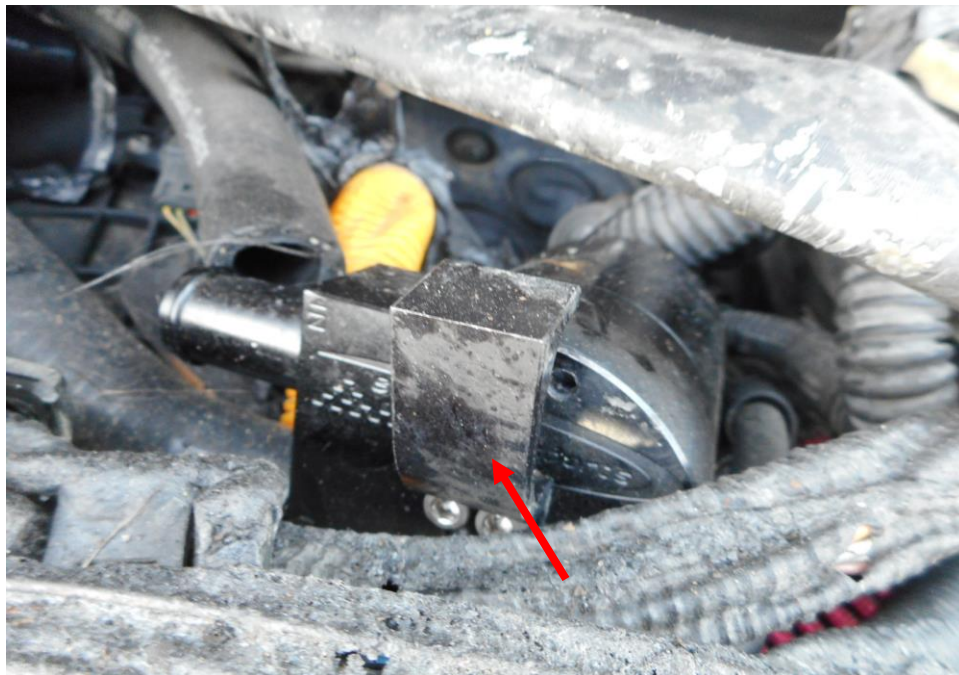
Photo 14 shows the additional fitted engine oil catch tank (arrowed) of the Insured Vehicle, which was observed to be damaged by the accident.

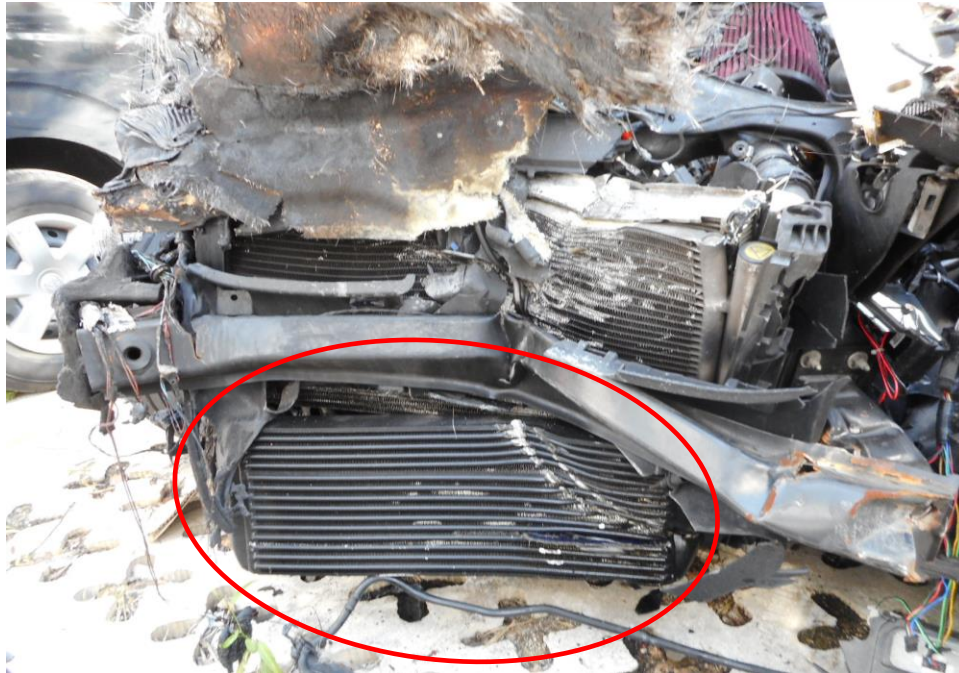
Photo 15 shows an aftermarket intercooler (circled) of the Insured Vehicle, which was observed to be damaged by the accident.

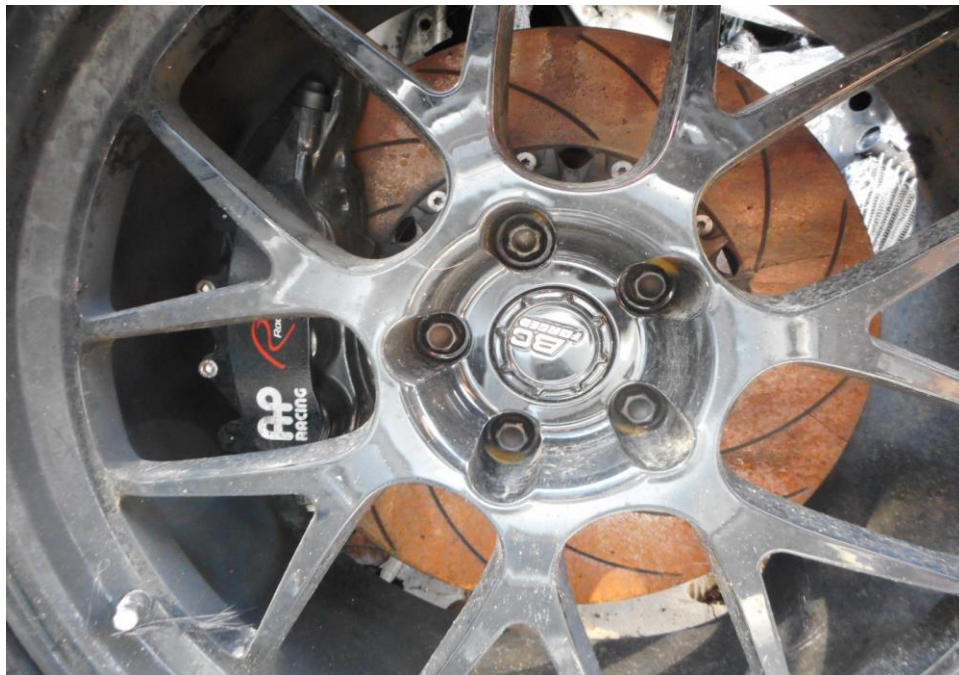
Photo 16 shows an aftermarket brake kit on of the Insured Vehicle, which was observed to be unaffected by the fire.

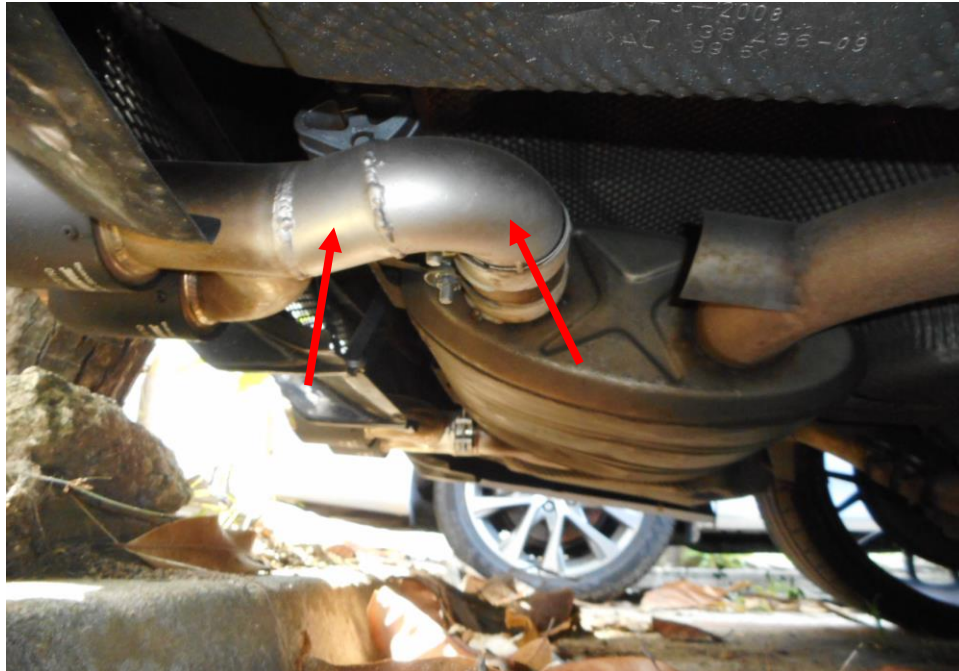
Photo 17 shows a modified exhaust system fitted on the Insured Vehicle, which was observed to be unaffected by the fire at the time of inspection.

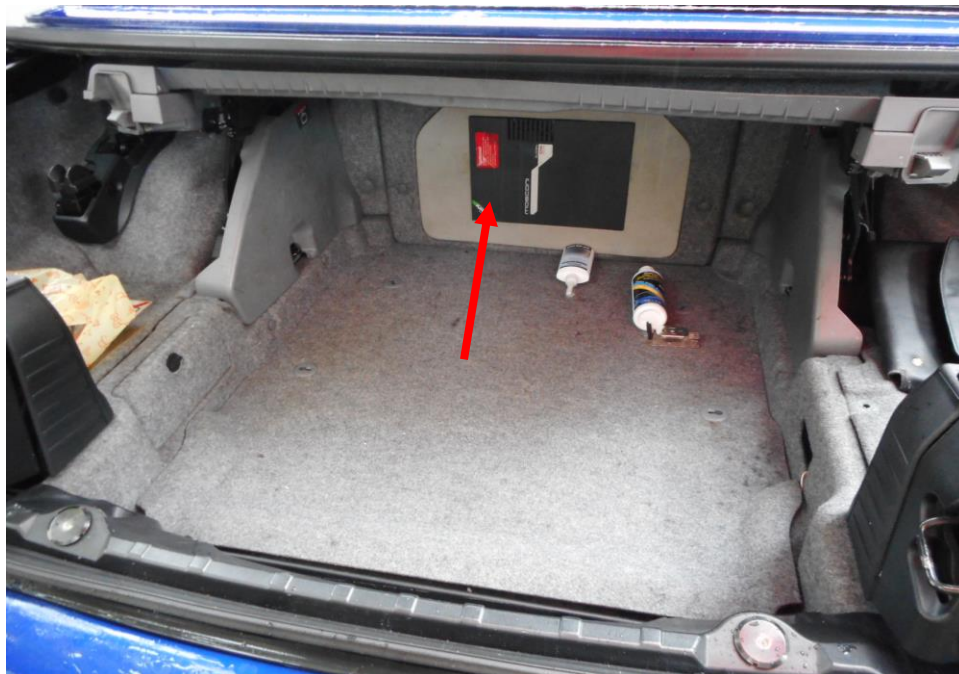
Photo 18 shows a general view of an additionally fitted audio amplifier system fitted at the boot of the Insured Vehicle, which was observed to be unaffected by the fire at the time of inspection.

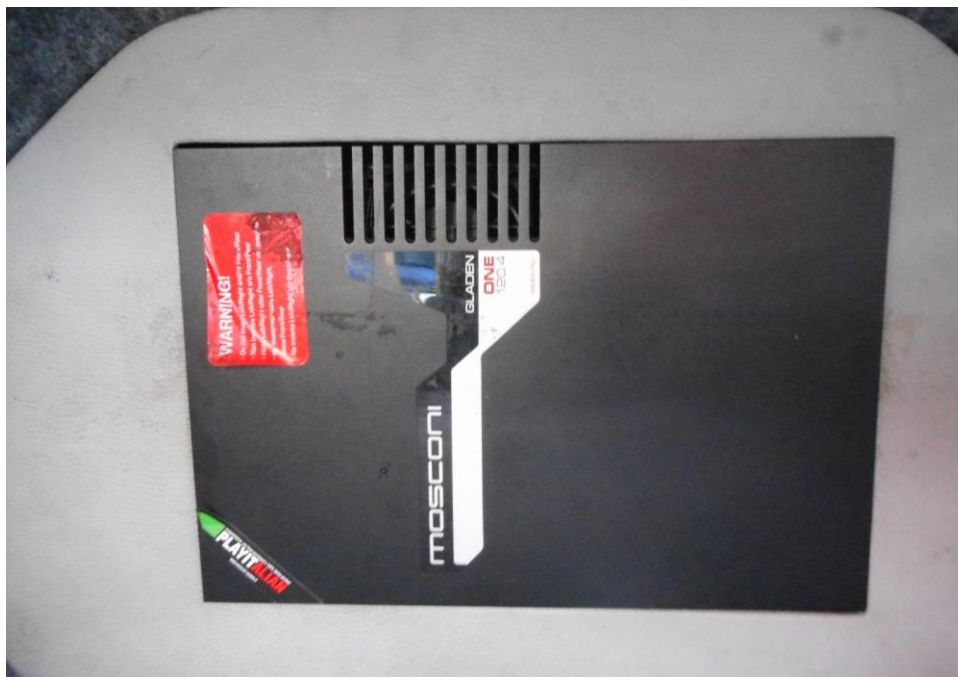
Photo 19 shows a close up view of an additionally fitted audio amplifier system fitted at the boot of the Insured Vehicle, which was observed to be unaffected by the fire at the time of inspection.

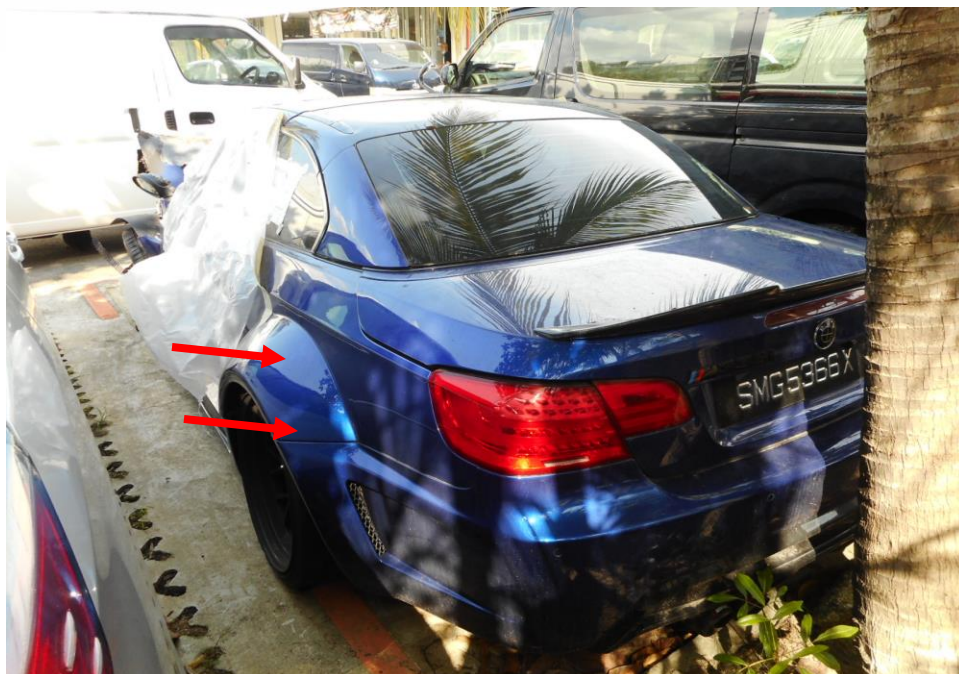
8. I had also found the insured vehicle to be fitted with a wide body kit, which is not LTA compliant as the additional attachments protrude laterally out of the body of the Insured Vehicle. A modified exhaust system was also found, this was at the rear, the exhaust muffler of the insured vehicle. There was additional piping and welding marks joining the exhaust muffler to the tailpipes of the Insured Vehicle's exhaust system. Such exhaust system is not LTA compliant. The exhaust system fitted on the insured vehicle will enhance the overall engine performance of the insured vehicle. See photo 20 - 22 below.

Photo 20 shows the general view of the aftermarket wide body kit additional attachments (arrowed) fitted on the Insured Vehicle, which was observed to be protruding laterally out of the body of the Insured Vehicle.

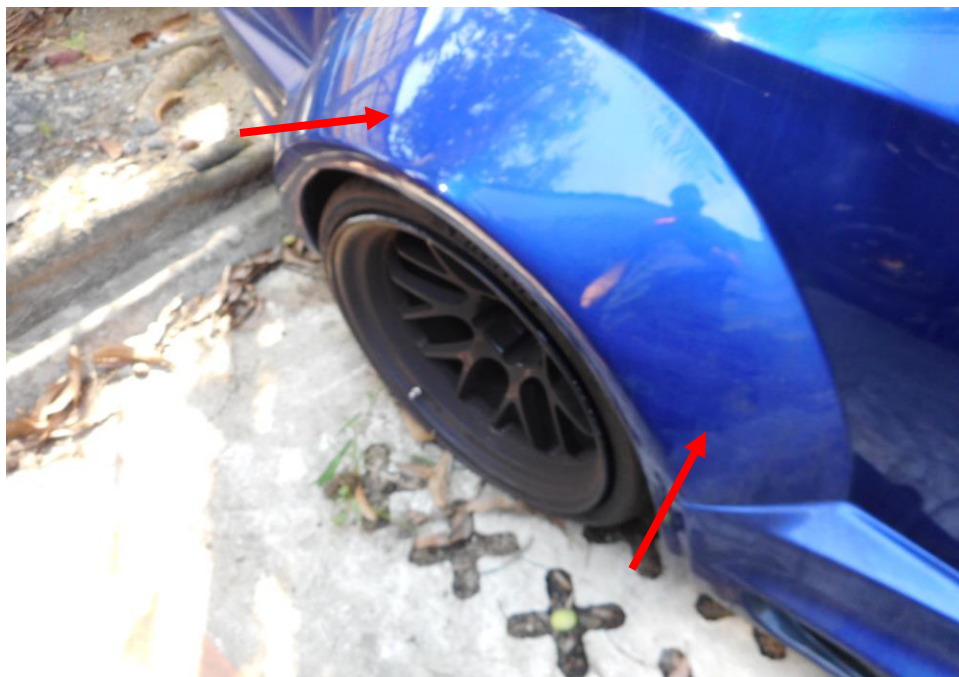
Photo 21 shows the close up view of the aftermarket wide body kit additional attachments (arrowed) fitted on the Insured Vehicle, which was observed to be protruding laterally out of the body of the Insured Vehicle.

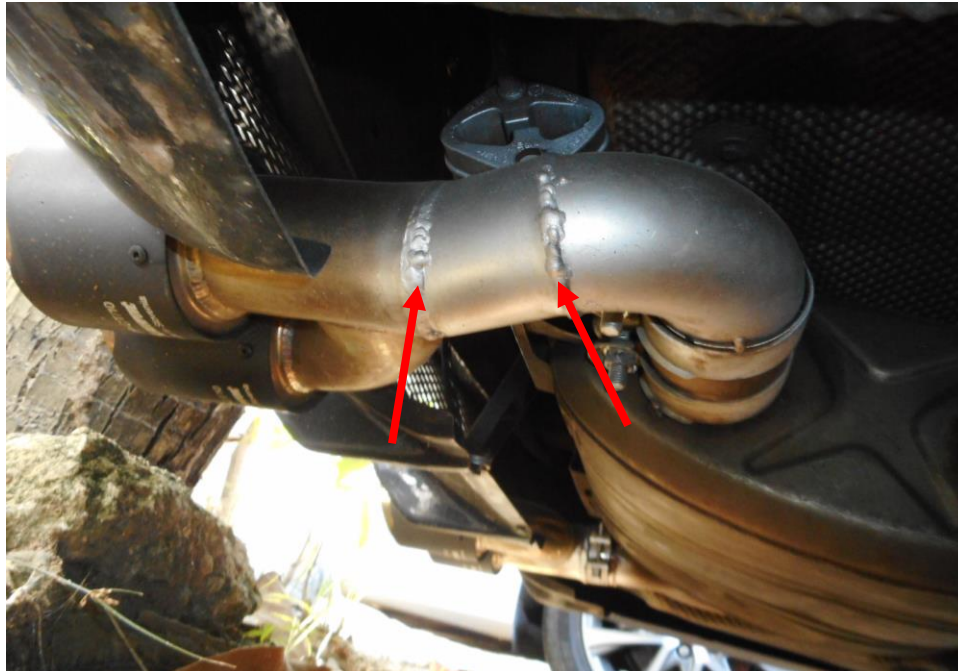
Photo 22 shows a modified exhaust system installed on the Insured Vehicle, this was at the rear, the exhaust muffer of the insured vehicle. There was additional piping and welding marks joining the exhaust muffer to the tailpipes of the Insured Vehicle's exhaust system. From my observations, the exhaust system fitted on the insured vehicle is not LTA compliant.

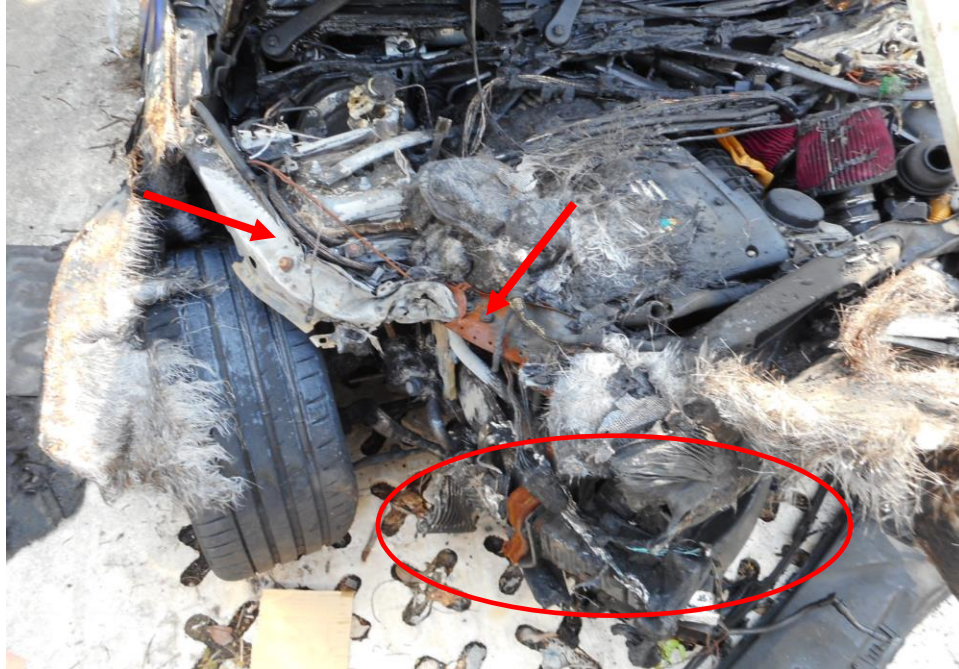
11. The whitish burn marks are a result of exposure to prolonged heat intensity. Rust would normally start to develop around these areas soon after a fire as prolonged exposure to high heat intensity usually causes steel/metal material body parts to be exposed to natural environmental condition. The rust that had developed on the metal brackets is an indication that the front right position of the Insured Vehicle had sustained exposure to prolonged high heat intensity. See photo 23 and 24 below.

Photo 23 shows a general view of the front right headlamp assembly (circled) and the various surrounding components. The headlamp assembly and various components was observed to be melted from the high heat intensity. Rust and high intensity burn marks (whitish burn marks) development was also observed on the metal brackets (arrowed) of the Insured Vehicle.

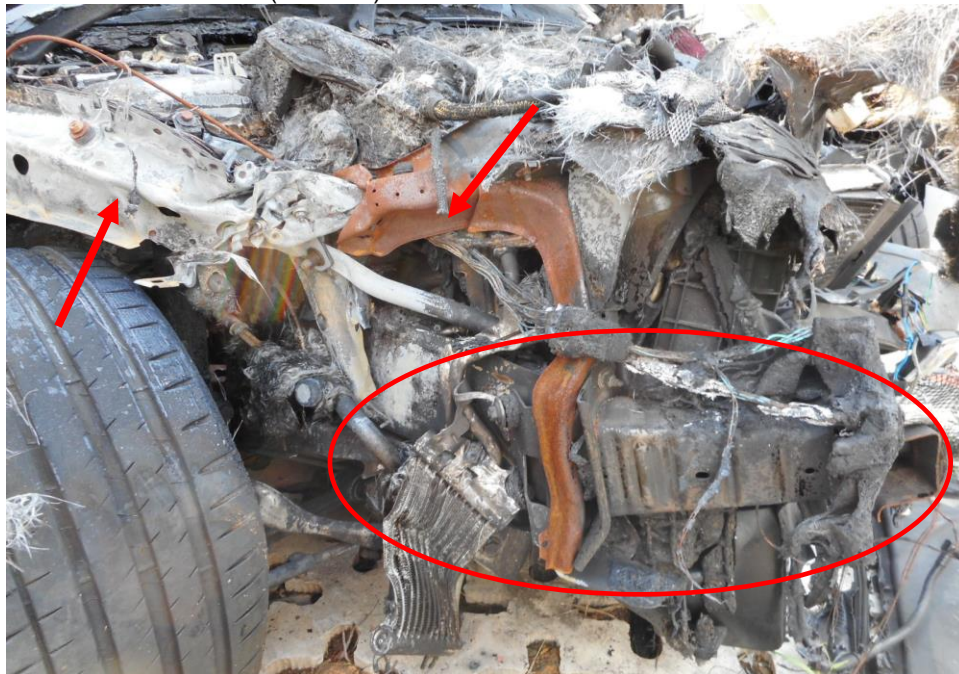
Photo 24 shows a close up view of the front right headlamp assembly (circled) and the various surrounding components. The headlamp assembly and various components were observed to be melted from the high heat intensity. Rust and high intensity burn marks (whitish burn marks) development was also observed on the metal brackets (arrowed) of the Insured Vehicle.

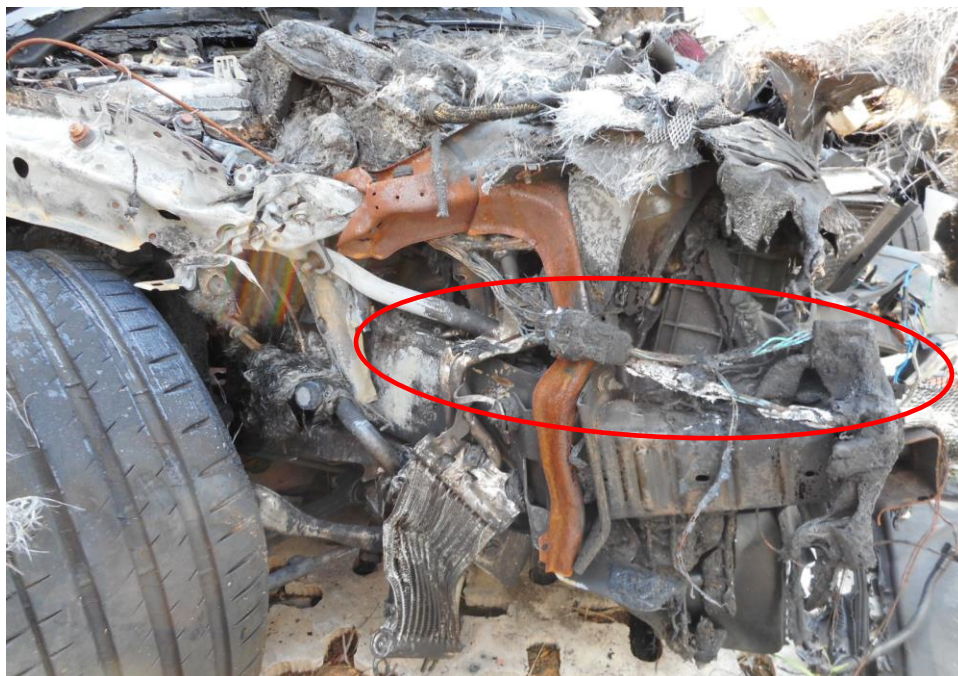
12. Upon closer examination of the front right portion of the Insured Vehicle which was where the fire had likely started, we had found traces of greenish residue on the wirings leading from the fuse box to the headlamp assembly. Both the fuse box and headlamp assembly were factory fitted. The presence of greenish residue indicates internal heating of copper wires, a sign of an electrical short circuit occurring. The greenish residue is normally left behind from oxidation as a result of chemical reaction involving the copper wires. This physical evidence would then appear to suggest that the cause of fire to the Insured Vehicle could have possibly been due to electrical in nature. See photos 25 - 29 below.

Photo 25 shows general view of the wirings leading from the fuse box to the headlamp assembly (circled). Both the fuse box to the headlamp assembly were factory fitted. The presence of greenish residue indicates internal heating of copper wires, a sign of an electrical short circuit occurring. The greenish residue is normally left behind from oxidation as a result of chemical reaction involving the copper wires.

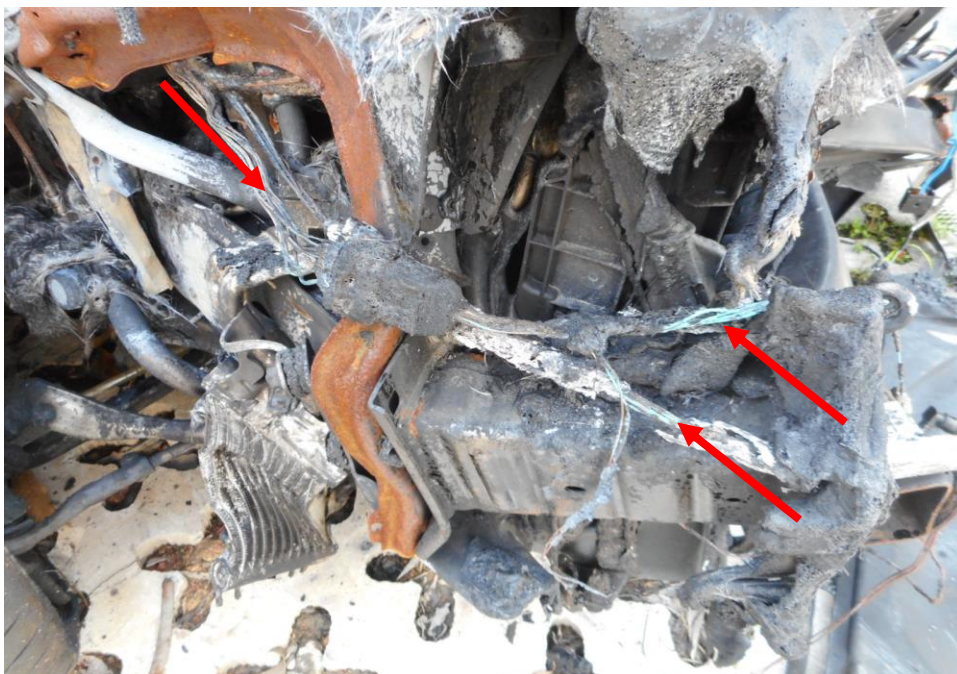
Photo 26 shows the close-up view of the headlamp assembly. Observed was greenish residue on the wiring harness leading (arrowed) from the fuse box to the headlamp assembly (arrowed). Observed was greenish residue on the wiring harness. The presence of greenish residue indicates internal heating of copper wires, a sign of an electrical short circuit occurring. The greenish residue is normally left behind from oxidation as a result of chemical reaction involving the copper wires.

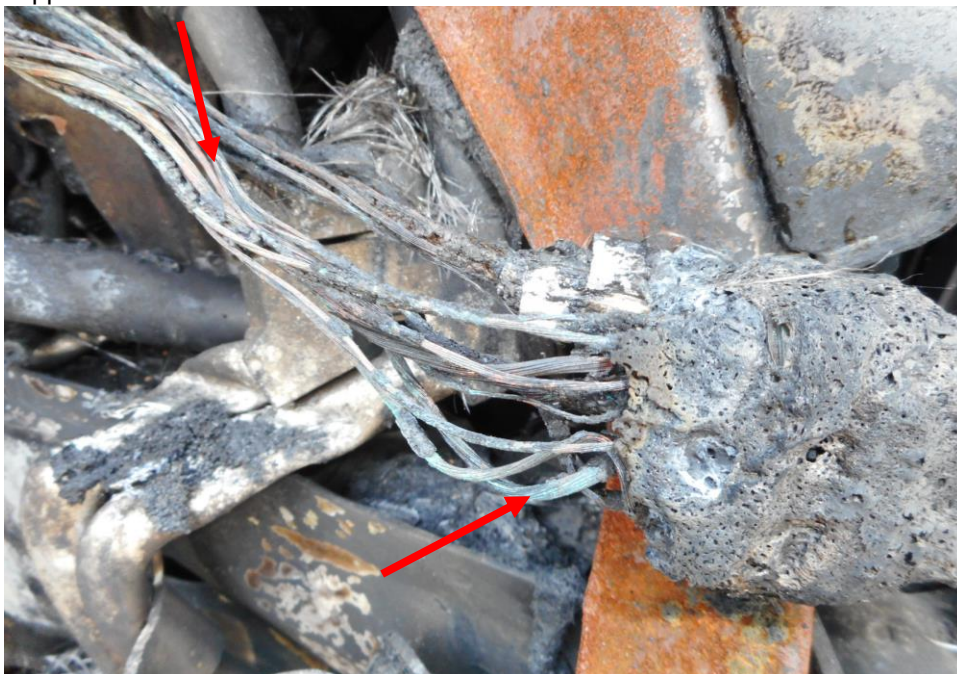
Photo 27 shows the close-up view of the headlamp assembly. Observed was greenish residue on the wiring harness leading (arrowed) from the fuse box to the headlamp assembly (arrowed). Observed was greenish residue on the wiring harness. The presence of greenish residue indicates internal heating of copper wires, a sign of an electrical short circuit occurring. The greenish residue is normally left behind from oxidation as a result of chemical reaction involving the copper wires.

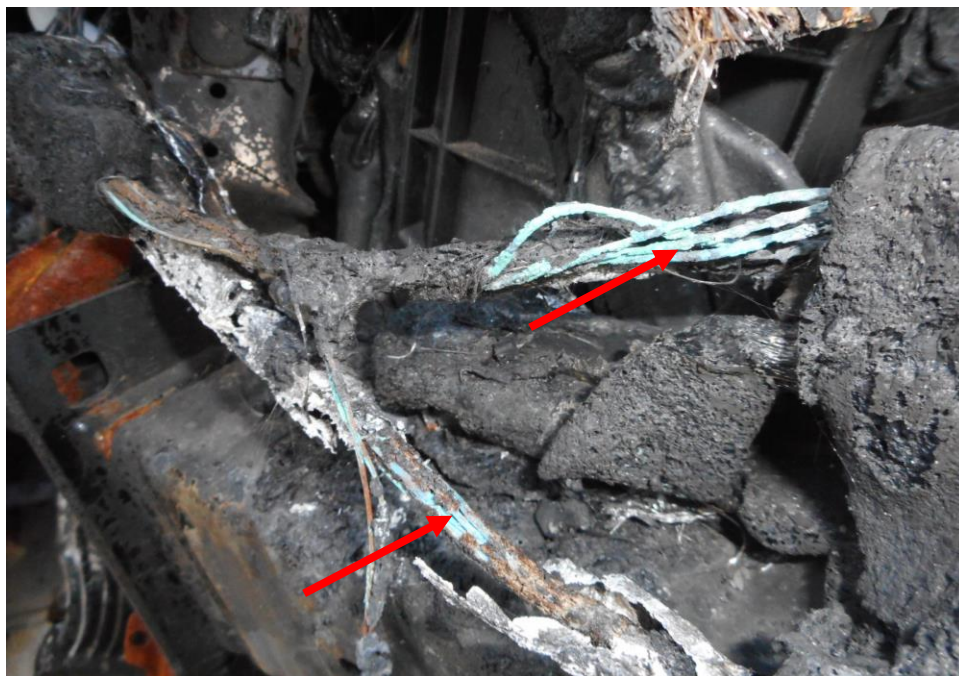
Photo 28 shows the close-up view of the headlamp assembly. Observed was greenish residue on the wiring harness leading (arrowed) from the fuse box to the headlamp assembly (arrowed). Observed was greenish residue on the wiring harness. The presence of greenish residue indicates internal heating of copper wires, a sign of an electrical short circuit occurring. The greenish residue is normally left behind from oxidation as a result of chemical reaction involving the copper wires.

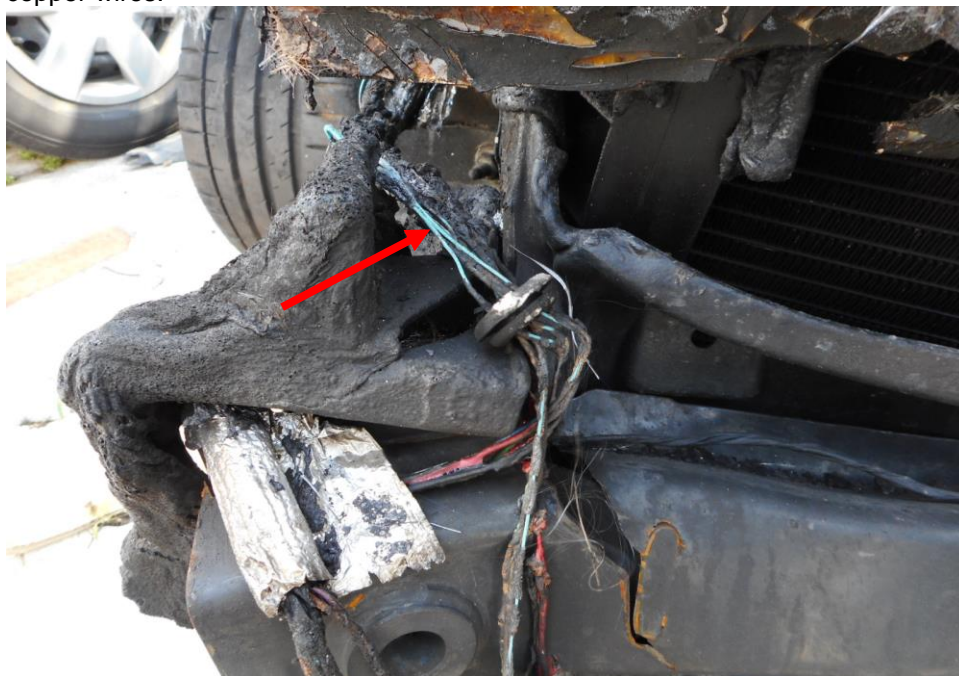
Photo 29 shows the close-up view of the headlamp assembly. Observed was greenish residue on the wiring harness leading (arrowed) from the fuse box to the headlamp assembly (arrowed). Observed was greenish residue on the wiring harness. The presence of greenish residue indicates internal heating of copper wires, a sign of an electrical short circuit occurring. The greenish residue is normally left behind from oxidation as a result of chemical reaction involving the copper wires.
