LKK Auto Consultants Pte Ltd

Vehicle No. SHC 5186D

ADJUSTMENT ON REPAIR COST FOR VEHICLE NO. SHC 5186D

PHOTOGRAPHS FOR VEHICLE NO. SHC 5186D

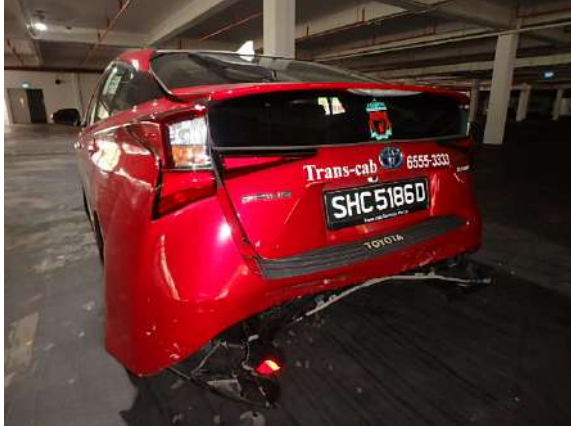
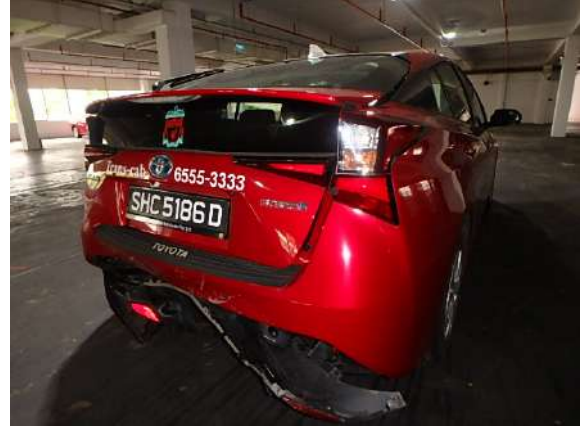
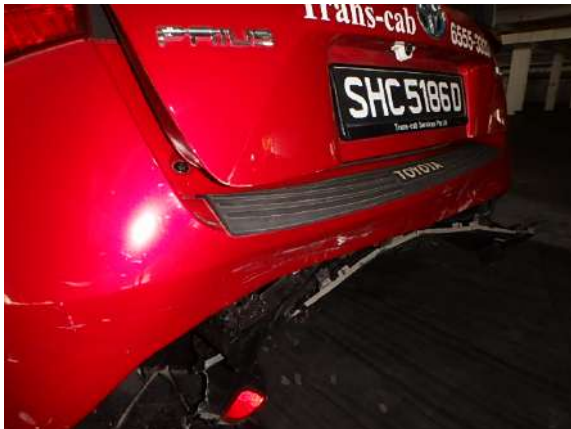
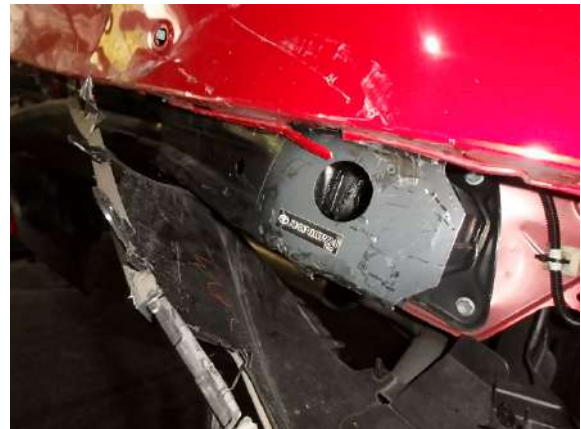
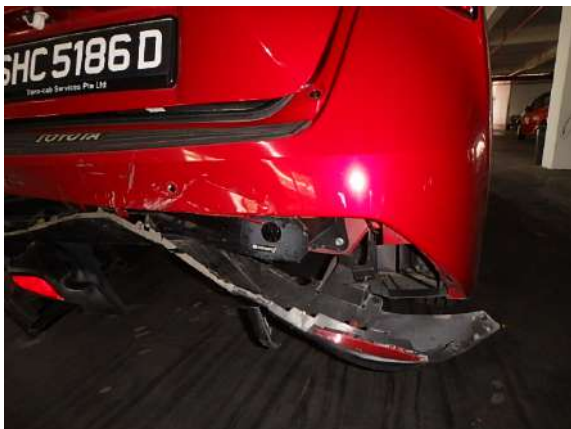
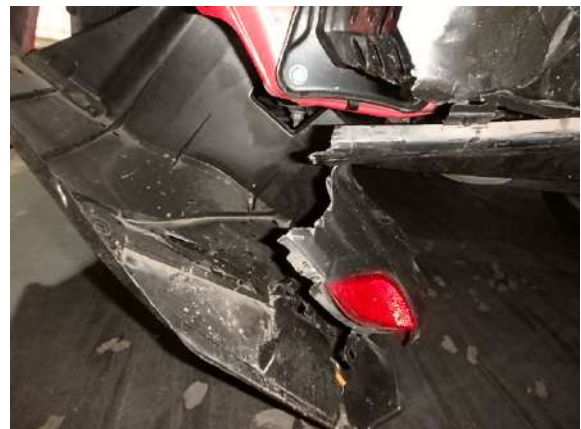
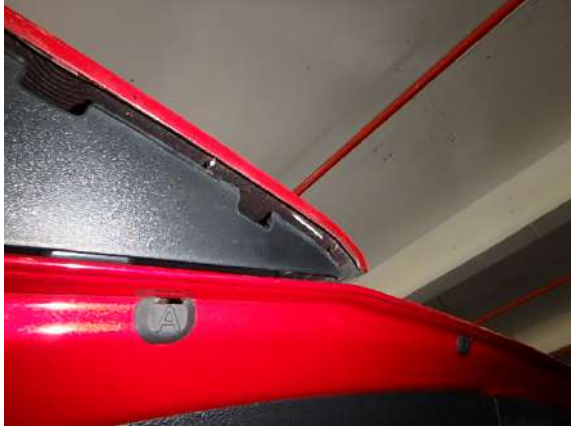
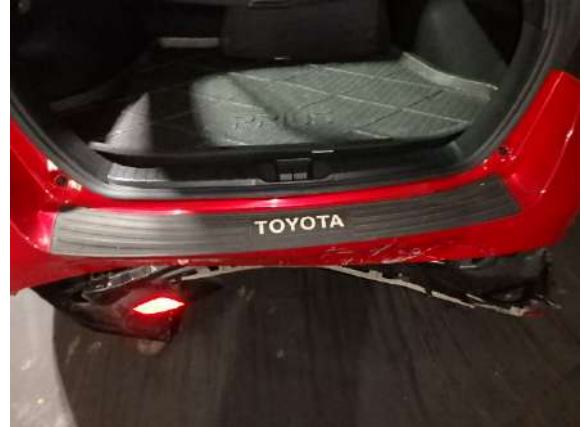
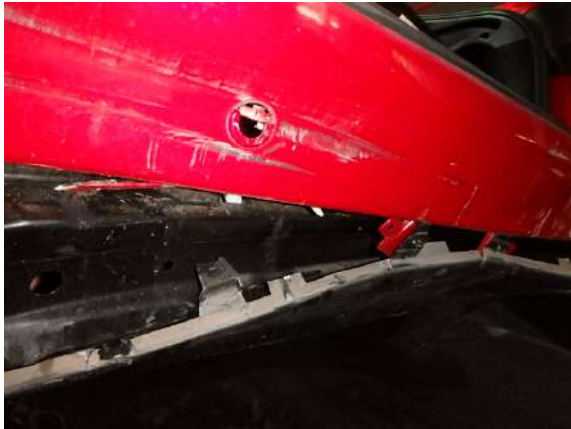
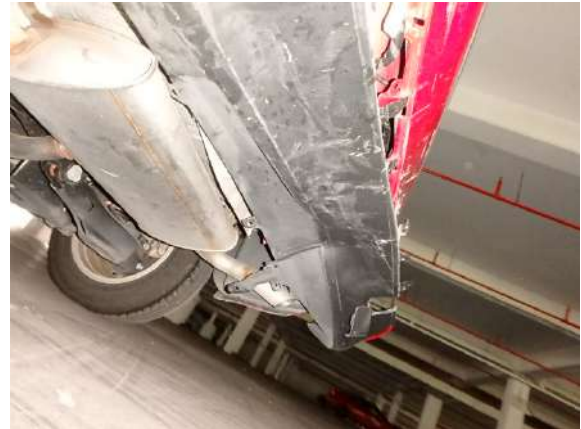
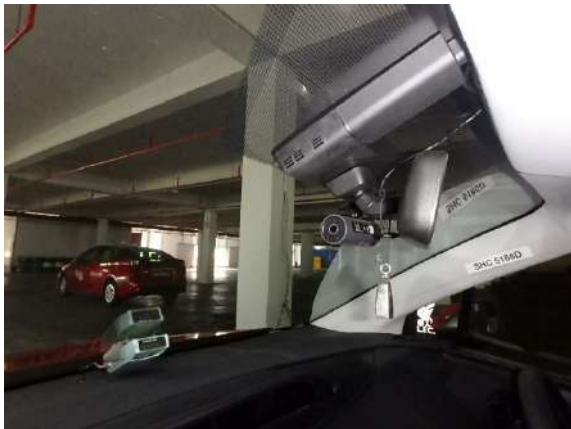
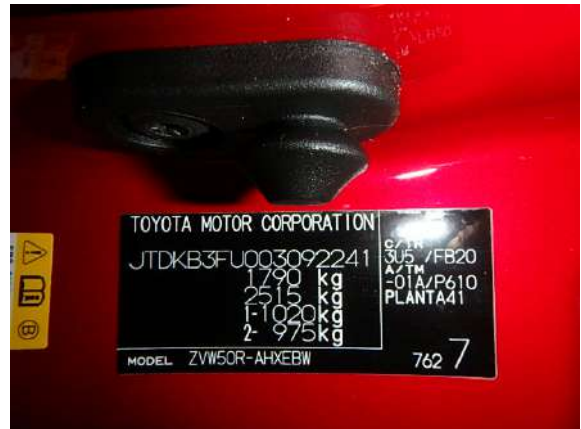
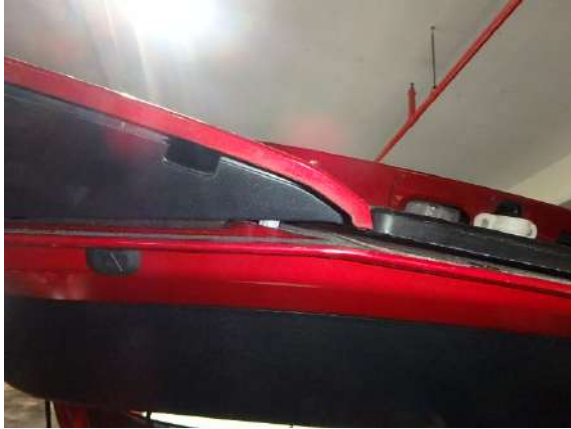
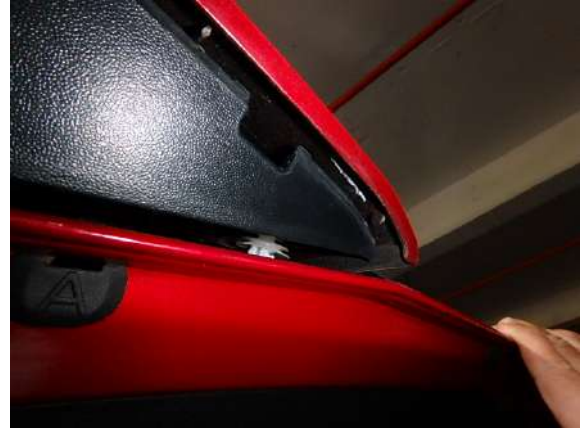
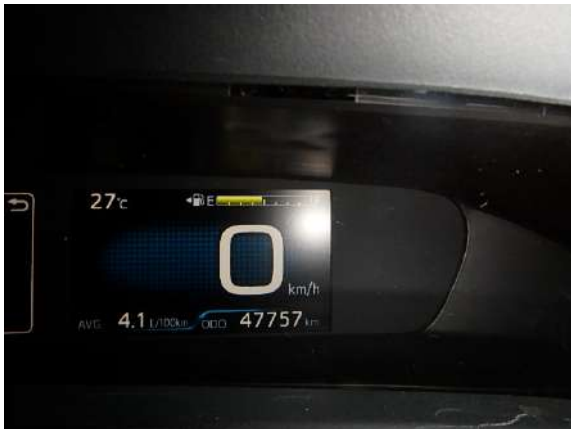
4. Description of Damages				
	THE VEHICLE SUSTAINED DAMAGES AT THE REAR PORTION. DAMAGES SEE DETAILS.			
5. General Information				
	Accident Date	27/04/2021	Inspection Date	30/04/2021
	Survey held at	TRANS-CAB AUTO SERVICES PTE LTD NO.2 ANG MO KIO ST 63 SINGAPORE 569111		
5a. Remarks				
	A)THE INSPECTION WAS CONDUCTED ON A"WITHOUT PREJUDICE" BASIS. B)IN ACCORDANCE TO YOUR INSTRUCTIONS, WE HAVE NOT AUTHORISED REPAIRS.			
5b. Estimate Days of Repair				
	ESTIMATED NORMAL PERIOD FOR REPAIR:		4 Working Days

Qty	Description of Parts	Condition	Estimate By Workshop (\$)	Our Adjusted (\$)
	<u>REPLACEMENT OF PARTS</u>			
1	COVER REAR BUMPER	BENT	485.60	485.60
1	REINFORCEMENT SUB-ASSY ,REAR BUMPER	BENT	332.70	332.70
1	GUARD ,REAR BUMPER CENTER	BENT	374.50	374.50
1	COVER REAR BUMPER LOWER	DENTED	22.00	22.00
1	RETAINER ,REAR BUMPER SIDE ,LH	SERVICEABLE	132.60	-
1	RETAINER ,REAR BUMPER SIDE ,RH	SERVICEABLE	132.60	-
1	REFLECTOR ASSY ,REFLEX LH	SERVICEABLE	39.00	-
1	REFLECTOR ASSY ,REFLEX RH	SERVICEABLE	39.00	-
1	BOX DECK FLOOR LH	SERVICEABLE	313.00	-
1	BOX DECK FLOOR REAR	SERVICEABLE	105.80	-
1	BOX DECK FLOOR RH	SERVICEABLE	313.60	-
1	BOARD ,REAR FLOOR NO.1	SERVICEABLE	519.00	-
1	PANEL SUB-ASSY ,BODY LOWER BACK	TO REPAIR SEE LABOUR	651.00	-
1	COVER ,DECK TRIM ,REAR	SERVICEABLE	126.70	-
1	COVER FLOOR UNDER NO.2 (RH)	SERVICEABLE	241.90	-
1	COVER FLOOR UNDER NO.1 (LH)	SERVICEABLE	175.10	-
1	COVER REAR FLOOR (CTR)	MISSING	229.90	229.90

1	PANEL SUB-ASSY ,BACK DOOR	TO REPAIR SEE LABOUR	1,147.80	-
1	GARNISH SUB-ASSY ,BACK DOOR ,OUTSIDE	CRACKED	913.60	913.60
1	STAY ASSY ,BACK DOOR LH	SERVICEABLE	242.50	-
1	STAY ASSY ,BACK DOOR RH	SERVICEABLE	242.50	-
1	HINGE ASSY ,BACK DOOR LH	TO REPAIR SEE LABOUR	61.00	-
1	HINGE ASSY ,BACK DOOR RH	TO REPAIR SEE LABOUR	61.00	-
1	ORNAMENT SUB-ASSY ,BACK DOOR	NECESSARY	47.90	47.90
1	PLATE LUGGAGE COMPARTMENT DOOR NAME NO.2	NECESSARY	54.60	54.60
1	PLATE BACK DOOR NAME NO.1	NECESSARY	54.60	54.60
	LESS 25% DISCOUNT		-1,764.88	-628.85
			5,294.62	1,886.55

TO TRANSFER OF REAR END PANEL FITTINGS ,ATTACHMENTS TO FACILITATE BODYWORK REPAIR .	NOT NECESSARY	380.00	-
	PUTTY AND SPRAY PAINTING OF THE AFFECTED PORTION .		1,600.00	660.00
	TO REMOVE AND REFIT REAR BIG & SMALL W/SCREEN GLASS TO FACILITATE BODYWORK REPAIR .		300.00	180.00
	TO REINSTALL REAR BUMPER PARKING SENSOR .		170.00	50.00
	TO CHECK ELECTRICAL LIGHTING CONCERNED.		170.00	20.00
			4,840.00	1,470.00
	GRAND TOTAL		11,934.62	4,026.55
