Your Ref: BMW M4 Coupe
(chassis number WBS4Y92030FH26553)
Our Ref : CI/TP21005364/D

02 May 2021

INSPECTION REPORT OF AN UNREGISTERD BMW M4 COUPE MOTOR CAR WITH CHASSIS NUMBER WBS4Y92030FH26553

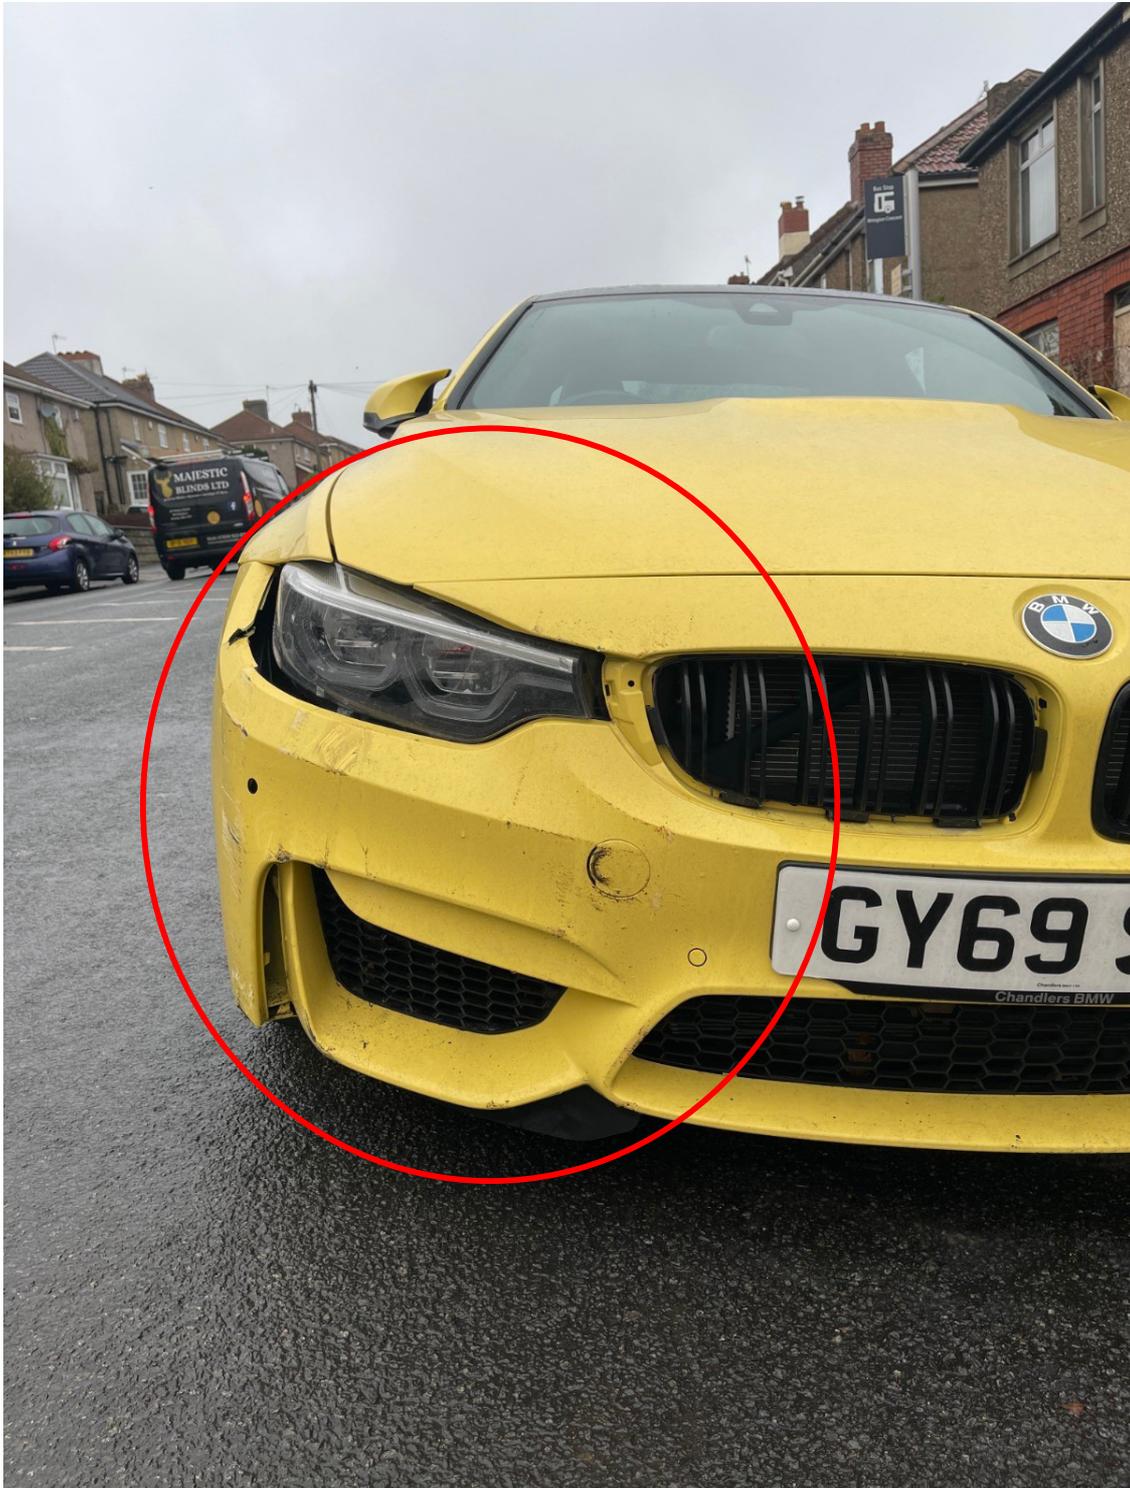
3. From the photographs provided to me, it was observed that the Motor Car had sustained damage at its front right portion. Body parts damaged include the front bumper, front bumper right lower grille, front bumper right corner grille, front right radiator grille, tow hook cover, front right headlamp and front right fender amongst others. See photo 1 – 3 below.

Photo 1 shows the front right body of the Motor Car (photograph provided to me). The Motor Car was observed to have sustained damages at its front right portion (circled). Body parts damaged include the front bumper, front bumper right lower grille, front bumper right corner grille, front right radiator grille, tow hook cover, front right headlamp and front right fender amongst others.

21. The body parts at the front right portion of the Motor Car were visually examined and it was noted that the repair/restoration works carried out to the damaged area of the Motor Car (refer to photograph 1 - 3 above) were reasonably adequate and in order.

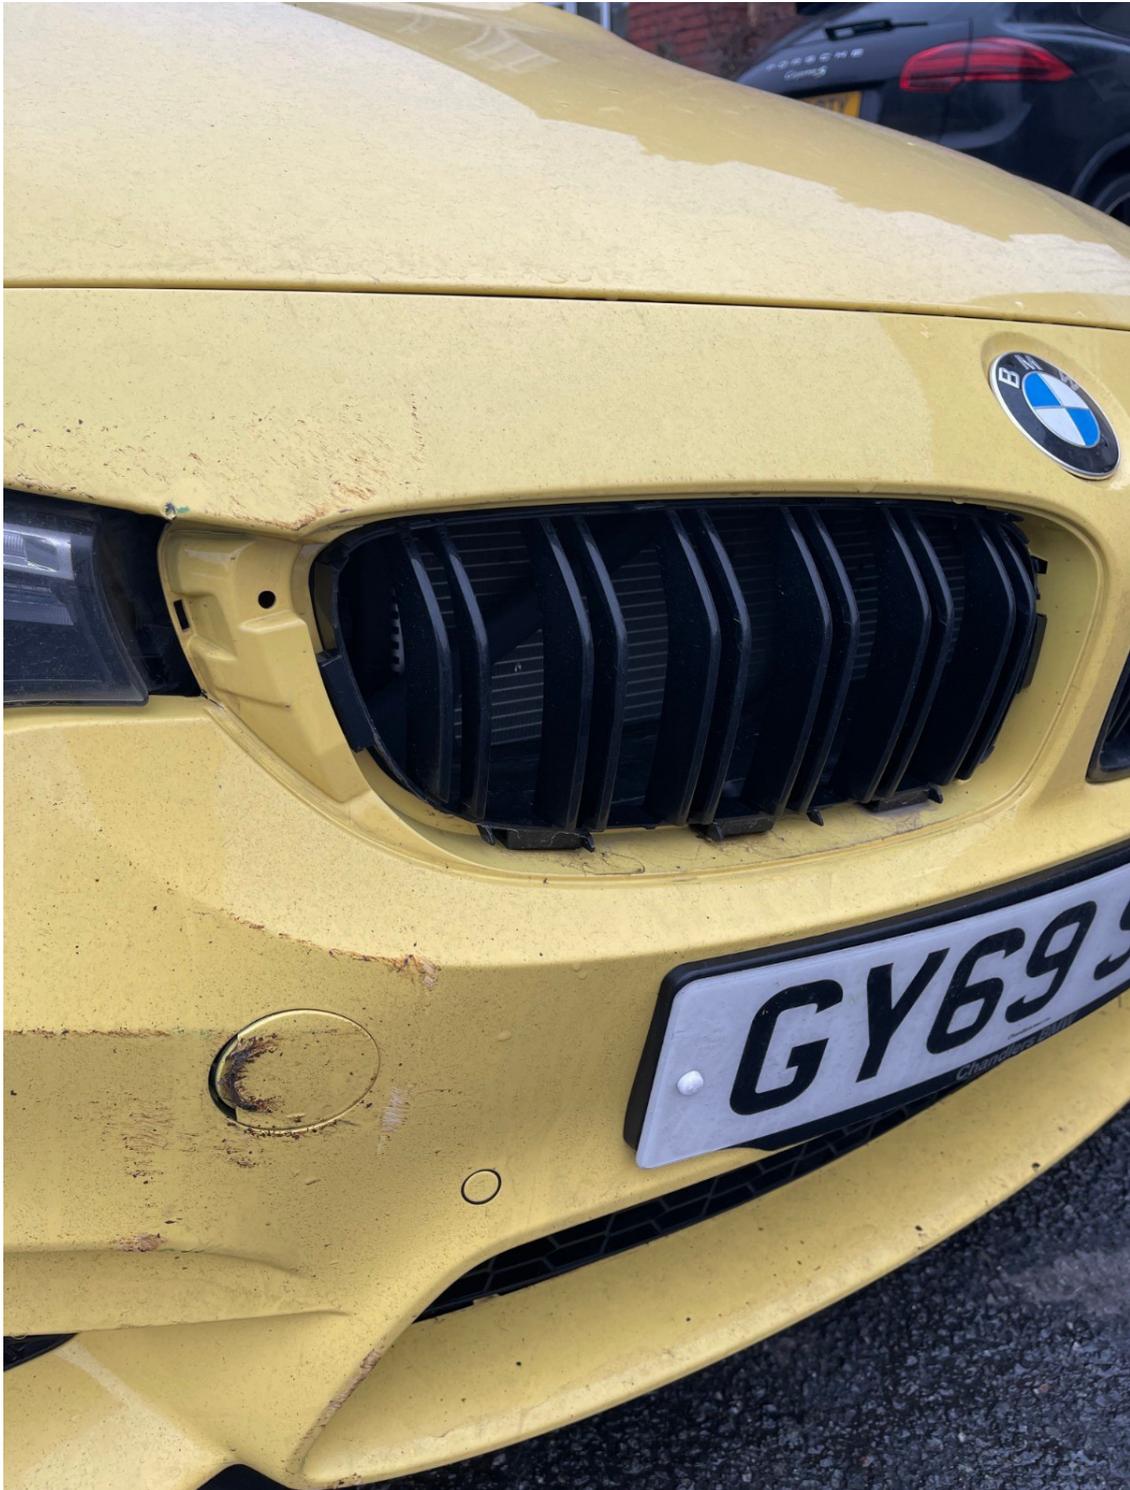
Photo 2 shows a closer view of the damaged front bumper, tow hook cover and front right radiator grille of the Motor Car (photograph provided to me).

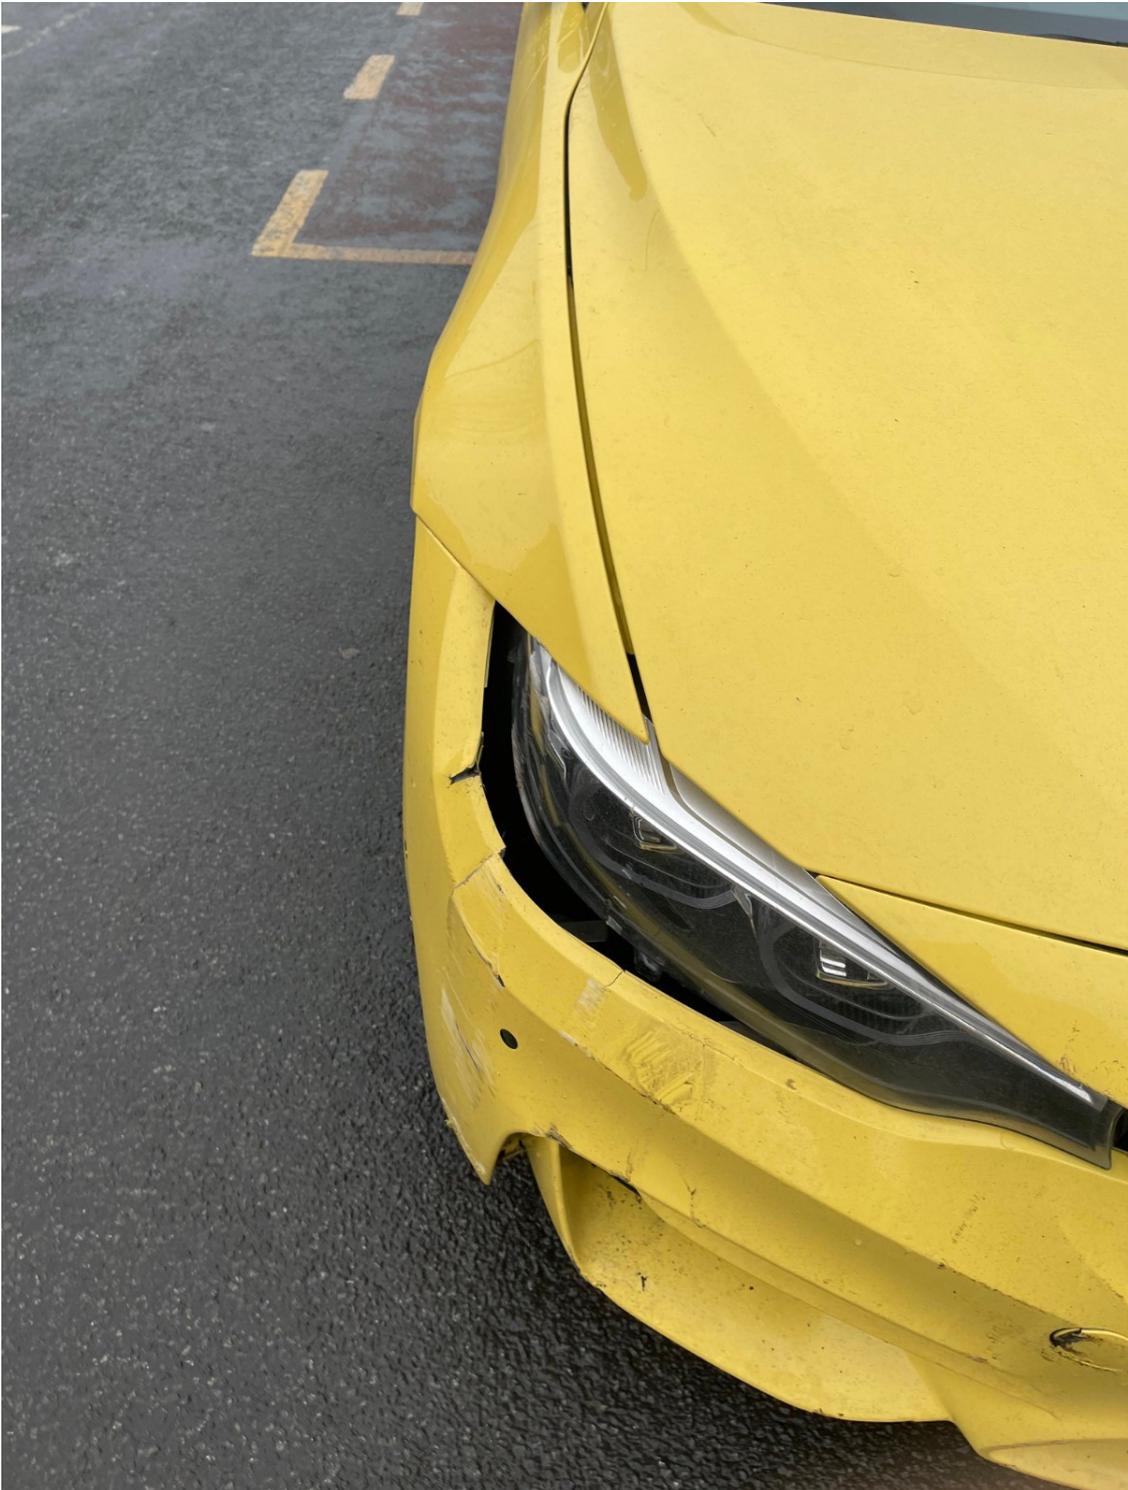
Photo 3 shows the damaged front bumper and front right headlamp of the Motor Car (photograph provided to me).

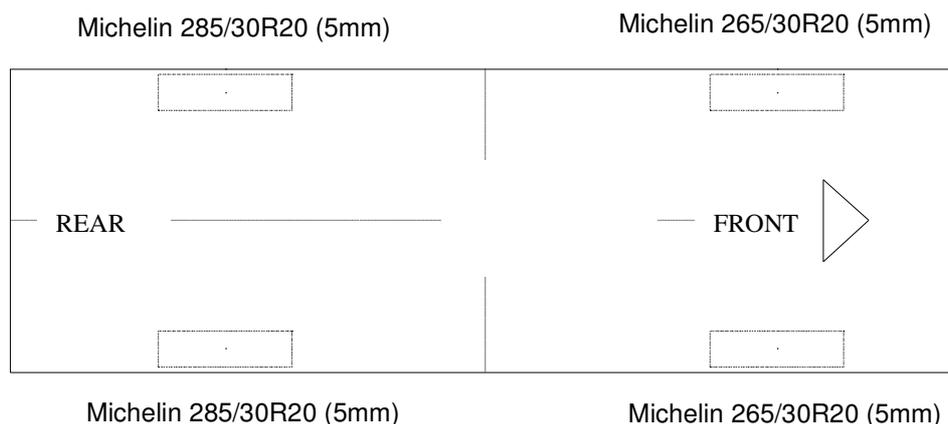
- It was fitted with 20inch sport wheel rims that were wrapped with tyres that were observed to be of serviceable condition. The tyres were also sufficiently inflated for vehicular operation. The tyre brand, tyre size and approximate remaining tread depth of the 4 tyres of the Motor Car were recorded as follows: -

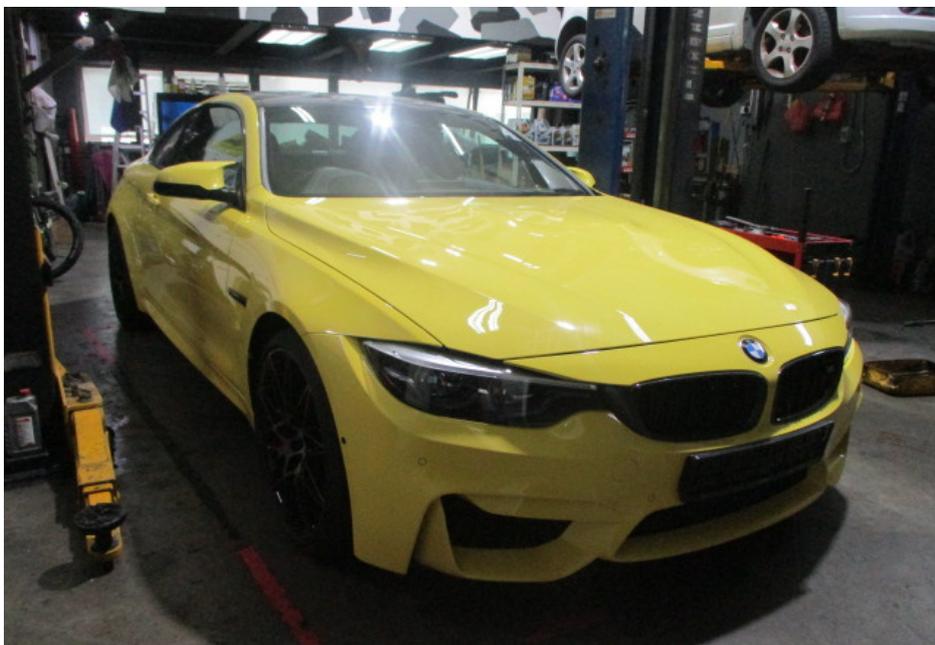
Photo 4 shows a general view of the front right body of the Motor Car at the time of my inspection. The Motor Car was observed to be in a relatively good general condition with no loose exterior fittings observed. The body parts at the front right portion of the Motor Car were visually examined and it was observed that the repair/restoration works carried out to the damaged area of the Motor Car (refer to photograph 1 - 3 above) were reasonably adequate and in order.

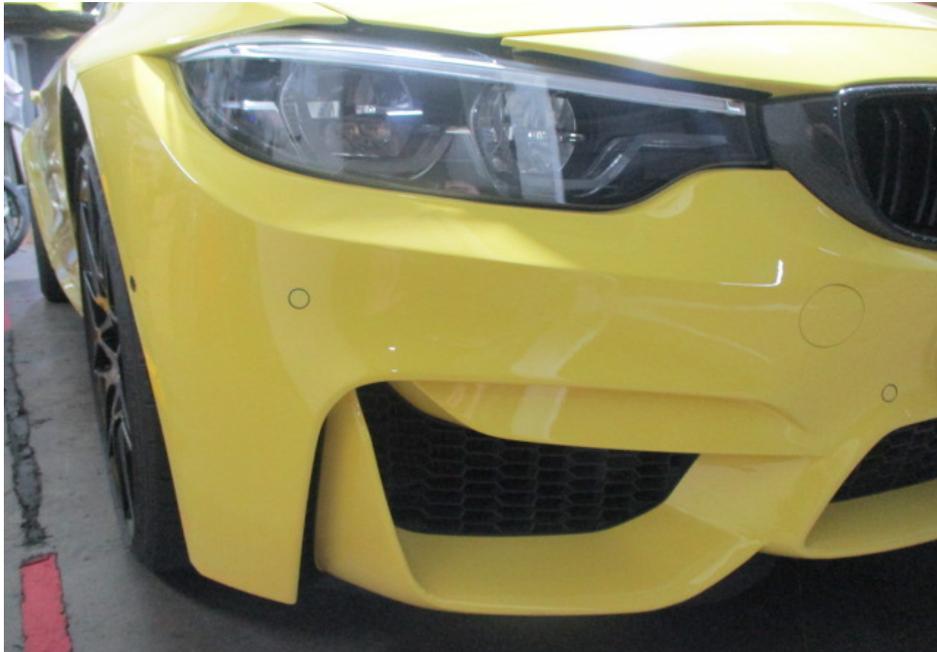
Photo 5 shows a closer view of front bumper, front bumper right lower grille and front right headlamp of the Motor Car. The body parts at the front right portion of the Motor Car were visually examined and it was observed that the repair/restoration works carried out to the damaged area of the Motor Car (refer to photograph 1 - 3 above) were reasonably adequate and in order.

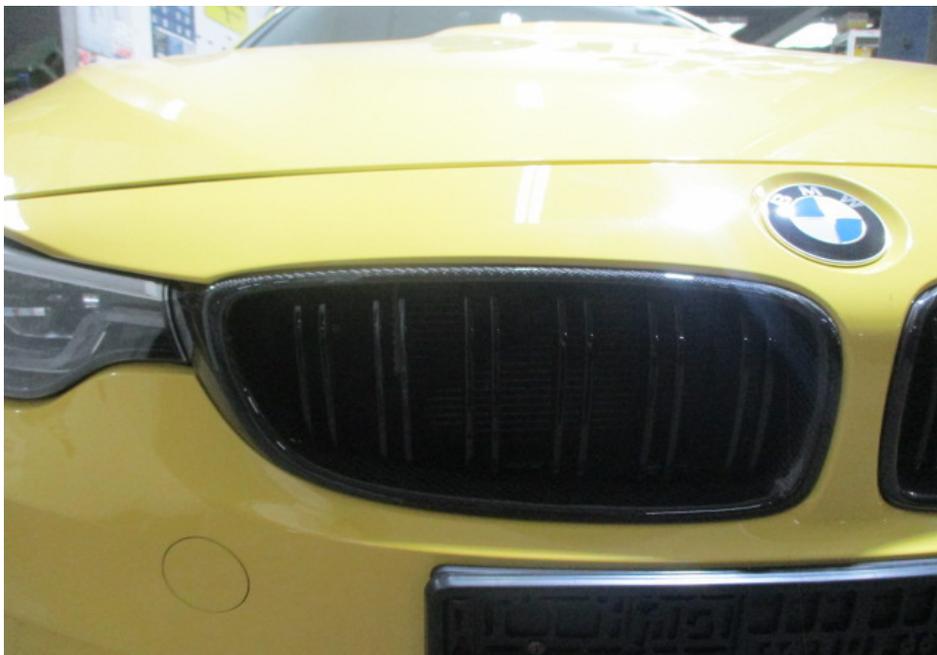
Photo 6 shows a closer view of front bumper, front right radiator grille and tow hook cover of the Motor Car. The body parts at the front right portion of the Motor Car were visually examined and it was observed that the repair/restoration works carried out to the damaged area of the Motor Car (refer to photograph 1 - 3 above) were reasonably adequate and in order.

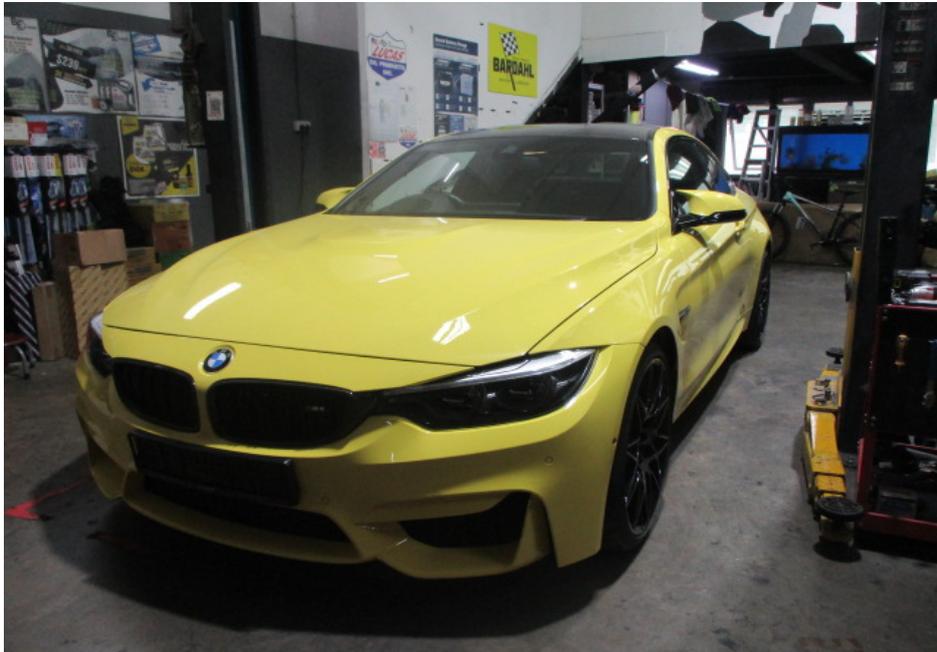
Photo 7 shows a general view of the front left body of the Motor Car at the time of my inspection. The Motor Car was observed to be in a relatively good general condition with no loose exterior fittings observed. The mileage of the Motor Car recorded at the time of my inspection was 5,040km.

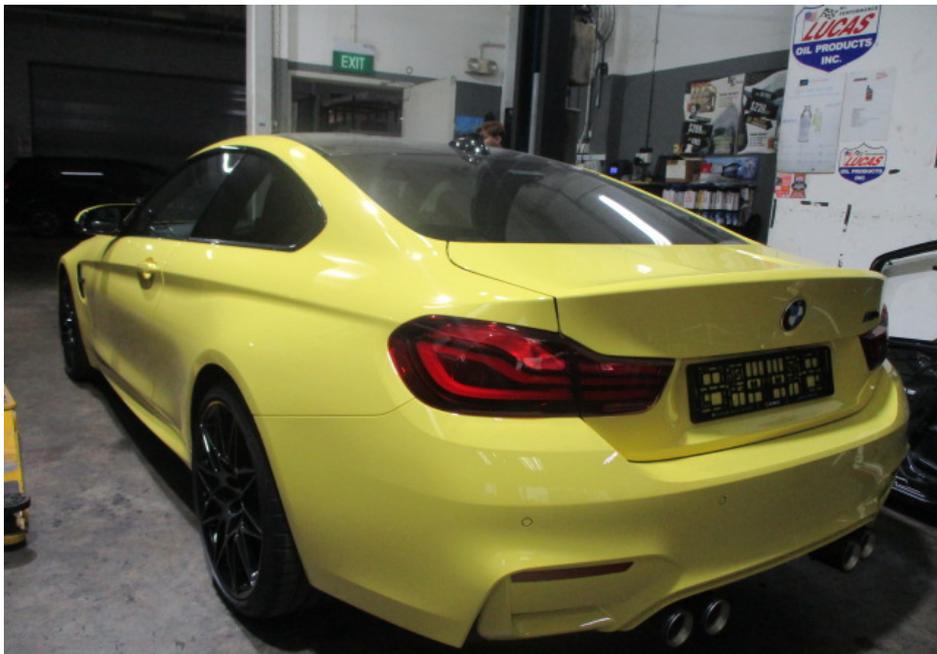
Photo 8 shows a general view of the rear left body of the Motor Car at the time of my inspection. The Motor Car was observed to be in a relatively good general condition with no loose exterior fittings observed. The mileage of the Motor Car recorded at the time of my inspection was 5,040km.

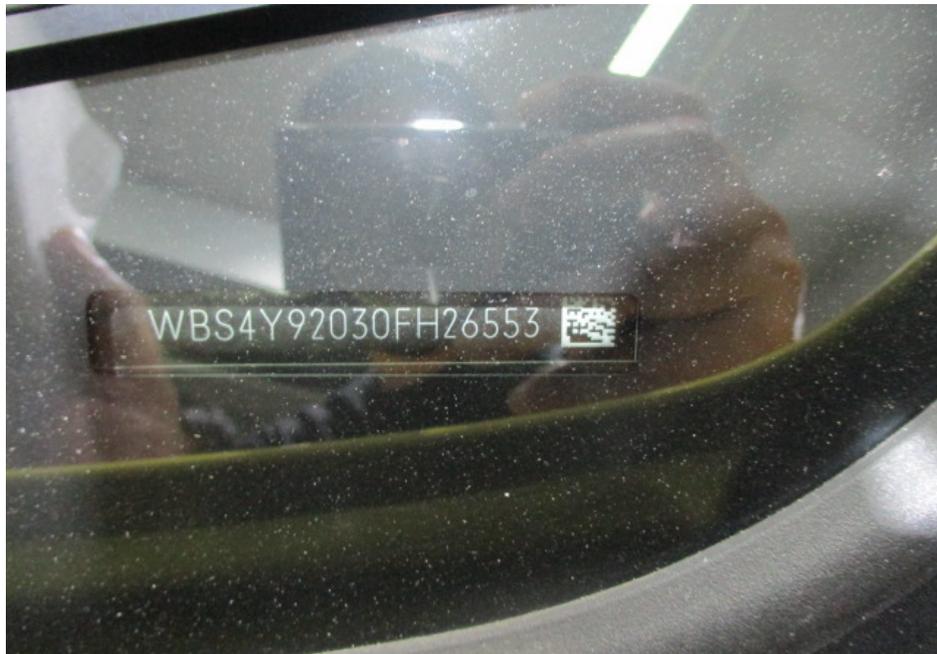
Photo 9 shows the chassis number of the Motor Car. The chassis number recorded was WBS4Y92030FH26553.

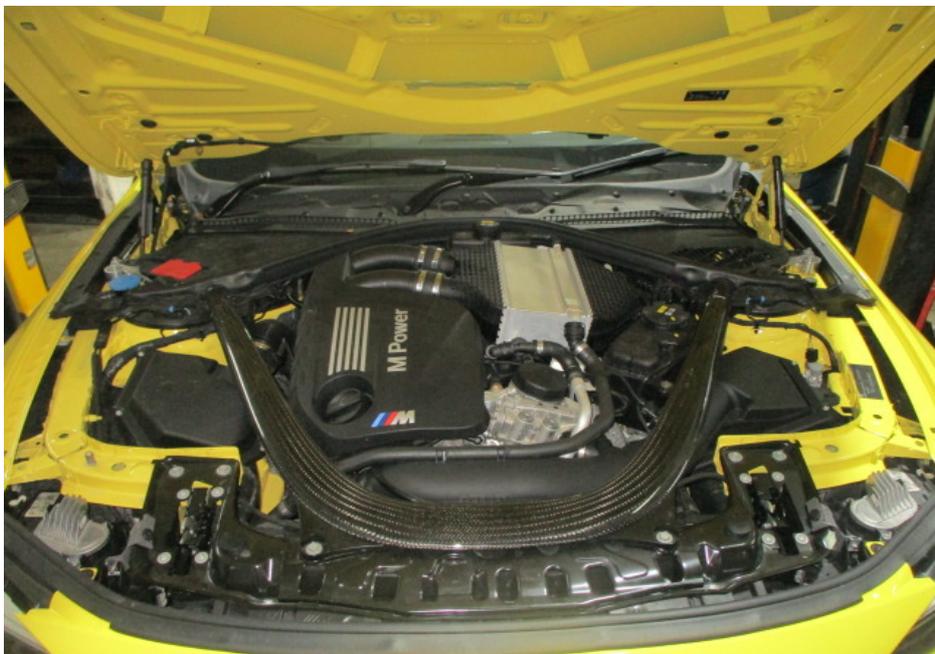
13. My examination of the engine compartment of the Motor Car revealed that the various parts and components inside the engine compartment were all intact and properly fitted. The engine oil, brake fluid and engine coolant were all found to be of sufficient level for operating purposes. Visually, there was also no contamination found to these fluids.

Photo 10 shows a general view of the engine compartment of the Motor Car at the time of my inspection. The various parts and components inside the engine compartment were all observed to be intact and properly fitted. There was also no sign(s) or indication(s) of fluid leak and/or fluid stain found inside the engine compartment.

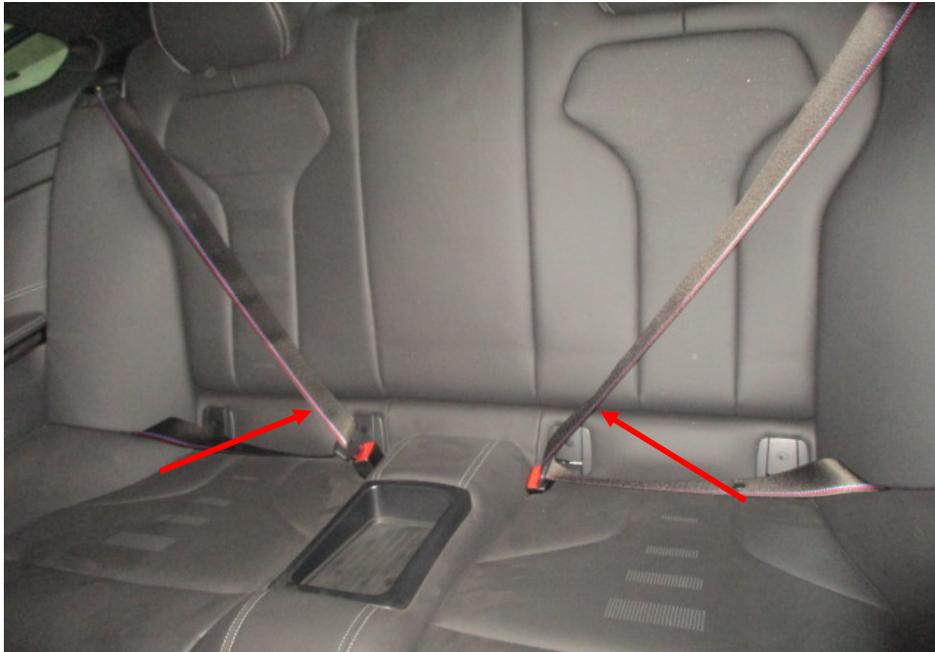
11. The seats of the Motor Car were found to be secured to the floorboard of the Motor Car via seat rails bolted onto the floorboard. Retractable seat belt reels and pre-tensioners were fitted on all seats of the Motor Car. The seat belts were tested and were able to be fastened securely into the respective pre-tensioners that were fixed to the side of all the seats.

Photo 11 shows the rear seats of the Motor Car. All the seats of the Motor Car were secured via seat rails to the floorboard. They were also fitted with a retractable seat belt reel and a pre-tensioner. The seat belts (arrowed) were tested and were able to be fastened into the respective pre-tensions that were fitted on the side of each individual seat.

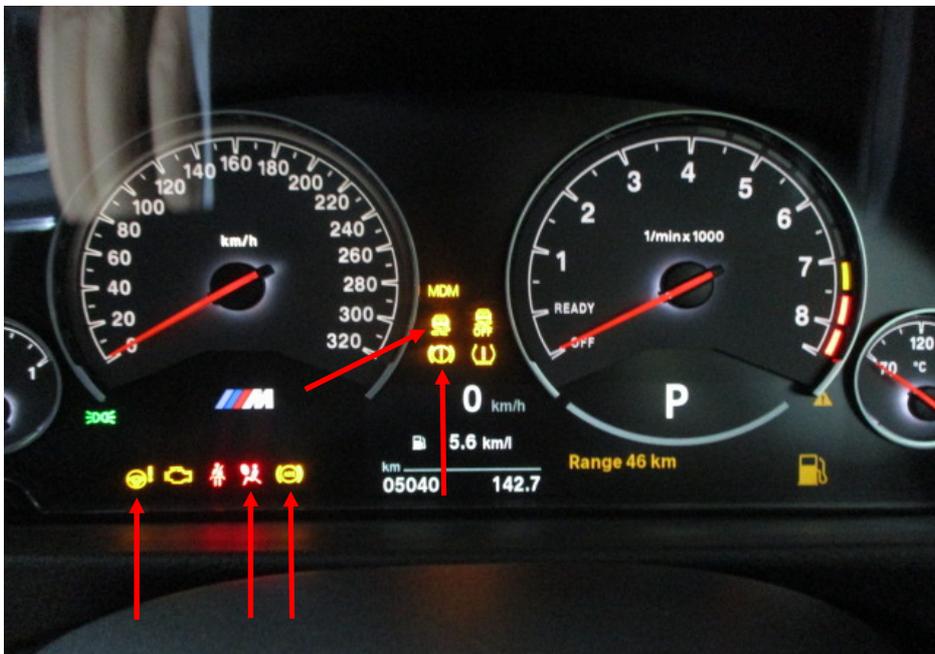
Photo 12 shows the warning lights for the various electronic safety features appearing on the instrument panel of the Motor Car during its self-test when the engine is cranked, in particular the ABS, SRS, IAS, TPM and DSC lights (arrowed).

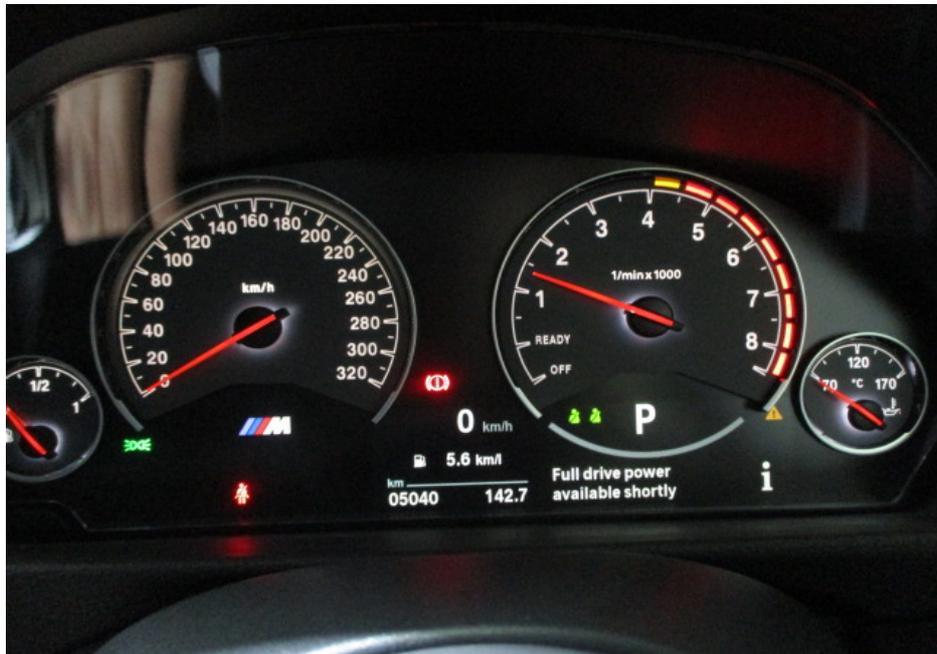
12. The Motor Car's automatic self-test of the functionality of its various electronic safety features like the Anti-Lock Brake System (ABS), Supplemental Restraint System (SRS), Integral Active Steering (IAS), Tyre Pressure Monitor (TPM) and Dynamic Stability Control (DSC) during cranking of the engine had indicated that these electronic systems were in working condition. This was determined from the respective warning lights disappearing from the instrument panel after the self-test.

Photo 13 shows the respective warning lights no longer illuminated, indicating that there is no fault detected to the ABS, SRS, IAS, TPM and DSC systems of the Motor Car during the self-test. These electronic systems were hence in working condition at the time of my inspection.

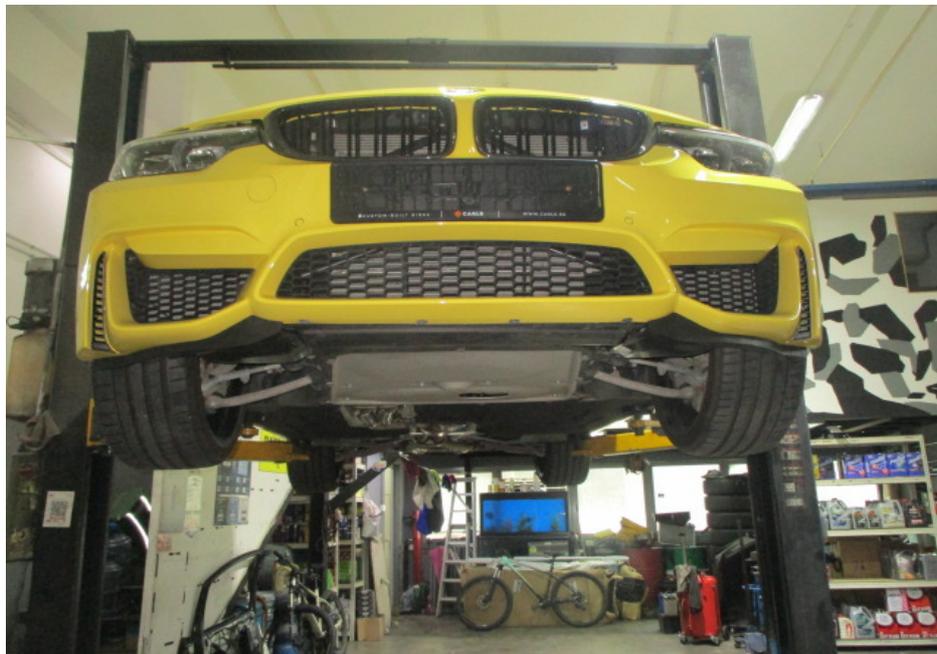
14. My checks on the underside of the Motor Car revealed no sign(s) or indication(s) of fluid leakage and/or fluid stain(s). The engine block and automatic transmission assembly were both secured properly. All undercarriage components of the Motor Car were also observed to be intact and secured in an appropriate manner.

Photo 14 shows the Motor Car hoisted up for checks on its undercarriage. There was no sign(s) or indication(s) of fluid leakage and/or fluid stain(s) on the underside of the Motor Car. The undercarriage components of the Motor Car were also all observed to be intact and secured in an appropriate manner.

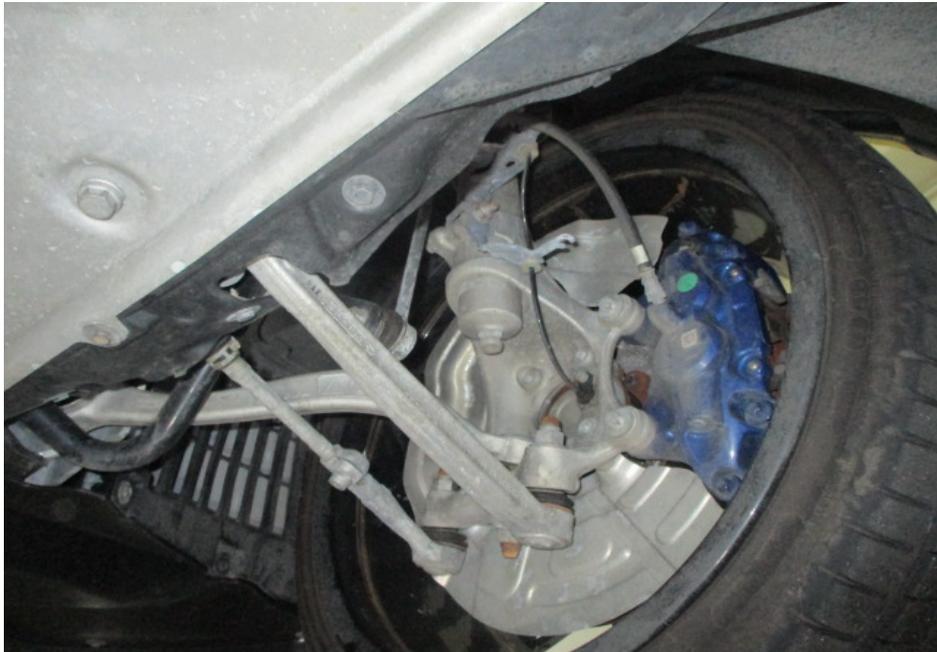
Photo 15 shows the various undercarriage components at the front right wheel of the Motor Car. The mechanical components, control arms and linkages were all found to be intact and secured in an appropriate manner. I also did not observe any fluid leak and/or fluid stain on the underside of the Motor Car.

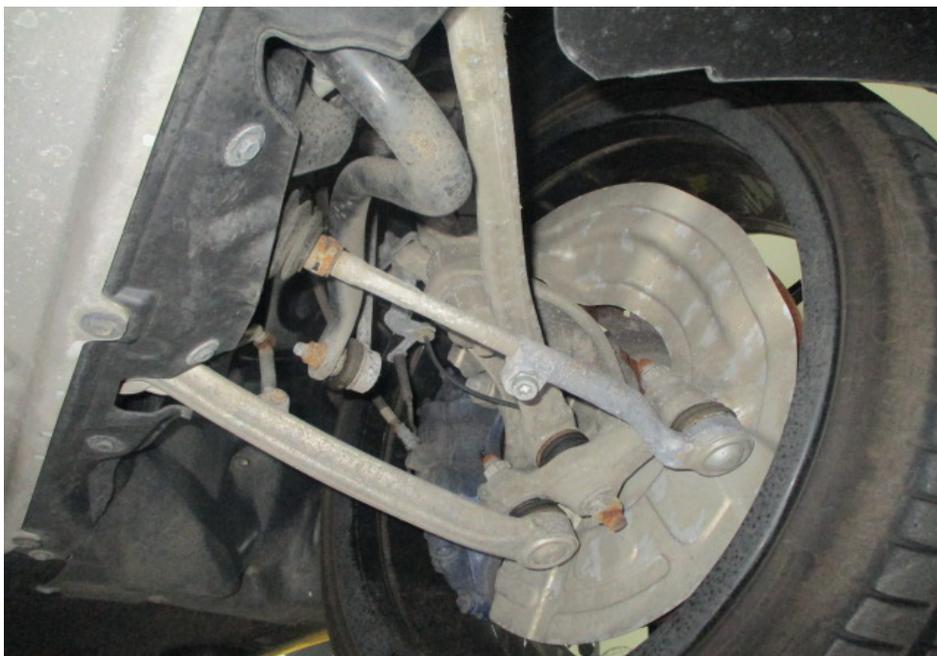
Photo 16 shows the various undercarriage components at the front left wheel of the Motor Car. The mechanical components, control arms and linkages were all found to be intact and secured in an appropriate manner.

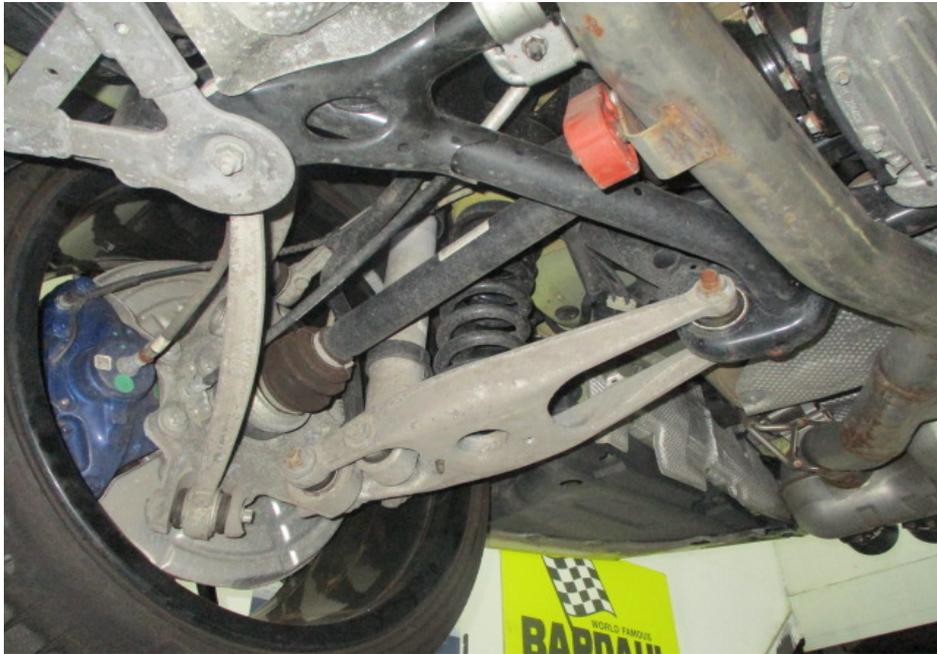
Photo 17 shows a general view of the control arms and linkages at the rear right wheel of the Motor Car. I did not observe any fluid leak and/or fluid stain on the underside of the Motor Car. All of the Motor Car's undercarriage components were observed to be intact and secured in an appropriate manner.

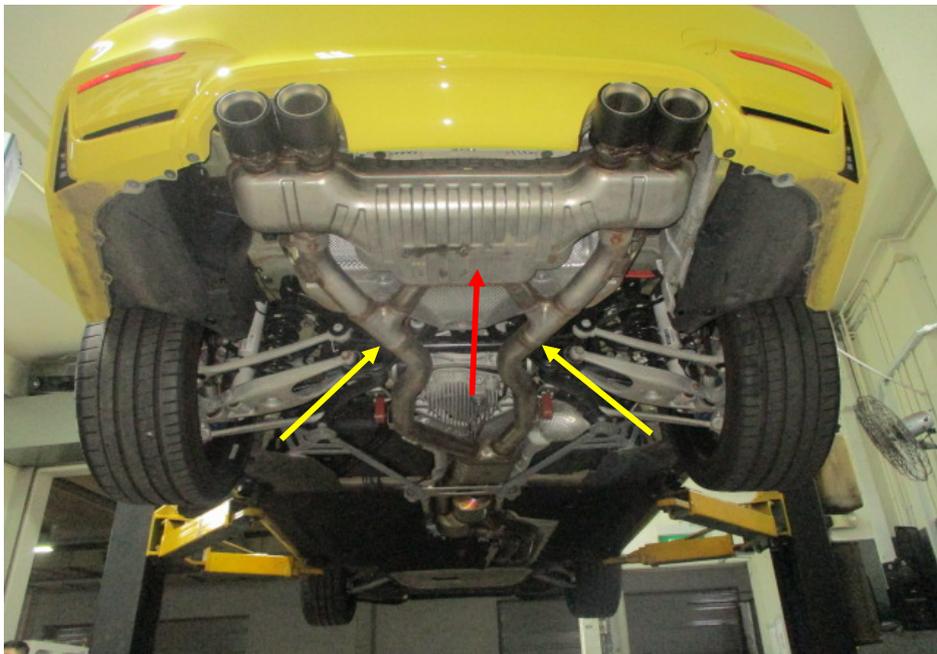
Photo 18 shows a general view of the Motor Car's exhaust system. My examination of the Motor Car's exhaust system revealed no sign(s) or indication(s) of any cut or weld marks on its rear muffler (red arrow), exhaust pipes (yellow arrow) and catalytic converters.

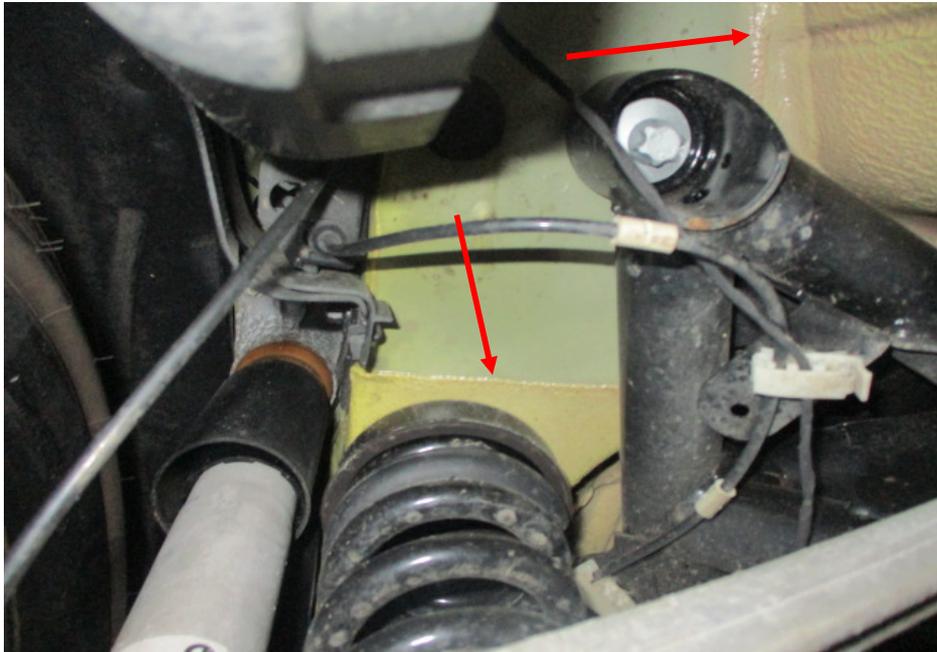
10. Visually, I did not find any weld marks, other than the original spot weld marks, on the chassis/structural body of the Motor Car. The original factory sealant at the joints along the chassis/structural body was also untouched, again indicating that no replacement of the chassis/structural body was carried out; and that the chassis/structural body was originally fitted.

Photo 19 shows the chassis/structural body at the underside rear left of the Motor Car. I did not find any weld marks other than original spot weld marks on the chassis/structural body of the Motor Car. The original factory sealant (arrowed) at the joints along the chassis/structural body was also untouched, indicating no work was done on the chassis/structural body of the Motor Car and that the chassis/structural body was originally fitted.

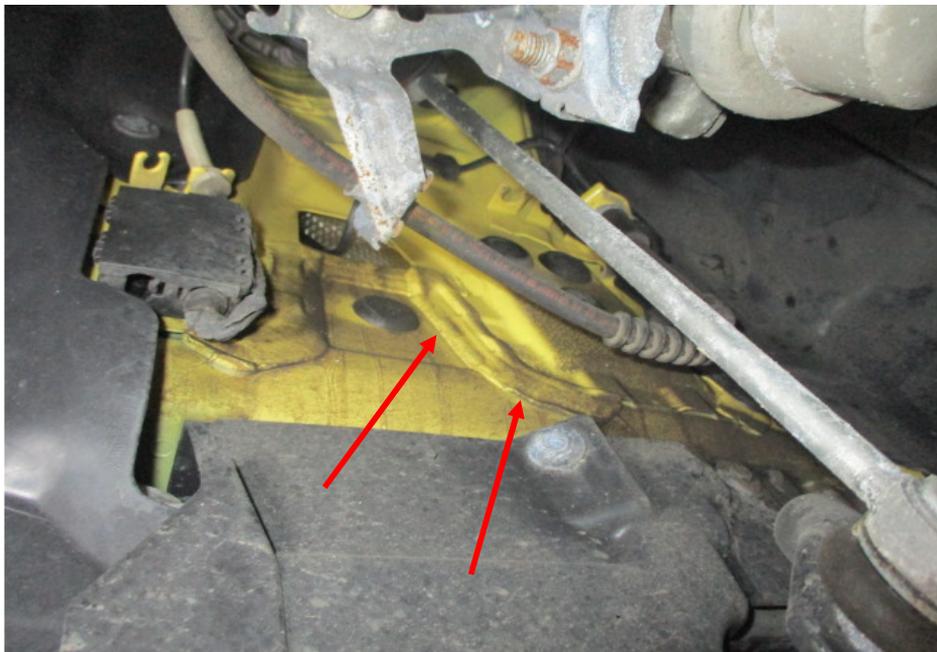
Photo 20 shows the chassis/structural body at the underside front right of the Motor Car. The original factory sealant (arrowed) at the joints along the chassis/structural body was observed to be untouched. In general, I had found no work was carried out on the chassis/structural body of the Motor Car. The chassis/structural body of the Motor Ca was originally fitted.

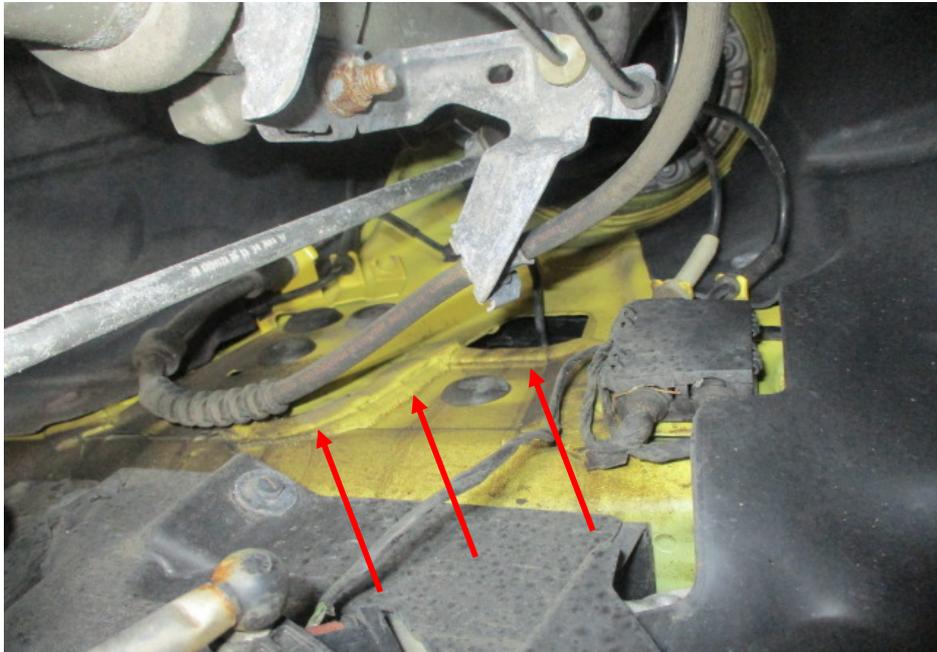
Photo 21 shows the chassis/structural body at the underside front left of the Motor Car. I did not find any weld marks other than original spot weld marks on the chassis/structural body of the Motor Car. The original factory sealant (arrowed) at the joints along the chassis/structural body was also untouched, indicating no work was done on the chassis/structural body of the Motor Car and that the chassis/structural body was originally fitted.

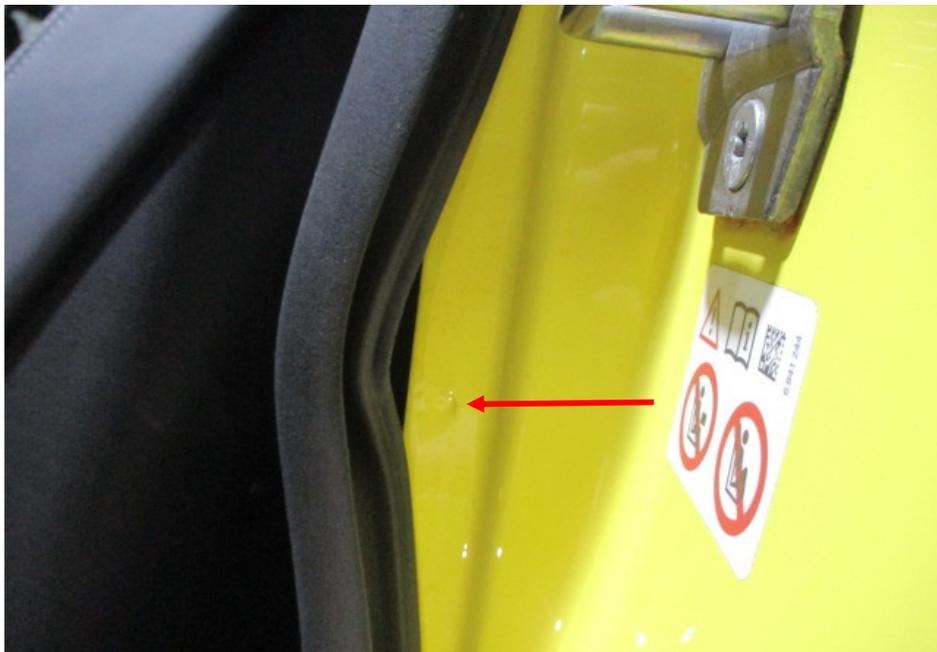
9. Checks on the non-detachable body panels like the rear body panels, floorboard, roof panel, pillars and rocker panels amongst others, revealed that these body panels were spot welded onto the chassis/structural body of the Motor Car. The original factory sealant at the joints of the non-detachable body panels was all untouched indicating no replacement of the non-detachable body panels was carried out; and that these body panels were all originally fitted.

Photo 22 shows the left side rear body panel of the Motor Car. I did not find any weld marks other than original spot weld marks (arrowed) on the left side rear body panel of the Motor Car, which indicates that there was no re-welding works carried out. In general, I had found all the non-detachable body panels of the Motor Car to be originally fitted at the time of my inspection.

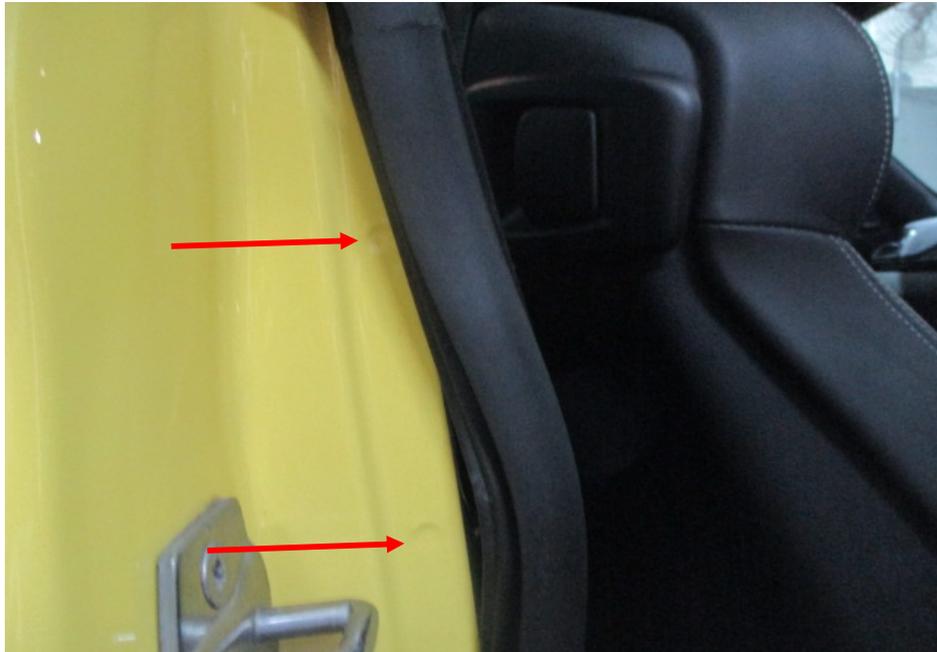
Photo 23 shows the right side rear body panel of the Motor Car. I did not find any weld marks other than original spot weld marks (arrowed) on the right side rear body panel of the Motor Car which, indicates that there was no re-welding works carried out. In general, I had found all the non-detachable body panels of the Motor Car to be originally fitted at the time of my inspection.
