ACCIDENT DAMAGED VEHICLE INSPECTION REPORT

Date : 12 January 2021
Our Ref : WG/TP/2021-05

Registration No : SLQ7175B
Make : KLA
Model : FORTE K3 1.6A
Year : 2017

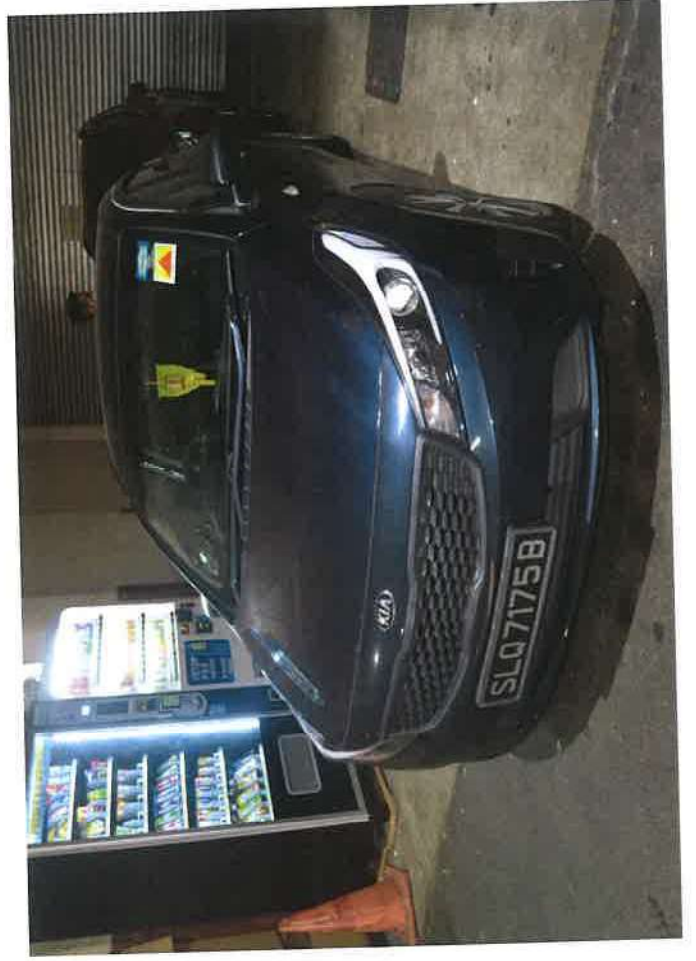
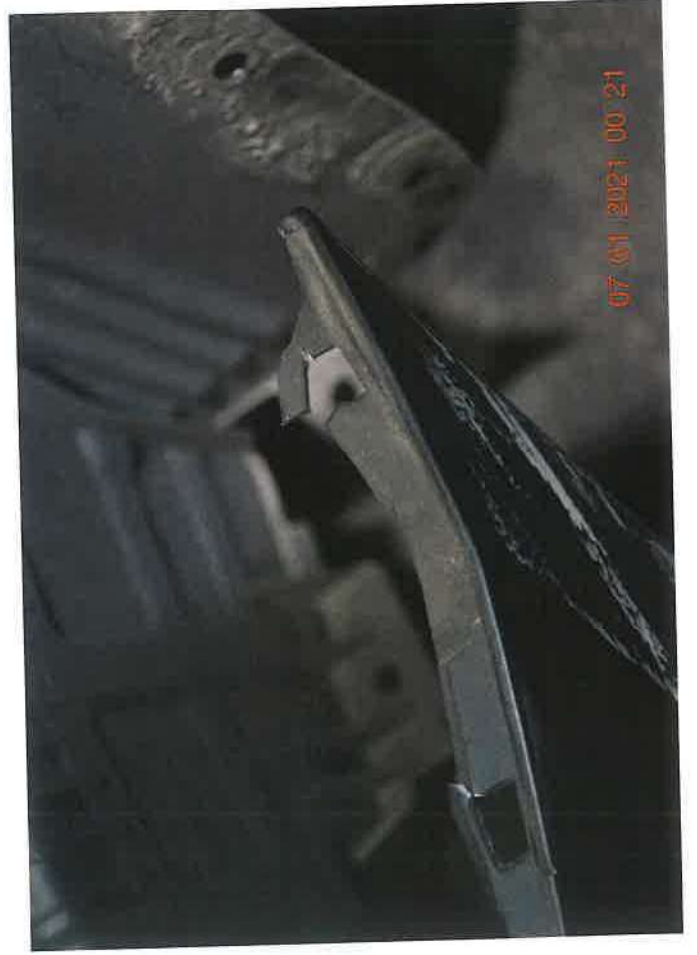
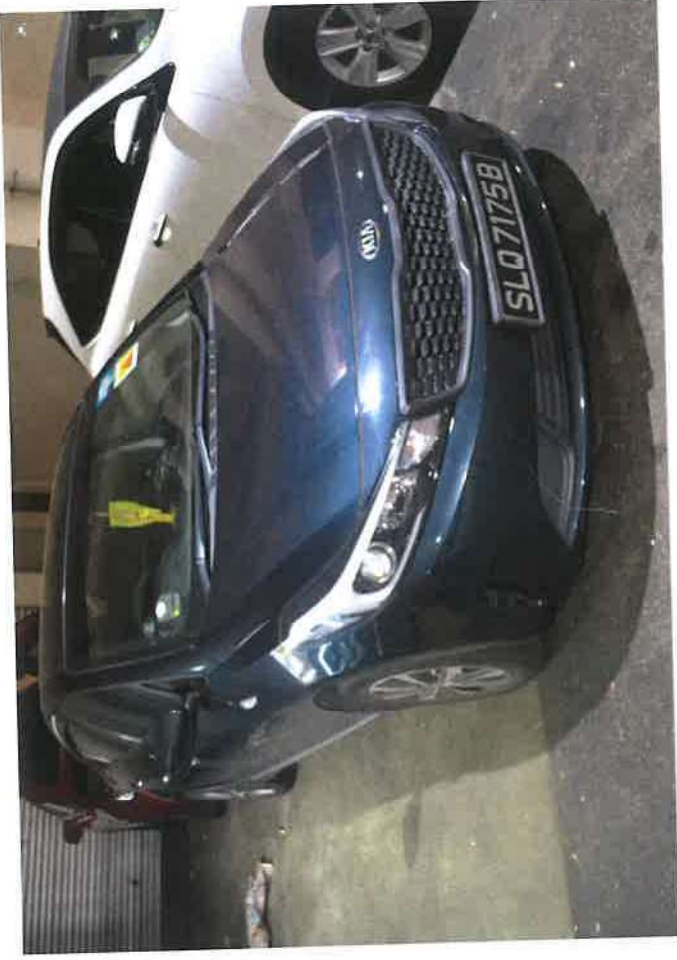
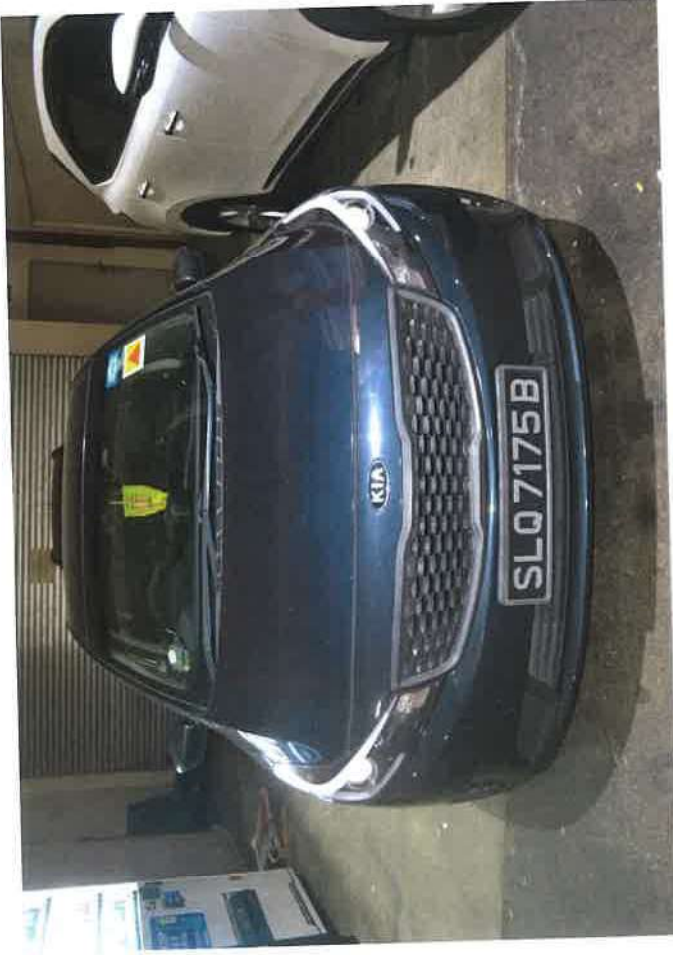
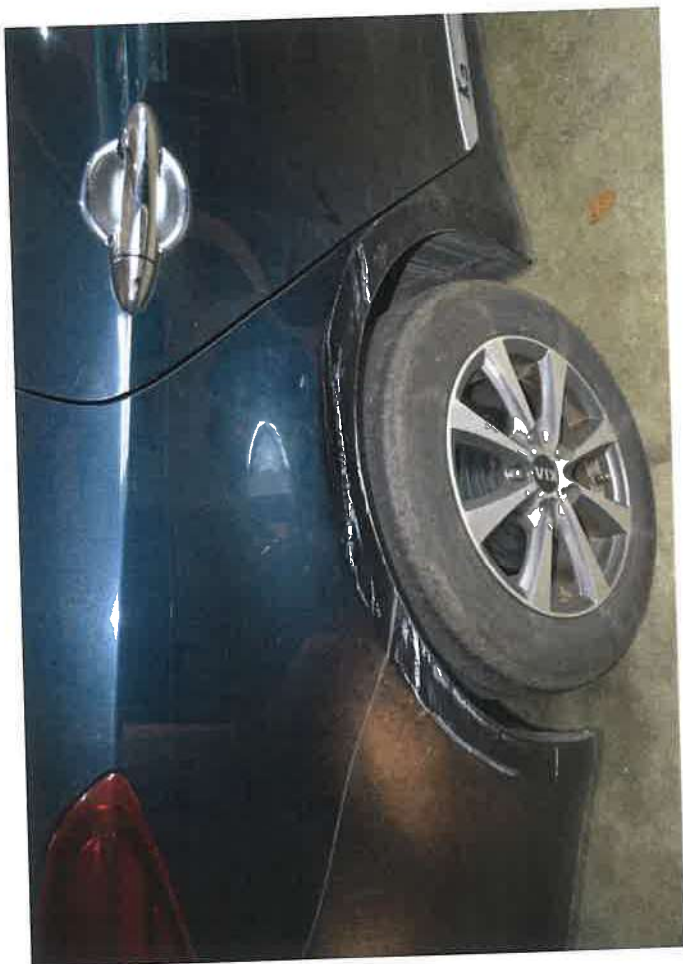
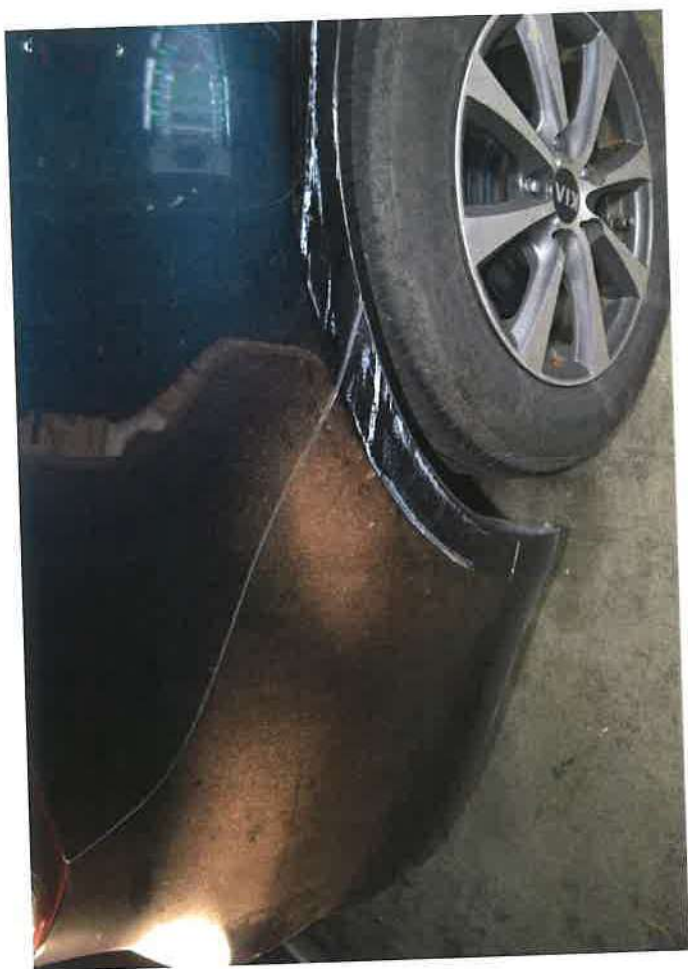
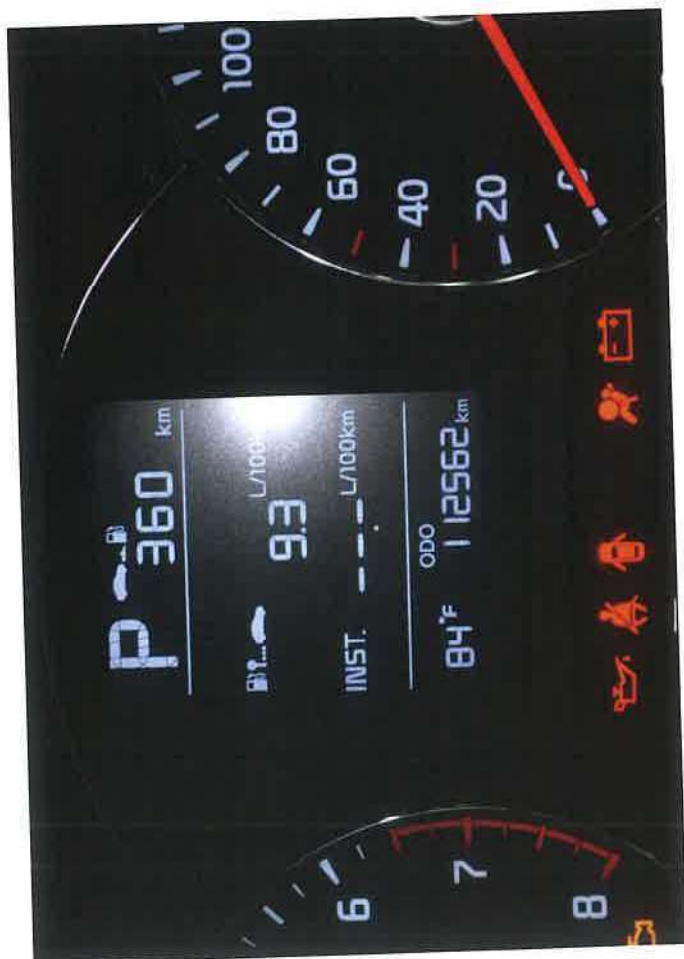
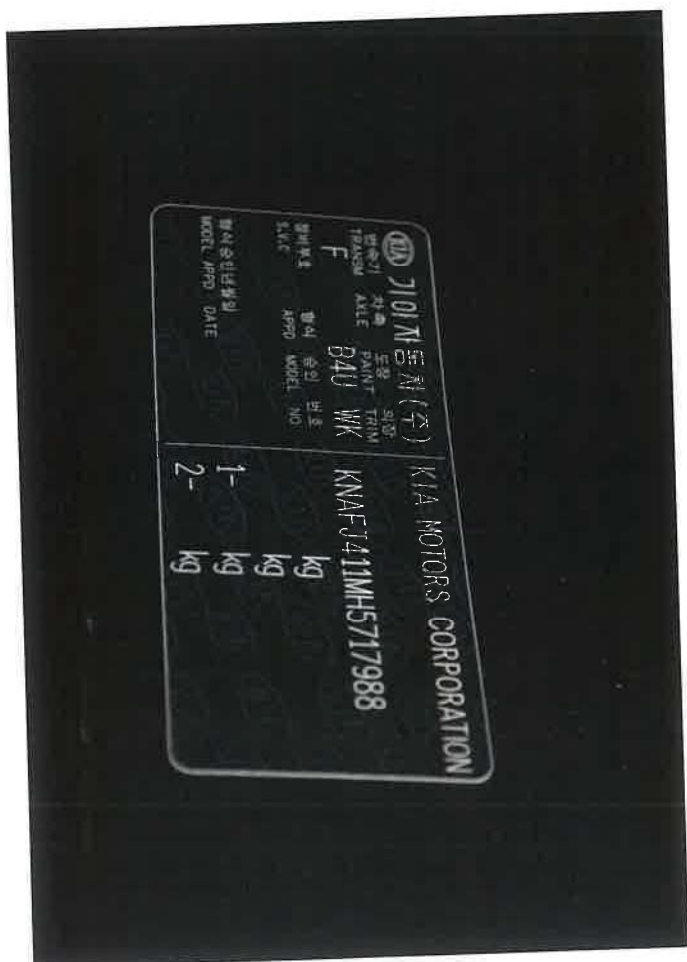
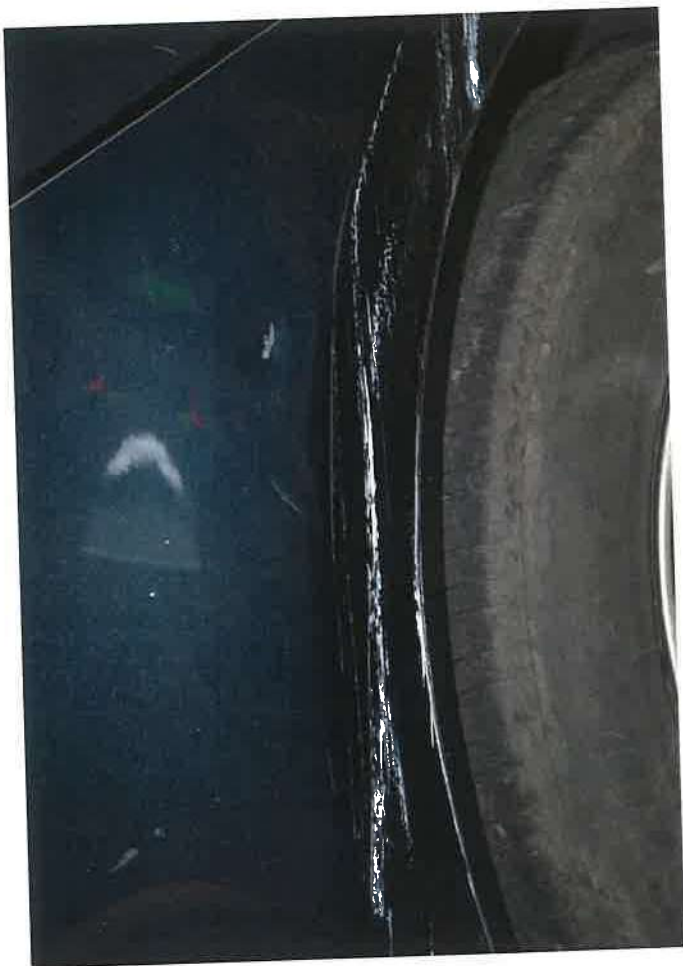
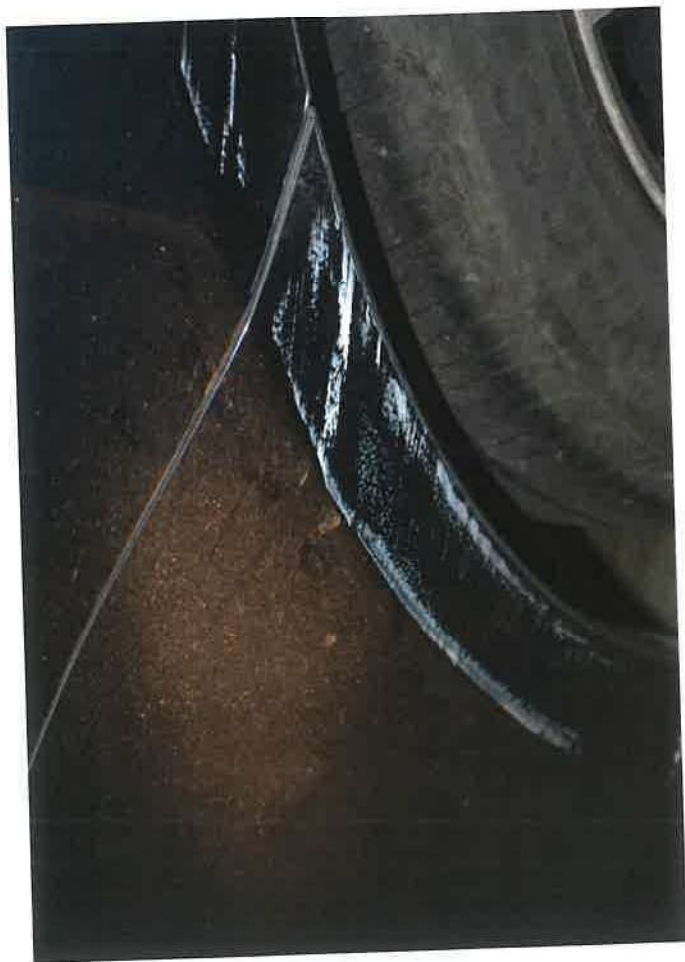
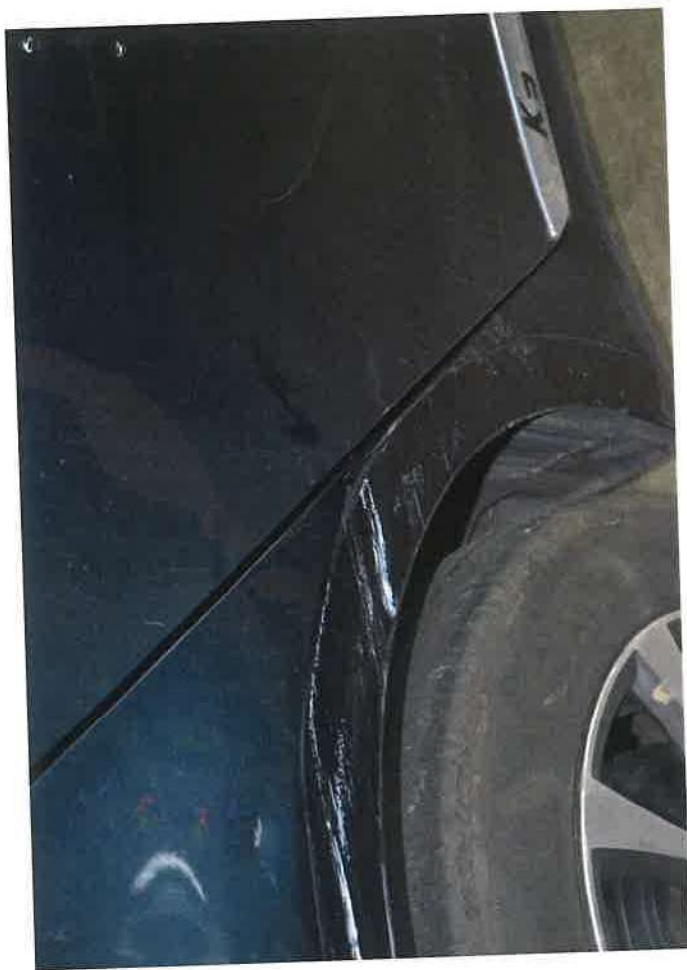
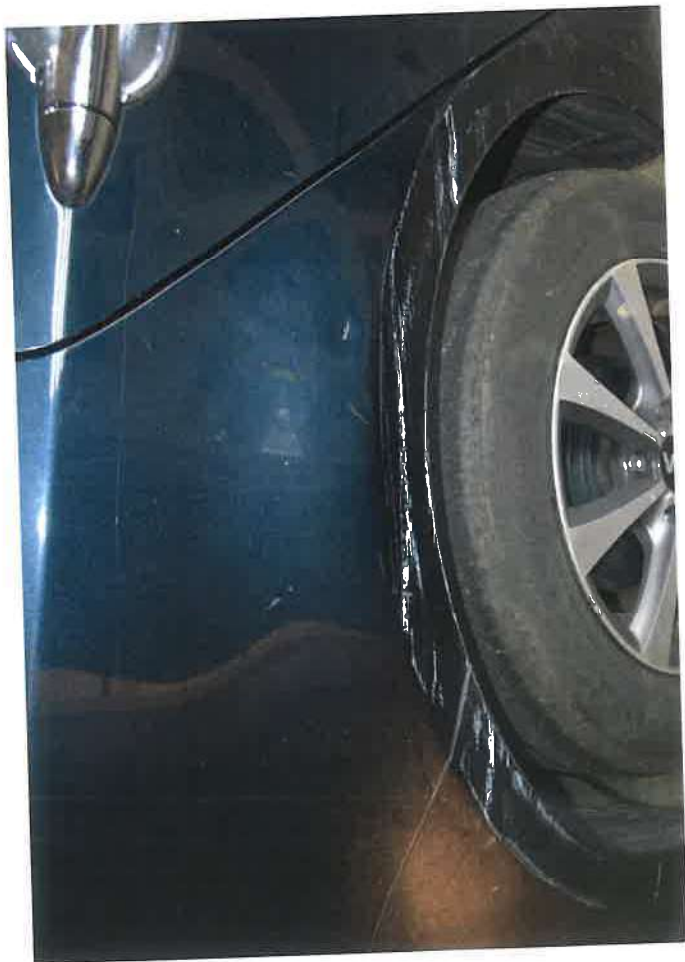
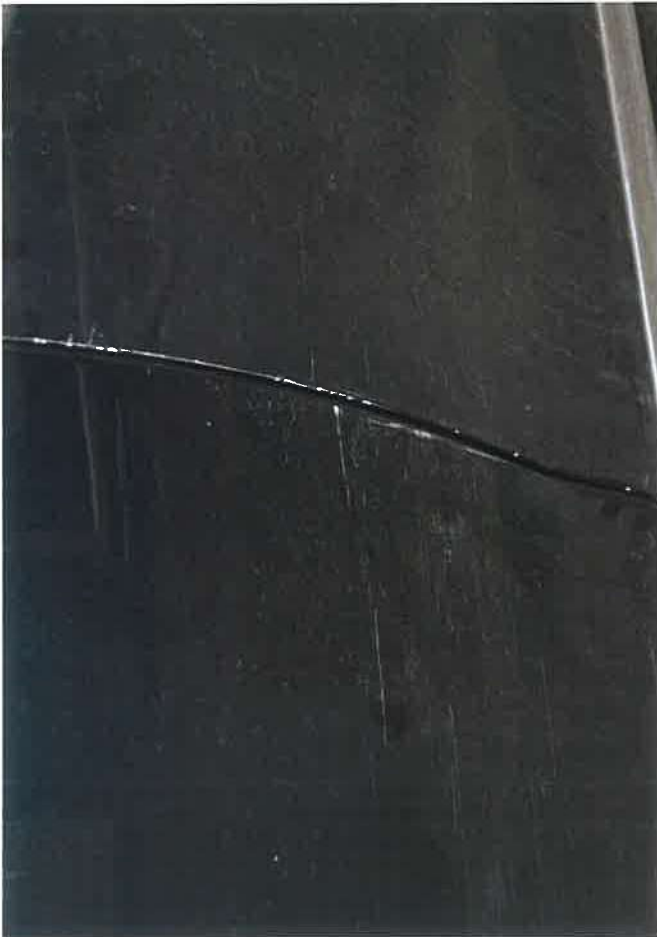
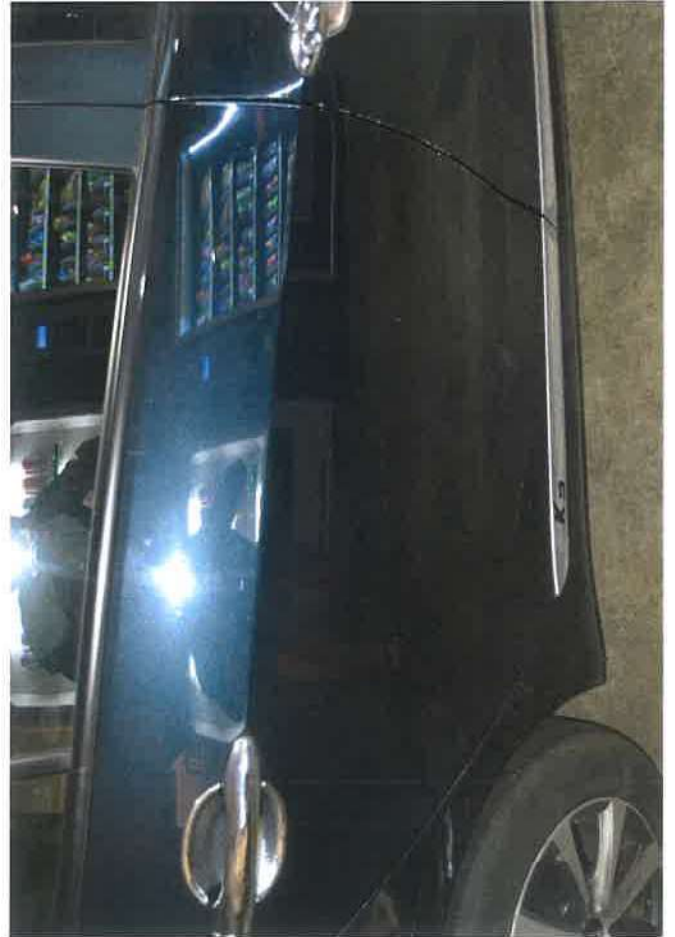
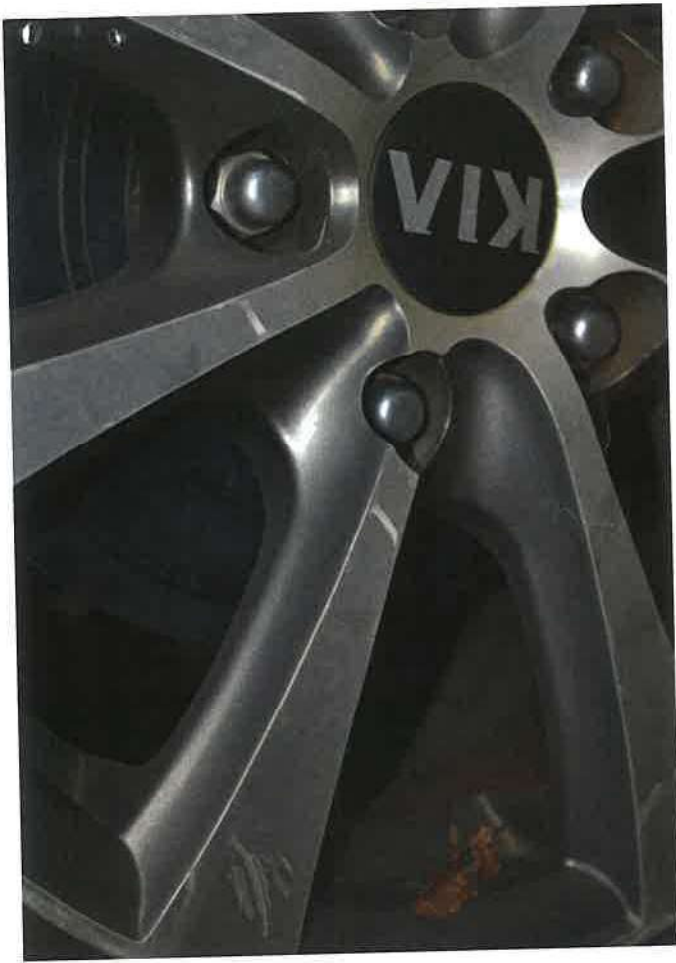
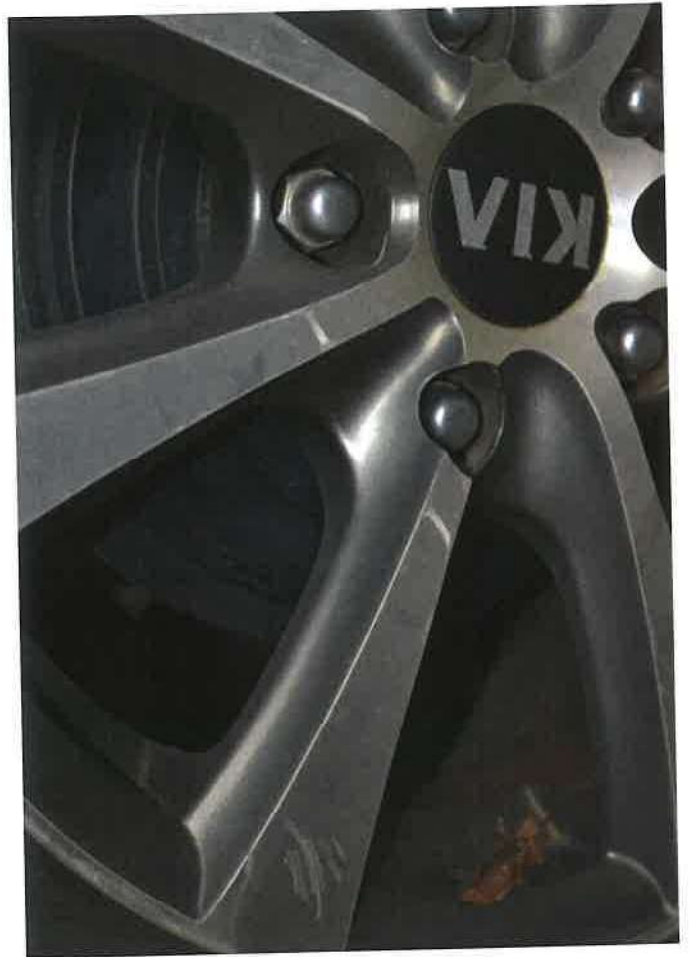
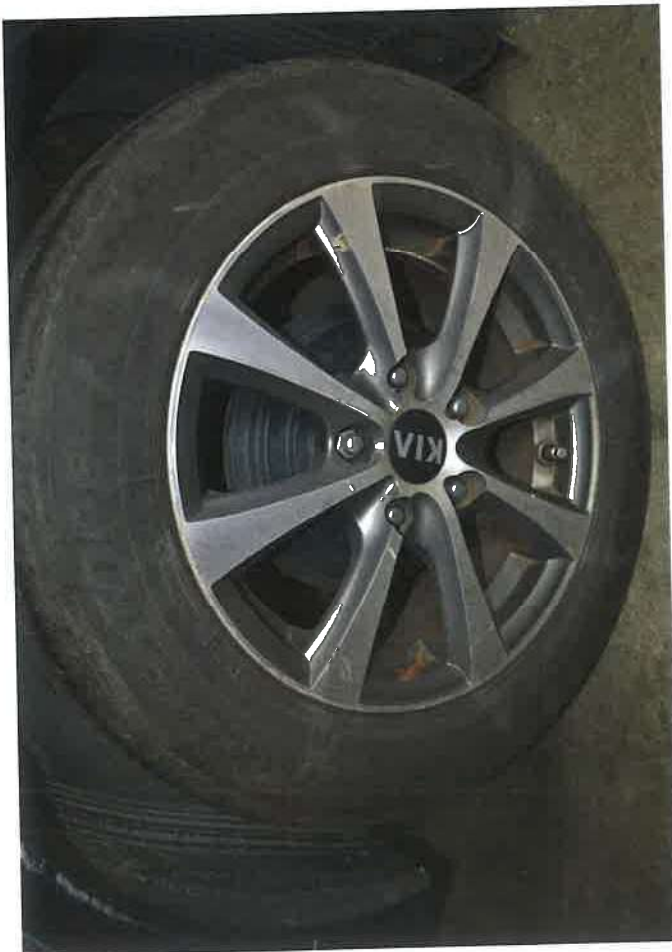
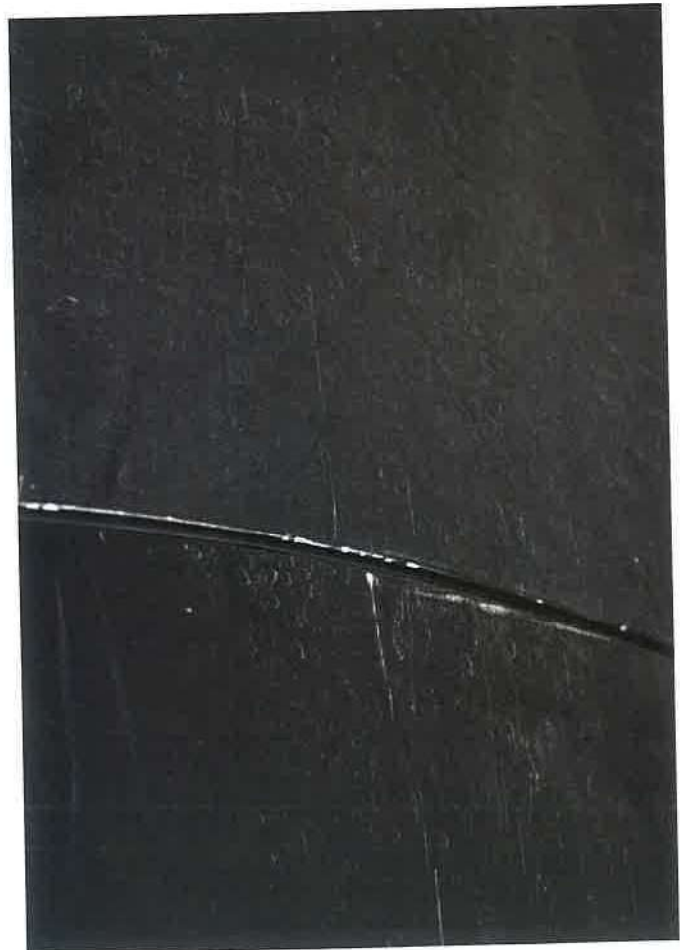
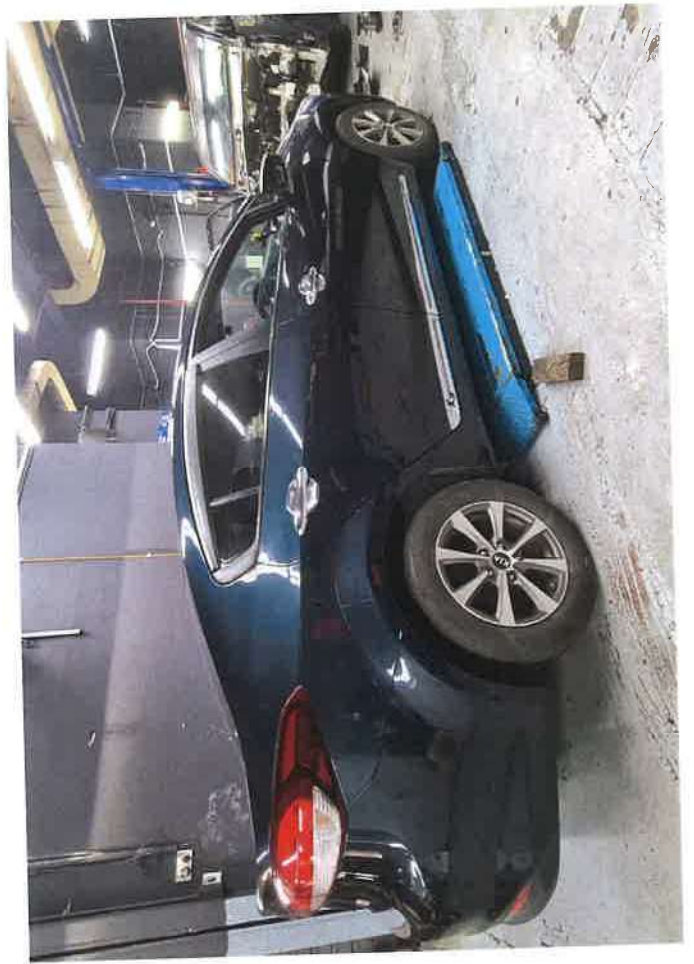
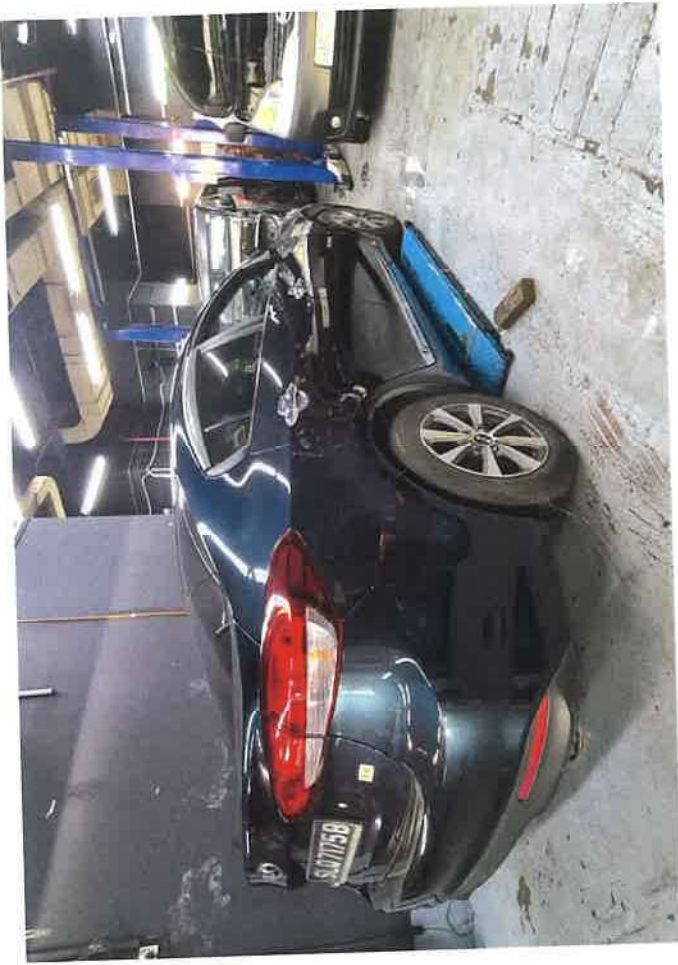
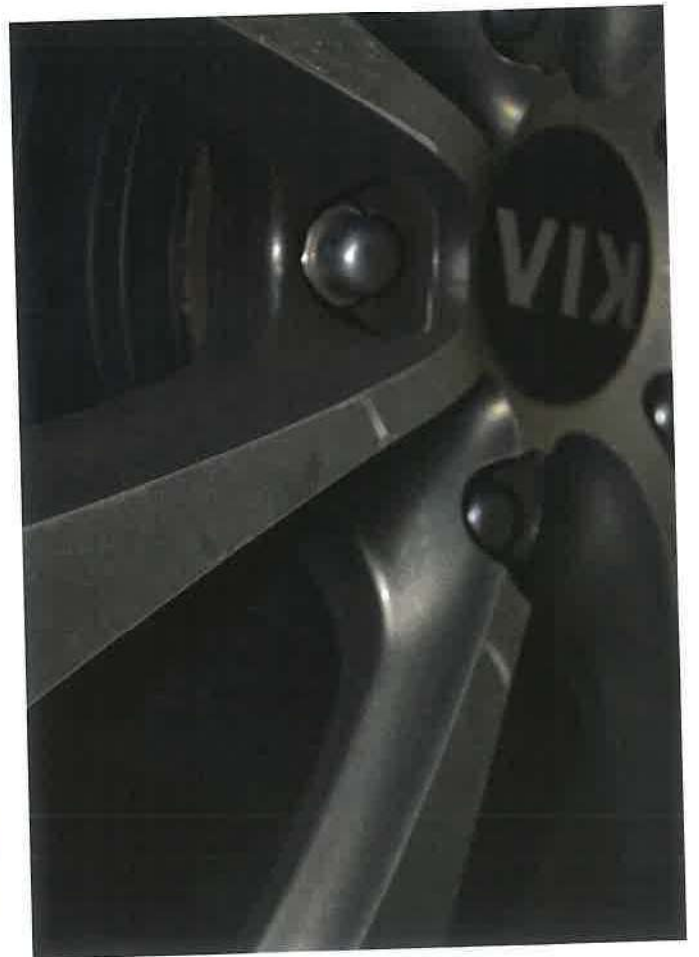
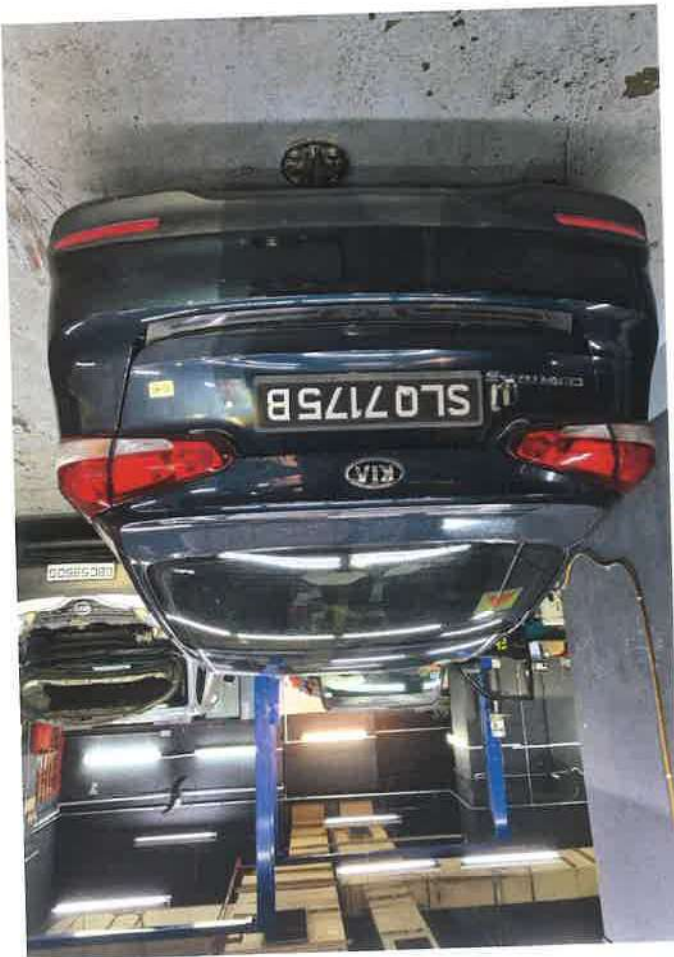
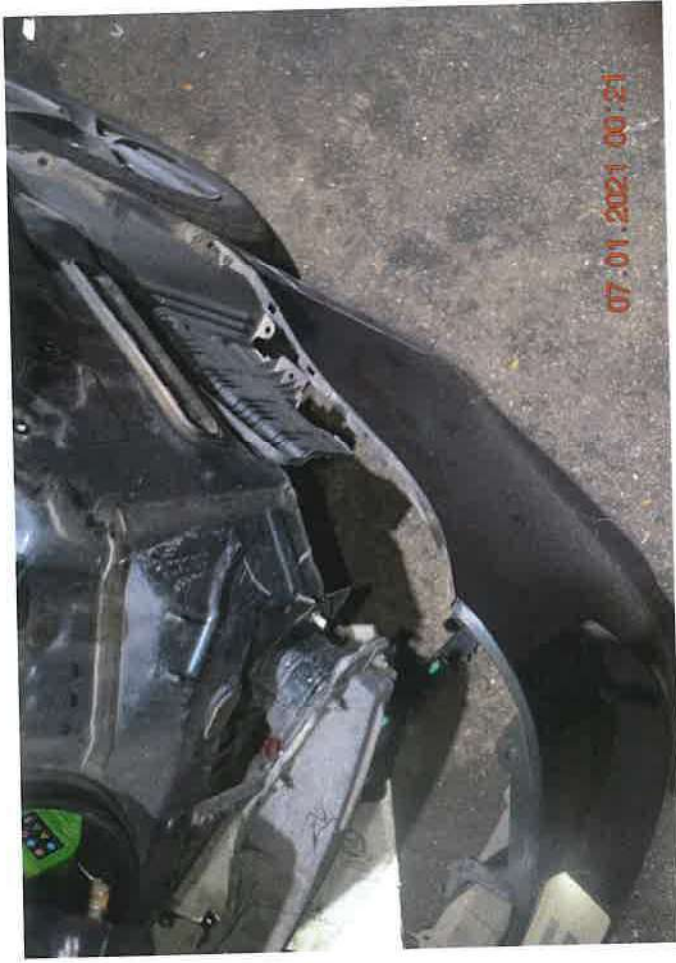
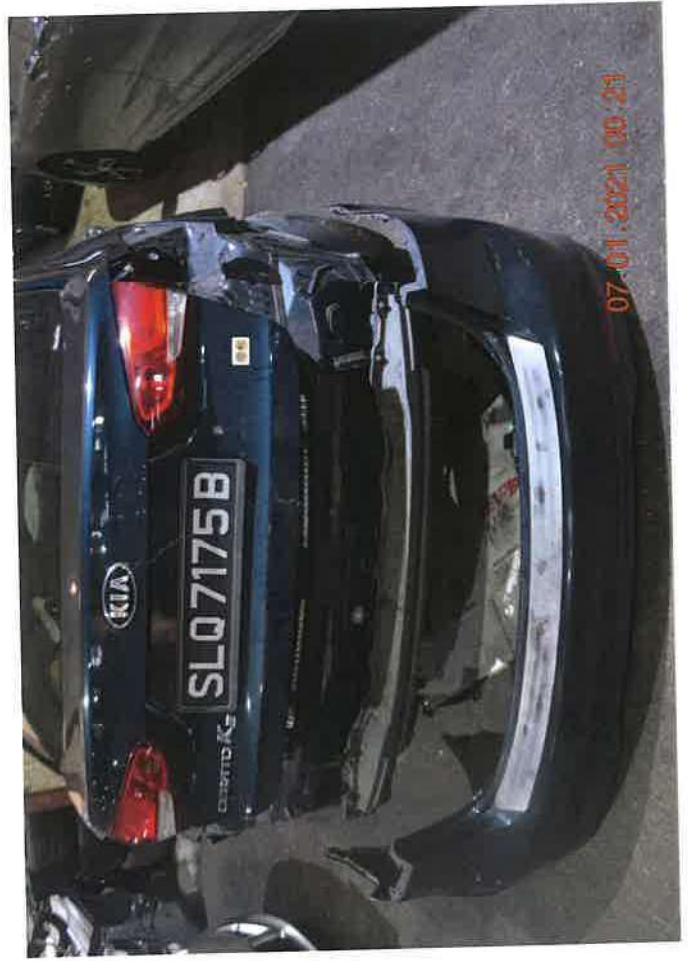
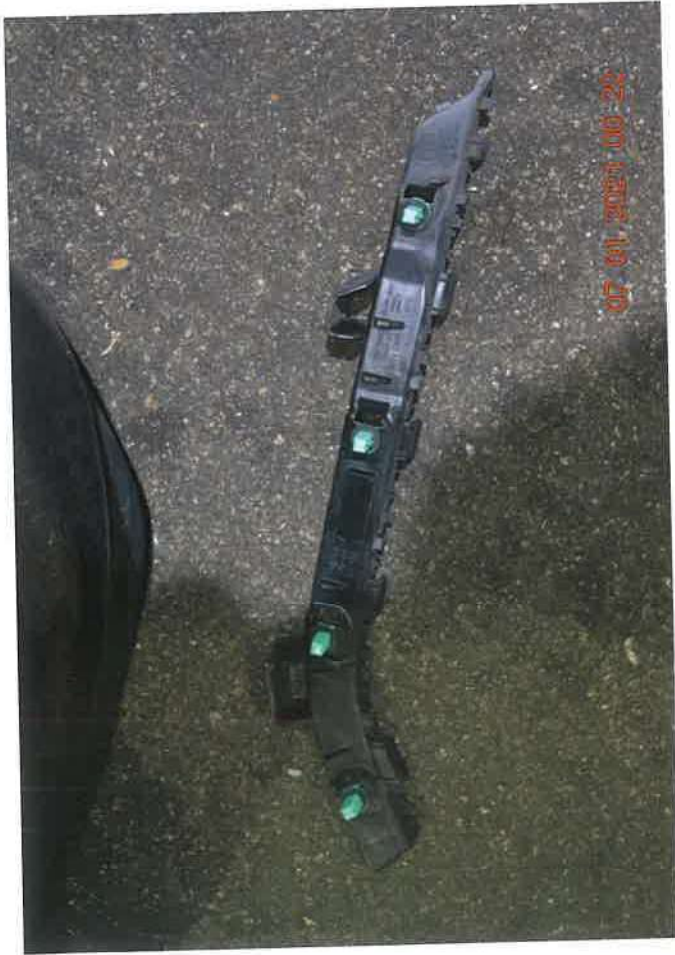
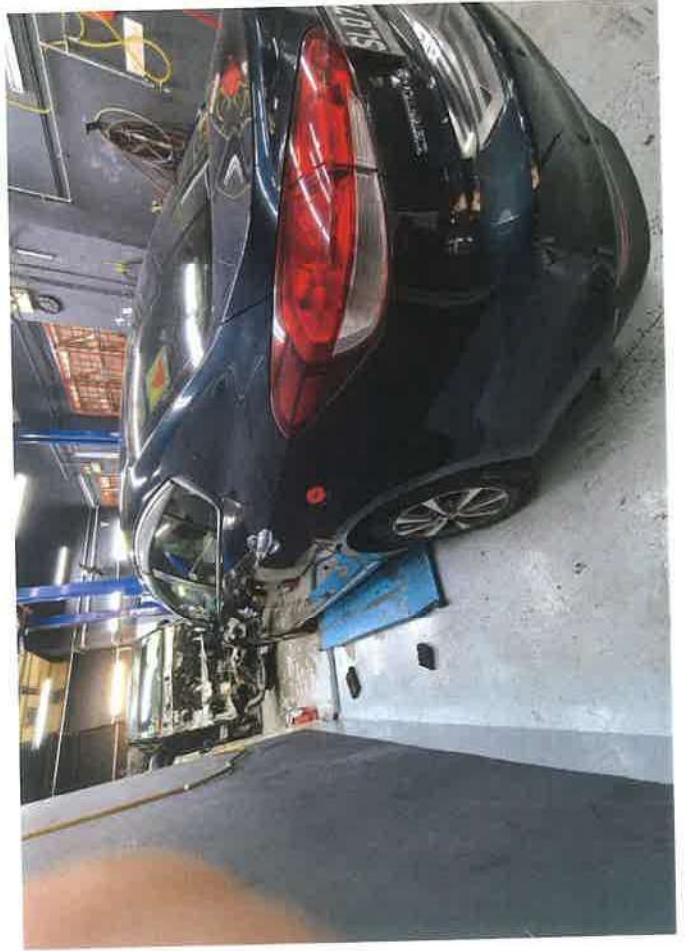
The vehicle sustained damage at the rear right portion.
For details, refer to assessment for repairs and photographs attached.

Enclosed Twenty-six (26) photographs depicting damage to the vehicle.

The impact was confined to the rear right portion of the vehicle.
The damages appeared to be consistent as per the accident report statement.
Please refer the attached schedule and photographs for details.
