## ACCIDENT DAMAGED VEHICLE INSPECTION REPORT

Date : 12 January 2021  
Our Ref : WG/TP/2021-05

Registration No : SLQ7175B  
Make : KLA  
Model : FORTE K3 1.6A  
Year : 2017

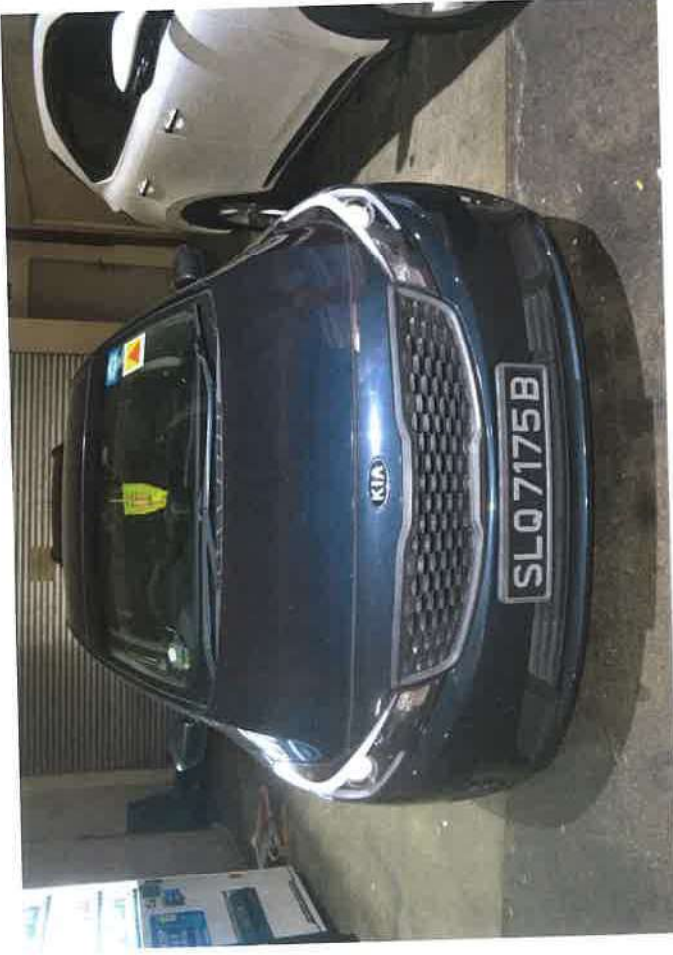
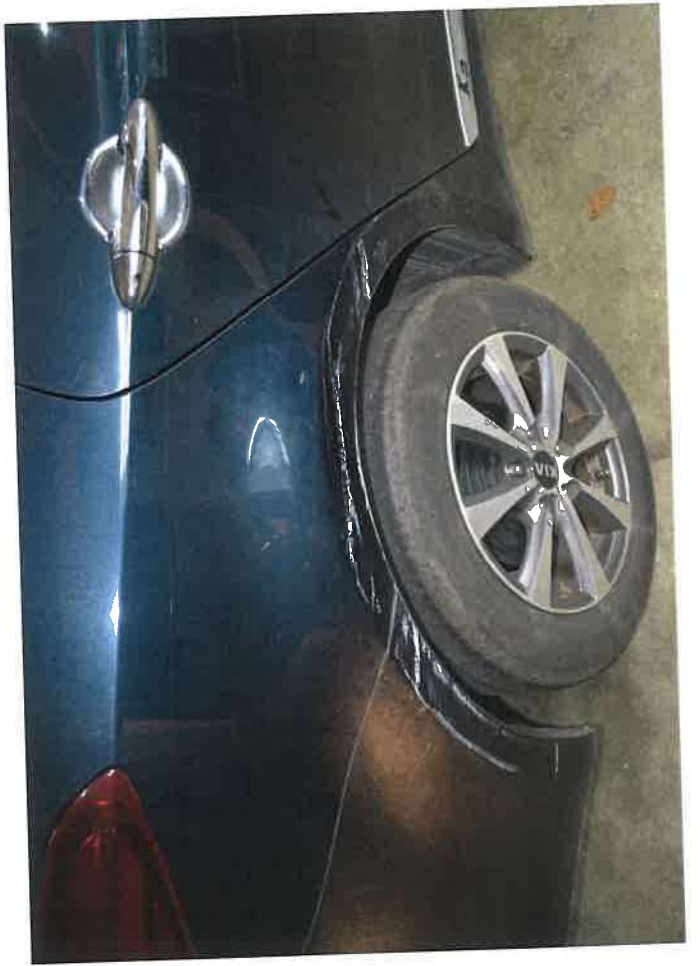
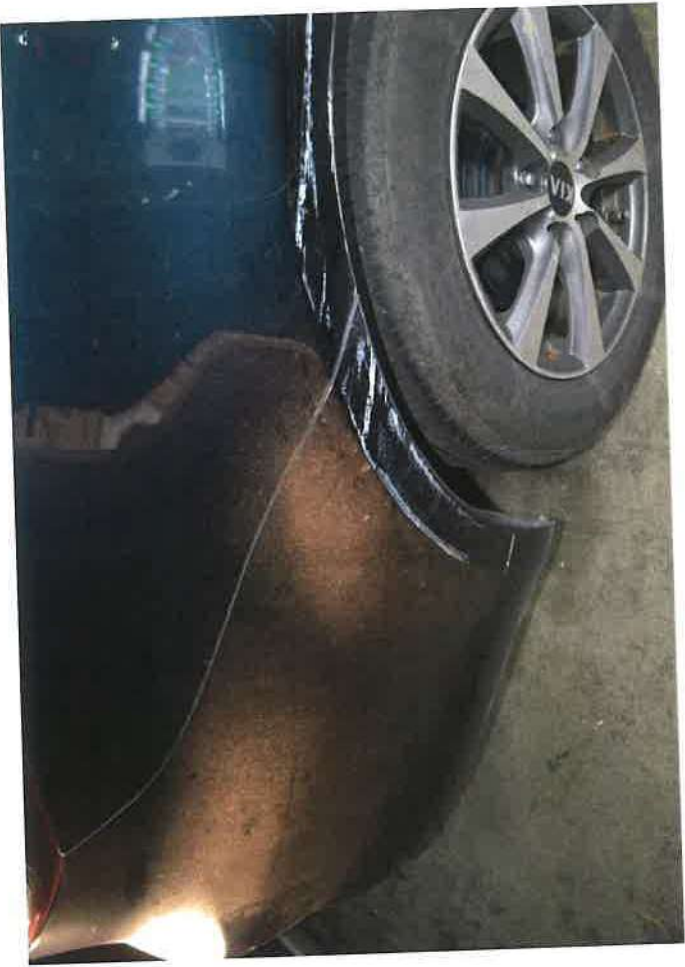
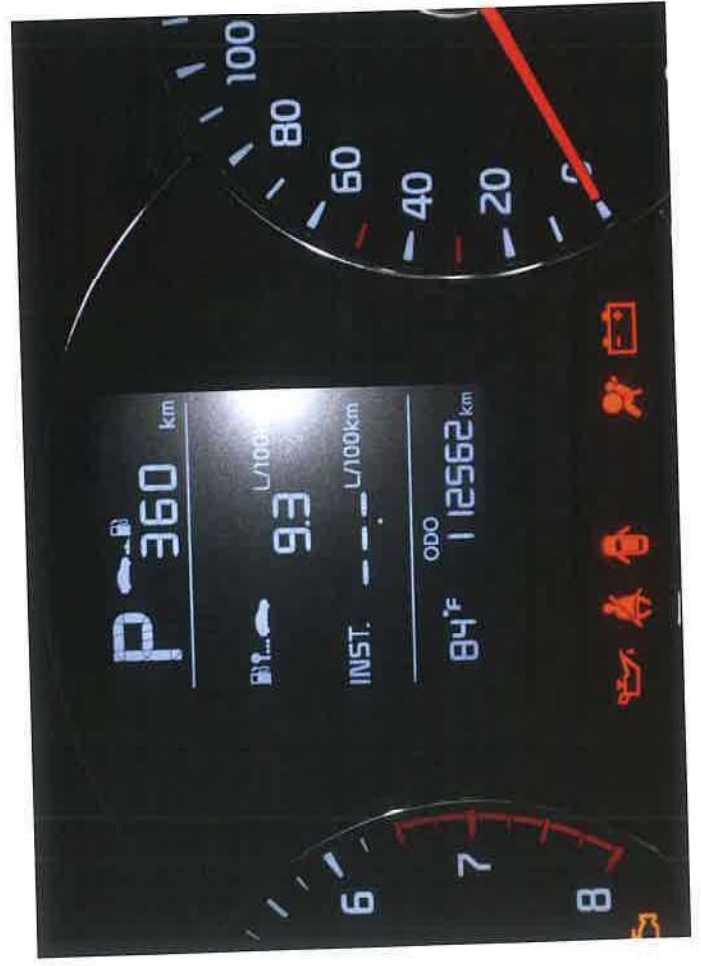
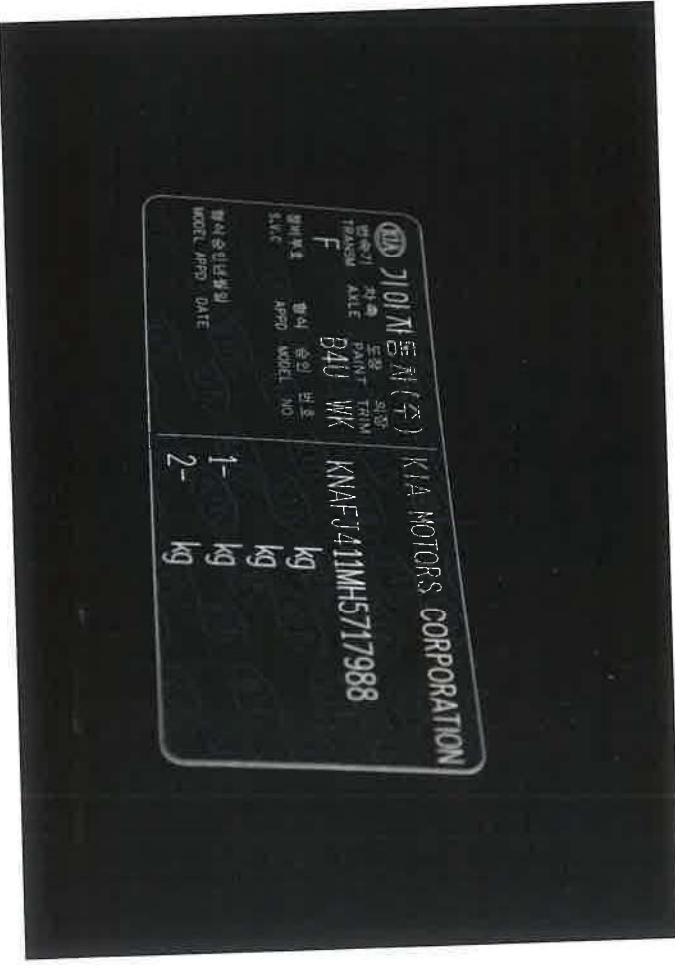
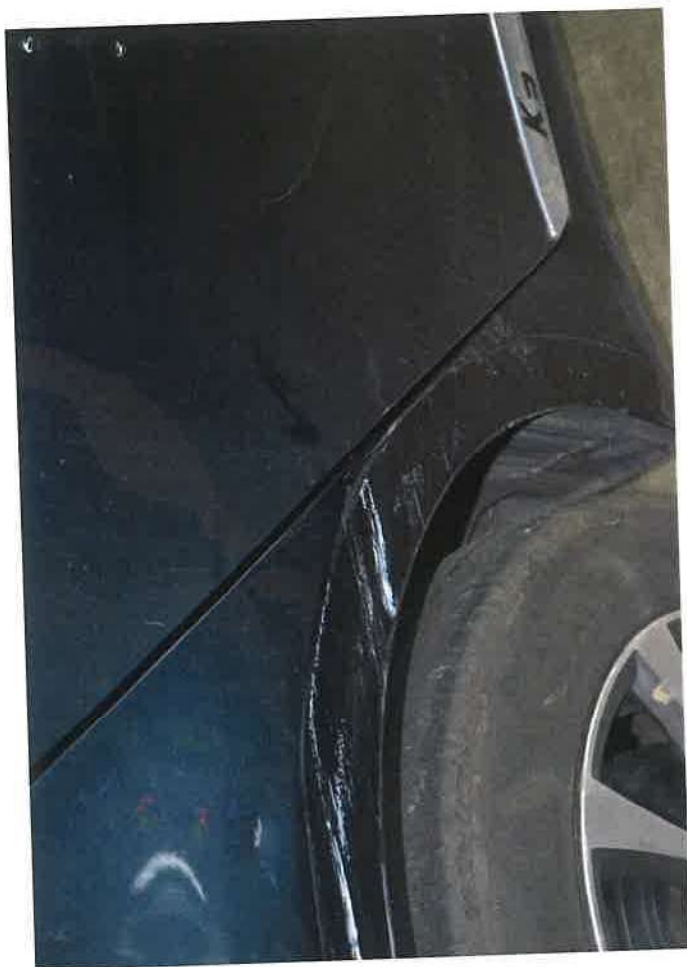
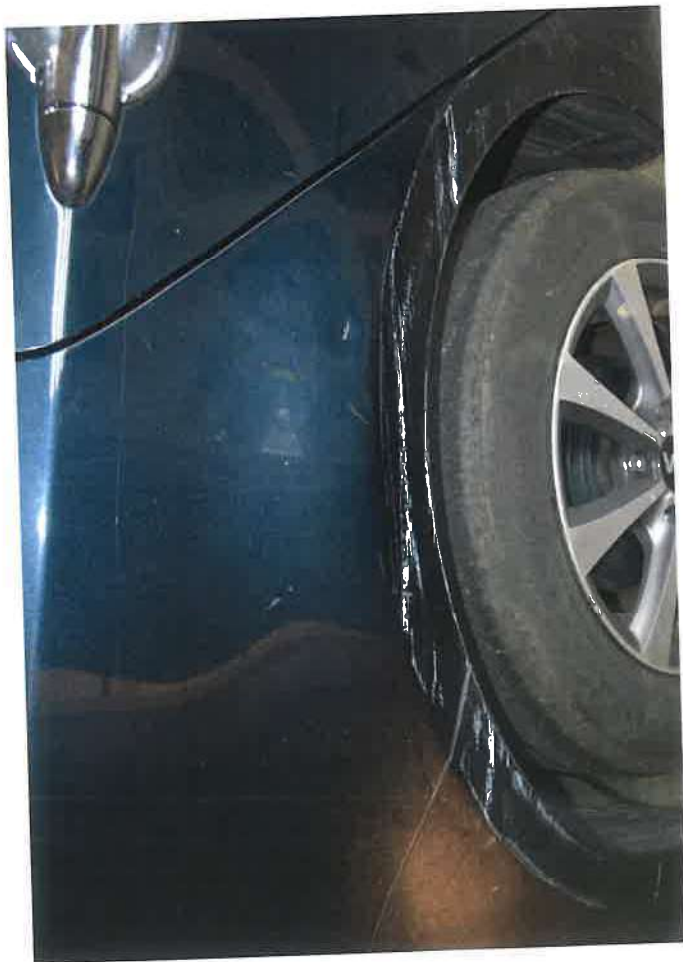
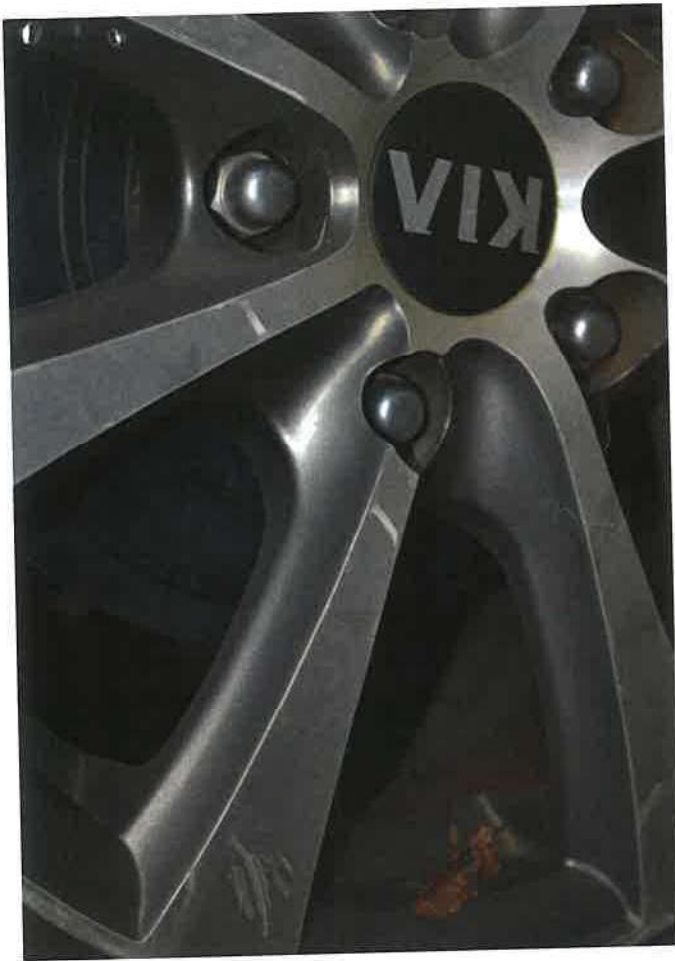
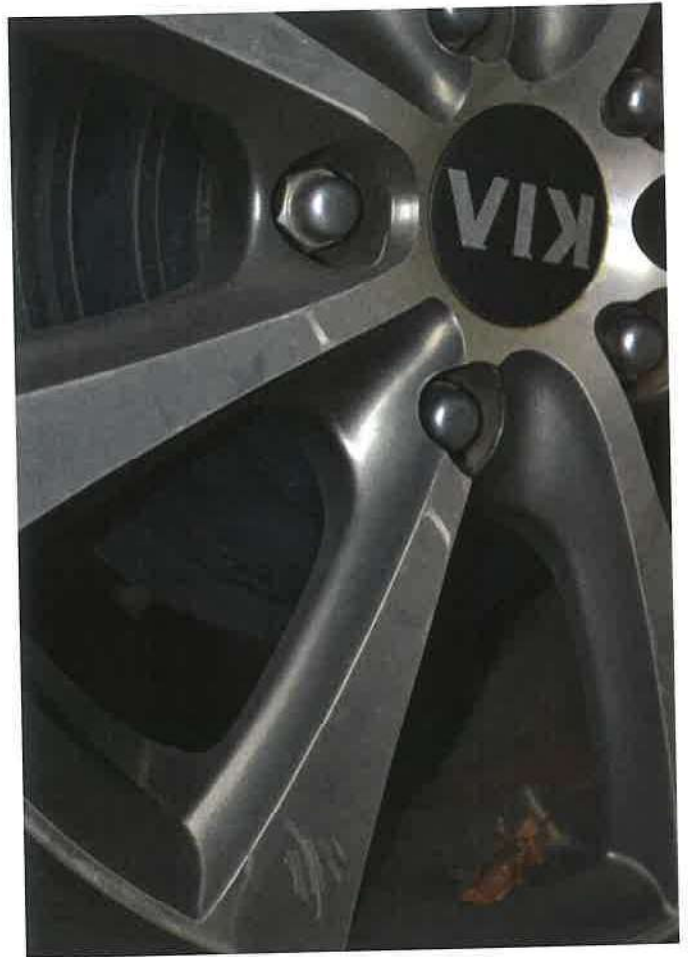
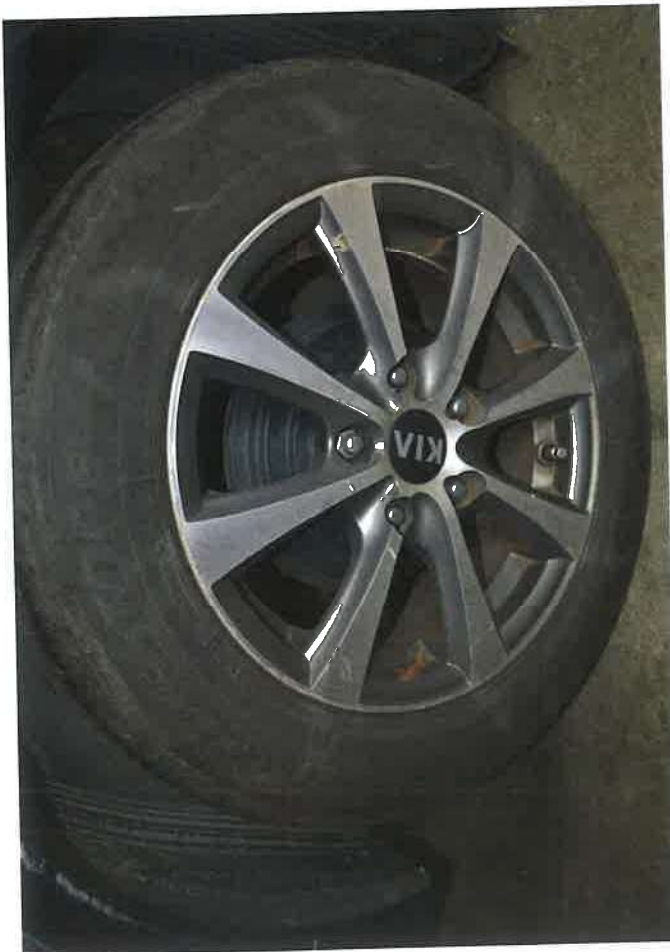
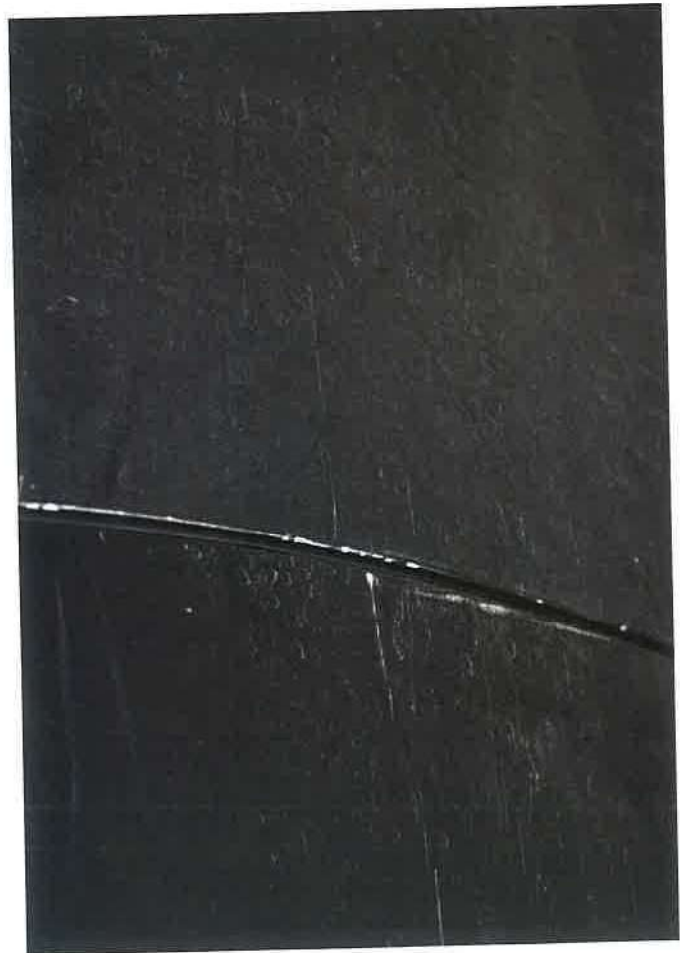
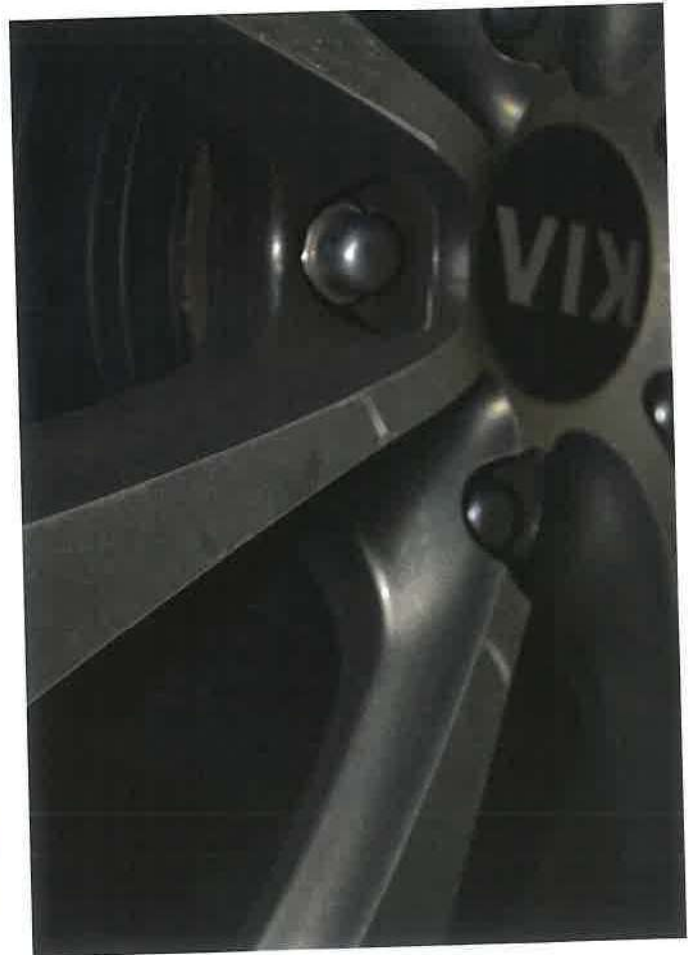
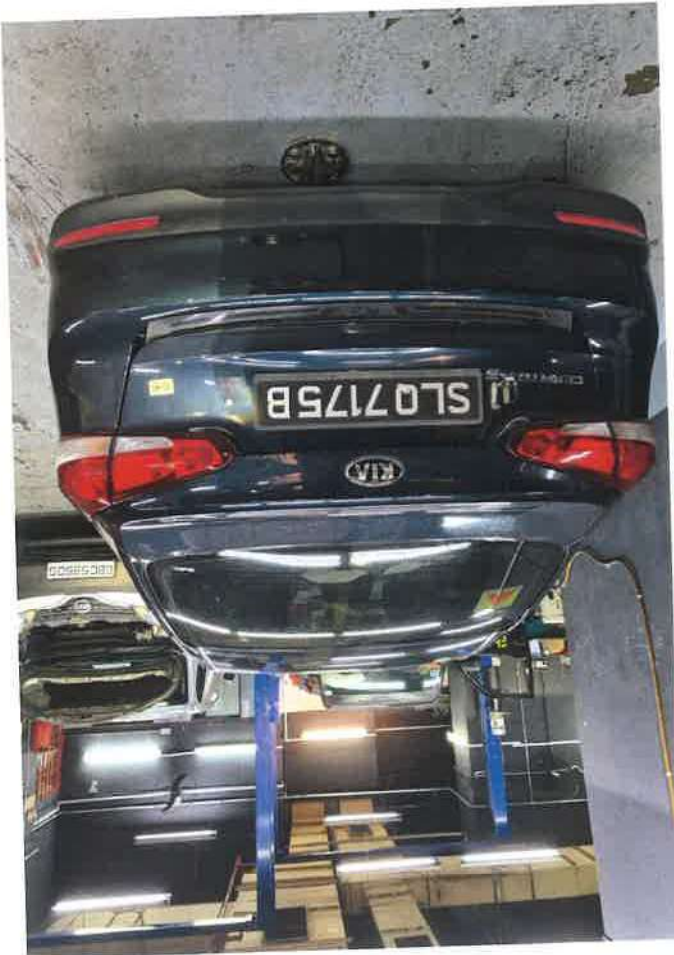
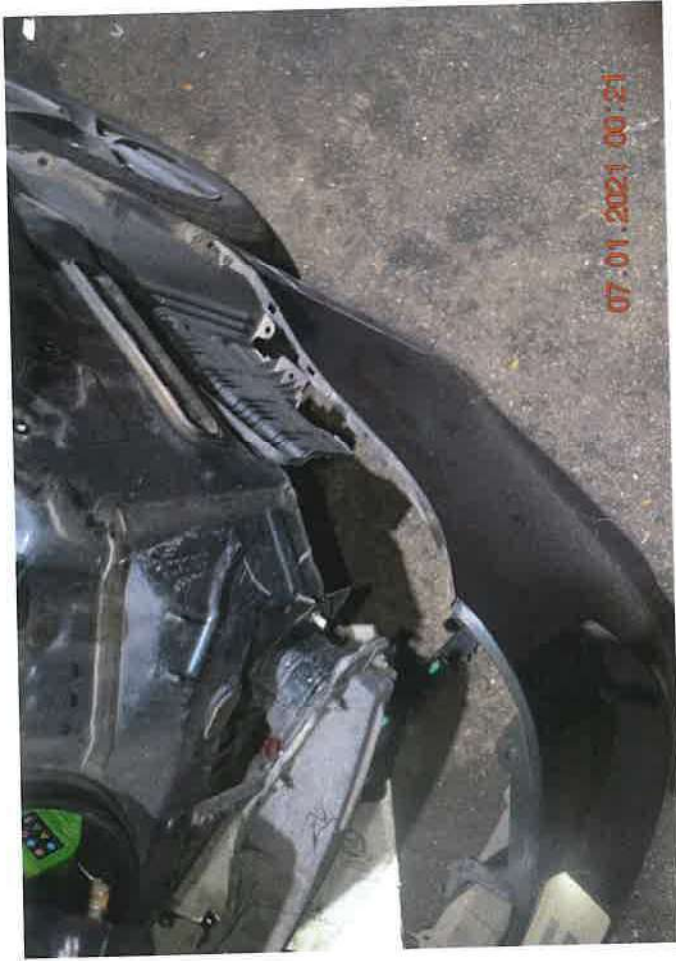
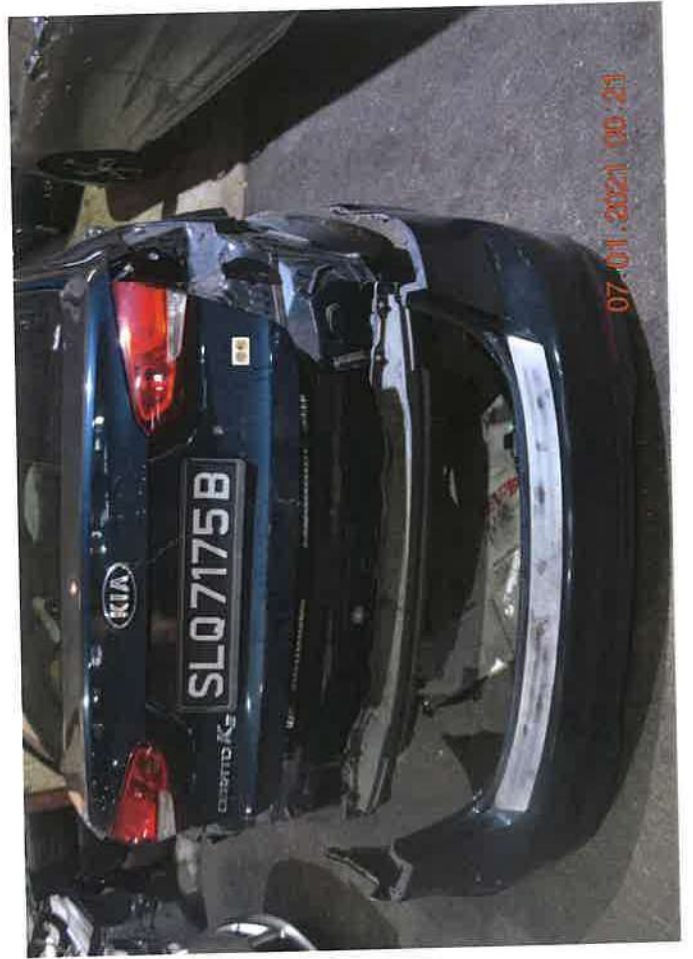
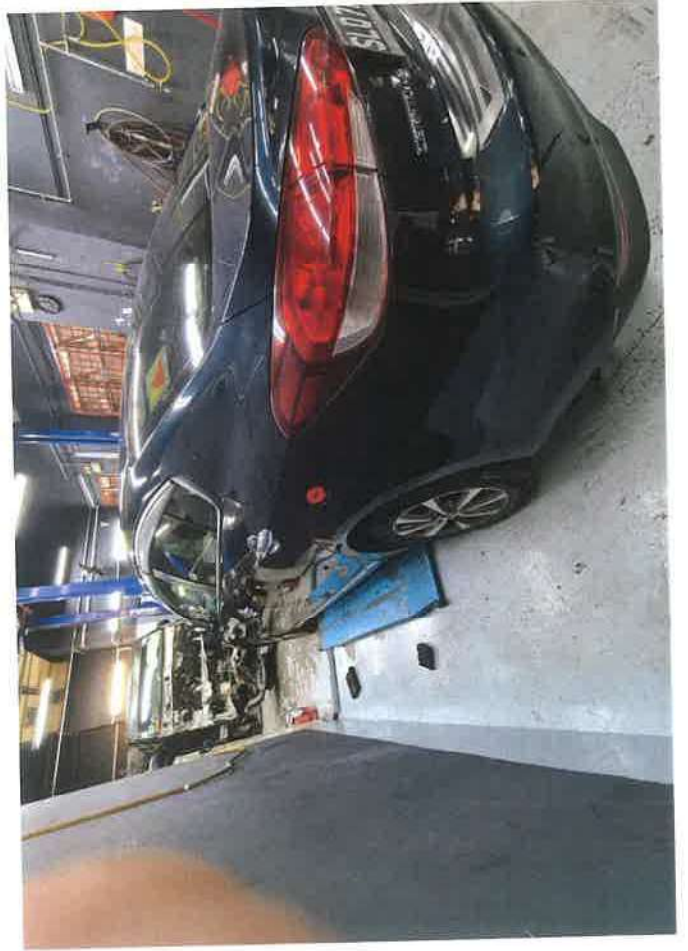
The vehicle sustained damage at the rear right portion.  
For details, refer to assessment for repairs and photographs attached.

The impact was confined to the rear right portion of the vehicle.  
The damages appeared to be consistent as per the accident report statement.  
Please refer the attached schedule and photographs for details.
