Your Ref: TP/IP/01199/2021
Our Ref : CI/TPD21005540/N

Fatal Accident Investigation Team

MECHANICAL INSPECTION REPORT OF MOTORCYCLE FBJ 1311U

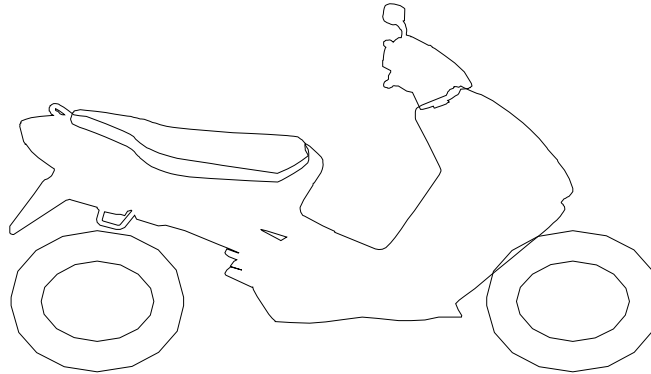
7. However the front tyre was observed to be deflated as a result of the accident. The tyre brand, tyre size and remaining tread depth of the 2 tyres of the Motorcycle were recorded as follows:-

Dunlop 90/80 R17 (3mm)

Dunlop 70/90 R17 (3mm)
(Deflated)

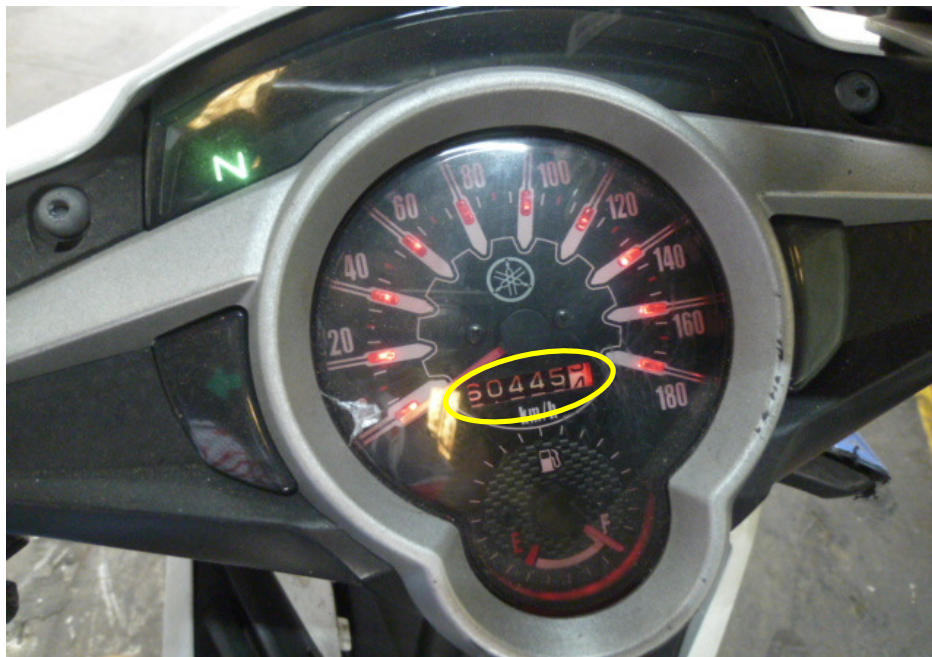
Photo 1 shows the speedometer gauge of the Motorcycle where the mileage recorded at the time of our inspection was 60, 445km (circled).

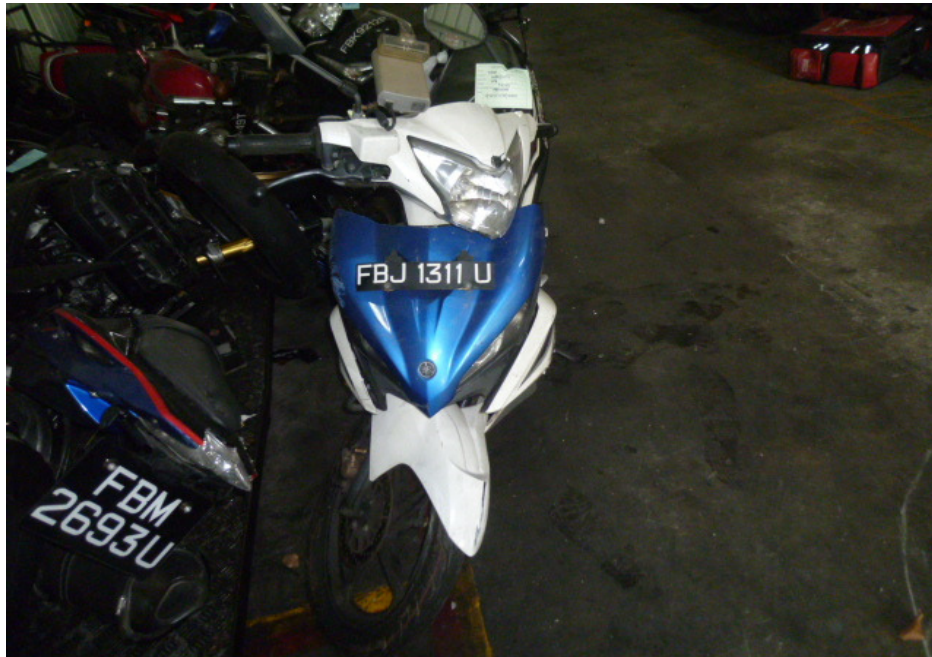
Photo 2 shows a general view of the frontal portion of the Motorcycle at the time of our inspection. The Motorcycle had sustained damages all around.

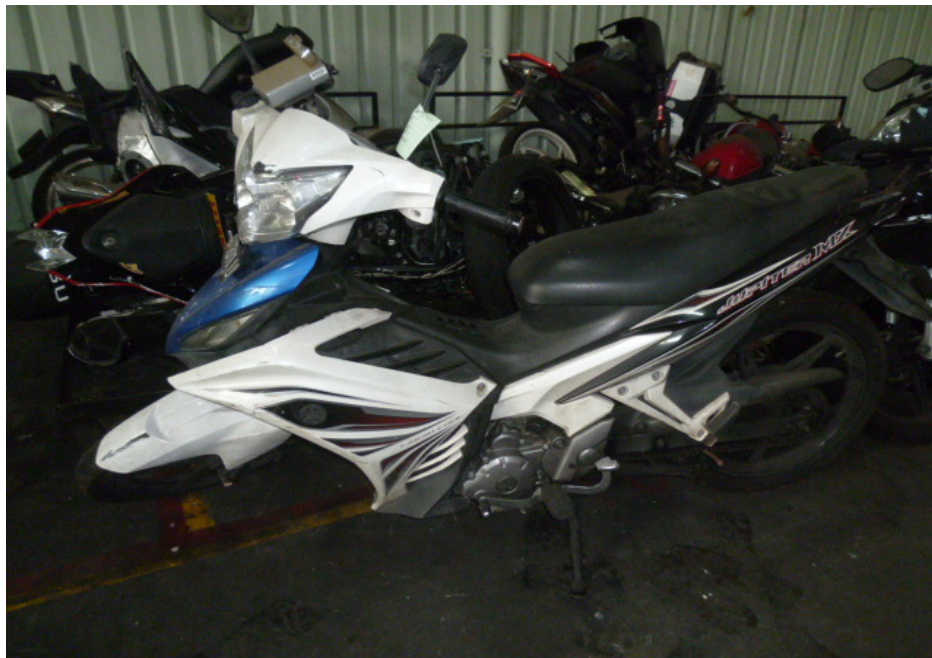
Photo 3 shows a general view of the left body of the Motorcycle at the time of our inspection. The Motorcycle had sustained damages all around.

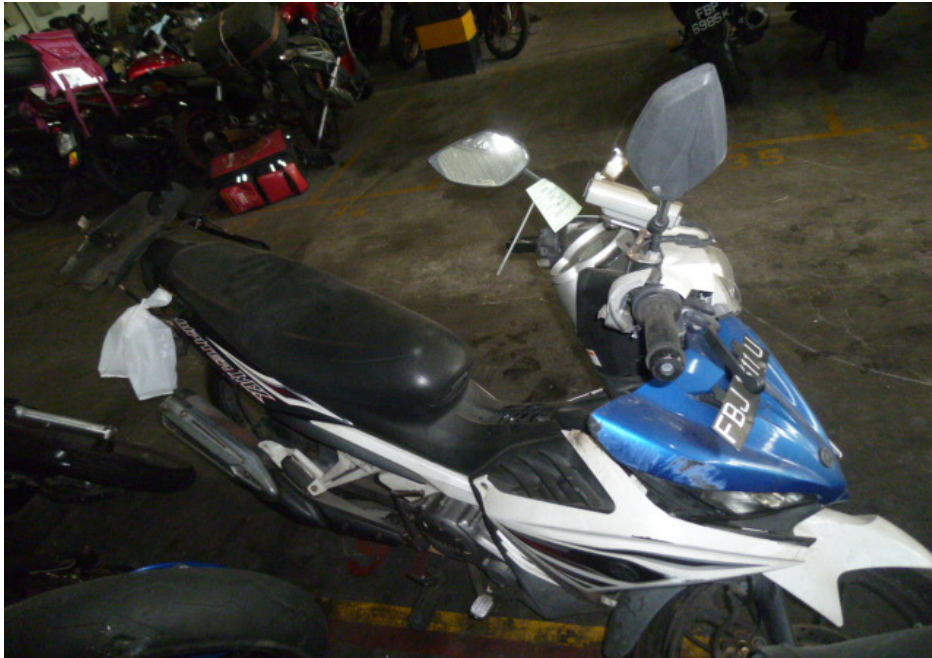
4. The mileage of the Motorcycle at the time of our inspection was 60, 445km.
5. The Motorcycle had sustained damages all around. Body parts that were found to have been damaged include its headlight assembly, head cowl, front fork assembly, front mudguard, side cowlings, left side mirror, right rear side cover, rear brake pedal, right front footrest, rear number plate, top box rack, exhaust muffler and exhaust muffler heat shield, amongst others.

Photo 4 shows a general view of the right body of the Motorcycle at the time of our inspection. The Motorcycle had sustained damages all around. Body parts that were found to have been damaged include its headlight assembly, head cowl, front fork assembly, front mudguard, side cowlings, left side mirror, right rear side cover, rear brake pedal, right front footrest, rear number plate, top box rack, exhaust muffler and exhaust muffler heat shield, amongst others.

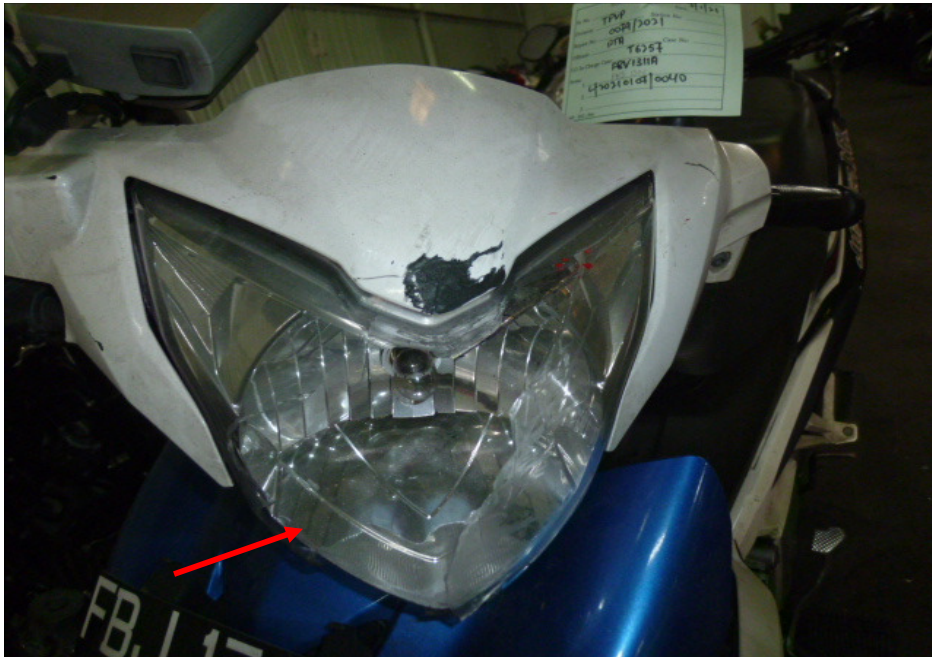
Photo 5 shows a closer view of the cracked headlight assembly of the Motorcycle as a result of the accident (arrowed).

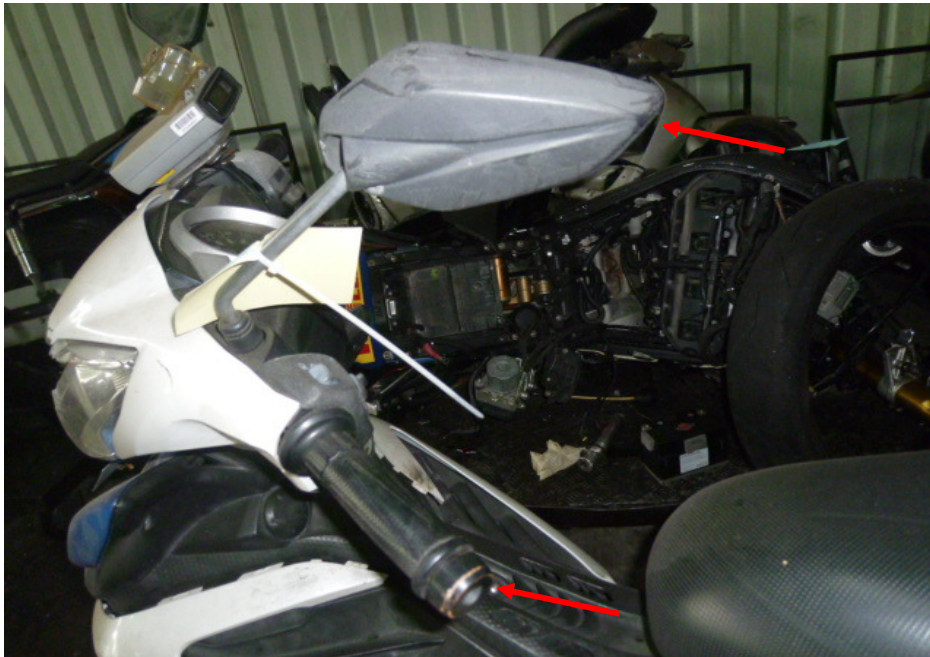
Photo 6 shows a closer view of the left side mirror and left handlebar end of the Motorcycle (arrowed). These parts were amongst the body parts of the Motorcycle which were damaged as a result of the accident.

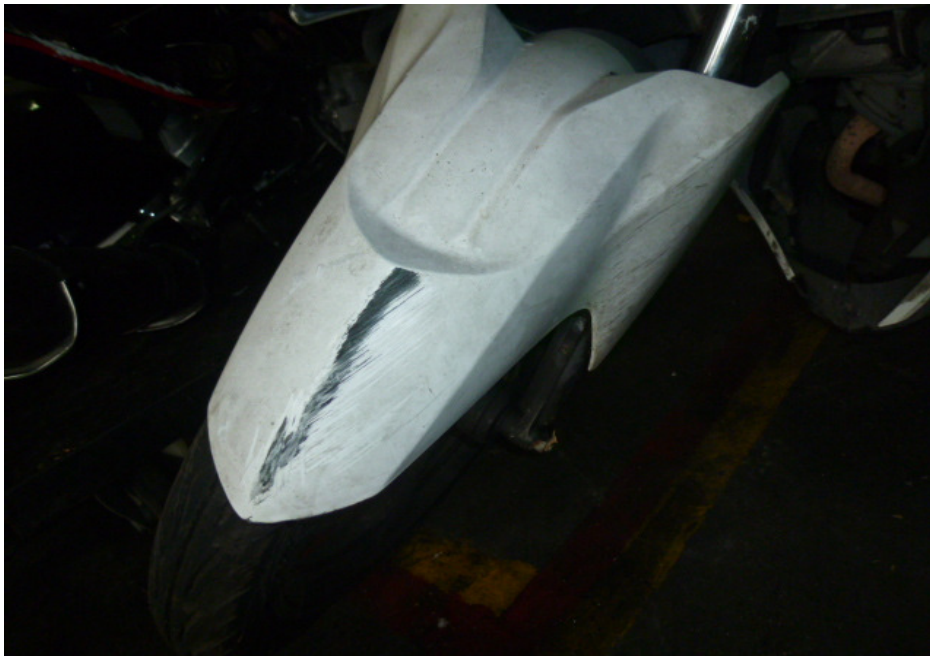
Photo 7 shows a closer view of the front mudguard, which was amongst the body parts of the Motorcycle that had sustained damage as a result of the accident.

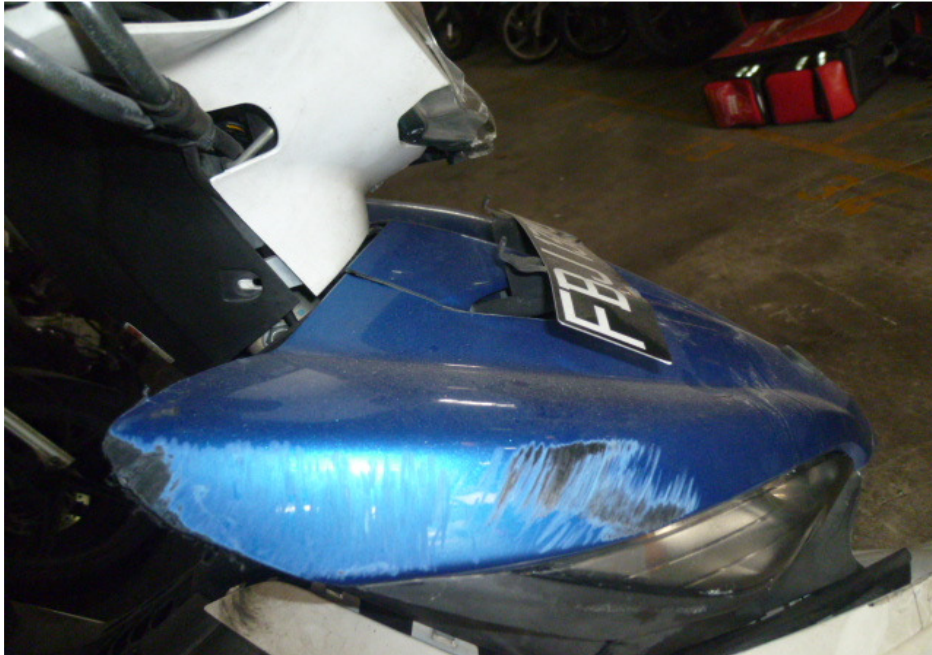
Photo 8 shows a closer view of the head cowl which was amongst the body parts at the front body of the Motorcycle that had sustained damages as a result of the accident.

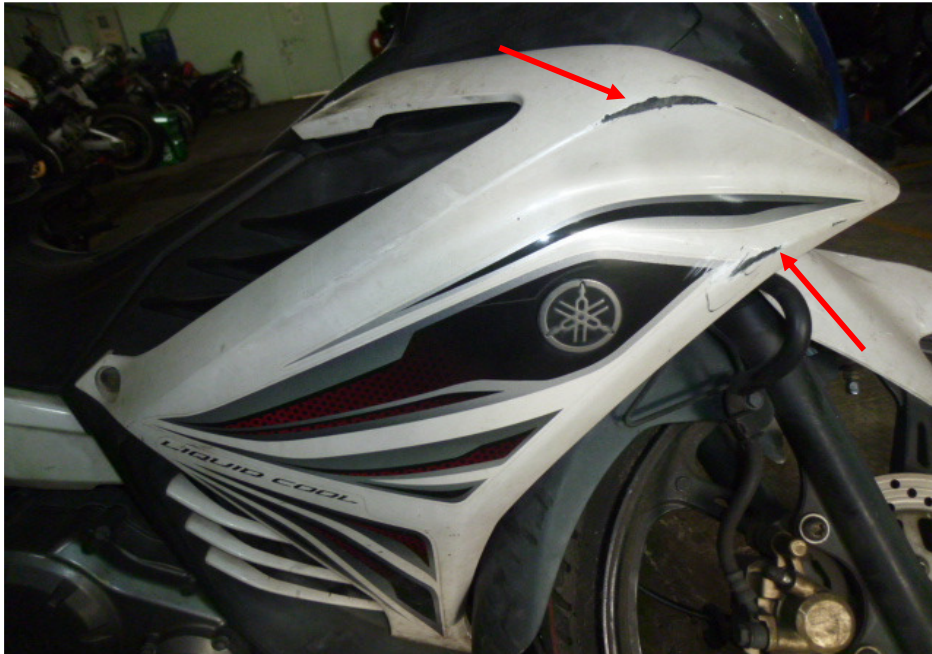
Photo 9 shows a closer view of the right cowl which was amongst the body parts at the front body of the Motorcycle that had sustained damages as a result of the accident.

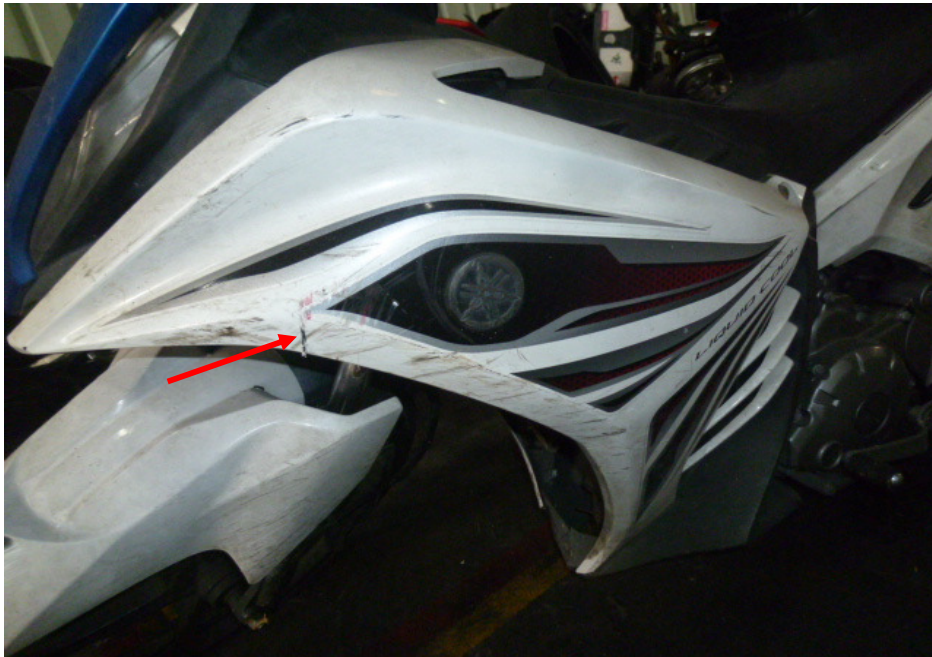
Photo 10 shows a closer view of the cracked left cowling which was amongst the body parts at the front body of the Motorcycle that had sustained damages as a result of the accident (arrowed).

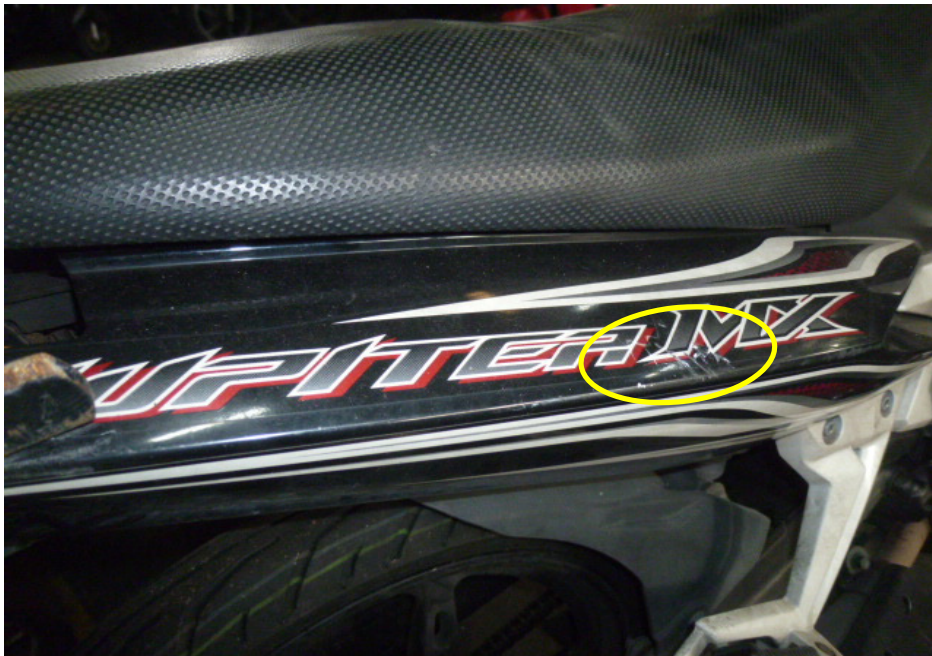
Photo 11 shows a closer view of the right rear side cover which was amongst the body parts of the Motorcycle that had sustained damages of grazing nature as a result of the accident (circled).

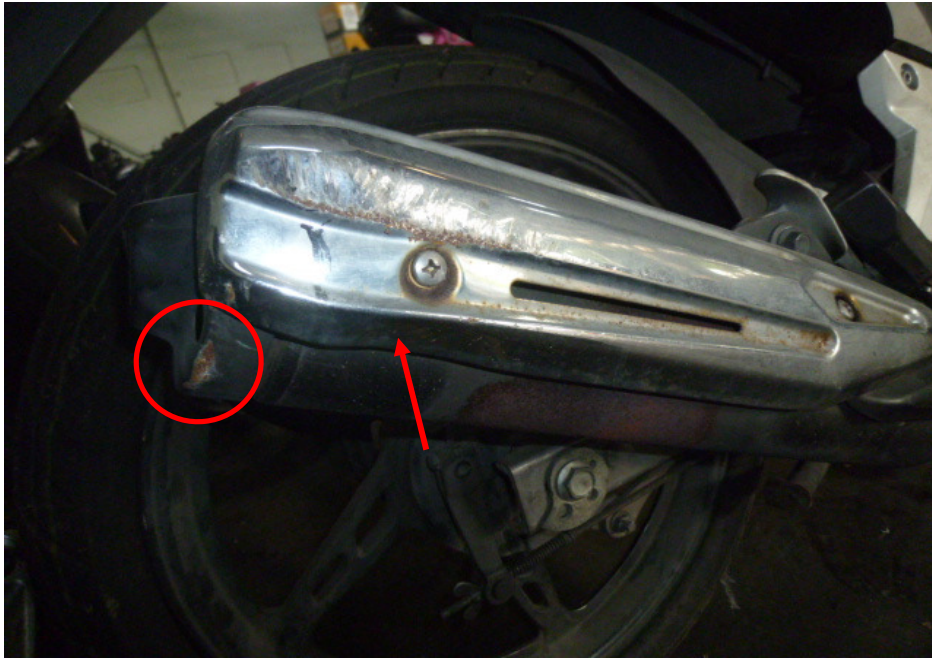
Photo 12 shows a closer view of the grazed exhaust muffler (circled) and dented exhaust muffler heat shield (arrowed) which were amongst the body parts of the Motorcycle that had sustained damage as a result of the accident.

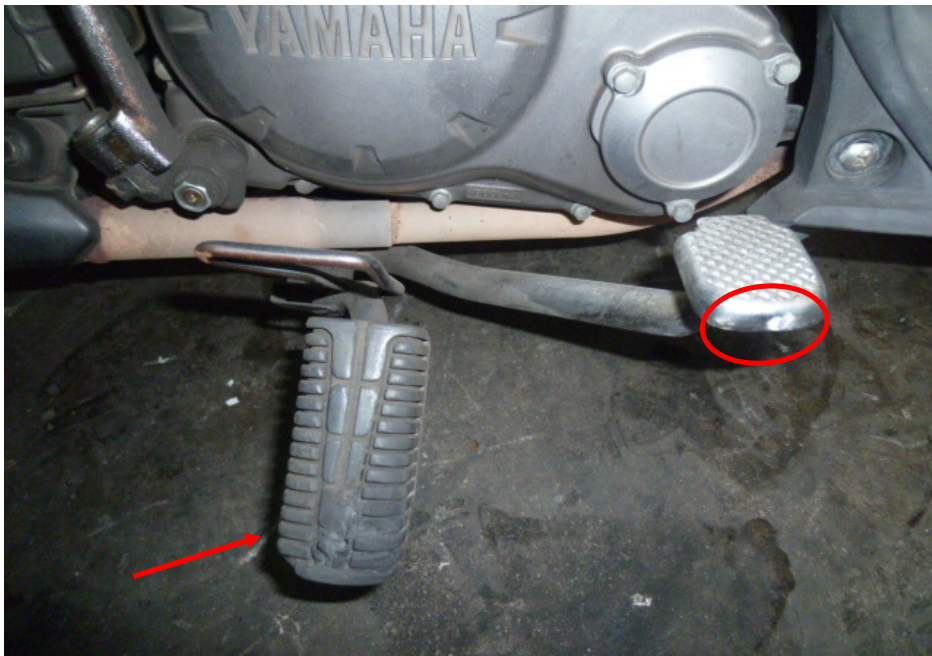
Photo 13 shows a closer view of the rear brake pedal (circled) and right front footrest (arrowed) which were amongst the body parts of the Motorcycle that had sustained damage as a result of the accident.

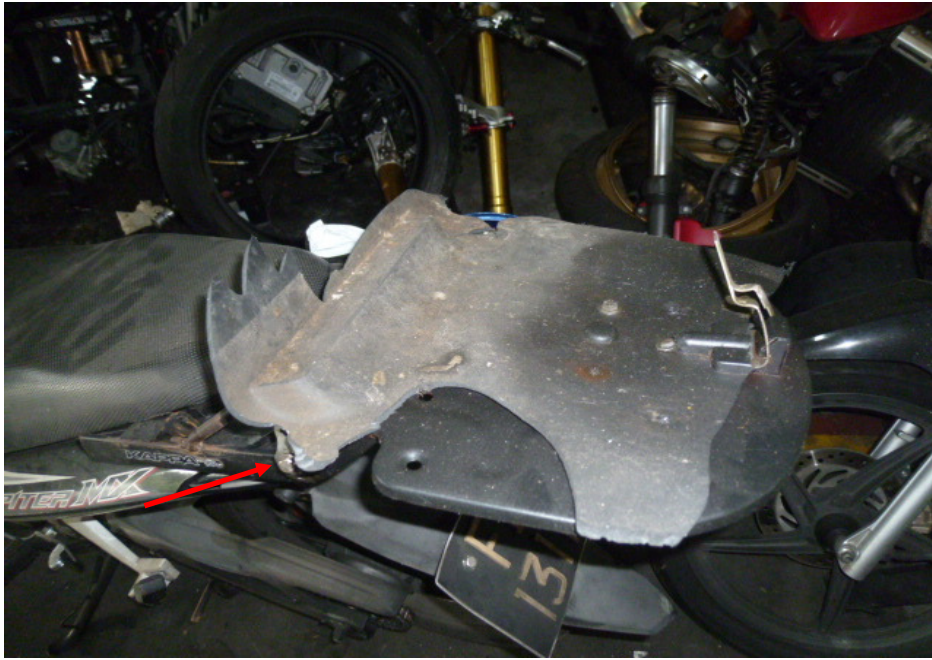
Photo 14 shows the broken top box rack of the Motorcycle at the time of our inspection (arrowed).

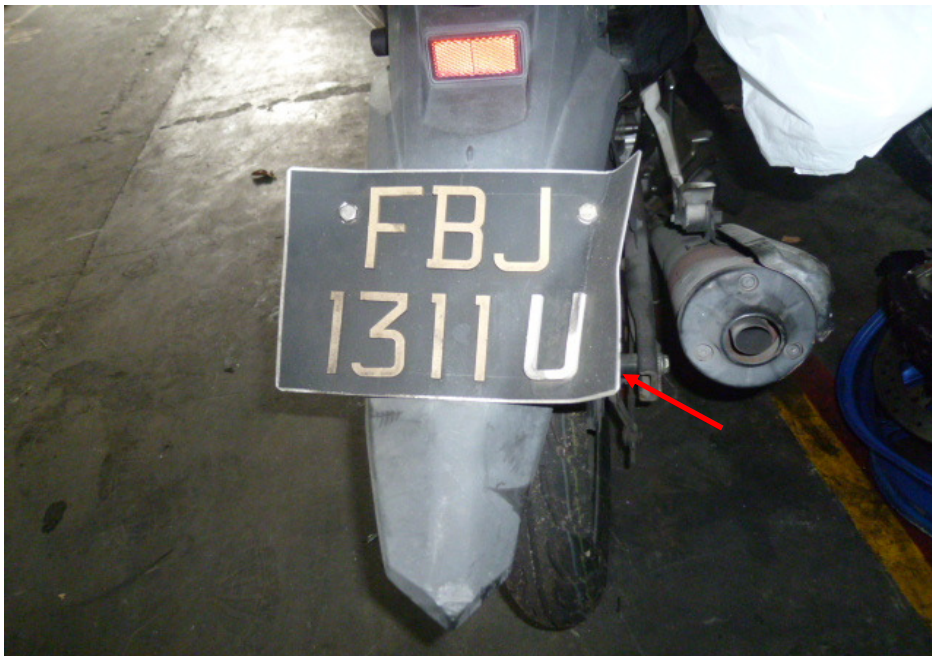
Photo 15 shows the dented rear number plate of the Motorcycle as a result of the accident (arrowed).

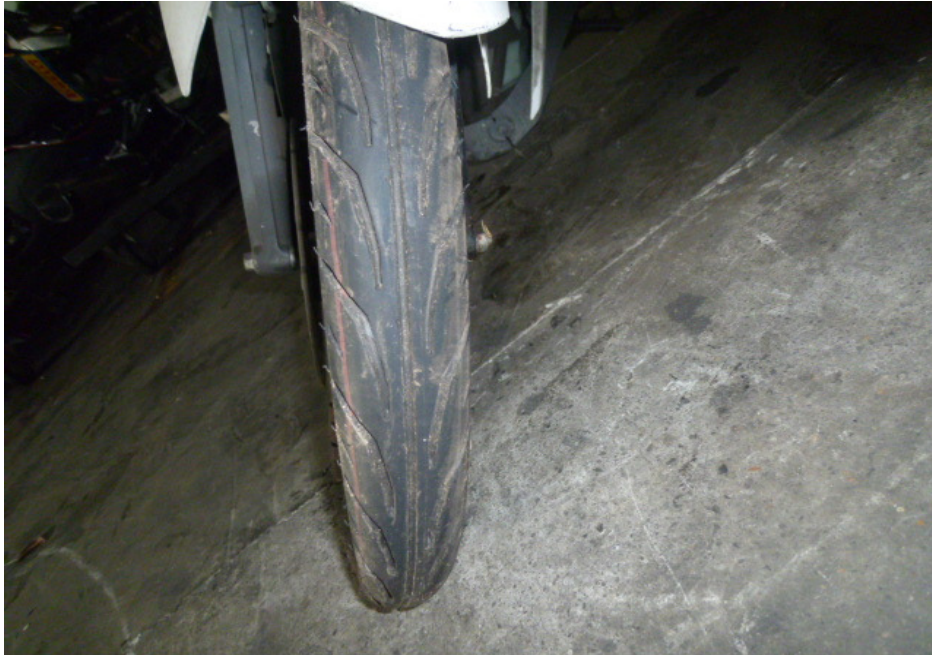
Photo 16 shows the condition of the Motorcycle's front tyre. The front tyre was observed to be in serviceable condition with remaining tread depth of approximately 3mm. We did not observe any tear, burst mark(s) and/or punctured hole(s) on the sidewalls as well as across the tread of the front tyre. However the front tyre was observed to be deflated as a result of the accident.

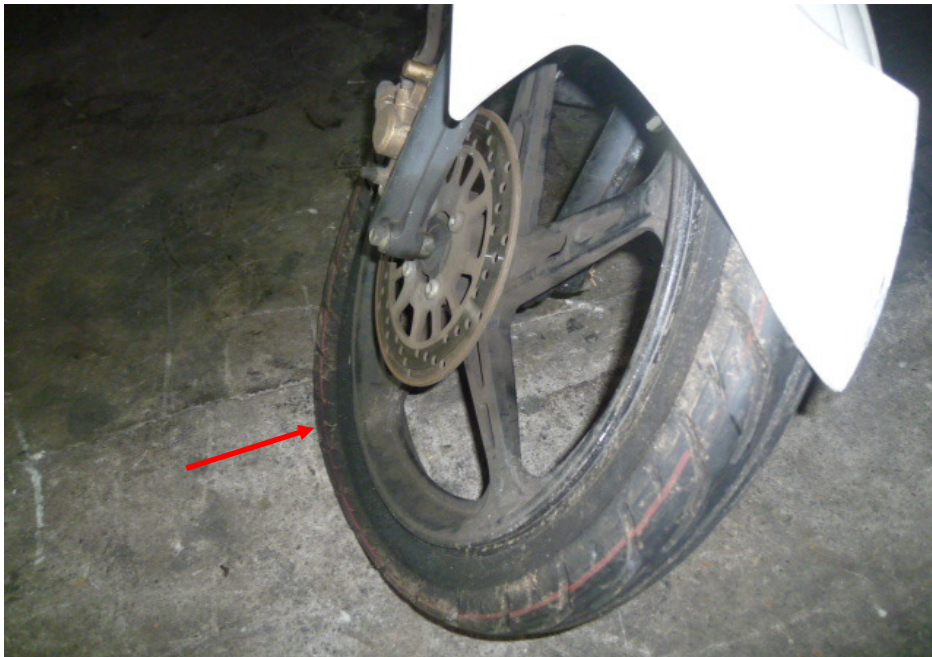
Photo 17 shows a closer view of the deflated front tyre of the Motorcycle as a result of the accident (arrowed).

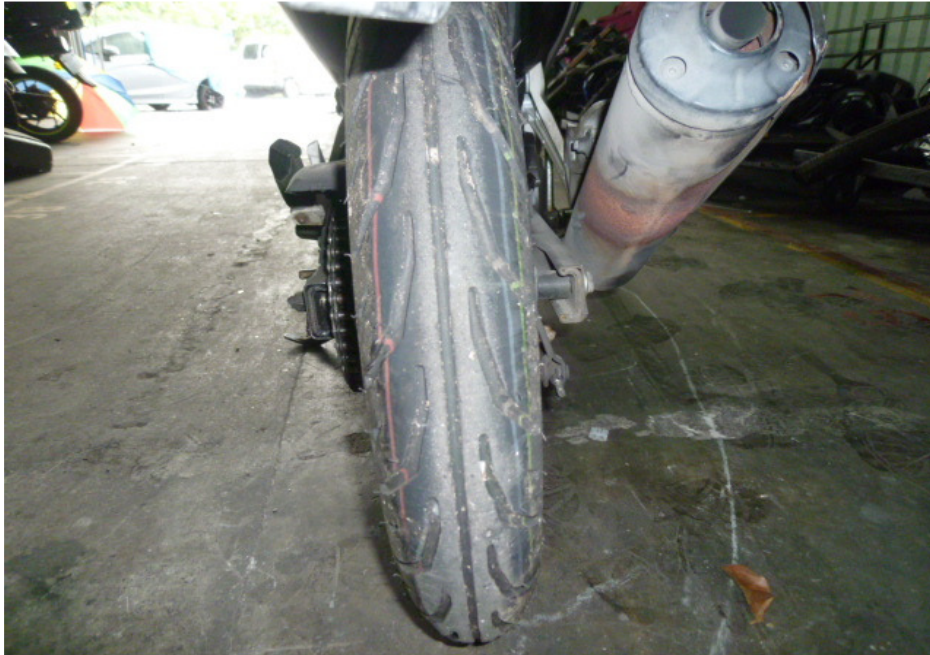
Photo 18 shows the condition of the Motorcycle's rear tyre. The rear tyre was observed to be in serviceable condition with remaining tread depth of approximately 3mm. The tyre was also observed to be sufficiently inflated for vehicular operation. We did not observe any tear, burst mark(s) and/or punctured hole(s) on the sidewalls as well as across the tread of the rear tyre.

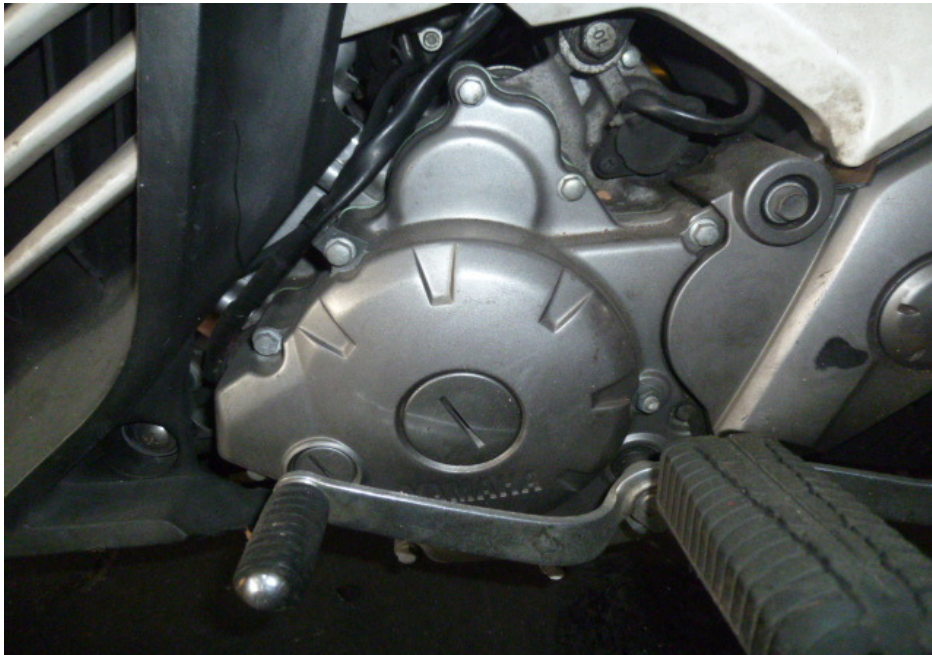
Photo 19 shows the left side of the engine of the Motorcycle at the time of our inspection. The various engine related parts and components were found to be intact with no visible damage. There was also no sign(s) or indication(s) of fluid leak observed around the left engine area of the Motorcycle.

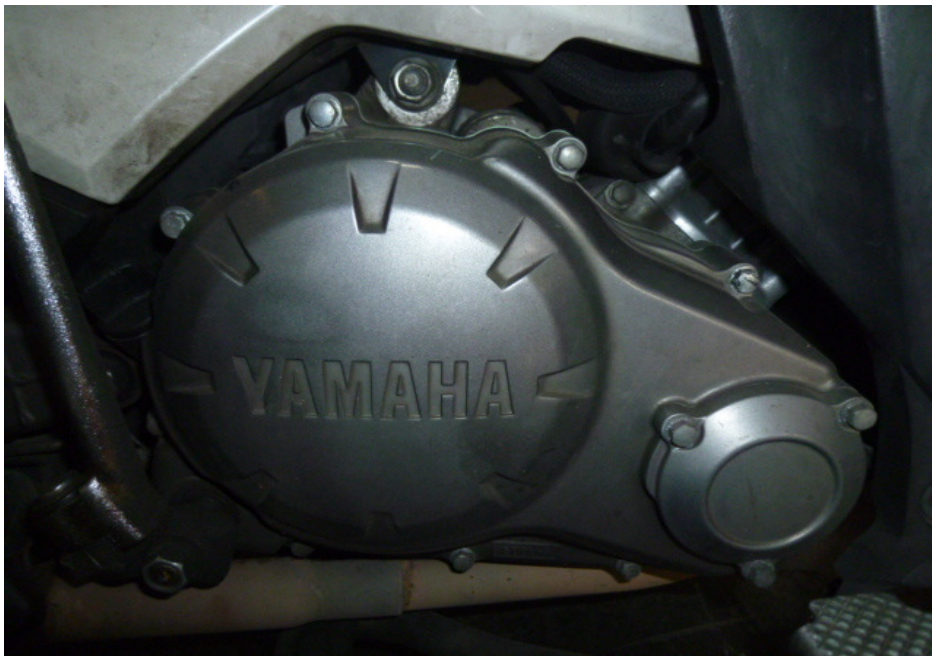
Photo 20 shows the right side of the engine of the Motorcycle at the time of our inspection. The various engine related parts and components were found to be intact with no visible damage. There was also no sign(s) or indication(s) of fluid leak observed around the right engine area of the Motorcycle.

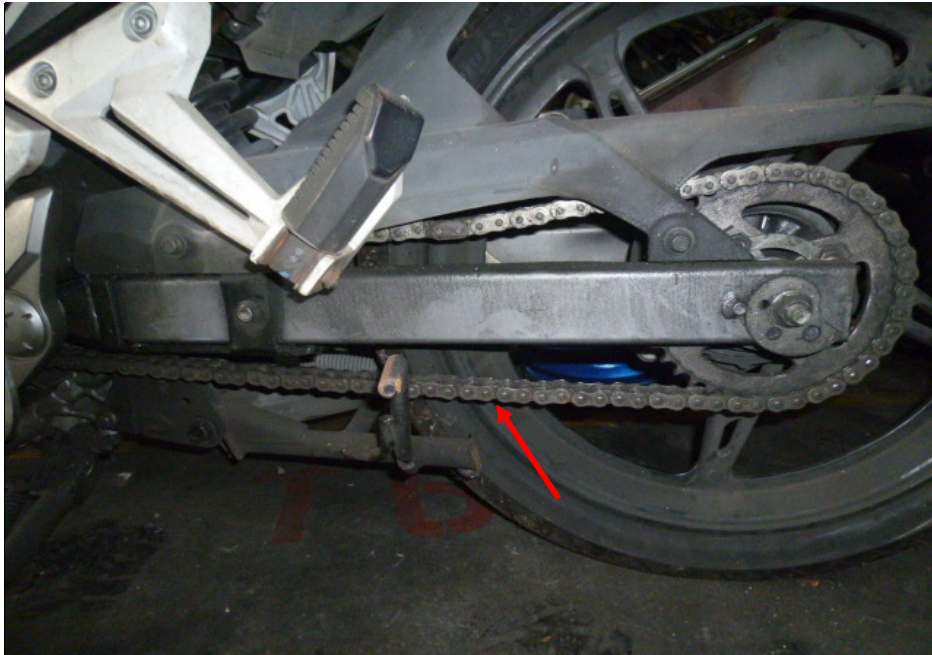
Photo 21 shows the gear chain (arrowed) of the Motorcycle, which was observed to be intact with no misalignment. It was also adequately lubricated for operating purposes. The gear chain rotates the rear wheel of the Motorcycle.

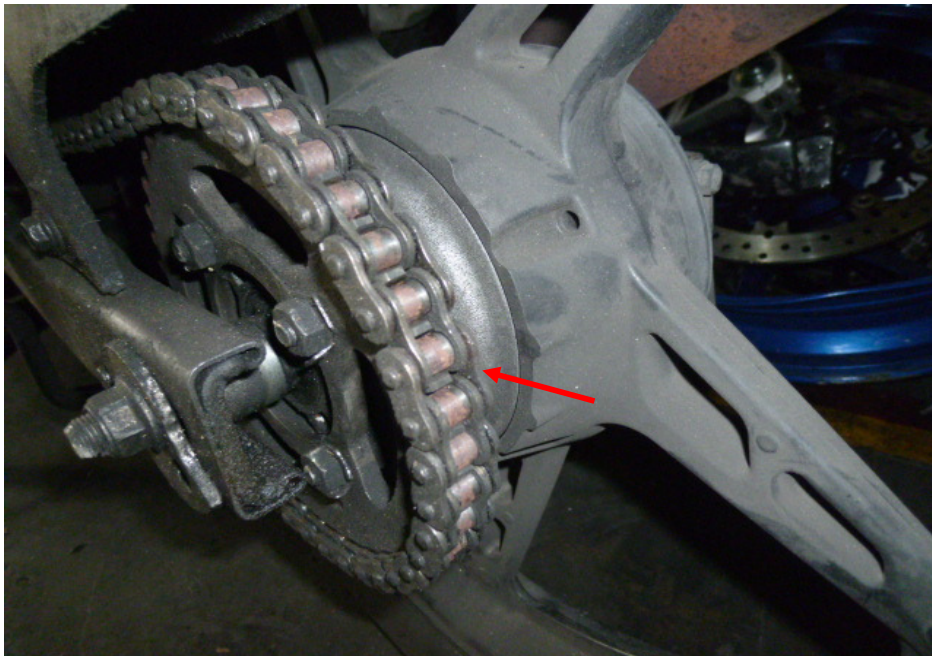
Photo 22 shows the closer view of the gear chain (arrowed) of the Motorcycle, which was observed to be intact with no misalignment. It was also adequately lubricated for operating purposes.

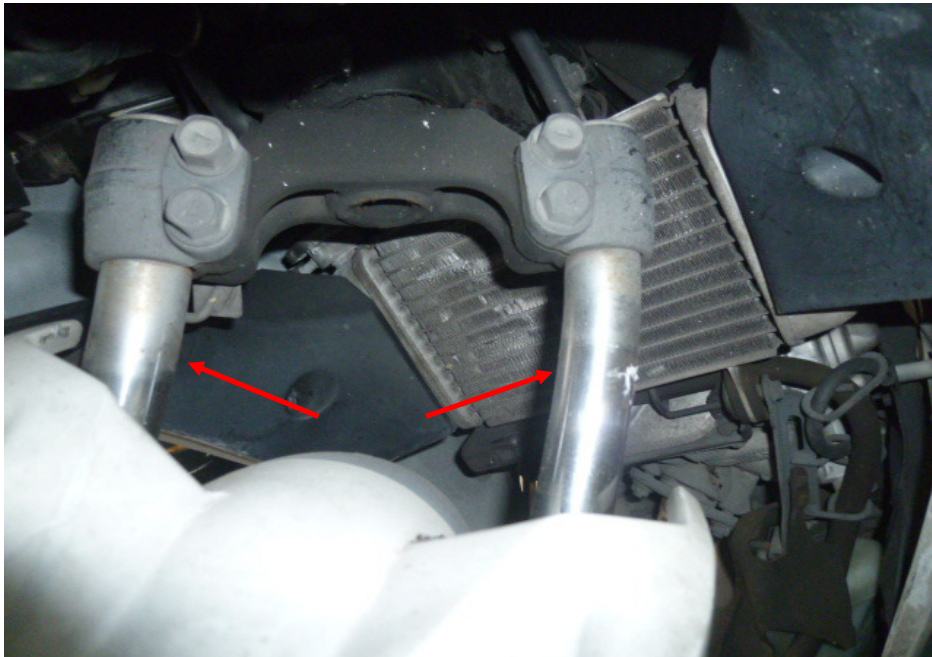
11. For this case, we were not able to conduct any test(s) on the steering system of the Motorcycle due to the damage of its front forks. The front forks were found to be bent as a result of the accident.

14. For this case, we were not able to carry out any operational tests to the steering system and front braking system of the Motorcycle due to the damage of its front forks, which had rendered the Motorcycle immobile for the operational tests. We were not able to push the Motorcycle manually forward and backward, simulating movement of the Motorcycle, for the operational tests.

Photo 23 shows the front forks of the Motorcycle. The front forks (arrowed) were observed to be bent as a result of the accident. We were hence not able to conduct any tests on the steering system of the Motorcycle.

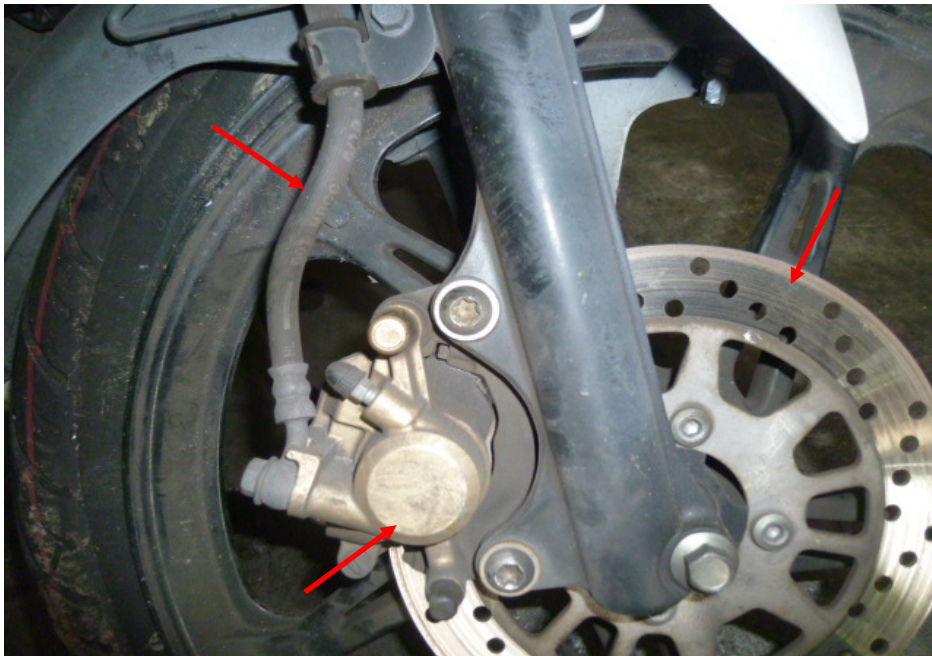
Photo 24 shows a close up view of the front brake caliper, front brake disc and front brake hose (arrowed) of the Motorcycle, which are all part of the components in the hydraulic front brake system of the Motorcycle. Our visual checks of these various components had revealed all to be intact with no visible damage. No leakage of brake fluid was also observed.

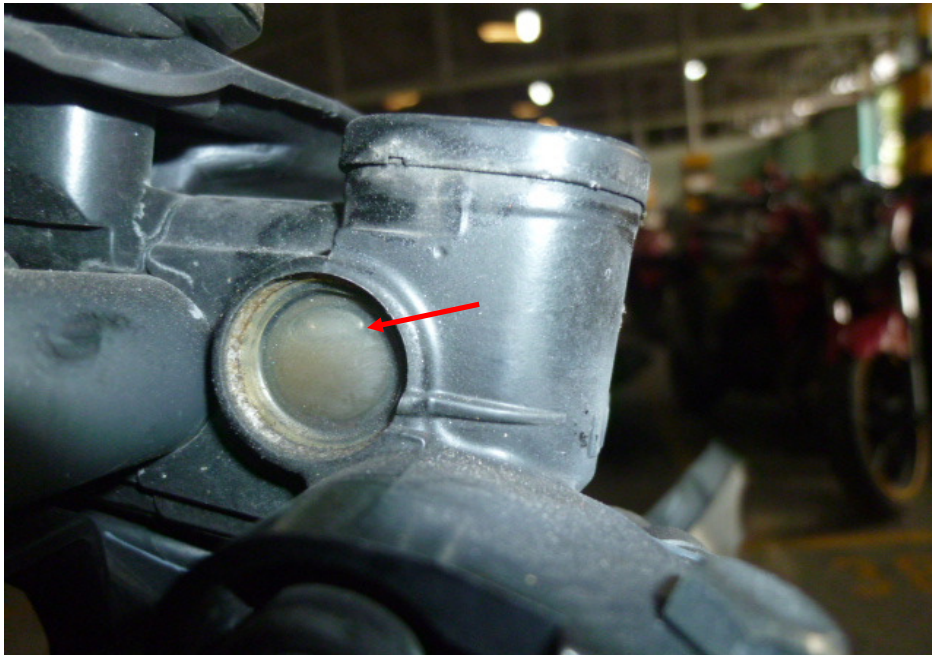
Photo 25 shows the brake fluid reservoir for the front brake of the Motorcycle. The brake fluid was observed to be of sufficient level (arrowed) and without contamination for operational purposes.

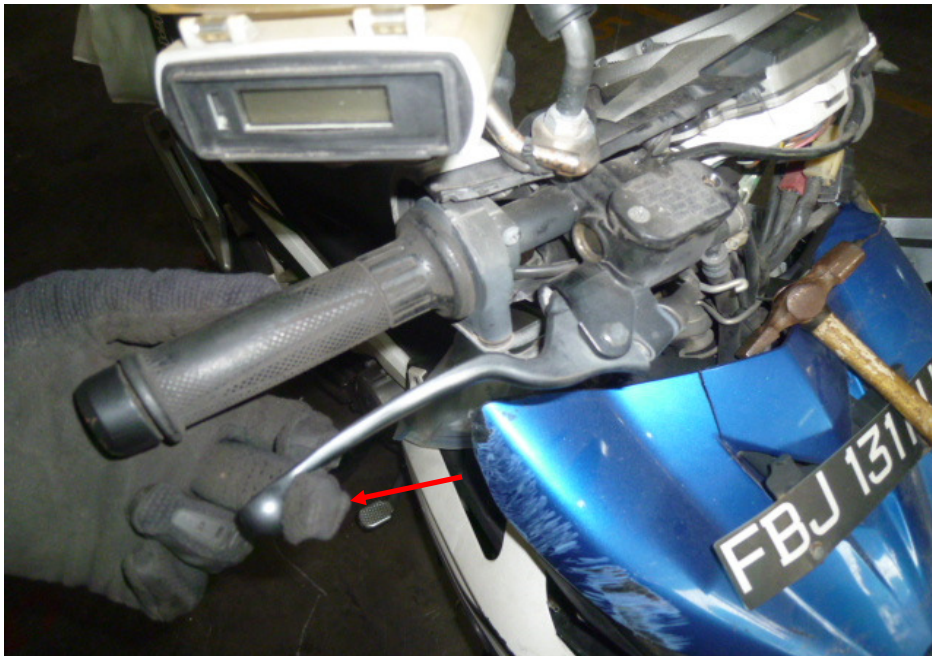
13. Static brake tests conducted on the Motorcycle had appear to indicate that the braking system of the Motorcycle was in serviceable condition. There was some resistance felt (spongy like feel) upon pressing the brake lever and upon stepping the brake pedal. This would indicate that there was no leakage of pressure/vacuum in the braking system.

Photo 26 shows the front brake lever being depressed. There was some resistance felt (spongy like feel) upon pressing the front brake lever (arrowed). This would indicate that there is no leakage of pressure/vacuum in the brake system.

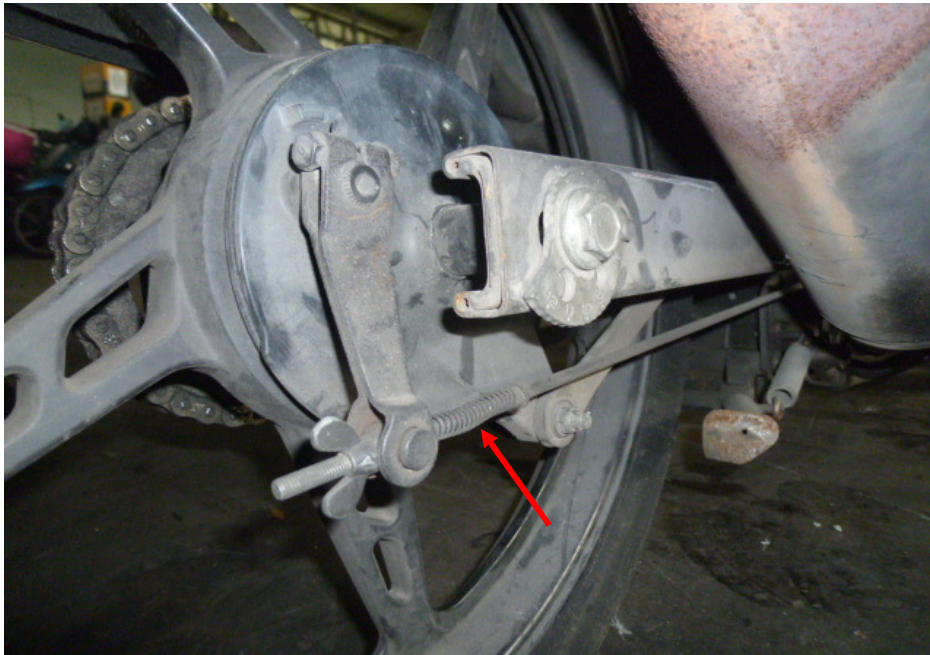
15. We subsequently carried out an operational test of the Motorcycle's rear braking system. This was done by firstly putting the Motorcycle on its main stand. We then proceeded to turn the rear wheel, allowing it to spin freely, simulating the Motorcycle in motion. We thereafter engaged the rear brake pedal of the Motorcycle. The rear wheel of the Motorcycle was able to stop rotating immediately upon depressing the brake pedal. At the end of the short operational test, we did not observe any abnormal behaviour of the Motorcycle's rear braking system. See photos 23 – 27 below.

Photo 27 shows the rear wheel of the Motorcycle. The type of brake system for the rear wheel was of a mechanical type, controlled by the brake foot pedal of the Motorcycle. Our checks of the cable (arrowed), spring and drum which are all part of the components in the rear brake system of the Motorcycle reveal all to be intact and without damage.
