Your Ref: TP/IP/09011/2021
Our Ref : CI/TPD21005541/N

5 May 2021

INSPECTION REPORT OF MOTORCYCLE FBL 9315X

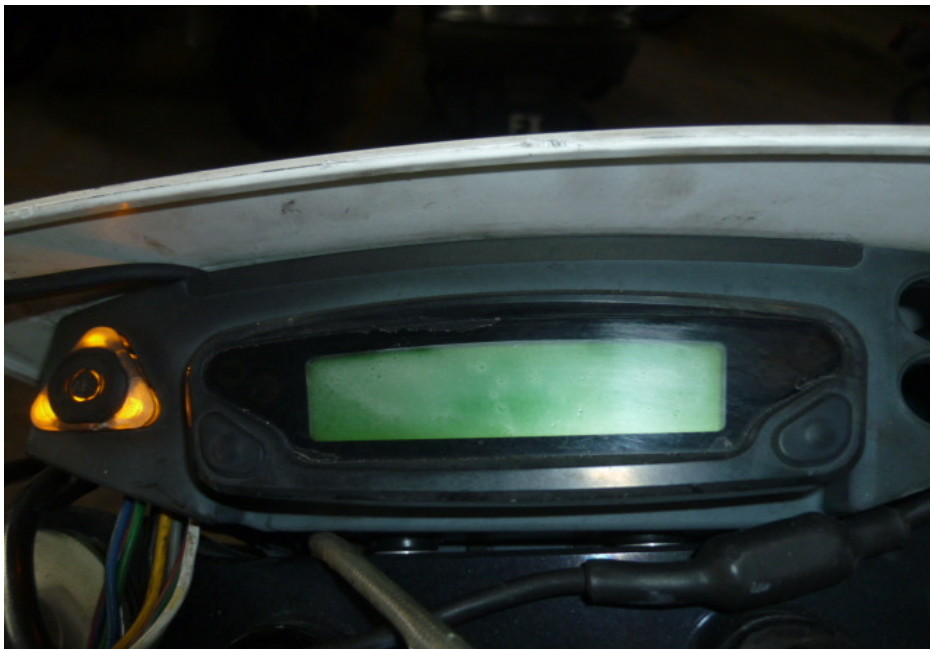
Photo 1 shows the damaged speedometer gauge of the Motorcycle as a result of the accident.

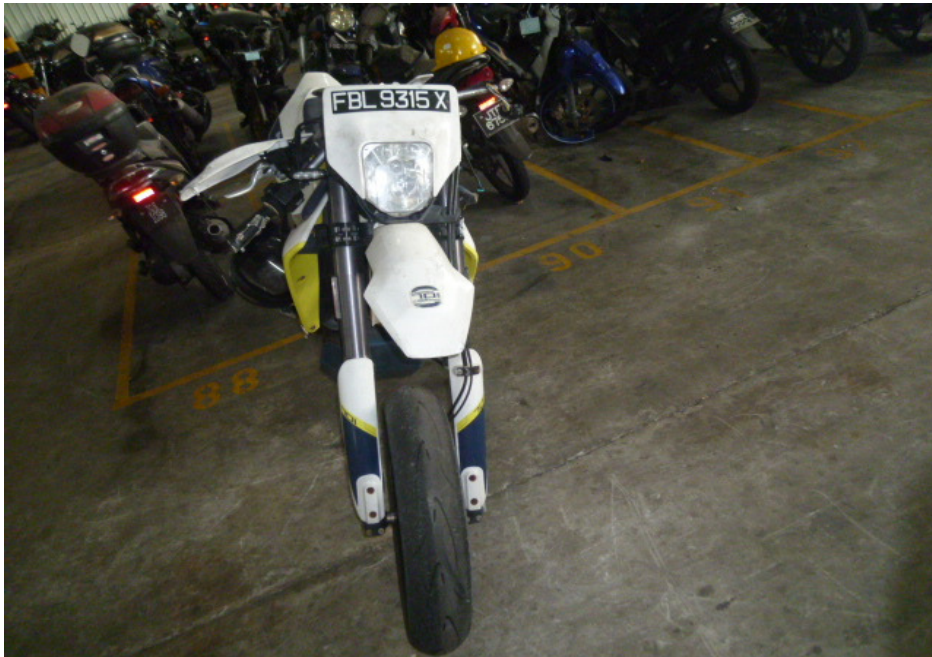
Photo 2 shows a general view of the frontal portion of the Motorcycle at the time of our inspection. The Motorcycle was observed to have sustained damages all around.

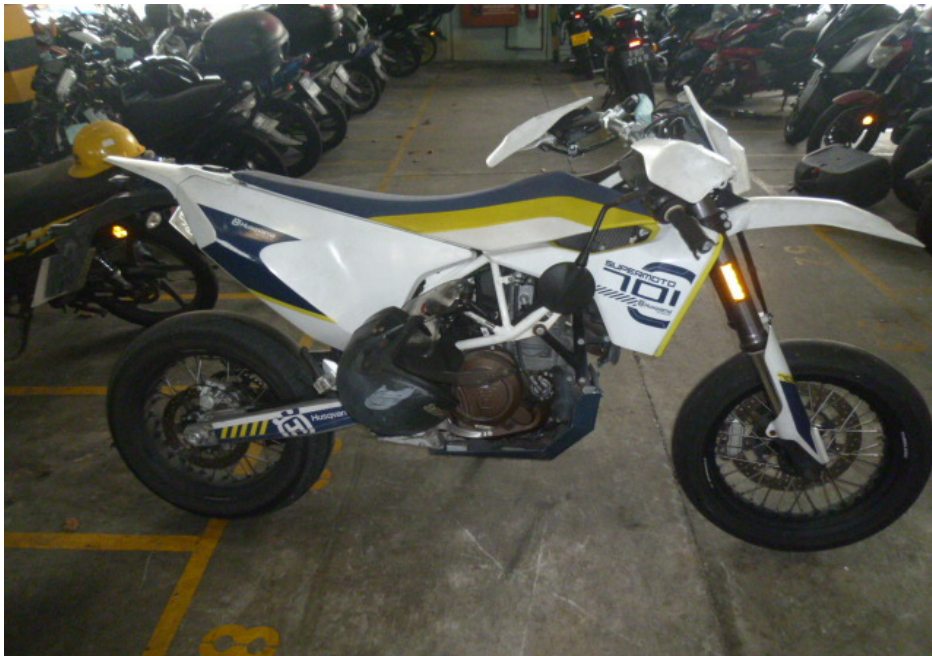
Photo 3 shows a general view of the right body of the Motorcycle at the time of our inspection. The Motorcycle was observed to have sustained damages all around.

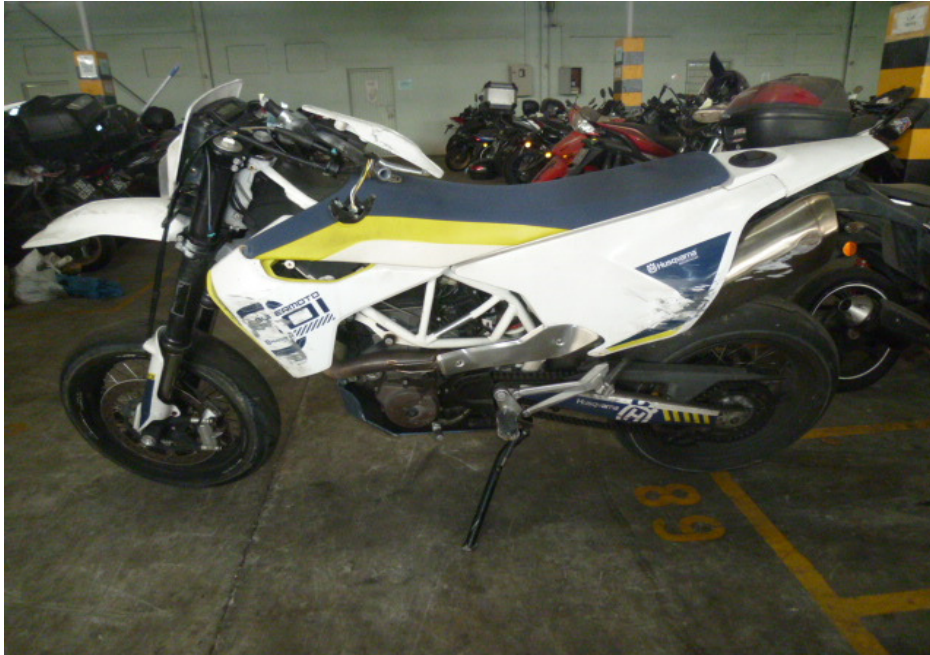
Photo 4 shows a general view of the left body of the Motorcycle at the time of our inspection. The Motorcycle was observed to have sustained damages all around. Amongst the body parts that were found to have been damaged include its head cowling, left cowling, front mudguard, front brake lever, belly pan rear brake pedal, right front footrest, rear side covers and exhaust muffler, amongst others.

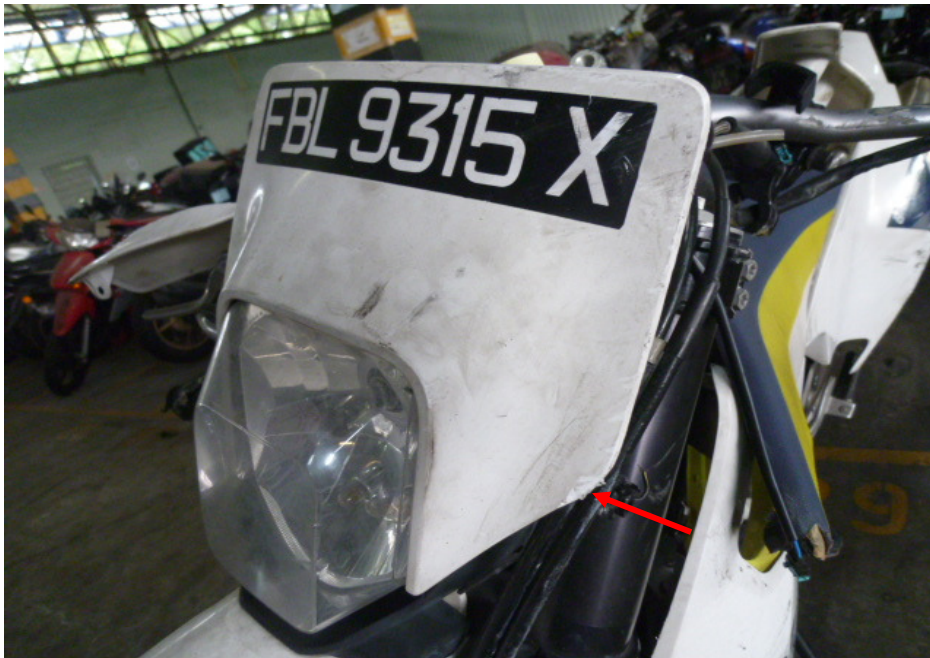
Photo 5 shows a close up view of the head cowling which was amongst the body parts of the Motorcycle that had sustained damage as a result of the accident (arrowed).

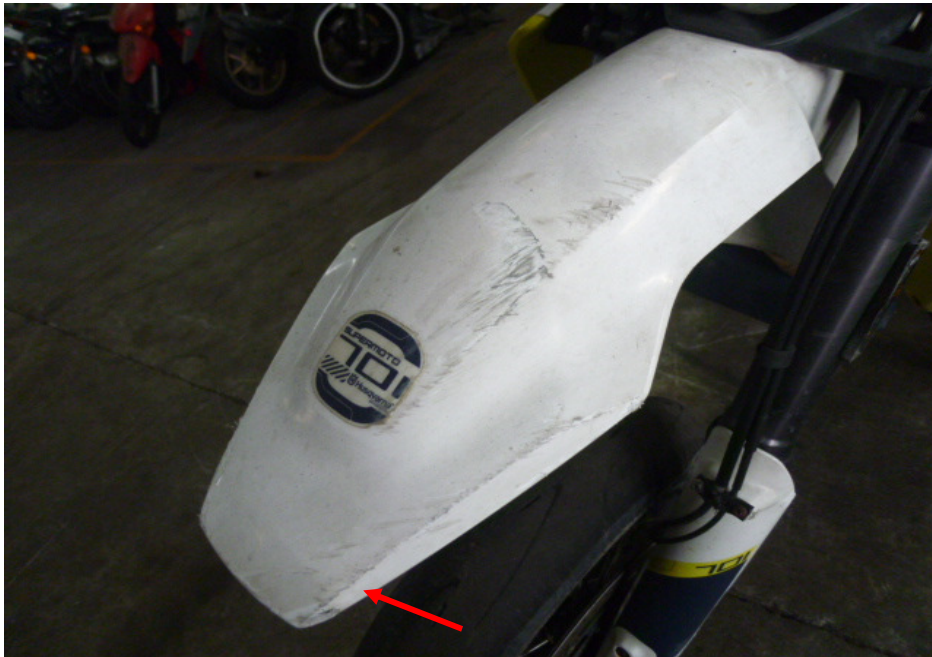
Photo 6 shows a closer view of the front mudguard (arrowed) which was amongst the body parts at the front body of the Motorcycle that had sustained damage as a result of the accident.

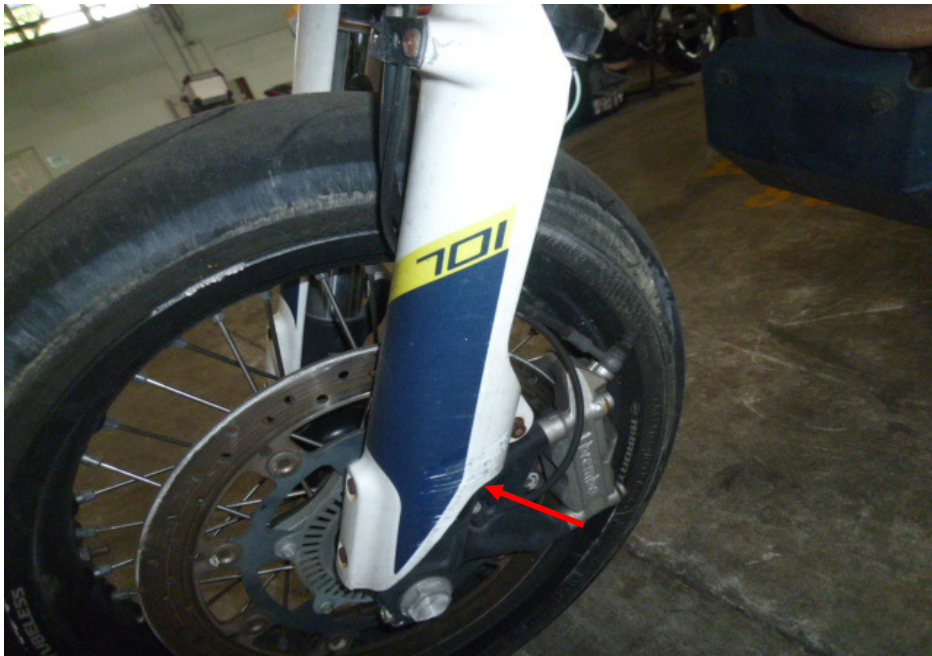
Photo 7 shows a closer view of the left lower front fork guard (arrowed) which was amongst the body parts at the front body of the Motorcycle that had sustained damage as a result of the accident.

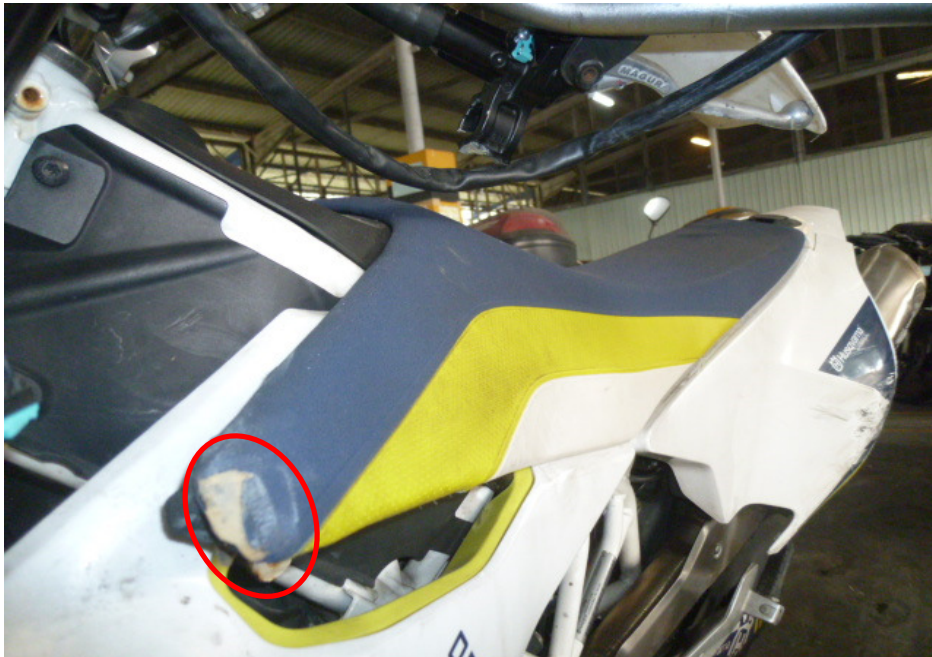
Photo 8 shows a closer view of the torn seat (circled) which was amongst the body parts of the Motorcycle that had sustained damage as a result of the accident.

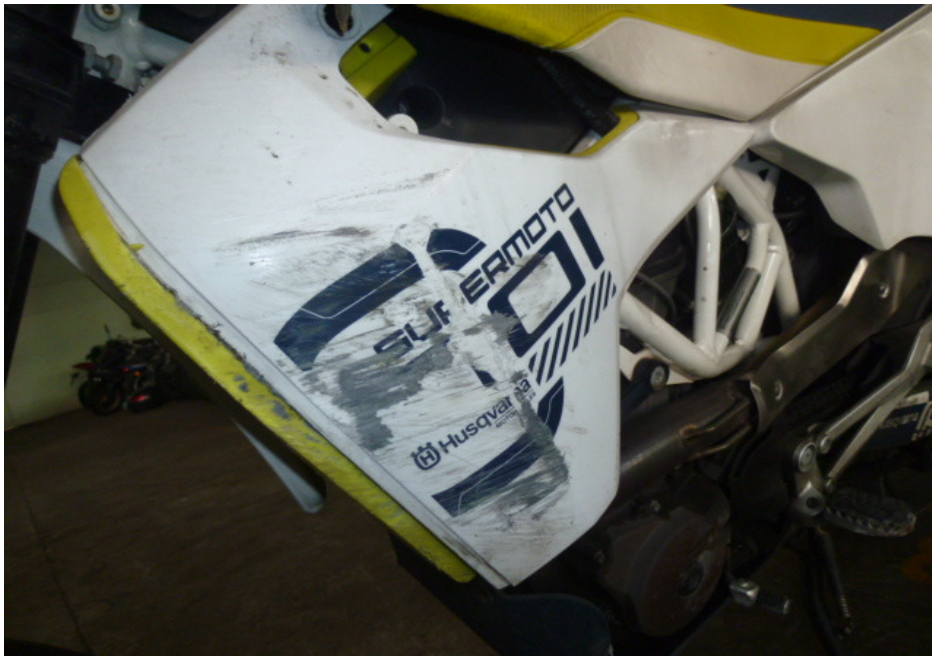
Photo 9 shows a closer view of the left cowl which was amongst the body parts of the Motorcycle that had sustained damage as a result of the accident.

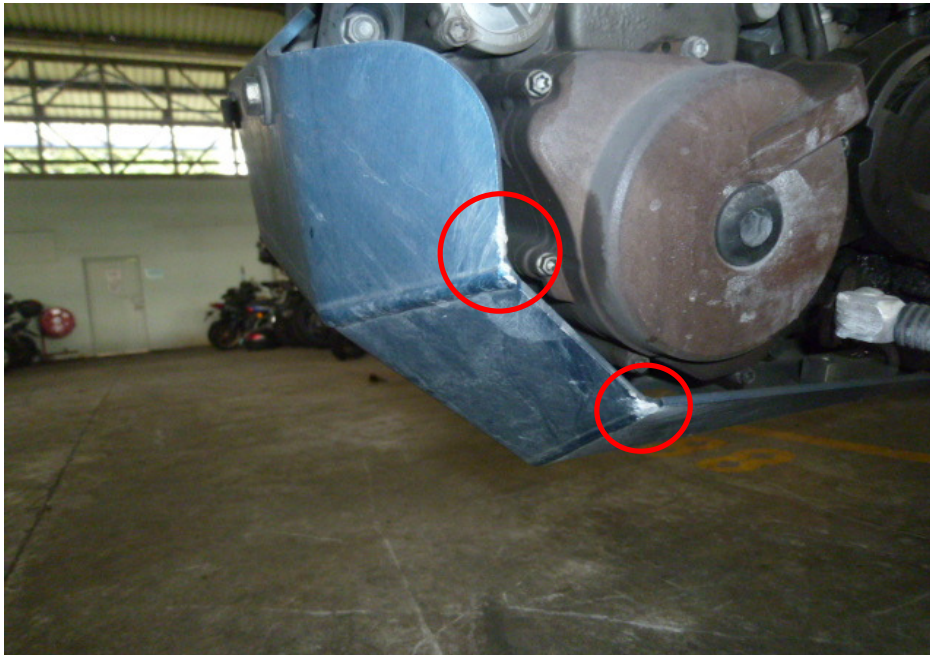
Photo 10 shows a closer view of the belly pan (circled) which was amongst the body parts of the Motorcycle that had sustained damage as a result of the accident.

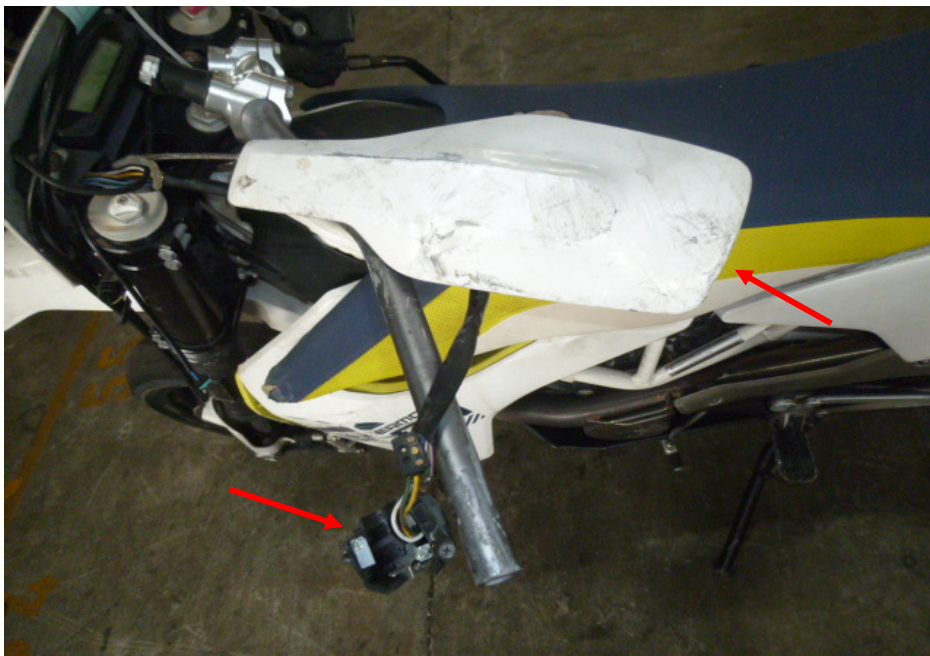
Photo 11 shows the missing clutch lever, left handlebar switch and clutch lever guard (arrowed), which were amongst the body parts of the Motorcycle that had sustained damage as a result of the accident.

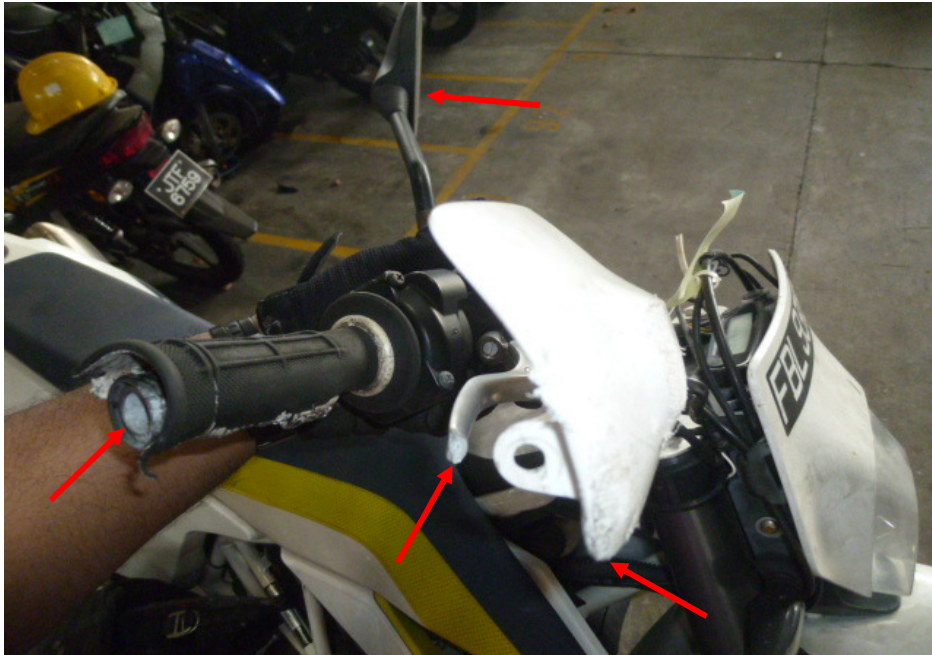
Photo 12 shows the front brake lever, right handlebar end, right side mirror and front brake lever guard (arrowed), which were amongst the body parts of the Motorcycle that had sustained damage as a result of the accident.

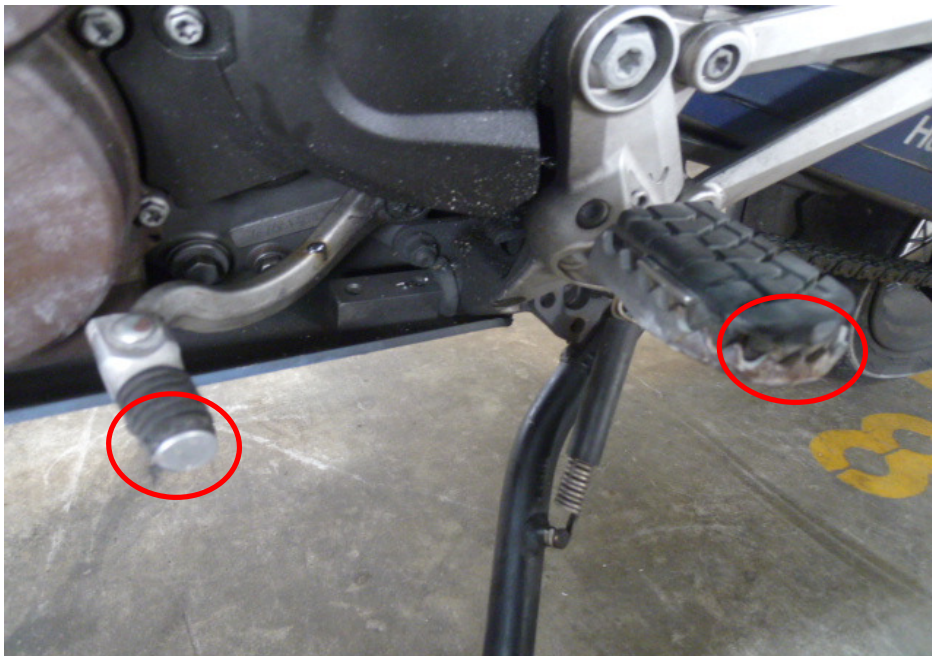
Photo 13 shows a closer view of the gear shift pedal and left front footrest (circled) which were amongst the body parts of the Motorcycle that had sustained damage as a result of the accident.

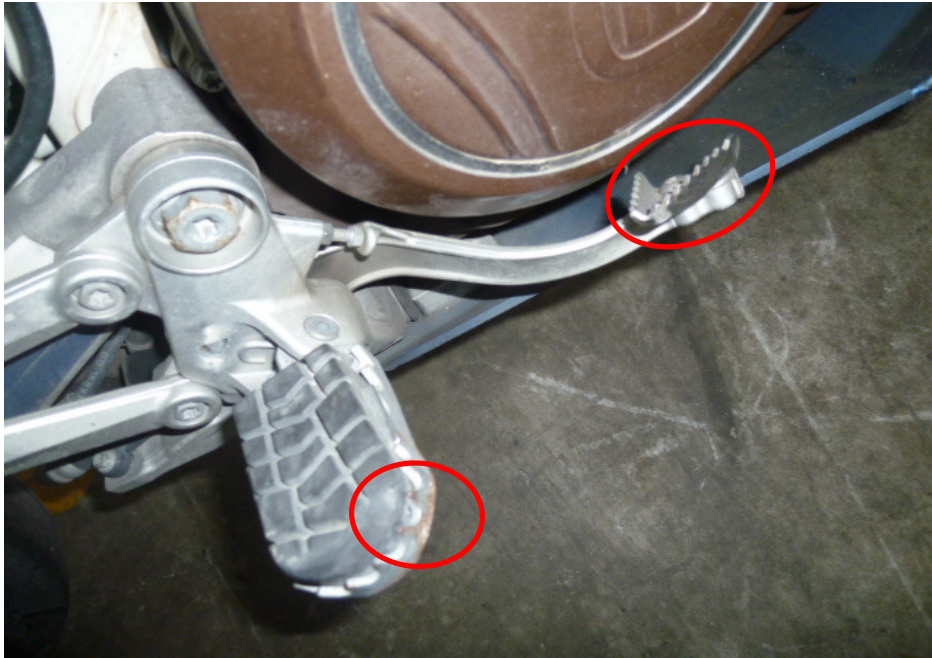
Photo 14 shows a closer view of the rear brake pedal and right front footrest (circled) which were amongst the body parts of the Motorcycle that had sustained damage as a result of the accident.

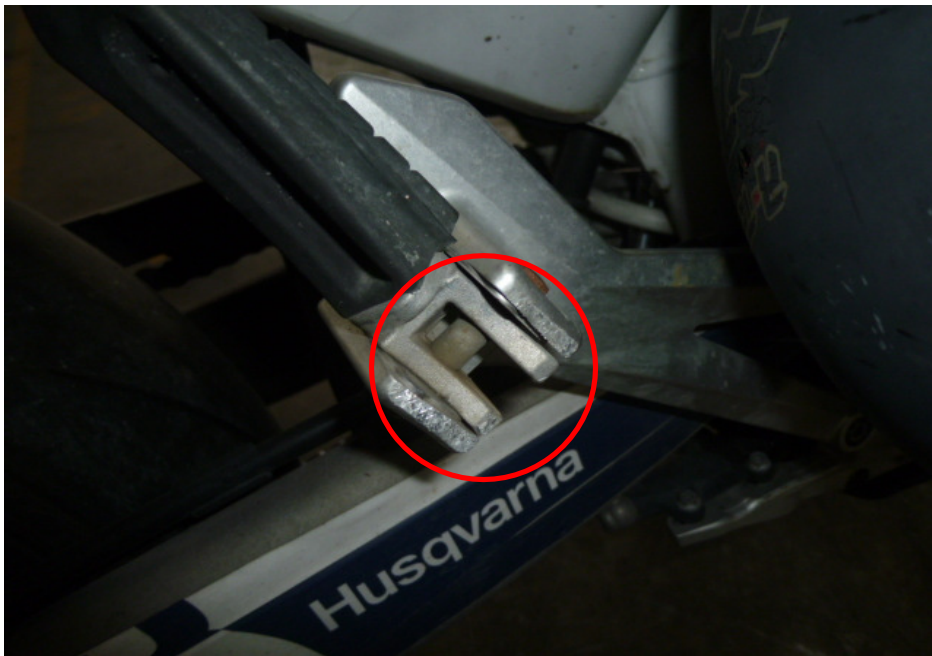
Photo 15 shows a closer view of the right pillion foot peg bracket (circled) which was amongst the body parts of the Motorcycle that had sustained damage as a result of the accident.

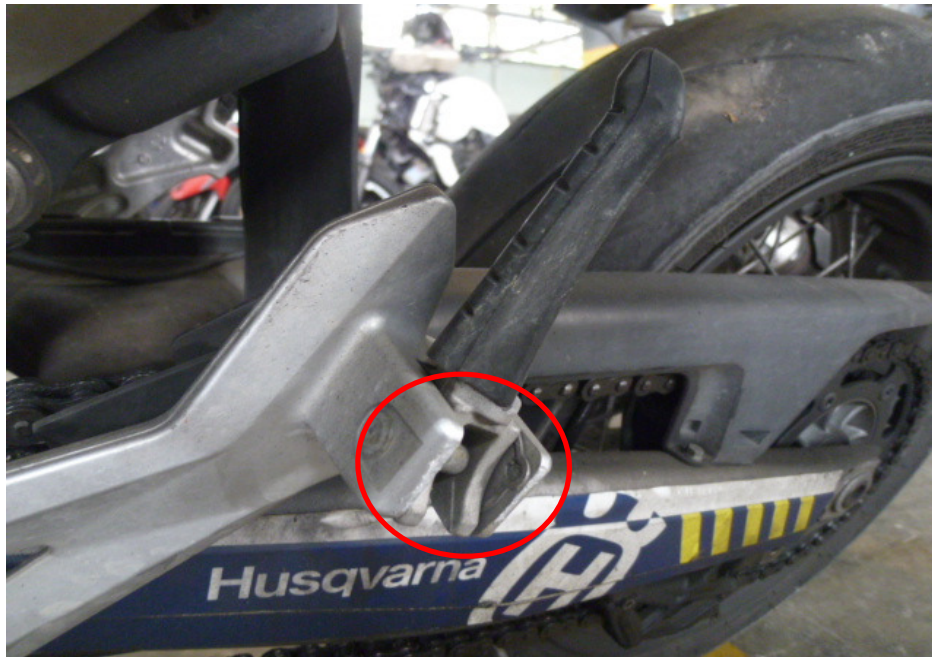
Photo 16 shows a closer view of the left pillion foot peg bracket (circled) which was amongst the body parts of the Motorcycle that had sustained damage as a result of the accident.

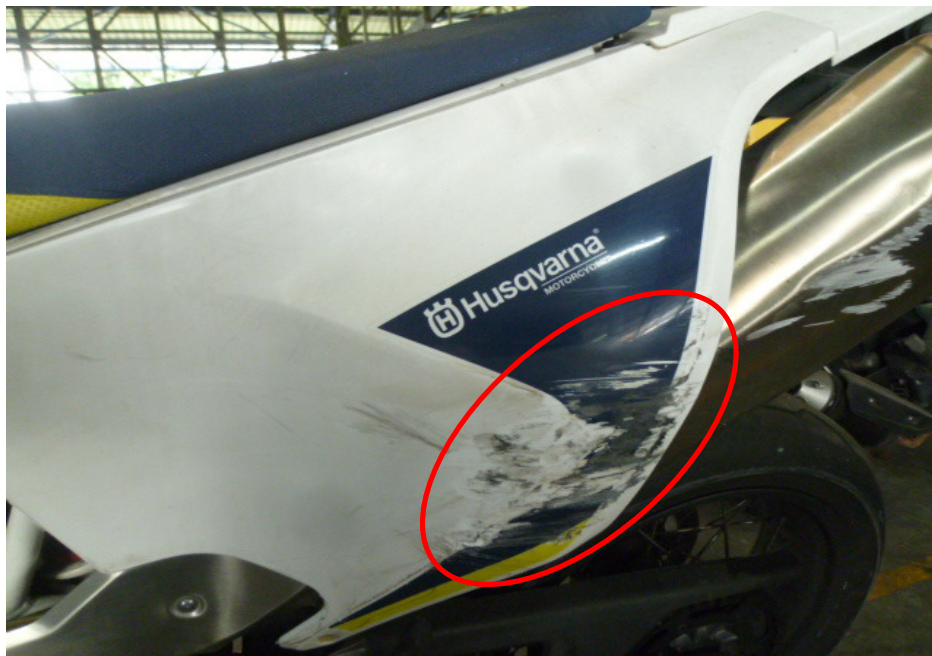
Photo 17 shows a closer view of left rear side cover which was amongst the body parts of the Motorcycle that had sustained damages of grazing nature as a result of the accident (circled).

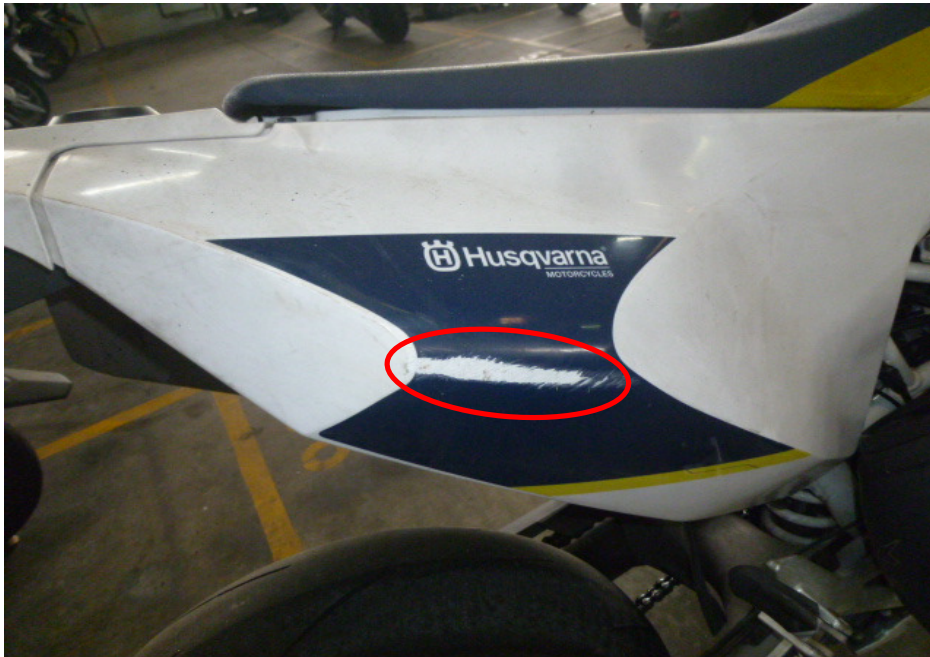
Photo 18 shows a closer view of right rear side cover which was amongst the body parts of the Motorcycle that had sustained damages of grazing nature as a result of the accident (circled).

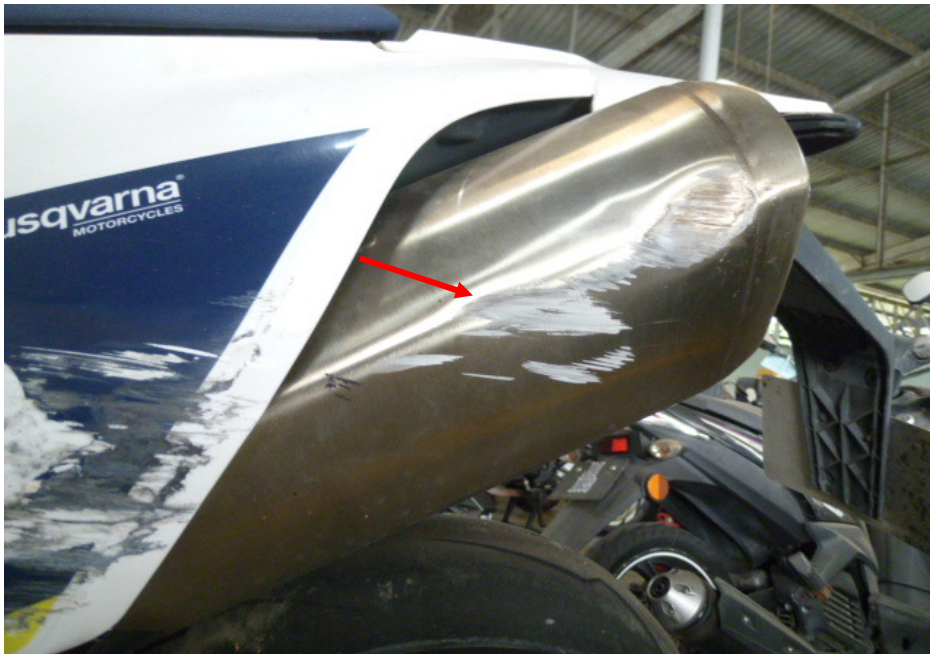
Photo 19 shows the exhaust muffler which was amongst the body parts of the Motorcycle that had sustained damage as a result of the accident.

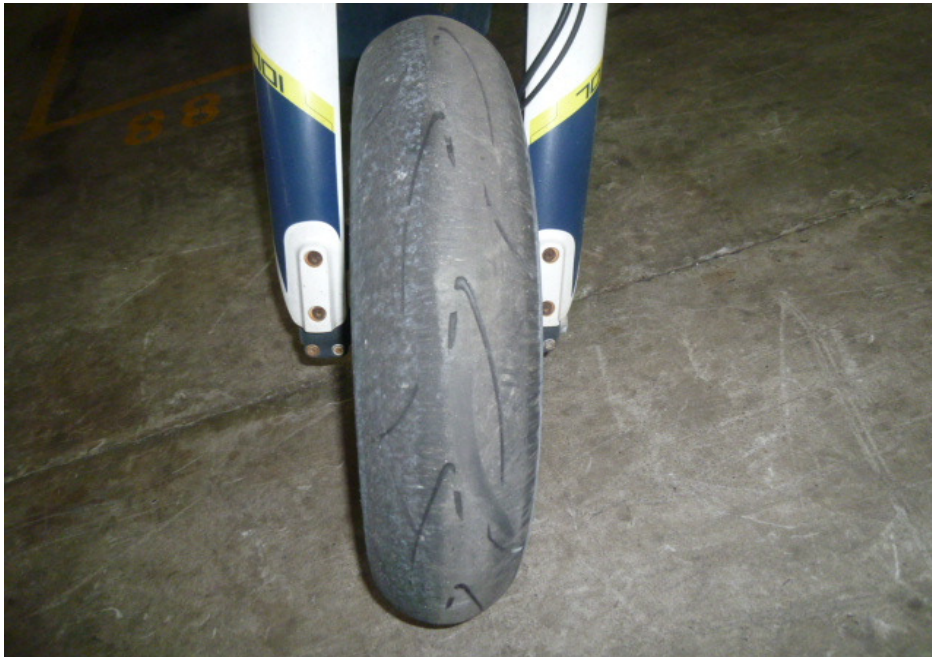
Photo 20 shows the front tyre of the Motorcycle at the time of our inspection. The front tyre was observed to be in serviceable condition with remaining tread depth of approximately 3mm. The pattern of the tread was also clearly visible. There was no tear, burst mark(s) and/or punctured hole(s) on the sidewalls as well as across the tread of the front tyre.

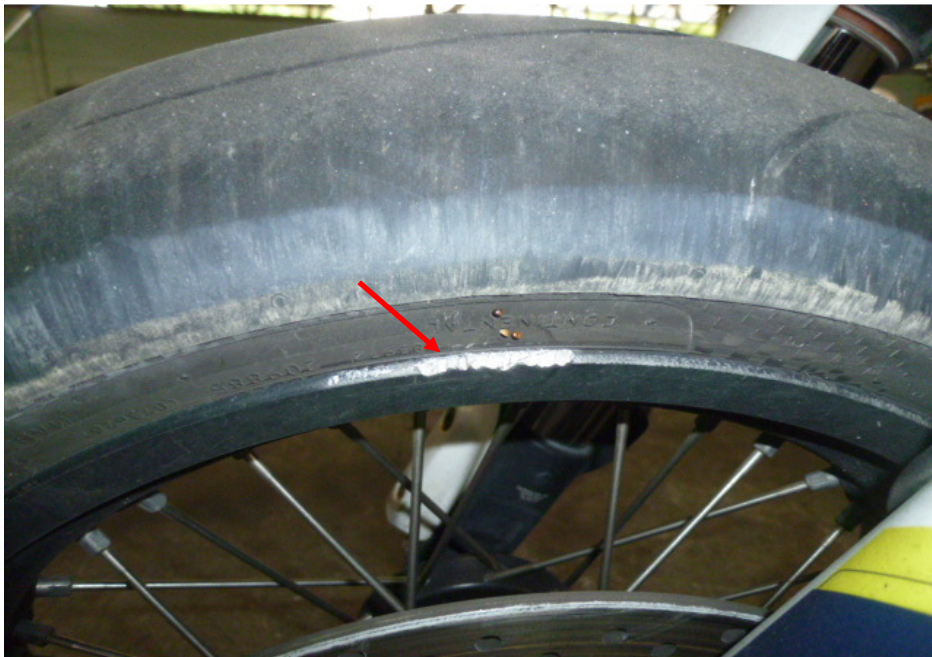
8. The 2 tyres were wrapped around alloy wheel rims. At the time of our inspection, we did not observe any visible damage on the rear wheel rim of the Motorcycle. However we did observe that the front wheel rim had sustained damages of grazing nature as a result of the accident. See photos 1 – 22 below.

Photo 21 shows the front wheel rim of the Motorcycle which had sustained damages of grazing nature as a result of the accident (arrowed).

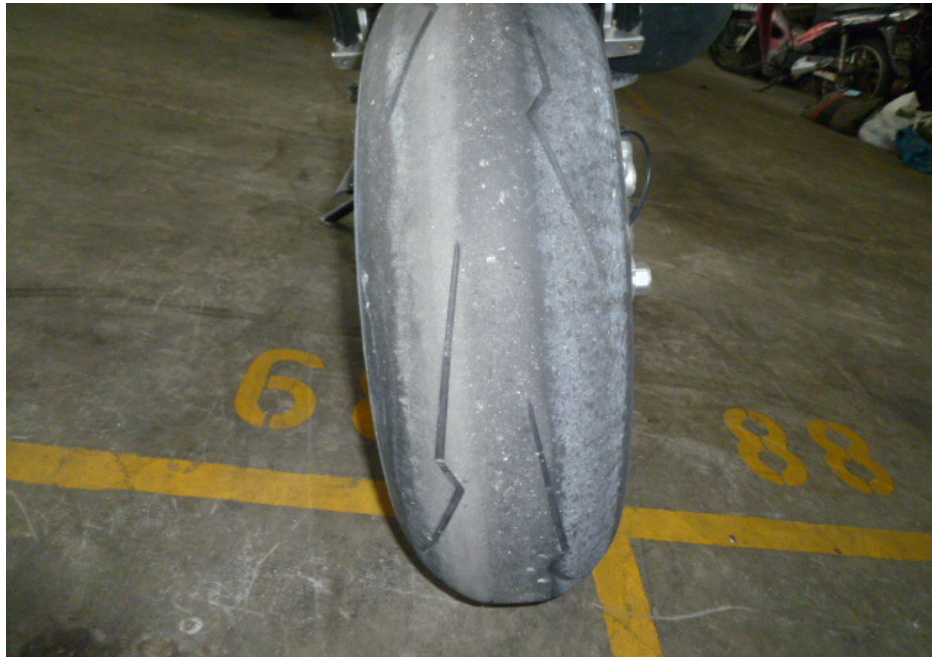
Photo 22 shows the condition of the Motorcycle's rear tyre. The rear tyre was observed to be in serviceable condition with remaining tread depth of approximately 3mm. The tyre was also observed to be sufficiently inflated for vehicular operation. We did not observe any tear, burst mark(s) and/or punctured hole(s) on the sidewalls as well as across the tread of the rear tyre.

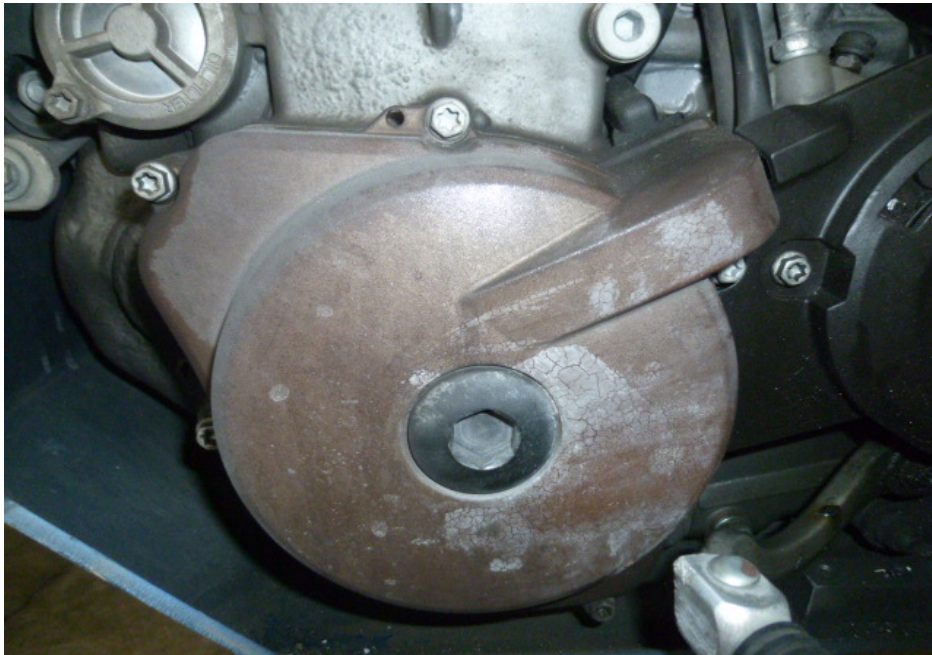
Photo 23 shows the left side of the engine of the Motorcycle at the time of our inspection. The various engine related parts and components were found to be intact with no visible damage. There was also no sign(s) or indication(s) of fluid leak observed around the left engine area of the Motorcycle.

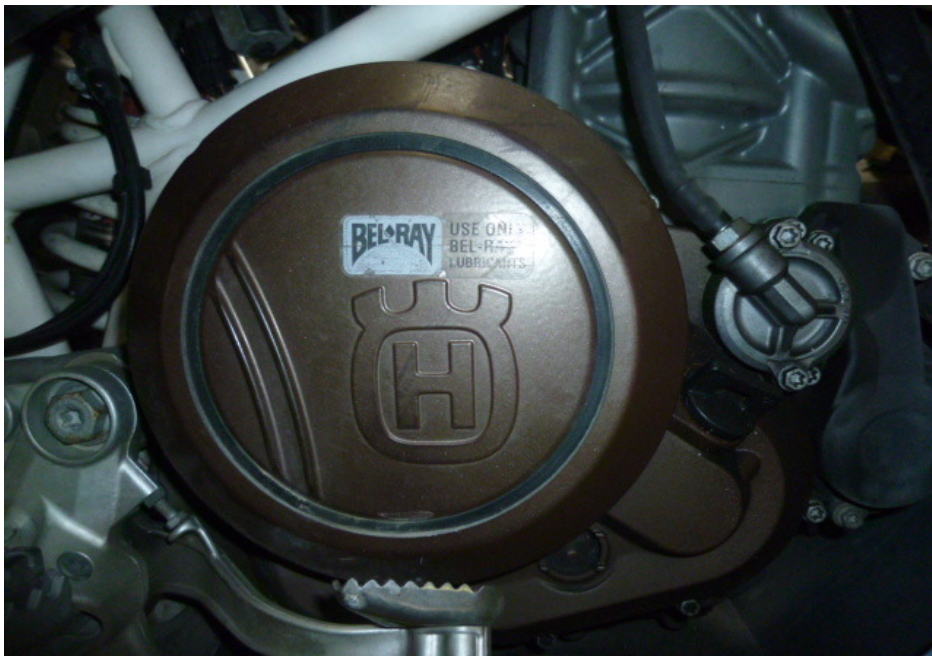
Photo 24 shows the right side of the engine of the Motorcycle at the time of our inspection. The various engine related parts and components were found to be intact with no visible damage. There was also no sign(s) or indication(s) of fluid leak observed around the right engine area of the Motorcycle.

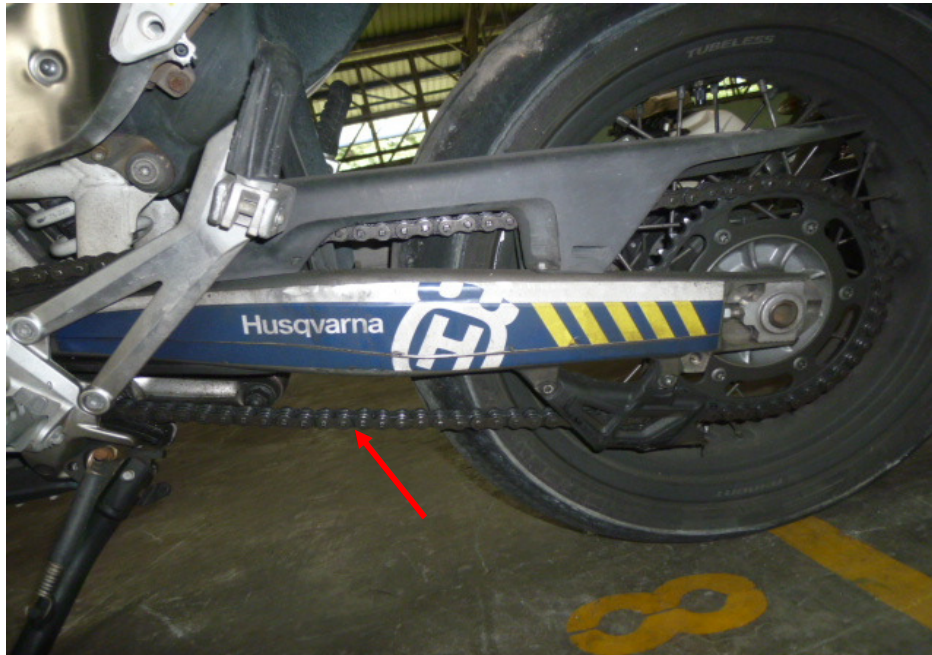
Photo 25 shows the general view of the gear train (arrowed) of the Motorcycle, which was observed to be intact with no misalignment. It was also adequately lubricated for operating purposes.

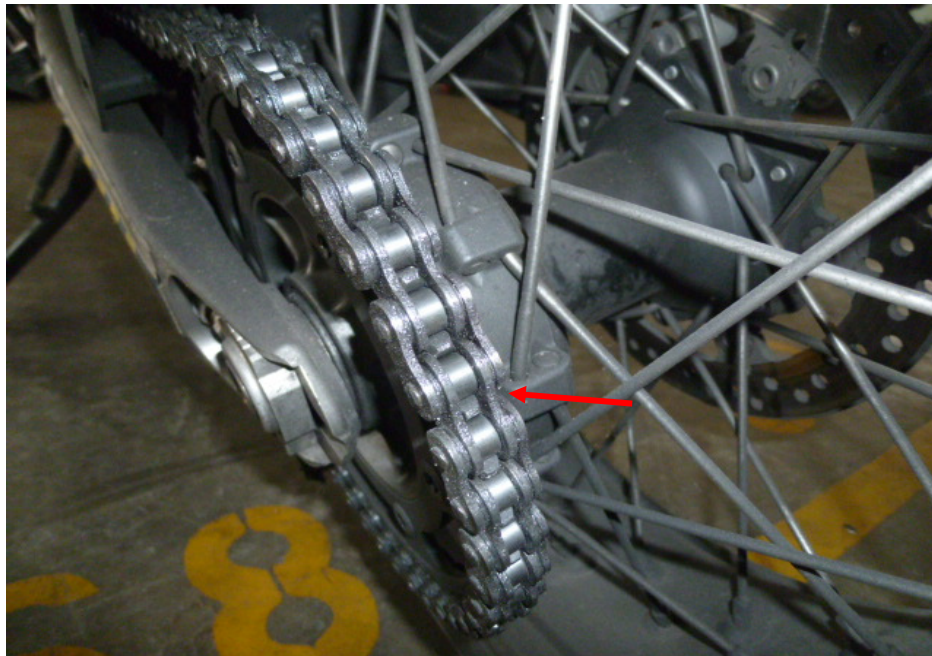
Photo 26 shows a closer view of the gear train (arrowed) of the Motorcycle, which was observed to be intact with no misalignment. It was also adequately lubricated for operating purposes.

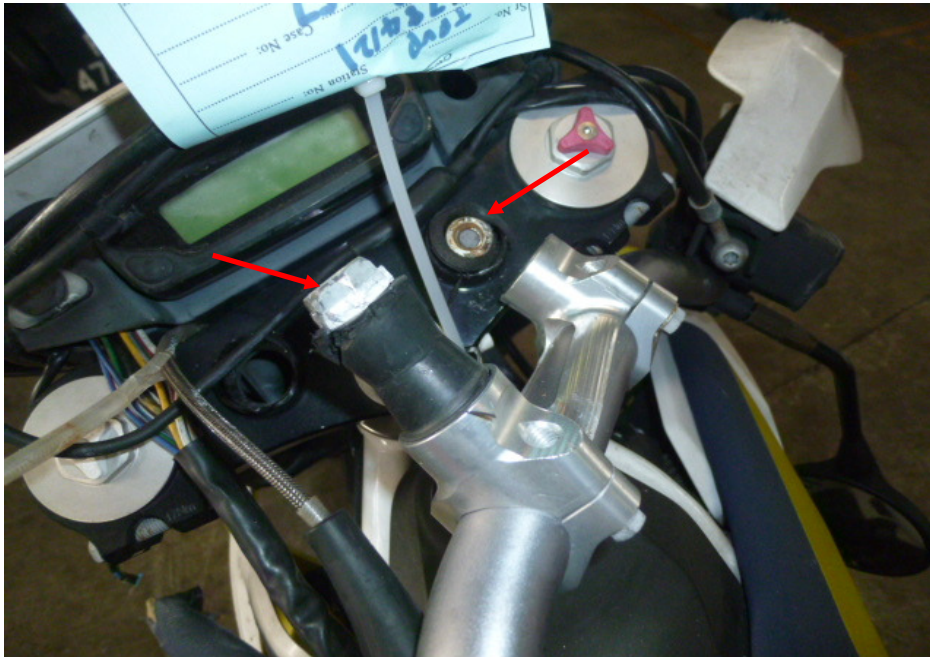
11. For this case, we were not able to conduct any test(s) on the steering system of the Motorcycle due to the damage to its handlebar clamp. The impact of the accident had caused the handlebar clamp to be broken. Hence we were unable to turn the handle bar towards the left or right.

16. For this case, we were not able to carry out any operational tests to the steering system of the Motorcycle due to the damage to its handlebar clamp, which had rendered the Motorcycle immobile. We were not able to push the Motorcycle manually forward and backward, simulating movement of the Motorcycle, for the operational tests. See photos 27 – 32 below.

Photo 27 shows the handlebar clamp of the Motorcycle which was broken as a result of the accident (arrowed). We were hence not able to turn the handlebar of the Motorcycle towards the left or right.

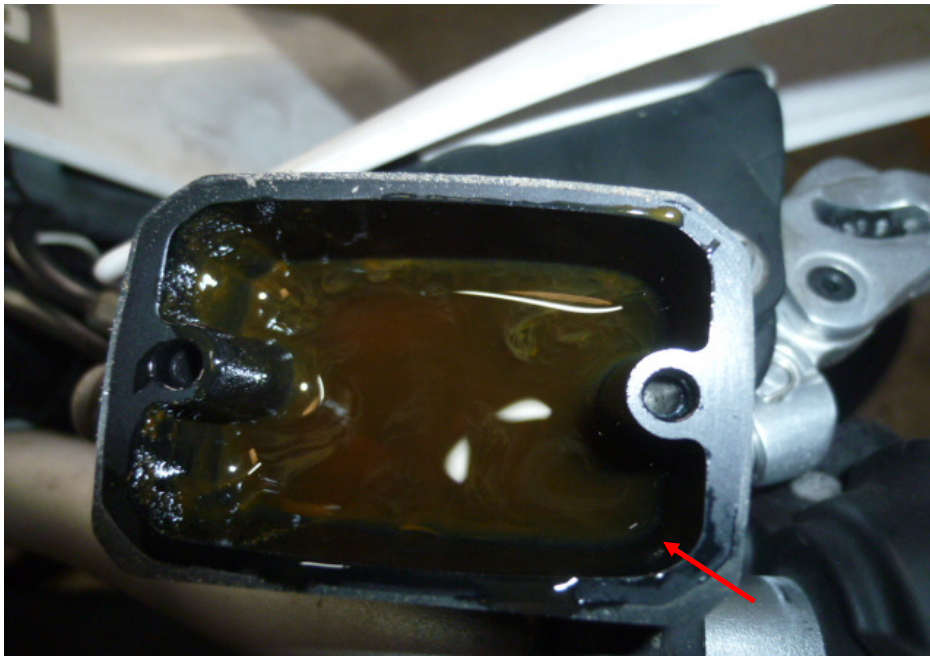
14. The brake fluid for the front brake was also found to be of sufficient level for operational purposes. However the front brake fluid was found to be slightly contaminated.

Photo 28 shows the brake fluid reservoir for the front brake of the Motorcycle. The brake fluid was observed to be of sufficient level for operational purposes. However the front brake fluid was found to be slightly contaminated (arrowed).

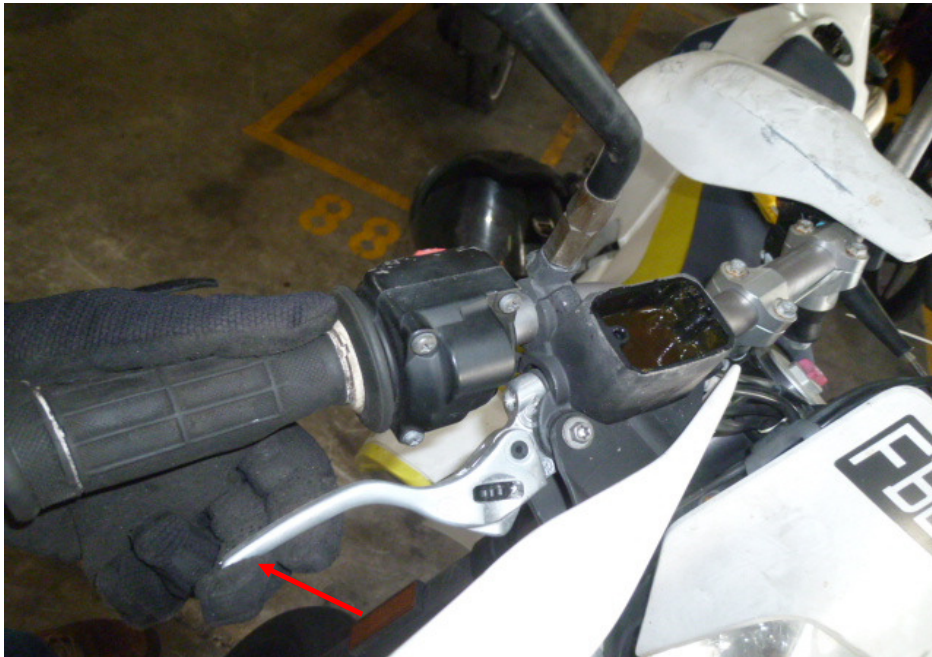
15. Static brake tests conducted on the Motorcycle had appear to indicate that the braking system of the Motorcycle was in serviceable condition. There was some resistance felt (spongy like feel) upon pressing the brake lever and upon stepping on the brake pedal. This would indicate that there was no leakage of pressure/vacuum in the brake system.

Photo 29 shows the front brake lever being depressed. There was some resistance felt (spongy like feel) upon pressing the front brake lever (arrowed). This would indicate that there is no leakage of pressure/vacuum in the front brake system.

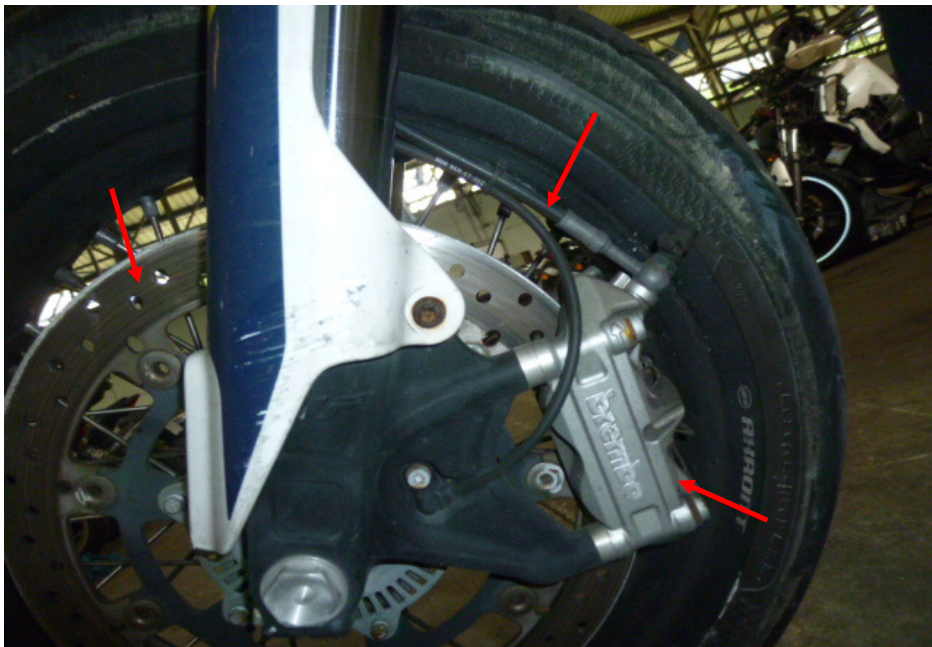
Photo 30 shows a close up view of the front brake caliper, front brake disc and front brake hose (arrowed) of the Motorcycle, which are all part of the components in the hydraulic front brake system of the Motorcycle. Our visual checks of these various components had revealed all to be intact with no visible damage.

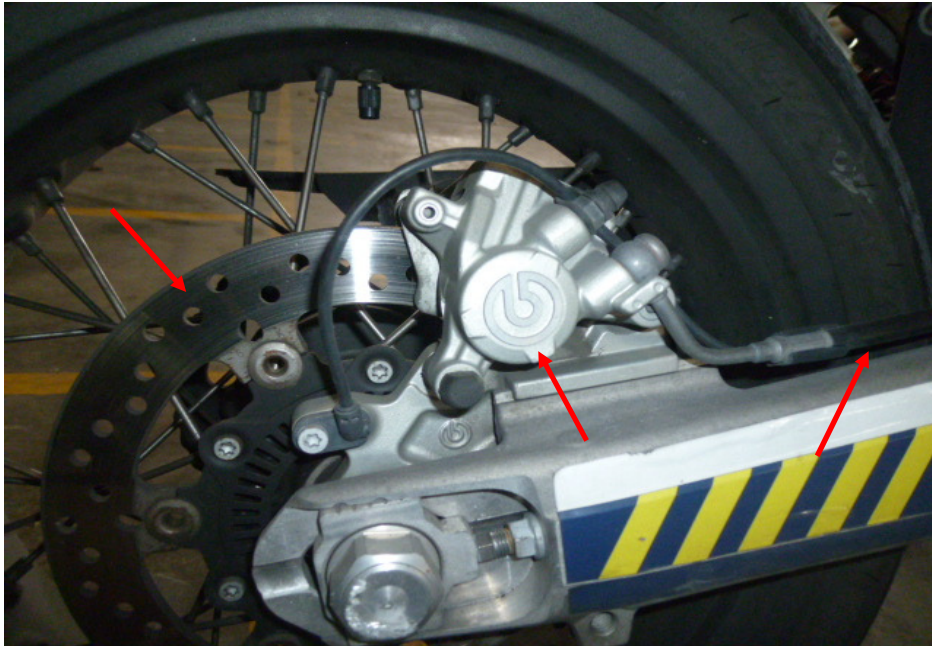
Photo 31 shows a close up view of the rear brake caliper, rear brake disc and rear brake hose (arrowed) of the Motorcycle, which are all part of the components in the hydraulic rear brake system of the Motorcycle. Our visual checks of these various components had revealed all to be intact with no visible damage. No leakage of brake fluid was also observed.

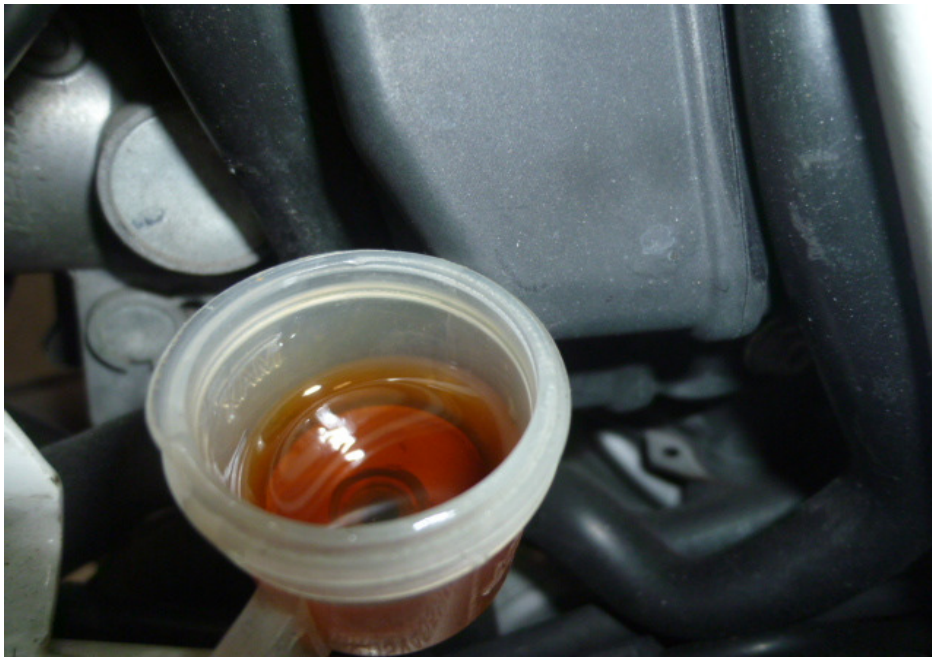
Photo 32 shows the brake fluid reservoir for the rear brake of the Motorcycle. The brake fluid was observed to be of sufficient level for operational purposes and without contamination.
