Your Ref: TP/IP/10833/2021
Our Ref : CI/TPD21005542/N

31 May 2021

Fatal Accident Investigation Team

MECHANICAL INSPECTION REPORT OF MOTORCYCLE FBM 2693U

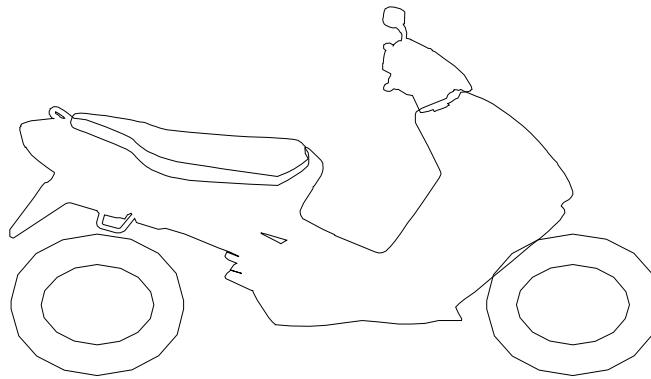
Pirelli 200/55 R17 (3mm)

Pirelli 120/70 R17 (3mm)
(Deflated)

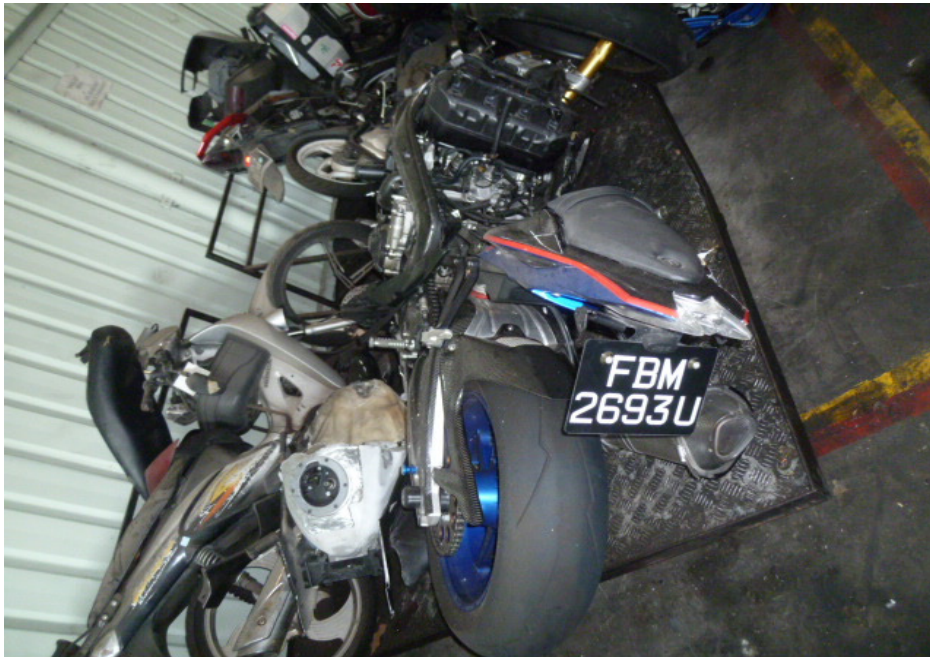
Photo 1 shows a general view of the rear portion of the Motorcycle at the time of our inspection. The Motorcycle had sustained damages all around. Body parts that were found to have been damaged include its top clamp, front fork assembly, radiator, speedometer gauge, left cowling, fuel tank, left front footrest, right rear side cover and exhaust muffler, amongst others.

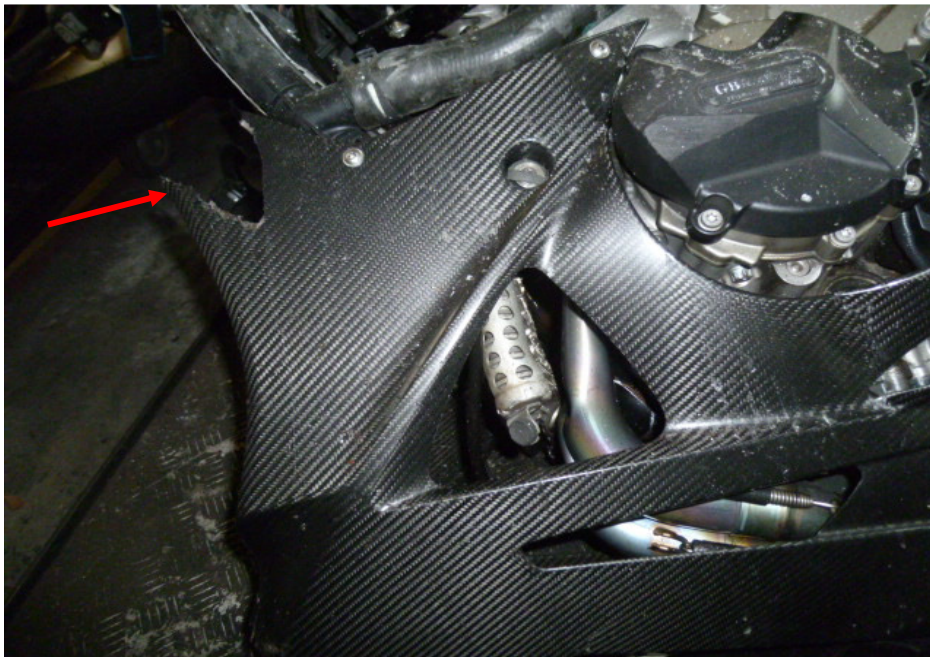
Photo 2 shows a closer view of the cracked left cowling which was amongst the body parts of the Motorcycle that had sustained damage as a result of the accident (arrowed).

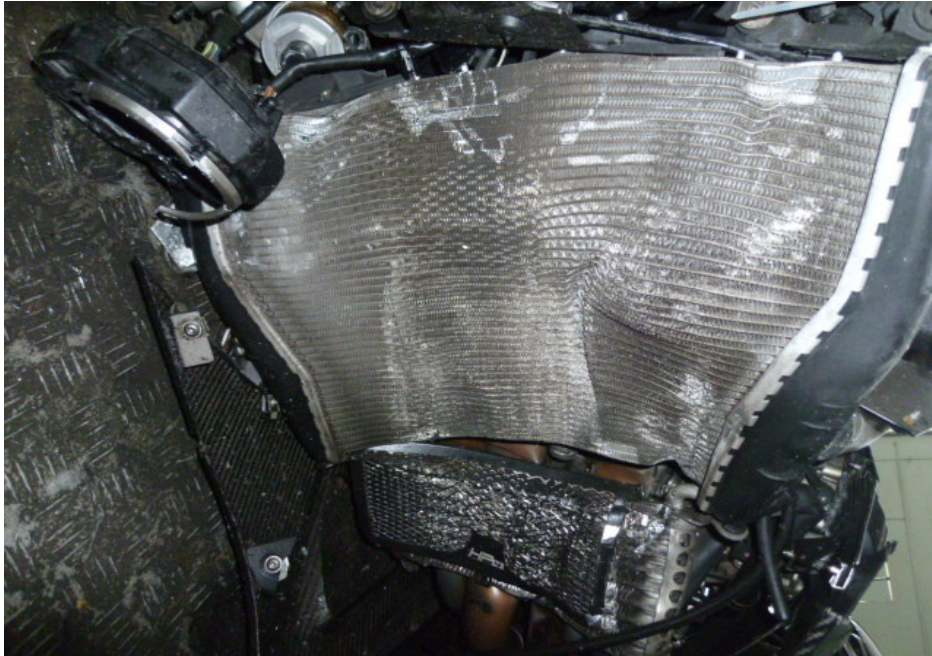
Photo 3 shows a closer view of the radiator which was amongst the body parts at the front body of the Motorcycle that had sustained damage as a result of the accident.

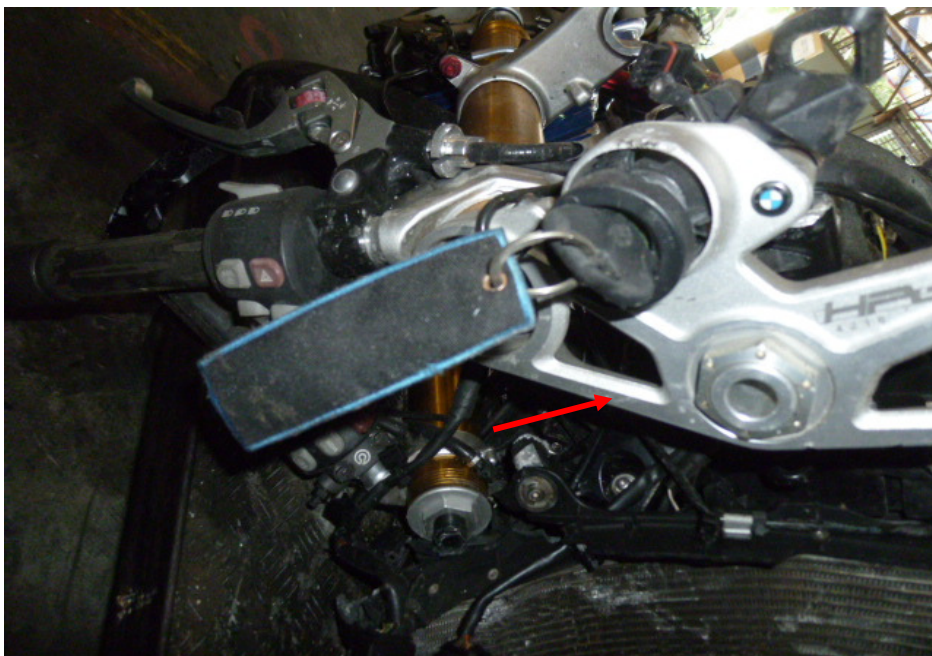
Photo 4 shows a closer view of the damaged top clamp the Motorcycle as a result of the accident (arrowed).

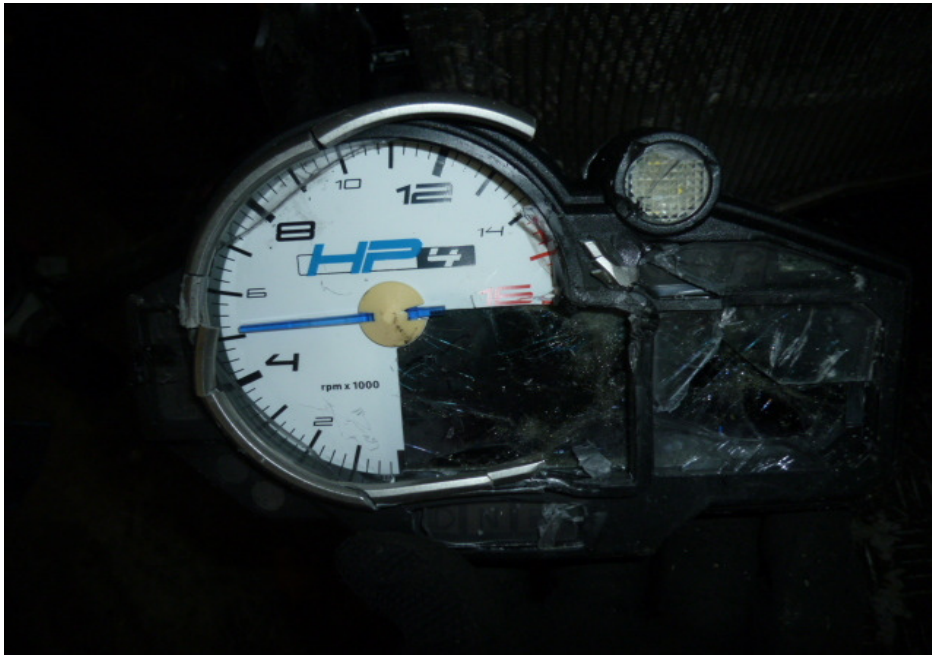
Photo 5 shows a closer view of the speedometer gauge of the Motorcycle. The mileage of the Motorcycle at the time of our inspection was not recorded due to the damage sustained to the speedometer gauge as a result of the accident.

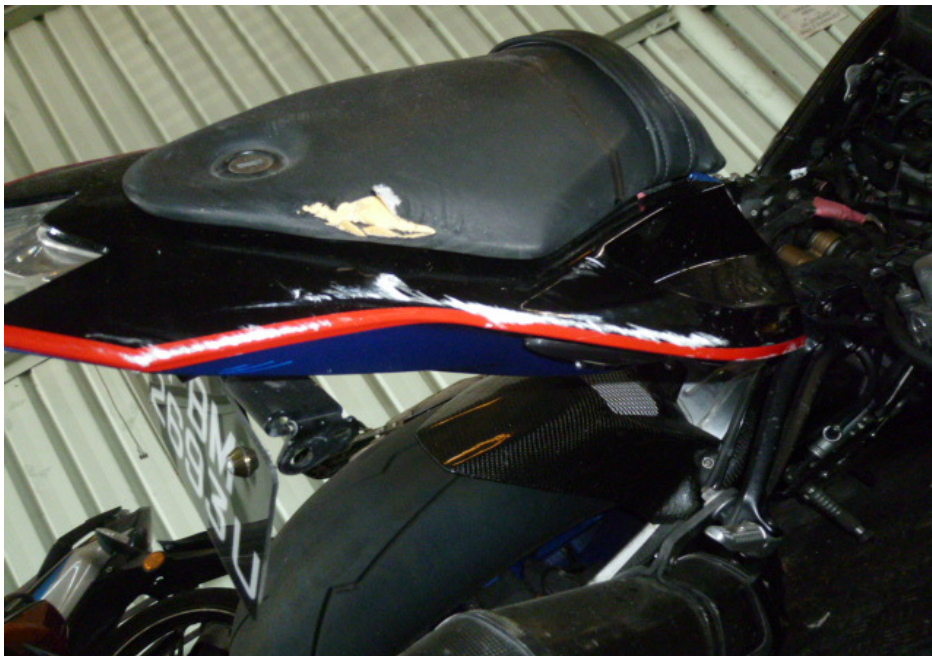
Photo 6 shows a closer view of the grazed right rear side cover of the Motorcycle as a result of the accident.

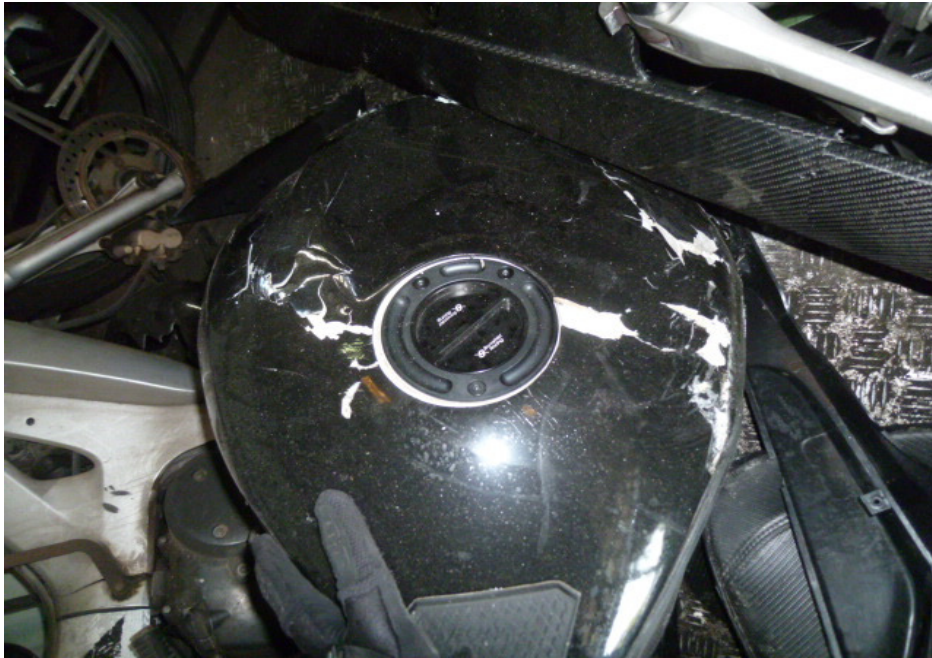
Photo 7 shows a closer view of the petrol tank, which was amongst the body parts of the Motorcycle that had sustained damage as a result of the accident.

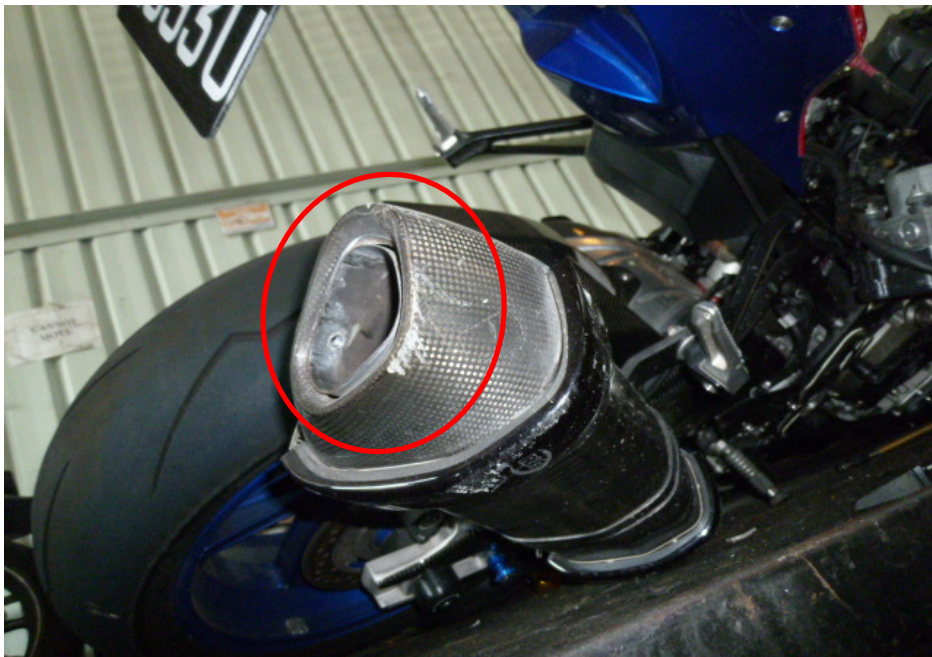
Photo 8 shows a closer view of the damaged exhaust muffler of the Motorcycle as a result of the accident (circled).

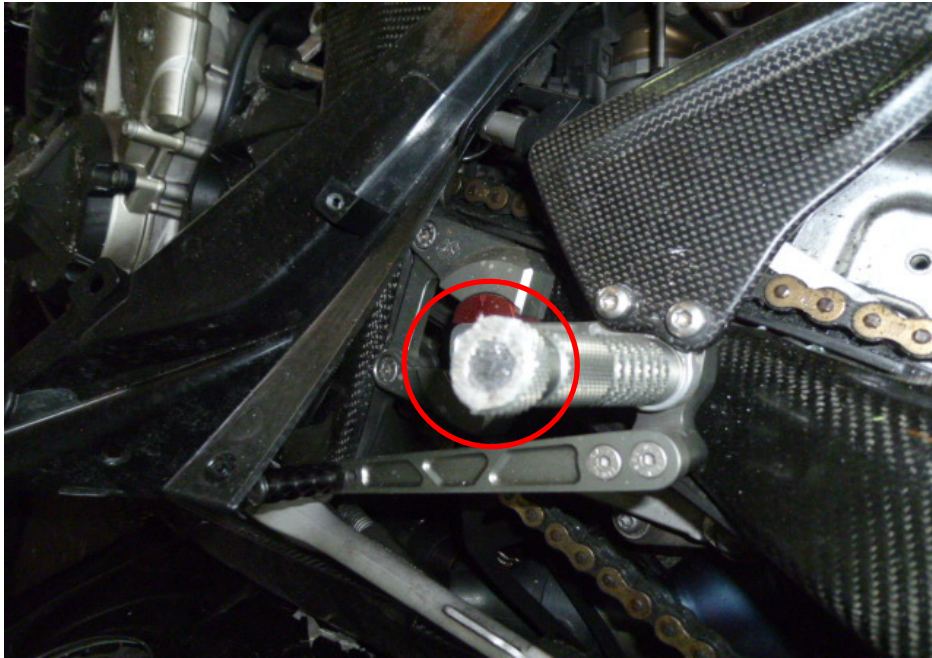
Photo 9 shows a closer view of the grazed left front footrest of the Motorcycle as a result of the accident (circled).

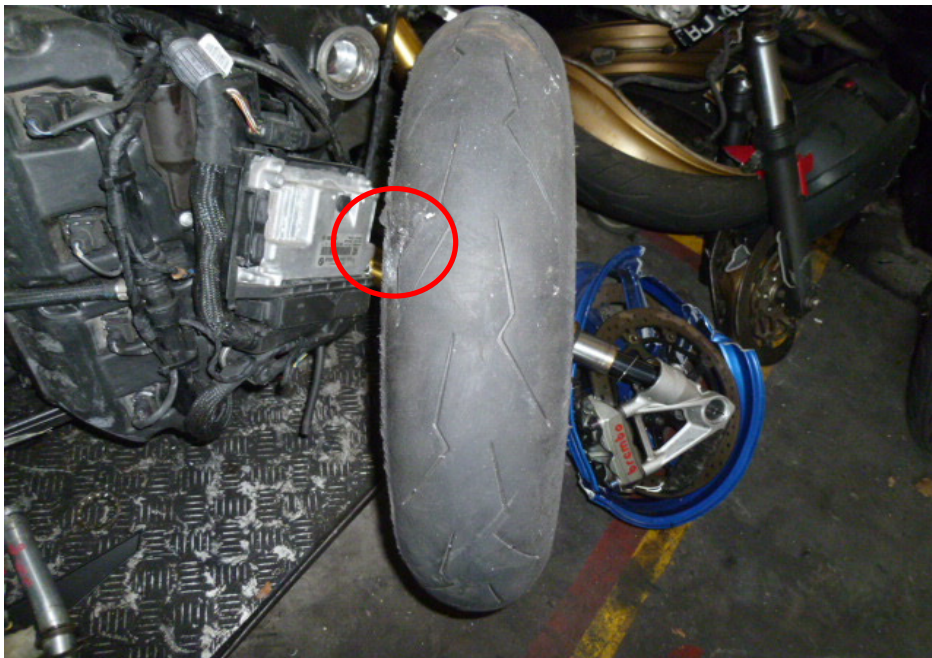
Photo 10 shows the condition of the Motorcycle's front tyre. The front tyre was observed to be in serviceable condition with remaining tread depth of approximately 3mm. The tyre was observed to be deflated. We also observed a tear on the right sidewall of the front tyre as a result of the accident (circled).

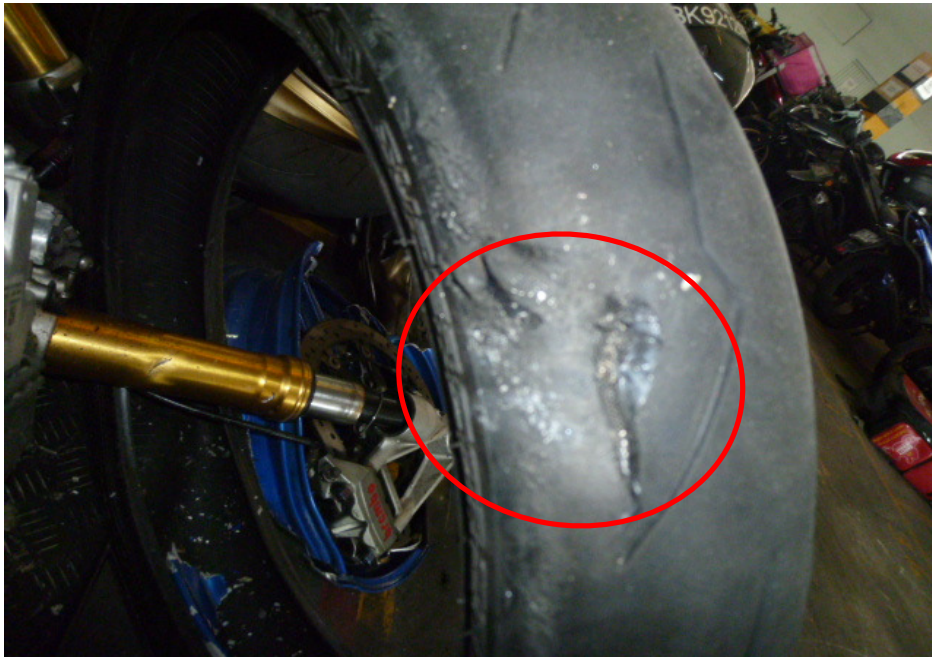
Photo 11 shows a closer view of the tear on the right sidewall of the front tyre as a result of the accident (circled).

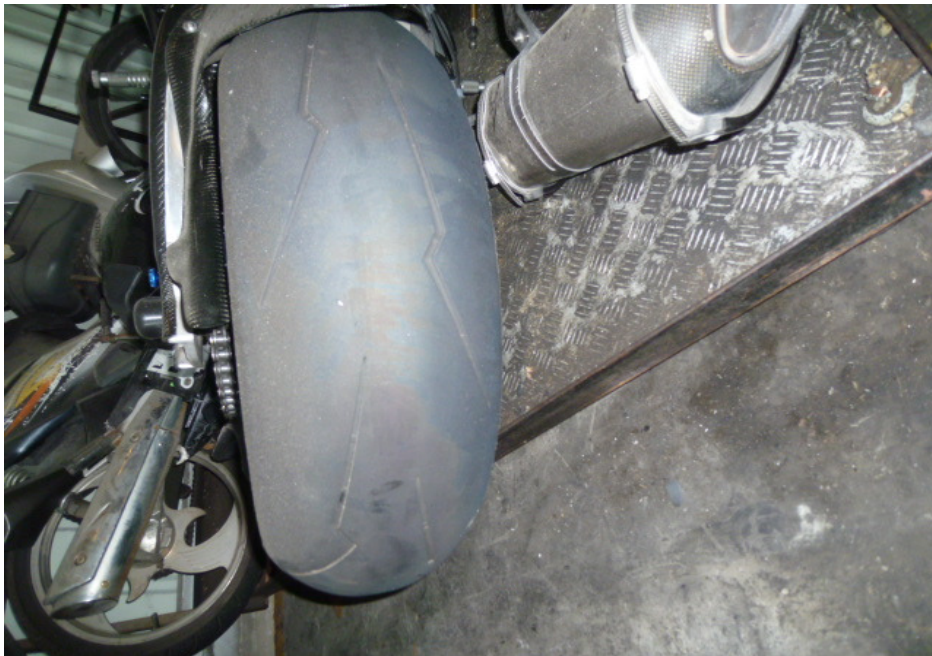
Photo 12 shows the condition of the Motorcycle's rear tyre. The rear tyre was observed to be in serviceable condition with remaining tread depth of approximately 3mm. The tyre was also observed to be sufficiently inflated for vehicular operation. We did not observe any tear, burst mark(s) and/or punctured hole(s) on the sidewalls as well as across the tread of the rear tyre.

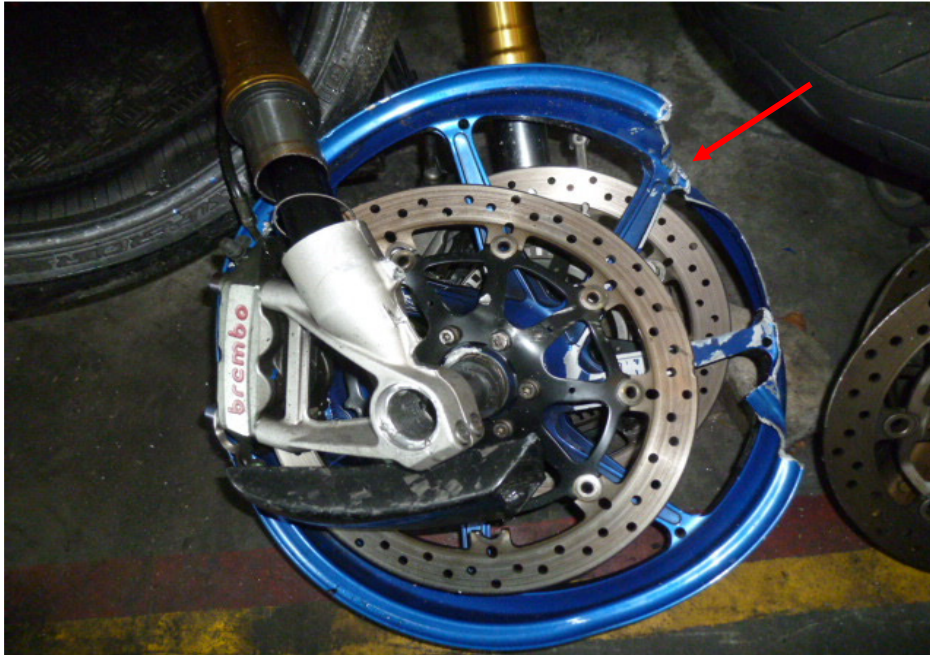
Photo 13 shows the broken front wheel rim of the Motorcycle as a result of the accident (arrowed) at the time of our inspection.

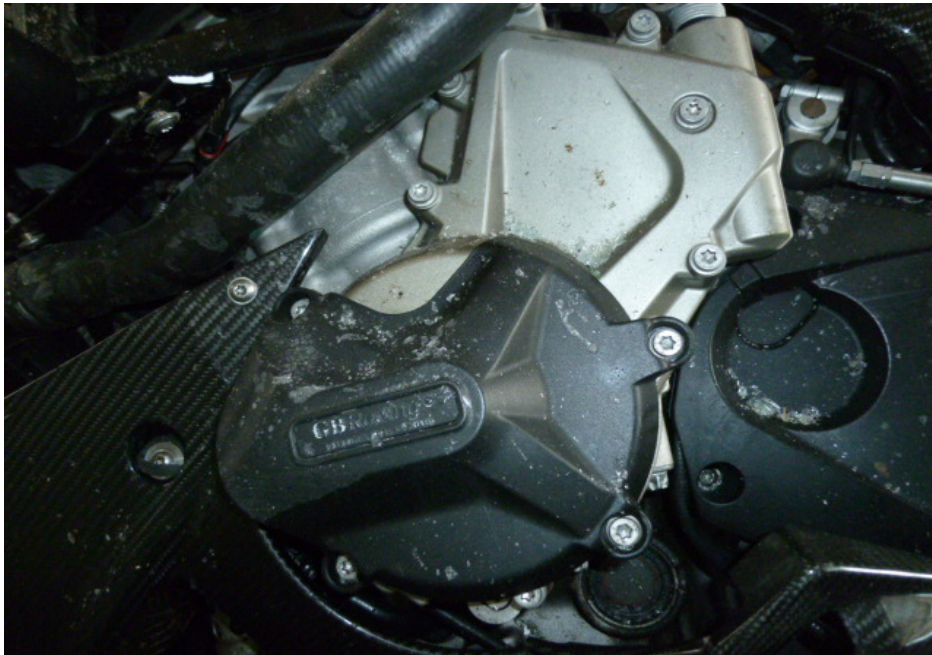
Photo 14 shows the left side of the engine of the Motorcycle at the time of our inspection. The various engine related parts and components were found to be intact with no visible damage. There was also no sign(s) or indication(s) of fluid leak observed around the left engine area of the Motorcycle.

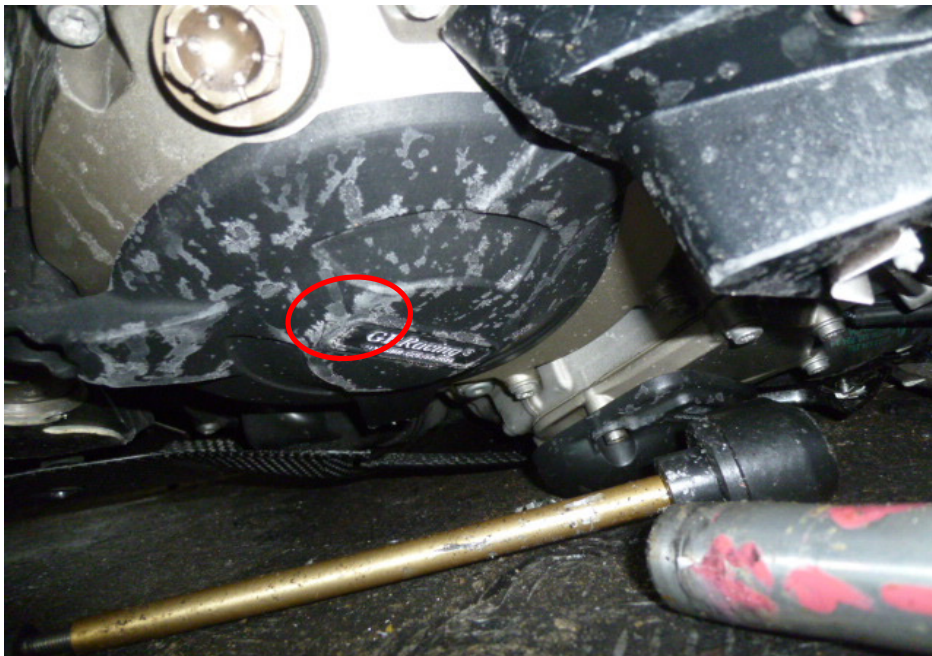
Photo 15 shows the right side of the engine of the Motorcycle at the time of our inspection. The various right engine components had sustained damage of grazing nature as a result of the accident (circled) however the engine components were still intact. There was also no fluid leak and/or fluid stain found around the right engine area of the Motorcycle.

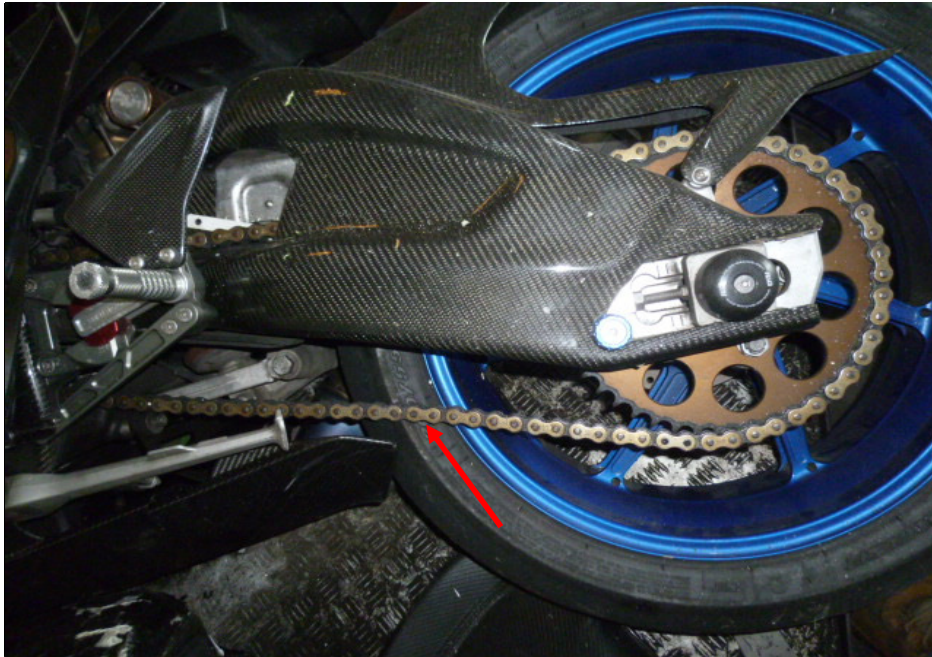
Photo 16 shows the gear chain (arrowed) of the Motorcycle, which was observed to be intact with no misalignment. It was also adequately lubricated for operating purposes. The gear chain rotates the rear wheel of the Motorcycle.

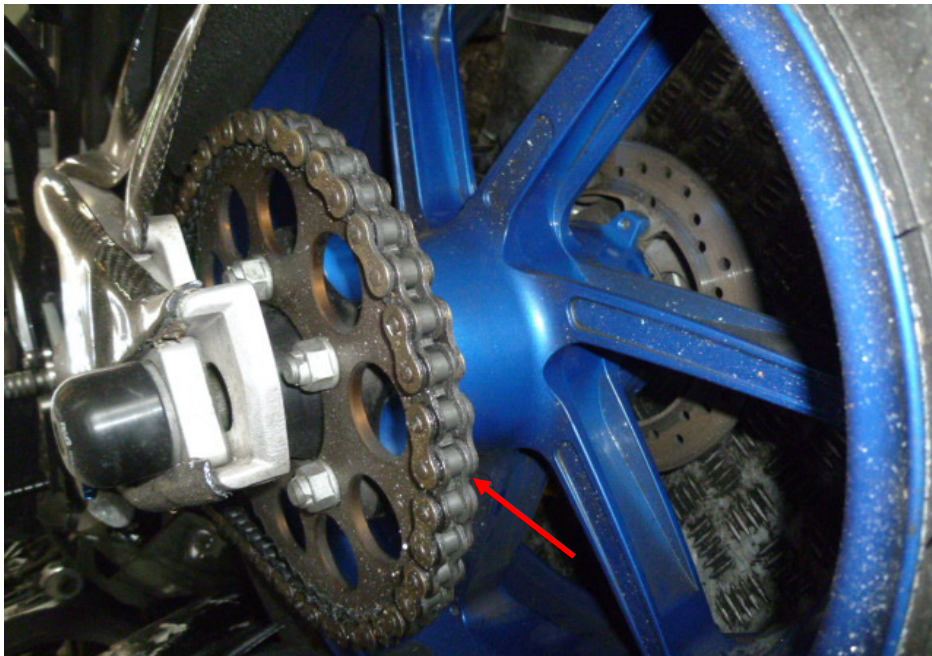
Photo 17 shows the closer view of the gear chain (arrowed) of the Motorcycle, which was observed to be intact with no misalignment. It was also adequately lubricated for operating purposes.

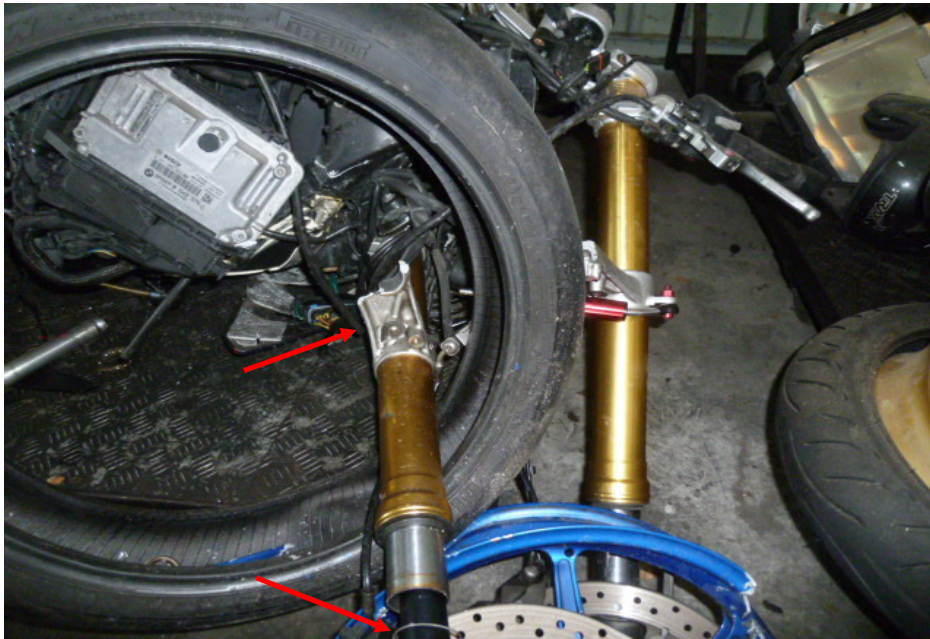
12. For this case, we were not able to conduct any test(s) on the steering system of the Motorcycle due to the damage of its front forks. The front forks were found to be broken as a result of the accident which had rendered the Motorcycle immobile.

Photo 18 shows the front forks of the Motorcycle. The front forks were found to be broken as a result of the accident (arrowed) which had rendered the Motorcycle immobile. Hence we were not able to conduct any test(s) on the steering system of the Motorcycle.

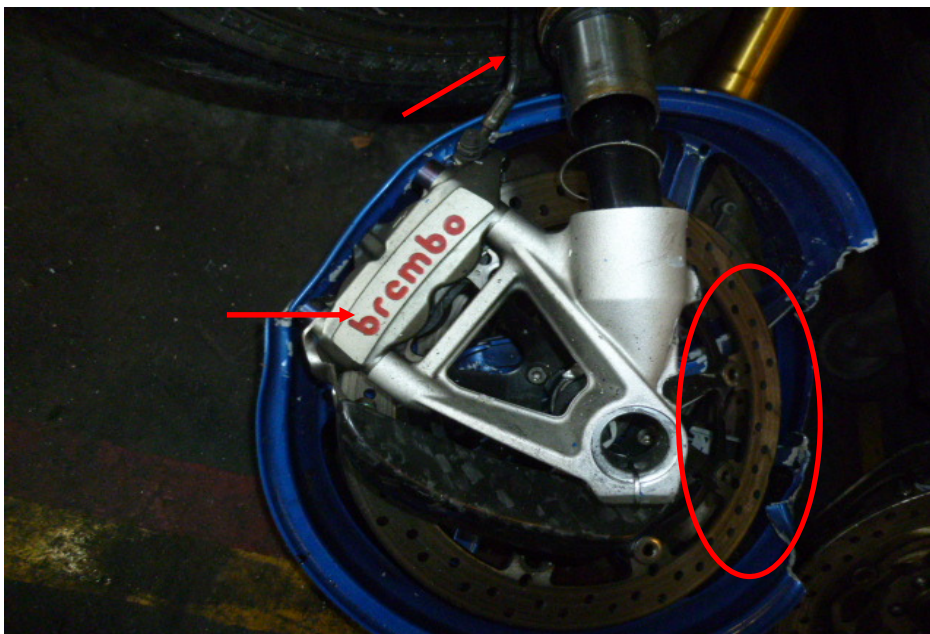
Photo 19 shows a close up view of the front brake caliper, front brake disc and front brake hose (arrowed) at the right side of the Motorcycle's front wheel, which are all part of the components in the hydraulic front brake system of the Motorcycle. Our visual checks of these various components had revealed all to be intact with no visible damage except for the front brake disc which was observed to be bent as a result of the accident (circled). No leakage of brake fluid was also observed.

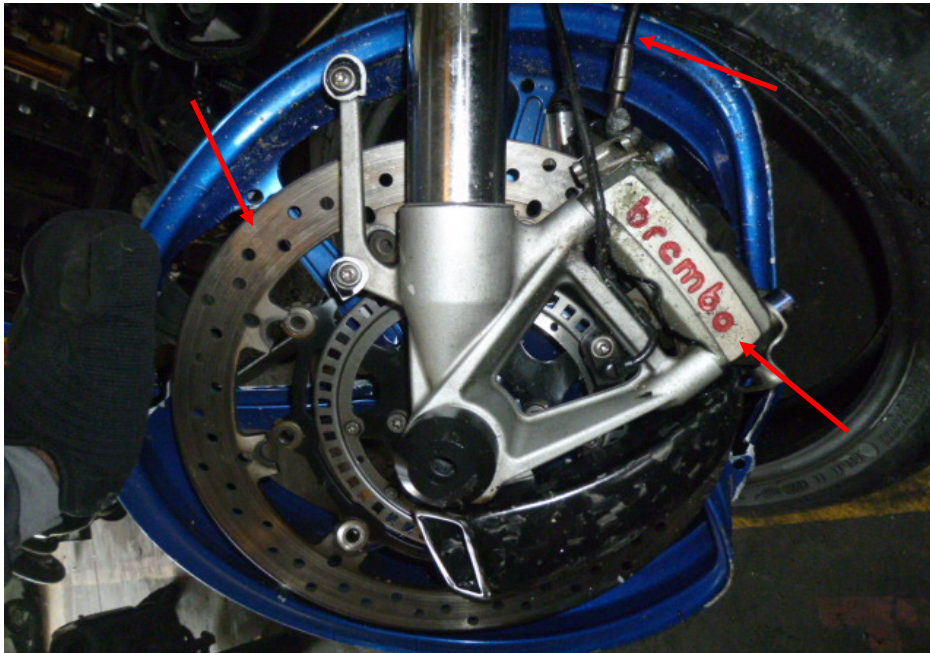
Photo 20 shows a close up view of the front brake caliper, front brake disc and front brake hose (arrowed) at the left side of the Motorcycle's front wheel, which are all part of the components in the hydraulic front brake system of the Motorcycle. Our visual checks of these various components had revealed all to be intact with no visible damage. No leakage of brake fluid was also observed.

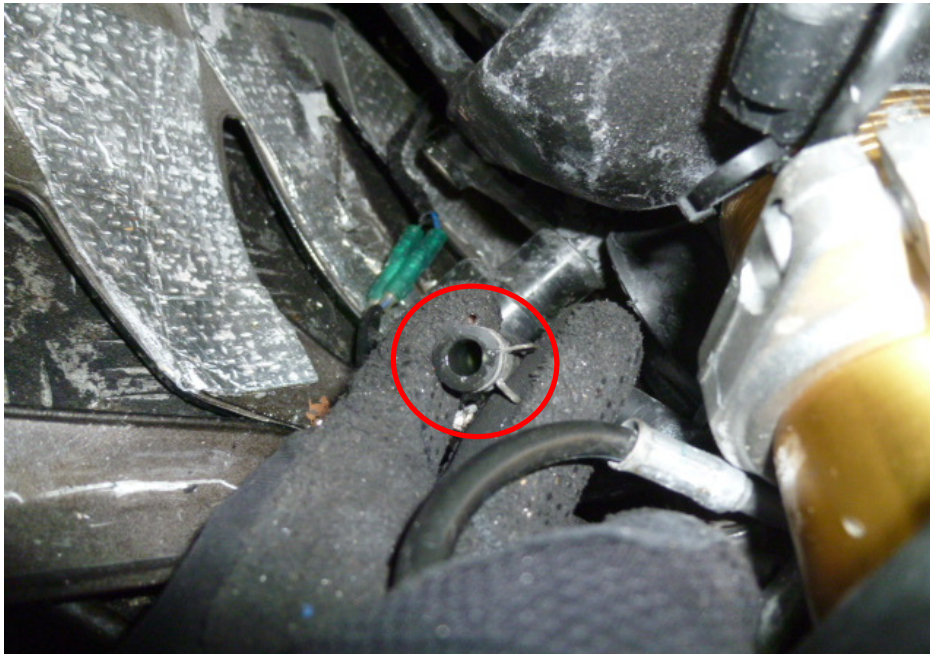
15. Static brake tests conducted on the Motorcycle had appear to indicate that the front braking system of the Motorcycle was not in serviceable condition. There was no resistance felt (spongy like feel) upon pressing the front brake lever. This would indicate that there was a leakage of pressure/vacuum in the brake system due to the missing front brake reservoir.

Photo 21 shows the missing front brake fluid reservoir of the Motorcycle at the time of our inspection (circled). Hence static brake tests conducted on the Motorcycle had appear to indicate that the front braking system of the Motorcycle was not in serviceable condition.

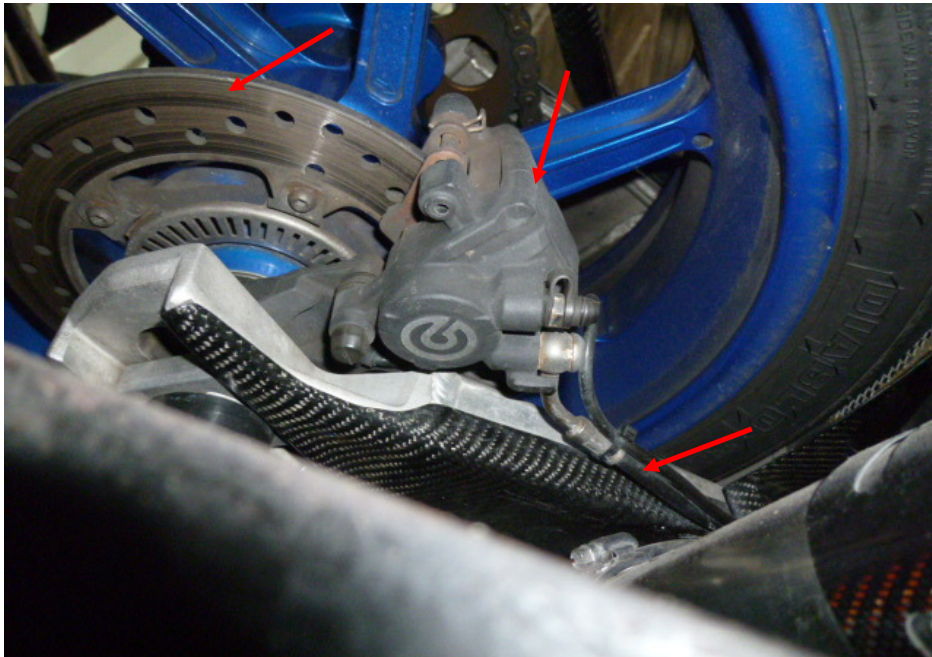
Photo 22 shows a close up view of the rear brake caliper, rear brake disc and rear brake hose (arrowed) of the Motorcycle, which are all part of the components in the hydraulic rear brake system of the Motorcycle. Our visual checks of these various components had revealed all to be intact with no visible damage. No leakage of brake fluid was also observed.

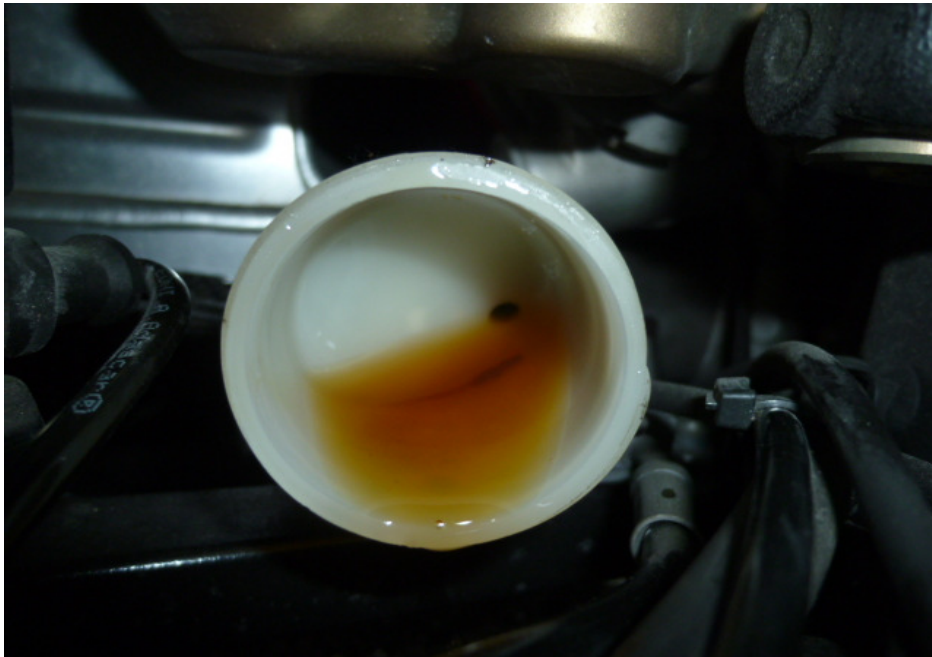
Photo 23 shows the brake fluid reservoir for the rear brake of the Motorcycle. The brake fluid was observed to be of sufficient level for operational purposes and without contamination.
