Your Ref: TP/IP/13053/2021  
Our Ref : CI/TPD21005548/N

31 May 2021

**INSPECTION REPORT OF MOTORCYCLE FBM 3130X**

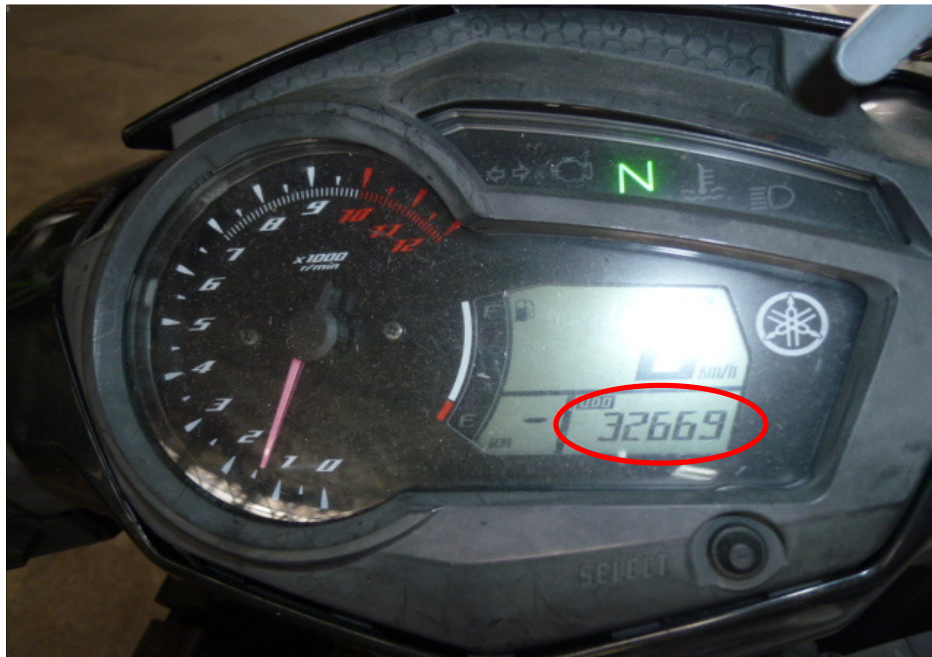
**Photo 1** shows the speedometer gauge of the Motorcycle. The mileage of the Motorcycle at the time of our inspection was 32, 669km (circled).

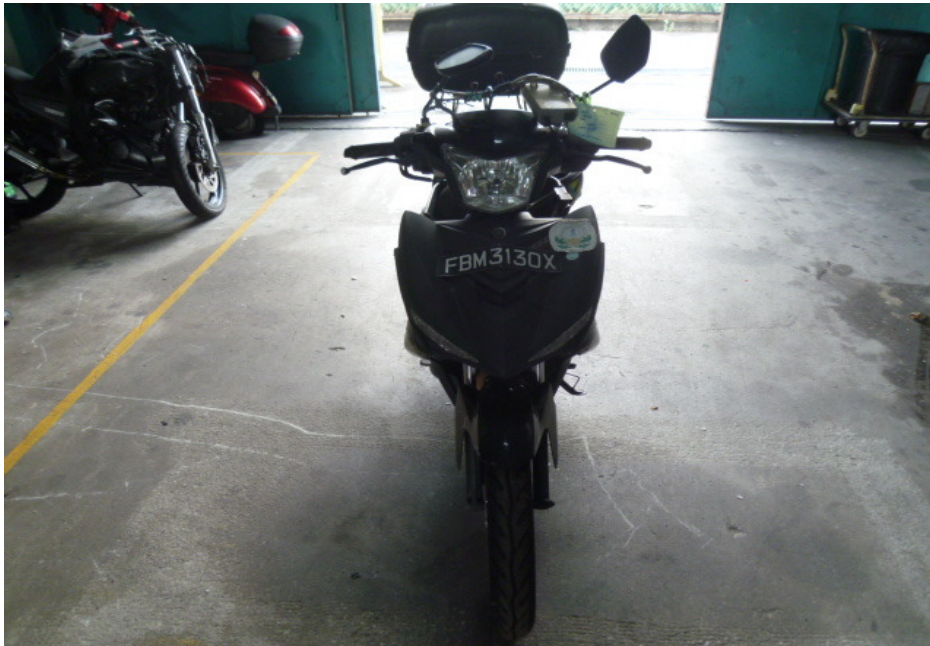
**Photo 2** shows a general view of the frontal portion of the Motorcycle at the time of our inspection. The Motorcycle was observed to have sustained damages at its frontal portion and right body.

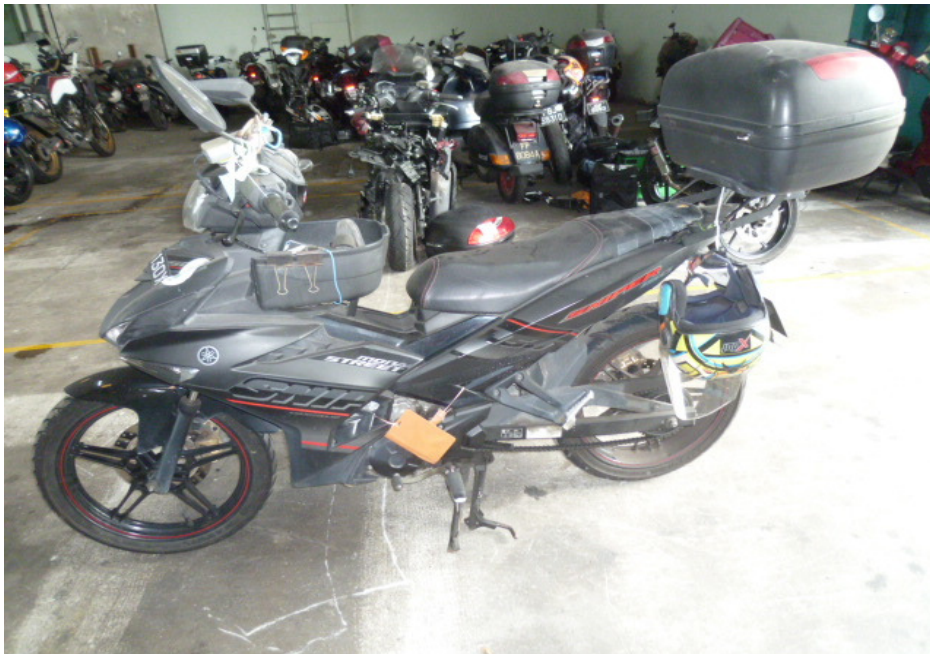
**Photo 3** shows a general view of the left body of the Motorcycle at the time of our inspection. The Motorcycle was observed to have sustained damages at its frontal portion and right body.

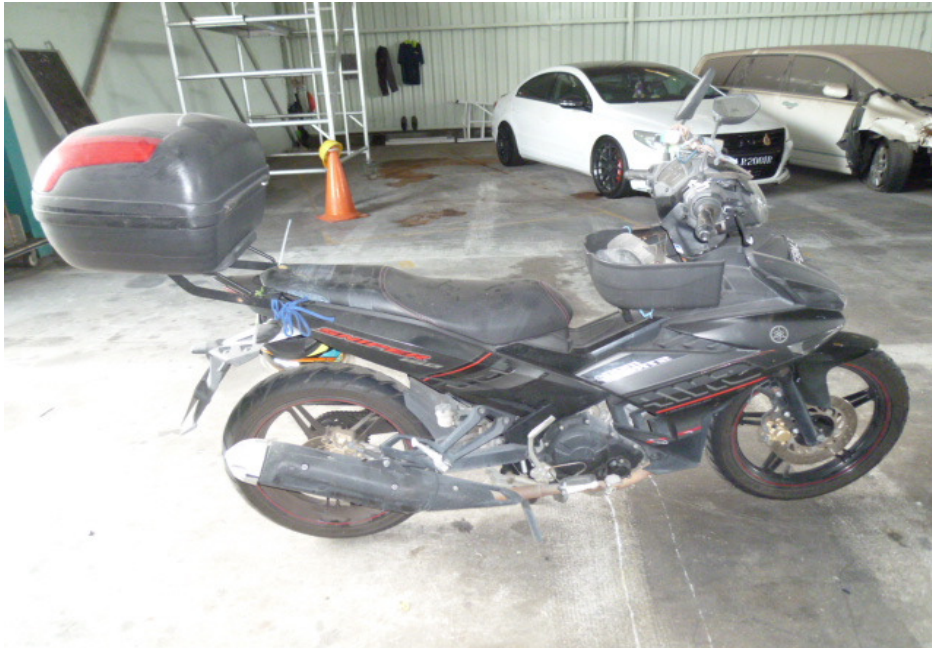
**Photo 4** shows a general view of the right body of the Motorcycle at the time of our inspection. The Motorcycle was observed to have sustained damages at its frontal portion and right body. The body parts that were found to have been damaged include its windshield, headlight assembly, head cowling, front mudguard, left cowling, left side mirror, front basket, gear shift pedal, left front footrest, left rear side cover, pillion grab rail and rear number plate, amongst others.

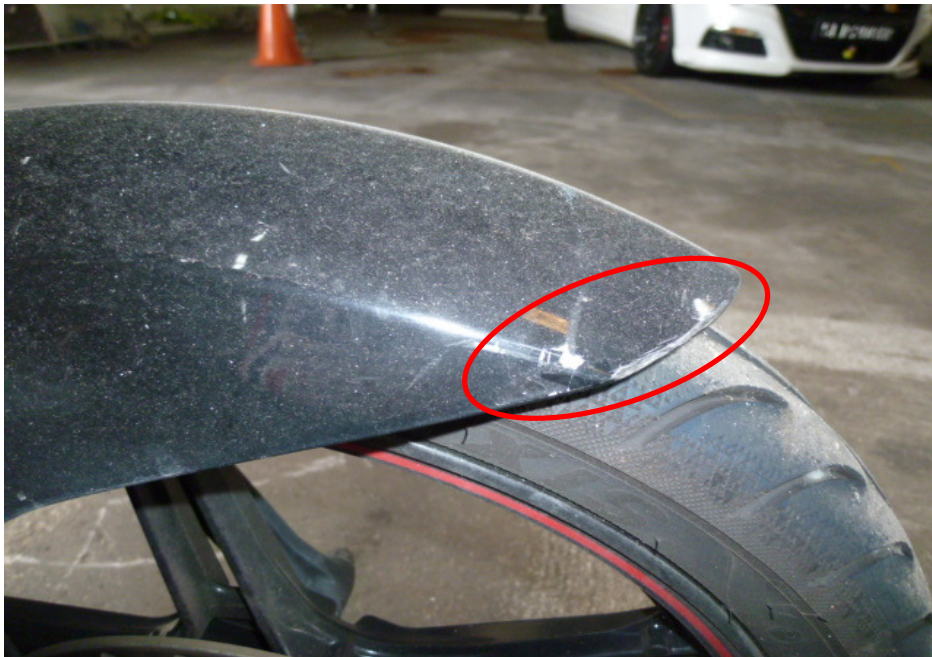
**Photo 5** shows a closer view of the front mudguard (circled) which was amongst the body parts of the Motorcycle that had sustained damage as a result of the accident.

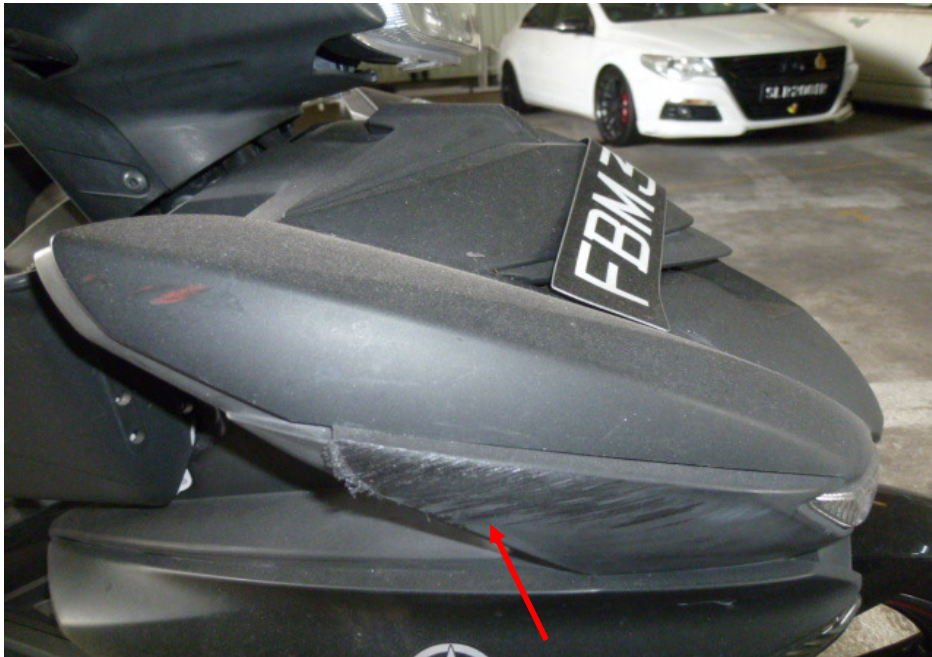
**Photo 6** shows the front cowling (arrowed), which were amongst the body parts of the Motorcycle that had sustained damage as a result of the accident.

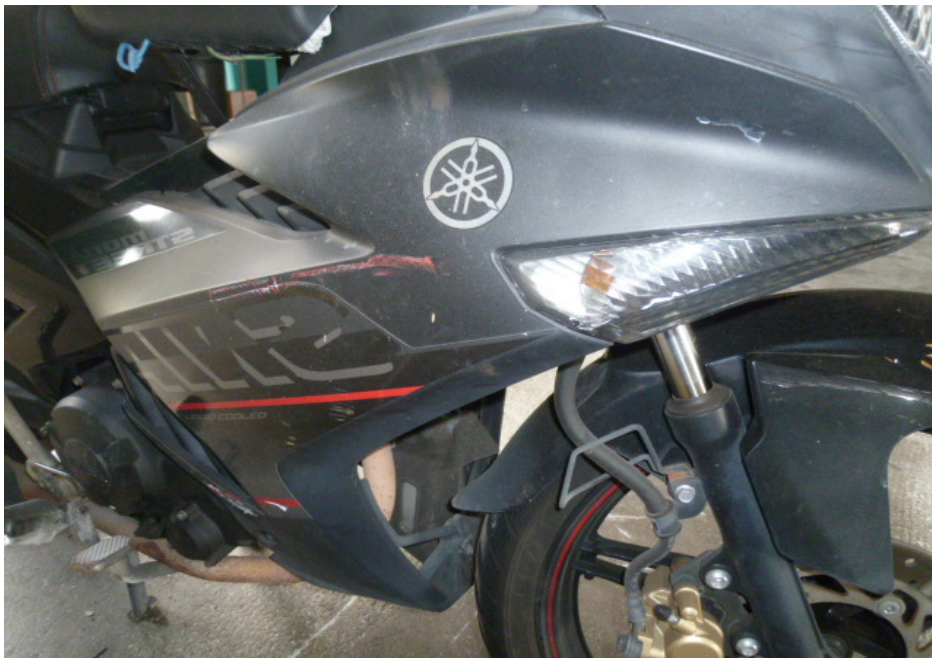
**Photo 7** shows a closer view of the right cowling which was amongst the body parts of the Motorcycle that had sustained damage as a result of the accident.

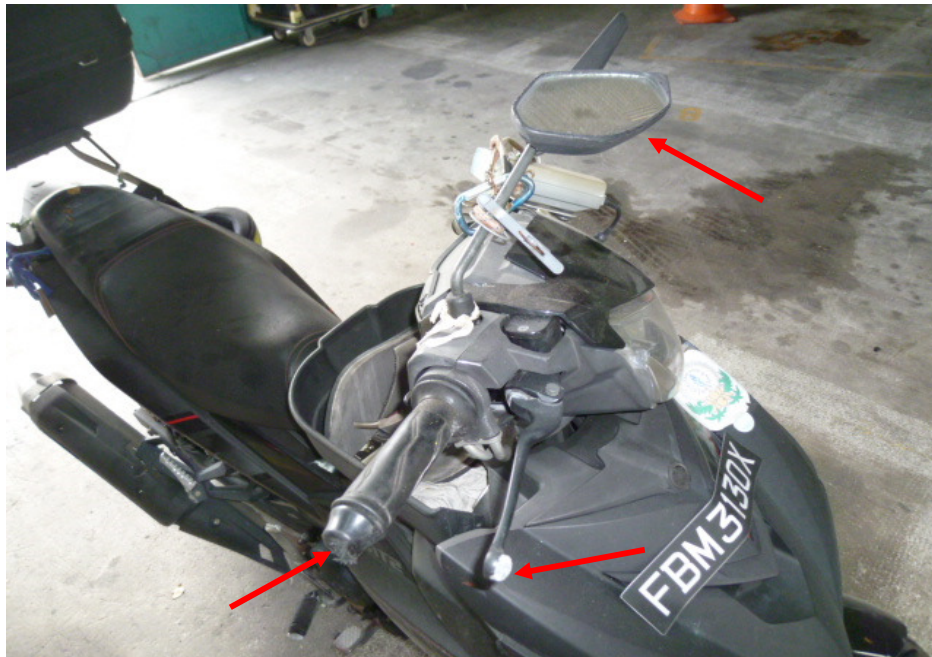
**Photo 8** shows the right handlebar end, front brake lever and right side mirror (arrowed), which were amongst the body parts of the Motorcycle that had sustained damage as a result of the accident.

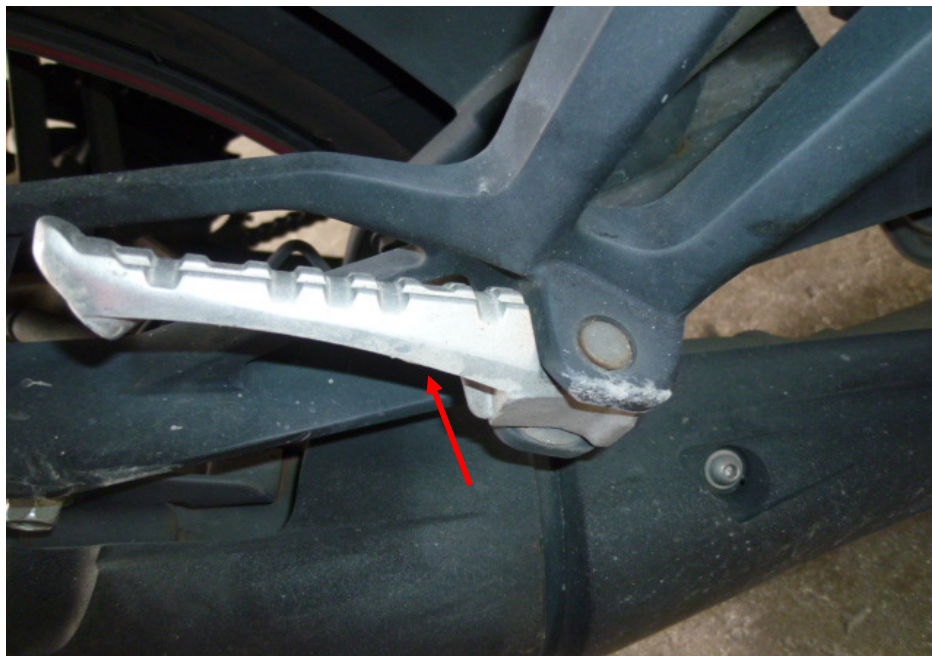
**Photo 9** shows a closer view of the right pillion footpeg which was amongst the body parts of the Motorcycle that had sustained damage as a result of the accident (arrowed).

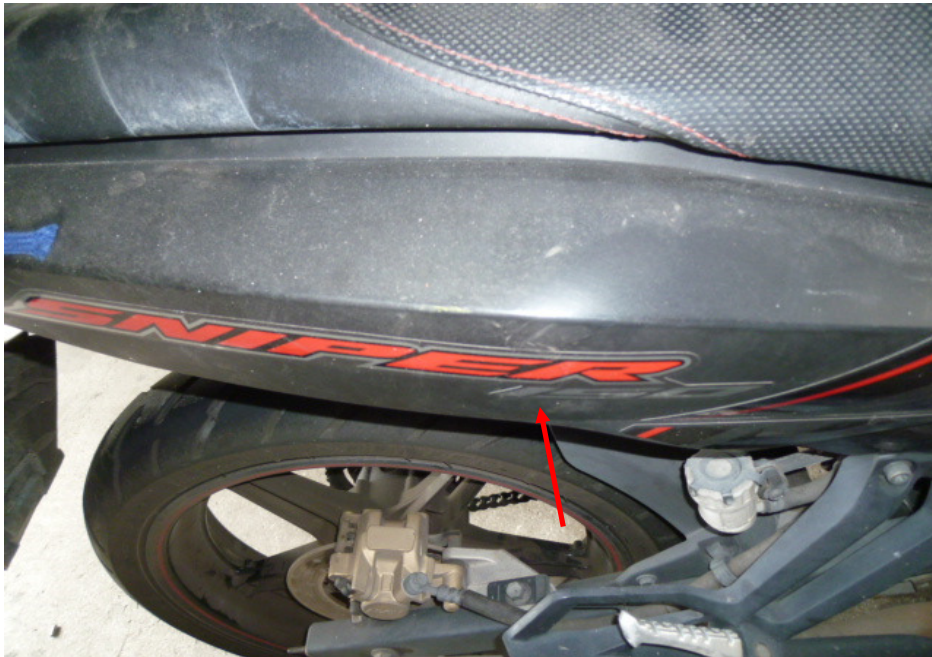
**Photo 10** shows a closer view of the grazed right rear side cover of the Motorcycle as a result of the accident (arrowed).

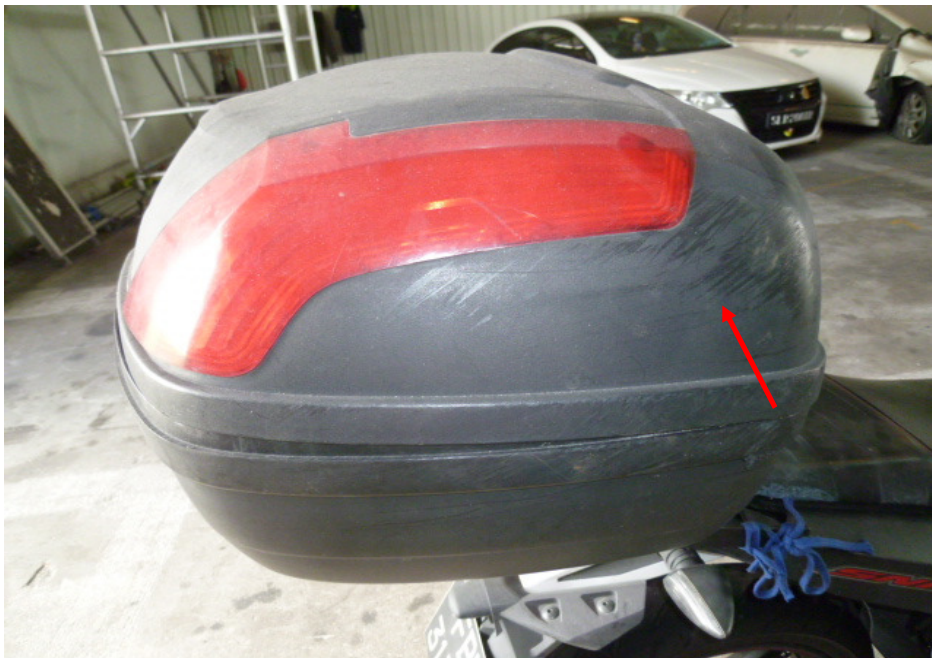
**Photo 11** shows a closer view of top box which was amongst the body parts of the Motorcycle that had sustained damages of grazing nature as a result of the accident (circled).

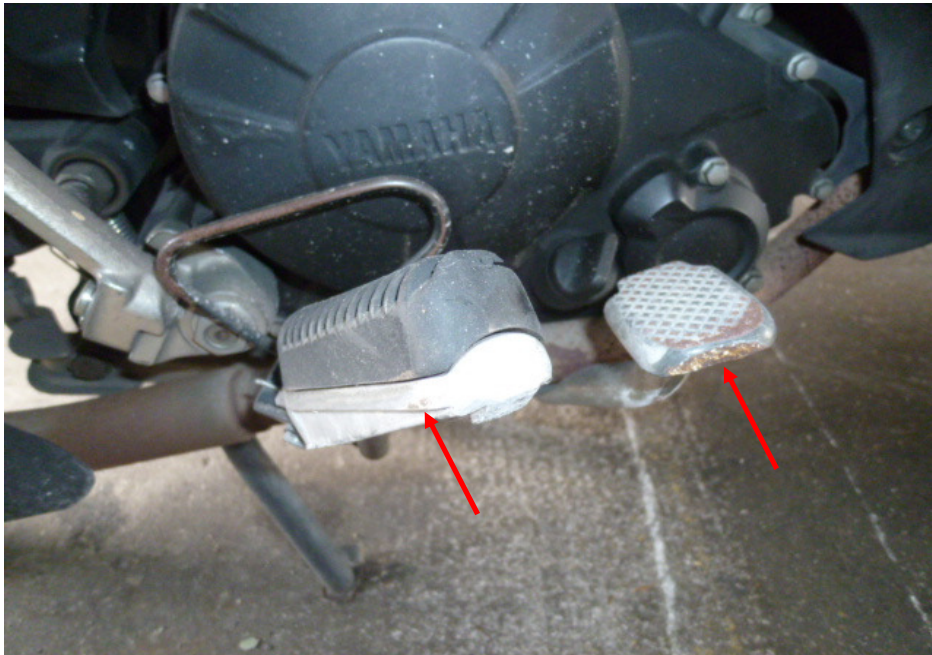
**Photo 12** shows the rear brake pedal and right front footrest of the Motorcycle that had sustained damage as a result of the accident (arrowed).

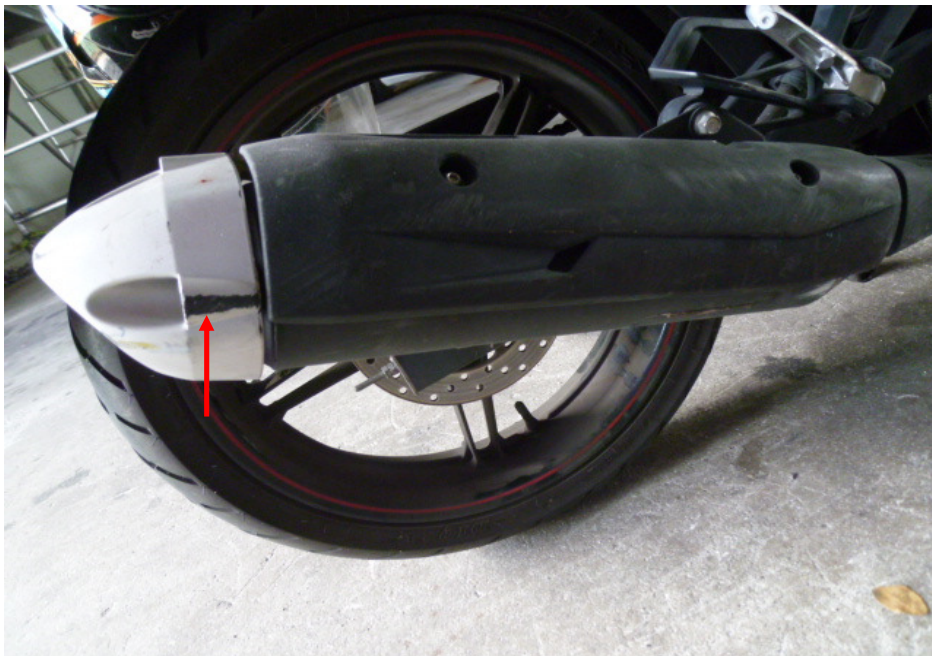
**Photo 13** shows the grazed exhaust muffler of the Motorcycle as a result of the accident (arrowed).

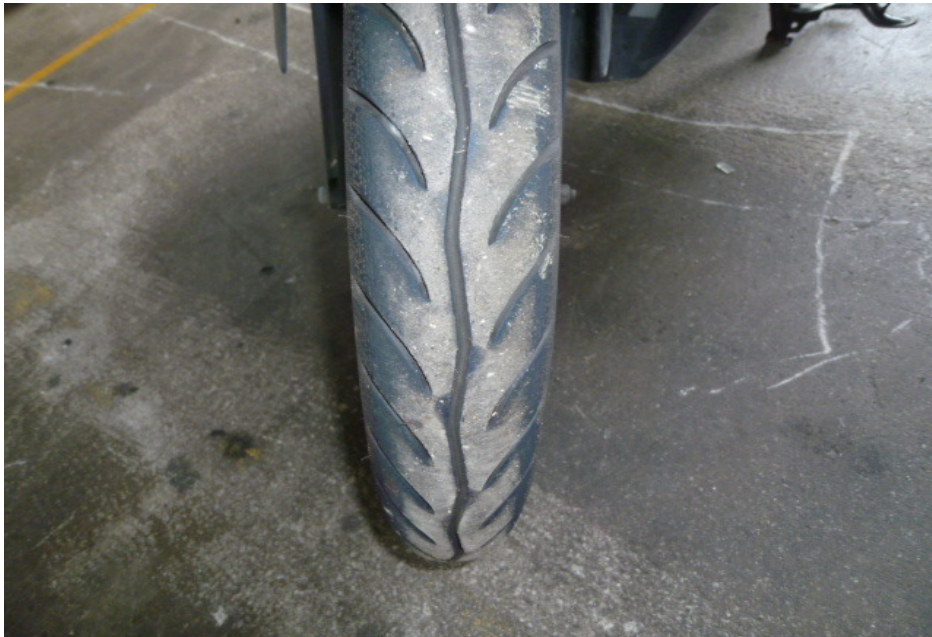
**Photo 14** shows the front tyre of the Motorcycle at the time of our inspection. The front tyre was observed to be in serviceable condition with remaining tread depth of approximately 3mm. The pattern of the tread was also clearly visible. There was no tear, burst mark(s) and/or punctured hole(s) on the sidewalls as well as across the tread of the front tyre.

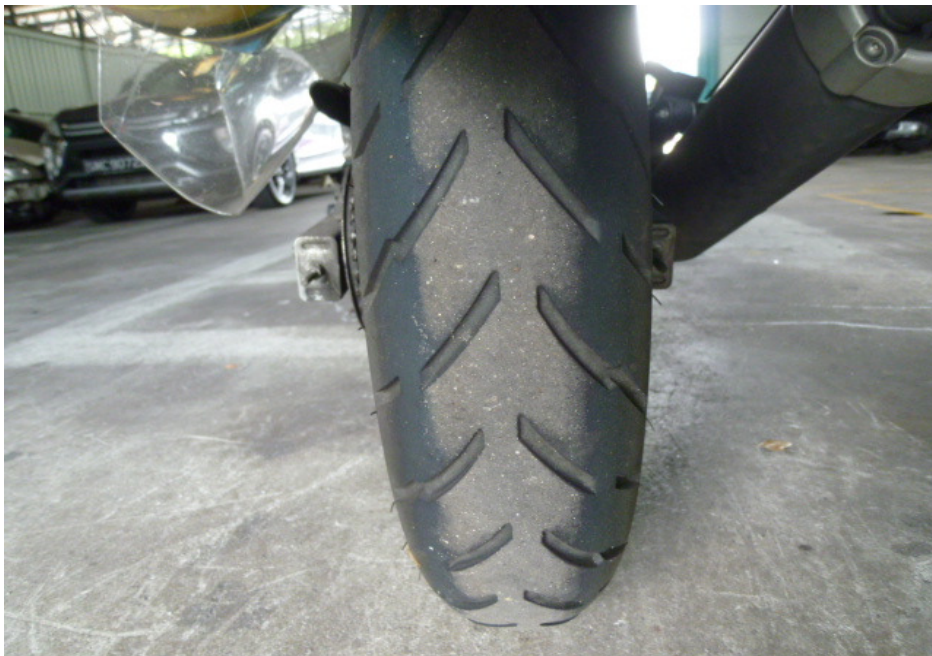
**Photo 15** shows the condition of the Motorcycle's rear tyre. The rear tyre was observed to be in serviceable condition with remaining tread depth of approximately 3mm. The tyre was also observed to be sufficiently inflated for vehicular operation. We did not observe any tear, burst mark(s) and/or punctured hole(s) on the sidewalls as well as across the tread of the rear tyre.

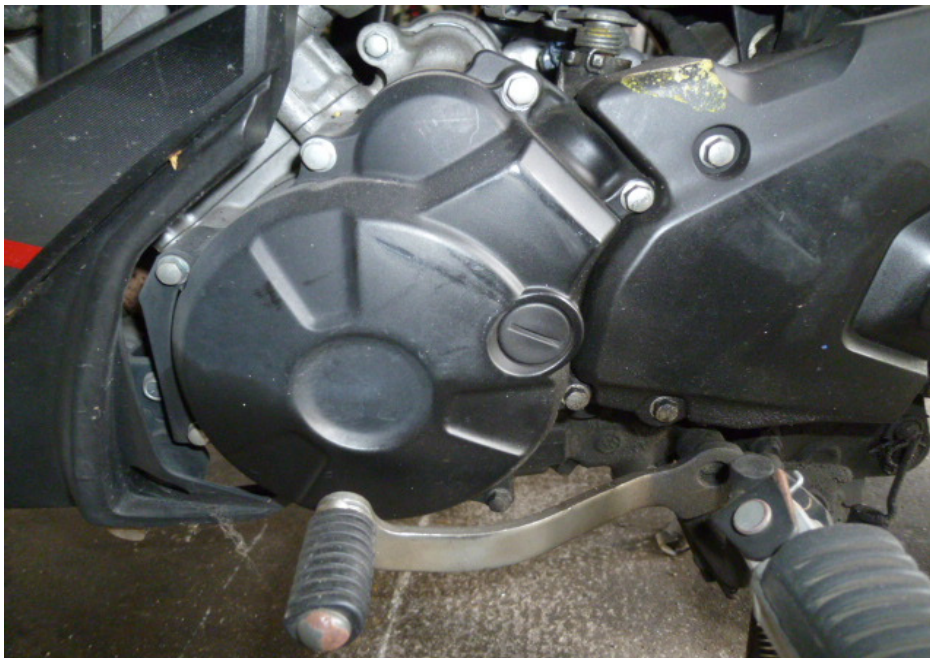
**Photo 16** shows the left side of the engine of the Motorcycle at the time of our inspection. The various engine related parts and components were found to be intact with no visible damage. There was also no sign(s) or indication(s) of fluid leak observed around the left engine area of the Motorcycle.

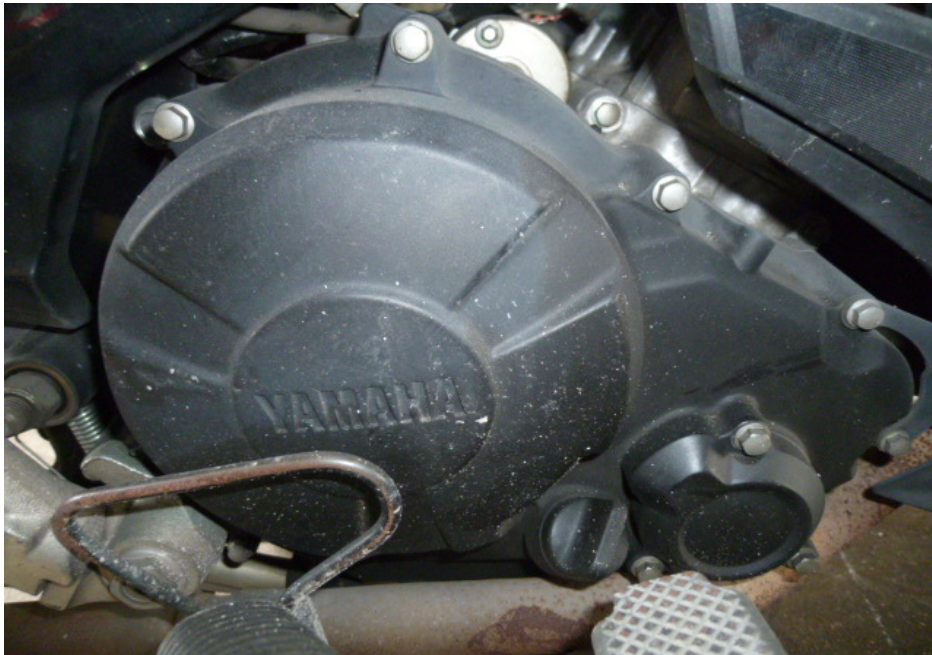
**Photo 17** shows the right side of the engine of the Motorcycle at the time of our inspection. The various engine related parts and components were found to be intact with no visible damage. There was also no sign(s) or indication(s) of fluid leak observed around the right engine area of the Motorcycle.

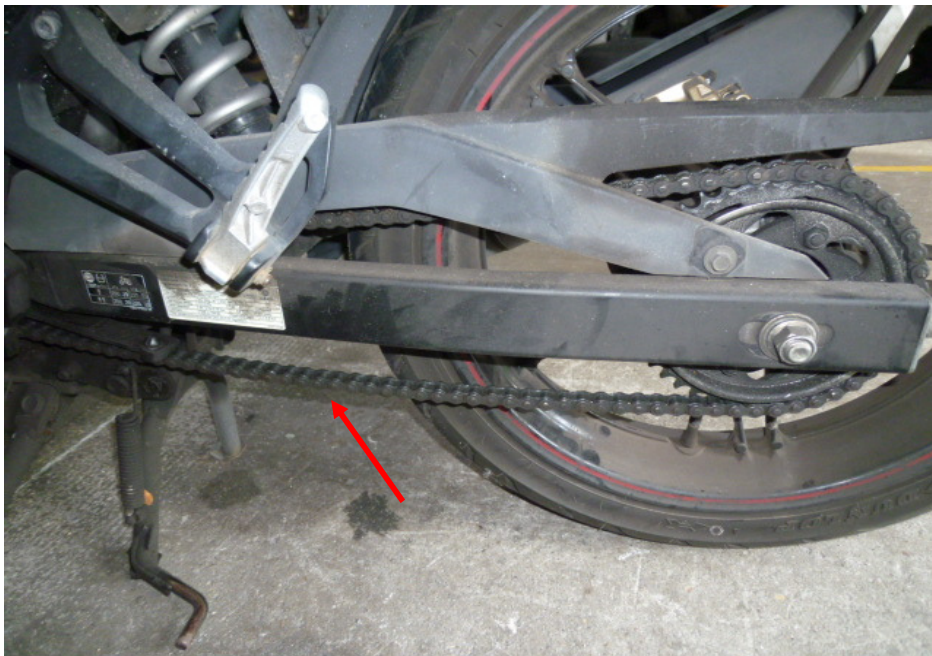
**Photo 18** shows the general view of the gear train (arrowed) of the Motorcycle, which was observed to be intact with no misalignment. It was also adequately lubricated for operating purposes.

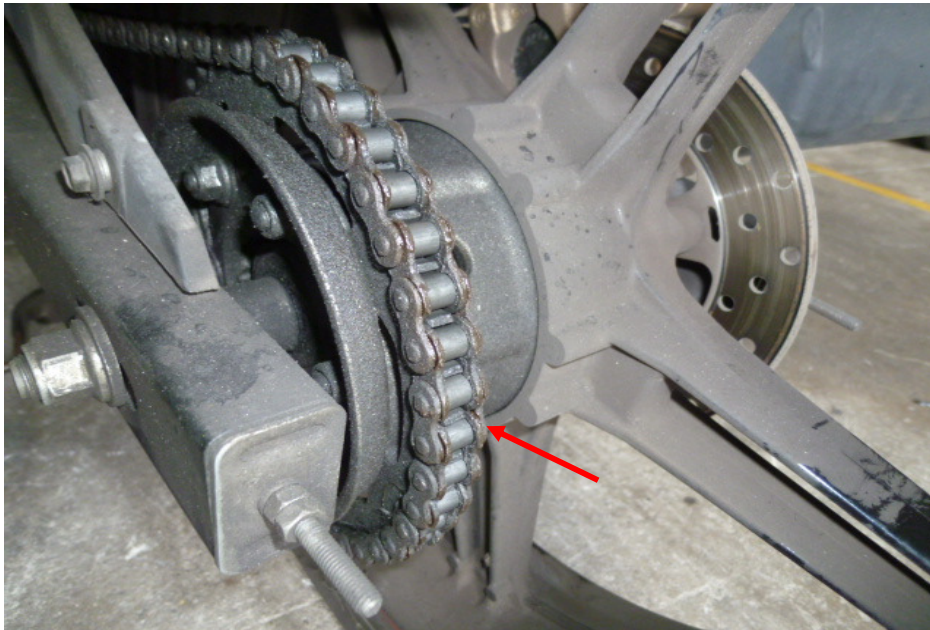
**Photo 19** shows a closer view of the gear train (arrowed) of the Motorcycle, which was observed to be intact with no misalignment. It was also adequately lubricated for operating purposes.

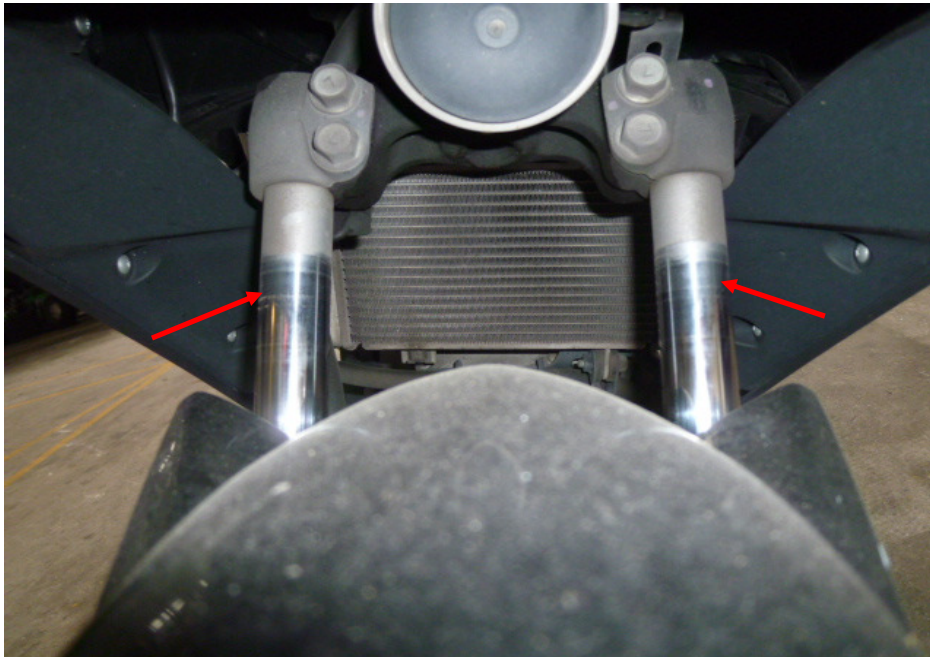
**Photo 20** shows the front fork (arrowed) of the Motorcycle. The front fork and fork bracket of the Motorcycle were both found to be intact and undamaged. Turning the Motorcycle's handle bar towards the left and right did not produce any abnormal free play. The steering system of the Motorcycle was in serviceable condition at the time of our inspection.

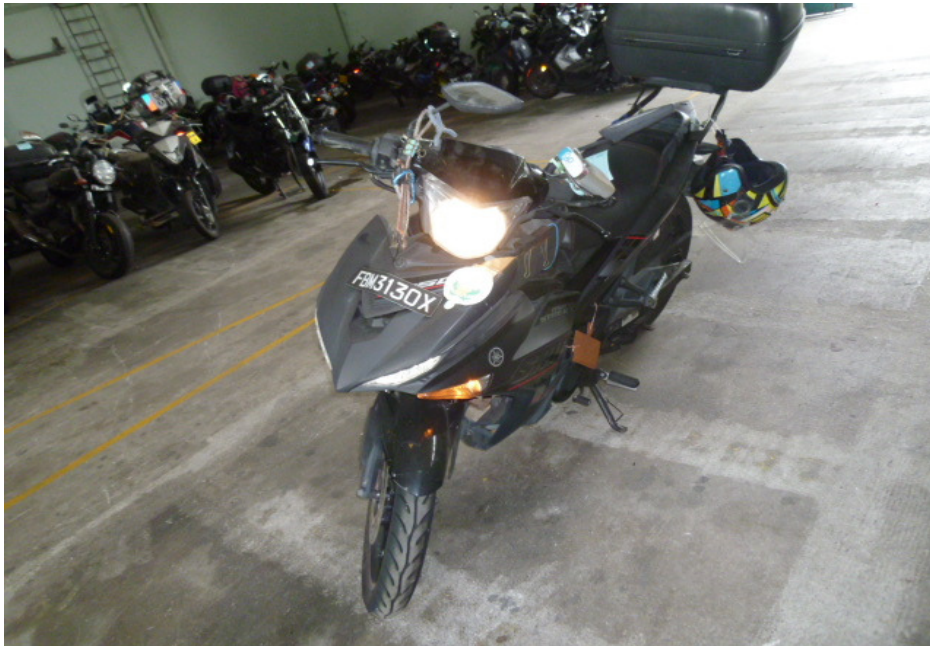
**Photo 21** shows the front wheel of the Motorcycle turned towards its full left. Turning the Motorcycle's handle bar towards the left did not produce any abnormal free play and/or resistance. This would indicate that the steering system of the Motorcycle was in serviceable condition at the time of our inspection.

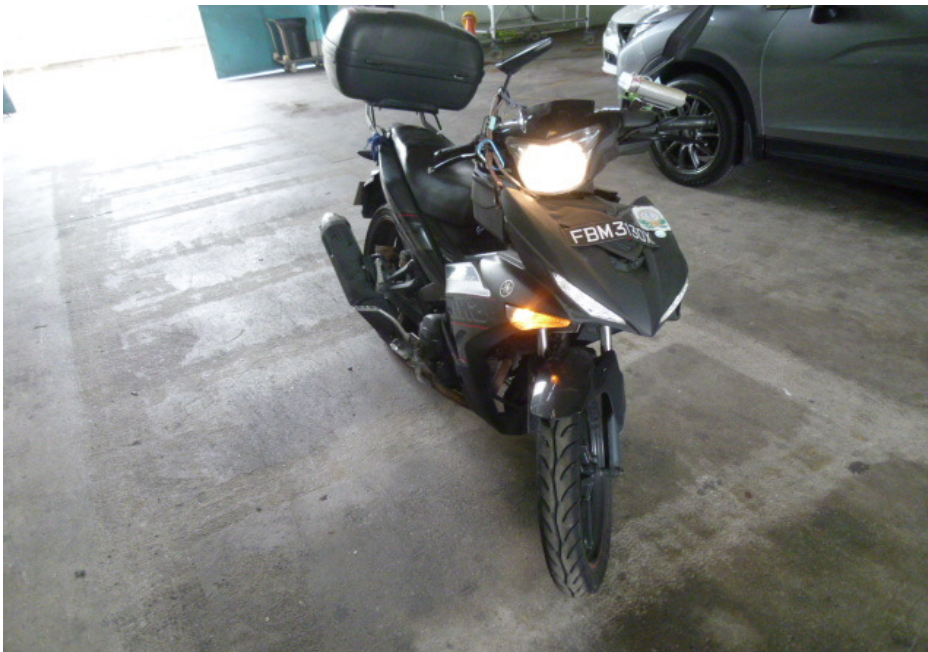
**Photo 22** shows the front wheel of the Motorcycle turned towards its full right. Turning the Motorcycle's handle bar towards the right did not produce any abnormal free play and/or resistance. This would indicate that the steering system of the Motorcycle was in serviceable condition at the time of our inspection.

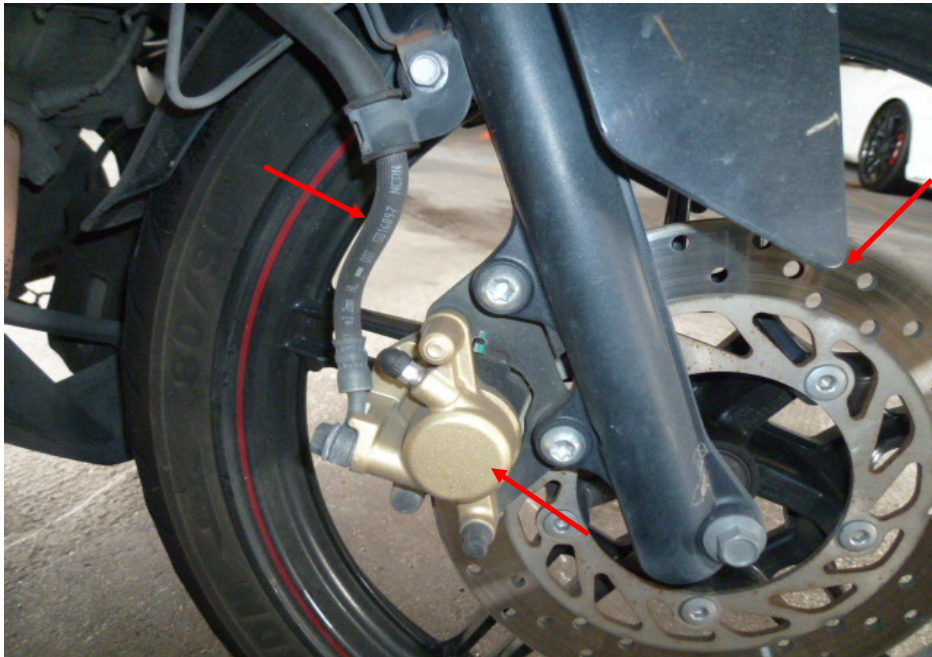
**Photo 23** shows a close up view of the front brake caliper, front brake disc and front brake hose (arrowed) of the Motorcycle, which are all part of the components in the hydraulic front brake system of the Motorcycle. Our visual checks of these various components had revealed all to be intact with no visible damage. No leakage of brake fluid was also observed.

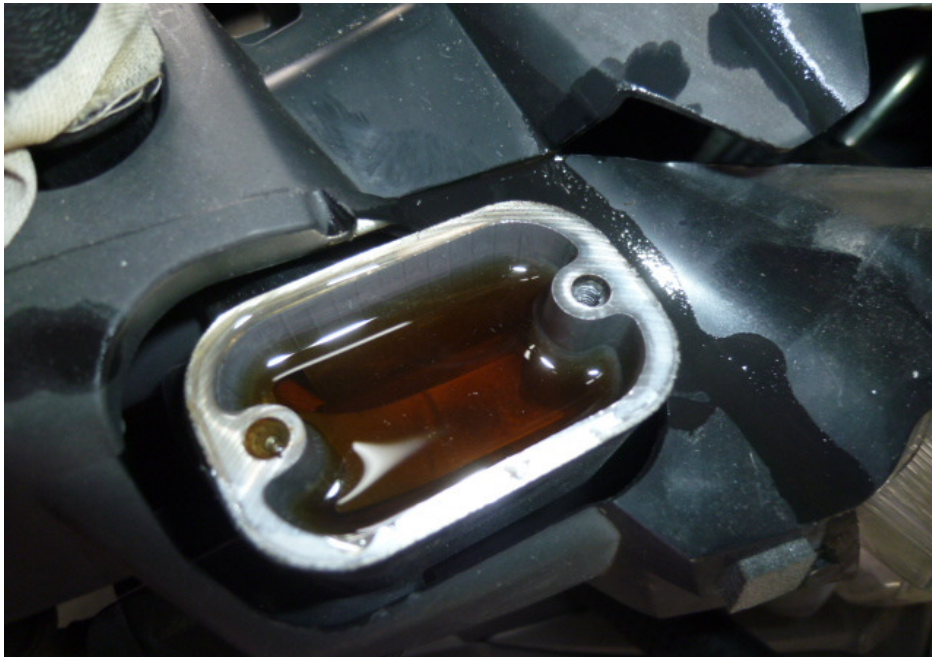
**Photo 24** shows the brake fluid reservoir for the front brake of the Motorcycle. The brake fluid was found to be without contamination and of sufficient level for operating purposes.

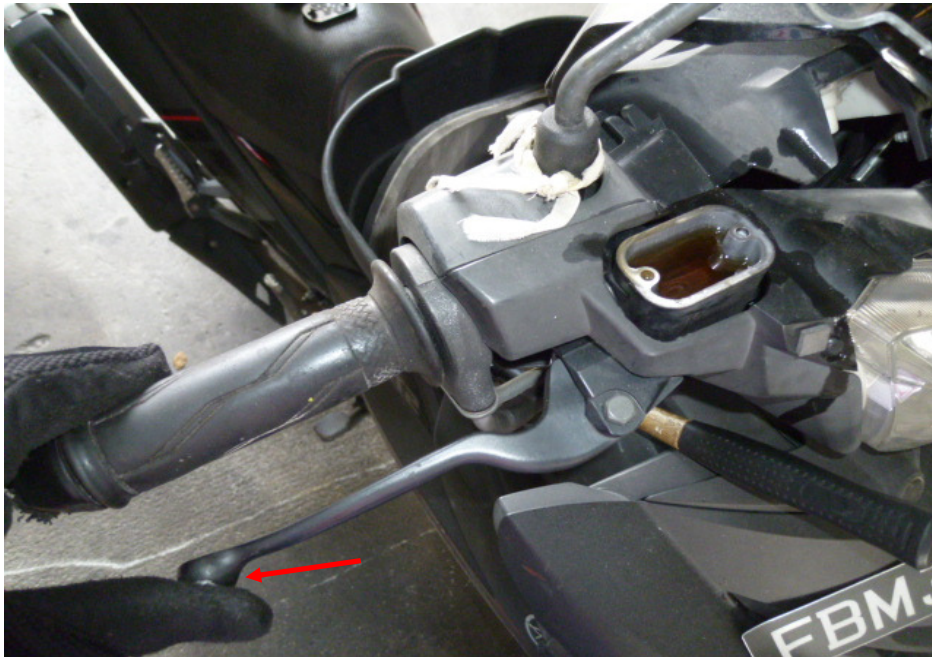
**Photo 25** shows the front brake lever being depressed. There was some resistance felt (spongy like feel) upon pressing the front brake lever (arrowed). This would indicate that there is no leakage of pressure/vacuum in the brake system.

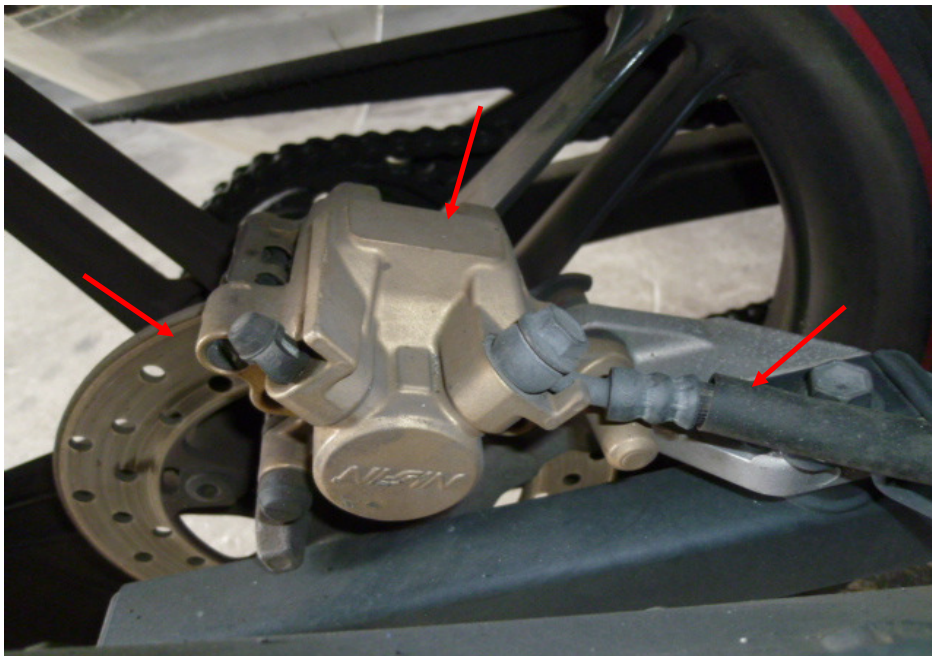
**Photo 26** shows a close up view of the rear brake caliper, rear brake disc and rear brake hose (arrowed) of the Motorcycle, which are all part of the components in the hydraulic rear brake system of the Motorcycle. Our visual checks of these various components had revealed all to be intact with no visible damage. No leakage of brake fluid was also observed.
