Your Ref: TP/IP/14861/2021
Our Ref : CI/TPD21005549/N

31 May 2021

**INSPECTION REPORT OF POWER ASSISTED BICYCLE PAB C255-
TRAFFIC POLICE POUND REPORT NO. 1071/21**

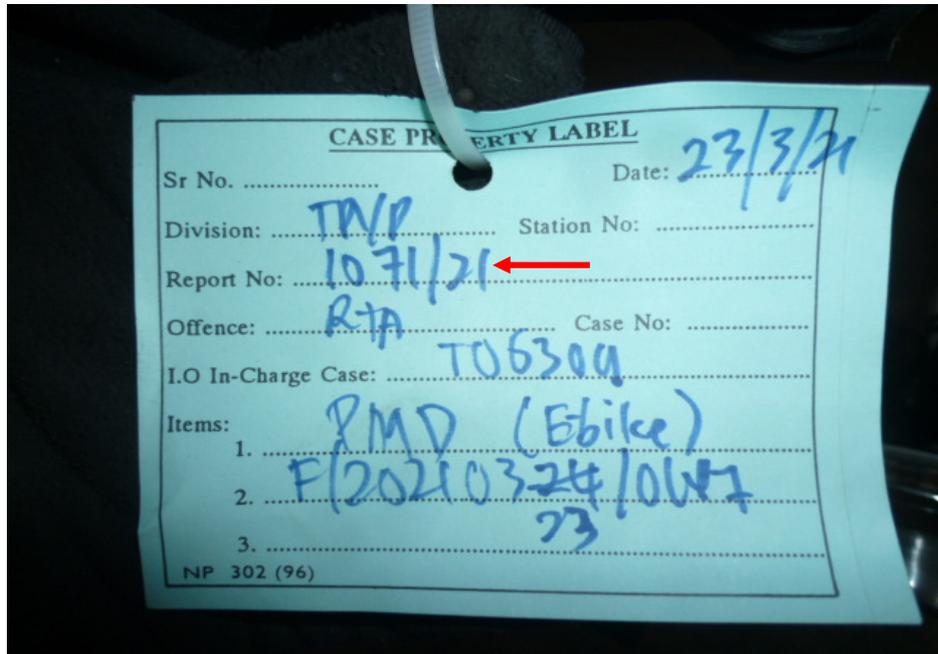
Photo 1 shows the identification of the PAB with reference to Traffic Police Pound Report No. 1071/21 (arrowed).

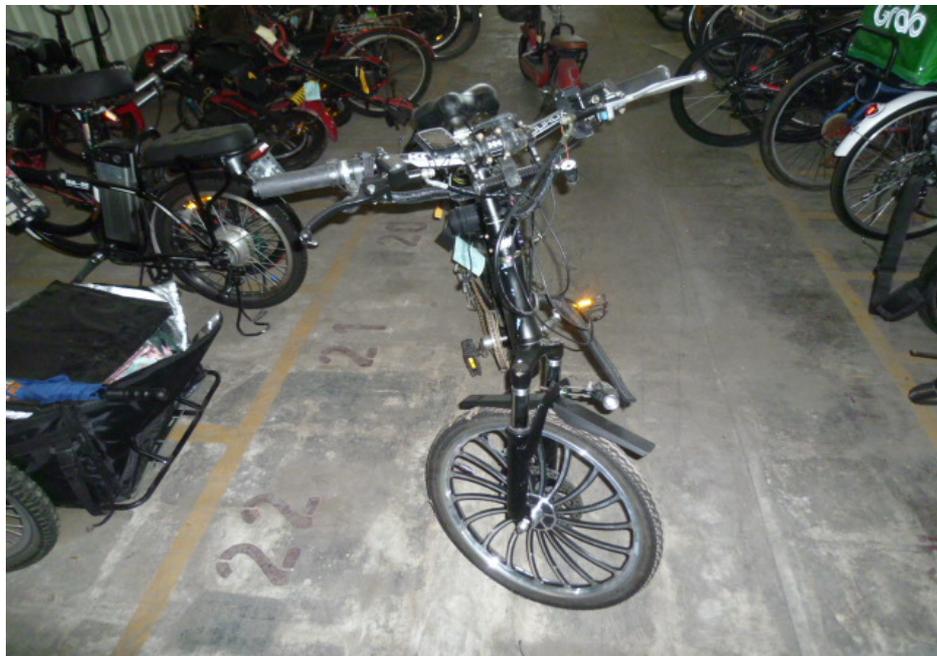
Photo 2 shows the frontal portion of the PAB at the time of our inspection. The PAB was observed to have sustained damages at its right body.

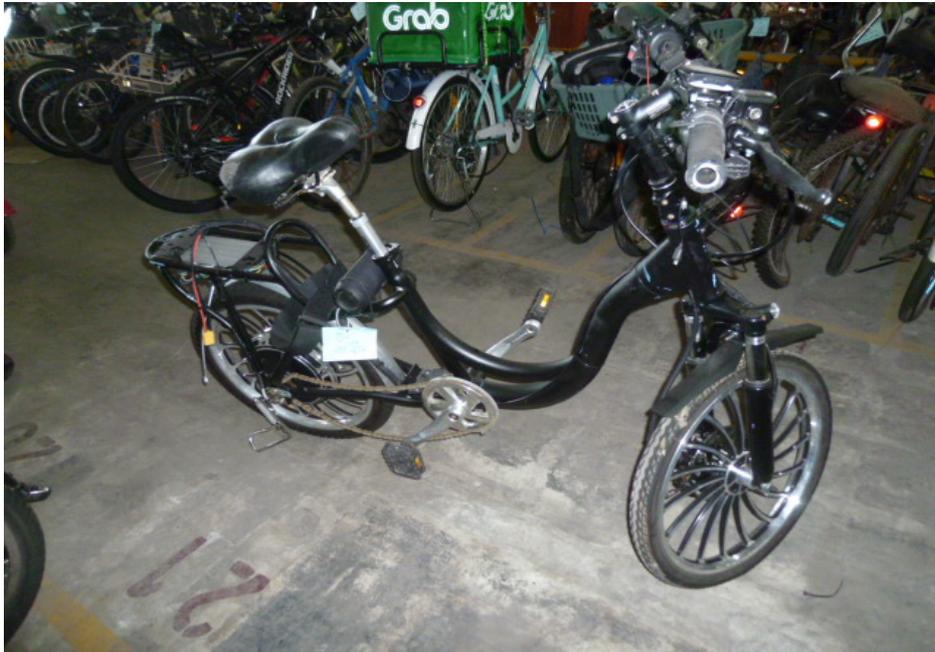
Photo 3 shows the right body of the PAB at the time of our inspection. The PAB was observed to have sustained damages at its right body.

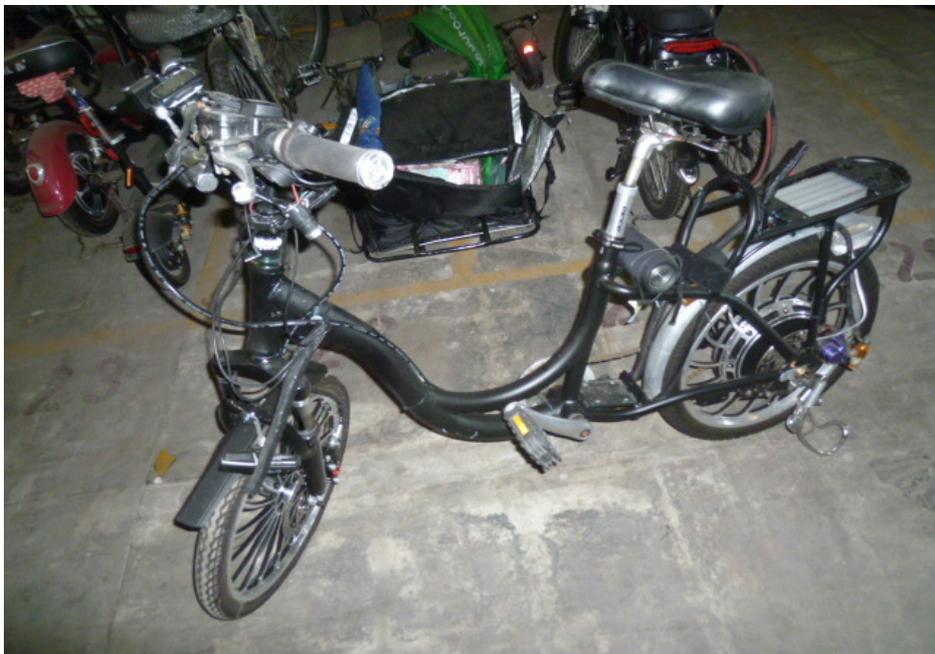
Photo 4 shows the left body of the PAB at the time of our inspection. The PAB was observed to have sustained damages at its right body. The body parts that were found to have been damaged include its right hand brake lever, right handlebar end, right pedal and seat, amongst others as a result of the accident.

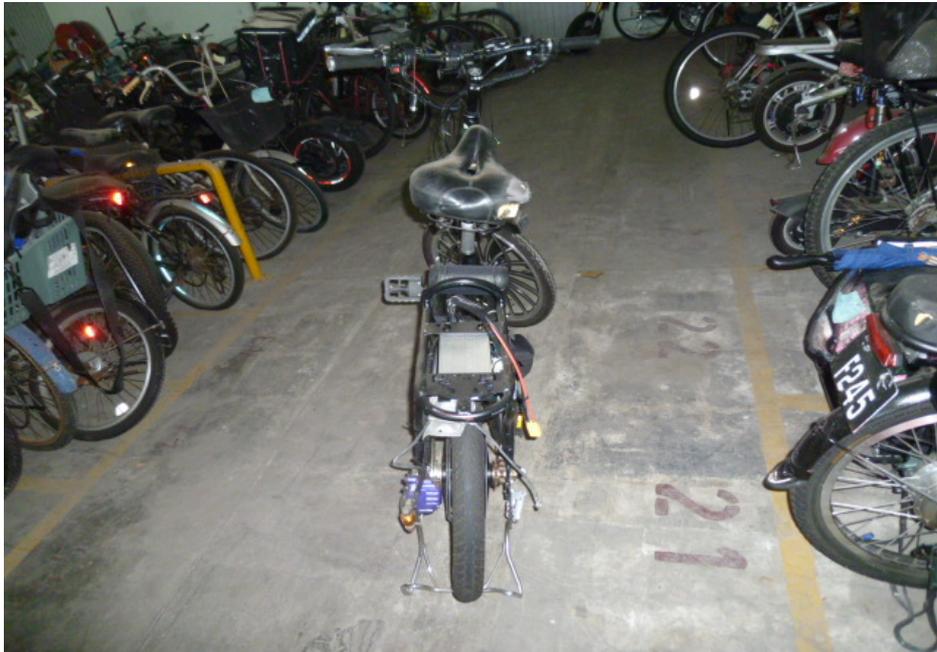
Photo 5 shows the rear portion of the PAB at the time of our inspection. The PAB was observed to have sustained damages at its right body. The body parts that were found to have been damaged include its right hand brake lever, right handlebar end, right pedal and seat, amongst others as a result of the accident.

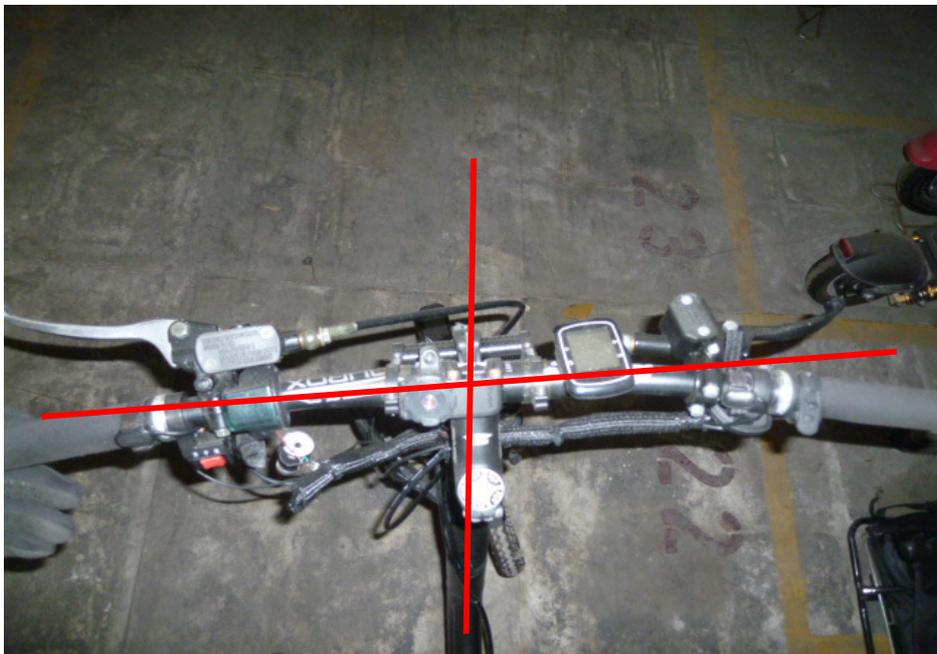
Photo 6 shows the frontal portion of the PAB (top view) at the time of our inspection. A slight misalignment of the handle bar & front tyre was observed.

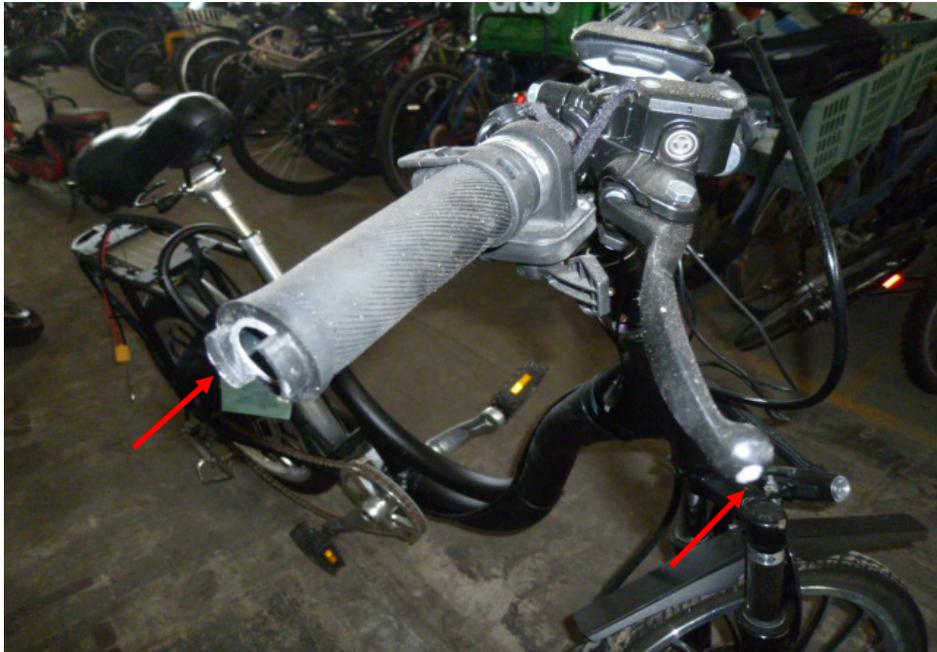
Photo 7 shows the damages on the right hand brake lever and right handlebar end (arrowed) of the PAB as a result of the accident.

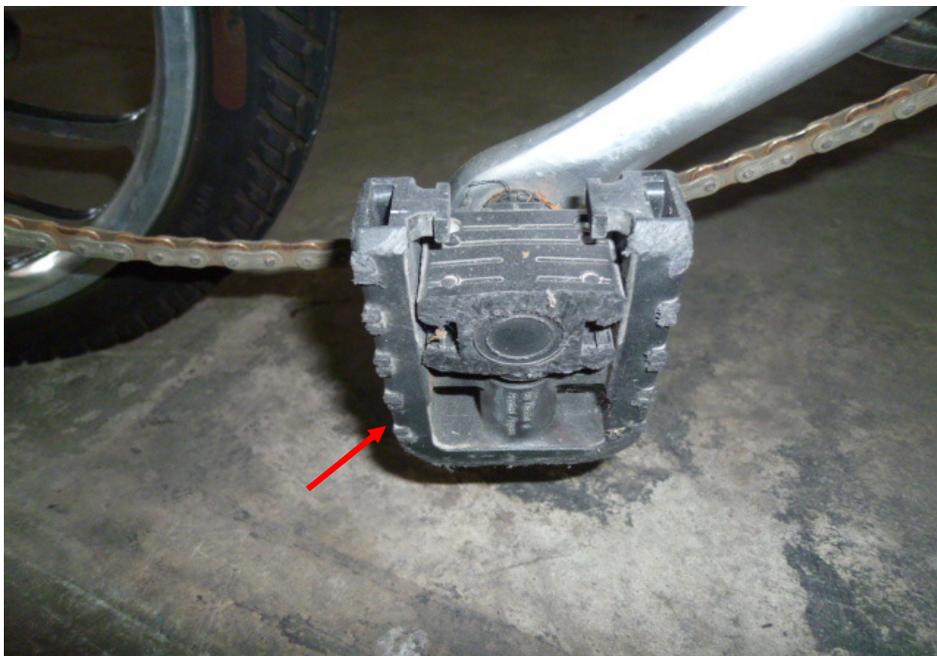
Photo 8 shows the damages of grazing nature on the right pedal (arrowed) of the PAB as a result of the accident.

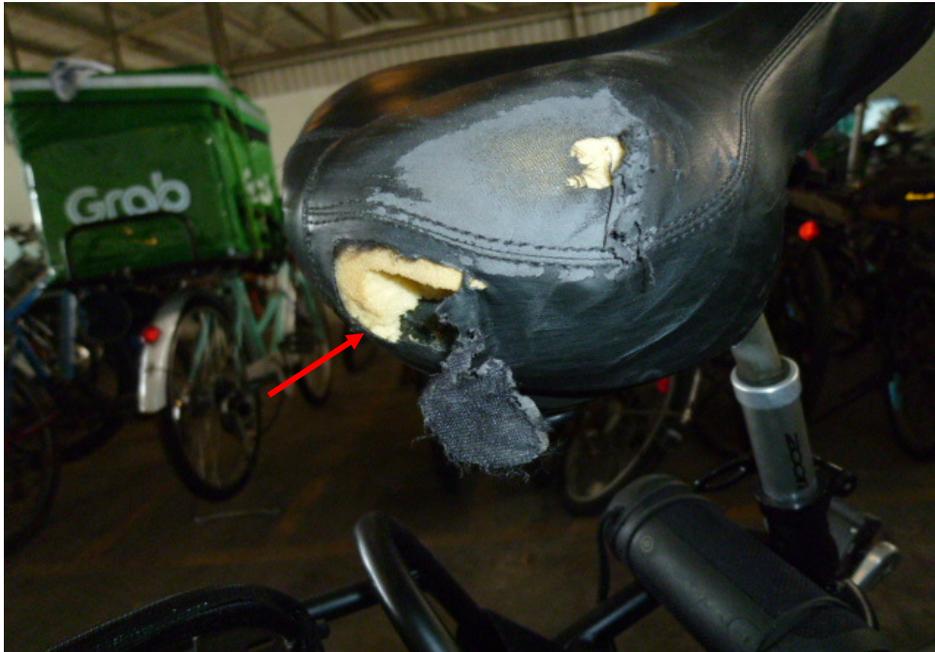
Photo 9 shows the torn seat (arrowed) of the PAB as a result of the accident.

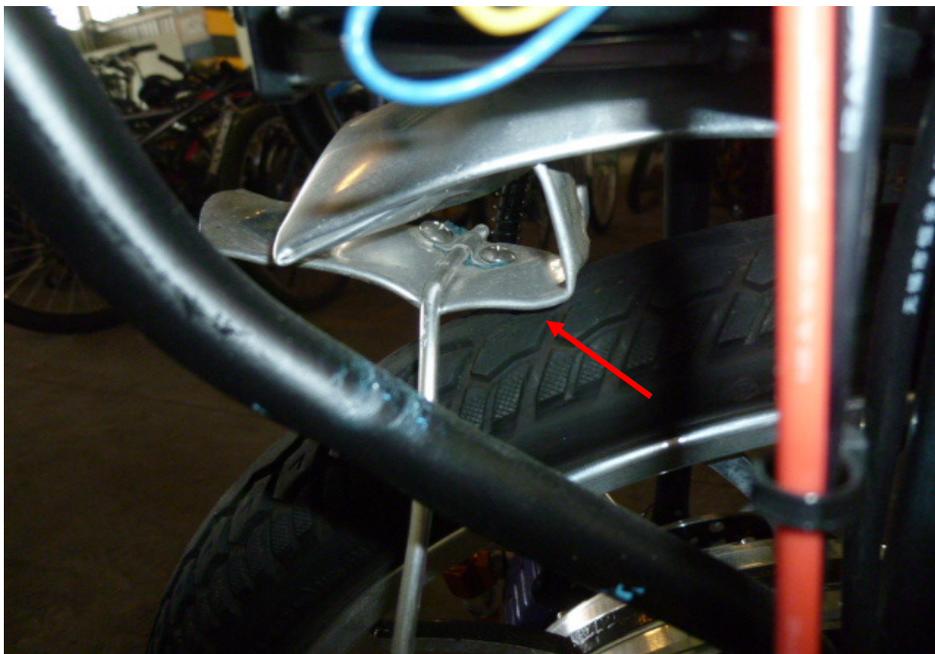
Photo 10 shows the deformed rear mudguard (arrowed) of the PAB as a result of the accident.

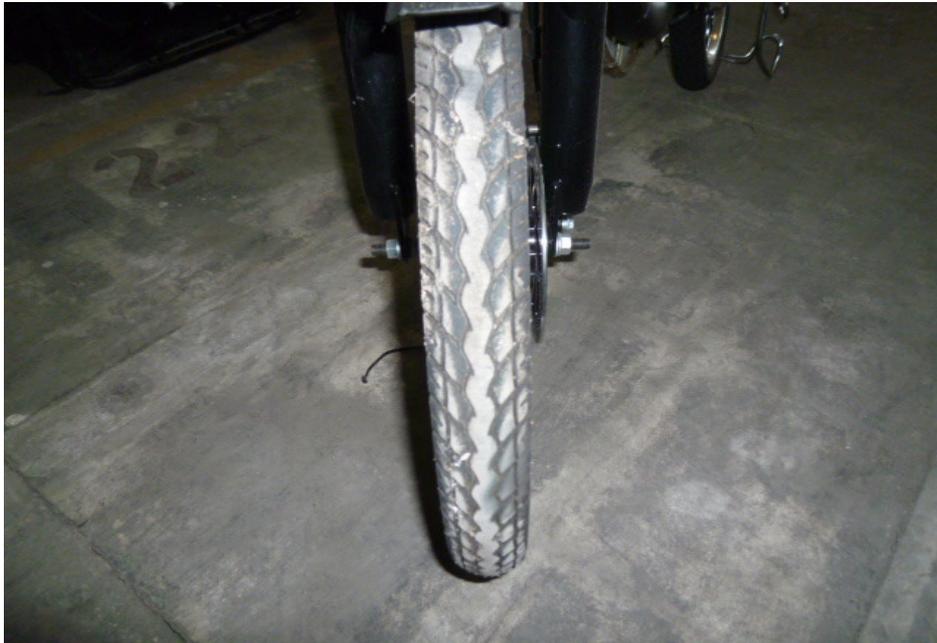
Photo 11 shows the front tyre of the PAB at the time of our inspection. The front tyre was observed to be in serviceable condition with remaining tread depth of approximately 3mm. The tyre was also observed to be sufficiently inflated for vehicular operation. We did not observe any tear, burst mark(s) and/or punctured hole(s) on the sidewalls as well as across the tread of the front tyre.

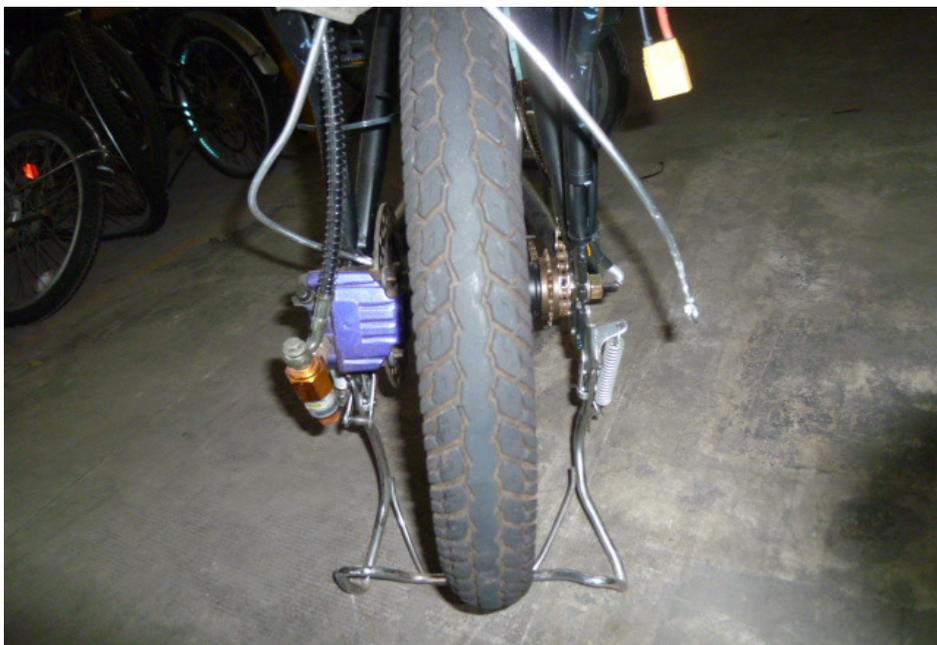
Photo 12 shows the rear tyre of the PAB at the time of our inspection. The rear tyre was observed to be in serviceable condition with remaining tread depth of approximately 3mm. The tyre was also observed to be sufficiently inflated for vehicular operation. We did not observe any tear, burst mark(s) and/or punctured hole(s) on the sidewalls as well as across the tread of the rear tyre.

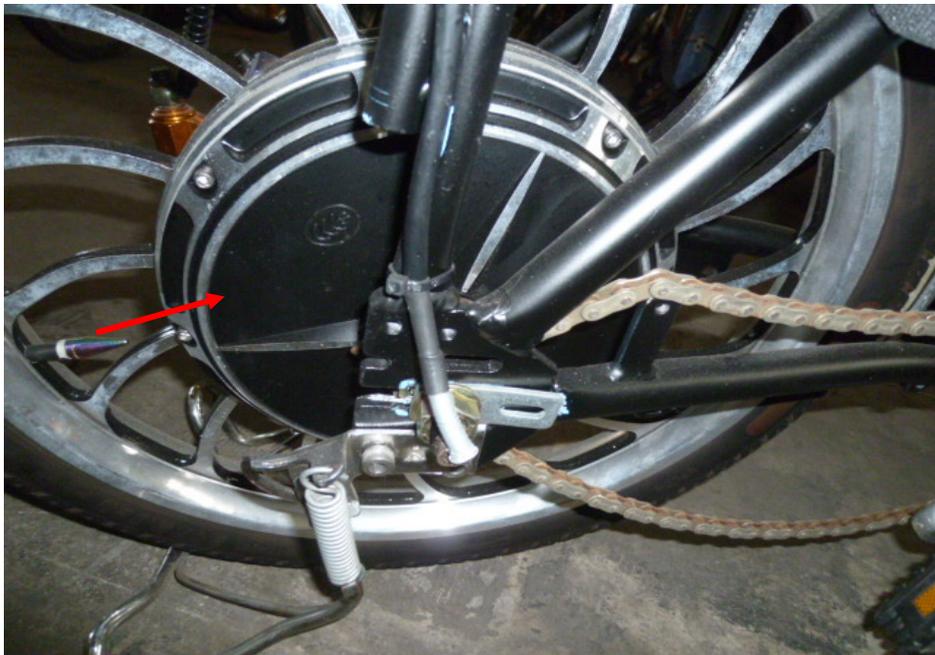
Photo 13 shows the general view of the drive motor (arrowed) of the PAB which was observed to be intact with no misalignment.

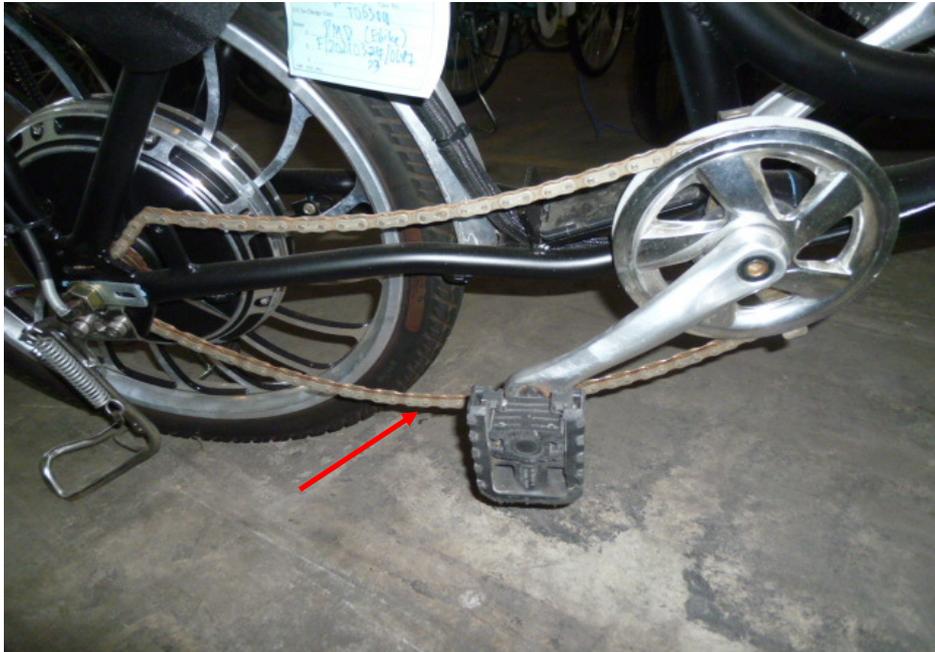
Photo 14 shows the general view of the gear train of the PAB, which was observed to be intact with no misalignment. It was also adequately lubricated for operating purposes. However the chain was observed to be dislodged from the gear train most likely as a result of the accident (arrowed).

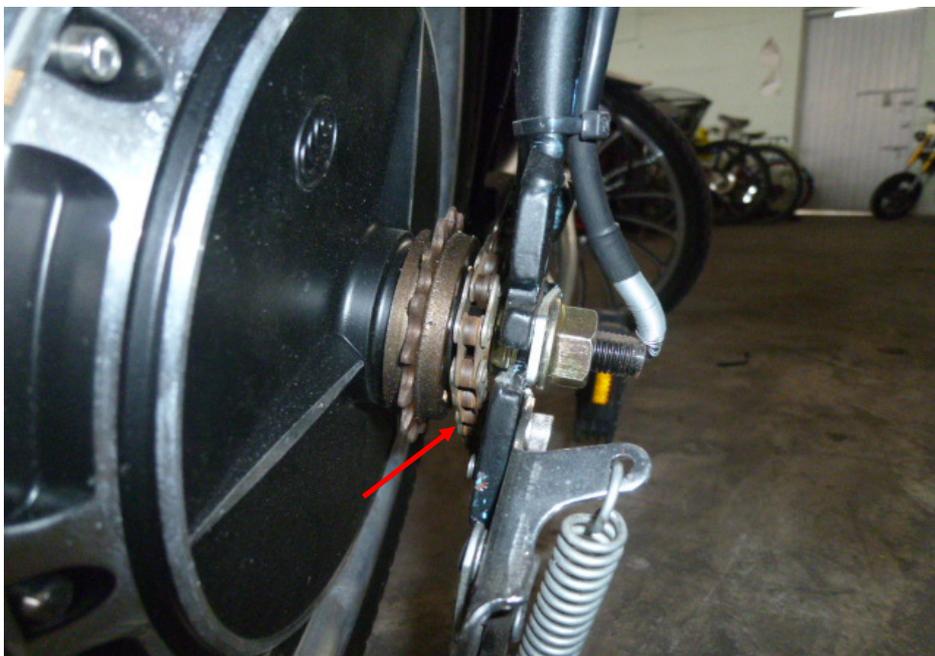
Photo 15 shows a closer view of the dislodged chain from the gear train of the PAB, most likely as a result of the accident. It was found to be adequately lubricated for operating purposes (arrowed).

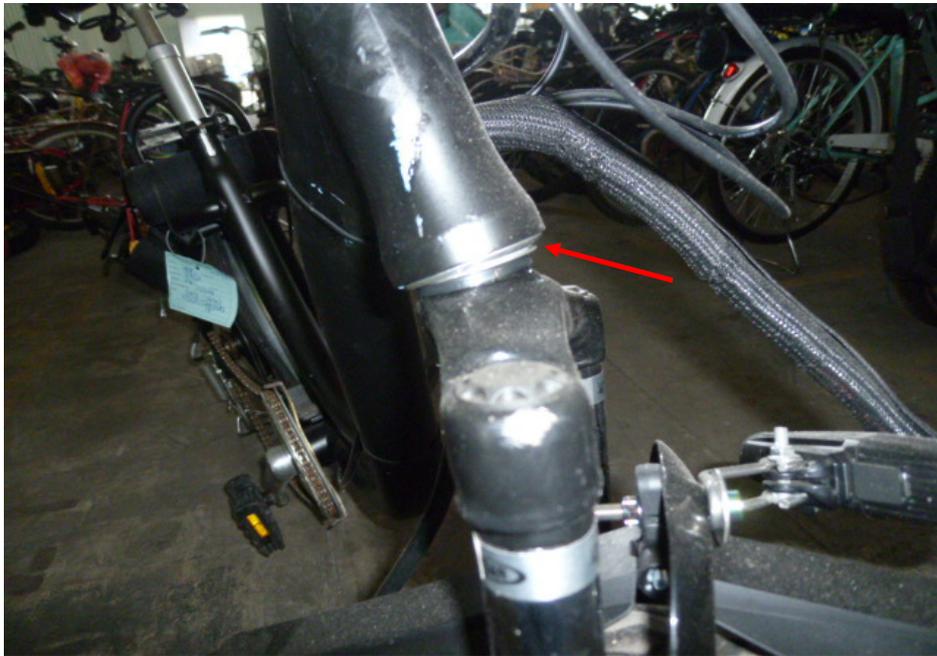
8. For this case, we were not able to conduct any test(s) on the steering system of the PAB due to the damages to its steering stem. The steering stem was found to be bent as a result of the accident, causing the whole steering system to be out of alignment, hence rendering the PAB immobile for any static or operational tests.

Photo 16 shows the steering stem of the PAB. The steering stem was found to be bent as a result of the accident (arrowed), causing the whole steering system to be out of alignment, hence rendering the PAB immobile for any static or operational tests.

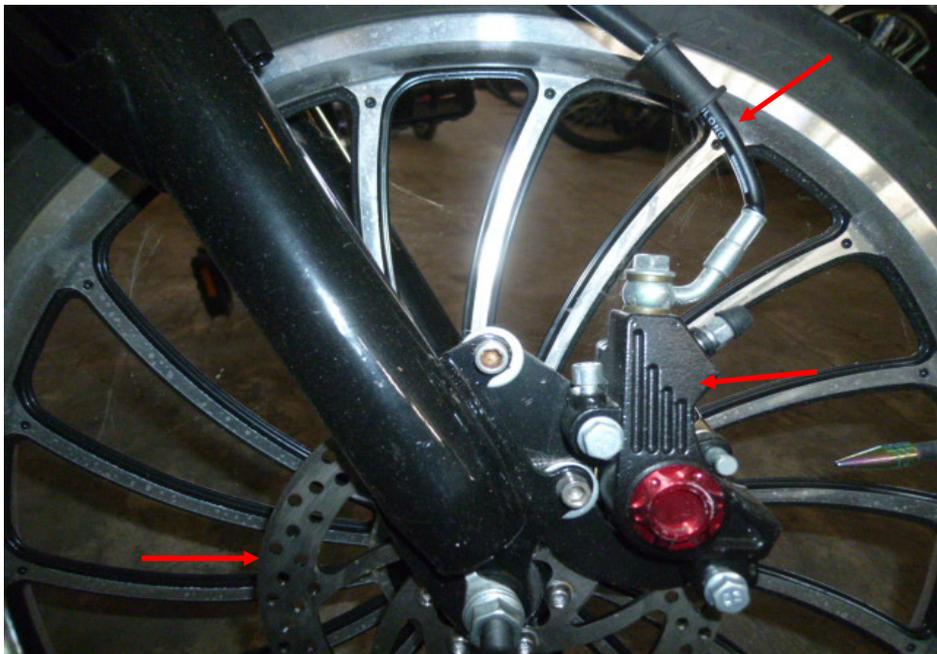
Photo 17 shows a close up view of the front brake caliper, front brake disc and front brake hose (arrowed) of the PAB, which are all part of the components in the hydraulic front brake system of the PAB. Our visual checks of these various components had revealed all to be intact with no visible damage. No leakage of brake fluid was also observed.

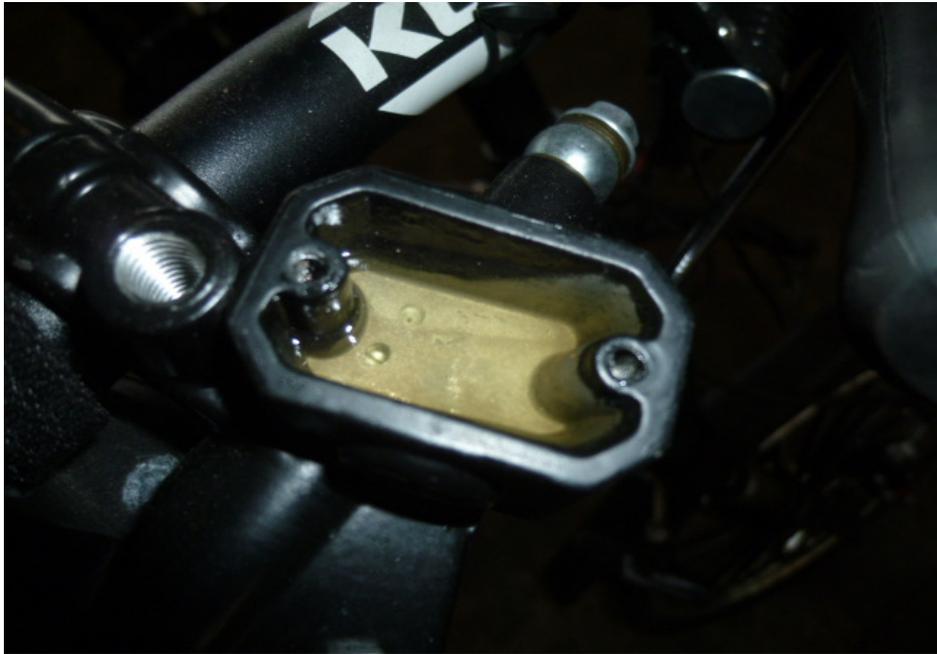
Photo 18 shows the brake fluid reservoir for the front brake of the PAB. The brake fluid was found to be without contamination and of sufficient level for operating purposes.

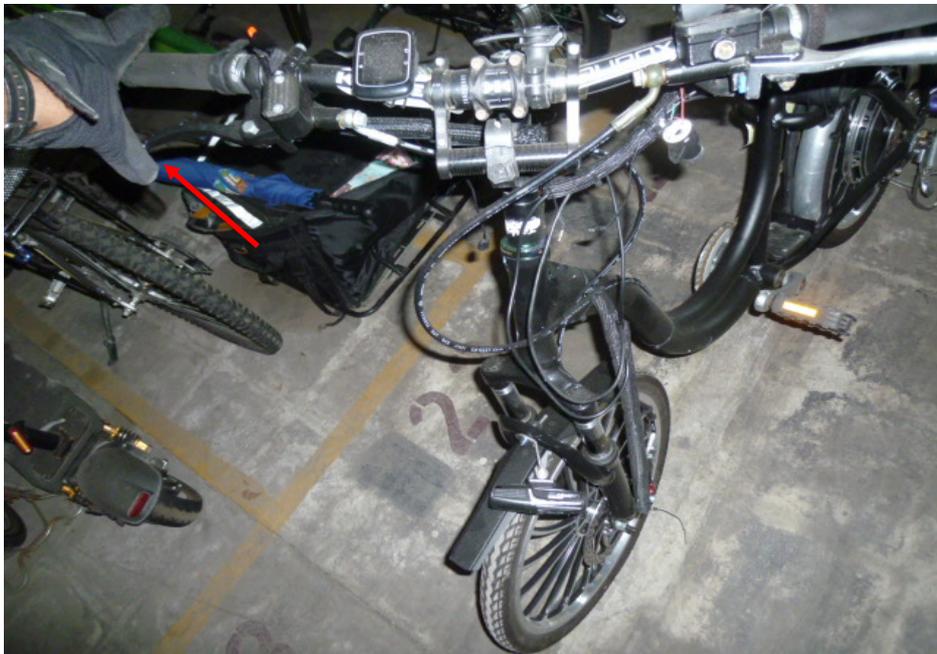
Photo 19 shows the front brake lever being depressed. There was some resistance felt (spongy like feel) upon pressing the front brake lever (arrowed). This would indicate that there is no leakage of pressure/vacuum in the front brake system.

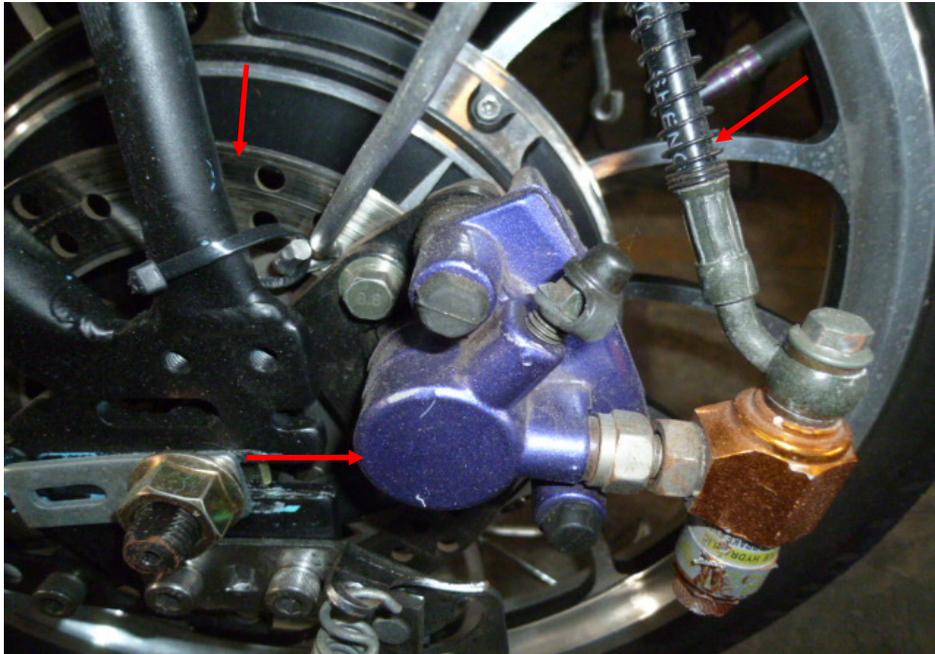
Photo 20 shows a close up view of the rear brake caliper, rear brake disc and rear brake hose (arrowed) of the PAB, which are all part of the components in the hydraulic rear brake system of the PAB. Our visual checks of these various components had revealed all to be intact with no visible damage. No leakage of brake fluid was also observed.

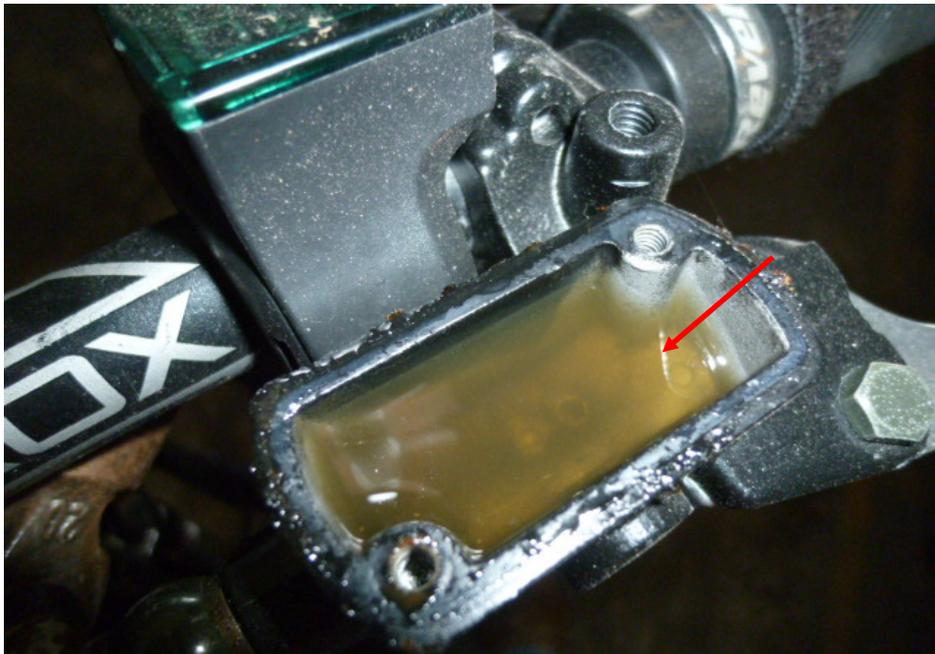
10. Our visual examination of the various components in the PAB's braking system like the brake discs, brake calipers, brake levers and brake hoses revealed all to be intact and without damage. There was also no leakage of brake fluid observed along the brake hoses. This was from the respective brake fluid reservoirs to the front brake caliper and rear brake caliper of the PAB. The brake fluid for the front and rear brake was also found to be of sufficient level for operational purposes. However the brake fluid for the rear brake was observed to be slightly contaminated.

Photo 21 shows the brake fluid reservoir for the rear brake of the PAB. The brake fluid was observed to be of sufficient level for operating purposes. However it found to be slightly contaminated (arrowed).

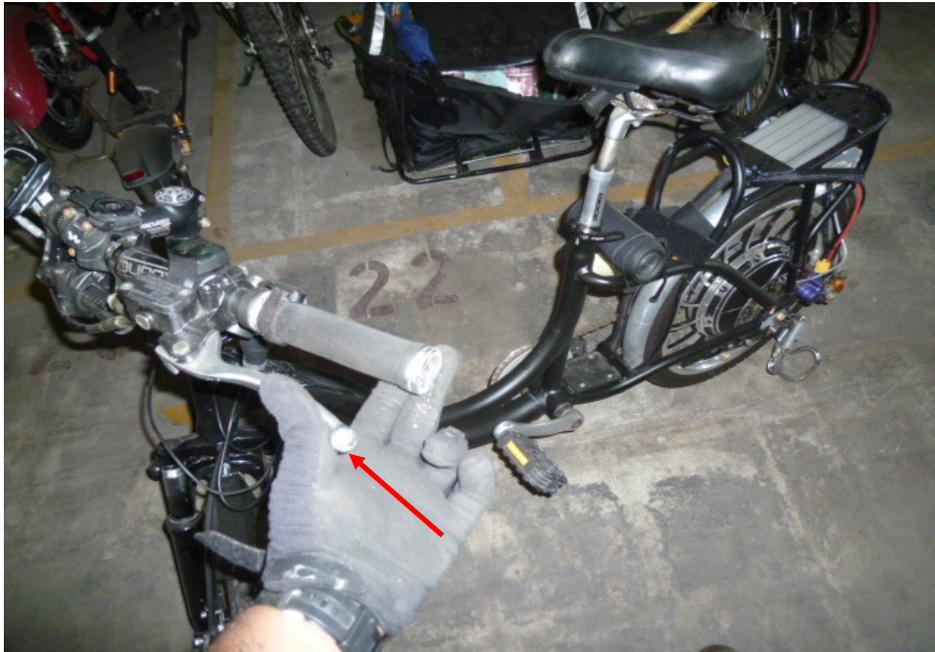
Photo 22 shows the rear brake lever being depressed. There was some resistance felt (spongy like feel) upon pressing the rear brake lever (arrowed). This would indicate that there is no leakage of pressure/vacuum in the rear brake system.
