Your Ref: TP/IP/17125/2021
Our Ref : CI/TPD21005553/N

31 May 2021

Fatal Accident Investigation Team

INSPECTION REPORT OF MOTORCYCLE FBL 5150E

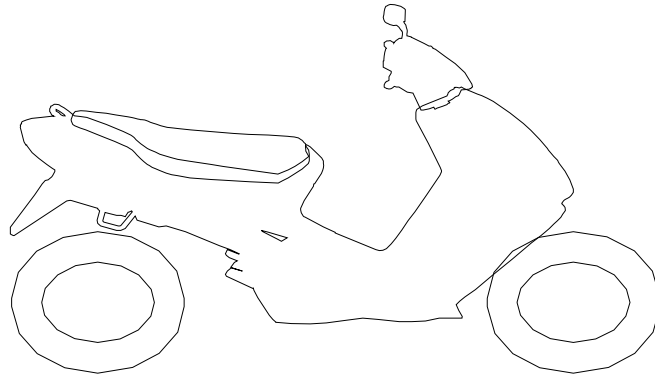
7. The tyre brand, tyre size and remaining tread depth of the 2 tyres were recorded as follows:-

Michelin 140/70 - 17 (4mm)

Michelin 100/80 - 17 (4mm)

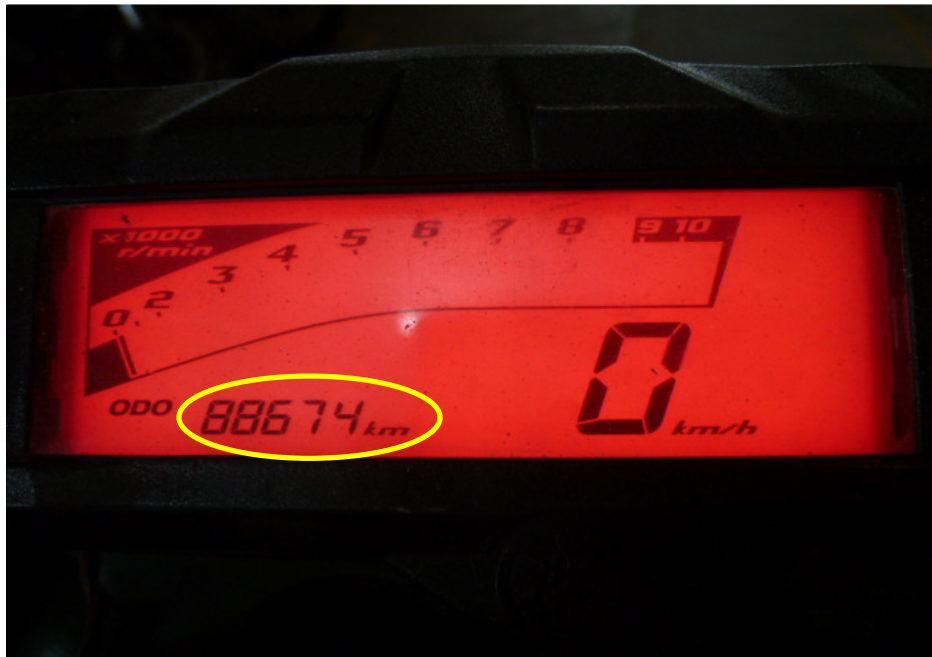
Photo 1 shows the speedometer gauge of the Motorcycle. The mileage of the Motorcycle at the time of our inspection was 88, 674km (circled).

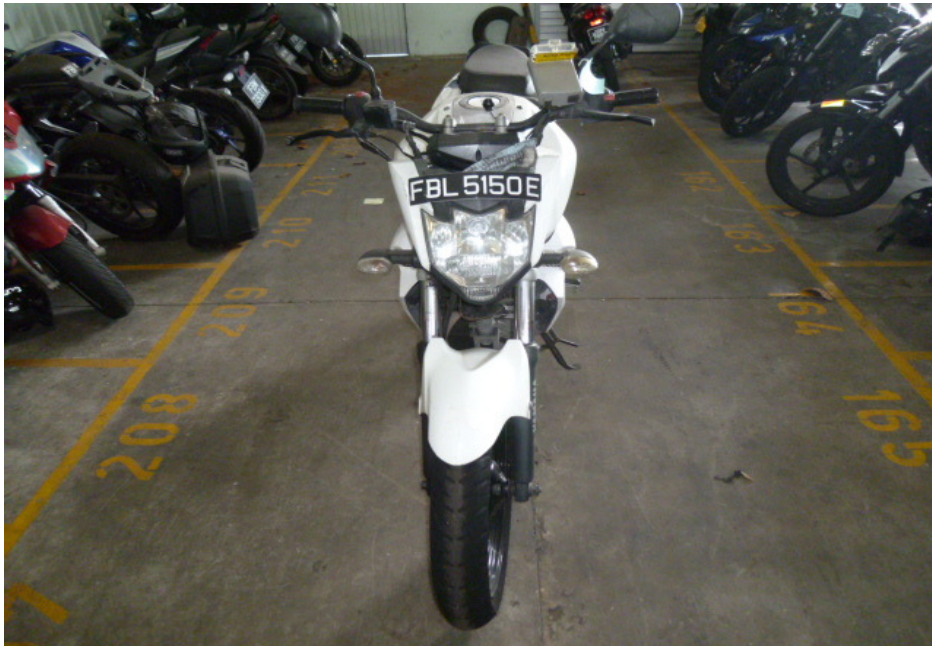
Photo 2 shows a general view of the frontal portion of the Motorcycle at the time of our inspection. The Motorcycle was observed to have sustained damages all around.

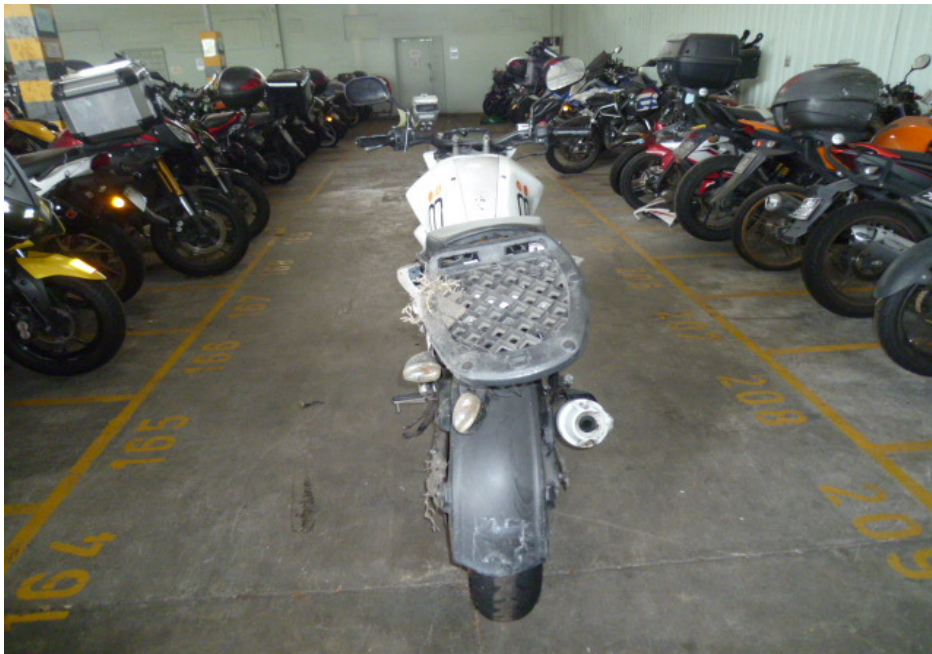
Photo 3 shows a general view of the rear portion of the Motorcycle at the time of our inspection. The Motorcycle was observed to have sustained damages all around.

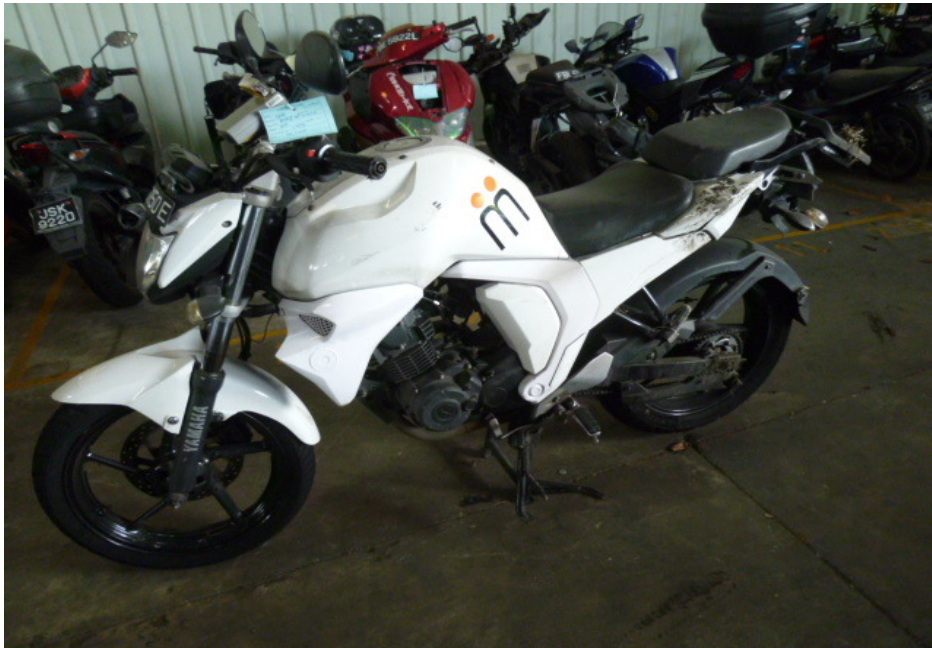
Photo 4 shows a general view of the left body of the Motorcycle at the time of our inspection. The Motorcycle was observed to have sustained damages all around. Amongst the body parts that were found to have been damaged include it front mudguard, gear shift pedal, clutch lever, left side mirror, left handlebar end, fuel tank, right pillion foot peg, rear side covers, left front footrest, exhaust muffler, exhaust muffler heat shield, top box rack and rear mudguard, amongst others.

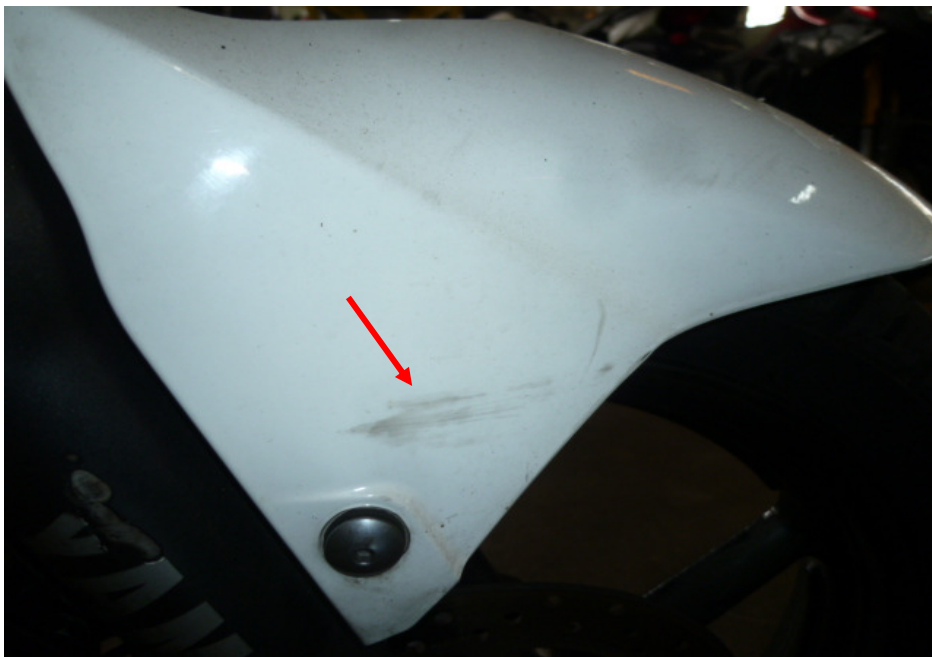
Photo 5 shows a closer view of the grazed front mudguard of the Motorcycle as a result of the accident (arrowed).

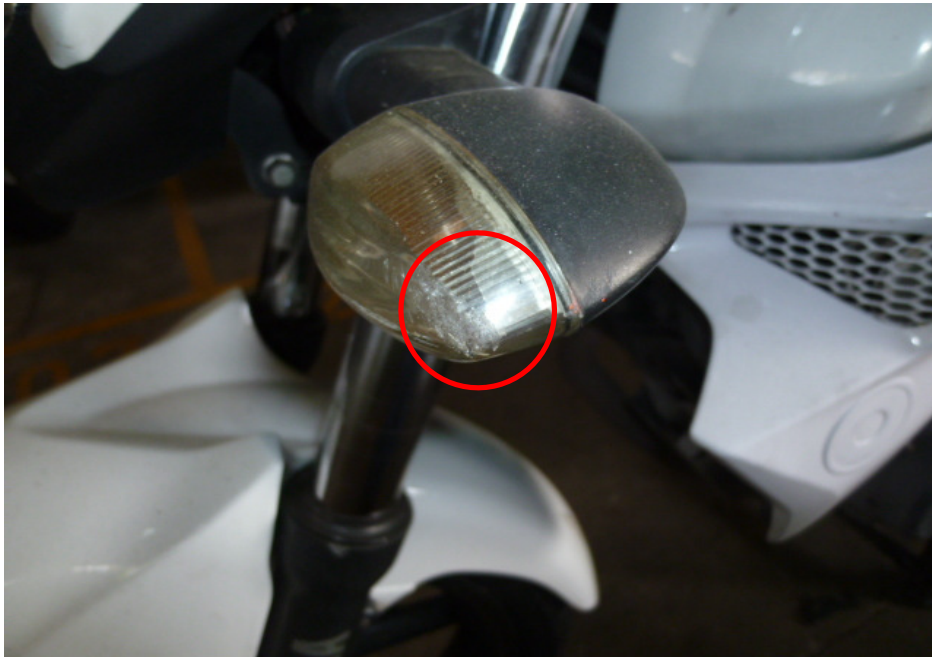
Photo 6 shows a closer view of the left front signal lamp which was amongst the body parts of the Motorcycle that had sustained damage as a result of the accident (circled).

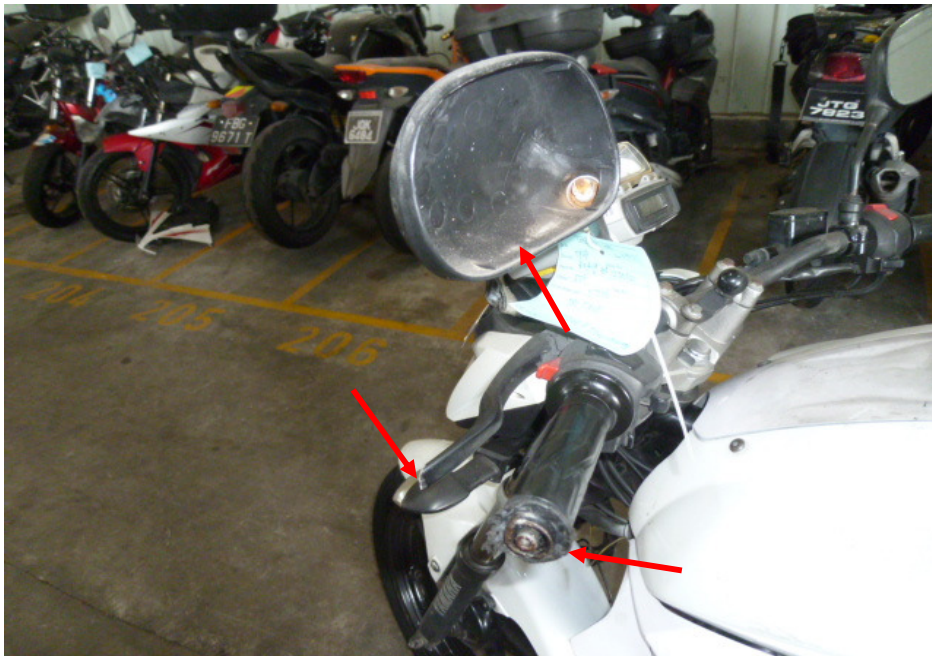
Photo 7 shows the clutch lever, left handlebar end and left side mirror (arrowed), which were amongst the body parts of the Motorcycle that had sustained damage as a result of the accident.

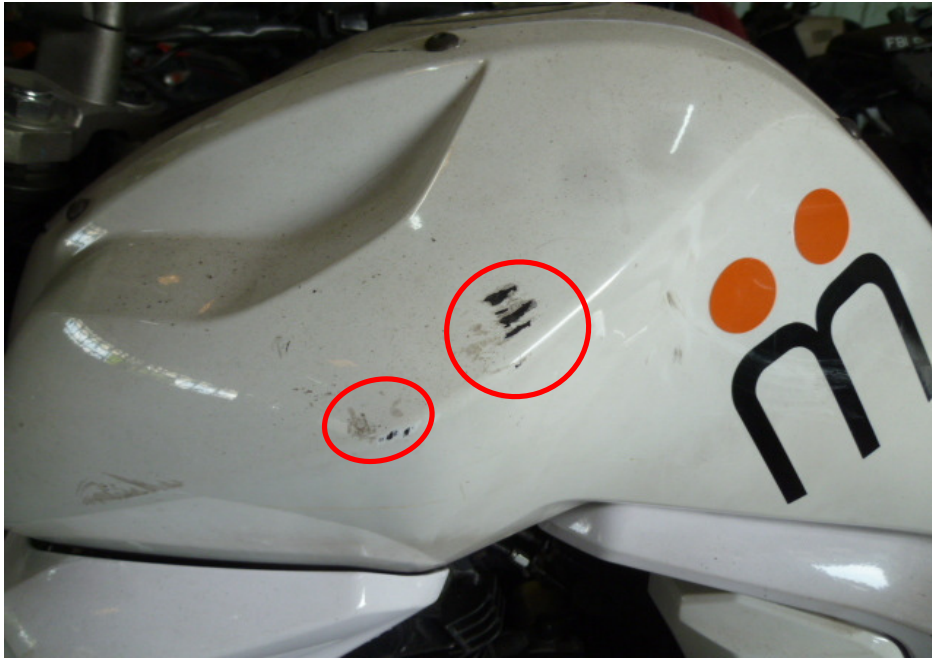
Photo 8 shows a closer view of the fuel tank (circled) which was amongst the body parts of the Motorcycle that had sustained damage as a result of the accident.

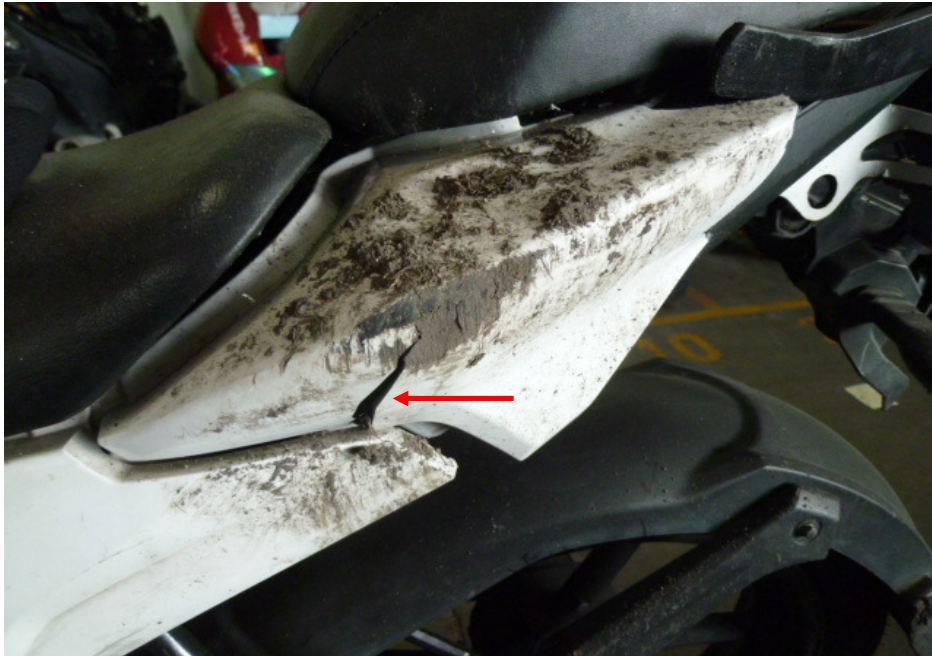
Photo 9 shows a closer view of the cracked left rear side cover (arrowed) of the Motorcycle as a result of the accident.

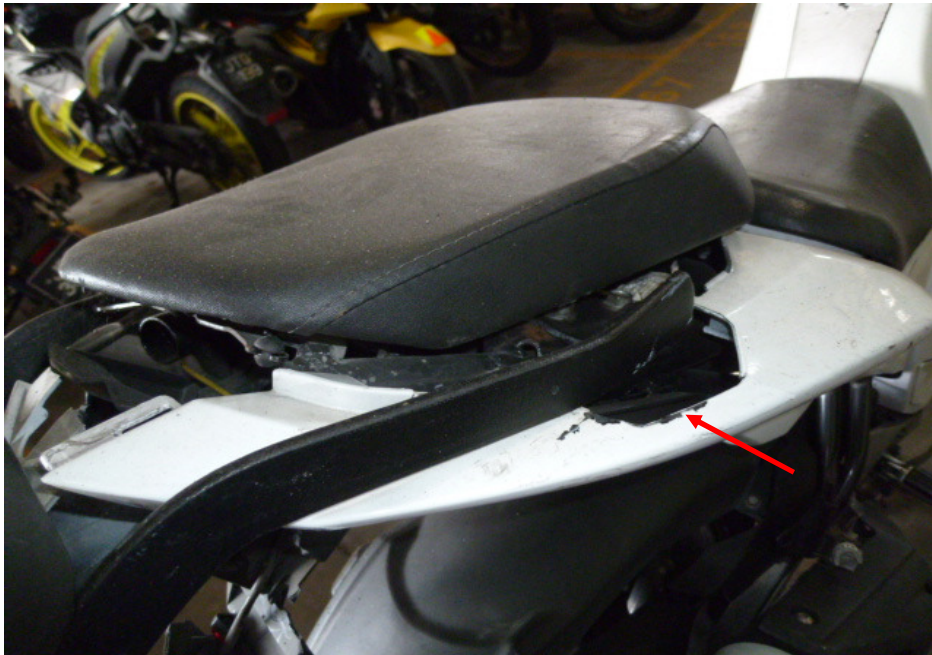
Photo 10 shows a closer view of the cracked right rear side cover (arrowed) of the Motorcycle as a result of the accident.

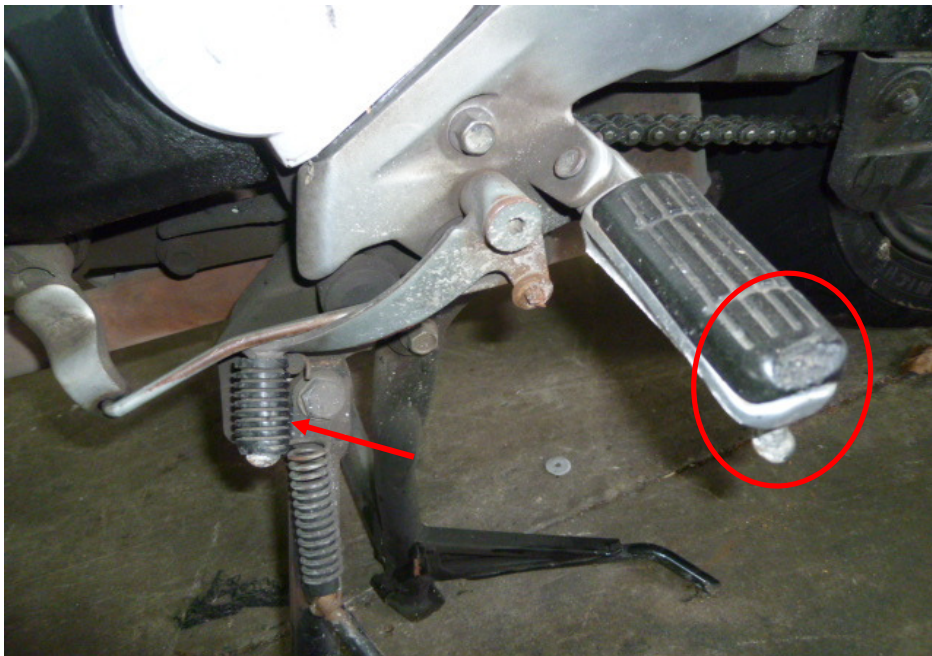
Photo 11 shows a closer view of the bent gear shift pedal (arrowed) and grazed left front footrest (circled) of the Motorcycle as a result of the accident.

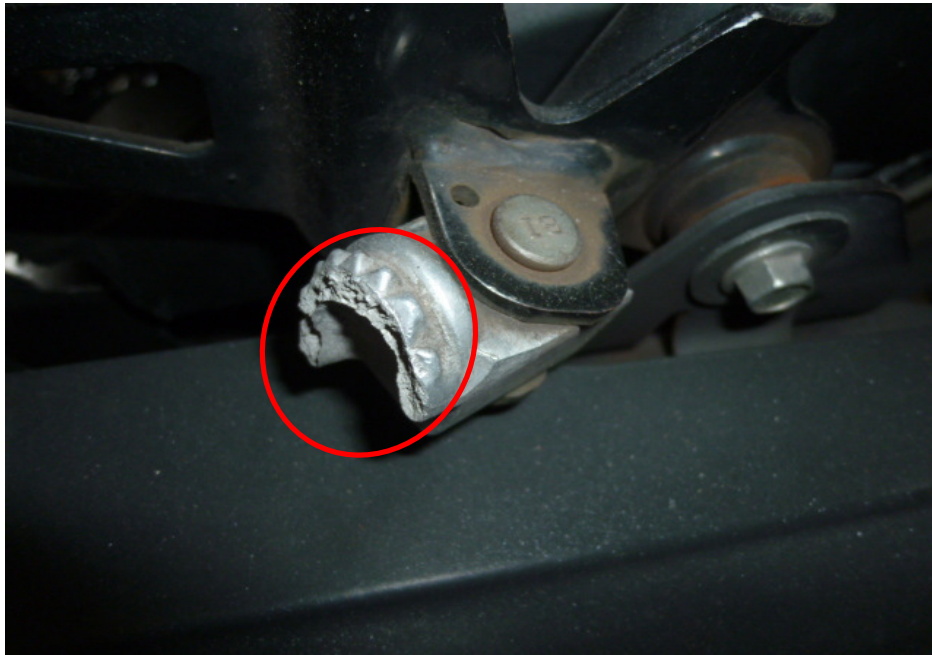
Photo 12 shows a closer view of the broken right pillion footpeg of the Motorcycle as a result of the accident (circled).

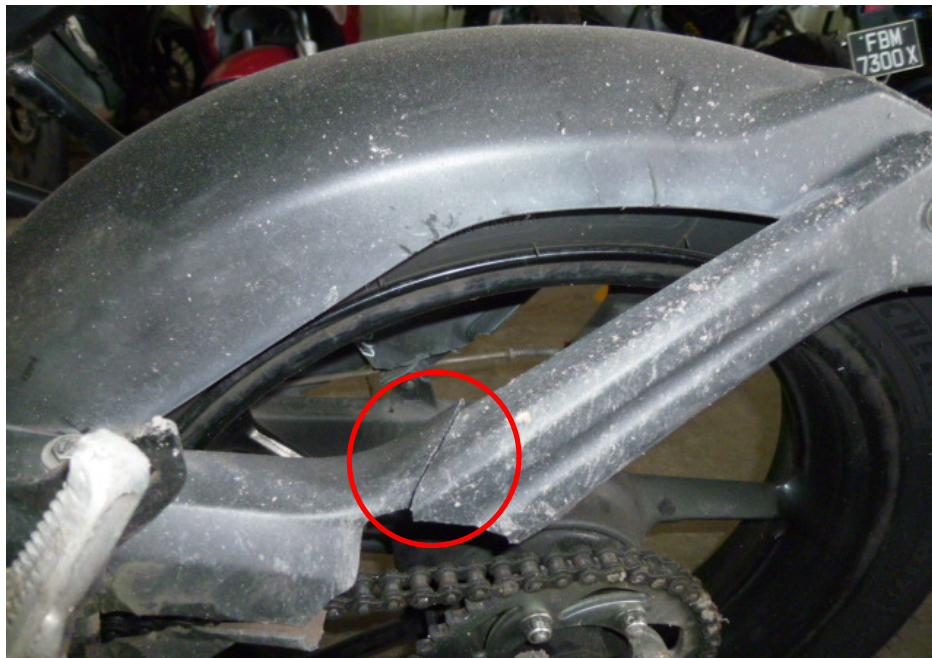
Photo 13 shows the cracked rear mudguard (circled) of the Motorcycle as a result of the accident.

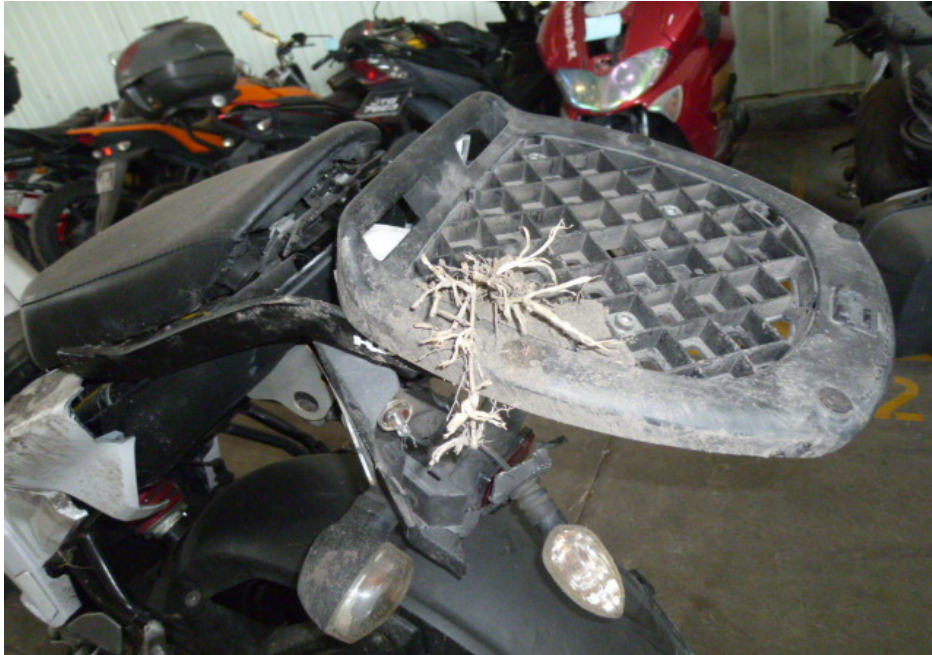
Photo 14 shows the top box rack of the Motorcycle that had sustained extensive damage as a result of the accident.

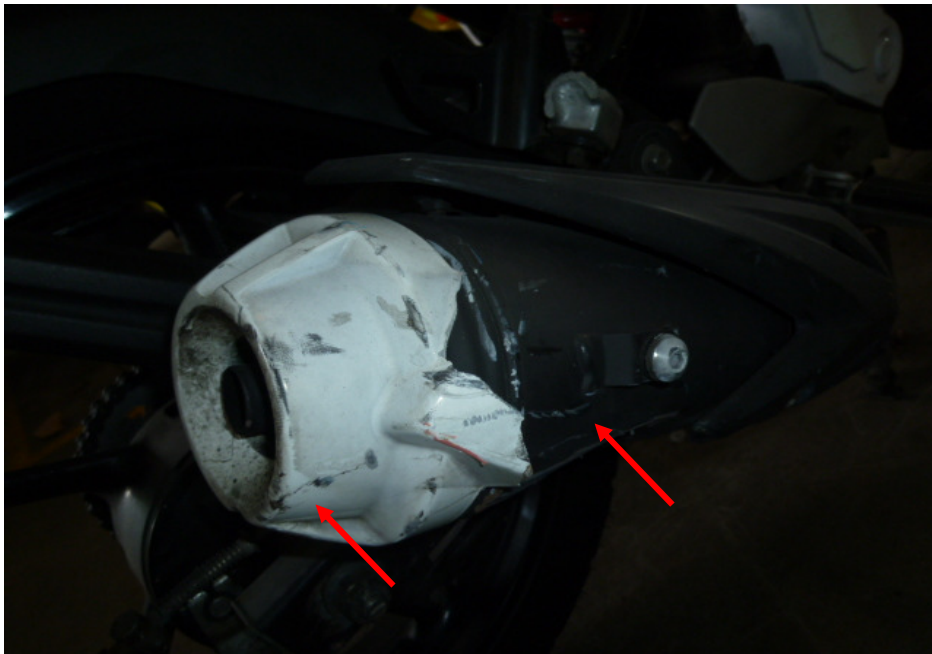
Photo 15 shows a closer view of the exhaust muffler and exhaust muffler heat shield which were amongst the body parts of the Motorcycle that had sustained damages of grazing nature as a result of the accident (arrowed).

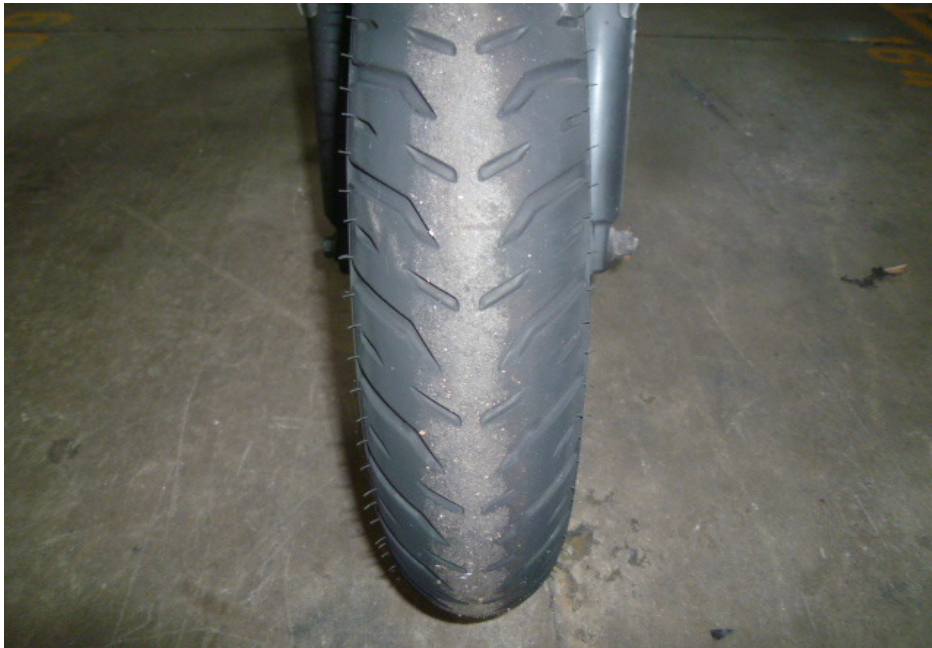
Photo 16 shows the front tyre of the Motorcycle at the time of our inspection. The front tyre was observed to be in serviceable condition with remaining tread depth of approximately 4mm. The pattern of the tread was also clearly visible. There was no tear, burst mark(s) and/or punctured hole(s) on the sidewalls as well as across the tread of the front tyre.

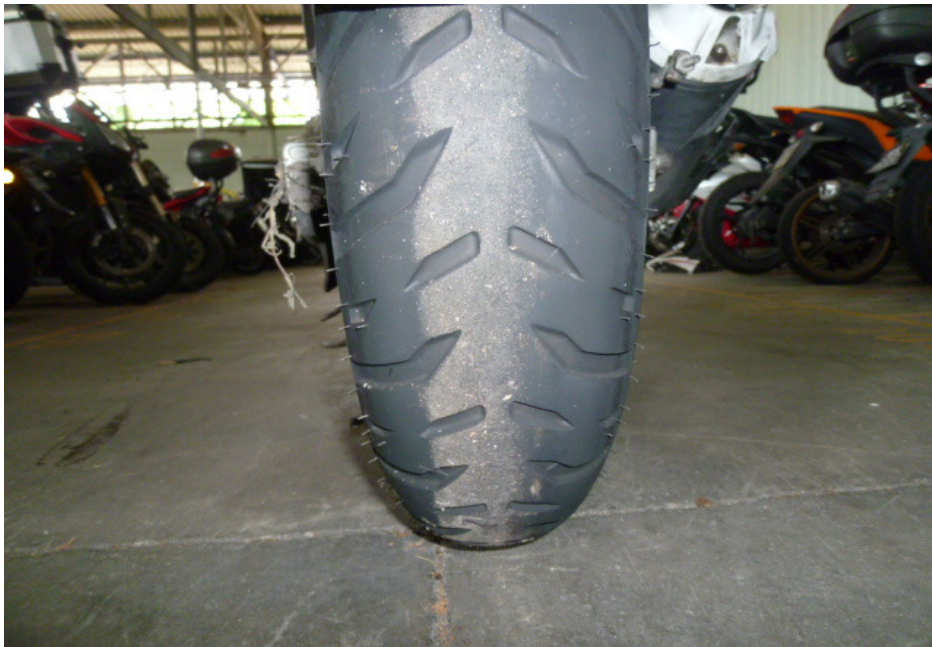
Photo 17 shows the condition of the Motorcycle's rear tyre. The rear tyre was observed to be in serviceable condition with remaining tread depth of approximately 4mm. The tyre was also observed to be sufficiently inflated for vehicular operation. We did not observe any tear, burst mark(s) and/or punctured hole(s) on the sidewalls as well as across the tread of the rear tyre.

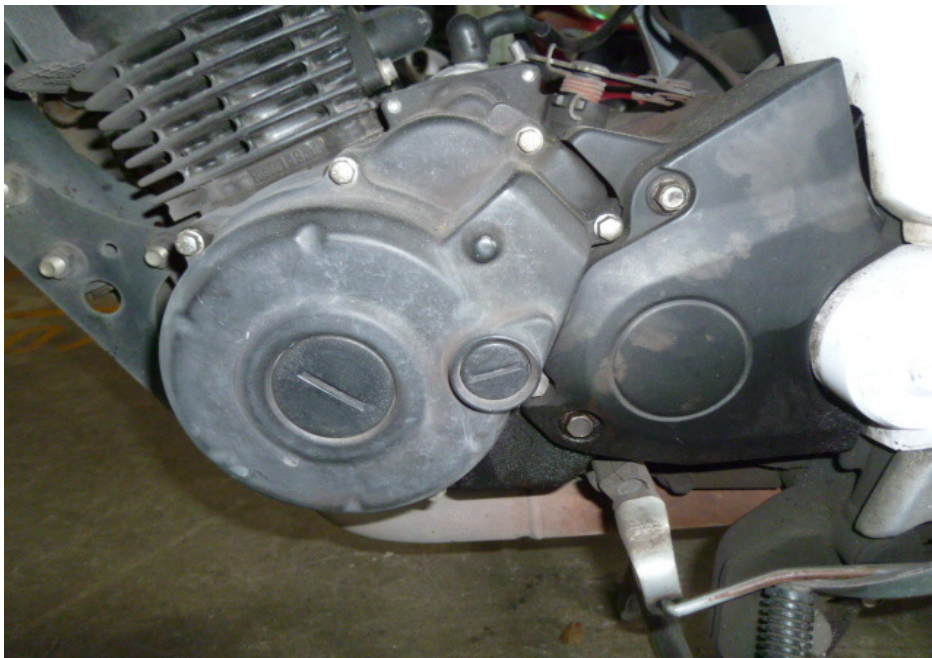
Photo 18 shows the left side of the engine of the Motorcycle at the time of our inspection. The various engine related parts and components were found to be intact with no visible damage. There was also no sign(s) or indication(s) of fluid leak observed around the left engine area of the Motorcycle.

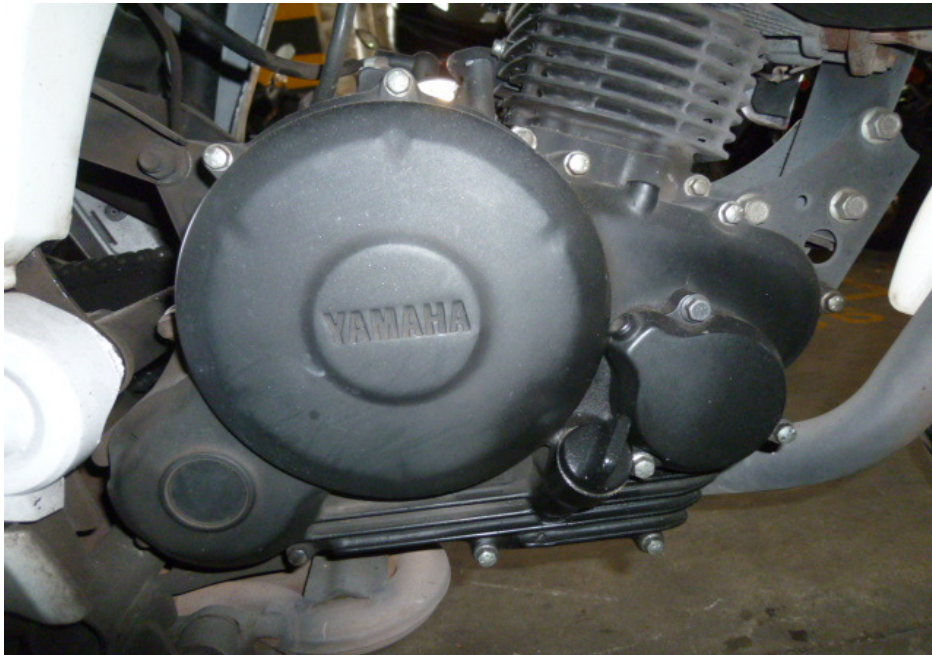
Photo 19 shows the right side of the engine of the Motorcycle at the time of our inspection. The various engine related parts and components were found to be intact with no visible damage. There was also no sign(s) or indication(s) of fluid leak observed around the right engine area of the Motorcycle.

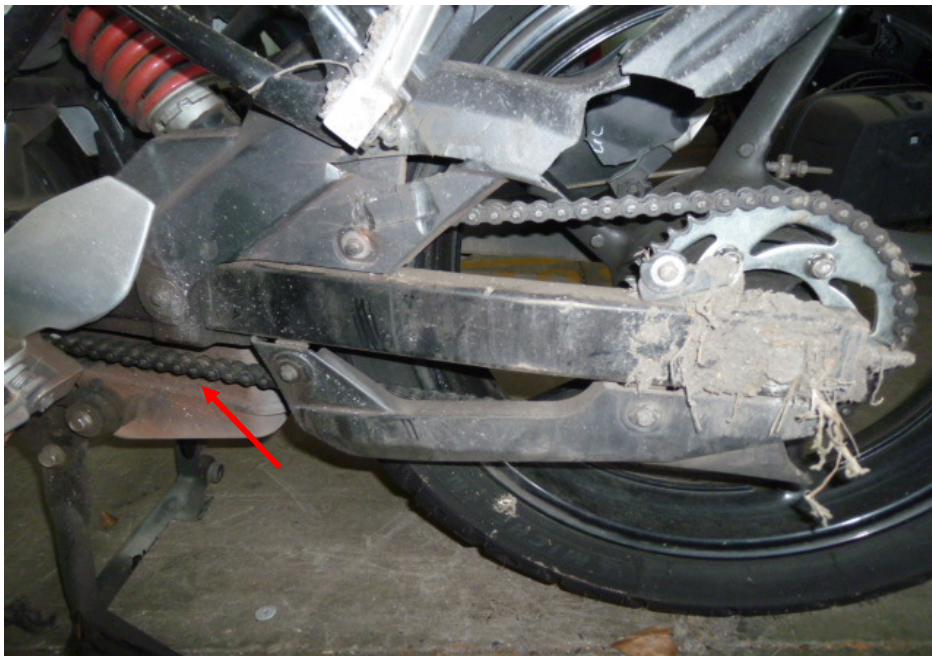
Photo 20 shows the general view of the gear train (arrowed) of the Motorcycle, which was observed to be intact with no misalignment. It was also adequately lubricated for operating purposes.

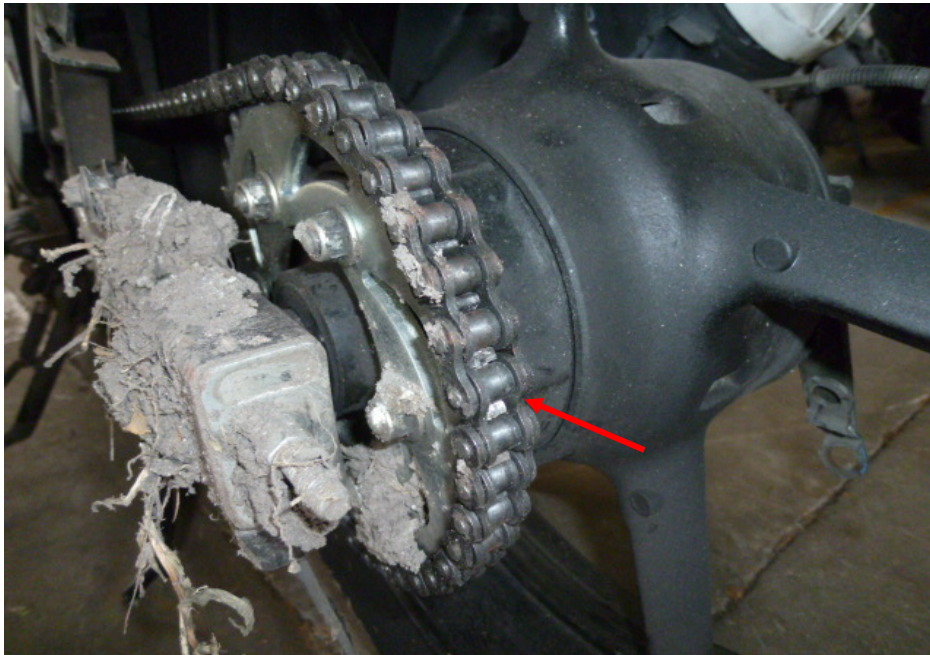
Photo 21 shows a closer view of the gear train (arrowed) of the Motorcycle, which was observed to be intact with no misalignment. It was also adequately lubricated for operating purposes.

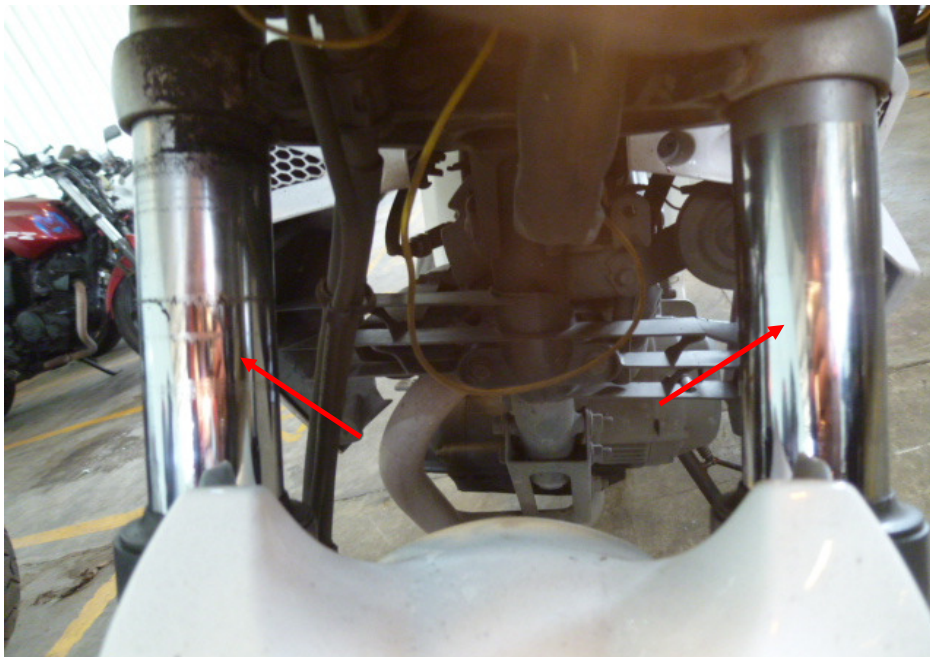
11. Our checks on the various steering components of the Motorcycle revealed that its steering system was in serviceable condition. Its front fork was found to be intact and undamaged. Turning the handle bar towards the left and right also did not produce any abnormal free play and/or resistance.

Photo 22 shows the front fork (arrowed) of the Motorcycle. The front fork and fork bracket of the Motorcycle were both found to be intact and undamaged. Turning the Motorcycle's handle bar towards the left and right did not produce any abnormal free play and/or resistance. The steering system of the Motorcycle was in serviceable condition at the time of our inspection.

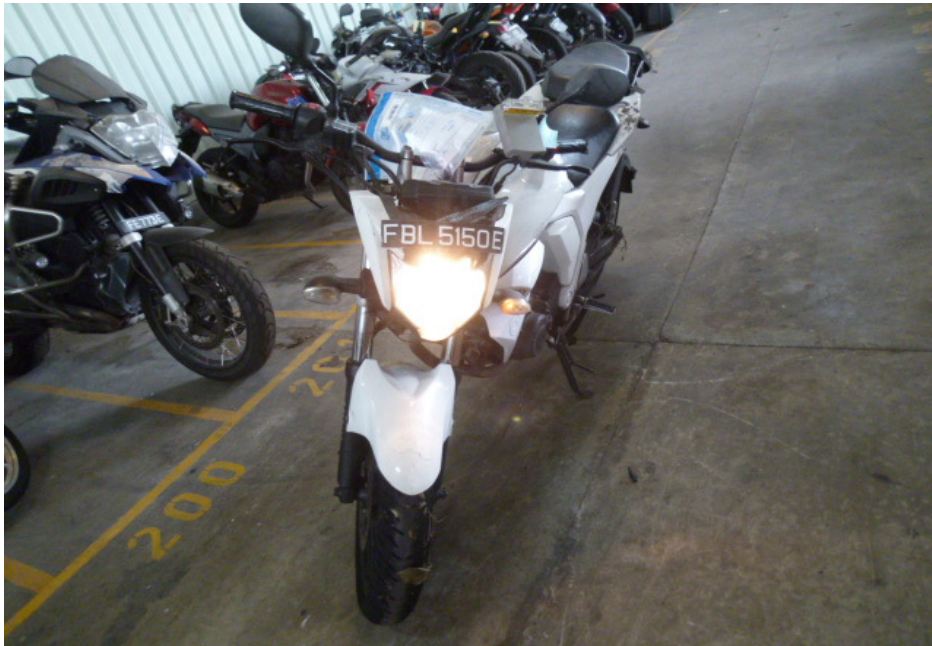
Photo 23 shows the front wheel of the Motorcycle turned towards its full left. Turning the Motorcycle's handle bar towards the left and right did not produce any abnormal free play and/or resistance. This would indicate that the steering system of the Motorcycle was in serviceable condition at the time of our inspection.

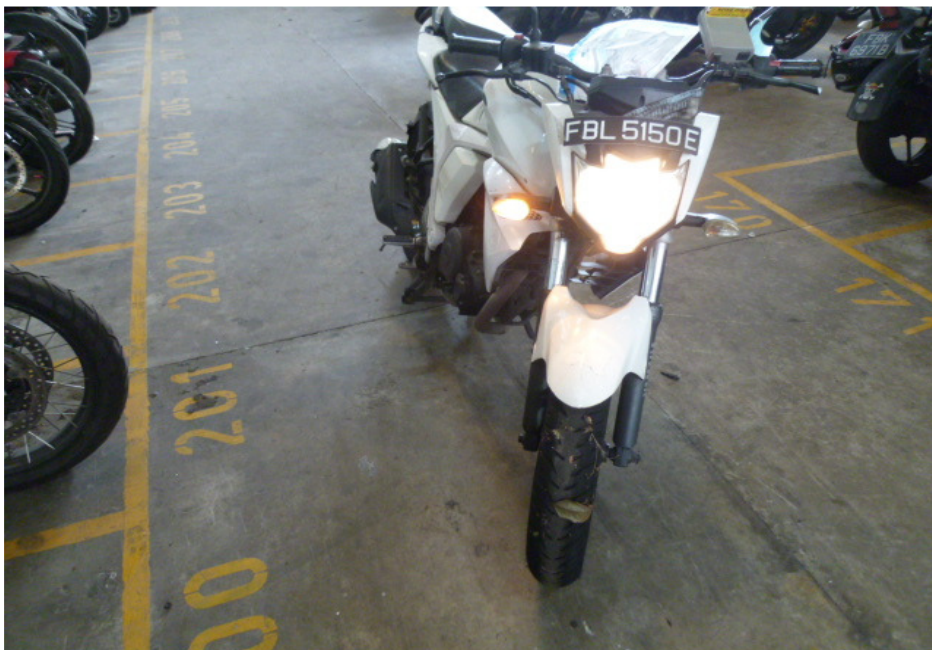
Photo 24 shows the front wheel of the Motorcycle turned towards its full right. Turning the Motorcycle's handle bar towards the left and right did not produce any abnormal free play and/or resistance. This would indicate that the steering system of the Motorcycle was in serviceable condition at the time of our inspection.

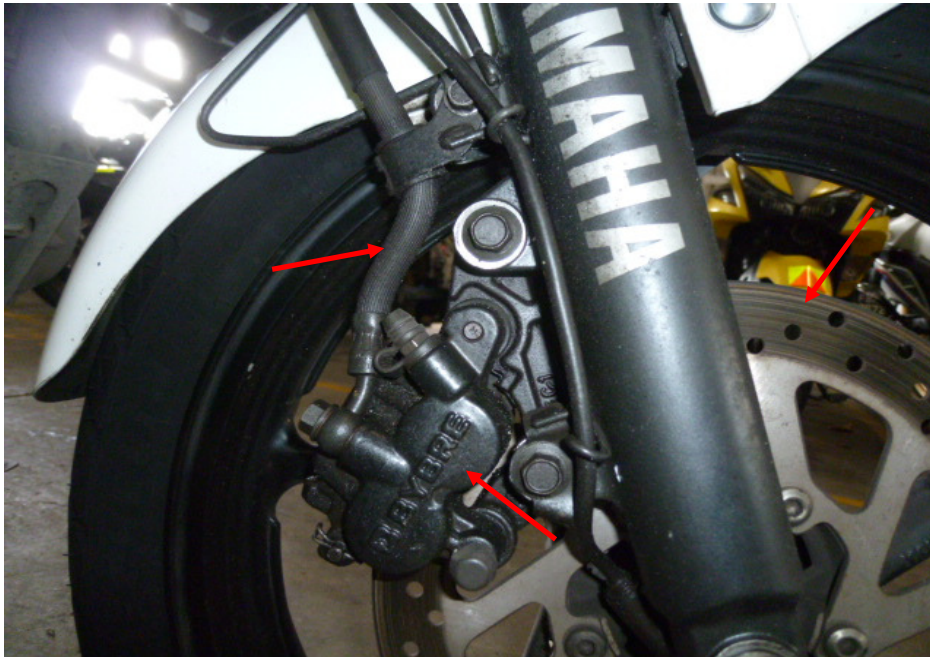
Photo 25 shows a close up view of the front brake caliper, front brake disc and front brake hose (arrowed) of the Motorcycle, which are all part of the components in the hydraulic front brake system of the Motorcycle. Our visual checks of these various components had revealed all to be intact with no visible damage. No leakage of brake fluid was also observed.

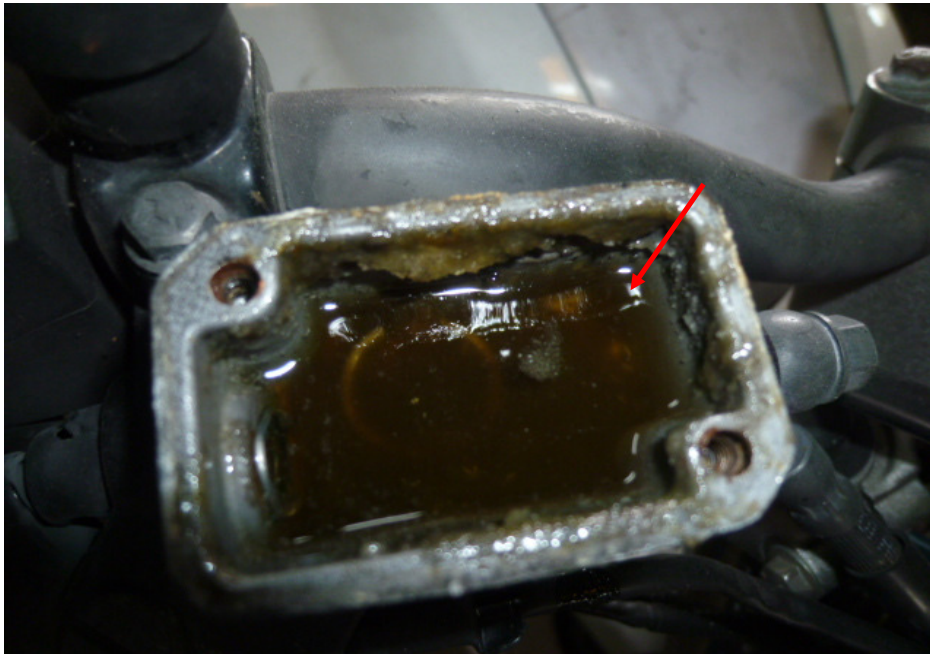
Photo 26 shows the brake fluid reservoir for the front brake of the Motorcycle. The brake fluid was found to be of sufficient level for operating purposes. However the brake fluid was found to be contaminated (arrowed).

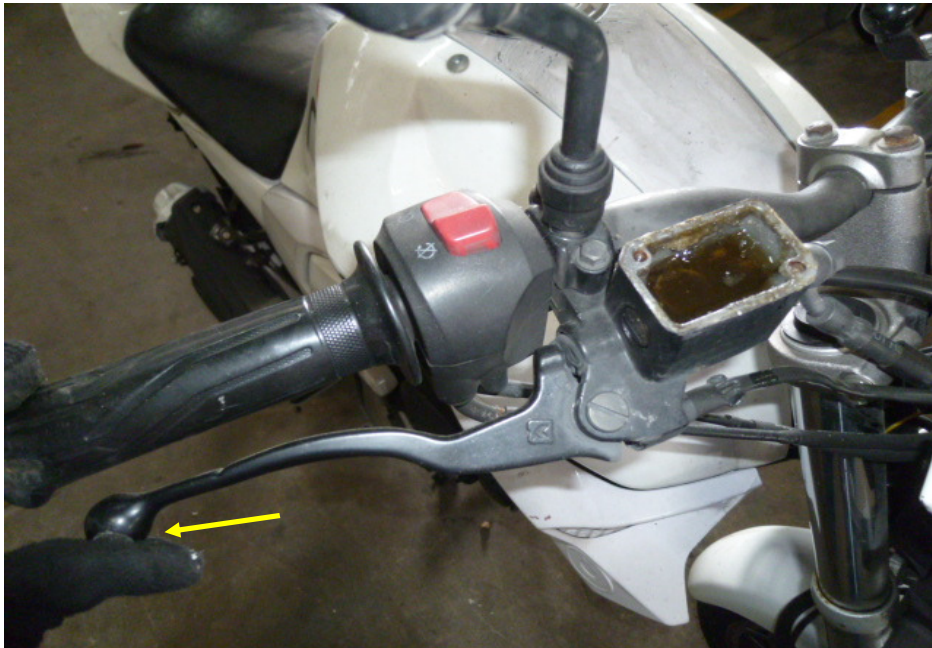
13. Static brake tests conducted on the Motorcycle had appeared to indicate that the front brake system of the Motorcycle was in serviceable condition. There was some resistance felt (spongy like feel) upon pressing the front brake lever. This would indicate that there's no leakage of pressure/vacuum in the front brake system.

Photo 27 shows the front brake lever being depressed. There was some resistance felt (spongy like feel) upon pressing the front brake lever (arrowed). This would indicate that there is no leakage of pressure/vacuum in the front brake system.

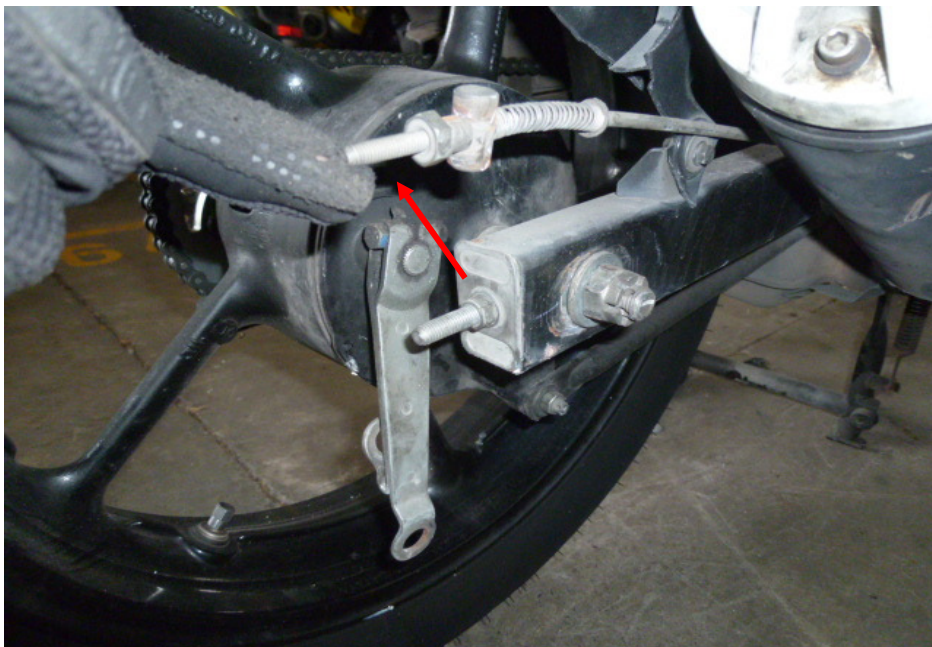
12. The brake system of the Motorcycle was of a semi-hydraulic type, where hydraulic (brake fluid) pressure controls the brake for the front wheel while the brake for the rear wheel is controlled by mechanical means (cables and springs). Our visual examination of the various components in the brake system, like the brake disc, brake caliper, drum, brake lever and brake foot pedal, revealed all to be intact and without damage. There was also no leakage of brake fluid observed along the front brake hose. This was from the respective front brake fluid reservoir to the front brake caliper of the Motorcycle. The brake fluid for the front brake was found to be of sufficient level for operating purposes. However the brake fluid was found to be contaminated. There was also no visible tear or cut observed on the connecting hoses and cables. However the rear brake cable was found to be dislodged as a result of the accident.

14. We subsequently carried out an operational test of the Motorcycle's braking system. This was done by manually pushing the Motorcycle forward and backward, simulating the Motorcycle in motion, and thereafter engaging the front brake and rear brake of the Motorcycle. At the end of the short operational test, we did not observe any abnormal behaviour of the Motorcycle's front braking system. The front wheel of the Motorcycle was able to stop rotating immediately upon depressing the brake lever. However the rear wheel of the Motorcycle was unable to stop rotating immediately upon stepping on the brake pedal due to the dislodged rear brake cable. See photos 22 – 28 below.

Photo 28 shows the rear wheel of the Motorcycle. The type of brake system for the rear wheel was of a mechanical type, controlled by the brake foot pedal of the Motorcycle. Our checks of the spring and drum which are all part of the components in the rear brake system of the Motorcycle reveal all to be intact and without damage. However the rear brake cable was observed to be dislodged as a result of the accident (arrowed).
