# ATA AUTO CONSULTANT

Vehicle No: CB6682X

Make & Model: TOYOTA HIACE HIROOF AUTO 14 SEATER

## ESTIMATE FOR ACCIDENT VEHICLE NOS CB6682X

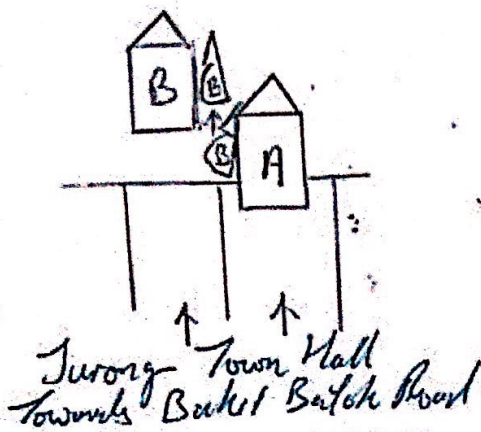
SKETCH PLAN

On mentioned date and time, I was along Jurong Town Hall Road towards Bukit Batok Road. When the traffic signal turn green, I started to move off. Suddenly I felt an impact, I immediately stopped my vehicle. It was vehicle B that came to collided onto my front left.
