Your Ref: TP/IP/10545/2021  
Our Ref : CI/TPD21005747/P

**Fatal Accident Investigation Team**

**MECHANICAL INSPECTION REPORT OF MOTOR LORRY GBD 4265G**

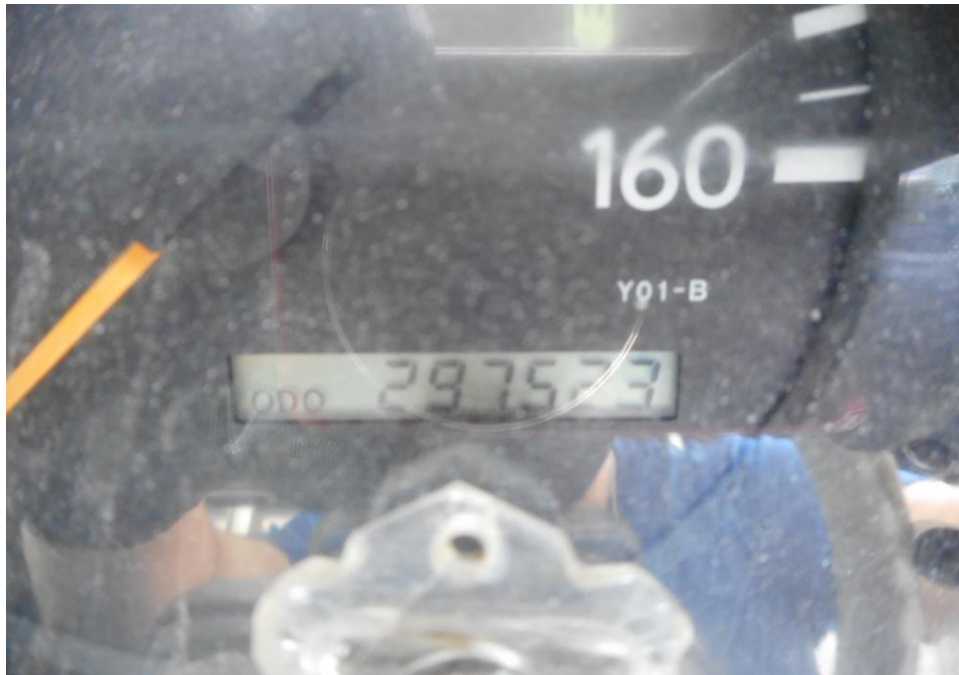
**Photo 1** shows a general view of the instrument cluster of the Motor Lorry at the time of my inspection. The mileage of the Motor Lorry was 297,523 km

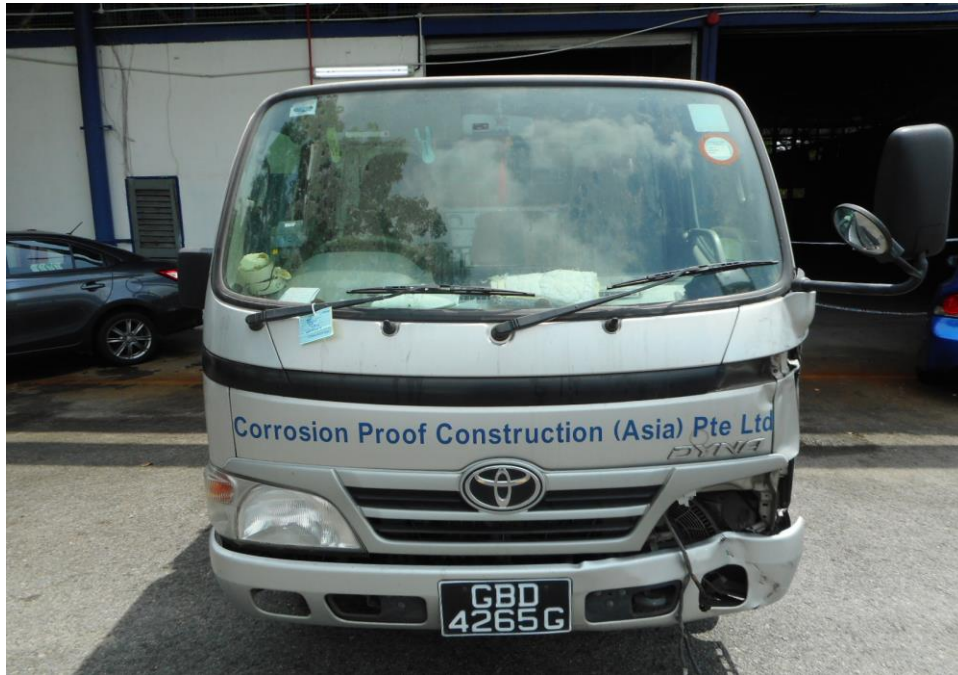
4. The mileage of the Motor Lorry at the time of my inspection was 297,523km.
5. The Motor Lorry was observed to sustained damage at its front portion. Its front left headlamp, front body panel and front bumper were damage at the time of my inspection as a result of the accident.

**Photo 2** shows a general view of the Motor Lorry's frontal portion at the time of my inspection. It appeared to have sustained damage at its front portion. Its front left headlamp, front body panel and front bumper were damage at the time of my inspection as a result of the accident.

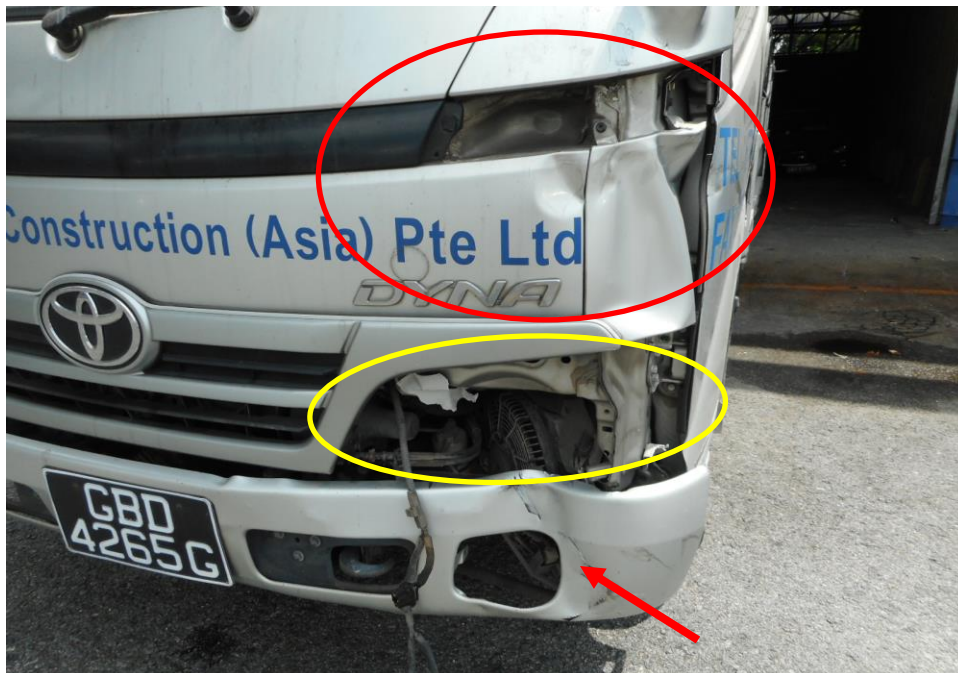
**Photo 3** shows a close up view of the Motor Lorry's front portion at the time of my inspection. Its front left headlamp (yellow circle) and front body panel (red circle) and front bumper (arrowed) was damage at the time of my inspection as a result of the accident.

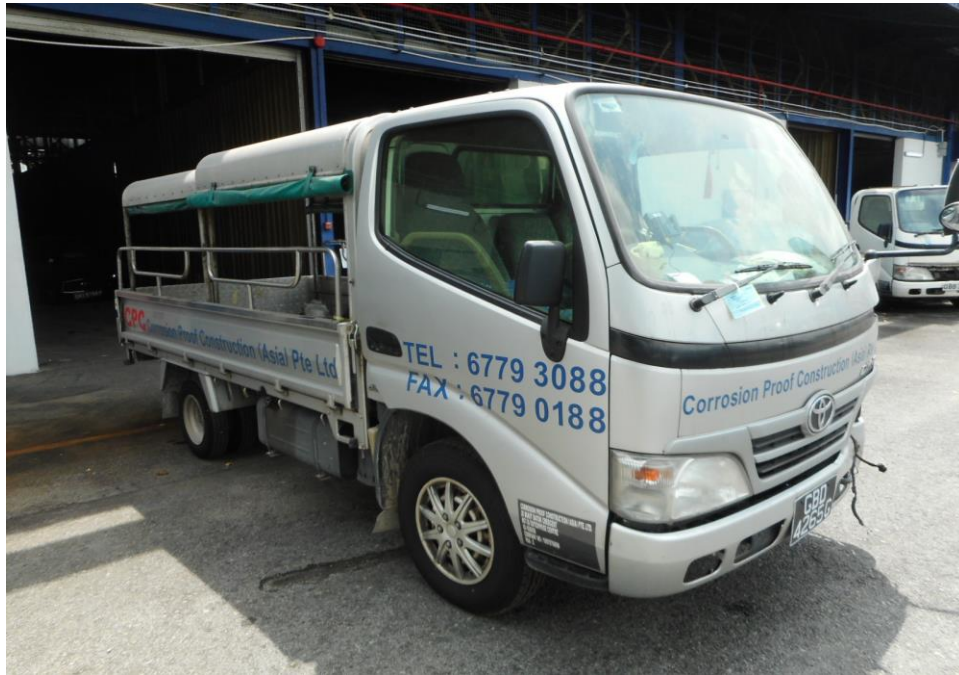
**Photo 4** shows a general view of the right body of the Motor Lorry at the time of my inspection. The Motor Lorry was observed to be intact and unaffected by the accident.

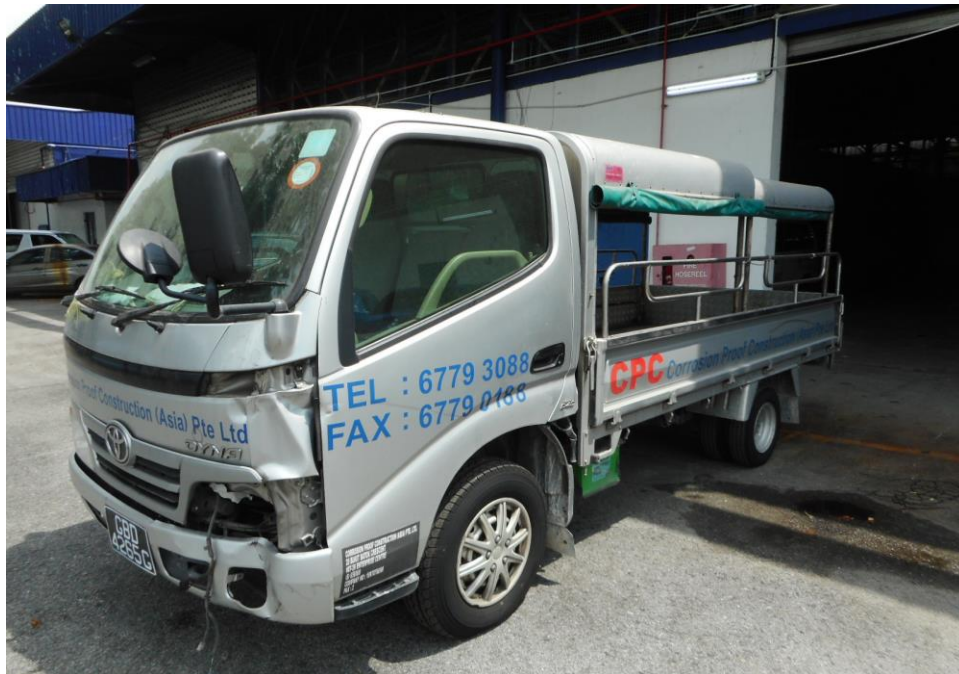
**Photo 5** shows a general view of the left body of the Motor Lorry at the time of my inspection. The Motor Lorry was observed to be intact and unaffected by the accident.

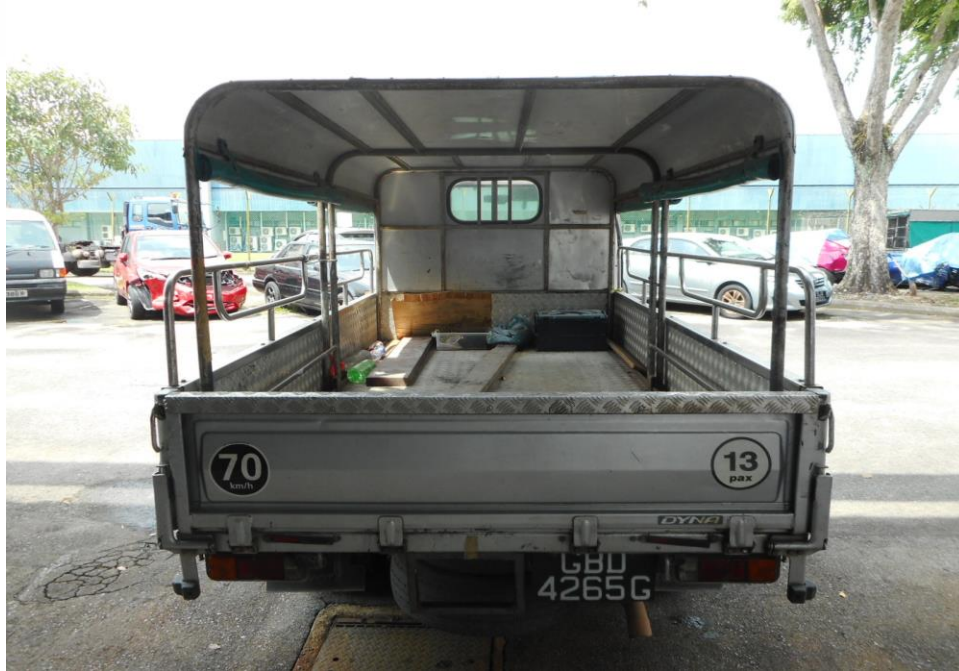
**Photo 6** shows a general view of the rear body of the Motor Lorry at the time of my inspection. The Motor Lorry was observed to be intact and unaffected by the accident.

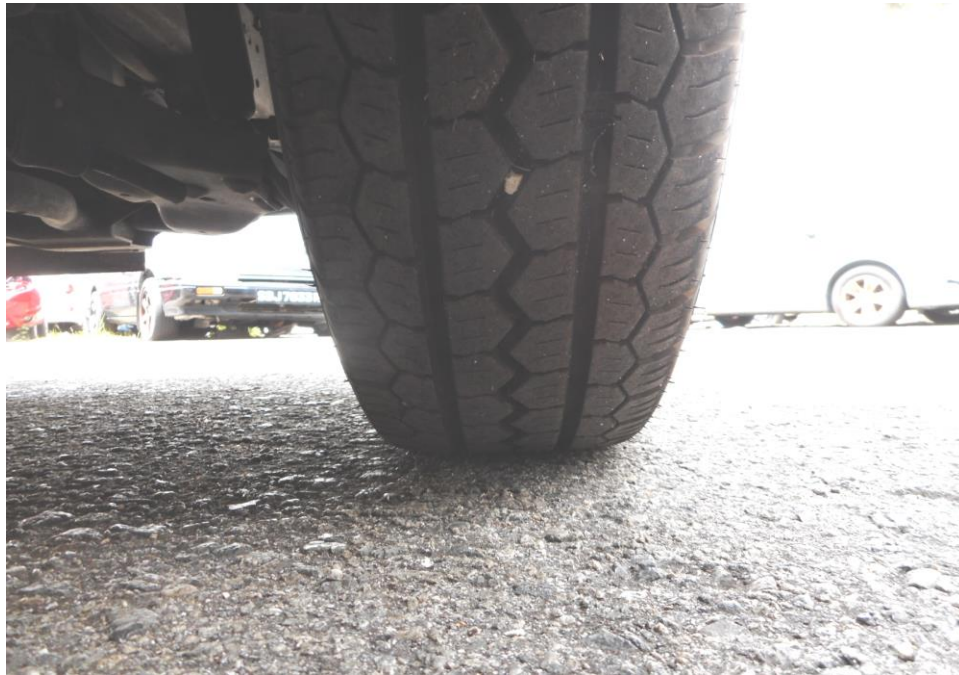
**Photo 7** shows the condition of the front right tyre of the Motor Lorry, which was observed to be in serviceable condition with remaining tread depth of approximately 8mm. The tyre, which was wrapped around standard steel wheel rim, was also observed to be sufficiently inflated for vehicular operation. There was no tear, cut or burst mark(s) on the outer and the inner sidewalls as well as across the tread of the 6 tyres that were fitted on the Motor Lorry.

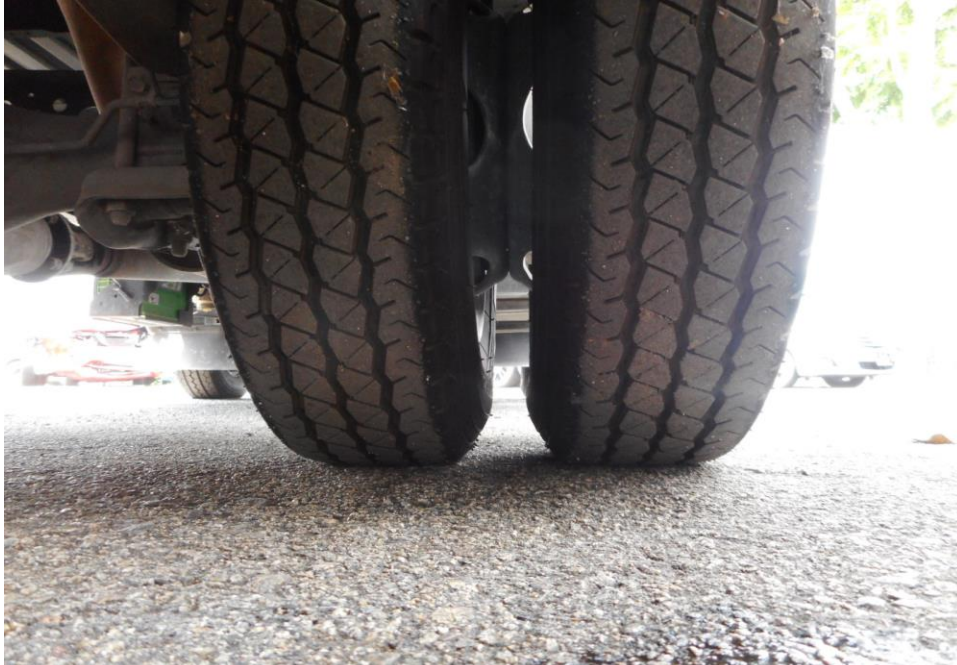
**Photo 8** shows the condition of the rear right tyre of the Motor Lorry, which was observed to be in serviceable condition with remaining tread depth of approximately 5.5mm. The tyre, which was wrapped around standard steel wheel rim, it was observed to be sufficiently inflated for vehicular operation.

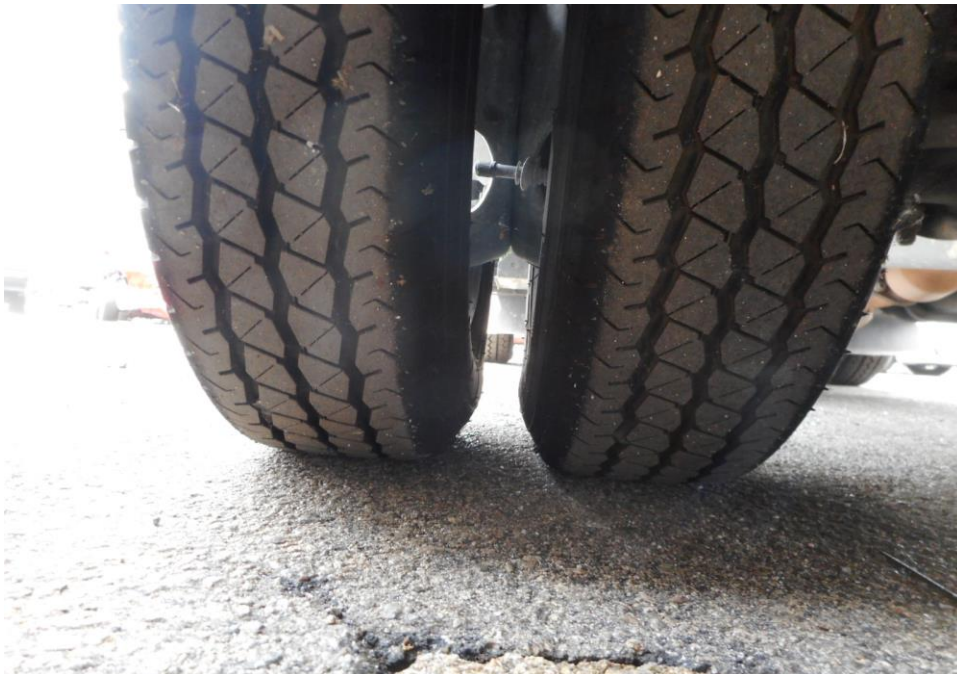
**Photo 9** shows the condition of the rear left tyres of the Motor Lorry, which was observed to be in serviceable condition with remaining tread depth of approximately 5.8mm. The tyres, which were wrapped around standard steel wheel rim, were also observed to be sufficiently inflated for vehicular operation. There was also no damage found on all 6 steel wheel rims of the Motor Lorry.

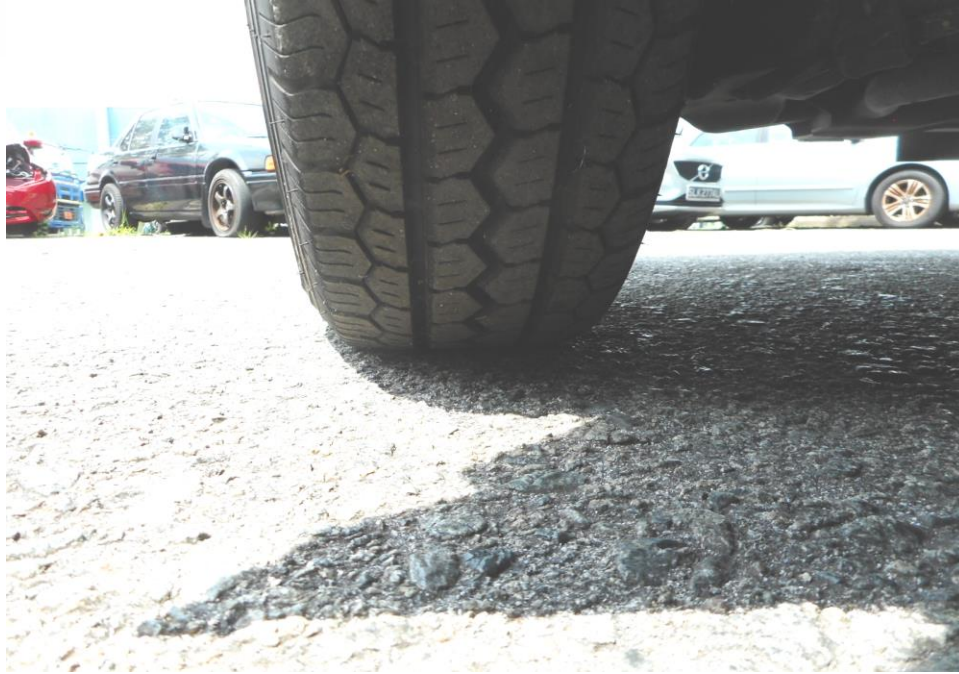
**Photo 10** shows the condition of the rear right tyres of the Motor Lorry, which were observed to be in serviceable condition with remaining, tread depth of approximately 7.7mm. There was also no tear, cut or burst mark(s) on the outer and the inner sidewalls as well as across the tread of the 6 tyres that were fitted on the Motor Lorry.

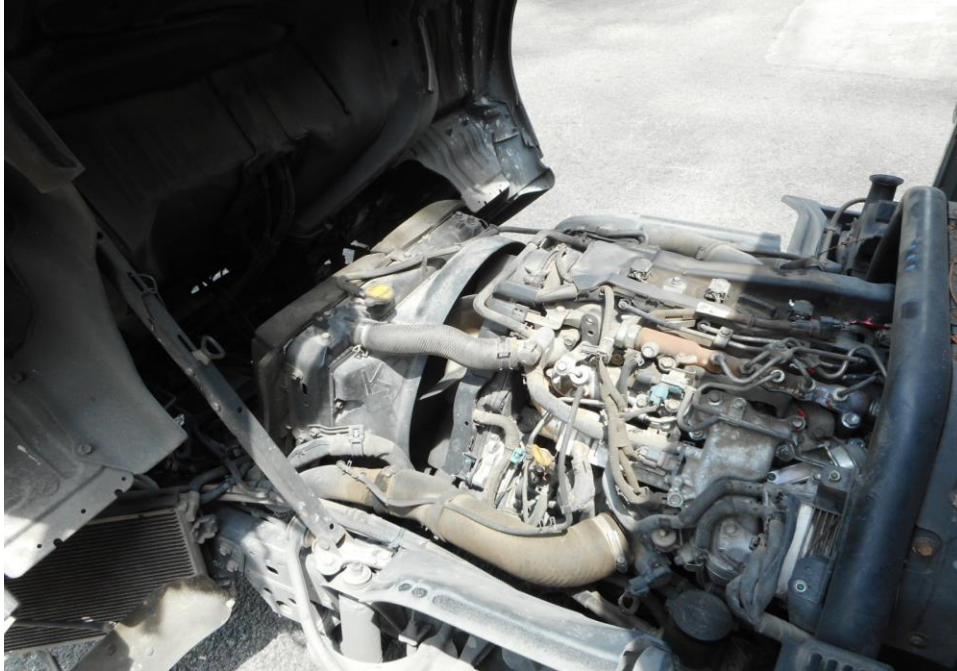
**Photo 11** shows a general view of the Motor Lorry's engine compartment, which was accessed by lifting the front cabin of the Motor Lorry. The various parts and components inside the engine compartment were unaffected by the accident. There was also no sign(s) or indication(s) of fresh fluid leakage and/or fluid stain within the engine compartment

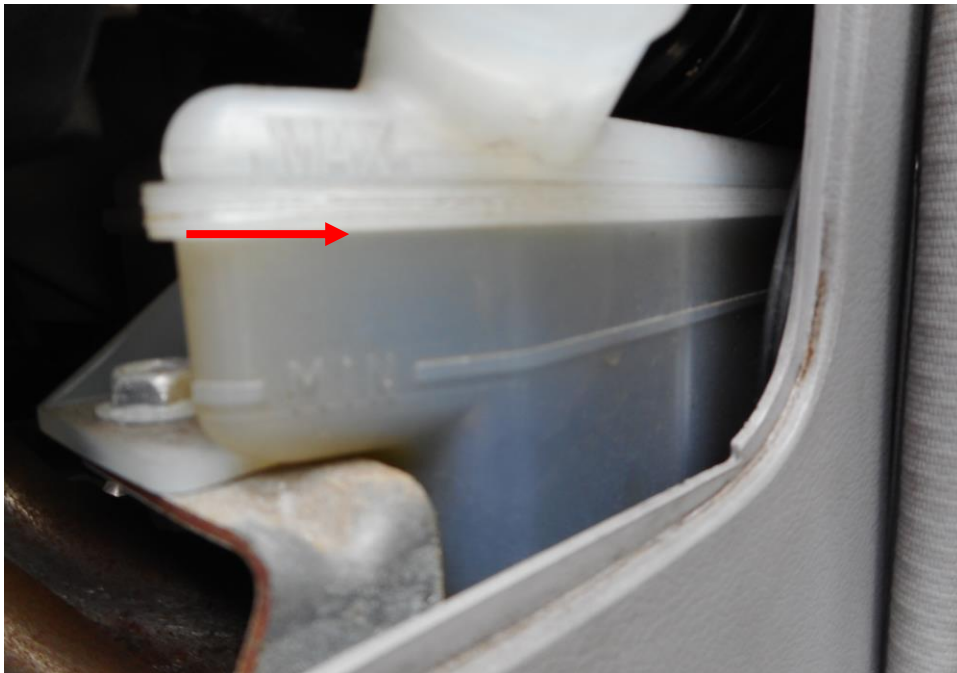
**Photo 12** shows the brake fluid reservoir of the Motor Lorry at the time of my inspection. The brake fluid was observed to be of sufficient level (arrowed) and without any visible contamination.

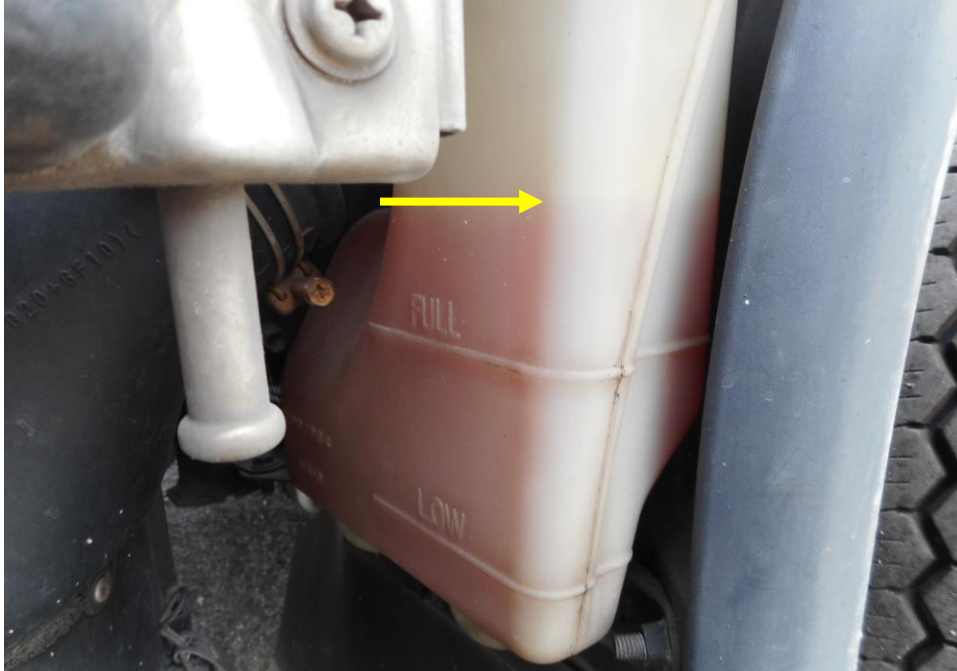
**Photo 13** shows the engine coolant reservoir of the Motor Lorry at the time of my inspection. The engine coolant was observed to be of sufficient level (arrowed) and without any visible contamination.

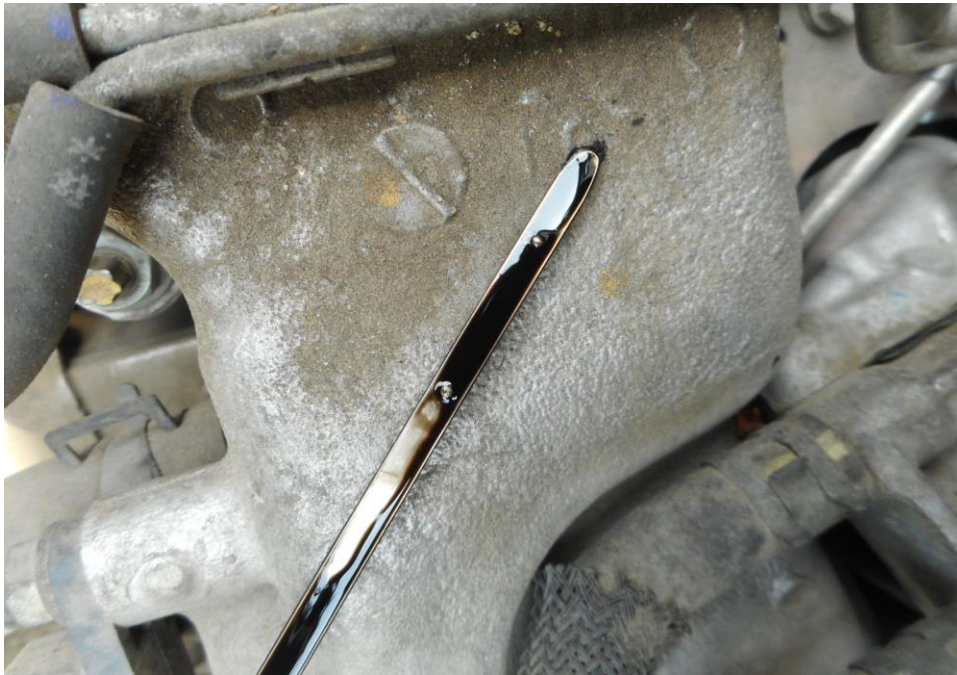
**Photo 14** shows the engine oil dip stick of the Motor Lorry at the time of my inspection. The engine oil was observed to be of sufficient level and without any visible contamination.

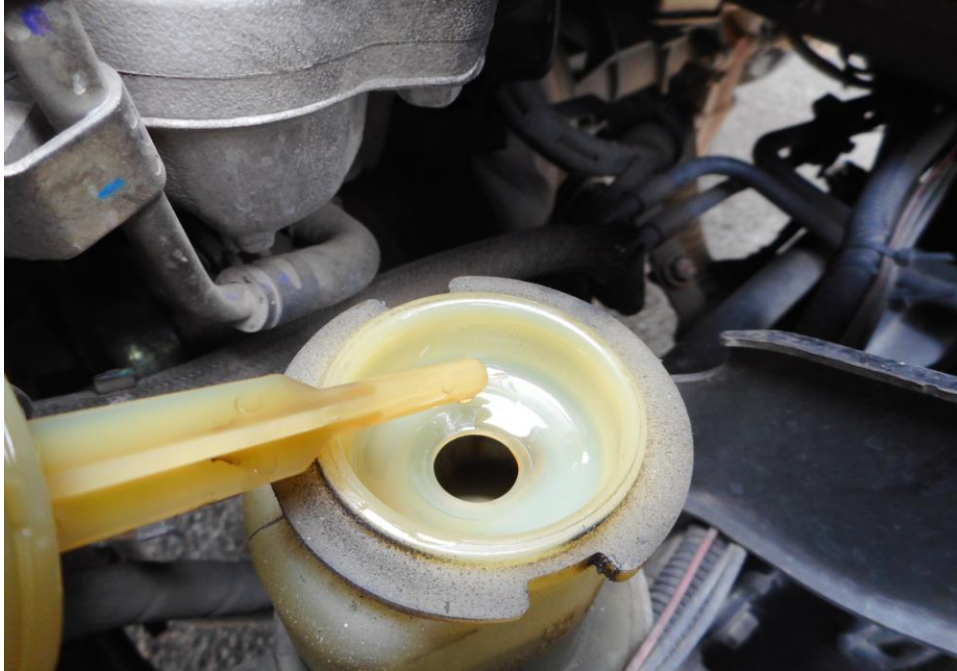
**Photo 15** shows the power steering fluid reservoir of the Motor Lorry at the time of my inspection. The power steering fluid was observed to be of sufficient level (arrowed) and without any visible contamination.

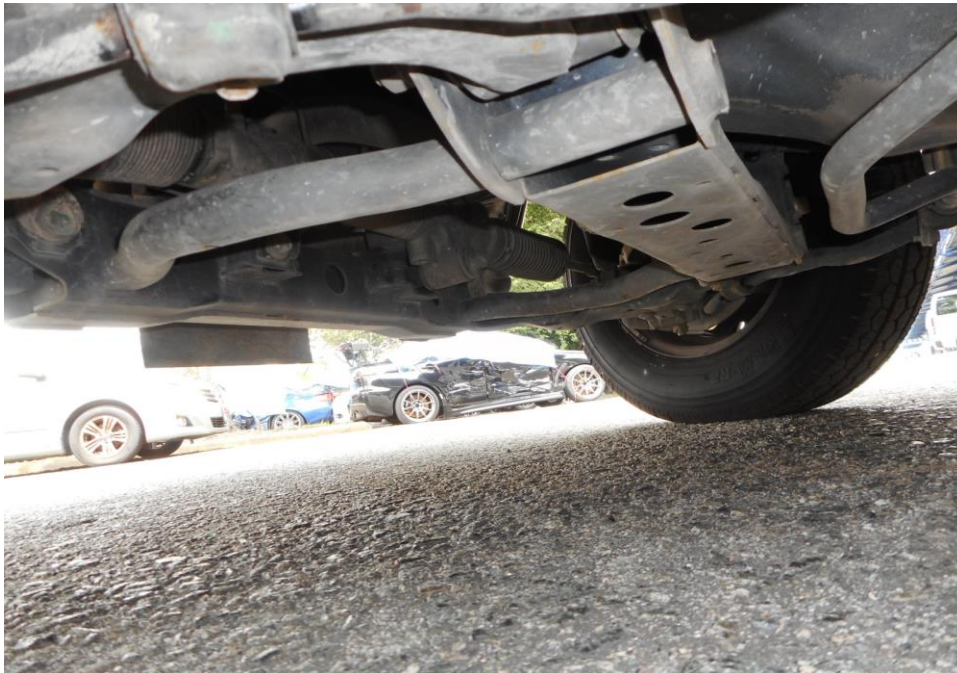
**Photo 16** shows the undercarriage of the Motor Lorry, at the area where the engine housing and transmission housing are located. I did not find any sign(s) or indication(s) of fluid leak and/or fluid stain(s) on the underside of the Motor Lorry.

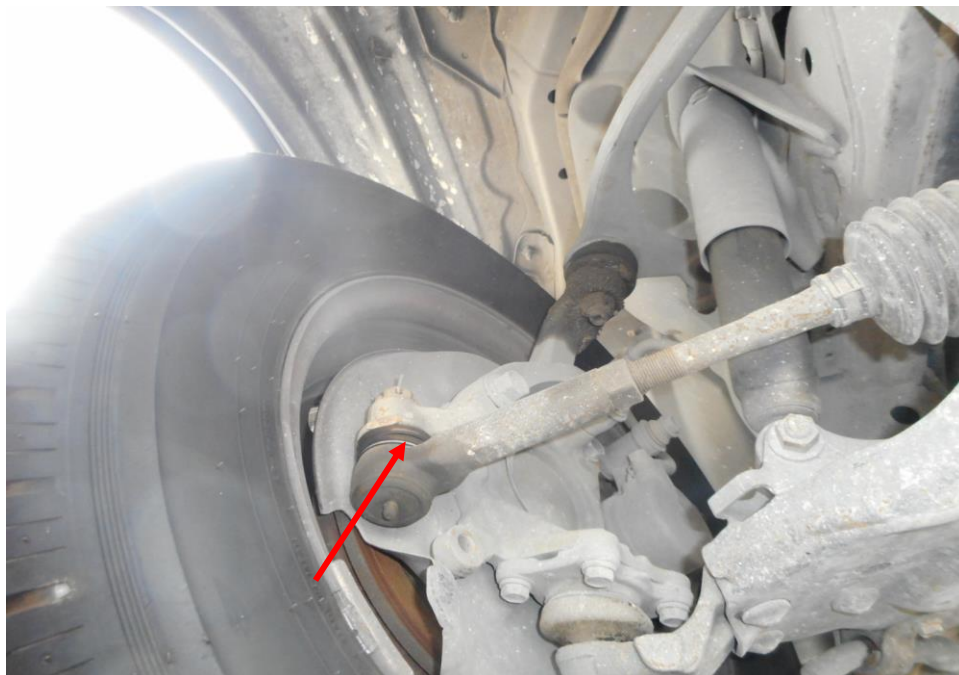
**Photo 17** shows the various undercarriage components at the front right wheel of the Motor Lorry, in particular the steering tie rod end (arrowed). The various steering components were all found to be intact, suggesting that the steering system of the Motor Lorry was likely to be in serviceable condition at the material time of accident. There was also no sign of fluid stain(s) observed on the various undercarriage components.

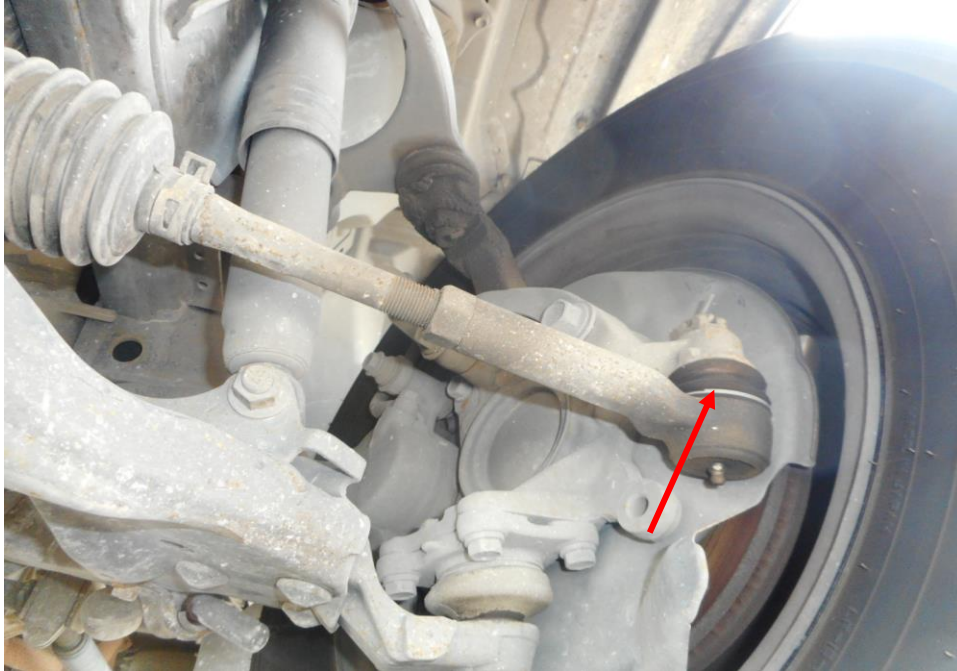
**Photo 18** shows the various undercarriage components at the front left wheel of the Motor Lorry, in particular the steering tie rod end (arrowed). The various undercarriage components of the Motor Lorry were all found to be intact without any visible damage. There was also no sign of fluid stain(s) observed on the various undercarriage components.

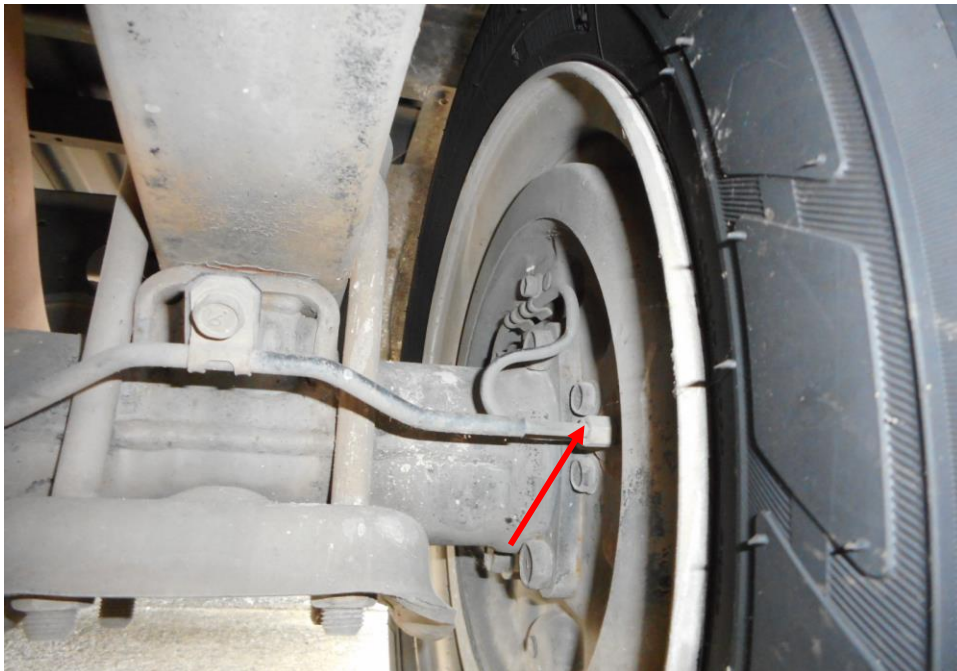
**Photo 19** shows the brake pipe (arrowed) at the rear right wheel of the Motor Lorry. I did not observe any leakage of brake fluid at the time of my inspection of the Motor Lorry. My static tests of the Motor Lorry's braking system, along with my visual examination of the various mechanical components in the braking system, had indicated that there was no internal leakage of pressure/vacuum. Hence the braking system of the Motor Lorry was likely to be in serviceable condition at the material time of accident.

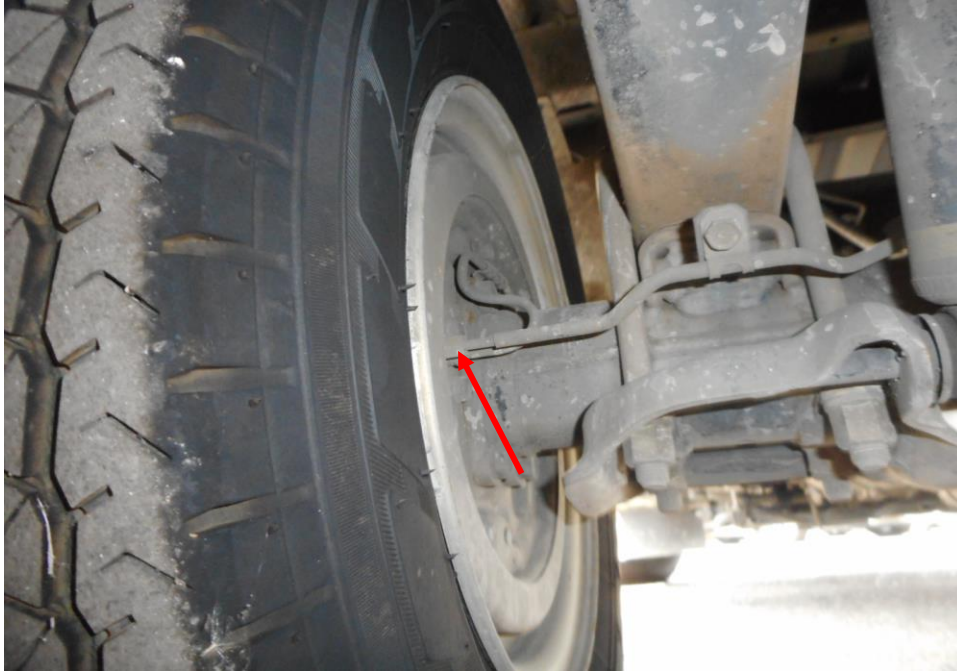
**Photo 20** shows the brake pipe (arrowed) at the rear left wheel of the Motor Lorry. I did not observe any leakage of brake fluid at the time of my inspection of the Motor Lorry. My static tests of the Motor Lorry's braking system, along with my visual examination of the various mechanical components in the braking system had indicated that there was no internal leakage of pressure/vacuum. Hence the braking system of the Motor Lorry was likely to be in serviceable condition at the material time of accident.

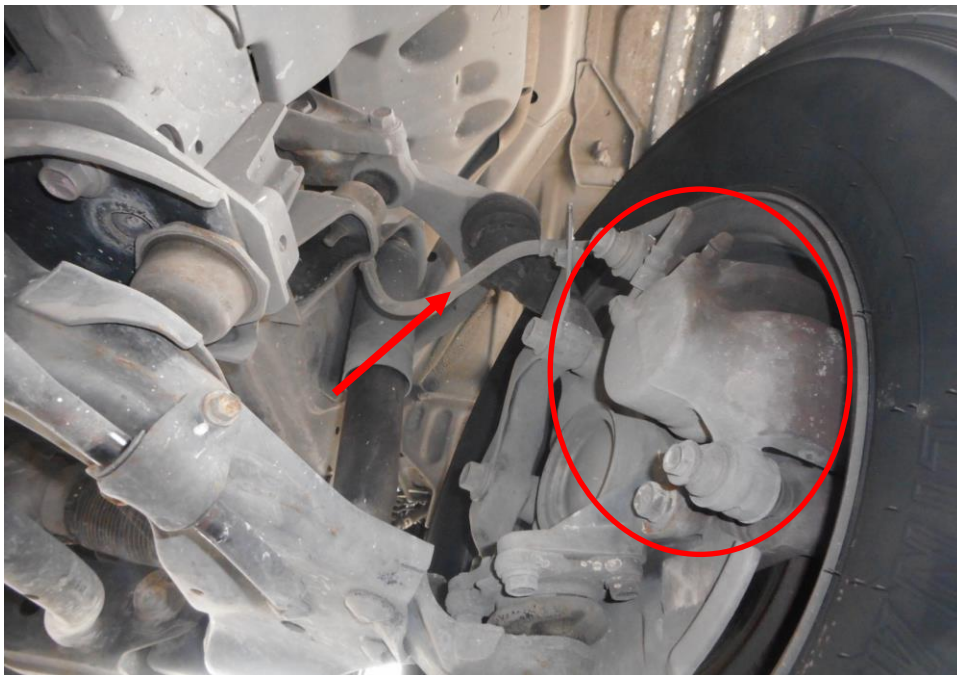
**Photo 21** shows the brake hose/pipe (arrowed) at the front right wheel of the Motor Lorry. No leakage of brake fluid was observed. Visual examination of the various components of the braking system like the brake caliper (circled), brake booster, brake pedal etc had revealed all to be intact and without visible damage at the time of accident. There was also no sign of fluid stain(s) observed on the various undercarriage components.

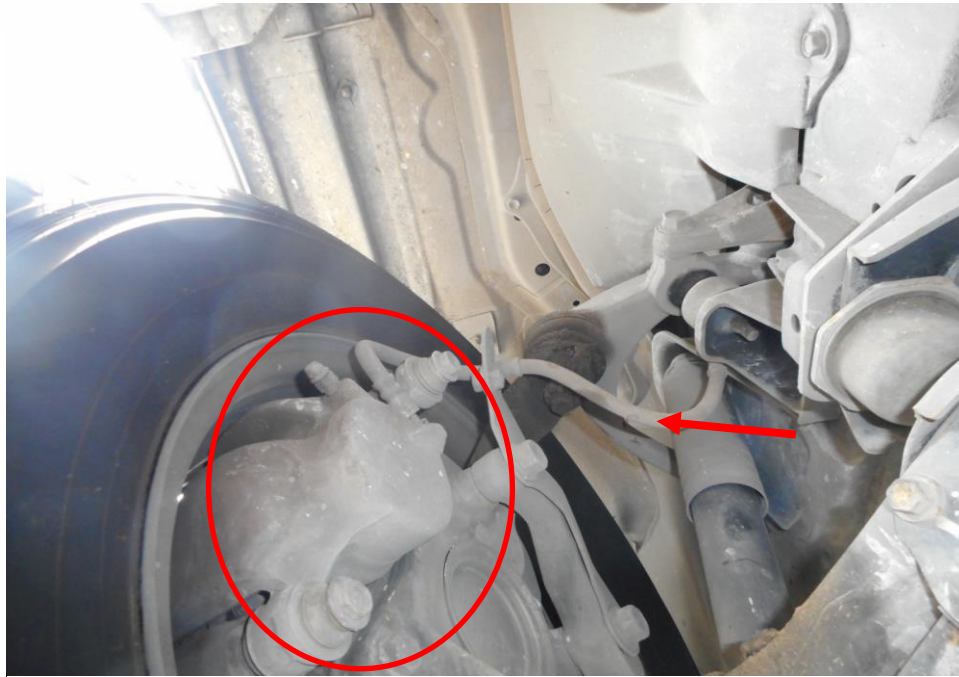
**Photo 22** shows the brake hose/pipe (arrowed) at the front left wheel of the Motor Lorry. No leakage of brake fluid was observed. Visual examination of the various components of the braking system like the brake caliper (circled), brake booster, brake pedal etc had revealed all to be intact and without visible damage at the time of accident. There was also no sign of fluid stain(s) observed on the various undercarriage components.

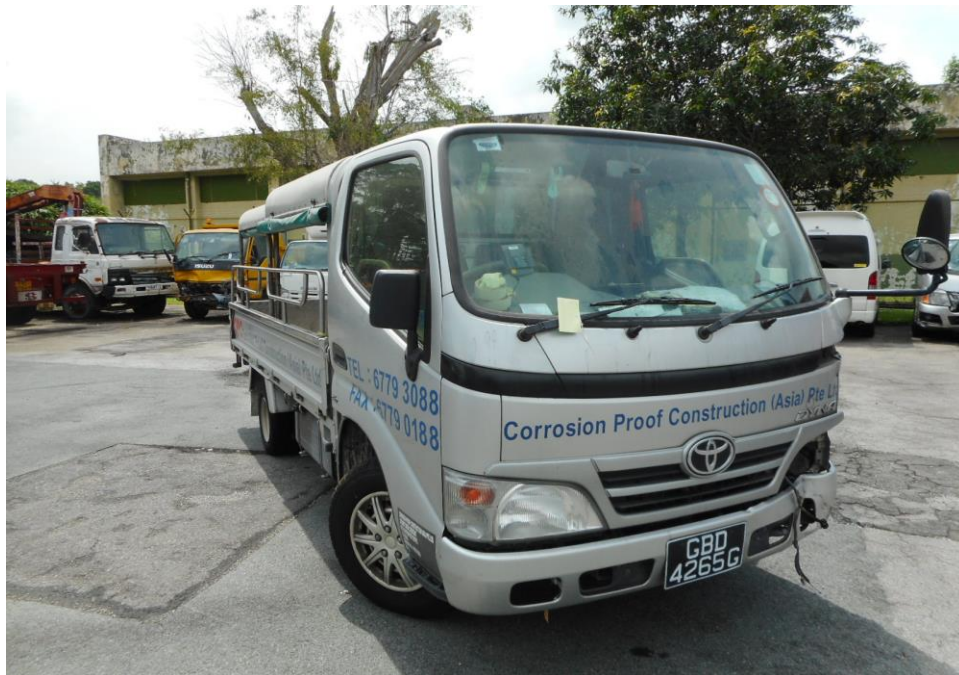
**Photo 23** shows the front right wheel of the Motor Lorry turned to its full left. During my steering system test, I did not experience any abnormal free play and/or resistance when I had turned the steering wheel towards full left and full right. This would suggest that the steering system of the Motor Lorry was likely to be in serviceable condition at the material time of accident.
