Your Ref: TP/IP/15079/2021
Our Ref : CI/TPD21005748/P

5th July 2021

MECHANICAL INSPECTION REPORT OF MOTOR TRAILER, JPL 6977

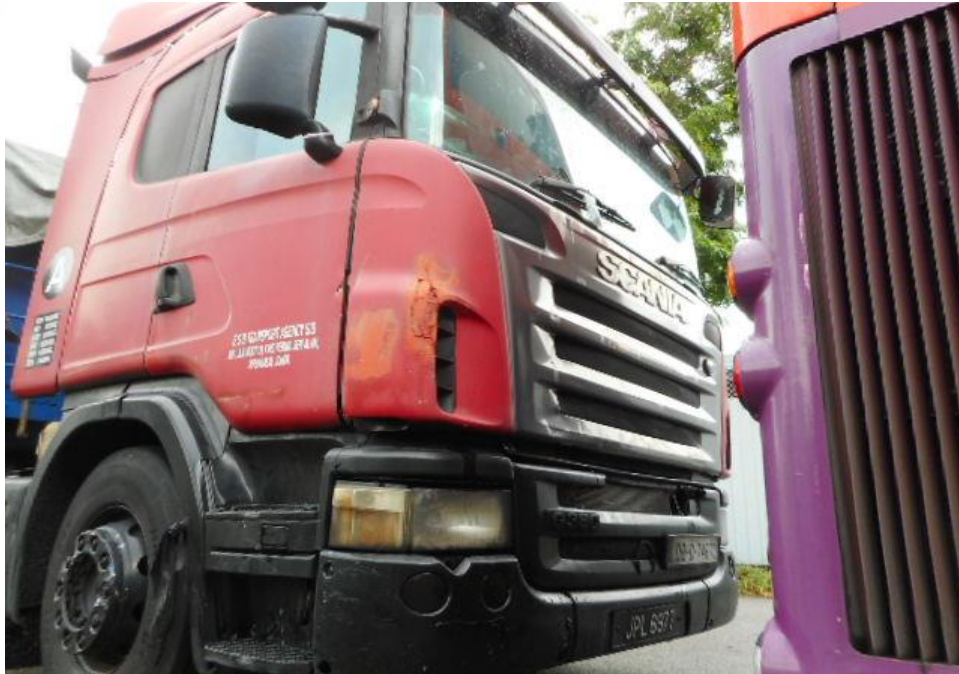
Photo 1 shows a general view of the front body of the Motor Trailer at the time of my inspection. The Motor Trailer was observed to be intact and unaffected by the accident.

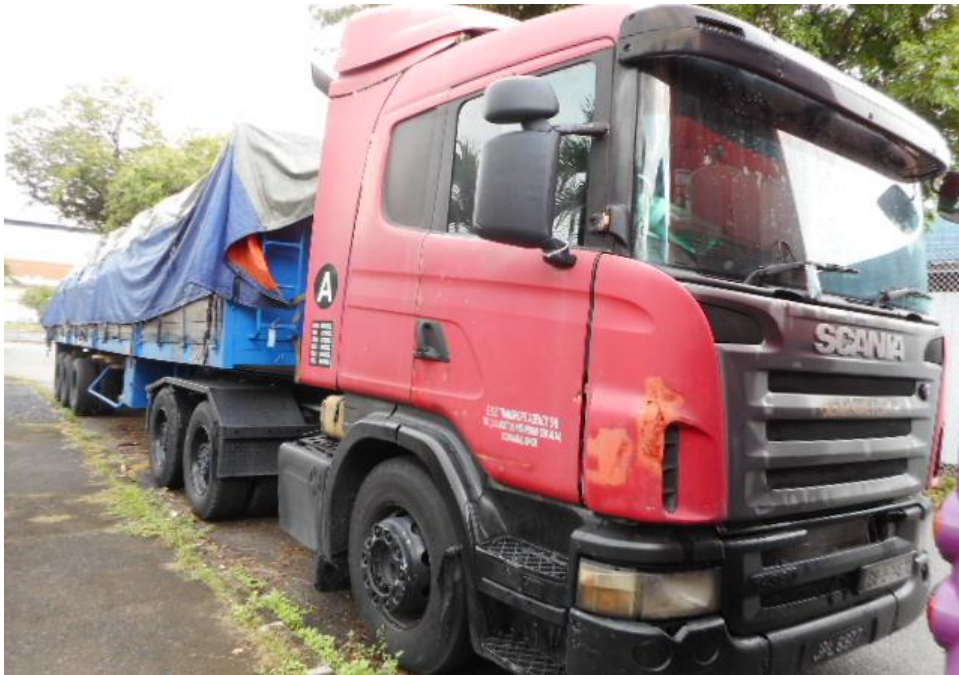
Photo 2 shows a general view of the right body of the Motor Trailer at the time of my inspection. The Motor Trailer was observed to be intact and unaffected by the accident.

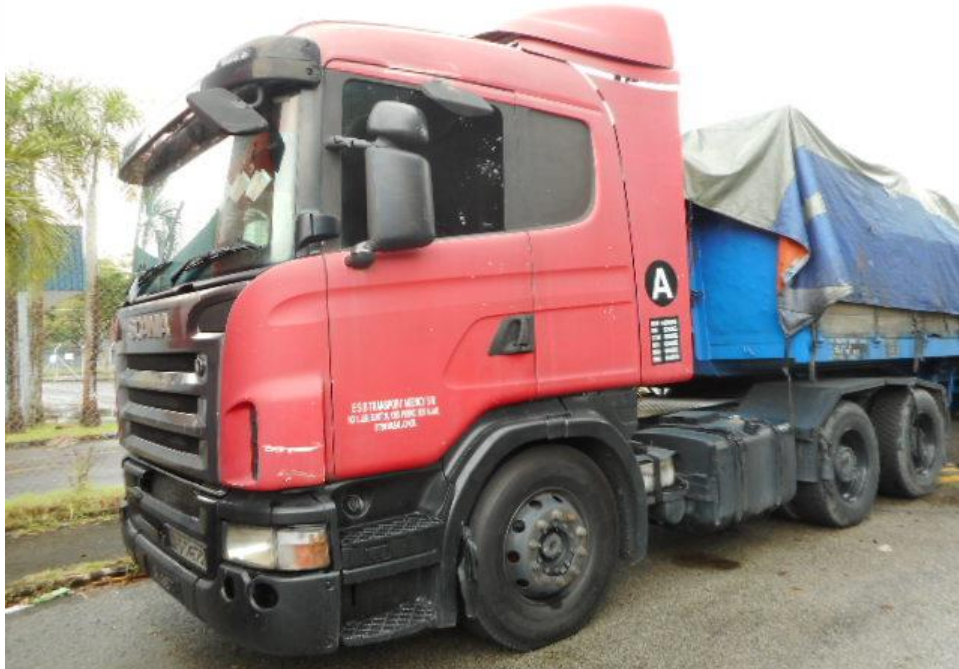
Photo 3 shows a general view of the left body of the Motor Trailer at the time of my inspection. The Motor Trailer was observed to be intact and unaffected by the accident.

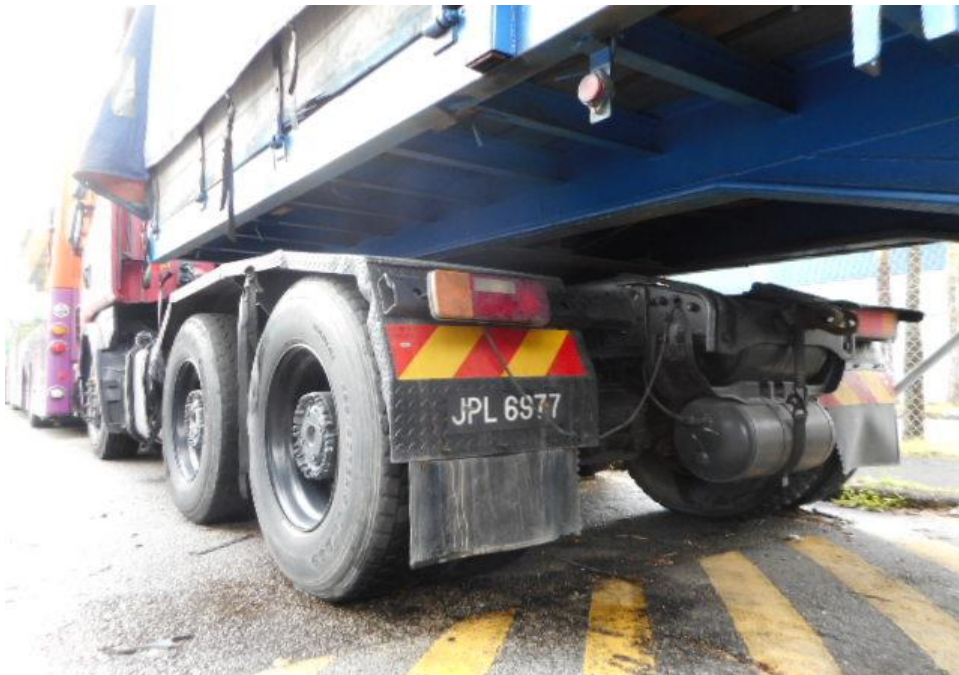
Photo 4 shows a general view of the Motor Trailer's rear body at the time of my inspection. The Motor Trailer was observed to be intact and unaffected by the accident.

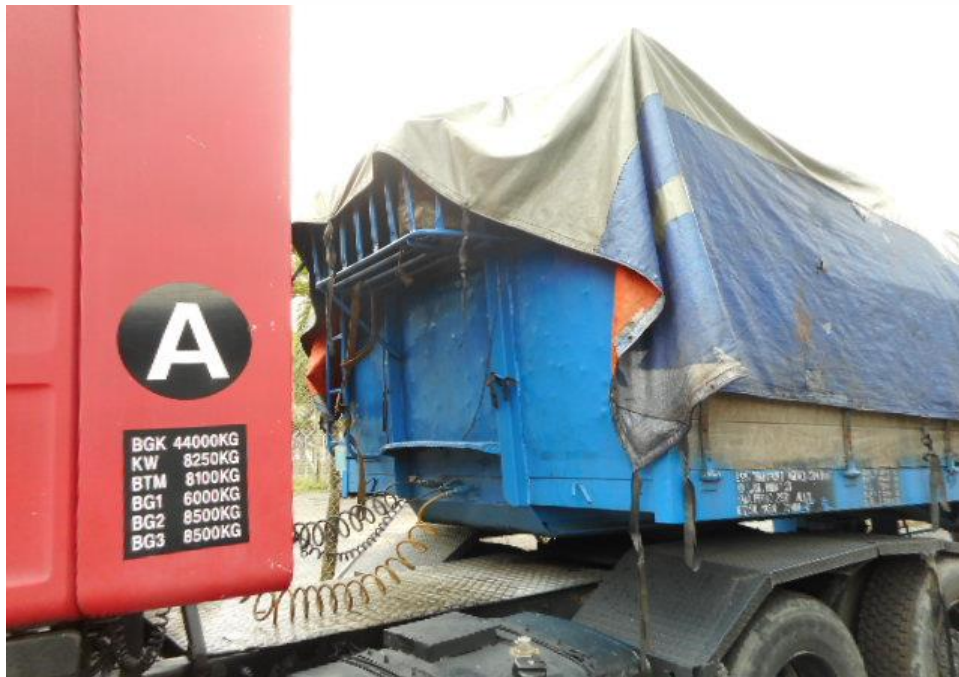
Photo 5 shows a general view of the Trailer front body at the time of my inspection. The Trailer was observed to be intact.

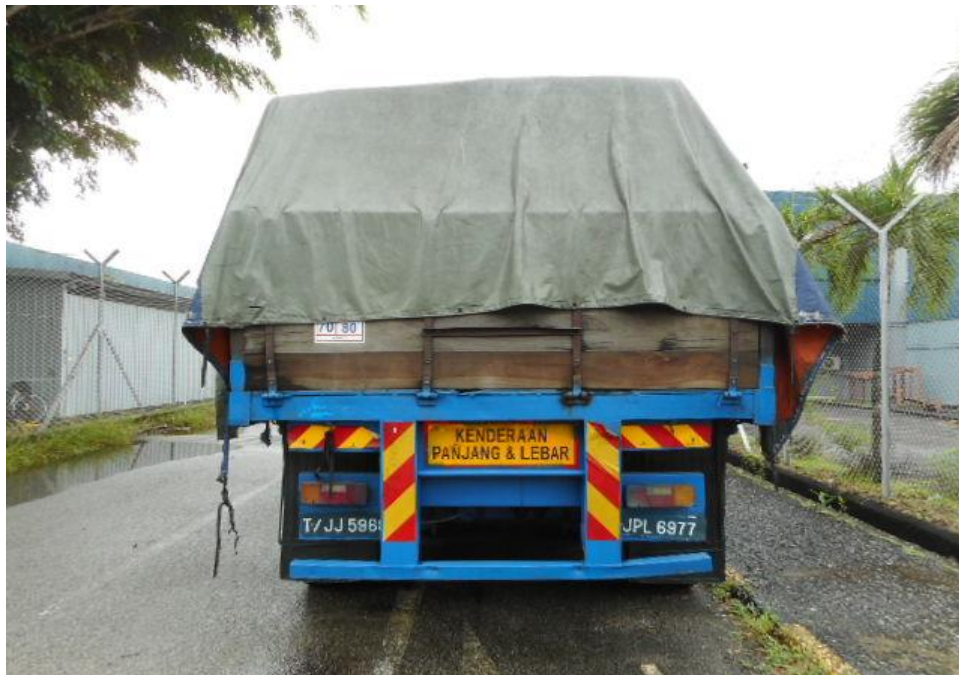
Photo 6 shows a general view of the rear body at the time of my inspection. The Trailer was observed to be intact and unaffected by the accident.

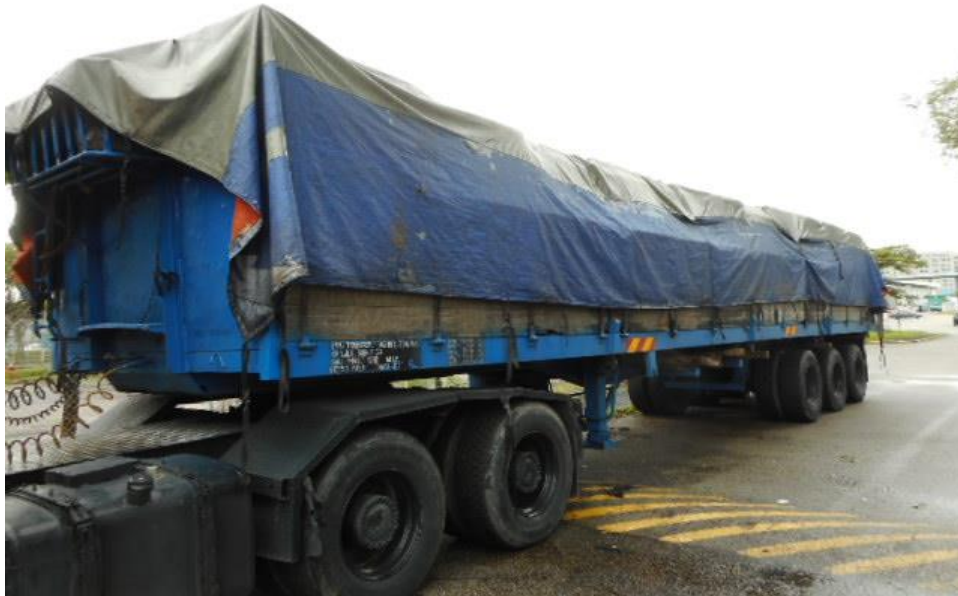
Photo 7 shows a general view of the Trailer left body at the time of my inspection. The Trailer was observed to be intact and unaffected by the accident.

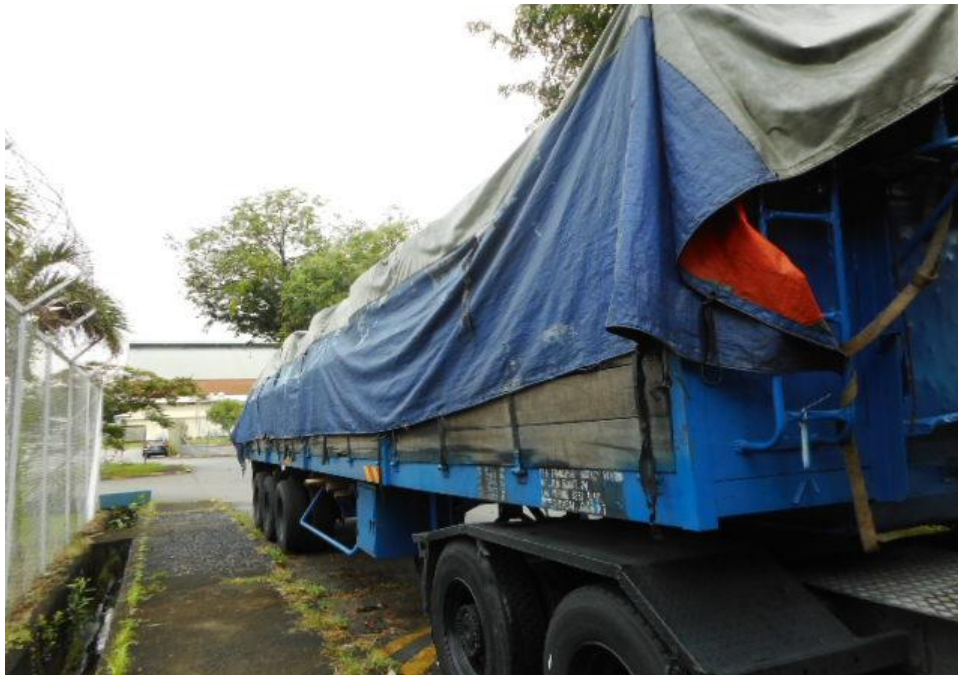
Photo 8 shows a general view of the Trailer right body at the time of my inspection. The Trailer was observed to be intact and unaffected by the accident.

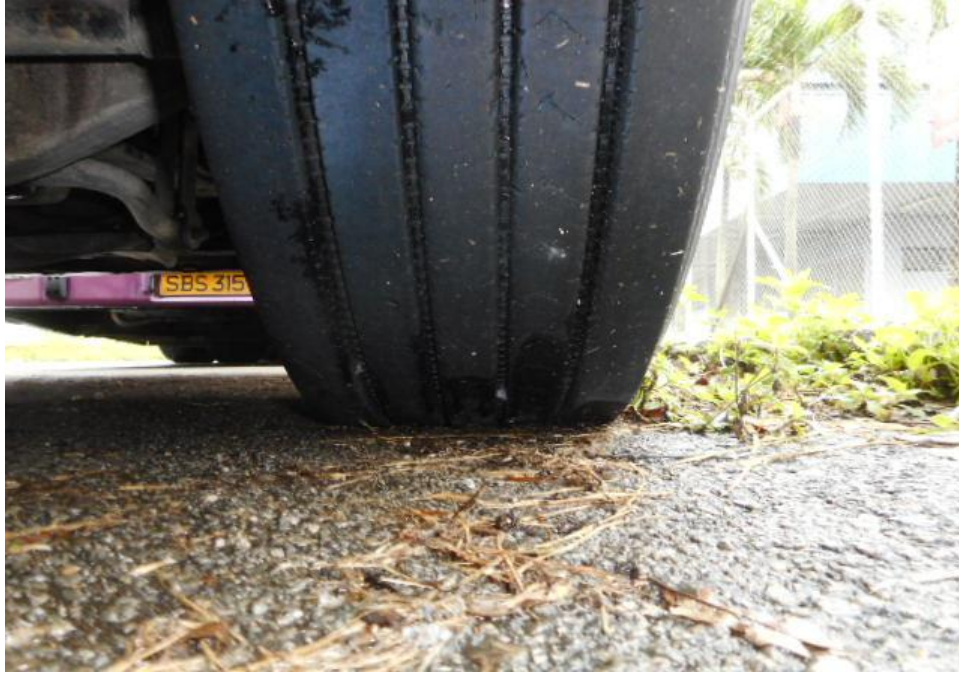
Photo 9 shows the condition of the front right tyre of the Motor Trailer, which was observed to be in serviceable condition with remaining tread depth of approximately .8.9 mm. The tyre, which was wrapped around standard steel wheel rim, was also observed to be sufficiently inflated for vehicular operation. There was no tear, cut or burst mark(s) on the outer and the inner sidewalls as well as across the tread of the 10 tyres that were fitted on the Motor Trailer.

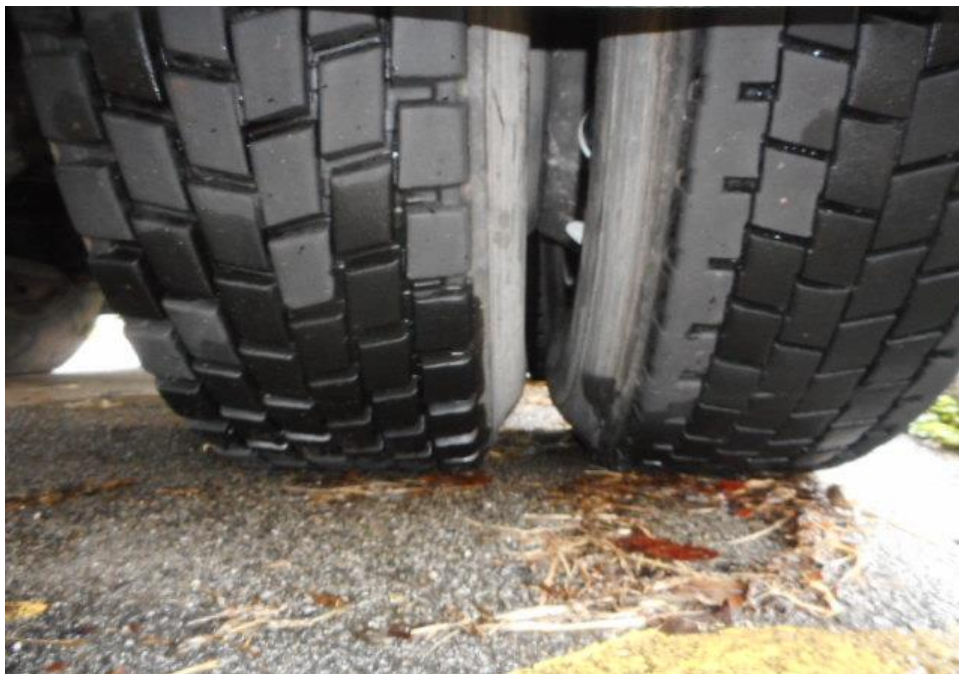
Photo 10 shows the condition of the rear right tyre of the Motor Trailer, which was observed to be in serviceable condition with remaining tread depth of approximately 10.8mm. The tyre, which was wrapped around standard steel wheel rim, was also observed to be sufficiently inflated for vehicular operation.

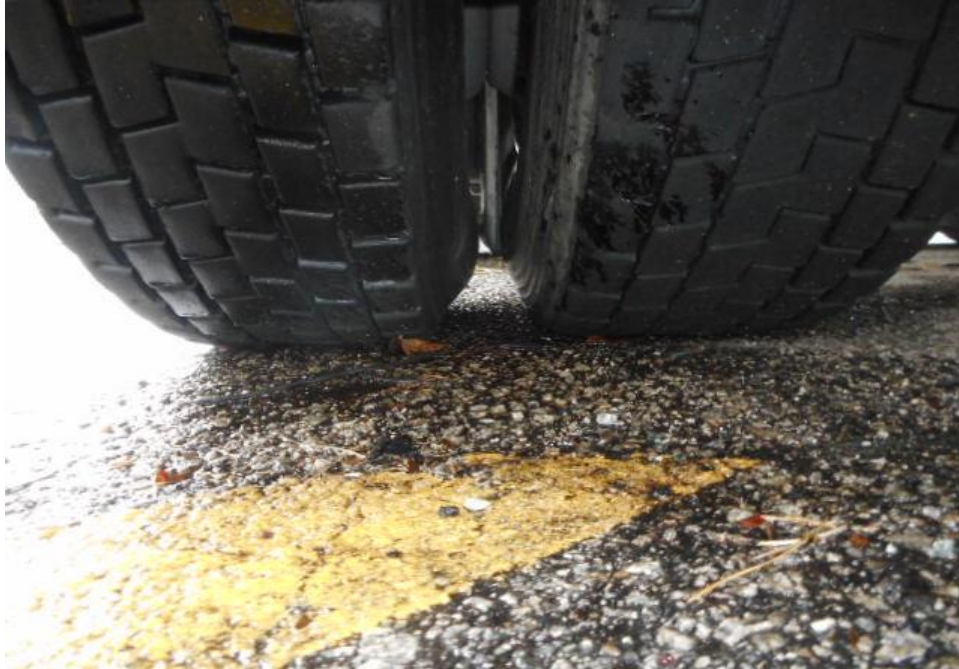
Photo 11 shows the condition of the rear left tyres of the Motor Trailer, which was observed to be in serviceable condition with remaining tread depth of approximately 6.3mm. The tyres, which were wrapped around standard steel wheel rim, were also observed to be sufficiently inflated for vehicular operation. There was also no damage found on all 10 steel wheel rims of the Trailer.

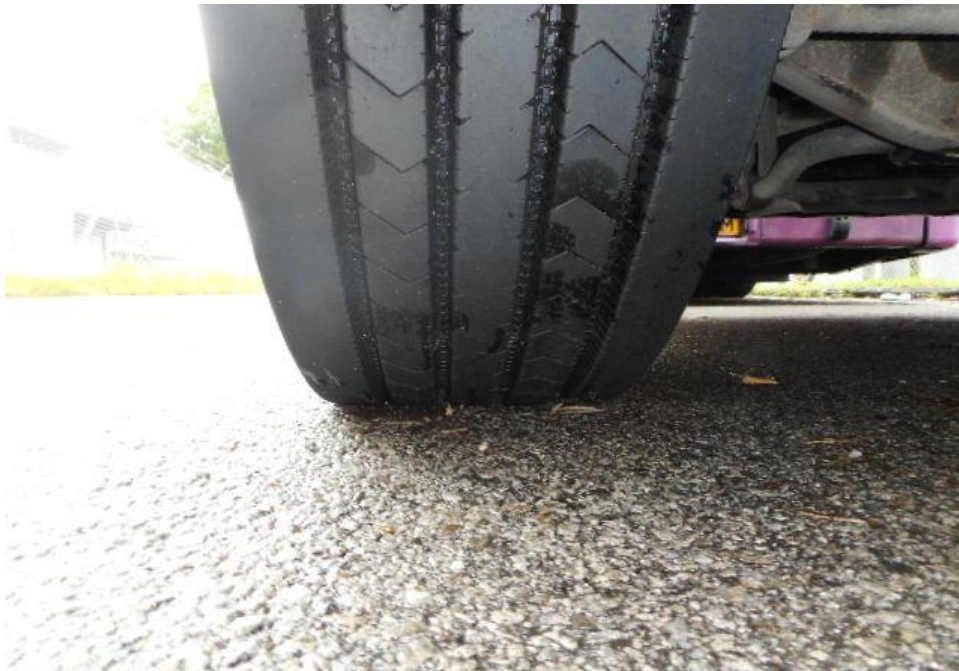
Photo 12 shows the condition of the front left tyres of the Motor Trailer, which were observed to be in serviceable condition with remaining tread depth of approximately 13.1mm. There was also no tear, cut or burst mark(s) on the outer and the inner sidewalls as well as across the tread of the 10 tyres that were fitted on the Trailer.

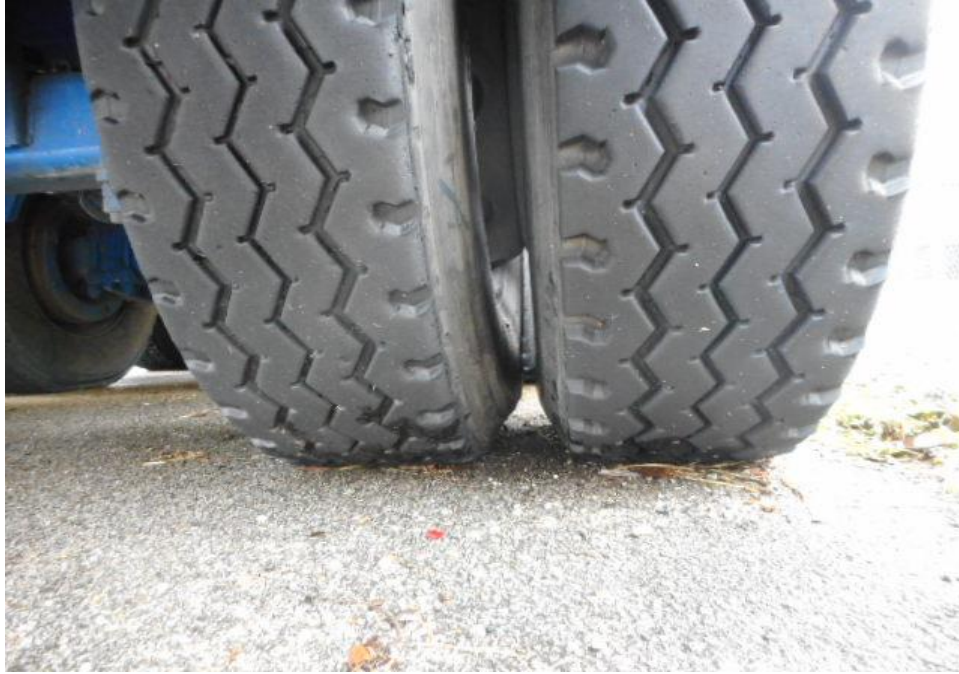
Photo 13 shows the condition of the right tyres of the Trailer, which was observed to be in serviceable condition with remaining tread depth of approximately 10.6mm. The tyre, which was wrapped around standard steel wheel rim, was also observed to be sufficiently inflated for vehicular operation.

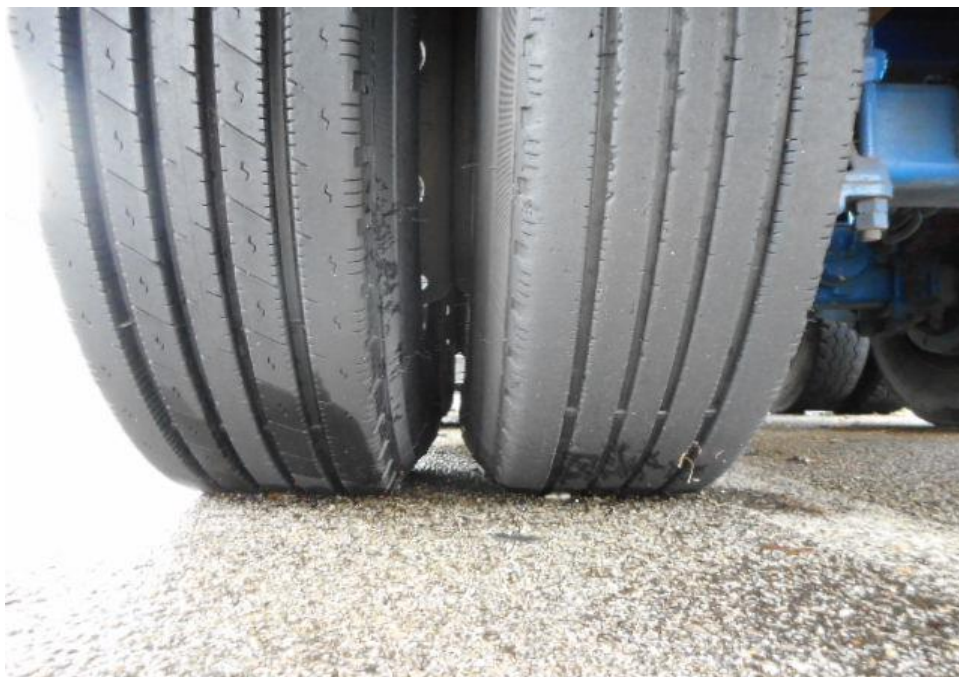
Photo 14 shows the condition of the left tyres of the Trailer, which was observed to be in serviceable condition with remaining tread depth of approximately 13.9mm. The tyres, which were wrapped around standard steel wheel rim, were also observed to be sufficiently inflated for vehicular operation. There was also no damage found on all 12 steel wheel rims of the Trailer.

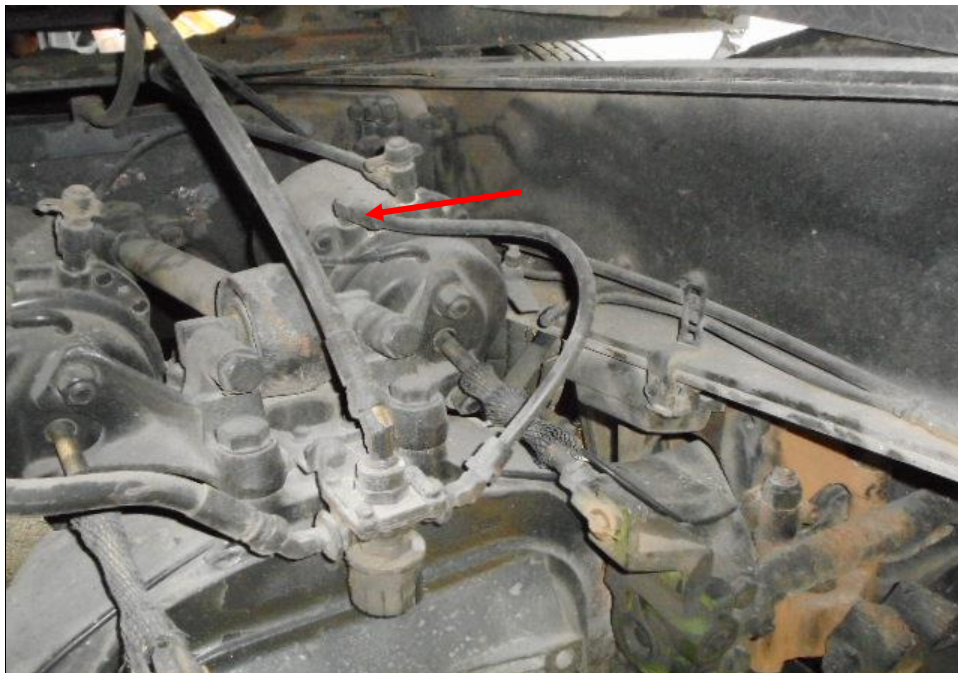
Photo 15 shows the brake pipe (arrowed) at the rear right wheel of the Motor Trailer. I did not observe any leakage of brake fluid at the time of my inspection of the Motor Trailer. My visual examination of the various mechanical components in the braking system, had indicated that there was no internal leakage of pressure/vacuum and there components were generally in good condition.

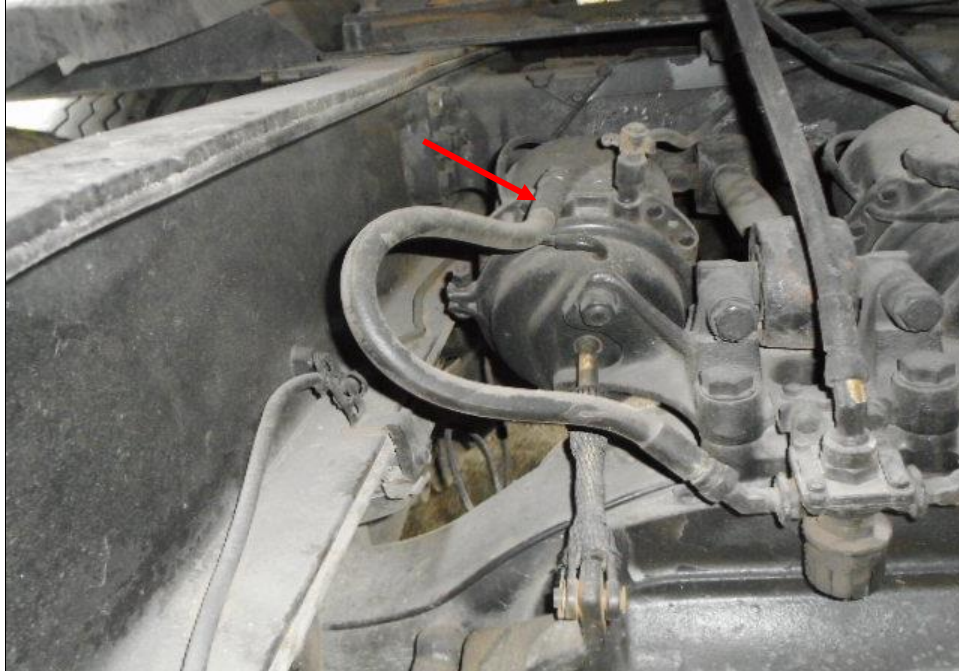
Photo 16 shows the brake pipe (arrowed) at the rear left wheel of the Motor Trailer. I did not observe any leakage of brake fluid at the time of my inspection of the Motor Trailer. My static tests of the Motor Trailer's braking system, along with my visual examination of the various mechanical components in the braking system, had indicated that there was no internal leakage of pressure/vacuum and there components were generally in good condition.

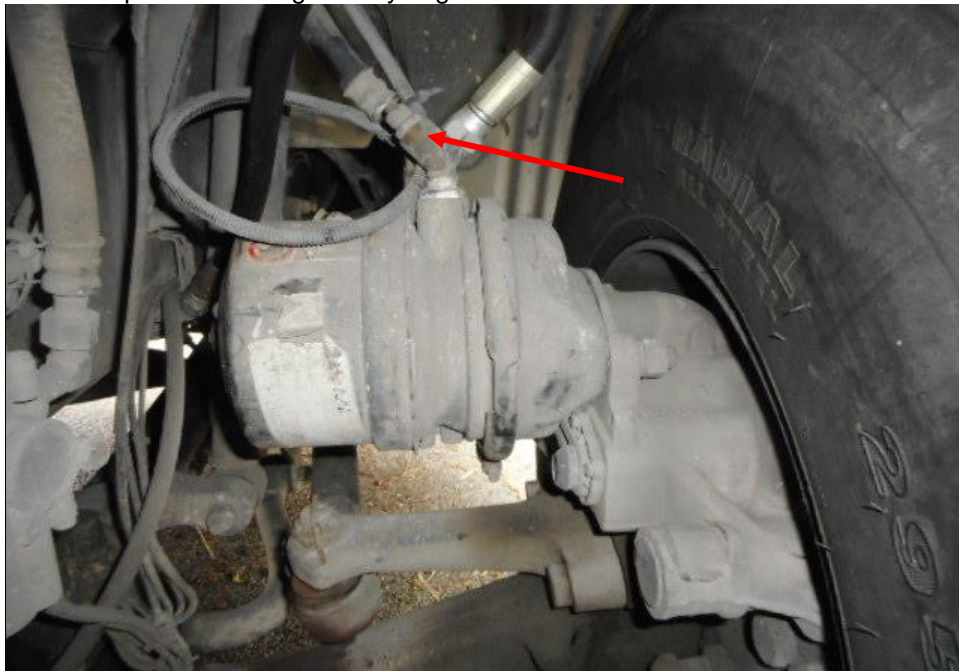
Photo 17 shows the brake pipe (arrowed) at the front right wheel of the Motor Trailer. I did not observe any leakage of brake fluid at the time of my inspection of the Motor Trailer. My static tests of the Motor Trailer's braking system, along with my visual examination of the various mechanical components in the braking system, had indicated that there was no internal leakage of pressure/vacuum and there components were generally in good condition.

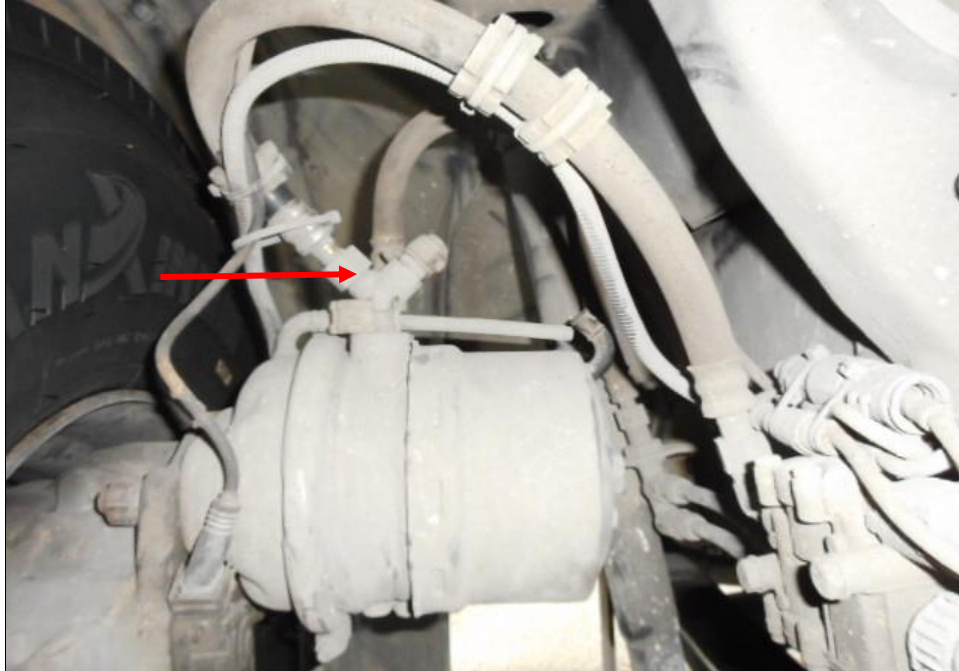
Photo 18 shows the brake pipe (arrowed) at the front left wheel of the Motor Trailer. I did not observe any leakage of brake fluid at the time of my inspection of the Motor Trailer. My visual examination of the various mechanical components in the braking system had indicated that there was no internal leakage of pressure/vacuum and there components were generally in good condition.

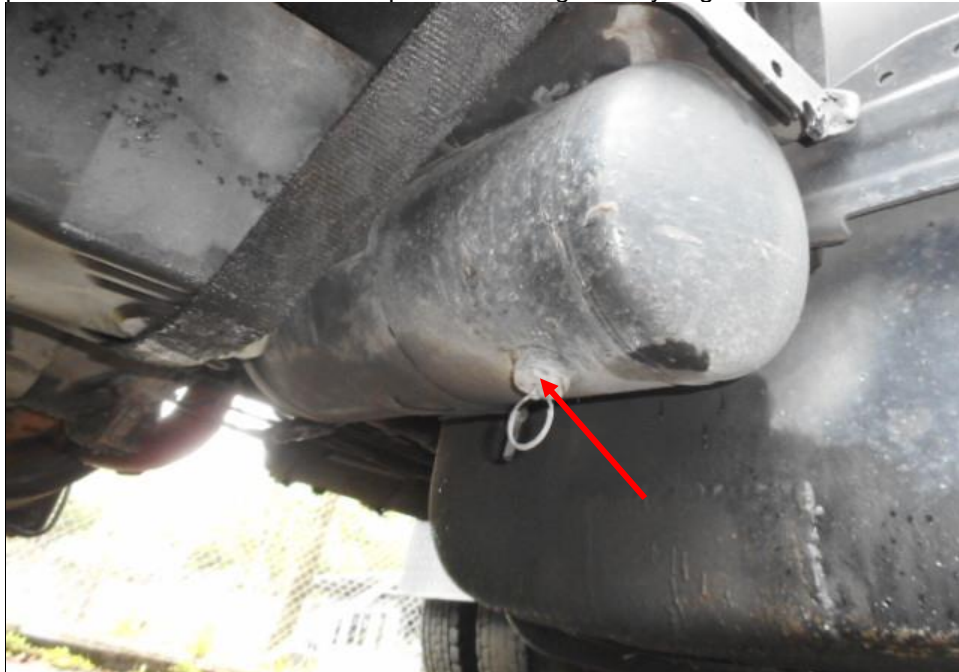
Photo 19 shows the air brake cylinders (arrowed) at the undercarriage of the Motor Trailer. I did not observe any leakage of air brake fluid at the time of my inspection of the Motor Trailer. My visual examination of the various mechanical components in the braking system had indicated that there was no internal leakage of pressure/vacuum and there components were generally in good condition.

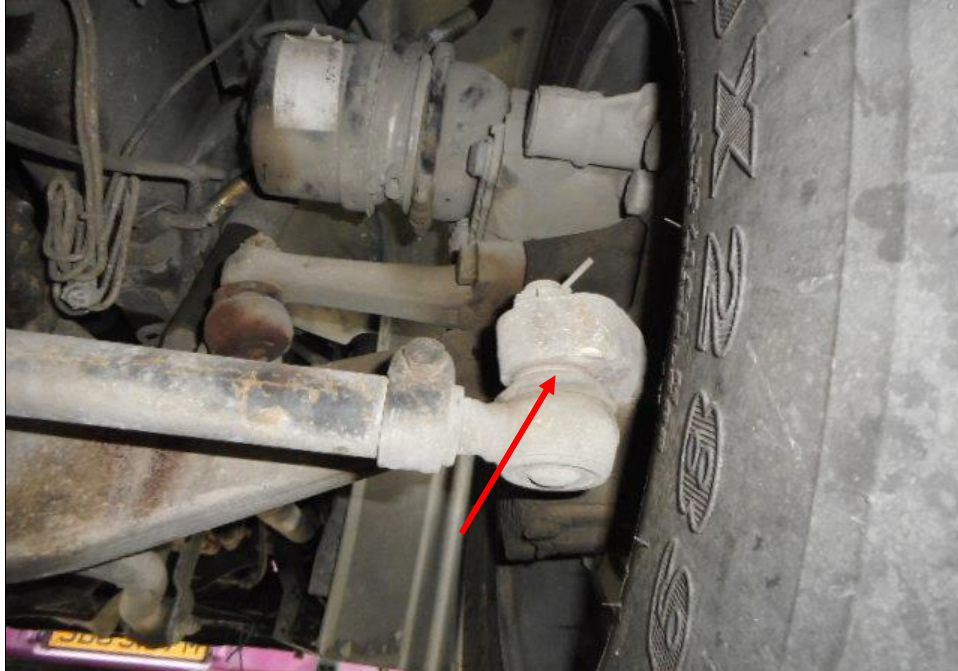
Photo 20 shows the various undercarriage components at the front right wheel of the Motor Trailer, in particular the steering tie rod end (arrowed). The various steering components were all found to be intact, suggesting that the steering system of the Motor Trailer was likely to be in serviceable condition at the material time of accident. There was also no sign of fluid stain(s) observed on the various undercarriage components.

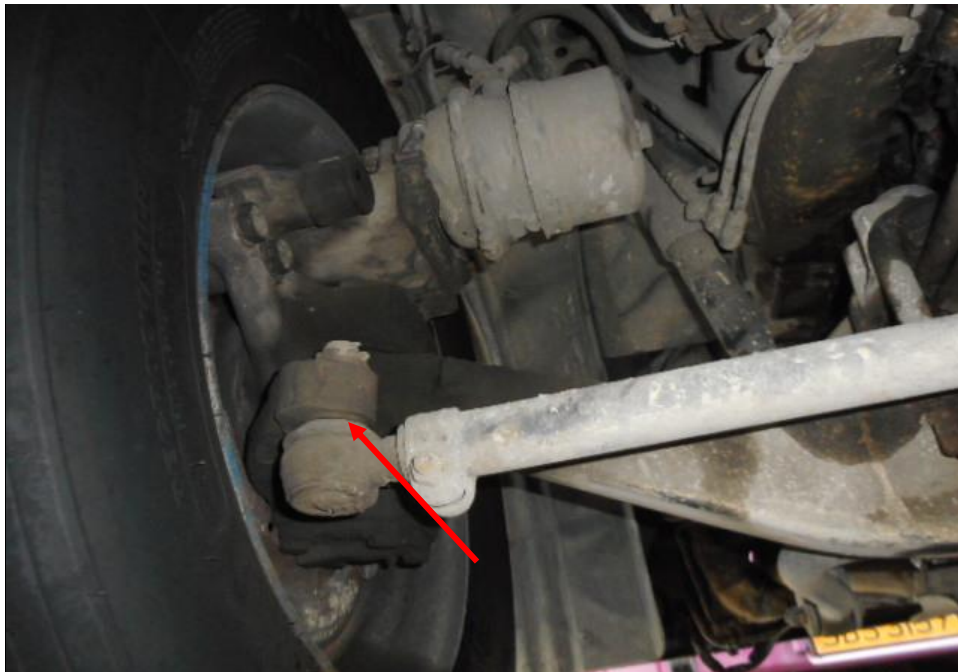
Photo 21 shows the various undercarriage components at the front left wheel of the Motor Trailer, in particular the steering tie rod end (arrowed). The various undercarriage components of the Motor Trailer were all found to be intact without any visible damage. There was also no sign of fluid stain(s) observed on the various undercarriage components.

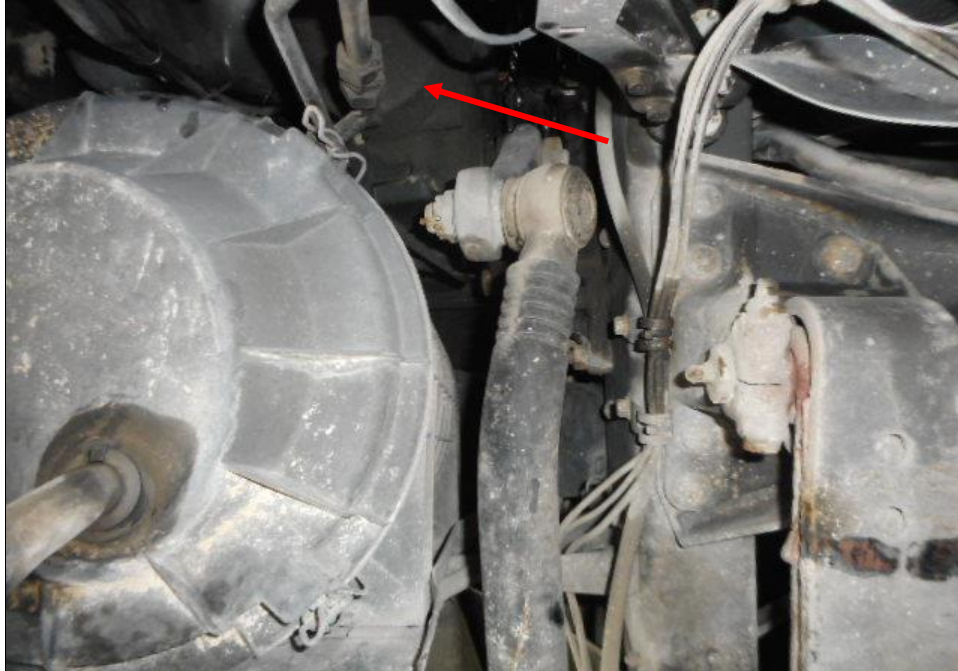
Photo 22 shows the steering box component (arrowed) at the undercarriage of the Motor Trailer was found to be intact without any visible damage. There was also no sign of fluid stain(s) observed on the various undercarriage components.
