You're Ref: TP/IP/19917/2021  
Our Ref: CI/TPD21005750/P

**General Investigation Team**

**MECHANICAL INSPECTION REPORT OF MOTOR TAXI SHC 2867S**

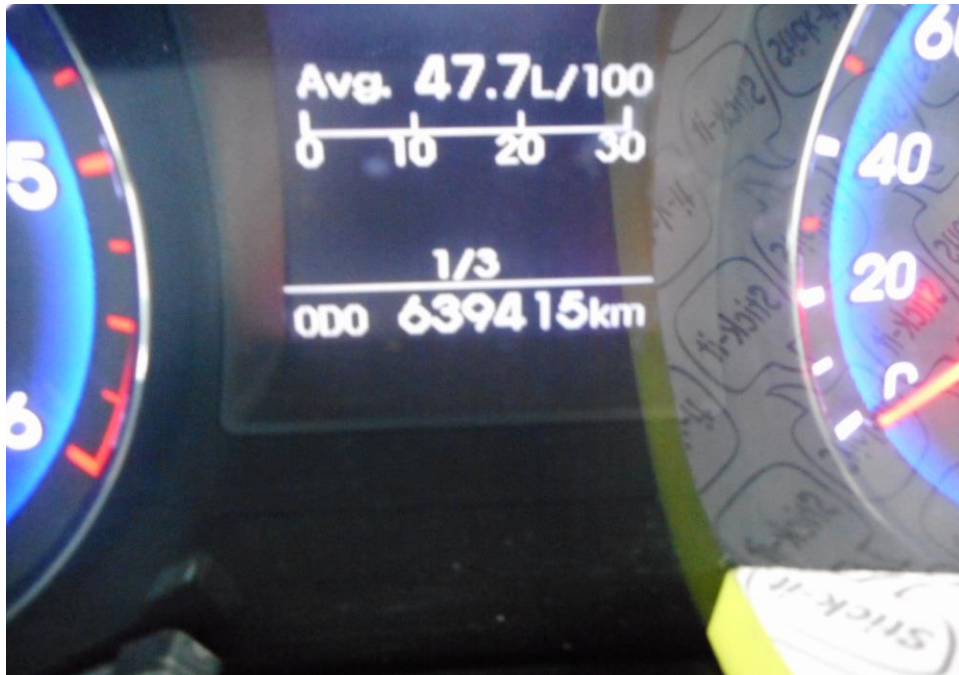
4. The mileage of the Motor Taxi at the time of my inspection was 639,415km.
5. The Motor Taxi was observed to have sustained damage at its front portion. Its front bumper, number plate and front grille was the body parts that were damaged as a result of the accident.

**Photo 1** shows the mileage of the Motor Taxi at the time of my inspection. The mileage observed was 639,415km.

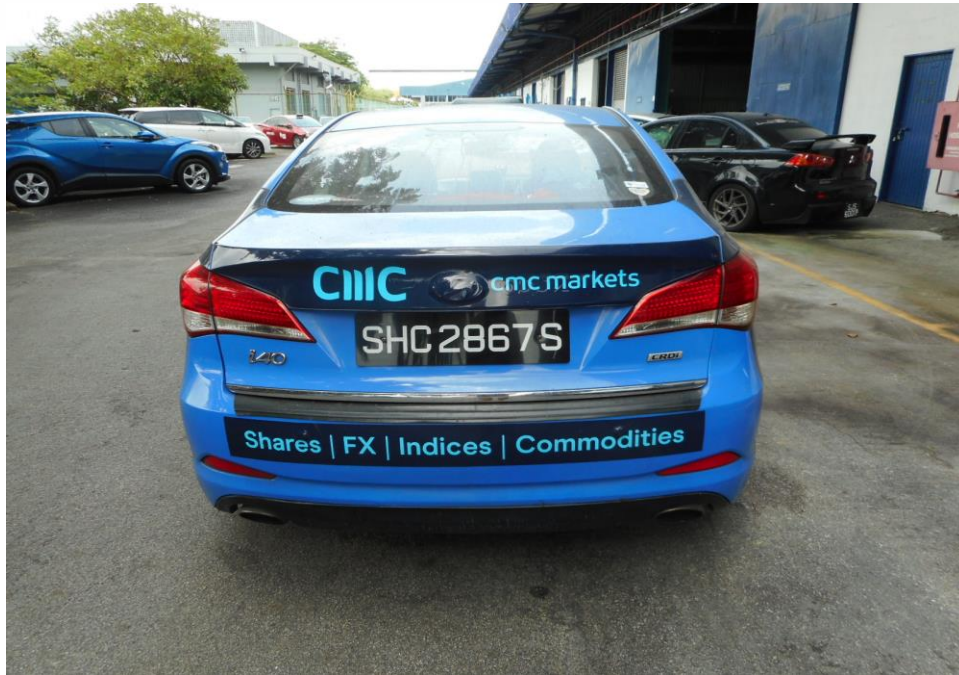
**Photo 2** shows the general view of the Motor Taxi's rear body at the time of my inspection. The Motor Taxi rear was observed to be unaffected by the accident.

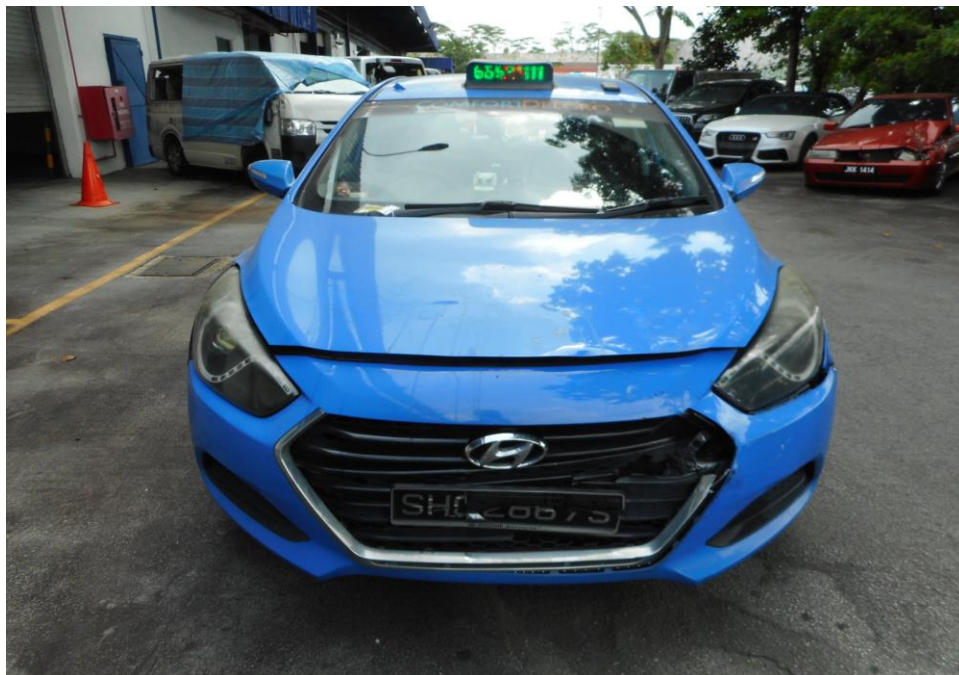
**Photo 3** shows a general view of the Motor Taxi's front body at the time of my inspection. The front portion of the Motor Taxi was observed to have sustained damage. Its front bumper, number plate and front right headlamp was the body parts that were damaged as a result of the accident.

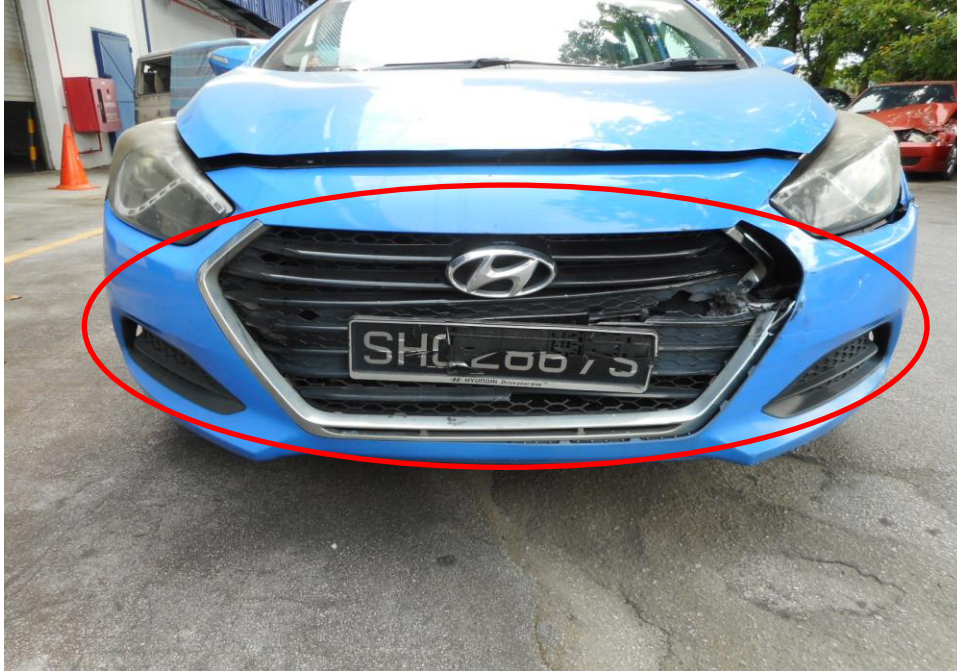
**Photo 4** shows the close up view of the Motor Taxi's front body at the time of my inspection. The Motor Taxi was observed to have sustained damage at its front bumper, number plate and front grille (circled) as a result of the accident.

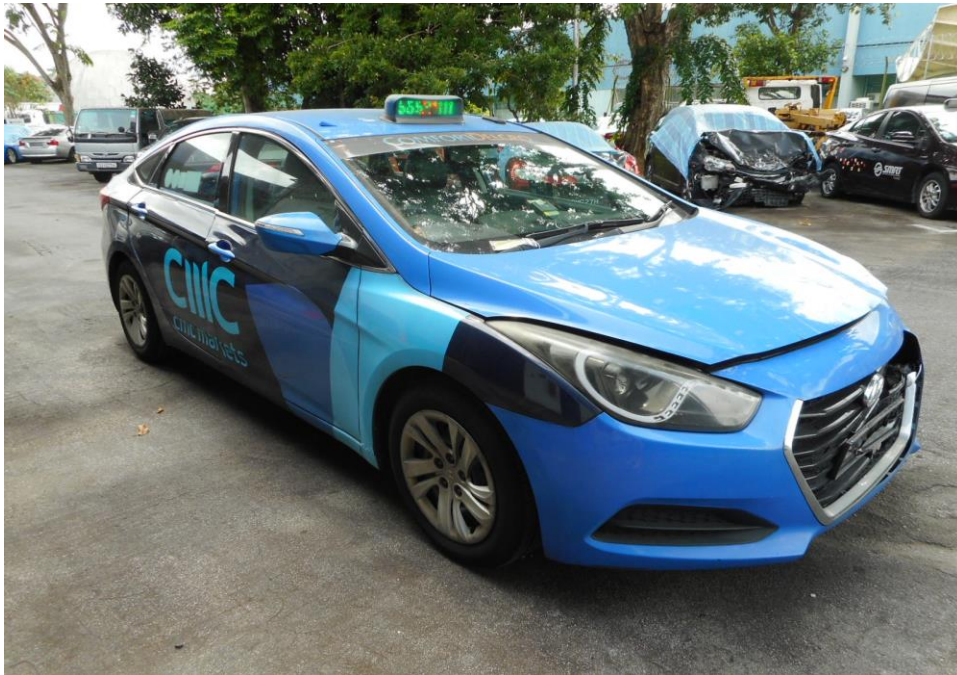
**Photo 5** shows a general view of the Motor Taxi's right body at the time of my inspection. The right portion of the Motor Taxi was observed to have been unaffected by the accident.

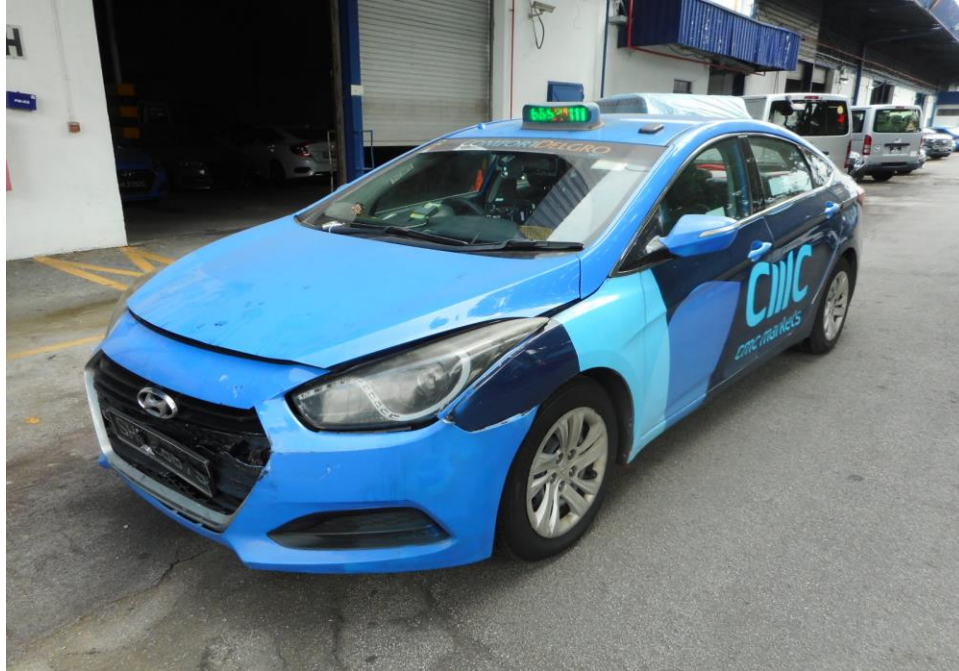
**Photo 6** shows a general view of the Motor Taxi's left body at the time of my inspection. The left portion of the Motor Taxi was observed to have been unaffected by the accident.

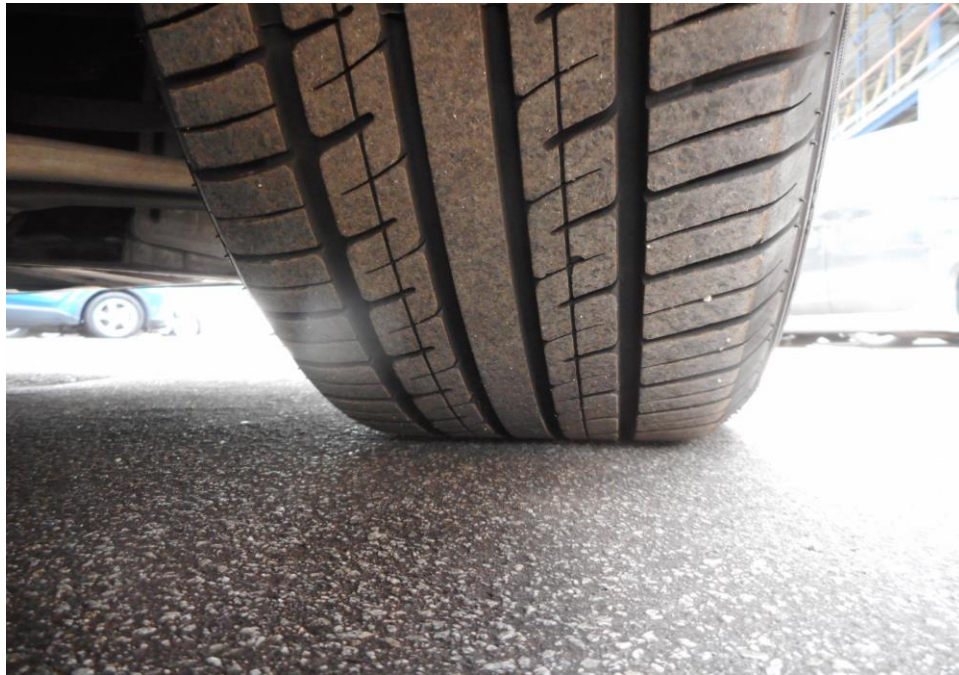
**Photo 7** shows the condition of the front right tyre of the Motor Taxi, which was observed to be in serviceable condition with remaining tread depth of approximately 5.6mm. The tyre was sufficiently inflated for vehicular operation with no tear, cut or burst mark(s) on the outer and the inner sidewalls as well as across the tread. The 4 tyres of the Motor Taxi were wrapped around standard steel wheel rims without any damage.

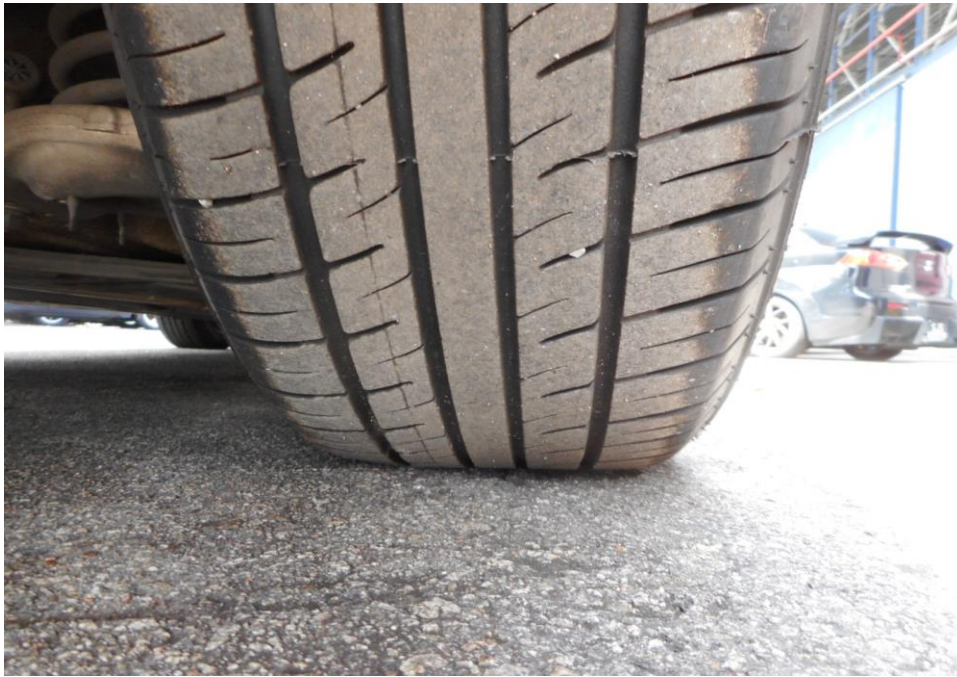
**Photo 8** shows the condition of the rear right tyre of the Motor Taxi, which was observed to be in serviceable condition with remaining tread depth of approximately 4.3mm. The tyre was also observed to be sufficiently inflated for vehicular operation with no tear, cut or burst mark(s).

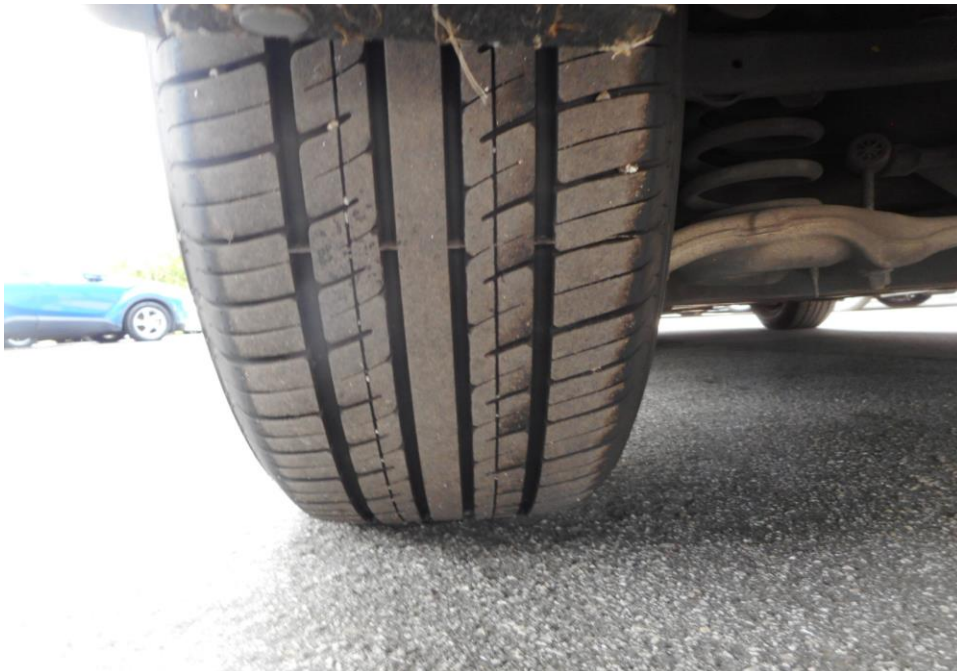
**Photo 9** shows the condition of the rear left tyre of the Motor Taxi, which was observed to be in serviceable condition with remaining tread depth of approximately 6.3mm. The tyre, which was wrapped around steel wheel rim, was also observed to be sufficiently inflated for vehicular operation. The 4 tyres of the Motor Taxi were wrapped around standard steel wheel rims.

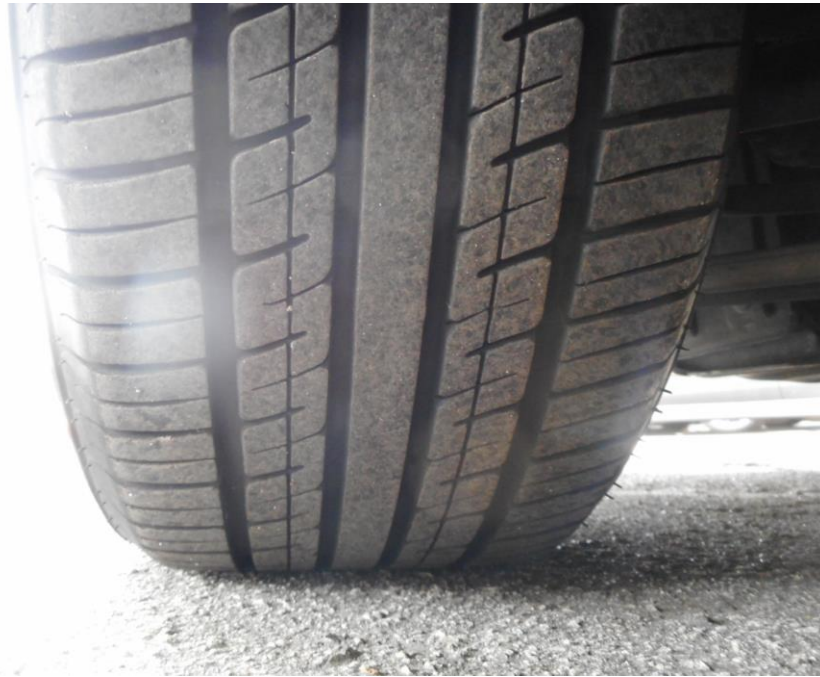
**Photo 10** shows the condition of the front left tyre of the Motor Taxi, which was observed to be in serviceable condition with remaining tread depth of approximately 5.9mm. There was also no tear, cut or burst mark(s) on the outer and the inner sidewalls as well as across the tread of the Motor Taxi's 4 tyres.

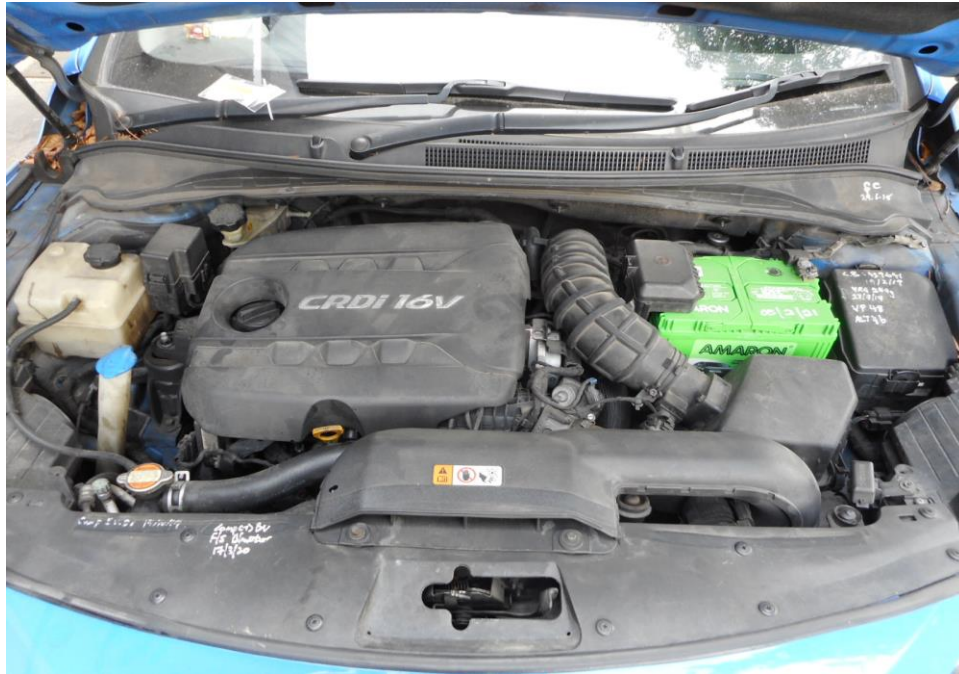
**Photo 11** shows a general view of the Motor Taxi's engine compartment. The various parts and components inside the engine compartment were unaffected by the accident. There was also no sign(s) or indication(s) of fluid leakage and/or fluid stain within the engine compartment.

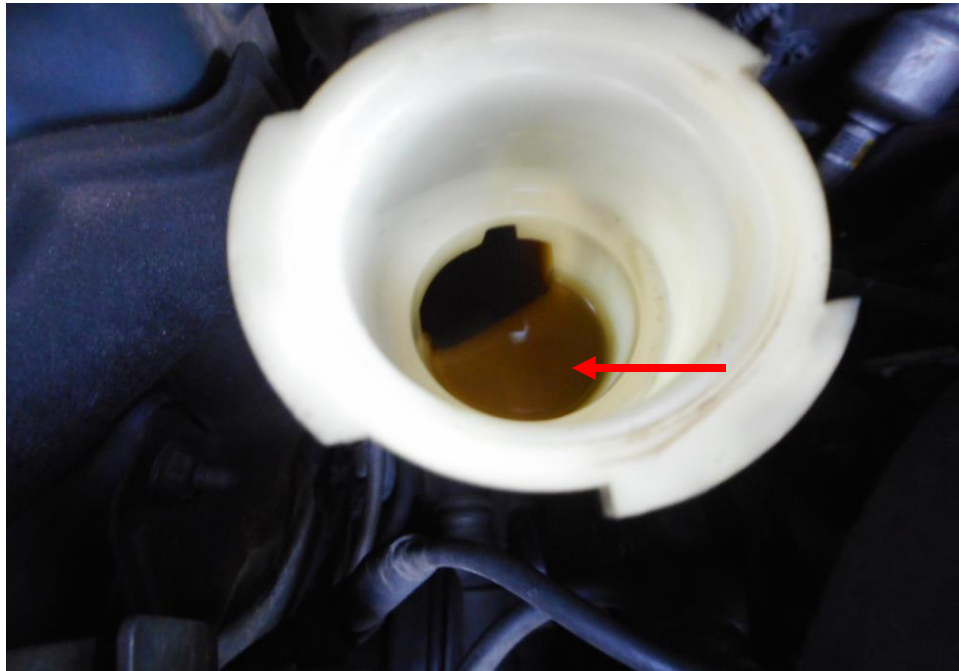
**Photo 12** shows the brake fluid reservoir of the Motor Taxi at the time of my inspection. The brake fluid was observed to be of sufficient level (arrowed) and without any visible contamination.

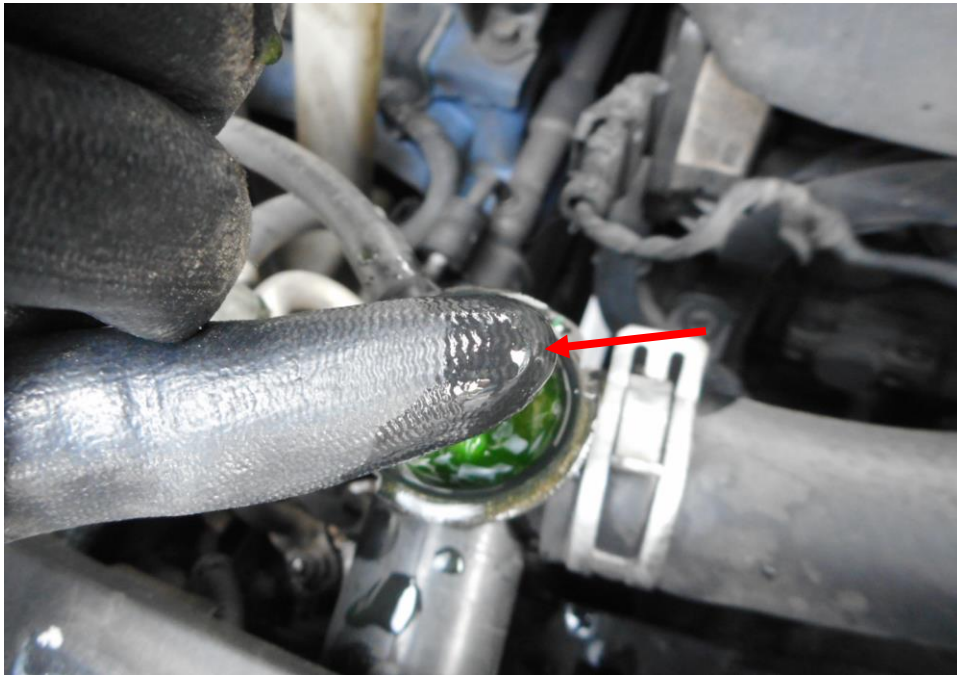
**Photo 13** shows checks being carried out to the engine coolant of the Motor Taxi at the time of my inspection. The engine coolant was observed to be of sufficient level (arrowed) and without any visible contamination.

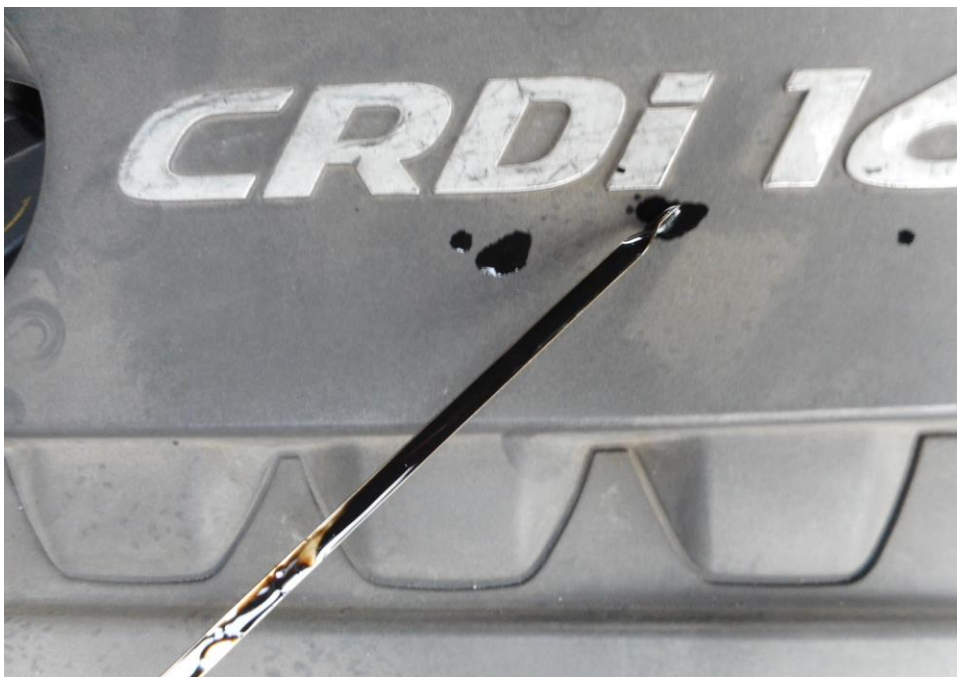
**Photo 14** shows the engine oil dip stick of the Motor Taxi at the time of my inspection. The engine oil was observed to be of sufficient level and without any visible contamination.

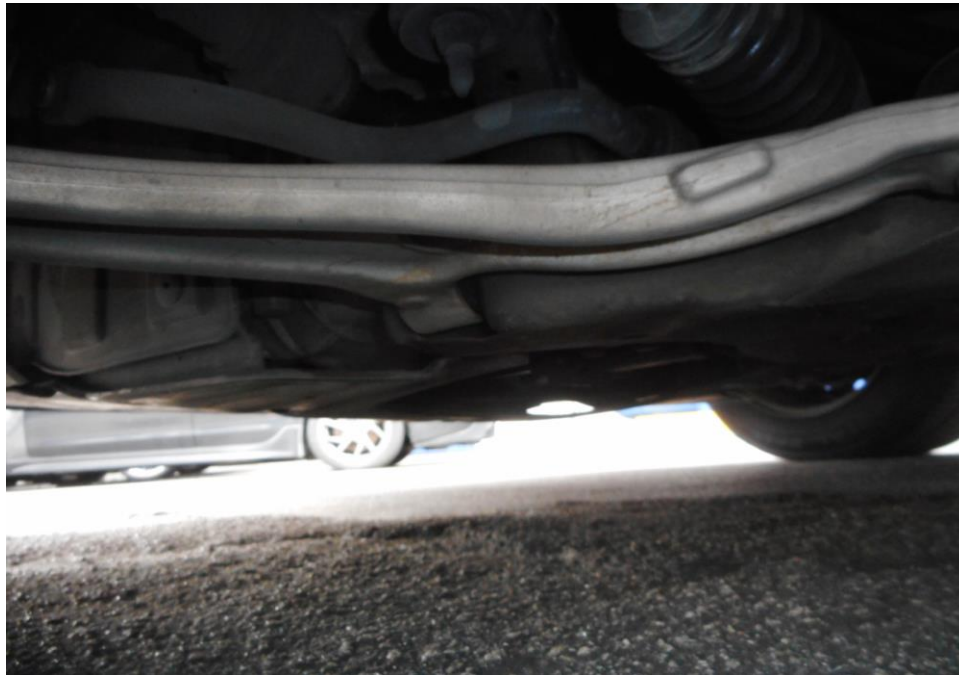
**Photo 15** shows the undercarriage of the Motor Taxi, at the area where the engine housing and transmission housing are located. I did not find any sign(s) or indication(s) of fluid leak and/or fluid stain(s) on the underside of the Motor Taxi.

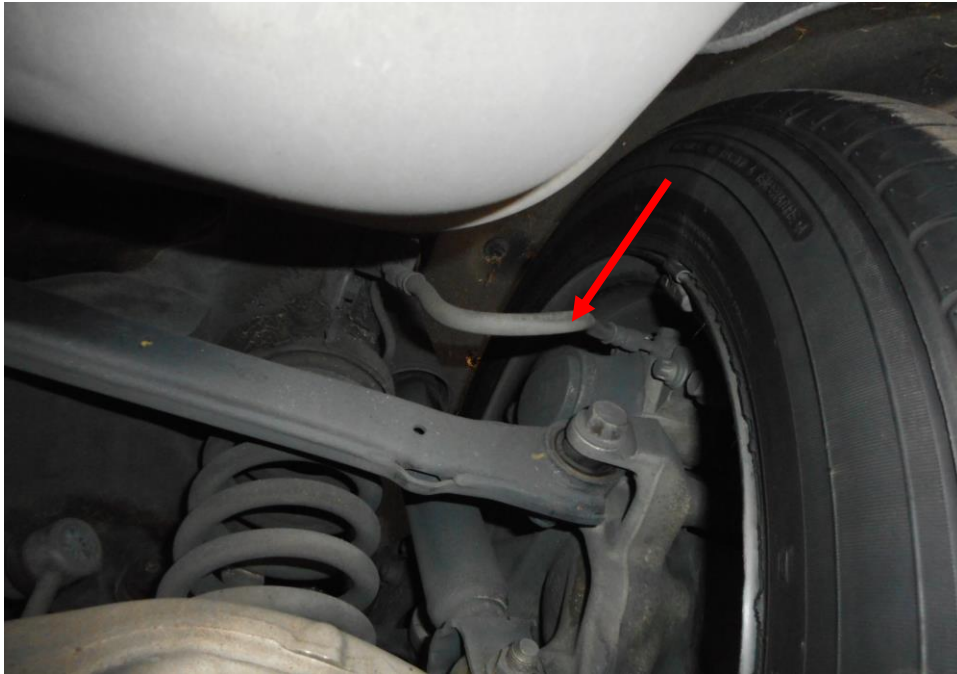
**Photo 16** shows the brake hose/pipe (arrowed) at the rear right wheel of the Motor Taxi. No leakage of brake fluid was observed. Visual examination of the various components of the braking system like the drum brake, brake booster, brake pedal etc. had revealed all to be intact and without visible damage.

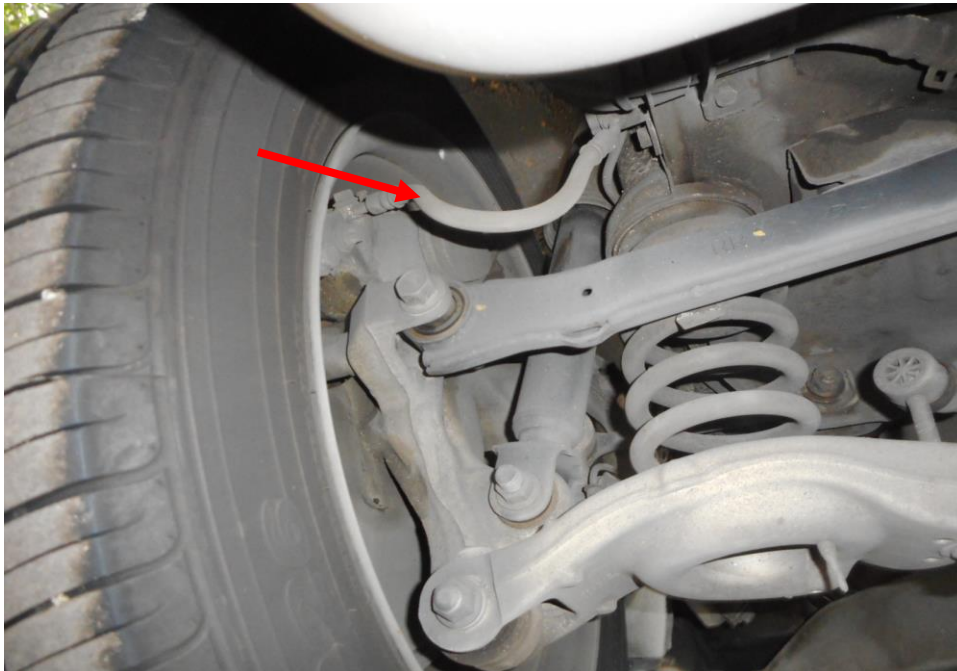
**Photo 17** shows the brake hose/pipe (arrowed) at the rear left wheel of the Motor Taxi. I did not observe any leakage of brake fluid at the time of my inspection of the Motor Taxi. Static tests of the Motor Taxi's braking system had indicated that there was no internal leakage of pressure/vacuum. The undercarriage components of the Motor Taxi were also all found to be intact and without any visible damage.

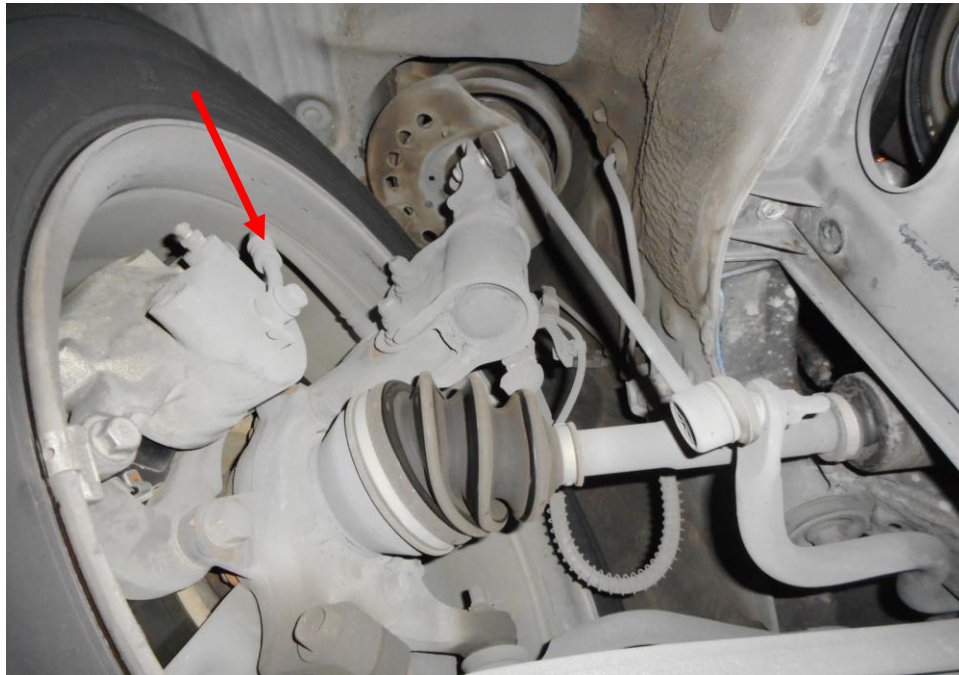
**Photo 18** shows the brake hose/pipe (arrowed) at the front right wheel of the Motor Taxi. I did not observe any leakage of brake fluid at the time of my inspection of the Motor Taxi. Static tests of the Motor Taxi's braking system had indicated that there was no internal leakage of pressure/vacuum. The undercarriage components of the Motor Taxi were also all found to be intact and without any visible damage.

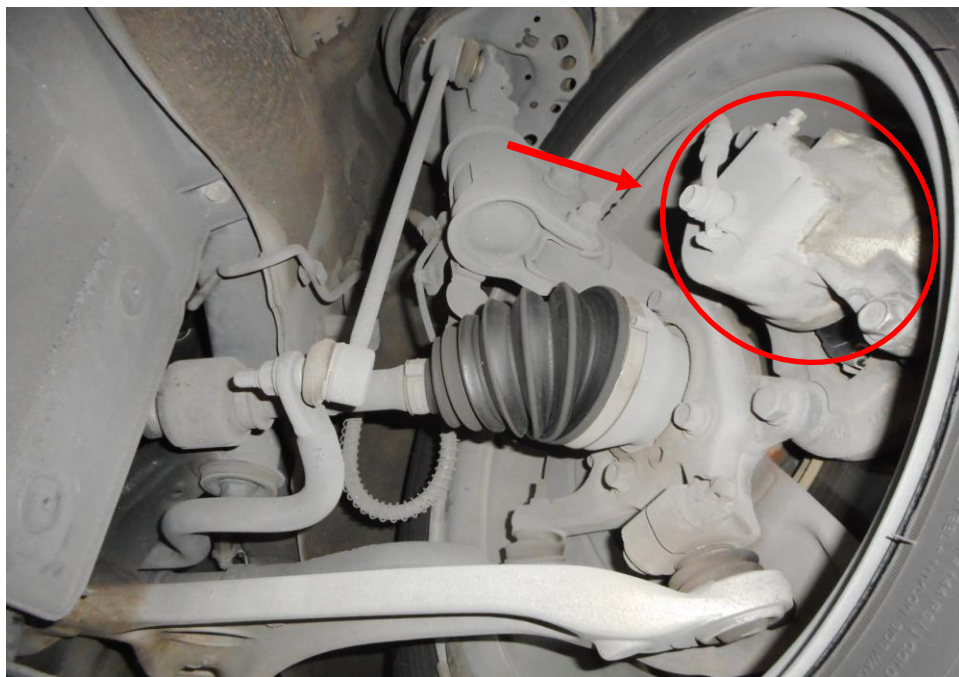
**Photo 19** shows the brake hose/pipe (arrowed) at the front left wheel of the Motor Taxi. No leakage of brake fluid was observed. Visual examination of the various components of the braking system like the brake caliper (circled), brake booster, brake pedal etc had revealed all to be intact and without visible damage.

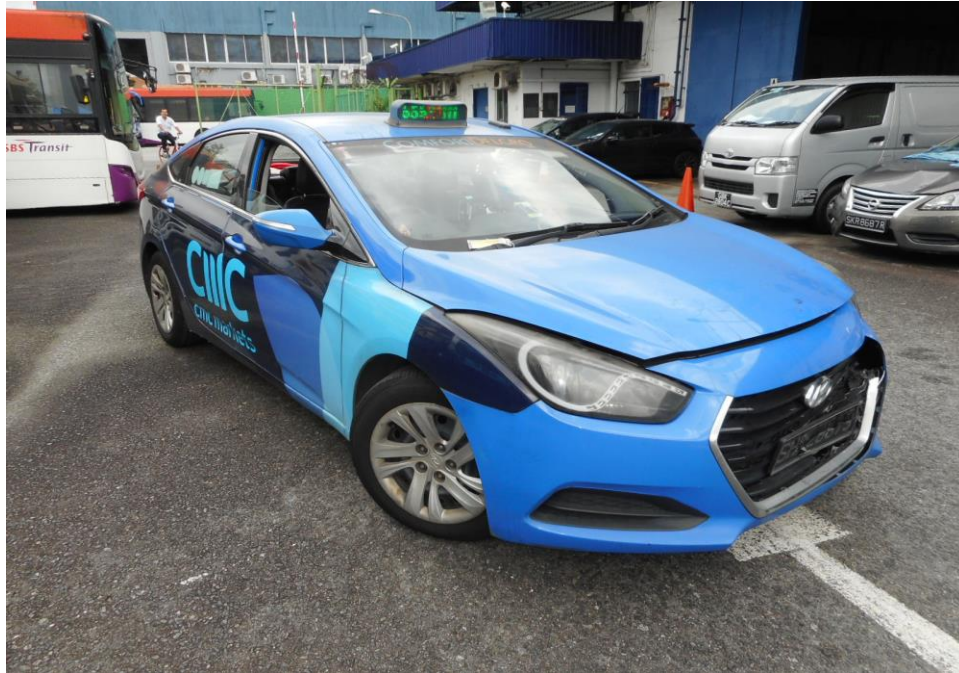
**Photo 20** shows the front right wheel of the Motor Taxi turned to its full left. During my steering system test, I did not experience any abnormal free play and/or resistance when I had turned the steering wheel towards the left and right. This would suggest that the steering system of the Motor Taxi was likely to be in serviceable condition at the material time of accident.

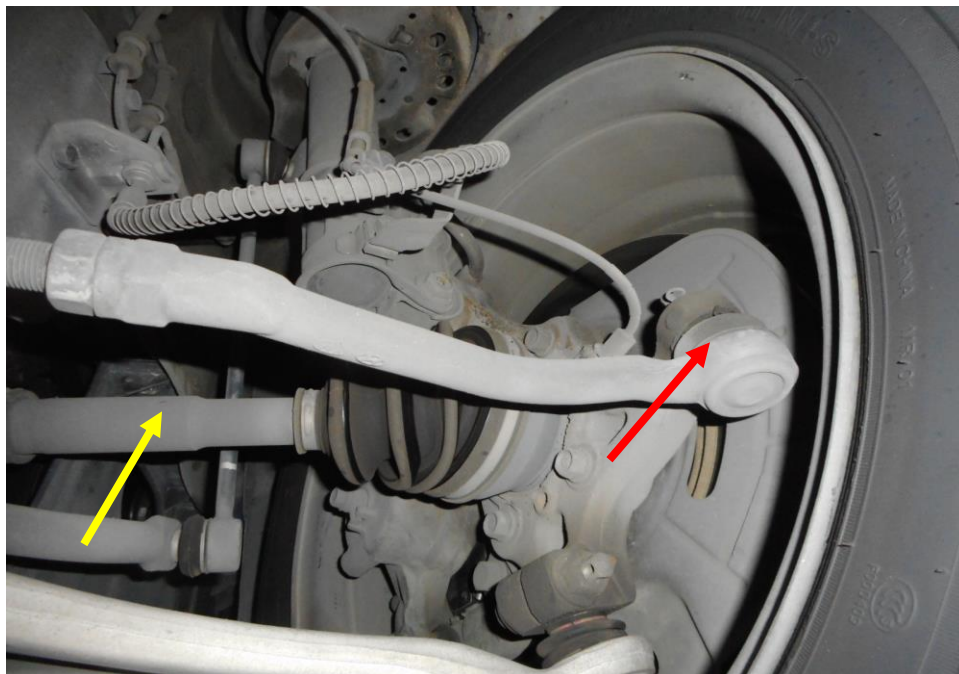
**Photo 21** shows the various undercarriage components at the front right wheel of the Motor Taxi, in particular the steering tie rod (red arrow) and drive shaft (yellow arrow). The various steering components were all found to be intact, suggesting that the steering system of the Motor Taxi was likely to be in serviceable condition at the material time of accident. There was also no sign of fluid stain observed on the various undercarriage components at the front right wheel of the Motor Taxi.

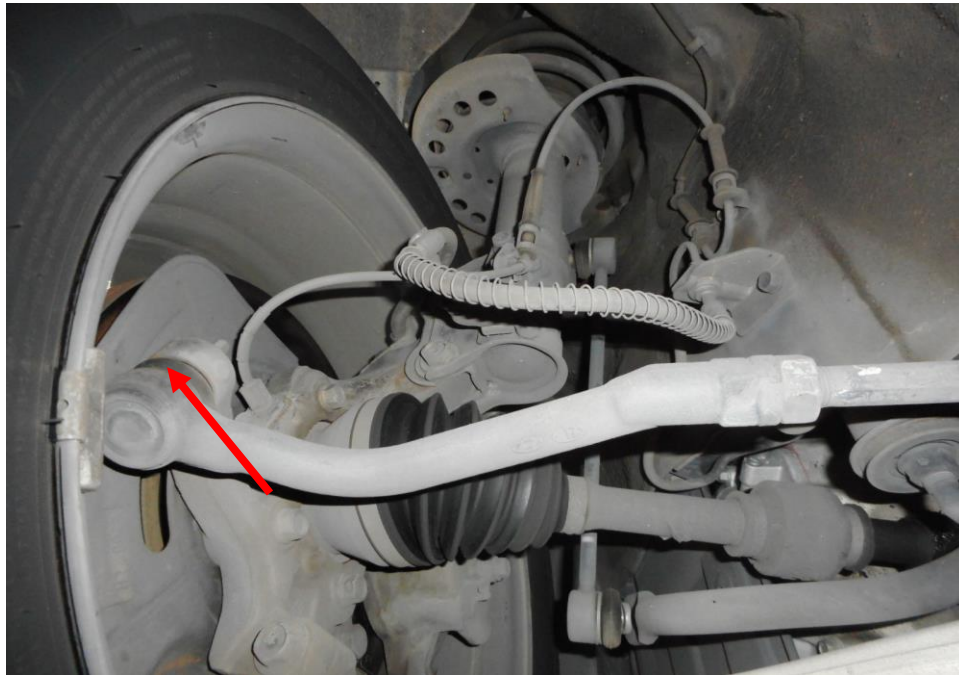
**Photo 22** shows the various undercarriage components at the front left wheel of the Motor Taxi, which had included the steering tie rod (red arrow). The various undercarriage components of the Motor Taxi were all found to be intact without any visible damage.

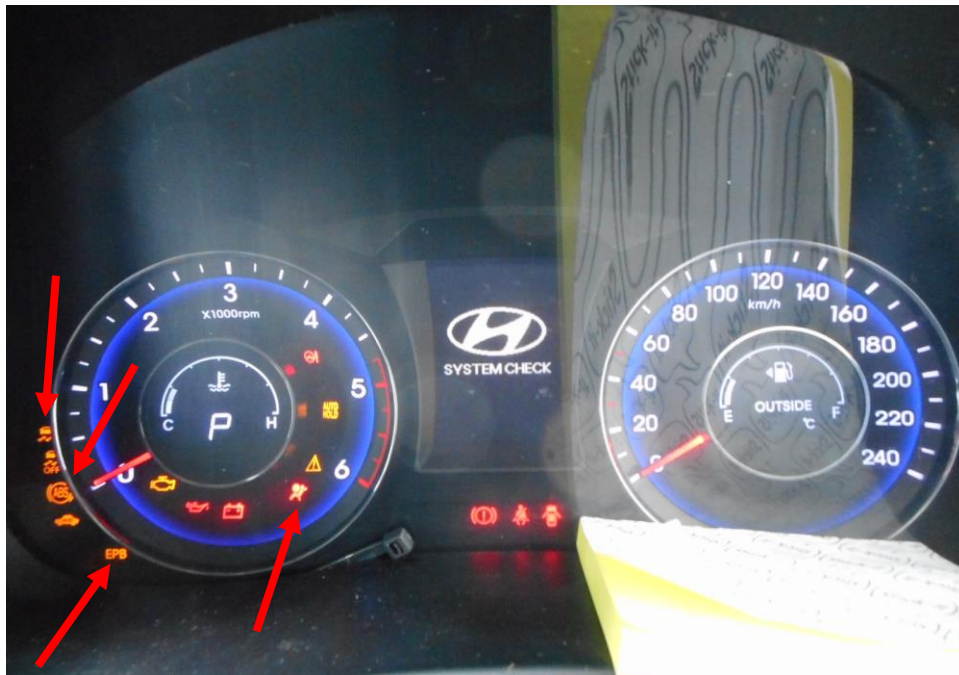
**Photo 23** shows the warning light for Anti-Lock Brake System (ABS) and Power Steering System (EPS), Supplemental Restraint System (SRS) and Traction Control (TC) (arrowed) appearing on the instrument panel of the Motor Taxi during the self-test of its various electronic operating systems when its engine was cranked.

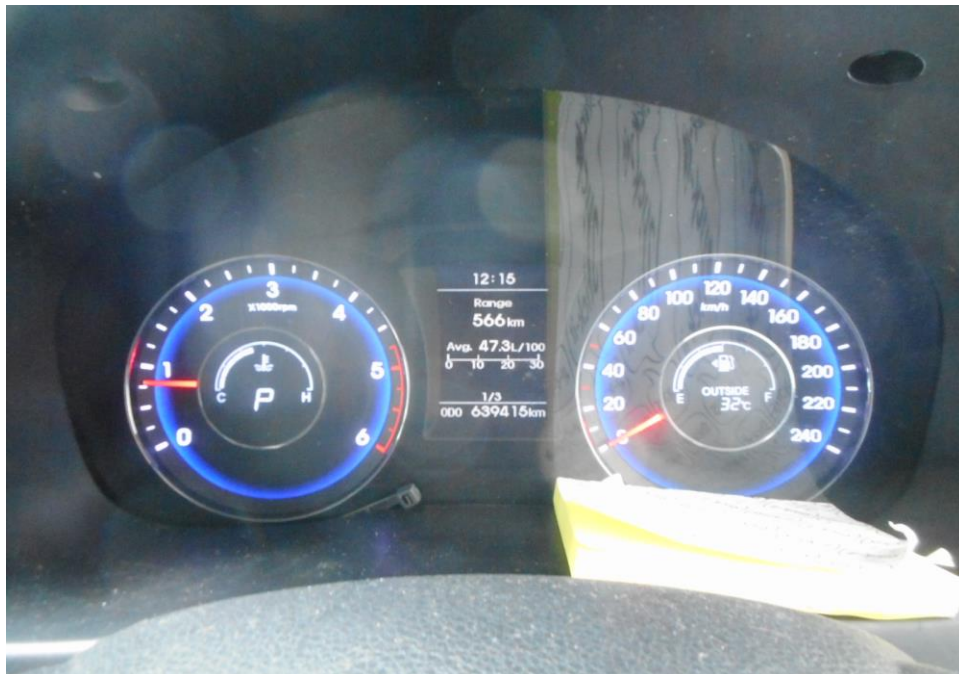
**Photo 24** shows no warning lights illuminated on the instrument panel of the Motor Taxi after the engine was cranked. This would suggest that there was no abnormality to the electronic operating system of the Motor Taxi, like the ABS, EPS, SRS, and TC etc.
