You're Ref: TP/IP/18939/2021  
Our Ref: CI/TPD21005752/P

27<sup>th</sup> May 2021

**MECHANICAL INSPECTION REPORT OF POLICE CAR QX 660S**

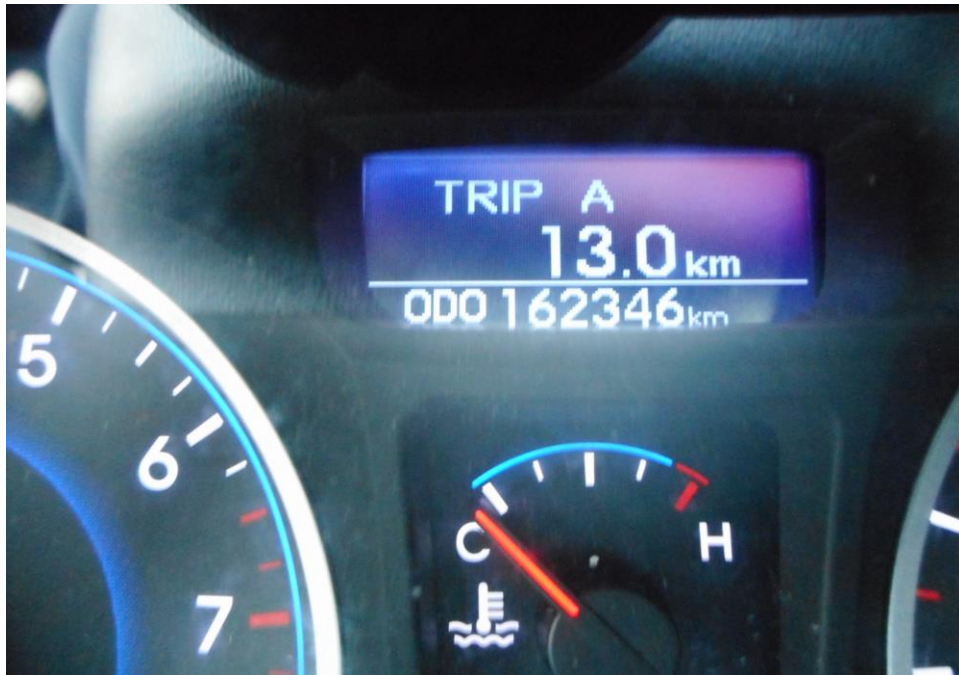
**Photo 1** shows the mileage of the Police Car at the time of my inspection. The mileage observed was 162,346km.

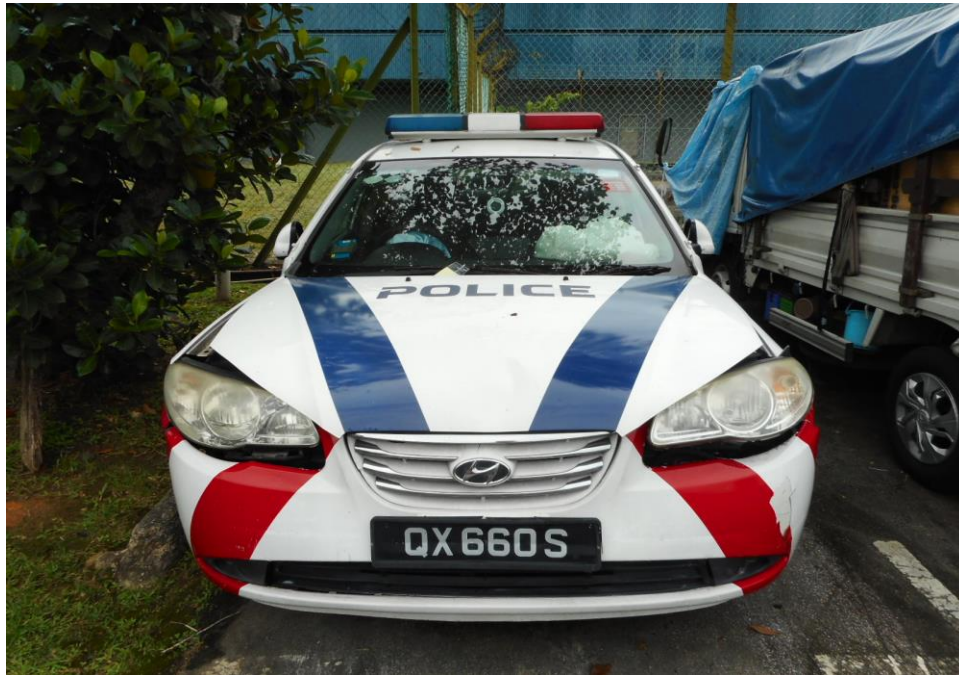
4. The mileage of the Police Car at the time of my inspection was 162,346km.
5. The Police Car was observed to have sustained damage at its front portion. Its front bumper, front bumper, both front left and right fender was the body parts that were damaged as a result of the accident. The Supplemental Restraint System (SRS) was activated as a result of the accident.

**Photo 2** shows a general view of the Police Car's front body at the time of my inspection. The front portion of the Police Car was observed to have sustained damage. Its front bumper, front bumper, both front left and right fender was the body parts that were damaged as a result of the accident. The Supplemental Restraint System (SRS) was activated as a result of the accident.

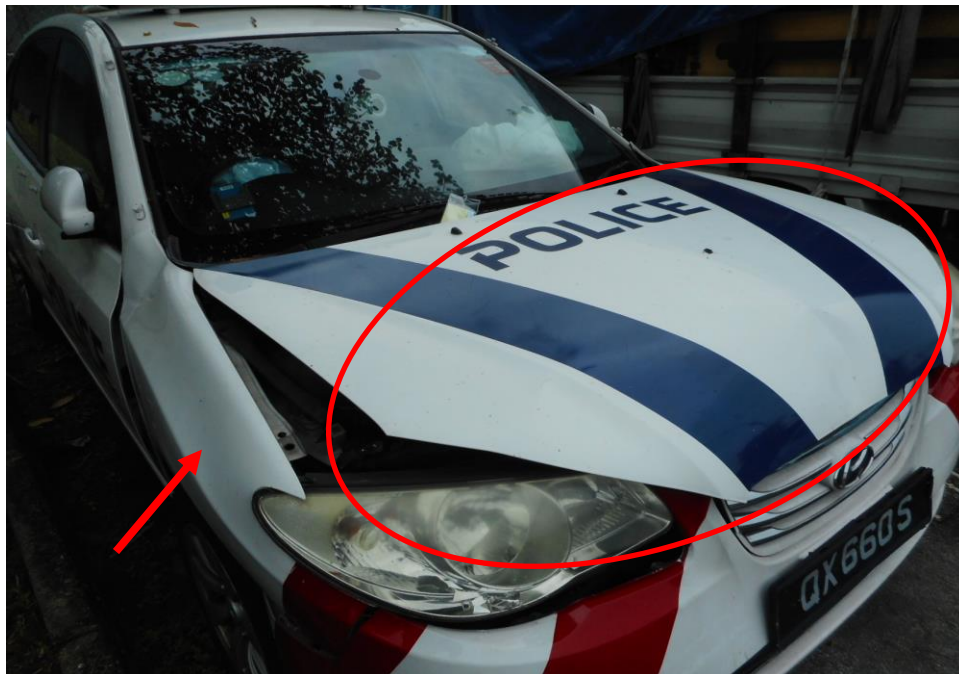
**Photo 3** shows the close up view of the Police Car's front body at the time of my inspection. The Police Car was observed to have sustained damage at its front bonnet (circled) & front right fender (arrowed), as a result of the accident.

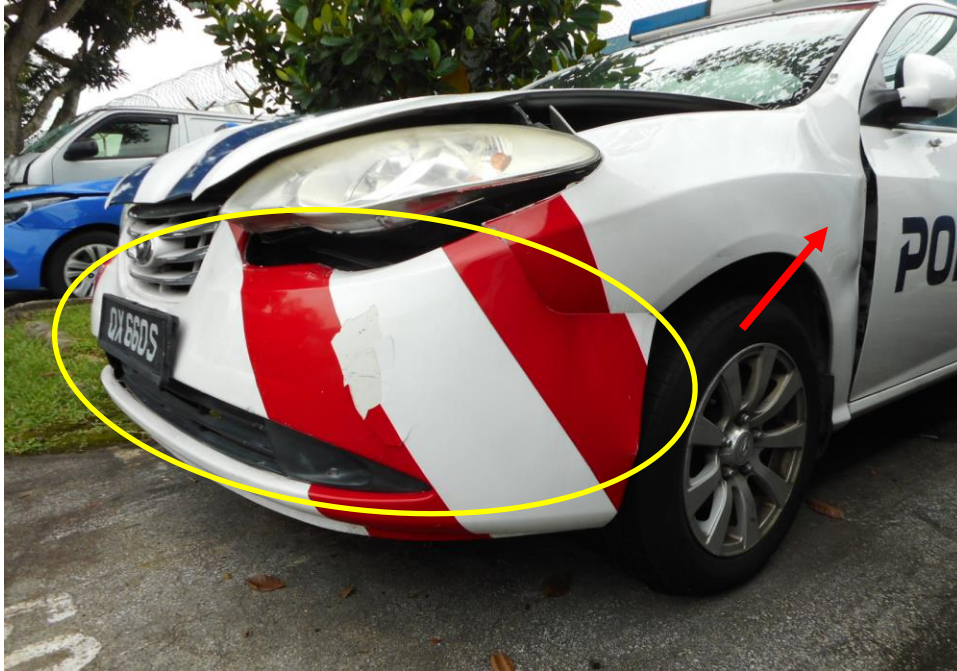
**Photo 4** shows the close up view of the Police Car's front body at the time of my inspection. The Police Car was observed to have sustained damage at its front bumper (circled) & front left fender (arrowed), as a result of the accident.

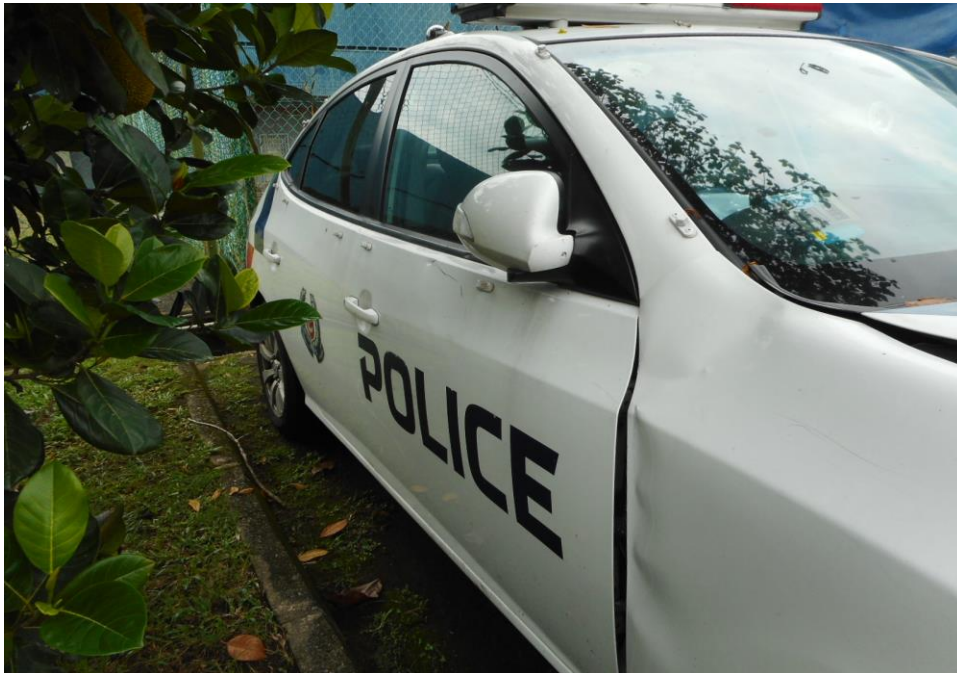
**Photo 5** shows a general view of the Police Car's right body at the time of my inspection. The right portion of the Police Car was observed to have been unaffected by the accident.

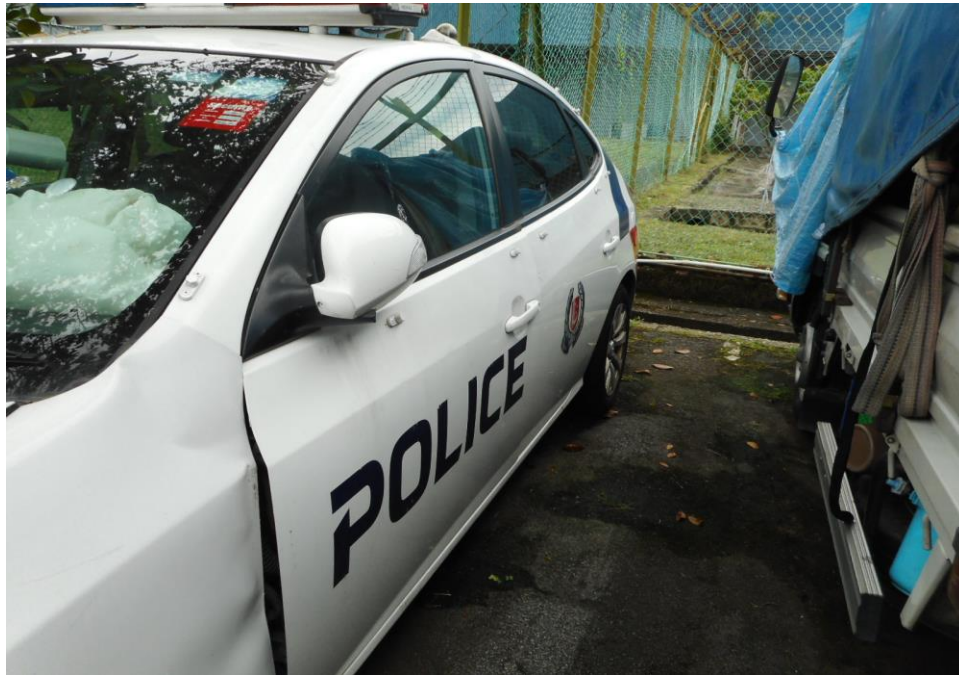
**Photo 6** shows a general view of the Police Car's left body at the time of my inspection. The left portion of the Police Car was observed to have been unaffected by the accident.

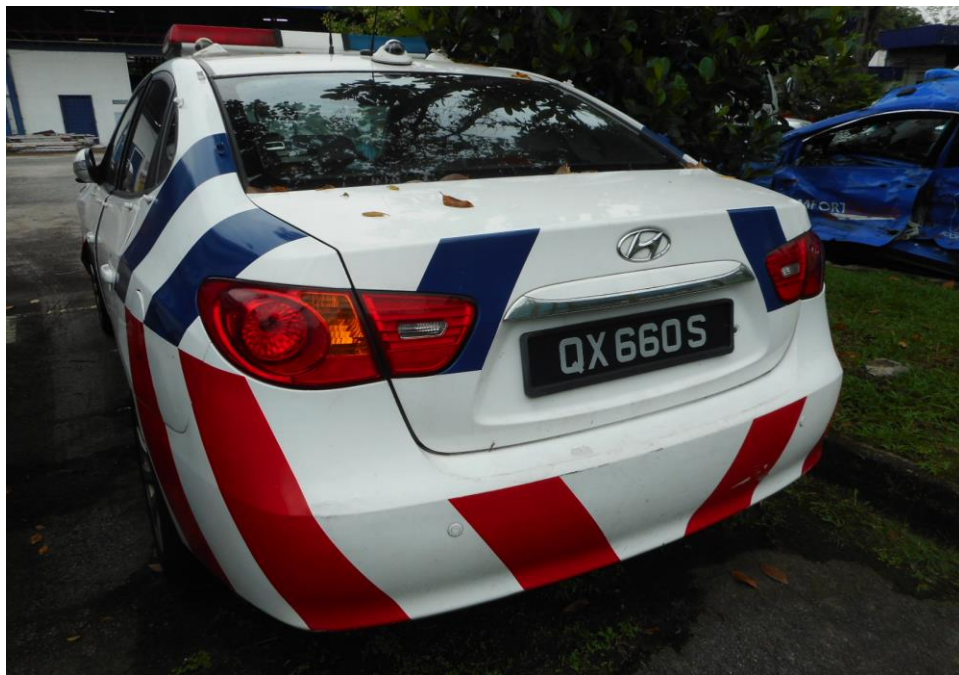
**Photo 7** shows the general view of the Police Car's rear body at the time of my inspection. The Police Car rear was observed to be unaffected by the accident.

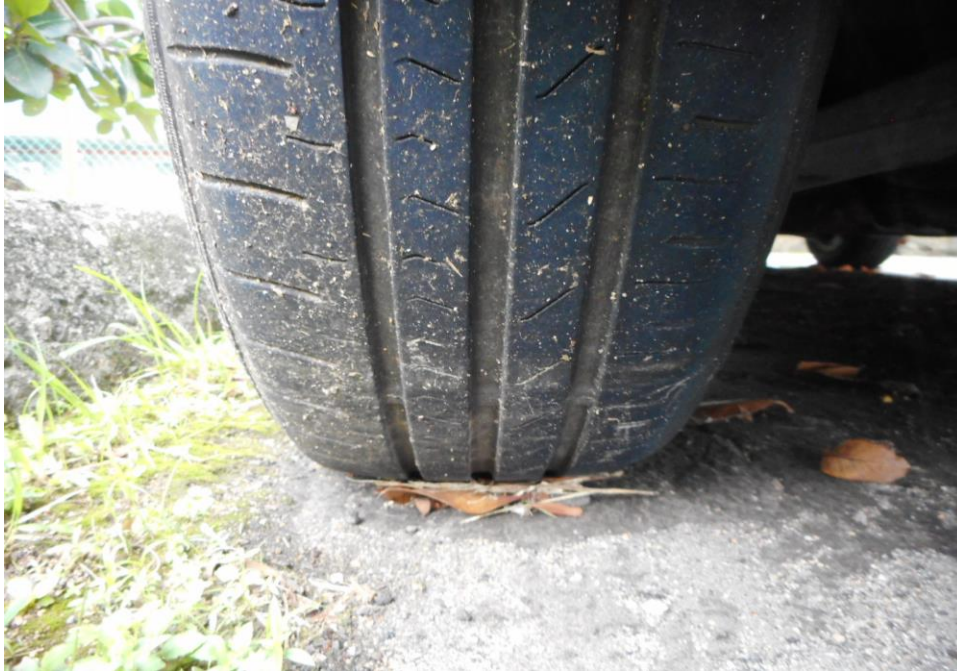
**Photo 8** shows the condition of the front right tyre of the Police Car, which was observed to be in serviceable condition with remaining tread depth of approximately 4.5mm. The tyre was sufficiently inflated for vehicular operation with no tear, cut or burst mark(s) on the outer and the inner sidewalls as well as across the tread. The 4 tyres of the Police Car were wrapped around standard steel wheel rims without any damage.

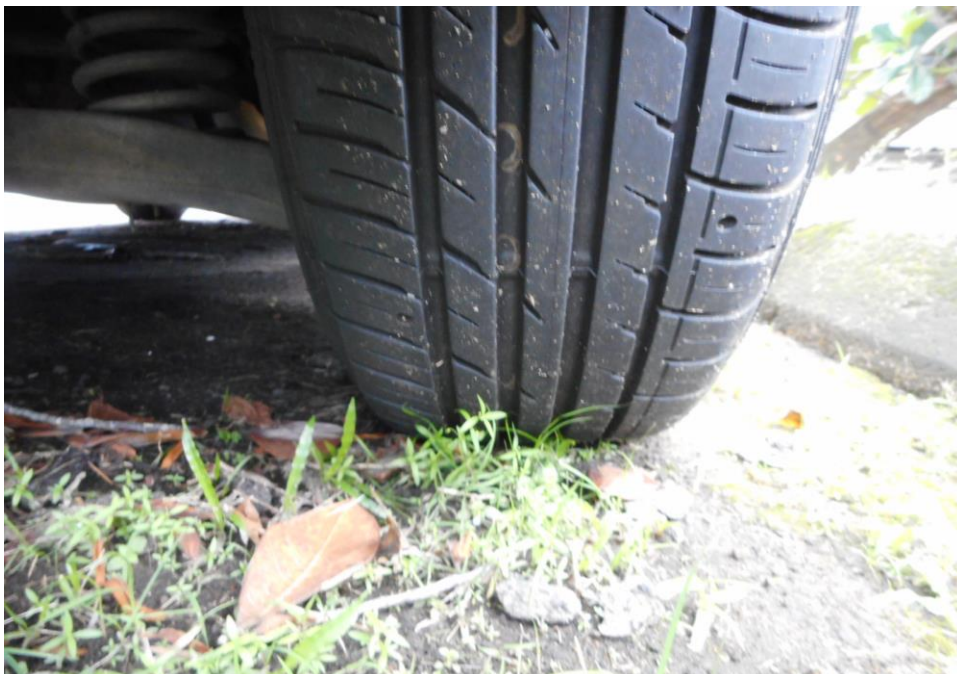
**Photo 9** shows the condition of the rear right tyre of the Police Car, which was observed to be in serviceable condition with remaining tread depth of approximately 6.5mm. The tyre was also observed to be sufficiently inflated for vehicular operation with no tear, cut or burst mark(s).

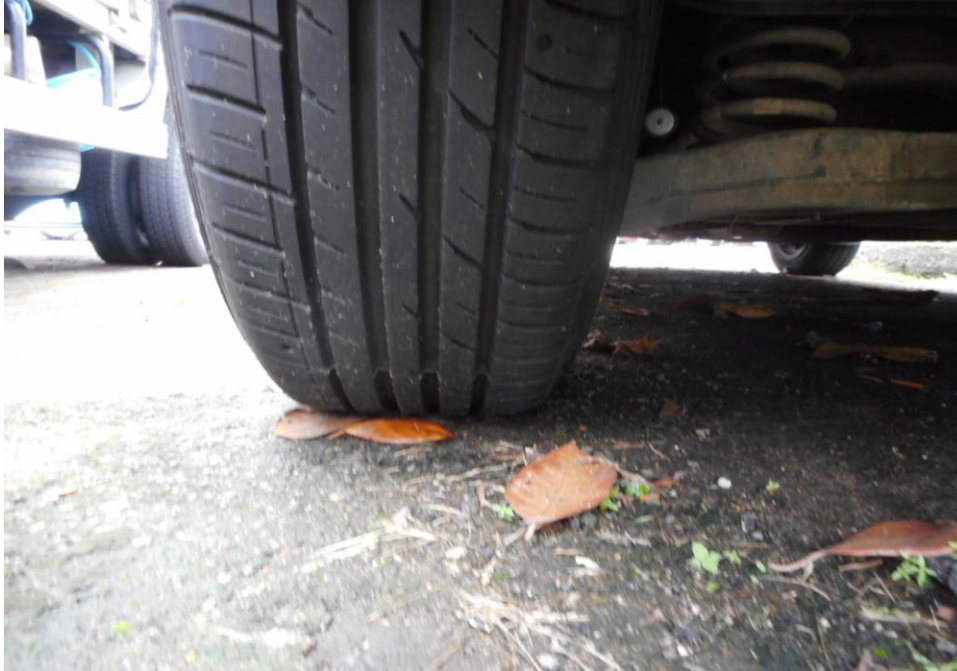
**Photo 10** shows the condition of the rear left tyre of the Police Car, which was observed to be in serviceable condition with remaining tread depth of approximately 6.7mm. The tyre, which was wrapped around steel wheel rim, was also observed to be sufficiently inflated for vehicular operation. The 4 tyres of the Police Car were wrapped around standard steel wheel rims.

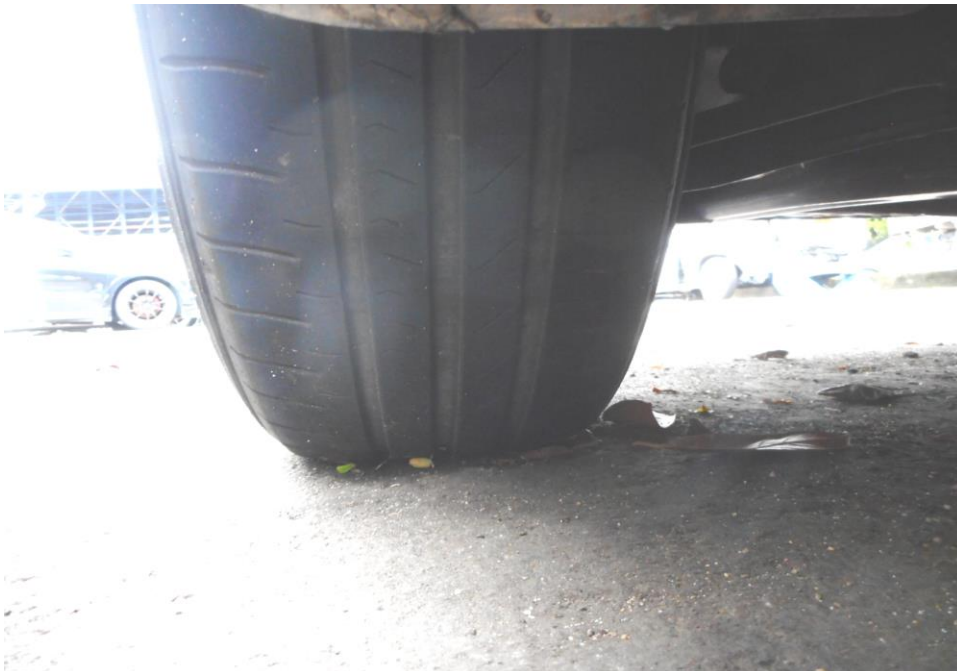
**Photo 11** shows the condition of the front left tyre of the Police Car, which was observed to be in serviceable condition with remaining tread depth of approximately 4.7mm. The tyre, which was wrapped around steel wheel rim, was also observed to be sufficiently inflated for vehicular operation. The 4 tyres of the Police Car were wrapped around standard steel wheel rims.

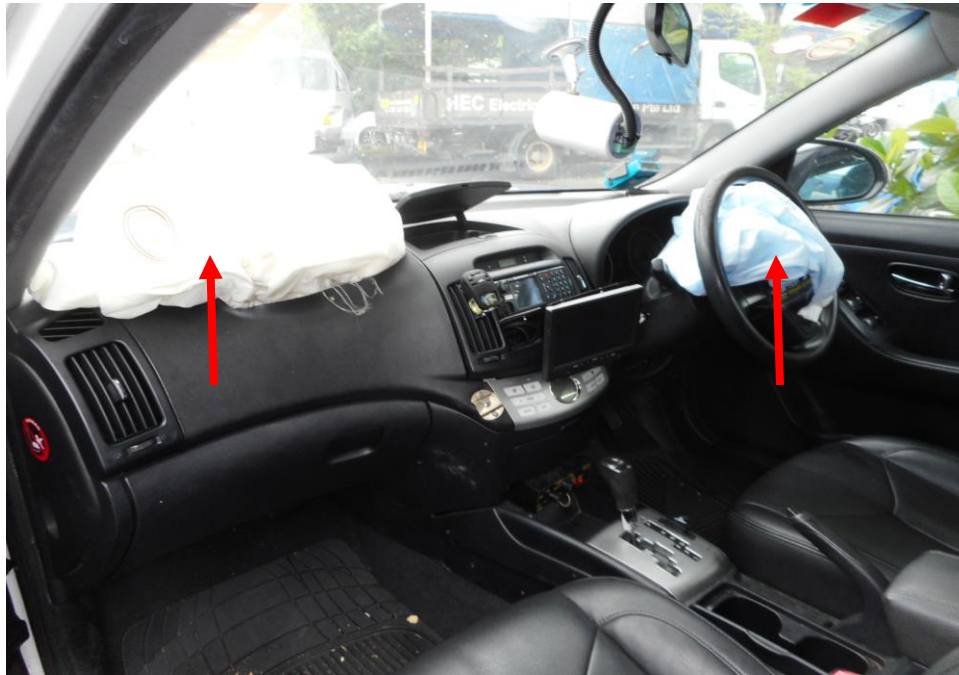
**Photo 12** shows the deployment of the Supplemental Restraint System (SRS) airbag (arrowed) in the Police Car as a result of the accident.

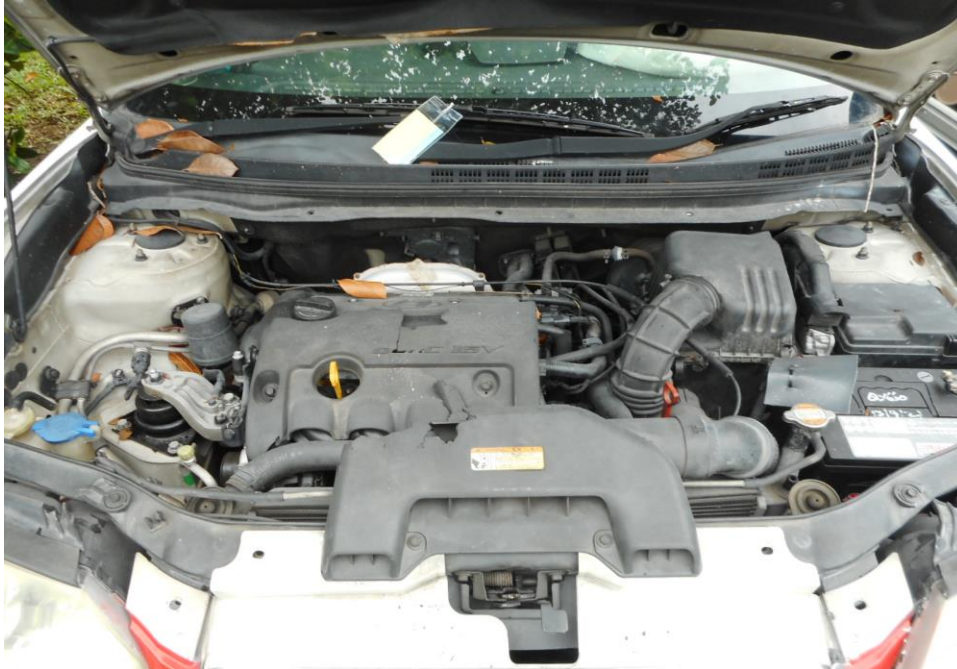
**Photo 13** shows a general view of the Police Car's engine compartment. The various parts and components inside the engine compartment were unaffected by the accident. There was also no sign(s) or indication(s) of fluid leakage and/or fluid stain within the engine compartment.

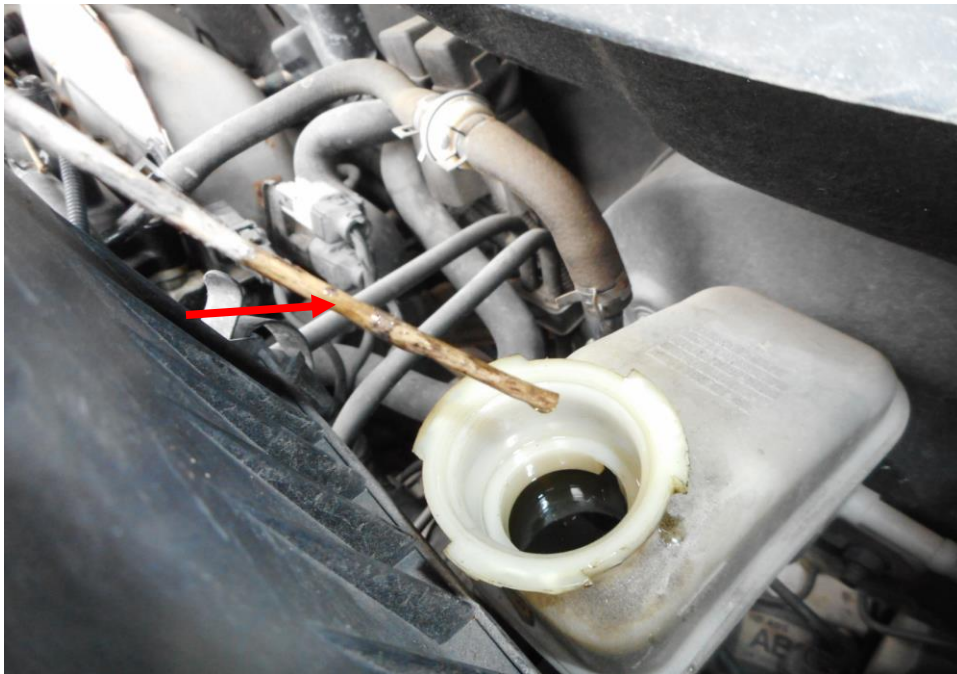
**Photo 14** shows the brake fluid reservoir of the Police Car at the time of my inspection. The brake fluid was observed to be of sufficient level (arrowed) and without any visible contamination.

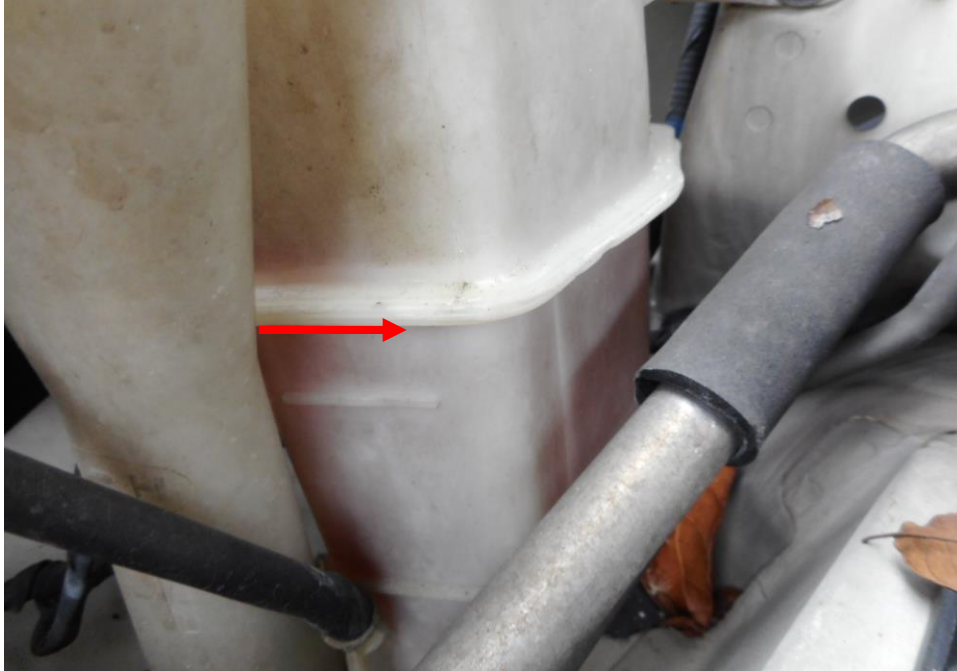
**Photo 15** shows checks being carried out to the engine coolant of the Police Car at the time of my inspection. The engine coolant was observed to be of insufficient level (arrowed) likely due to the damaged to the front radiator which caused the leakage of coolant.

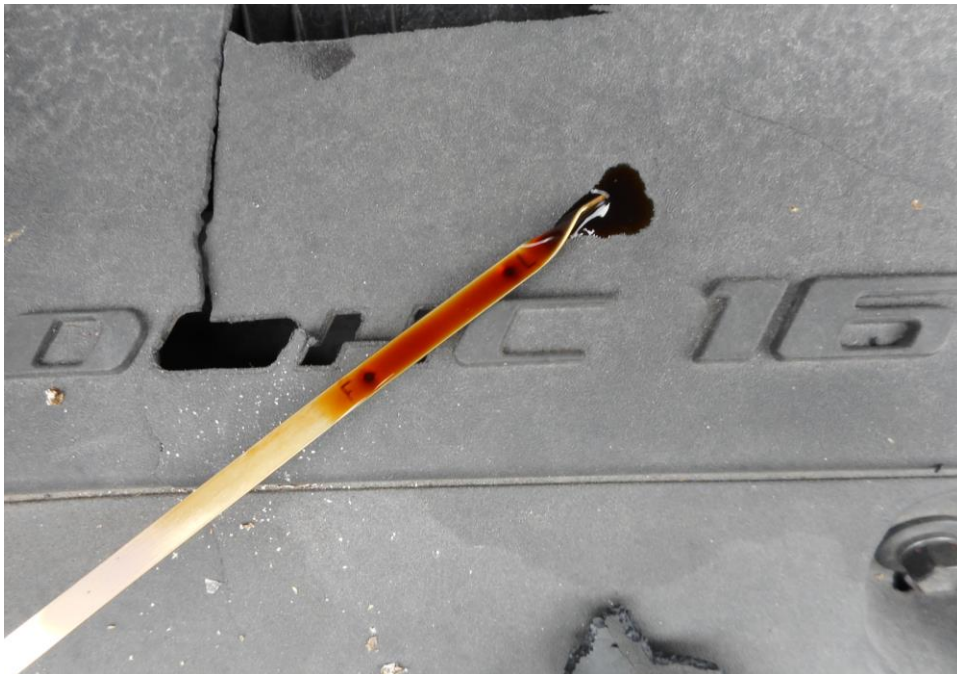
**Photo 16** shows the engine oil dip stick of the Police Car at the time of my inspection. The engine oil was observed to be of sufficient level and without any visible contamination.

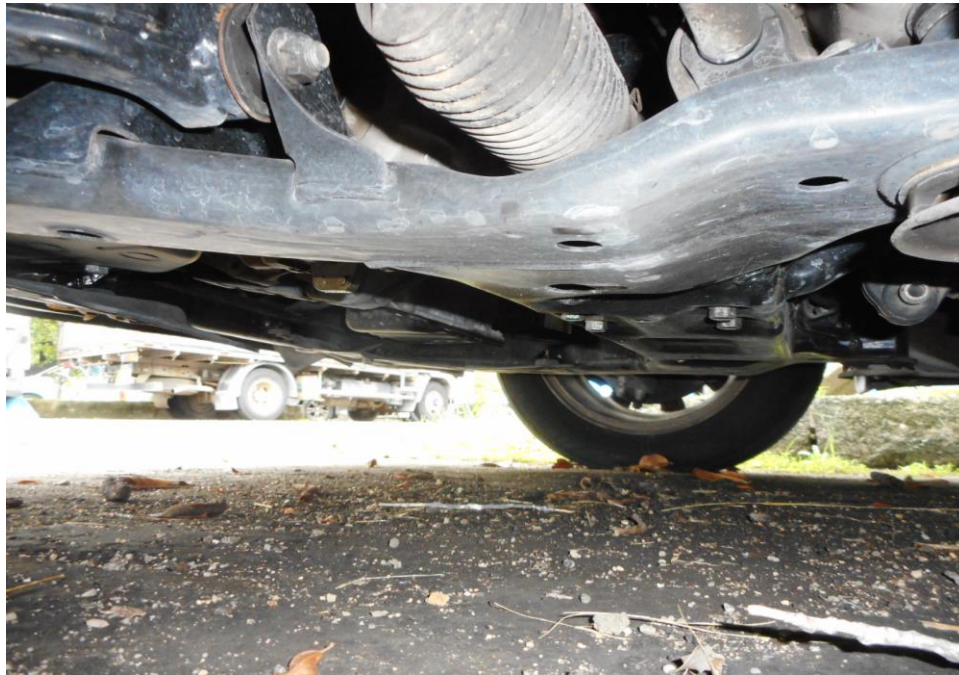
**Photo 17** shows the undercarriage of the Police Car, at the area where the engine housing and transmission housing are located. I did not find any sign(s) or indication(s) of fluid leak and/or fluid stain(s) on the underside of the Police Car.

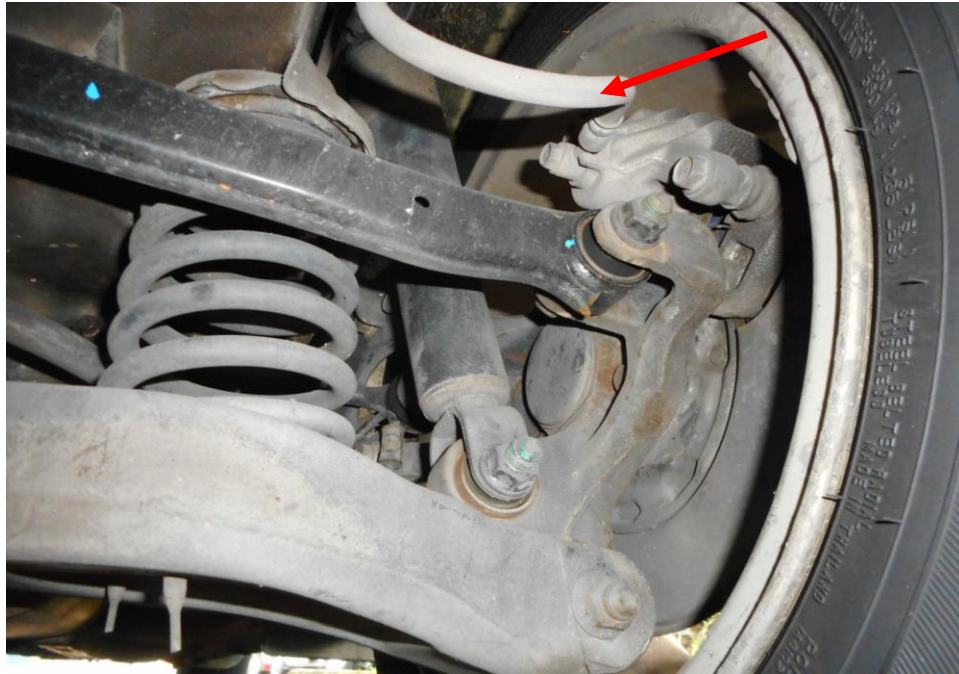
**Photo 18** shows the brake hose/pipe (arrowed) at the rear right wheel of the Police Car. No leakage of brake fluid was observed. Visual examination of the various components of the braking system like the drum brake, brake booster, brake pedal etc. had revealed all to be intact and without visible damage.

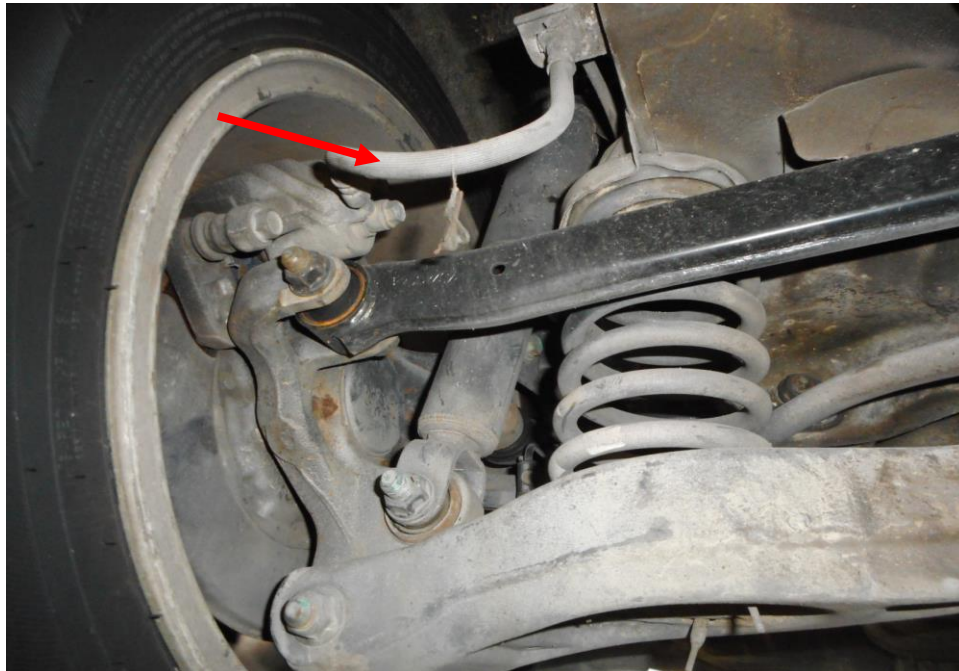
**Photo 19** shows the brake hose/pipe (arrowed) at the rear left wheel of the Police Car. I did not observe any leakage of brake fluid at the time of my inspection of the Police Car. Static tests of the Police Car's braking system had indicated that there was no internal leakage of pressure/vacuum. The undercarriage components of the Police Car were also all found to be intact and without any visible damage.

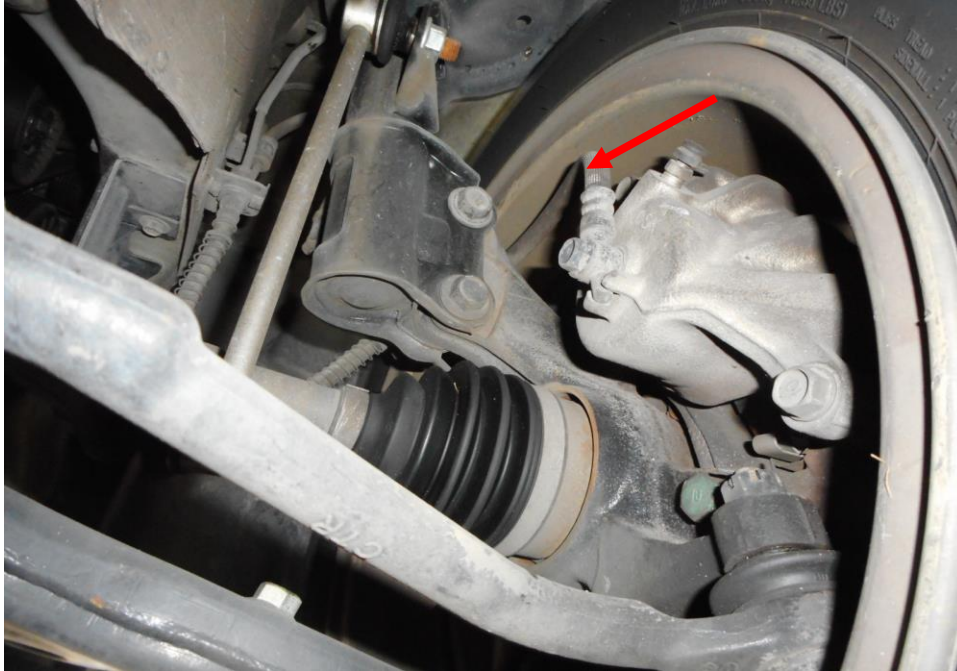
**Photo 20** shows the brake hose/pipe (arrowed) at the front right wheel of the Police Car. I did not observe any leakage of brake fluid at the time of my inspection of the Police Car. Static tests of the Police Car's braking system had indicated that there was no internal leakage of pressure/vacuum. The undercarriage components of the Police Car were also all found to be intact and without any visible damage.

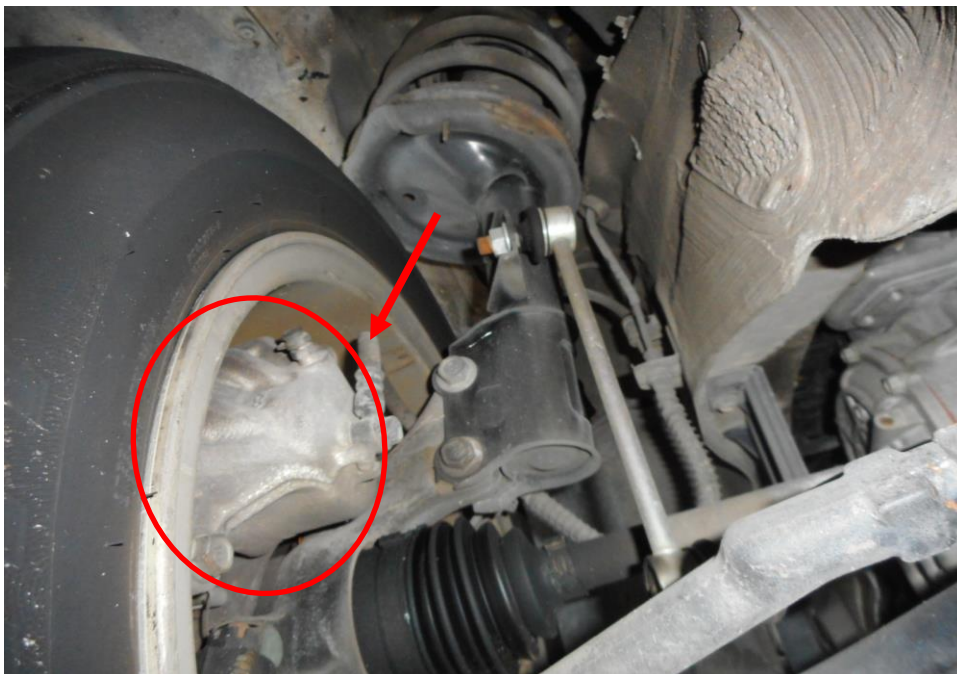
**Photo 21** shows the brake hose/pipe (arrowed) at the front left wheel of the Police Car. No leakage of brake fluid was observed. Visual examination of the various components of the braking system like the brake caliper (circled), brake booster, brake pedal etc had revealed all to be intact and without visible damage.

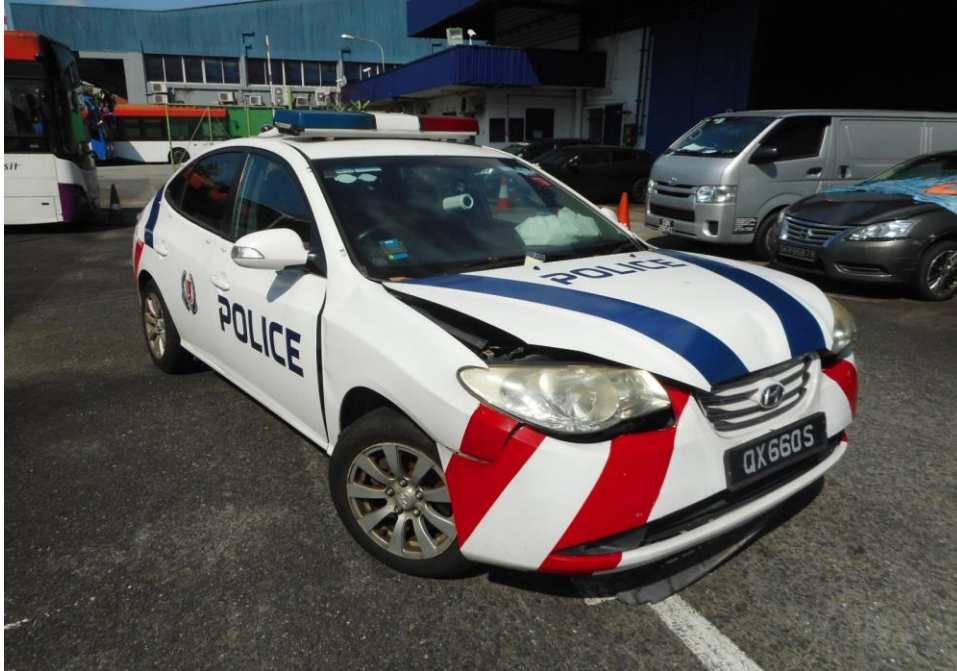
**Photo 22** shows the front right wheel of the Police Car turned to its full left. During my steering system test, I did not experience any abnormal free play and/or resistance when I had turned the steering wheel towards the left and right. This would suggest that the steering system of the Police Car was likely to be in serviceable condition at the material time of accident.

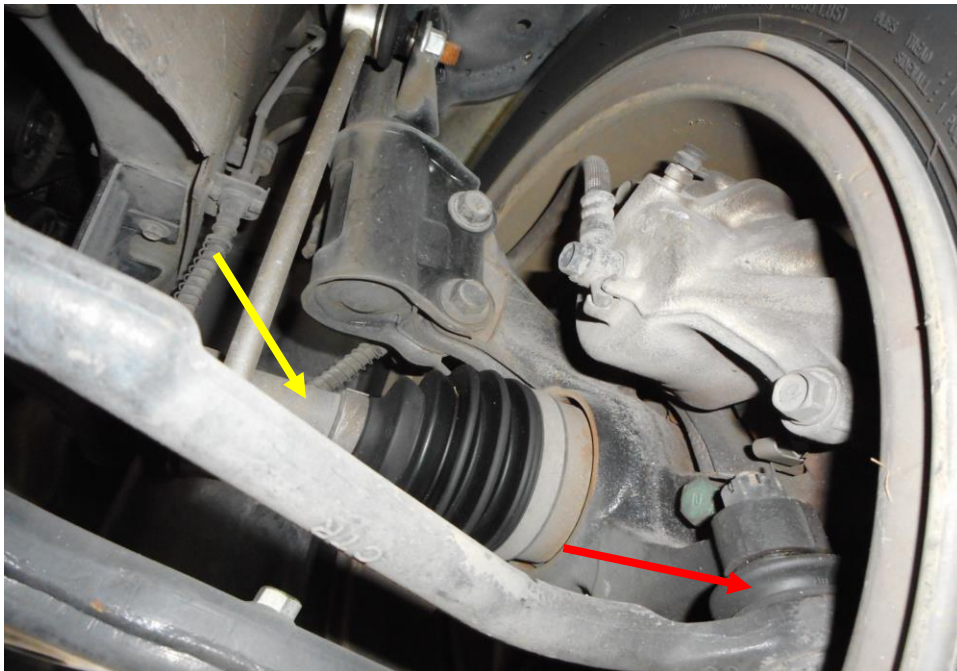
**Photo 23** shows the various undercarriage components at the front right wheel of the Police Car, in particular the steering tie rod (red arrow) and drive shaft (yellow arrow). The various steering components were all found to be intact, suggesting that the steering system of the Police Car was likely to be in serviceable condition at the material time of accident. There was also no sign of fluid stain observed on the various undercarriage components at the front right wheel of the Police Car.

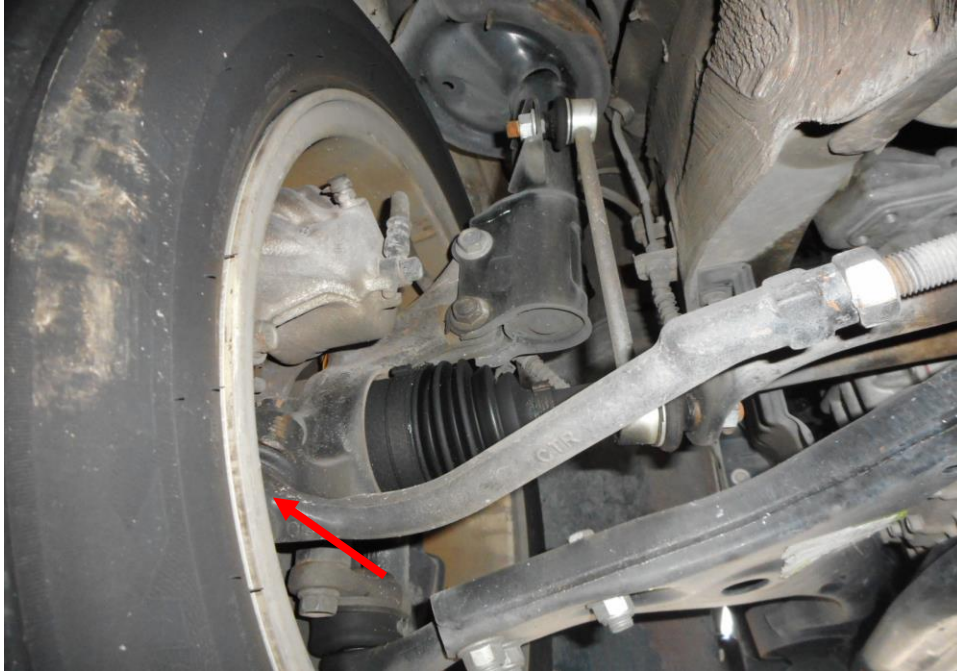
**Photo 24** shows the various undercarriage components at the front left wheel of the Police Car, which had included the steering tie rod (red arrow). The various undercarriage components of the Police Car were all found to be intact without any visible damage.

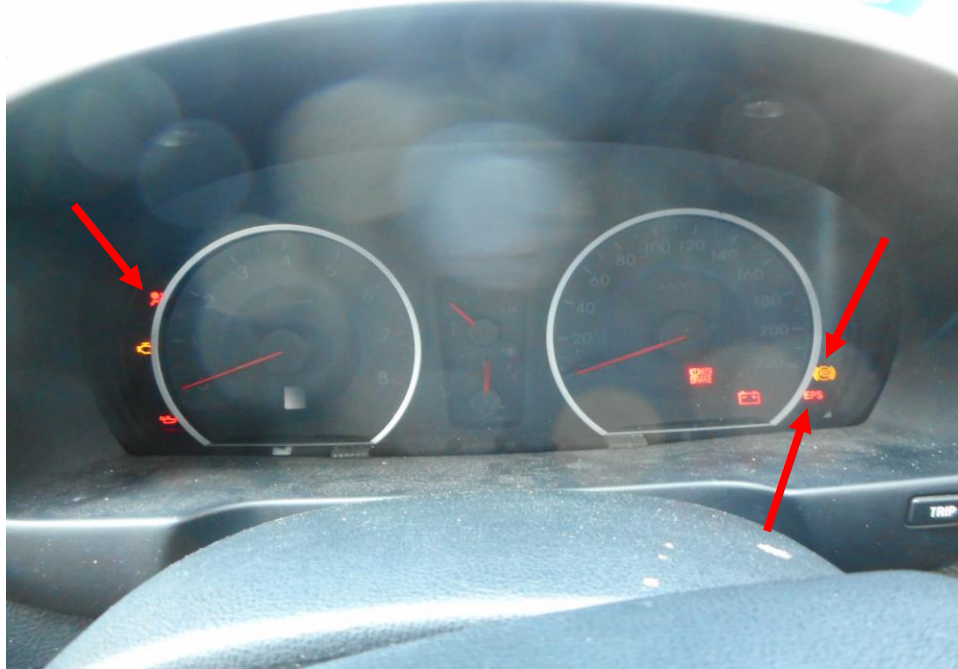
**Photo 25** shows the warning light for Anti-Lock Brake System (ABS) and Power Steering System (EPS), and Supplemental Restraint System (SRS) (arrowed) appearing on the instrument panel of the Police Car during the self-test of its various electronic operating systems when its engine was cranked.

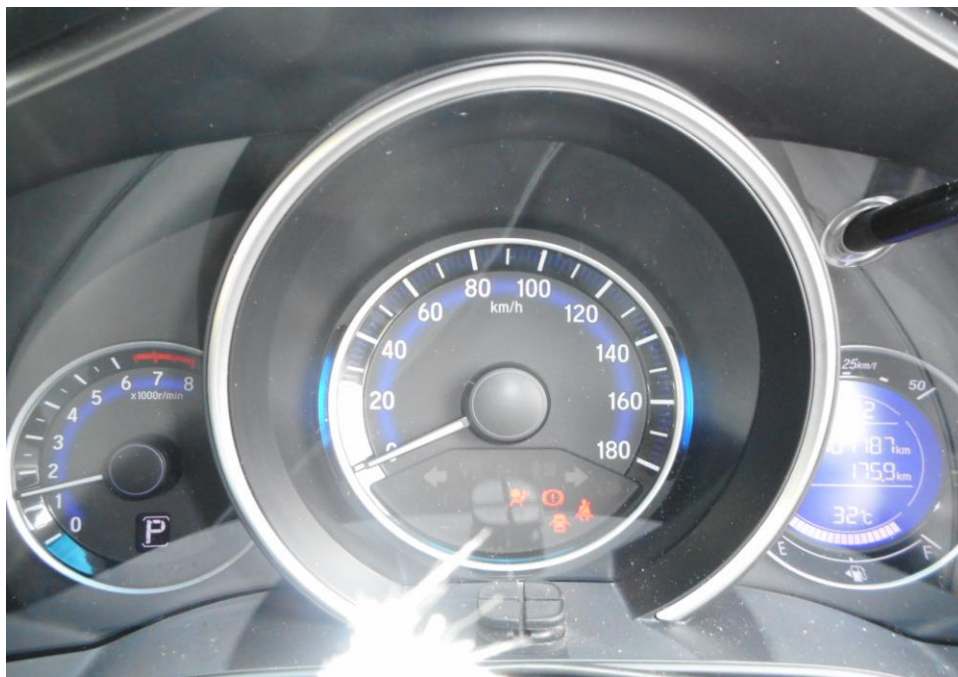
**Photo 26** shows only the Supplemental Restraint System (SRS) warning light remained illuminated on the instrument panel of the Police Car after the engine was cranked. This was due to the deployment of the airbag.

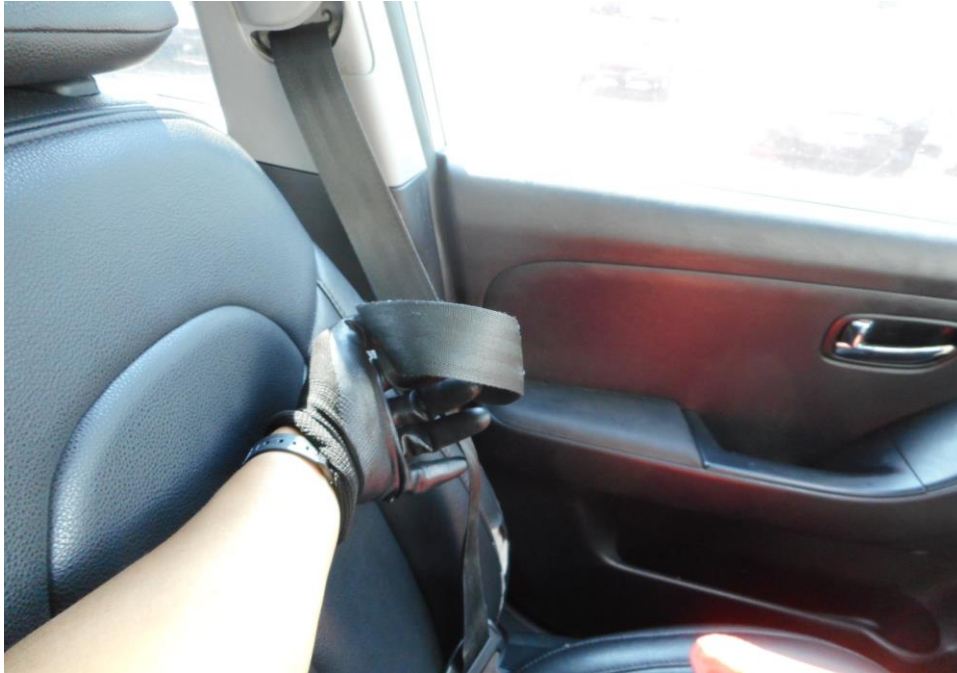
**Photo 27** shows that the seat belt on the left seat was worn at the material time of accident as the safety pre-tensioners was activated at the moment of impact and caused the seat belts to be locked into the last position of the user.

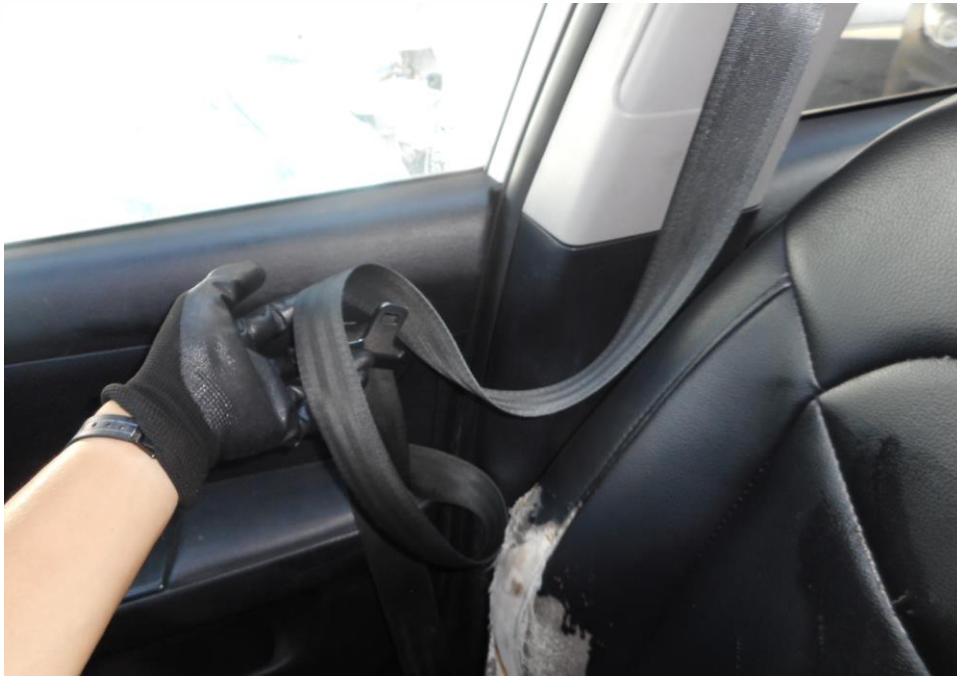
**Photo 28** shows that the seat belt on the right seat was worn at the material time of accident as the safety pre-tensioners was activated at the moment of impact and caused the seat belts to be locked into the last position of the user.
