Your Ref: TP/IP/18921/2021
Our Ref : CI/TPD21005754/P

3rd June 2021

MECHANICAL INSPECTION REPORT OF MOTOR TRAILER, XD 2796T with TRAILER: TRB 5972M

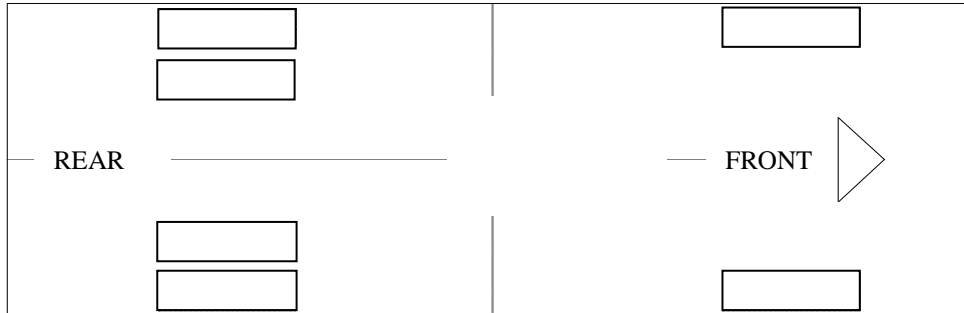
Motor Trailer

Taitong 295/80R22.5 (10.2mm)

Annaite 295/80R22.5 (12mm)

Linglong 295/80R22.5 (3mm)

Annaite 295/80R22.5 (6.6mm)

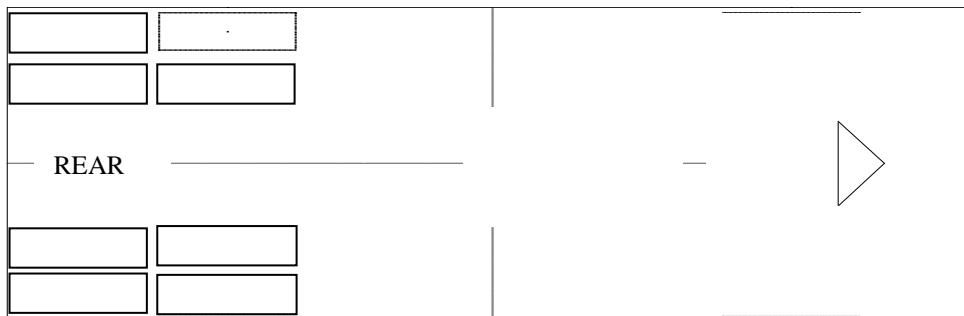
Trailer

Doupro 10.00 R20 (11.9mm)

Doupro 10.00 R20 (9.2mm)

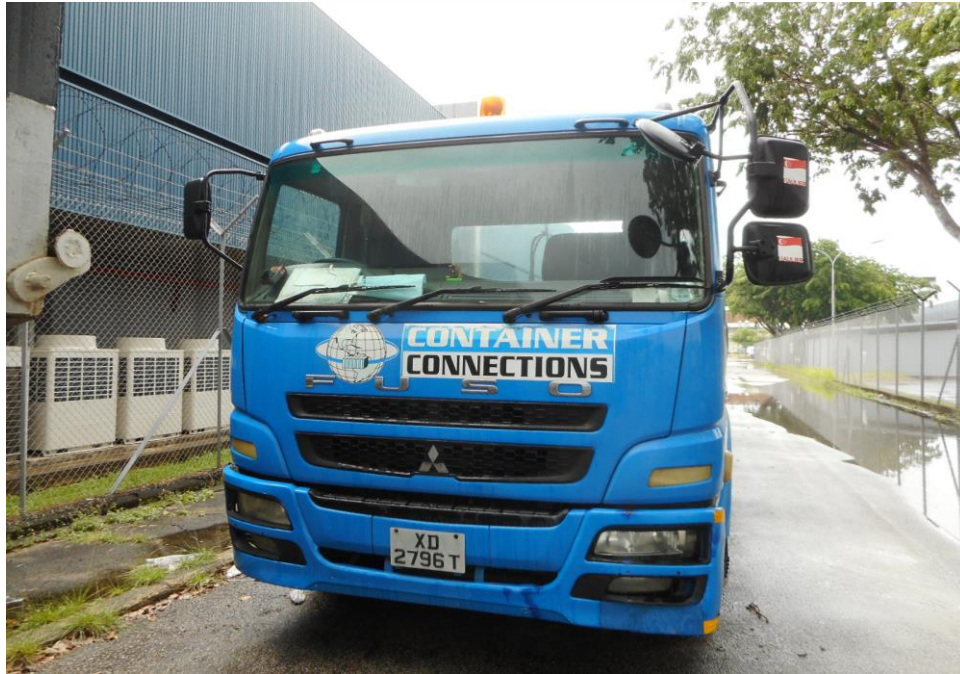
Photo 1 shows a general view of the front body of the Motor Trailer at the time of my inspection. The Motor Trailer was observed to be intact and unaffected by the accident.

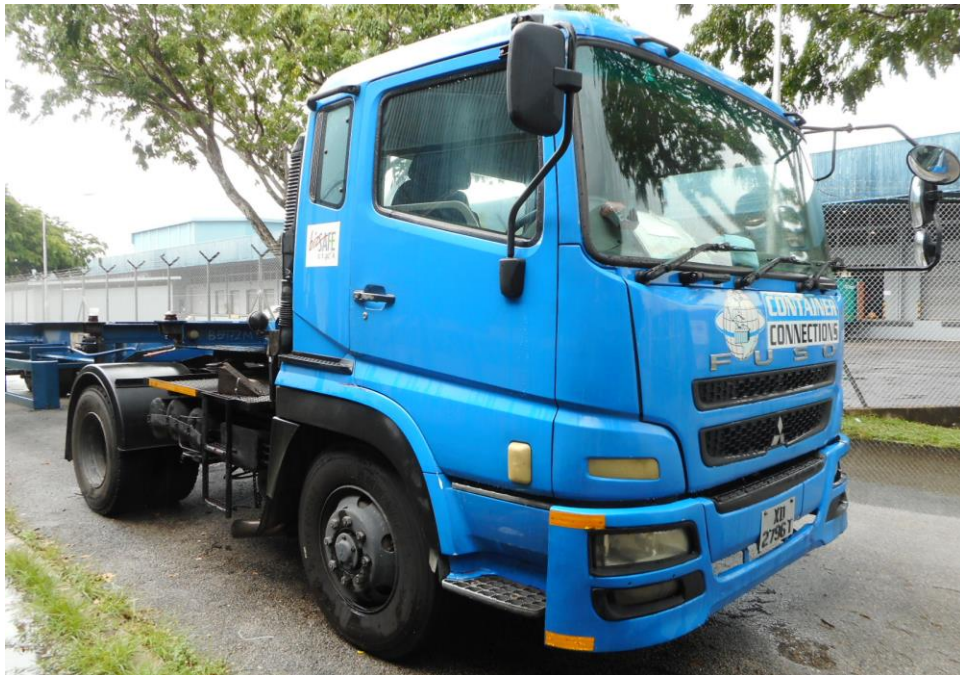
Photo 2 shows a general view of the right body of the Motor Trailer at the time of my inspection. The Motor Trailer was observed to be intact and unaffected by the accident.

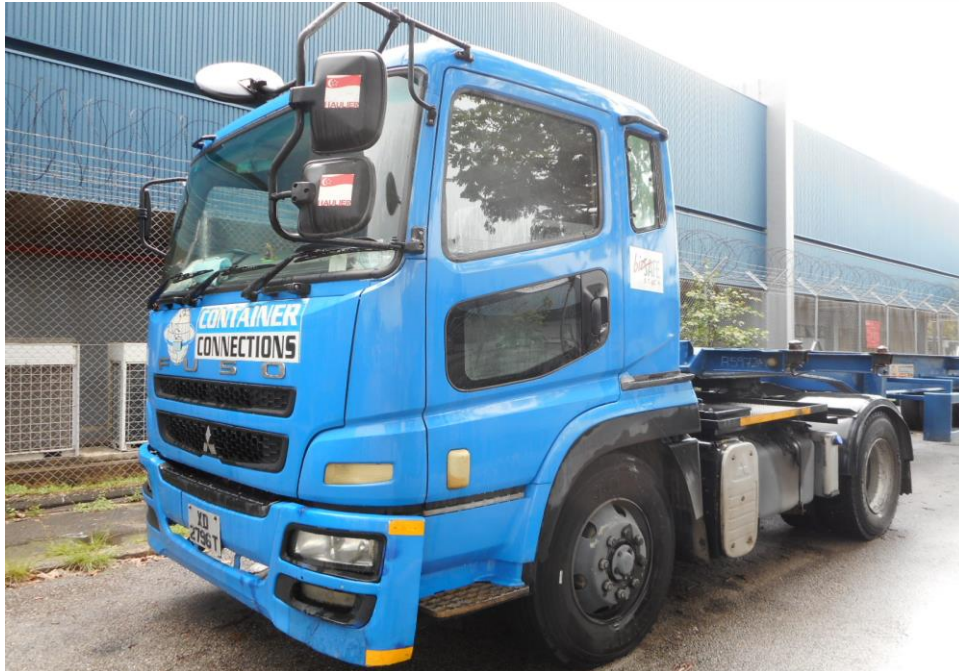
Photo 3 shows a general view of the left body of the Motor Trailer at the time of my inspection. The Motor Trailer was observed to be intact and unaffected by the accident.

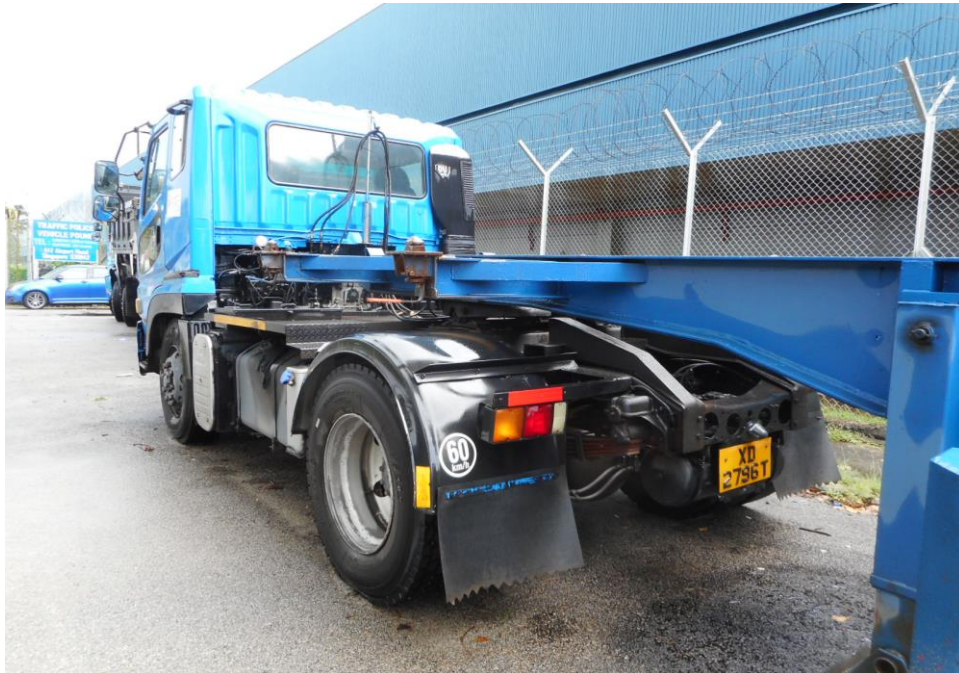
Photo 4 shows a general view of the Motor Trailer's rear body at the time of my inspection. The Motor Trailer was observed to be intact and unaffected by the accident.

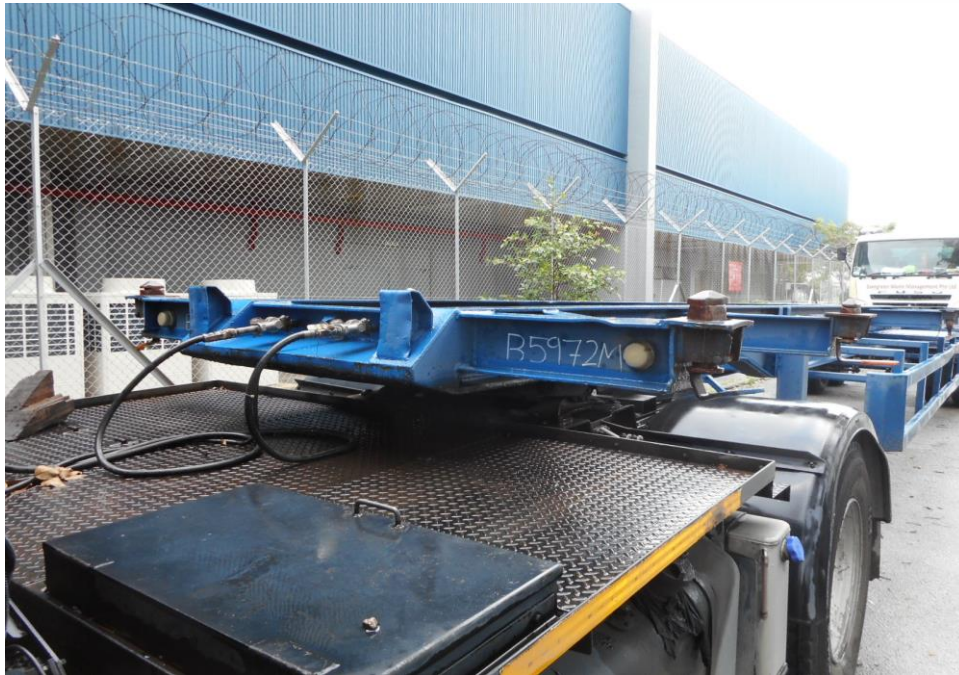
Photo 5 shows a general view of the Trailer front body at the time of my inspection. The Trailer was observed to be intact.

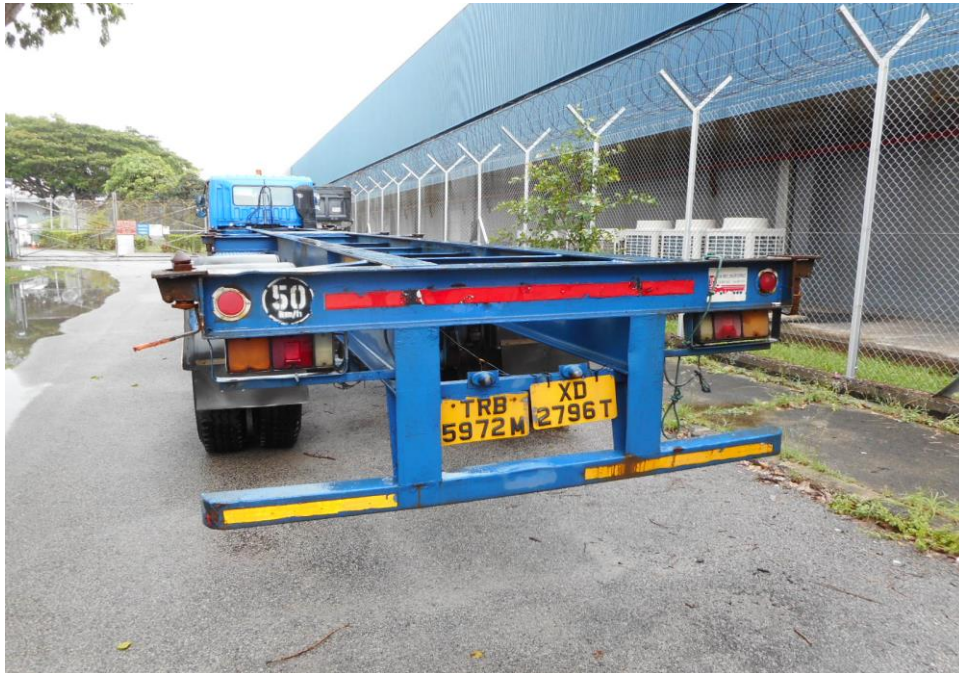
Photo 6 shows a general view of the rear body of the Trailer at the time of my inspection. The Trailer was observed to sustained damage at its rear portion. Its rear body panel was damaged as a result of the accident.

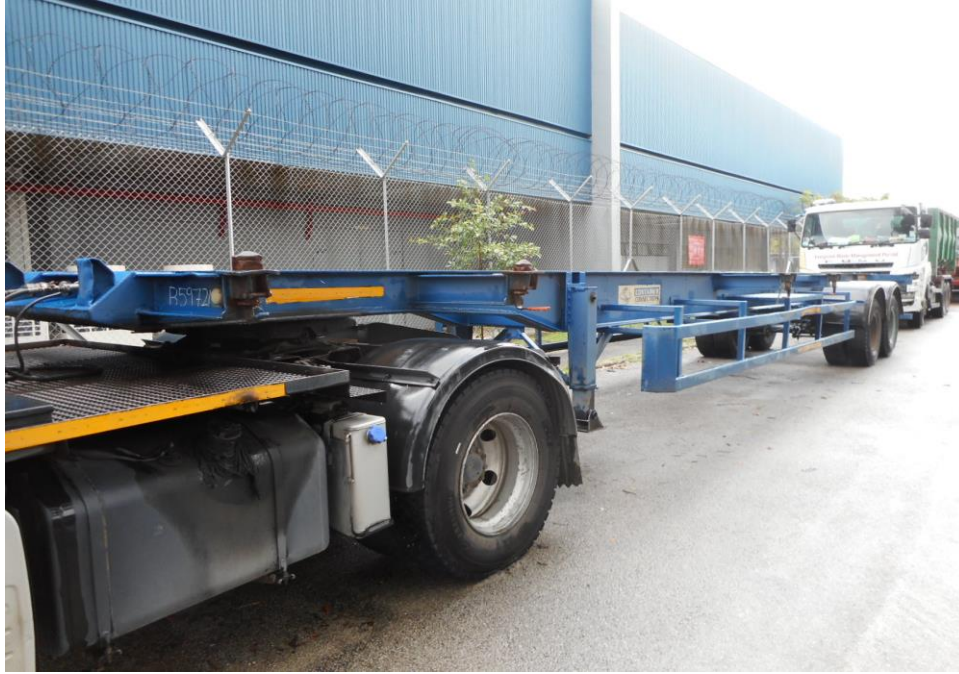
Photo 7 shows a general view of the Trailer left body at the time of my inspection. The Trailer was observed to be intact and unaffected by the accident.

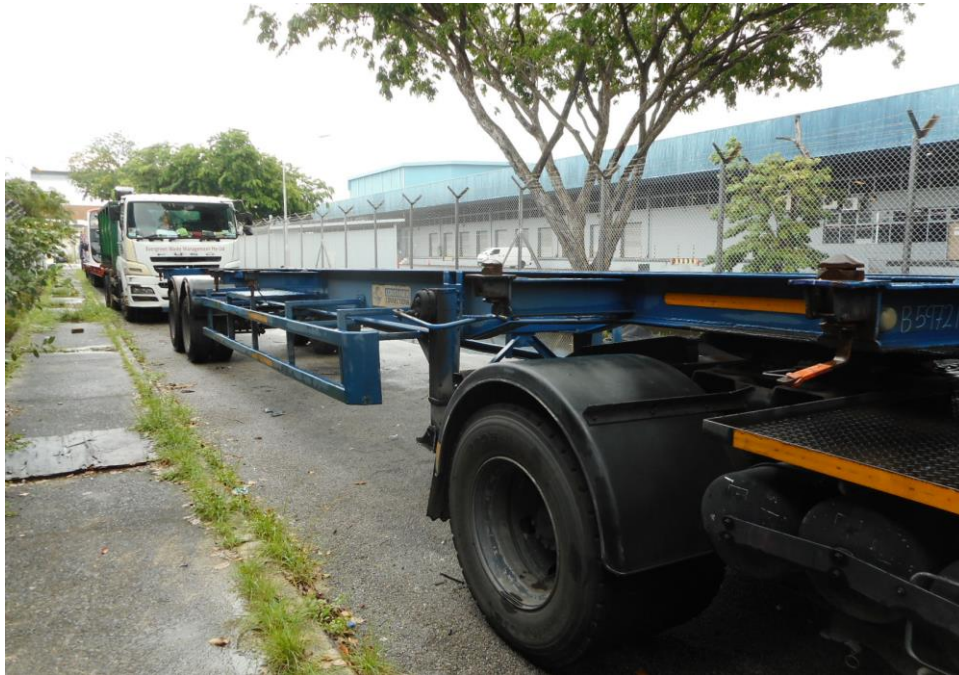
Photo 8 shows a general view of the Trailer right body at the time of my inspection. The Trailer was observed to be intact and unaffected by the accident.

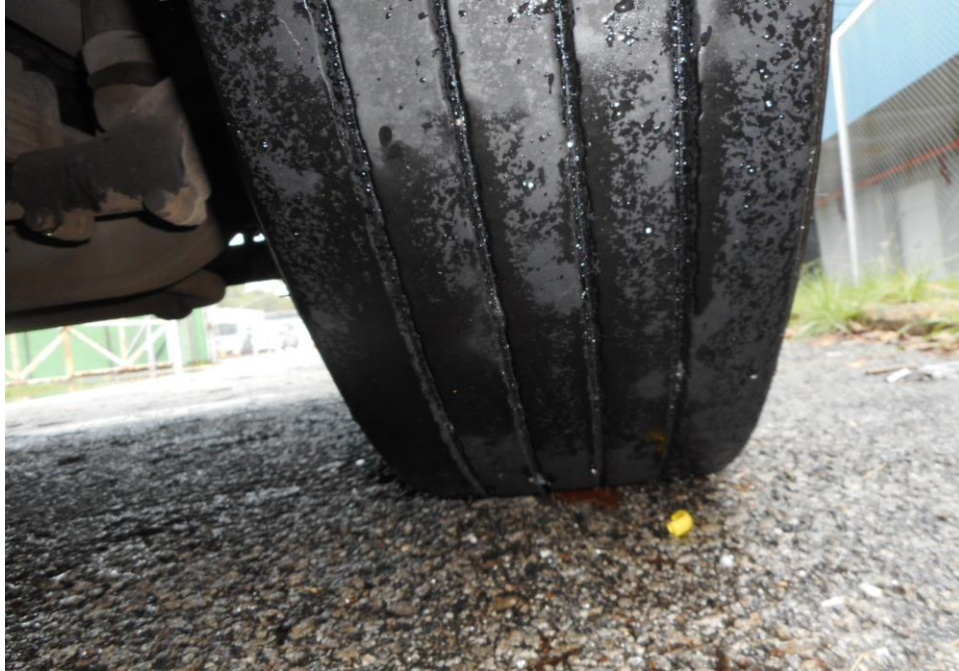
Photo 9 shows the condition of the front right tyre of the Motor Trailer, which was observed to be in serviceable condition with remaining tread depth of approximately 6.6 mm. The tyre, which was wrapped around standard steel wheel rim, was also observed to be sufficiently inflated for vehicular operation. There was no tear, cut or burst mark(s) on the outer and the inner sidewalls as well as across the tread of the 6 tyres that were fitted on the Motor Trailer.

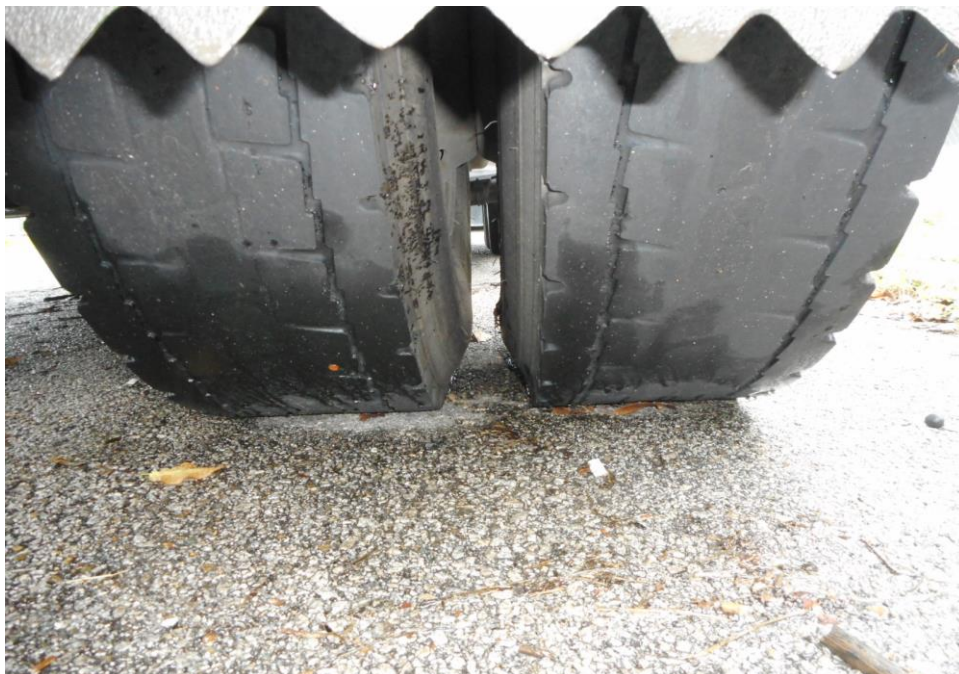
Photo 10 shows the condition of the rear right tyre of the Motor Trailer, which was observed to be in serviceable condition with remaining tread depth of approximately 3mm. The tyre, which was wrapped around standard steel wheel rim, was also observed to be sufficiently inflated for vehicular operation.

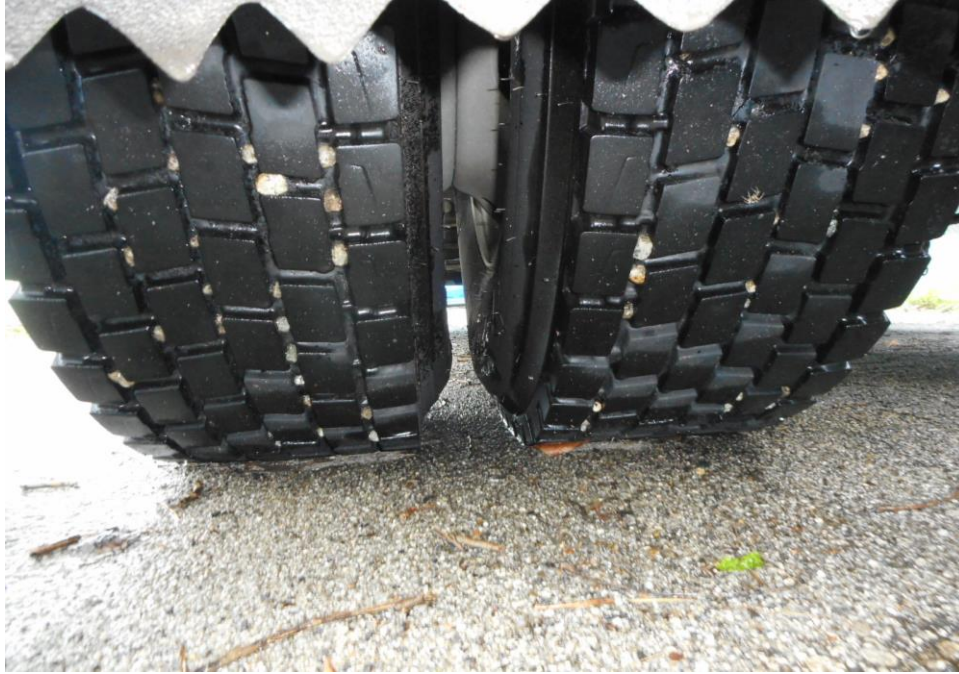
Photo 11 shows the condition of the rear left tyres of the Motor Trailer, which was observed to be in serviceable condition with remaining tread depth of approximately 10.2mm. The tyres, which were wrapped around standard steel wheel rim, were also observed to be sufficiently inflated for vehicular operation. There was also no damage found on all 6 steel wheel rims of the Trailer.

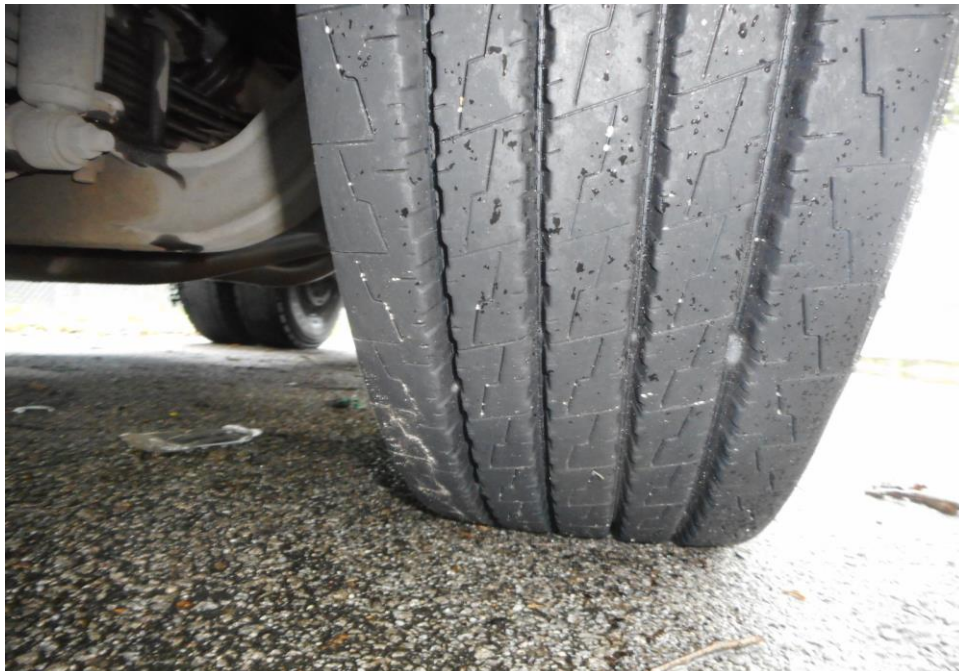
Photo 12 shows the condition of the front left tyres of the Motor Trailer, which were observed to be in serviceable condition with remaining tread depth of approximately 12mm. There was also no tear, cut or burst mark(s) on the outer and the inner sidewalls as well as across the tread of the 6 tyres that were fitted on the Trailer.

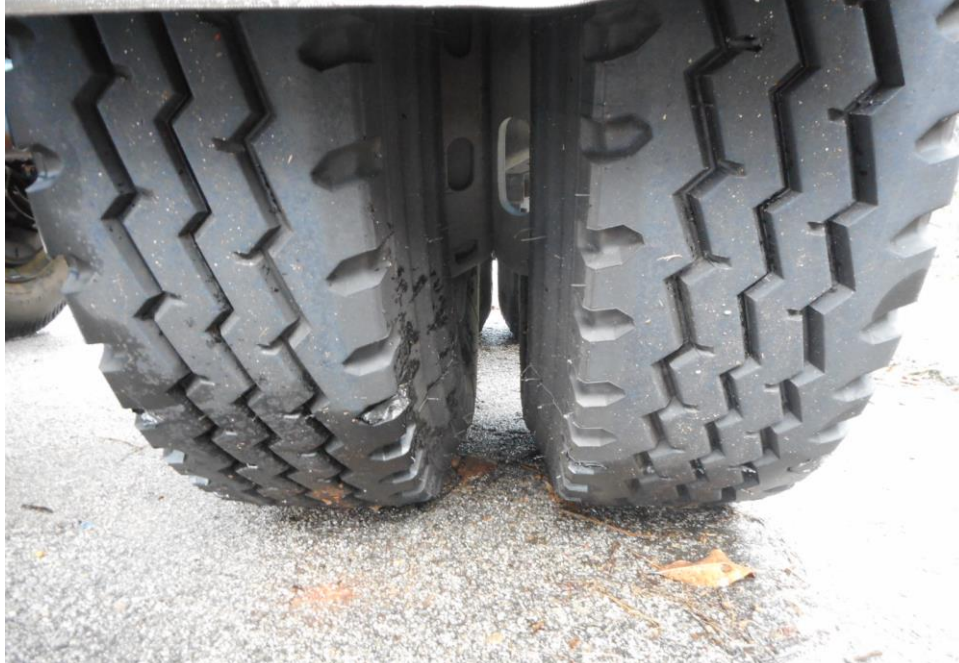
Photo 13 shows the condition of the right tyres of the Trailer, which was observed to be in serviceable condition with remaining, tread depth of approximately 11.9mm. The tyre, which was wrapped around standard steel wheel rim, was also observed to be sufficiently inflated for vehicular operation.

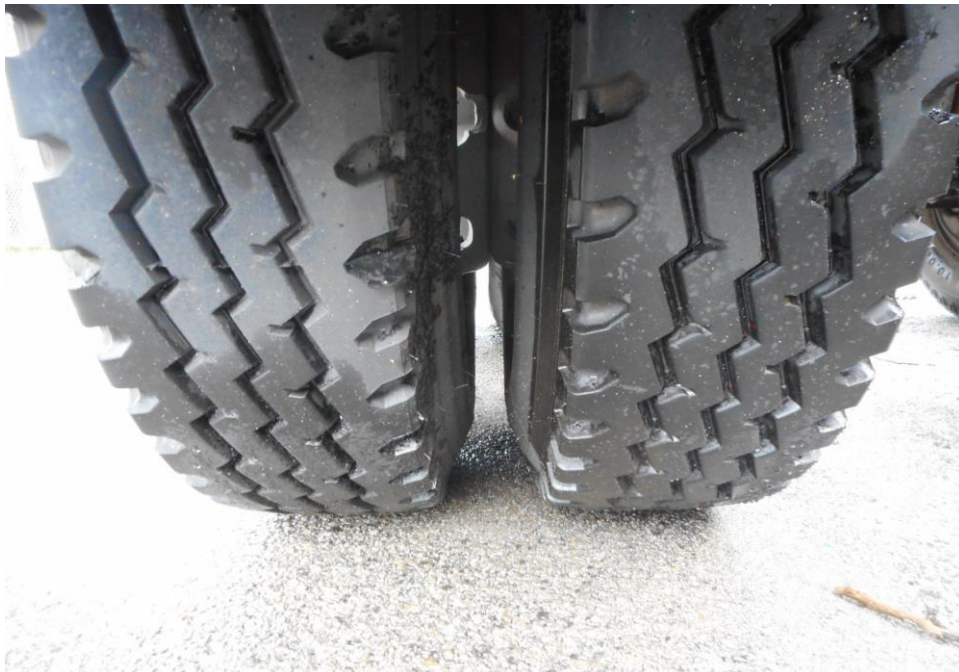
Photo 14 shows the condition of the left tyres of the Trailer, which was observed to be in serviceable condition with remaining tread depth of approximately 9.2mm. The tyres, which were wrapped around standard steel wheel rim, were also observed to be sufficiently inflated for vehicular operation. There was also no damage found on all 12 steel wheel rims of the Trailer.

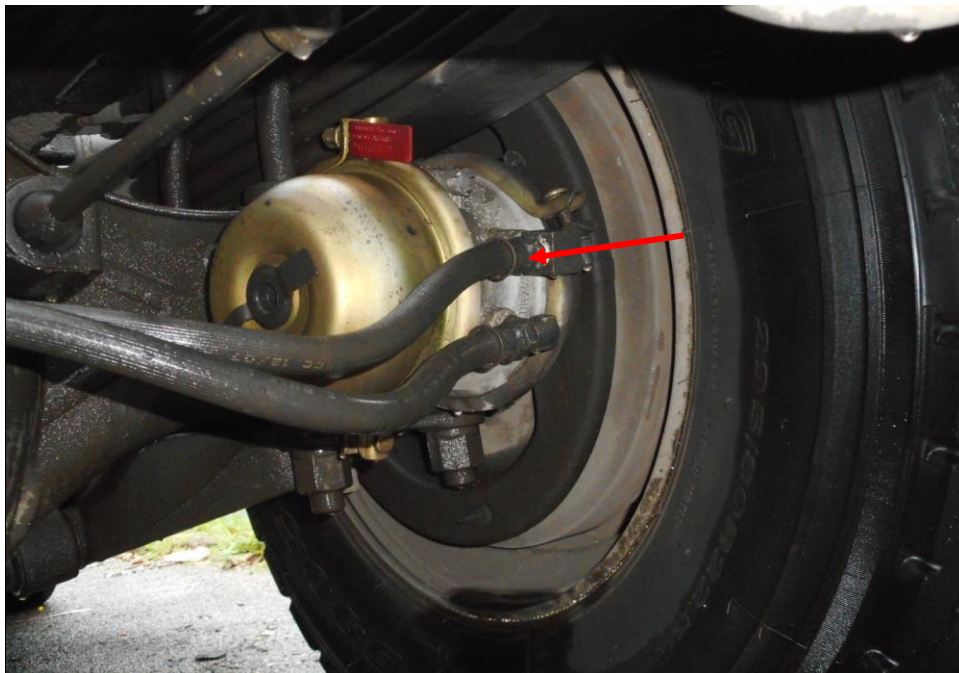
Photo 15 shows the brake pipe (arrowed) at the rear right wheel of the Motor Trailer. I did not observe any leakage of brake fluid at the time of my inspection of the Motor Trailer. My visual examination of the various mechanical components in the braking system, had indicated that there was no internal leakage of pressure/vacuum and there components were generally in good condition.

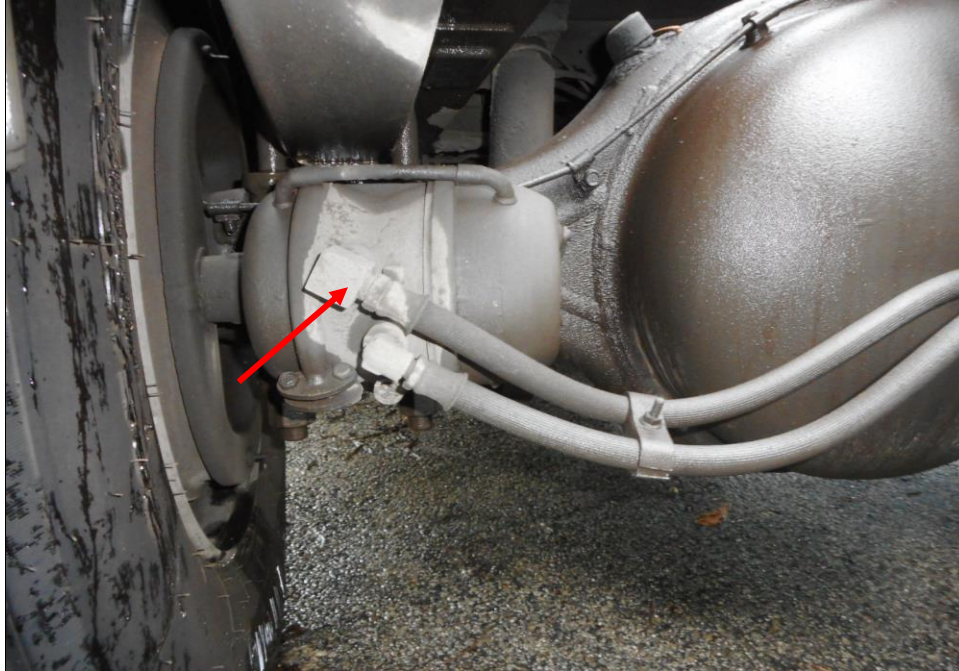
Photo 16 shows the brake pipe (arrowed) at the rear left wheel of the Motor Trailer. I did not observe any leakage of brake fluid at the time of my inspection of the Motor Trailer. My static tests of the Motor Trailer's braking system, along with my visual examination of the various mechanical components in the braking system, had indicated that there was no internal leakage of pressure/vacuum and there components were generally in good condition.

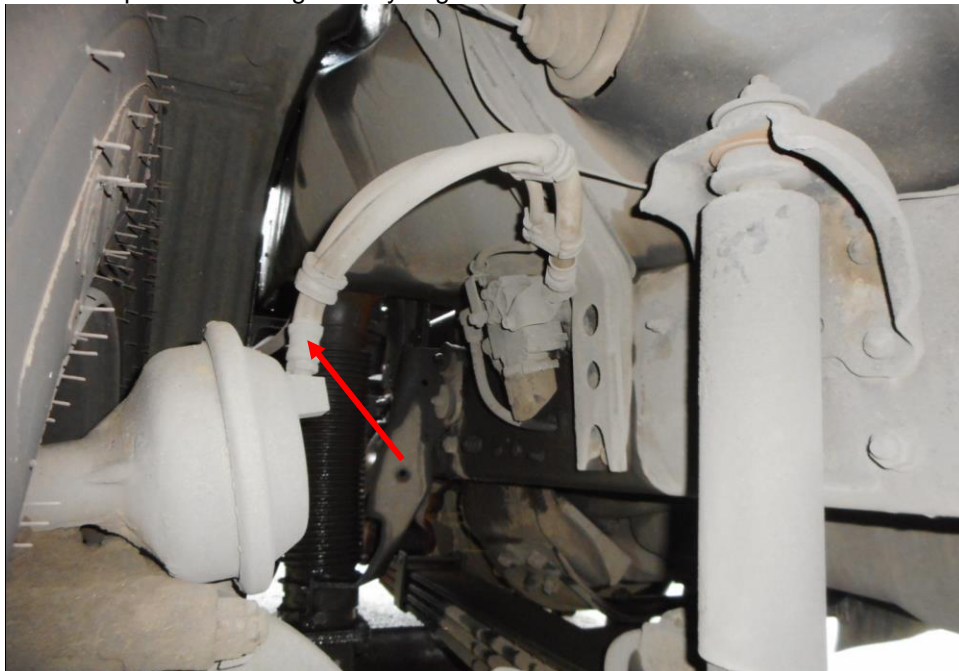
Photo 17 shows the brake pipe (arrowed) at the front right wheel of the Motor Trailer. I did not observe any leakage of brake fluid at the time of my inspection of the Motor Trailer. My static tests of the Motor Trailer's braking system, along with my visual examination of the various mechanical components in the braking system, had indicated that there was no internal leakage of pressure/vacuum and there components were generally in good condition.

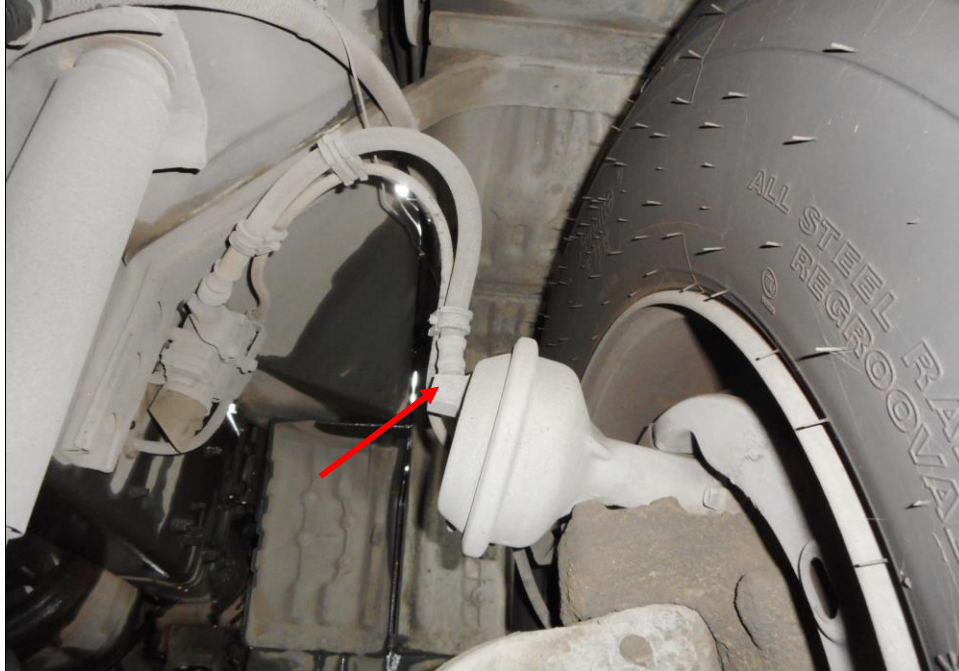
Photo 18 shows the brake pipe (arrowed) at the front left wheel of the Motor Trailer. I did not observe any leakage of brake fluid at the time of my inspection of the Motor Trailer. My visual examination of the various mechanical components in the braking system had indicated that there was no internal leakage of pressure/vacuum and there components were generally in good condition.

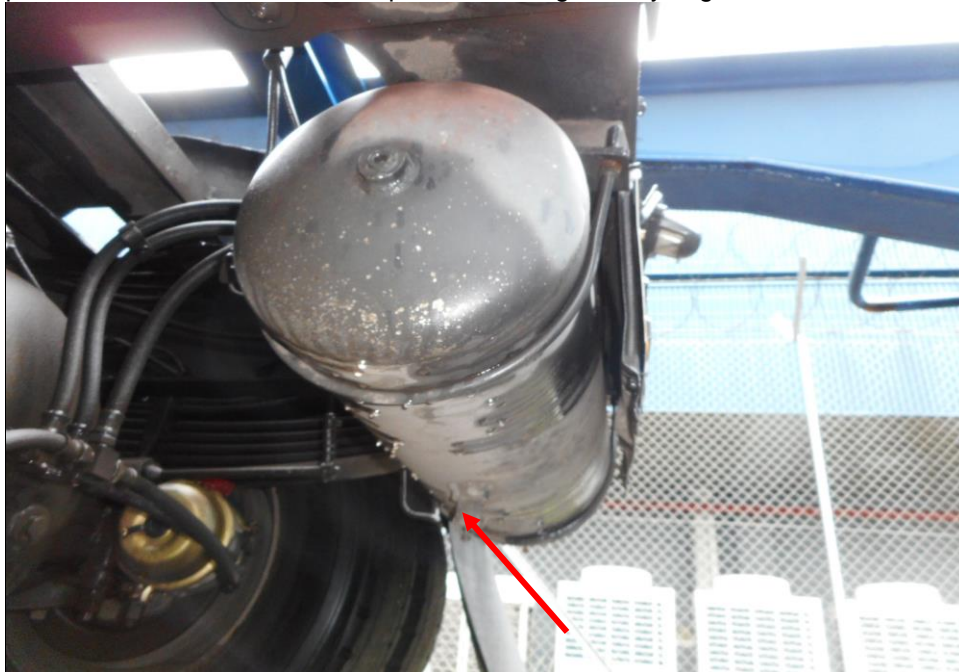
Photo 19 shows the air brake cylinders (arrowed) at the undercarriage of the Motor Trailer. I did not observe any leakage of air brake fluid at the time of my inspection of the Motor Trailer. My visual examination of the various mechanical components in the braking system had indicated that there was no internal leakage of pressure/vacuum and there components were generally in good condition.

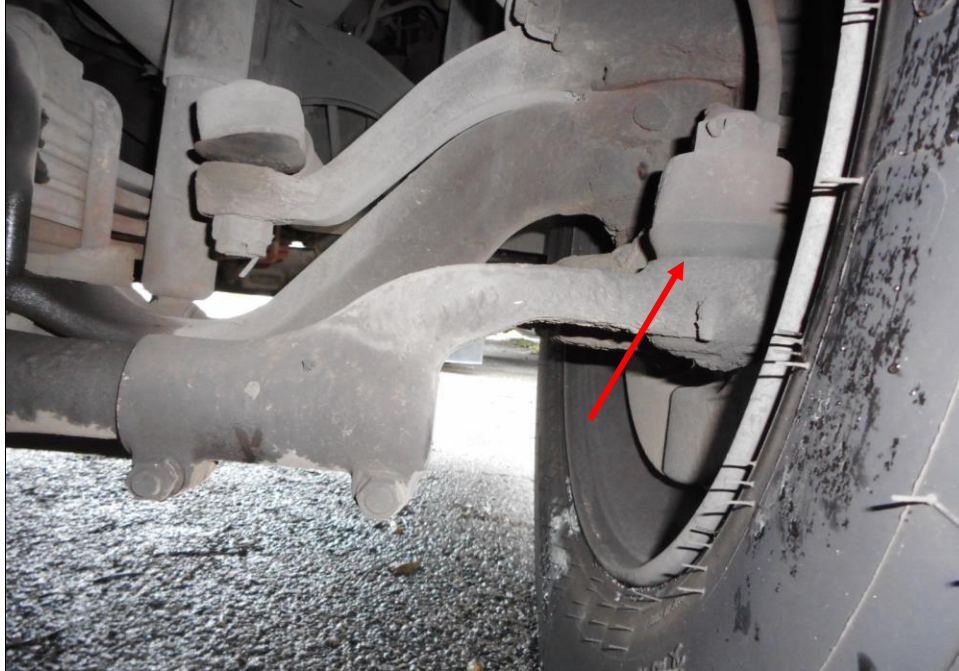
Photo 20 shows the various undercarriage components at the front right wheel of the Motor Trailer, in particular the steering tie rod end (arrowed). The various steering components were all found to be intact, suggesting that the steering system of the Motor Trailer was likely to be in serviceable condition at the material time of accident. There was also no sign of fluid stain(s) observed on the various undercarriage components.

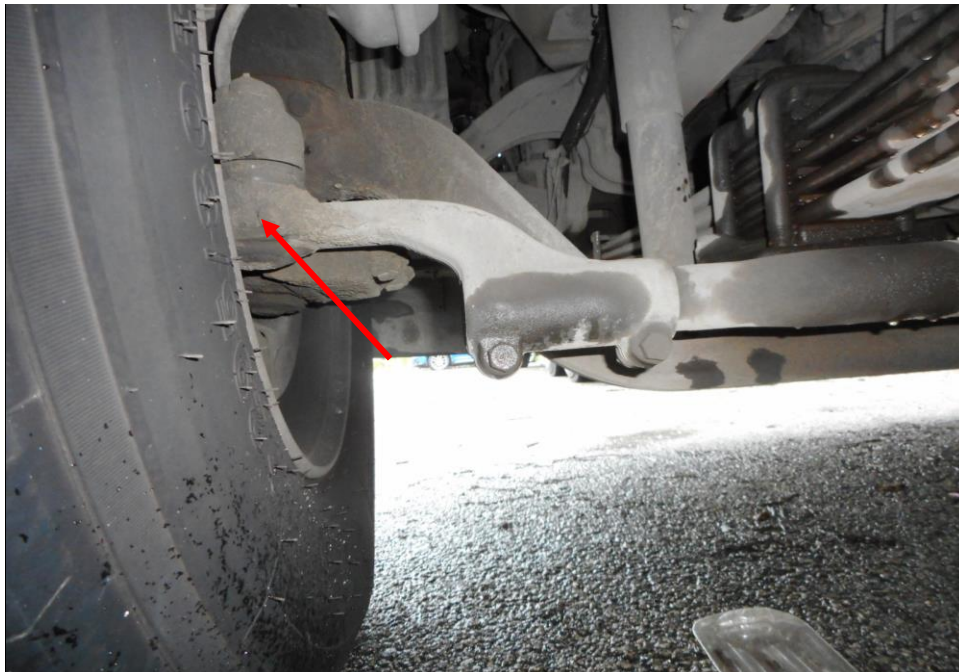
Photo 21 shows the various undercarriage components at the front left wheel of the Motor Trailer, in particular the steering tie rod end (arrowed). The various undercarriage components of the Motor Trailer were all found to be intact without any visible damage. There was also no sign of fluid stain(s) observed on the various undercarriage components.

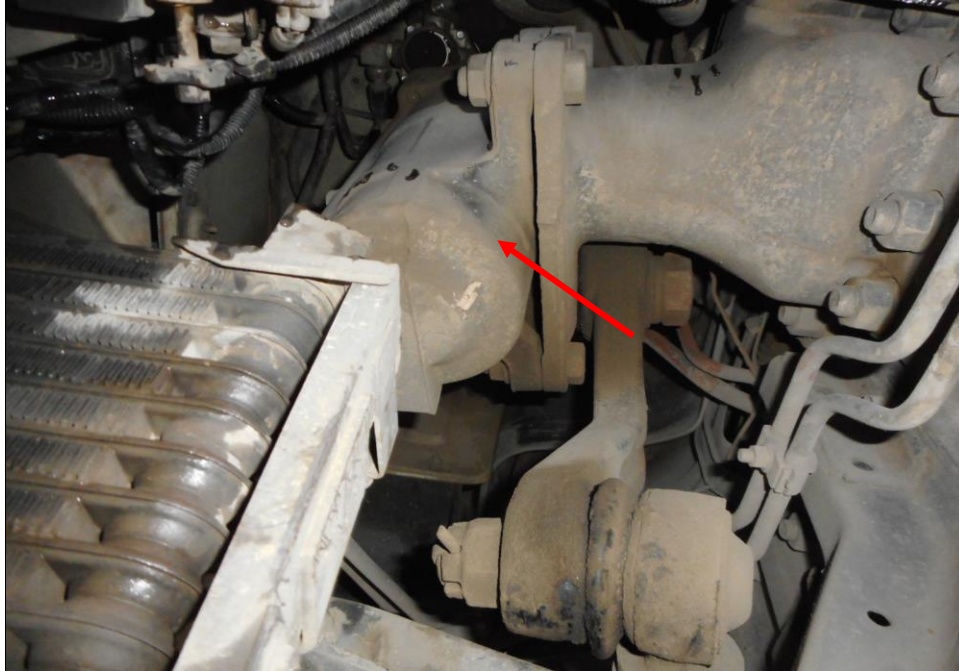
Photo 22 shows the steering box component (arrowed) at the undercarriage of the Motor Trailer was found to be intact without any visible damage. There was also no sign of fluid stain(s) observed on the various undercarriage components.
